"2000" SEMINAR INFORMATION "FIXES TODAY FOR Y2K"

INDEX FORD & CHRYSLER

AUTOMATIC TRANSMISSION SERVICE GROUP

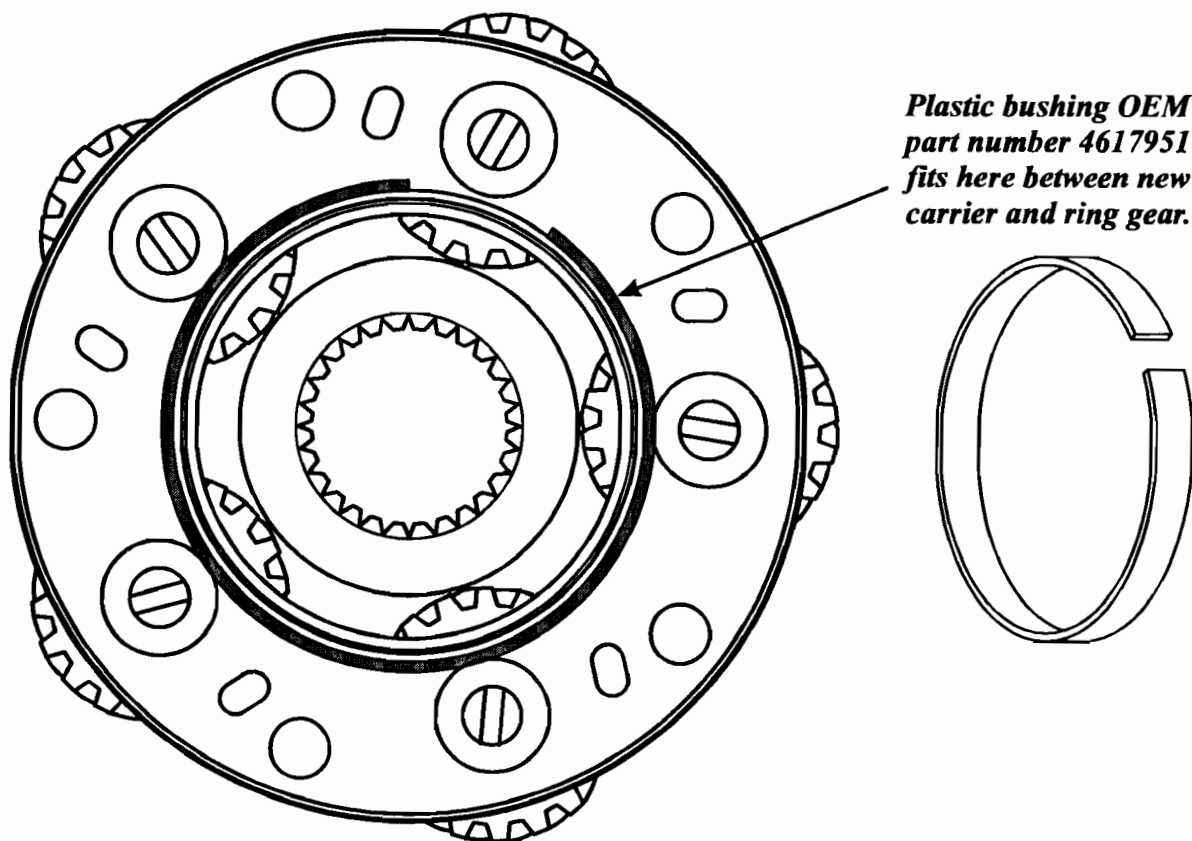
Figure 1

CHRYSLER A518 (46RH) AND 46RE BROKEN FRONT PLANETARY

COMPLAINT: Before and/or after rebuild the vehicle returns with the front planetary carrier broken, and will occur with a lot more frequency if it is equipped with the Diesel engine.

CAUSE: Not enough torque carrying capacity with previous design aluminum, 4 pinion carrier.

Front Planetary Carrier, 5 Pinion, Steel	4617998
Thrust Washer, 5 Tang	4539129
Plastic Front Carrier Bushing	4617951

5 PINION STEEL FRONT CARRIER OEM PART NUMBER 4617998

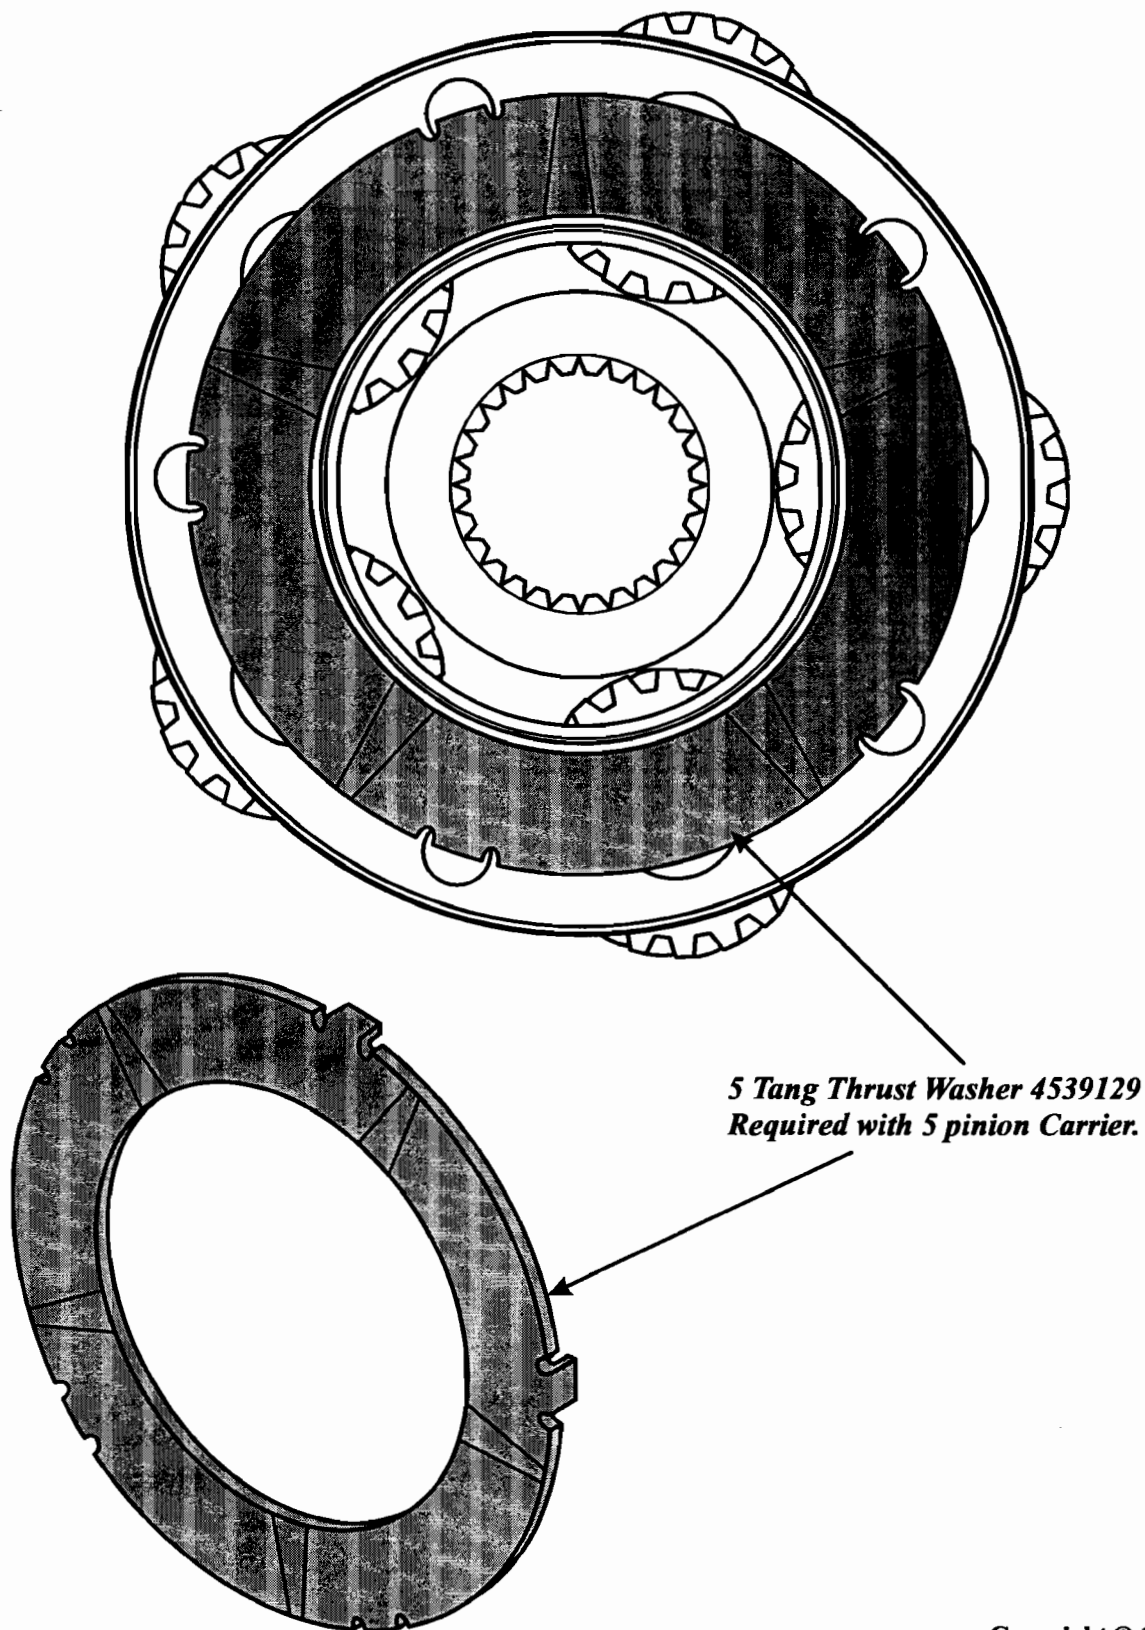
Figure 2

*View looking at back side of carrier
with 5 tang thrust washer in place.*

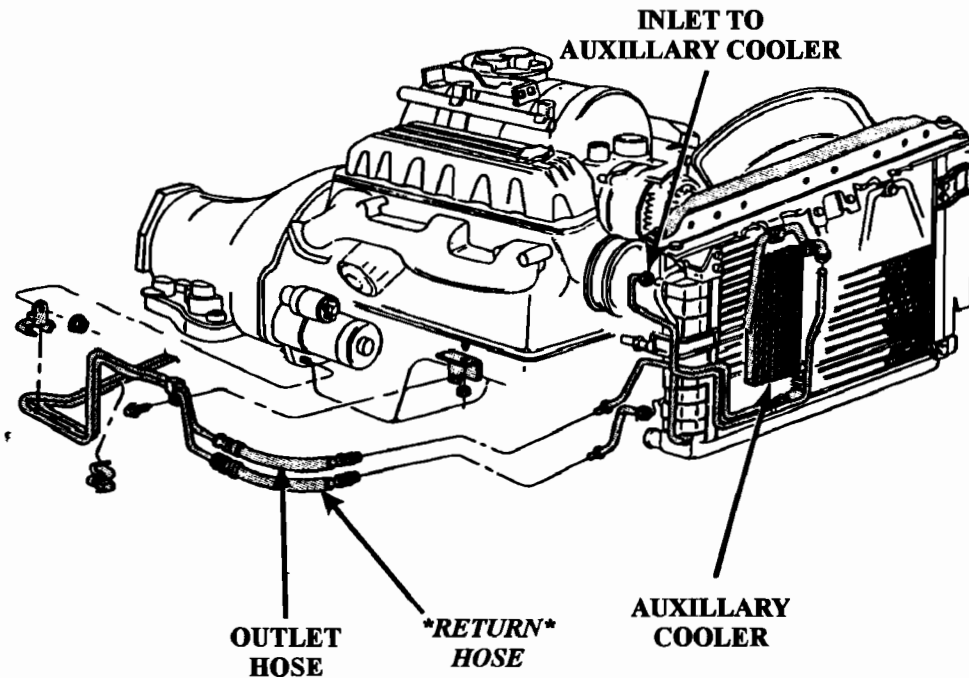
Figure 2

CHRYSLER REAR DRIVE PREMATURE PLANETARY FAILURE

COMPLAINT: Before or after overhaul, some 94 and later Chrysler or Jeep vehicles equipped with rear wheel or 4 wheel drive transmissions may exhibit premature planetary failure.

CAUSE: The cause may be, the one-way ball and spring located in the return cooler hose as shown in Figure 1, may be sticking and inhibiting cooler flow to the return cooler fitting which is the rear cooler fitting on the transmission.

COOLER RETURN HOSE LOCATION
