## **"2008" SEMINAR INFORMATION INDEX**

### ***Ford, Chrysler & Imports***

## ***AUTOMATIC TRANSMISSION SERVICE GROUP***

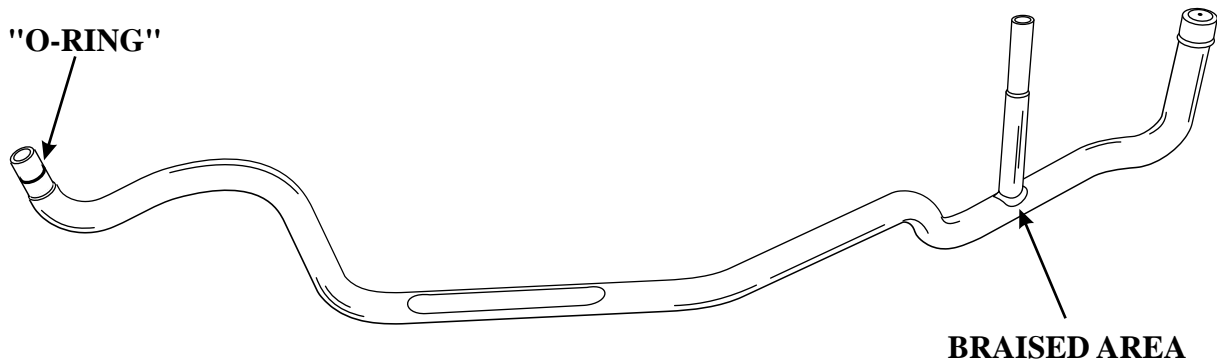
Figure 5

**CAUSE:** The cause may be, a leak in the lube circuit, which is now fed directly from pump output, through an .089" orifice in the main spacer plate, as shown in Figure 5. This leak may be from a broken o-ring on the lube pipe where it fits in the case or a crack in the braised area where it feeds the support, or a damaged "orange" lube seal in the support (see Figures 6 and 7). A leak in the lube circuit may cause a low overall line pressure condition, when the PCM notices that forward has not been engaged, it will elevate line pressure causing the bang when forward is finally engaged.

**CORRECTION:** To correct this condition, ensure that the lube pipe o-ring and the braised area of the pipe are in good condition, also make sure that the "orange" seal in the support is in good condition.

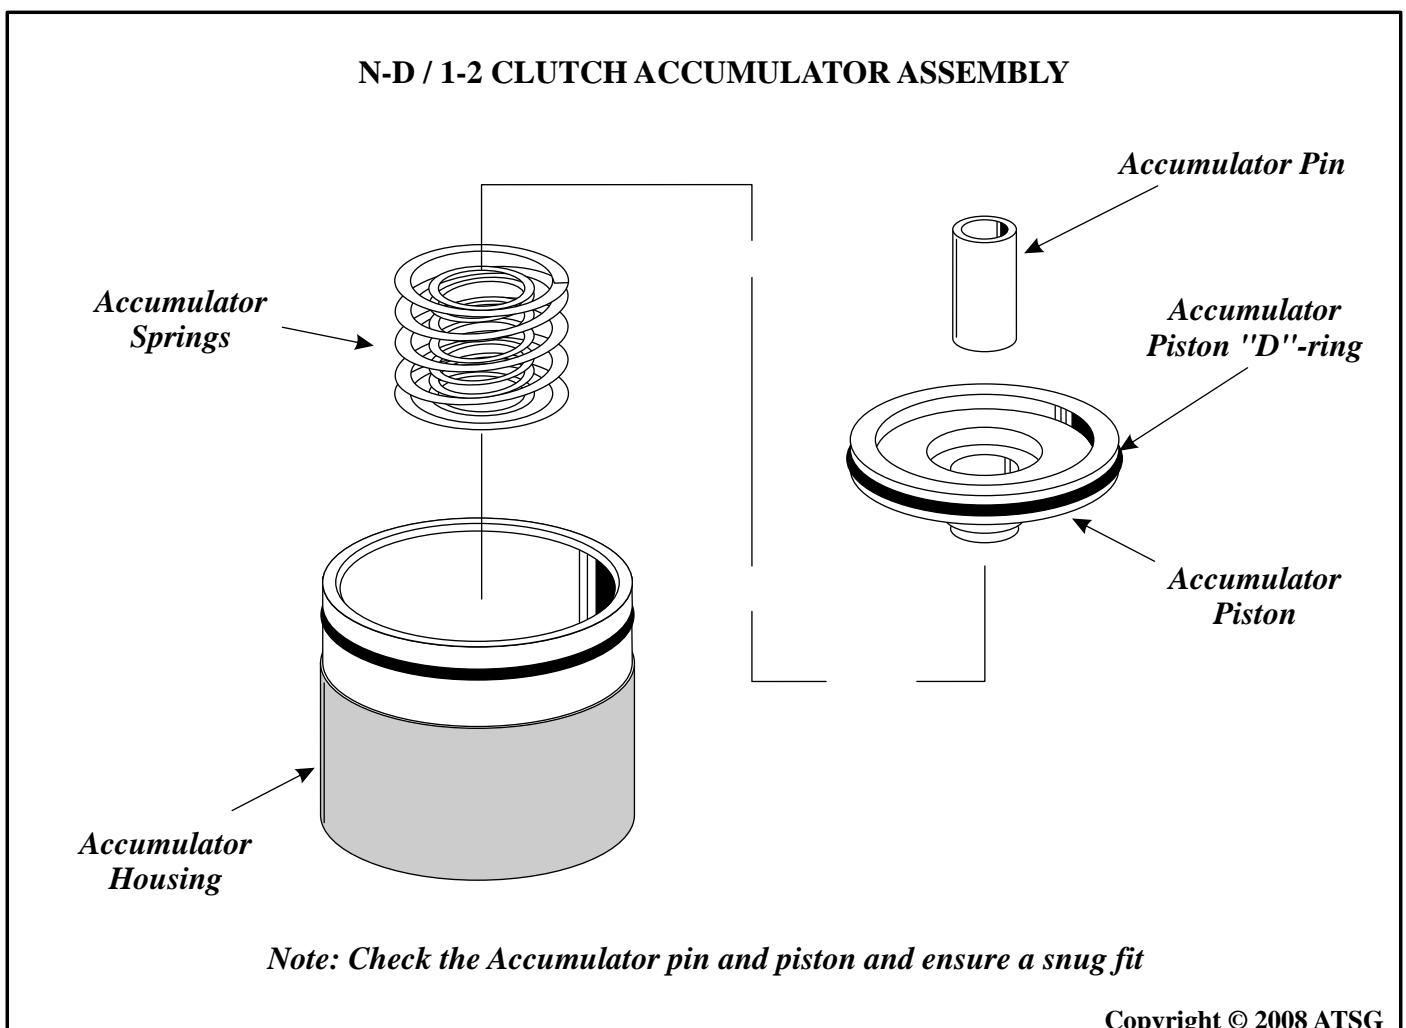
**CAUSE:** The cause may be, a worn 1-2 Clutch Accumulator pin and piston causing a slow engagement into Drive. This slow engagement will cause the PCM to elevate line pressure which causes the harsh / bang on engagement. Refer to Figure 8 for the identification of the 1-2 Accumulator pin and piston. Refer to Figure 9 for a cross-sectional view of the 1-2 Clutch Accumulator hydraulic circuit.

## N-D / 1-2 CLUTCH ACCUMULATOR ASSEMBLY

*Note: Accumulator Pressure is fed thru the pin to the spring side of the Accumulator Piston, when the Pin wears it will allow 1-2 Clutch Apply pressure to leak into the Accumulator Circuit causing a slow engagement of the 1-2 Clutch.*

**CORRECTION:** To correct this condition, ensure that the Accumulator pin and piston have a snug fit, replace as necessary.

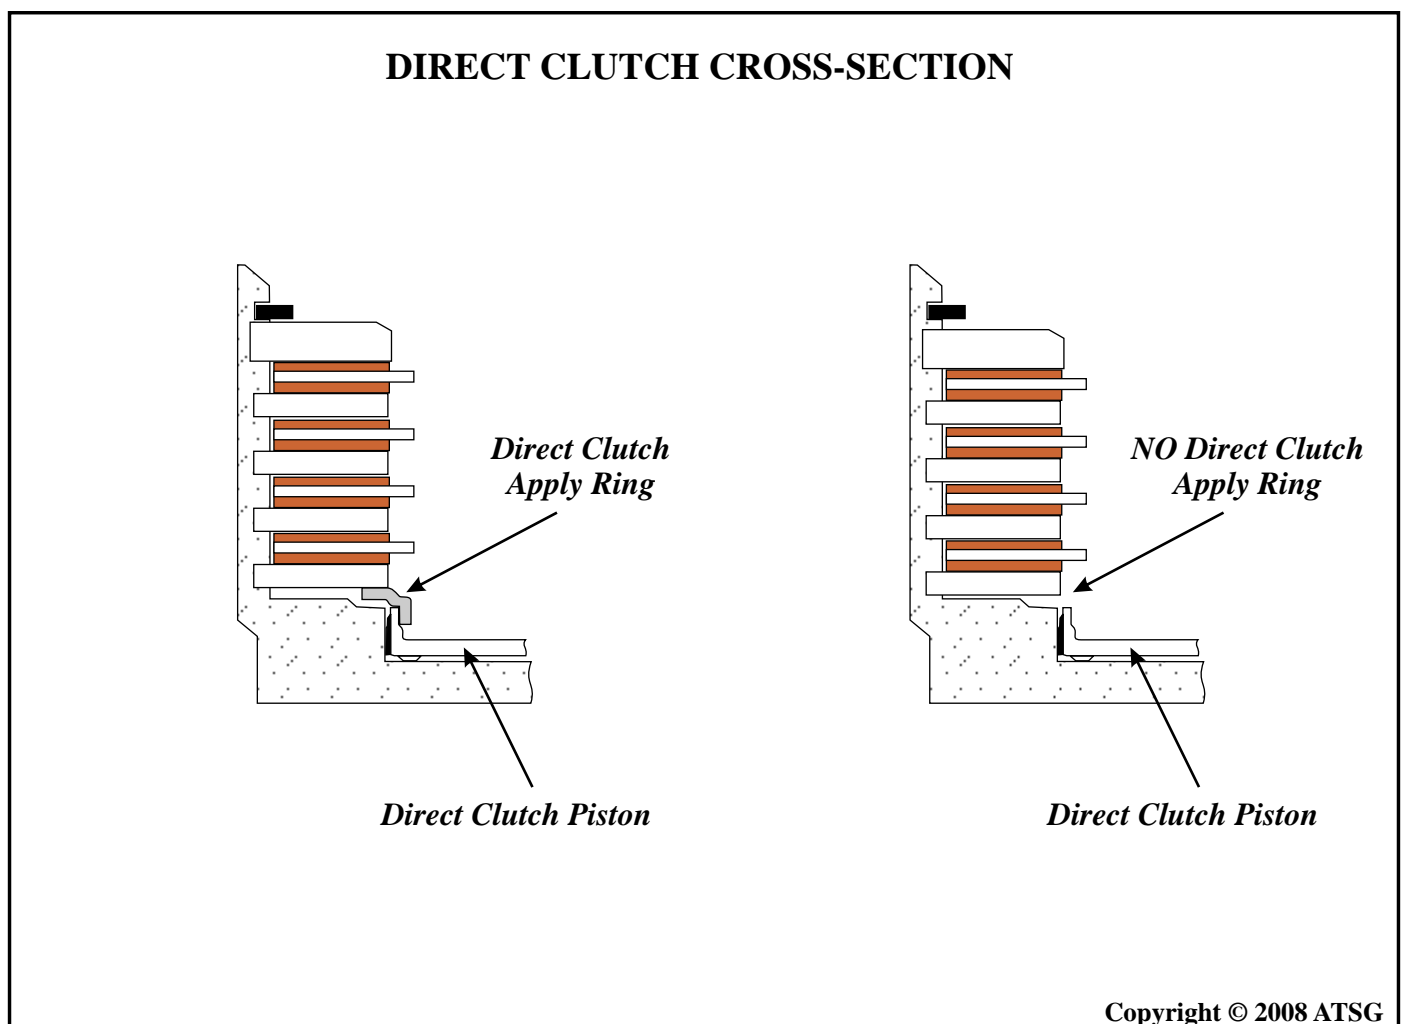
**CAUSE:** The cause may be that during overhaul, the direct clutch bonded piston was replaced and the apply ring was not transferred to the new piston. Refer to the cross-sectional view in Figure 10 which shows that when the apply ring is left off, the Direct clutch piston will not contact the Direct clutch bottom steel.

**DIRECT CLUTCH PISTON AND APPLY RING**

**CORRECTION:** To correct this condition ensure the apply ring is assembled onto the Direct Clutch Piston as shown in Figure 11.

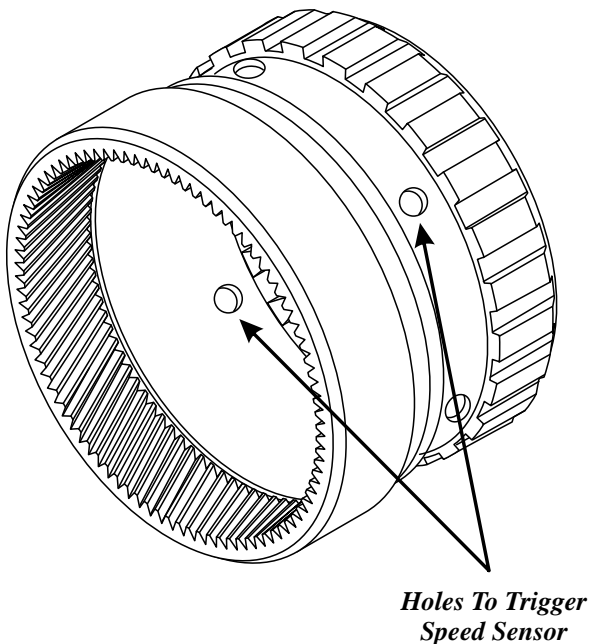
Figure 1

**CAUSE:** Beginning at the start of production for the 2004 model year, this family of transmissions is manufactured with extended parking lugs on the ring gear to trigger the output speed sensor, instead of the previous design with holes in the ring gear, which also required a strategy change in the PCM. If either a transmission earlier than 2004, or the use of 2003 or earlier ring gear is installed in a 2004-up vehicle, the PCM will not be able to correctly calculate vehicle speed, and will result in either no speedometer reading, or a slow speedometer reading. DTC's P0720-P0722 may be set. The 2004-up Rear Ring that has the extended park lugs utilizes the Output Shaft Speed Sensor with the white body, and a black connector (See Figure 5). The 2003-earlier units had the Rear ring gear with the holes, and utilizes the all black Output Shaft Speed Sensor, which is .083 inches longer than the 2004-up Output Shaft Speed Sensor (See Figure 4).

### "PREVIOUS DESIGN" RING GEAR 2003-EARLIER

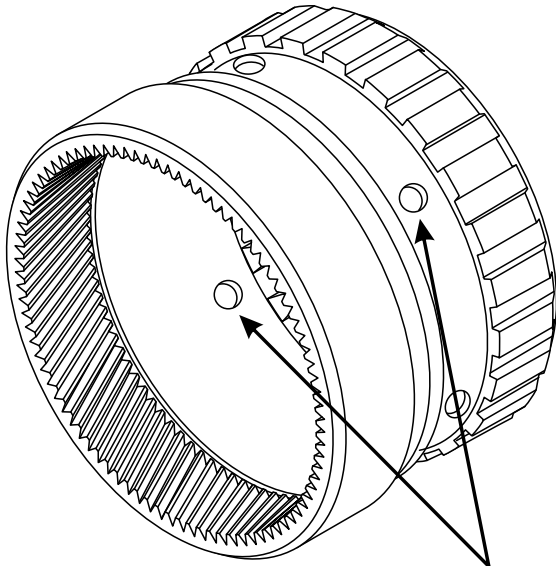
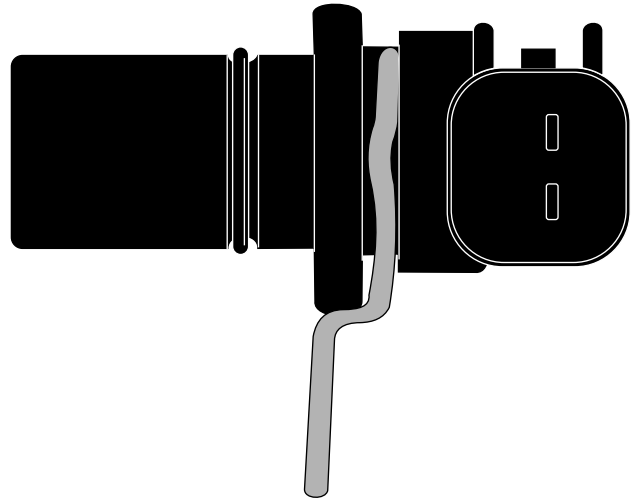
Figure 3

**"PREVIOUS DESIGN" RING GEAR  
2003-EARLIER**

*Holes To Trigger  
Speed Sensor*

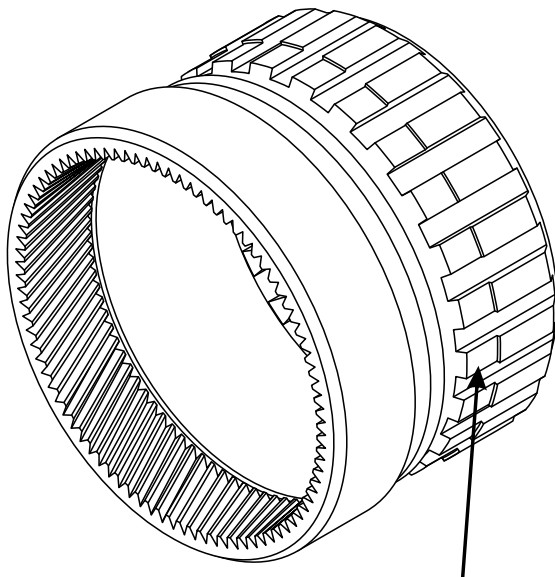
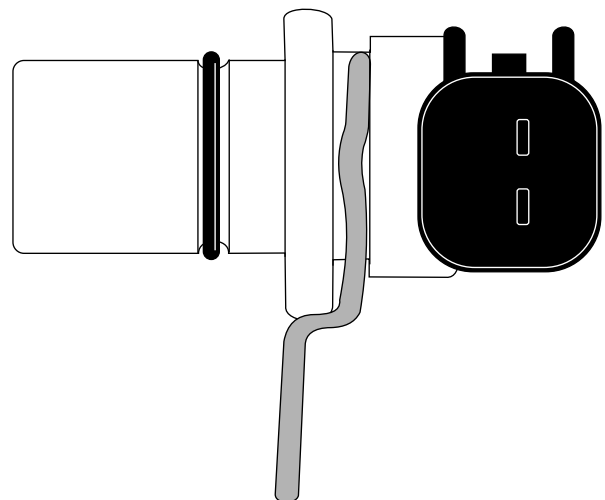
Figure 4

**"NEW DESIGN" RING GEAR  
2004-UP**

*Extended Teeth To Trigger  
Speed Sensor*

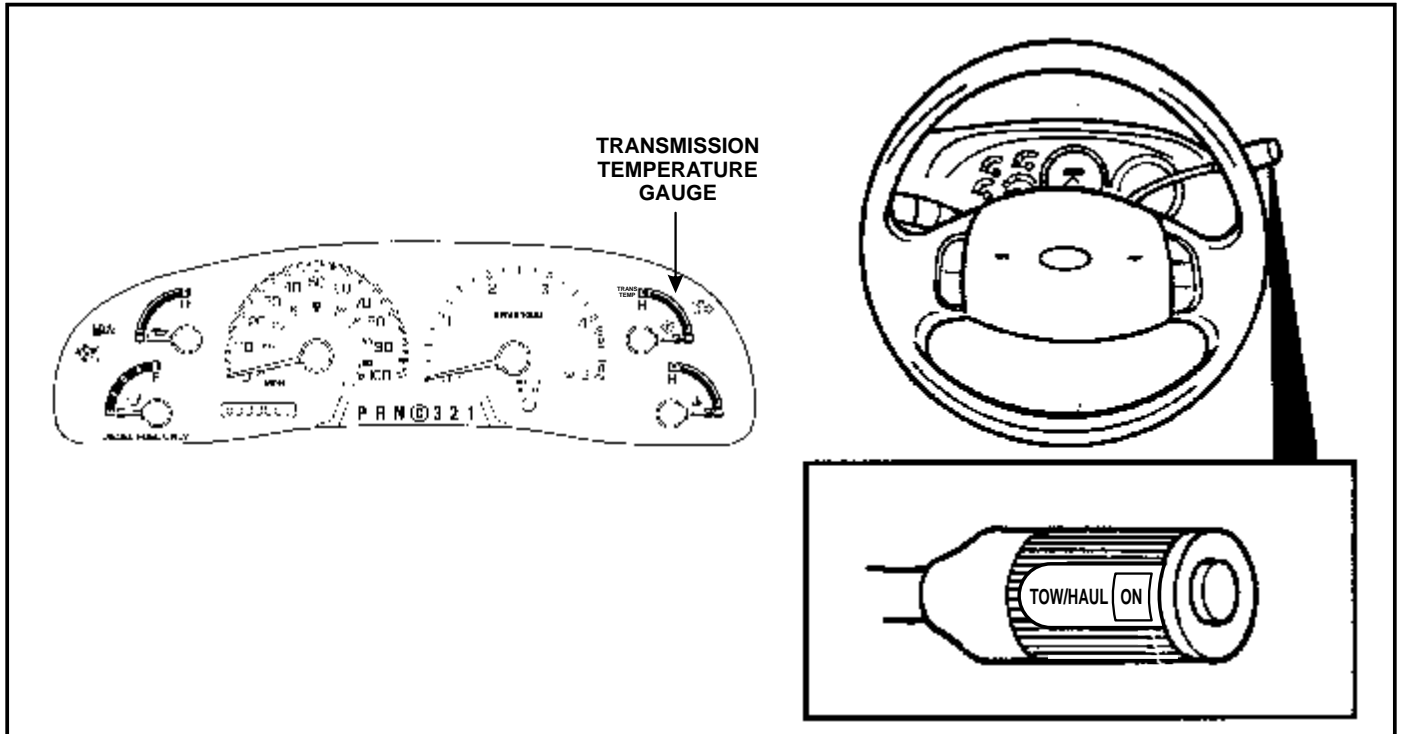
Figure 1

## ERRATIC SHIFTS AND TFT GAUGE OPERATION

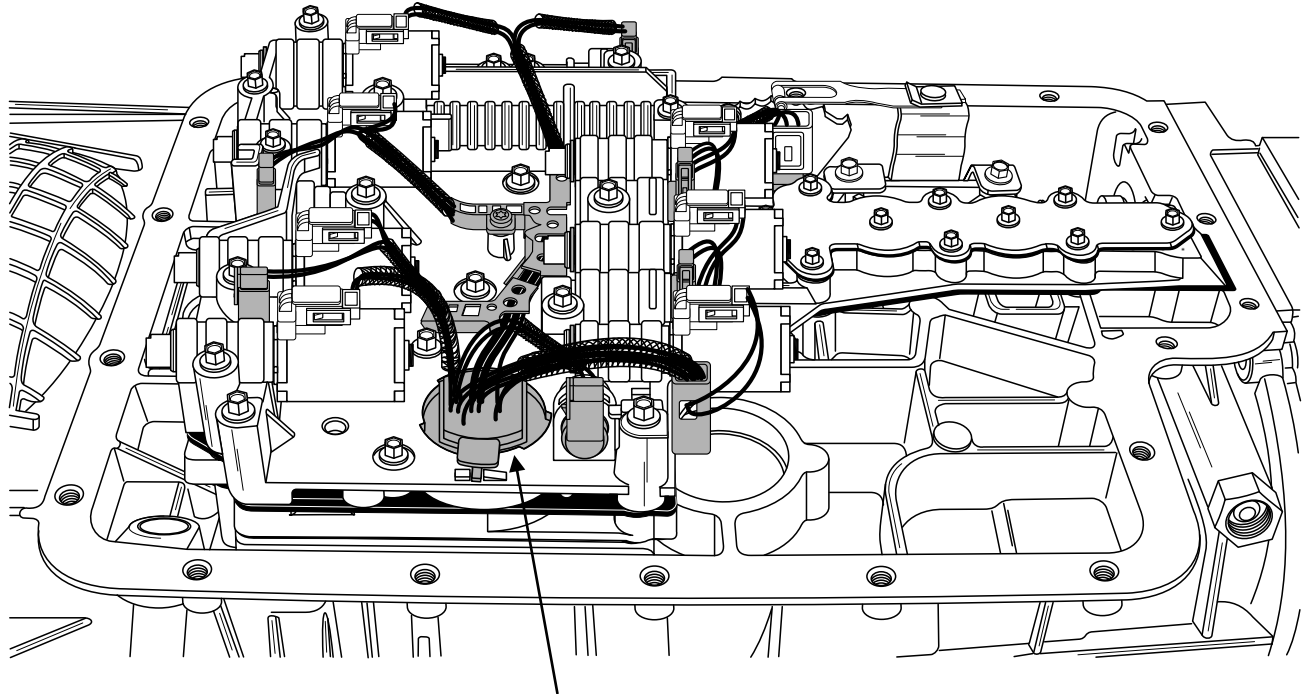
Figure 2

**CAUSE:** Either the TFT sensor is faulty (Figure 2) or the internal wiring harness is faulty (Figure 3). The transmission fluid temperature (TFT) sensor twist-locks into the solenoid body and is a temperature sensitive device called a thermistor (Figure 2). As the fluid temperature increases, the TFT resistance decreases, as shown in the chart in Figure 4. The PCM uses the TFT signal as an input to determine cold and hot temperature shift scheduling and for TCC apply and release scheduling. When the transmission is in cold mode operation, below -15°C (5°F), as determined by the TFT sensor, the transmission shifts 1st gear, 2nd gear, 3rd gear, 4th gear (ratio 1.09), 6th gear. When in hot mode the transmission will shift 1st gear, 2nd gear, 3rd gear, 5th gear (ratio 1.00), 6th gear. Either way it is still a five speed unit with six forward gear ratios available, dependant upon cold mode or hot mode operation.

### INTERNAL HARNESS

*Note: Plug in the trans harness connector and the same voltage and ground tests can be performed with the trans pan removed at the 2 terminal connector when unplugged from the TFT sensor as seen in figure 2. This will confirm the complete circuit integrity to the sensor. If this test fails, the internal harness is faulty.*

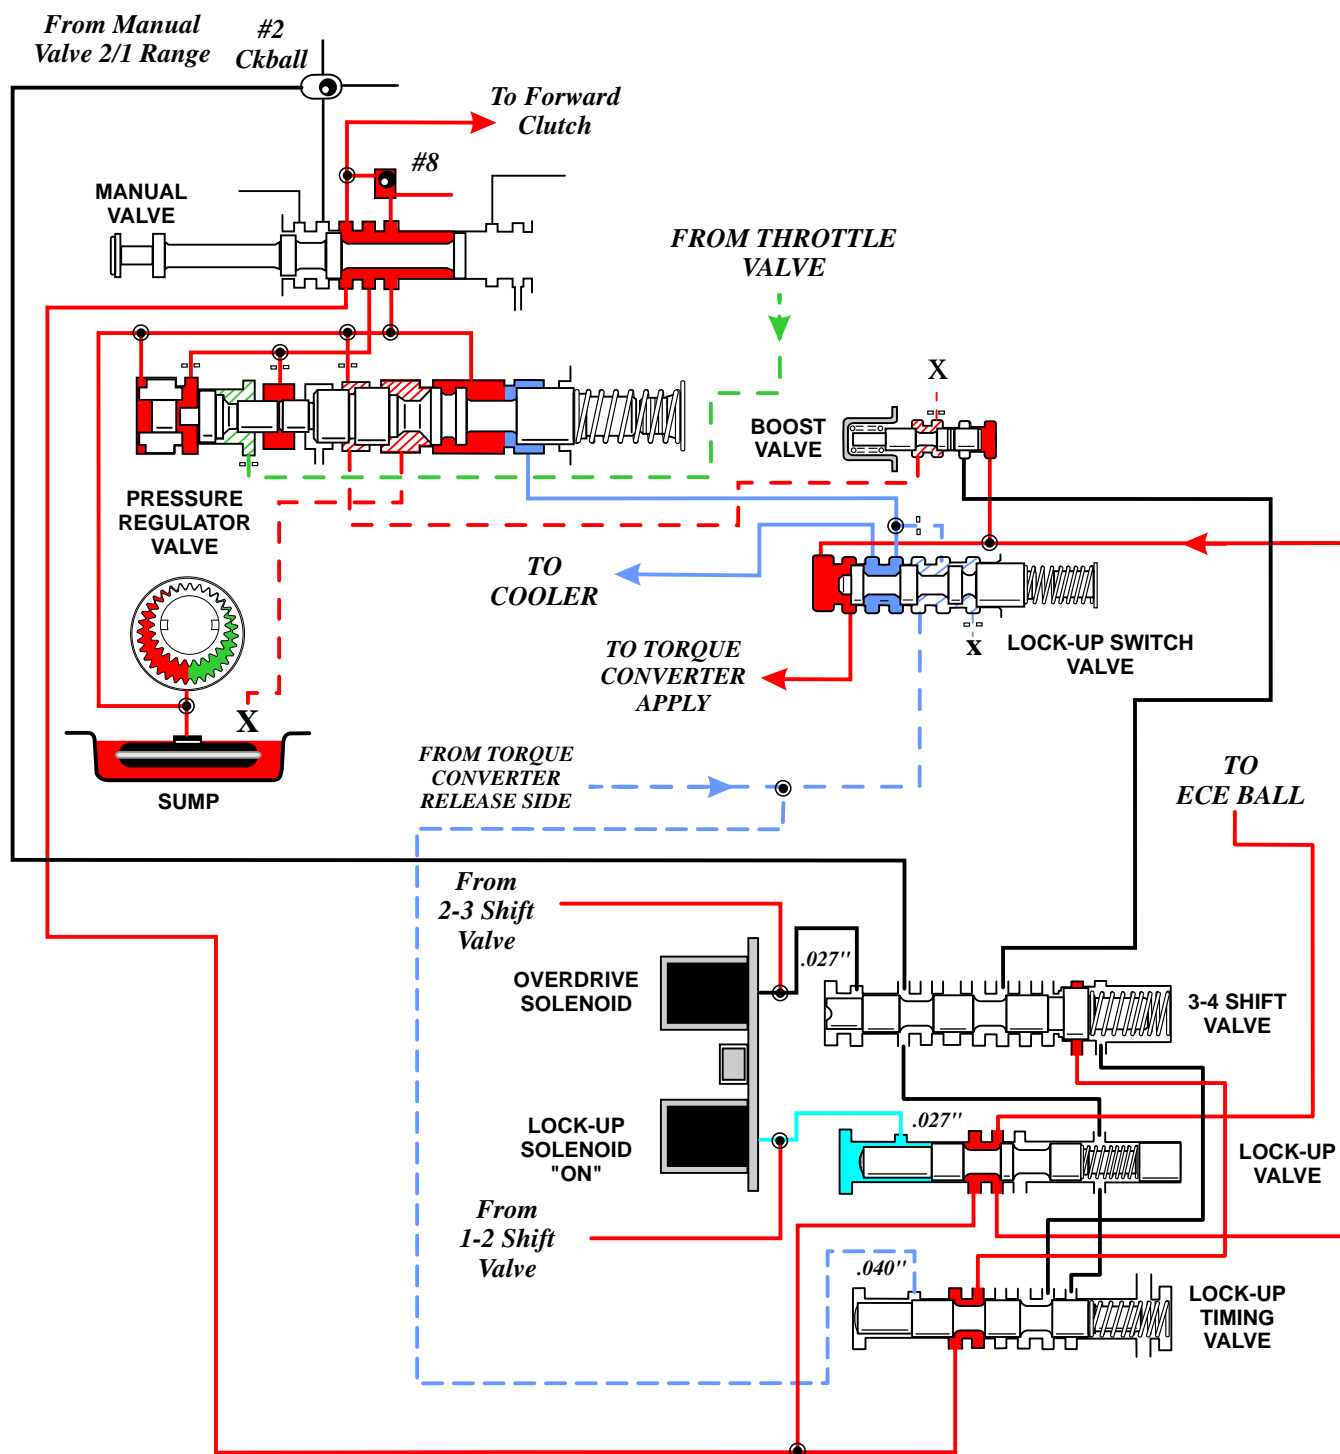
Figure 2  
Automatic Transmission Service Group

*Note: The number 2 Checkball, on 46 and 47RE, is used for a 3-2 manual downshift and for TCC cancel in Manual 2 and Manual 1 ranges, by applying line pressure from the Manual valve to the spring side of the Lock-up and 3-4 Shift Valve, and second land of the Lock-up Timing Valve to Prevent application.*

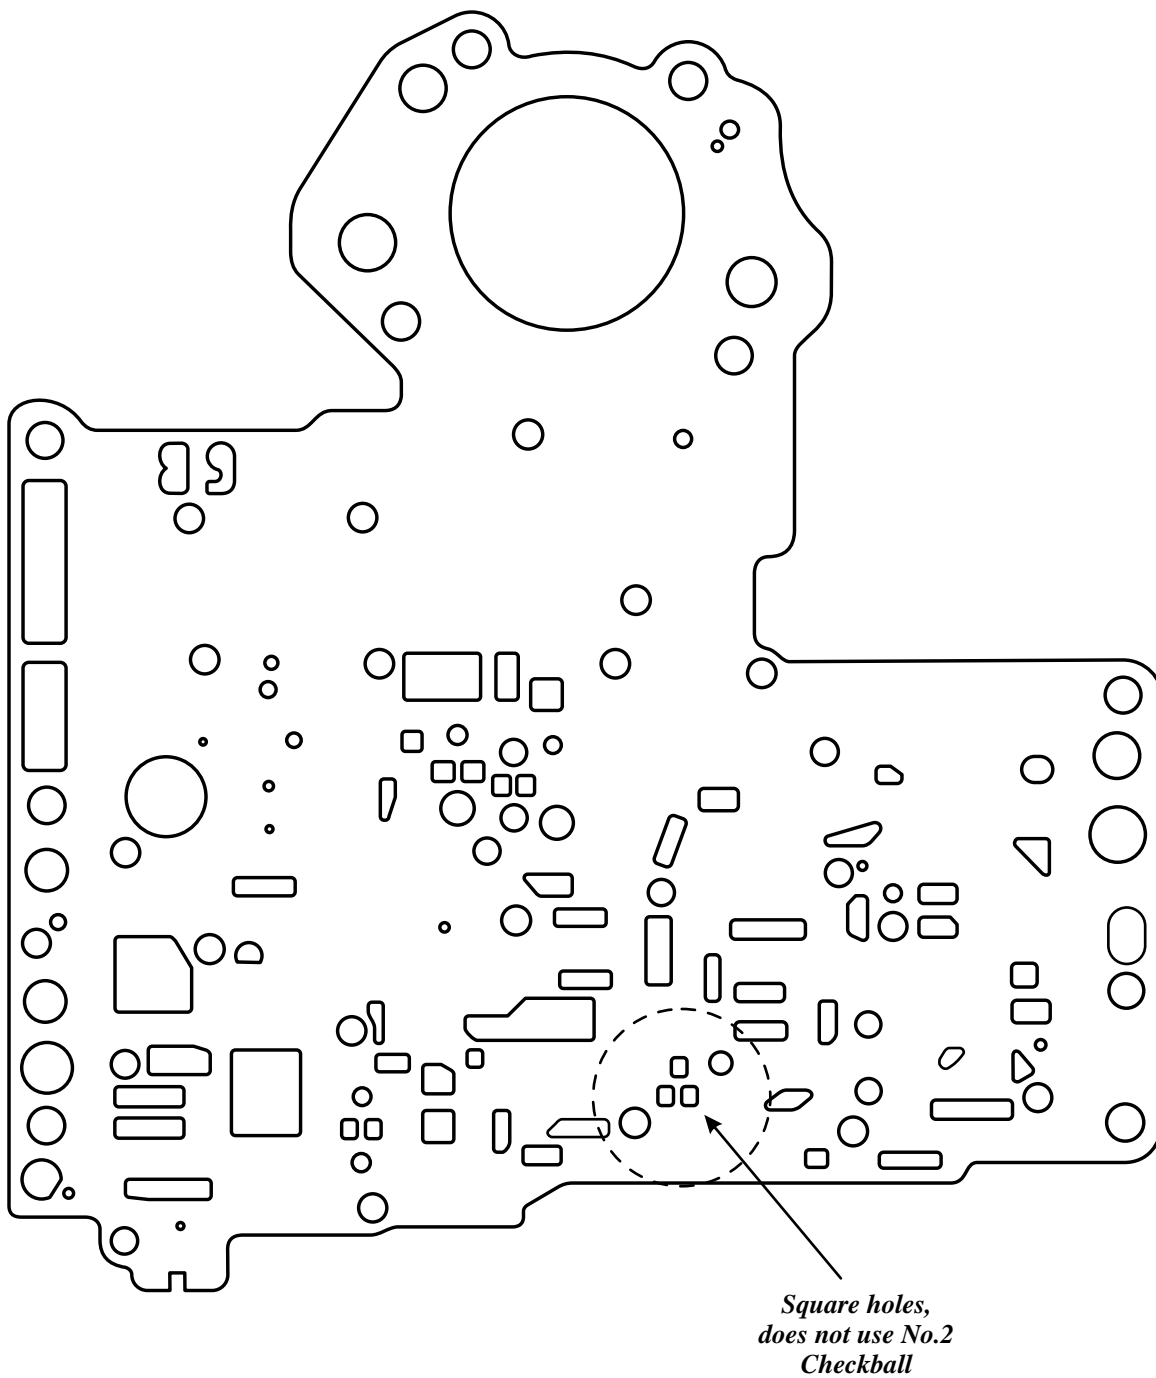
Figure 7  
Automatic Transmission Service Group

*Refer to Figure 7 for a view of the Main Spacer Plate on the 48RE, and the hole configuration for where the Number 2 checkball used to be. Notice there are only 3 holes, which are square, when compared to the previous plate in Figure 4.*

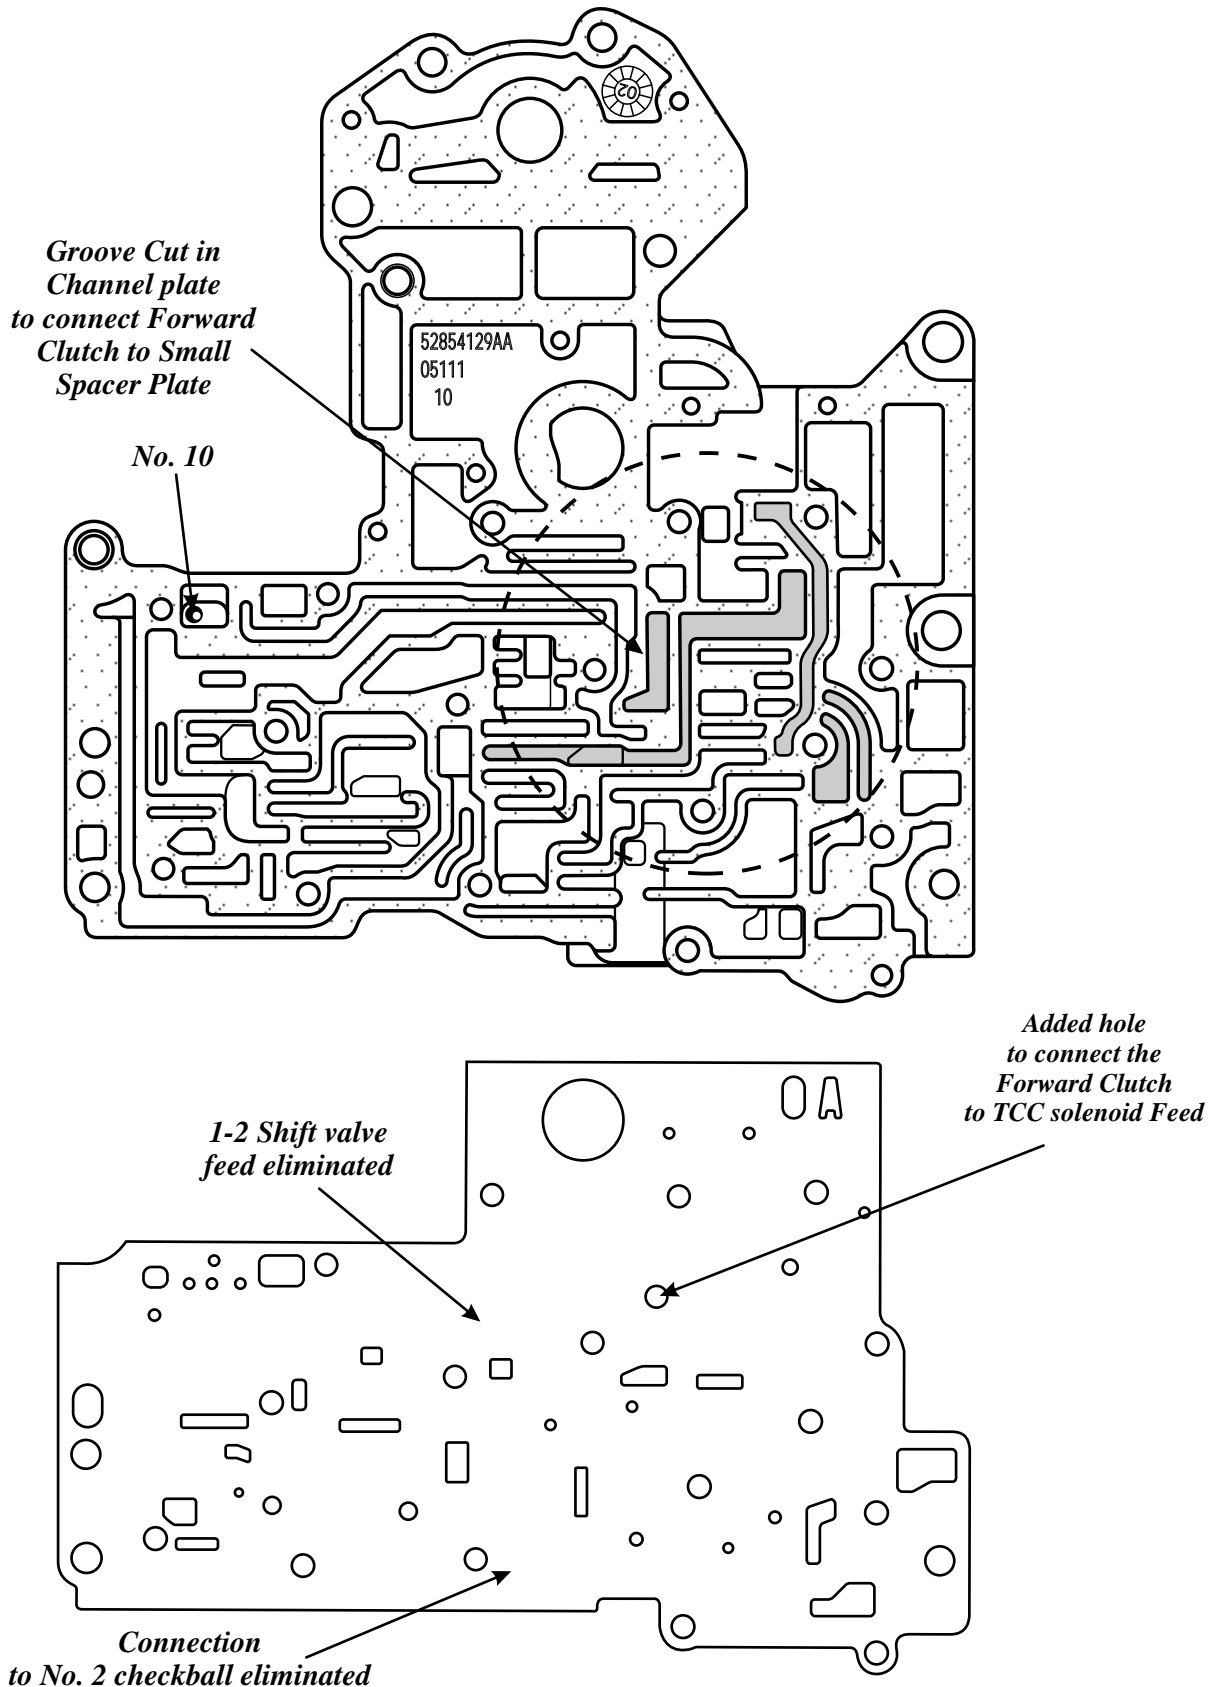
Figure 8  
Automatic Transmission Service Group

*Refer to Figure 8 for a view of the Lower Transfer Plate and Lower Spacer Plate on the 48RE, and the hole configuration for the Number 2 checkball is eliminated. Also Figure 8 shows the Previous design TCC solenoid feed from the 1-2 shift valve has been eliminated and the new hole connects the slot in the channel plate to the Forward Clutch circuit.*

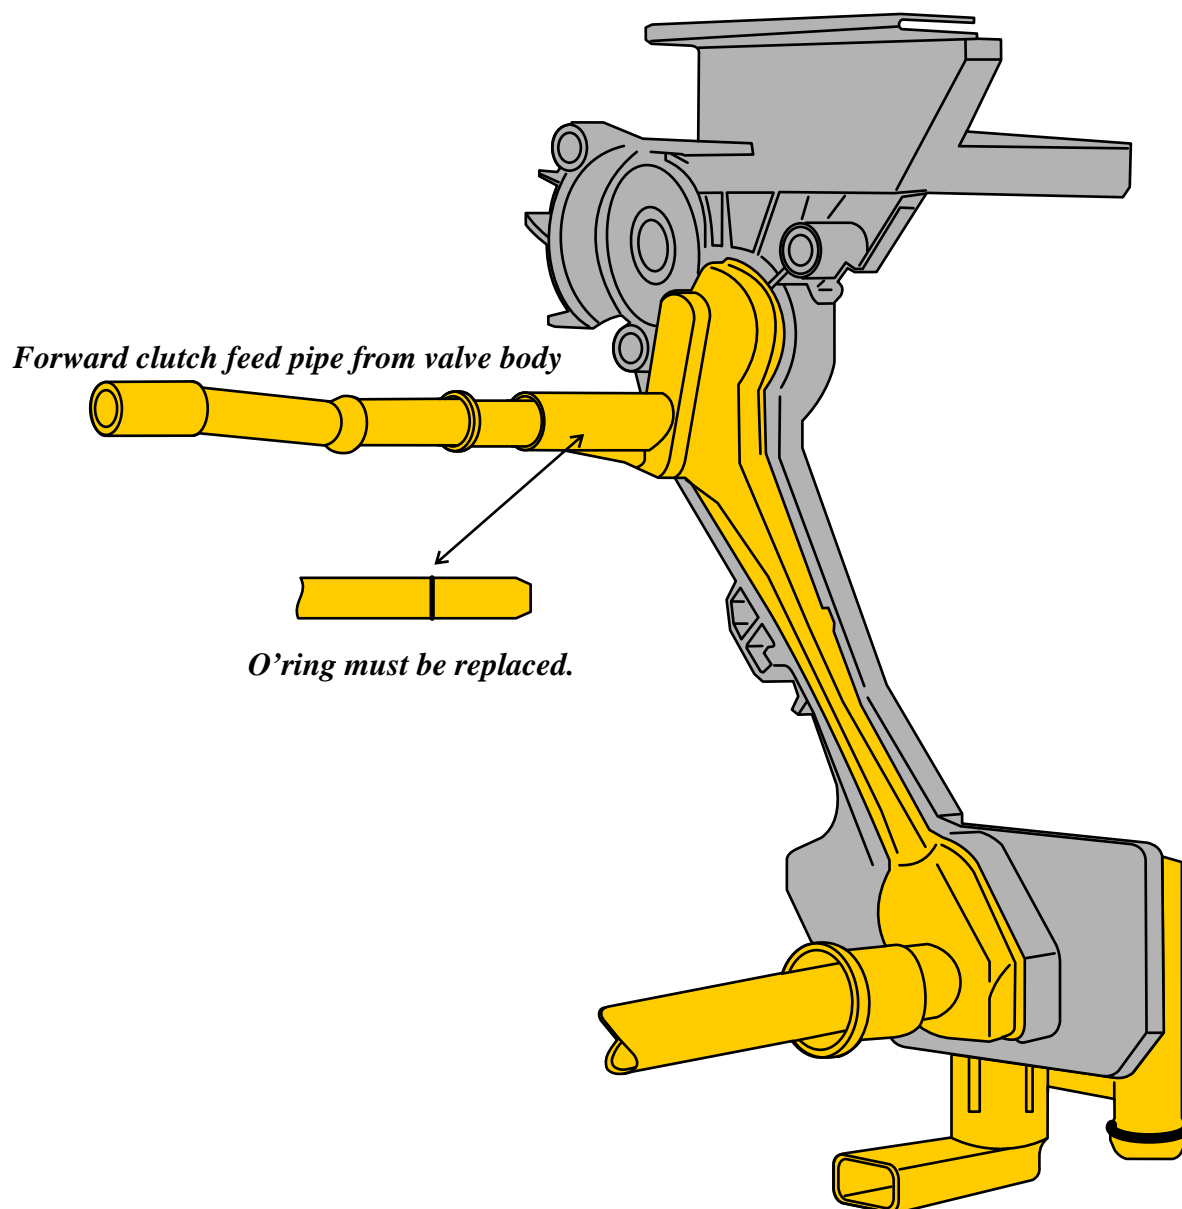
Figure 8

*A view of the entrainment pump on the  
forward clutch feed pipe valve body side.*

There is another very critical seal in the forward clutch circuit that will need to be replaced. It is located on the forward clutch feed pipe that runs from the valve body and fits into the entrainment as seen in Figure 8.
