1995 SEMINAR INFORMATION  
"HOW TO SURVIVE IN 95"

# "HOW TO SURVIVE IN '95"

## INTRODUCTION

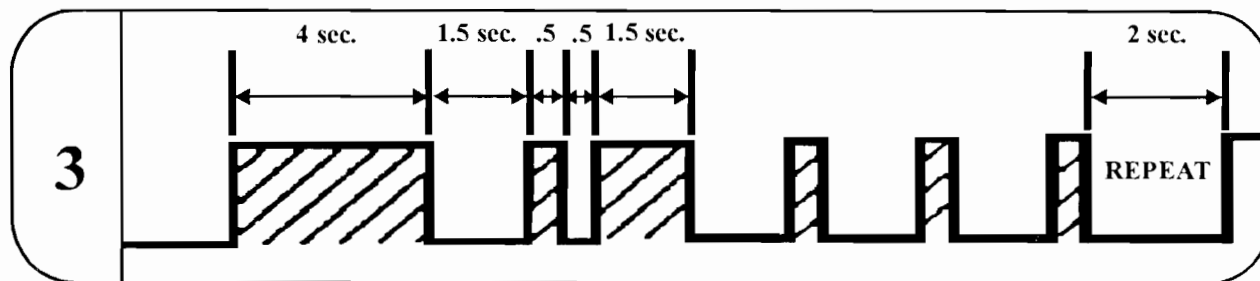
Figure 2

Illustrated on the following page in figure 2 is the numerically listed #3 malfunction code shown in the chart above, which has been singled out for clarity. The first multimeter 12 volt sweep is the "BEGIN CODE" indicator. This sweep will be 4 seconds long and must be 12 volts. If this sweep is not 12 volts, this may be an indication of a poor ground or a faulty computer.

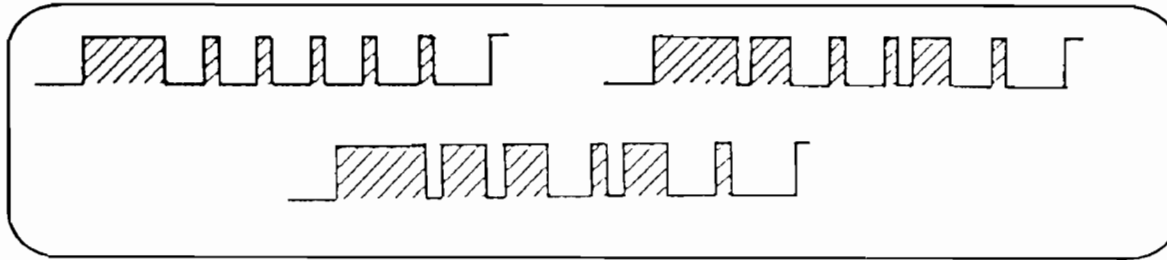
Figure 3

When checking the system for codes as explained on the previous page, remember to ALWAYS verify vehicle year of manufacture. The numerically listed code configurations will vary from year to year. For example, illustrated on the following page in figure 3 is an example of 3 different numerically listed #9 malfunctions. One is for a 1985 vehicle, another is for a 1986 vehicle, and the remaining sequence is for a 1987 vehicle. This is why it is imperative that you verify the year of the vehicle that you are working on, and that you choose the appropriate malfunction chart and compare it to your analog meter needle sweeps. The diagnostic connector locations for the various models can be found on pages 7-14, figures 5-16.

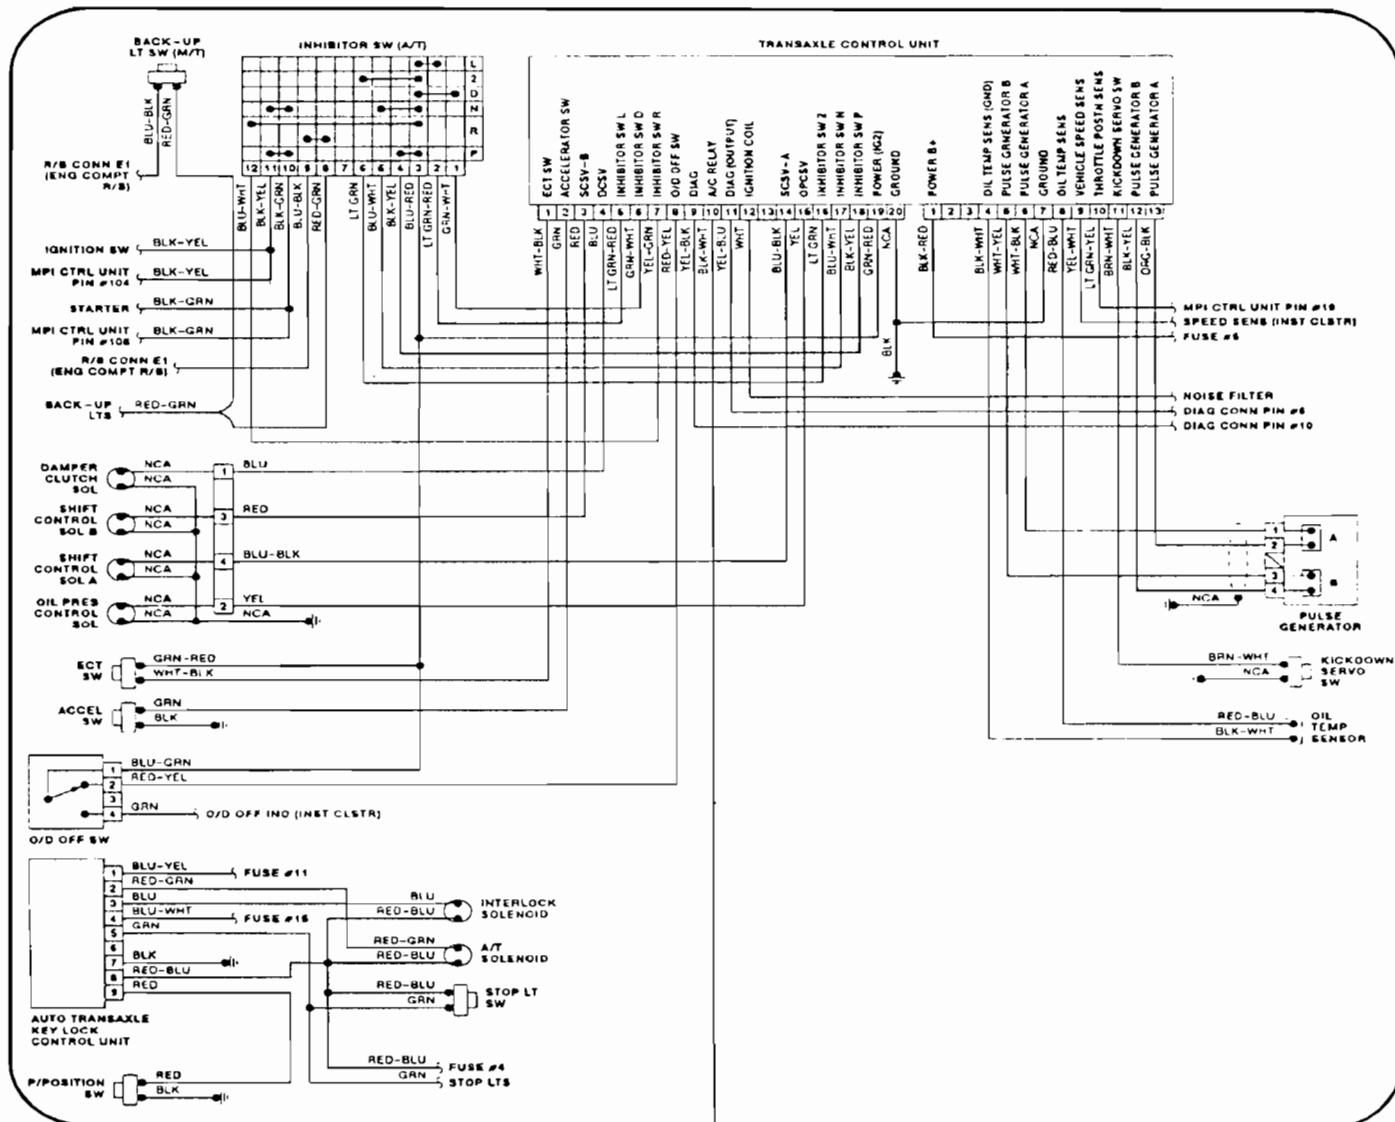
Figure 4

Illustrated below in figure 4 is a wiring schematic found in a typical KM equipped vehicle. A further explanation of what is meant by a "DEAD SYSTEM" and what to check for can be seen below by finding terminal #1 in the 13 pin connector, we see that it is the computers power supply. This terminal must be checked for battery voltage. Next, terminal #19 in the 20 pin connector would be checked for battery voltage. This is the circuit that the inhibitor switch inputs to the computer. If either of these circuits do not have battery voltage, a "DEAD SYSTEM" would exist, resulting in third gear only as soon as the vehicle is put in drive.

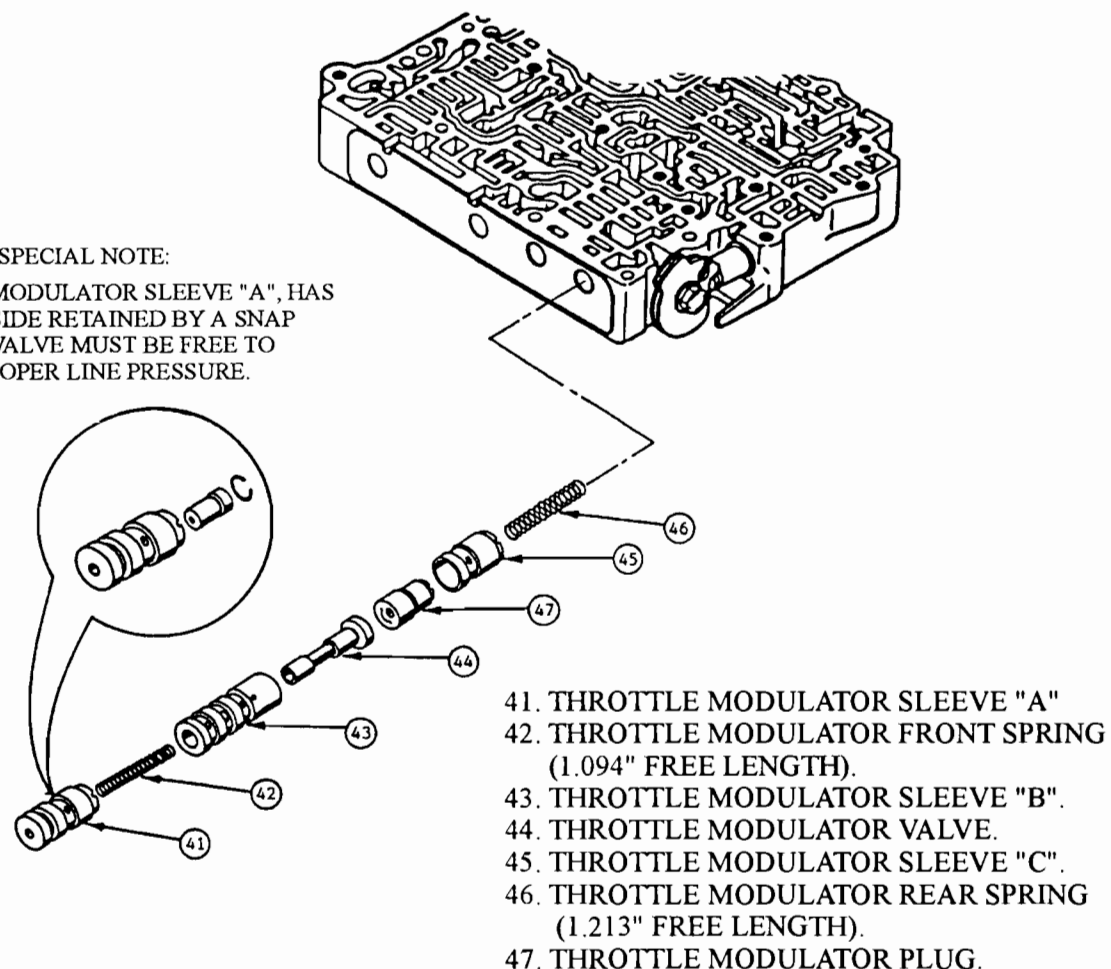
Figure 35

**SPECIAL NOTE:**  
THROTTLE MODULATOR SLEEVE "A", HAS  
A VALVE INSIDE RETAINED BY A SNAP  
RING. THIS VALVE MUST BE FREE TO  
ACHIEVE PROPER LINE PRESSURE.

**CORRECTION:** Install the Throttle Modulator Valve Line-up into the valve body as shown in Figure 35. Install throttle modulator sleeve "C", throttle modulator rear spring, throttle modulator plug, throttle modulator valve and throttle modulator sleeve "B", throttle modulator front spring, throttle modulator sleeve "A", and the retaining pin, as shown in Figure 35.

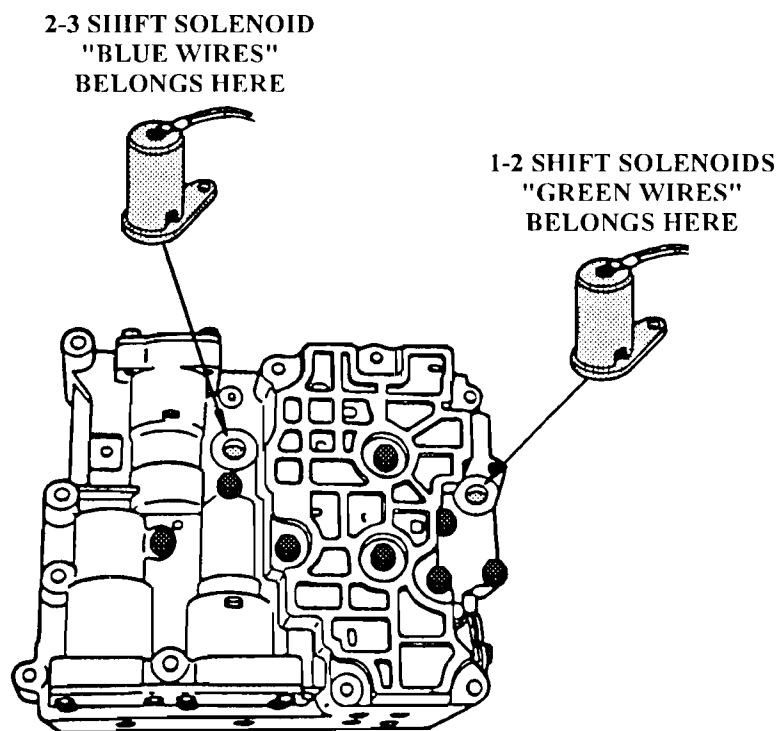
**CAUSE:** The cause may be the 1-2 shift solenoid and the 2-3 shift solenoid reversed in their locations in the valve body (See Figure 36).

**CORRECTION:** Install the shift solenoids in their proper locations, as shown in Figures 36 and 37. Use Figure 36 for the 1-2 and 2-3 shift solenoids, and Figure 37 on the following page, for the 3-4 and lockup.

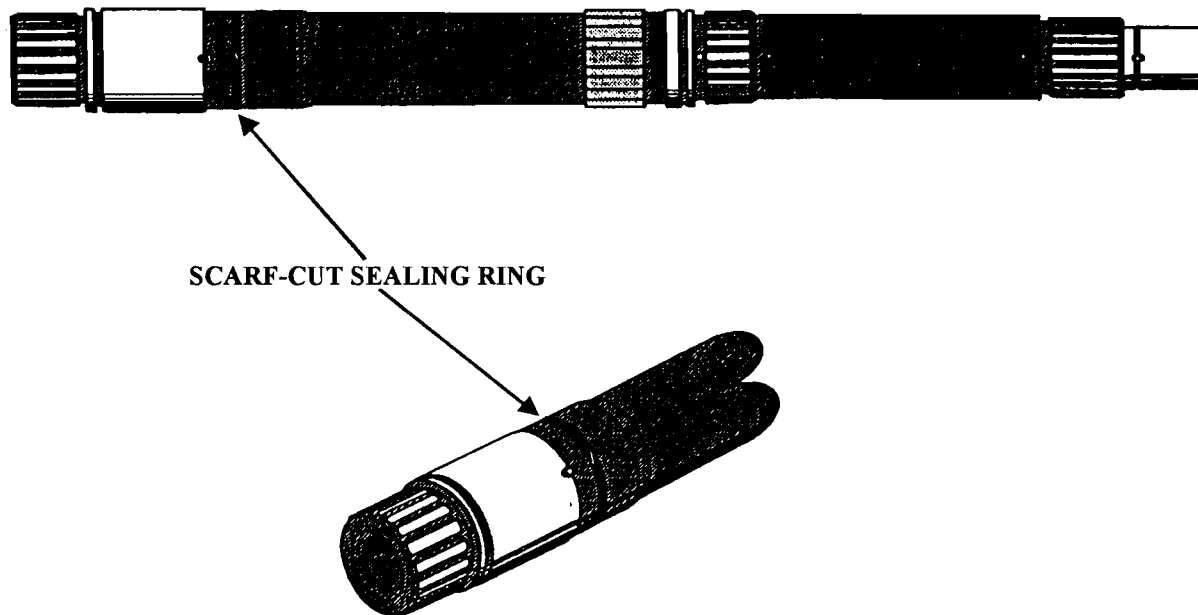
Figure 38

**CAUTION: THERE ARE TWO DIFFERENT DIAMETERS OF THE G4A-EL INPUT SHAFT, AND THEY REQUIRE DIFFERENT SIZE SCARF-CUT SEALING RINGS.**

**CORRECTION:** Install a new Teflon scarf-cut sealing ring in the input shaft groove, as shown in Figure 38.

Be very careful to select the proper size scarf cut sealing ring for the input shaft.

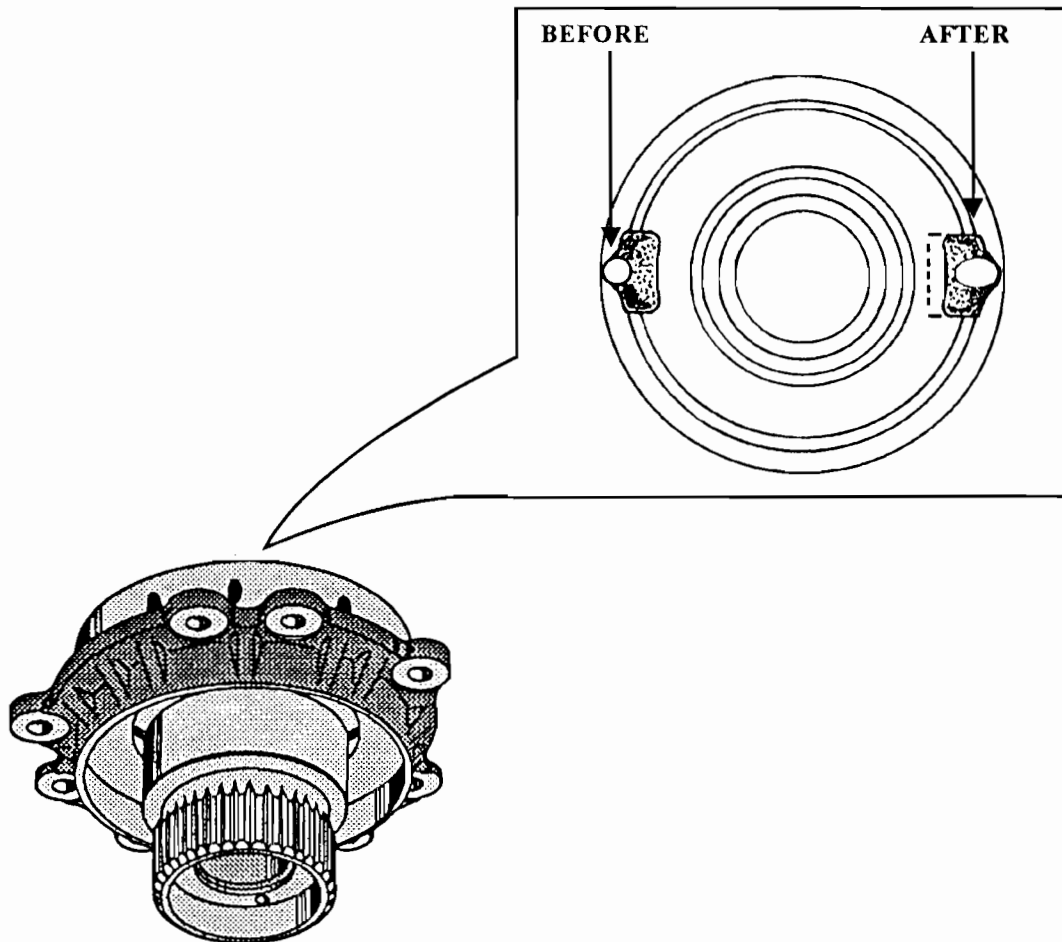
Figure 39

**CAUSE:** **A:** Insufficient drainback passages in the Stator Support.

**CORRECTION:** **A:** Remove Stator Support and bearing race. With Drill or Die Grinder enlarge and deepen the factory drainback passage in the "Rear" of the Stator Support as shown in Figure 39. Notice the drainback hole and the passage to "Dotted Line" enlarged.

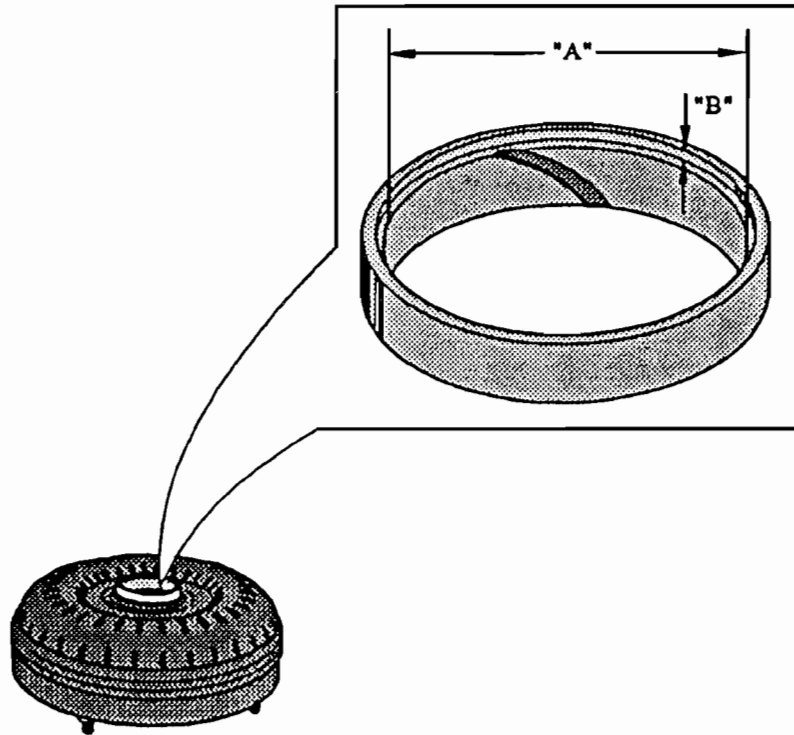
Figure 40

**B:** Worn or misplaced bushing in Torque Converter.

**B:** Measure dimension "A" in figure 40, then measure dimension "C" in Figure 41. Subtract C from A and ensure the difference is .003"-.006". Also check the clearance between the bushing and the top of the converter hub. The bushing should be "Recessed" approximately .078" to .125" as shown in Figure 40, dimension "B".

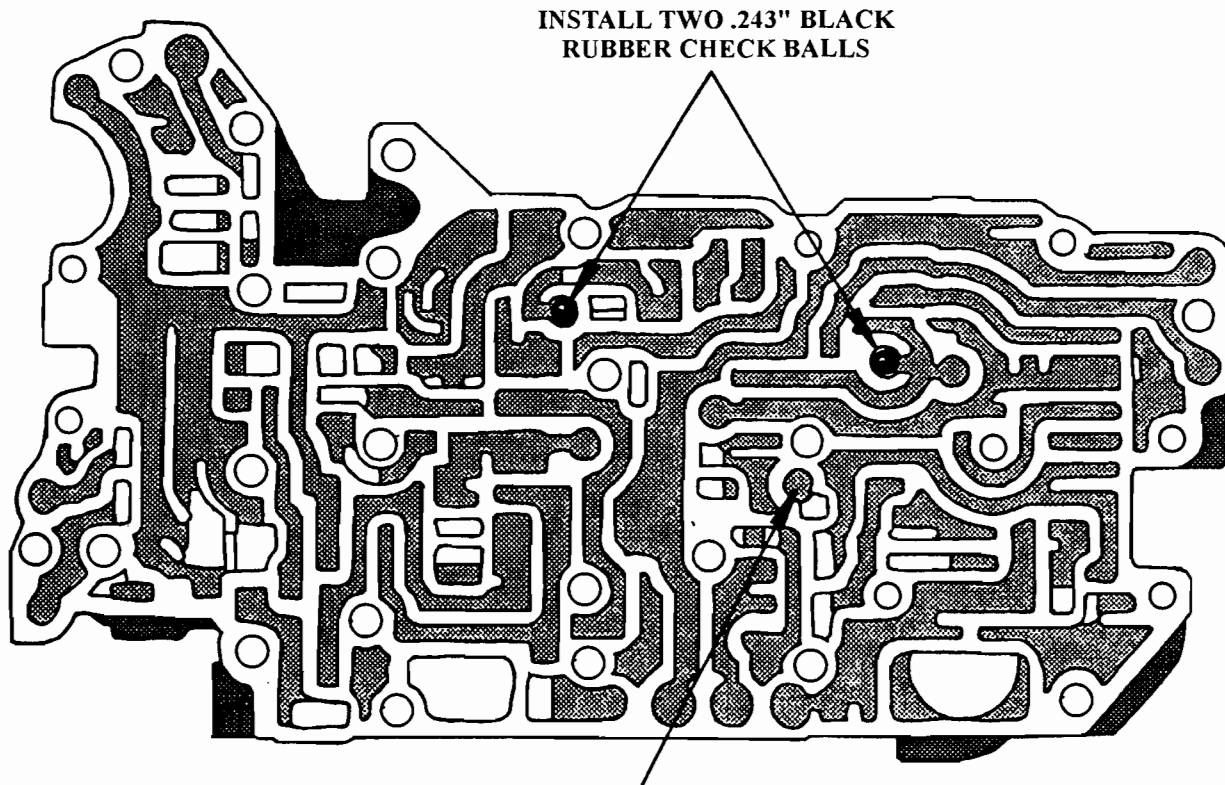
Figure 43

**CAUSE:** The cause may be a clogged or partially clogged 2-4 servo feed orifice. The 2-4 servo feed orifice is only .038" in diameter, and will not tolerate much debris before the slipping condition will exist. If the 2-4 servo orifice becomes totally closed, there will be NO 2nd gear, and NO 4th gear. Another cause for NO 2nd and NO 4th gears could be a checkball that has been installed in the wrong location in the Premain valve body, as shown in Figure 43.

IF A CHECKBALL IS INSTALLED IN THIS LOCATION,  
THE RESULT MAY BE NO 2ND AND 4TH GEARS.

**CORRECTION:** Remove the 2-4 servo feed orifice assembly using a 10mm Hex socket. Refer to Figure 42 for the location in the case. Thoroughly clean the 2-4 servo orifice and all case passages with clean solvent. The spring in this assembly is larger on one end, and the larger end goes into the Hex bolt (See Figure 42). Also ensure that you have only TWO .243" diameter checkballs installed into the Premain valve body, in the locations shown in Figure 43.

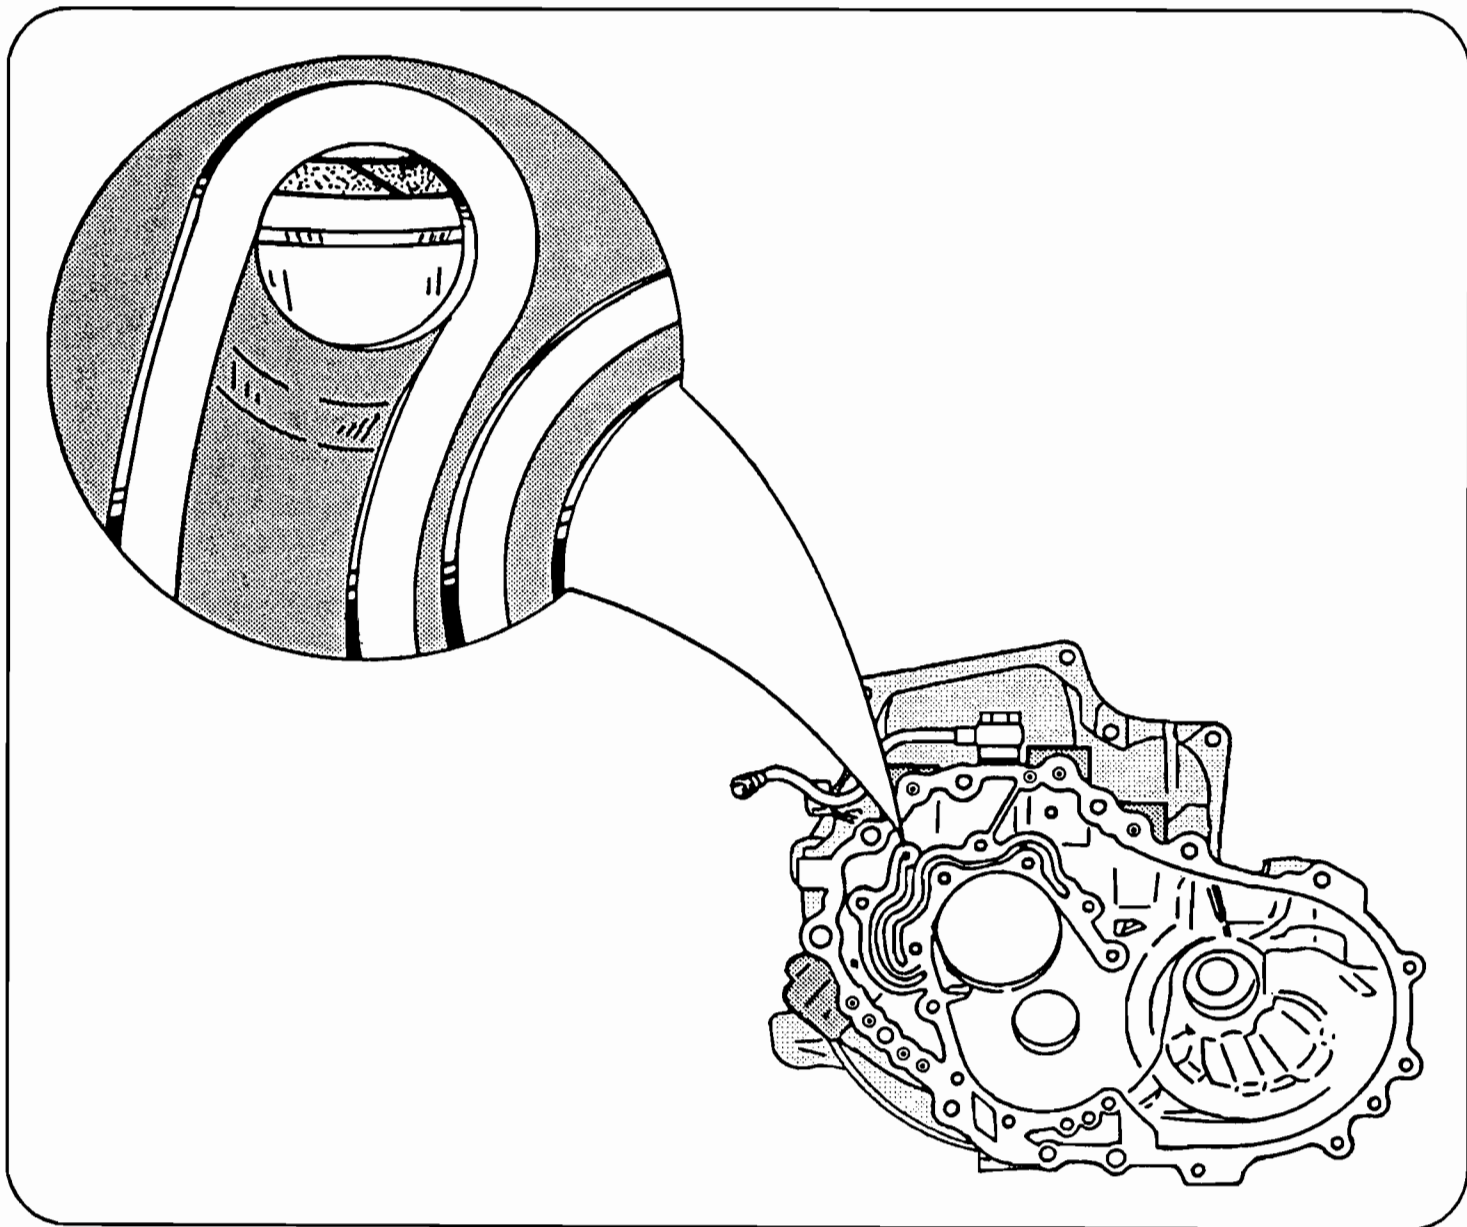
Figure 44

B: The cause may be the 2-3, N-D or N-R accumulator was installed into the 1-2 accumulator bore, or the sealing ring at the small diameter of the 1-2 accumulator was damaged on installation into it's bore.

Because of the difference in overall length, when the 2-3 or N-D accumulator is installed into the 1-2 accumulator bore, "LINE PRESSURE" can be forced past the accumulator piston into the 3-4 clutch circuit. (Refer to figure 44)

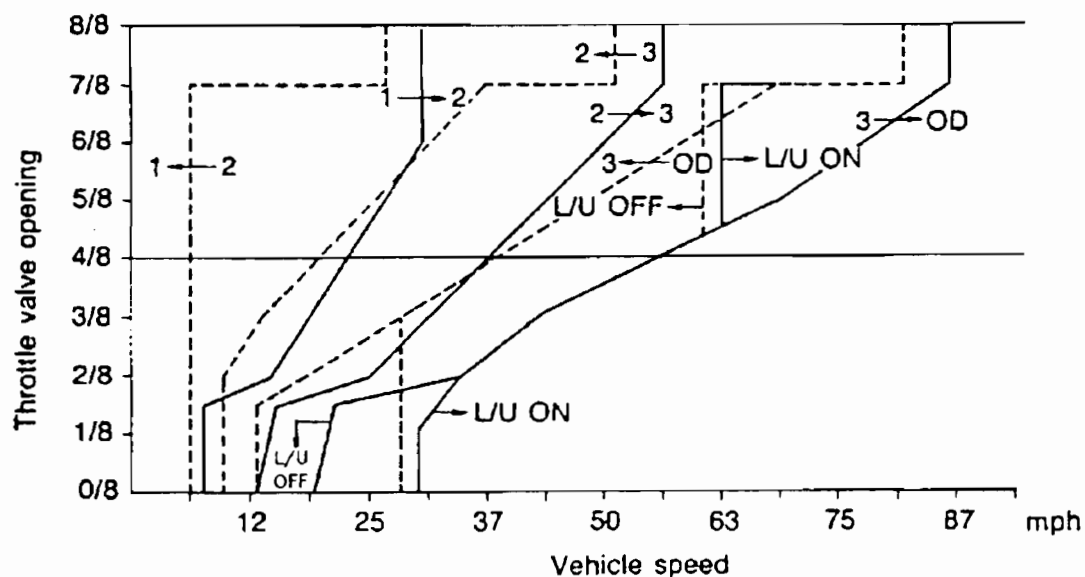
Figure 46

**CAUSE:** The EC-AT Computer strategy allows 1-2 upshifts as early as 7 mph at light throttle when the "normal" mode is selected. The shifts at 1/8 throttle or less occur at 7 mph, 13 mph, and 19 mph. (See Figure 46) It is not until 1/4 throttle or more that the shifts are perceptibly spread out.

**CORRECTION:** As long as other shift quality concerns have been addressed, no other action is necessary or possible.

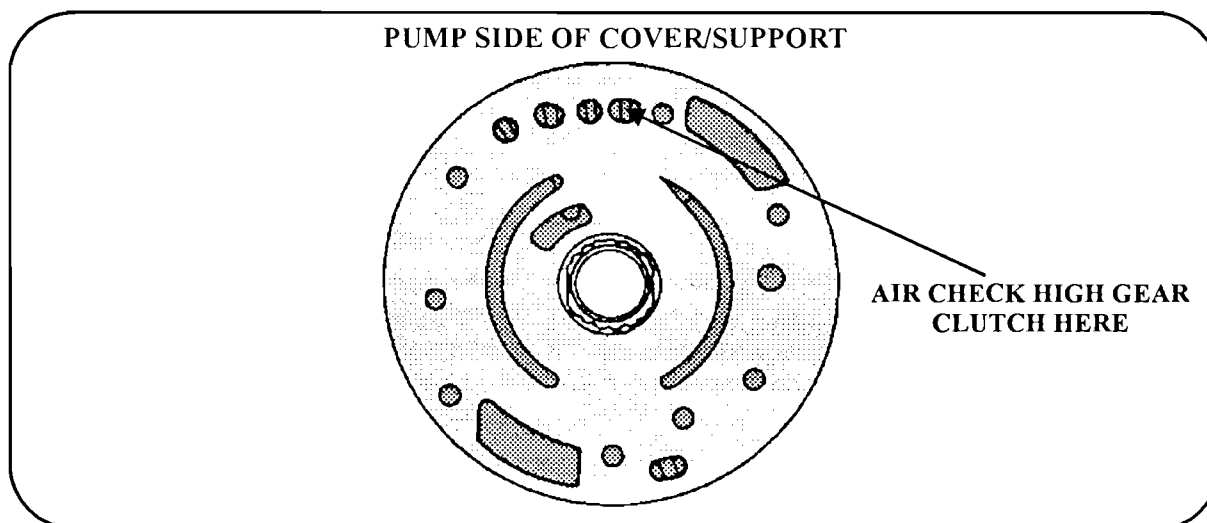
Figure 50

**CAUSE:** Premature failure of the high gear clutch may be caused by a leaking high clutch check valve, which is located in the pump cover /support. (See figure 49)

**CORRECTION:** With a GOOD FITTING set of sealing rings in place, install the high gear drum onto the pump cover/support. Then pour some solvent into the high gear check valve and air check the high gear drum through the high gear clutch feed passage in the pump side of the pump cover/support while checking the high gear check valve for leakage. (See figure 50)

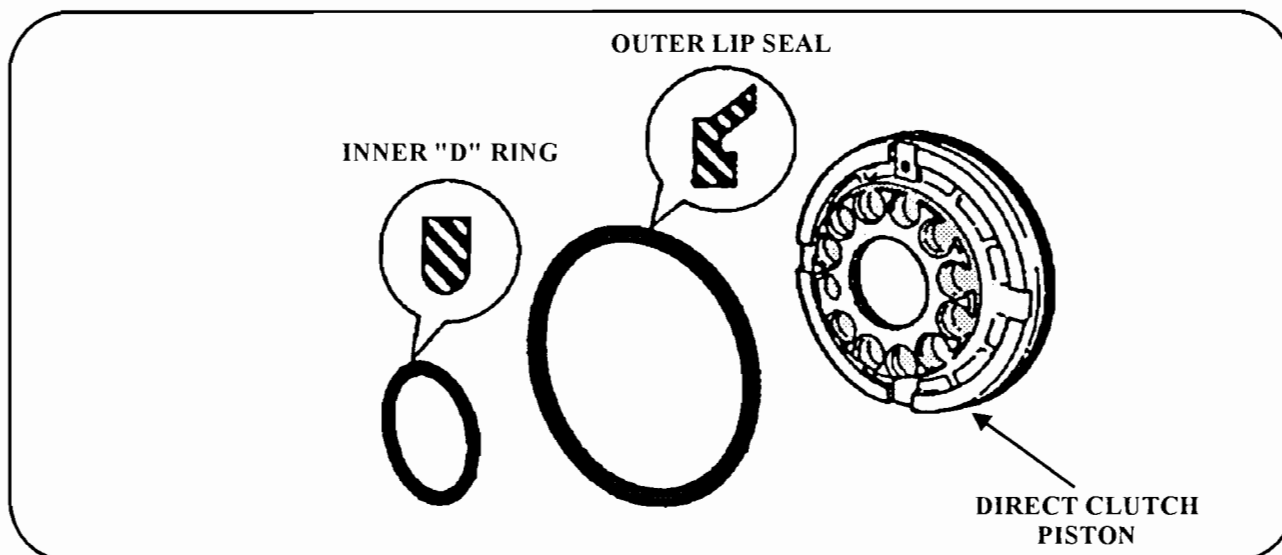
Figure 51

**CAUSE:** #1-It has been determined that the inner "D" ring on the direct clutch piston wears badly and/or shrinks, creating a leak of direct clutch oil at the inner seal. (See figure 51)

**CORRECTIO** #1-Remove the outer lip seal from the direct clutch piston and install the piston back into the direct drum with only the "D" ring in the piston. Rotate the piston and check the "D" ring for "DRAG", as shown in figure 53. "D" ring wear and/or shrinkage is what normally creates this complaint, and simply replacing the "D" ring solves the problem.

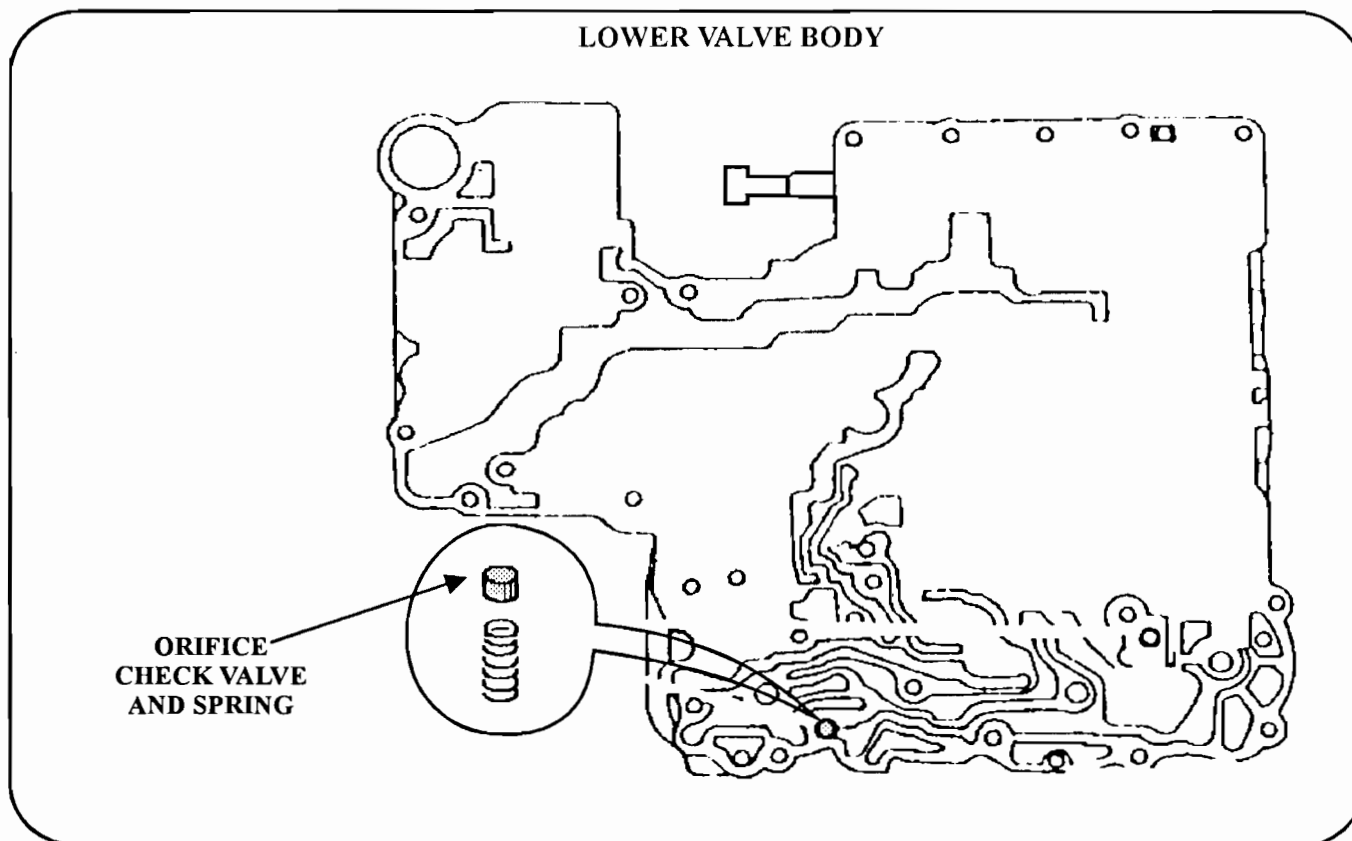
Figure 54

**CAUSE:** This complaint may be caused by a worn and broken Orifice Check Valve, which is located in the lower valve body (to figure 54). When wear occurs in the Orifice Check Valve, it may break, causing pieces of the check valve to become lodged in the Accumulator Control Valve, (Refer to figure 55) which is located in the upper valve body section.

**CORRECTION:** Remove the Orifice Check Valve and spring and check to see if it is broken. If it is broken, clean the broken pieces out of the Accumulator Check Valve and reassemble the valve body **WITHOUT** the Orifice Check Valve.

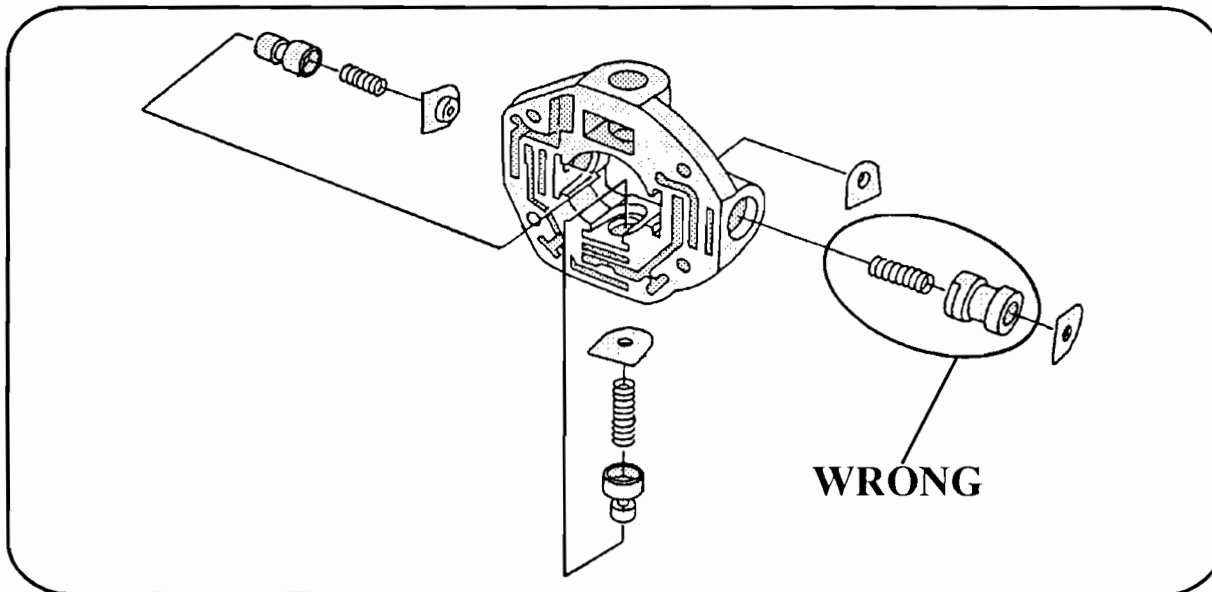
Figure 57

**CAUSE:** Installing the primary valve into the governor body incorrectly as shown in figure 57 will cause the vehicle to make a wrong gear start. The reason for the incorrect installation may be caused by the fact that the incorrect primary valve line-up shown in figure 57 is also shown incorrectly in various repair manuals.

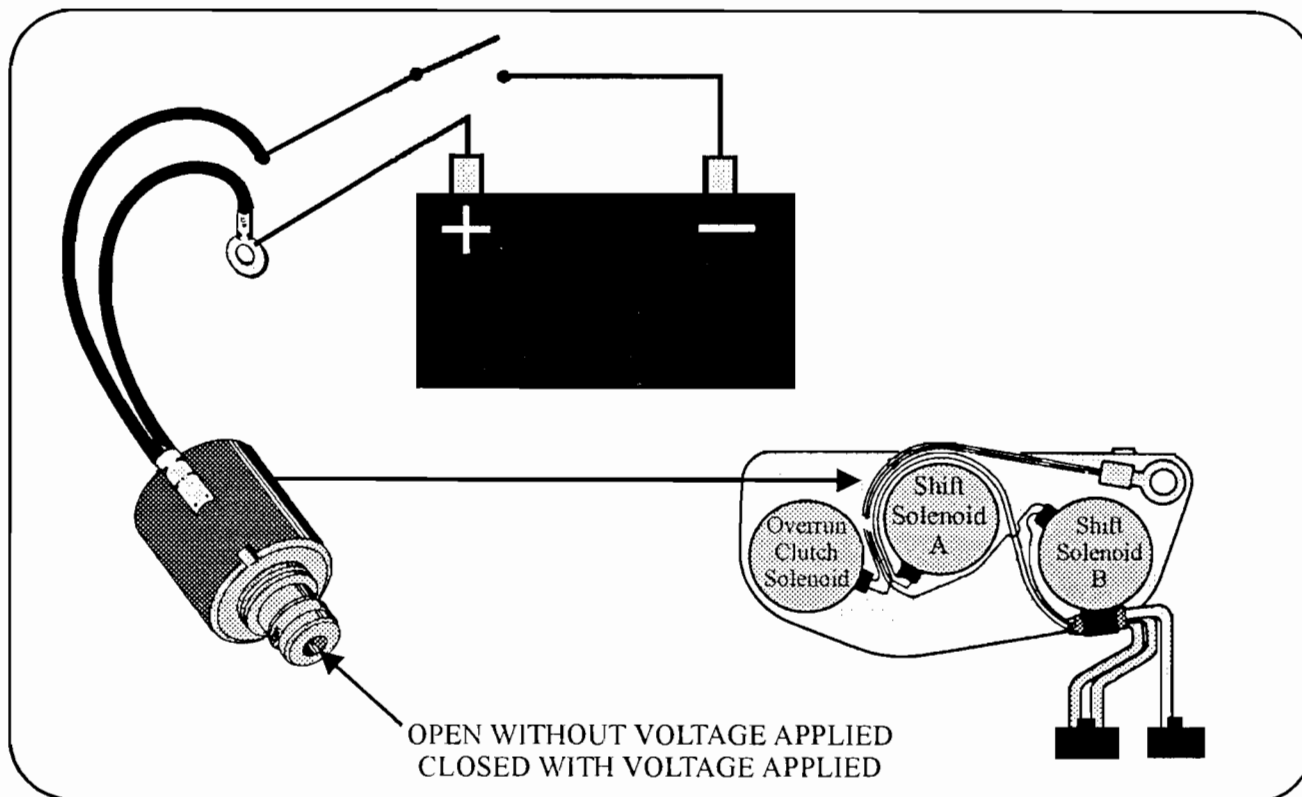
Figure 61

1. Shift solenoid A is stuck open or has electrically failed.
2. Shift valve A is stuck.
3. The bore plug between shift valve A and the 4-2 relay valve has broken at the roll pin and is preventing shift solenoid A pressure from stroking the shift valve.

1. Check shift solenoid A resistance. It should be 20 - 40 ohms to ground. Check shift solenoid A with battery voltage to make sure that it closes when it is energized. See Figure 61.
2. Disassemble the valve body and clean thoroughly.
3. Replace the broken bore plug, making sure that no pieces are lodged in the worm tracks. Clean the bore so that the plug fits smoothly and the the roll pin holds it securely in place. See Figure 62.

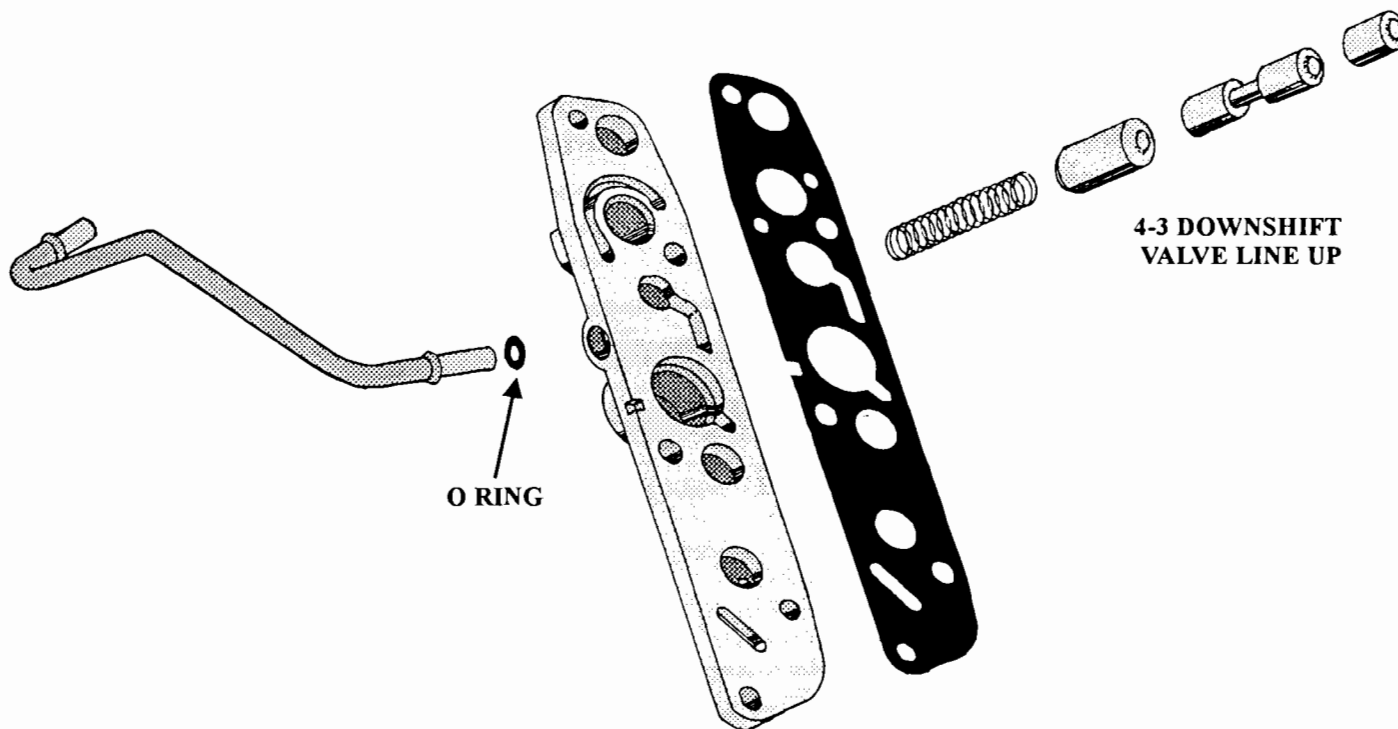
Figure 63

Saab 9000 vehicles that are turbo equipped, will have a tube that connects the turbo charger to the valve body. Its function is to provide pressure to the spring side of the 4-3 downshift valve during turbo boost periods. When a turbo 4-3 downshift takes place, the forward clutch will fully apply before the 2-4 band is fully released. This added shift overlap is needed during a turbo 4-3 downshift due to the increased torque demand. If the "O" ring that seals the pipe to the valve body end plate is missing or damaged, transmission fluid will be drawn up through the turbo during non-boost periods. This will allow the oil to be burned by the engine resulting in excessive white smoke exiting the tail pipe. (See Figure 13 below)

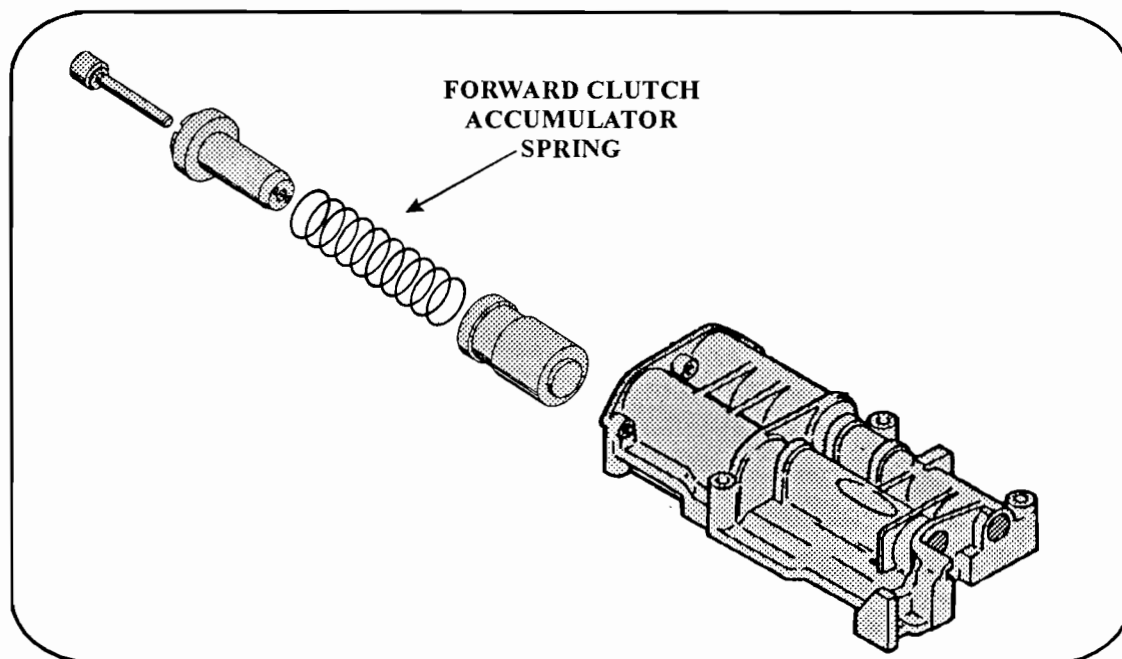
Figure 67

Both the Saab and Eagle Premiers may exhibit a harsh engagement into drive and a harsh 4-3 downshift. One cause may be a faulty forward clutch (A clutch) accumulator spring (See Figure 67). This allows the forward clutch to come on abruptly when doing a 4-3 downshift or placing the selector lever into any forward ranges. If upon inspection of this spring you find that it is not broken, collapse the spring and see if there is uneven coil binding. A new spring can be ordered through a local authorized ZF distributor. To order the properly calibrated spring for the transmission you are working on, obtain the 3 digit number that is pressed into the identification plate (See Chart Below). Saab has this plate mounted on top of the bellhousing and Premiers mount the plate on the side of the case next to the servo. Once the number has been located, cross reference the number in the chart below to obtain the appropriate part number.

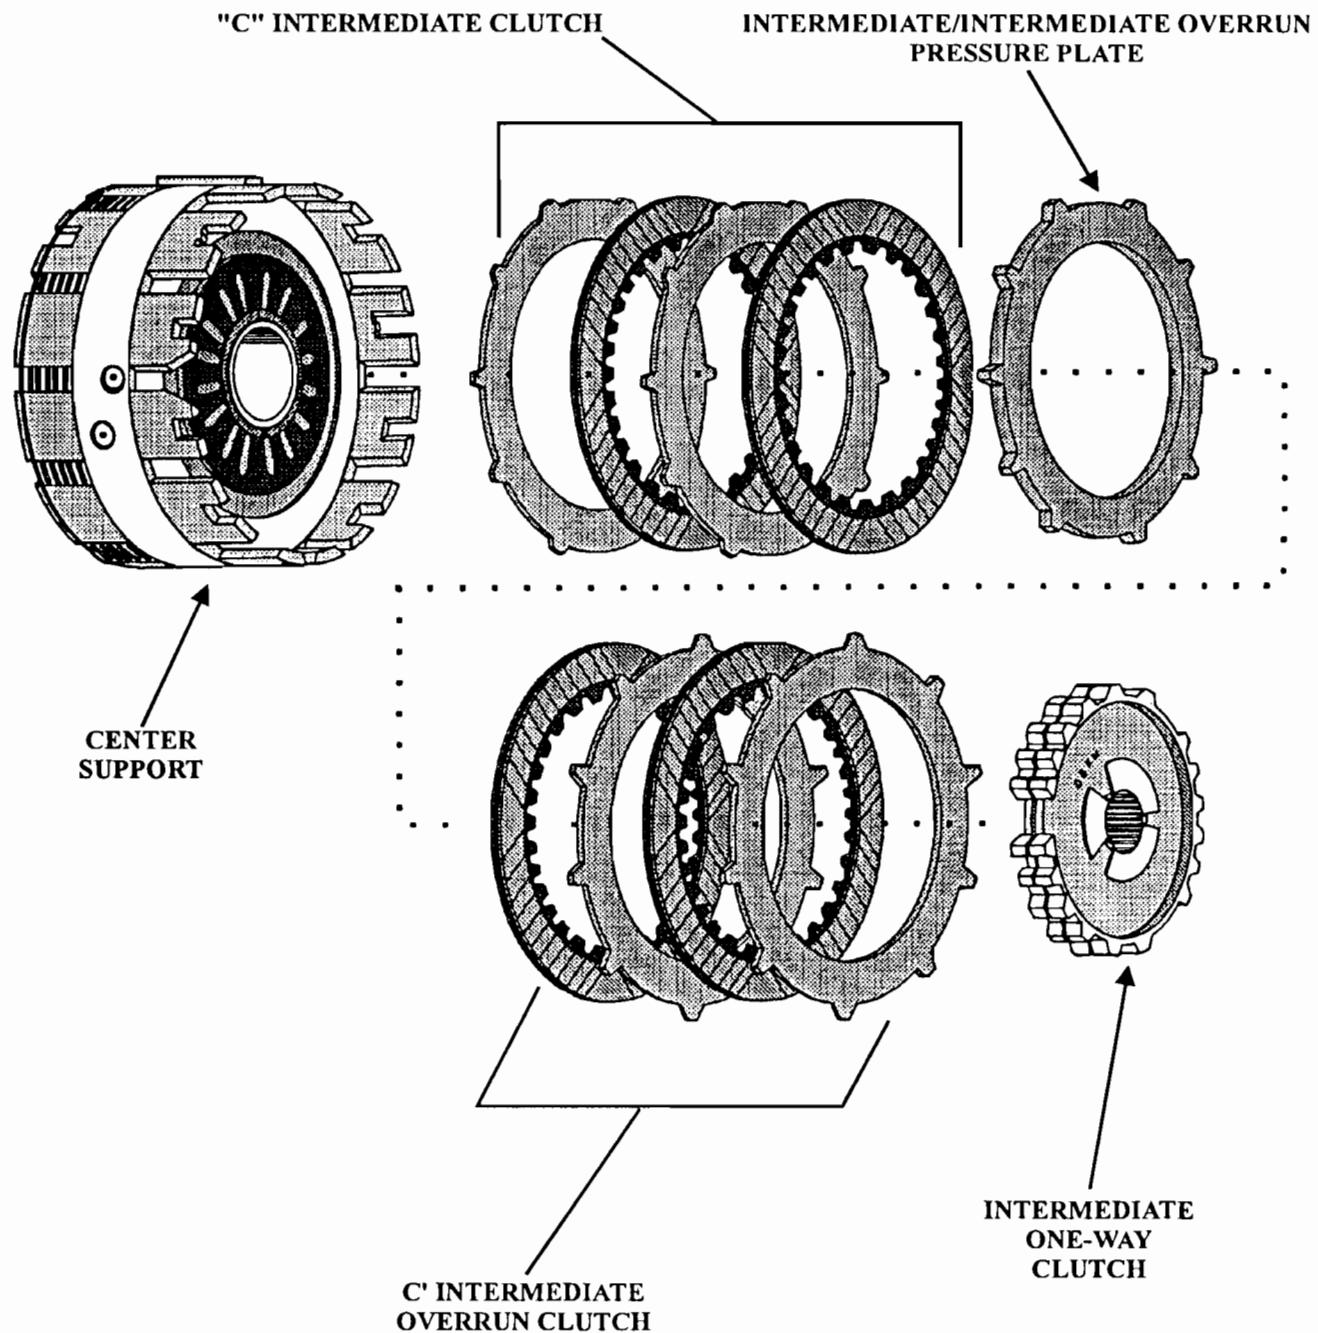
Figure 68

**CAUSE:** A: Incorrectly assembling the intermediate and intermediate overrun friction and steel plates into the front half of the center support assembly will create a space between the intermediate overrun clutches and the intermediate/intermediate overrun pressure plate, depending on where the assembly error was made, causing either of the clutch pistons to over extend its travel, thereby cutting the piston seal on the return travel of the piston. Refer to figure 68 for the correct order of assembly.

**CORRECTION:** A: Refer to the illustration in figure 68 and assemble the intermediate section as follows:

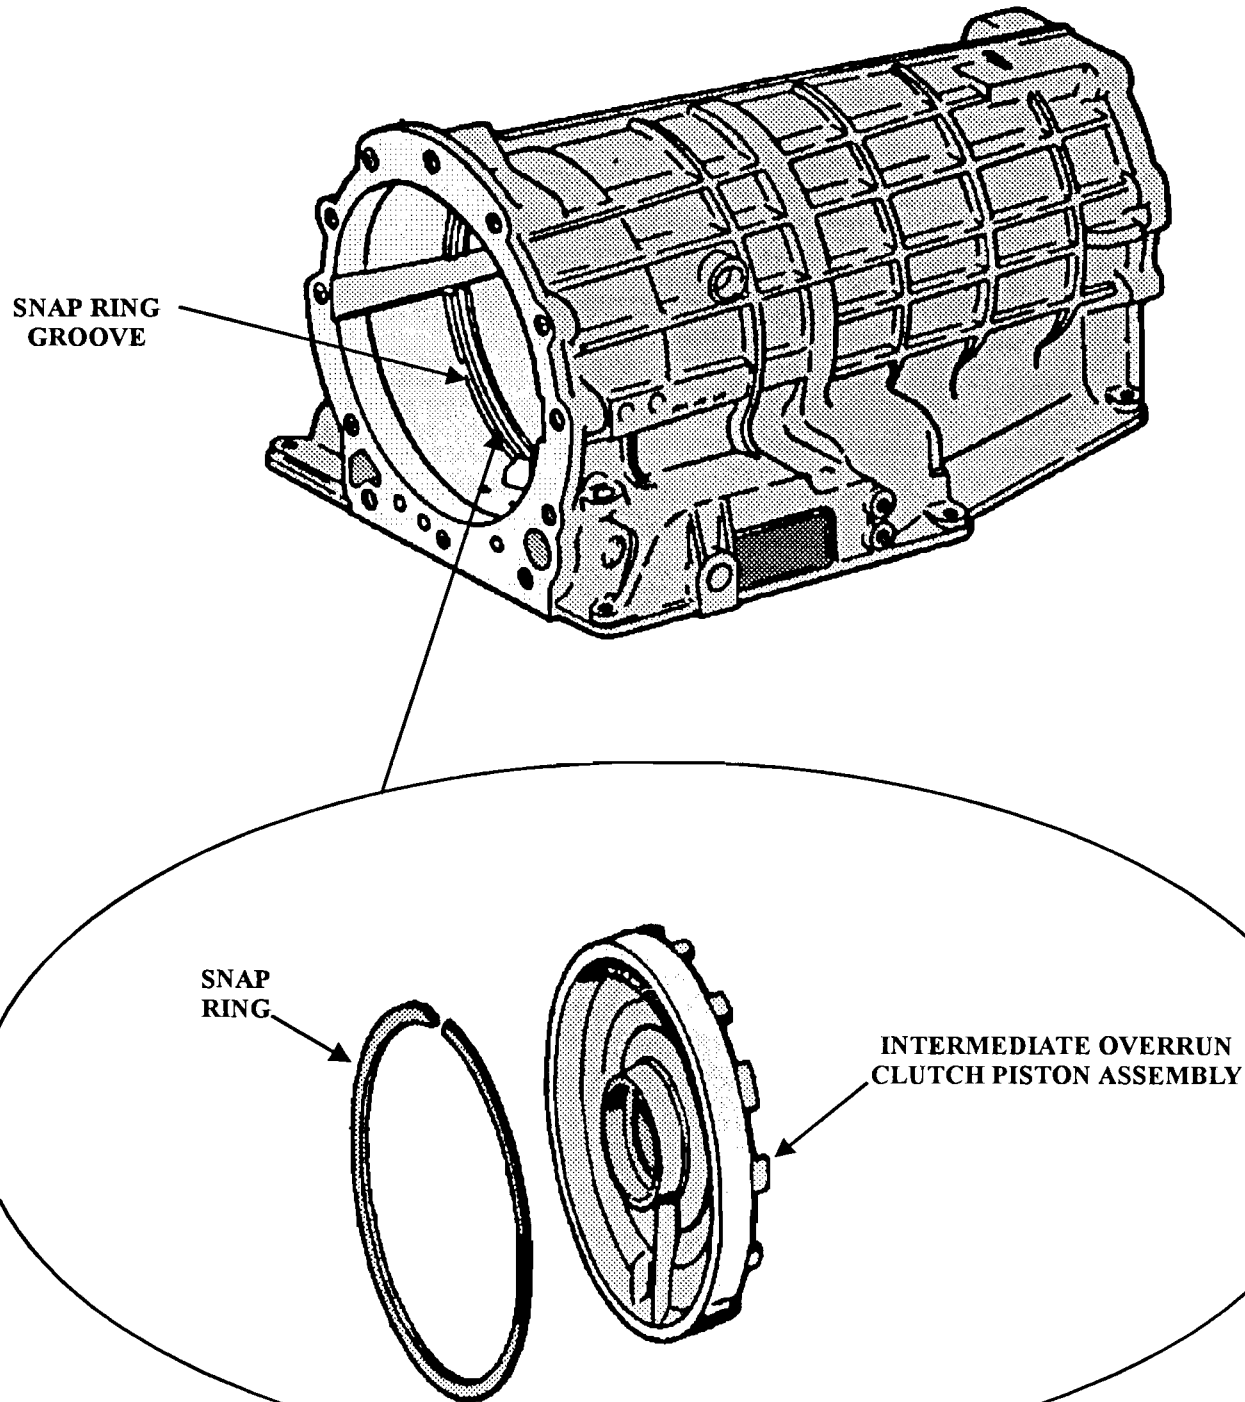
Figure 70

B: When installing the center support assembly into the case, an incorrect stack-up of the components will cause the intermediate overrun piston assembly to be located above the snap ring groove in the case, making it impossible to install the snap ring. (Refer to figure 70)

B: Follow the above procedure, making certain that the snap ring groove in the case is exposed after the center support assembly is installed into the case. (Refer to figure 70)
