1995 SEMINAR INFORMATION  
"HOW TO SURVIVE IN 95"

# "HOW TO SURVIVE IN '95"

## INTRODUCTION

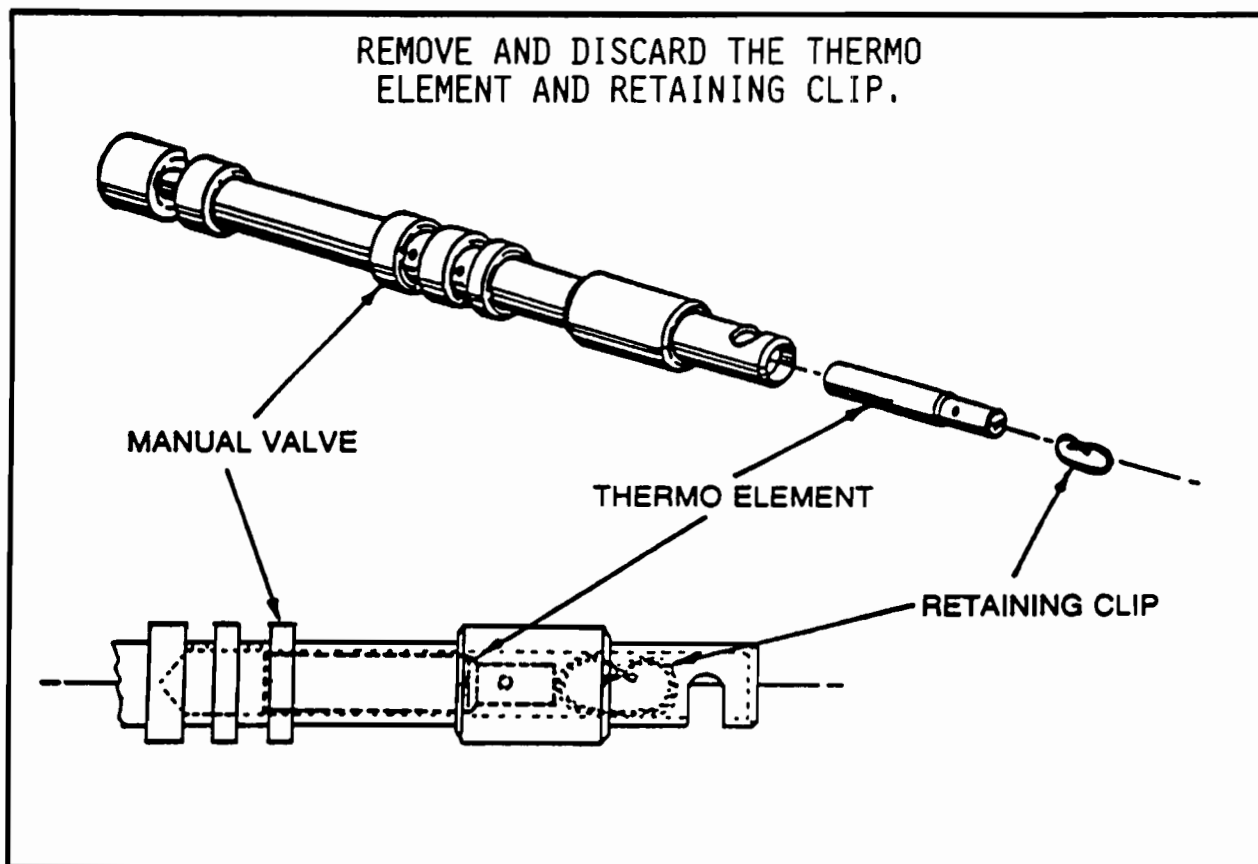
Figure 1

**REASON:** Improved garage shift from "Reverse to Drive" after removal of the thermo element from the manual valve. The thermo element was eliminated from the manual valve in production models effective April 1, 1993, on all models except "A" Car and "T" Car applications (See Figure 1).

**NOTE:** We recommend that the thermo element be removed from the manual valve on ALL models so equipped, and install the conversion package part number listed below.

Removing the thermo element will eliminate premature Lo/Reverse clutch failure (ATSG Bulletin 92-40), and installing the conversion package will restore the proper shift feel from "Reverse to Drive" with the thermo element removed.

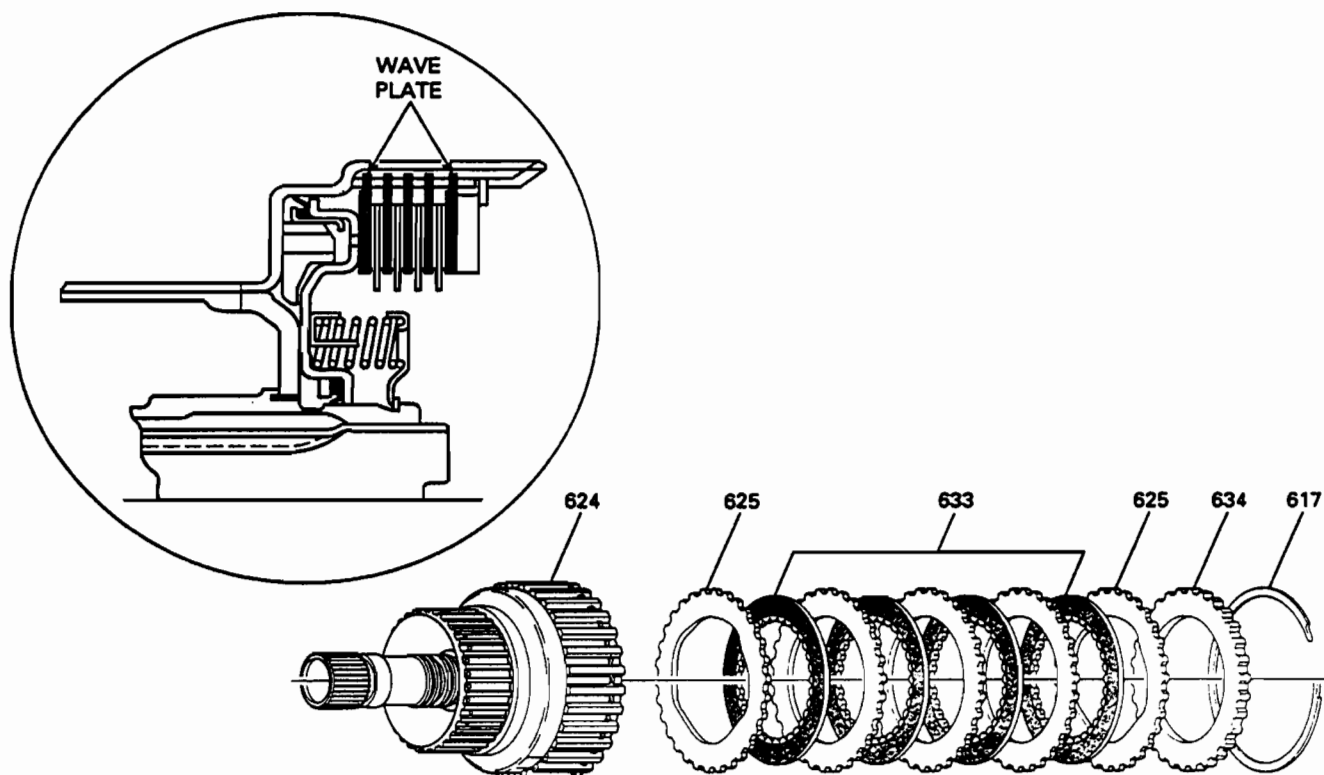
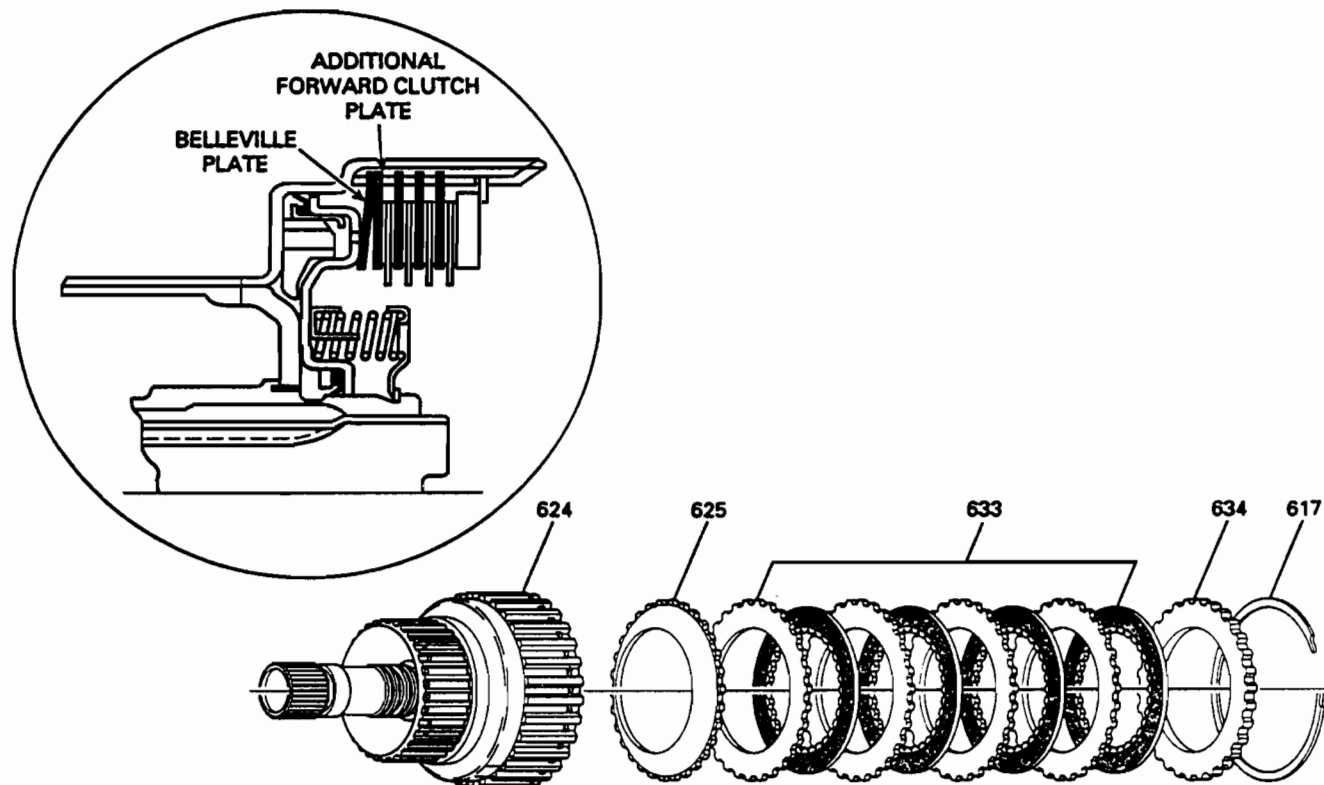
Figure 2

**CHANGE:** Beginning June 24, 1993 (Julian Date 154) ALL 3T40 (125C) transaxles were built with a re-designed Forward Clutch Pack, as shown in Figure 2.

- (1) **WAVE PLATES** - The two previous "Wave" plates have been eliminated, as shown in Figure 2.
- (2) **BELLVILLE PLATE** - Added to the forward clutch pack to replace the two wave plates, and provides more resistance to improve the forward clutch apply feel (See Figure 2).

- (3) **STEEL PLATE** - There is one "Flat" Steel plate added next to bellville plate, as shown in Figure 2.
- (4) **BACKING PLATE** - The backing plate used in the re-designed forward clutch pack happens to be the thinnest of the current design selective backing plates, and was used to make the forward clutch clearance correct. Because of the elimination of the "Wave" plates there is no longer any need for selective backing plates and this backing plate will be used in all models. The backing plate being used is .125"-.131" thick and is stamped "D" for identification.

Forward Clutch Bellville Plate (New Design) .....	8685867
Forward Clutch Backing Plate (Stamped "D") .....	8664163
Forward Clutch Backing Plate Snap Ring (Stronger) .....	8631028
Conversion Kit Service Package (Includes 3 Parts Listed Above) .....	24200477
Forward Clutch Steel Plate (Current Design) .....	8683084

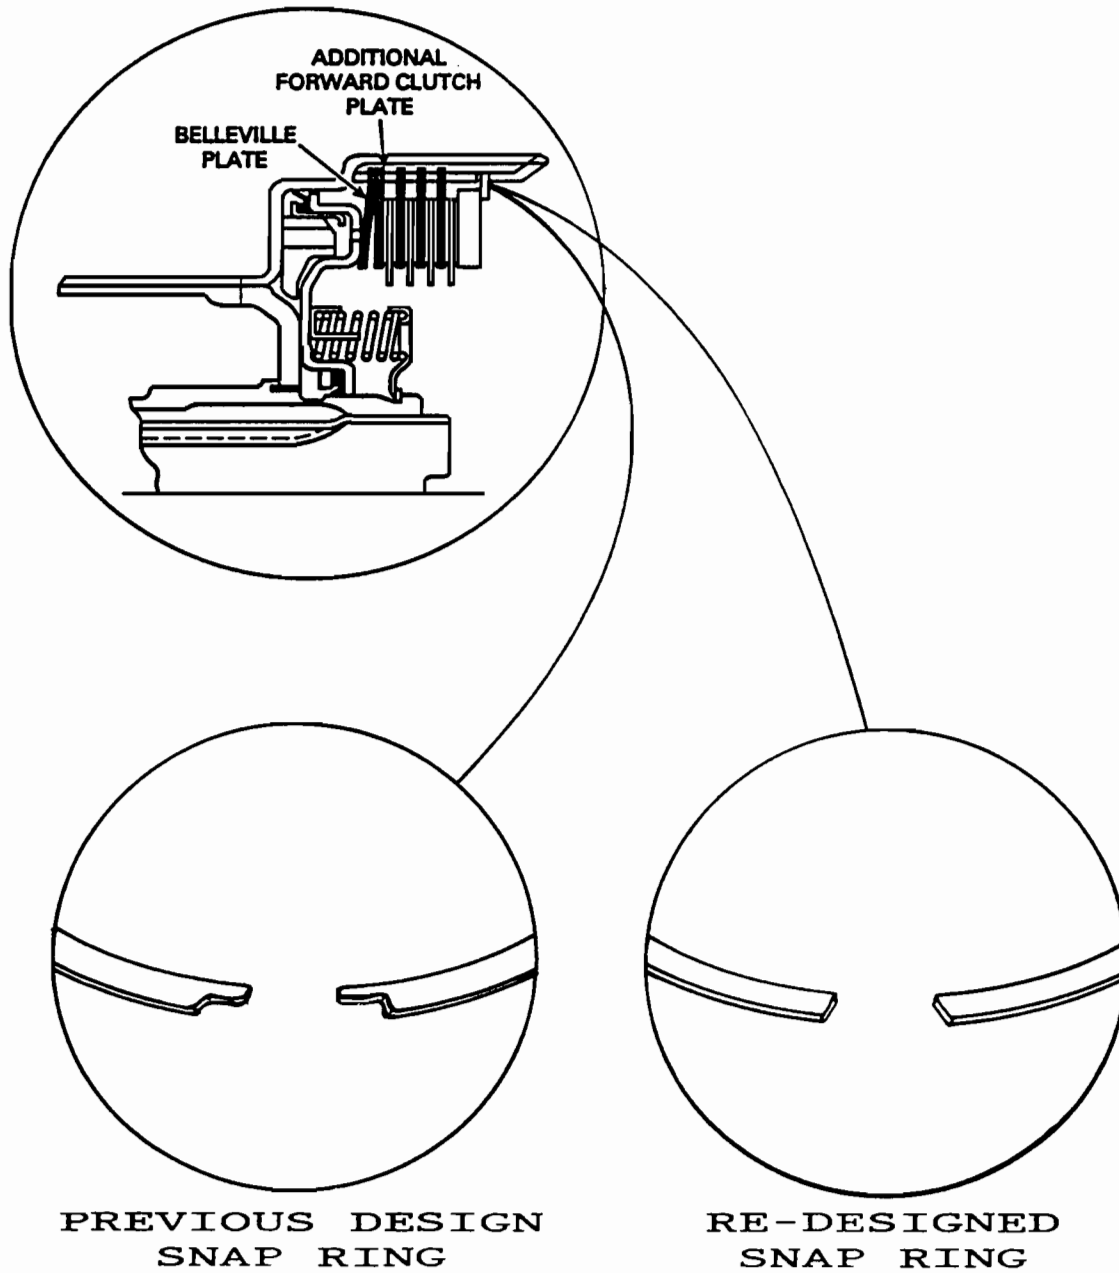
Figure 3

- (5) **BACKING PLATE SNAP RING** - The backing plate snap ring used in the new design forward clutch pack is also a previous design level snap ring that is slightly larger in diameter (Stronger) than the current snap ring, to accomodate the added bellville plate. The stronger snap ring is identified with "Square" cut ends instead of "Stepped" cut ends as shown in Figure 3. The "Stepped" cut snap ring is now used ONLY in the direct clutch pack.

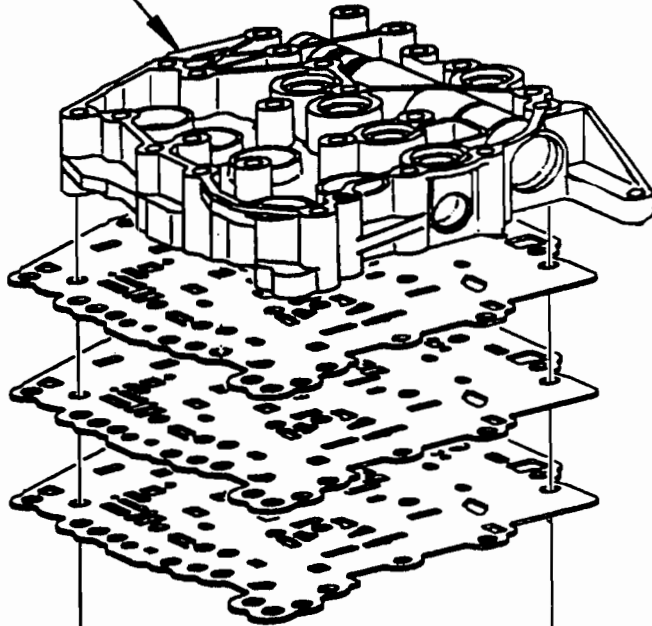
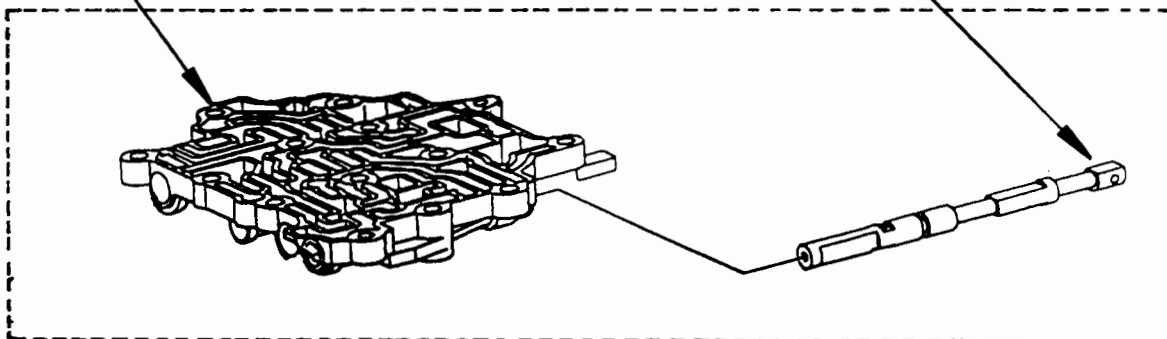
Figure 5

- COMPLAINT: After overhaul, you have a bad grinding noise when the selector lever is placed in reverse, and the vehicle feels as if it wants to move forward.
- CAUSE: The cause may be, the manual valve installed improperly, with the "Flat" oriented so that it is facing down towards the case.
- CORRECTION: Remove the valve body and rotate the manual valve so that the "Flat" is facing UP TOWARDS THE TOP PAN, as shown in Figure 5. Re-install the valve body and torque to proper specifications.

MANUAL VALVE SHOULD BE INSTALLED WITH  
THE "FLAT" FACING UP TOWARDS THE TOP  
PAN AS SHOWN IN THIS ILLUSTRATION.

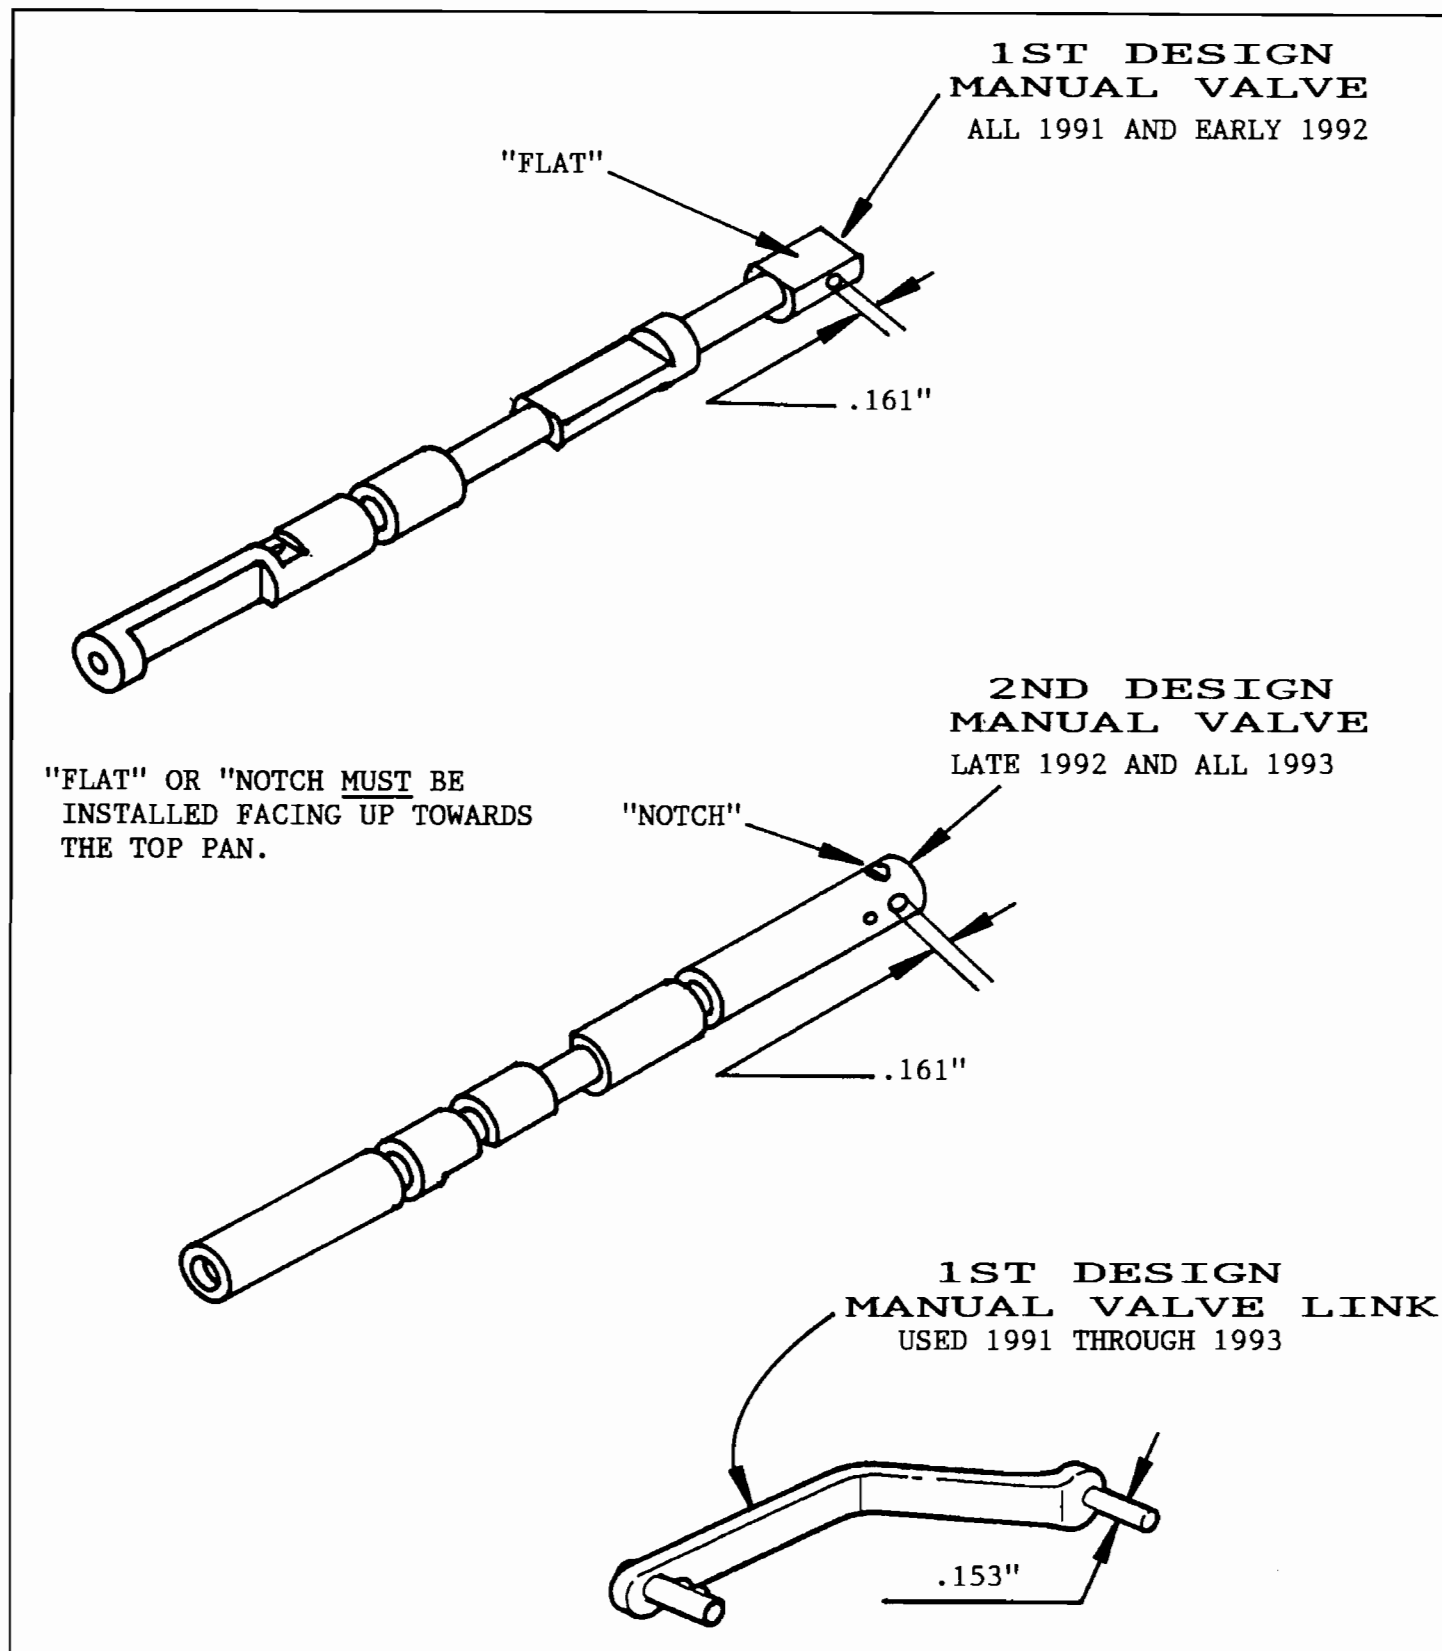
Figure 6

2nd design Manual Valve installed improperly with the "Notch" facing down towards the case. The "Notch" MUST face up towards the top pan (See Figure 6).

1st design "Stamped Form" Manual Valve Link is used on all 91-93 models, and the stem diameter is .153" (See Figure 6).

On ALL 1991 to 1993 models, remove the valve body and orient the Manual Valve with the "Flat" (1st Design) or "Notch" (2nd Design) on the Manual Valve facing UP TOWARDS THE TOP PAN, as shown in Figure 6. Reinstall the valve body and torque to proper specifications.
