AUTOMATIC TRANSMISSION SERVICE GROUP

REVISED EDITION

Since the introduction of the THM 440-T4 Transaxle in April, 1984, there have been many major engineering design changes. These changes have affected nearly every part used in the THM 440-T4. This Update Handbook will explain each change, the parts affected by the change, and any parts interchangeability problems created by the change.

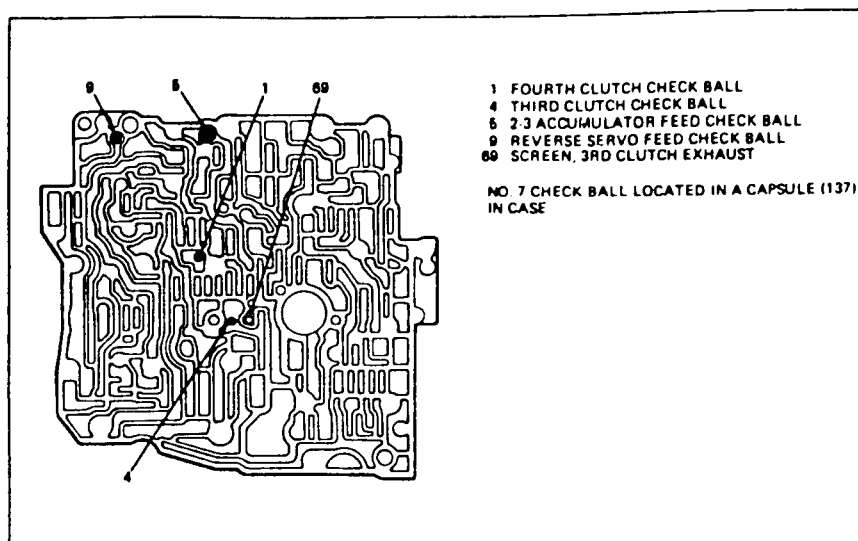
Figure 11 (1985 1/2-up)

Refer to Figure 11 for 1985 1/2 and up locations. Notice that the number 5 check ball moved, and at the same time became larger in diameter. 1985 1/2 and up, the No. 5 check ball is 3/8" diameter. All of the others are 1/4" diameter.

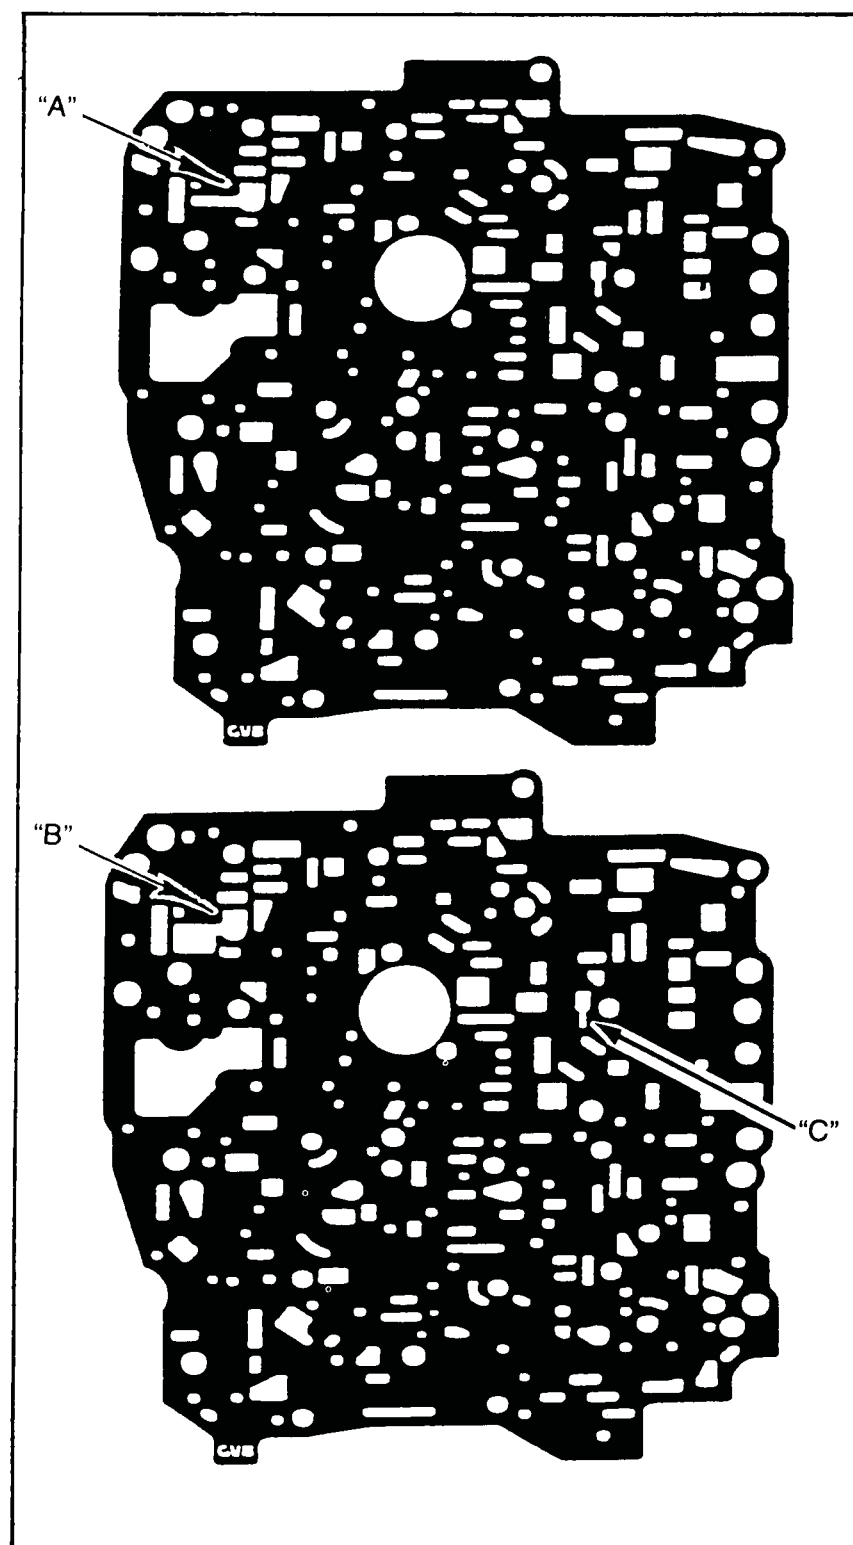
Note the difference in the "Pipe Stem" between "A" and "B", Figure 16. This change occurred about Oct. 1985.

In June 1987 the "Finger" shown at "C", Figure 16 was made Approx. .020 wider.

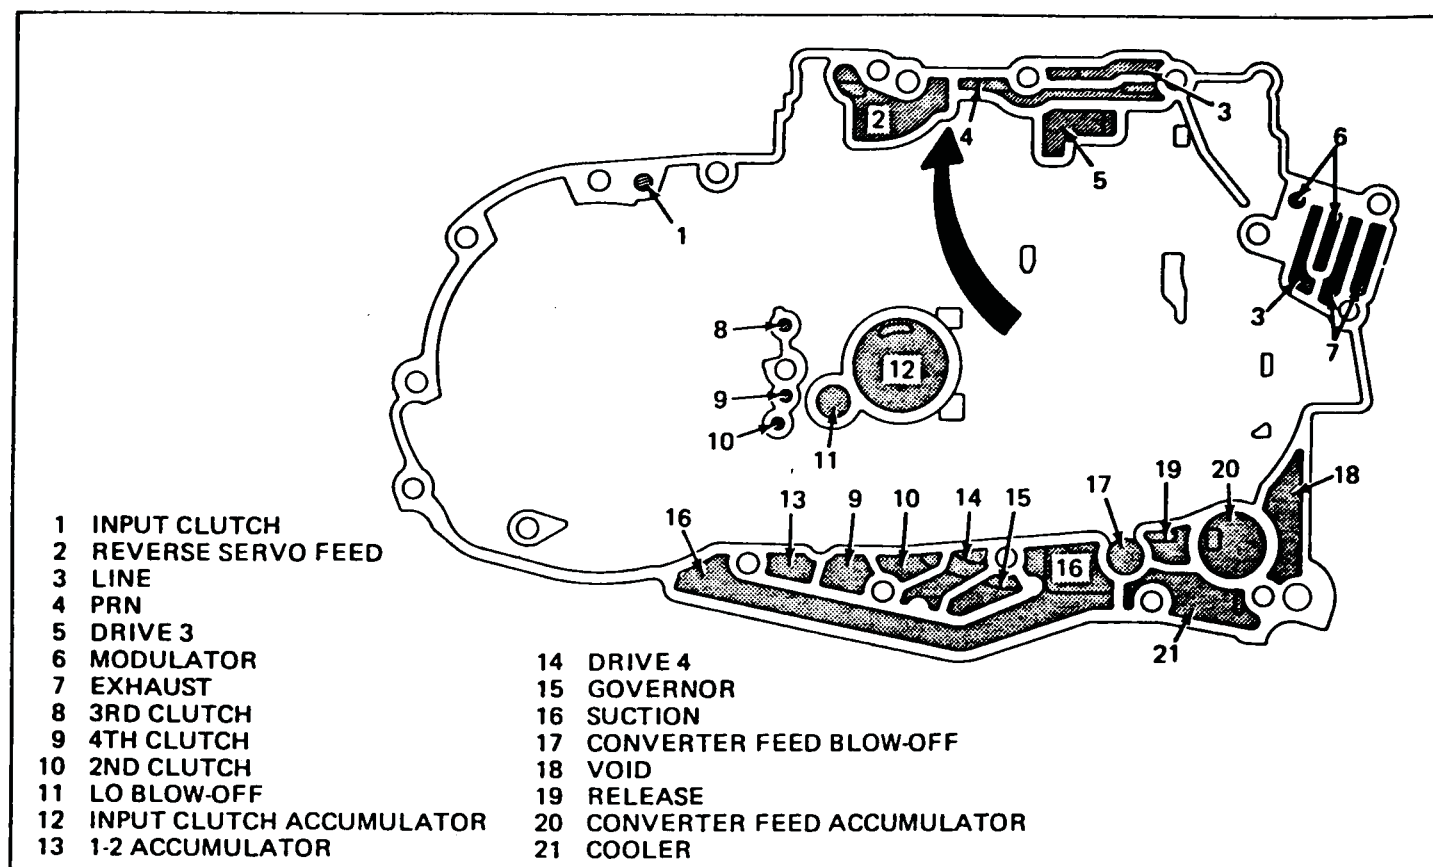
Figure 17 (1985 Only)

Identification: The easiest way to identify the channel plates apart is the location of the dam in the upper channel plate worm track area. (See Figure 17 and Figure 18). The dam was moved to an area directly under the upper dowel pin bore.

If the second design gasket (See Figure 10), is used on the 1985 channel plate (Figure 17), it allows PRN oil to enter the reverse servo feed circuit and applies the reverse band. The end result will be, that the transaxle will be in reverse and park at the same time because we also have the input clutch on in park in the 440-T4.

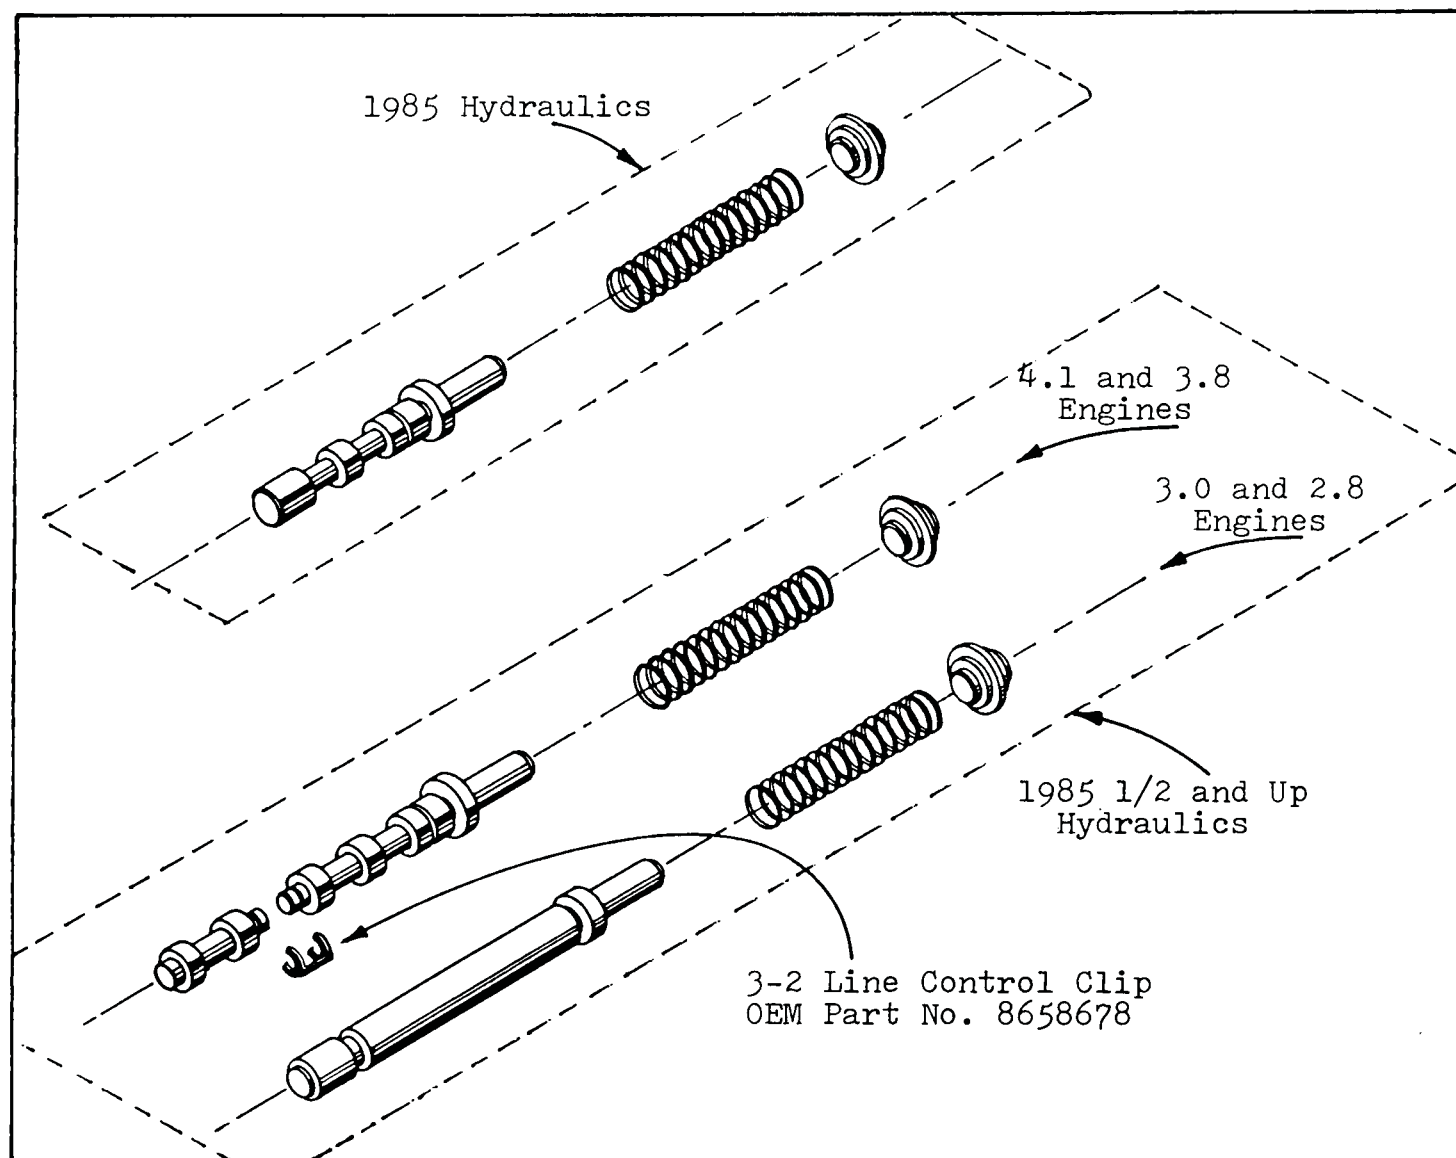
Figure 21

- 2) The 3-2 line control valve located in the channel plate (See Figure 20 For Location), was changed from a single valve, to a two piece valve (See Figure 21). The 2 piece is connected together with a small clip that has a bad habit of breaking, and will create no 3-2 downshift.

Also notice (See Figure 21) that there are 2 line ups for the 85 1/2 and up models. The 2 piece 3-2 line control valve is used on 4.1 Cadillac, and 3.8 Buick engines. The "Plug" that is also shown (Figure 21), is used on 3.0 Buick, and 2.8 Chevrolet engines.

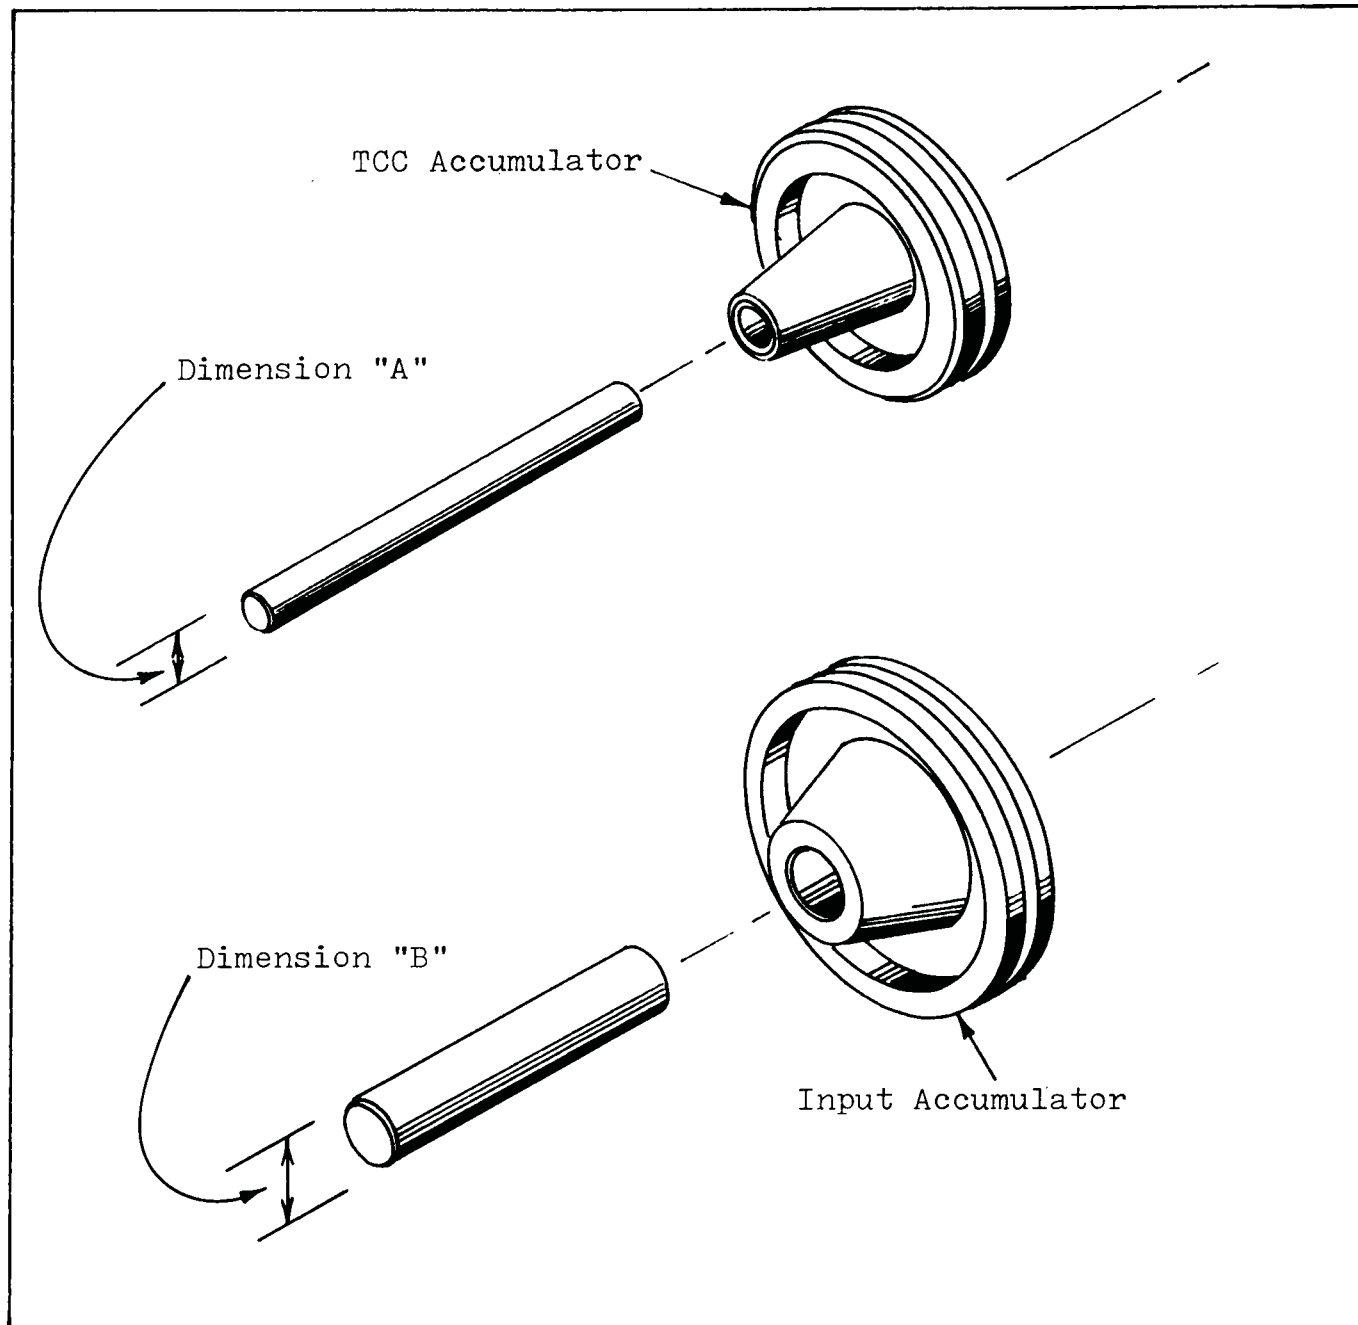
Figure 23

In mid 1985 the dimensions of both the TCC accumulator pin and piston, and the input accumulator pin and piston changed. We have included the dimensions of both early and late for identification purposes. (See Figure 23).

EARLY .309 Inches
LATE .314 Inches

When the TCC accumulator pin is worn, or mismatched, TCC shudder is the result.

When the input accumulator pin is worn, or mismatched, input clutch durability is drastically reduced.

Obviously you would not be able to install the late pin into the early piston, but you could go the other way very easily. Make sure you measure these pins and "Always" up-date to the larger 2nd design.

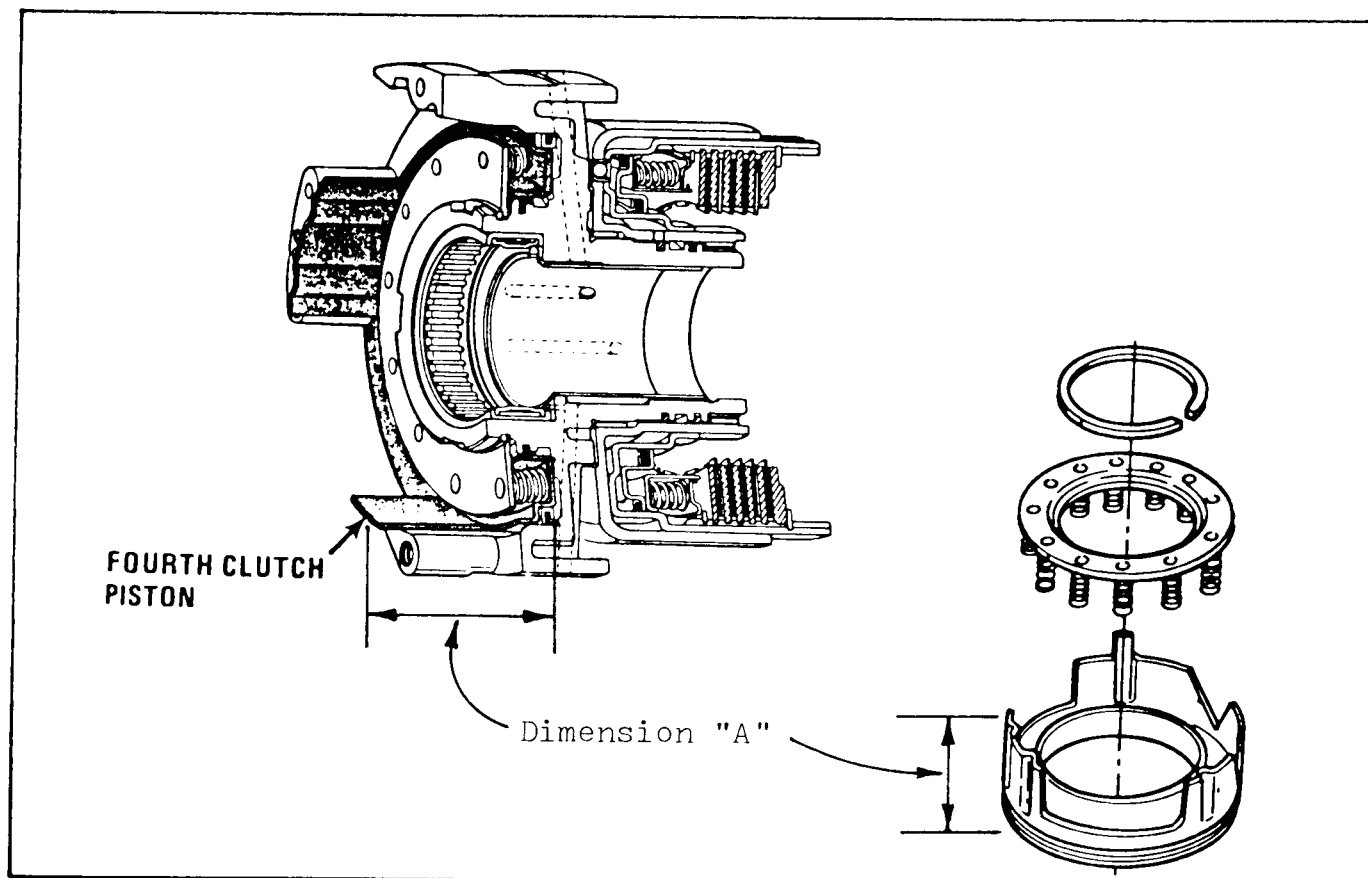
Figure 26

To identify, use a dial caliper set, and locked, at 1.930" and check as shown at dimension "A" in Figure 26. If dial caliper will go over the top of the piston, you have the late style piston.

If not put together with compatible parts, the fourth clutch will burn immediately.

If the dial caliper will not go over the top of the piston, the 4th clutch piston will have to be replaced with OEM part No. 8658388.

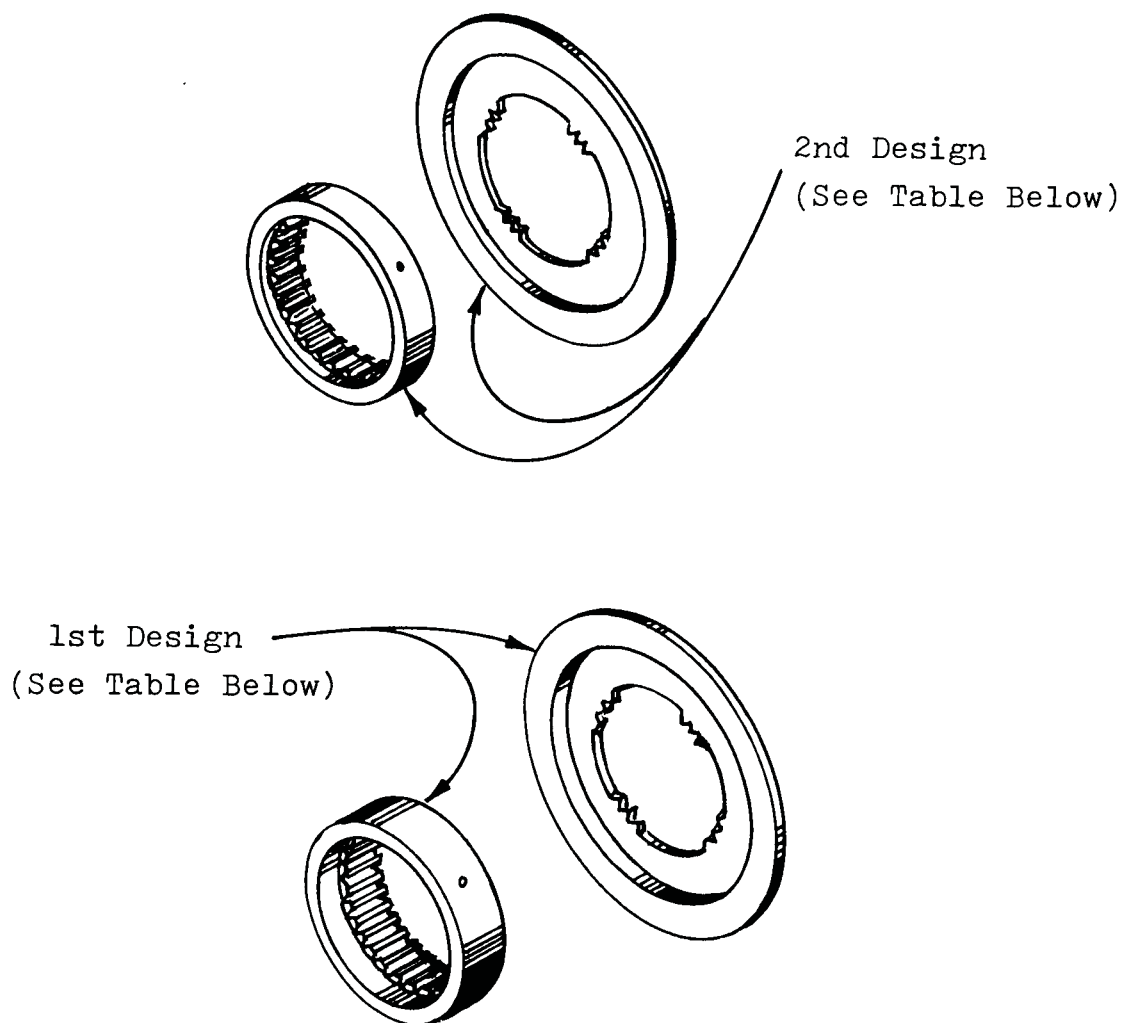
Figure 49

- 1) Input Sprag Assy(653) - Length of sprags increased by .095" and redimensioned end plates.
- 2) Outer Race(654) - Wider by .050".
- 3) Inner Race(650) - Wider by .142".
- 4) Retainer(655) - Shallower by .065" (See Figure 49).
- 5) Spacer(657) - Thinner by .142" (See Figure 49).
- 6) Input Carrier(622) - Shoulder machined down to shorter dimension (See Figure 46).

EARLY	LATE
Individual Sprags(653)	.095" Wider	.305"	.400"
Outer Race(654)	.050" Wider	.964"	1.014"
Inner Race(650)	.142" Wider	.790"	.932"
Retainer(655)	.065" Shallower	.140"	.075"
Spacer(657)	.142" Thinner	.495"	.353"

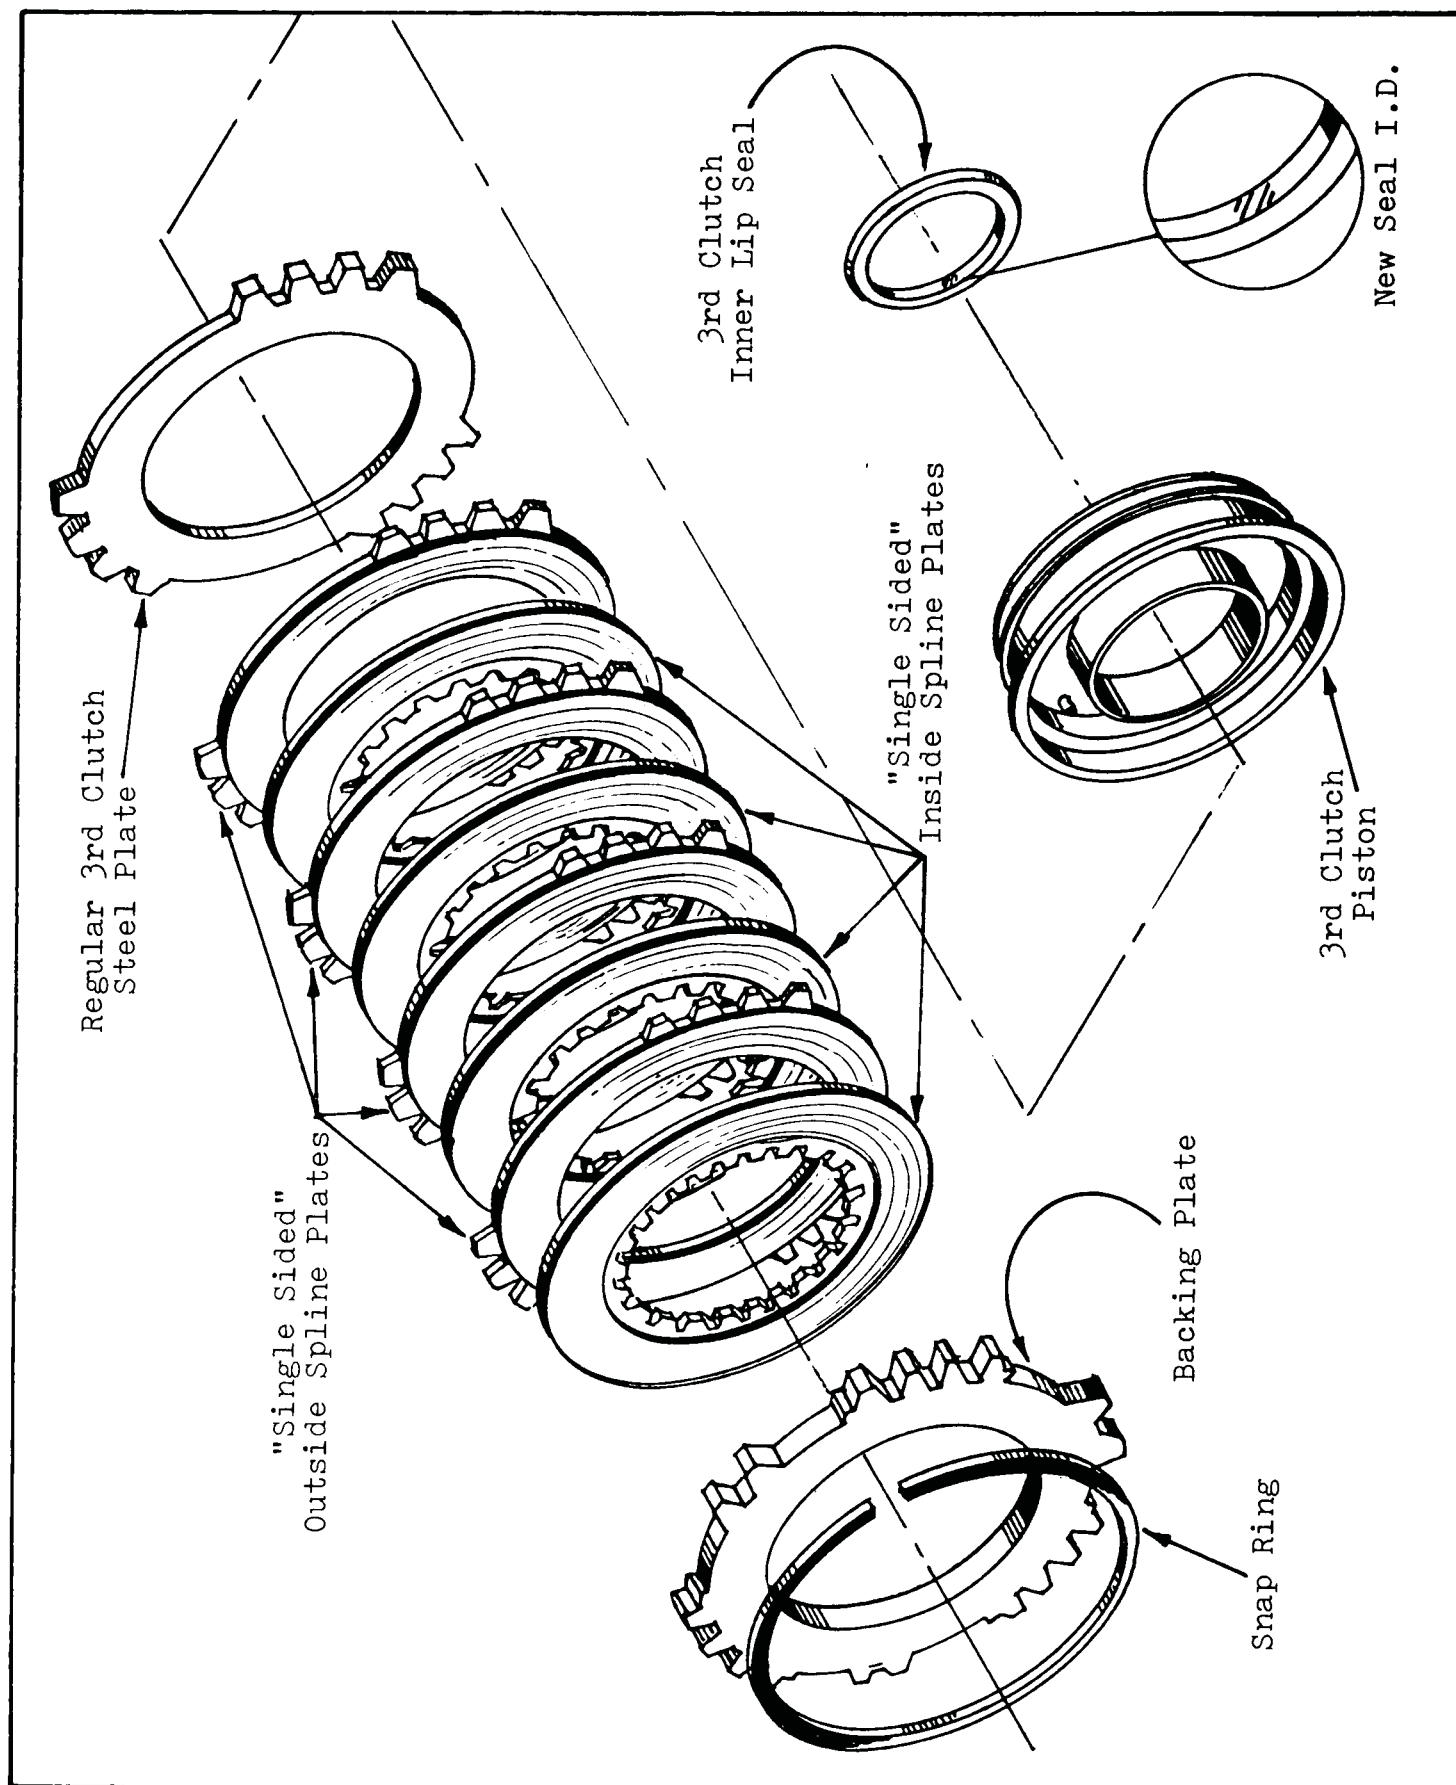
Figure 51

1st Change: Single Sided 3rd Clutch Plates - Lining on one side only both inside and outside spline plates (See Figure 51).

Will retro fit backwards, and is recommended, as long as proper assembly procedures are used.

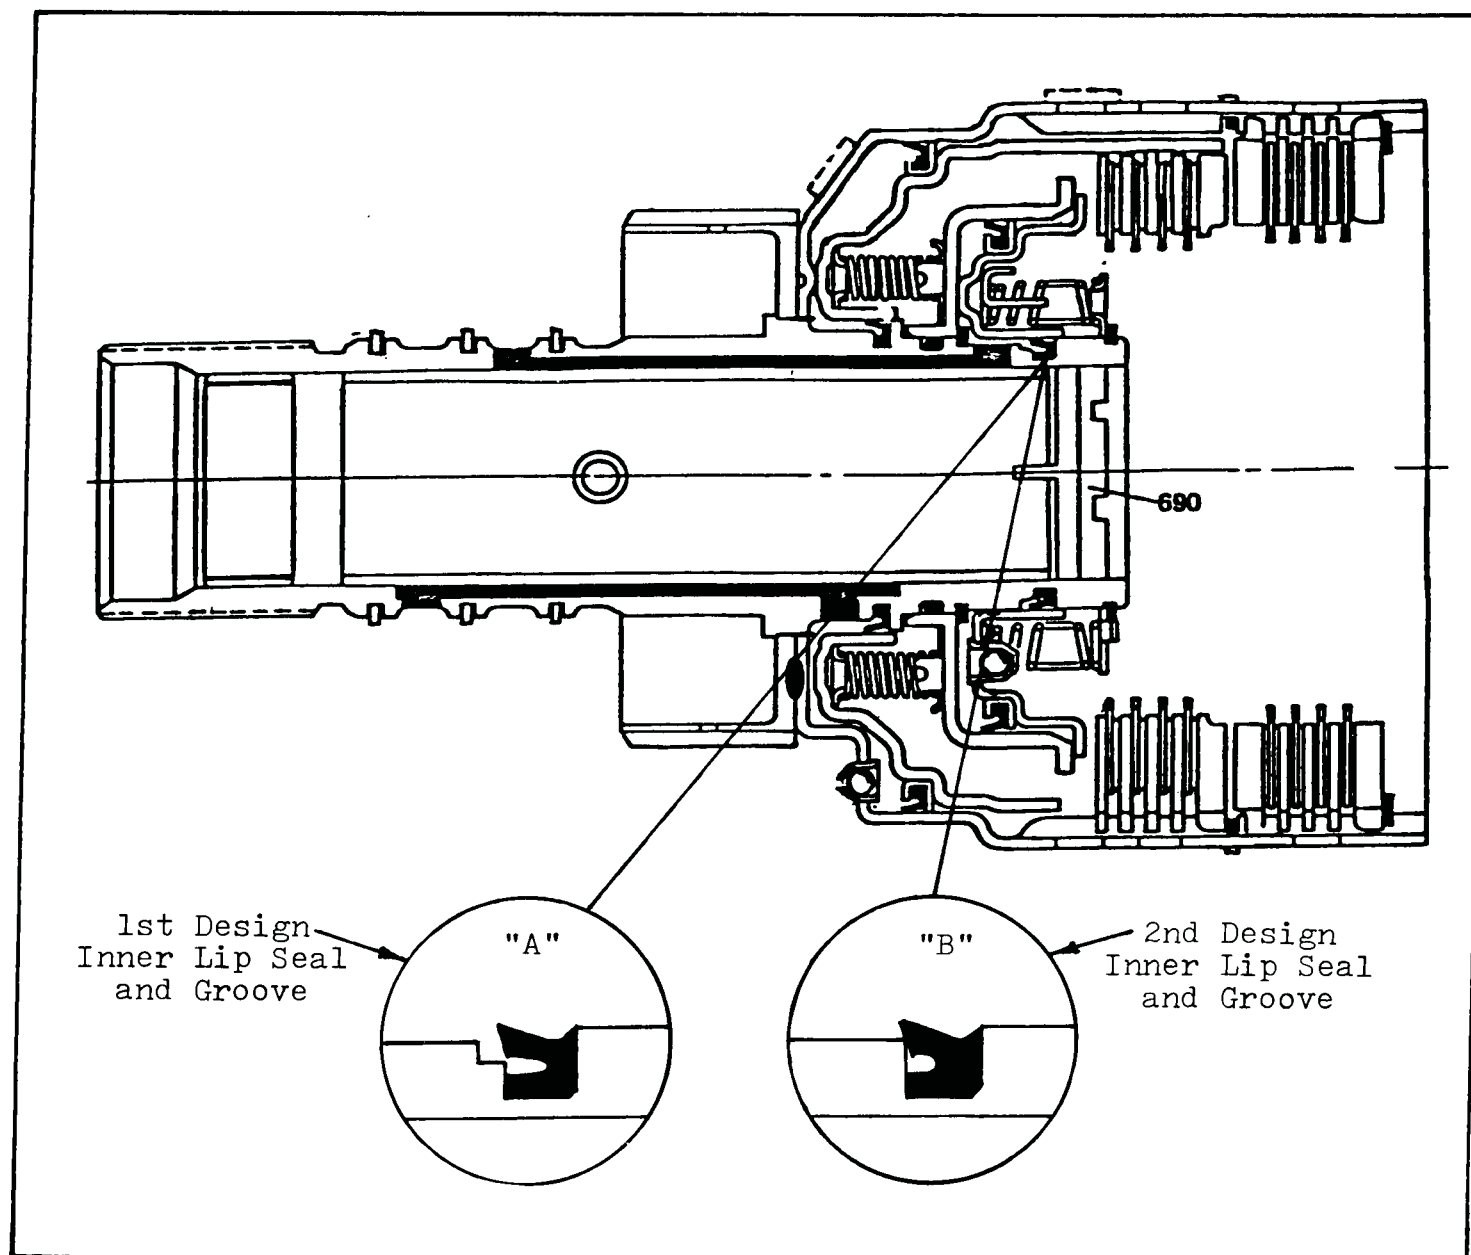
Figure 52

- 1) 3rd Clutch Inner Lip Seal - Thicker profile to help prevent seal from rolling (See Inset, Figure 52).

Will retro fit backwards, and is recommended. New OEM Part No. is 8662673 on the new 3rd clutch lip seal. For positive identification of the new seal, check for hash marks on inside diameter of lip seal (See Inset, Figure 51). For difference in profile compare Inset "A" and "B" in Figure 52.

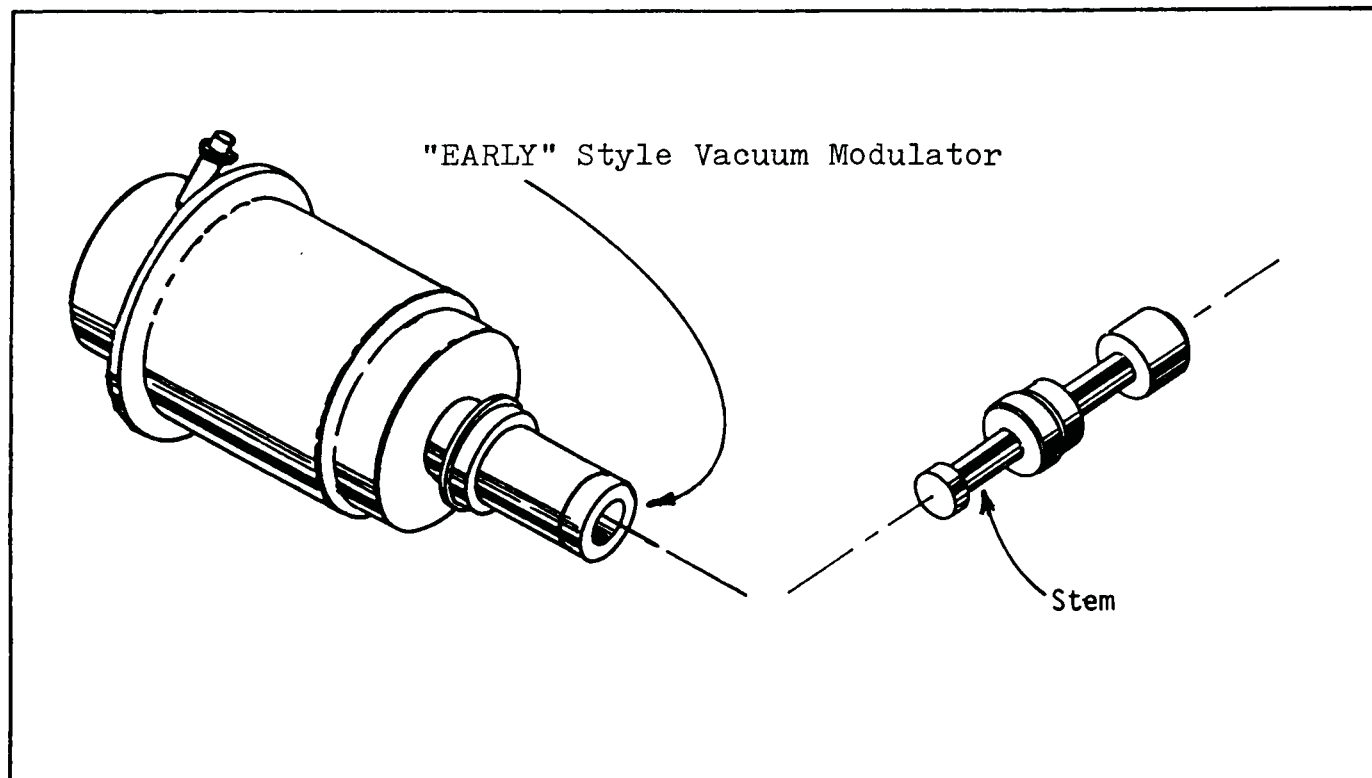
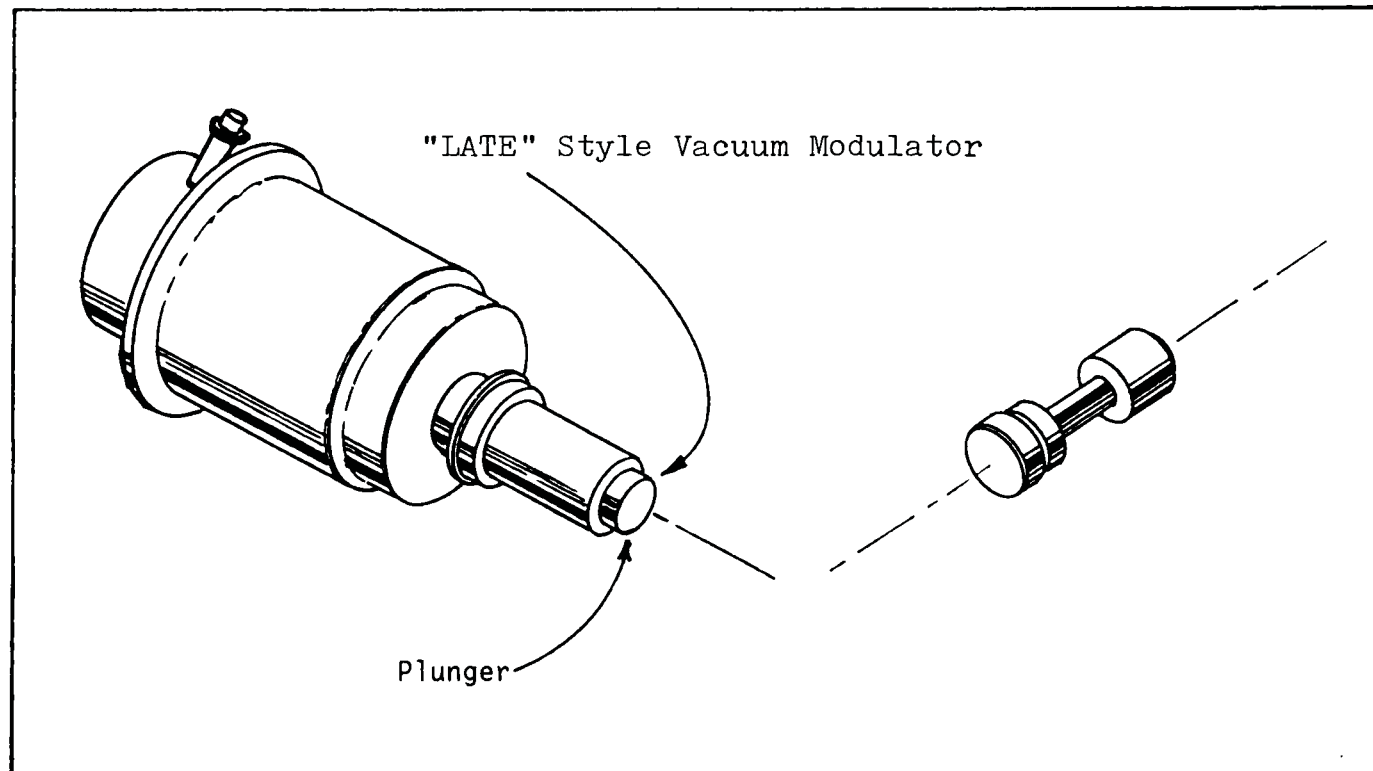
- 1) Vacuum Modulator - Late design has plunger sticking out of modulator (See Figures 54 and 55).
- 2) Modulator Valve - Redesigned to be compatable with "Plunger" style modulator. (Stem Removed--See Figures 54 and 55).
- 3) Channel Plate - Orificed cup plug added to channel plate to stabilize modulator valve action (See Figure 53).

CAUTION: Be certain, if changing modulators, that you have compatable parts together. You cannot install the late style modulator on top of the early style valve, but you can go the other way very easily.

If you install the early style modulator on top of the late style valve, you lose all modulator boost, and clutch damage will occur in about 15 minutes of normal vehicle operation.

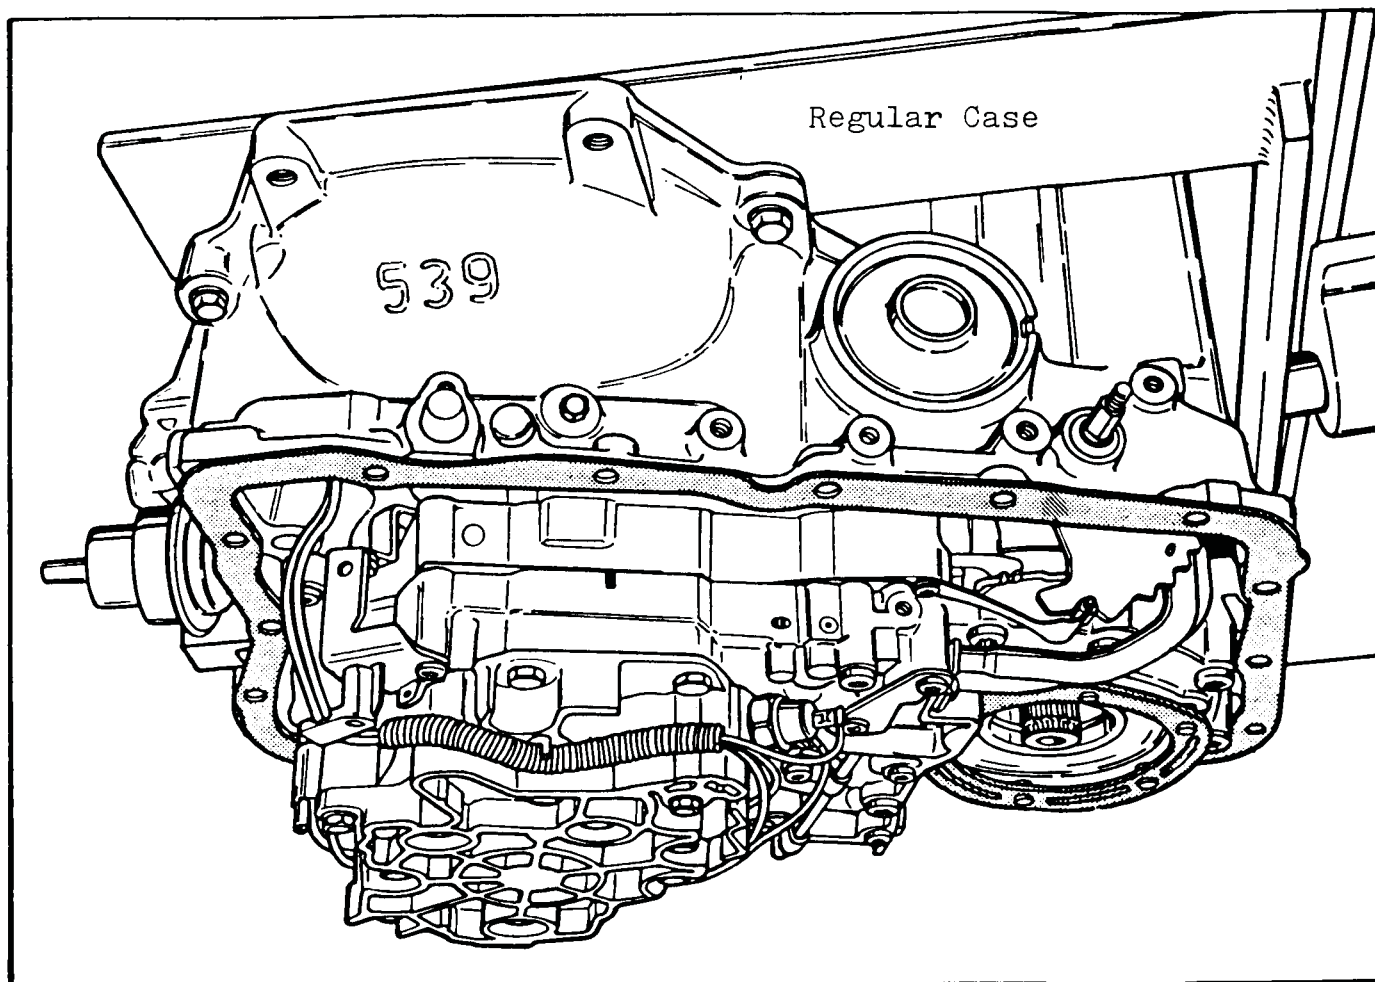
- 1) Transaxle Case - 3 bosses added to the case assembly (See Figures 56 and 57). The larger bosses on top of the case are for mounting purposes in the "E" and "K" bodies only. The smaller boss is for fuel line bracket in the "E" and "K" bodies only (See Figure 56). We can immediately see why it is called the E/K case.
- 2) Manual Shaft - The manual shaft is 1/4" longer on the E/K cars only.

Will retro fit backwards, but would not be smart to waste an E/K case on a non E/K vehicle, as they are in short supply.

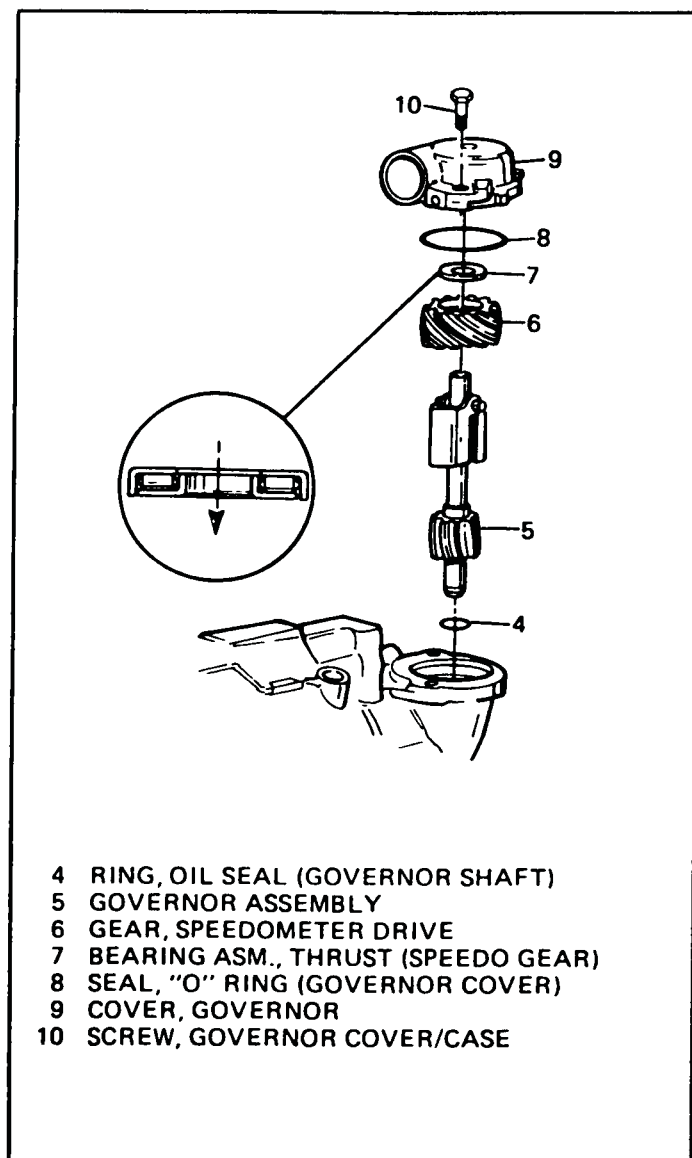
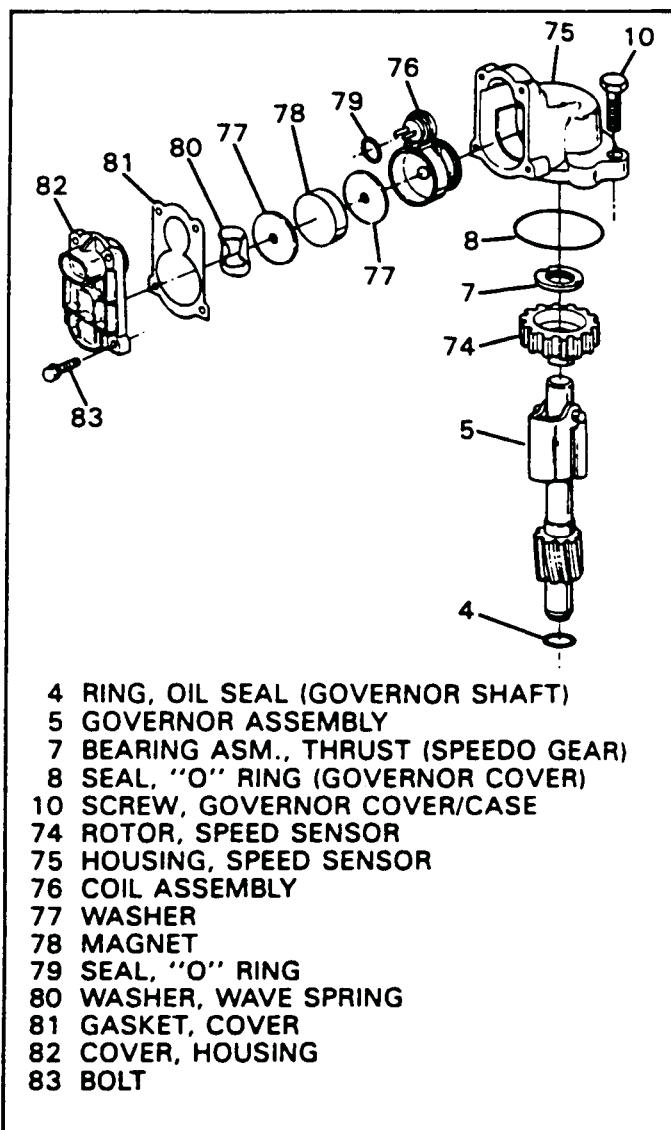
- 1) Governor Cover - Redesigned and speed sensor added to governor cover (See Figures 58 and 59).
- 2) Speedometer Gear - Replaced by 14 tooth rotor (11 Tooth on Allante) That is pressed on governor shaft (See Figure 59).

Not Interchangeable.

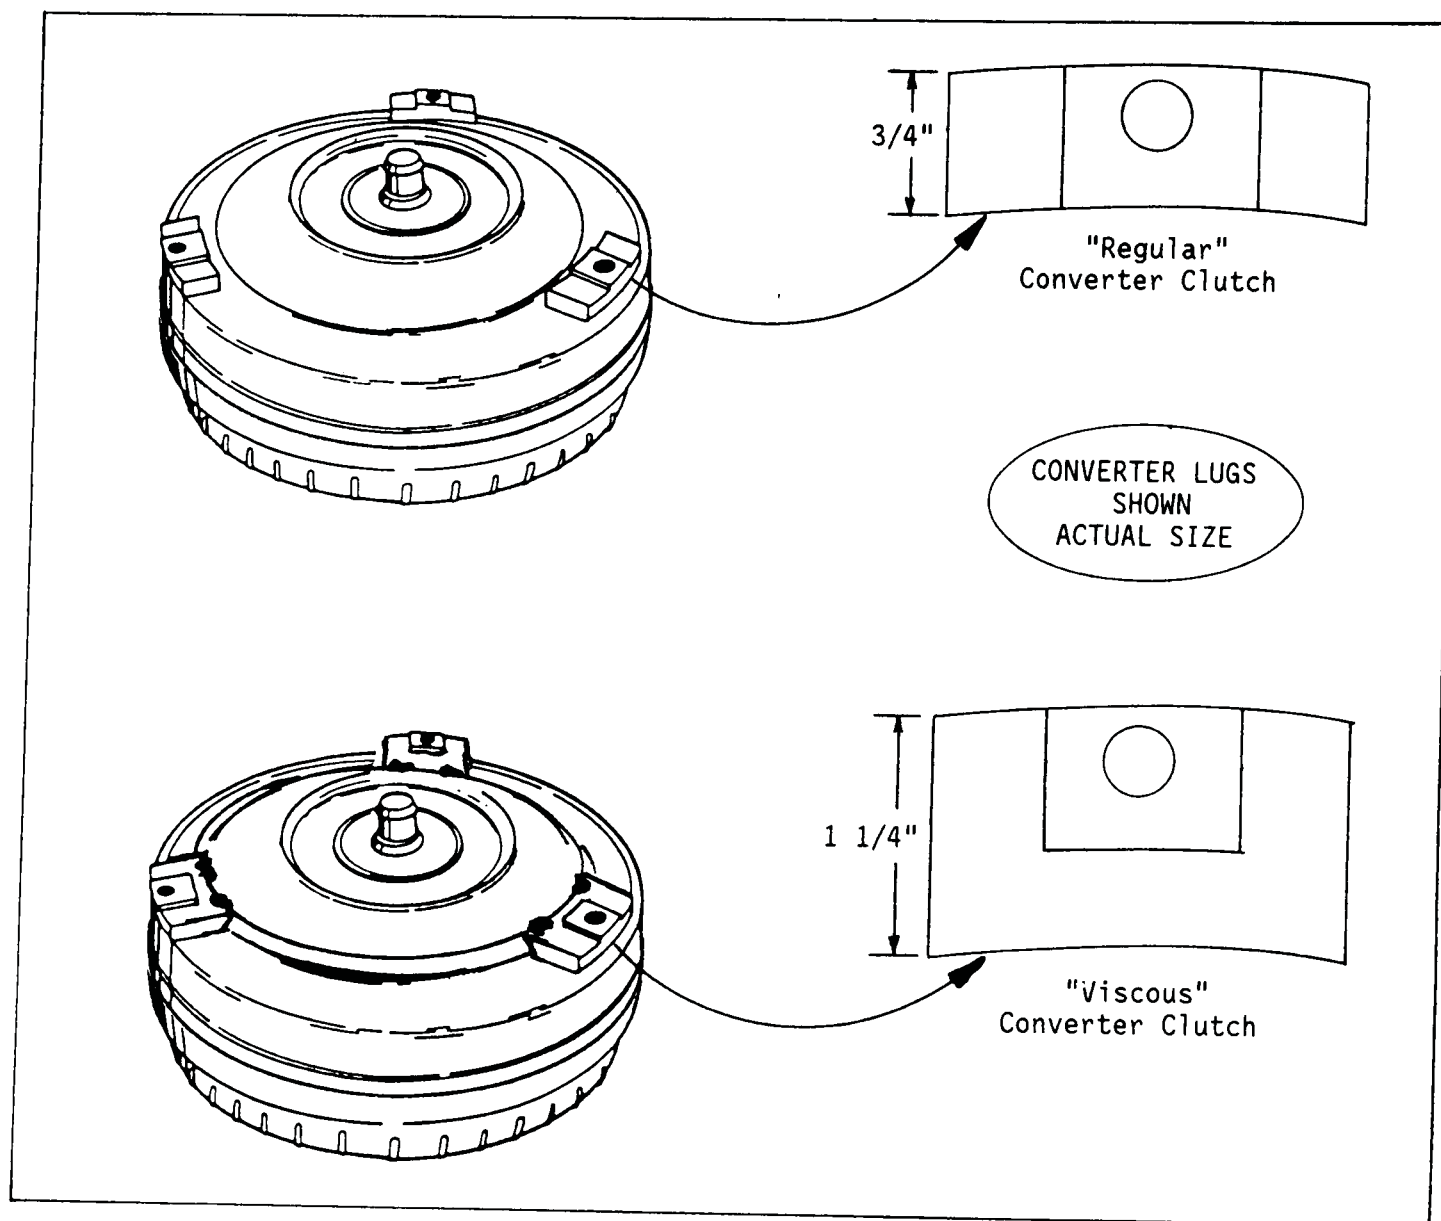
Figure 60

Identification of the "VISCOUS" converter from the "REGULAR" converter, can be done very easily externally. Notice the difference in the size of the converter drive lugs (see Figure 60). The profile of the converter covers are also different, but takes a closer look to detect, than do the drive lugs.

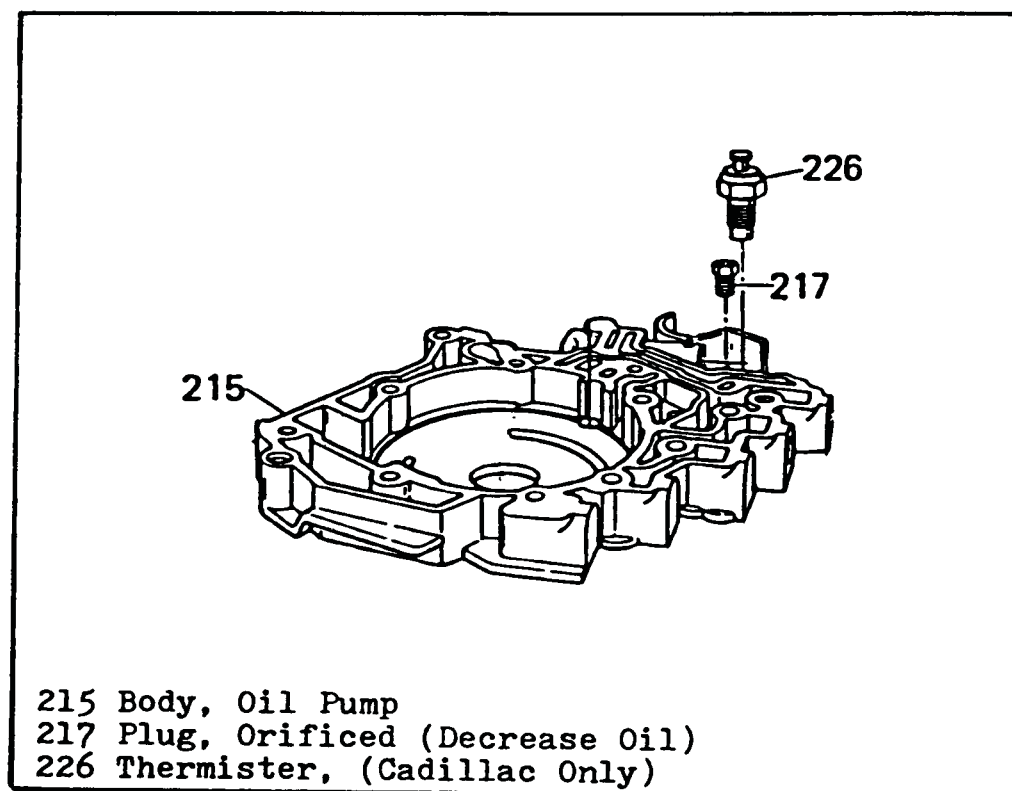
Figure 72

- (1) Thermister - Removed from pump housing (See Figure 72).
- (2) Temperature Switch - Eliminated (See Figure 73).
- (3) Cooler Line - Temperature Sensor added (See Figure 74).
- (4) Case Connector - "E" terminal that normally carried the thermister wire is now empty (See Figure 75).
- (5) Vehicle Wiring Harness.

NOTE: SOME EARLY 1988 CADILLAC MODELS MAY HAVE "NO" COOLER FLOW CREATED BY NEW TEMPERATURE SENSOR IN COOLER LINE. CHECK COOLER FLOW ON "ALL" 1988 CADILLAC MODELS AND REPLACE COOLER LINE ASSEMBLY WITH OEM PART NUMBER 25036979 IF NECESSARY.
