AUTOMATIC TRANSMISSION SERVICE GROUP

REVISED EDITION

Since the introduction of the THM 440-T4 Transaxle in April, 1984, there have been many major engineering design changes. These changes have affected nearly every part used in the THM 440-T4. This Update Handbook will explain each change, the parts affected by the change, and any parts interchangeability problems created by the change.

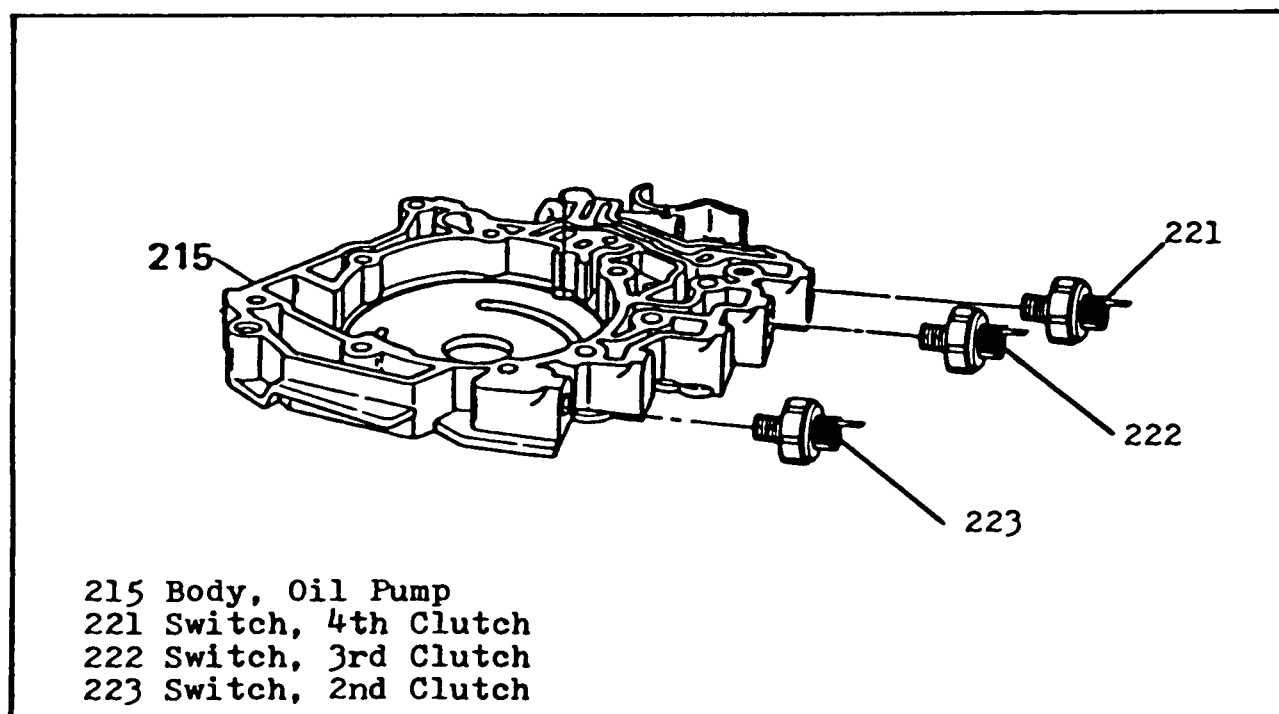
Figure 76

- (1) Pump Body - Drilled and tapped for 2nd clutch switch.
(See Figure 76).
- (2) Valve Body - Extra hole drilled in valve body to carry 2nd clutch oil to pump body.
- (3) Case Connector - Now round black connector (Same as Cadillac), and "E" terminal now carries 2nd clutch signal wire (See Figure 77).
- (4) Transaxle Wiring Harness - Extra wire in harness for 2nd clutch signal to ECM (See Figure 77).
- (5) Vehicle Wiring Harness

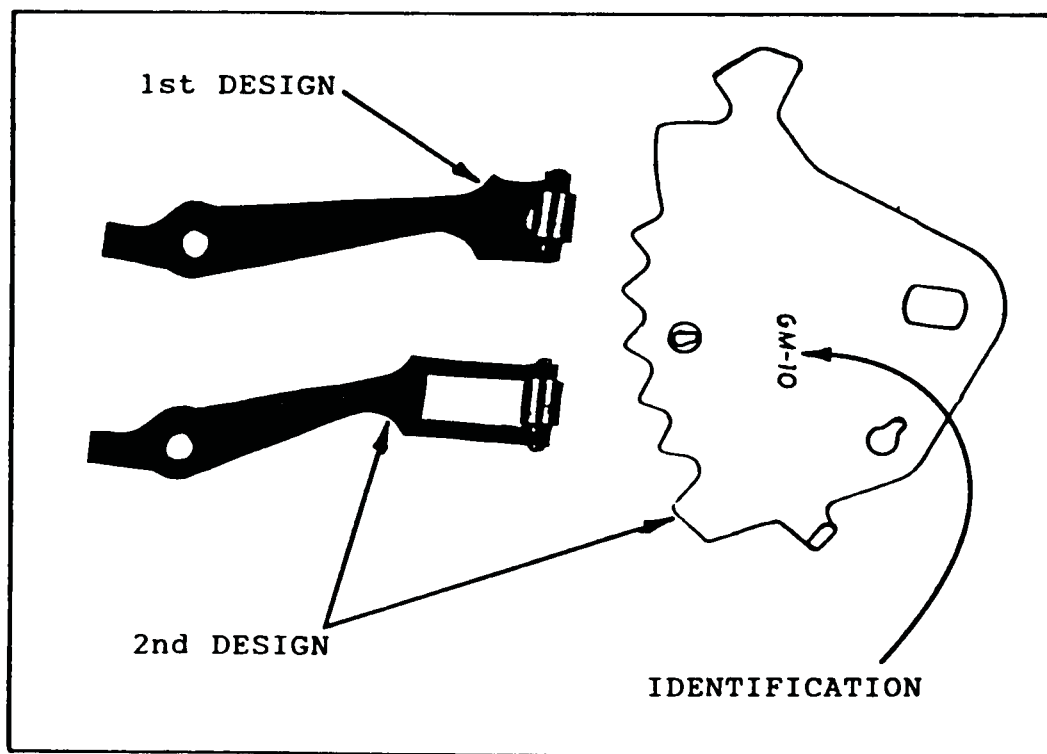
Figure 78

- (1) Detent Roller and Spring Assembly - Different profile.
(See Figure 78)
- (2) Inside Detent Lever - Different profile on the detents only.
2nd design can be identified by "GM-10" stamped into detent
lever as shown in Figure 78.

Will retro fit back on all models but, 2nd design Inside
Detent Lever "MUST" be used with the 2nd design Detent Roller
and Spring Assembly (See Figure 78).
DO NOT MIX THESE PARTS.

Spring and Roller, Detent (2nd Design).....8662737
Lever, Inside Detent (2nd Design).....8662736

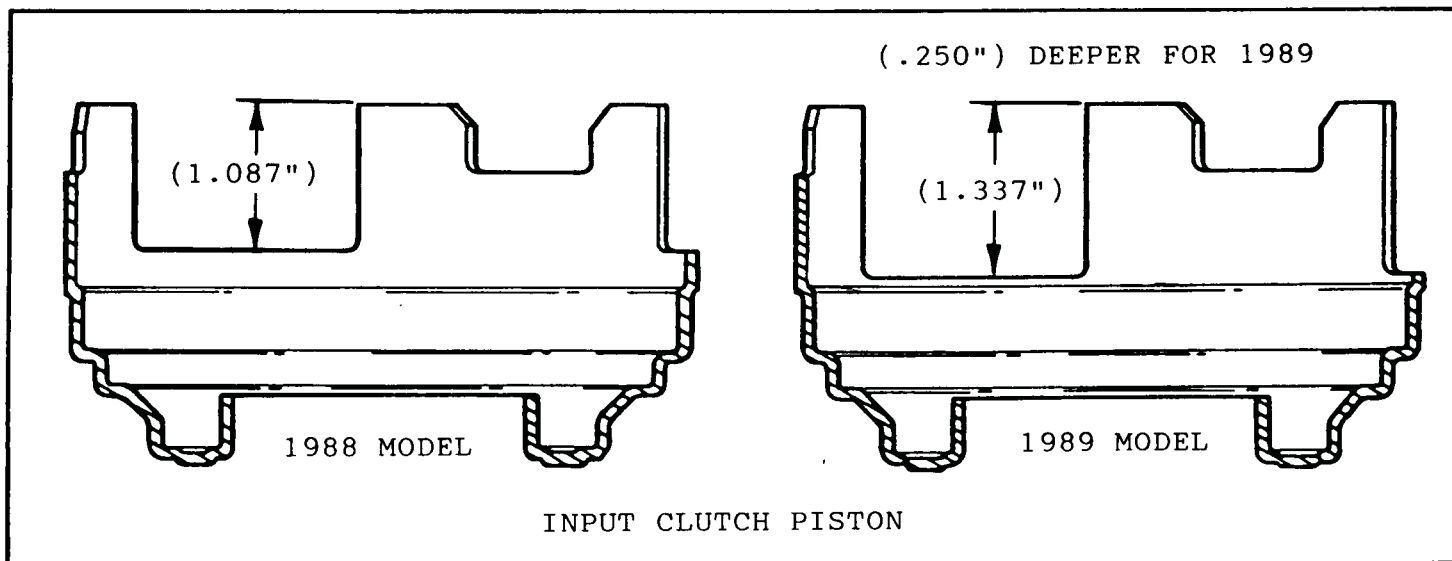
Figure 85

- (4) Input Clutch Piston - The cutouts in the piston for the 3rd clutch plates are .250" deeper to accomodate the additional two clutch plates in the 3rd clutch pack (See Figure 85).

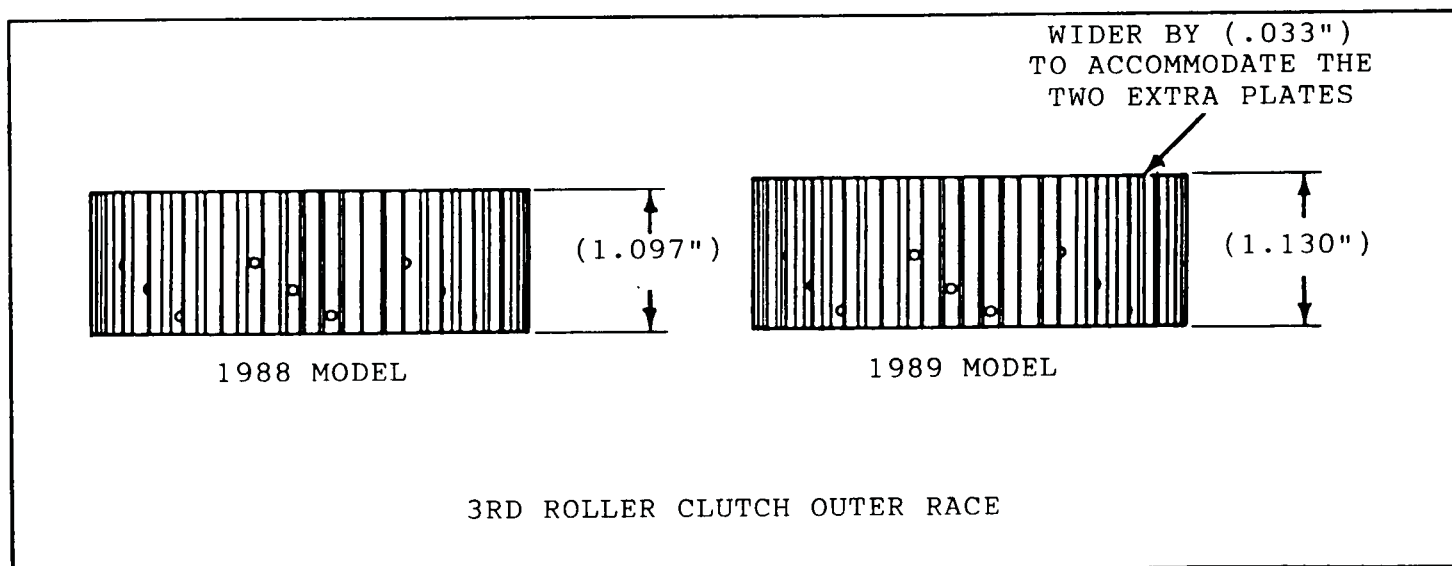
Figure 86

- (5) 3rd Roller Clutch Outer Race - The outer race was made wider by .033" to accomodate the two extra plates. The rollers have not changed in width (See Figure 86).

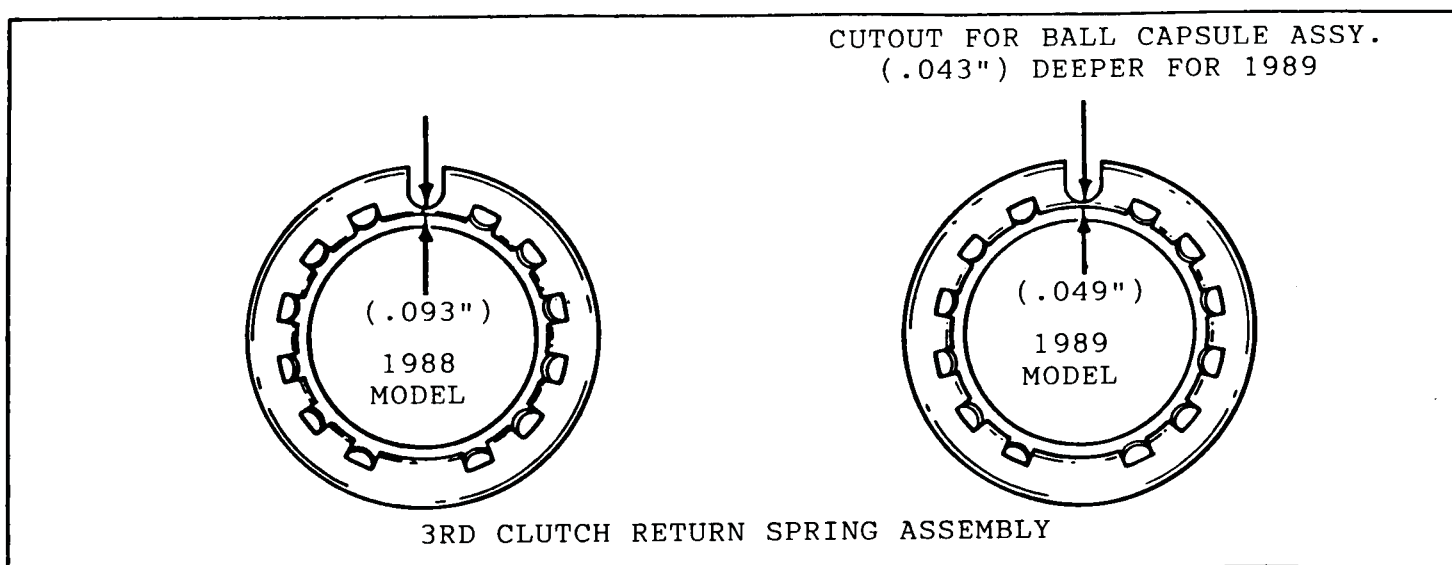
Figure 87
87

- (6) 3rd Clutch Return Spring Assembly - The cutout in the retainer is .045" deeper to accomodate the relocated ball capsule in the new (Smaller Diameter) 3rd clutch piston and seal Assy. (See Figure 87).

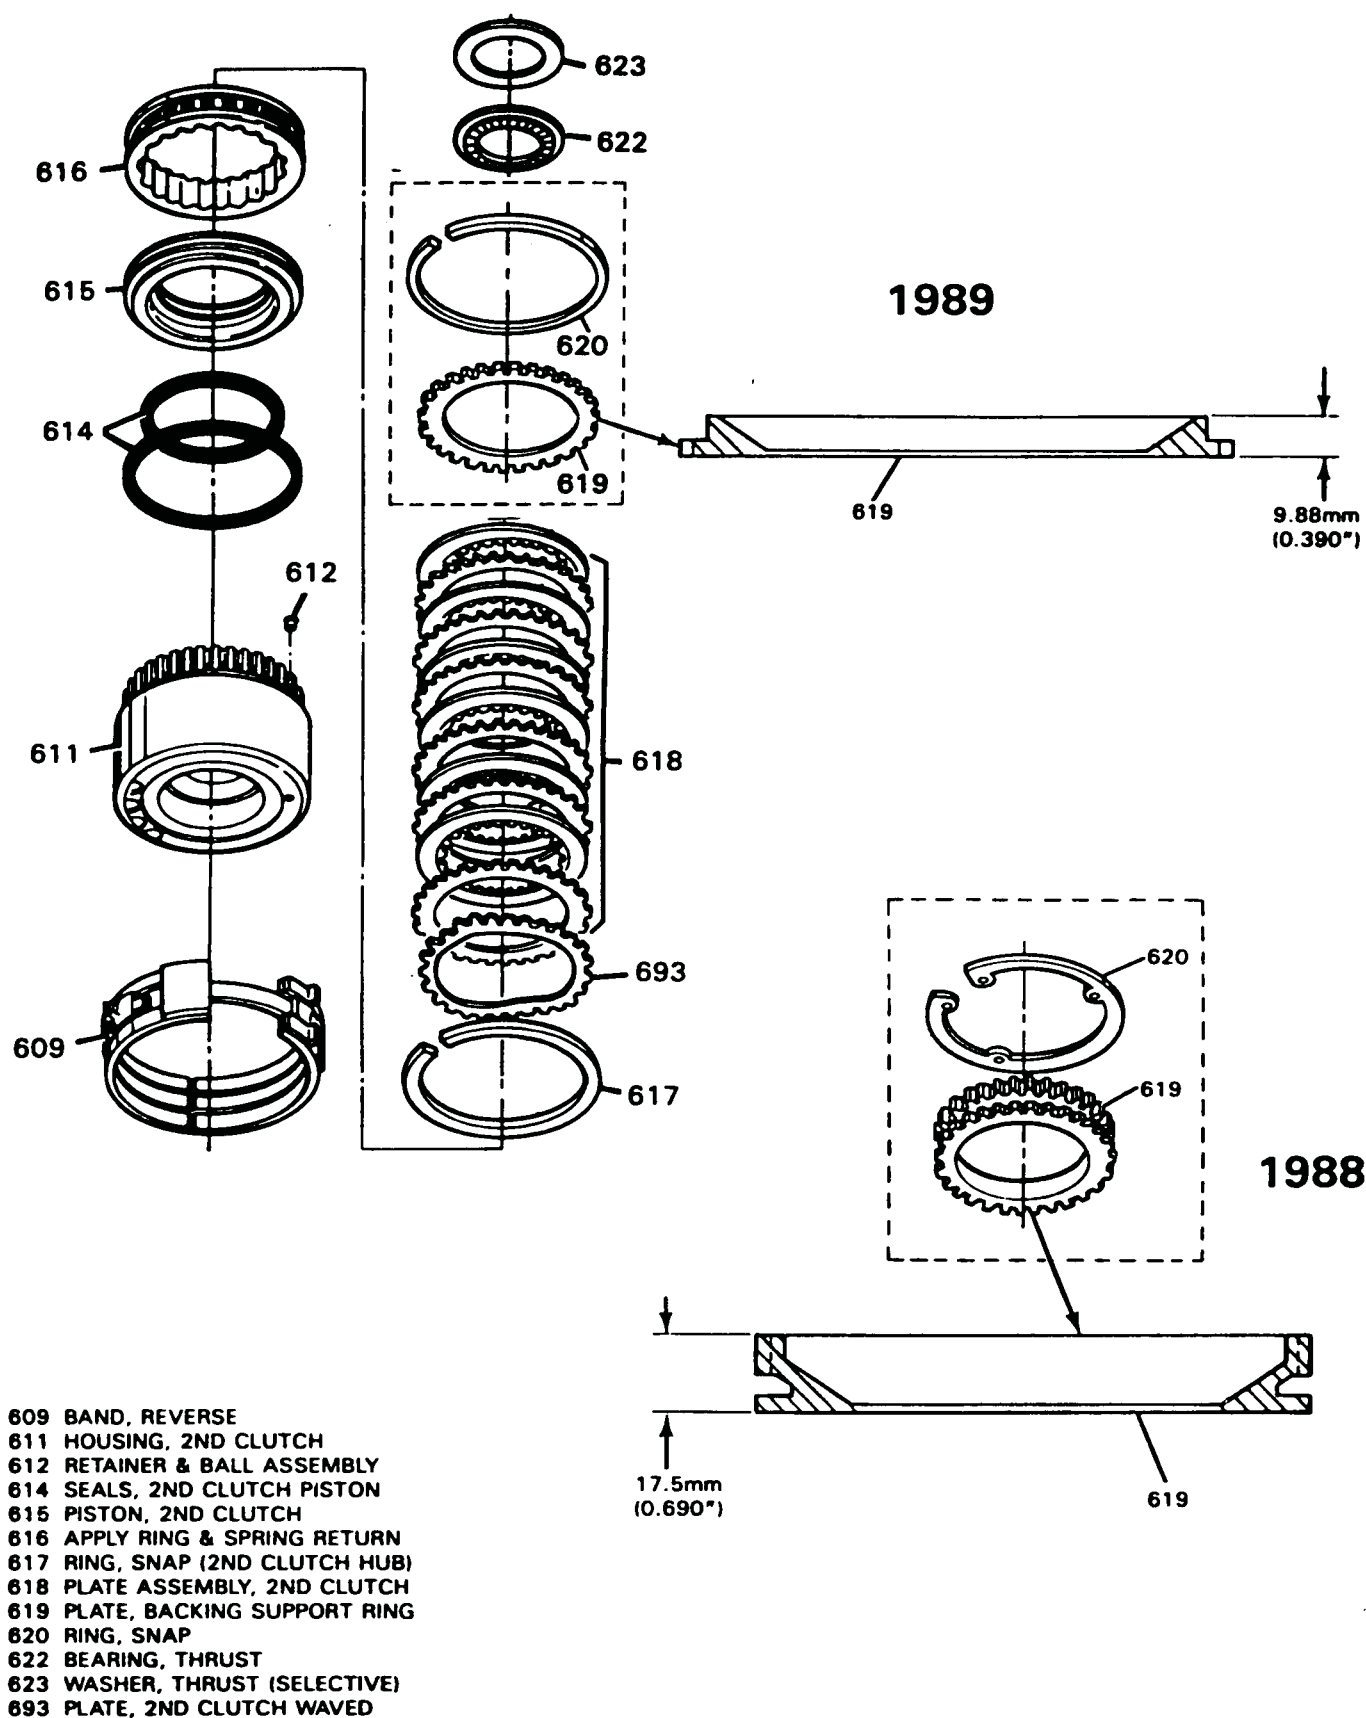
Figure 88

CHANGE: 2nd Clutch Backing Plate was redesigned (See Figure 88).

- (1) 2nd Clutch Backing Plate - "Windows" in backing plate are eliminated which makes the backing plate less prone to warpage. Also notice (See Figure 88) that the support ring has been eliminated from the backing plate and is no longer used, because "Engine Torque Management" was added as an ECM function. This was one of the reasons for the addition of the 2nd clutch switch in 1988.
- (2) 2nd Clutch Backing Plate Snap Ring - The new snap ring is only half as wide as the previous models and must be used with the third design backing plate.

2nd Clutch Backing Plate (3rd Design).....8668566
2nd Clutch Snap Ring (3rd Design).....8668567

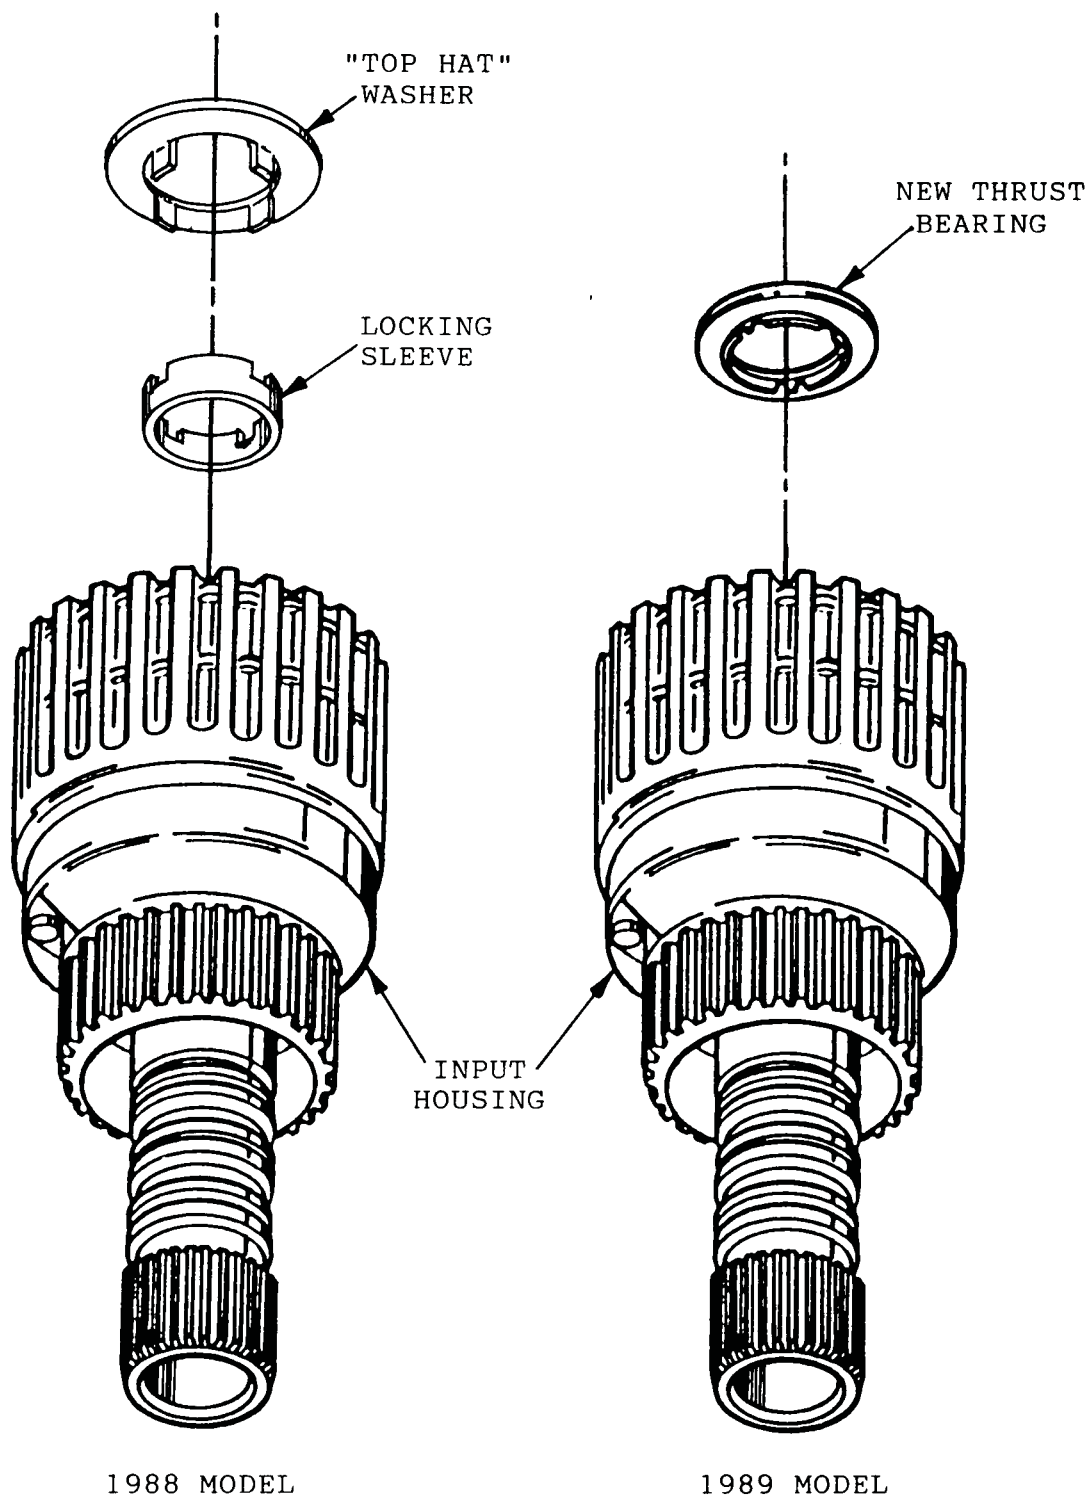
Figure 89

CHANGE: A new Thrust Bearing Assembly replaces the "Top Hat" Thrust Washer and Lock Up Sleeve in the input housing. (See Figure 89). The new bearing and related parts went into production on all 1989 models on November 28, 1988 (Julian Date 333).

Thrust Bearing Assembly (New Design).....8668422
3rd Roller Clutch Complete (New Design).....8657046
Service Package.....8662970
Contains the following;
1. New design Input Housing.
2. New design Thrust Bearing Assembly.
3. New design 3rd Roller Clutch Complete.
4. Instruction Sheet.

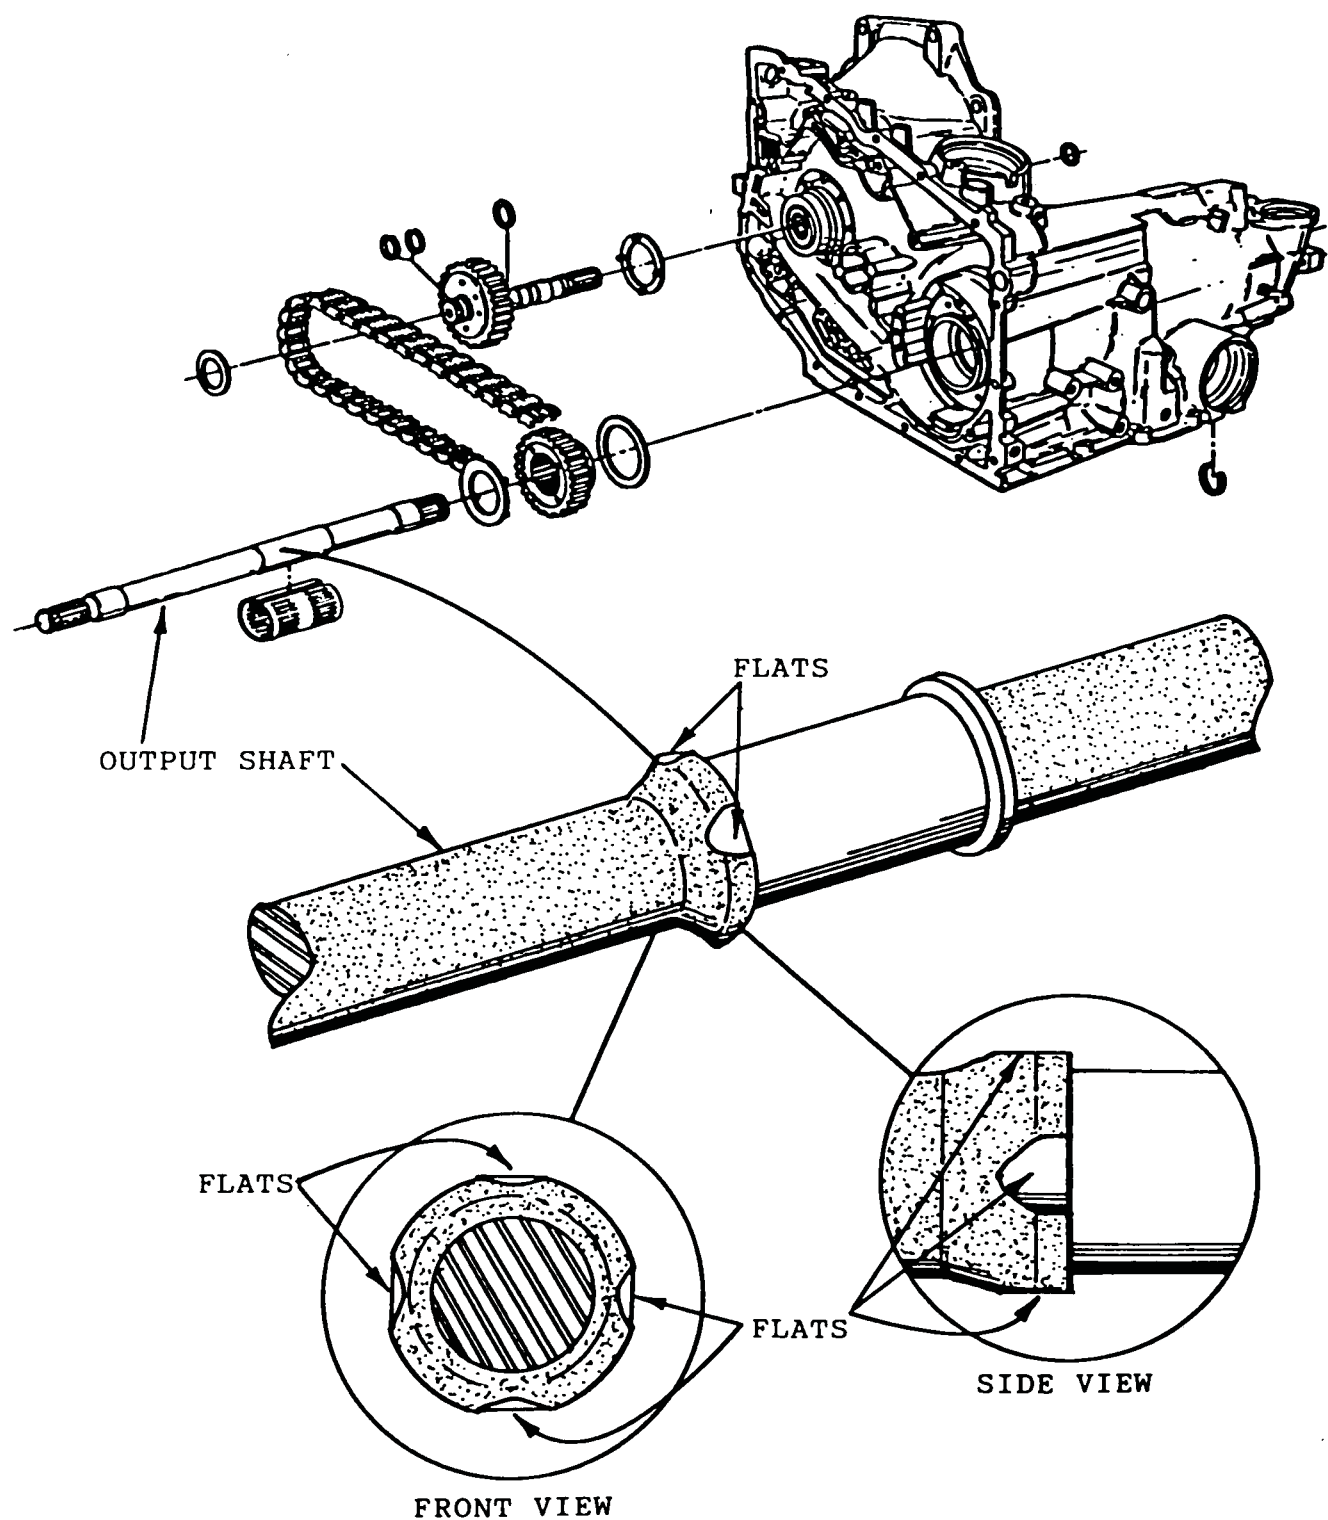
Figure 92

3RD ROLLER CLUTCH AND INPUT SPRAG FAILURE

- COMPLAINT: Repeated failure of the 3rd Roller Clutch and/or the Input Sprag Assembly.
- CAUSE: Lack of lube oil to 3rd Roller Clutch and Input Sprag.
- CORRECTION: Modification as follows, of the parts indicated, will increase lube flow to both the 3rd Roller Clutch and the Input Sprag.

1. MODIFY OUTPUT SHAFT:
Grind four (4) flats on the Output Shaft at the front of the bearing in the locations shown in Figure 92.
 2. MODIFY OUTPUT SHAFT BEARING:
Remove individual needle bearings as shown in Figure 93 in three equally spaced locations around the bearing, to provide three "Troughs" for additional lube oil to flow. Removing the needles does not impair the durability of the bearing assembly.

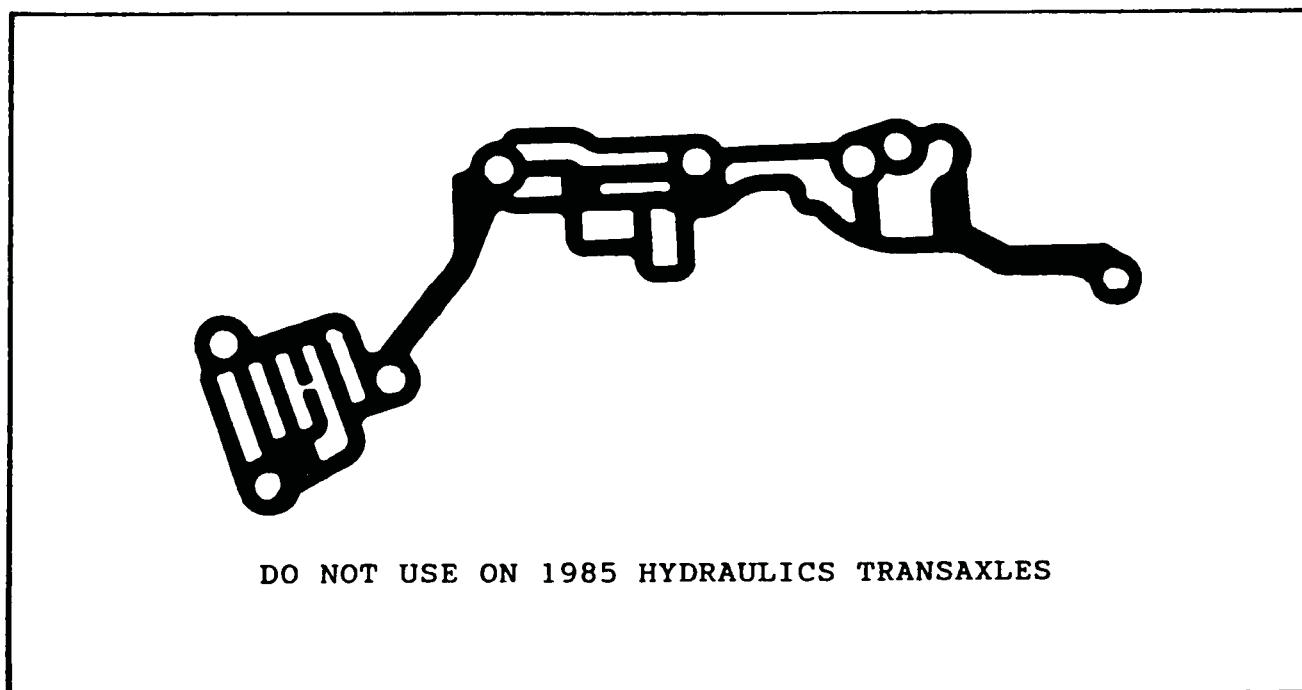
Figure 95

CHANGE: Upper Channel Plate Gasket (See Figure 95).

- (1) Upper Channel Plate Gasket - The Upper Channel Plate Gasket and Modulator Port Gasket are now connected together as one gasket (See Figure 95).

The new design Upper Channel Plate Gasket will most likely "Not Appear" in aftermarket gasket sets, as the previous design gaskets will work fine.

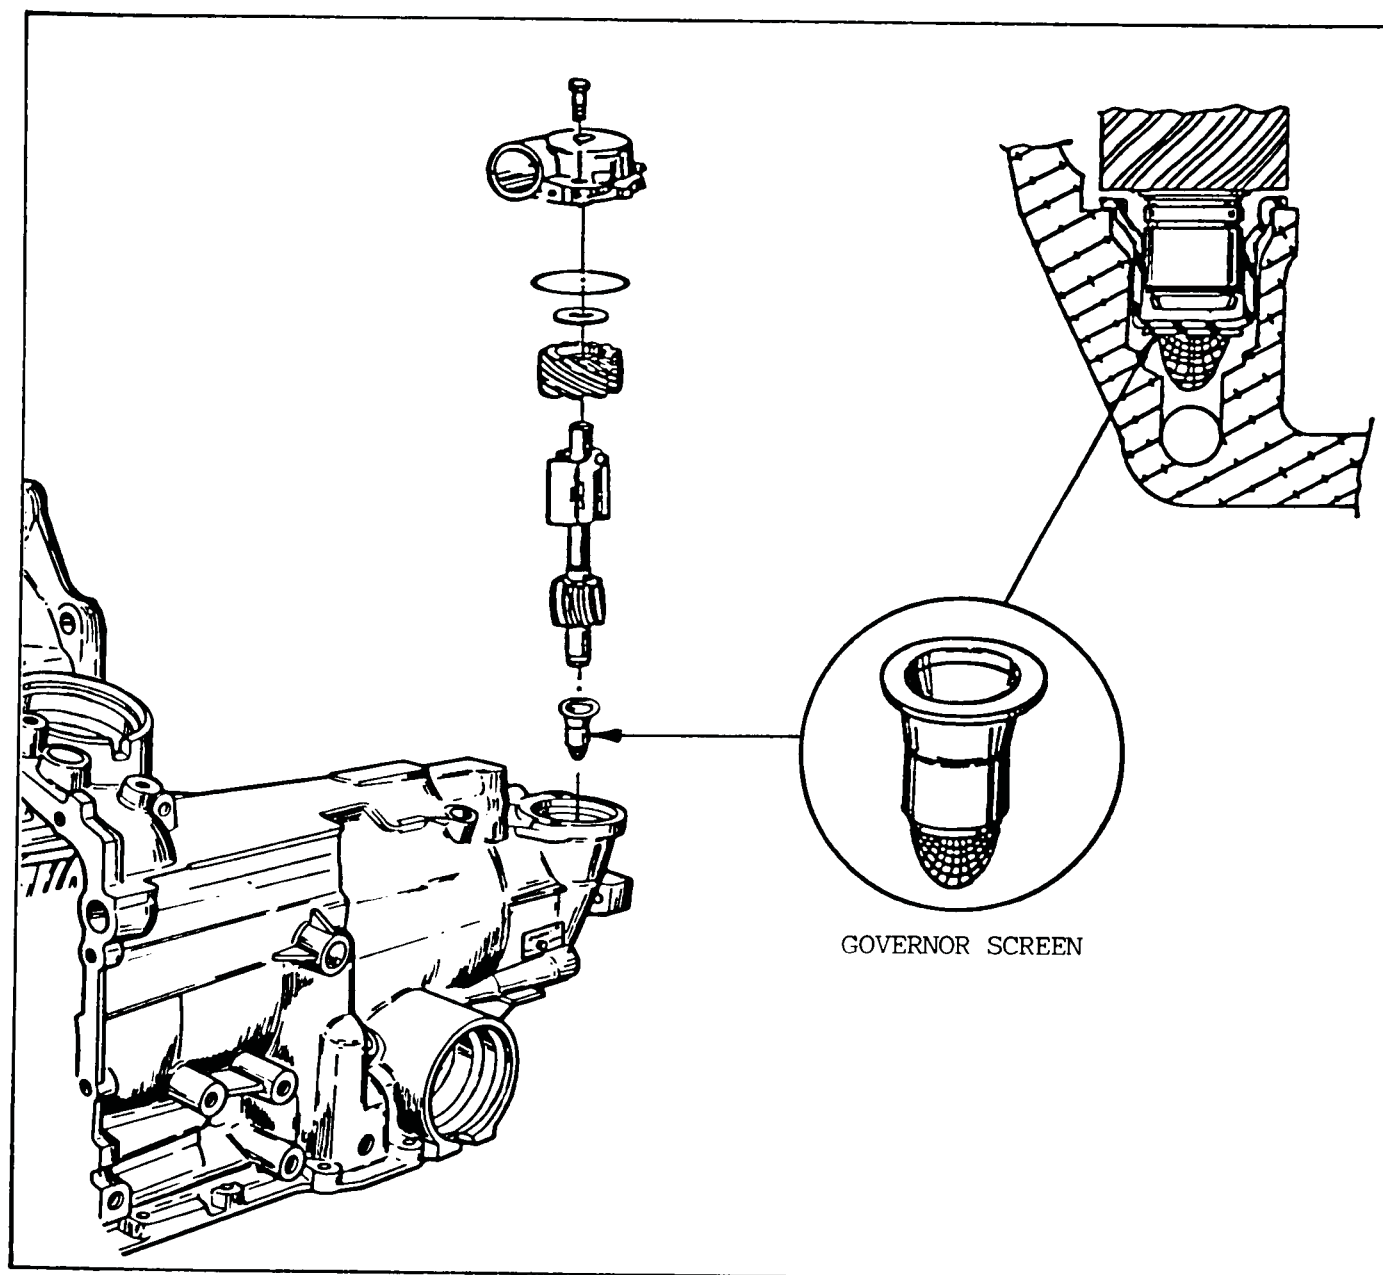
Figure 96

The governor screen was added in 1989 to the governor sleeve in the case, to minimize the possibility of sediment entering the governor assembly and preventing the governor balls from seating properly. (See Figure 96).

A machining change was necessary in the case to make room for the new governor screen, thus it will not retro fit to previous models.

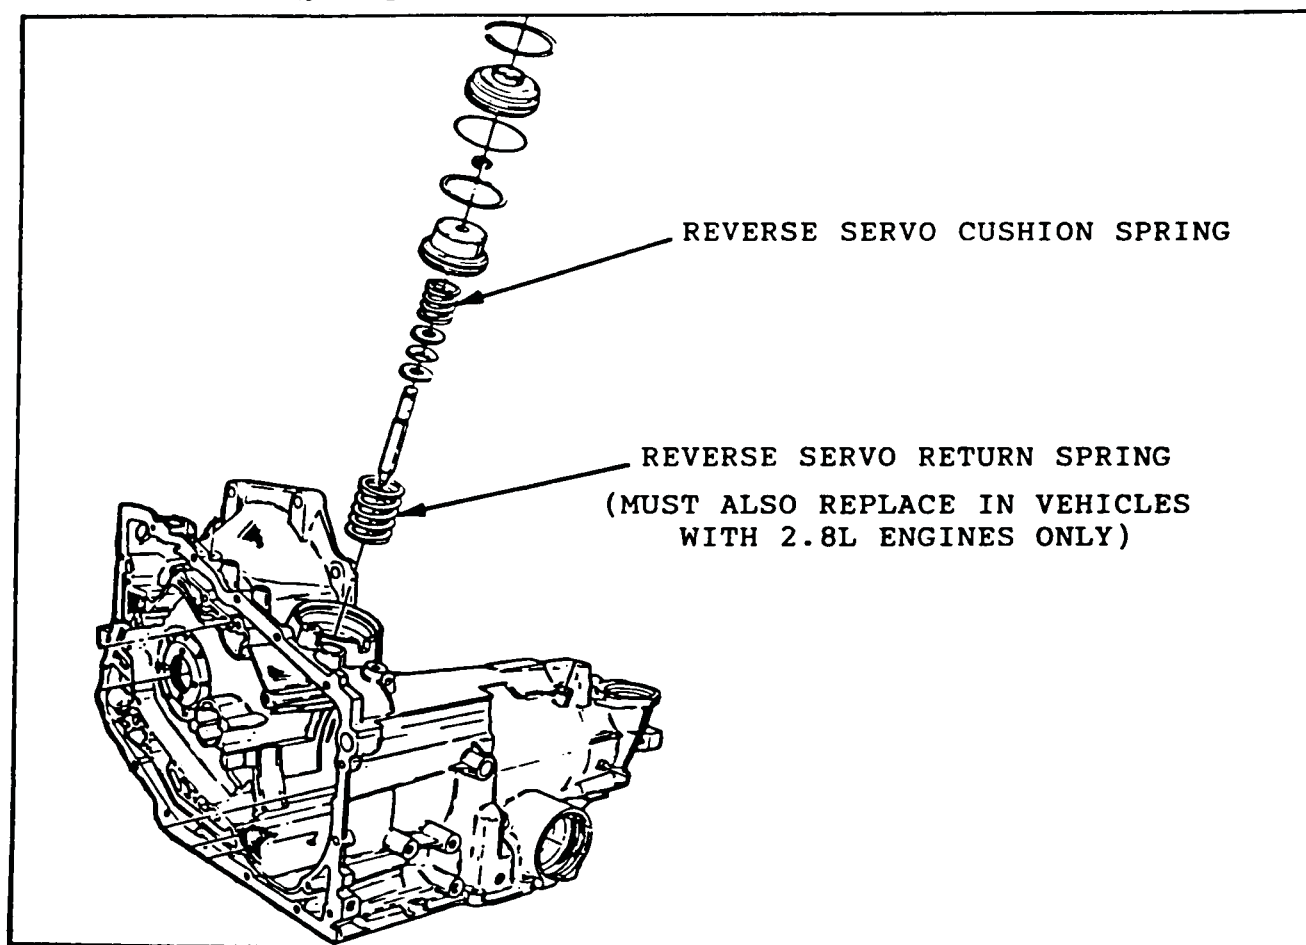
Figure 97

CAUSE: The cause may be:

1. Low vacuum supply to the vacuum modulator.
2. Stuck modulator valve in case.
3. No. 9 checkball missing or off location.

CORRECTION: AFTER ALL OF THE ABOVE ARE ELIMINATED:
There is now available a new Reverse Servo Cushion Spring, and a new Reverse Servo Return Spring. Replacing these springs should correct the harsh reverse condition. The reverse servo return spring should only be replaced on the 2.8L engines.

Spring, Reverse Servo Cushion (All).....8668121
Spring, Reverse Servo Return (2.8L Only)...8668127

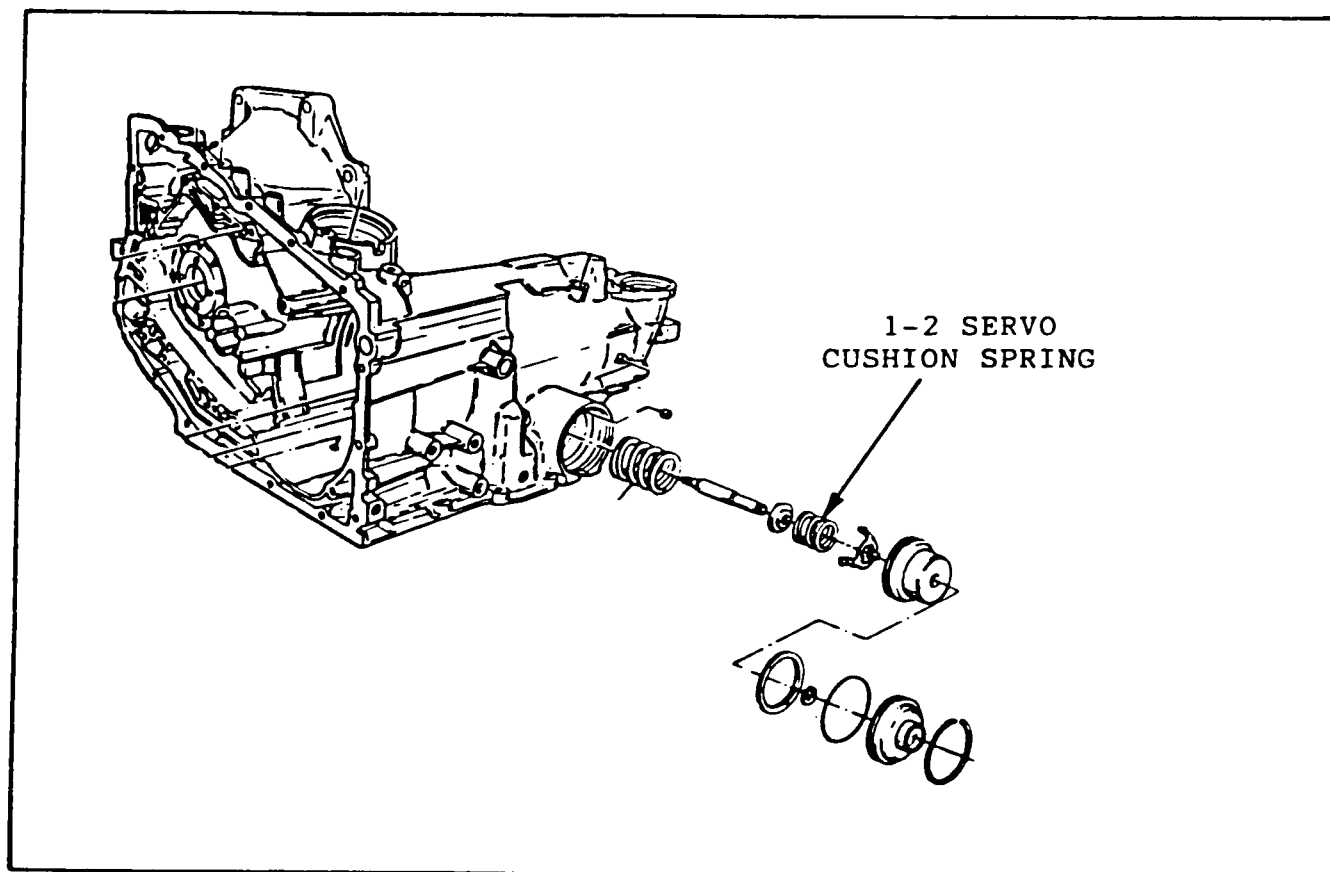
Figure 98

CAUSE: The cause may be:

1. Low vacuum supply to vacuum modulator.
2. Stuck modulator valve in case.
3. No. 12 checkball missing or off location.

CORRECTION: AFTER ALL OF THE ABOVE ARE ELIMINATED:
There is now available a new 1-2 Servo Cushion Spring.
Replacing this spring should correct the harsh drive condition (See Figure 1).

Spring, 1-2 Servo Cushion (A11).....8668123
