"2004" SEMINAR INFORMATION

AUTOMATIC TRANSMISSION SERVICE GROUP

"What's in Store for 2004" Seminar Information

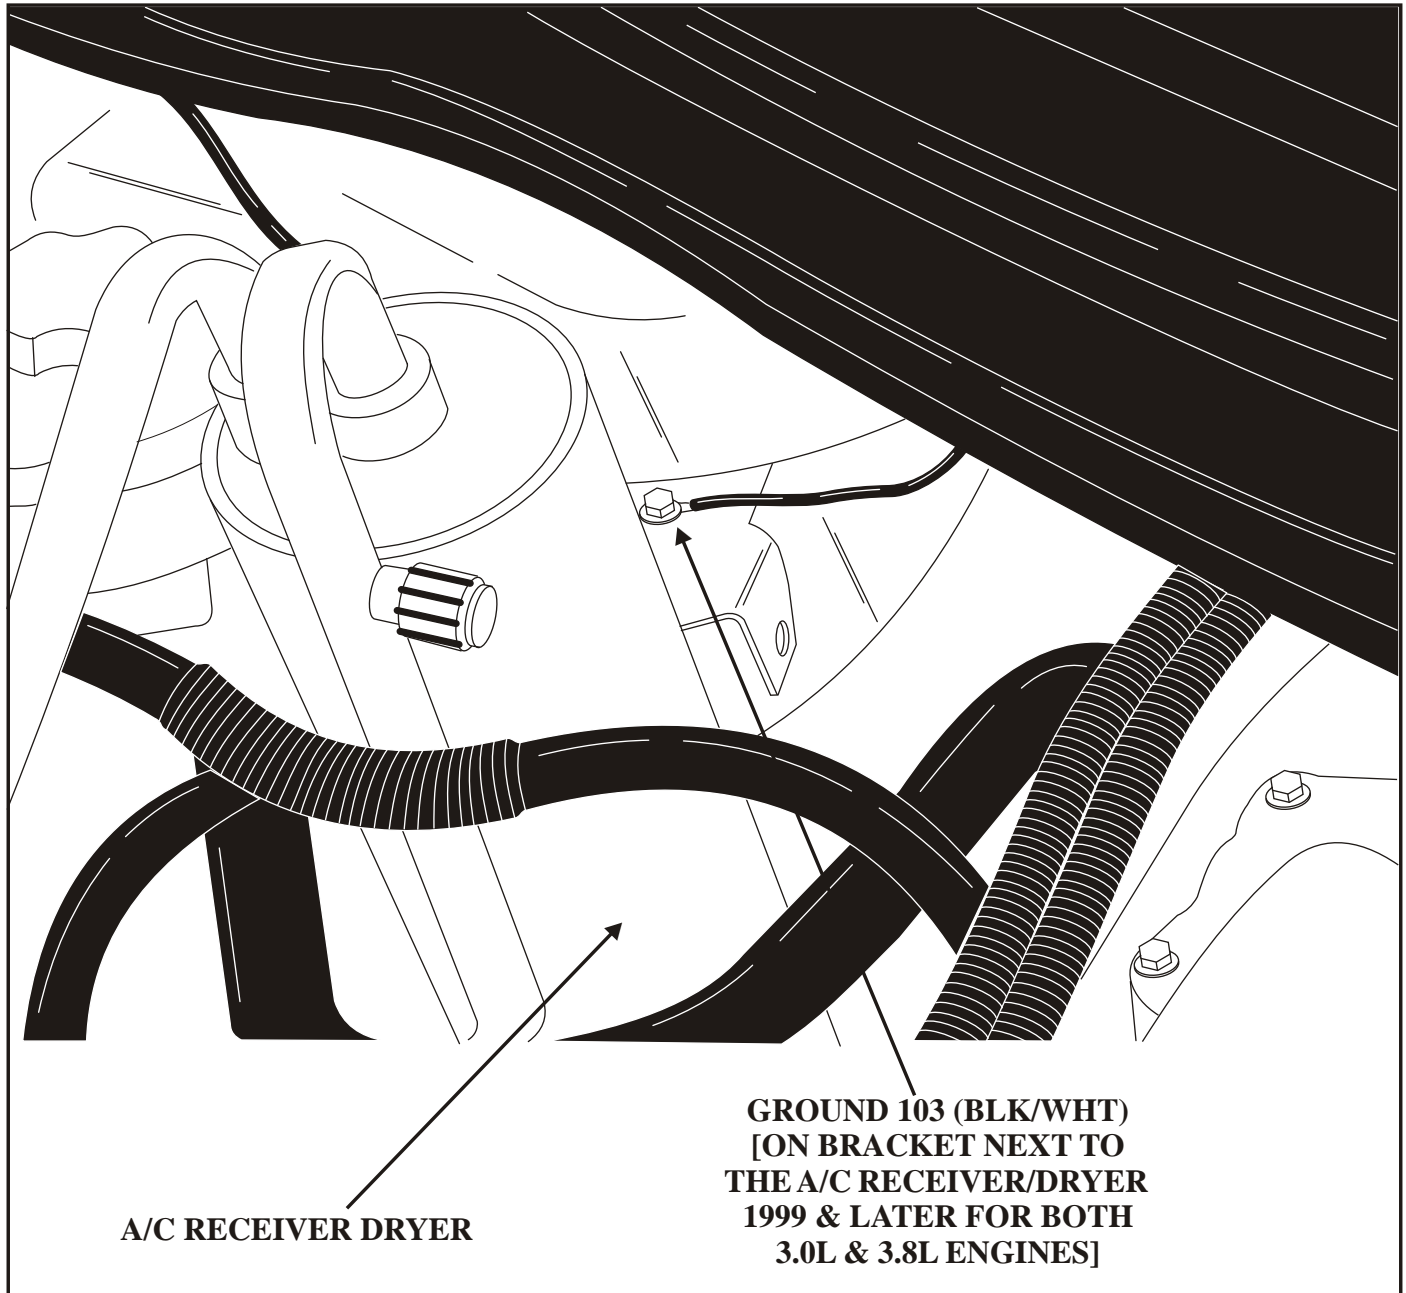
WINDSTAR PCM GROUND DISTRIBUTION

CAUSE: The **G103** ground is bad and is responsible for the above complaints. *When* this ground is located on the unpainted bracket next to the A/C Receiver/Dryer at the passenger side strut tower, condensation from the Receiver/Driver collects on this ground and causes rust and corrosion to form, resulting in a poor ground at this location. The G103 ground serves as ground for the PCM as seen in Figure 1.

This is the source of the confusion. When the technician looks for the **G103** ground at the transmission bell housing stud on a 1999 and later Windstar, none is found.

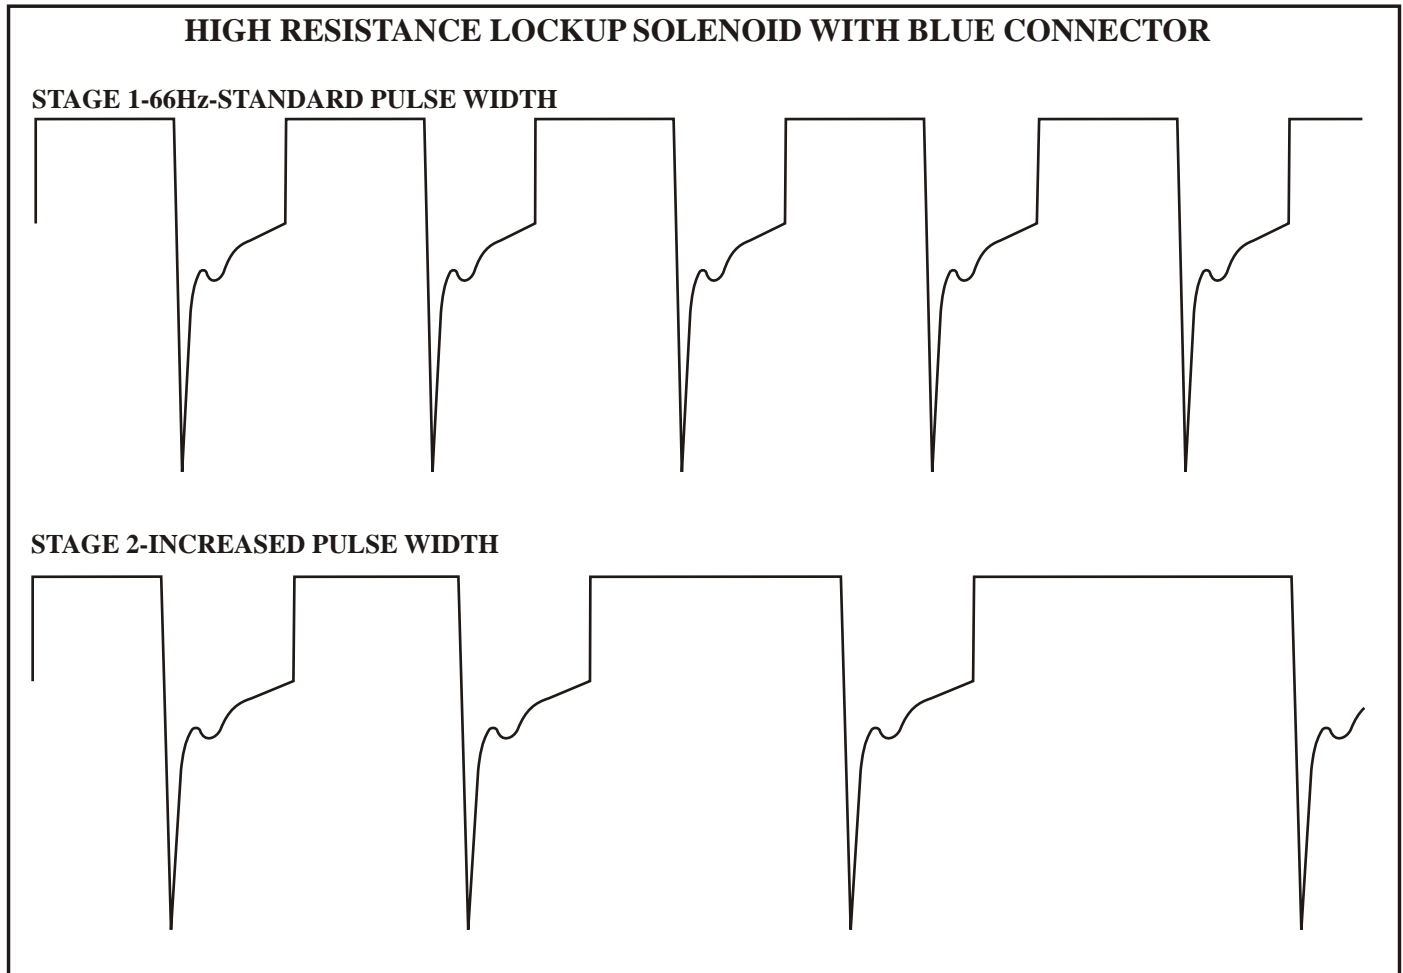
Figure 3

- CAUSE:**
- #1. The incorrect lockup solenoid was installed in the transmission. The lockup solenoid with the **WHITE** connector, which has a resistance value of 0.98 to 1.6 ohms, is NOT interchangeable in all applications with the lockup solenoid with the **BLUE** connector which has a resistance value of 13 to 24 ohms as shown in Figure 1.
Installing the lockup solenoid with the **BLUE** connector on vehicle/transmission combinations that were originally equipped with the lockup solenoid with the **WHITE** connector could be responsible for the above complaints with the exception of the P0743 code.
Installing the lockup solenoid with the **WHITE** connector on vehicle/ transmission combinations that were originally equipped with the lockup solenoid with the **BLUE** connector could be responsible for the P0743 code due to the additional amperage that’s allowed to flow through the circuit.

CORRECT LOCKUP SOLENOID & TORQUE CONVERTER USAGE

CORRECTION: #1. Refer to the chart in Figure 7 for the correct solenoid application and usage.

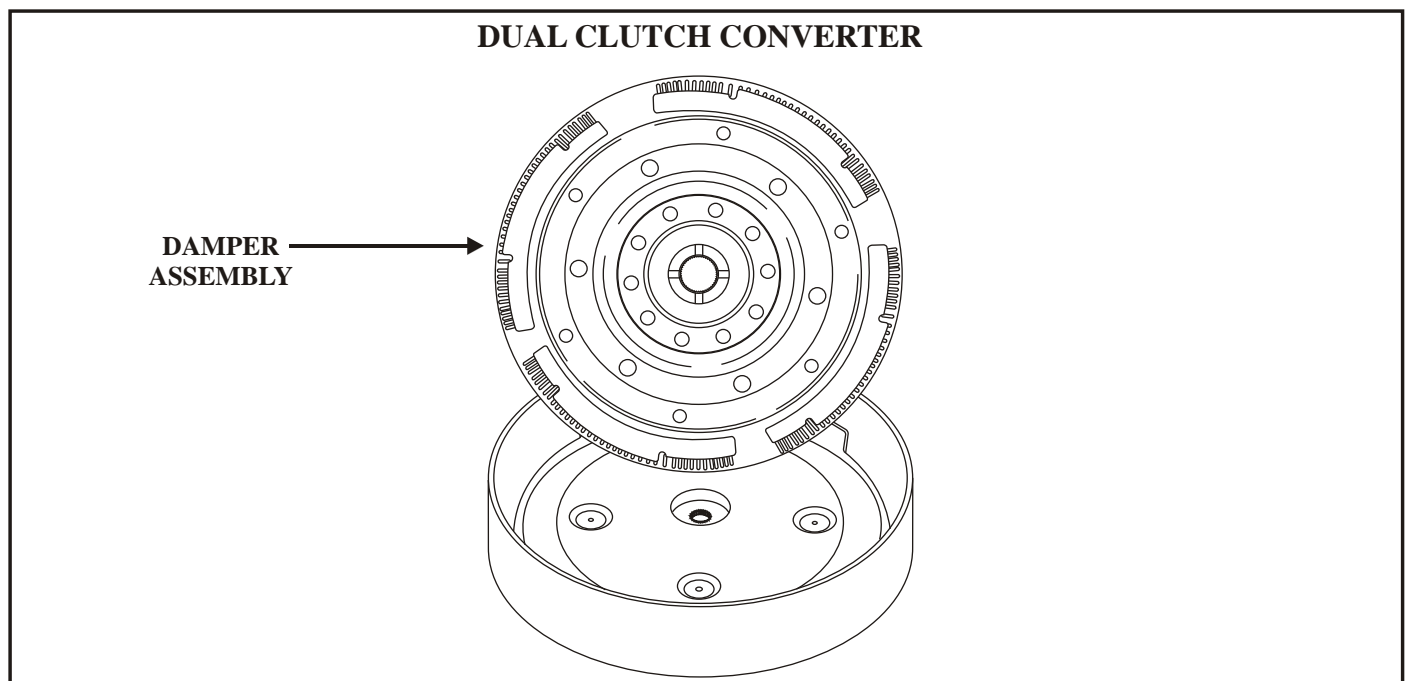
Figure 6

#2. The incorrect converter was installed in the vehicle. There are two types of converter used for these vehicle/transmission combinations. The differences in these converters involve the type of converter clutch used inside them. The use of a single sided clutch type converter in a vehicle that requires a dual clutch converter can cause the above complaint. The converter clutch can be a single sided clutch, with the clutch bonded to the front cover, and the damper/apply piston shown above it in Figure 4. Or it can be a Dual Modulated, two sided converter clutch with a friction surface bonded to the front and rear sides of a disc suspended between the cover and the apply piston. The apply piston has four ball and spring dowel pins which align and snap into the cover in order to keep the suspended friction disc centered between the disc and the cover (Refer to Figure 5), and connect to the damper assembly as shown in Figure 6.

#2. The way to tell which converter you have, whether it is the original or the replacement converter, is to look down into the center of the converter just outside the turbine spline area and see if you have four tabs as seen in figure 8 or two tabs. Two tabs is a single clutch type converter, and four tabs is the dual clutch type.

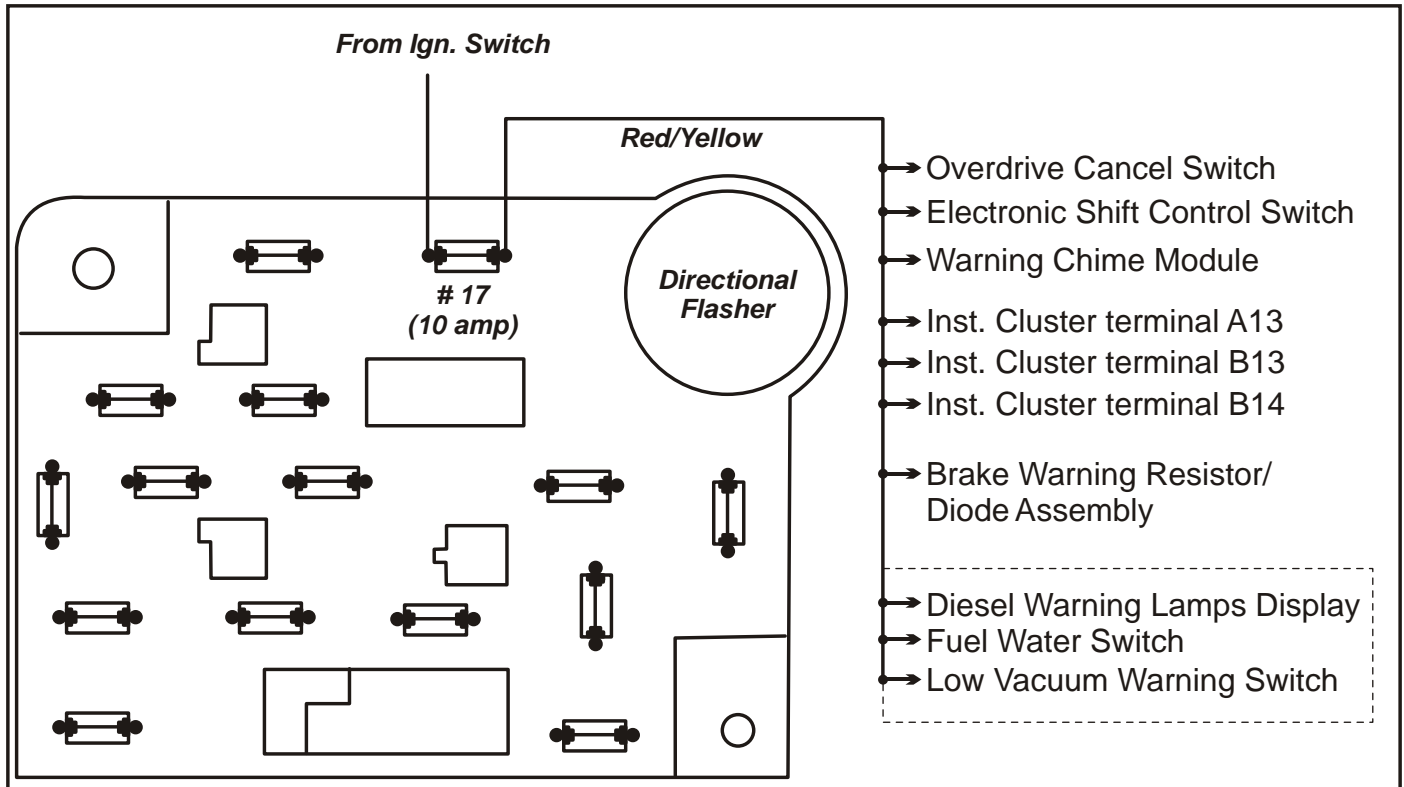
Figure 1

CAUSE: The wiring for the overdrive cancel switch is incorrectly routed and can come in contact with a steering column cover mounting screw. The most common location for the short to occur is near the shift lever pivot point, the location of which is shown in the illustration in Figure 3.

The resulting short circuit causes the #17 or #19 fuse to blow creating the above listed symptoms and the subsequent safety hazards due to the fact that these fuses power the PCM, which in turn power the electronically controlled throttle system as well as the overdrive cancel switch.

COLUMN MOUNTED MANUAL SHIFT LEVER SAFETY ALERT

CORRECTION: Remove the shift lever and provide an extra piece of shrink wrap to the problem area, or replace the shift lever with a newly designed lever which has a longer wire harness for the overdrive cancel switch which avoids contact with the steering column cover mounting screw.

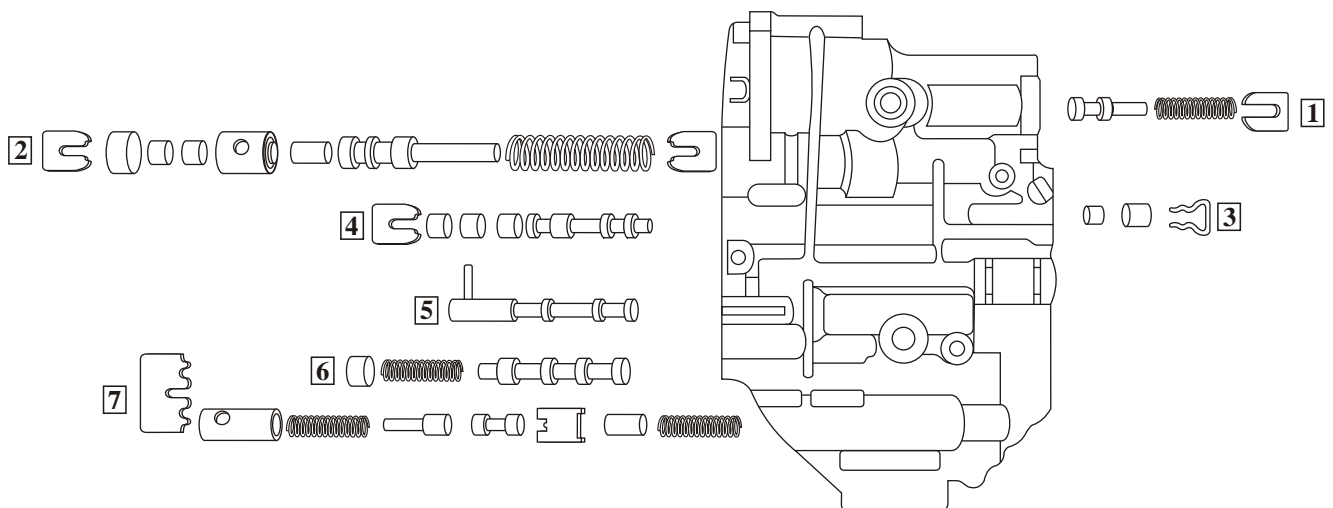
Figure 7

42RLE VALVE IDENTIFICATION

1. TORQUE CONVERTER REGULATOR VALVE
2. PRESSURE REGULATOR VALVE
3. LOW/REVERSE SWITCH VALVE
4. SOLENOID SWITCH VALVE
5. MANUAL VALVE
6. CONVERTER CLUTCH SWITCH VALVE
7. CONVERTER CLUTCH CONTROL VALVE

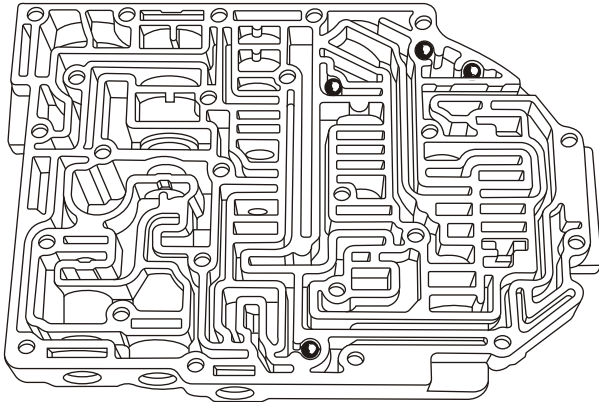
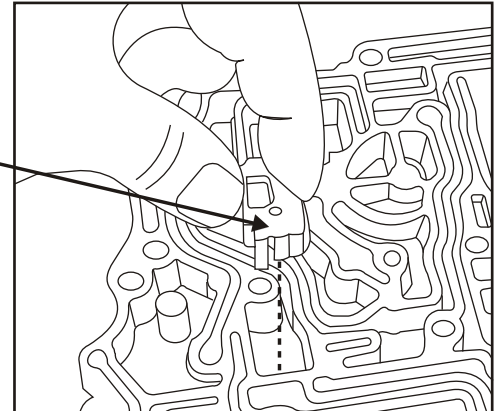
Figure 8

42RLE CHECKBALL LOCATIONS

FOUR (4) CHECKBALLS IN VALVE BODY

*Installing the
thermal valve
in the transfer
plate*

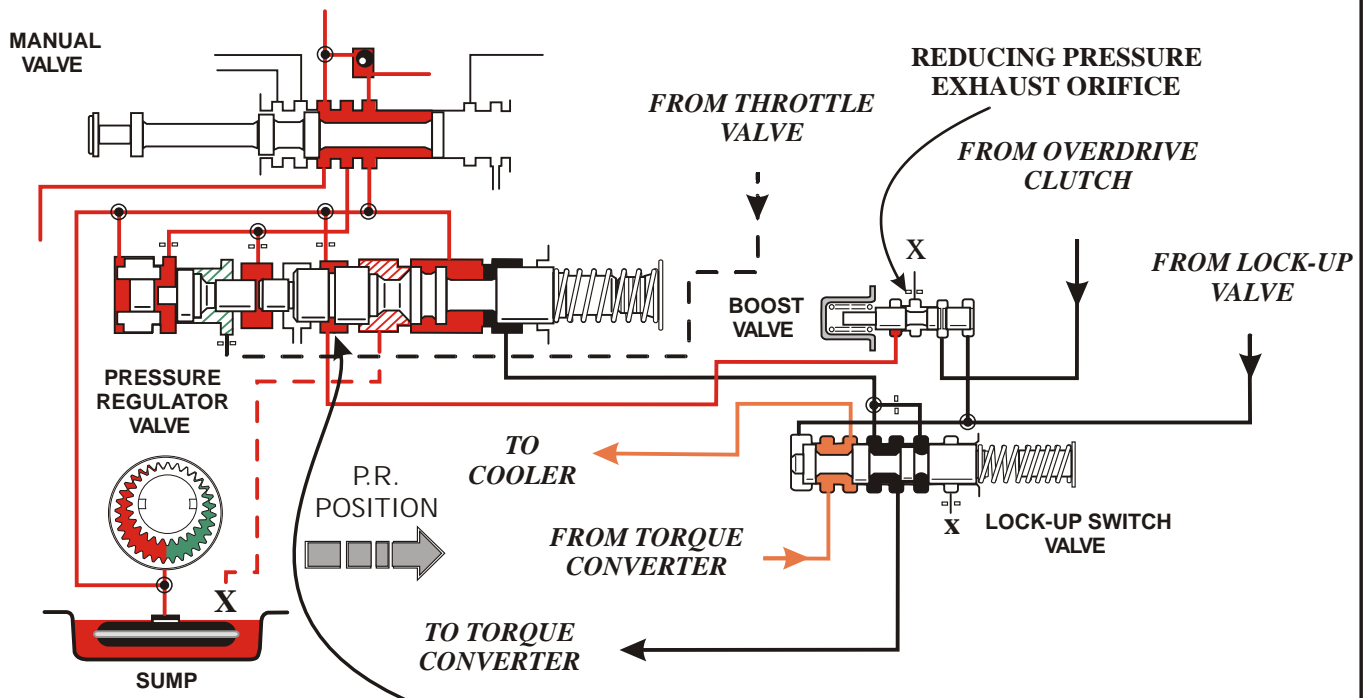
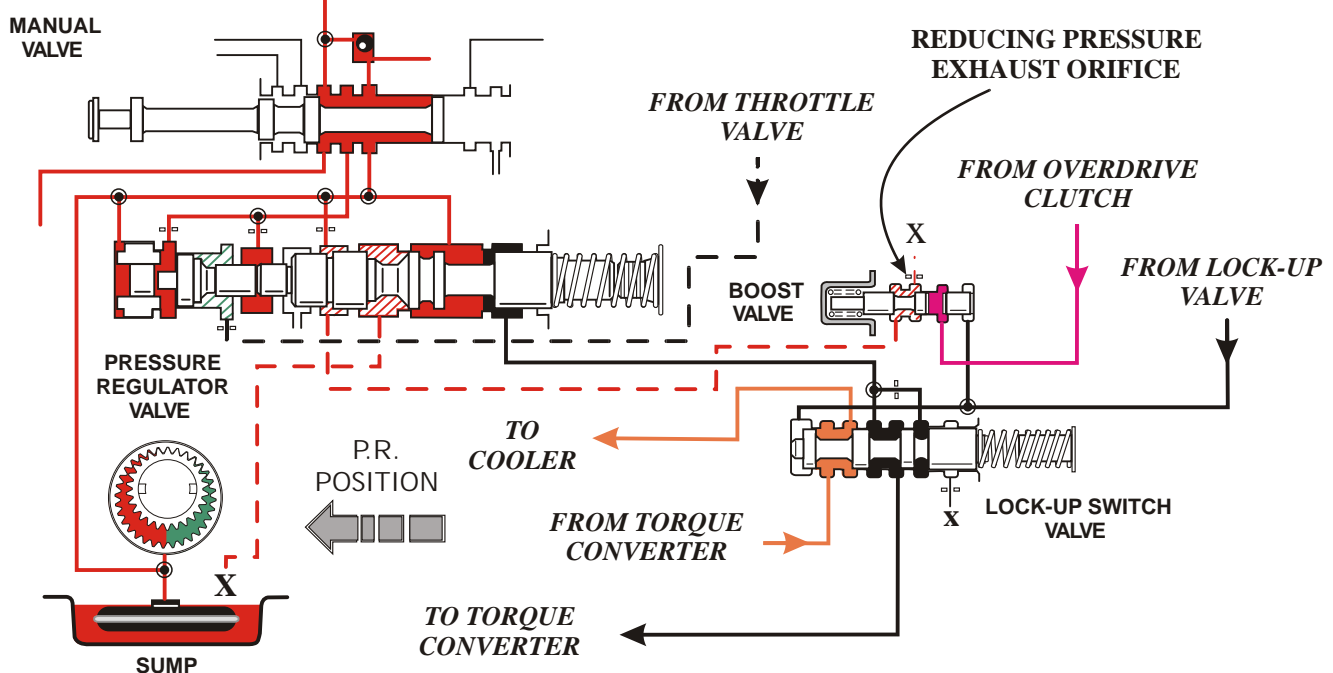
Figure 2
Automatic Transmission Service Group

COMPLAINT: Some 2000-2001 Ram Vans, Dakotas, Ram Trucks and Durangos, may exhibit a flashing Check Engine Light, caused by a DTC P1740. (P1740 is a Torque Converter Clutch or Overdrive Solenoid Performance fault).

Summary: Reducing pressure is applied to the 3rd land of the Pressure Regulator Valve which forces the valve to the right reducing line pressure when in 1st 2nd and 3rd gear.

Summary: The Boost Valve is stroked via Overdrive Clutch pressure or Lock-up Signal Pressure from the Lock-up Valve, while in 3rd or 4th gear. This drains the Reducing Pressure from the 3rd land of the Pressure Regulator Valve. This allows the Pressure Regulator Valve to move to the left, increasing Main Line Pressure.

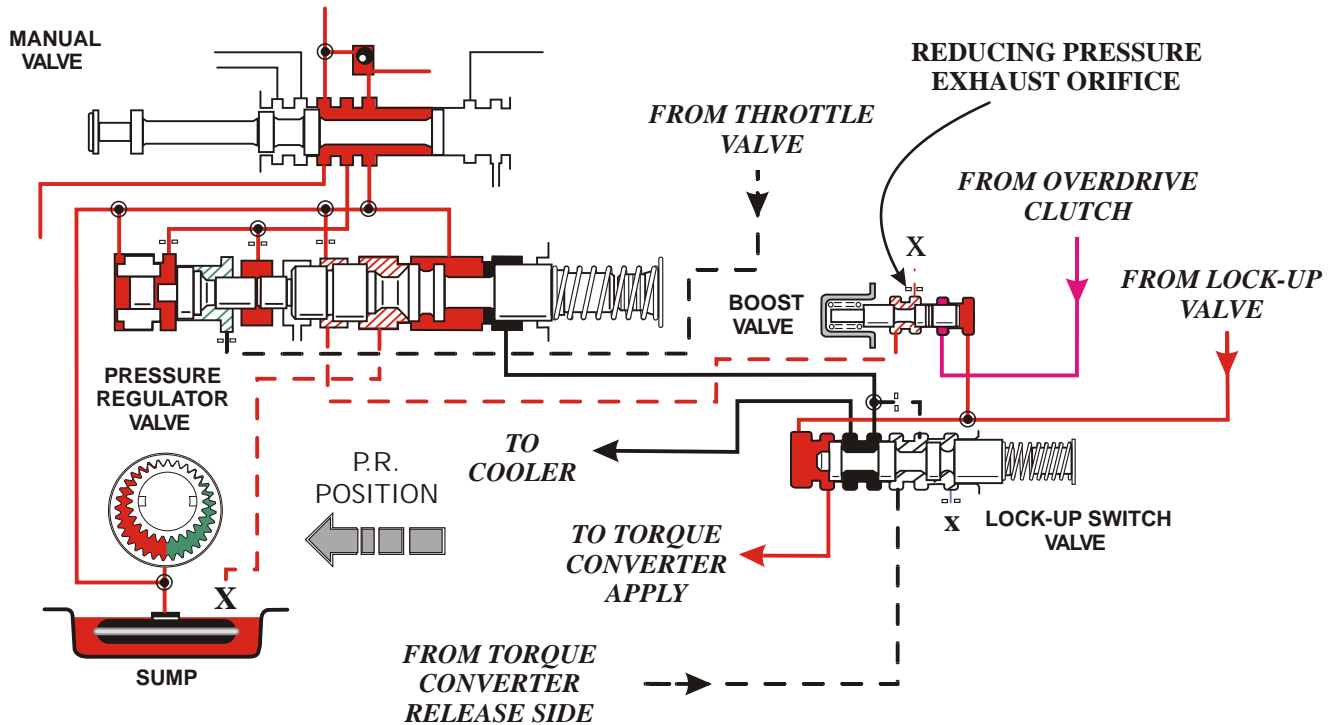
Summary: The Boost Valve is stroked via Overdrive Clutch pressure or Lock-up Signal Pressure from the Lock-up Valve, while in 3rd or 4th gear. This drains the Reducing Pressure from the 3rd land of the Pressure Regulator Valve. This allows the Pressure Regulator Valve to move to the left, increasing Main Line Pressure.

NOTE: Increasing the diameter of the Reducing Pressure Exhaust orifice, will allow the Pressure Regulator Valve to stroke to the left at a faster rate which will allow Line Pressure to increase quicker for Torque Converter Clutch application and for the 4th clutch application.

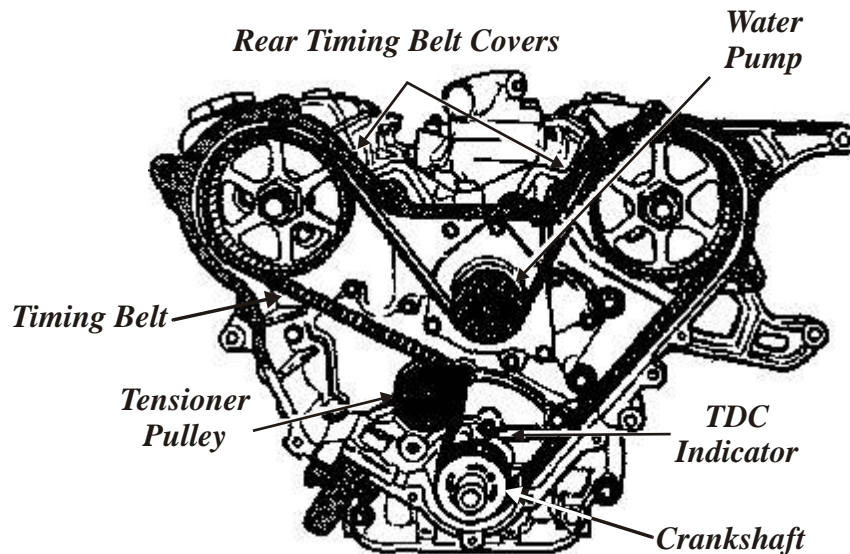
Figure 3

CAUSE: One such known cause has been that during the removal or installation process of the transmission, while turning the torque converter, the crankshaft kicked back from compression in the engine causing the timing belt to skip one cog, or the crankshaft was turned opposite to normal engine rotation causing the skip (See Figure 3). This incident had occurred with a vehicle that had 80,000 plus miles. So the belt was worn.

CORRECTION: Re-position or replace the timing belt. .

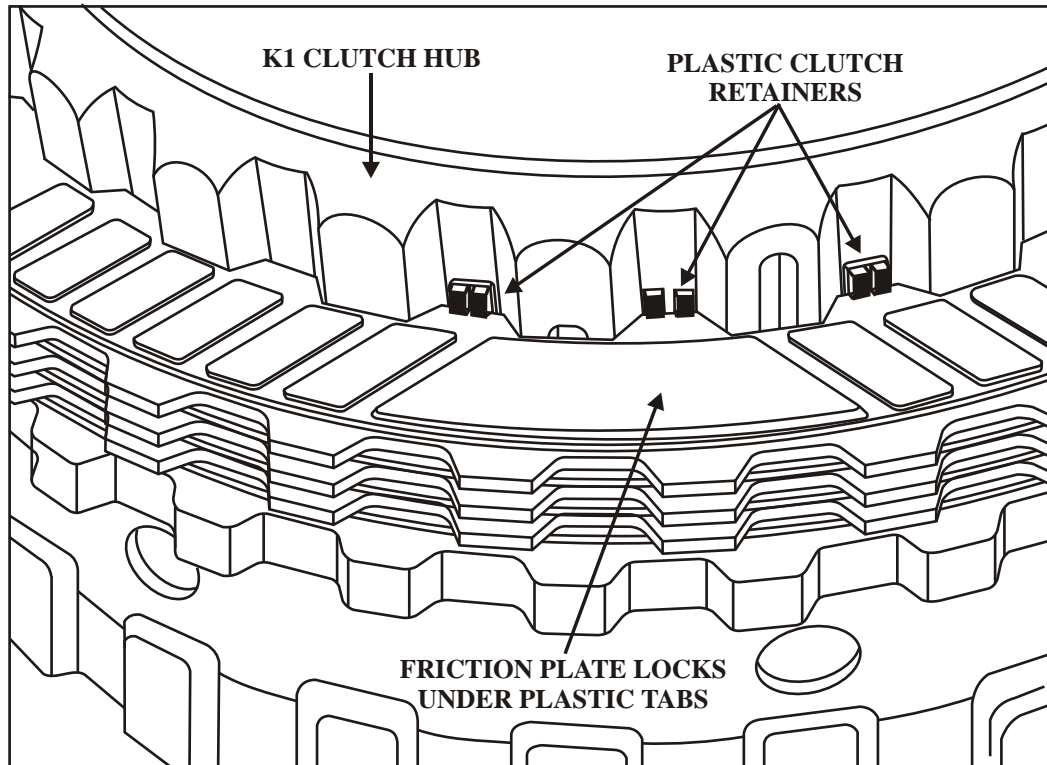
Figure 1

K1 CLUTCH ASSEMBLY

1. After the bottom piston, coil spring assembly, top spring assembly and snap ring have been installed into the drum, install the waved plate.
2. Install the .079" steel plate.
3. Install 1 friction plate and 1 .057" steel plate.
4. Place the K1 clutch hub, large diameter end, down on the bench, See Figure 1.
5. Install the top pressure plate onto the clutch hub.
6. Stack the remaining friction and steel plates onto the clutch hub, ending with a friction plate.
7. Install the 4 plastic clutch retainers, making certain that they snap into their respective holes in the clutch hub. Make certain the top friction plate on the clutch hub is below the tab of the plastic retainers as seen in Figure 1. The retainers for the Phase 2 K1 clutch are .640" tall.
