## **"2008" SEMINAR INFORMATION**

## ***AUTOMATIC TRANSMISSION SERVICE GROUP***

## ***"Shiftin' Great in 2008" Seminar Information***

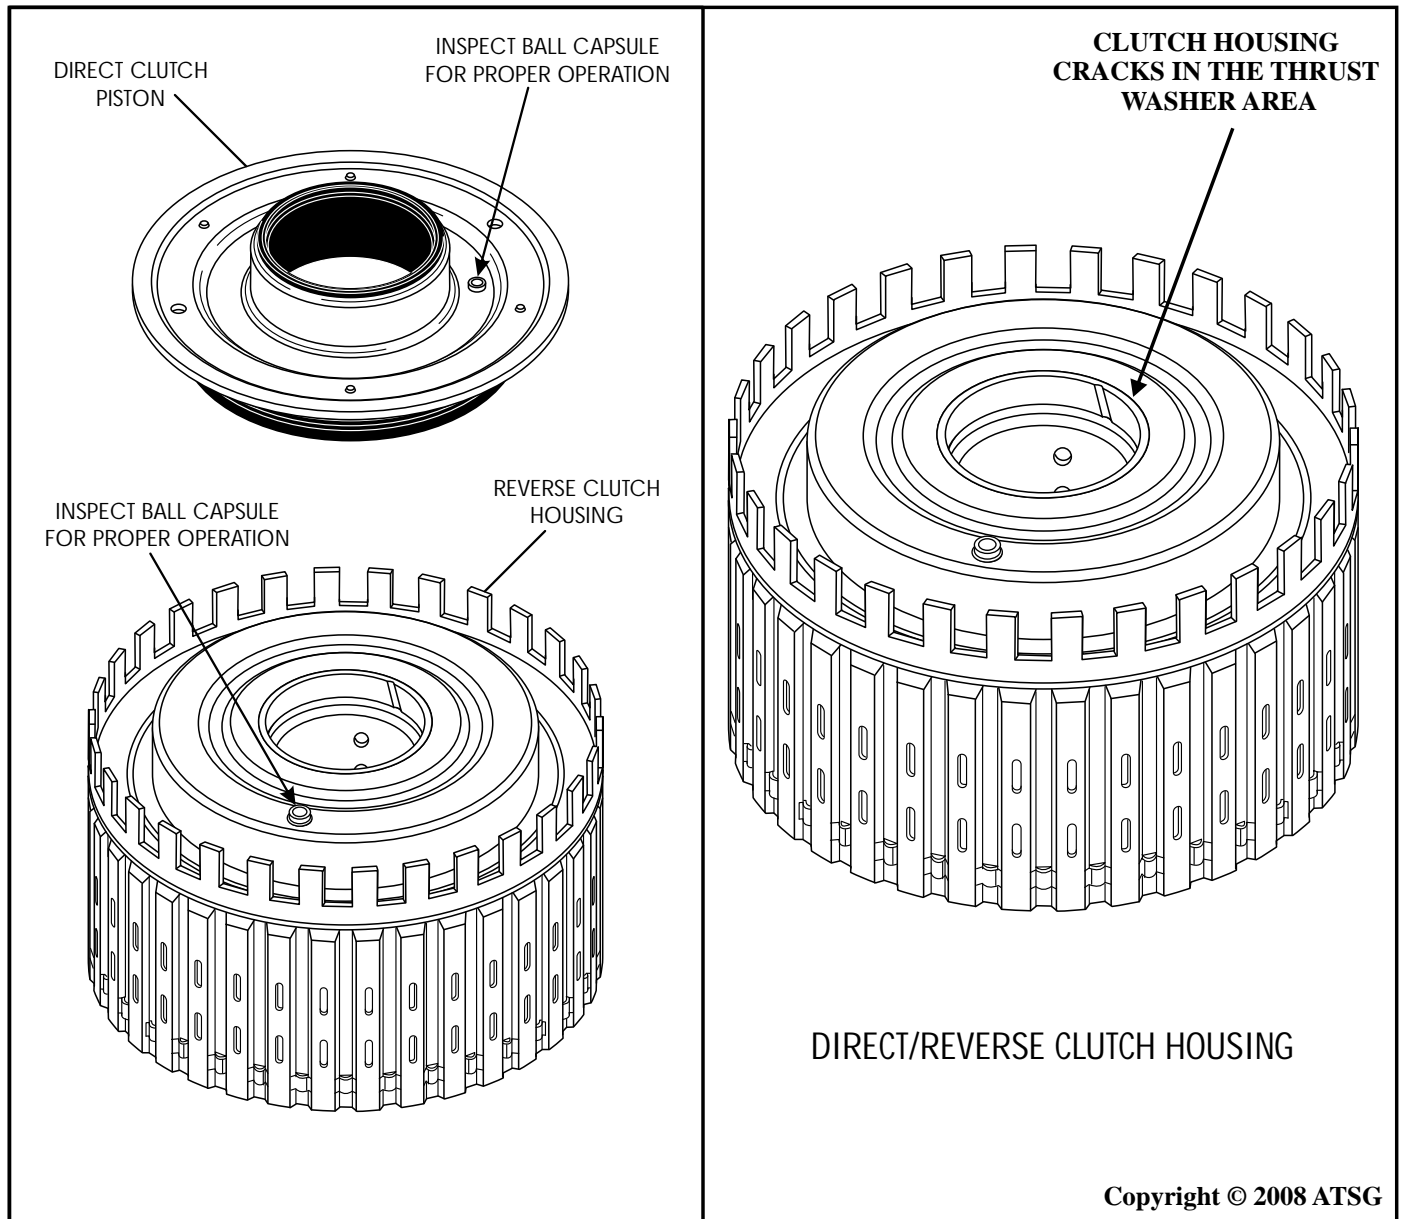
- COMPLAINT:** The MIL lamp is illuminated with code 55 or P0735 stored for a "Gear Ratio Error in 5th Gear". There may be no complaint of slipping or drive ability problems.
- CAUSE:** The Direct/Reverse clutch housing has cracked in the thrust washer area where it contacts the oil pump cover. (Refer to Figure 5 Below)
- CORRECTION:** Change the housing. Also, pay close attention to the OD accumulator, the seal sleeve in the case between the valve body and OD/INT clutch housing and the # 12 check ball as these are other known causes.

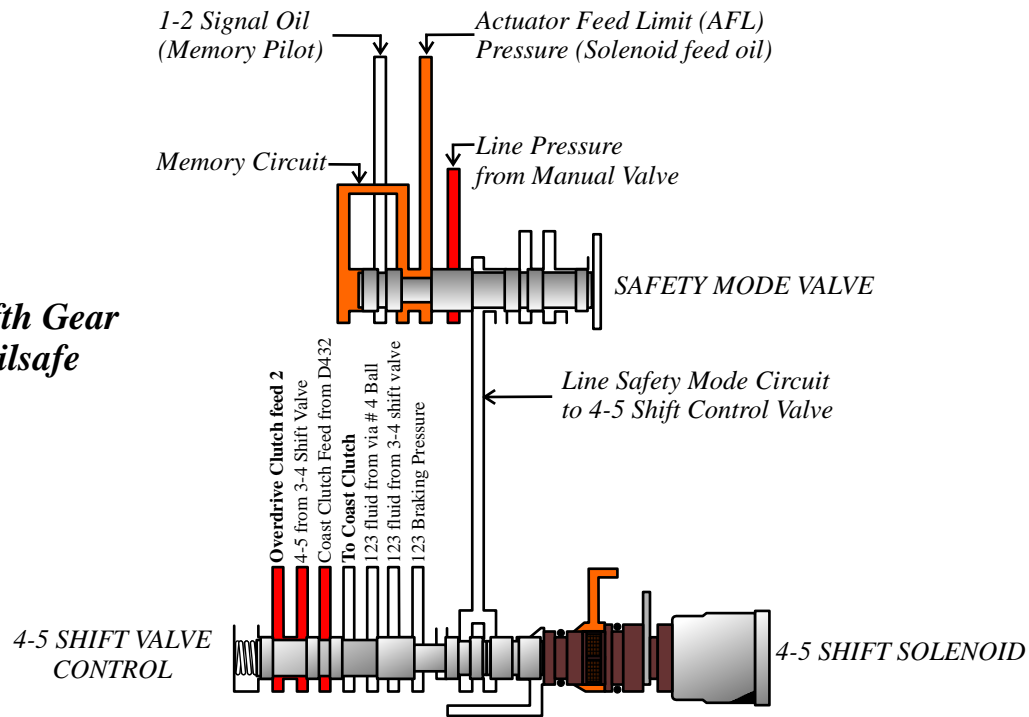
Figure 12

When a fault is detected while the vehicle is being driven, all solenoids turn off and 5th gear is the failsafe gear.

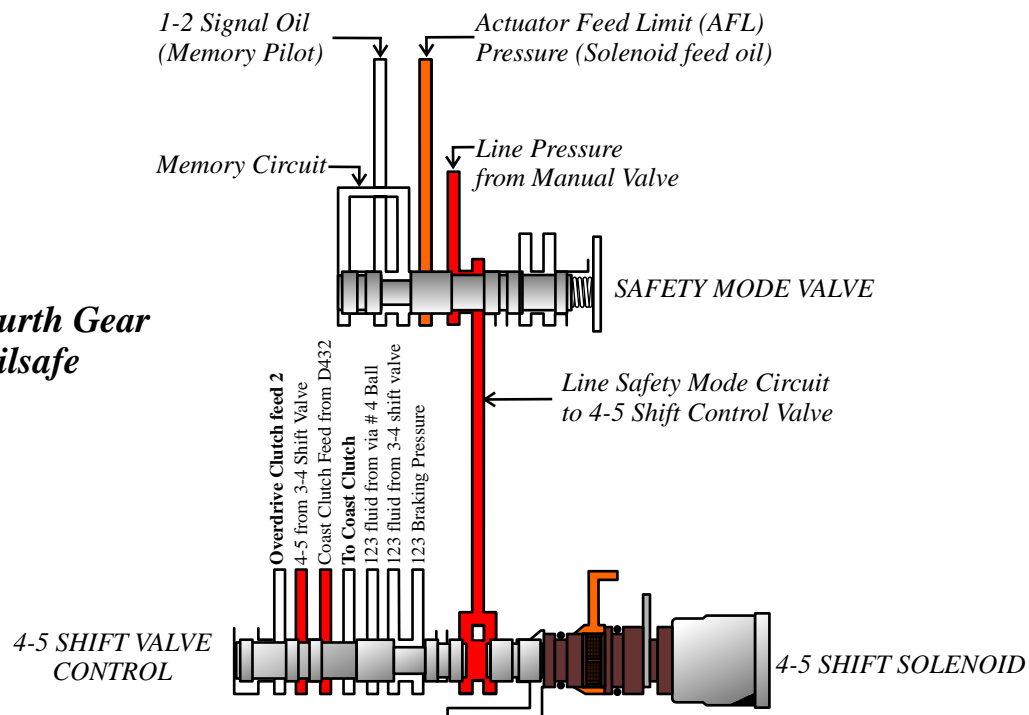
Figure 13

But once the vehicle stops and the ignition is cycled, the Safety Mode Valve is forced closed by spring pressure. Line pressure passes through the valve and into the Line Safety Mode Circuit where it strokes the 4-5 Shift Control Valve. With all solenoids Off, this blocks 4-5 oil from entering the Overdrive Clutch Feed 2 circuit placing the vehicle into a 4th gear failsafe. (See Figure 13)

After an ignition cycle of a failsafed vehicle, the Safety Mode Valve un-strokes where the valve sends line pressure to stroke the 4-5 Shift Control Valve. This blocks 4-5 oil from entering the Overdrive Clutch Feed 2 circuit and now the vehicle will have a 4th gear failsafe.

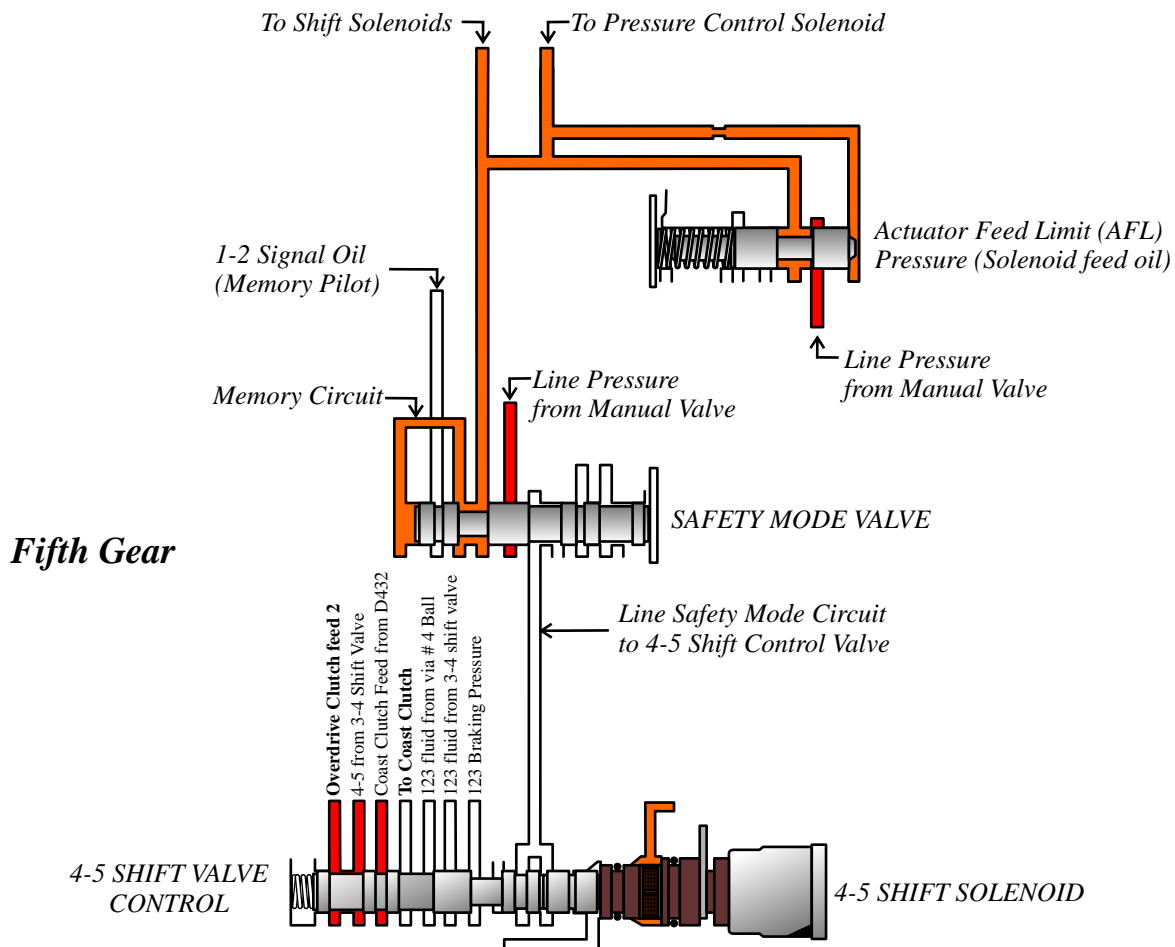
Figure 14

**CAUSE:** The Actuator Feed Limit (AFL) valve has developed sufficient bore and valve wear that it causes a pressure drop in the memory pilot circuit. This causes the Safety Mode valve to be closed by spring tension. When the valve closes, line pressure passes through the valve and into the 4-5 shift valve circuit forcing the valve into a 4th gear position. (See Figures 14 and 15) The AFL bore and valve can wear to a point where it prevents 5th gear completely.

When a shift into 5th occurs, the 4-5 solenoid turns off and 4-5 oil enters the Overdrive Clutch Feed 2 circuit applying the Overdrive Clutch. The Coast Clutch is exhausted and the Safety Mode Valve remains stroked.

**CORRECTION:** Repair the AFL valve/bore wear with a reamer and sleeve kit or replace the valve body.

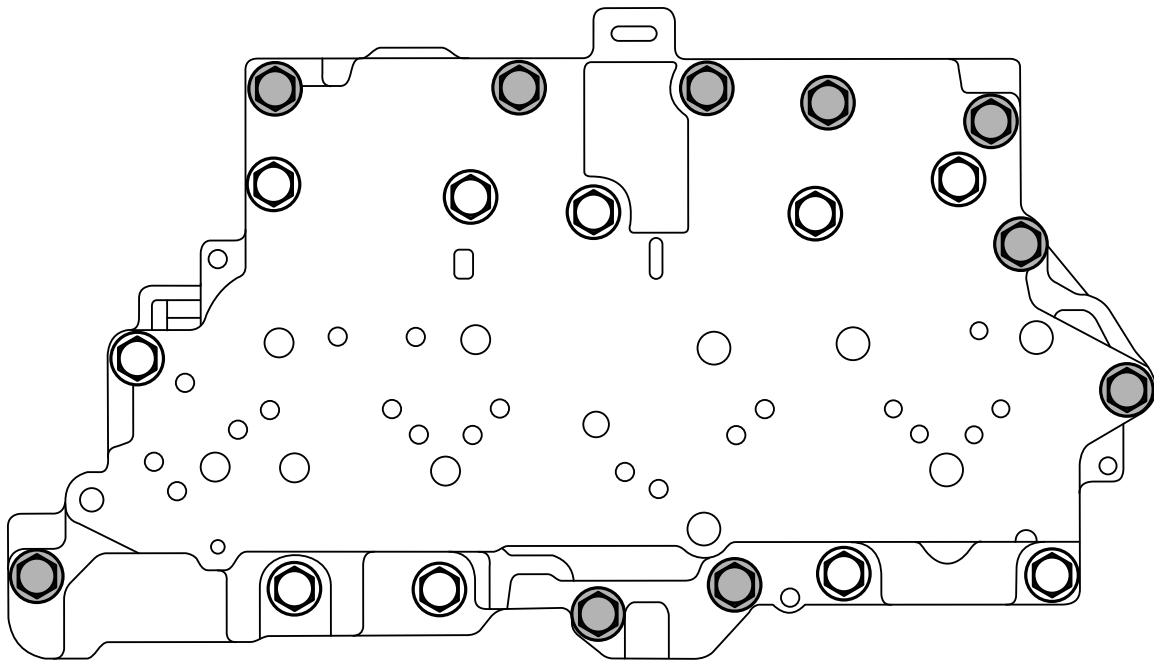
**CAUSE:** The Input and/or Output Speed Sensors are faulty.

REMOVE ONLY THE SHADED BOLTS TO REMOVE THE VALVE BODY ASSEMBLY

**CORRECTION:** Use a scan tool to check input and output rpm and replace the defective speed sensor(s).

To replace the ISS or OSS speed sensor, the valve body will have to be removed. Remove only the shaded bolts shown in Figure 1 to remove the valve body assembly.  
The location of the speed sensors is explained in Figure 2.

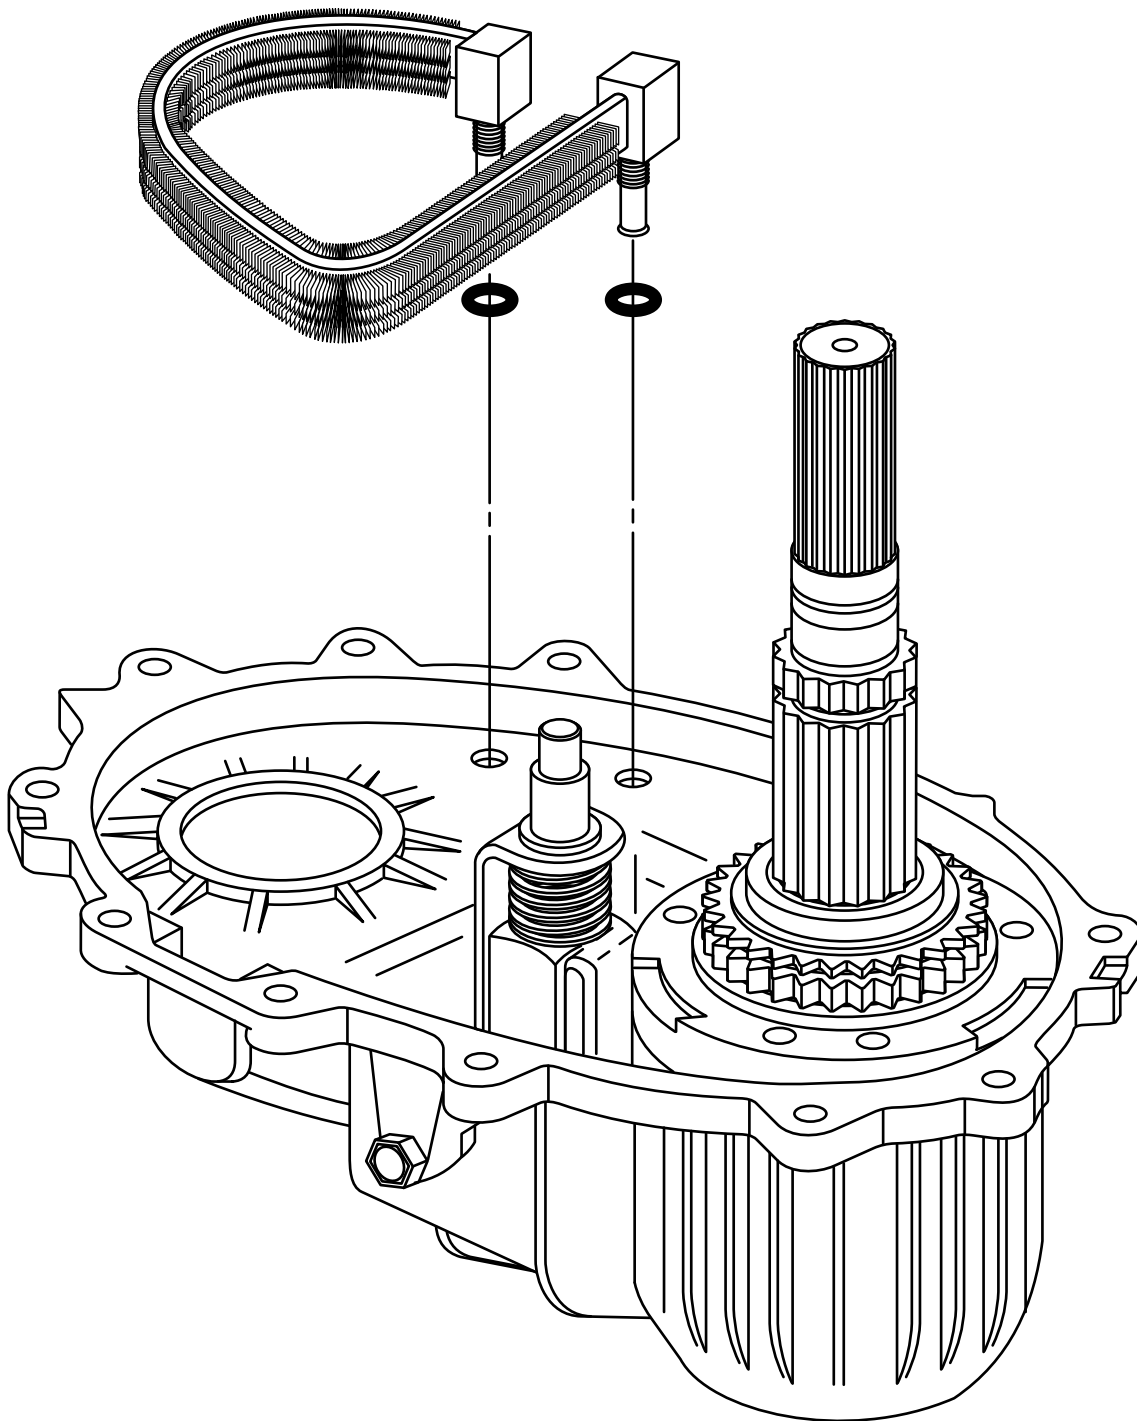
**CAUSE:** One cause may be the oil cooler in the transfer case has a crack and is leaking ATF into the transfer case.

Refer to Figure 1 for Cooler location in the Transfer Case. Refer to Figure 2 for cracking location of the Cooler Tube. Refer to Figure 3 for description and depiction of revised Transfer Case Cooler. Refer to Figure 4 for Transfer Case Cooler, hose and cooler line routing diagram.

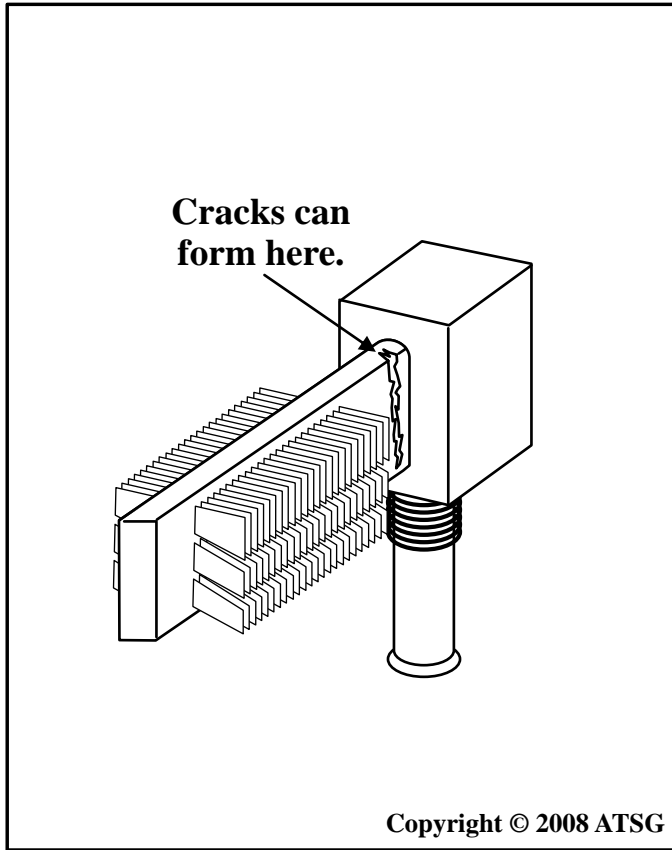
Figure 2

Hummer uses a cooler inside the NV242HD Transfer Case. The cooler tube is prone to cracking which will allow transmission cooler pressure to leak into the transfer case. Once this begins occurring, the transfer case will become overfilled and depending on the severity of the crack, fluid may vent from the transfer case, or the fluid can make its way into the air cleaner and contaminate the air filter and leak near the right front tire. It is also possible for the fluid pressure to push out the rear seal. Transmission damage may also occur if the transmission fluid level becomes too low.

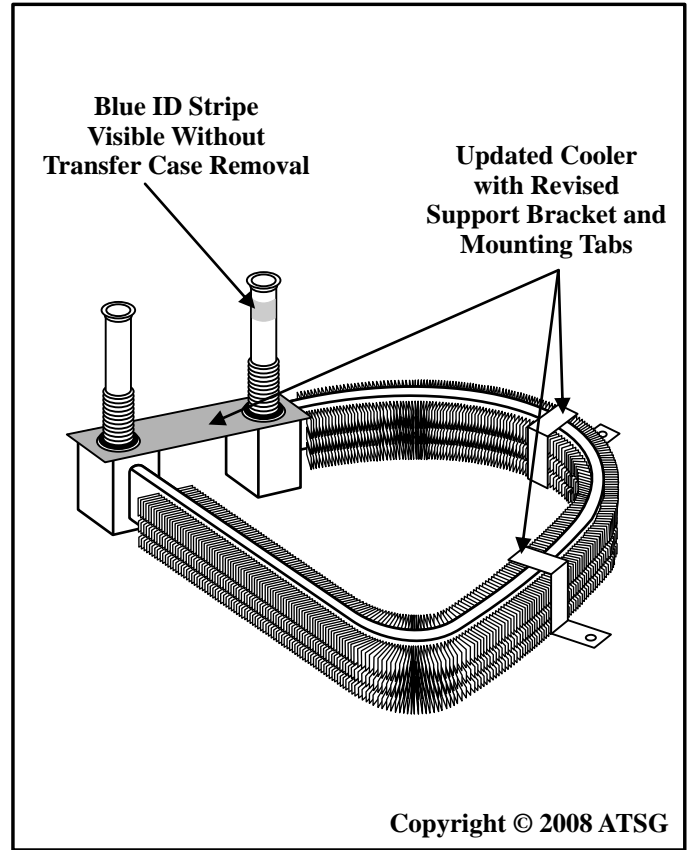
Figure 3

In 2001 Hummer introduced an updated cooler with a revised support bracket and additional mounting tabs to restrict movement and eliminate cracking of the cooler. This revised cooler can be identified by the "Blue" ID Stripe located on one of external fittings.

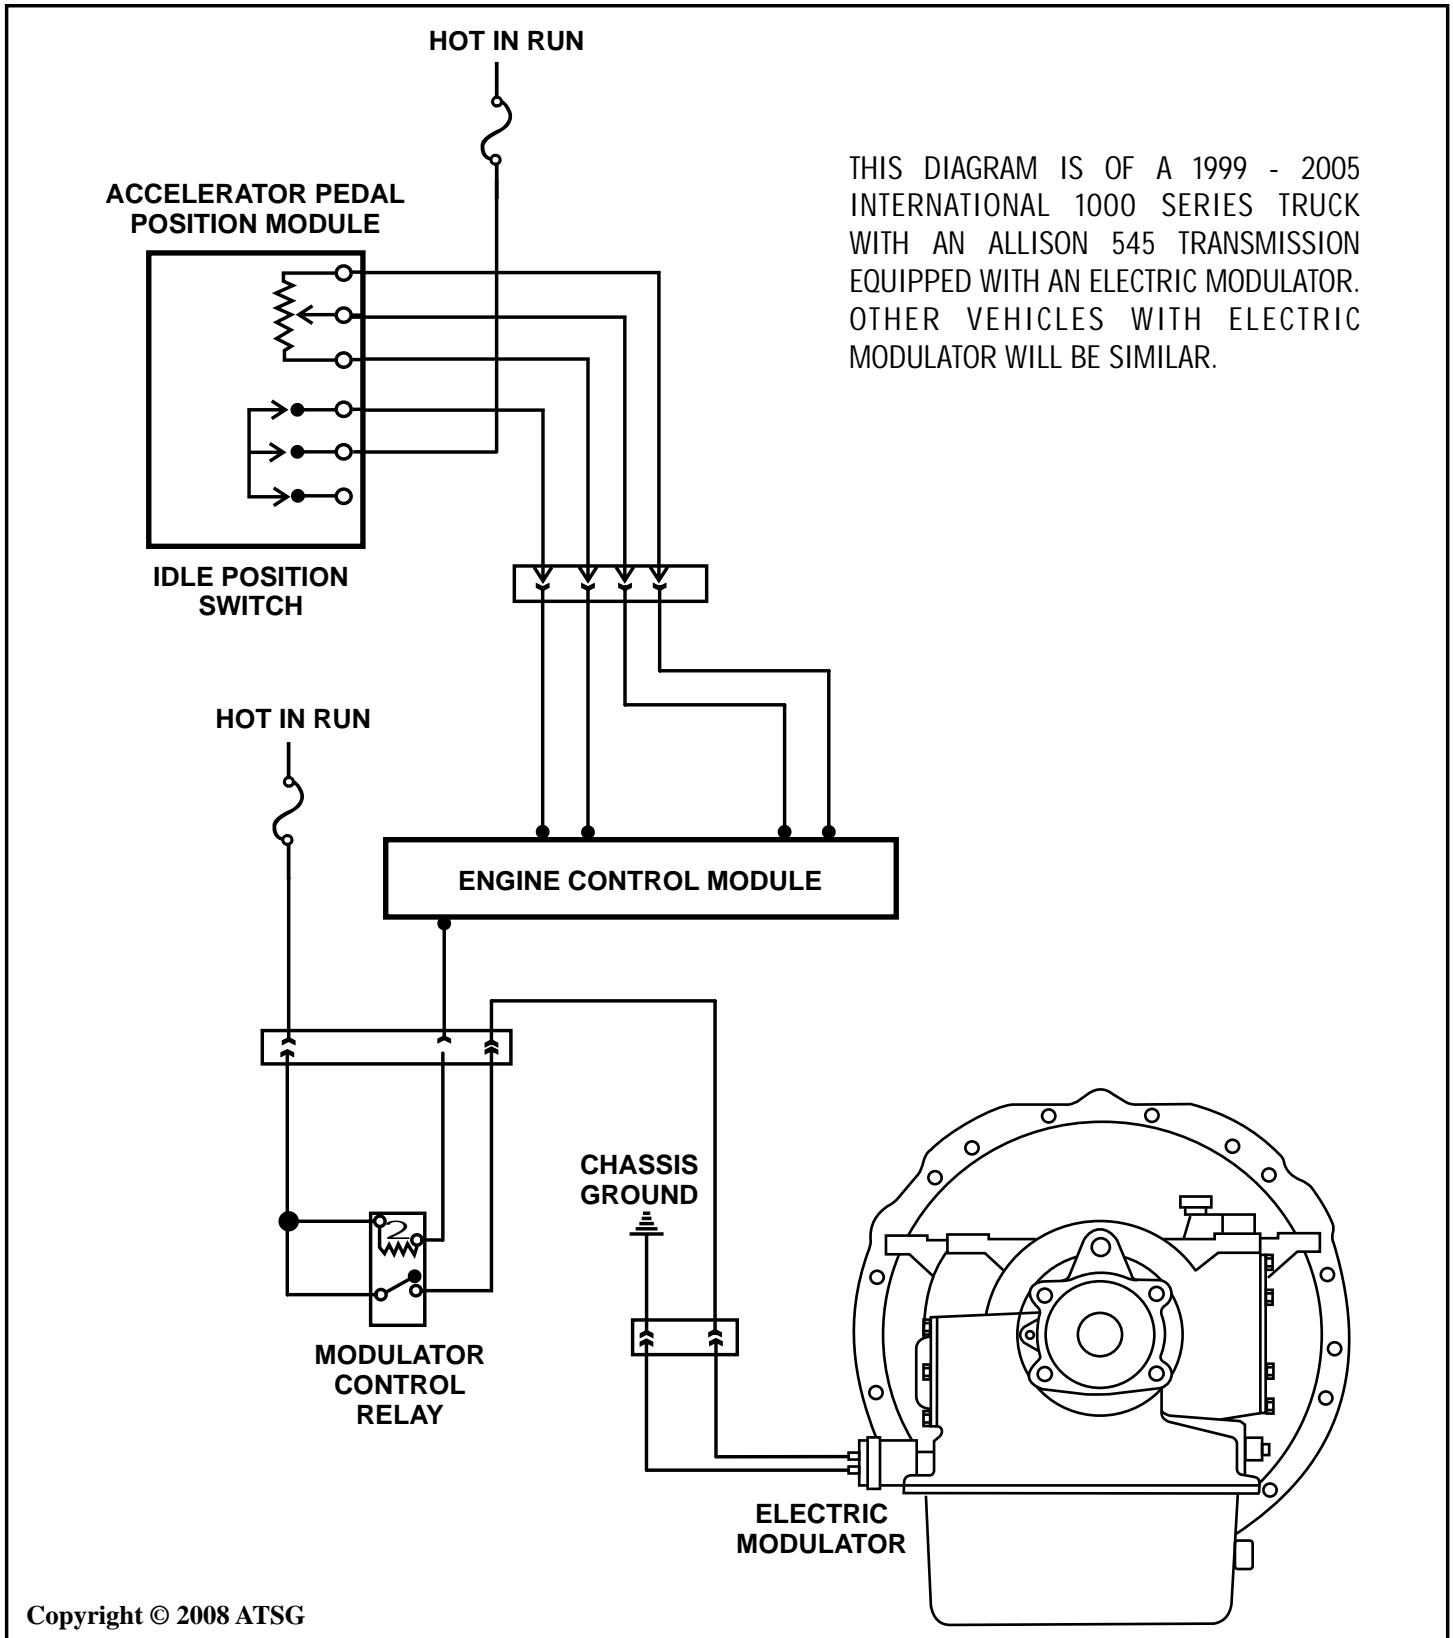
Figure 4

Check for system voltage to be present at the modulator on full throttle and no electricity when the throttle is released, (Refer to the wire diagram in Figure 4). In most cases the faulty component is usually the modulator or the relay.

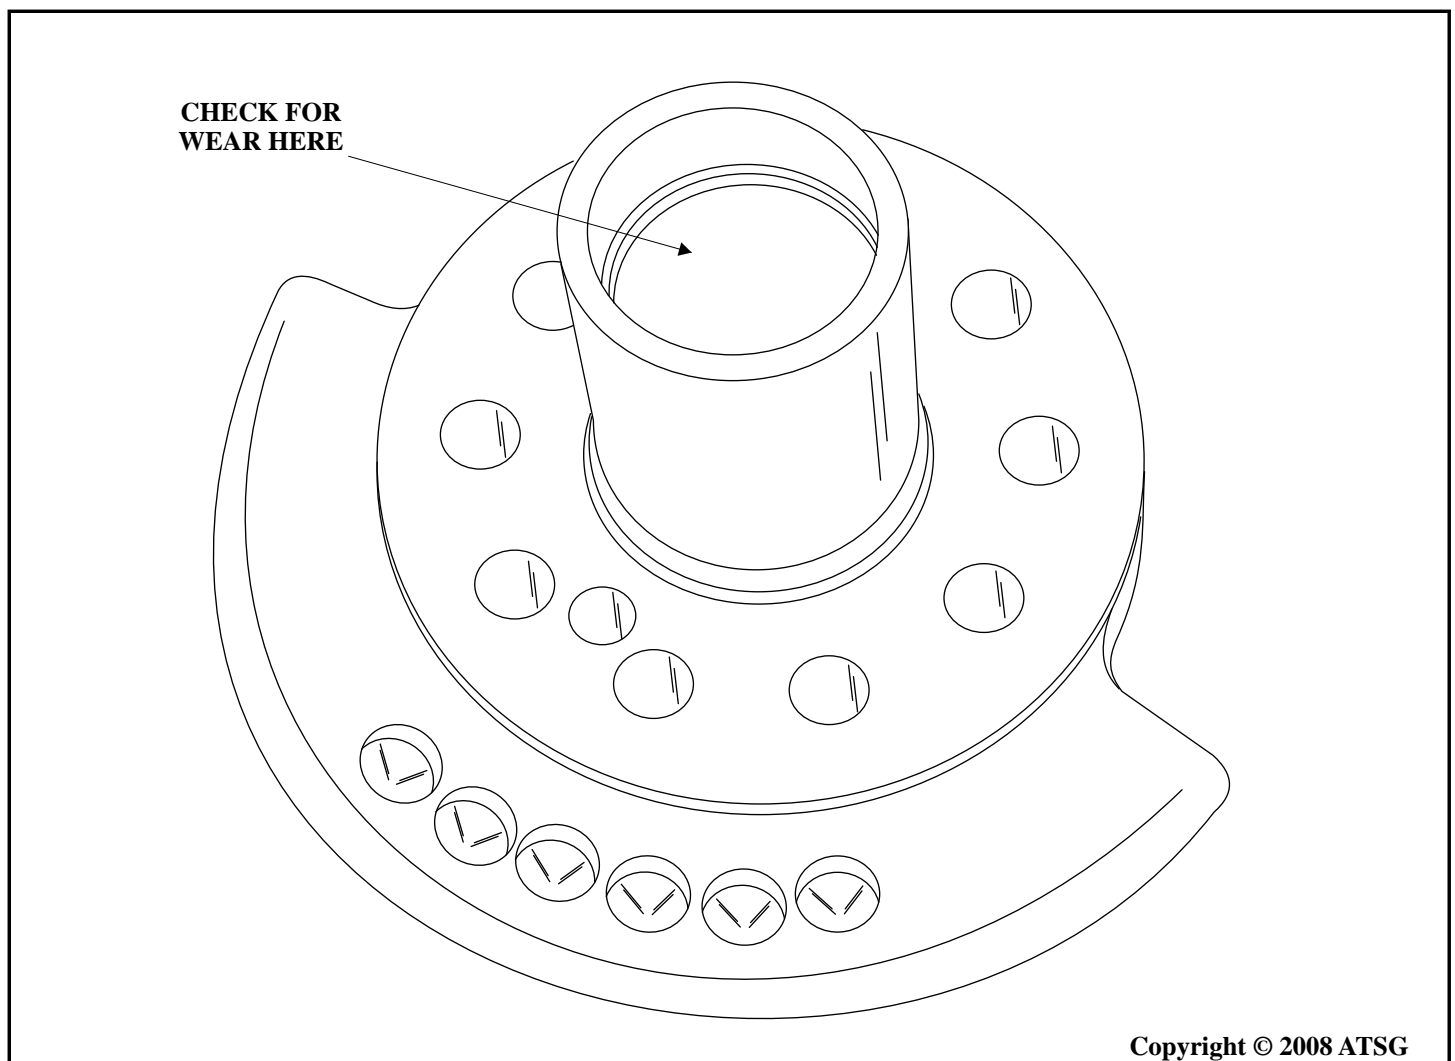
Figure 1

**COMPLAINT:** The vehicle returns with a complaint of leaking out the front of the transmission and a slight vibration at higher engine speeds. When the transmission is removed, the flywheel is cracked and the front pump bushing is damaged.

**CAUSE:** The crankshaft pilot (Refer to Figure 1) is worn.

**CORRECTION:** Replace the crankshaft pilot or have sleeved to original specifications.
