"2001" SEMINAR INFORMATION "PRACTICAL TECH"

AUTOMATIC TRANSMISSION SERVICE GROUP

"FIXES THAT WORK"

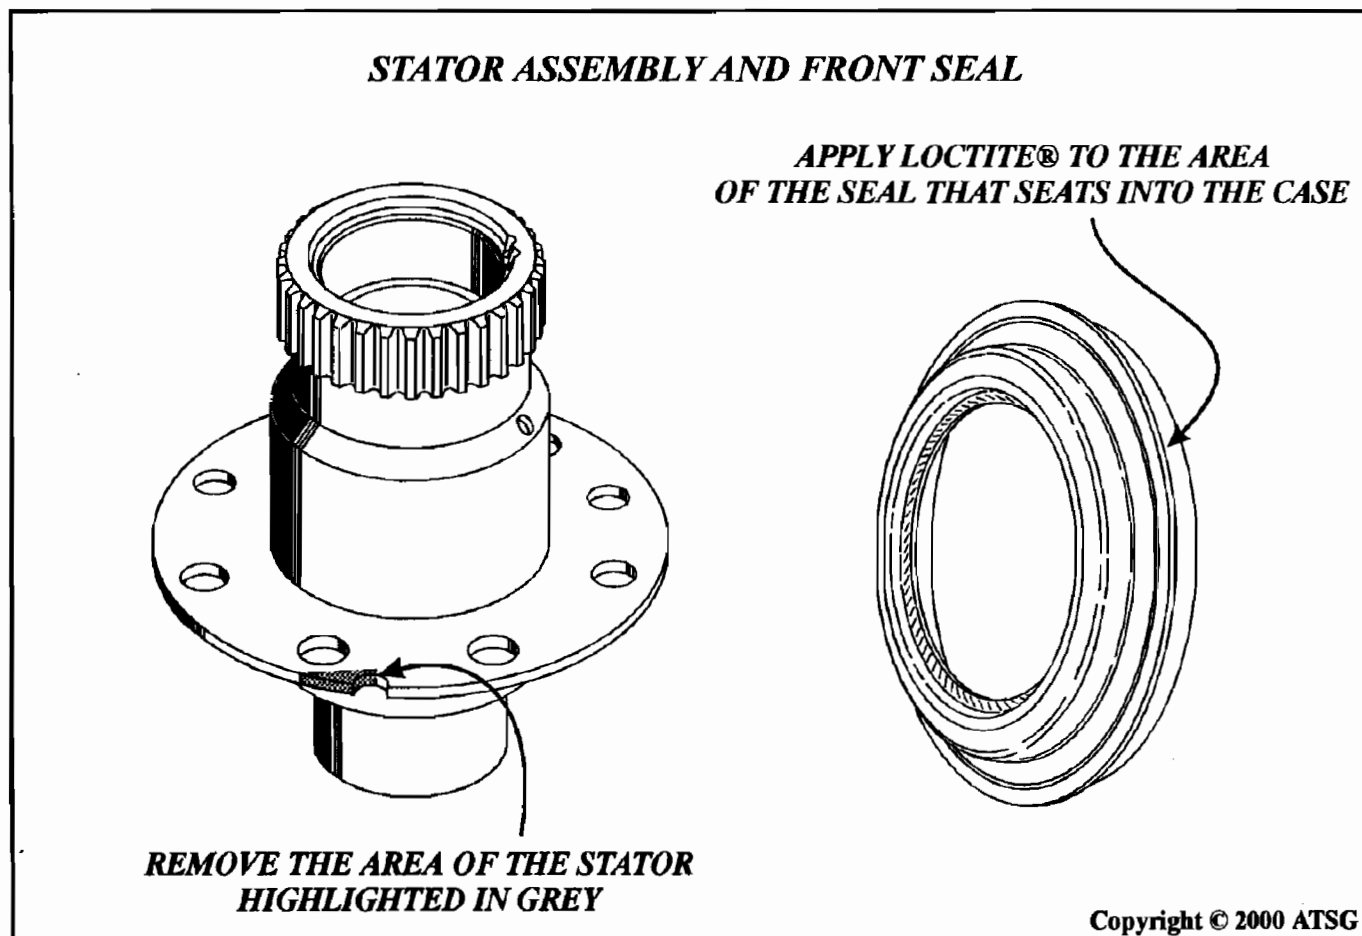
Figure 1

FORD CD4E/MAZDA LA4A-EL FRONT SEAL BLOW-OUT OR CONSTANT LEAK

COMPLAINT: Vehicles equipped with CD4E/LA4A-EL transmissions may exhibit repeated front seal "blow-out" or constant front seal leak.

CAUSE: The cause may be, an undersized drain back passage in the bellhousing.

2. With a 3/16" or 13/64" drill bit, drill at an angle through the area shown in Figure 2.
3. Refer to Figure 3 to see the modified drain back passage from the front side of the bellhousing.
4. Apply Loctite ® to the front seal before installing it into the bellhousing as shown in Figure 1.

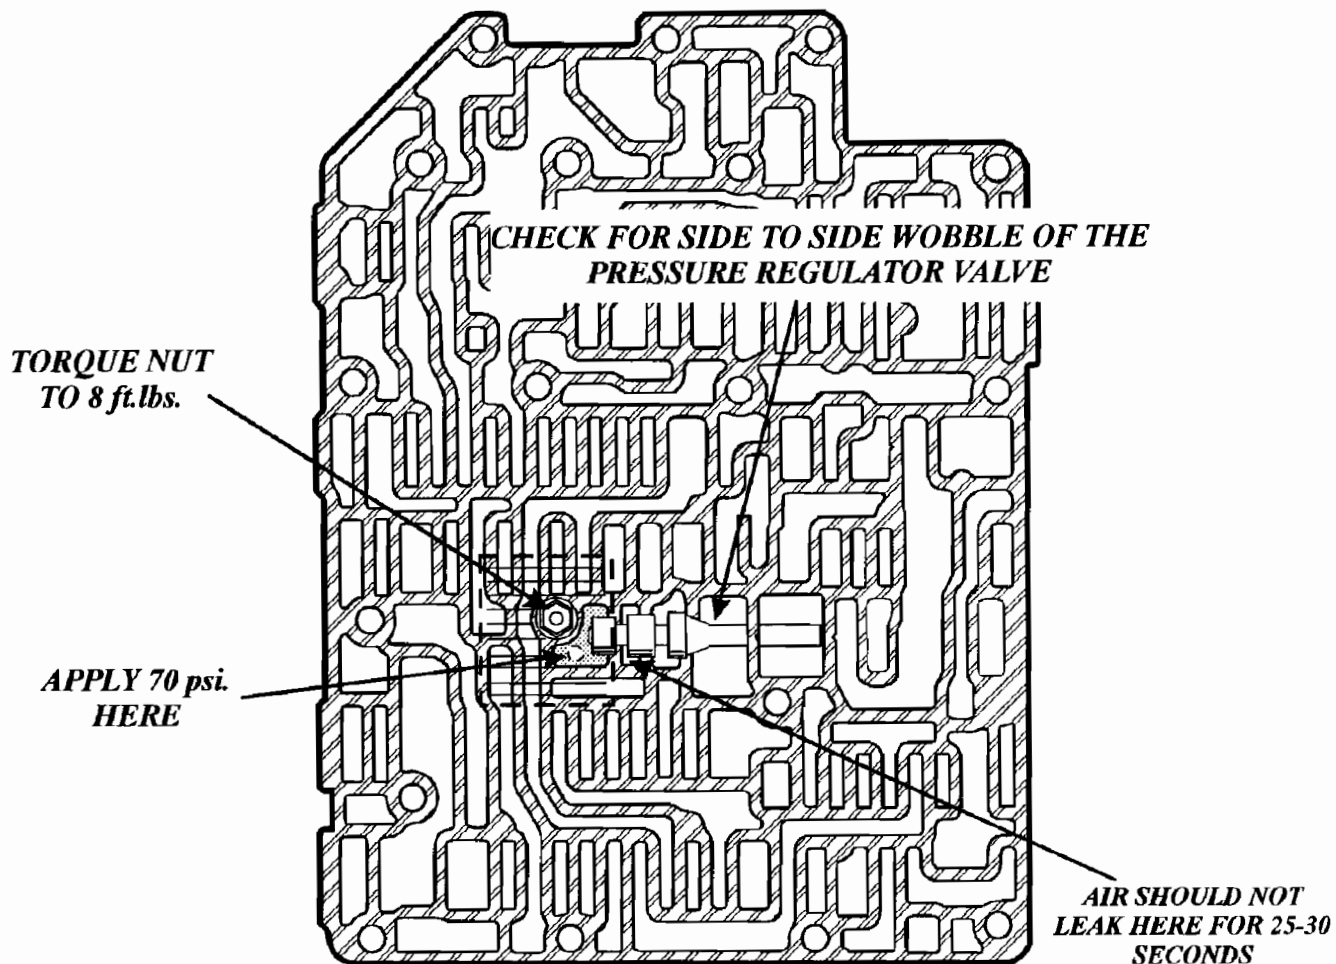
**FILL THE AREA HIGHLIGHTED IN GREY WITH ATF AND COVER WITH A
SUITABLE PLATE AS OUTLINED WITH THE DOTTED LINE**

**APPLY 70 psi. OF AIR PRESSURE TO THE DOTTED HOLE IN THE
PLATE. THE VALVE BODY BORE SHOULD HOLD THIS AIR PRESSURE
FOR APPROXIMATELY 25-30 SECONDS OR THE BORE IS WORN.**

- D. Refer to Figures 5 and 6 to check for bore wear. Remove the Pressure Regulator valve and inspect it for wear which normally shows up as brown lines. Re-install the Pressure Regulator valve back into its bore and check for wobble from side to side. Fill the cavity shown in Figure 6 with ATF. Place a suitable block over the passage shown in Figure 6 and torque the hold down bolt too 8ft. lbs. Apply 70psi. of air pressure to the hole in the block so the cavity is full and ensure there is no leakage between the block and the valve body. There should be no leakage between the first land of the Pressure Regulator Valve and the wall shown in Figure 6 for approximately 25-30 seconds. A new valve body will hold air pressure for 45-50 seconds. If the valve body in question leaks at 25 seconds or less, the bore is worn and the valve body will require replacement or Sonnax part no. 73840-RK regulating valve kit installed. **Note: requires reamer Sonnax part no. 73840-RTL.**

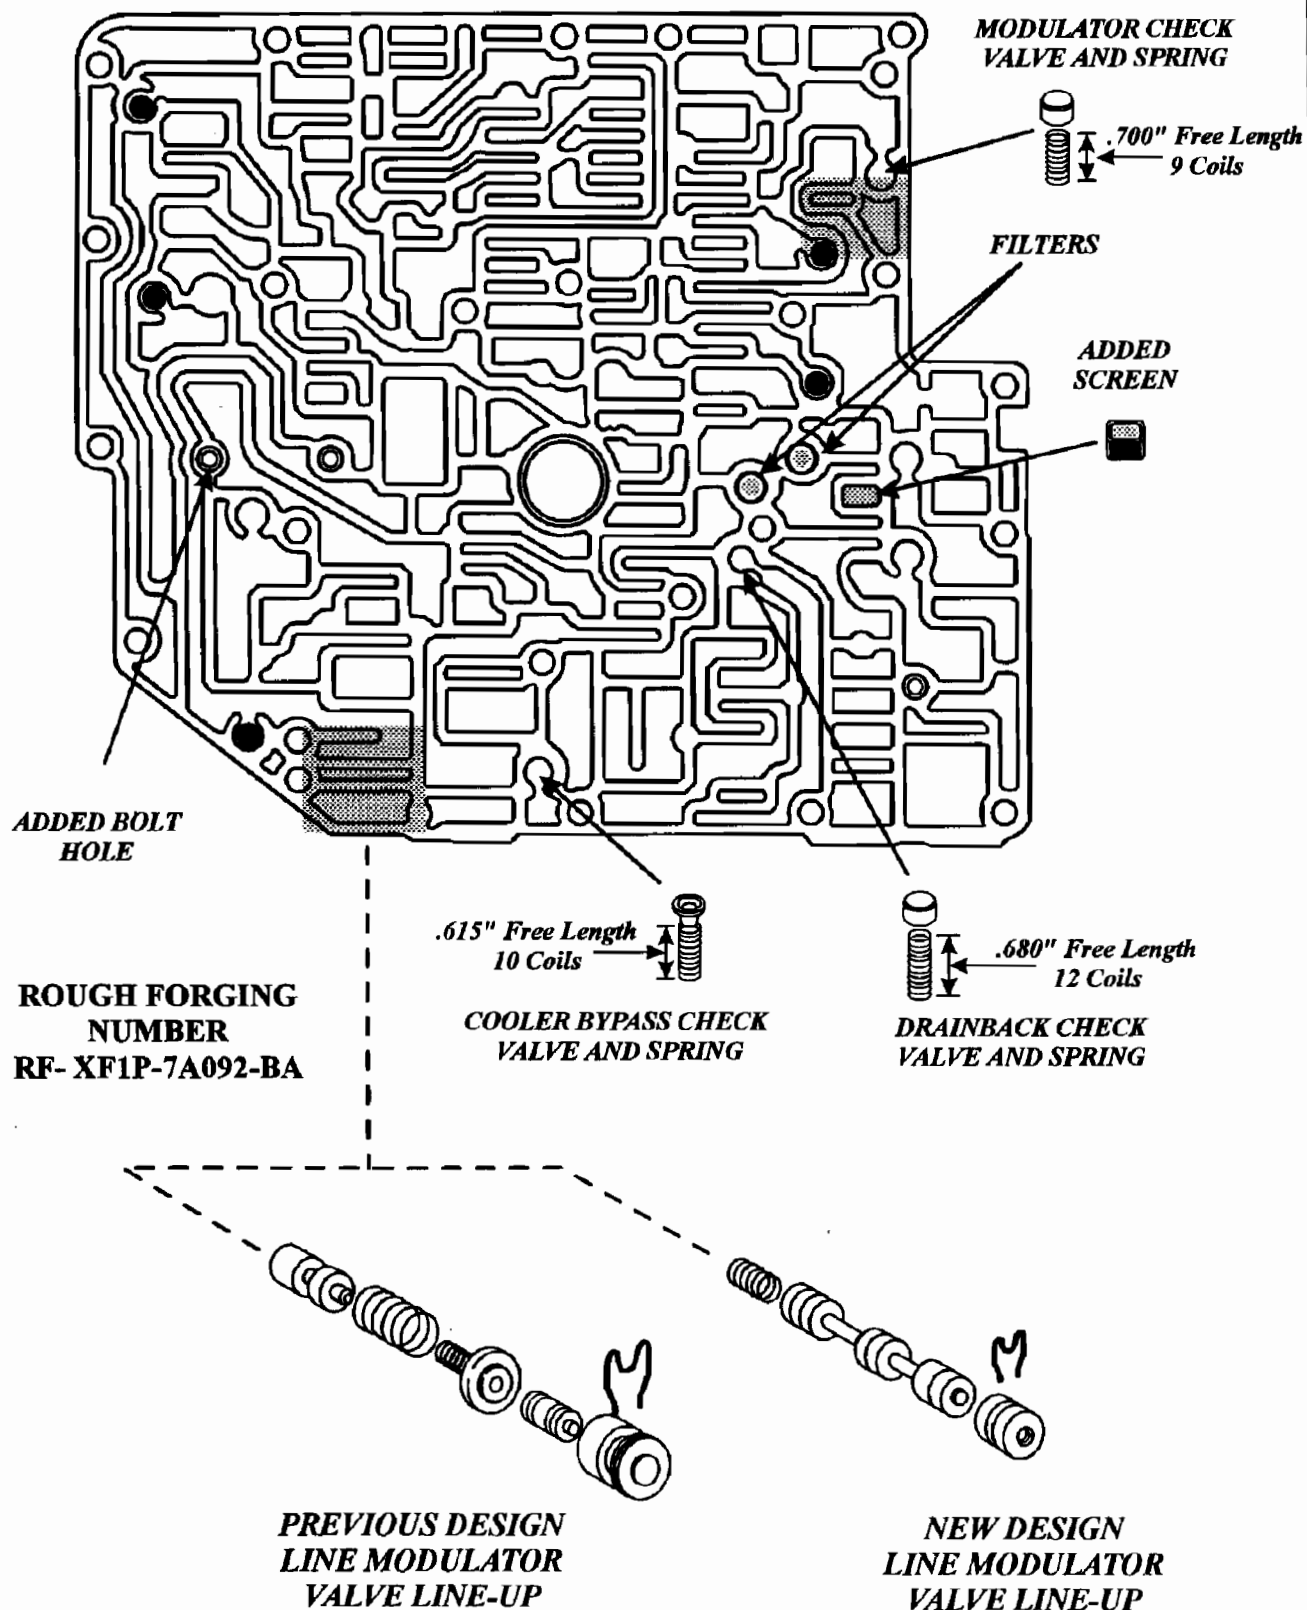
Figure 1

AX4N VALVE BODY CHANGES

NOTE: CASTING CHANGES ARE SHADED IN GREY

None of the parts listed above will interchange with the previous design level parts, however, when all parts above are used as a service package, we see no reason that they will not retro-fit back on all previous models.

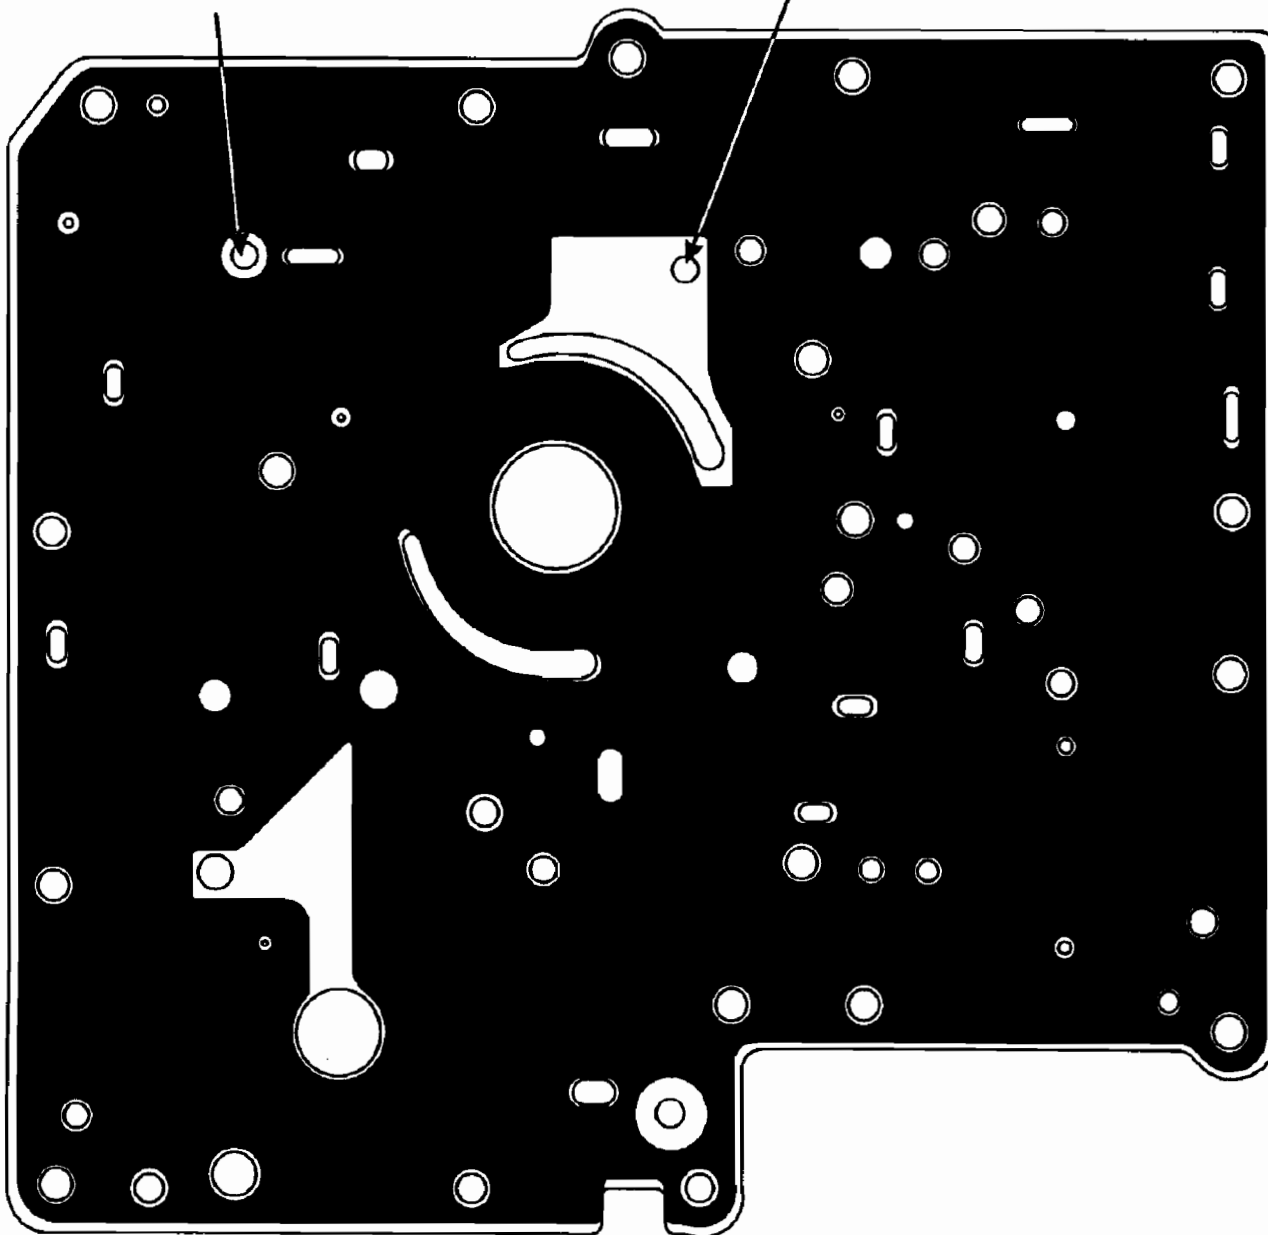
Figure 4

**PREVIOUS DESIGN LOWER PUMP SPACER
PLATE RETAINING BOLT LOCATION
WHICH HAS BEEN ELIMINATED**

**LOWER PUMP SPACER PLATE
RETAINING BOLT RELOCATED HERE**

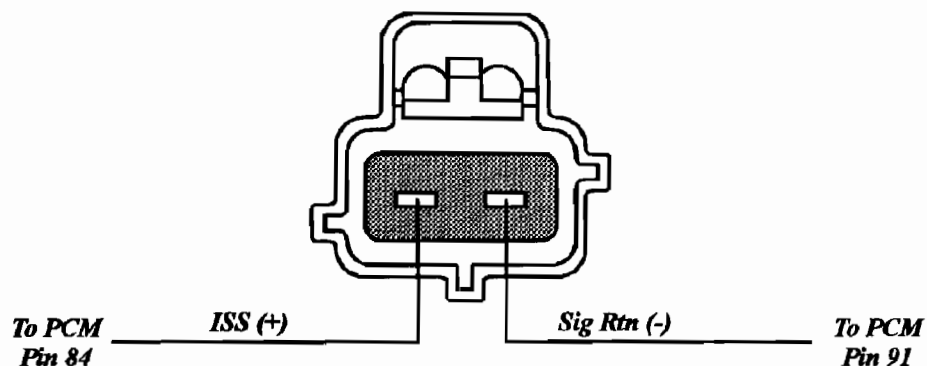
Figure 3

5R44E/5R55E ADDED DIAGNOSTICS AND TROUBLE CODE CHART

DTC	DESCRIPTION	SYMPTOM	POSSIBLE CAUSES
P0791	ISS Sensor Failure (Signal Loss)	Harsh 2-3 Shifts	ISS Sensor or Wiring
P0794	ISS Sensor Signal Intermittent	Harsh 2-3 Shifts	ISS Sensor or Wiring
P1636	SSx ISIG Communication Error	None	Replace PCM

Intermediate Shaft Speed Sensor
325-485 Ohms Resistance @ 20°C (70°F)

None of the parts listed above are interchangeable with the previous design level parts. For diagnosis of Intermediate Shaft Speed sensor, refer to Figure 3.

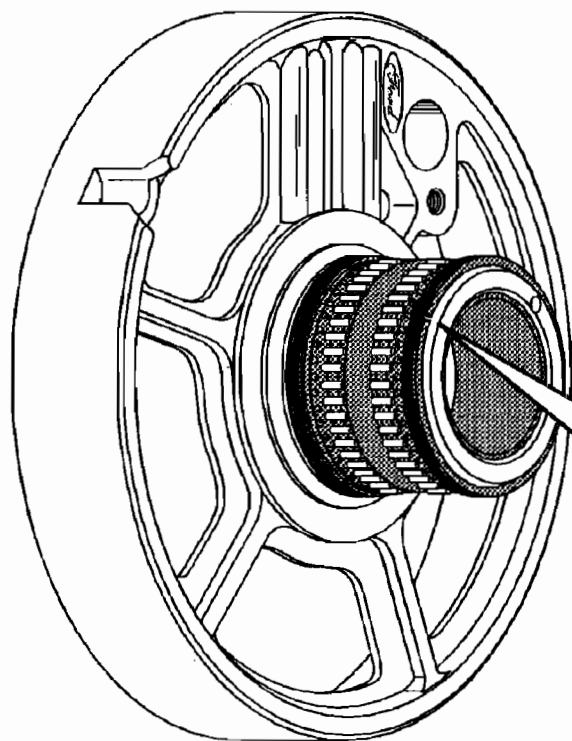
Figure 1

**INSPECT INNER
RACE FOR CRACKS**

Center Support With BearingXW4Z-7A130-DA

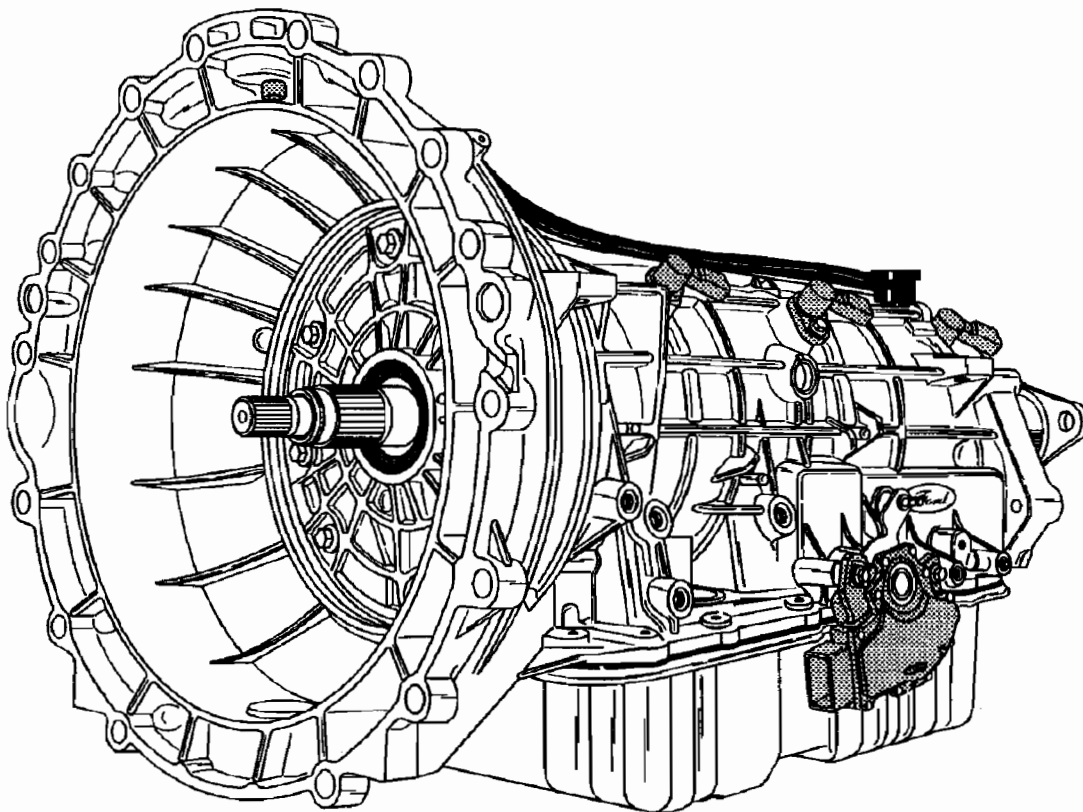
CHECKING FLUID LEVEL

However, this is a **"Fill" plug only** on the new 5R55N transmission from Ford Motor Company, which is currently found in the 2000 Lincoln LS and some Jaguars. To **"Check"** for the correct fluid level, you must remove the check plug, which is located in the center of the bottom pan drain plug, and is removed with an allen wrench, as shown in Figure 1, while holding the drain plug with the proper size wrench so as not to loosen the drain plug.

We have provided you with a cut-away drawing of the bottom oil pan and the drain plug so that you will understand how this system works. Notice that the drain plug actually has a "stem" made on it that extends some distance up into the bottom pan, which is our way to establish the proper fluid level in the transmission. By removing the "Check" plug from the "Drain" plug, the fluid should just trickle over the stem and out through the center of the drain plug, as shown in Figure 1. The "Fill" plug in the extension housing is your only way to replace fluid in the transmission.

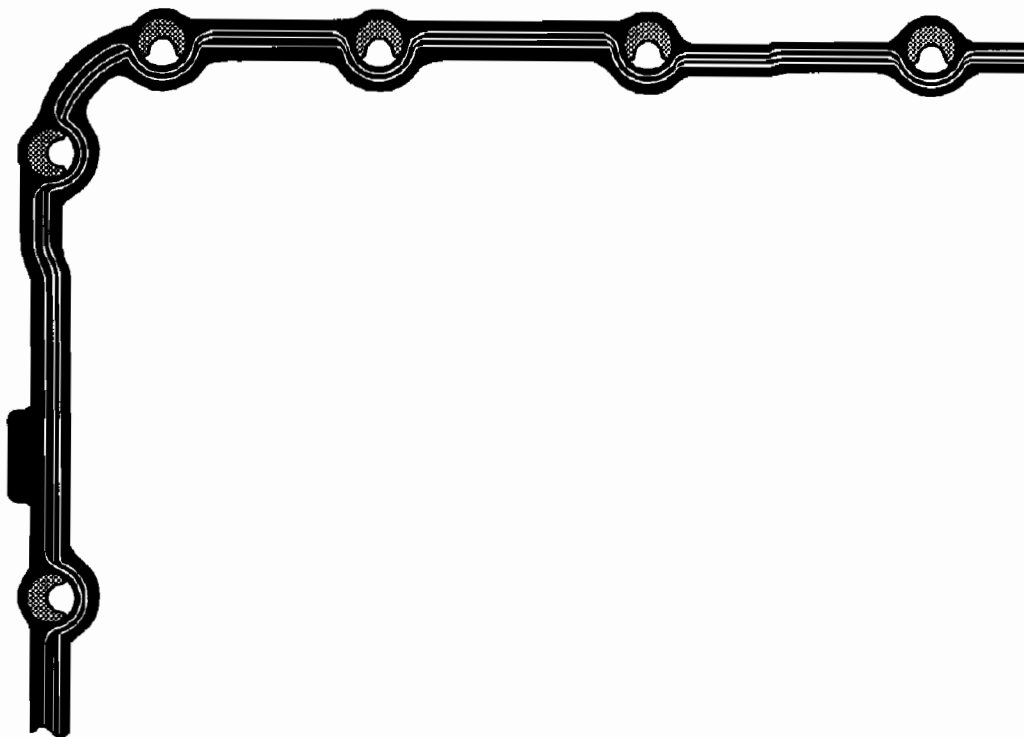
FORD 5R55N PREVIOUS DESIGN PAN GASKET
(NOT RECOMMENDED FOR USE)

Pan Gasket (New Design) XW4Z-7A191-CA

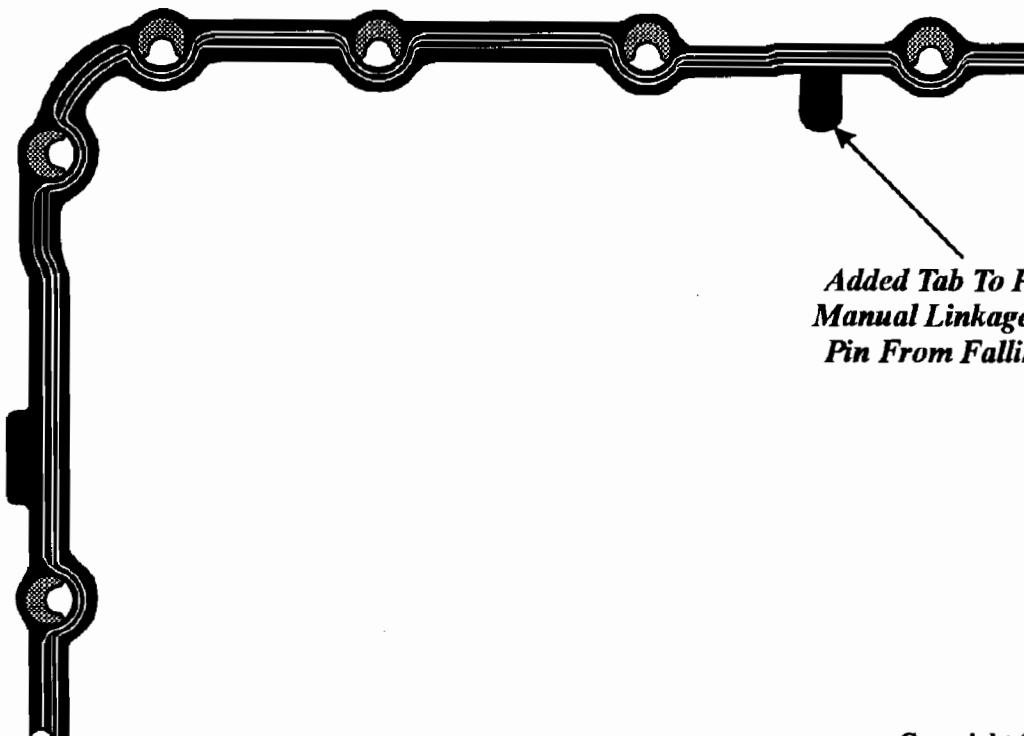
**FORD 5R55N CURRENT DESIGN PAN GASKET**
PART NUMBER XW4Z-7A191-CA

*Added Tab To Prevent
Manual Linkage Rolled
Pin From Falling Out*

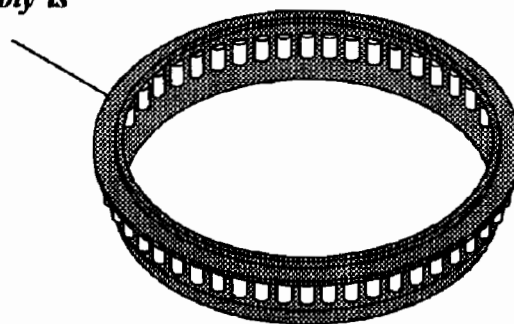
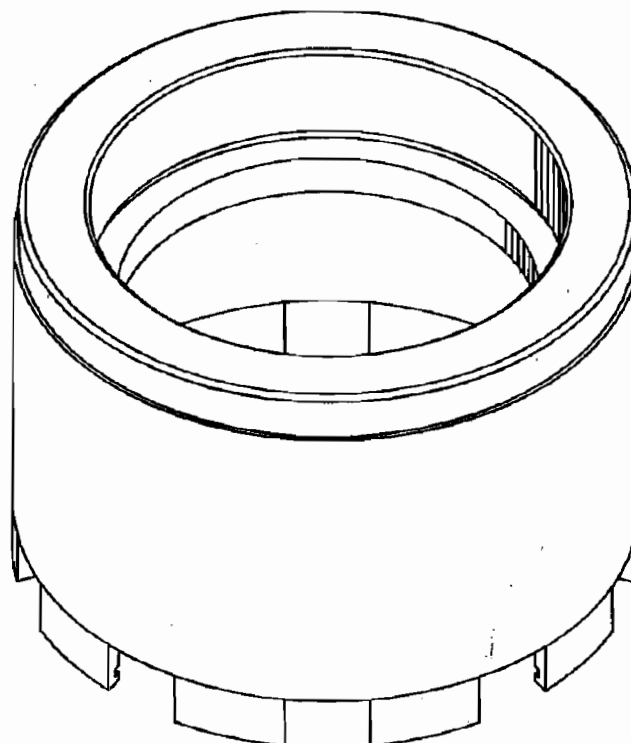
Figure 3

1. The reverse drum to sprag inner race caged needle bearing must be installed into the reverse drum first, as shown in Figure 3. The Low Sprag Assembly is very difficult to remove if this bearing is forgotten.
2. The Low Sprag Assembly **must** be installed into the reverse drum with the locking tabs facing down as shown in Figure 3. It is very easy to install in the other direction, but reverse drum will freewheel in the wrong direction.
3. We have also provided you with illustrations of the gear train in Figures 1 and 2, to assist you in the assembly process, in case you encounter one of these units before you have a manual. ATSG will have a manual available very soon.

Second, ensure that sprag assembly is installed with the "Tabs" facing down as shown here. It is very easy to install in opposite direction, but you won't like it.

First, ensure that this caged needle bearing has been installed in direction shown, before sprag assembly is installed, as sprag assembly is difficult to remove.

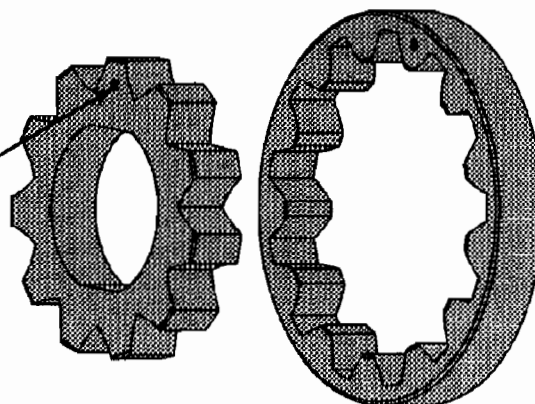
Figure 1

1. The Inner and Outer Pump Gears *must* be placed into the pump body with the identification marks facing *down*, as shown in Figure 1. If they are placed in the opposite direction, the Inner Gear "O" ring will be in the wrong position, and the torque converter will be very difficult if not impossible to install.
2. There is a Line Pressure Limit Valve Assembly in this pump body that is not found in most other transmissions, and is installed in the direction shown in Figure 2.
3. The Pump Alignment Tool is mandatory with this transmission and is the same one that is used on the A4LD, 4R55E/4R55E, and 5R55E transmissions, as shown in Figure 4. Pump alignment pins are also necessary for this transmission.
4. There is also an inner gear "O" ring seating tool, as shown in Figure 5, to ensure that the "O" ring is fully seated in the groove in the inner gear.

Pump Gears Go Into Cover With "Dots" Facing Down

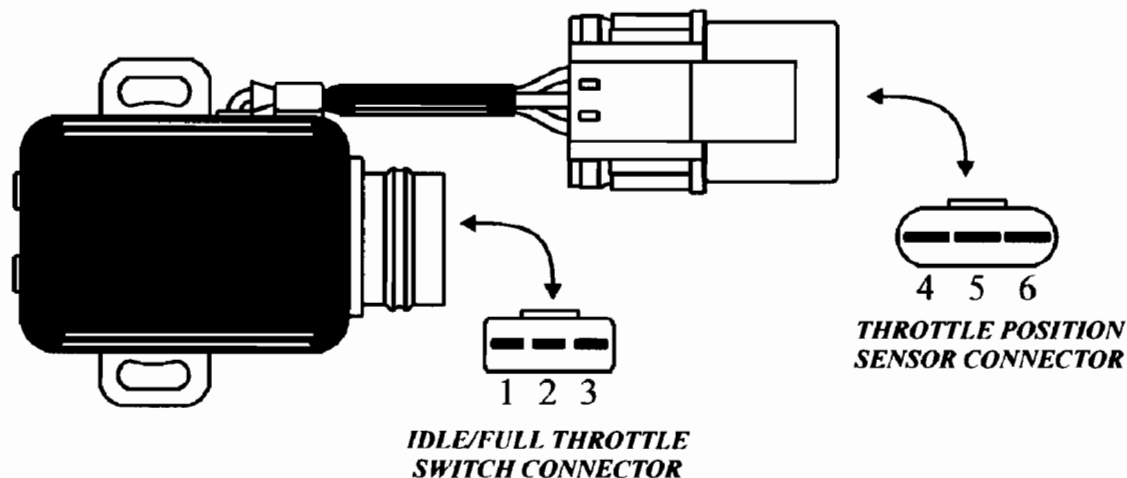
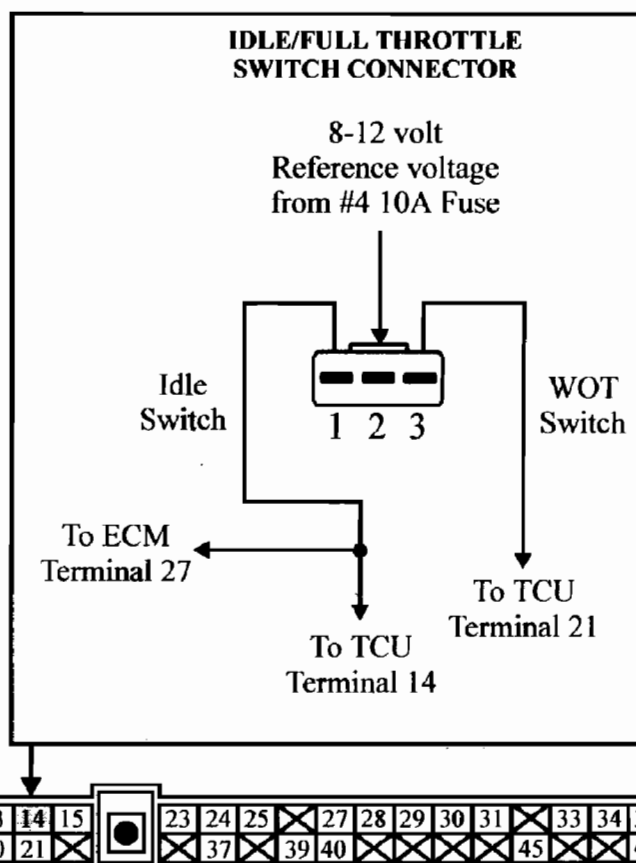
Figure 1

CAUSE: The cause is a malfunctioning Throttle Position Sensor. When coasting down from a vehicle speed of 40mph (68km/h) or higher, the Idle Switch is indicating closed throttle. The Transmission Control Module (TCM) senses higher than idle TPS voltage as well as a decrease in vehicle speed and engine rpm which will cause one or more of the above mentioned codes to be stored.

Terminal 1	Idle switch voltage 8-12 volts at idle 0 volts off idle
Terminal 2	Throttle switch reference voltage 8-12 volts
Terminal 3	Full throttle switch 8-12 volts at WOT 0 volts off WOT
Terminal 4	Throttle position sensor reference voltage 5 volts
Terminal 5	Throttle position sensor signal return voltage varies .3 volts to 5 volts
Terminal 6	Throttle position sensor signal ground less than .1 volts

CORRECTION: Diagnose the Idle Switch circuits as illustrated in figure 1 and replace the TPS if the Idle Switch is faulty.

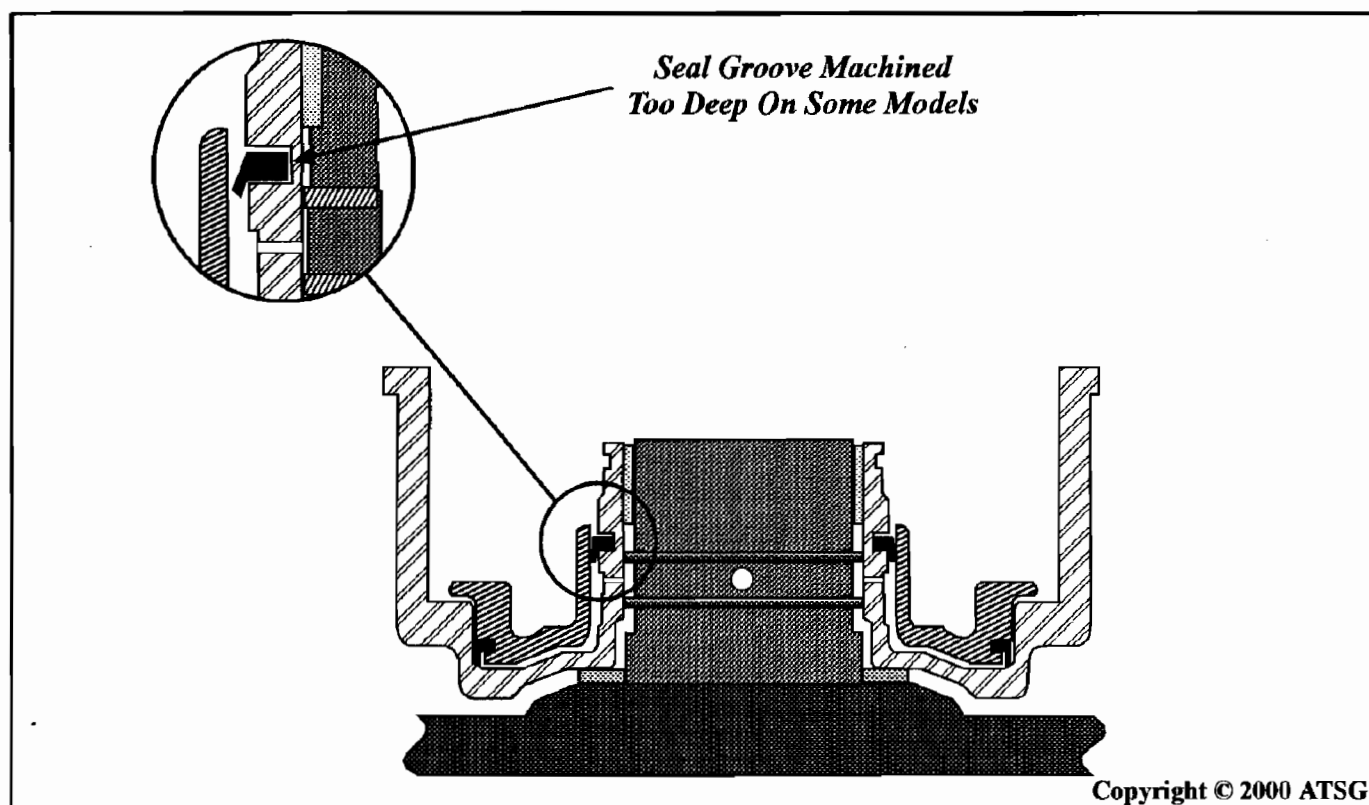
Figure 1

CAUSE: Some direct clutch drums had the inner seal groove cut too deep. This allows for the inner seal to be swallowed up into the groove causing poor retention of fluid (See Figure 1). Another possibility is the outer lip seal being worn due to a poor finish of the drum, in the contact area of the outer lip seal.

CORRECTION: Replace the inner lip seal with a larger radial base. Aftermarket sources such as TransTec/Freudenberg-NOK and Precision International produce a wider base seal to accommodate the deeper groove. Also Shift Technology Products packages an inner lip seal in their K500-618 kit. Replace the outer lip seal, after polishing the drum surface, in the contact area of the outer lip seal.

There have also been reports of the same complaint with the inner lip seals on A500 and 42RE style units. In these cases, a lip seal from a 200-4R servo has worked very well in this location.

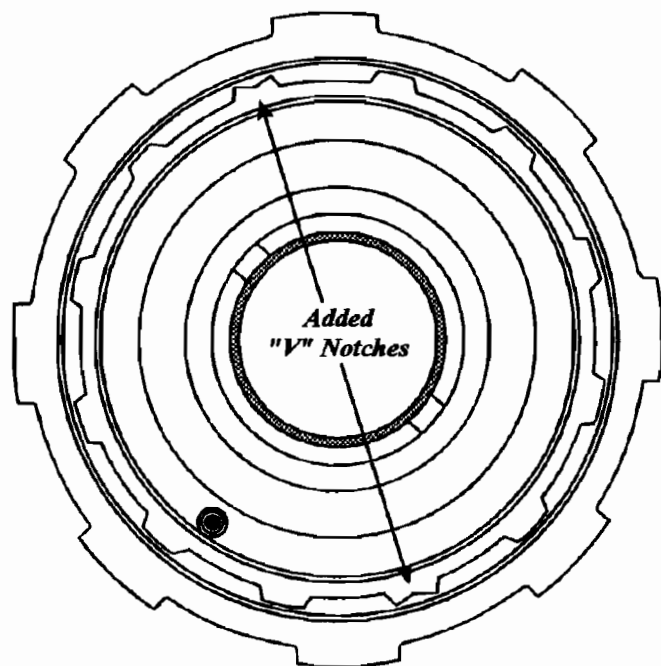
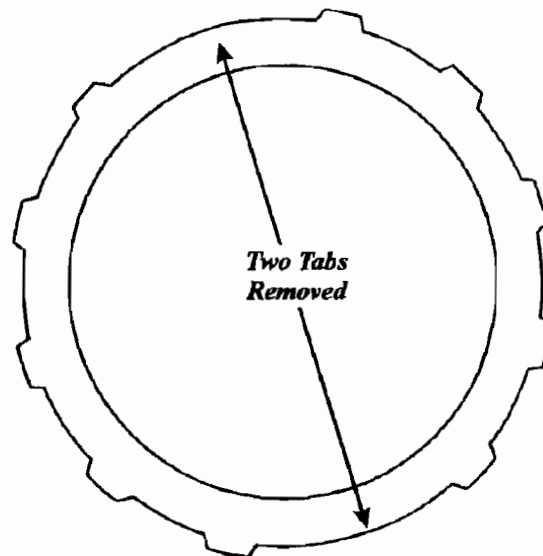
Figure 3

- (4) **REAR (DIRECT) CLUTCH PRESSURE PLATE** - Now manufactured with two of the locating tabs missing, and must be oriented properly to fit into the clutch housing because of the added "V" shaped grooves, as shown in Figure 3.

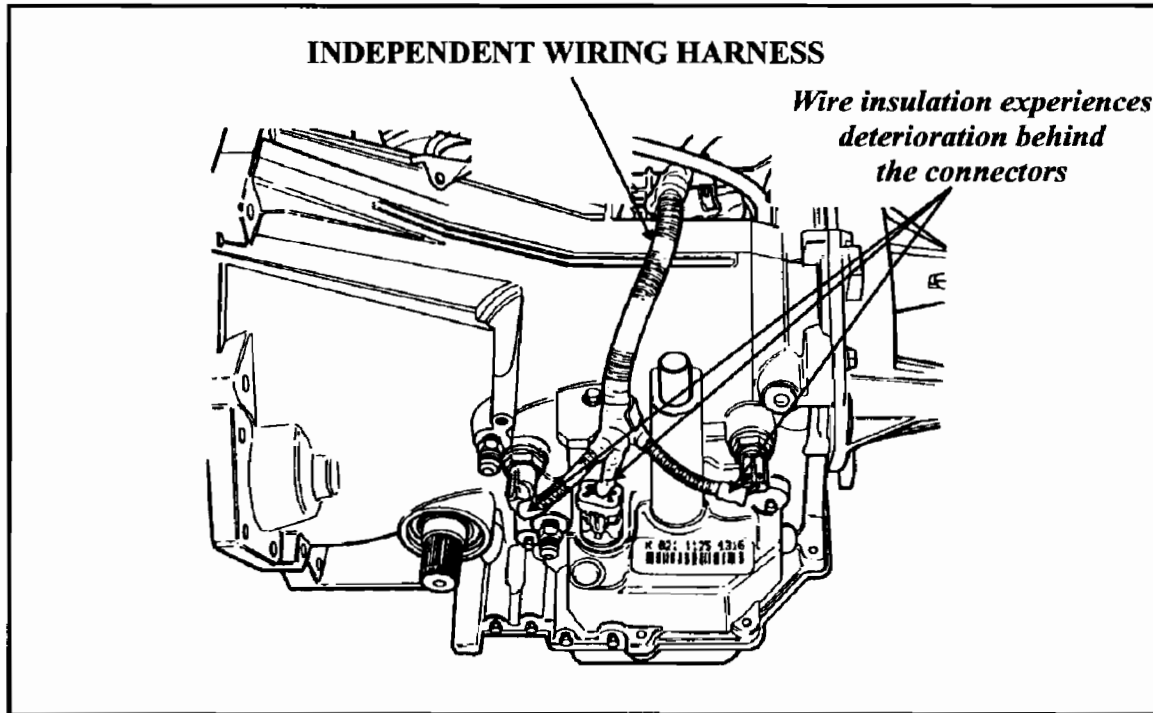
Figure 1

CAUSE: The 42LE/A606 transaxle has an independent wiring harness for the solenoid body and transmission range sensor as seen in Figure 1. The opposite end of the wiring harness which plugs into the main wiring harness is bracketed among a gang of connectors located in the engine compartment near the right side passenger shock tower (See Figure 2). It has been noted on several occasions that the insulation in the wiring coming from the transmission into the back of the connector experiences premature deterioration (See Figure 3). This deterioration allows individual wires to make contact one with another producing the chronic codes.

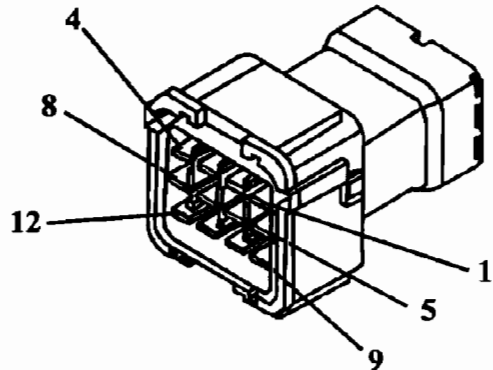
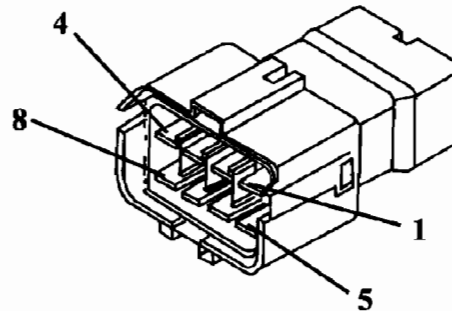
Figure 5 provides additional information such as wire colors for the 8 way connector as well as the 12 way connector. The 12 way connector contains wiring for both the RPM sensors, transmission range sensor and temperature sensor. Wiring problems in this connector has also been known to occur. The same tip can be applied here as there should not be any resistance of any amount between any combination of wires from this connector with the transmission range sensor and RPM sensors unplugged. This will check for shorted wires within the harness. Should resistance of any amount be seen, there is a short within the harness that will need to be repaired.

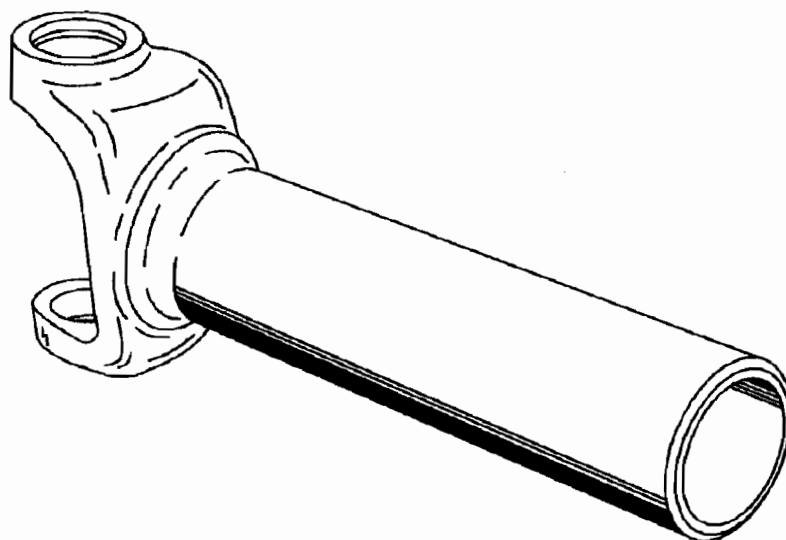
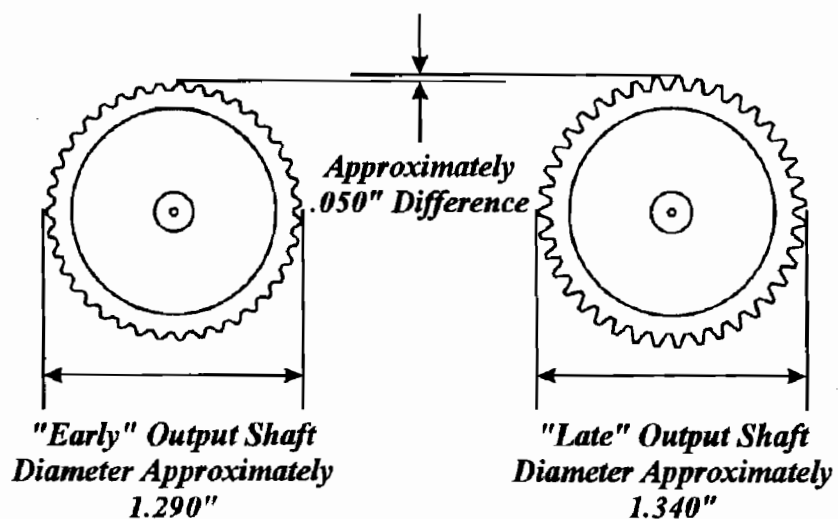
Figure 1

CAUSE: *Late* output shaft in the transmission with *early* driveshaft yoke in vehicle.

**"LATE" DRIVESHAFT YOKE
PART NUMBER 4384437 FITS
BOTH EARLY AND LATE SHAFTS**

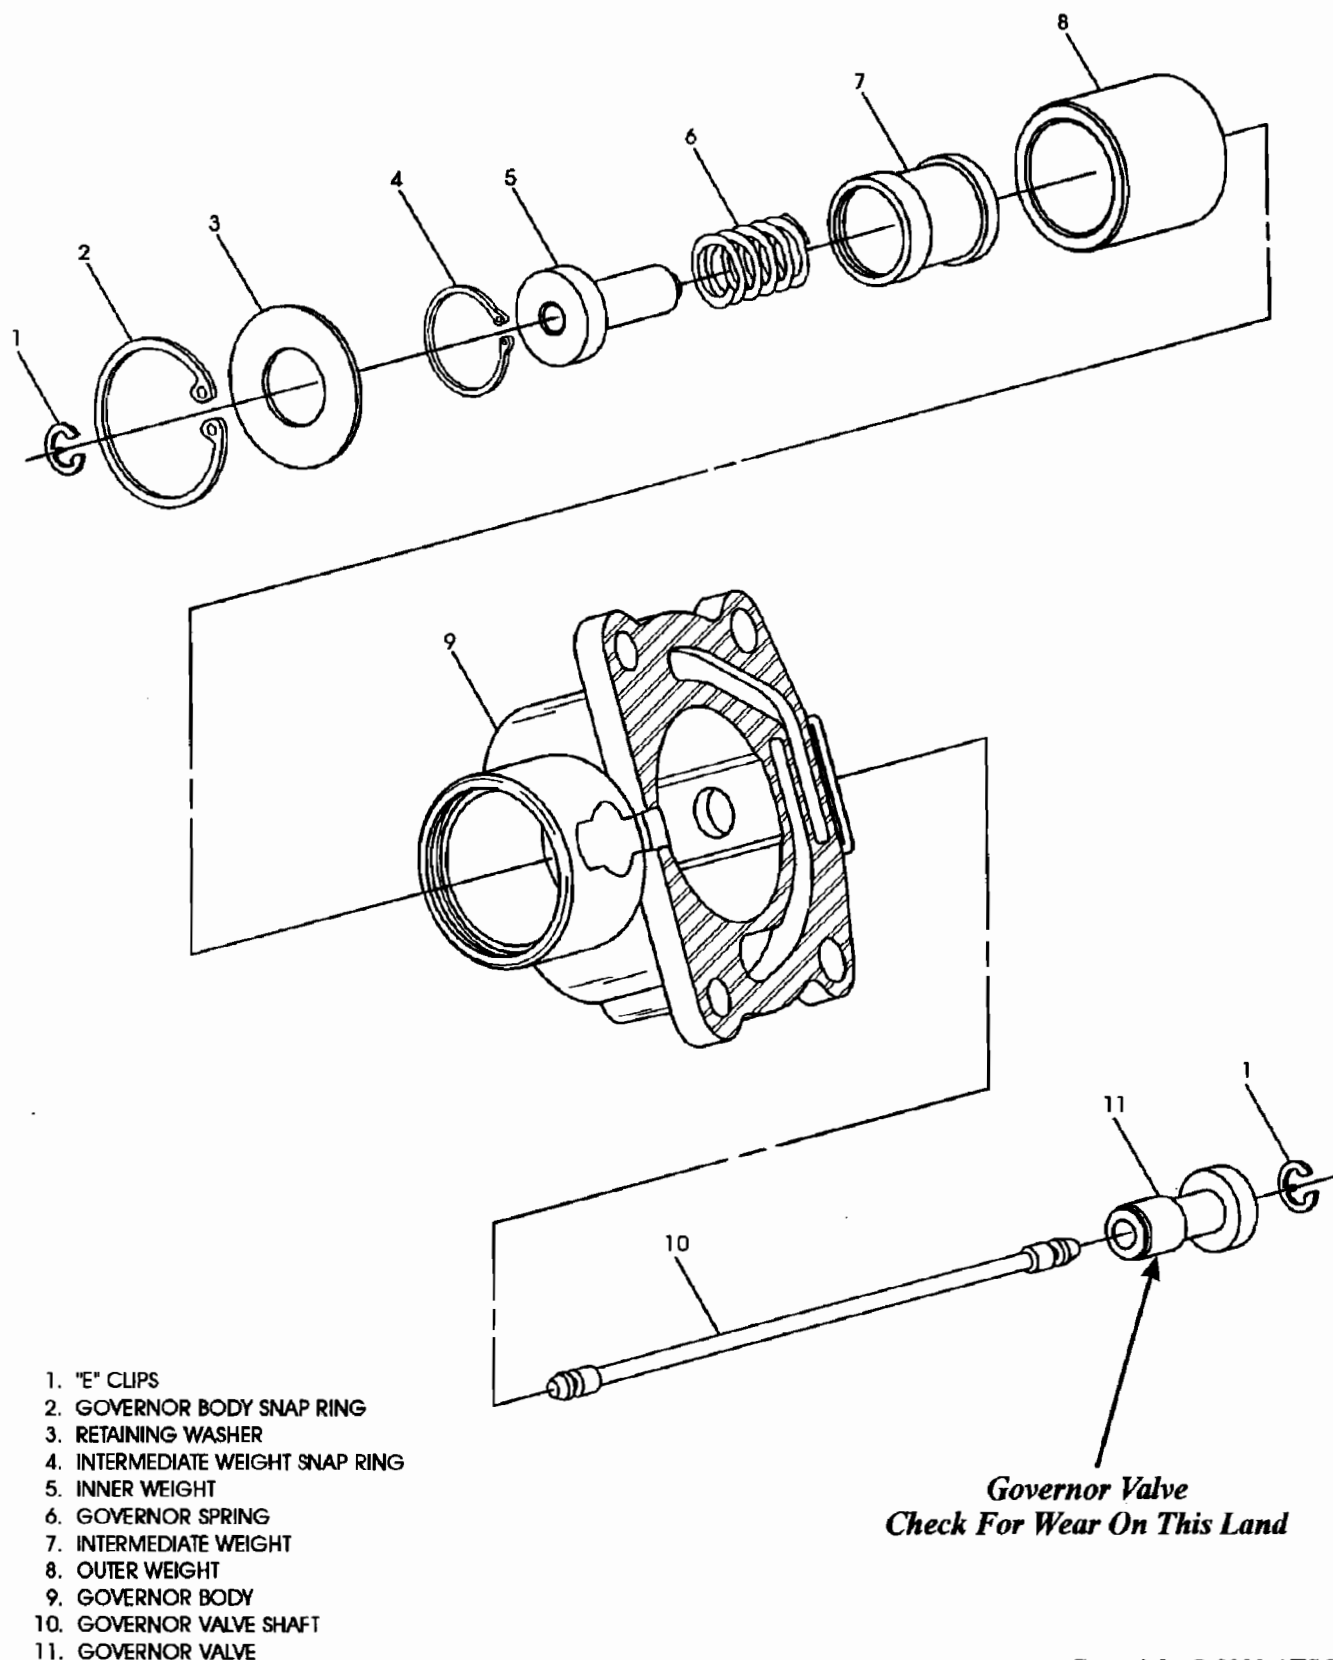
CAUSE: One cause may be a worn governor valve in the governor assembly, not allowing governor pressure to increase properly. Refer to Figure 1 for identification of the governor valve.

CORRECTION: Replace the governor valve, as shown in Figure 1.

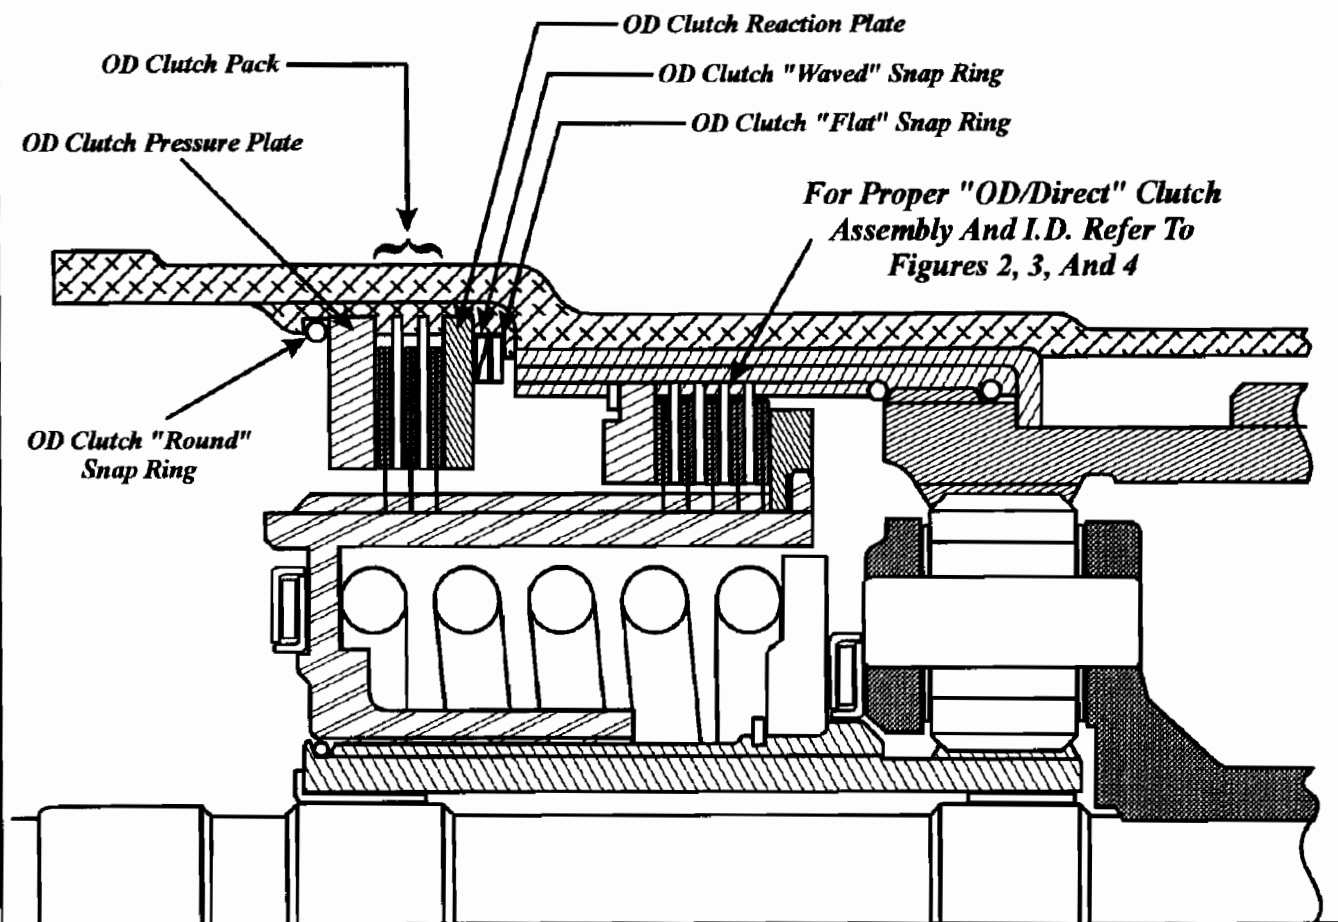
PROPER OVERDRIVE CLUTCH ASSEMBLY AND USAGE

Refer to Figure 1 for the proper assembly procedure and identification of the Overdrive Clutch components for all models. Notice that the first design clutch stack is not recommended, and there are two snap rings that go in first, one being flat and one being waved.

SPECIAL NOTE: *"Always" use the special tools and procedures to measure and determine the correct thickness Overdrive Piston Shim that your set-up requires. An incorrect shim selection may also cause, no reverse or tie-up on 3-4 shift.*

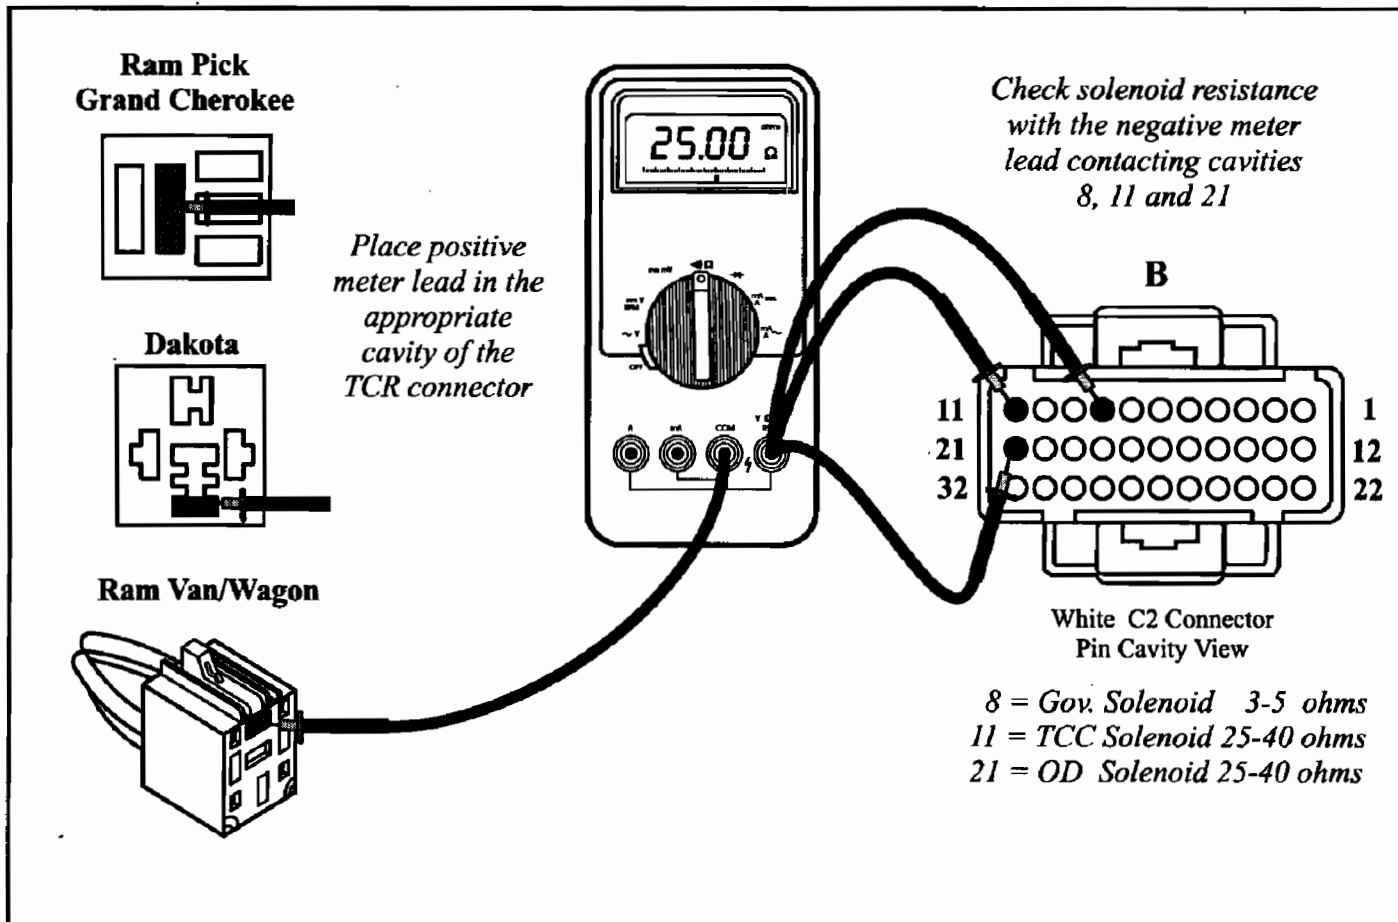
4. The PCM has three 32 pin connectors, black, grey and white. Unplug the middle connector which is the white connector. With the negative lead resistance checks on the Torque Converter Clutch, Governor and Overdrive solenoids may be checked at terminals 8, 11 and 21 individually as seen in Figure 10 below. Both the TCC and OD solenoids should measure between 25 and 40 ohms. The Governor Pressure Solenoid should measure between 3 to 5 ohms.
