"2001" SEMINAR INFORMATION "PRACTICAL TECH"

AUTOMATIC TRANSMISSION SERVICE GROUP

"FIXES THAT WORK"

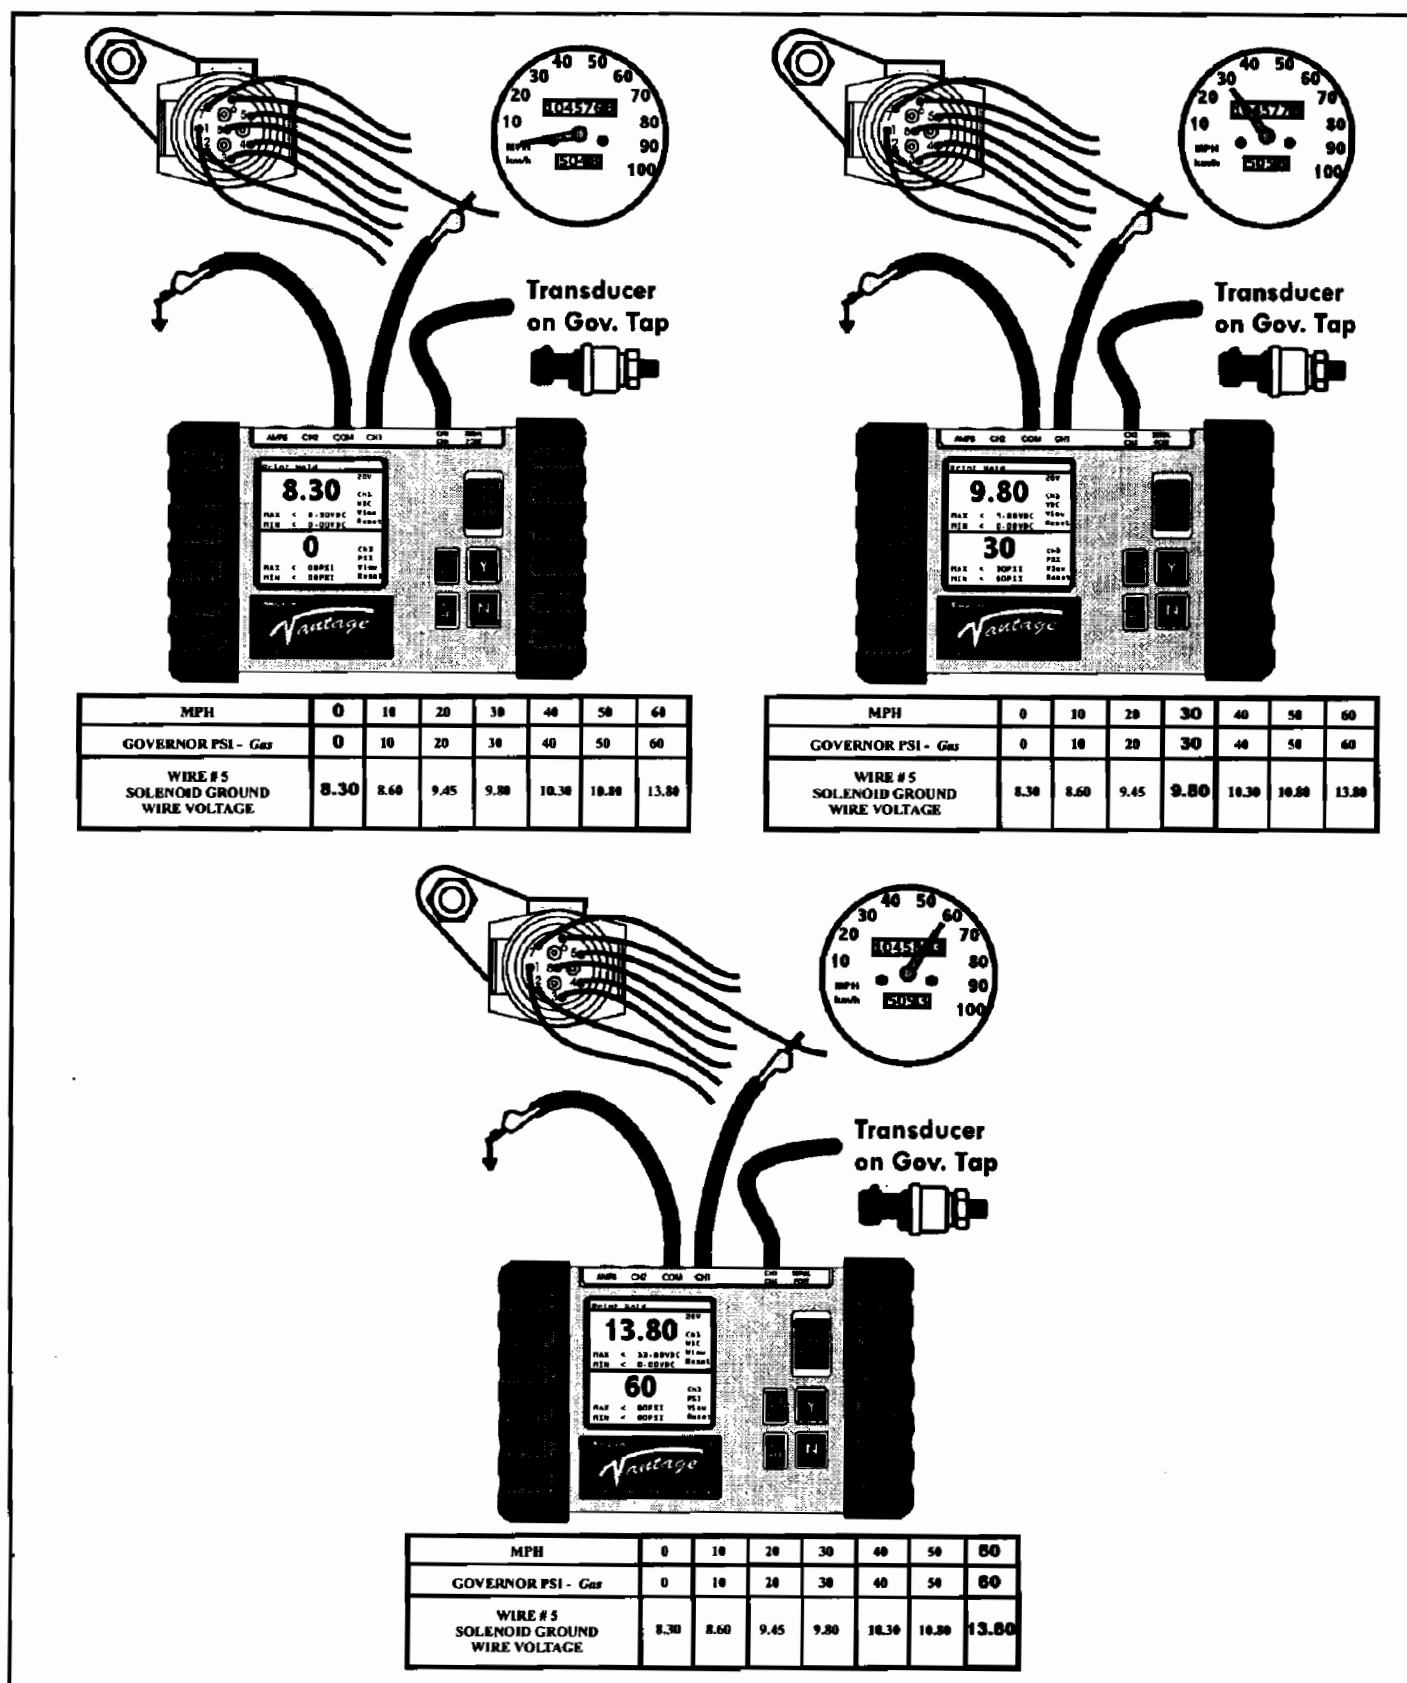
Figure 13 is an example of monitoring the governor pressure with the use of Snap-On's pressure transducer connected to Snap-On's Vantage digital graphing multi meter. The multi meter is set up in a dual screen mode making it available to monitor both pressure and voltage. The voltage being monitored is the ground side of the solenoid which is wire #5 in the case connector. If a Vantage multi meter is not available, a typical pressure gauge can be used on the governor tap and a voltmeter probed into wire #5 with the positive lead and the negative placed to ground.

approximately 13 to 13.5 volts. This system voltage goes through the coil in the solenoid and out through the #5 ground wire to the TCM or PCM. Figure 13 shows that when the vehicle is not moving and governor pressure is at 0 psi, approximately 8.5 of unused volts is seen. Since this solenoid is being supplied with approximately 13.5 volts and 8.5 unused volts are observed on the # 5 ground wire, it means that the computer is using 5 volts to fully energize the governor solenoid producing 0 psi. As the vehicle speed increases, the computer slowly begins to turn the solenoid off explaining the observance of increased voltage as the voltage seen is the voltage not being used. When a maximum of 60 to 70 psi is seen in the governor circuit, system voltage will be seen on the # 5 ground wire as the solenoid at this point is completely turned off.

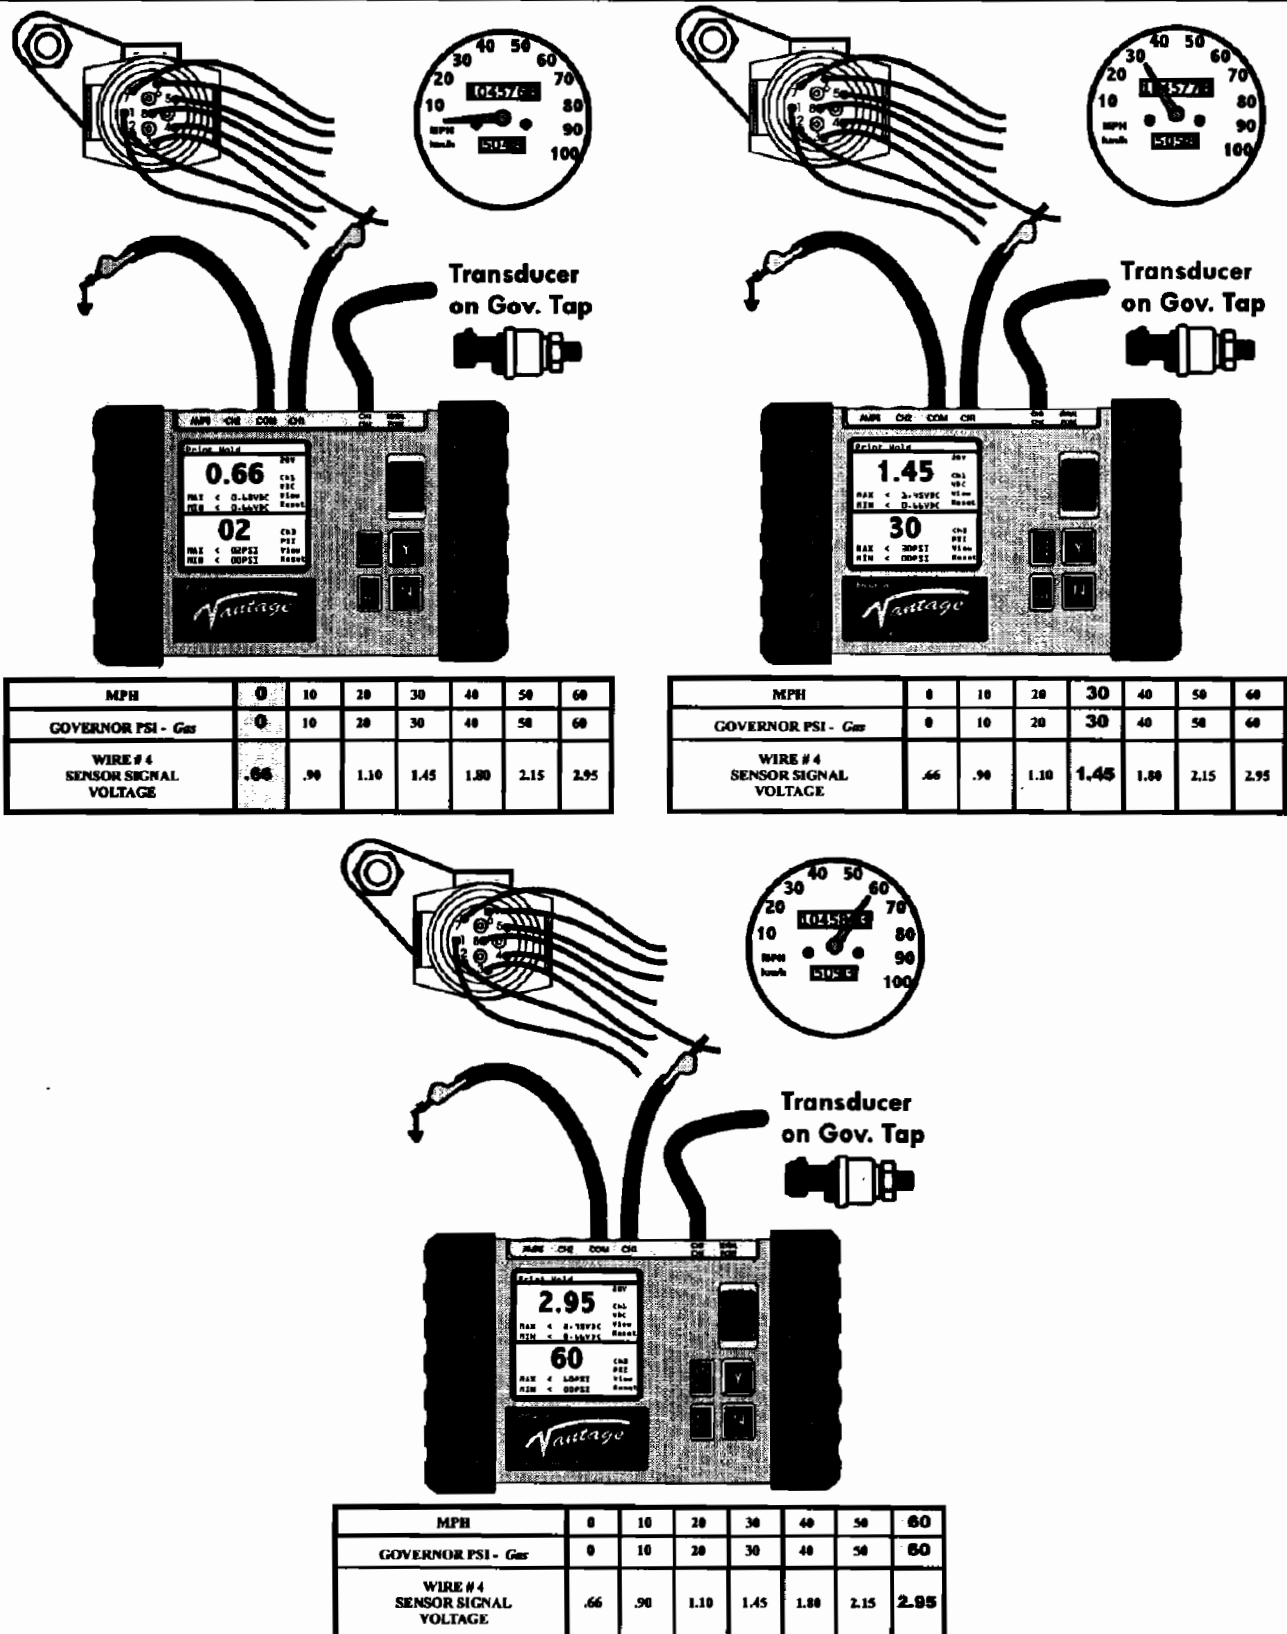
Figure 14
Automatic Transmission Service Group

Figure 14 is an example of a good working governor transducer. The sensor (Transducer) is a device sending information to the computer as to the approximate pressure inside the governor circuit produced by the governor solenoid. When 0 psi exists in the circuit the transducer sends approximately 0.5 volts to the TCM or PCM through wire # 4 from the case connector. As governor pressure increases, this pressure presses on the tip of the sensor causing the voltage to increase proportional to the pressure increasing. When a maximum of 60 to 70 psi is reached in the governor circuit, the transducer sends approximately 3 volts back to the TCM or PCM.

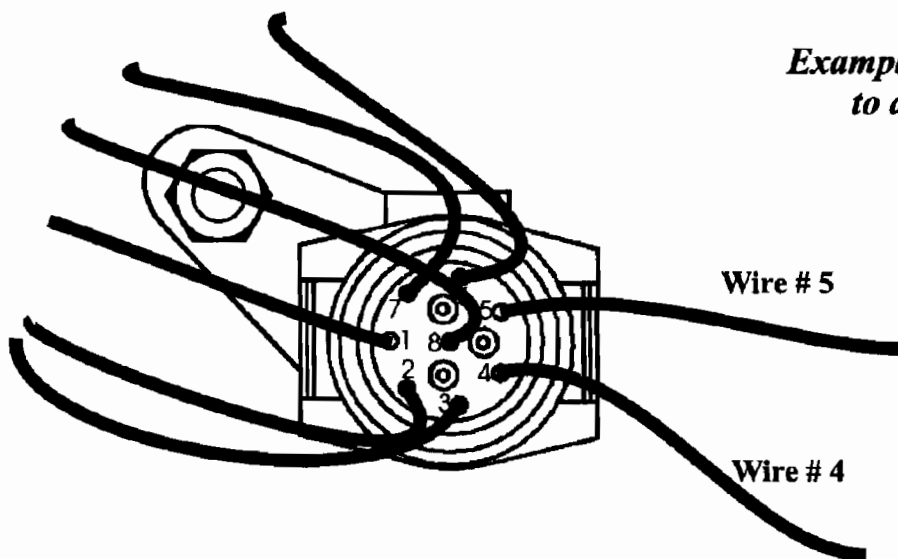
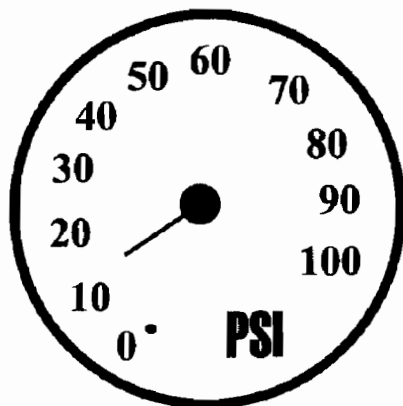
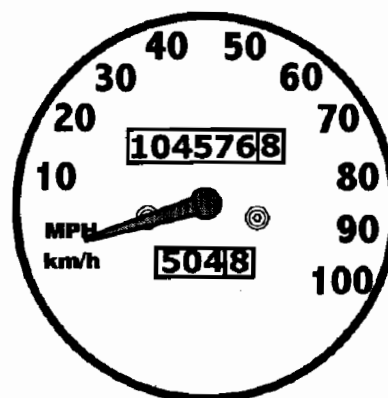
Figure 15 is an example of what would be observed with a 2nd gear start complaint due to a defective governor pressure sensor (Transducer). To make this diagnosis, what should be noticed is that the pressure gauge indicates 10 to 12 psi at 0 miles per hour. This amount of governor pressure will keep the 1-2 shift valve stroked in an up shifted 2nd gear position. Comparing this chart to the one seen in Figure 12, it is noticed in Figure 15 that with 10 pounds of governor pressure the sensor is sending to the computer a 0.66 volt reading. This indicates to the computer that there is 0 psi in the circuit when actually there is 10. At 10 pounds of pressure, approximately 0.9 volts should be observed as seen in Figure 12. With the computer thinking that it controlled the governor solenoid to produce 0 psi due to faulty data produced by the sensor, it did not attempt to energize the solenoid any further. Changing the sensor will solve this complaint.

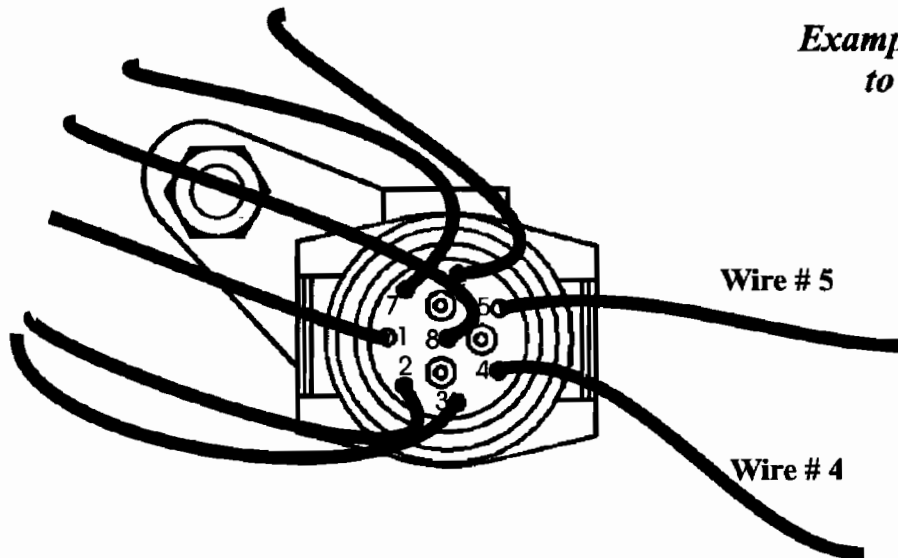
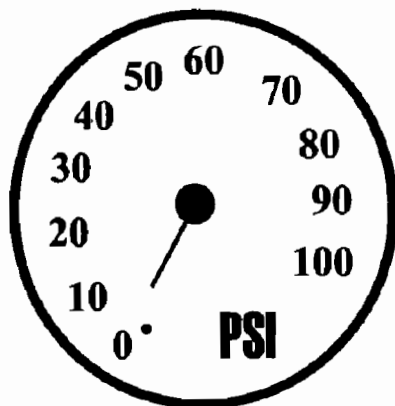
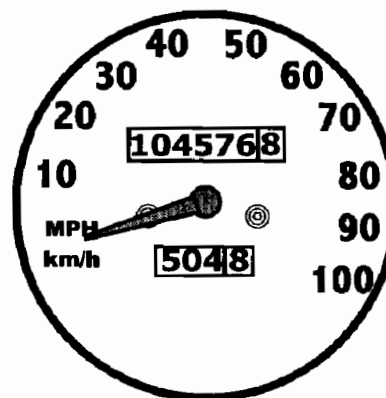
Figure 16 is an example of what would be observed with a second gear start due to a stuck 1-2 shift valve. Notice that there is 0 psi of governor pressure and the sensor indicates the same in voltage (0.66). The only way a second gear start could be possible is a 1-2 shift valve stuck in a stroked position.

Example of a 2nd Gear Start due to a stuck 1-2 shift valve

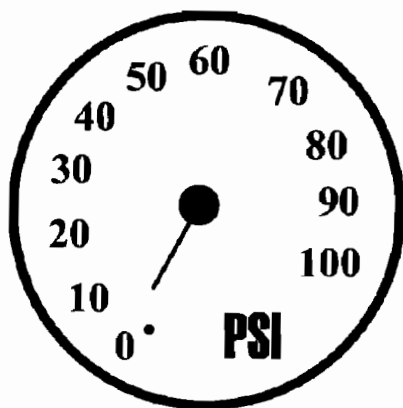
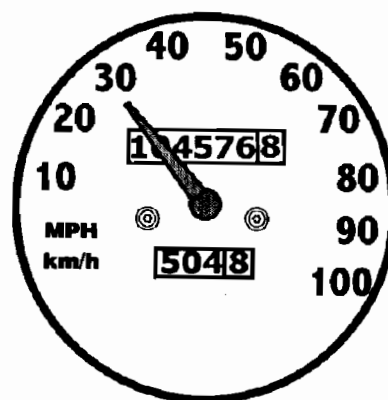
FIGURE 17: No up shift..

Figure 17 is an example of what would be observed in a no up shift situation due to a leak in the governor circuit or a clogged inlet port to the governor solenoid. Notice that the computer is trying to raise governor pressure by turning the solenoid off. The pressure gauge indicates 0 psi in the governor circuit and it never rises. The governor sensor remains at a 0.66 voltage indicating to the computer that governor pressure is not rising which means the sensor is working properly. By 30 mph the computer has turned off the governor solenoid as indicated by the full system voltage observed on the ground wire (#5). A leak in the governor circuit or a clogged inlet port to the governor solenoid can then be concluded.

*Example of a no up shift condition
due to a leak in the governor
circuit or a clogged inlet port
to the solenoid*

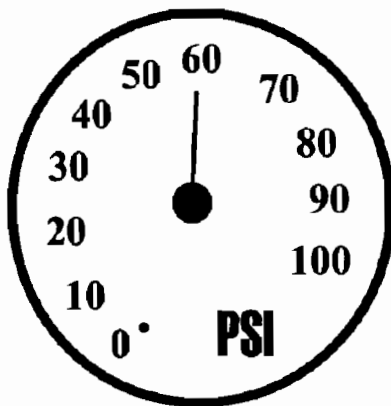
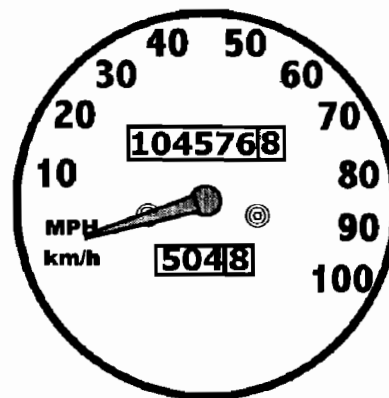
FIGURE 18: Third gear start...

Figure 18 is an example of a third gear start problem due to a mechanically failed governor solenoid. Notice how governor pressure is at a full 60 psi. The governor sensor is sending a 2.95 volt reading which tells the computer that governor pressure is at 60 psi. The computer then begins to increase current draw on the governor solenoid to try to bring down governor pressure. Notice how the voltage is dropping on the # 5 wire. Remember, the voltage seen on the # 5 wire is voltage not being used. The lowest voltage reading observed is 6.3 volts. If you subtract that from 13.5 volts, the computer used as much as 7.2 volts in an attempt to bring down governor pressure based on the information it was receiving from the sensor. With the pressure gauge verifying that governor pressure was high as well as having a third gear start problem, a mechanically failed governor solenoid would be the logical reason for this complaint. It just so happened that this example was taken from a vehicle where the magnet that was in the pan was improperly placed onto the solenoid. The magnet kept the solenoid in a fully applied position causing full governor pressure to remain in the circuit. Another point is that this was a pre 96 vehicle making it a TCM version. Notice that after the computer used as much as 7.2 volts in an attempt to bring down governor pressure it suddenly went to 13.8 volts. This action means the computer had decided to shut the solenoid off going into a failsafe mode. If this was a 96 and later vehicle, the relay would have been turned off cutting the supply voltage to wire # 1 and wire # 5 would have gone to 0 volts.

Example of a 3rd Gear Start due to a defective solenoid mechanically
