## *"The Seminar to See for 2003" Technical Seminar*

### ***AUTOMATIC TRANSMISSION SERVICE GROUP***

## *“The Seminar to See for 2003”*

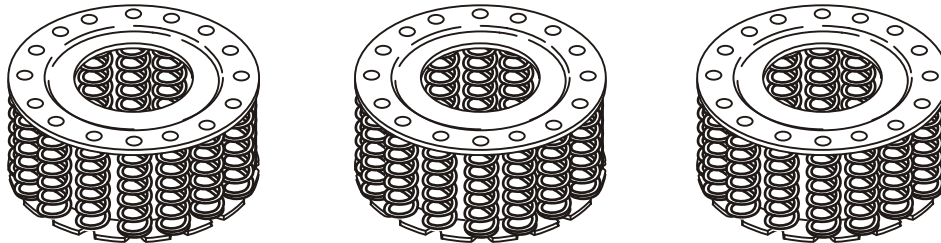
**CAUSE:** The cause may be, that during overhaul, the 2nd, 3rd or 4th Clutch return spring assembly was mistakenly used in place of the 1st Clutch spring assembly. When this happens, the 1st Clutch can not fully engage until line pressure is increased. Refer to Figure 5 and 6 to compare the 1st Clutch return spring assembly to the 2nd, 3rd and 4th. Notice that the coil diameter of the springs, on 2nd, 3rd and 4th are approximately .010" larger and the number of coils are one more than the 1st which makes them stronger.

**2nd, 3rd and 4th CLUTCH RETURN  
SPRING ASSEMBLIES**

<i>2nd, 3rd and 4th CLUTCH RETURN SPRING DIMENSIONS</i>	
Wire Diameter	.072"
Number of Coils	9

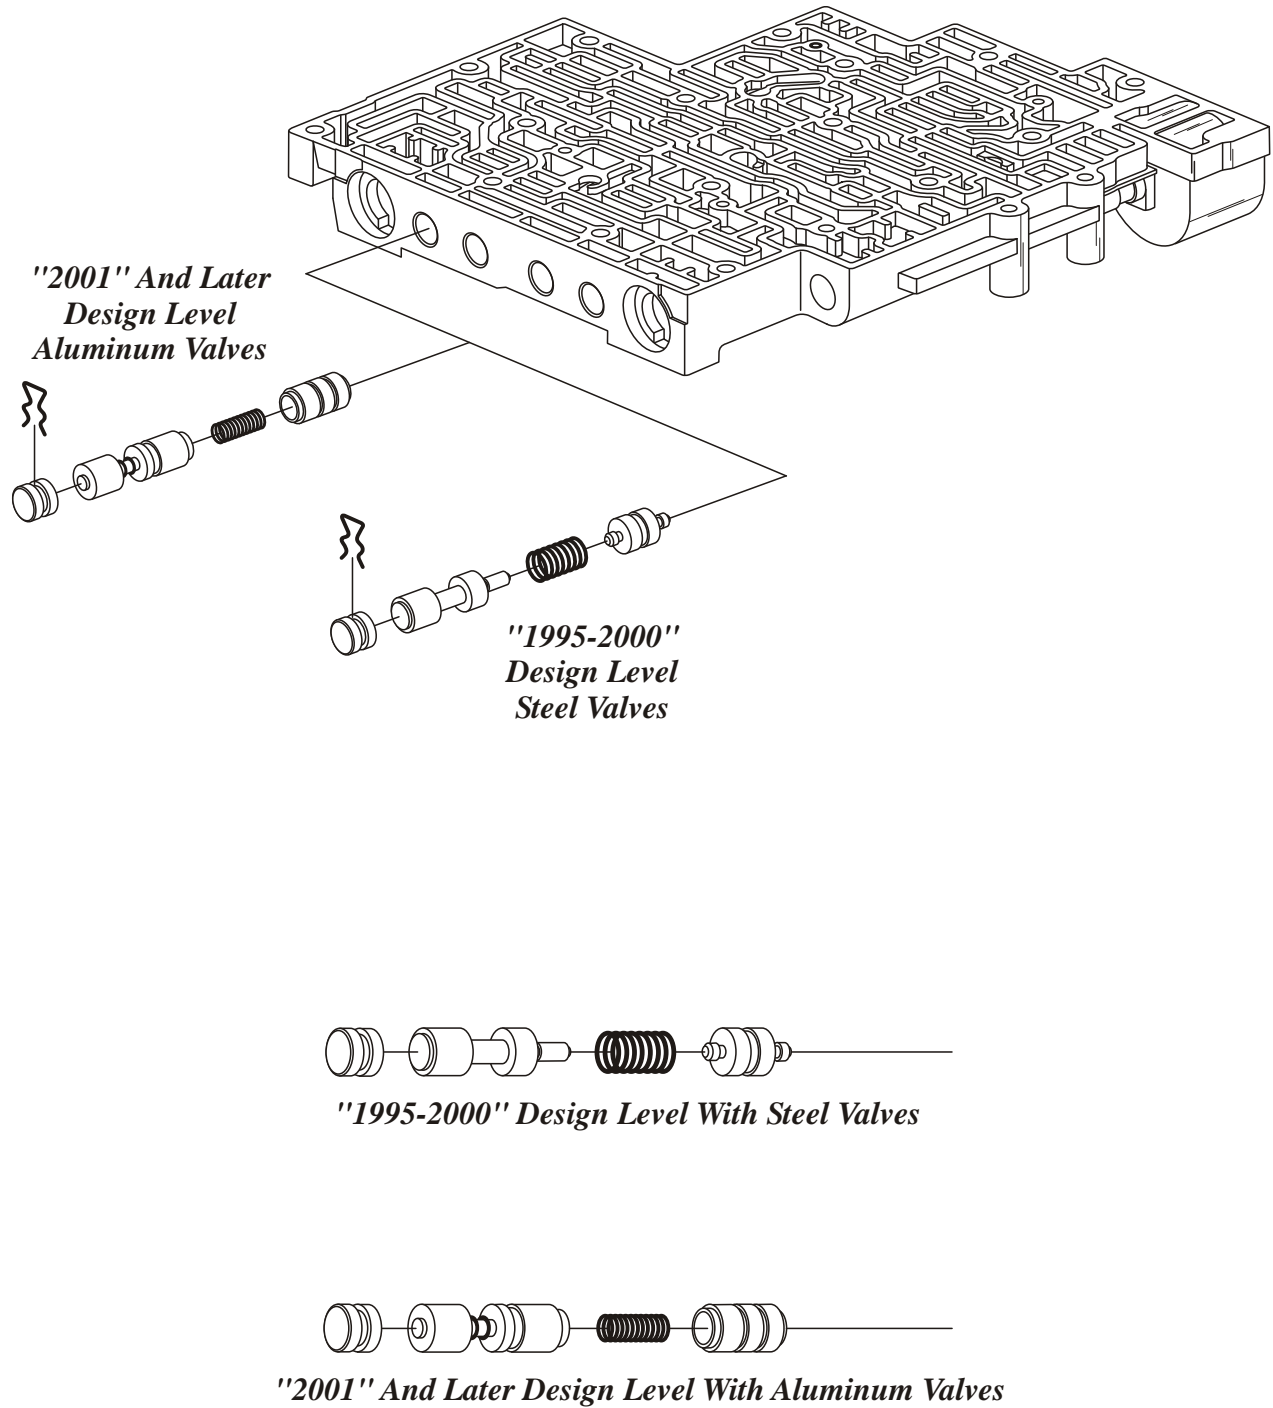
Figure 1

**REASON:** Reduced bore wear and improved performance for apply and release of the converter clutch.

**CONVERTER CLUTCH REGULATOR VALVE LINE-UP**

None of the parts listed above will interchange with the previous design level parts. However, when new design valve body and spacer plate are used as a service package, they will back service to 1998 models.

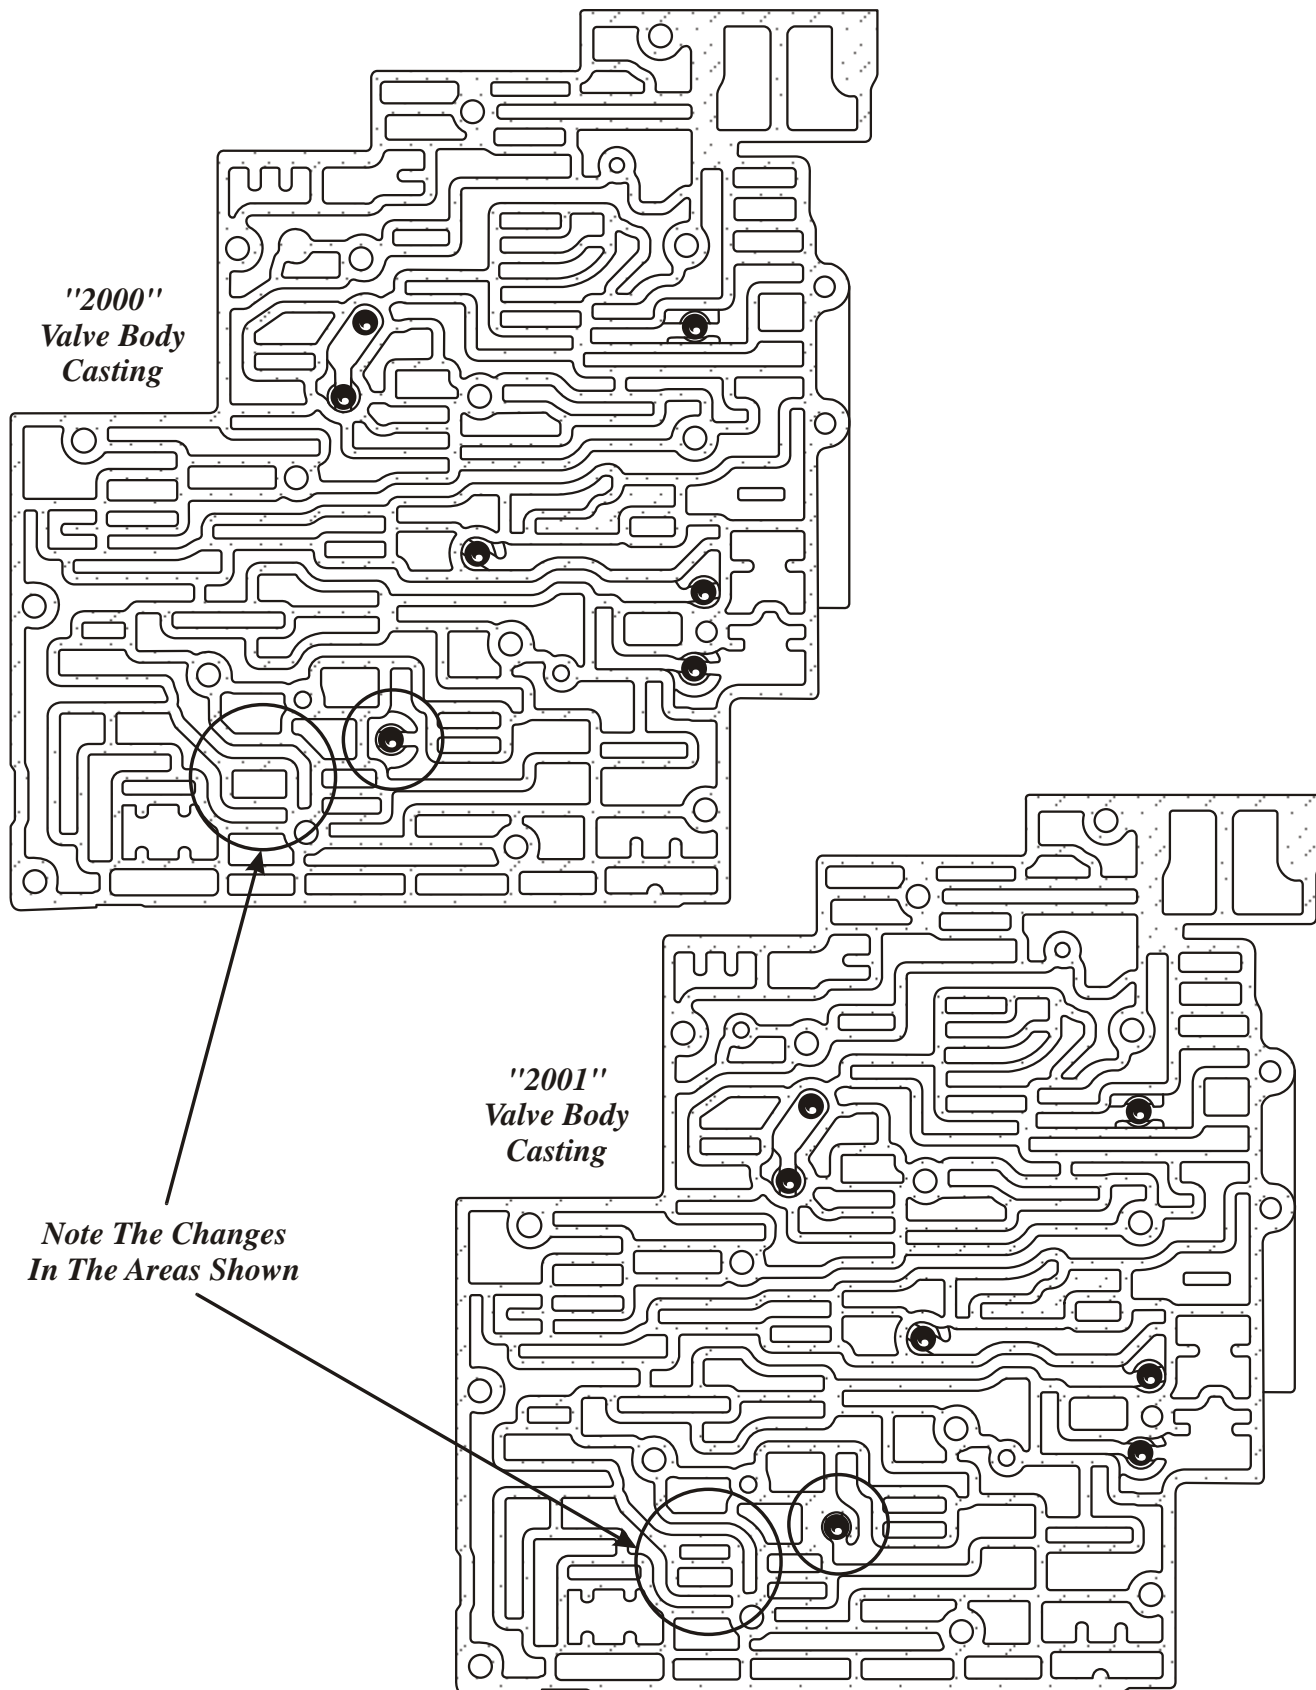
Figure 2

2000 AND 2001 VALVE BODY CASTINGS

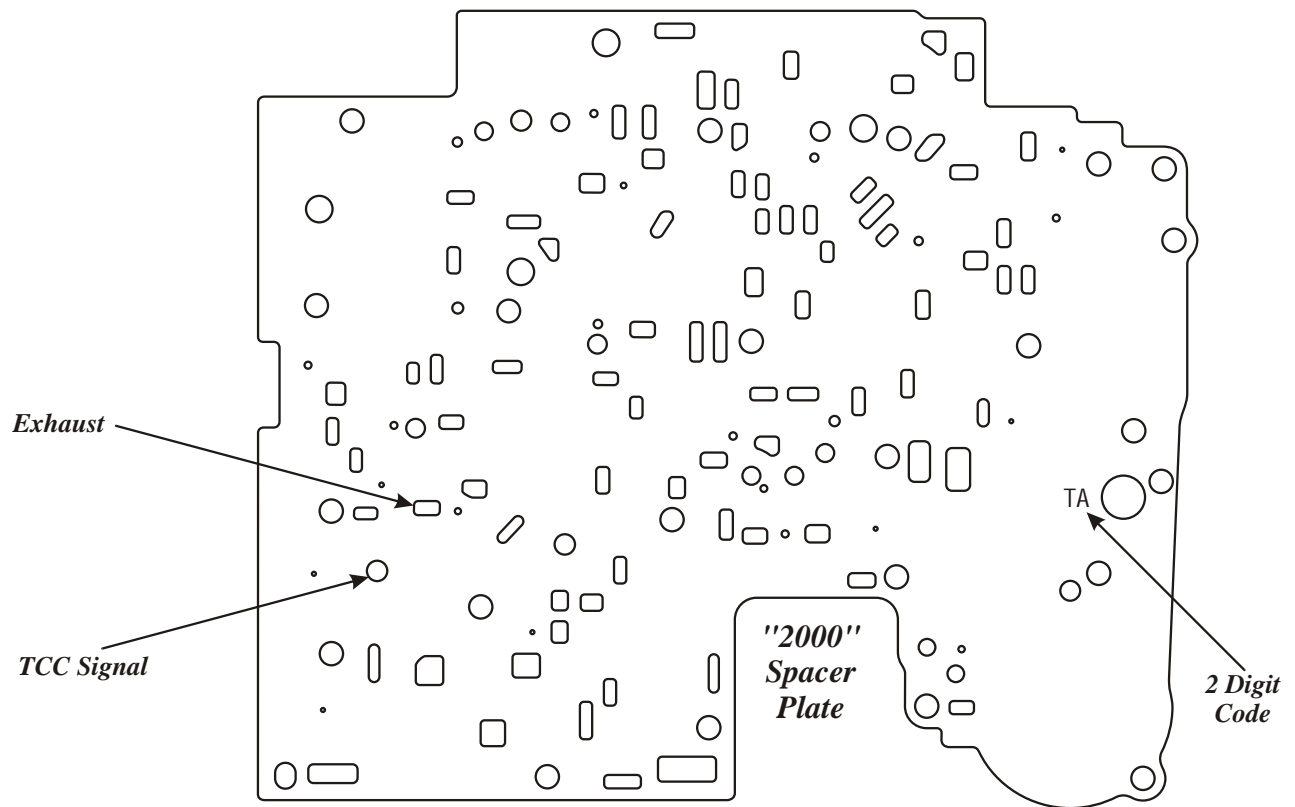
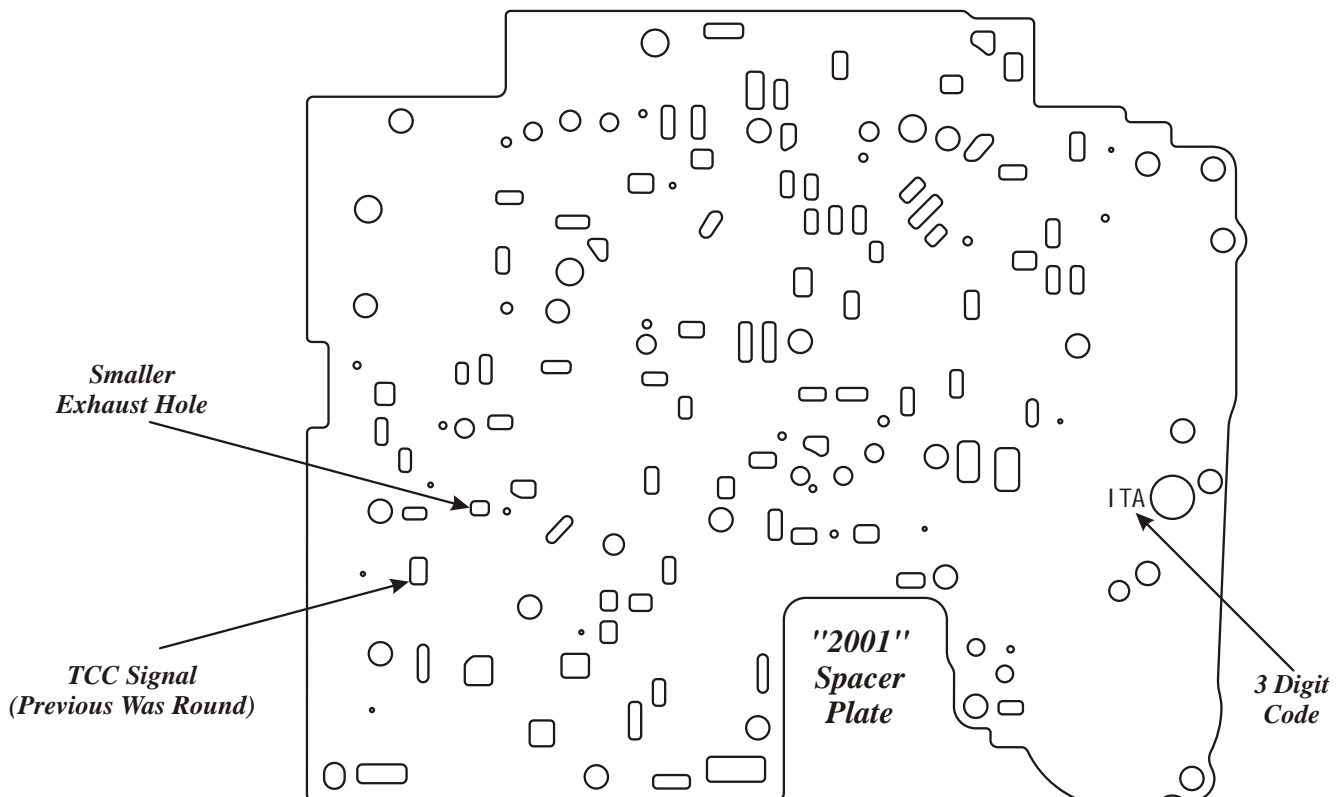
Figure 3

### 2000 AND 2001 SPACER PLATES

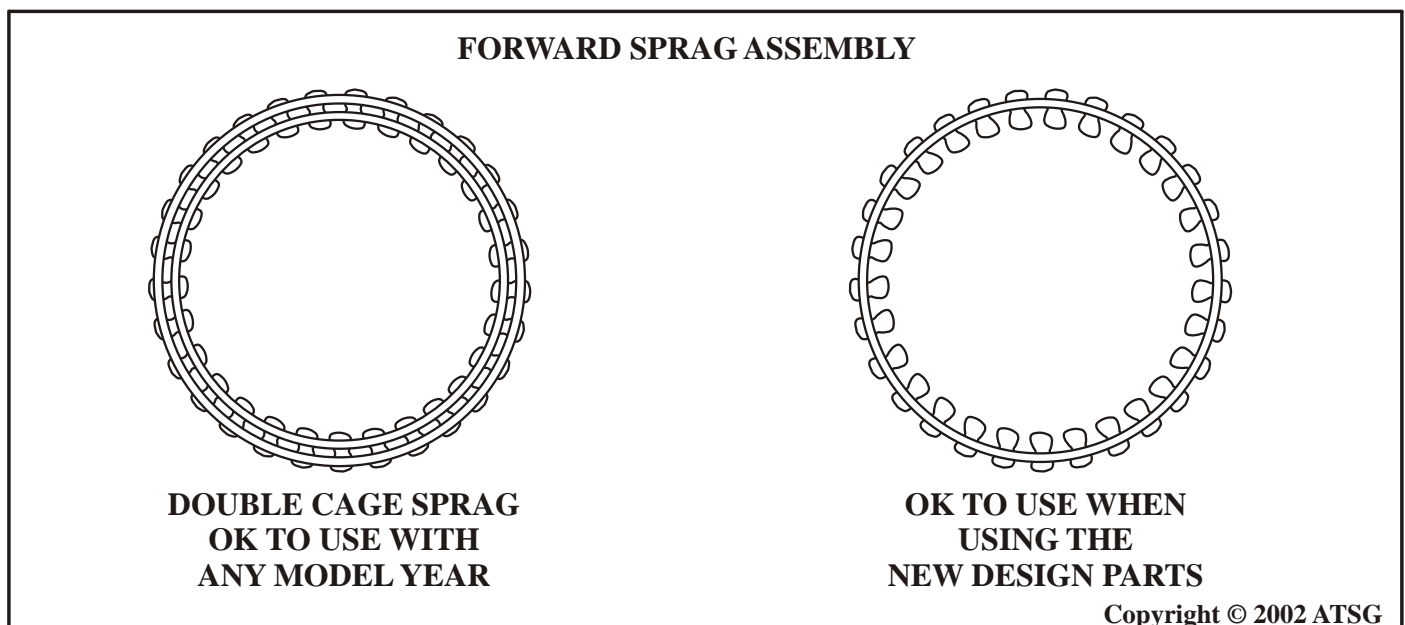
Figure 1

The 29 element single cage "SKF" sprag and cage is available from Raybestos.

The 29 element dual cage sprag is available from Borg Warner.

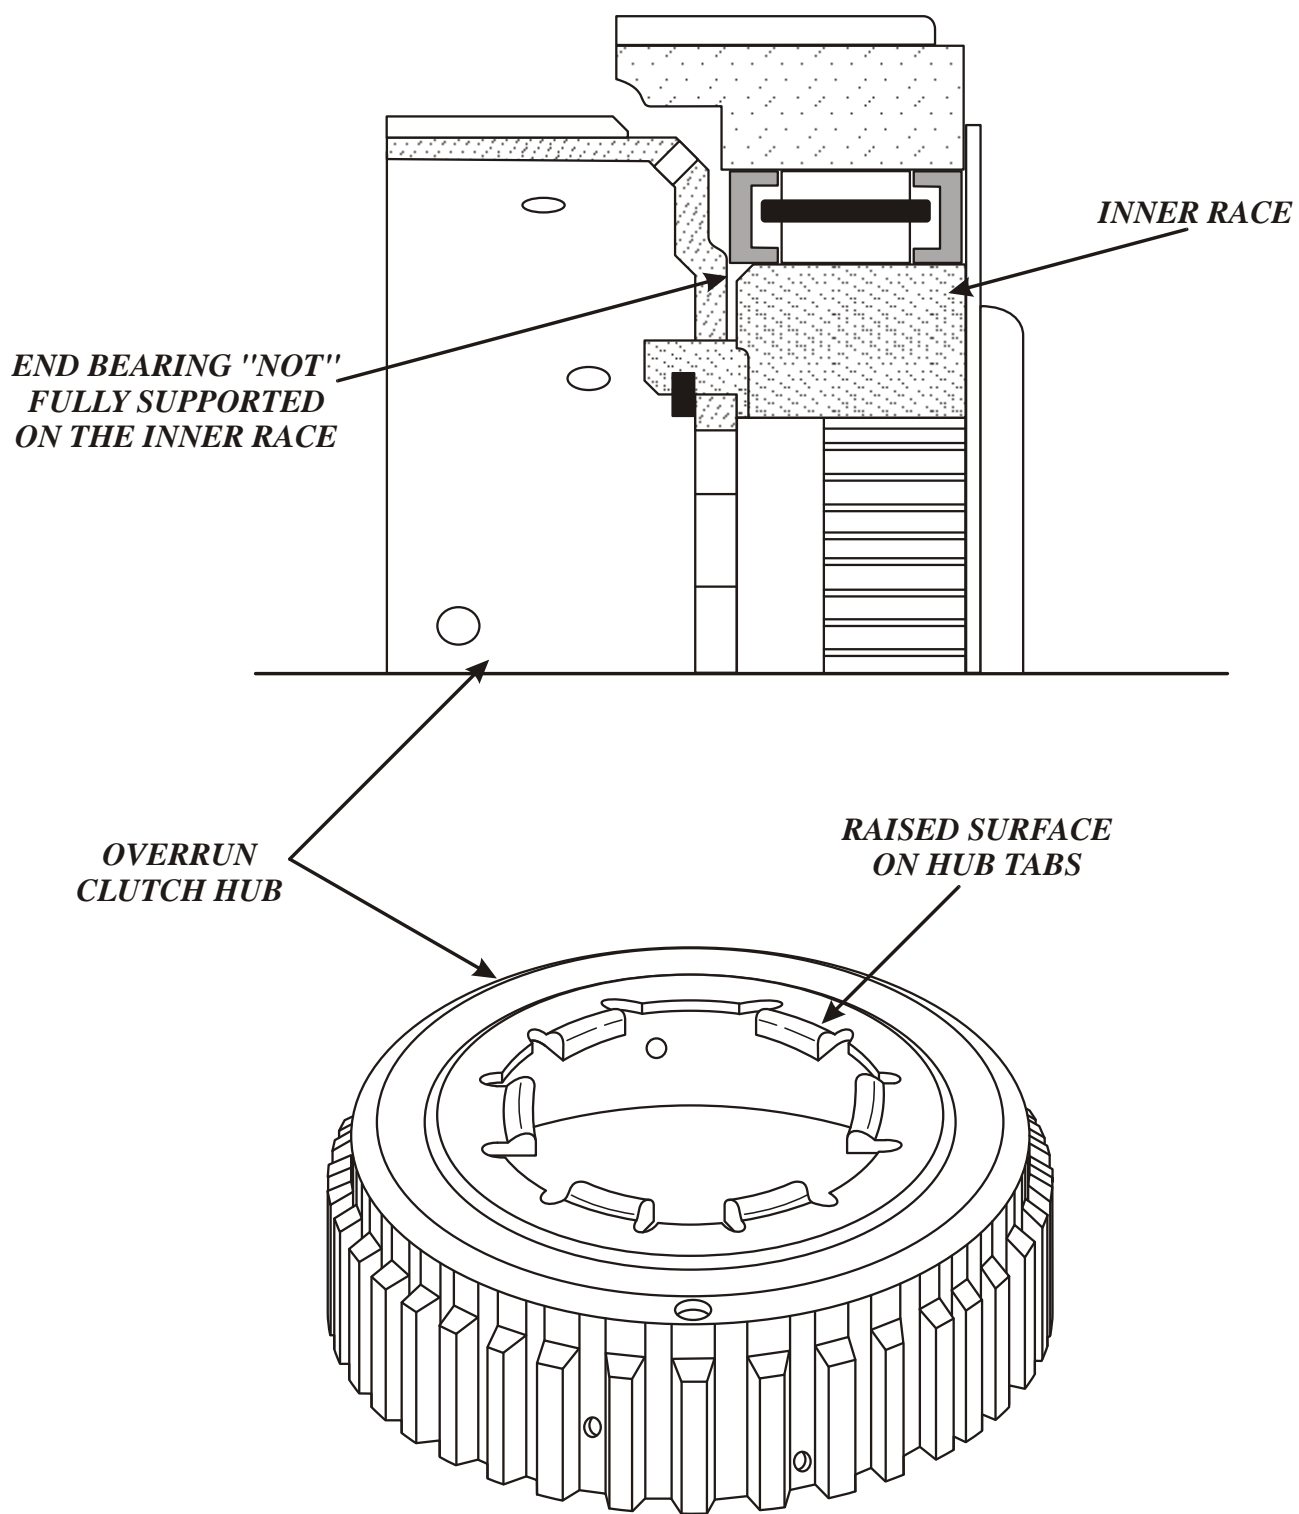
Figure 2

**PREVIOUS "SKF" INPUT SPRAG**

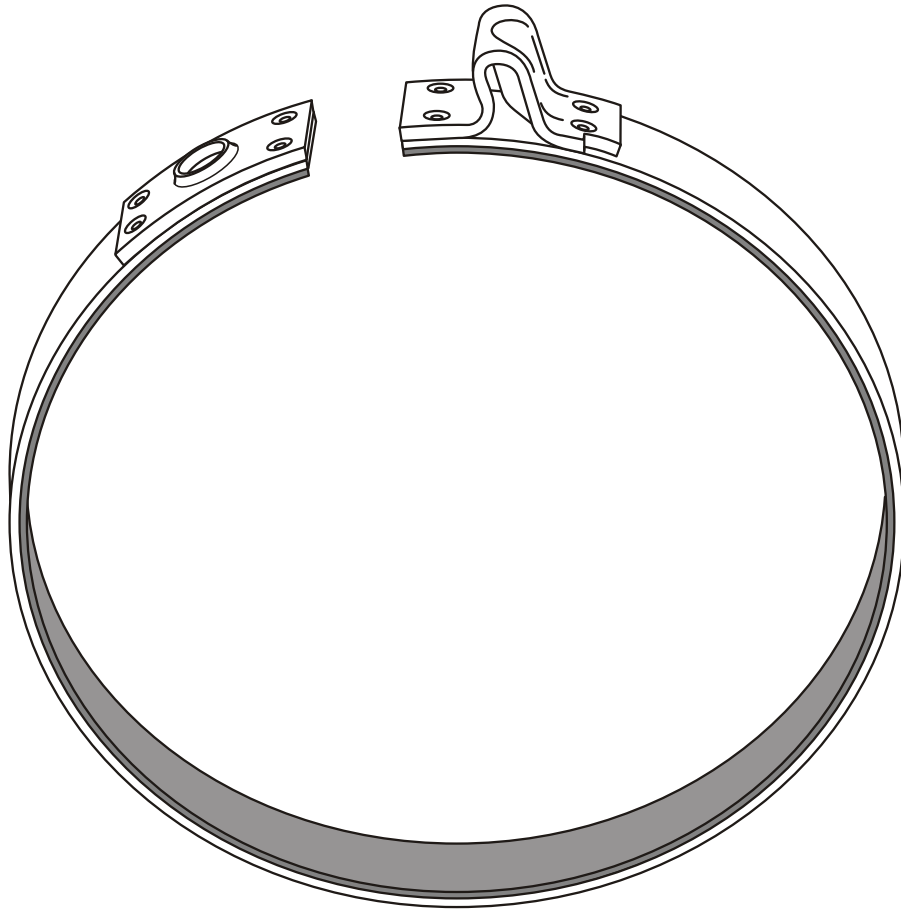
Figure 1

*If the "Narrow Band" is used with the Wide Band Apply Pin, the result will be 2nd Gear Starts and tie-up on the 2-3 shift and tie-up in reverse, because you have mechanically applied the band because of the length of the pin.*

MANUAL 2ND BAND

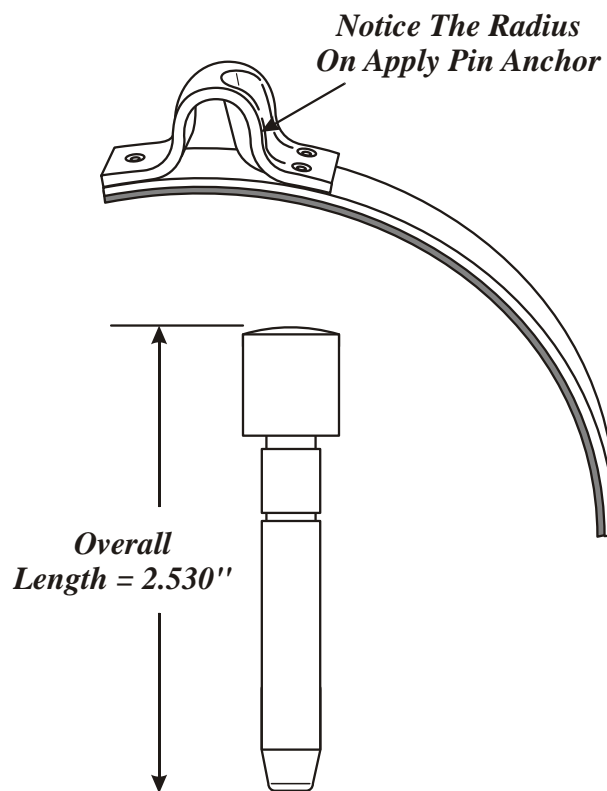
**"NARROW" MANUAL 2ND BAND**

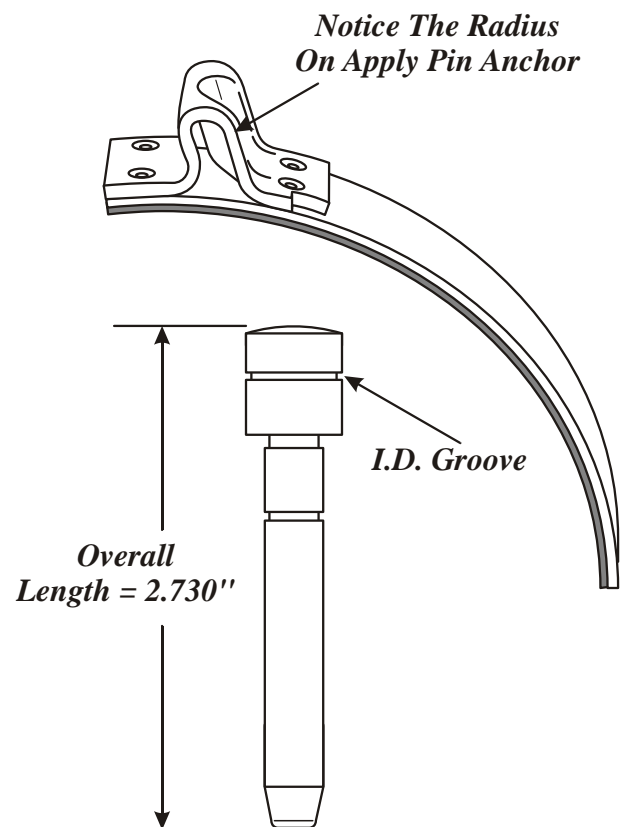
**"WIDE" MANUAL 2ND BAND**

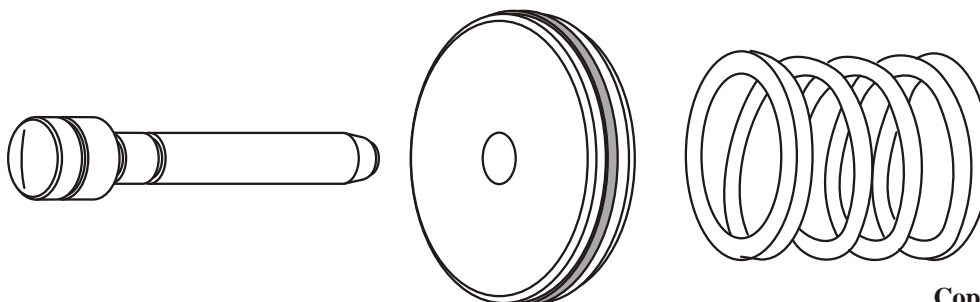
Figure 2

**CONTENTS OF SERVICE PACKAGES**

"Wide Band" Service Package Part Number 24223081  
"Narrow Band" Service Package Part Number 24200418

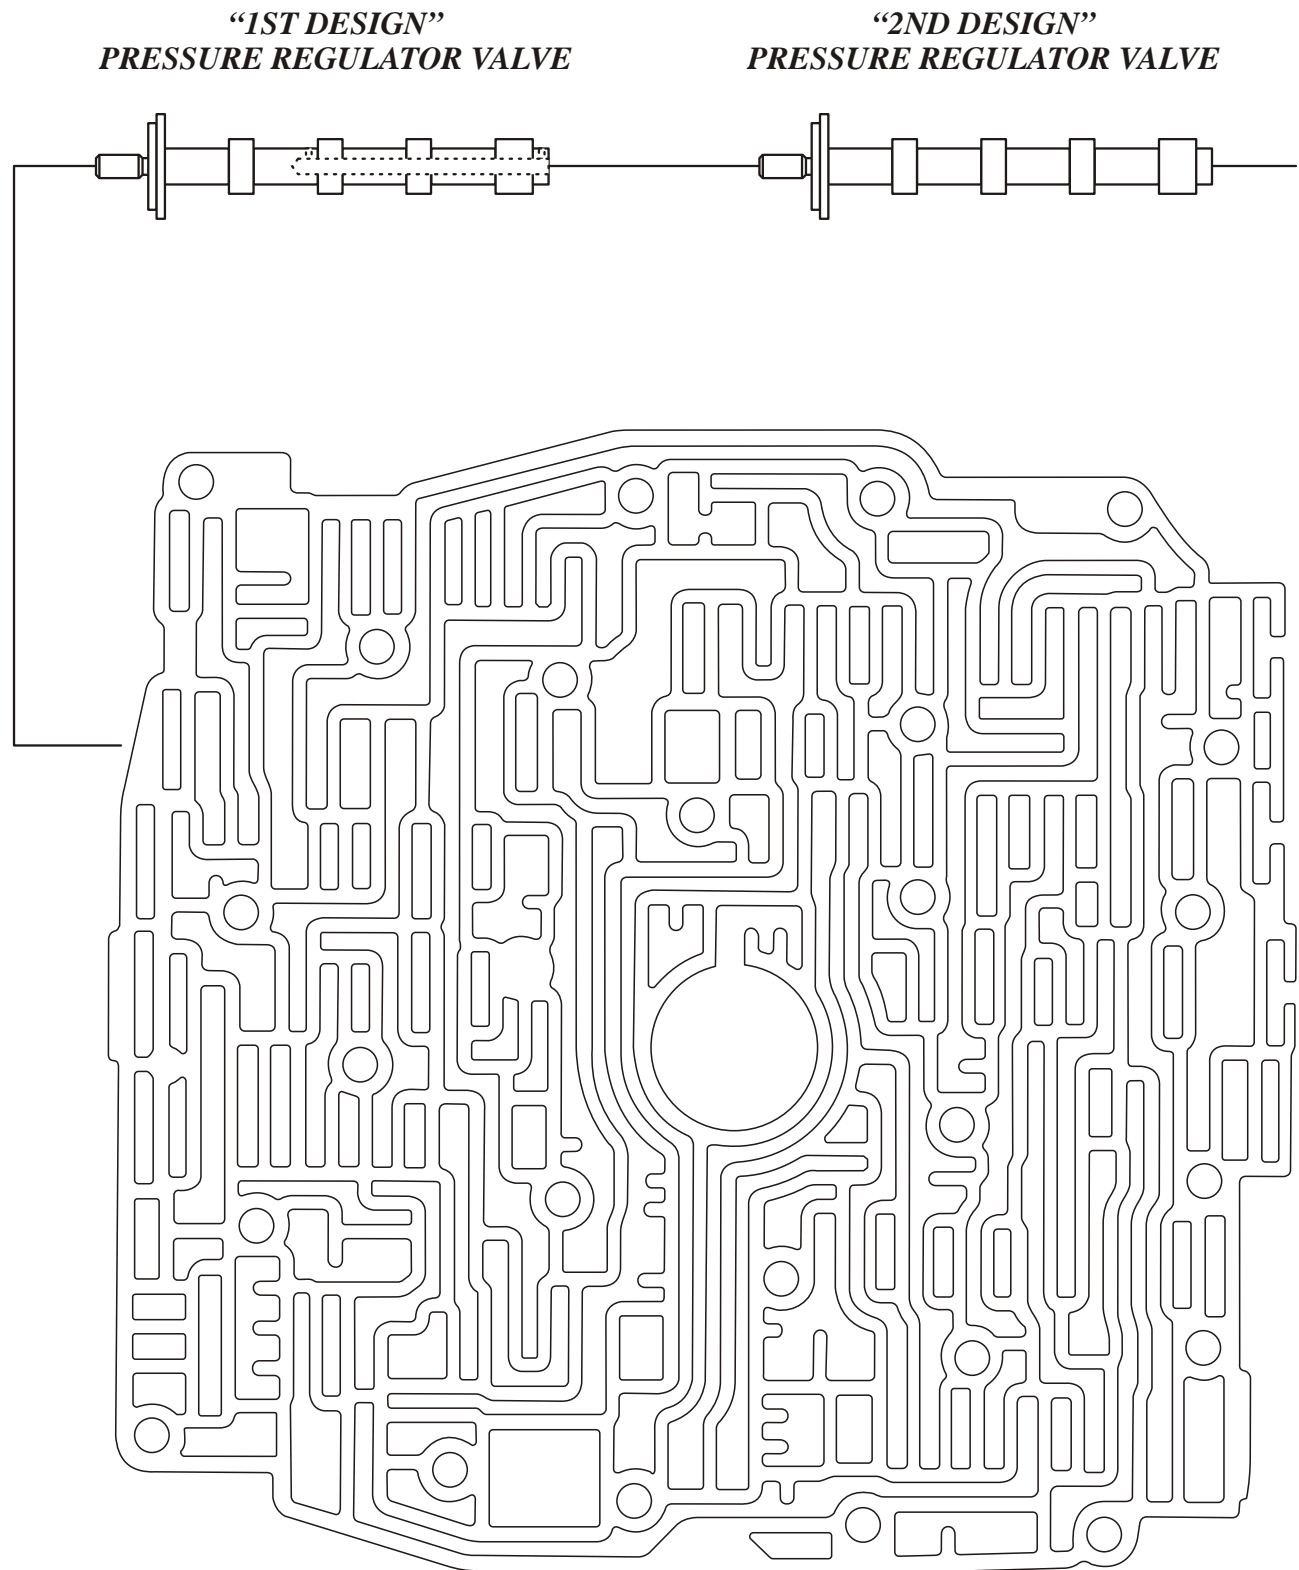
Figure 1

Using 1st design valve body spacer plate gaskets with 2nd design level parts will create extremely high line pressure and possibly no converter fill.

The 2nd design valve body spacer plate gaskets can be used to back service all models.

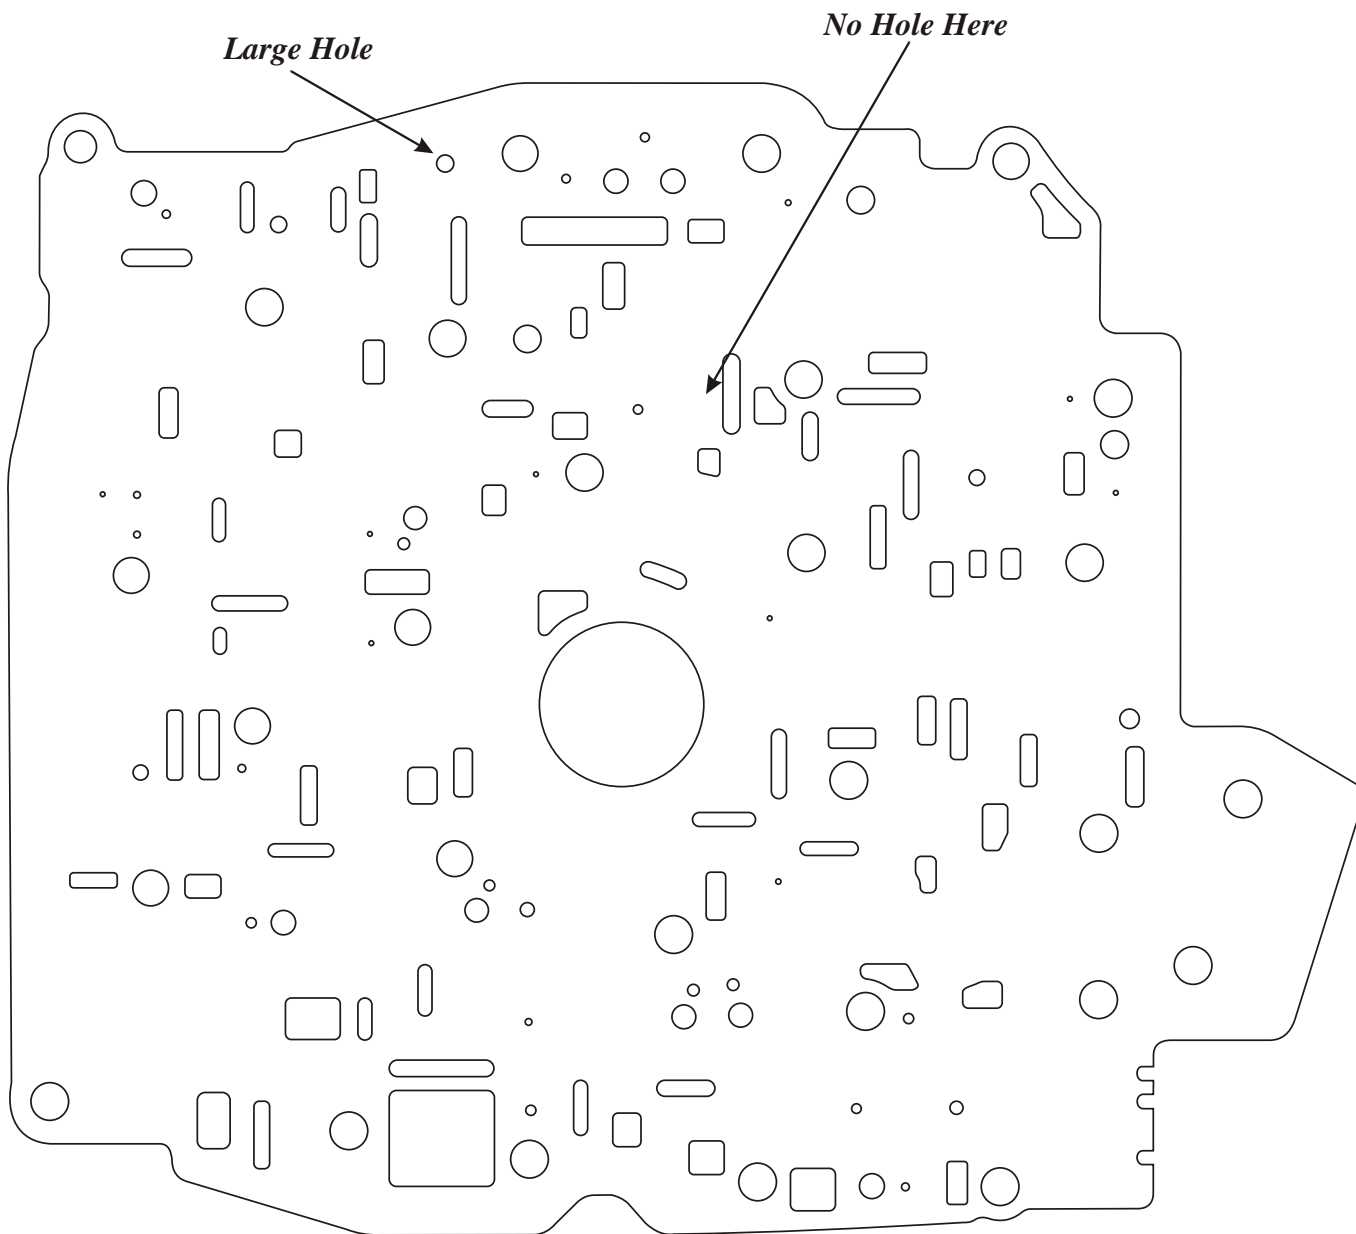
Figure 2

*This Spacer Plate "Requires"  
This "Cross Drilled" PR Valve*

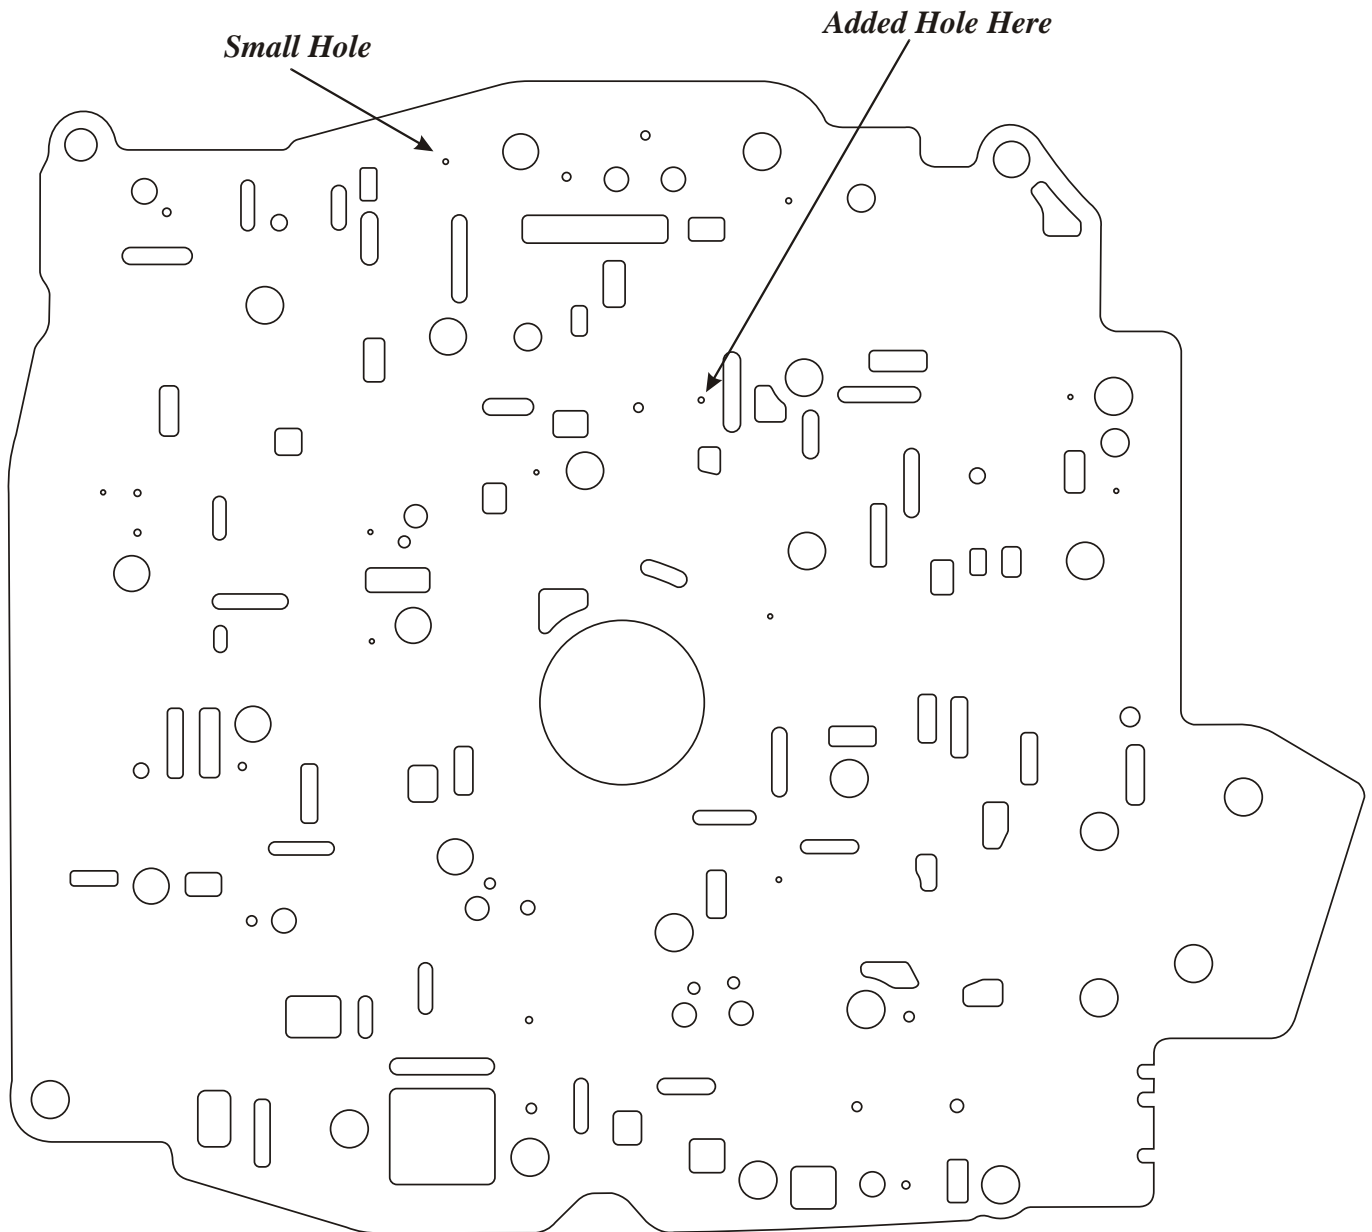
*This Spacer Plate "Requires"  
This "Non-Drilled" PR Valve*

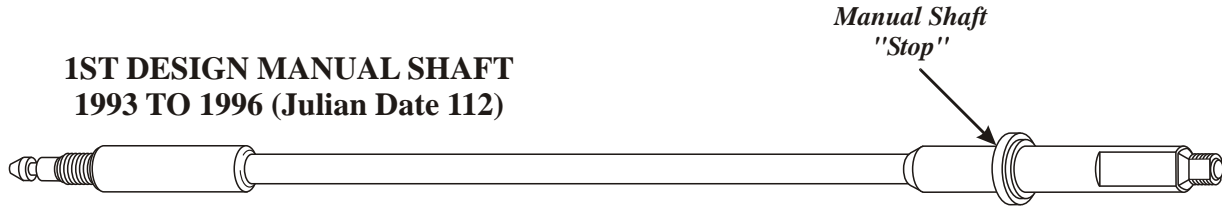
**1ST DESIGN MANUAL SHAFT  
1993 TO 1996 (Julian Date 112)**

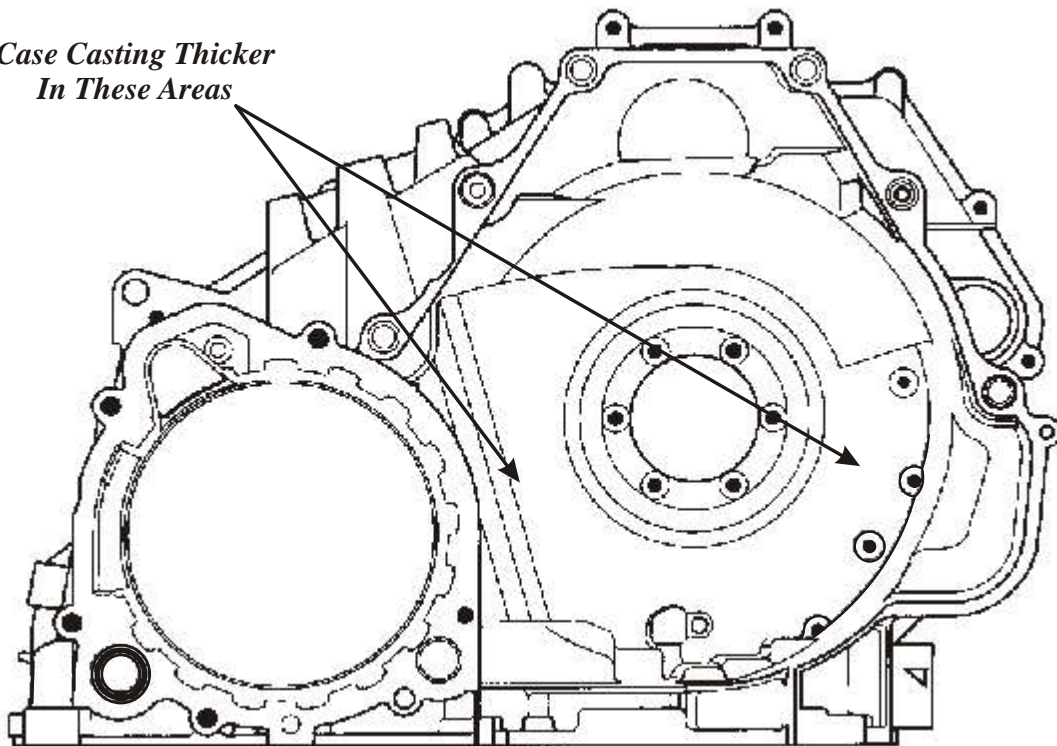
Figure 1

**2ND DESIGN MANUAL SHAFT  
1996 (Julian Date 113) TO 2003**

*Case Casting Thicker  
In These Areas*

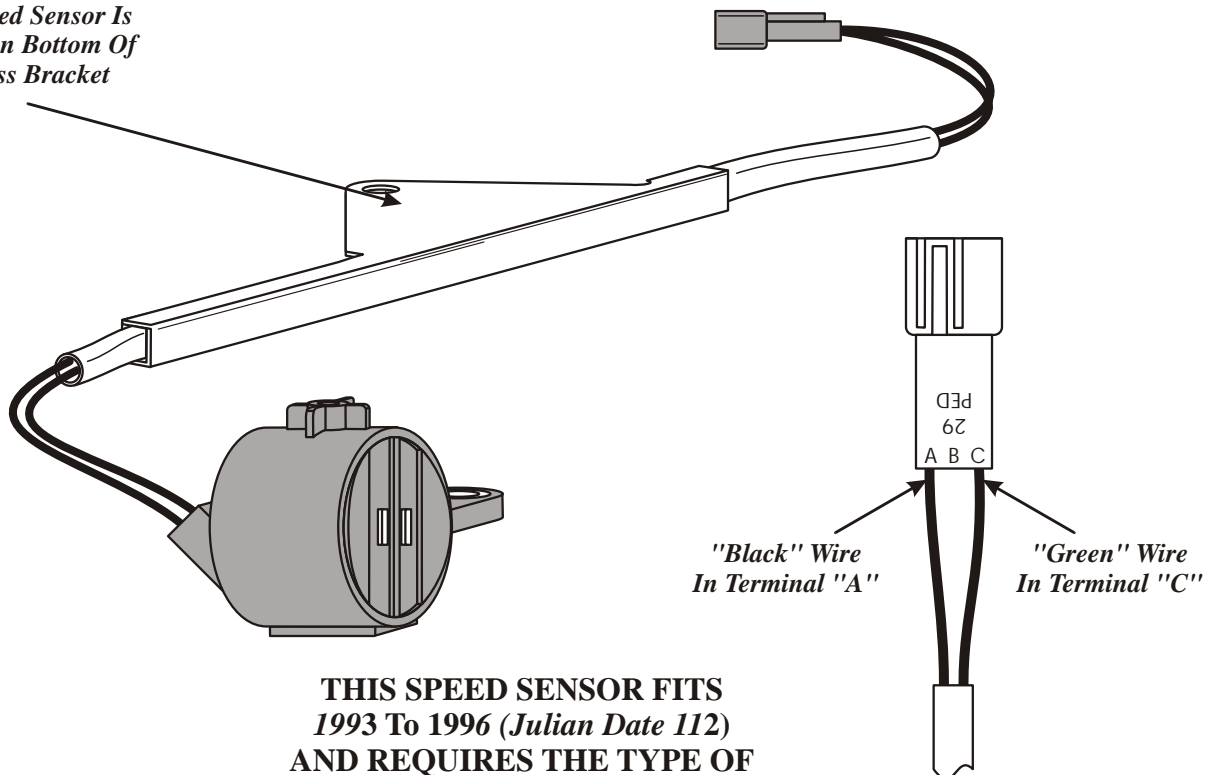
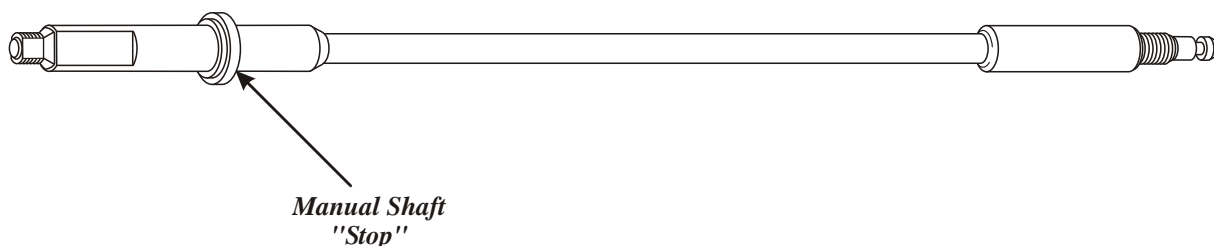
### THM 4T80-E 1ST DESIGN TURBINE SHAFT SPEED SENSOR OEM PART NUMBER 24209654

*This Speed Sensor Is  
"Flat" On Bottom Of  
Harness Bracket*

**THIS SPEED SENSOR FITS  
1993 To 1996 (Julian Date 112)  
AND REQUIRES THE TYPE OF  
MANUAL SHAFT SHOWN BELOW**

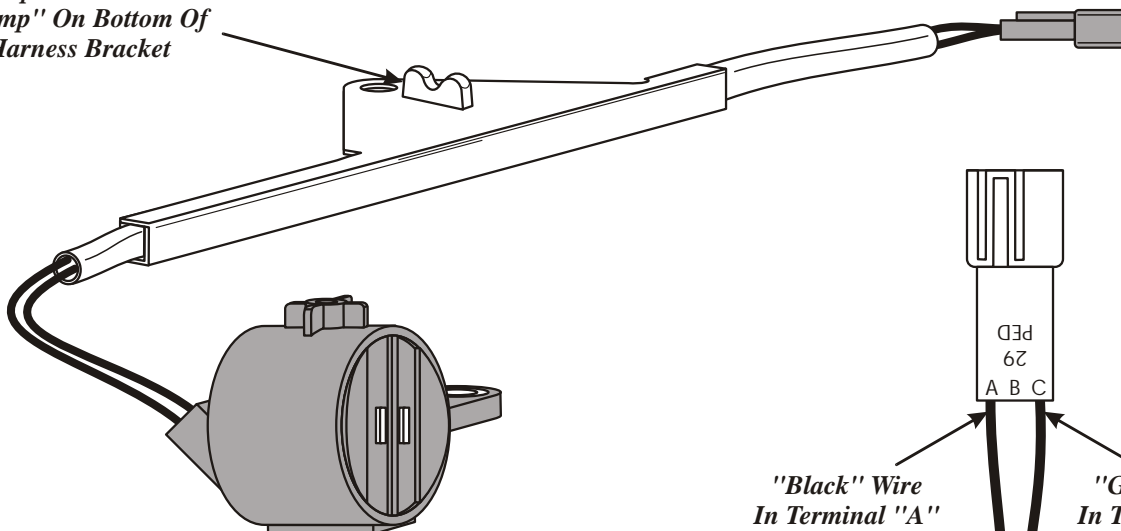
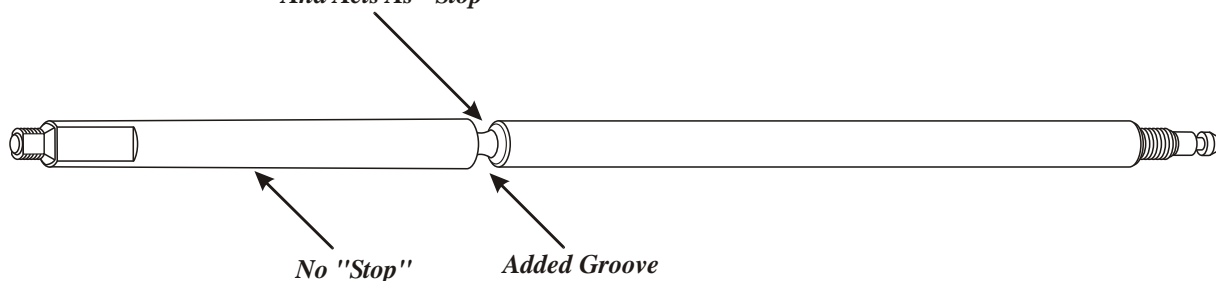
### THM 4T80-E 2ND DESIGN TURBINE SHAFT SPEED SENSOR OEM PART NUMBER 24207491

*This Speed Sensor Has  
"Bump" On Bottom Of  
Harness Bracket*

**THIS SPEED SENSOR FITS  
1996 (Julian Date 113) TO CURRENT  
AND IS "MANDATORY" FOR  
THESE MODELS AS TRANSAXLE  
IS EQUIPPED WITH THE MANUAL  
SHAFT SHOWN BELOW**

*"Bump" On Bottom Of Harness Bracket  
Fits Into Groove In Manual Shaft And  
Positions Manual Shaft In Case  
And Acts As "Stop"*

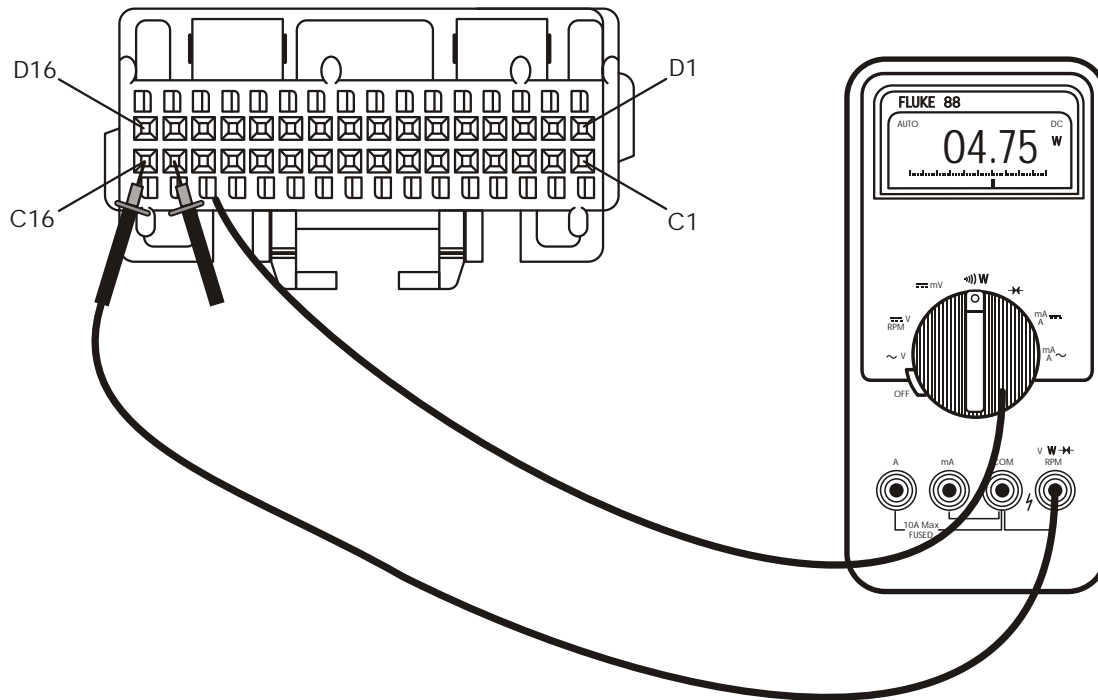
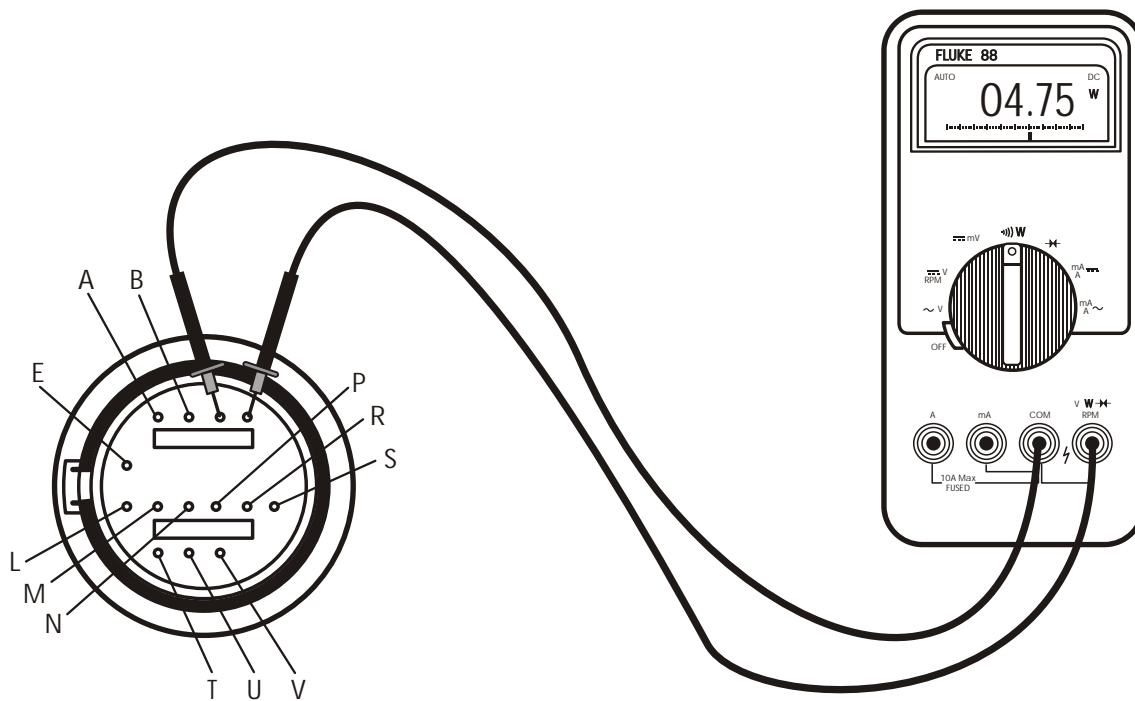
PCM CONNECTOR C2

"White" In Color

View Looking Into  
Transaxle Case Connector

*If it becomes necessary to replace the turbine speed sensor, ensure that your new sensor has the wires in terminals "A" and "C", as shown in Figures 2 and 3. We have had some reports that the new sensor came with the green wire in terminal "B" and had to be moved to terminal "C". We have also had some reports of the black wire being in terminal "A" and the green wire being in terminal "B" on both sides of the connecting harness. Ensure that your wires match on both sides of connector, regardless of where they are located. Refer to Figures 2 and 3.*
