## *"The Seminar to See for 2003" Technical Seminar*

### ***AUTOMATIC TRANSMISSION SERVICE GROUP***

## *“The Seminar to See for 2003”*

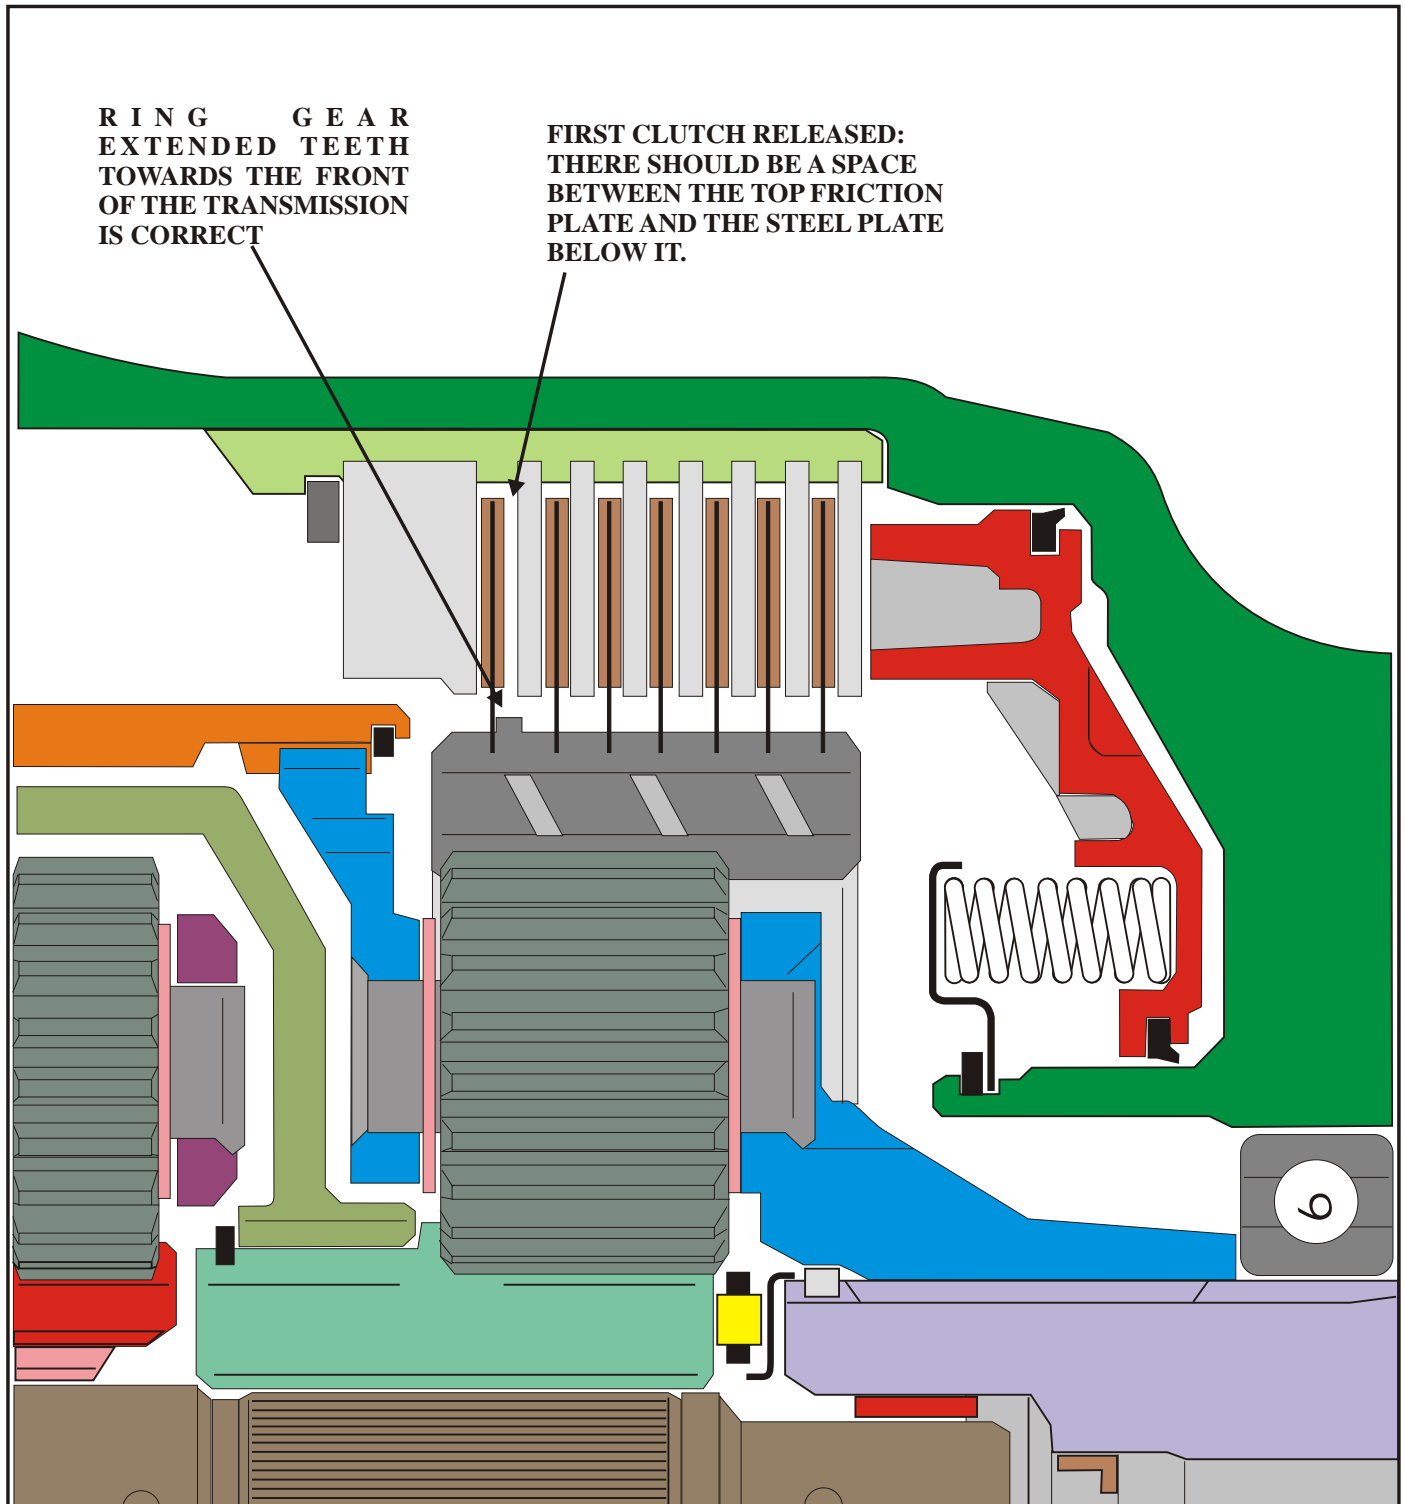
Figure 3

### CORRECT ASSEMBLY OF THE FIRST CLUTCH

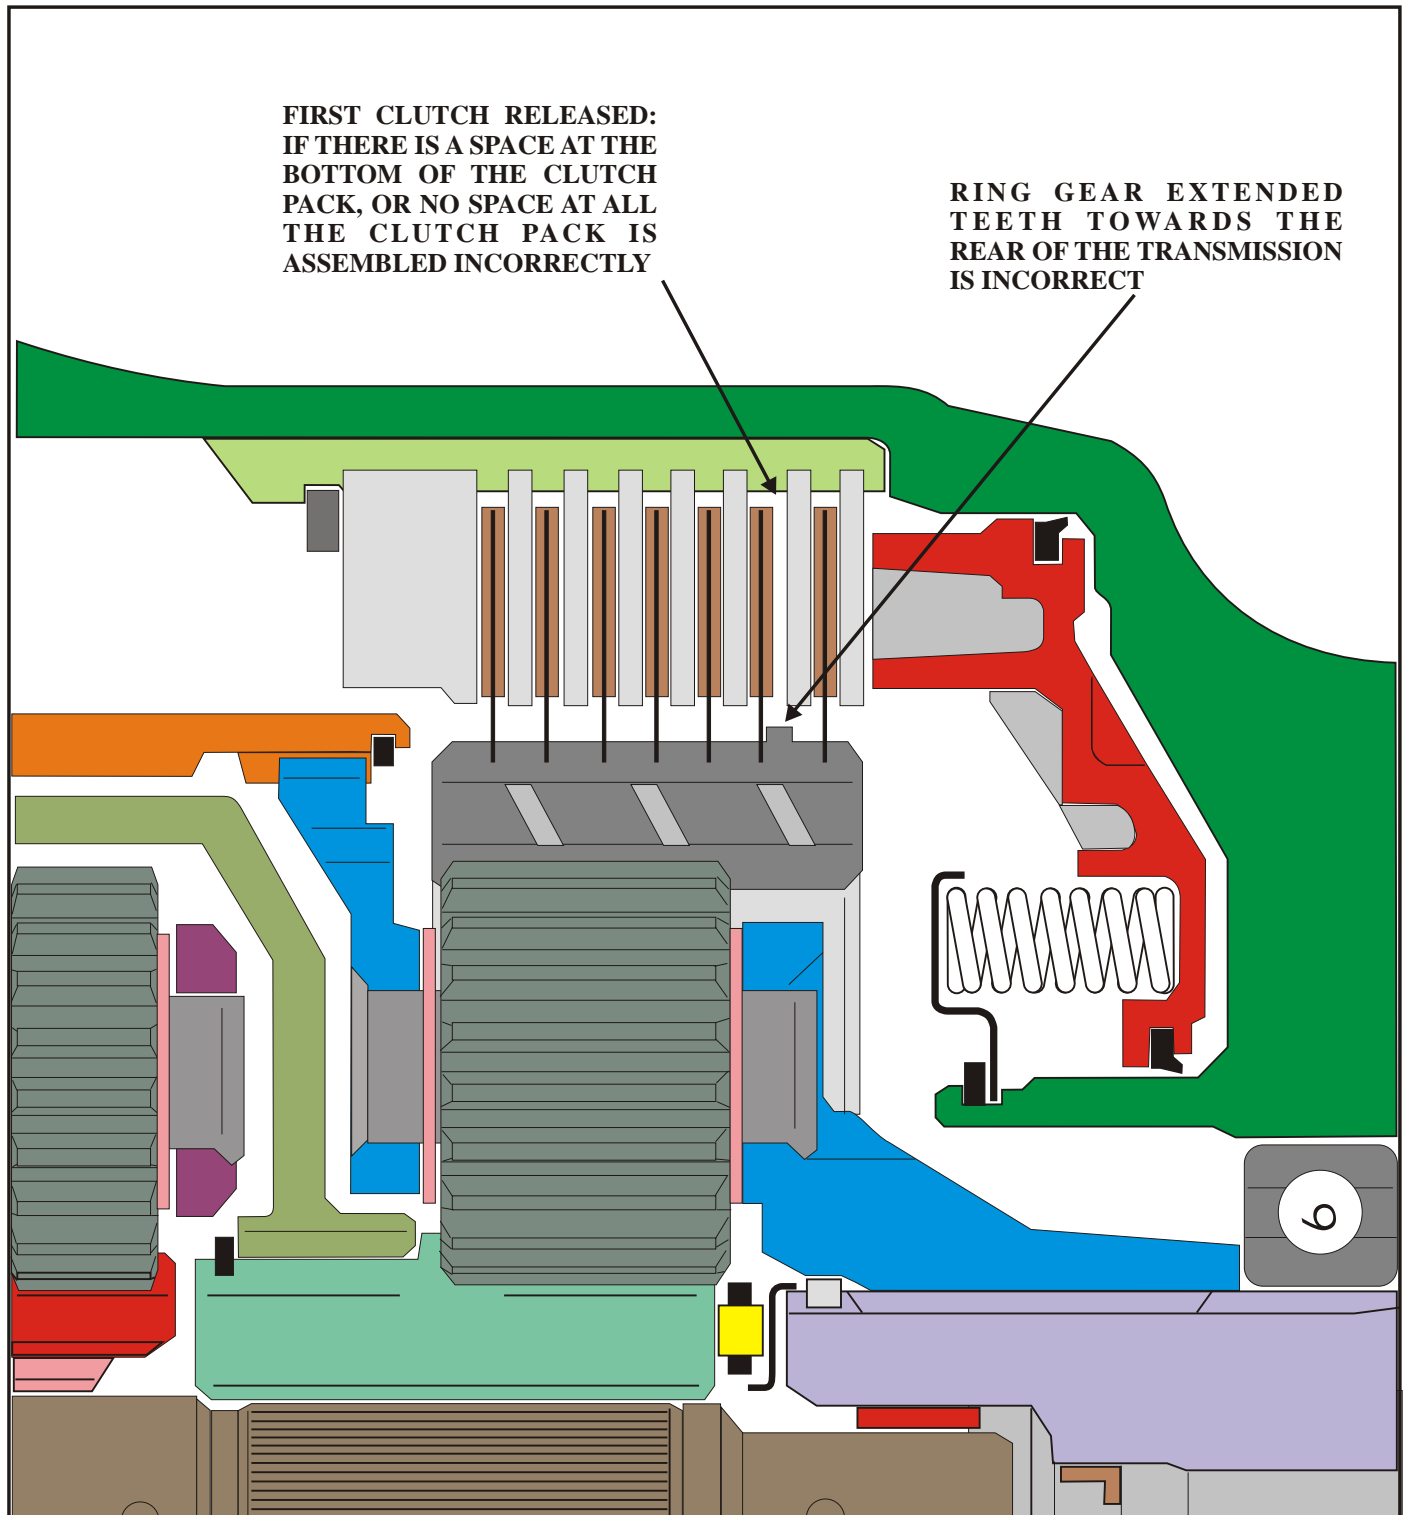
Figure 4

### INCORRECT ASSEMBLY OF THE FIRST CLUTCH

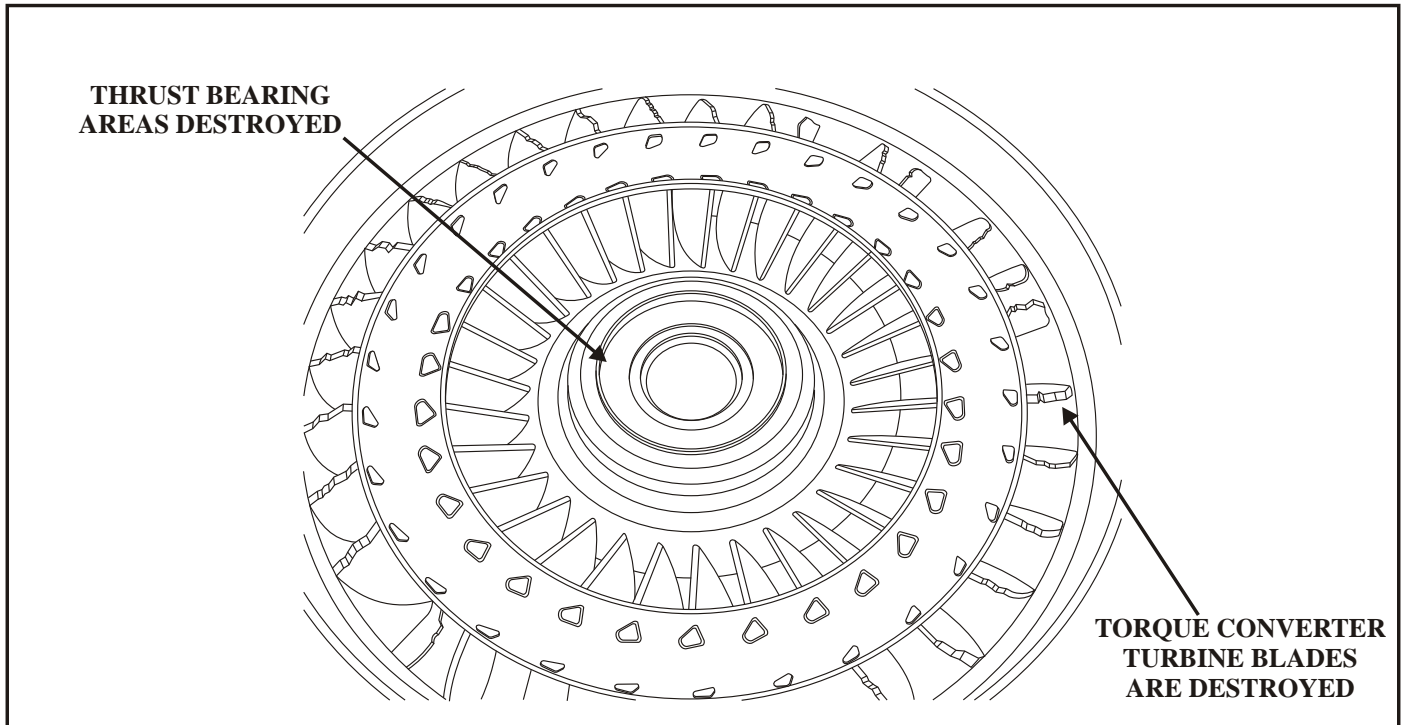
Figure 1

**CAUSE:** The torque converter has catastrophically failed internally resulting in the above conditions as illustrated in figure 1.

**AISIN SEIKI 450-43LE**  
**SEVERE TORQUE CONVERTER DAMAGE**

**CORRECTION:** Replace the torque converter along with other necessary repairs and a thorough flush of the transmission cooling system.

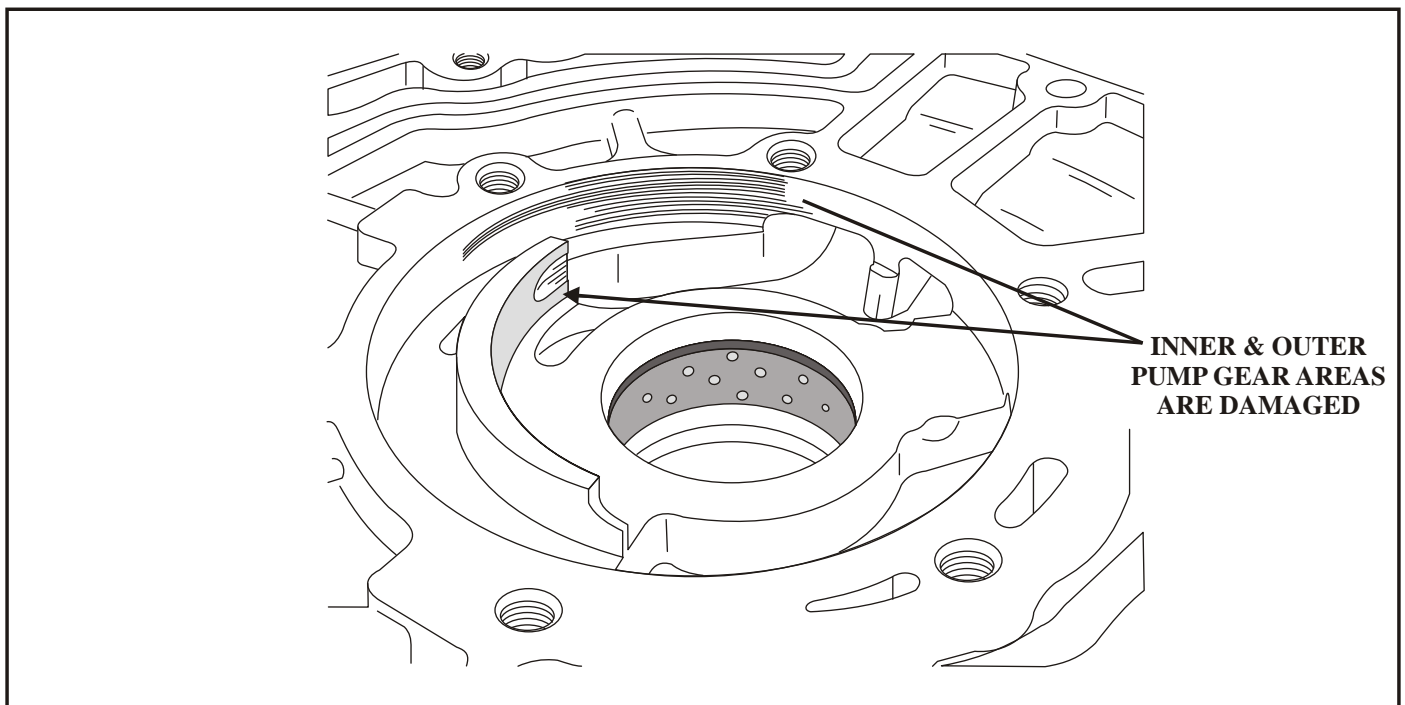
Figure 2

**NOTE:** When the transmission fluid is in this condition, the torque converter is almost certainly damaged and the pump body and pump cover are also unuseable shown in figure 2.

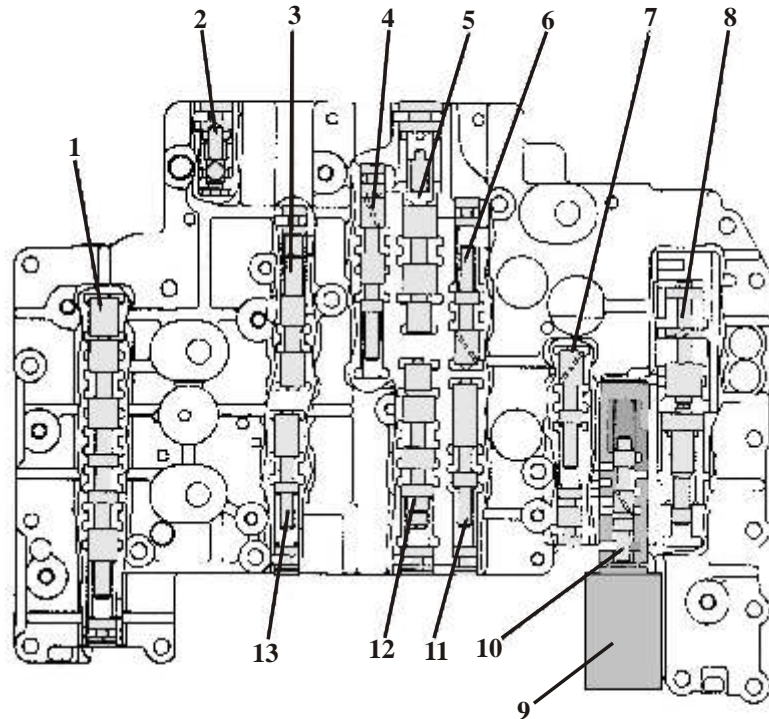
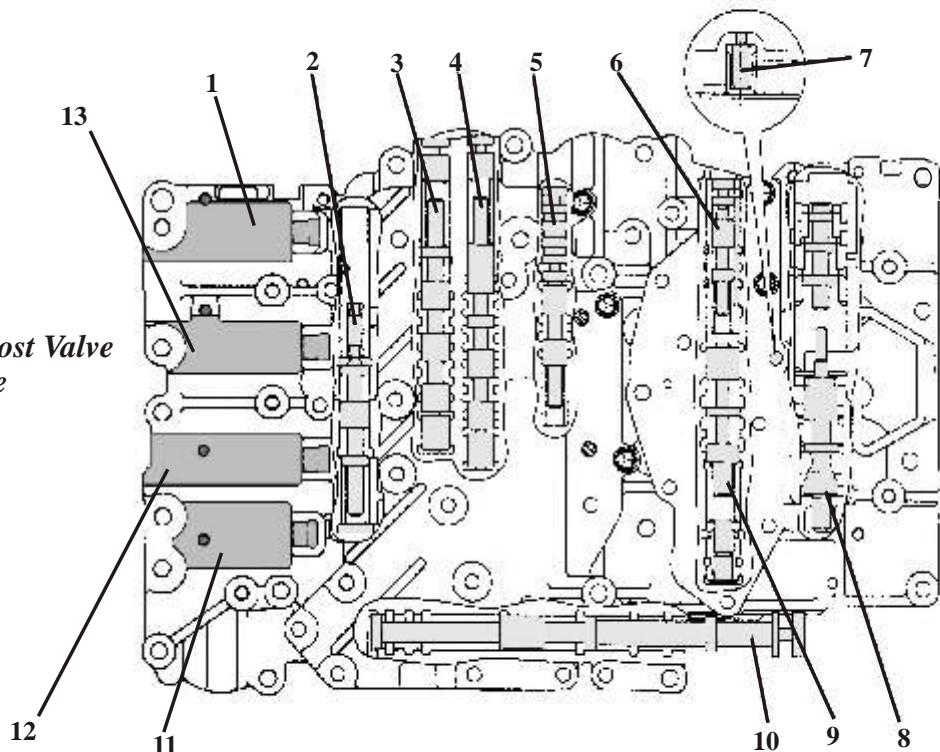
Figure 3

**NOTE:** Observation of this condition has shown that the valve body is usually trash and cannot be successfully reconditioned. The valve body components are identified in figure 3.

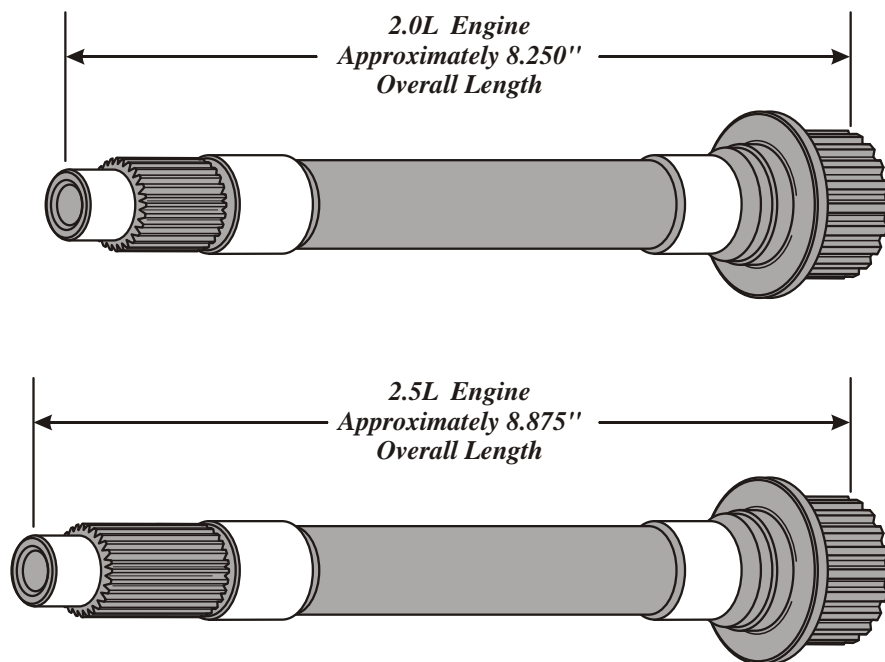
Figure 1

**CAUSE:** One cause may be, a mis-matched turbine shaft and torque converter that was mistakenly installed in the vehicle. The turbine shaft and oil pump drive shaft for the 2.0L engine are approximately 5/8" shorter than the turbine shaft and oil pump drive shaft for the 2.5L engine as shown in Figures 1 and 2. If the short turbine shaft is installed with the 2.5L engine and converter, the vehicle will exhibit the above concerns. Torque converter identification is provided for you in Figure 3, and as you can see in the height dimension chart, there is approximately 5/8" difference.

## CD4E TURBINE SHAFT DIFFERENCES

*All we have to do , is exercise a little extra care when selecting replacement parts for this location, depending on the vehicles engine size. Also, under the extra care category, I want to point you to an excellent article written, by Bob Warnke, in the September 2001 issue of Transmission Digest Magazine, entitled "CD4E Converter Clutch Codes". This article has several tests, including but not limited to, a CD4E converter bench test. We have experienced several remanufactured and new converters, that turned out to be the root cause of converter slip codes being set. This bench test would have eliminated these concerns, and saved the technician many hours of diagnostic time. This article is also available, at no charge, on our web site, at [ATSGMIAMI.COM](http://ATSGMIAMI.COM), or [ATSGBIZ](http://ATSGBIZ).*

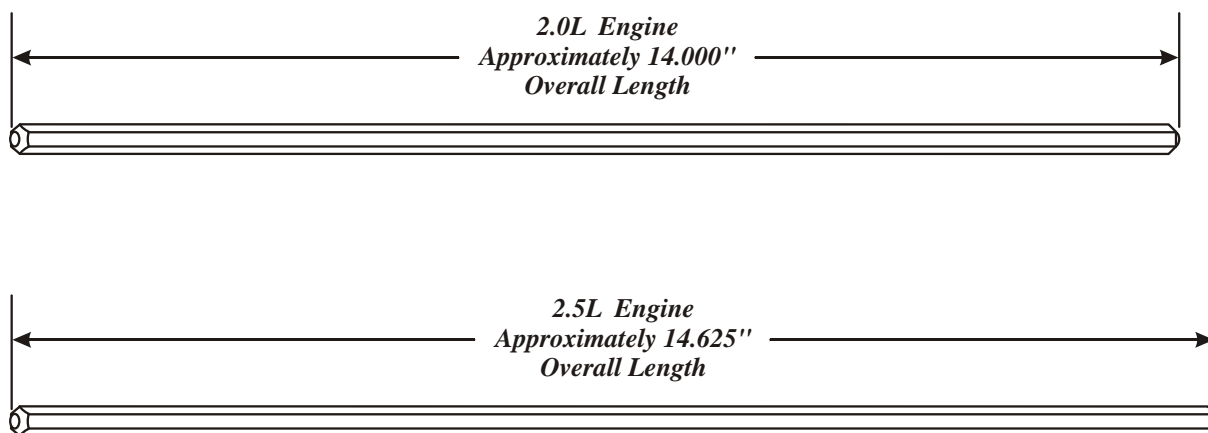
Figure 2

## CD4E PUMP DRIVE SHAFT DIFFERENCES

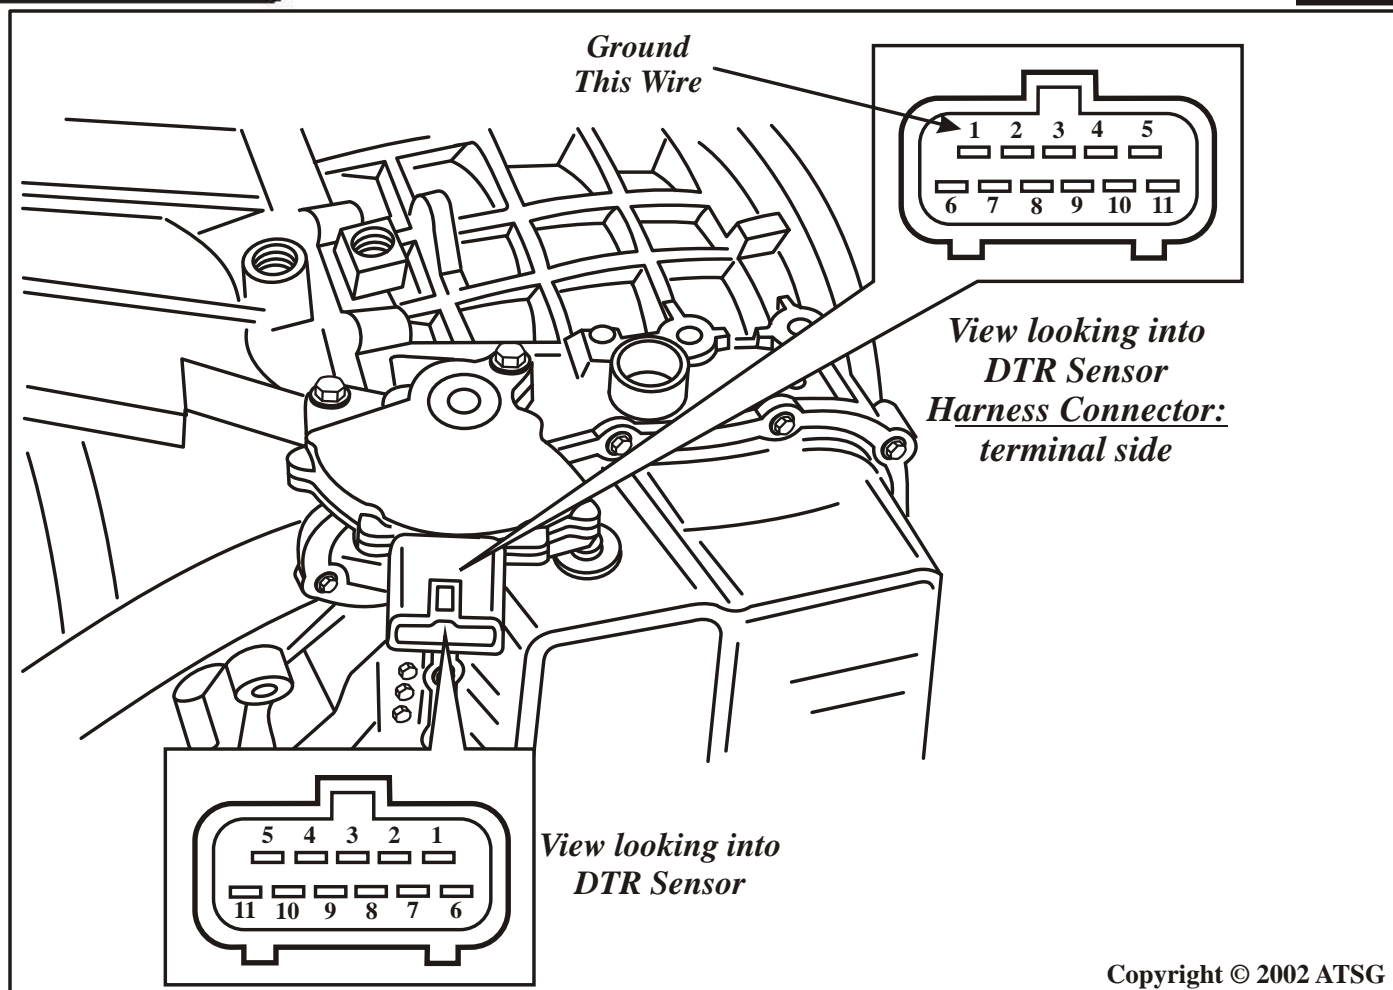
Figure 3

**CAUSE:** One possible cause for this behavior is a bad connection in the "Signal Return" circuit. The Signal Return circuit is a wire coming off of pin 46 in an EEC IV system or pin 91 and 30 on an EEC V system (See Figure 1). This "signal return" is the ground for a large number of sensors. It is routed through several splice points and connectors (See Figure 2). The route the wire takes is different for different vehicles. To further complicate matters, sensors between the poor connection and the PCM may operate normally.

**CORRECTION:** There are three possible methods to repair this problem. One is to simply ground that wire at a point past the problem. Say for example at the Transmissions Range Sensor (TRS) as seen in Figure 3. Another would be to run a bypass wire from a downstream sensor to the computer. The preferred repair method is to find the bad connection, clean or repair it, and protect it from whatever caused it to fail. Refer to the chart in Figure 4 for the color of the Signal Return wire at the Transmissions Range Sensor harness connector.

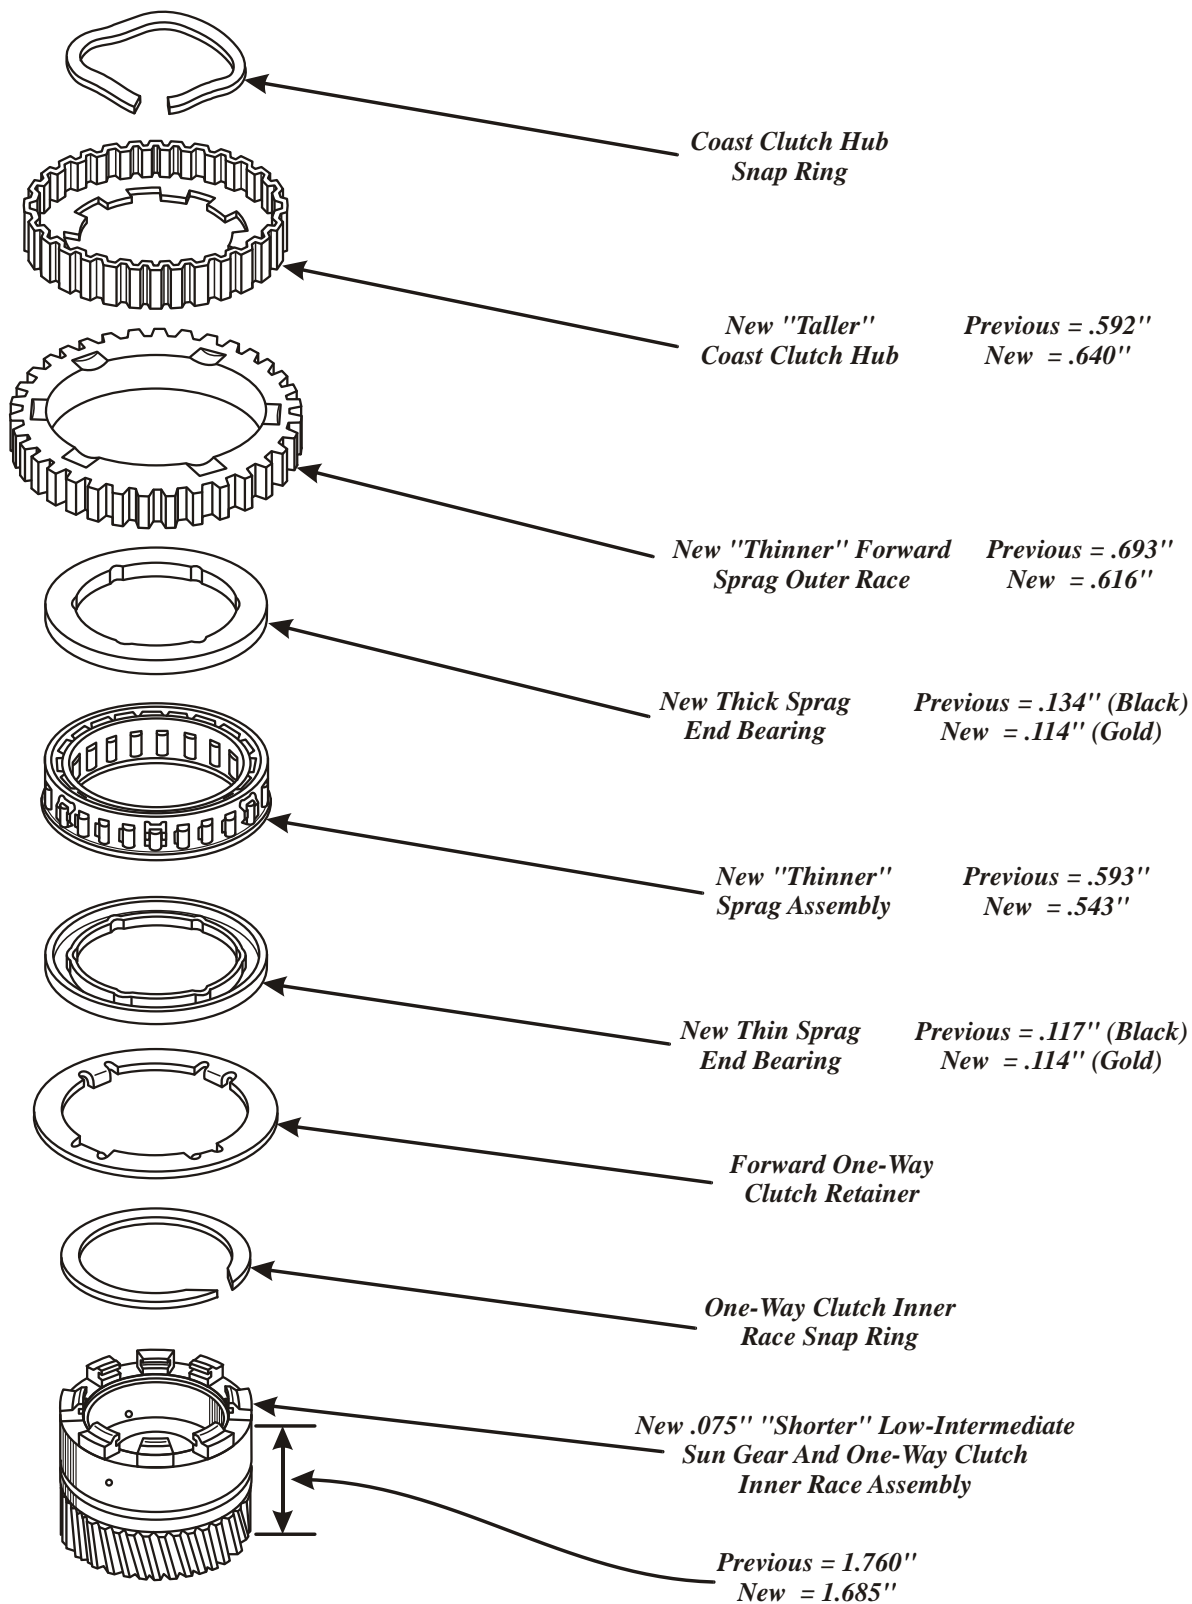
- (9) FORWARD ONE-WAY CLUTCH AND SUN GEAR ASSEMBLY - The forward sprag and sun gear assembly is available only as a complete service package of all of the pieces shown in Figure 6 under OEM part number F8RZ-7A089-AA. However, many of the service package parts have revised dimensions that you need to be aware of and are as follows:

- (A) **Coast Clutch Hub Retaining Ring** - No changes. Refer to Figure 6.
  - (B) **Coast Clutch Hub** - Has been made .053" **taller** to accommodate changes in the forward clutch pack, as shown in Figure 6.  
Previous Design = .592".  
New Design = .640".

- (C) **Forward Sprag Outer Race** - Has been made .077" **narrower** to accommodate the changes in the forward clutch pack, as shown in Figure 6.  
Previous Design Cage = .693".  
New Design Cage = .616".

- (D) **Thick End Bearing** - Has been made **.020" thinner** to accommodate the changes in the forward clutch pack, as shown in Figure 6. Both end bearings now the same.  
Previous Design = .134" (Black in color)  
New Design = .114" (Gold in color).

- (E) **Forward Sprag Assembly** - Has been made **.050" narrower** to accommodate the changes in the forward clutch pack, as shown in Figure 6.  
Previous Design = .593", Sprag Elements = .372".  
New Design = .543", Sprag Elements = .307".

- (F) **Thin End Bearing** - Has been made **.003" thinner** to accommodate the changes in the forward clutch pack, as shown in Figure 6. Both end bearings now the same.  
Previous Design = .117" (Black in color).  
New Design = .114" (Gold in color).

- (G) **Forward Sprag Retainer** - No Changes. Refer to Figure 6.
- (H) **Forward Sprag Retaining Ring** - No Changes. Refer to Figure 6.
- (J) **Forward Sprag Inner Race And Sun Gear Assembly** - Has been made **.075" shorter** to accommodate the changes in the forward clutch pack, as shown in Figure 6.  
Previous Design = 1.760".  
New Design = 1.685".

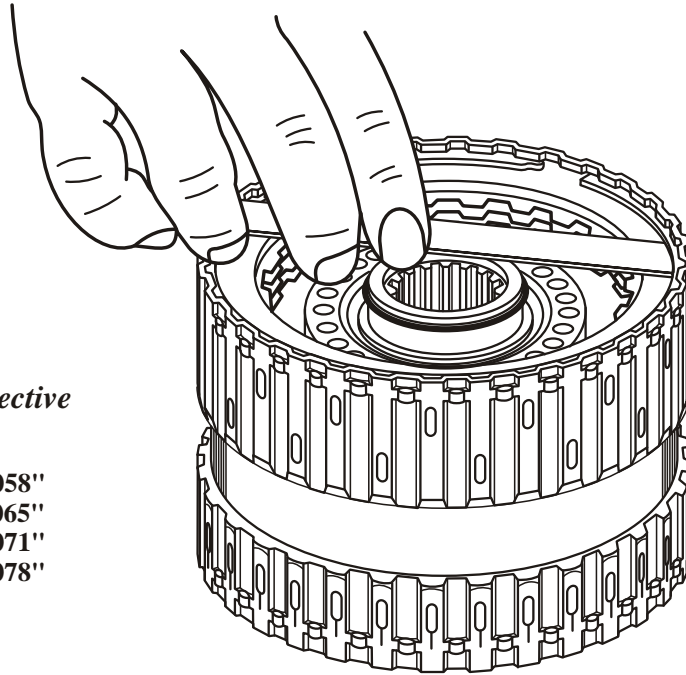
- (8) FORWARD CLUTCH SNAP RING - Has always been selective to achieve the proper clutch clearance, but the above changes necessitated a new set of selective snap ring thickness to ensure the proper clutch clearance. Refer to Figure 8 for dimensions and part numbers.
