AUTOMATIC TRANSMISSION SERVICE GROUP

SEMINARS '88

TECHNICAL INFORMATION PACKAGE

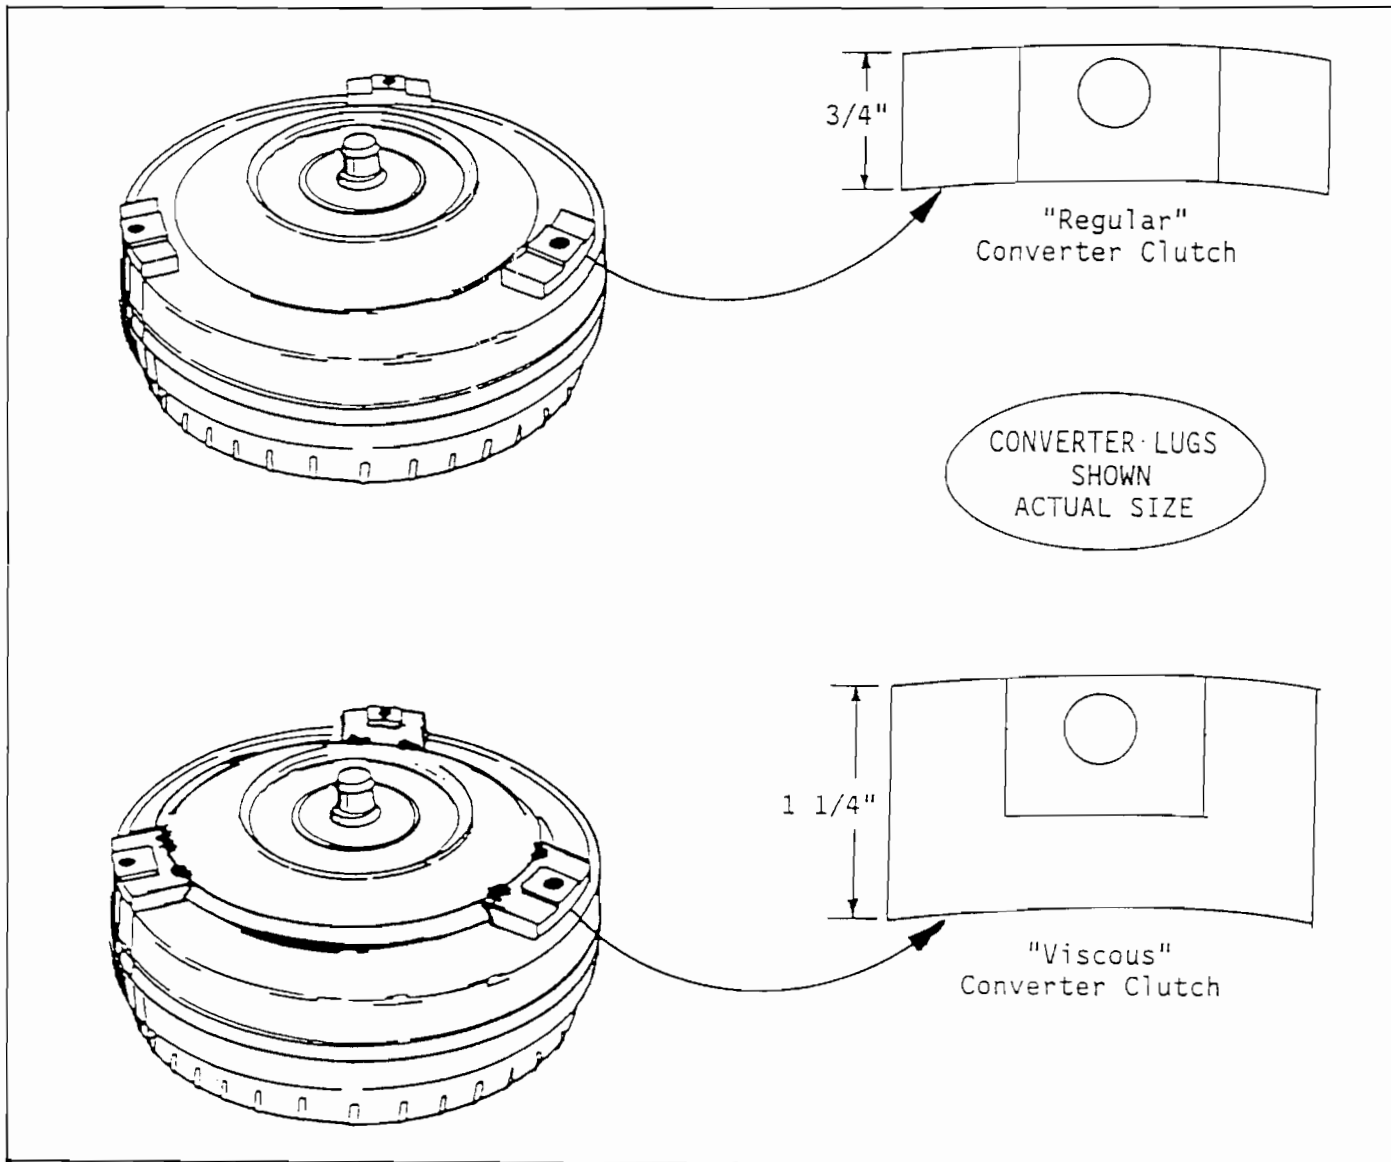
Figure 60

Identification of the "VISCIOUS" converter from the "REGULAR" converter, can be done very easily externally. Notice the difference in the size of the converter drive lugs (see Figure 60). The profile of the converter covers are also different, but takes a closer look to detect, than do the drive lugs.

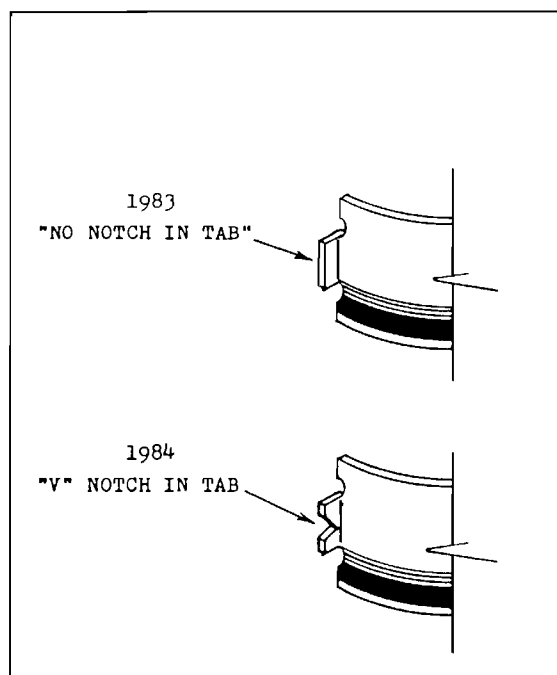
Figure 2

For 1984 the THM 125C has 5 L&R friction plates that are .010" thicker, and 5 L&R steel plates that are .010" thicker, for a total of .100". They had to make room for that extra .100" in the L&R clutch pack. They accomplished this by moving the final drive ring gear spacer snap ring .050" closer to the final drive and of course this requires a thinner ring gear spacer (See Figure 1). The 1983 ring gear spacer measures 1.344" and can be identified by no notch in the tab. The 1984 ring gear spacer measures 1.294" and can be identified by a "V" notch in the tab (See Figure 2).

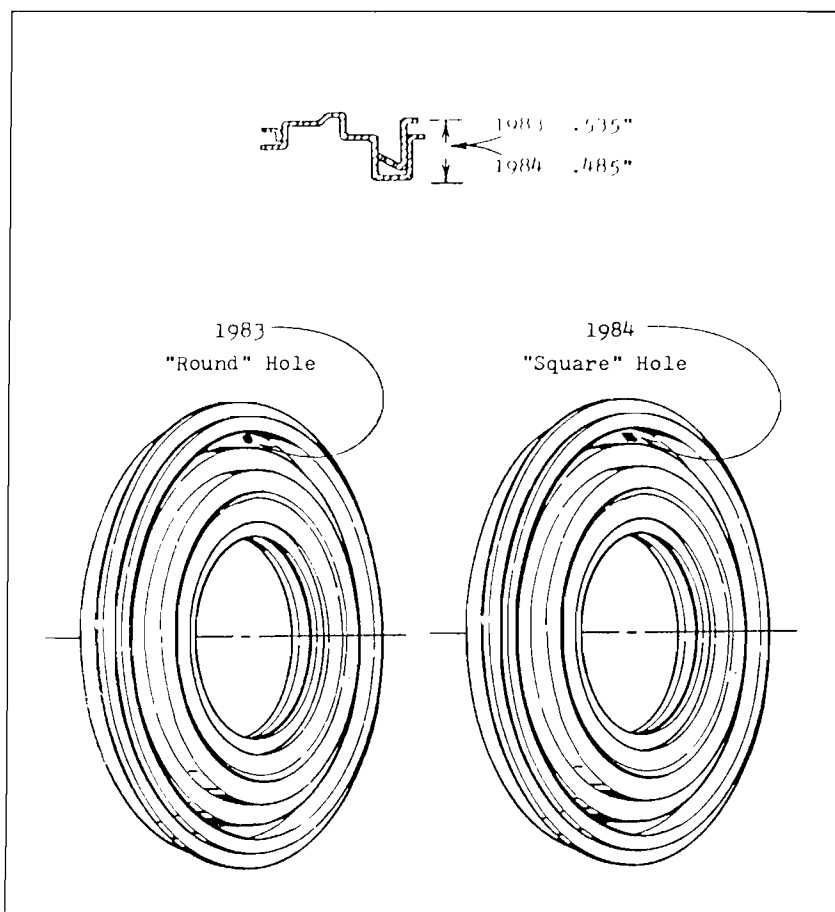
Figure 3

The other .050" was handled by making the L&R piston .050" thinner. The 1983 piston measures .535" (total height) and is identified by a "round" hole in the lip seal retainer on the back of the piston. The 1984 piston measures .485" (total height) and is identified by a "square" hole in the lip seal retainer on the back of the piston (See Figure 3). Needless to say these parts cannot be interchanged.

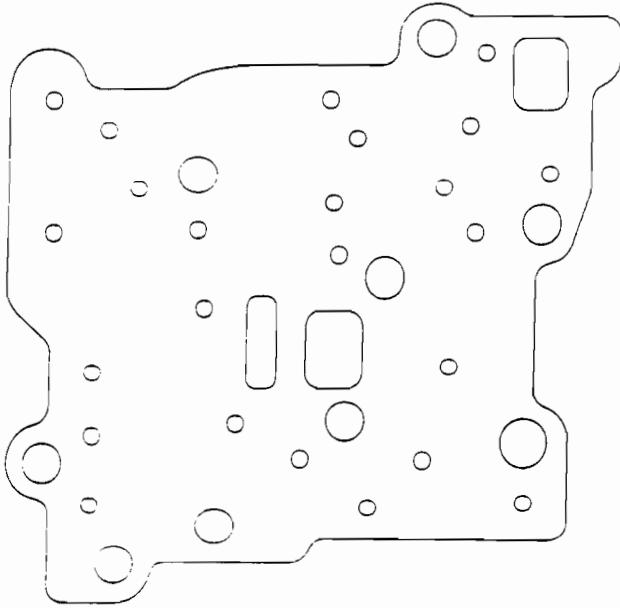
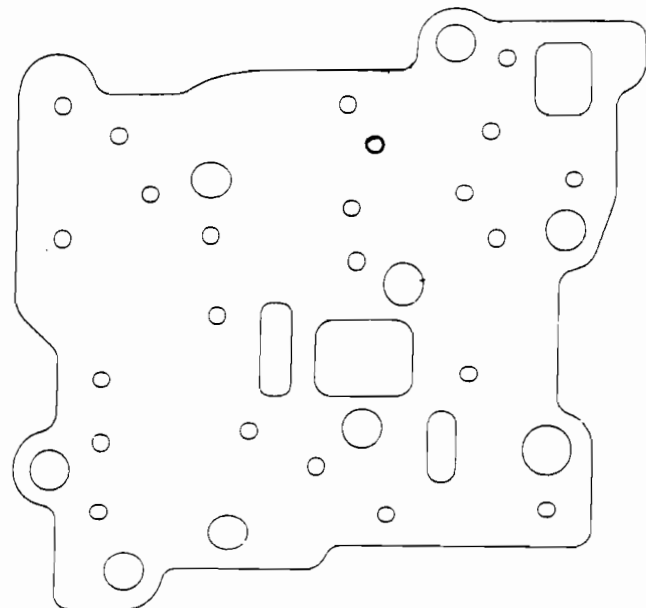
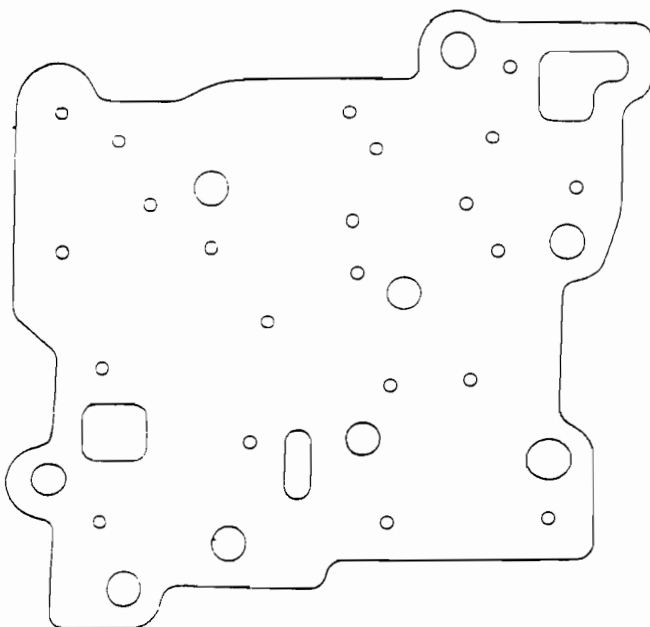
NOTE: GASKETS DO NOT RETROFIT, MISMATCH CAN CAUSE NO TCC ENGAGEMENT OR NO TCC RELEASE.

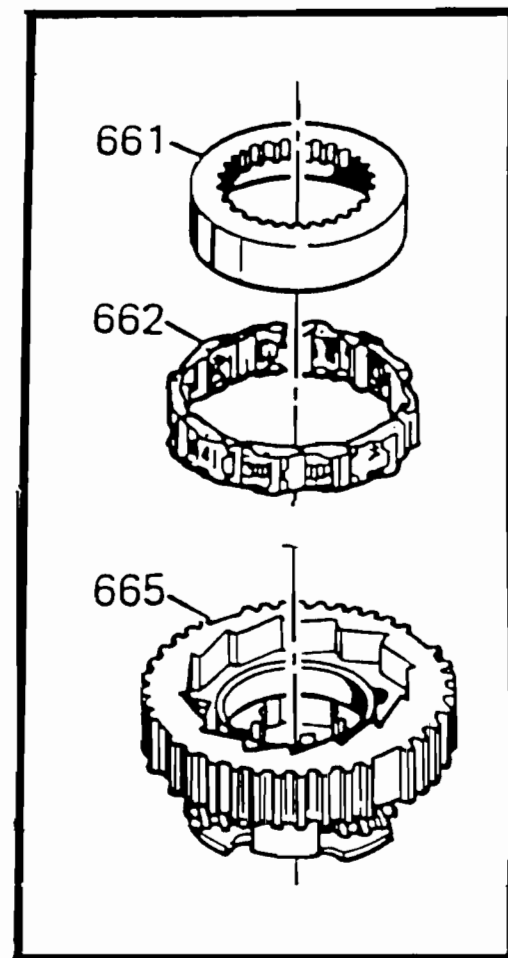
COLD WEATHER CONDITION VEHICLE WILL NOT DRIVE IN DRIVE OR INTERMEDIATE RANGE. HOWEVER IT WILL MOVE IN LOW OR REVERSE. MAKE SURE IF YOU HAVE THIS PROBLEM ALWAYS CHECK INTERMEDIATE RANGE.

THE CAUSE MAYBE A WORN OUT ROLLER CLUTCH. SOMETIMES THE SPRINGS CAN BE WEAK, BENT OR BROKEN.

INSTALL A NEW ROLLER CLUTCH ASSEMBLY ITEM 662 IN ILLUSTRATION

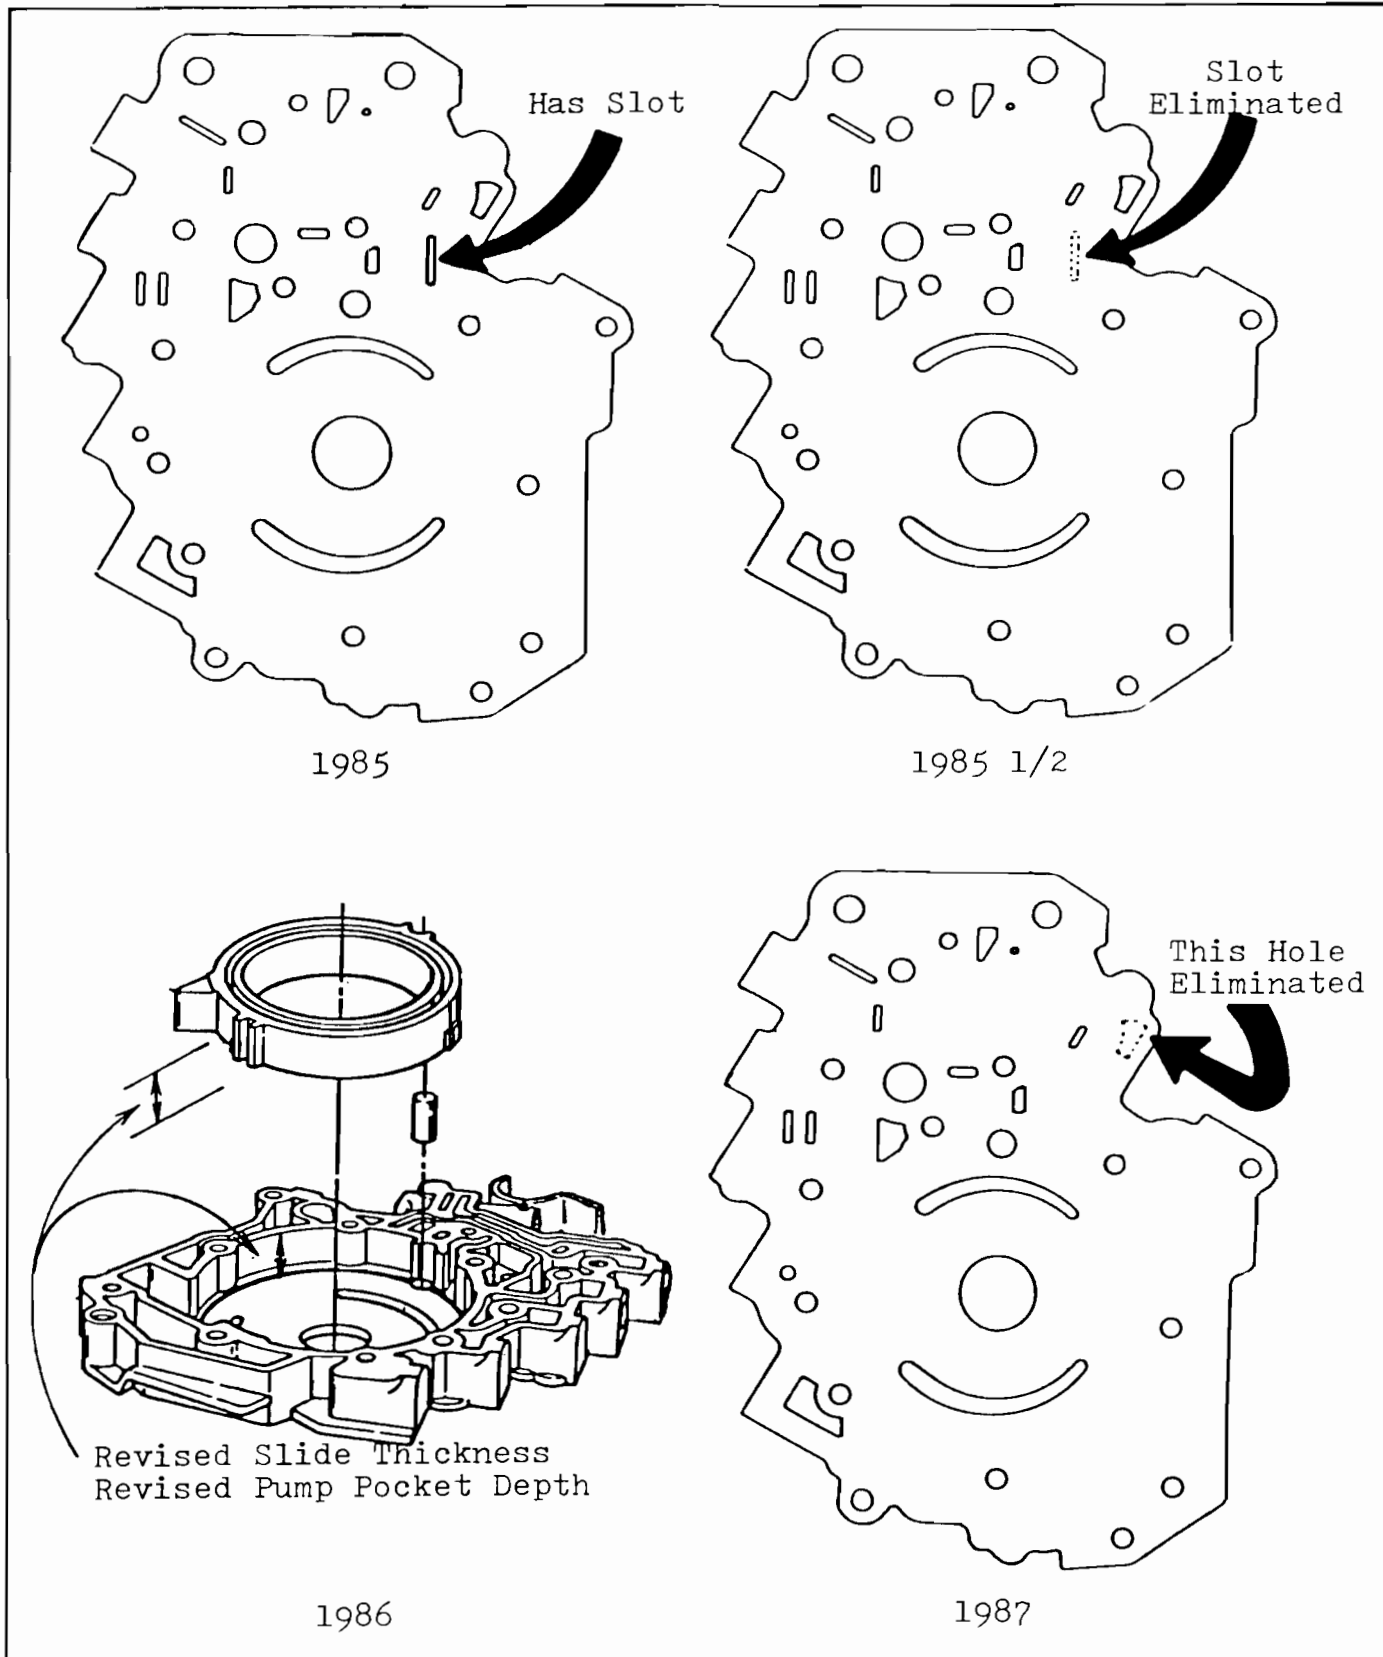
Figure 5

1985	Identification:	Has slot in pump body (See Figure 5).
	Interchangeability:	The 1985 pump body will not work on 1985 1/2 up valve body unless spacer plate is used to eliminate slot. If used without the spacer plate result will be tie-up when transaxle shifts to 4th gear.
1985 1/2	Identification:	Slot in pump body was eliminated (See Figure 5).
	Reason:	Addition of 3-2 TV bias valve in valve body and complete revision of hydraulic circuit for improved 3-2 downshift.
	Interchangeability:	Will interchange on 85 1/2 and 1986 models only.
1986	Identification:	No way to identify from 1985 1/2. Pump pocket depth was made shallower by .0001" which created 5 new slide sizes unique to the 1986 pump. See chart on page 6.
	Reason:	Improved pump capacity.
	Interchangeability:	Will interchange with 85 1/2 only, as long as proper slide selection is made to correspond with depth of pump pocket.
1987	Identification:	Hole eliminated in pump body (See Fig. 5).

Reason:	Improved 3-2 downshift. Modulator oil was fed thru the hole in pump body to stroke the 3-2 coastdown valve. Improved 3-2 downshift could be obtained by using servo release oil to stroke the valve, so hole was eliminated and the 3-2 maneuver pipe was added to carry servo release oil to the 3-2 coastdown valve in pump body (See Figure 6). This also made a change in the pump cover necessary with an additional hole and seal to accept the 3-2 maneuver pipe.
	Interchangeability:	Will retro fit back to 85 1/2, and is recommended. The 3-2 maneuver pipe must be used with it. Not interchangeable unless 3-2 maneuver pipe is used.

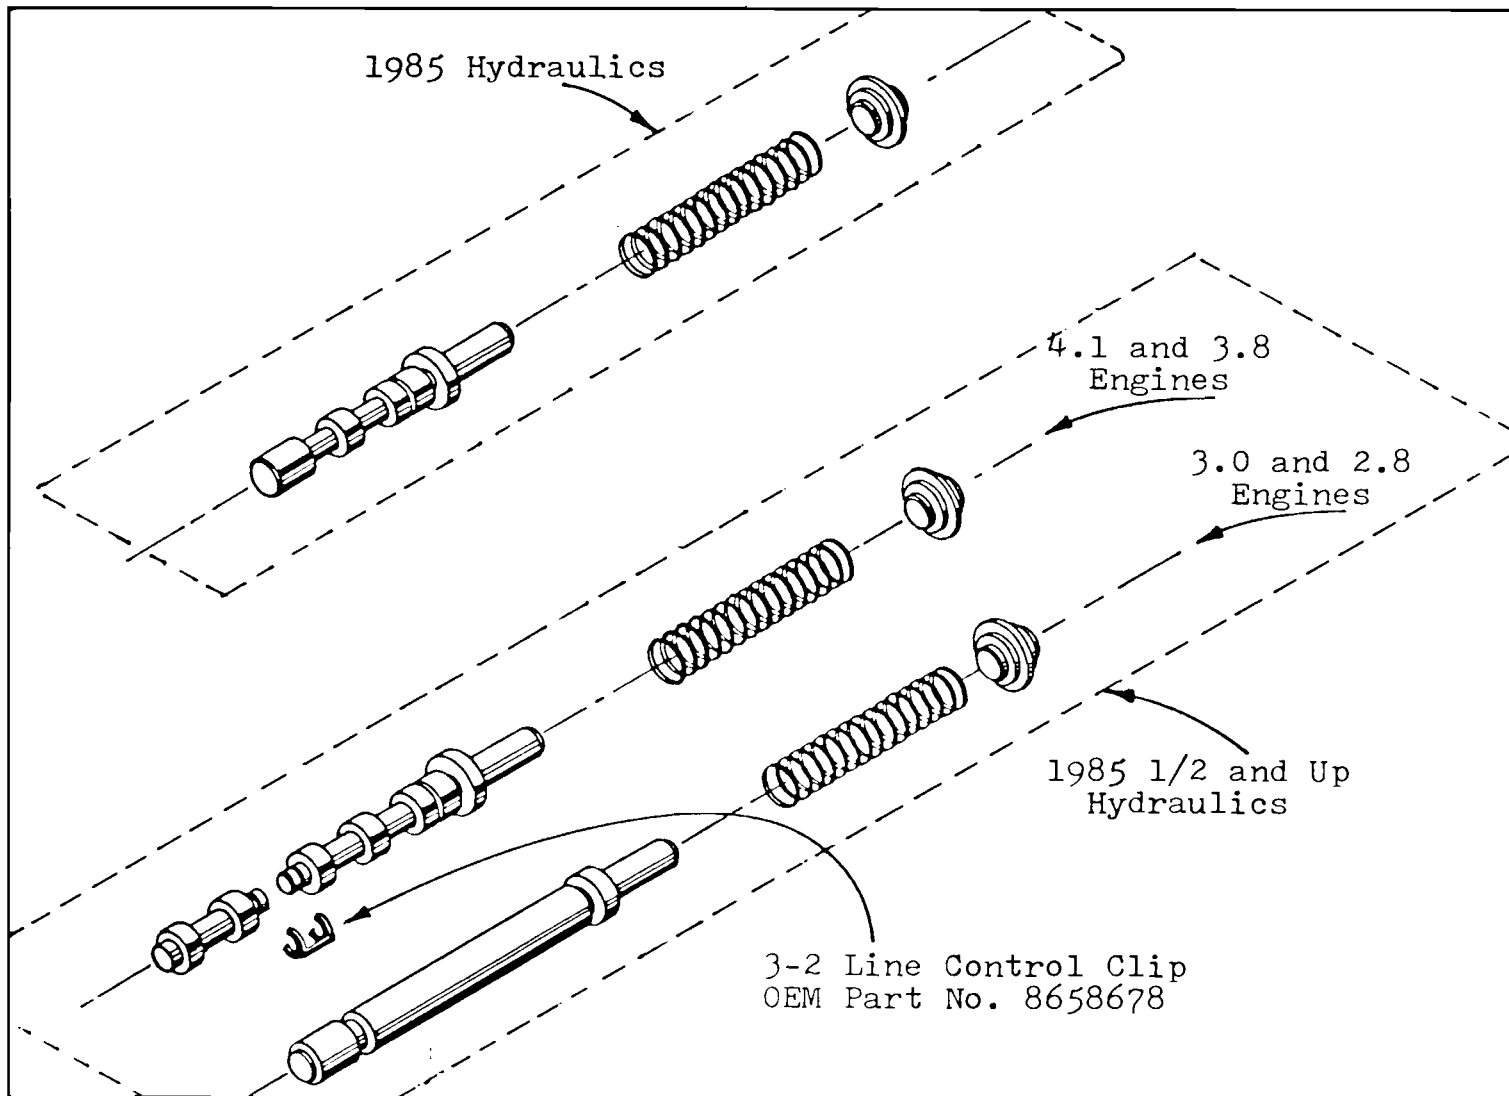
The main reason, besides calibration, is the 3-2 Line Control Valve located in the channel plate directly under the spacer plate. There are currently three different line-ups on this valve (Shown Below), and this affects the number of holes that are punched into a particular model spacer plate.

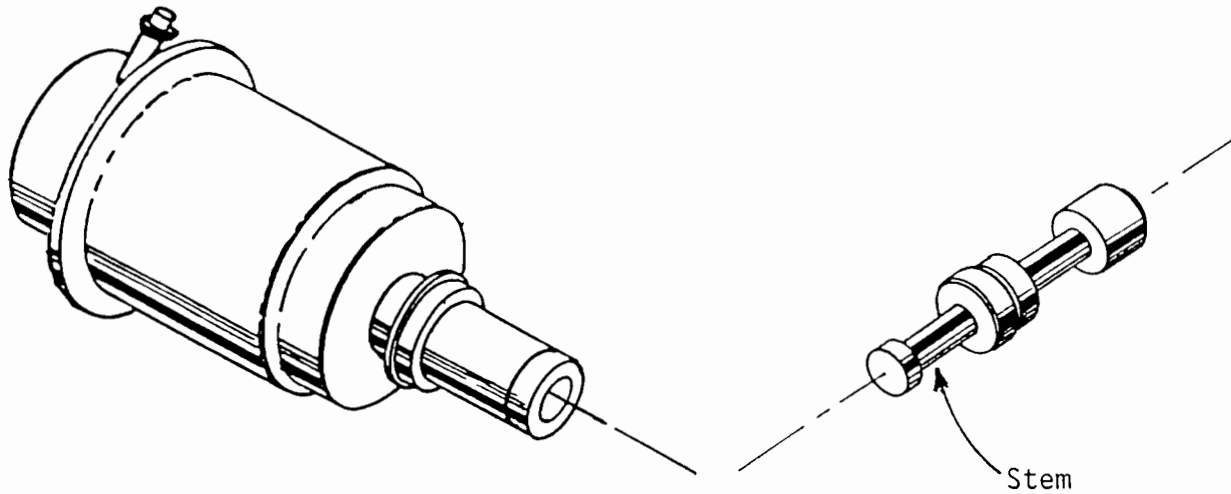
Some THM 440-T4 transaxle models may exhibit harsh upshifts when operated at high altitudes. This condition may be caused by excessive line pressure resulting from insufficient engine vacuum.

Refer to Figure 1 for the previous vacuum modulator and modulator valve, and Figure 2 for the latest vacuum modulator and modulator valve.

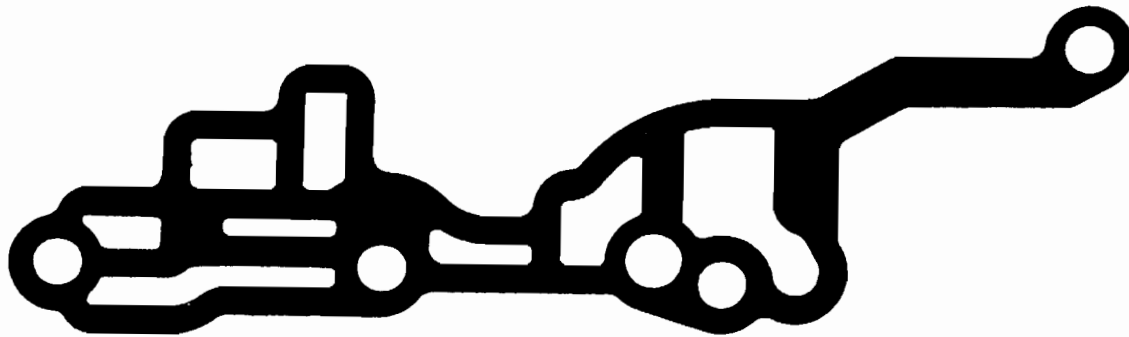
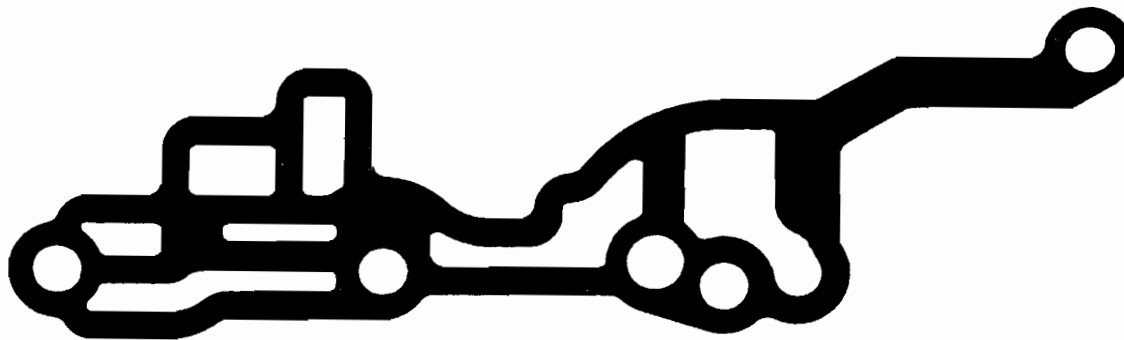
NOTE: Early gasket will fit the late model units, but late will not fit early.

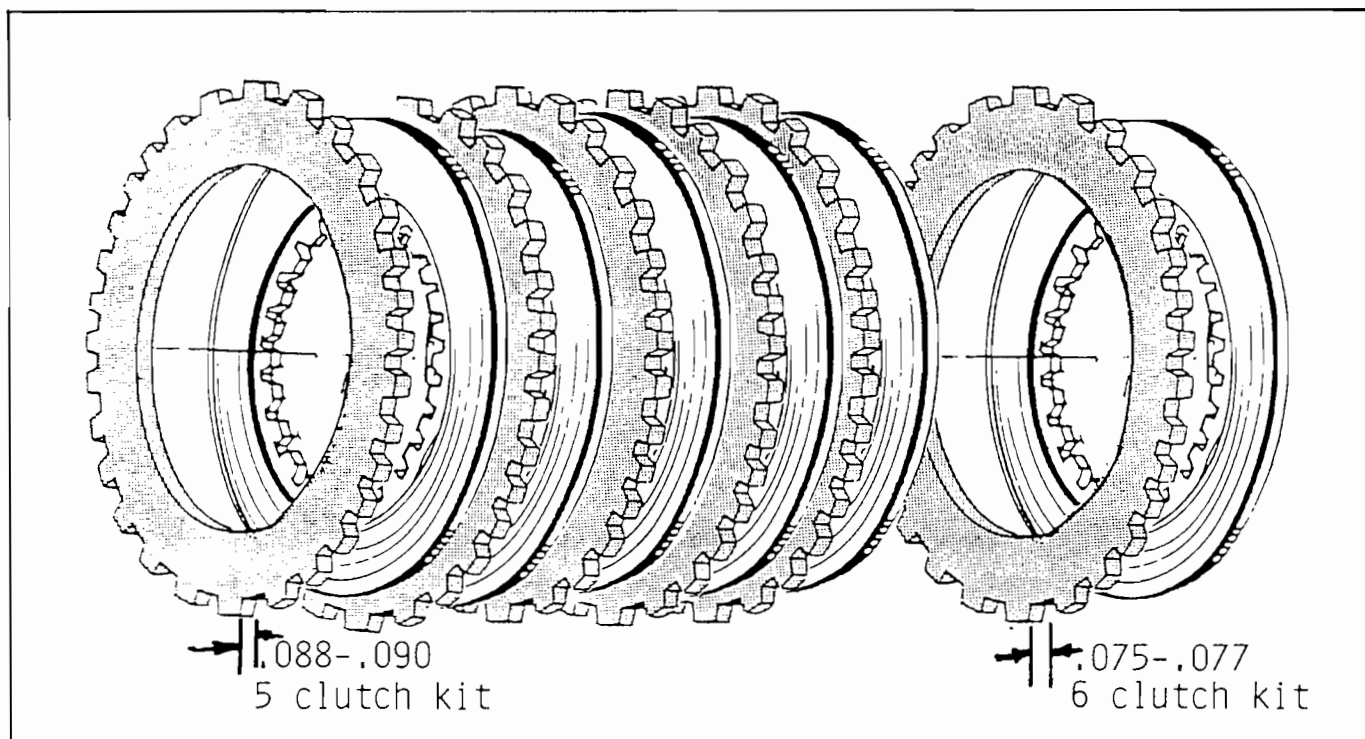
8662914 (6) Clutch Kit 1987

Complaint of a 1-2 slide shudder on THM 440 T4 1984-87. Can be caused by clutch lining compatability of lined plates. This can also be a problem encountered with SRTA or factory rebuilt units. To correct this problem Install kit number 8662913 for 1984 thru 1986 which comes with 5 lined plates and 5 steel (koline) plates. the koline plates in this kit are .088-.090 thick. For the 1987 units use kit number 8662914 comes with 6 lined plates and 6 steel (koline) plates. The koline plates in this kit are .075-.077 thick.

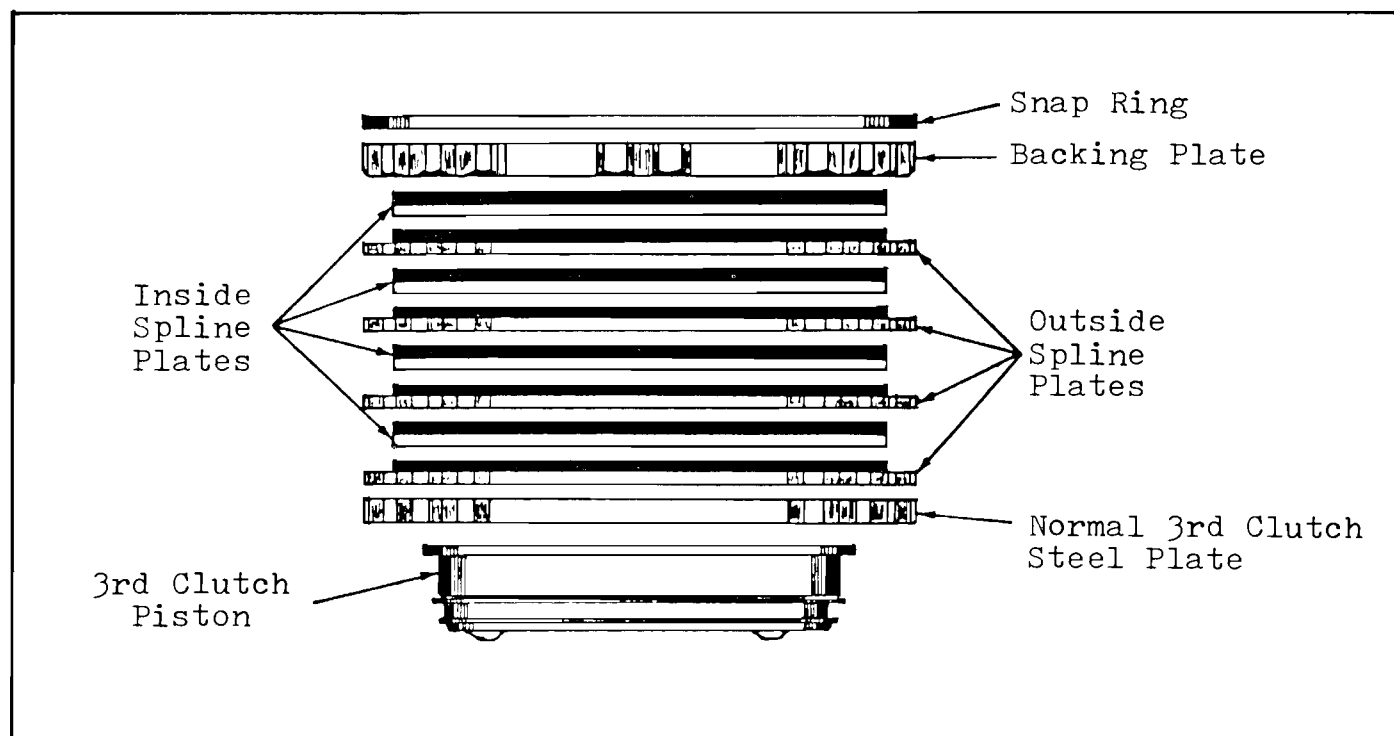
The 3rd clutch pack on the models mentioned above have single sided clutch plates, or clutch plates with lining on one side only. Notice that the outside spline plates, or what we normally refer to as "Steel" plates, also have lining on one side only. Notice also that the clutch pack is started with a normal 3rd clutch steel plate, and is followed with an outside spline plate with the "Lining UP". Steel against steel will not be a problem as long as they are both outside spline plates, because they cannot counter rotate against one another. Obviously if you followed the normal steel plate with an inside spline plate you would have steel counter rotating against steel, and damage to the clutch pack would result.

They must be assembled as shown, and you must start with a normal 3rd clutch steel plate to obtain proper clutch clearance.

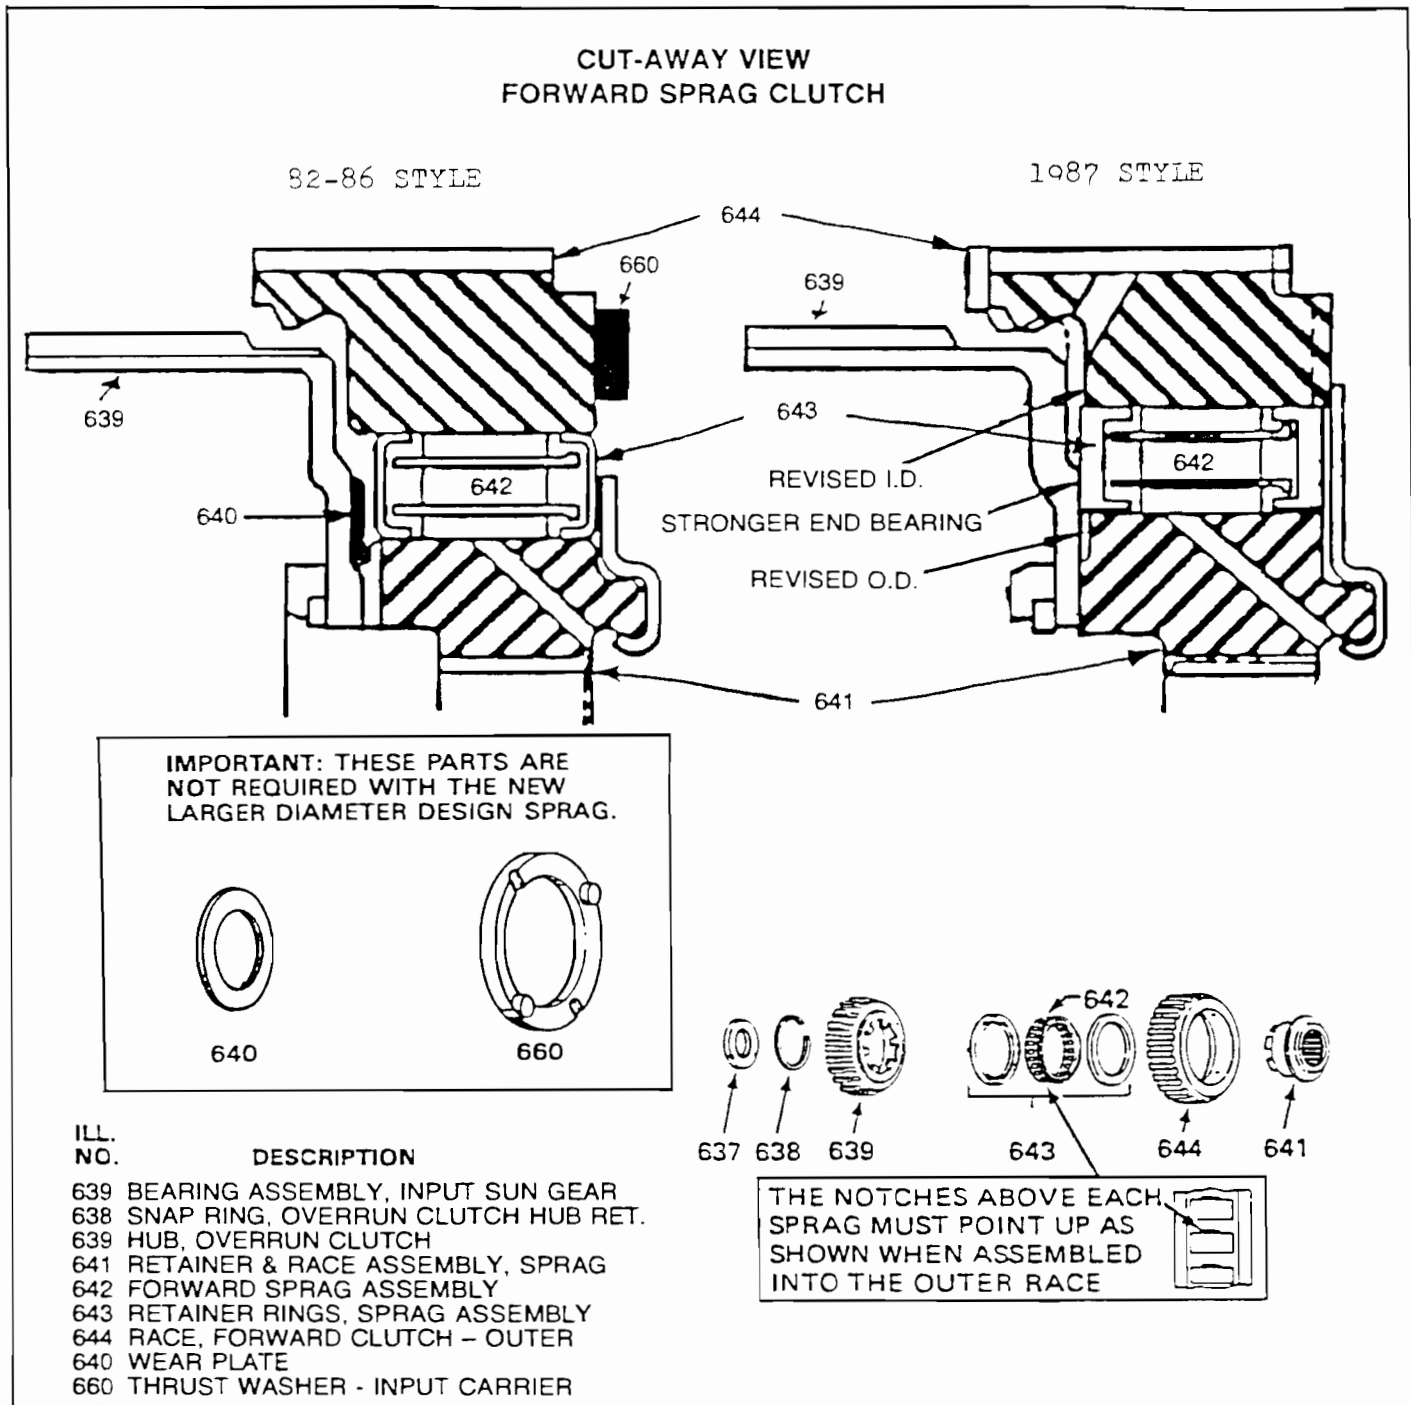
Figure 1

When the new design sprag is used, the wear plate and the black plastic input carrier thrust washer are eliminated (See Inset Fig. 1). The wear plate (640) is eliminated to make room for the solid steel end bearings, and the long lip of the retainer on the sprag inner race takes the place of the input carrier thrust washer (660). See Figure 1.

Use of the input carrier thrust washer (660) with the new design sprag assembly will cause a misbuild (Correct end clearance cannot be obtained).

The new design sprag will retro fit all the way back to 1982 models by replacing the entire assembly, OEM Part Number 8657928, and is highly recommended.

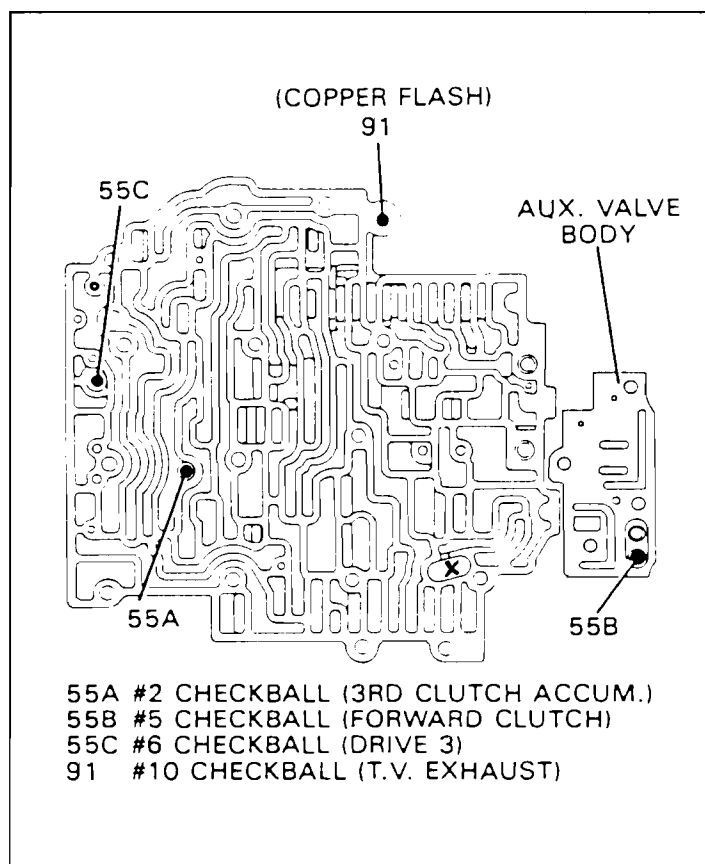
The number 5 check ball has been removed from the bath tub in the valve body, and relocated in the auxiliary valve body on all 1987 model THM 700-R4 transmissions.

NOTE: If this check ball is installed in the old position when the auxiliary valve body is used, the low and reverse clutch pack will burn in approximately 15 minutes of normal operation. See figures below.

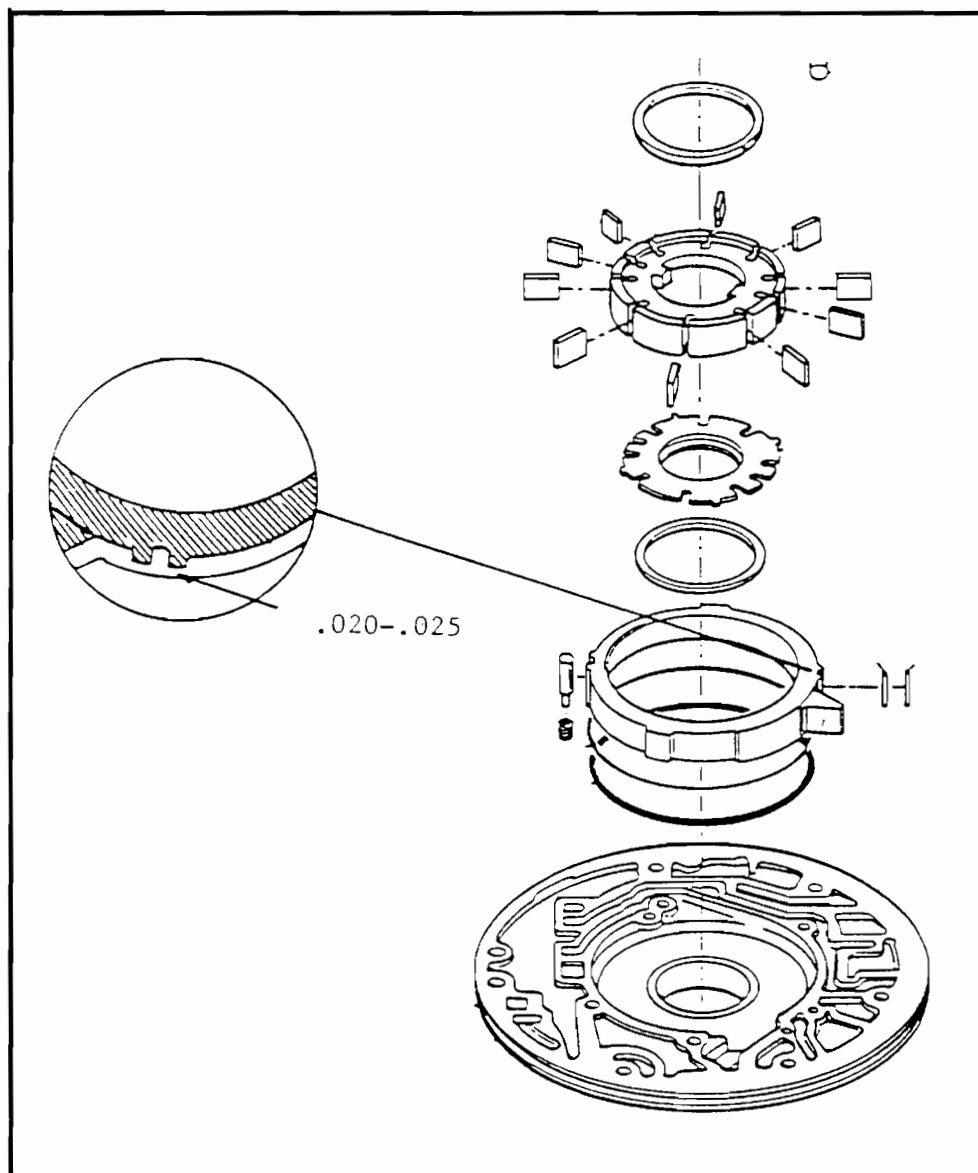
THM 700-R4 PUMP CHANGE

The ten vane rotor and slide can be used in an oil pump body which originally had seven vanes. However, be sure to check for clearance between the slide and the slide pocket where the slide seal and support go. The normal clearance is approximately .025". If the clearance gets much closer than .020" you may run into oil pressure problems. See inset in figure below.

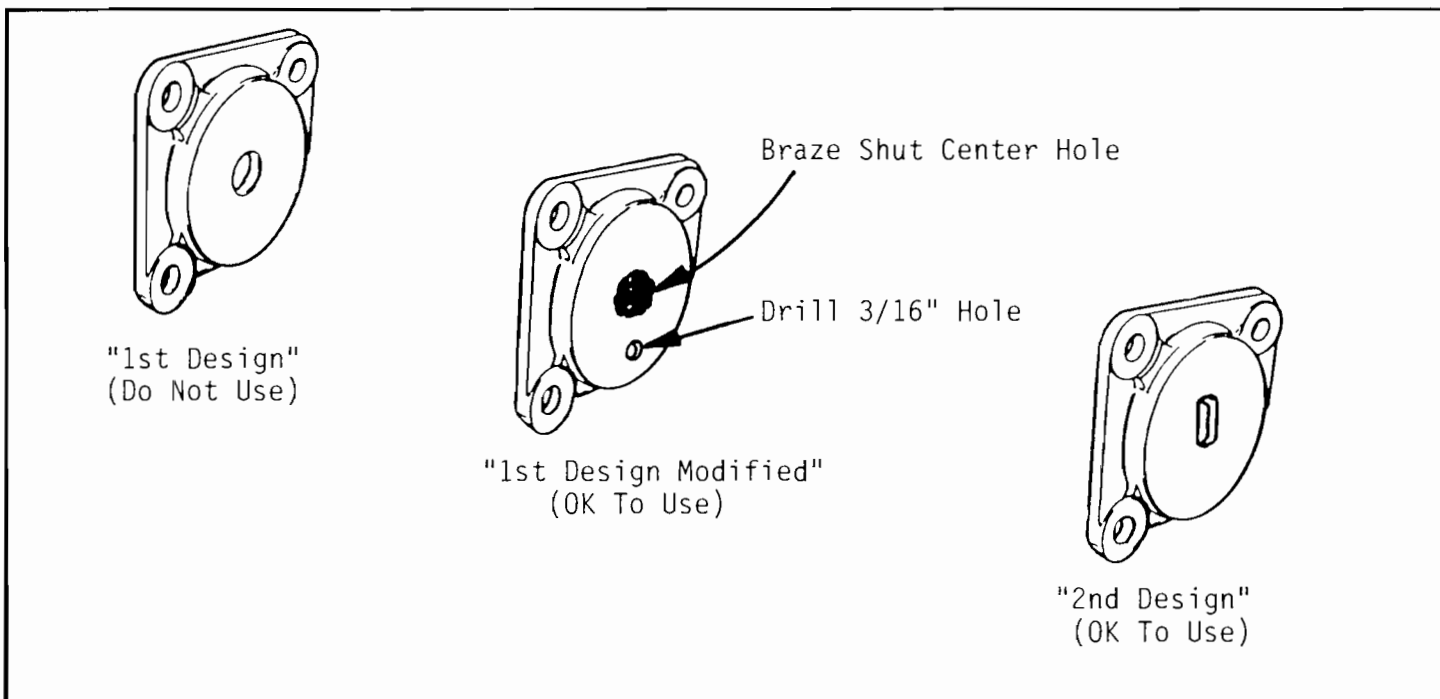
Figure 2

- COMPLAINT: Premature forward clutch failure on 1987 THM 700-R4 with auxilary valve body.
- CAUSE: The cause could be the forward clutch accumulator pin in the auxilary valve body moving out thru the hole in the center of the 1st design accumulator cover, and creating a loss of forward clutch oil. The original press fit of the pin was not sufficient to retain the pin in the auxilary valve body casting.
- CORRECTION: If you have the 1st design cover, braze shut the hole in the center of the cover and drill a 3/16" hole off center. (See Figure 1). The 2nd design cover with the oblong hole in the center is OK to use as is. If the pin has moved out the back side of the auxilary valve body, a simple "staking" process will prevent it from moving that direction again. The 2nd design auxilary valve body casting has a step machined in that area to prevent the pin from moving.

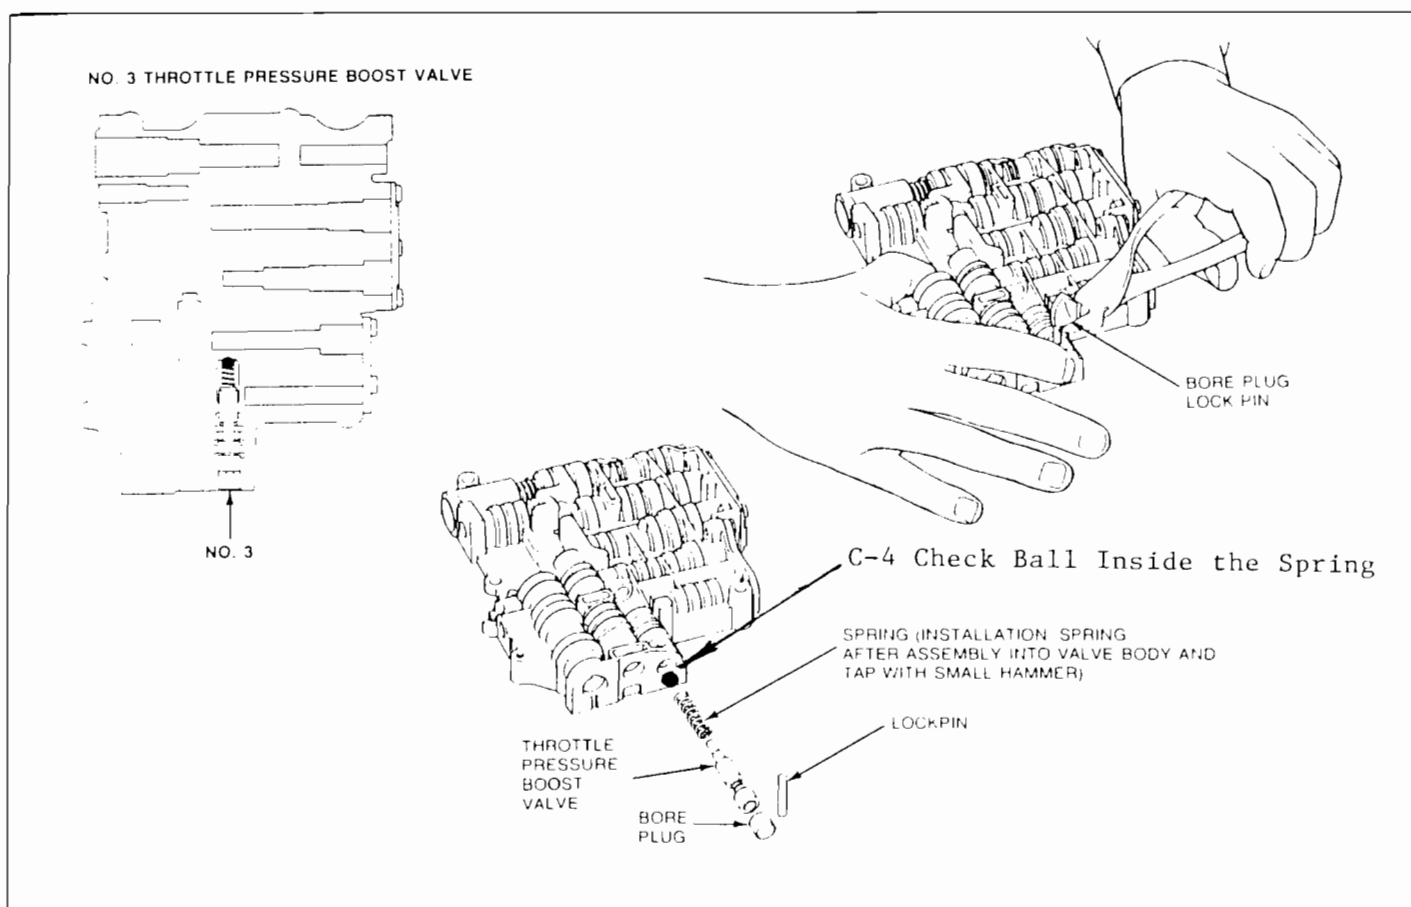
If you know that all of the above are correct, you can block the throttle booster valve by using a C-4 check ball inside the spring as shown below.

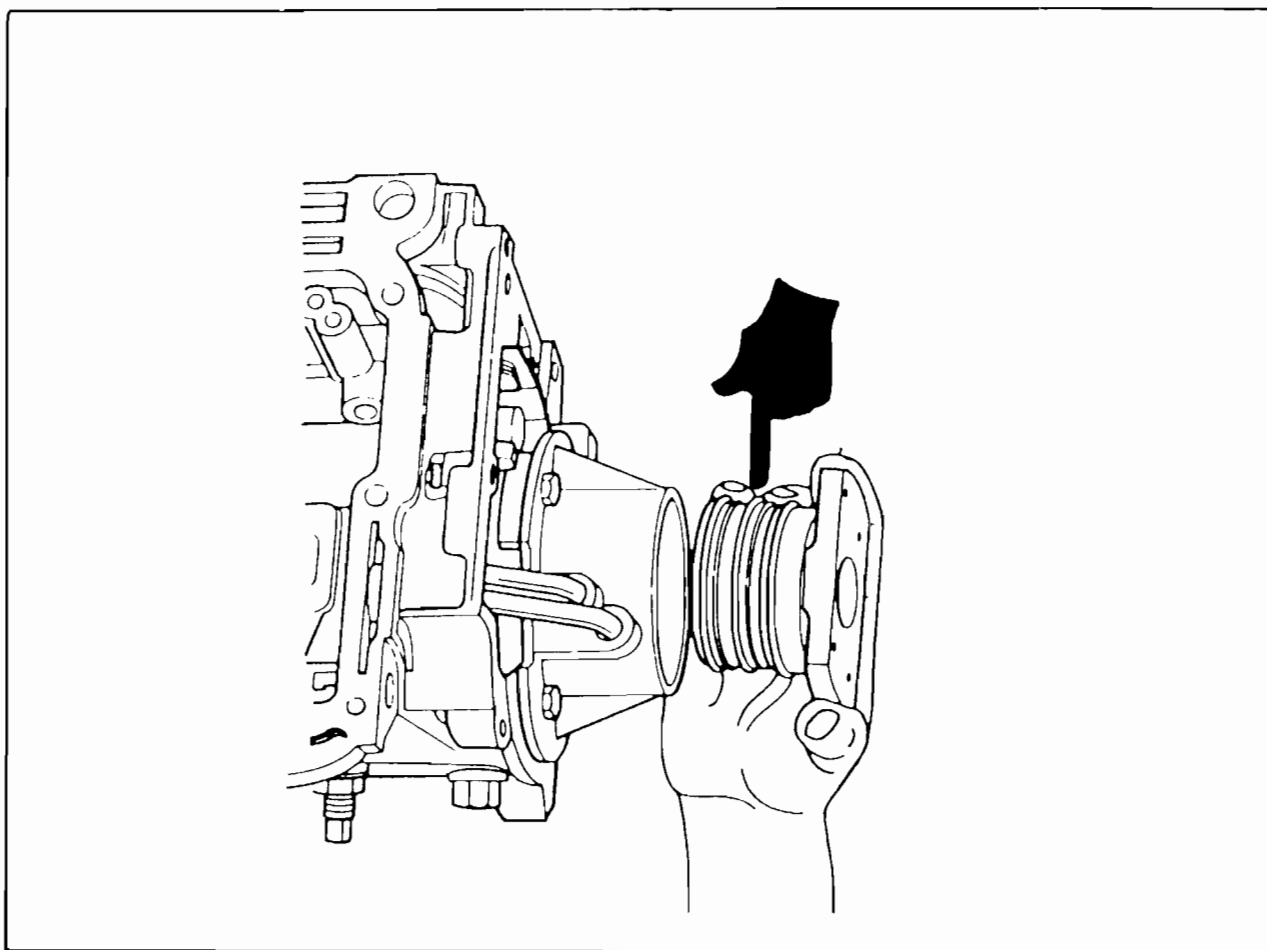
C-4 / C-5 DELAYED ENGAGEMENT

A complaint of delayed engagement in Forward or reverse on C-4 or C-5 transmissions that have just been overhauled, can be caused by a gap in the butt rings used on the governor support. Some replacement rings in overhaul kits have a .012 ring gap. So be sure to check the rings in the case support. There should be no gap greater than .001 to .002.

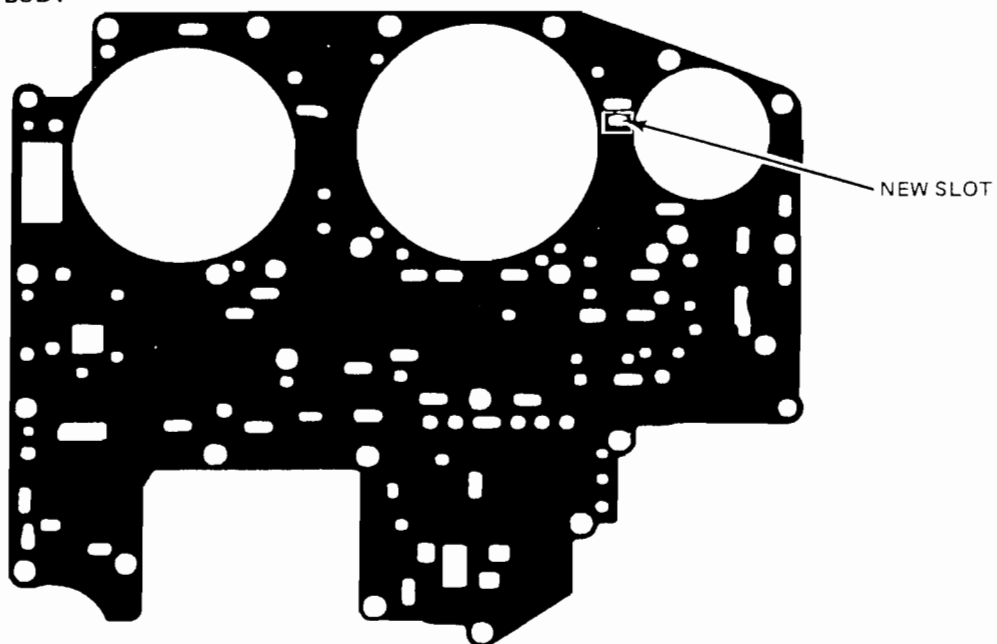
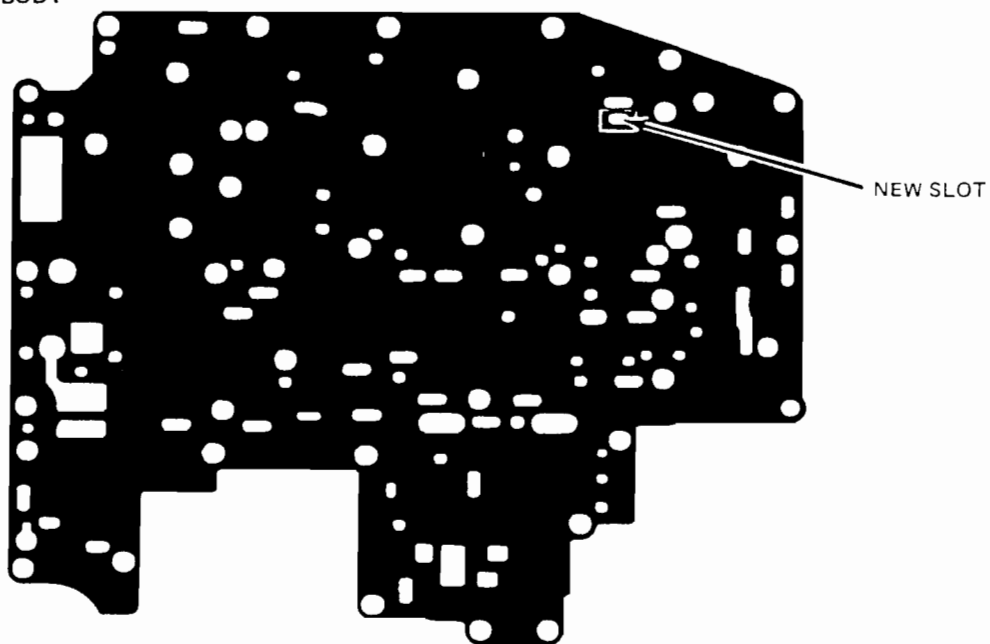
New upper and lower main control valve body gaskets have been released for service. The new gasket has an additional slot, which reduces the chance for contamination of the 3-4 shift valve (refer to Figures 11 and 12). The new gaskets can be used on all AOD main control valve bodies produced for the 1980-86 model years.
