AUTOMATIC TRANSMISSION SERVICE GROUP

SEMINARS '88

TECHNICAL INFORMATION PACKAGE

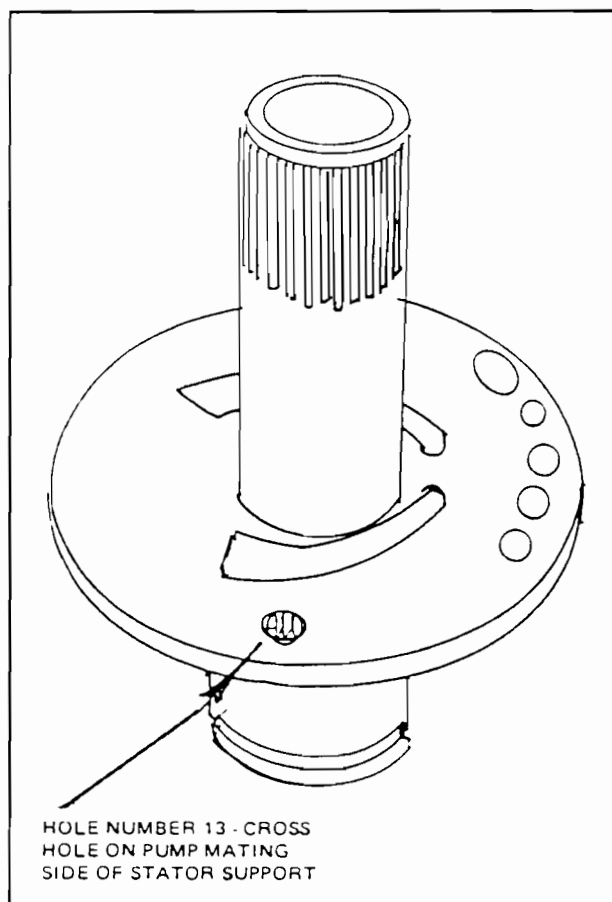
Figure 8 — Article No. 85-11-9

When overhauling a low mileage AOD transmission with evidence of overheating, inspect the converter drainback cross hole passage in the pump stator support for contamination, or a spring compressed solid which would indicate a stuck open check ball. (See Figure 8, Hole No. 13.)

The converter drainback valve in Hole No. 12 of the pump stator support consists of a spring and a ball with an aluminum ball plug pressed in the passage. If contamination can be seen in the exposed cross hole passage area or if the spring is compressed solid which would indicate a stuck open check ball (can be seen when the stator support is turned over — refer to Figure 8, Hole No. 13), then follow the procedure included here for removal and cleaning of the converter drainback valve. In addition, the converter will have to be replaced.

1. To remove the drainback valve (check ball and spring) in Hole No. 12, remove the aluminum ball plug. This can be done by using a suitable punch inserted into the cross Hole No. 13. (See Figure 8.) Discard the aluminum ball plug and the spring. The check ball must be retained for reinstallation.

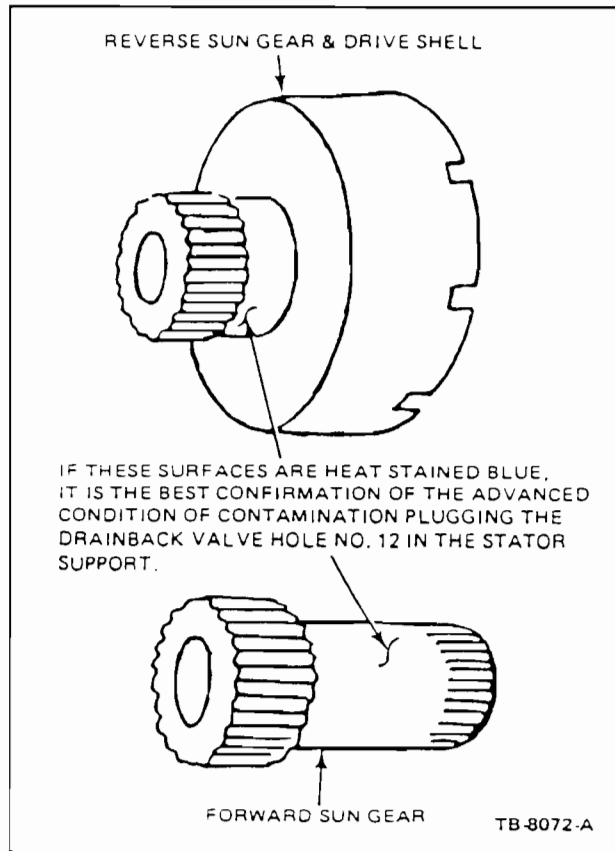
Figure 9 — Article No. 85-11-9

Contamination blocking the converter drainback valve could prevent proper lubrication and result in overheating and malfunction of various transmission components. Any overheating will be indicated by heat stained blue surfaces on the forward sun gear, reverse sun gear and drive shell and the planetary assembly. Refer to Figure 9.

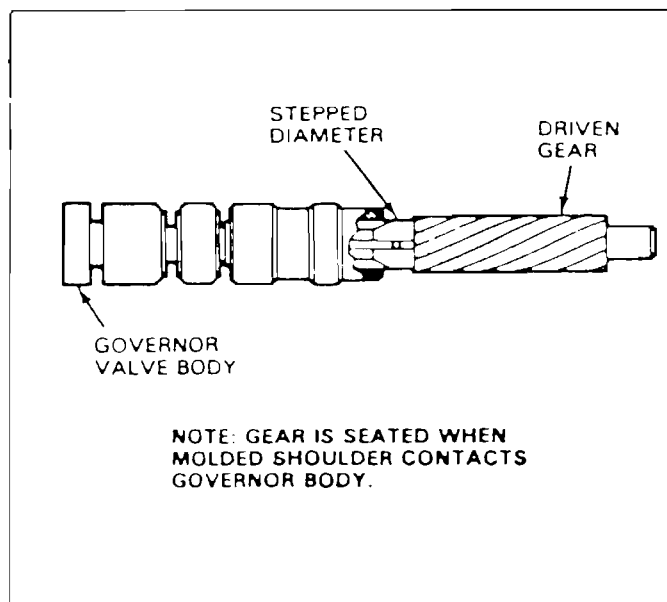
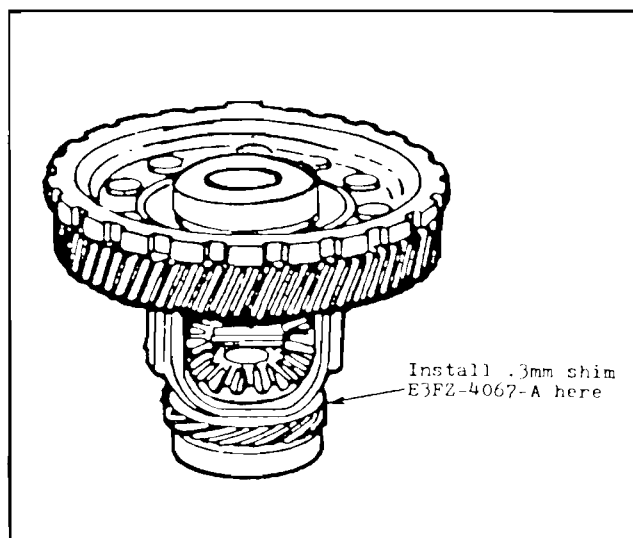
ATX - SPEEDOMETER DRIVE/DRIVEN AND GOVERNOR GEAR DAMAGE WITH BALL BEARING DIFFERENTIAL

Loss of speedometer, speed control, and/or transaxle governor operation or function may be caused from the speedometer drive gear wearing against the differential housing causing gear wear and looseness. This condition will cause speedometer driven gear wear, and a "Hourglass" wear pattern of the governor gear. To service this condition replace the speedometer drive gear on the differential housing (OEM Part No E3FZ-17285-B). Prior to installing the drive gear, install a .3mm shim (E3FZ-4067-A) between the differential and the speedometer drive gear to eliminate repeat repairs. Replace speedometer driven gear and governor gear as required. Refer to ATSG Techtran Manual, Page 92, for differential removal without removing entire transaxle.

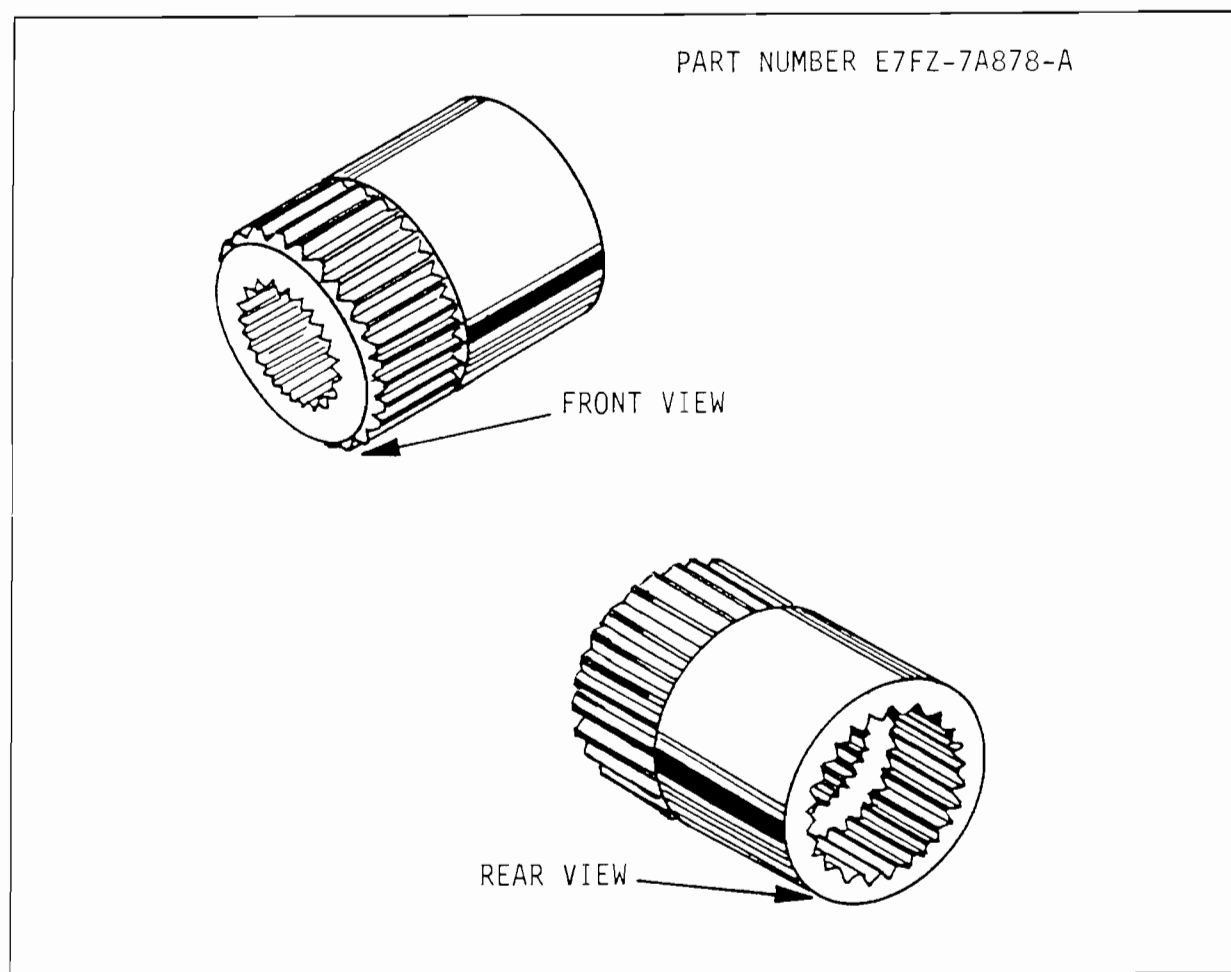
Figure 1

1987-88 Tempo Topaz only use a converter adapter sleeve, Part Number E7FZ-7A878-A. This sleeve has two internal splines and one external spline. (See Figure 1) Since this is a slip on adapter, it can stay engaged in the torque converter turbine hub upon removal of the converter from the transmission. If this adapter IS NOT reinstalled on the transmission (turbine and intermediate shafts), a NO DRIVE CONDITION WILL BE THE COMPLAINT AFTER INSTALLATION. (See Figure 2)

Remove Converter Turbine Sleeve.

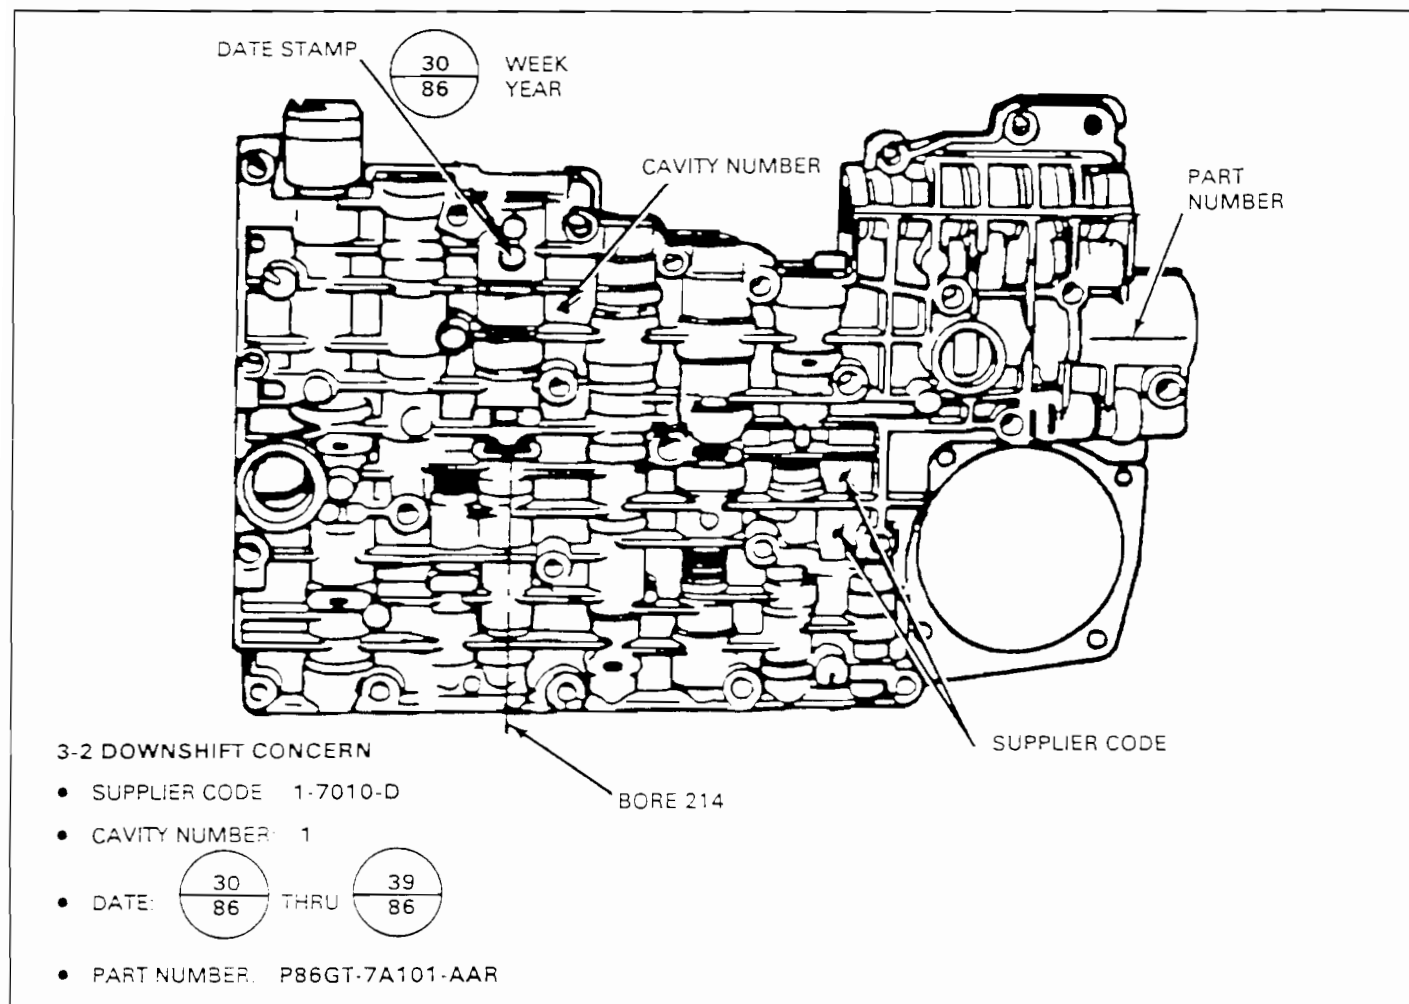
ISSUE: An increase of approximately 1000 engine RPM when downshifting to 2nd gear in Drive or Overdrive during a 3-2 or 4-2 downshift may be caused by a mispositioned channel in the #214 (3-2 kickdown timing valve) bore of the main control casting (see Figure 29). This condition usually occurs within a narrow 3 mph/5 km/h range at a normal speed of 38 mph/61 km/h depending upon axle ratio and tire size.

1. Confirm that increase in engine RPM occurs on downshift by road testing the vehicle.
2. If the transmission build date falls within the July 30-October 1, 1986 time period, remove oil pan to determine casting supplier code, casting date and cavity number (Figure 29).
3. If the main control has the matching identification specified in Figure 29 (Supplier Code 1-7010-D, Cavity No. 1, Build Date 30th Week '86 through 39th Week '86 and Part No. P86GT-7A101-AAR), remove main control using the procedure in Section 17 of the appropriate Shop Manual and repair as follows:
4. Drive vehicle to determine if repair has corrected the concern.

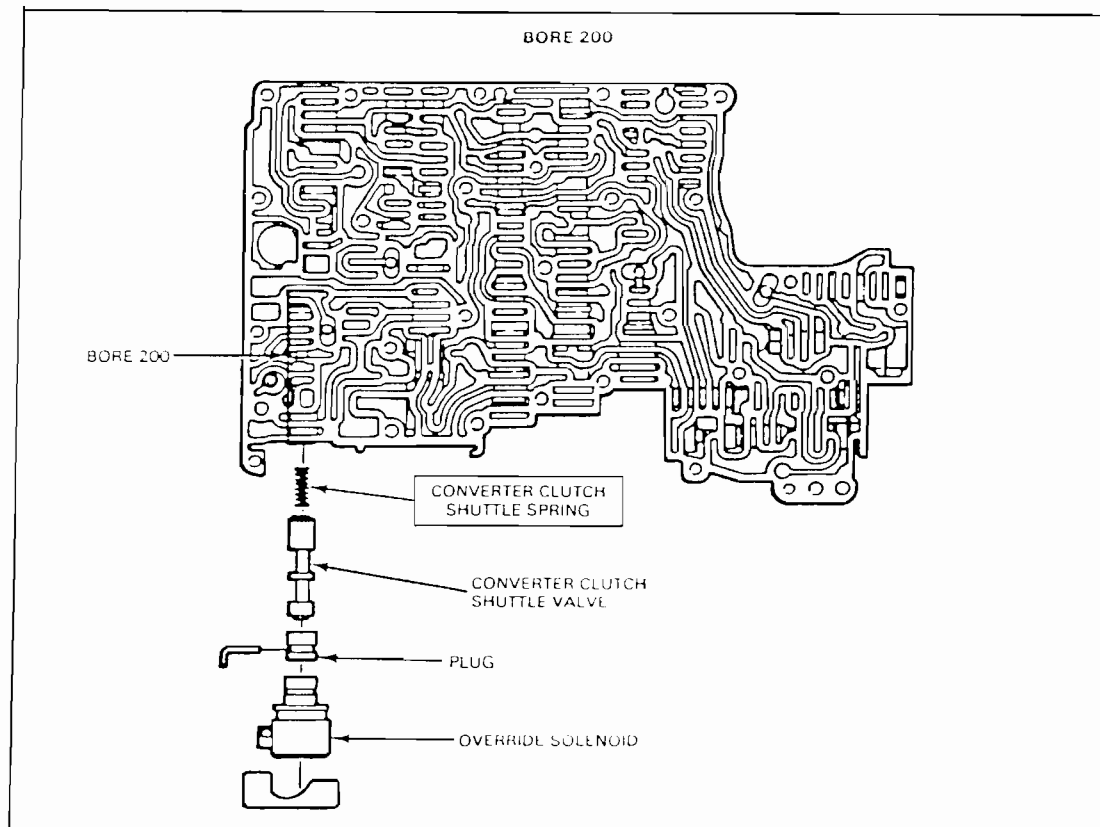
Figure 21

A possible cause of this condition is a broken converter clutch shuttle valve spring. This will allow the shuttle valve to remain in the bottom on its bore thereby continuously applying the piston plate clutch in the torque converter. This provides a mechanical connection between the engine and wheels thus resulting in engine stall when the transmission is engaged.

Refer to the valve body identification illustration in Section 17-08 of the Shop Manual or Figure 21, for the shuttle valve bore location (bore reference number 200). Locate the converter clutch shuttle valve spring. See Figure 21.

Install the separator plate and assemble the valve body into the transmission assembly per the procedure in Section 17-08 of the Shop Manual.

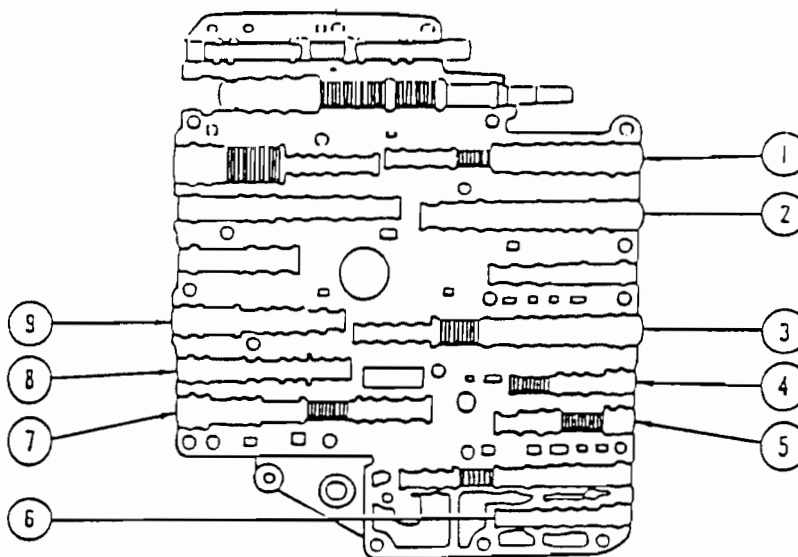
Loss of transmission forward engagement and/or a no downshift condition may be caused by the valve plug retaining clips coming loose and allowing the valves to move out of position. For complaints of this type, use the following procedure to install new valve plug retainers in the nine locations shown in Figure 18.

3. Place a thumb against the valve plug to maintain bore alignment.
4. Using a pic, pry the retainer off the plug and push on the new retainer. Repeat for all nine retainers.
5. Verify check ball locations.
6. Install separator plate and install a new gasket.
7. Install separator plate guide pins, T86P-70100-A or equivalent. (Refer to Taurus/Sable Shop Manual, Section 17-15-96 for guide pin locations).
8. Install Torx® bolts and tighten to 9-12 Nm (7-9 lbs.-ft.).

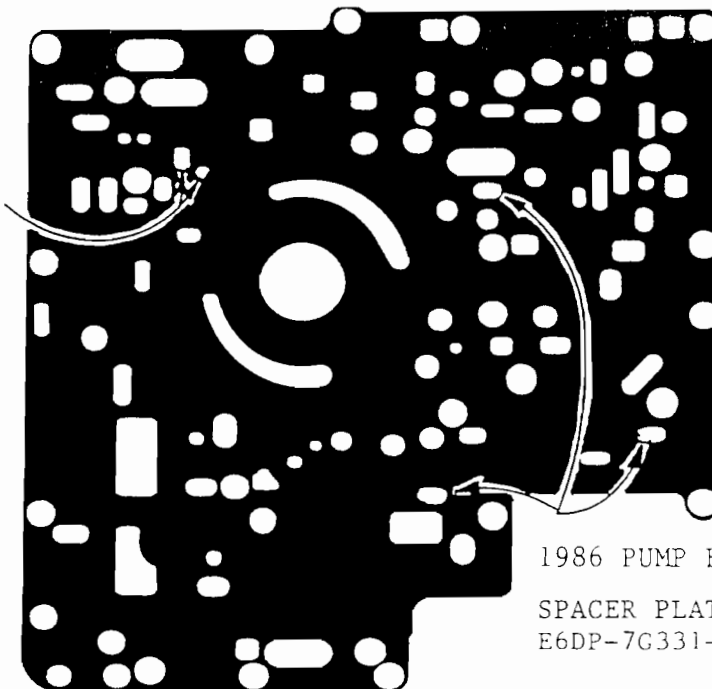
1986 PUMP BODY TO
SPACER PLATE
E6DP-7G331-AA

A MIS-MATCH OF THESE GASKETS CAN CAUSE A SLIP, A DELAYED ENGAGEMENT OR A 1-2 SLIDE BUMP.

NOTE; 5 HOLES HAVE BEEN ELIMINATED IN THE 1987 GASKET

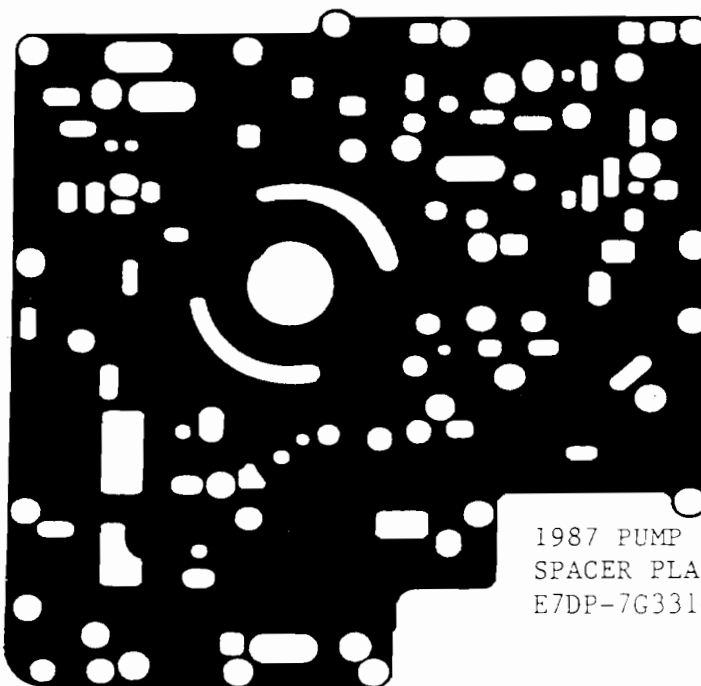
1987 PUMP BODY TO
SPACER PLATE
E7DP-7G331-AA

IMPORTANT- THE 1986 GASKETS WILL NOT FIT THE 1987 UNITS. NOR WILL THE 1987 GASKETS FIT THE 1986 UNITS.

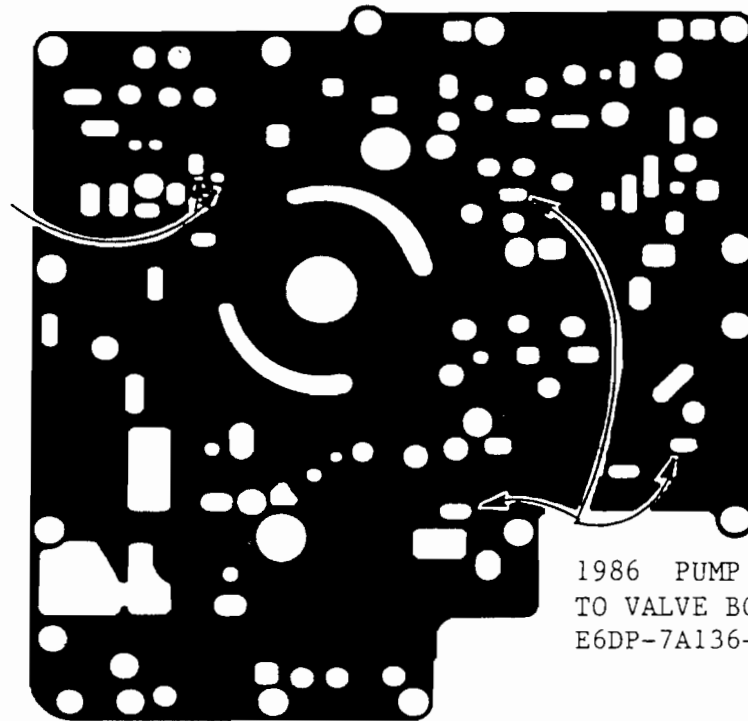
1986 PUMP SPACER PLATE
TO VALVE BODY
E6DP-7A136-AA

NOTE: 5 HOLES HAVE BEEN ELIMINATED IN THE 1987 GASKET

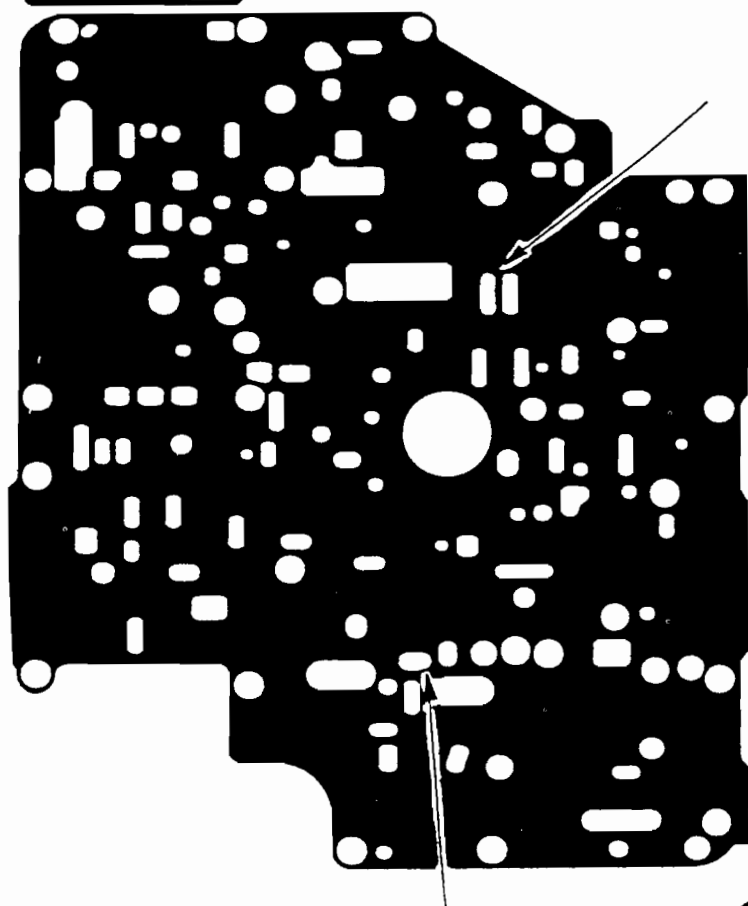
1987 VALVE BODY TO SPACER
PLATE GASKET E7DP-7D100-AA

NOTE: THESE THREE HOLES
ADDED TO THE 1987 GASKET

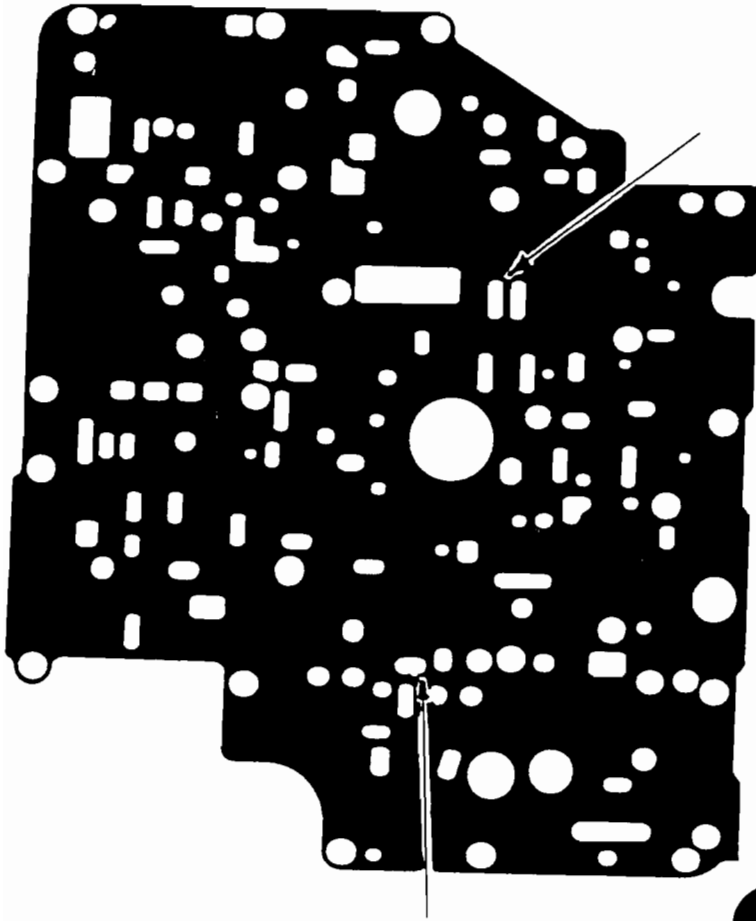
1986 SPACER PLATE TO
CHAIN COVER E6DP-7C155-AA

NOTE: THESE THREE SLOTS
ELIMINATED IN 1987 GASKETS

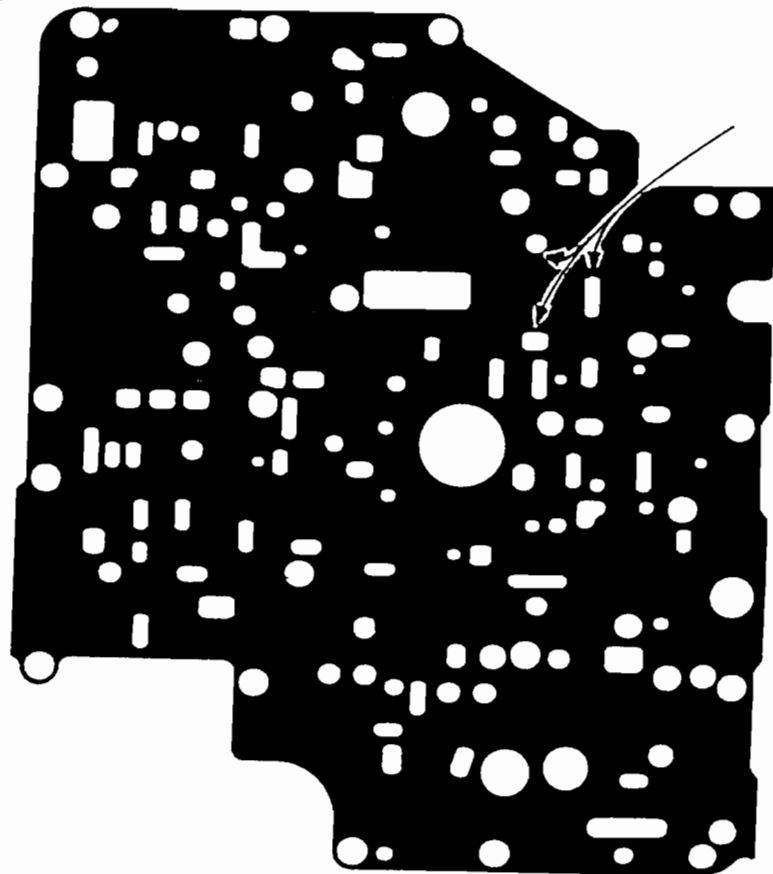
1987 SPACER PLATE TO
CHAIN COVER E7DP-7C155-AA

NOTE: THESE THREE HOLES
ADDED TO THE 1987 GASKET

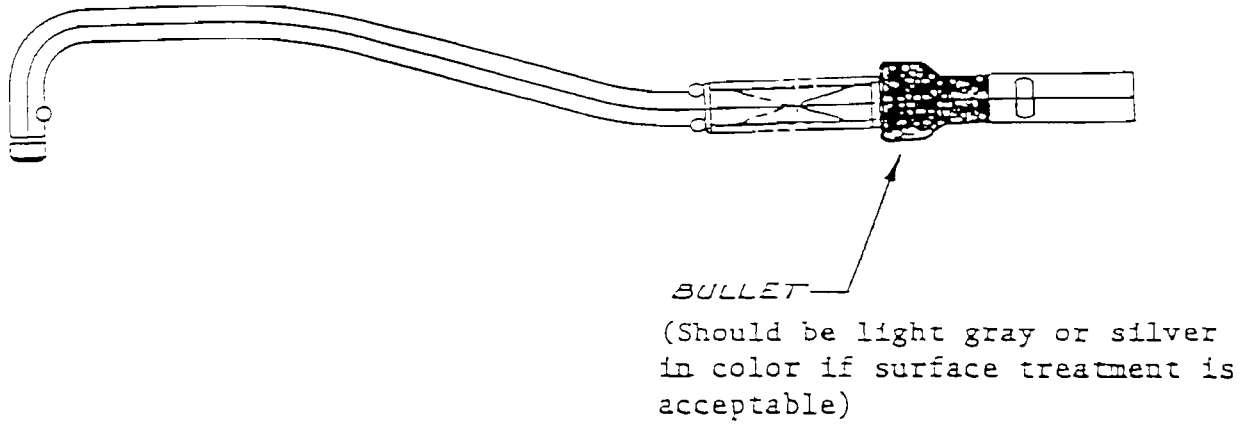
Figure 3

Inspect shift cable and linkage for proper routing and adjustment. If routing and adjustment are proper, the condition may be due to improper surface finish of the bullet end of the park sprag rod (Figure 3).

NOTE: Only transaxles built between 12-2-81 and 7-12-82 with serial numbers 7432-XXXX to 7654-XXXX are suspect for this condition.

1. Remove the transaxle oil pan.
2. Remove the "E" clip retaining the park sprag rod to the valve body (Figure 4).
3. Remove the park sprag rod from the transaxle assembly and inspect the bullet end of the rod. If the bullet end surface is dark blue or black, replace the park rod assembly with PN 4207130 containing a bullet that is silver or light gray in color.
4. Reinstall "E" clip, install the transaxle oil pan, and refill with automatic transmission fluid.

NOTE: The manual shift lever (at the transmission) may have been bent if the vehicle operator has attempted to force a transmission with an improperly finished rod out of the park position. Therefore, after replacing the park sprag rod, check the shift lever and replace if lever is bent.
