# Technical Service Information

## HONDA/ACURA BAXA/B7XA FAMILY TIE UP IN REVERSE WHEN HOT

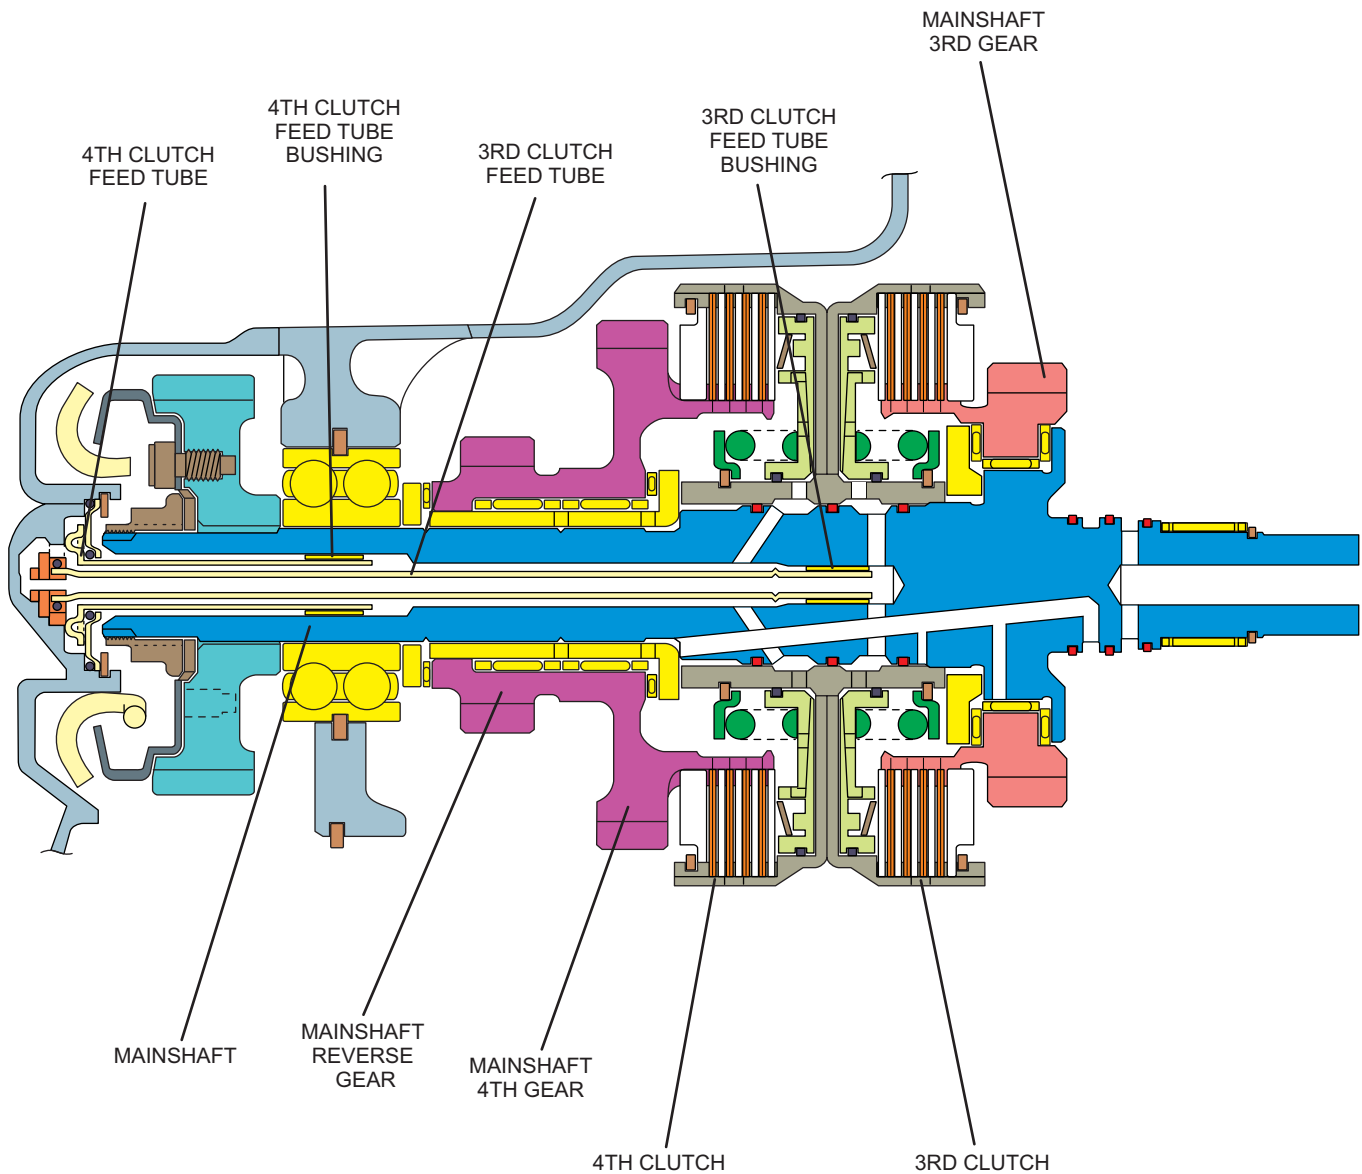
Figure 1

The partial cutaway drawing in figure 1 shows the parts associated with the main shaft including the tubes, bushings, gears, and clutch drum. Refer to the partial cutaway drawing in figure 2. This diagram shows the area of concern within the mainshaft where the cross over leak may occur.

## HONDA/ACURA BAXA/B7XA FAMILY PARTIAL CUTAWAY MAINSHAFT PARTS
