Technical Service Information

VOLVO 50-40LE/50-42LE NO REVERSE, 1ST OR 4TH GEAR

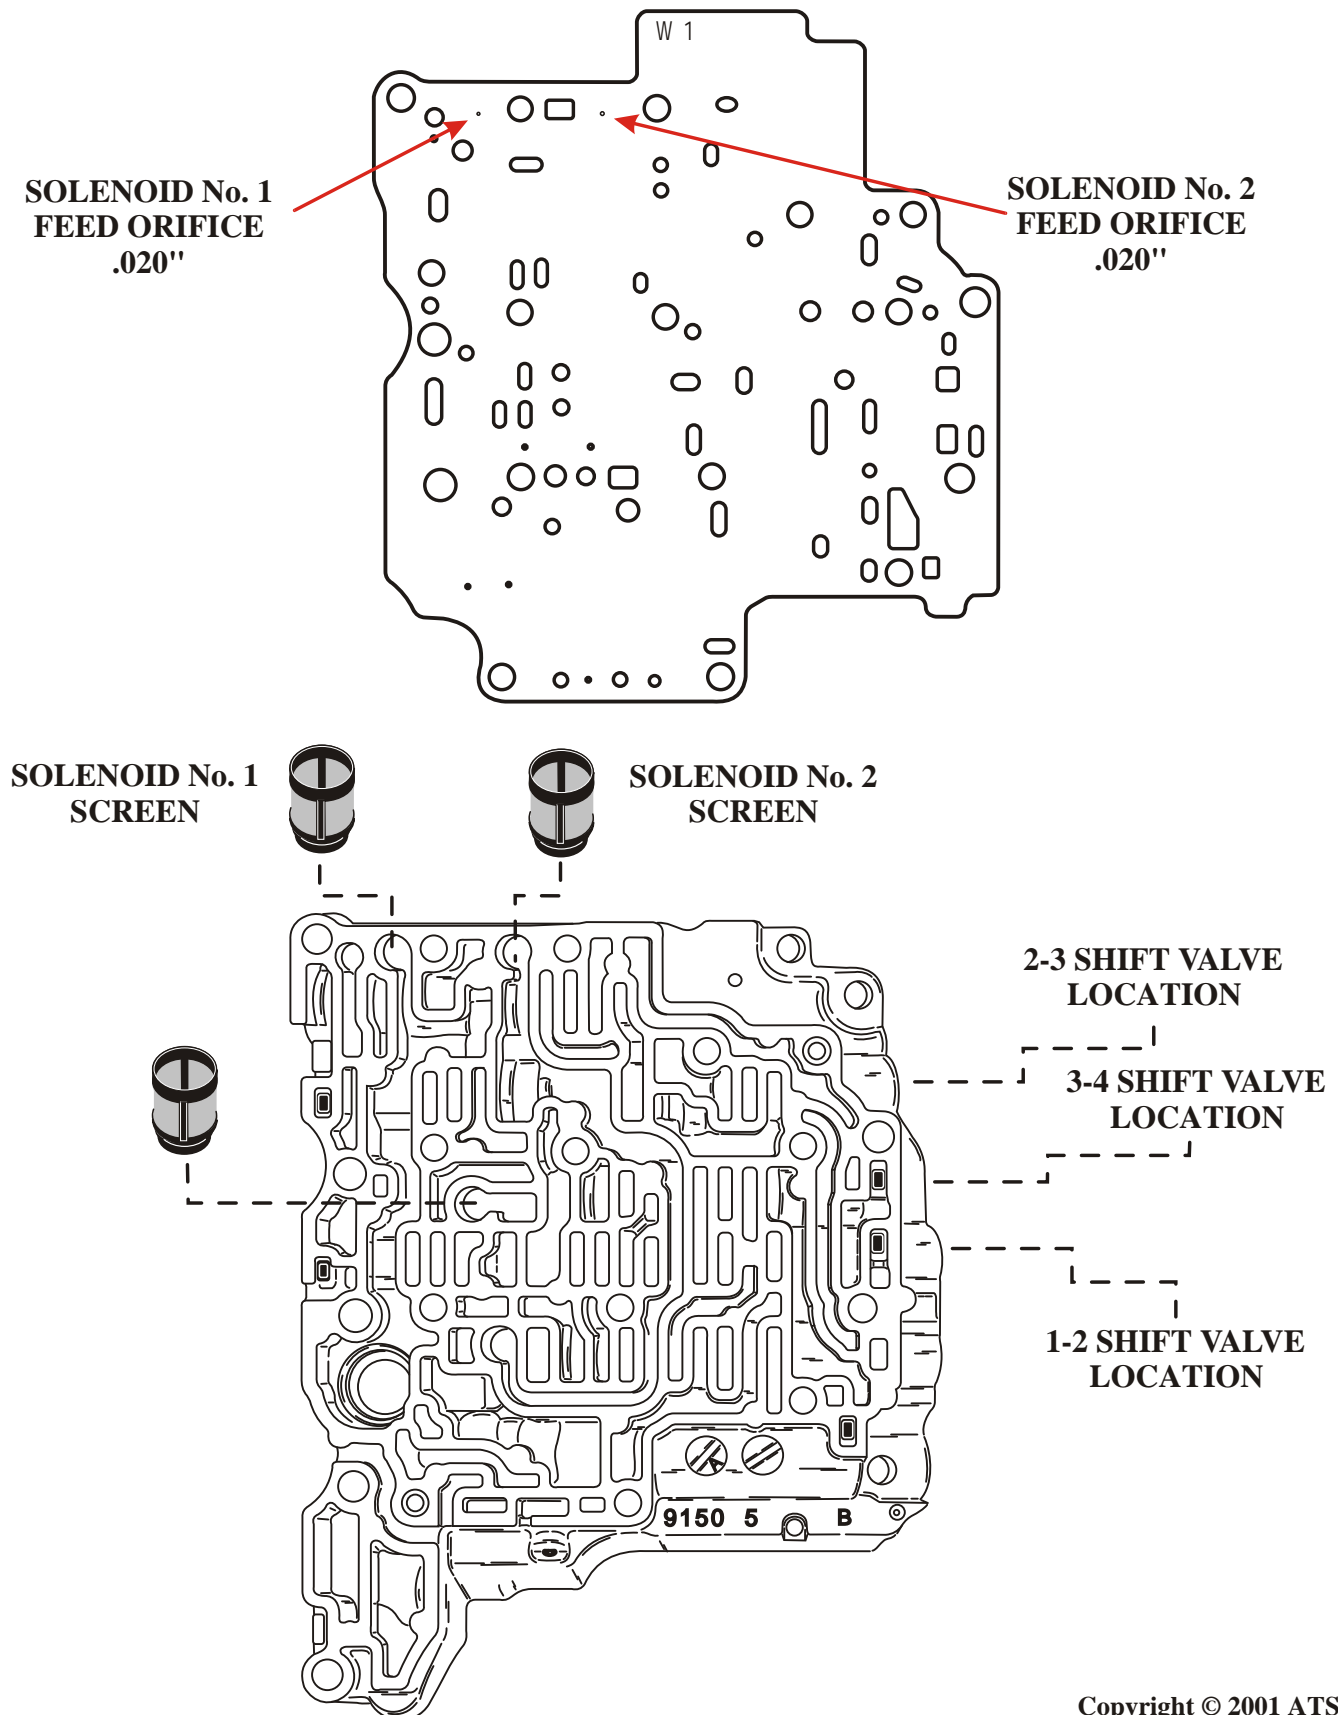
Figure 3

CENTER VALVE BODY AND SPACER PLATE

CORRECTION: Follow the corrections listed below:
1. Assemble the solenoid screens as shown in Figure 3.
2. Check the Shift Solenoids mechanically as shown in Figure 4 and replace as necessary.
