# **THE SEMINAR WITH MORE IN '94**

AUTOMATIC TRANSMISSION SERVICE GROUP  
9200 S. DADELAND BLVD. STE 720  
MIAMI, FLORIDA 33156  
(305) 670-4161

# TRANSMISSION SEMINAR 1994

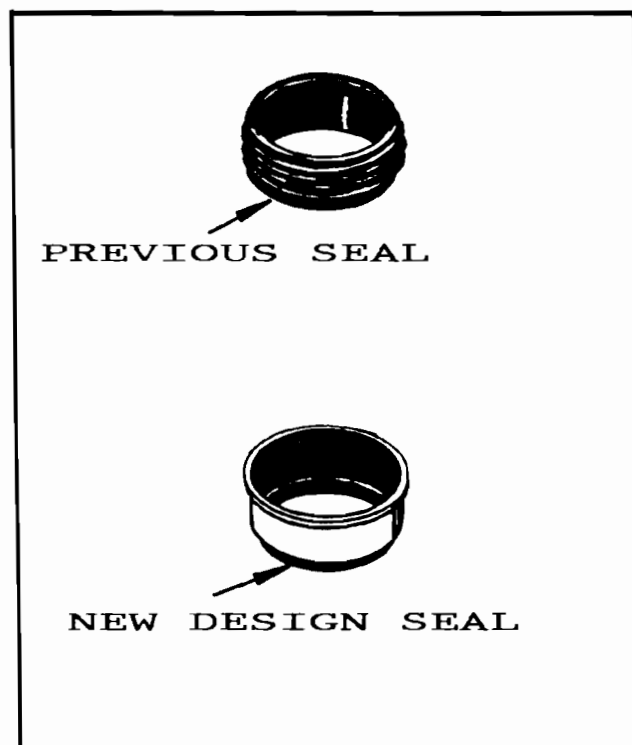
There is now in production a new design filter seal that should be used on every rebuild process. The new design seal is a metal clad filter seal made like the 440 filter seal but, different dimensions. Both the previous seal and new design seal are shown in Figure 8 below.

ALWAYS USE THE NEW DESIGN FILTER SEAL!

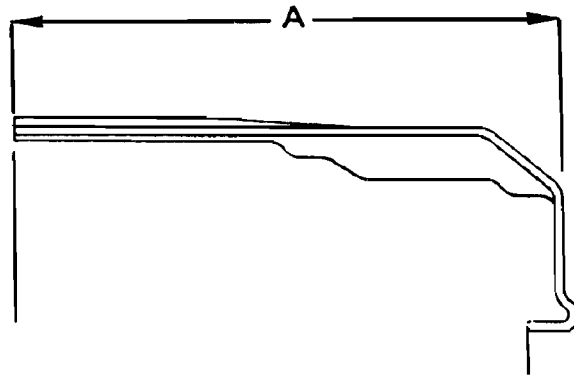
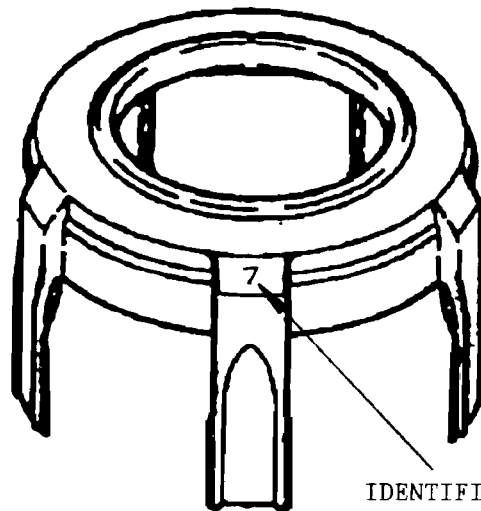
Figure 11

DIMENSION "A" ON NEW DESIGN IS 3.671"-3.682" (93.26mm-93.52mm).

IDENTIFICATION FOR NEW DESIGN IS  
NUMBER "7" STAMPED ON ONE LEG.

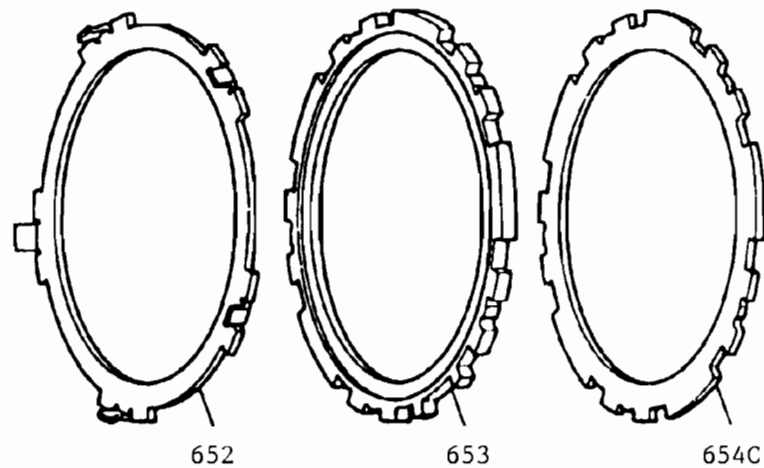
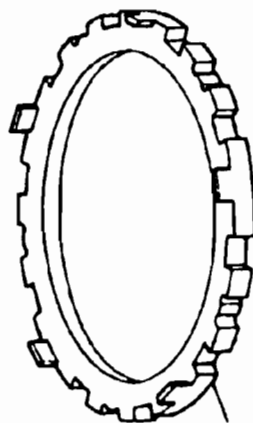
Figure 12

- (2) 3-4 CLUTCH RETAINER RING - Eliminated (See Figure 12).
- (3) 3-4 CLUTCH STEPPED APPLY PLATE - Eliminated (See Figure 12).
- (4) 3-4 CLUTCH APPLY PLATE - Eliminated (See Figure 12).

NEW DESIGN 3-4 APPLY PLATE REPLACES  
ALL THREE OF THE PIECES ABOVE.

- (5) 3-4 CLUTCH APPLY PLATE NEW - There is now a new design apply plate to replace the three pieces above that were eliminated (See Figure 12). This change was also to accomodate the thicker 3-4 steel plates.

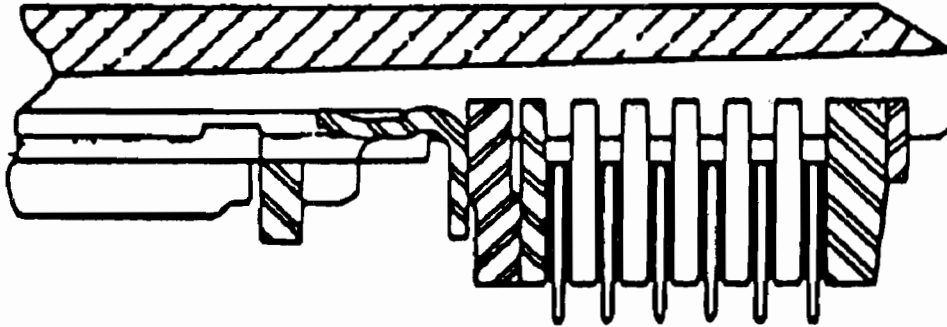
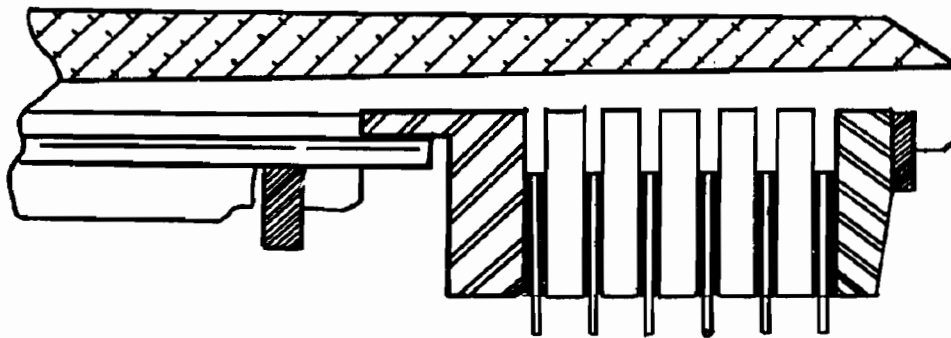
Figure 15

- (1) None of the components listed above are compatable with the previous components in the 3-4 clutch pack (See Figure 15).
- (2) The new 3-4 clutch pack will retro-fit back to all previous models but **MUST** be replaced as a package. Service package part numbers are listed below. There are two different part numbers because the "Lined" plates are included in the service packages and the lined plates are calibration sensitive on the different models.

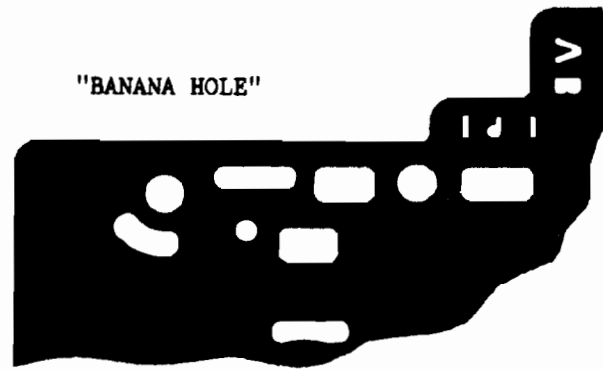
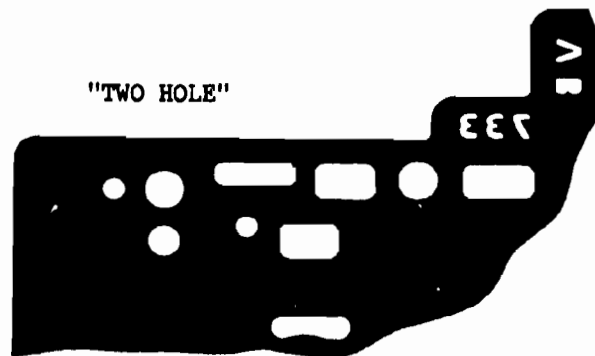
Figure 26

- (1) TRANSMISSION CASE - Oil dam added in the torque signal circuit in the location shown in Figure 24, to orifice torque signal oil thru the revised spacer plate to the boost valve in the pump.
- (2) VALVE BODY SPACER PLATE - The "Banana Hole" in the previous spacer plate was eliminated, with a round feed hole and orifice hole added on each side of the new dam in the case to make orifice effective (See Figure 25).
- (3) SPACER PLATE GASKETS - Revised hole configuration to accomodate the new spacer plate and case, as shown in Figure 26.

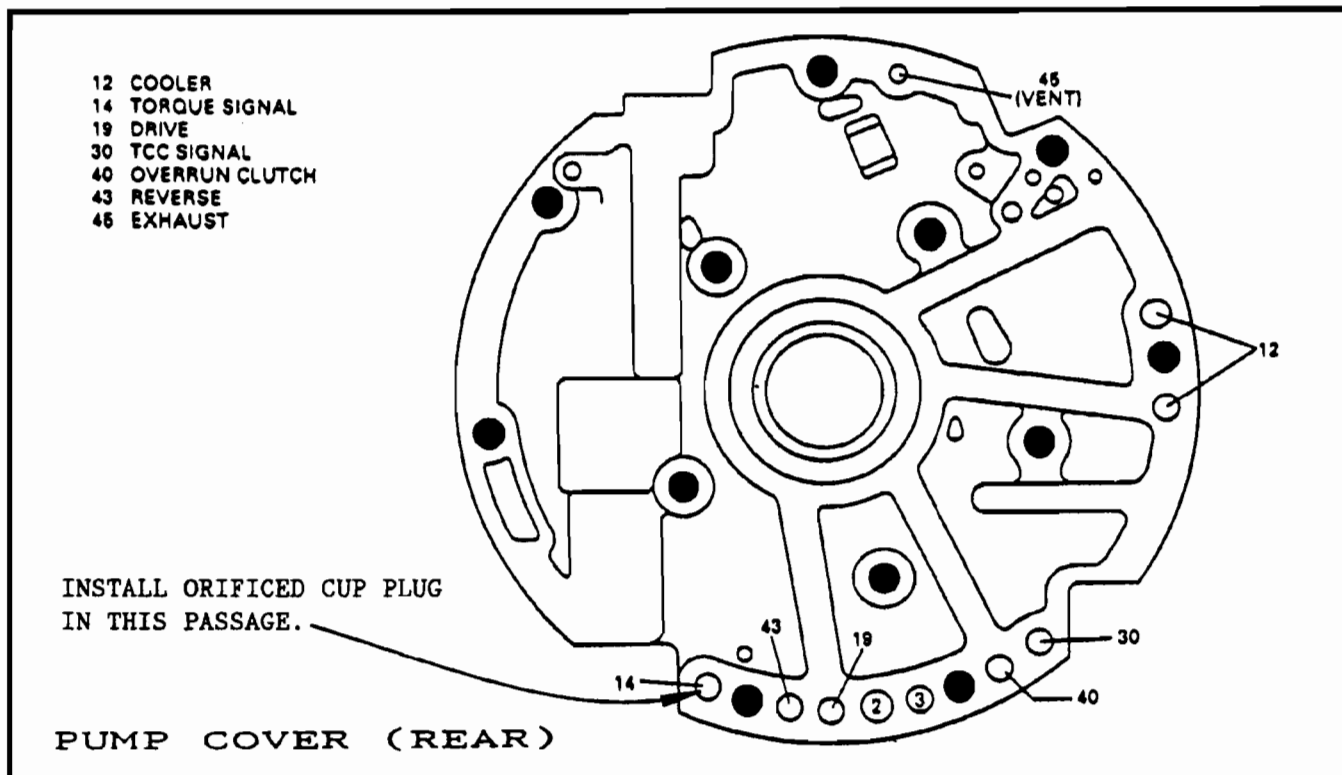
Figure 27

**CAUSE:** The cause may be line pressure instability in the pressure regulator valve line-up located in the pump cover.

Install a 9/32" diameter cup plug, with a .075" orifice hole drilled into the center of the cup plug, into the torque signal oil passage of the pump cover as shown in Figure 27.

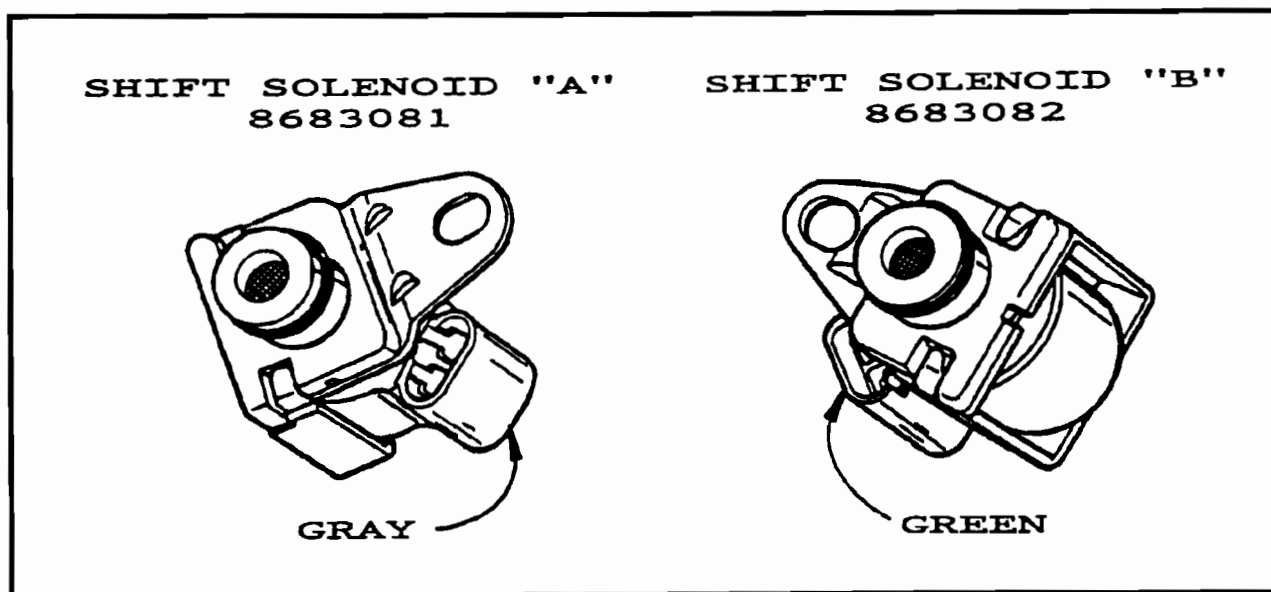
Figure 31

- (1) SHIFT SOLENOID "A" - Revised to incorporate reversible diaphragm, increased coil wire size, and inlet filter screen within the solenoid. Shift Solenoid "A" is now GRAY in color, instead of the previous Blue (See Figure 31).
- (2) SHIFT SOLENOID "B" - Revised to incorporate reversible diaphragm, increased coil wire size, and inlet filter screen within the solenoid. Shift Solenoid "B" is now GREEN in color, instead of the previous Red (See Figure 31).

Shift Solenoid "A" (GRAY) .....	8683081
Shift Solenoid "B" (GREEN) .....	8683082

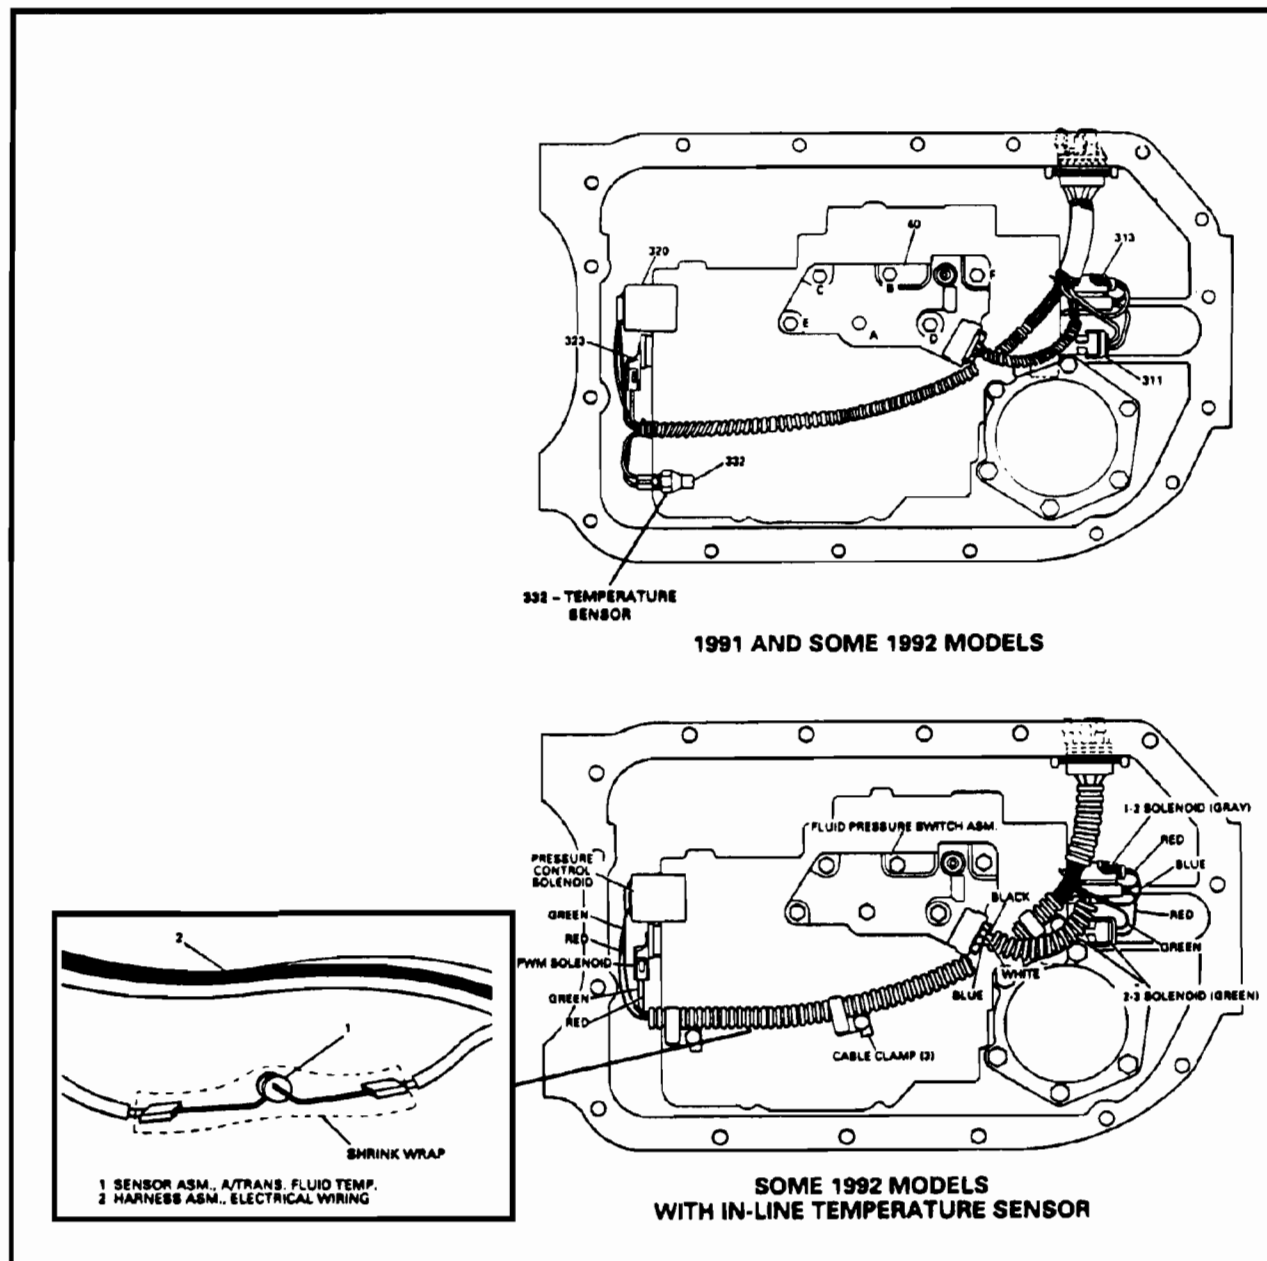
Figure 32

Some 1992 model THM 4L80-E/4L80-EHD transmissions are now equipped with a new Transmission Oil Temperature (TOT) sensor incorporated within the transmission wiring harness as shown in Figure 32, and replaces the TOT sensor that screwed into the valve body on previous models.

OEM part number for the revised wiring harness is 8686985, and will retro-fit back on all models. Leave the old TOT sensor in valve body as a plug.

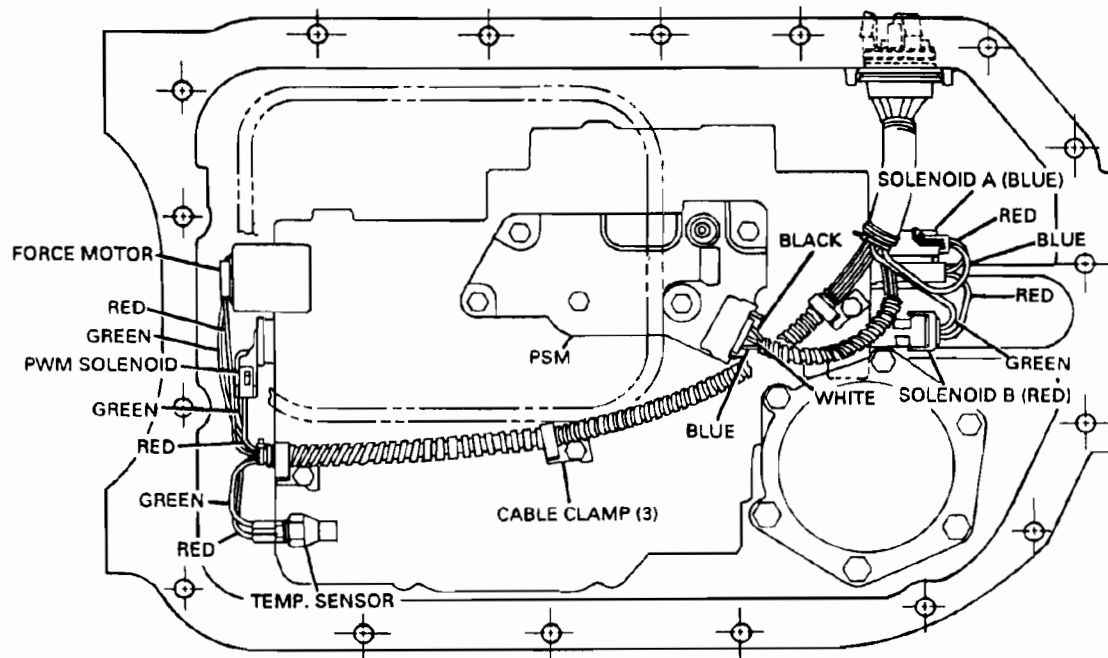
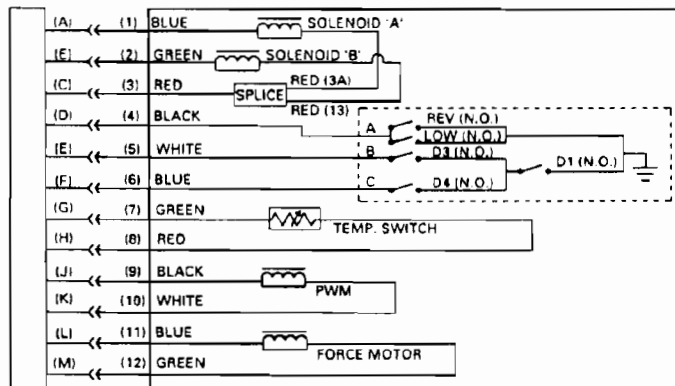
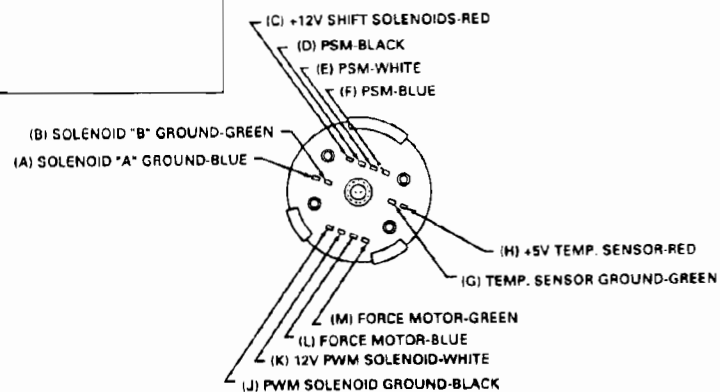
Figure 33  
AUTOMATIC TRANSMISSION SERVICE GROUP

- (1) CASE CONNECTOR AND INTERNAL WIRING HARNESS - Now has a much more durable case connector and also REVISED pin locations.  
REFER TO FIGURE 33 FOR PREVIOUS TRANSMISSION CASE CONNECTOR.  
REFER TO FIGURE 34 FOR NEW DESIGN TRANSMISSION CASE CONNECTOR.
- (2) EXTERNAL VEHICLE HARNESS CONNECTOR - Changed to accomodate the new design transmission case connector and also REVISED cavity locations.  
REFER TO FIGURE 35 FOR NEW DESIGN VEHICLE HARNESS CONNECTOR.

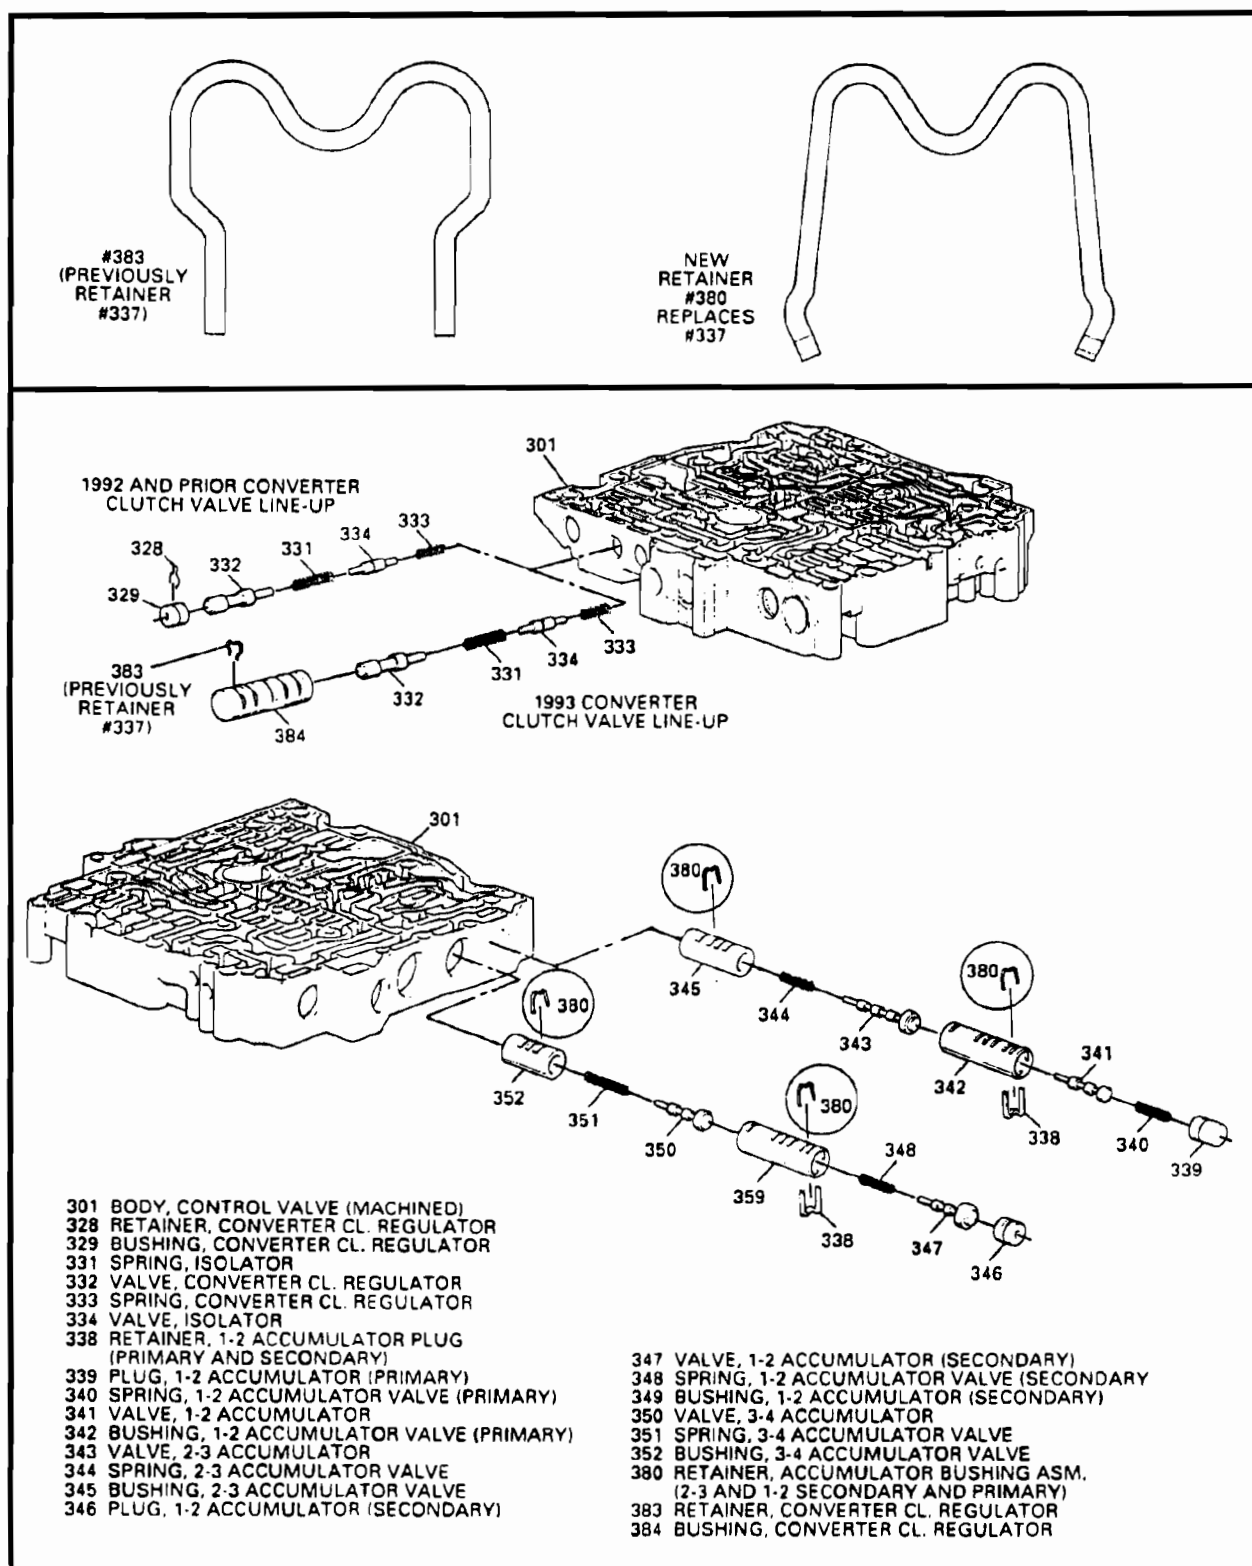
Figure 37

- (1) **VALVE BODY CASTING** - The aluminum plug and retainer clip for the converter clutch regulator valve were eliminated and replaced with a new bushing and a new style retainer. This makes it much easier to remove this line-up out of its valve body bore (See Figure 37).  
The 1-2 accumulator valve bushing (Both Primary and Secondary). The 2-3 accumulator valve bushing, and the 3-4 accumulator valve bushing were also re-designed for improved shift feel.  
These changes required changes in the worm tracks in the valve body casting, and the easiest way to identify the 1993 valve body is the diameter of the TCC regulator valve bore, as shown in Figure 38.

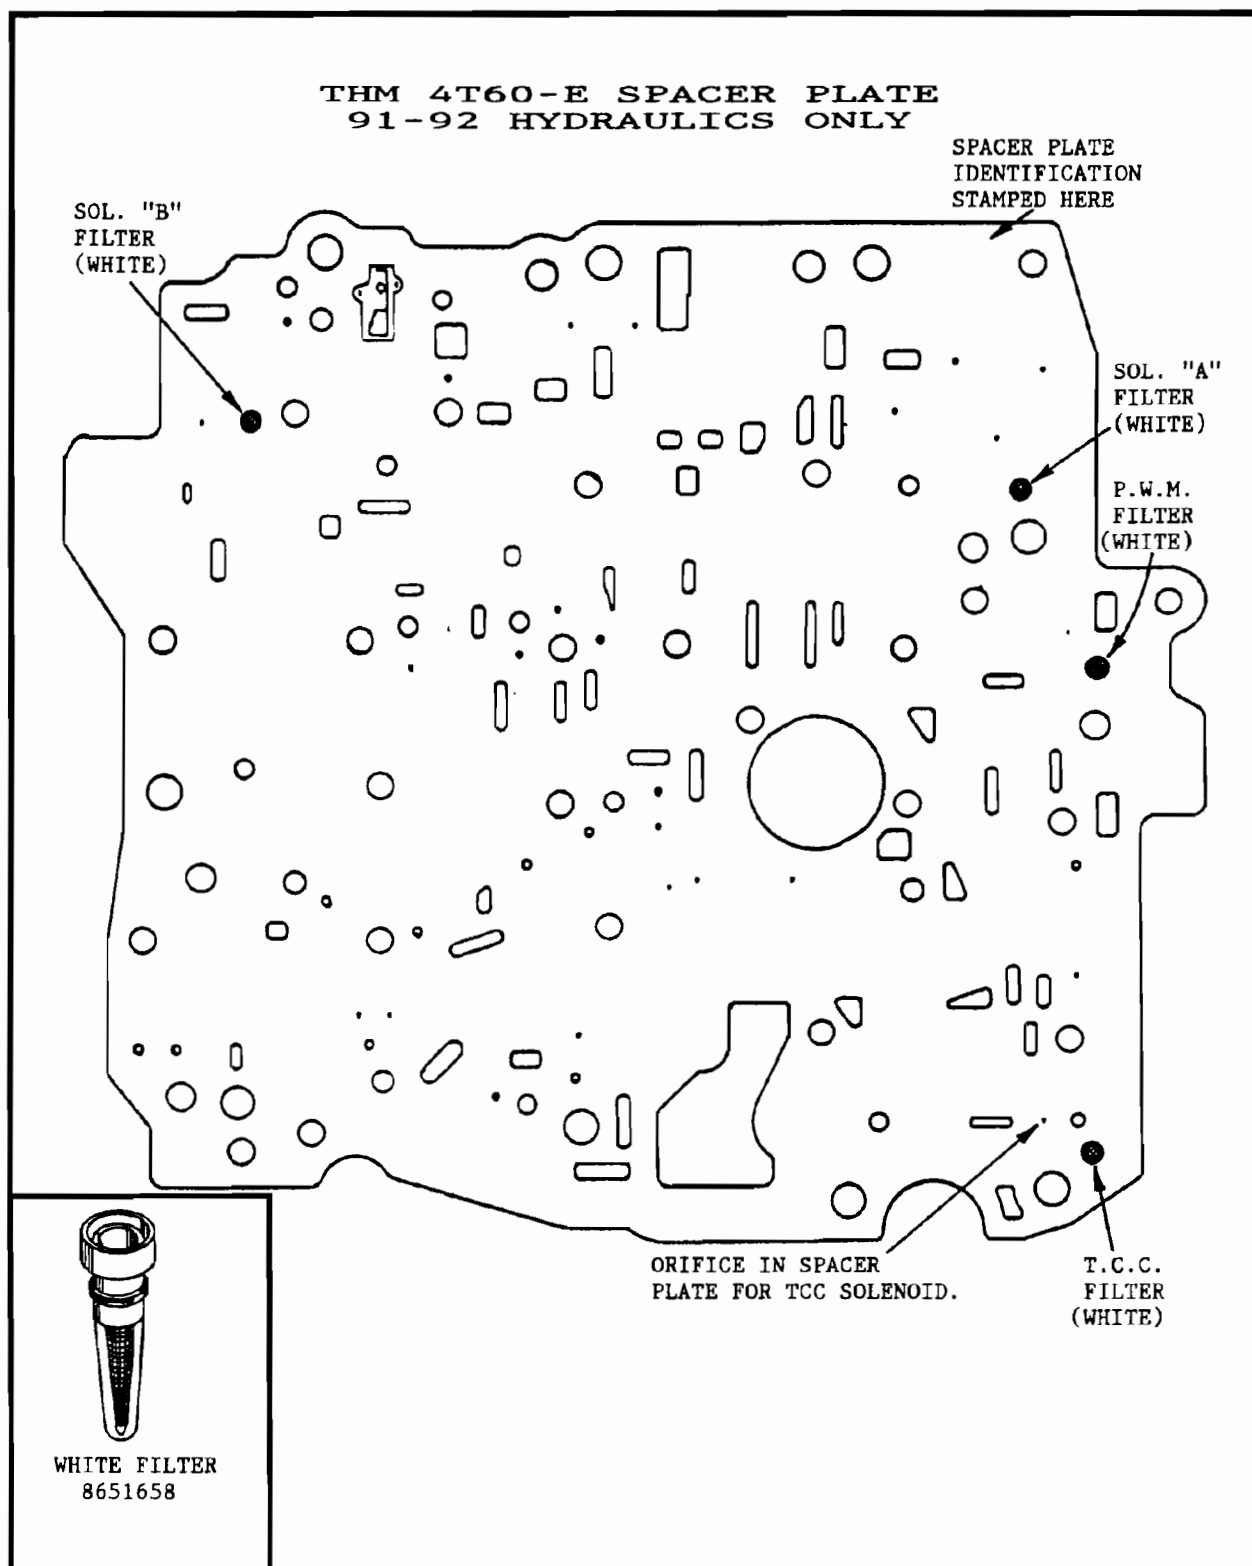
Figure 39

- (2) **VALVE BODY SPACER PLATE** - Different hole spacing to accommodate the valve body and channel plate casting changes. Also the 91-92 hydraulics spacer plate has the TCC solenoid orifice in the spacer plate, and the 1993 hydraulics requires the screen and orifice assembly, with the "O" ring, that we seen in the THM 440-T4 transaxle (See Figures 39 and 40).

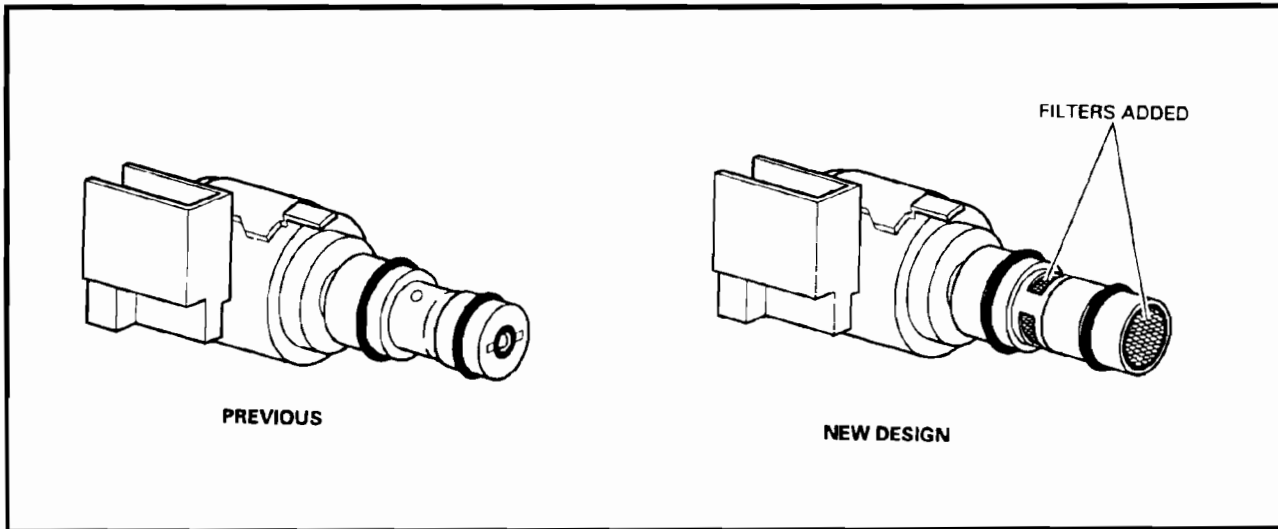
Figure 45

**CORRECTION:** Replace the Pulse Width Modulated (PWM) Solenoid with OEM part number 8683535. This is the new design solenoid, in which screens were added to the solenoid control and feed passages (See Figure 45). The PWM spacer plate filter has also been eliminated on the later models that use the new design PWM Solenoid (See Figure 46). The new design PWM Solenoid with screens added should be installed on all rebuilds to prevent contamination. It is not necessary to remove spacer plate filter when installing the new design PWM Solenoid.

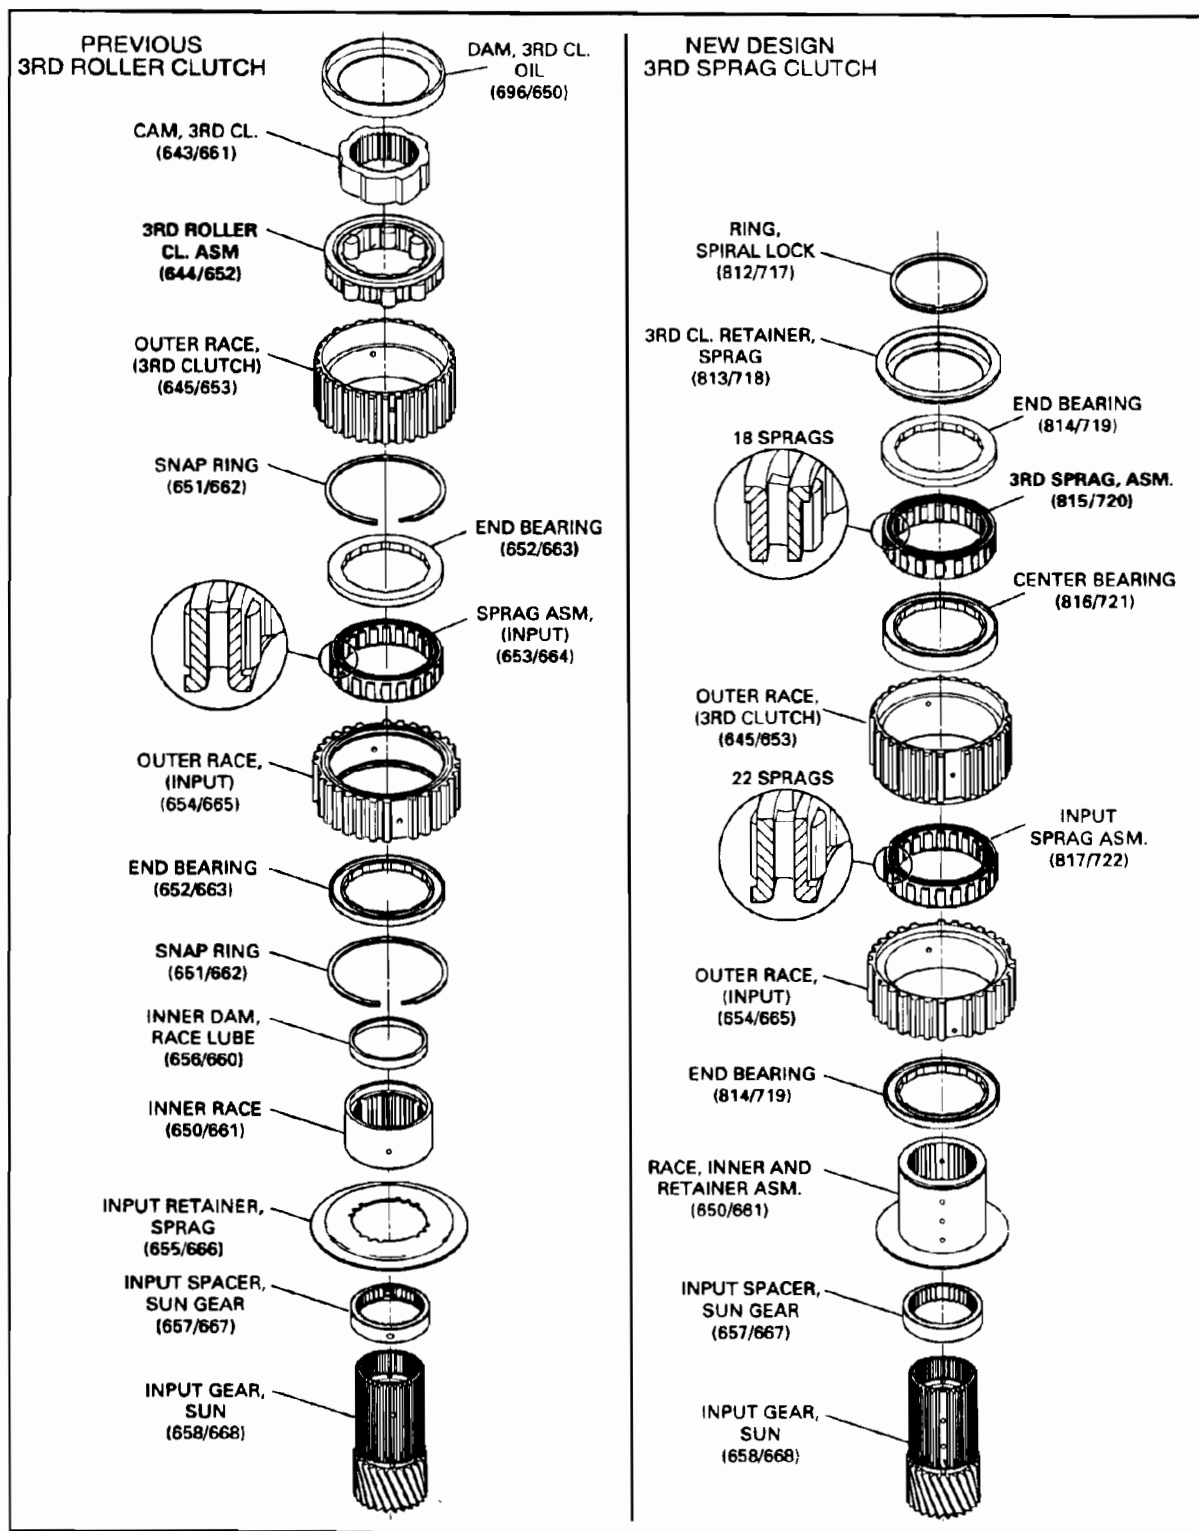
Figure 47

CHANGE: Beginning on February 1, 1993 (Julian Date 032) all THM 4T60-E transaxles were built with a new "Double Sprag" assembly, in place of the previous 3rd roller clutch and input sprag assembly (See Figure 47).

- (1) INPUT/3RD SPRAG ASSEMBLY - Completely changed in design and dimensions on ALL components of the assembly. Refer to Figure 47.
- (2) INPUT SUN GEAR - Now has two "Blind Splines" 180° from one another, to accomodate the new sprag inner race, and insure that the lube holes are aligned (See Figure 48).
- (3) INPUT SUN GEAR SPACER - Revised thickness to accomodate the dimensional changes on the double sprag assembly, and no longer has any lube holes. (See Figure 48).

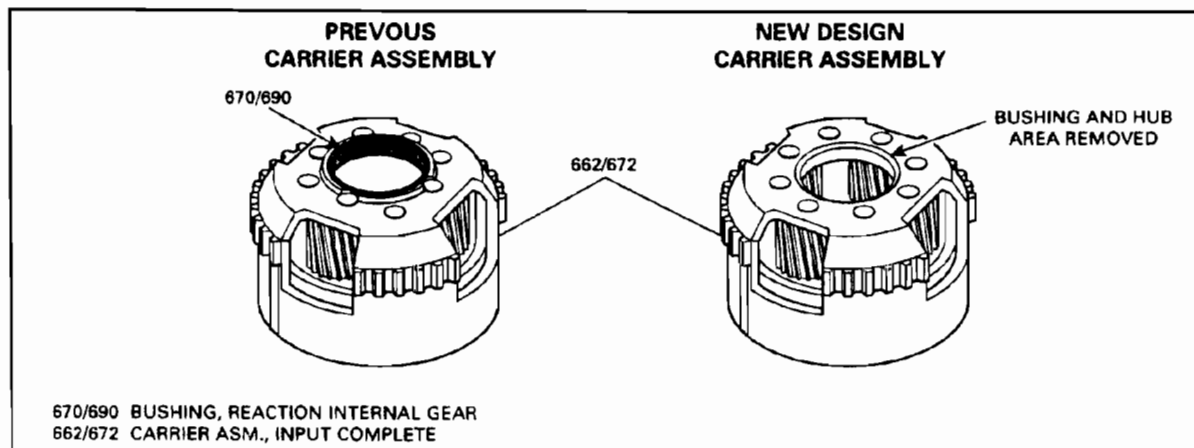
Figure 49

- (4) INPUT CARRIER - Lip on top of input carrier completely removed, and the bushing completely removed, to accomodate double sprag assembly. There have also been some internal changes to improve lube and durability. (See Figure 49).

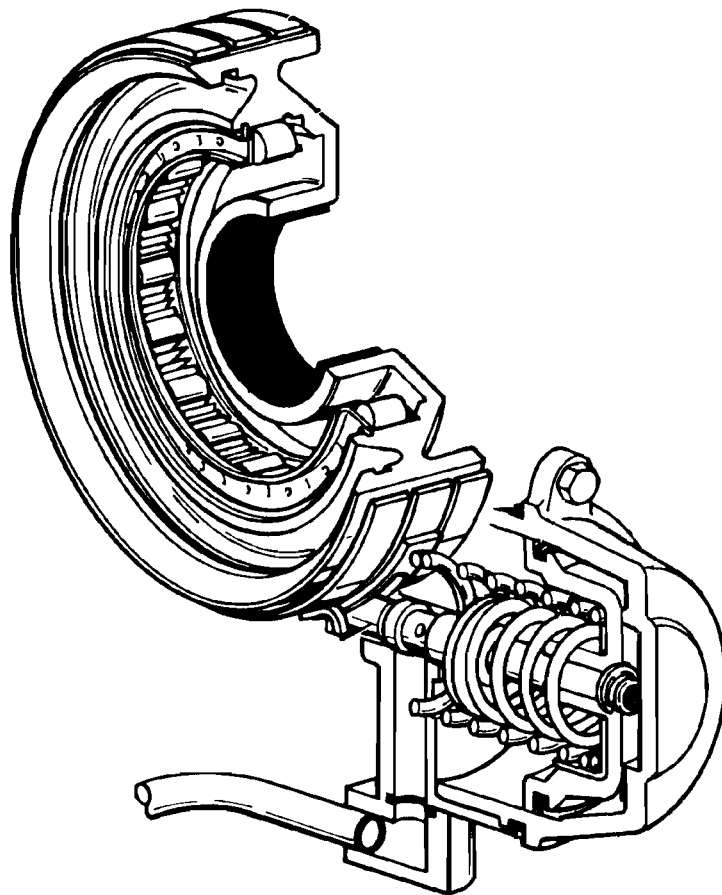
Figure 53

- COMPLAINT: NO. 1:  
Some 1991-1993 models equipped with the THM 4T60-E transaxle may exhibit a no movement condition, with the selector lever in the D4 or D3 ranges, but will move when the selector lever is placed into D2 or Lo range.
- NO. 2:  
When the engine RPM is increased with the selector lever in the Park and/or Neutral position, you may hear a noise that sounds like "Marbles in a Can", but still moves and shifts properly.
- CAUSE: The cause for both complaints listed above is a 1-2 roller clutch failure. (See Figure 53)
- CORRECTION: Replace the 1-2 Roller Clutch Assembly and any related parts that may be damaged or broken.
- WARNING: DO NOT EXCEED 3000 RPM WITH THE SELECTOR LEVER IN REVERSE AND THE WHEELS OFF OF THE GROUND.  
IF YOU DO THIS, YOU CAN FAIL THE 1-2 ROLLER CLUTCH BEFORE IT EVER LEAVES THE SHOP!

WARNING: DO NOT EXCEED 3000 RPM WITH THE SELECTOR LEVER IN REVERSE AND THE WHEELS OFF OF THE GROUND.

IF YOU DO THIS, YOU CAN FAIL THE 1-2 ROLLER CLUTCH BEFORE IT EVER LEAVES THE SHOP!

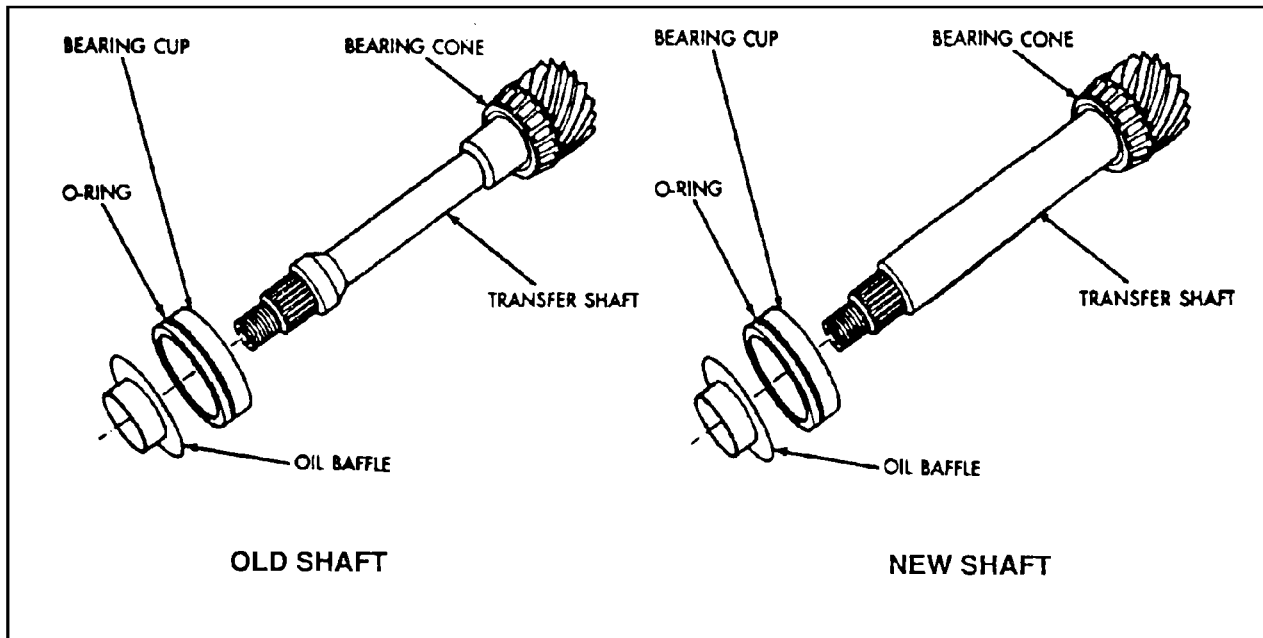
Figure 60

Change: Starting in July of 1990 and all 1991 and up production, the transfer shaft was re-designed and made thicker. This was done because some of the earlier transfer shafts were showing signs of torsional deflection under load in lab tests. There were no field failures for this condition. See figure 60.

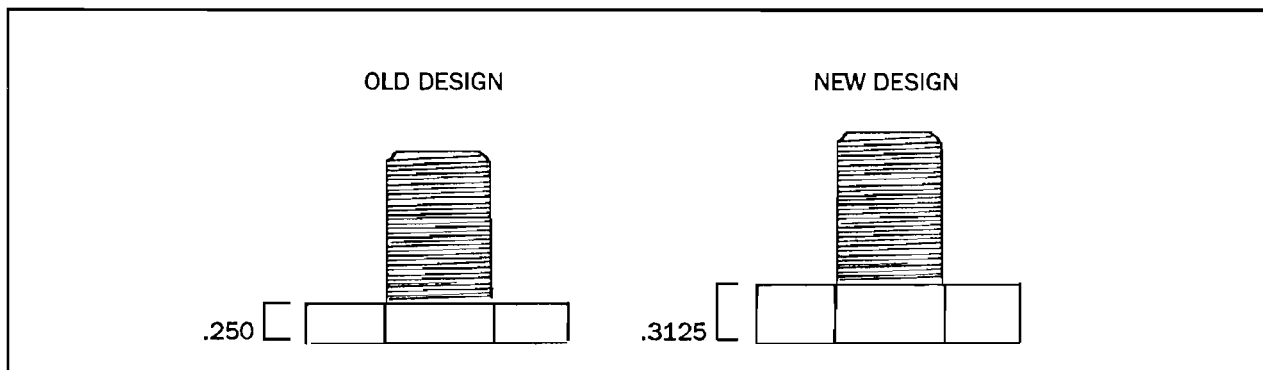
Figure 61

Chrysler increased the thickness of the output shaft bolt head from approximately .250 to .3125 (Figure 61). This necessitated an extended transfer gear cover to accomodate the thicker head bolt (Figure 62).

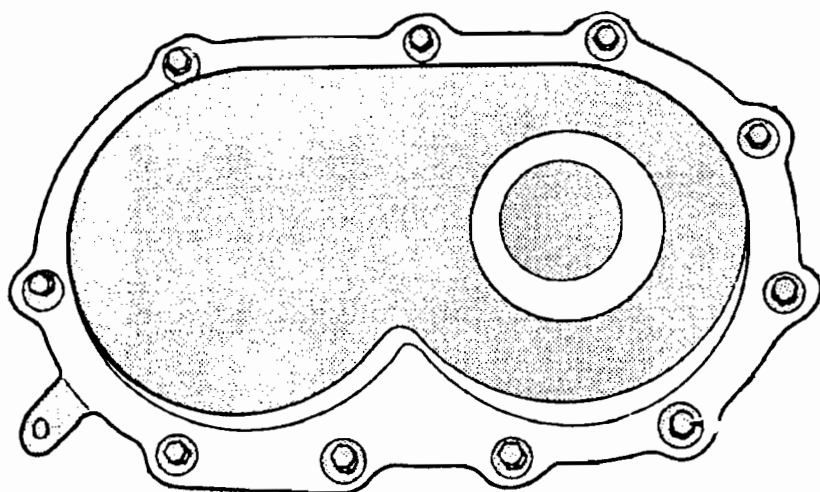
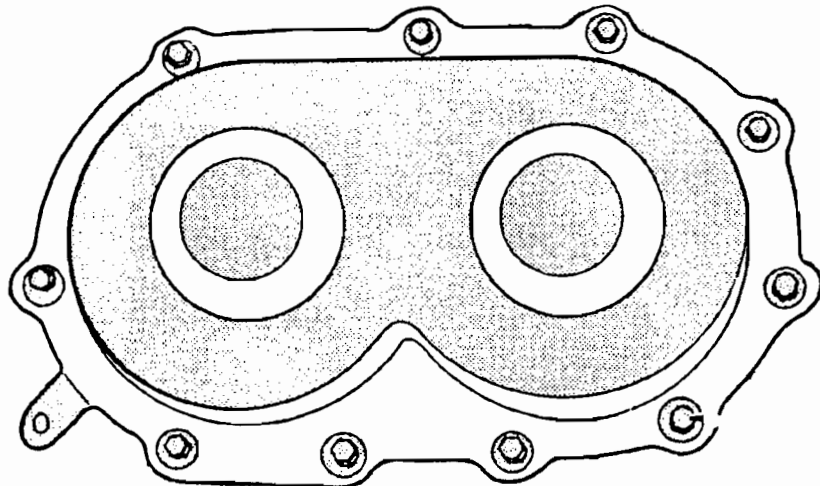
Figure 62

NOTE: THE NEW DESIGN EXTENDED COVER WILL RETRO-FIT BACK TO EARLY MODELS.

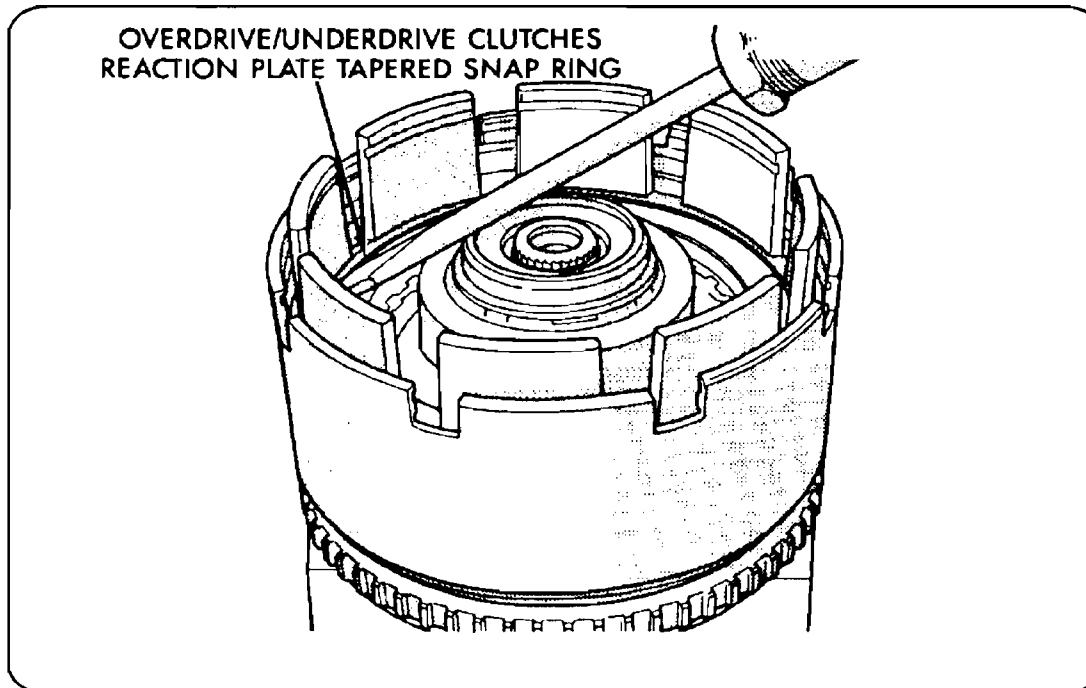
Figure 64

**COMPLAINT:** The color coded taperd snap ring that goes on top of the Underdrive/Overdrive reaction plate, in the input housing, is found broken and usually in many pieces (see figure 64).

**Note:** The part numbers listed above INCLUDES THE UPDATED TAPERED SNAP RING. If you need just the updated snap ring, the part number is 4567602. This change was implemented at the start for all 1993 model A604 transaxle.

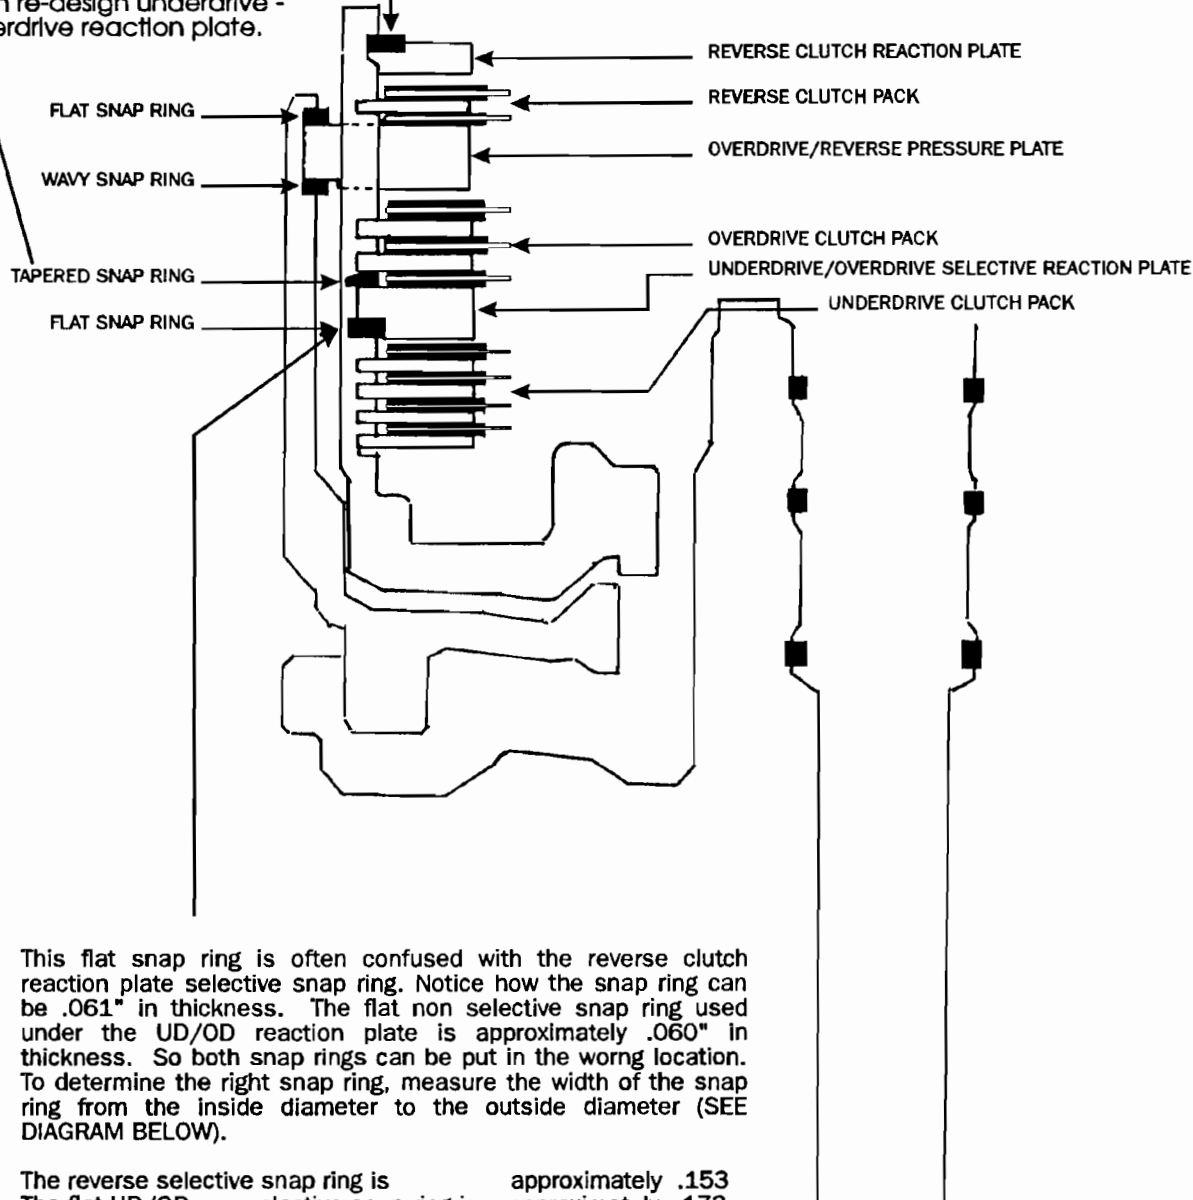
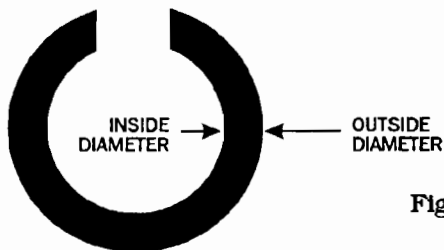
Figure 66

This flat snap ring is often confused with the reverse clutch reaction plate selective snap ring. Notice how the snap ring can be .061" in thickness. The flat non selective snap ring used under the UD/OD reaction plate is approximately .060" in thickness. So both snap rings can be put in the wrong location. To determine the right snap ring, measure the width of the snap ring from the inside diameter to the outside diameter (SEE DIAGRAM BELOW).

The reverse selective snap ring is approximately .153  
 The flat UD/OD non selective snap ring is approximately .173

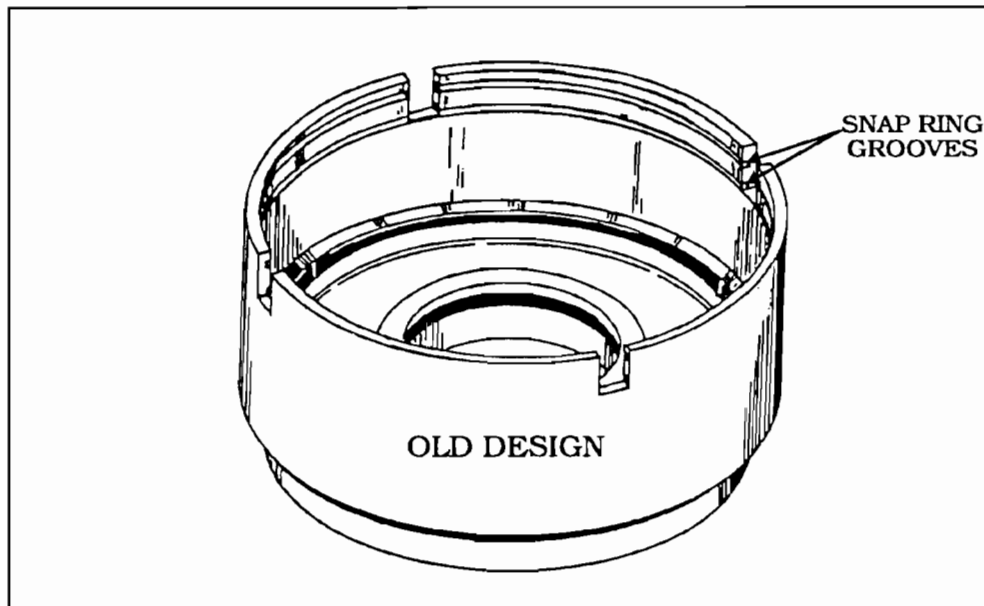
Figure 67

A running change on the Overdrive/Reverse piston took place in 1991 where the two top snap ring grooves are located (See Figure 67). The removal of the drum material between the two snap rings prevents the overdrive/reverse pressure plate from binding up in the drum (See Figure 68). The assembly of the pressure plate and snap rings has not changed. The wavy snap ring goes down first, then the overdrive/reverse pressure plate is installed (lip down) with the flat snap ring on top.

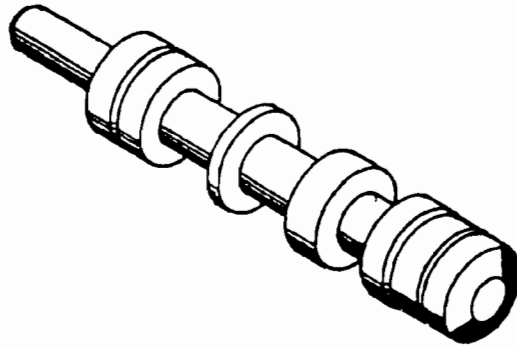
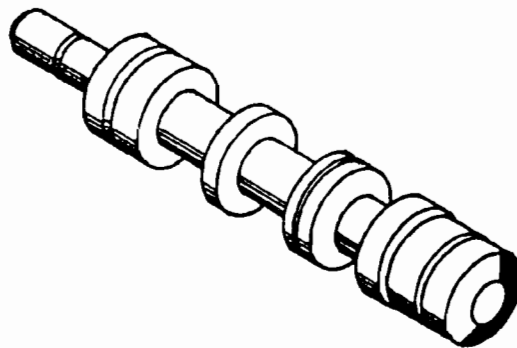
Figure 70

- (1) TORQUE CONVERTER CONTROL VALVE - 3rd design valve has two lands machined .020" thicker than the previous, and has a "Groove" cut into the stem for I.D. (See Figure 70).
- (2) TORQUE CONVERTER CONTROL VALVE SPRING - Calibration changes to accommodate the new design TCC valve.
- (3) VALVE BODY SPACER PLATE - 3rd design is identified with "96" stamped into the plate and the 2nd design is identified with "46" stamped in plate. The 3rd design "96" spacer plate has calibration changes to accommodate the new TCC control valve. (See Figure 73).

1ST DESIGN USES "33" SPACER PLATE  
2ND DESIGN USES "46" SPACER PLATE  
3RD DESIGN USES "96" SPACER PLATE
