# **THE SEMINAR WITH MORE IN '94**

AUTOMATIC TRANSMISSION SERVICE GROUP  
9200 S. DADELAND BLVD. STE 720  
MIAMI, FLORIDA 33156  
(305) 670-4161

# TRANSMISSION SEMINAR 1994

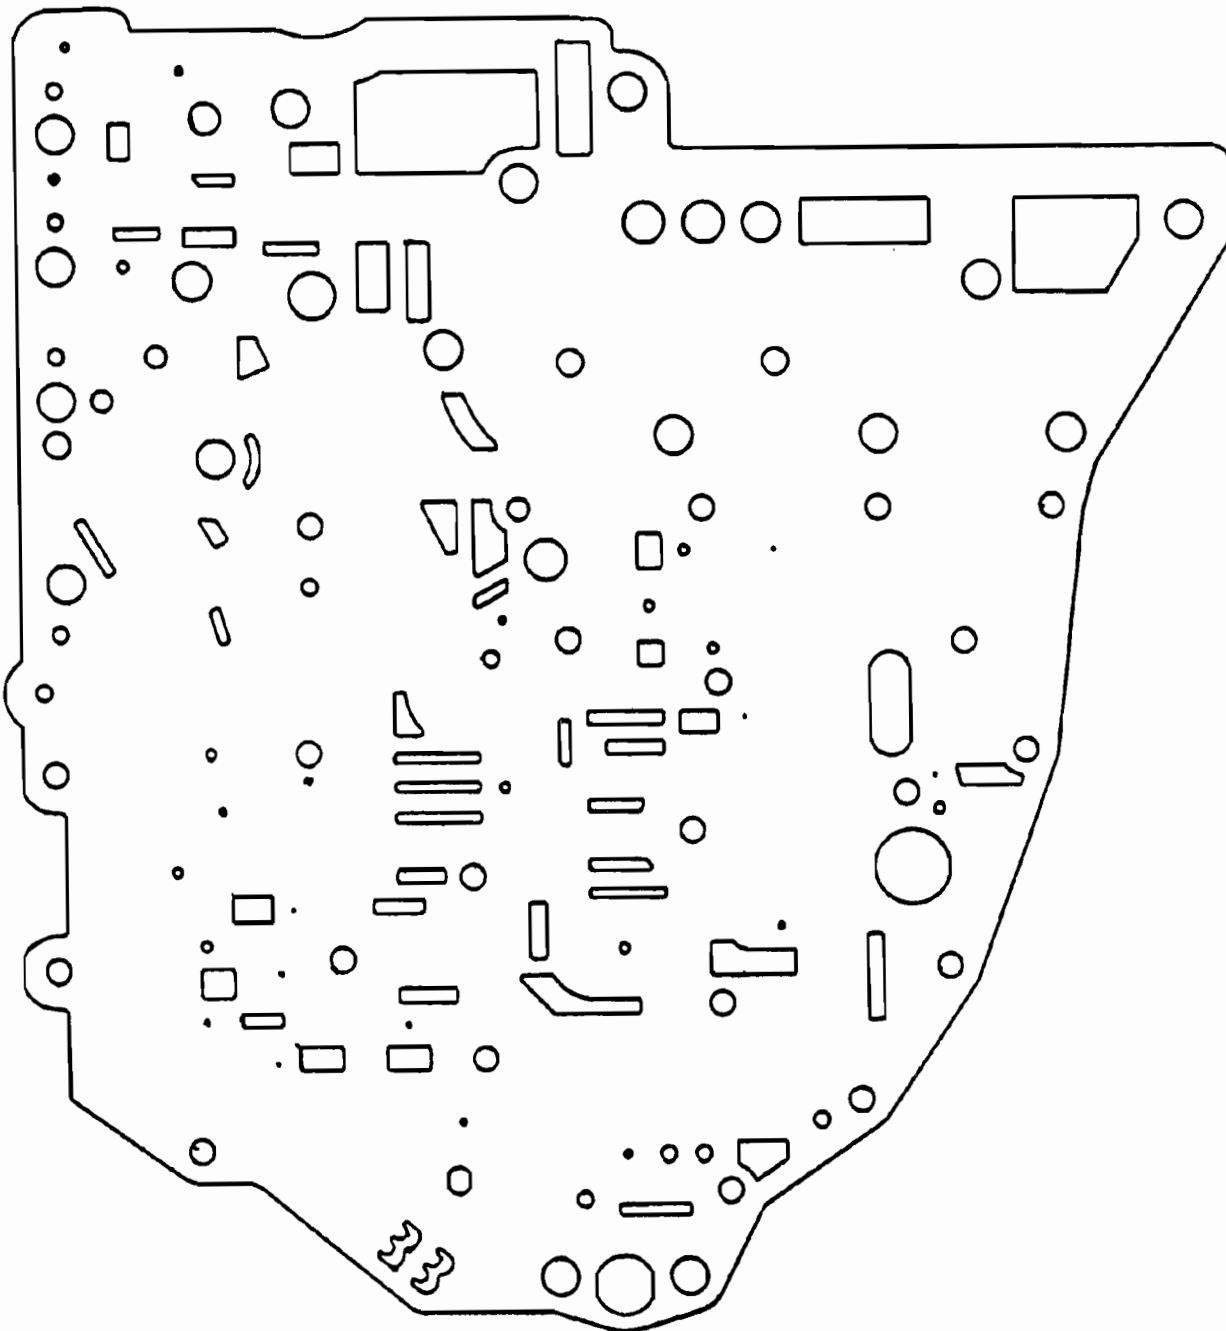
Figure 71

Fits ONLY Valve Body Casting Number 4446639  
Fits ONLY Transfer Plate Casting Number 4446640

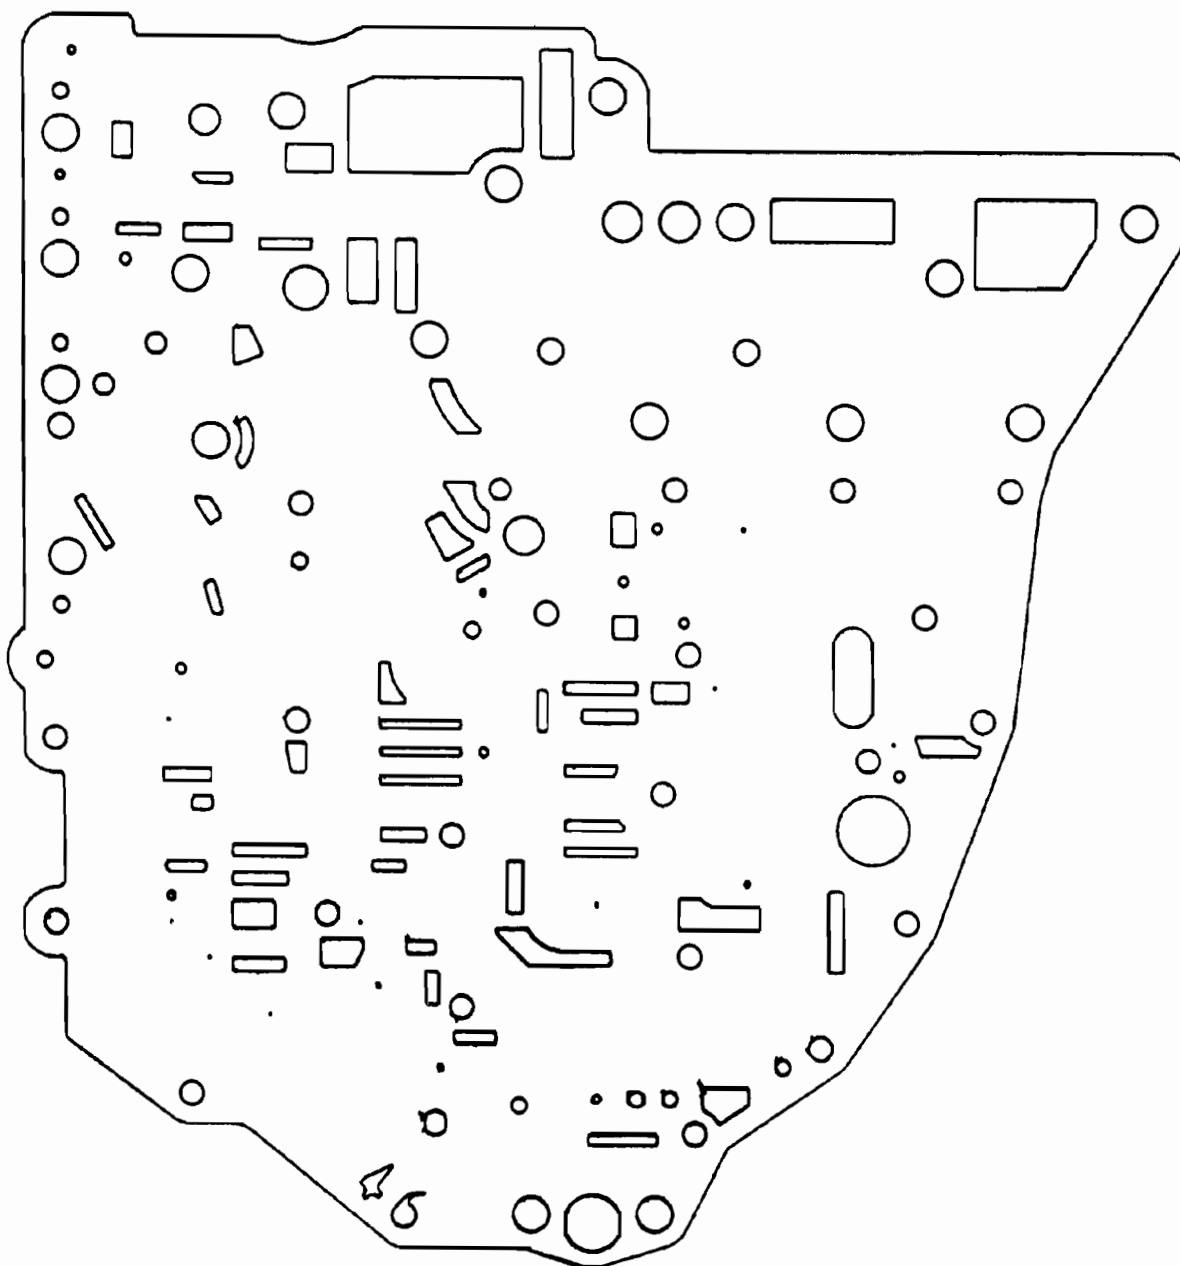
Figure 72

- (4) TORQUE CONVERTER CONTROL VALVE SPRING - 2nd design is calibrated different than 1st design.
- (5) VALVE BODY SPACER PLATE - 2nd design is identified with "46" stamped in the plate and 1st design being identified with "33" stamped in the plate. 2nd design "46" plate is TOTALLY different to accommodate new TCC control valve and casting changes (See Figures 71 and 72).

Fits ONLY Valve Body Casting Number 4511644  
Fits ONLY Transfer Plate Casting Number 4511645  
(Implemented in model year 1992)

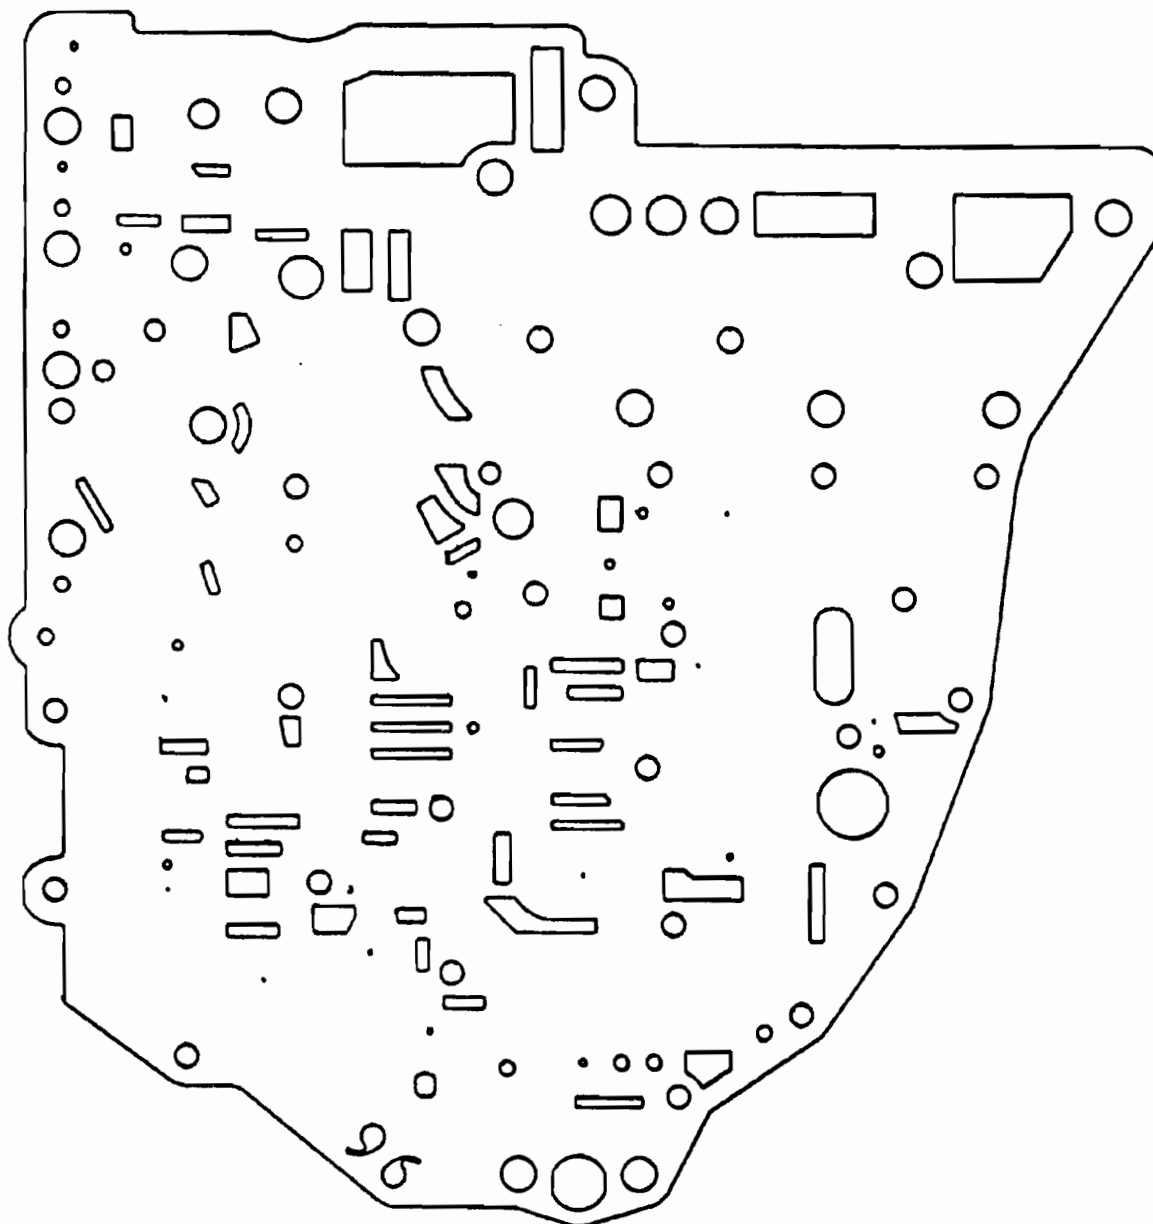
Figure 73

- (1) TORQUE CONVERTER CONTROL VALVE - 3rd design valve has two lands machined .020" thicker than the previous, and has a "Groove" cut into the stem for I.D. (See Figure 70).
- (2) TORQUE CONVERTER CONTROL VALVE SPRING - Calibration changes to accommodate the new design TCC valve.
- (3) VALVE BODY SPACER PLATE - 3rd design is identified with "96" stamped into the plate and the 2nd design is identified with "46" stamped in plate. The 3rd design "96" spacer plate has calibration changes to accommodate the new TCC control valve. (See Figure 73).

Fits ONLY Valve Body Casting Number 4511644  
Fits ONLY Transfer Plate Casting Number 4511645  
(Implemented in model year 1993, and will interchange with "46" plate)

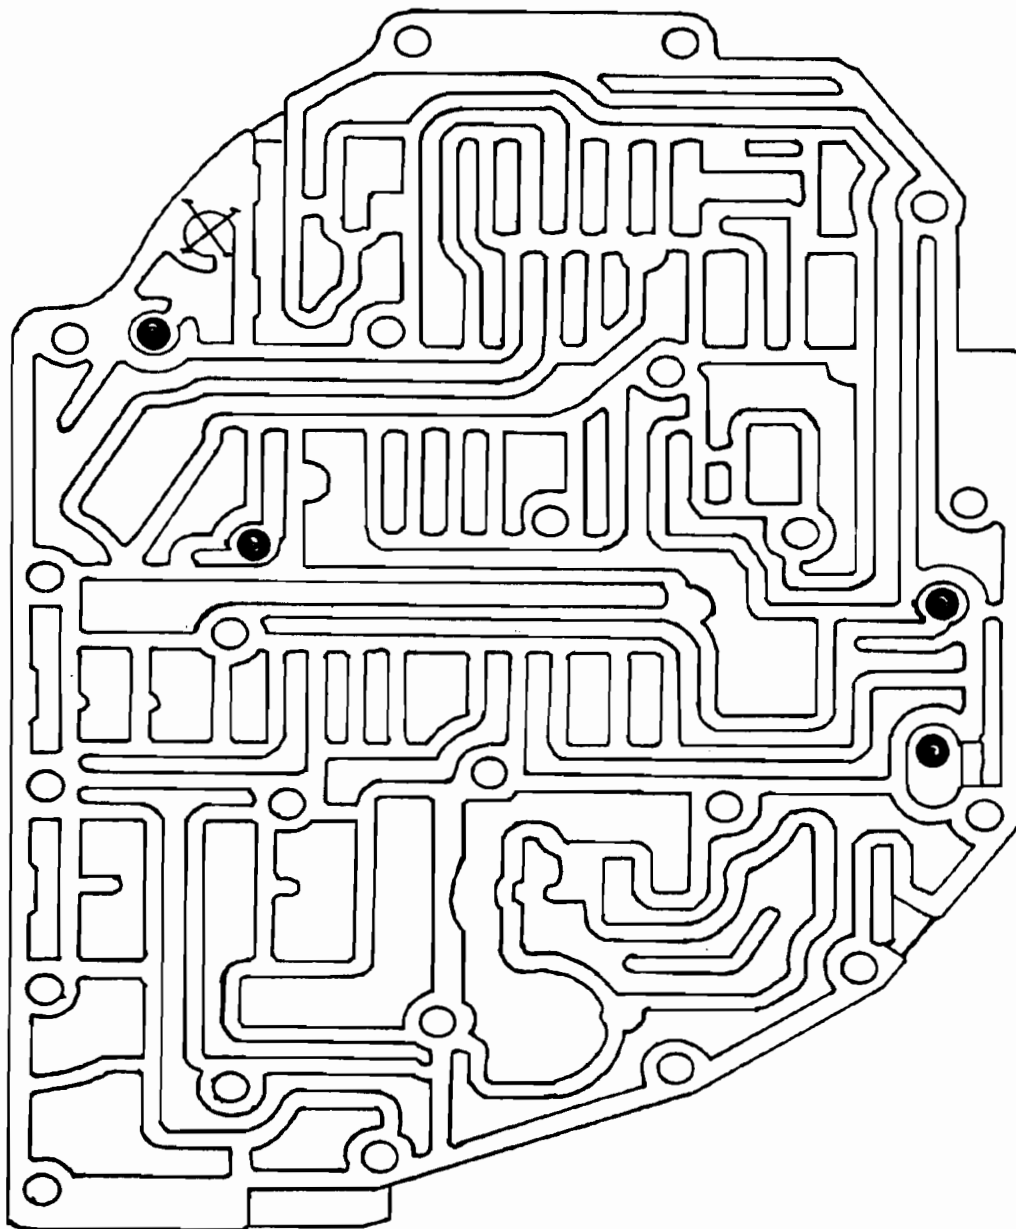
Figure 75

- (1) VALVE BODY CASTING - 2nd design required machining and casting changes to accommodate new lock-up valve and torque converter control valve components. For positive identification, 2nd design valve body casting number is 4511644, and the previous (1st Design) valve body casting number is 4446639. (See Figures 74 and 75).

CHRYSLER A604 VALVE BODY CASTING NO. 4511644  
(IMPLEMENTED 1992 MODEL YEAR)

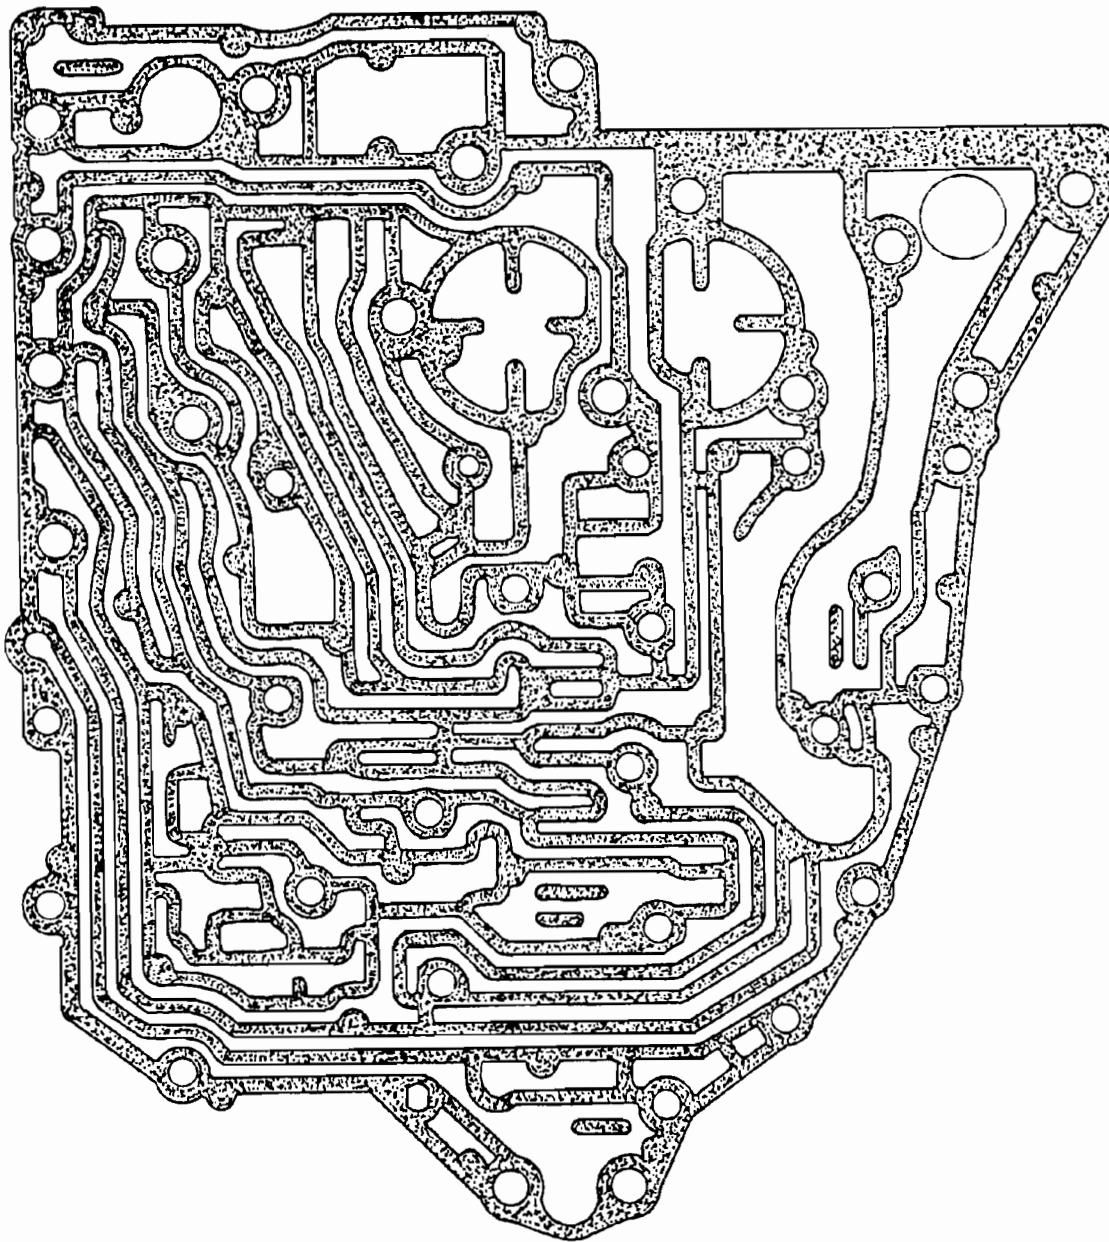
Figure 76

- (2) TRANSFER PLATE - 2nd design required machining and casting changes to accommodate new lock-up valve and torque converter control valve components. For positive identification, 2nd design transfer plate casting number is 4511645, and the previous (1st Design) transfer plate casting number is 4446640 (See Figures 76 and 77).

CHRYSLER A604 TRANSFER PLATE  
CASTING NUMBER 4446640  
(FITS MODEL YEARS 1989-1991)

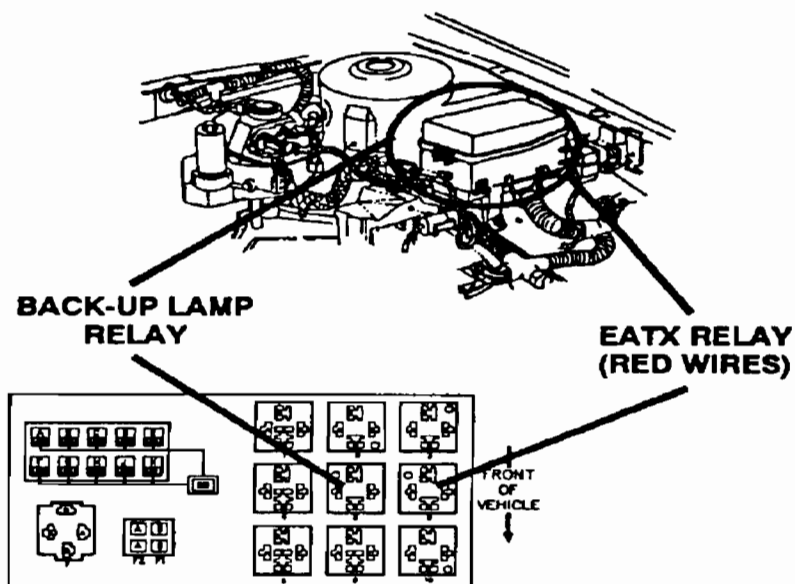
Figure 79

- COMPLAINT:** 2nd gear starts and no upshifts occur even after an ignition cycle. A code 15 may be accompanied with this complaint.
- CAUSE:** The cause may be a loss of voltage supply to pin number 4 at the solenoid body which is controlled by the EATX relay. The EATX relay (Electronic Automatic Transaxle) is operated by the controller. Its purpose is to provide battery voltage to the solenoids and switches. When the controller receives an ignition run signal from the ignition switch, it will first perform a number of circuit checks and a EATX relay check. The controller will initialize and activate the EATX relay if no circuit problems are found. One side of the EATX relay coil is grounded and the controller applies battery voltage to the opposite side. This power comes from the controllers direct battery supply circuit. When the EATX relay contacts close, battery voltage is supplied to pin number 4 at the solenoid body and pins 16 & 17 on the controller. This is referred to as switched battery voltage (See Figure 78). The controller uses pins 16 & 17 to monitor the relay function and applied voltage. If the contacts in the EATX relay cannot close, switched battery voltage cannot be supplied to pin number 4 at the solenoid body or pins 16 & 17 at the controller causing the 2nd gear starts and no upshifts even after an ignition cycle. Fault code 15 may be accompanied with this fault which means EATX relay off.

# EATX RELAY LOCATION FOR NEW YORKER, DYNASTY, IMPERIAL AND FIFTH AVENUE.

- (1) Locate the EATX relay in the Power Distribution Center as shown in Figure 79.
- (2) With the ignition OFF, remove the relay and refer to figure 80 for cavity identification.

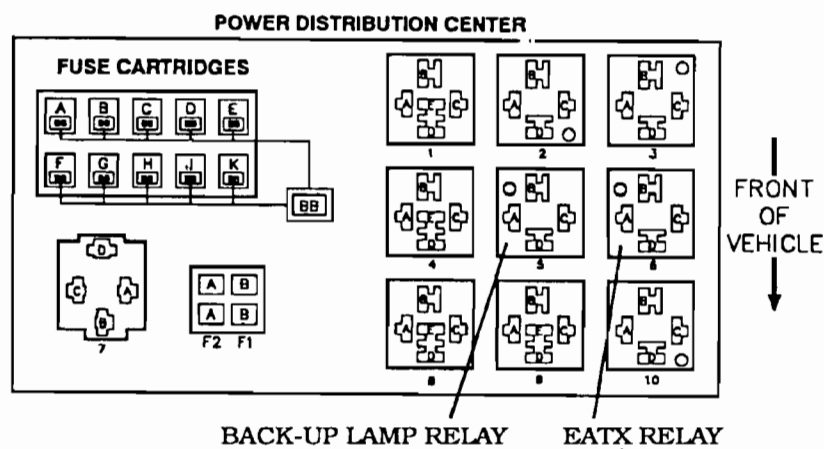
Figure 80

CAV .. CIRCUIT .....	FUNCTION
A .....	T15 18LG ..... Relay Coil Power
B .....	A14 18RD/WT ..... Battery 12V
C .....	18BK/RD ..... Ground
D .....	T16 18RD ..... Relay Output
E .....	Not Used

- (4) Using a Volt Meter set to DC volts, place the positive lead onto terminal B and the negative lead on the ground post of the battery. Battery voltage should be seen here with the ignition switch either on or off. If no voltage appears, inspect and repair the wiring for an open or a blown fusible link. If there is battery voltage, go to step 5.

- (5) Using an OHM meter, place the positive lead onto terminal C and the negative lead to a good ground and check for continuity. If there is continuity, go to step 6. If there is no continuity, the wire coming out of cavity C has a bad ground. Repair the ground wire coming out of cavity C and repeat this check to insure that you have good continuity.

- (6) Using a volt meter set to DC volts, place the positive lead onto terminal A and the negative lead onto the ground post of the battery. Battery voltage should be seen here when the ignition switch is turned on. If no battery voltage is seen, check continuity between cavity A at the relay and terminal 15 at the controller (See figure 81 for terminal location at the controller). If there is continuity, go to step 7. If there is no continuity, the wire from terminal 15 at the controller to cavity A at the relay has an open. Repair the wire and repeat this step to insure that you have continuity across this wire.

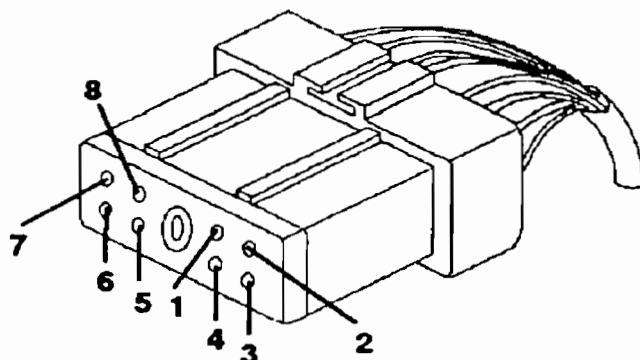
Figure 82

## SOLENOID CONNECTOR TERMINAL IDENTIFICATION

- (9) Using an OHM meter, check for continuity between cavity D at the relay and terminal 4 at the solenoid body connector. See figure 82 for solenoid connector terminal identification. If there is no continuity, the wire from cavity D at the relay to terminal 4 in the solenoid connector has an open. Repair the wire and repeat this check to insure that you have continuity across this wire.

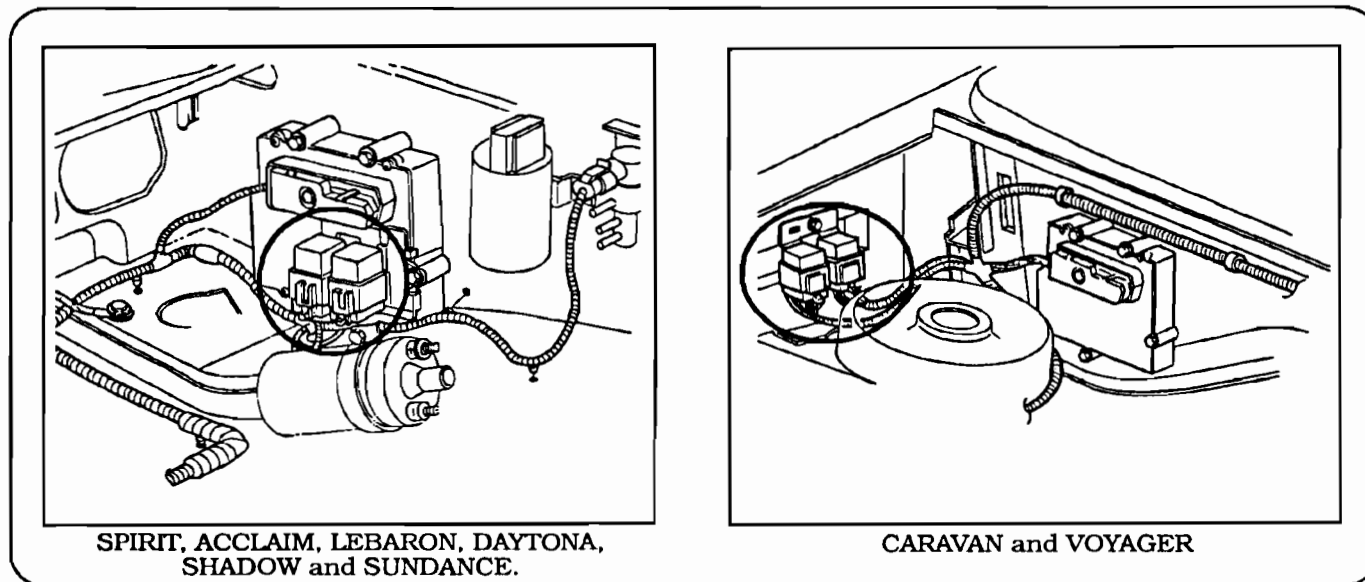
Figure 83

# EATX RELAY LOCATION FOR SPIRIT, ACCLAIM, LEBARON, DAYTONA, SHADOW, SUNDANCE, CARAVAN and VOYAGER.

- (1) Locate the EATX relay location by using figure 83 and refer to figure 84 for cavity identification.
- (2) Carefully bend the EATX relay bracket to gain access to back probe the connector. NOTE: FOLLOWING TEST CANNOT BE MADE WITH CONNECTOR REMOVED.

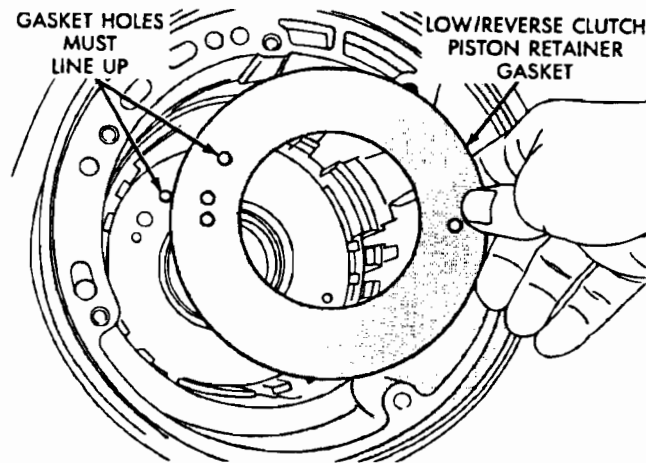
Figure 86

### Low/Reverse Piston Retainer Gasket

Replace the low/reverse clutch piston gasket as shown in figure 86. Also replace the low/reverse retainer plate to ensure that you have an even compression on the gasket (See figure 87). The part number for this retainer plate is 4431648. Also, in 1993 the low/reverse piston was redesigned so that the outer diameter above the lip seal is now .002" smaller. This was done to prevent the possibility of the piston having a thermal bind up in the piston retainer which can cause a similar complaint. The part number for the low/reverse piston did not change with the redesign. If you order this piston, be sure to ask for a 1993 or later piston or you will get the same style piston that you are trying to change. The part number for the low/reverse piston is 4431672. You could cut your original piston down by .002" on your own in the area shown in figure 88. When you place the piston in the lathe, cut in only .001", this will reduce the outer diameter .002 of an inch as you cut all the way around.

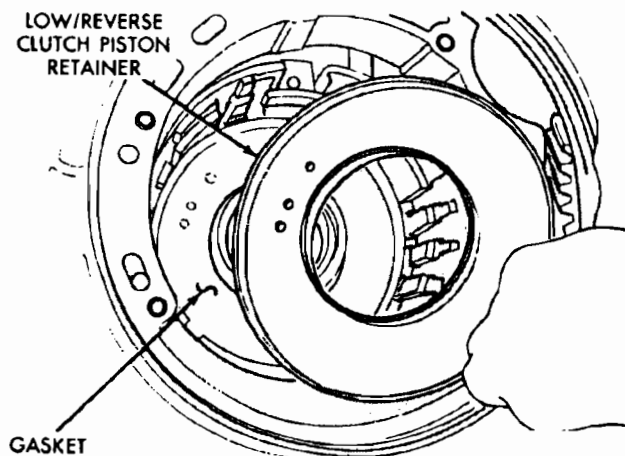
Figure 87

### Low/Reverse Piston Retainer

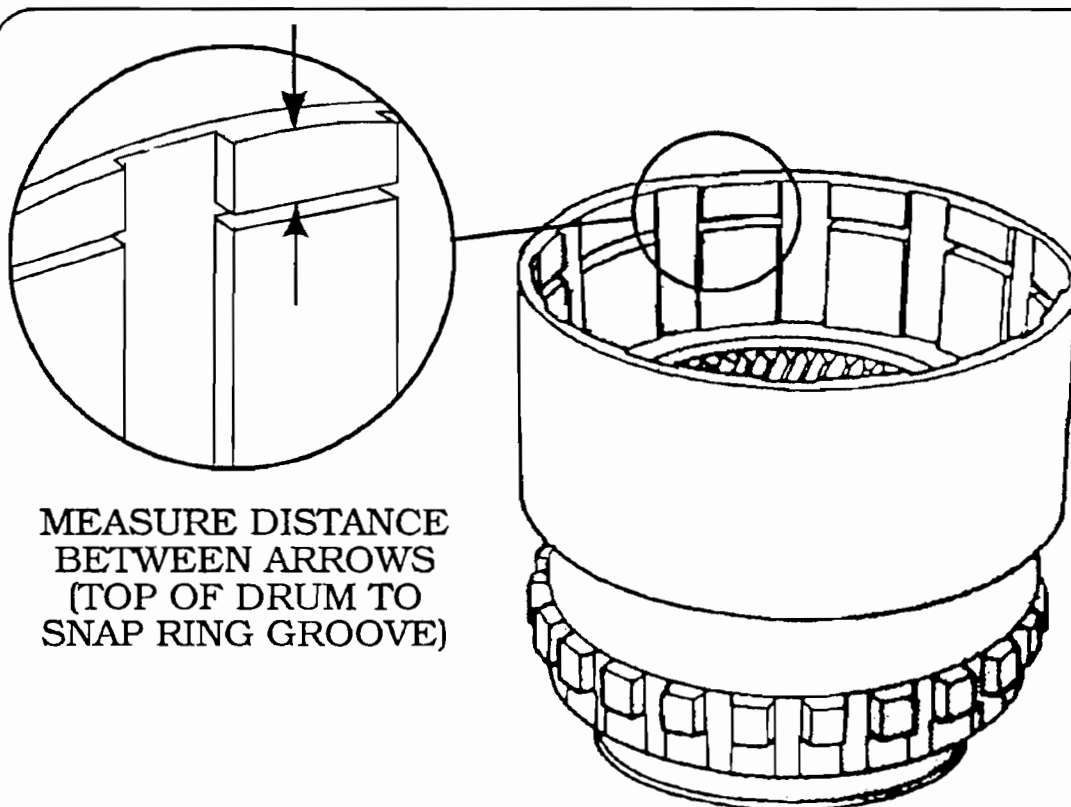
There are presently three Overdrive/Direct clutch drums depending on the engine size and transmission. If your overdrive section has been destroyed due to lack of lubrication to the thrust plate bearing, the drum may need replacement. When a new drum is bought, it may not be the same as the original drum and the wrong amount of frictions and steel plates can be installed. This could lead to a bind up on the 3-4 shift or a no reverse condition depending on if the drum received too many friction, or not enough. To determine the amount of frictions and steels that belong in the drum that you have, measure the distance between the snap ring groove to the top of the drum as shown in figure 89. If the distance is approximately .485", then 5 lined plates and 4 steel plates belong in this drum. If the distance is approximately .350", then 6 lined plates and 5 steel plates belong in this drum. If the distance is approximately .100", then 8 lined plates and 7 steel plates belong in this drum.

MEASURE DISTANCE  
BETWEEN ARROWS  
(TOP OF DRUM TO  
SNAP RING GROOVE)

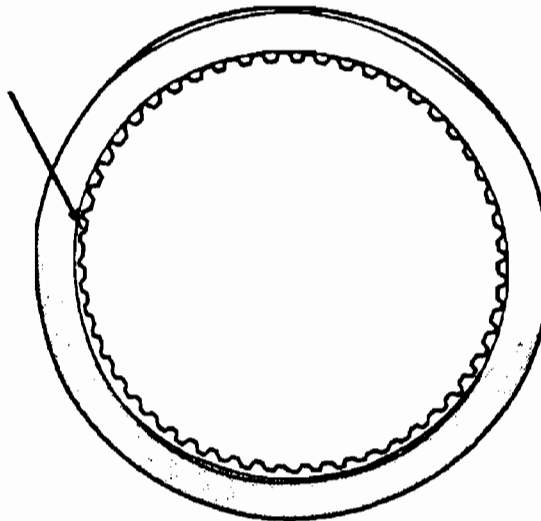
Figure 90

Overdrive/Direct Clutch Reaction plate  
inside lip faces down over the sliding hub.  
When installed correctly, this plate will be  
flush across the bottom of the hub.

**Correction:** Install the Overdrive/Direct clutch reaction plate with the inside step facing down so that it will fit over the lugs on the direct clutch sliding hub. The reaction plate when installed correctly, should be flush with the end of the hub (See Figure 90).

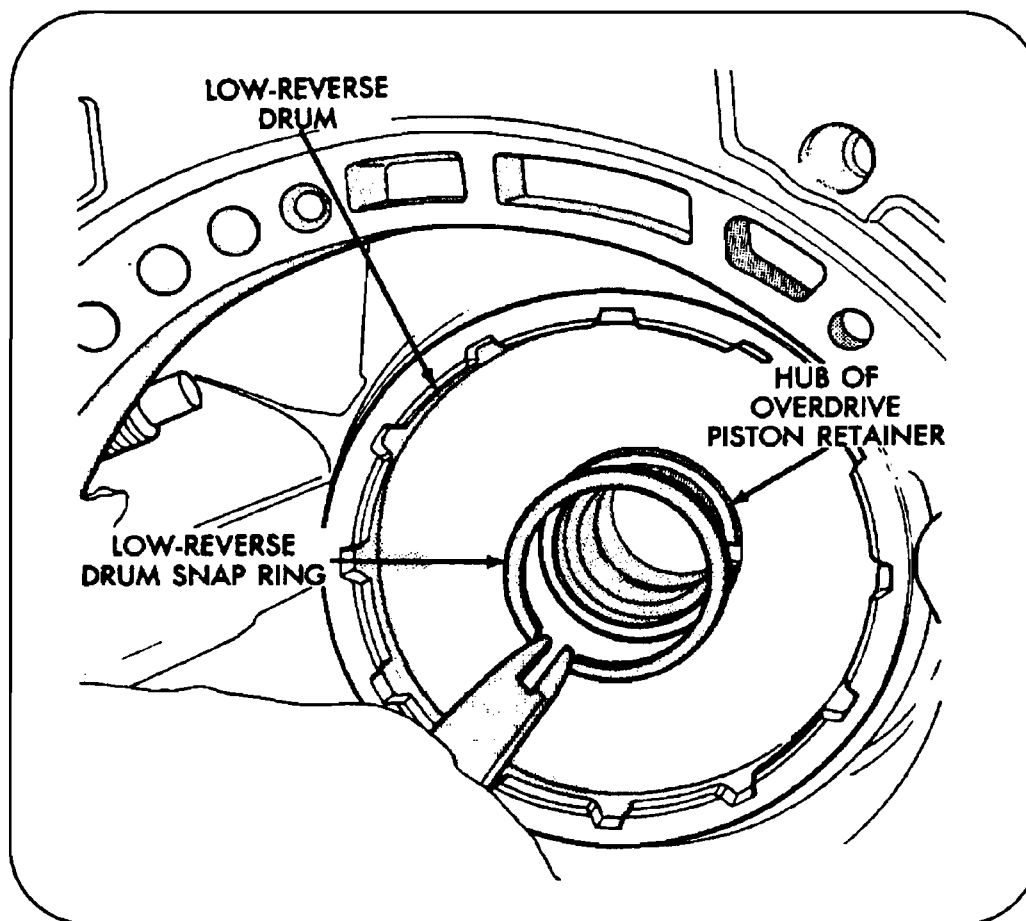
Figure 91

**Change:** A running change was made to the low/reverse drum where the snap ring retains the drum to the OD Piston retainer. Previous models had a washer located between the snap ring and drum. The new design eliminates the washer (See figure 91). To determine if your drum takes the washer, there will be an inside step machined into the drum to accommodate the washer. If the drum has a flat face, no washer is required.
