1997 SEMINAR INFORMATION

"THE RIGHT DIRECTION FOR '97"

AUTOMATIC TRANSMISSION SERVICE GROUP
9200 S. DADELAND BLVD.
SUITE 720
MIAMI, FL 33156
(305) 670-4161

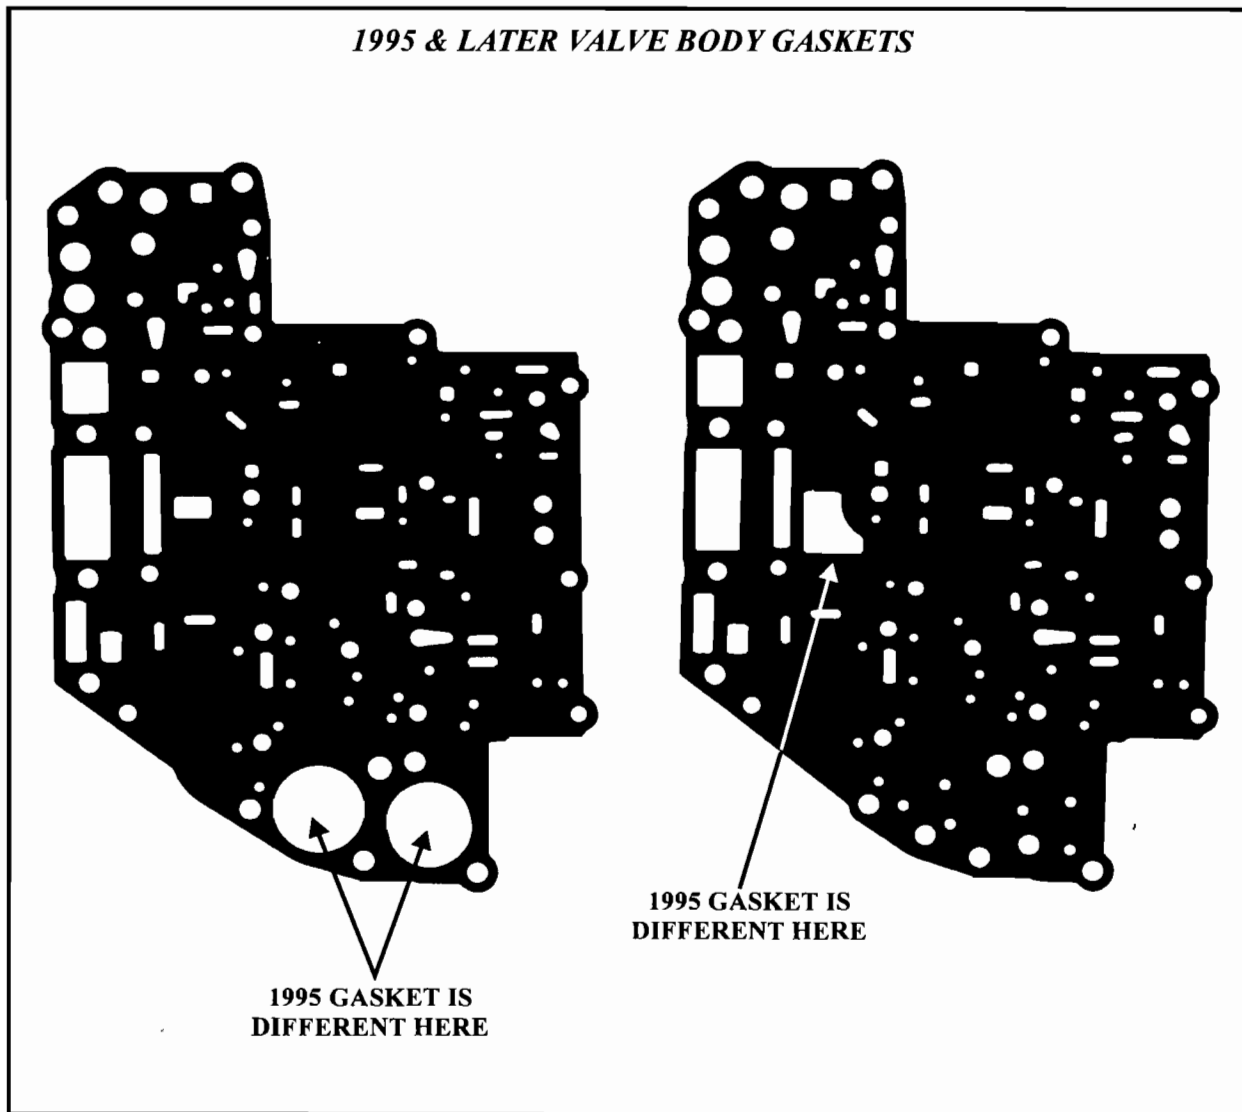
Figure 2

CAUSE: The valve body gaskets used in 1994 (Refer to Figure 1) and earlier MX17 transaxles found in GEO METRO, SUZUKI SWIFT and DAIHATSU CHARADE automobiles **CANNOT** be used in 1995 models. In 1995 the valve body gaskets changed (Refer to Figure 2) and if used in the 1994 and earlier models, will cause the above complaint.

VALVE BODY GASKET CHANGE

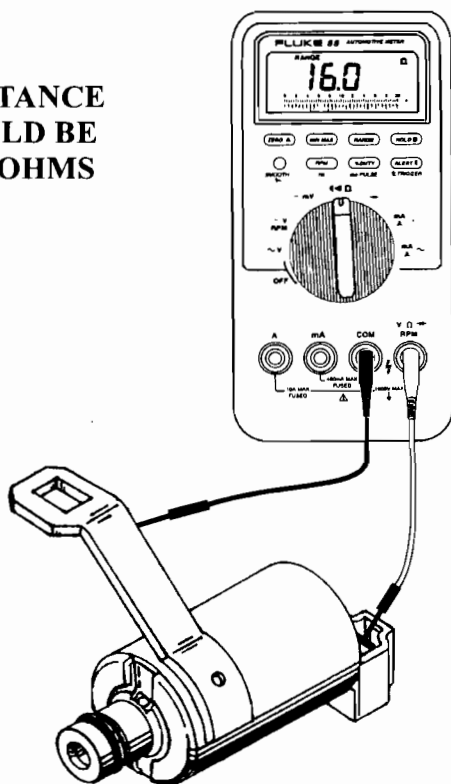
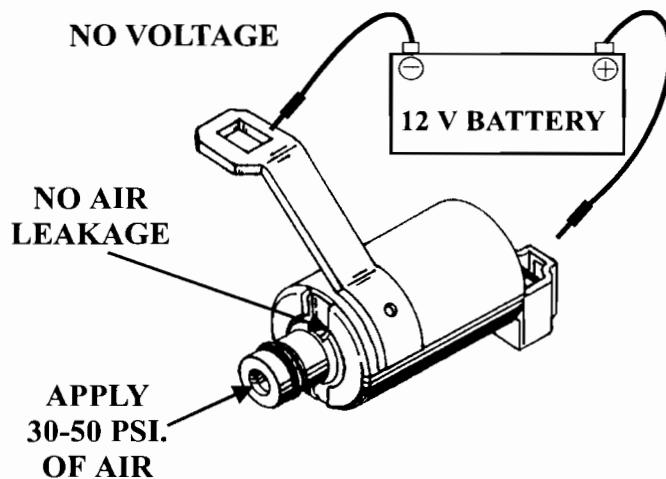
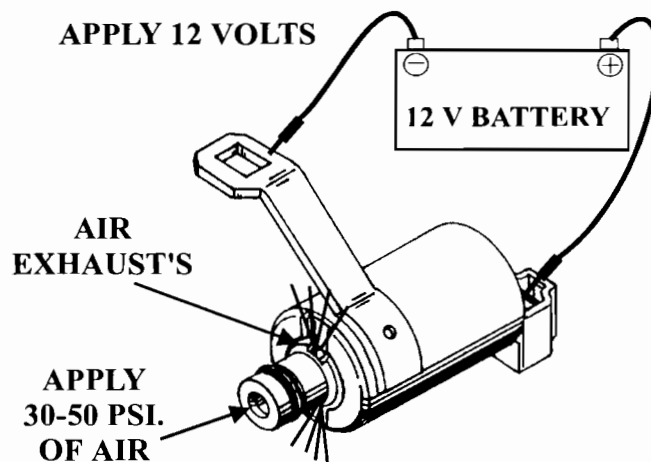
Figure 3

SOLENOID	INTERNAL WIRE COLOR
1-2	GREEN
2-3	BLUE
3-4	YELLOW
LOCK-UP	WHITE

**RESISTANCE
SHOULD BE
13-27 OHMS**

3. Ensure that there are only two checkballs in the "Main" valve body, and that they are in their proper locations, as shown in Figure 5.
4. Ensure that the solenoids are in their proper locations and the internal wire color to the solenoids using the chart in Figure 3.

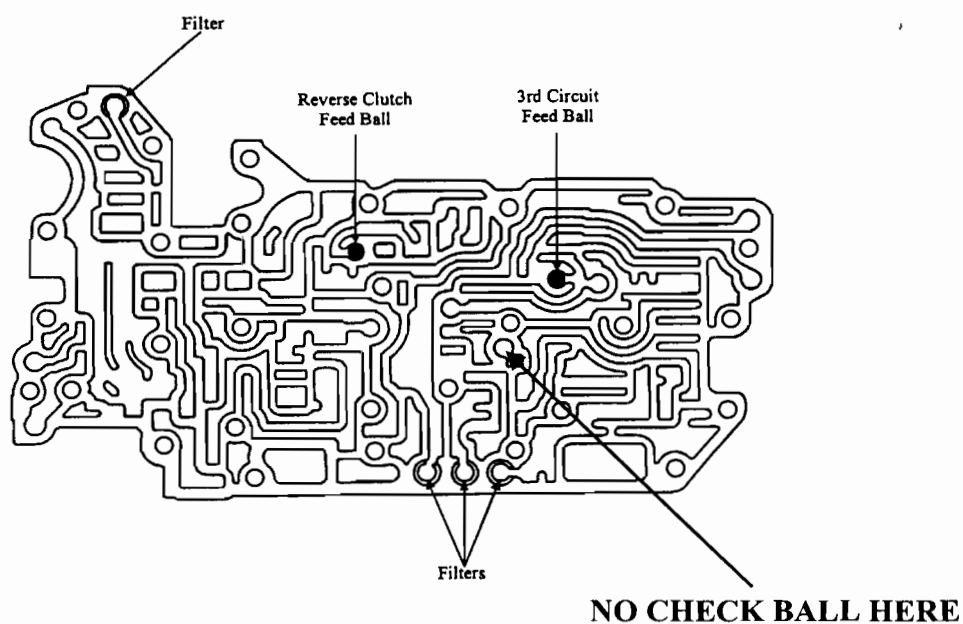
Figure 5

MAIN VALVE BODY CHECK BALL LOCATIONS

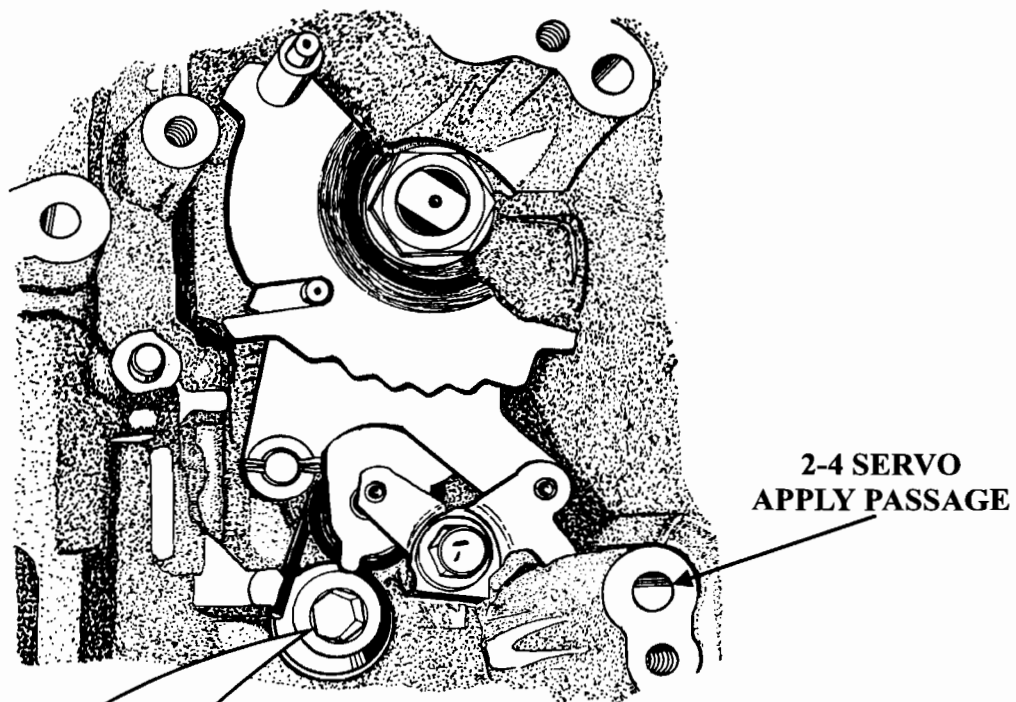
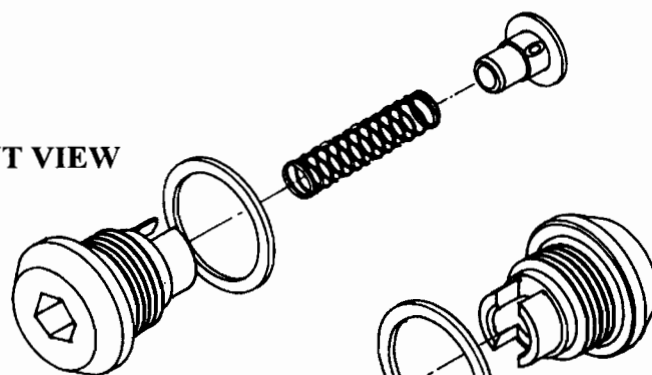
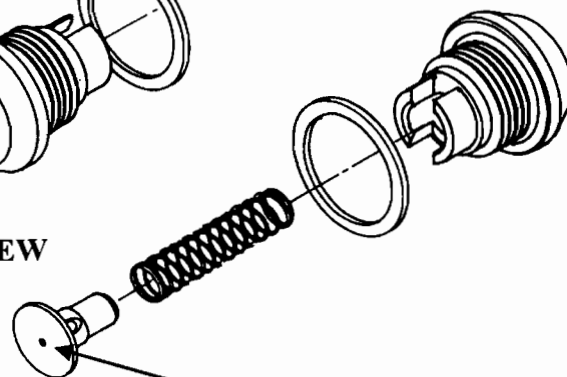
Figure 6
Automatic Transmission Service Group

2-4 SERVO ORIFICE LOCATION

**ENSURE THAT 2-4 SERVO ORIFICE
IS FREE OF DEBRIS**

5. Air check the servo through the 2-4 servo apply passage, as shown in Figure 6. If the servo cannot be applied, or is slow to apply, remove the 2-4 servo orifice assembly from the case, using a 10mm "Hex" socket, thoroughly clean and reassemble. (See Figure 6).

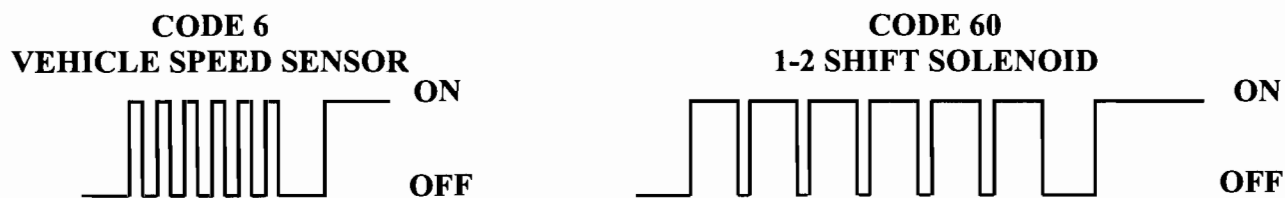
6 SHORT FLASHES OR SWEEPS OF THE VOLT METER = CODE 6
6 LONG FLASHES OR SWEEPS OF THE VOLT METER = CODE 60

1. While checking for trouble codes, give extra attention to the length of the needle sweep if you are using a volt meter, or the length of the flash if you are watching the "Hold" light. Trouble Code "6", vehicle speed sensor, can be easily confused with Trouble Code "60", 1-2 shift solenoid circuit error. Refer to Figure 7 for trouble code identification.

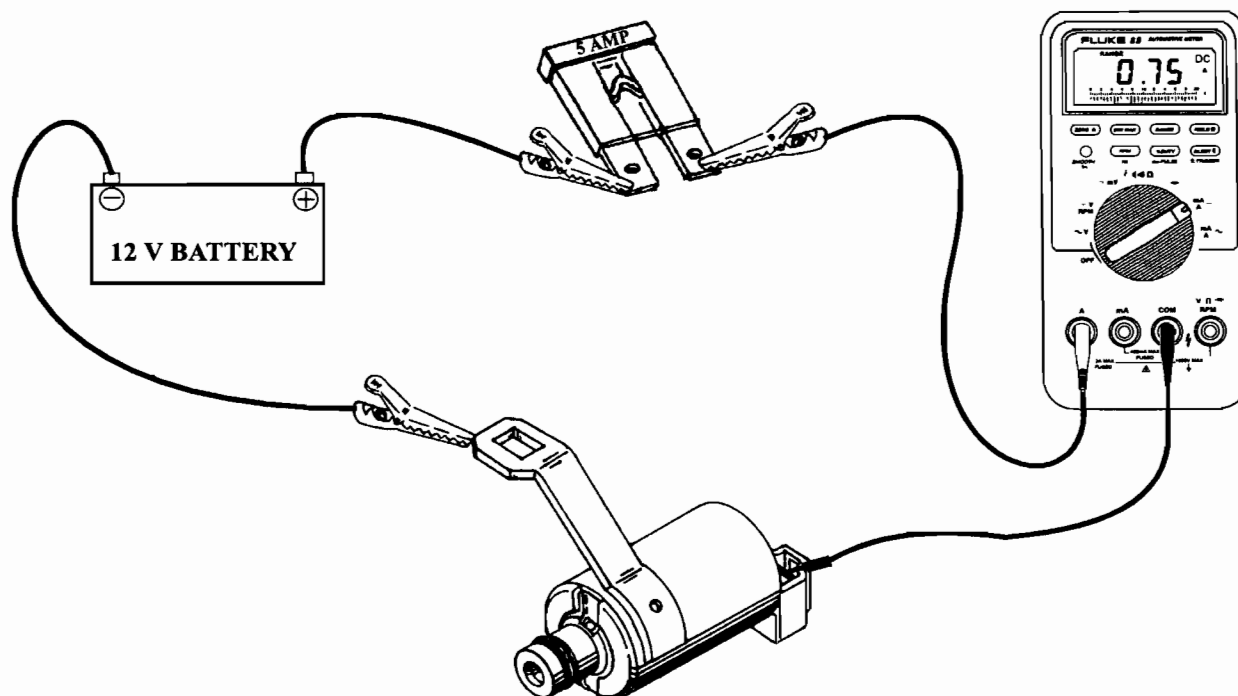
Figure 8

$$12 \text{ volts} \div 16 \text{ ohms} = .75 \text{ amps}$$

Before replacing the computer, let's go one step further for some "Cheap Insurance". Apply 12 volts to the solenoid, using a jumper wire with a 5 amp fuse from the vehicle fuse panel (See Figure 8). Using a DVOM, set to mA/A, measure the amperage draw of the solenoid in question (See Figure 8). We know that the solenoids on this transmission operate with a 12 volt signal, and we know that the resistance of the solenoid we are testing is 16 ohms. With a simple math equation we can know what the amperage draw of the solenoid *should* be.

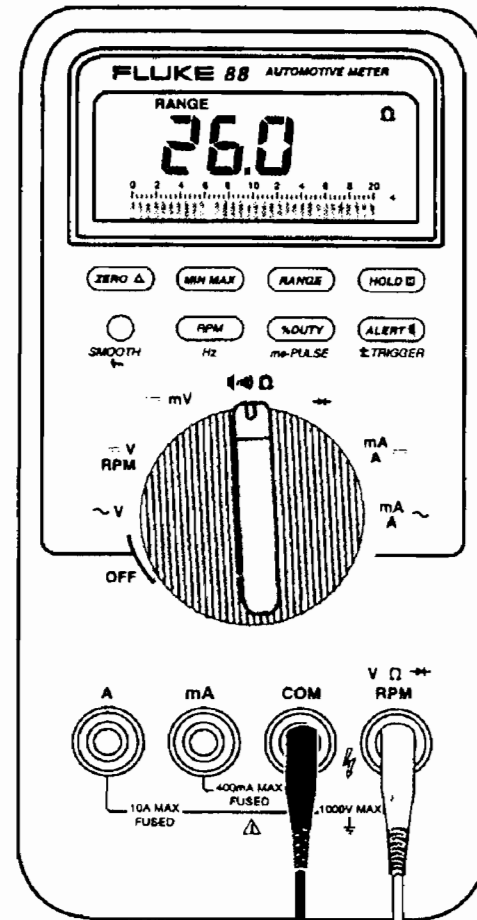
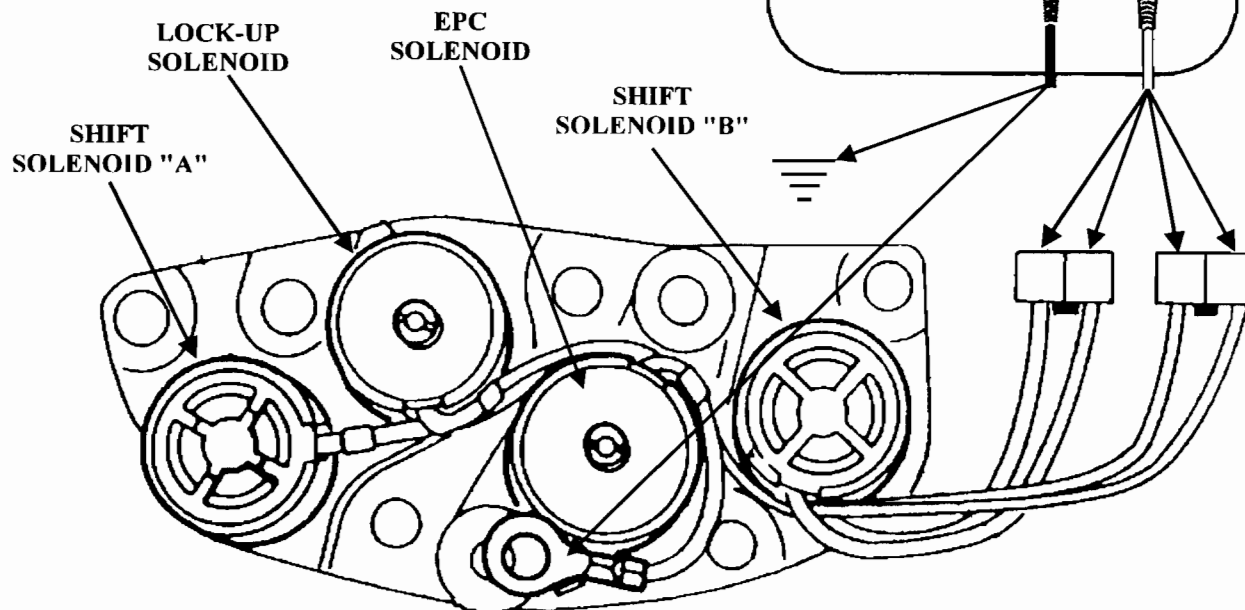
Figure 2

SOLENOID RESISTANCE CHART	
Solenoid	Ohms Resistance
Shift "A"	20 - 40
Shift "B"	20 - 40
Overrun (RE4R01A Only)	20 - 40
Lock-up	10 - 16
EPC	2.5 - 5.0

RE4FO2A SOLENOID LOCATION
IS SHOWN BELOW

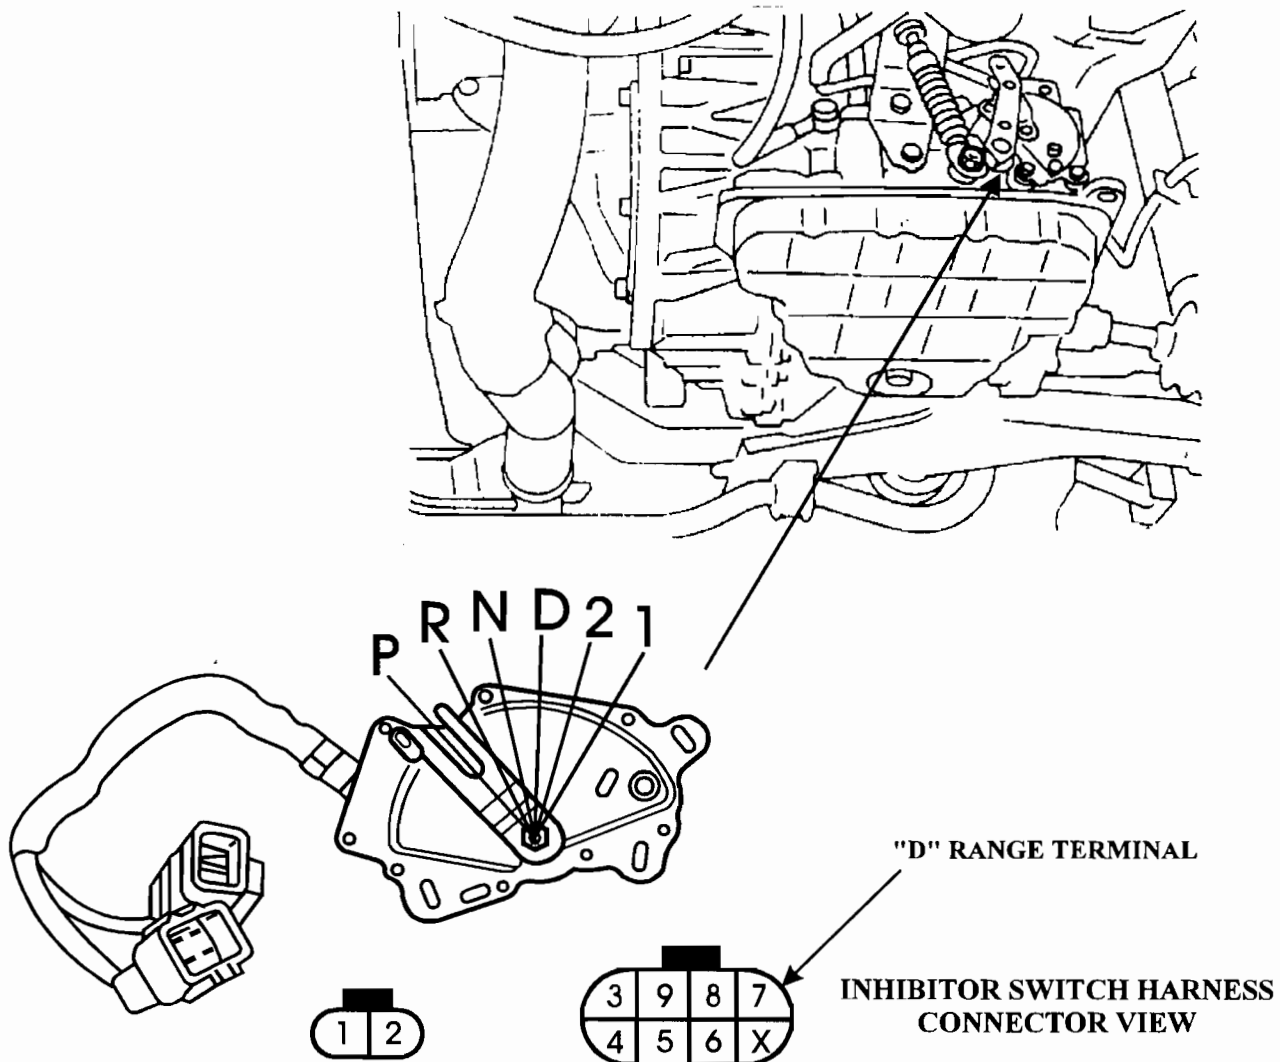
Figure 2

COMPLAINT: Vehicle exhibits a "Cycling" condition from 4th to 3rd to 4th gear. This condition may appear before and/or after rebuild.

CAUSE: The cause may be, a loose or broken, "D" range signal wire to the inhibitor switch, a bent or corroded pin in the harness connector, or a defective inhibitor switch.

NISSAN RE4FO4A
INHIBITOR SWITCH CONNECTORS

CORRECTION: Check the inhibitor switch and the connectors for any bent and/or corroded pins. If the connectors and pins are good, inspect the wires in the harness from the computer to the inhibitor switch, for any opens or shorts to ground with your DVOM. Refer to Figures 1 and 2 for locations of the inhibitor switch and views of the connectors on the RE4R01A and RE4F04A.

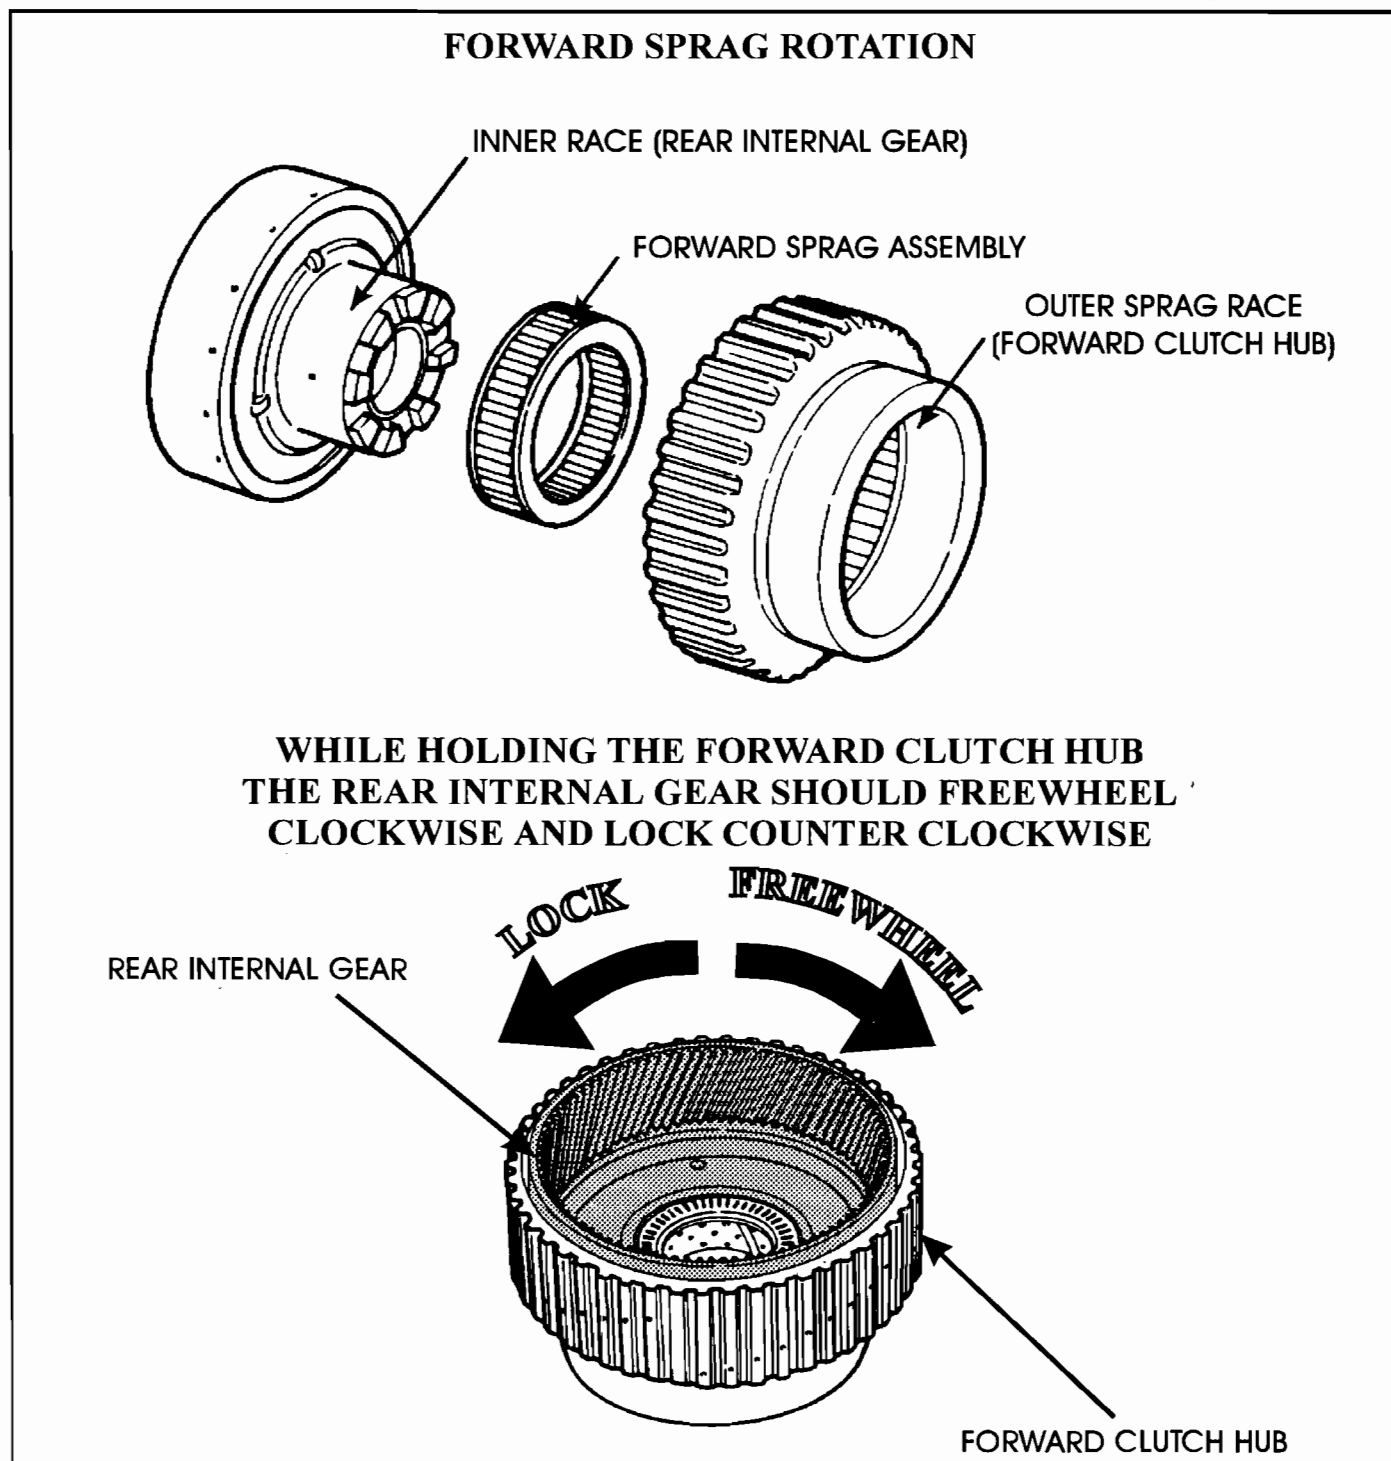
Figure 1

Some repair manuals are very confusing on which way the forward sprag should freewheel and which way that it should lock on the following transmissions: Isuzu JR403E, Nissan RL4F03A/V, RE4F03A/V, RE4F04A/V, Ford 4F20E. When the Forward Sprag is properly assembled, the internal ring gear should freewheel in a clockwise direction, and lock in a counter-clockwise direction, as shown in Figure 1.

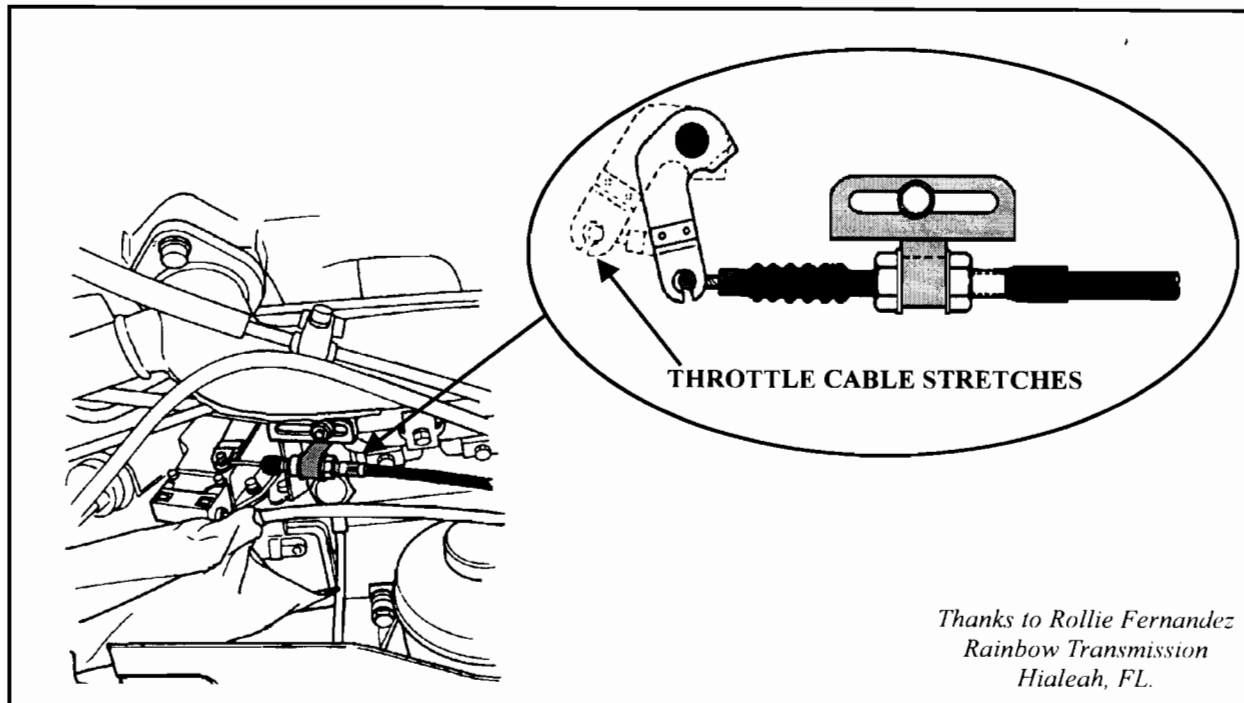
Figure 2

CAUSE: The cause of this problem is a stretched throttle cable which runs from the throttle pedal to the injector body lever. Due to the fact that the cable is so long,, the cable eventually stretches which causes the Throttle Position Sensor to drop in voltage before the throttle actually responds. The reason for this is, the TPS is mounted on the throttle pedal and responds to pedal movement before the cable opens the throttle. as shown in Figure 1. TPS voltage in these vehicles starts at 4.3 volts at closed throttle and ranges to 0.8 volts at wide open throttle. This allows the Transmission Control Unit to send late shift timing signals and an increase in line pressure at relatively low speed because the TCM thinks the throttle opening is greater than it is. (Refer to Figure 2)

CORRECTION: Replace the throttle cable.

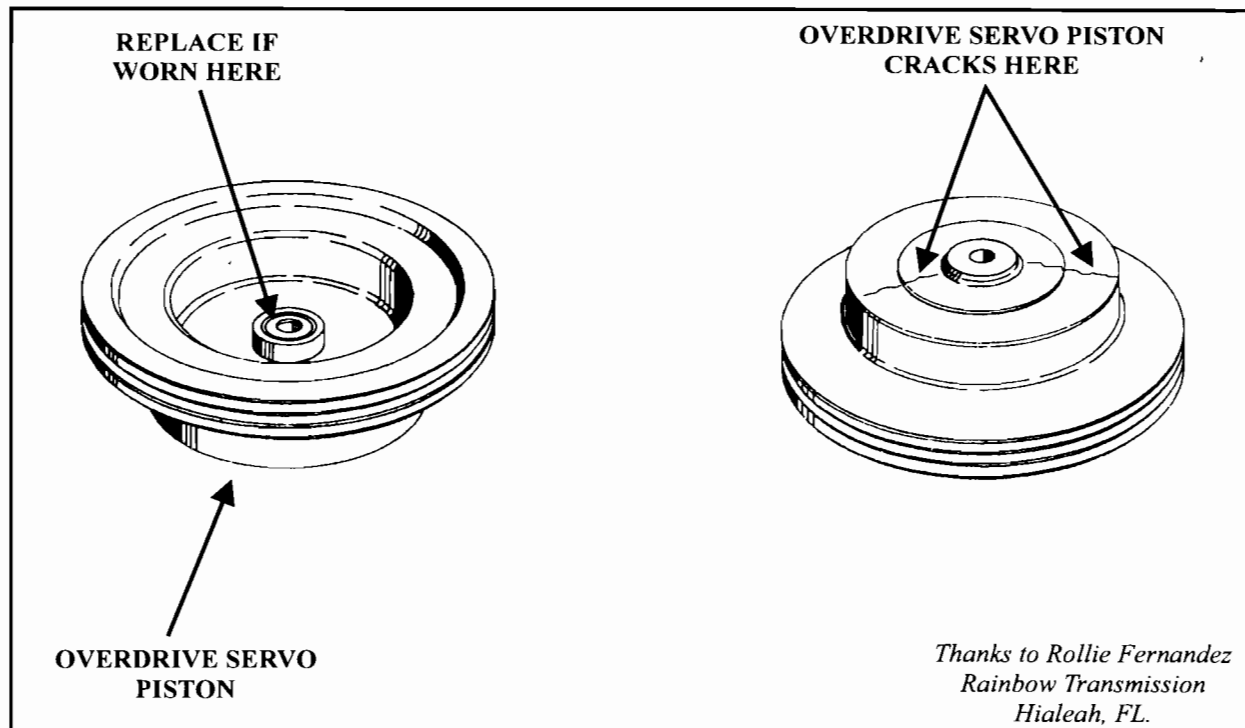
Figure 1

CAUSE: The cause is 2-4 band servo cover bolt fracture. Cracking of the overdrive servo piston also occurs as shown in Figure 1.
The servo cover retaining bolts are not hard enough, causing them to stretch and break, as illustrated in Figure 2, resulting in the servo cover coming loose, thereby creating a serious hydraulic leak within the servo circuit.
When this occurs, the overdrive servo piston will cock during its travel and due to lack of support, the servo piston will crack, adding to the severity of the above complaint.

Overdrive Servo Piston.....Part # 8-97039481-0
Hardened Servo Cover Retaining Bolts (4 Required).....Part # 8-97107-000-0

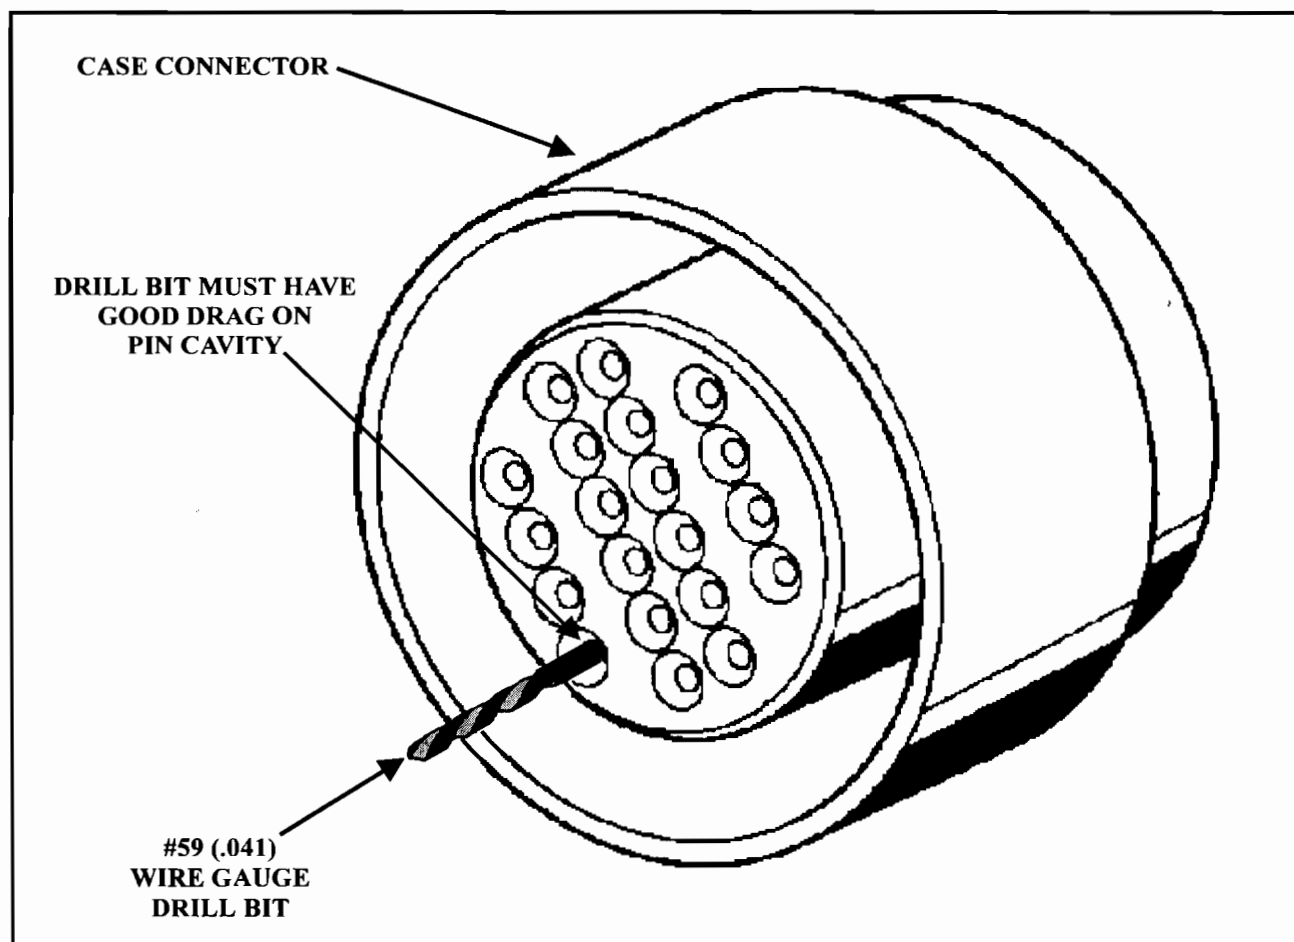
Figure 2

COMPLAINT: Some or all of codes 81, 82, 66, (84 on B & D Bodies) and 67 (85 on B & D Bodies) have been stored by the vehicles computer. After replacing all the related solenoids and clearing the codes, the above codes immediately return and computer replacement also does NOT cure the problem.

CORRECTION: First, check the pin cavities for good pin retention by using a #59 wire gauge drill bit, which measures .041 in diameter. Insert the drill bit into the pin cavities of the vehicle harness plug making certain the drill bit has a good drag in the cavity as shown in Figure 2. If the drill bit fits loosely, the vehicle harness plug will have to be replaced. Cavity and circuit identification for 1993-94 connectors are shown in Figures 3 and 4. Cavity and circuit identification for 1995 and later connectors are shown in Figures 5 and 6. The next step is to verify circuit integrity. This is done by checking the resistance for the complete circuit in question.

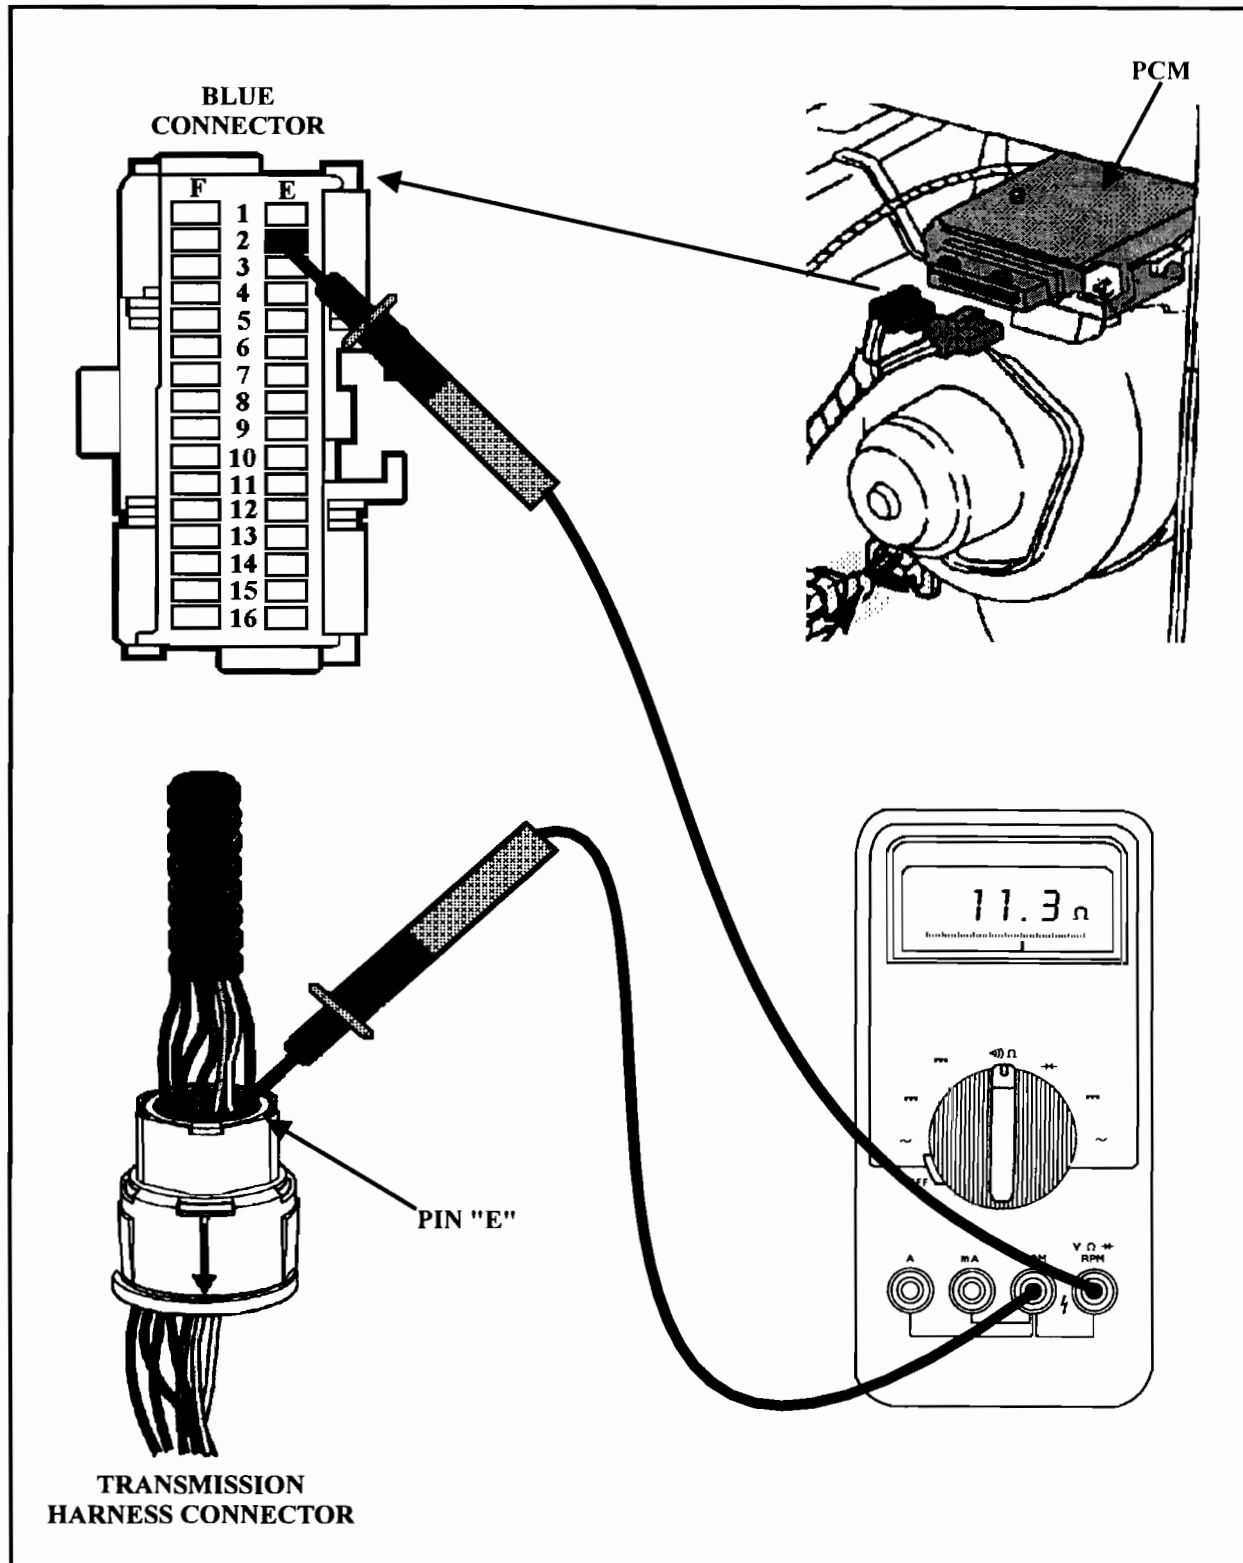
Figure 27

4L60E REOCCURRING CODES

DTC's 81, 82, 66, 67, 84 and 85

The example used here is a reoccurring code 66 which is a 3-2 control solenoid circuit fault in a 1994 GMC "C" Truck.
- 4-Referring to Figure 27, disconnect the WHITE wire at terminal E2. This will be the negative side of the circuit. This is where the BLACK lead of the ohm meter will go.

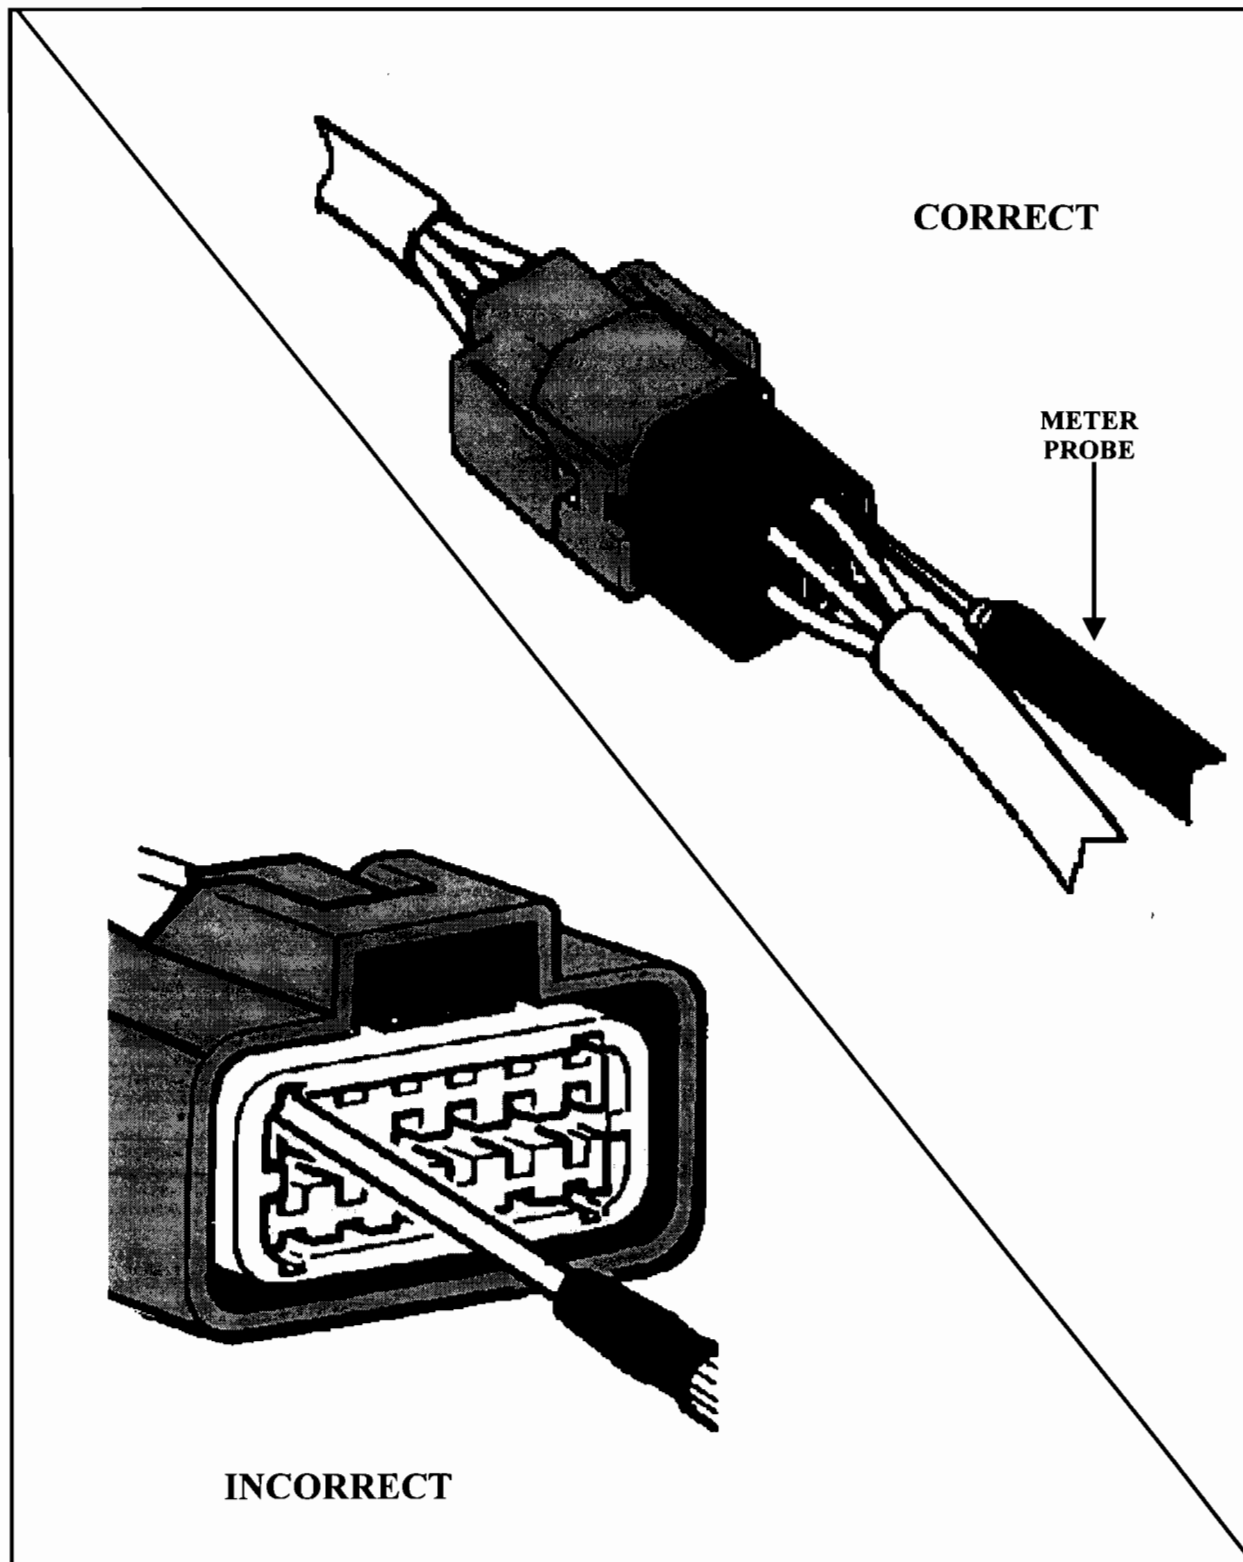
Figure 28

4L60E REOCCURRING CODES

DTC's 81, 82, 66, 67, 84 and 85

CAUTION: When probing connector terminals, always back probe the terminals to avoid expanding the connector cavities as shown in Figure 28.

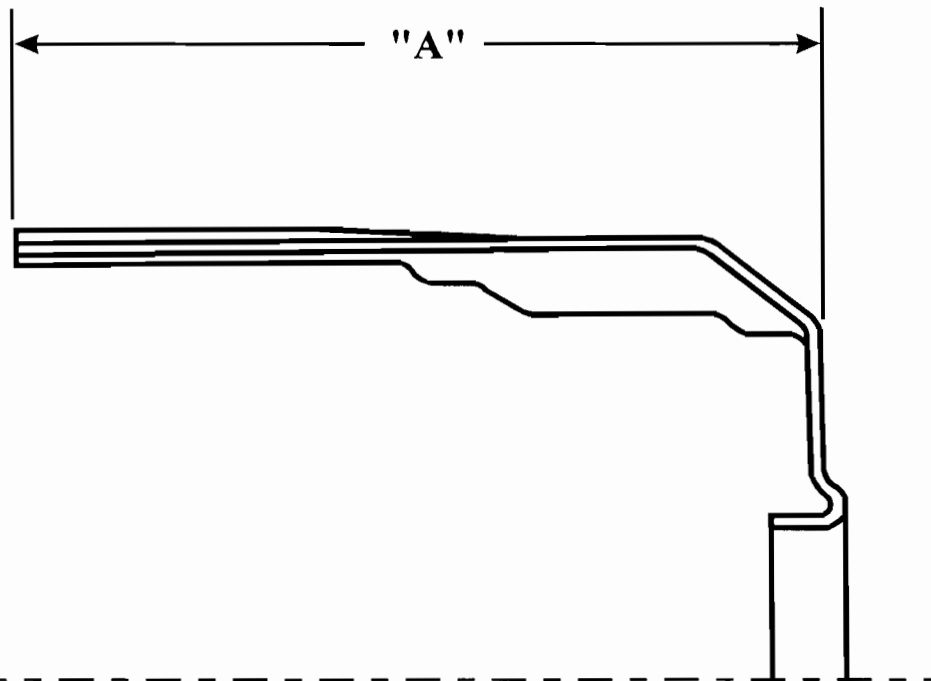
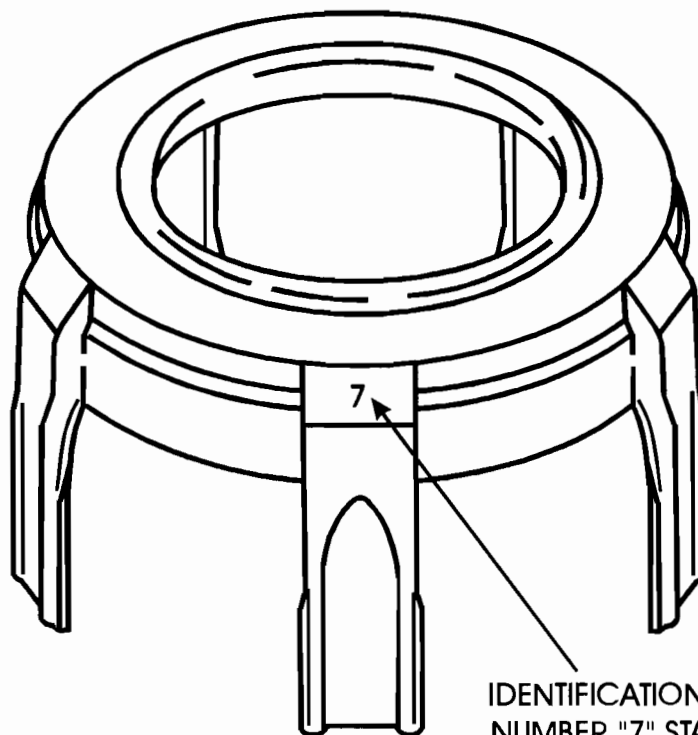
Figure 1

NEWEST DESIGN LEVEL 3-4 APPLY RING

DIMENSION "A" ON NEW DESIGN IS 3.671" - 3.682" (93.26mm - 93.52mm)

IDENTIFICATION FOR NEW DESIGN IS
NUMBER "7" STAMPED ON ONE LEG.

1. New design 3-4 Apply Ring with shorter legs (See Figure 1).
2. New design one piece 3-4 Apply Plate (See Figure 2).
3. New design .106" thick 3-4 Steel Plates, 5 required (See Figure 3).
4. New design high energy 3-4 Friction Plates, 6 required (See Figure 3).
5. New design 3-4 Selective Backing Plate, as they are thinner (See Figure 4).
6. Re-install the 3-4 Load Release Springs in the late design stack-up (See Figure 5).
7. **Note:** Ensure that you have .050"-.070" clutch clearance (See Figure 4).

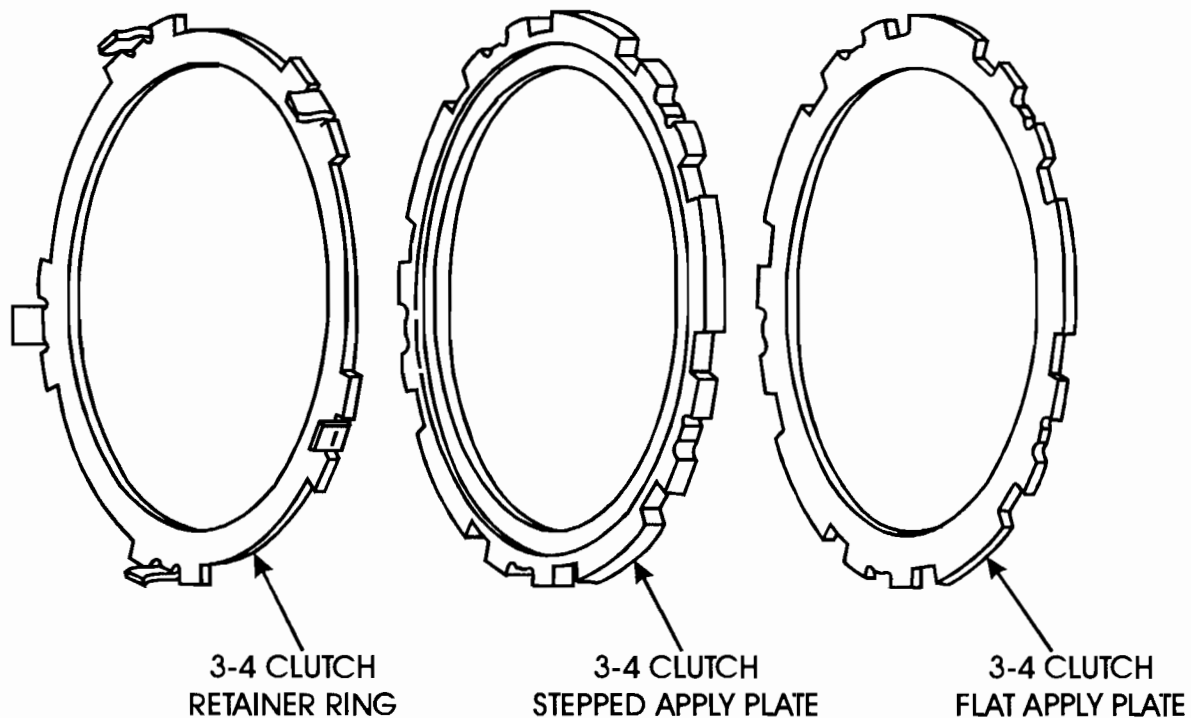
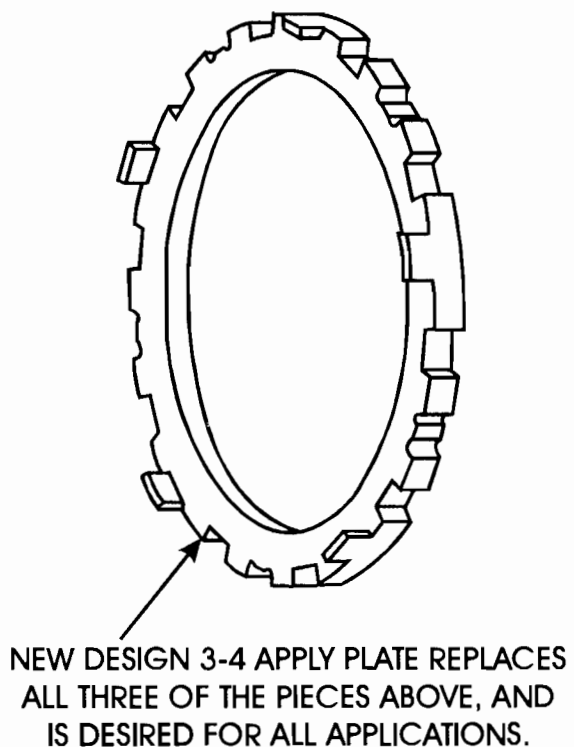
Figure 2

PREVIOUS DESIGN LEVEL APPLY PLATES

NEWEST DESIGN LEVEL APPLY PLATE

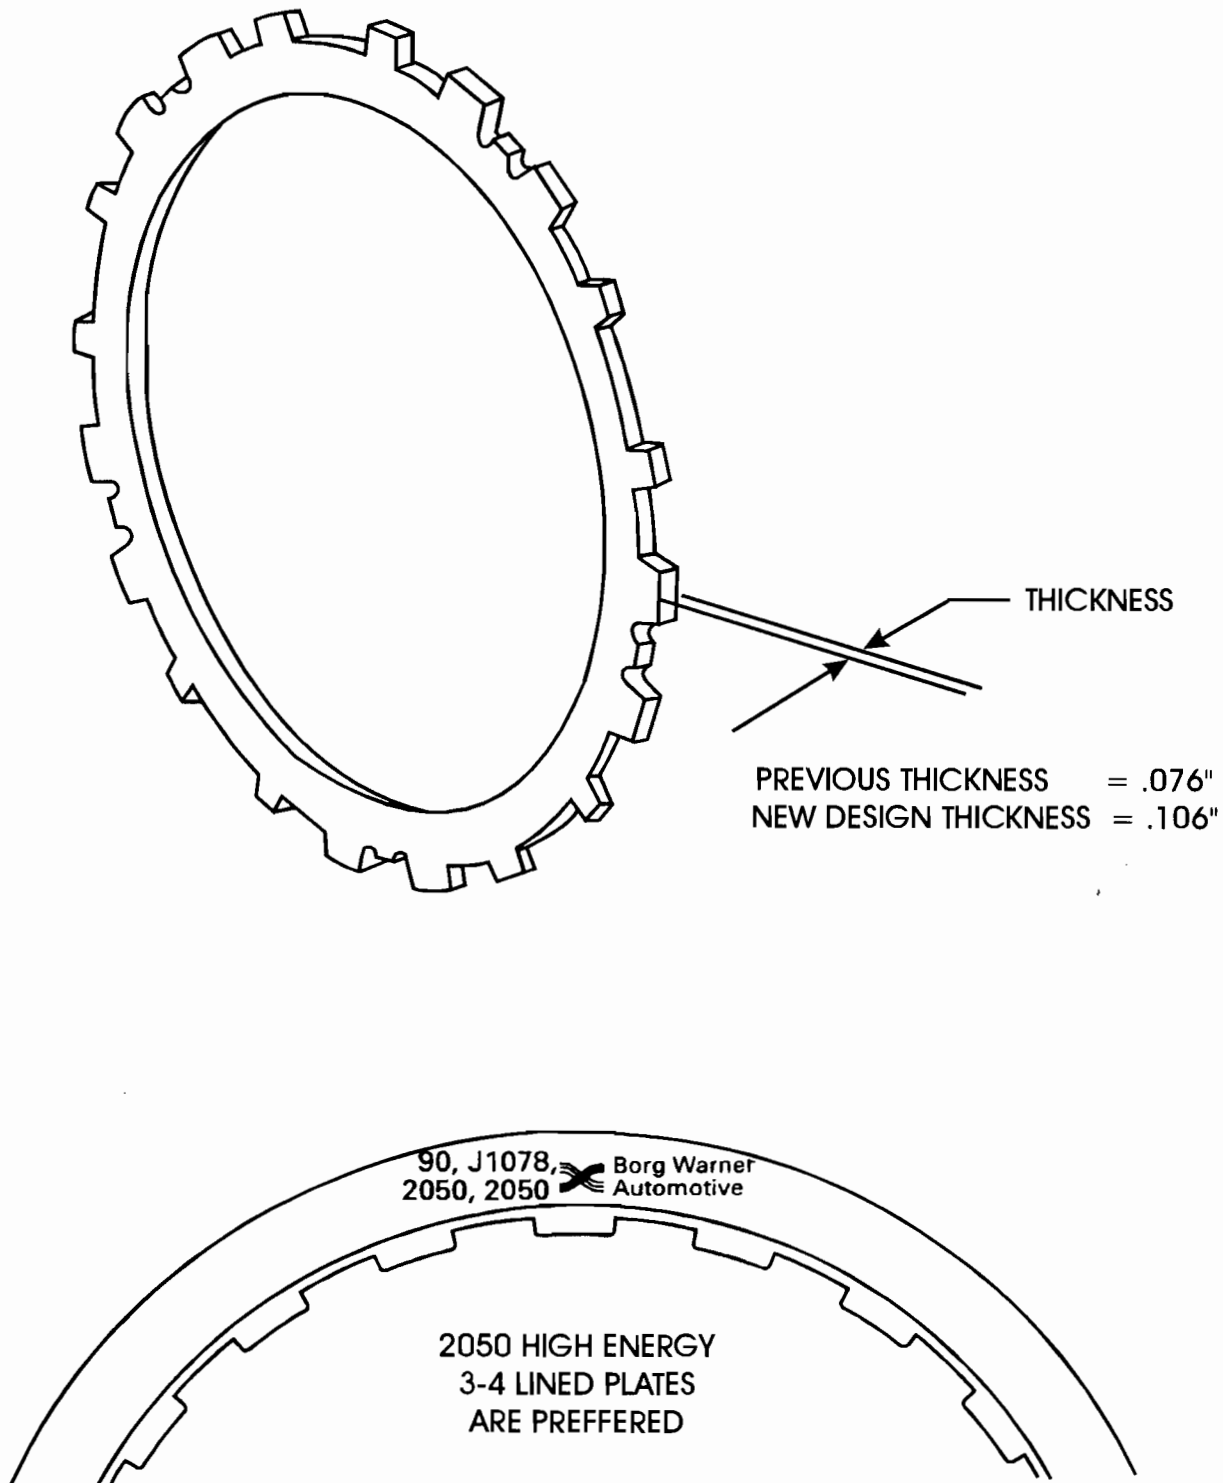
Figure 3

3-4 CLUTCH LINED AND STEEL PLATES
