1997 SEMINAR INFORMATION

"THE RIGHT DIRECTION FOR '97"

AUTOMATIC TRANSMISSION SERVICE GROUP
9200 S. DADELAND BLVD.
SUITE 720
MIAMI, FL 33156
(305) 670-4161

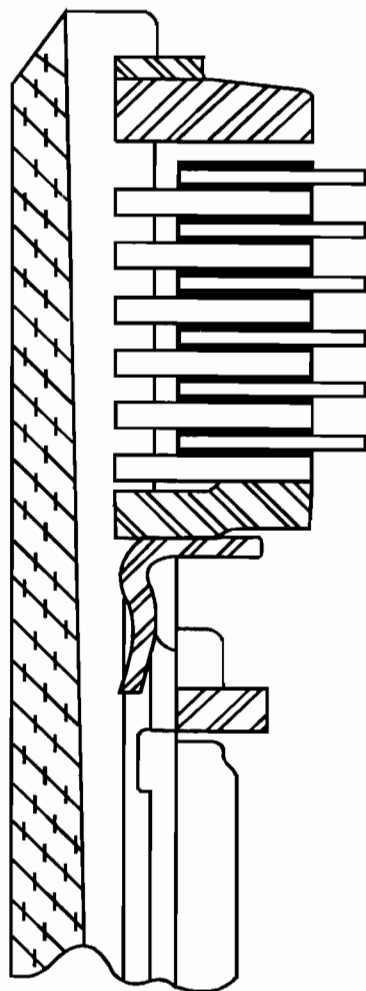
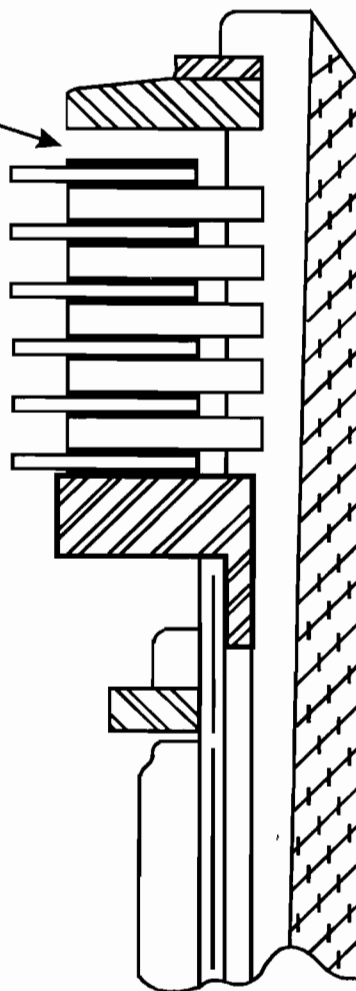
Figure 4

3-4 CLUTCH STACK-UP

CHECK FOR .050" - .070"
CLEARANCE HERE

1. New design 3-4 Apply Ring with shorter legs (See Figure 1).
2. New design one piece 3-4 Apply Plate (See Figure 2).
3. New design .106" thick 3-4 Steel Plates, 5 required (See Figure 3).
4. New design high energy 3-4 Friction Plates, 6 required (See Figure 3).
5. New design 3-4 Selective Backing Plate, as they are thinner (See Figure 4).
6. Re-install the 3-4 Load Release Springs in the late design stack-up (See Figure 5).
7. **Note:** Ensure that you have .050"-.070" clutch clearance (See Figure 4).

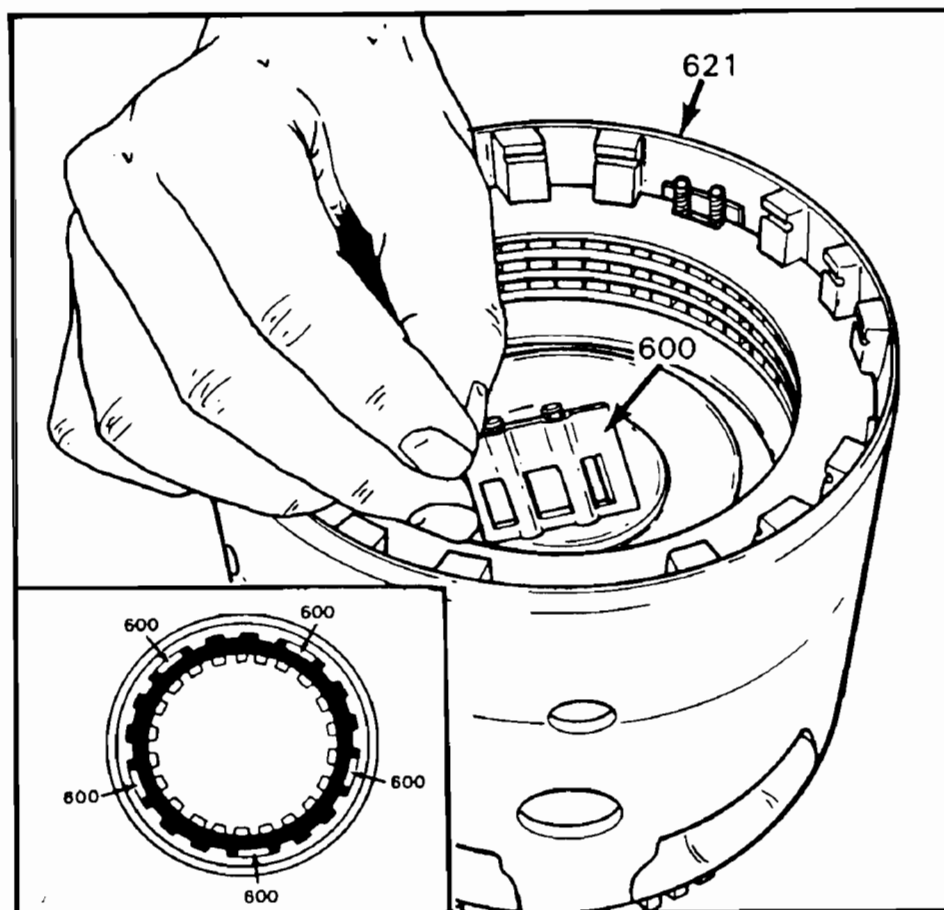
Figure 5

**RE-USE THE 3-4 LOAD RELEASE SPRINGS
IN THE NEW DESIGN CLUTCH PACK ONLY**

Re-install the 3-4 load release springs when you are using the .106" thick steel plates, 2050 high energy lined plates, new design 3-4 apply ring, new design one piece apply plate, and new design backing plate.

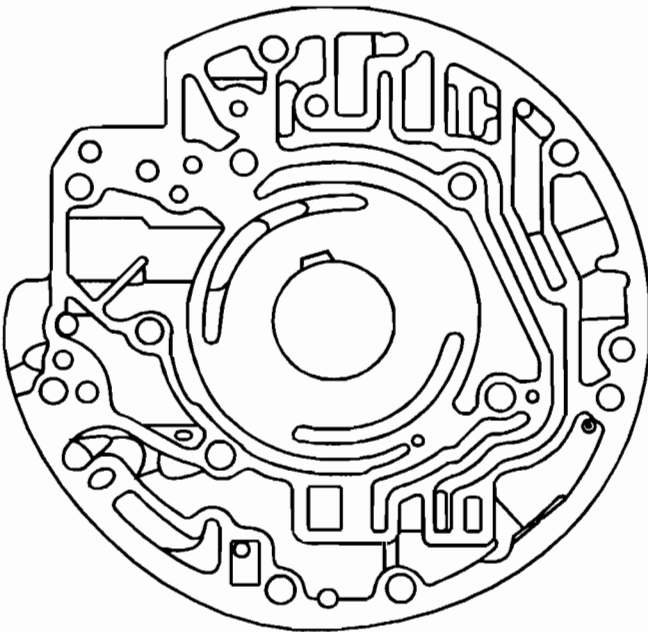
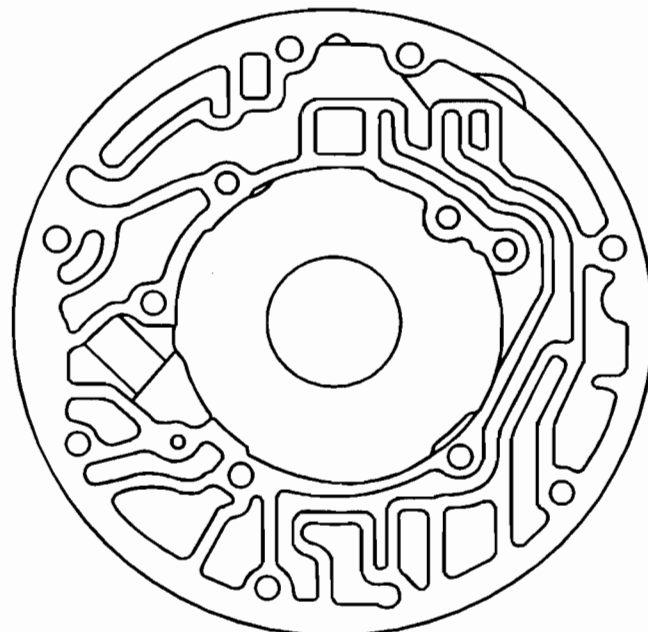
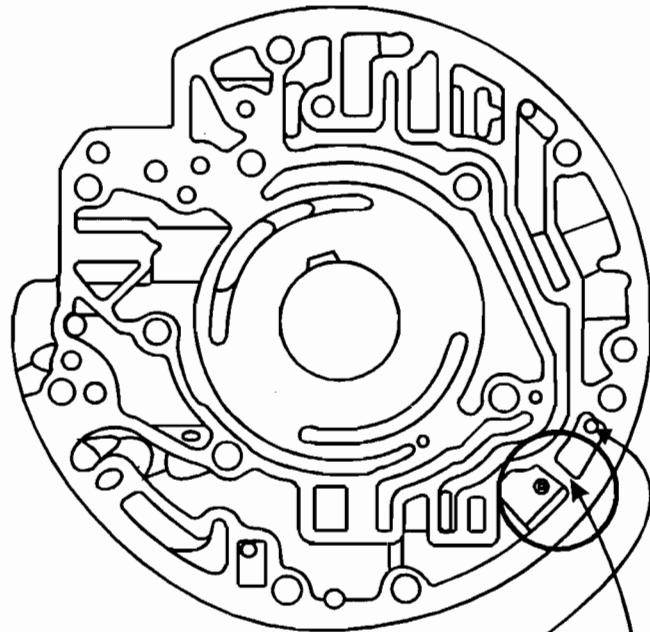
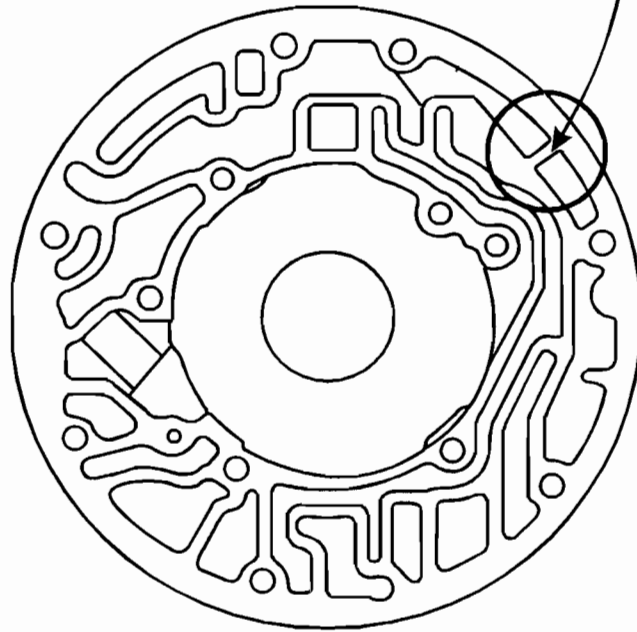
REASON: To reduce pump fluid leaks and a "Moaning" noise created by the small leak.

- (1) PUMP BODY - Oil dam added in the line pressure passage to stop the channels from spreading in that particular area during higher line pressure conditions. The casting changes can easily be seen in Figure 1.
- (2) PUMP COVER - Oil dam added in the line pressure passage to correspond with the oil dam added in the pump body. The casting changes can be easily seen in Figure 1.

"A"
ADDED
OIL DAM

- (1) The new design Pump Body, *with oil dam*, will function with the previous design Pump Cover, but is not recommended.
- (2) The new design Pump Cover, *with oil dam*, **CANNOT** be used with the previous design Pump Body, unless modifications are made. Loss of main line pressure will be the result

However, if you are experiencing any pump leakage or strange noises, you should use the "Dam Type" Pump Body and Cover.

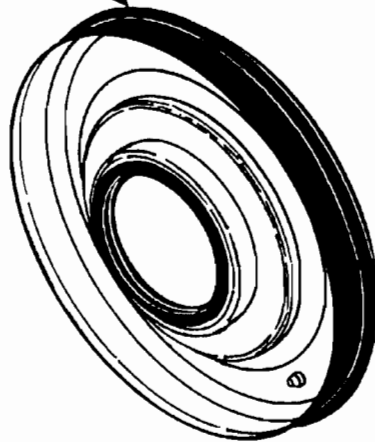
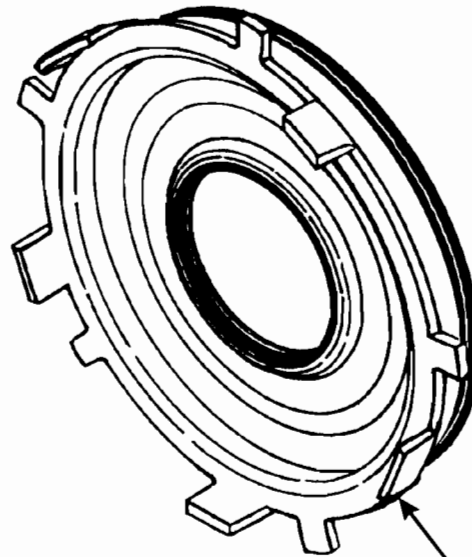
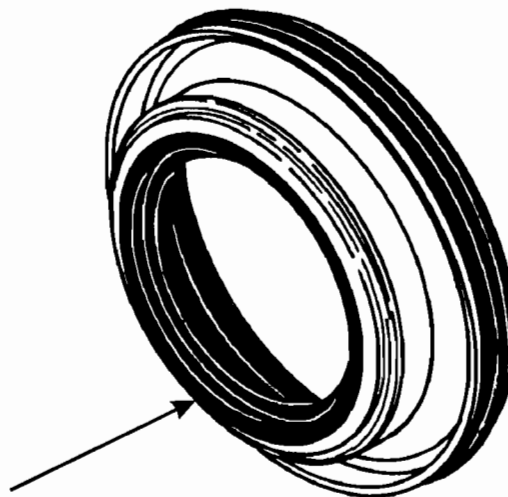
Figure 1

- (1) FORWARD CLUTCH PISTON - Now manufactured of stamped steel with moulded rubber inner and outer seals, for increased durability against cracking (See Figure 1).
- (2) OVERRUN CLUTCH PISTON - Now manufactured of stamped steel with moulded rubber inner and outer seals, for increased durability and cost savings (See Figure 1).
- (3) 3-4 CLUTCH PISTON - Now manufactured of stamped steel with moulded rubber inner and outer seals, for increased durability and cost savings (See Figure 1).

ALL PISTONS IN THE INPUT HOUSING ARE NOW
STAMPED STEEL, WITH MOULDED RUBBER SEALS
