"2006" SEMINAR INFORMATION

AUTOMATIC TRANSMISSION SERVICE GROUP

"Top Tech Tricks for 2006"

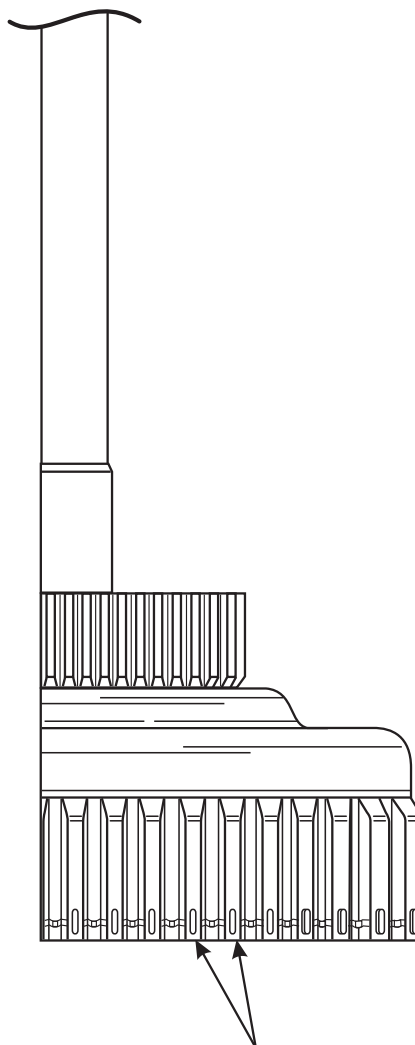
NEW DESIGN

***34 STAMPED PROJECTIONS
ON THE OUTSIDE OF THE DRUM
THAT THE ADDED TURBINE SENSOR
READS FROM***

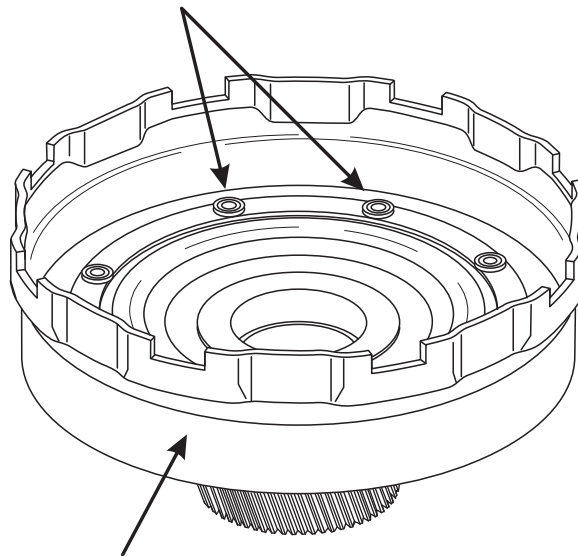
NEW DESIGN
4L3Z-7A019-BA

***New Sun Shell Is Now Riveted
To The Sun Gear And Hub***

NON-FERROUS METAL

***NOTE: The New Sun Shell is made from
a non-magnetic material so the Turbine sensor
can read the Forward drum.
2005 models use the same type of Sun Shell
and there are no rivets for identification.
Ford Part number 5L3Z-7A019-AB***

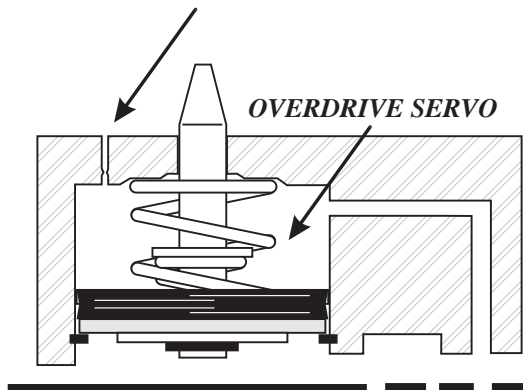
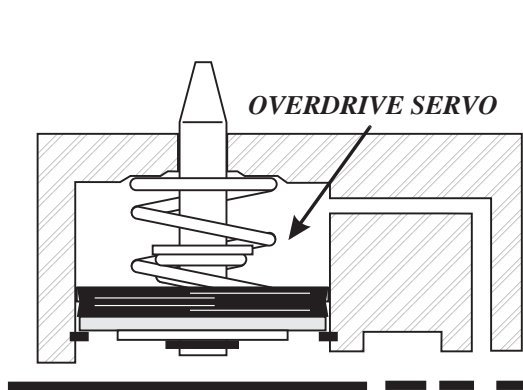
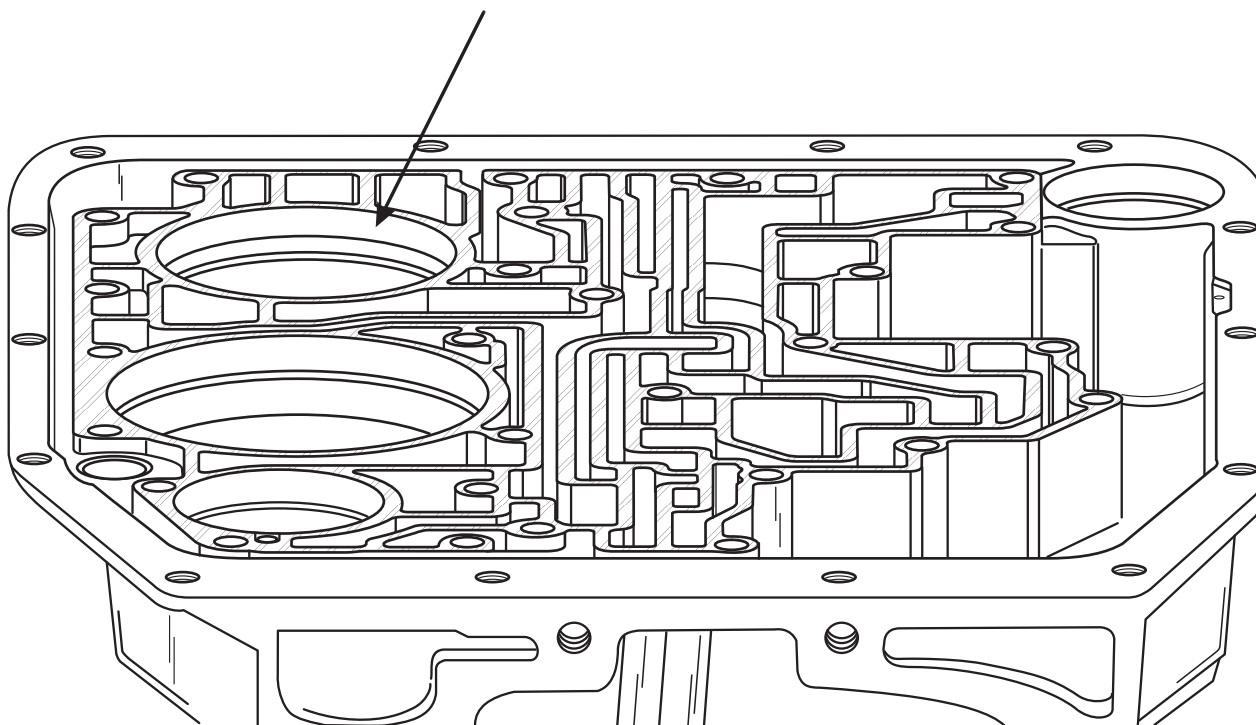
Figure 10

- (6) CASE - The Overdrive Servo Bleed orifice, as shown in Figure 10, was eliminated to accommodate the hydraulic circuit changes in the Overdrive Servo Regulator Valve. See Figure 11 for a partial hydraulic circuit diagram identifying the 2001 and up hydraulic circuit.

PREVIOUS DESIGN
CASE WITH .020" BLEED ORIFICE

2001 & UP DESIGN
CASE WITHOUT BLEED ORIFICE

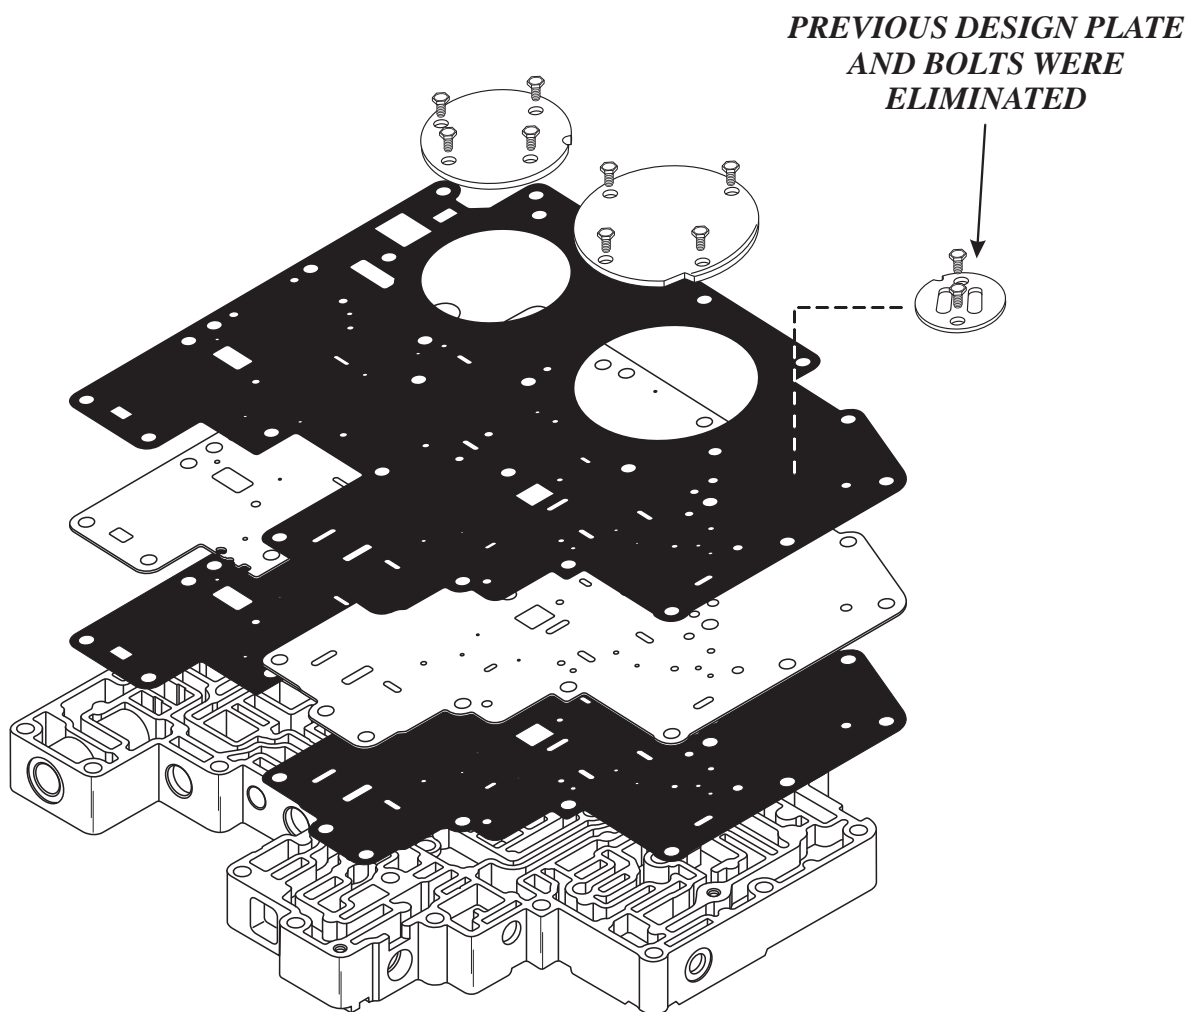
Figure 2

2001 MODEL 4R70W VALVE BODY

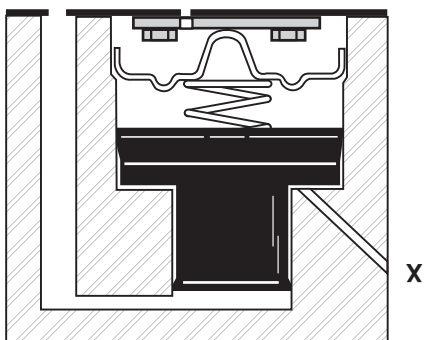
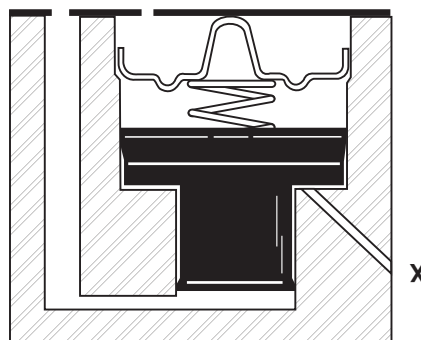
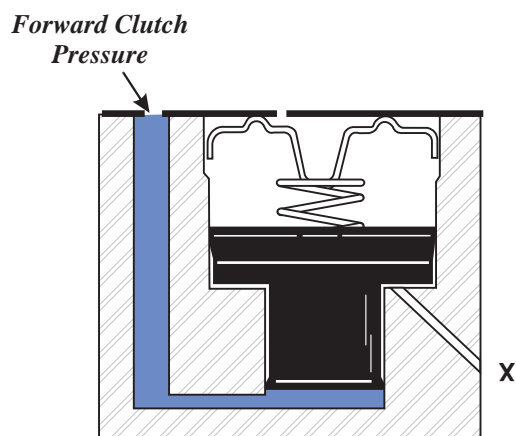
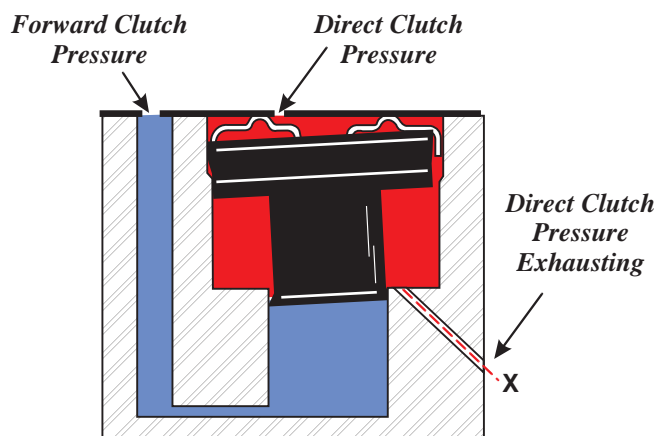
CAUSE: The cause may be that a previous design 2-3 accumulator retainer was used, or the retainer was assembled upside down, when installing it into the case. **NOTE:** 2001 and up Valve Body assemblies, as shown in Figure 2, do not use the small plate that is over the 2-3 accumulator retainer. This made necessary a taller 2-3 accumulator retainer as shown in Figure 1. When the wrong 2-3 accumulator retainer is used or if the retainer is upside down, the 2-3 accumulator piston may pop out of its bore dumping Direct Clutch pressure to an exhaust. See Figure 3 for a cutaway of the correct and incorrect assembly.

2-3 ACCUMULATOR AND RETAINER CUTAWAY

**INCORRECT ASSEMBLY
BEFORE**

**INCORRECT ASSEMBLY
AFTER**

Note: When the 2-3 Accumulator piston retainer is installed up-side down the Accumulator may come out of it's bore and connect the Direct Clutch to an exhaust

CORRECTION: Refer to Figure 4 for the location and installation of the 2-3 accumulator retainer, piston and spring.

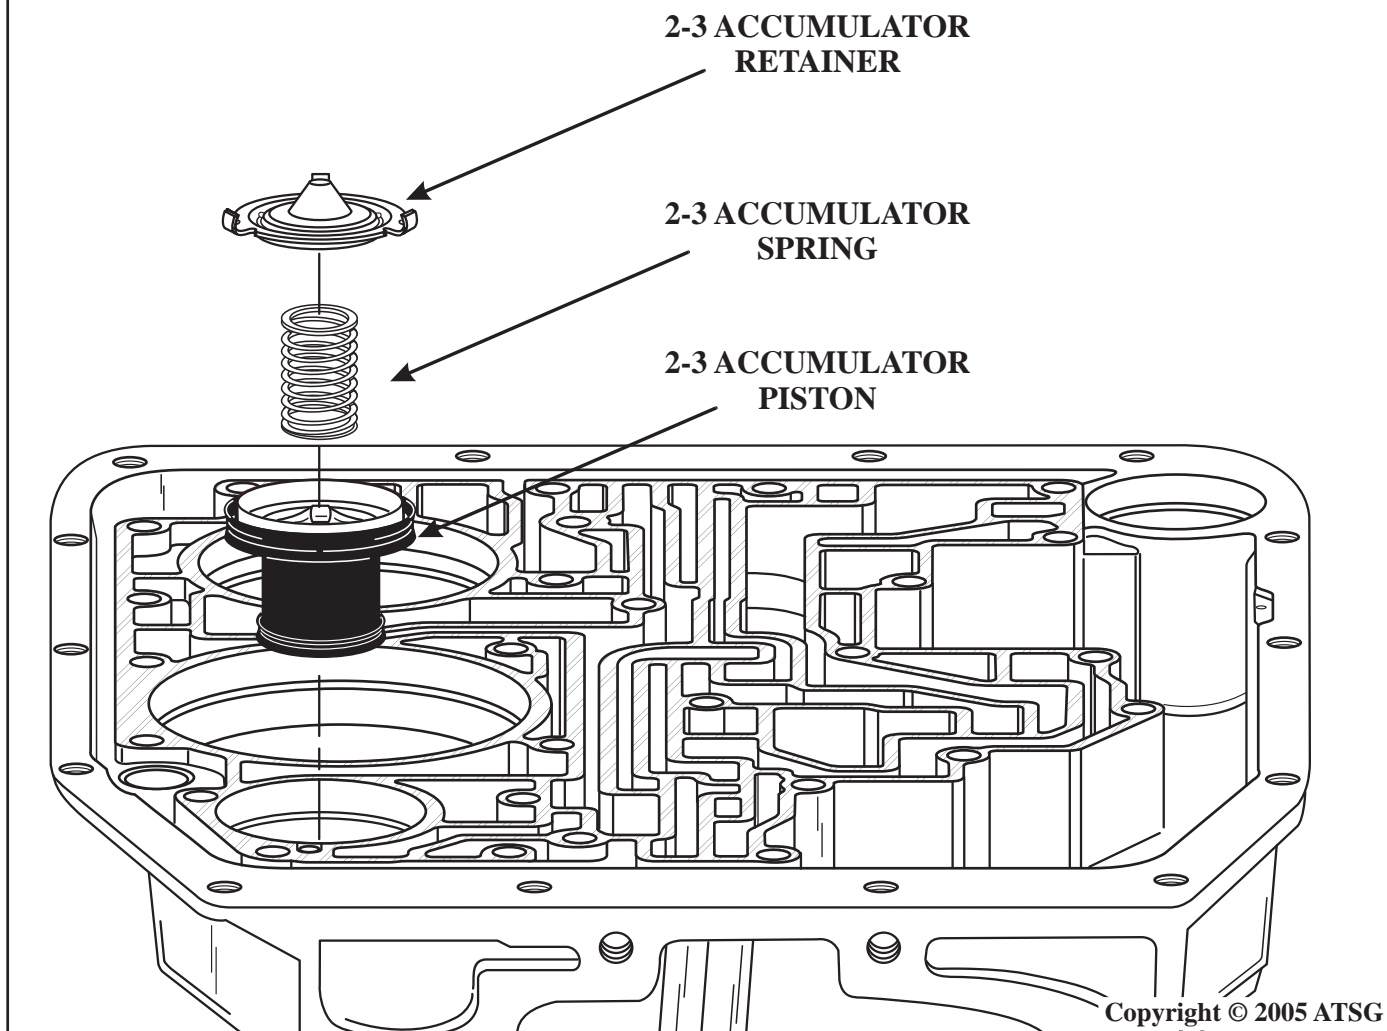
Figure 4

2-3 ACCUMULATOR LOCATION

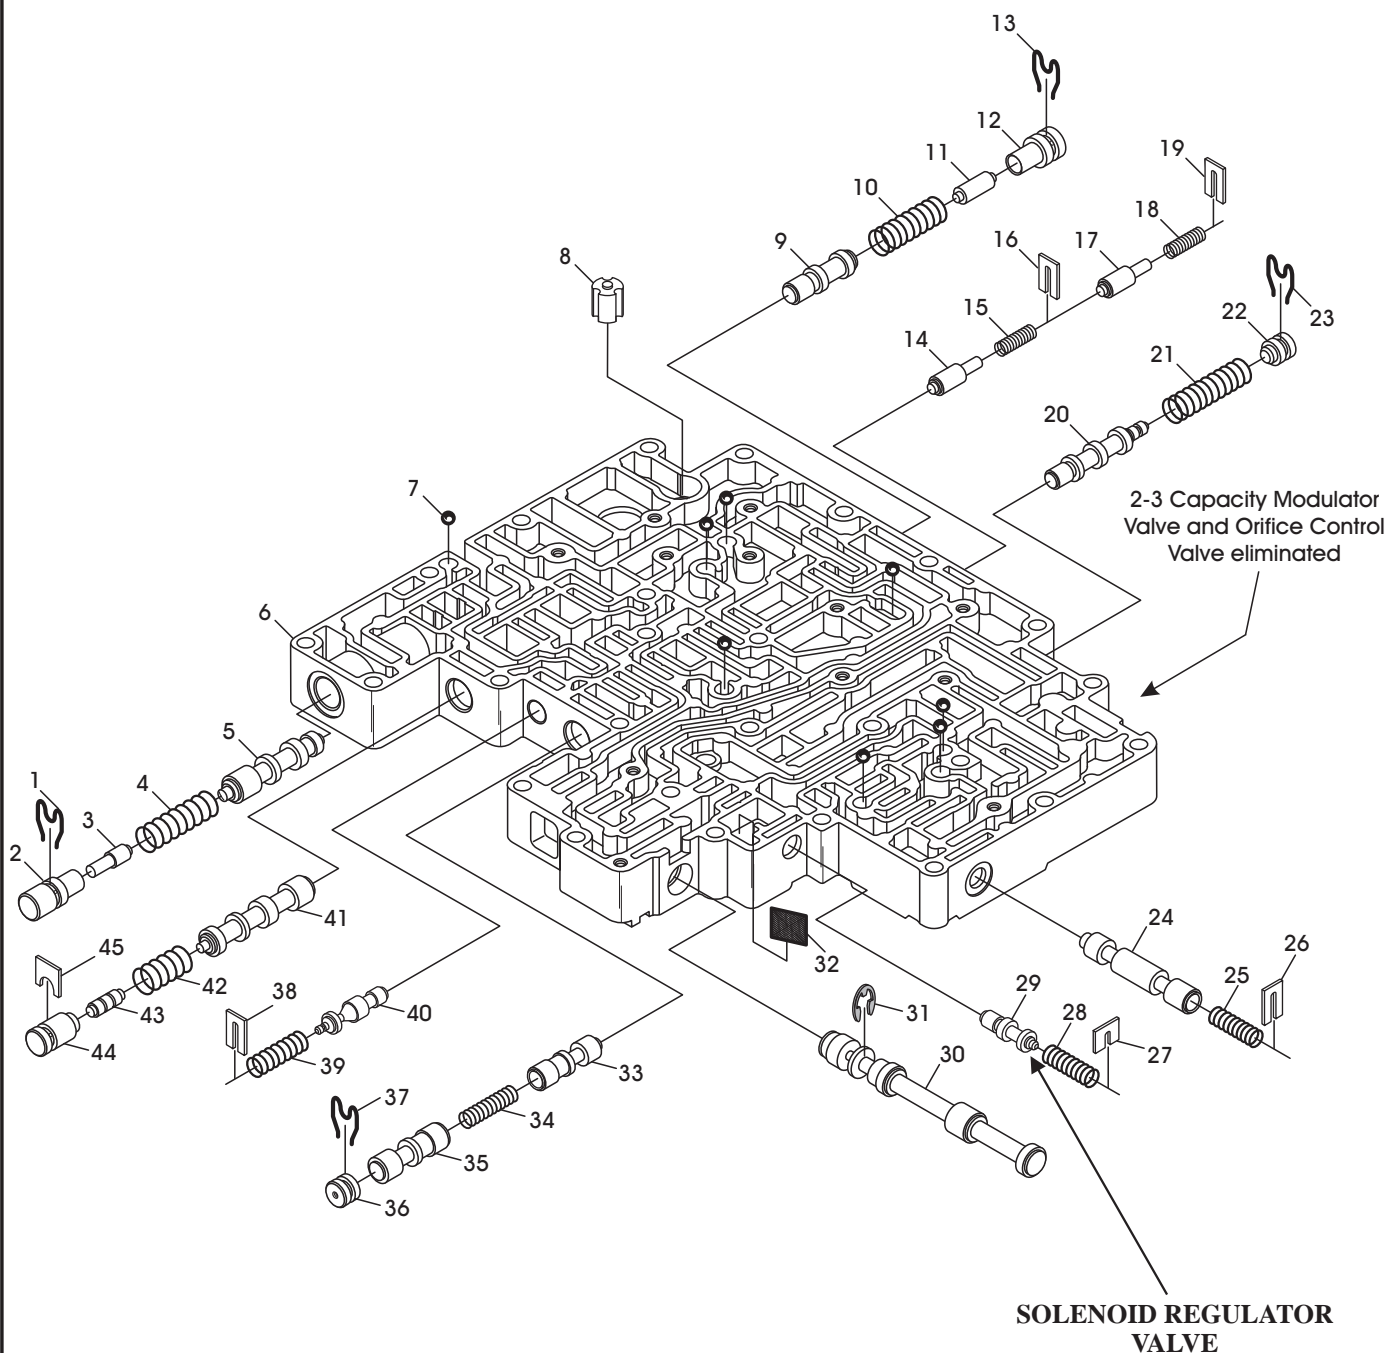
Figure 3

- (2) Another cause for this condition may be that the Solenoid Regulator Valve has become stuck down in the bottom of the Valve Body bore causing the pressure in the Solenoid Regulator Circuit to become higher than the Shift Solenoid 2 can exhaust, allowing the Shift Solenoid 2 pressure to build up and strokes the 3-4 Shift Valve to the right exhausting the Forward Clutch, creating the neutral condition. (See Figure 2) No Diagnostic Trouble Codes will be set. See Figures 3 and 4 for valve identification.

FORD 4R70W 2001-UP MAIN VALVE BODY EXPLODED VIEW

- (1) Repair or replace the damaged Shift Solenoid 2 wire. Refer to Figures 7 and 8 to locate the proper year and model vehicle that you are working on. Wire Diagrams have been provided in Figures 9, 10, 11 and 12.
- (2) Locate the Solenoid Regulator Valve in the Valve Body. See Figures 3 and 4 To repair a sticking Solenoid Regulator Valve, it may become necessary to replace the valve assembly. There are replacement Solenoid Regulator Valve Kits available in the Aftermarket.
- (3) Replace the Shift Solenoid 1 and 2 assembly.

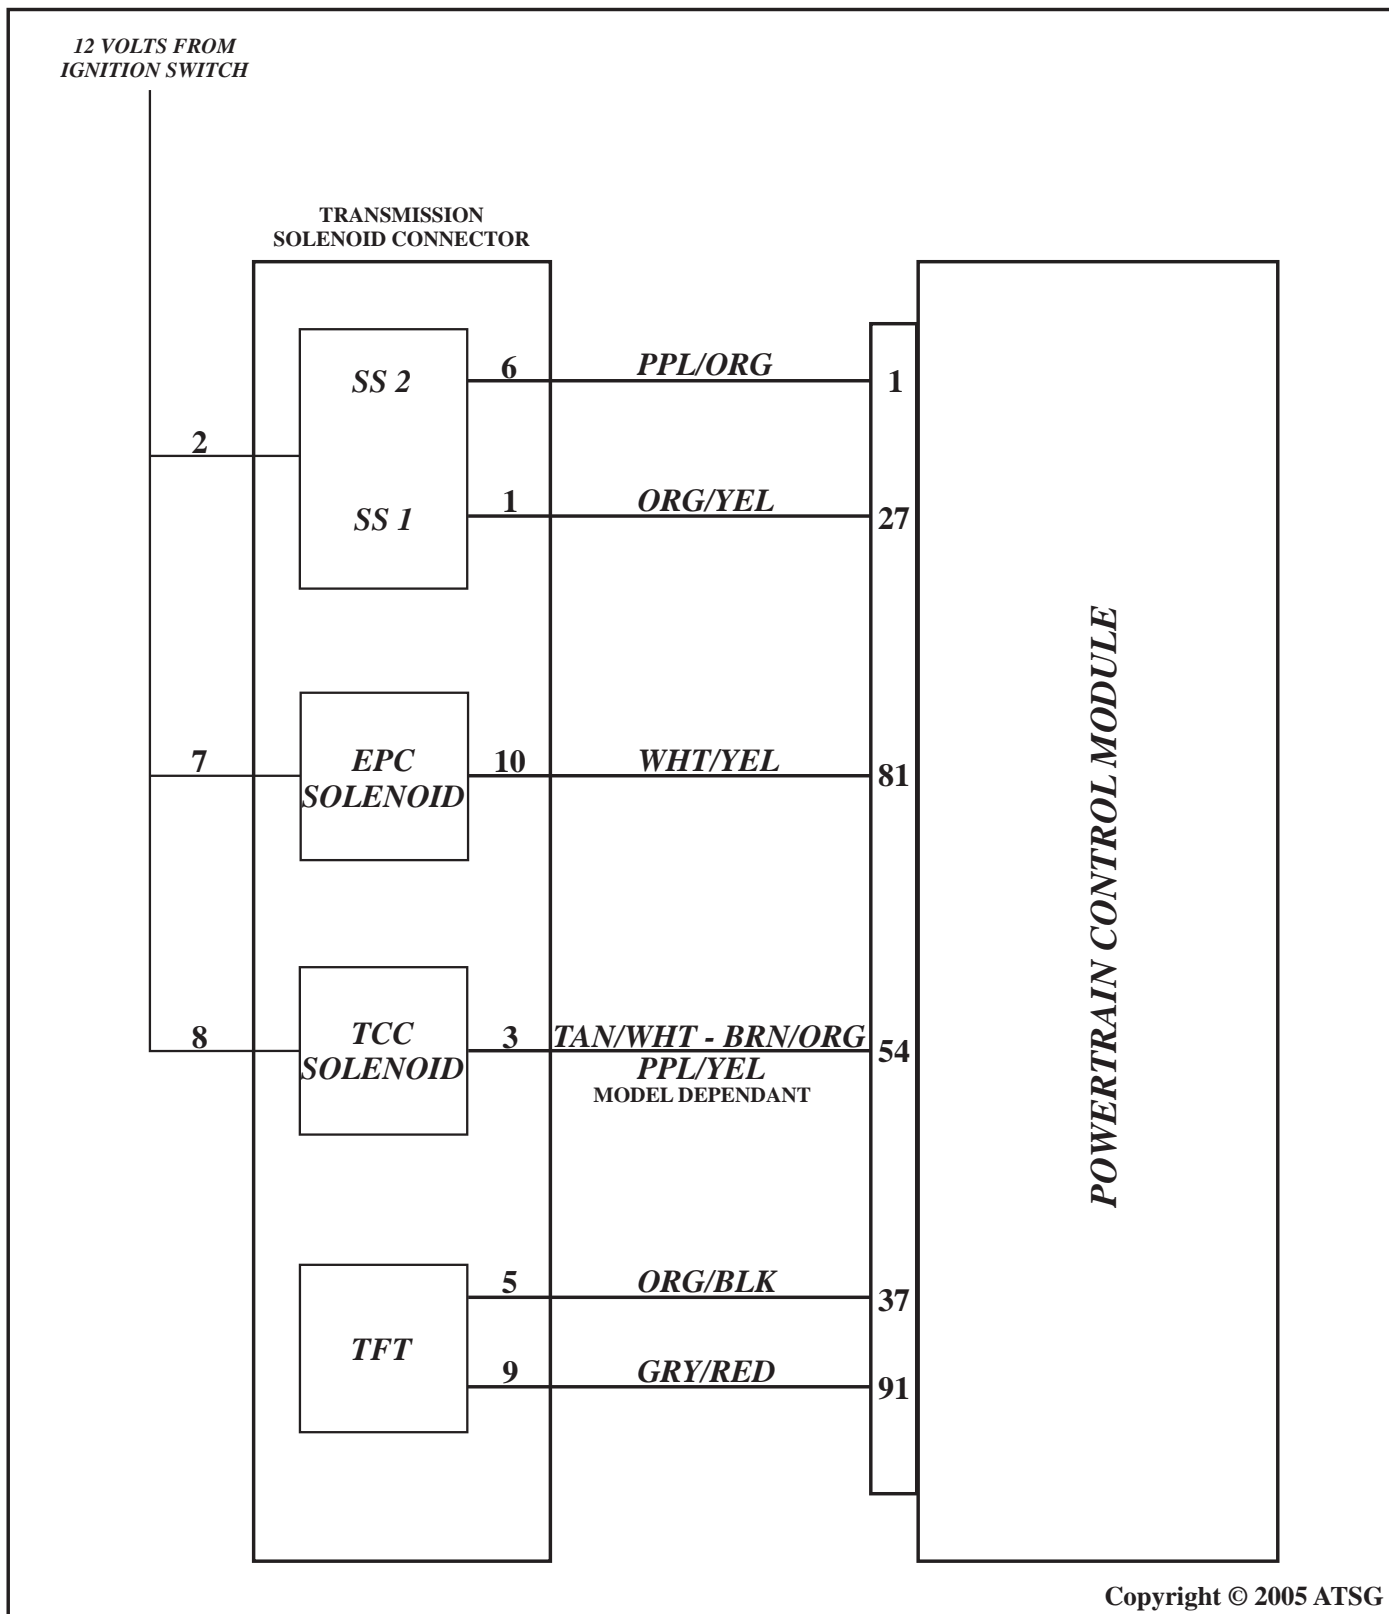
Figure 9

SHIFT SOLENOID 2 ELECTRICAL DIAGRAMS

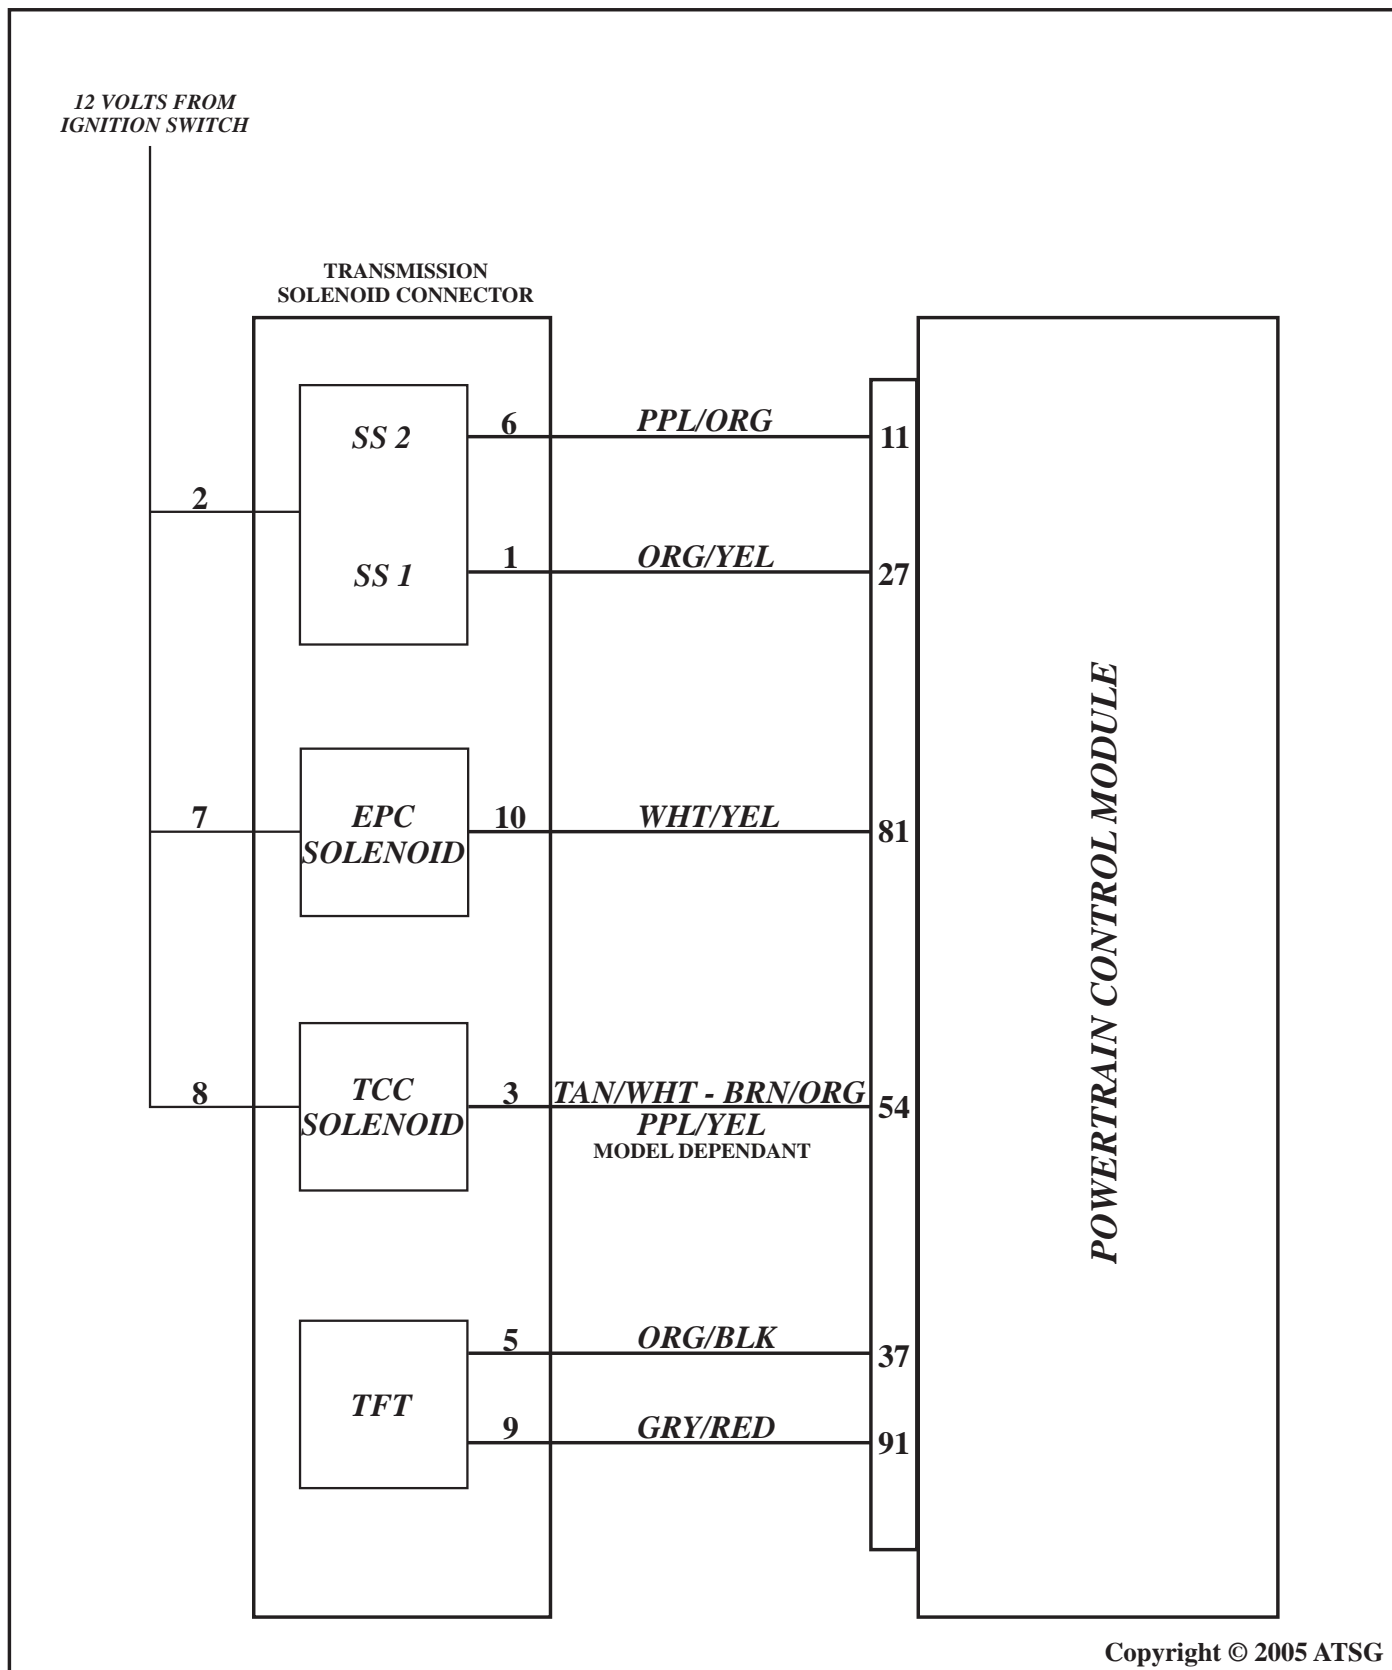
Figure 10

SHIFT SOLENOID 2 ELECTRICAL DIAGRAMS

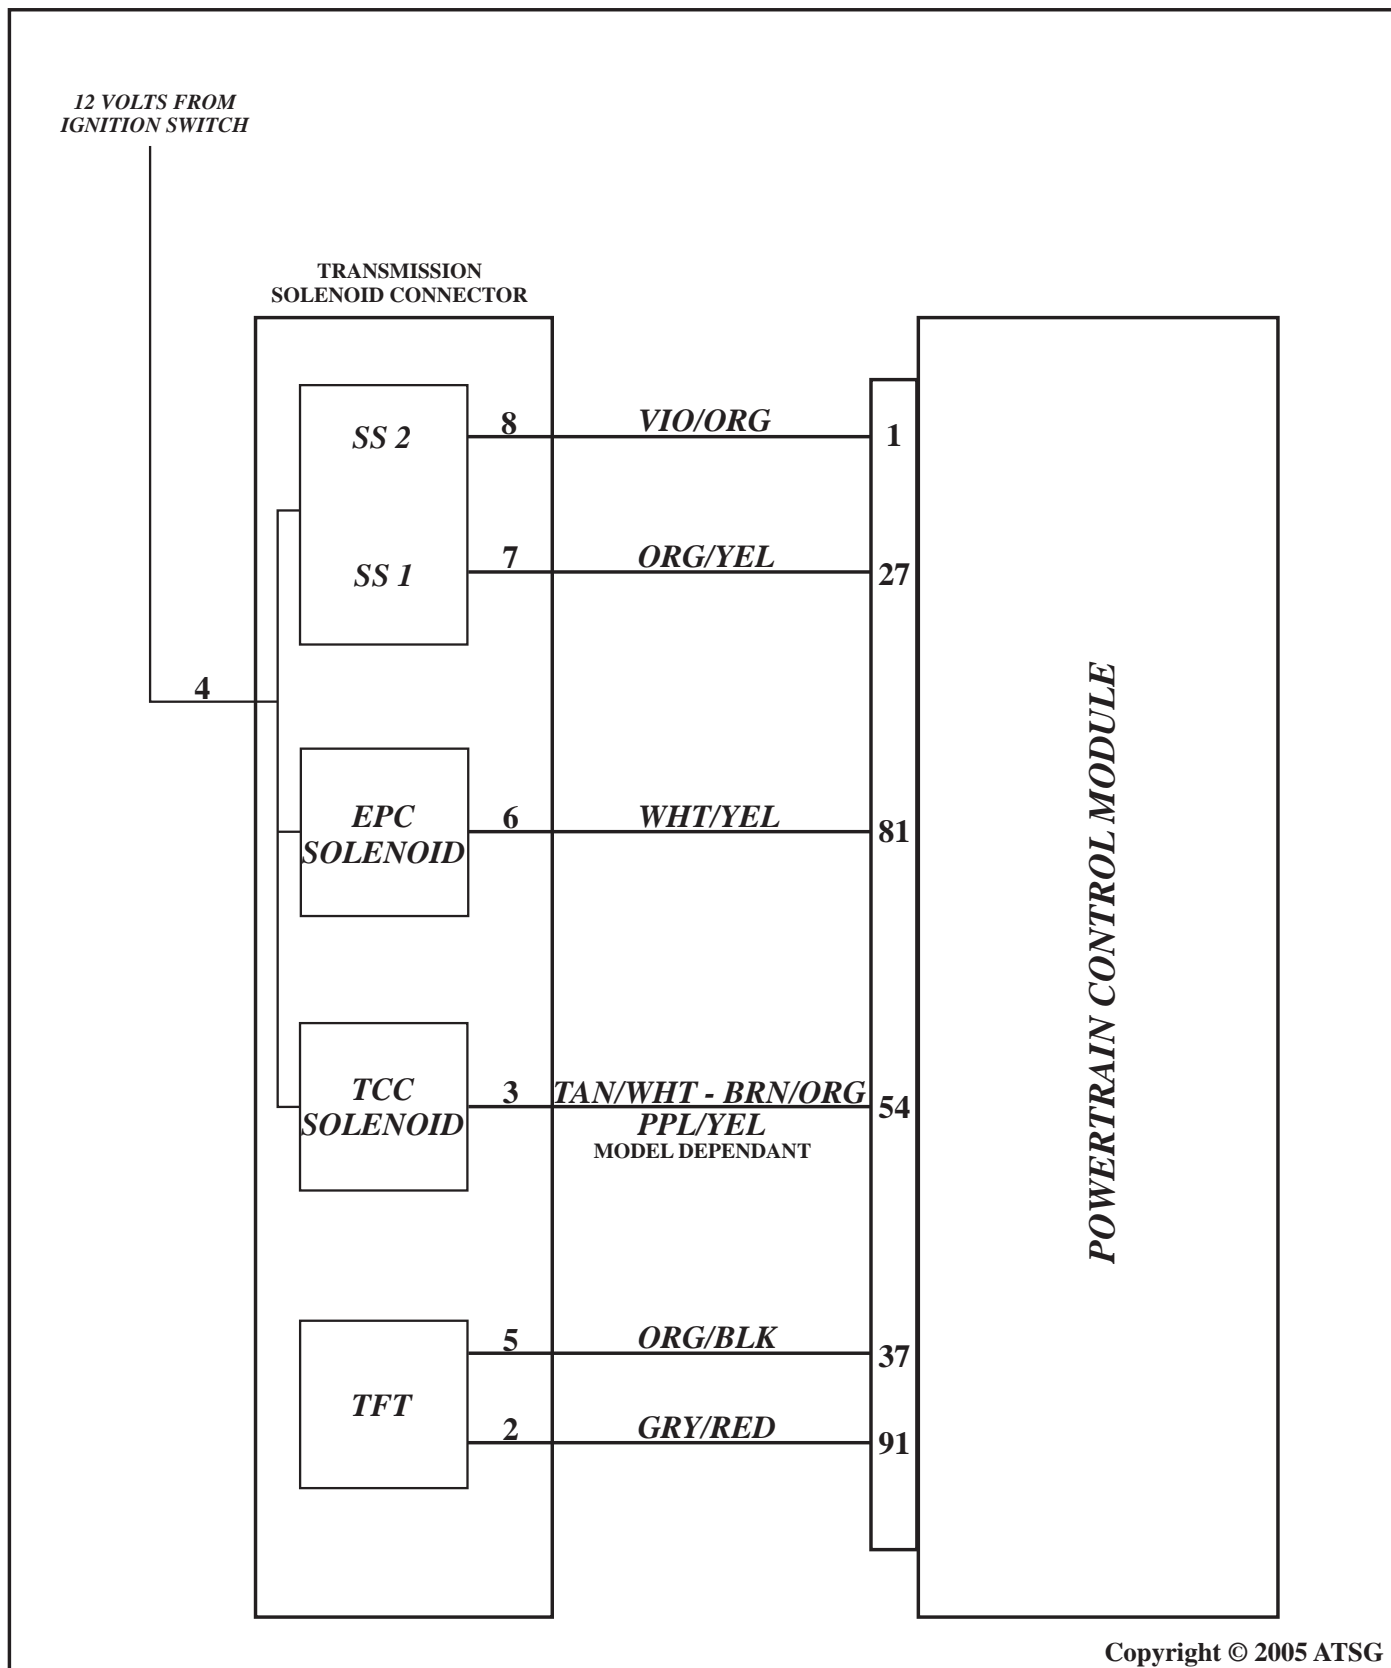
Figure 11

SHIFT SOLENOID 2 ELECTRICAL DIAGRAMS

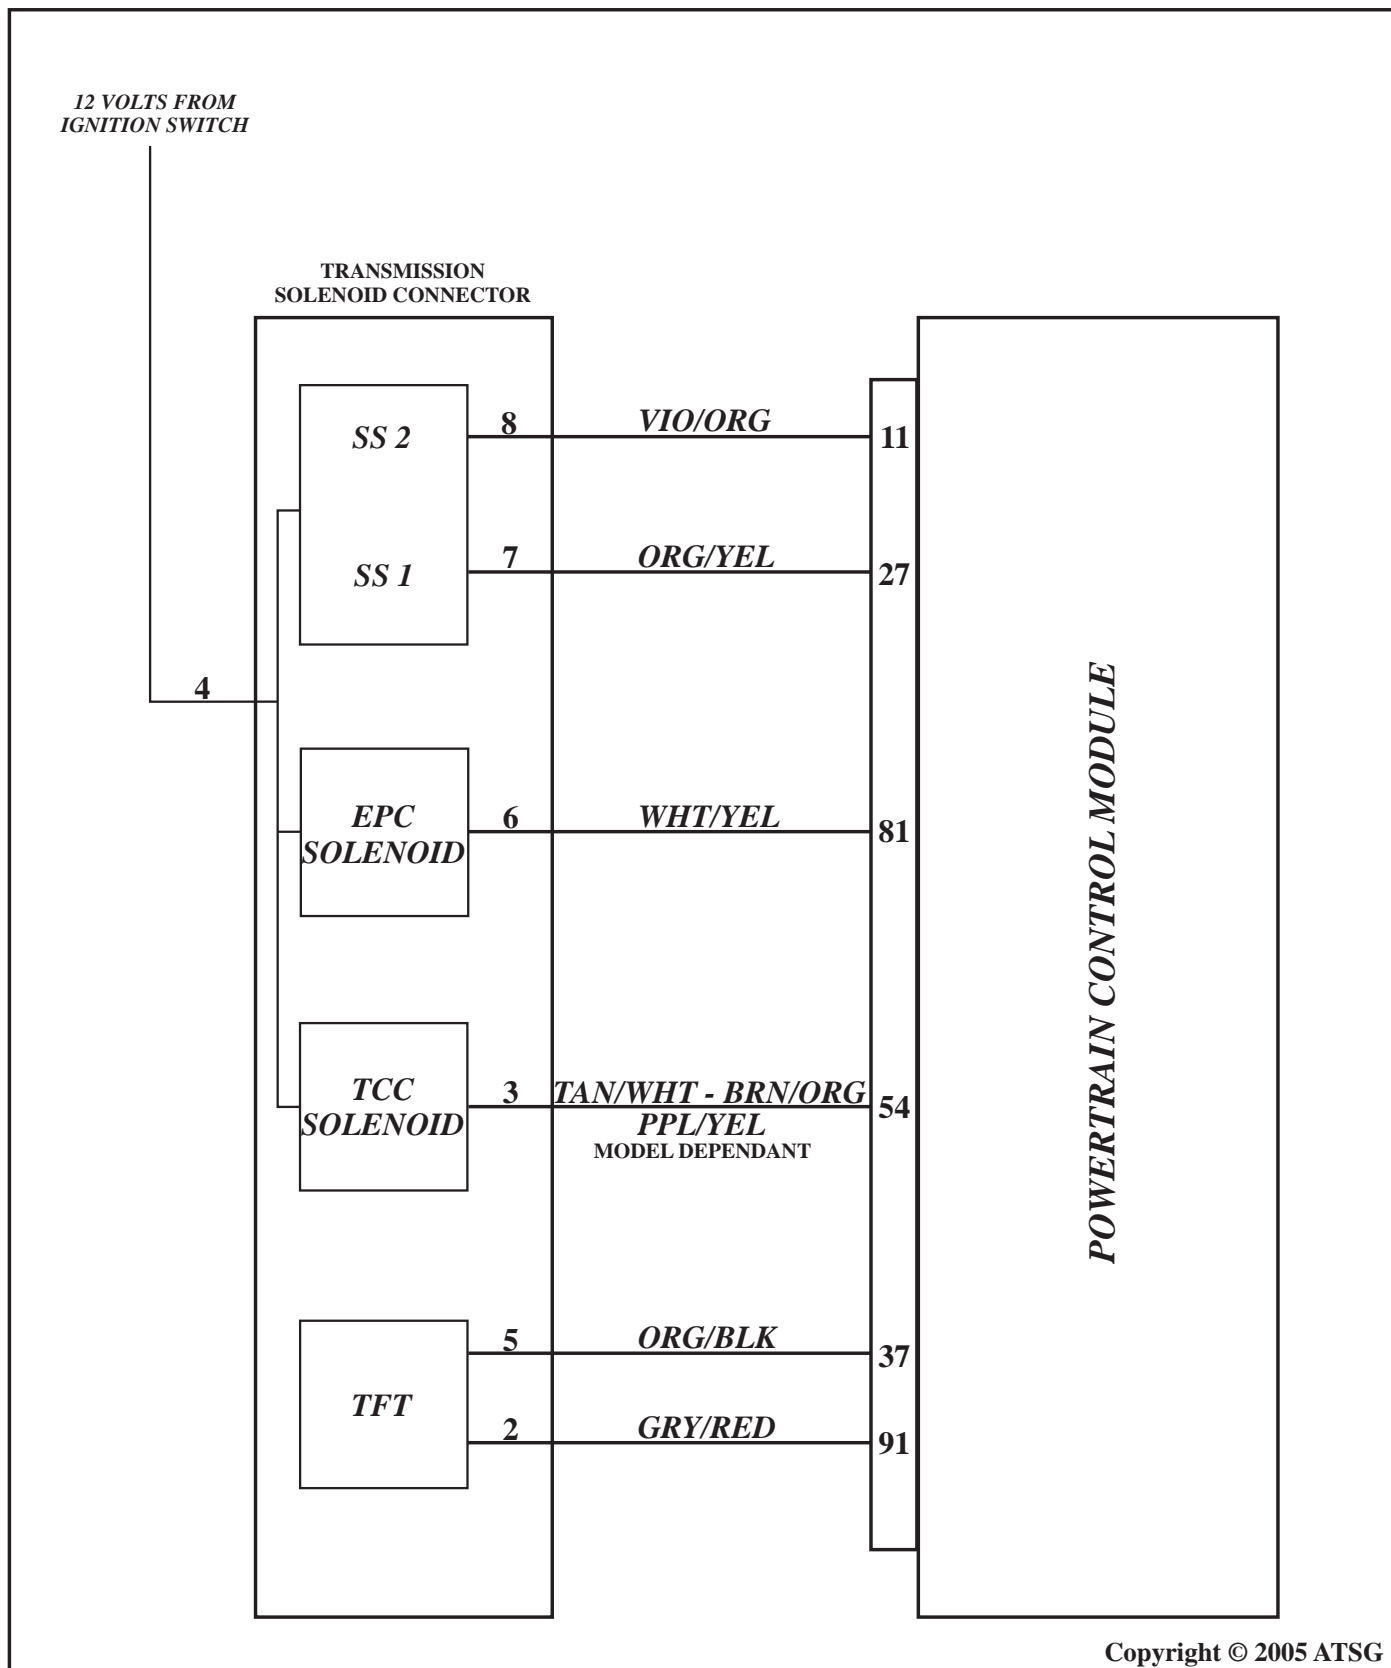
Figure 12

SHIFT SOLENOID 2 ELECTRICAL DIAGRAMS

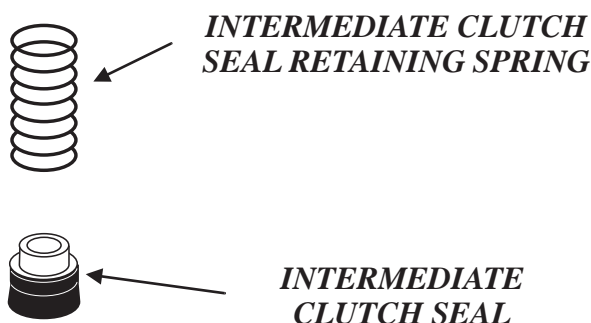
Figure 1

CAUSE: The cause may be the Intermediate Clutch Seal, as shown in Figure 1, was not installed deep enough into the case. When this happens Intermediate Clutch pressure is lost between the case and the Intermediate piston housing.

CORRECTION: Using a suitable punch, push the Intermediate Clutch Seal against the Intermediate Clutch Piston Housing, as shown in Figure 3. Place the retaining spring on top of the seal, as shown in Figure 4, and re-assemble the valve body onto the case.

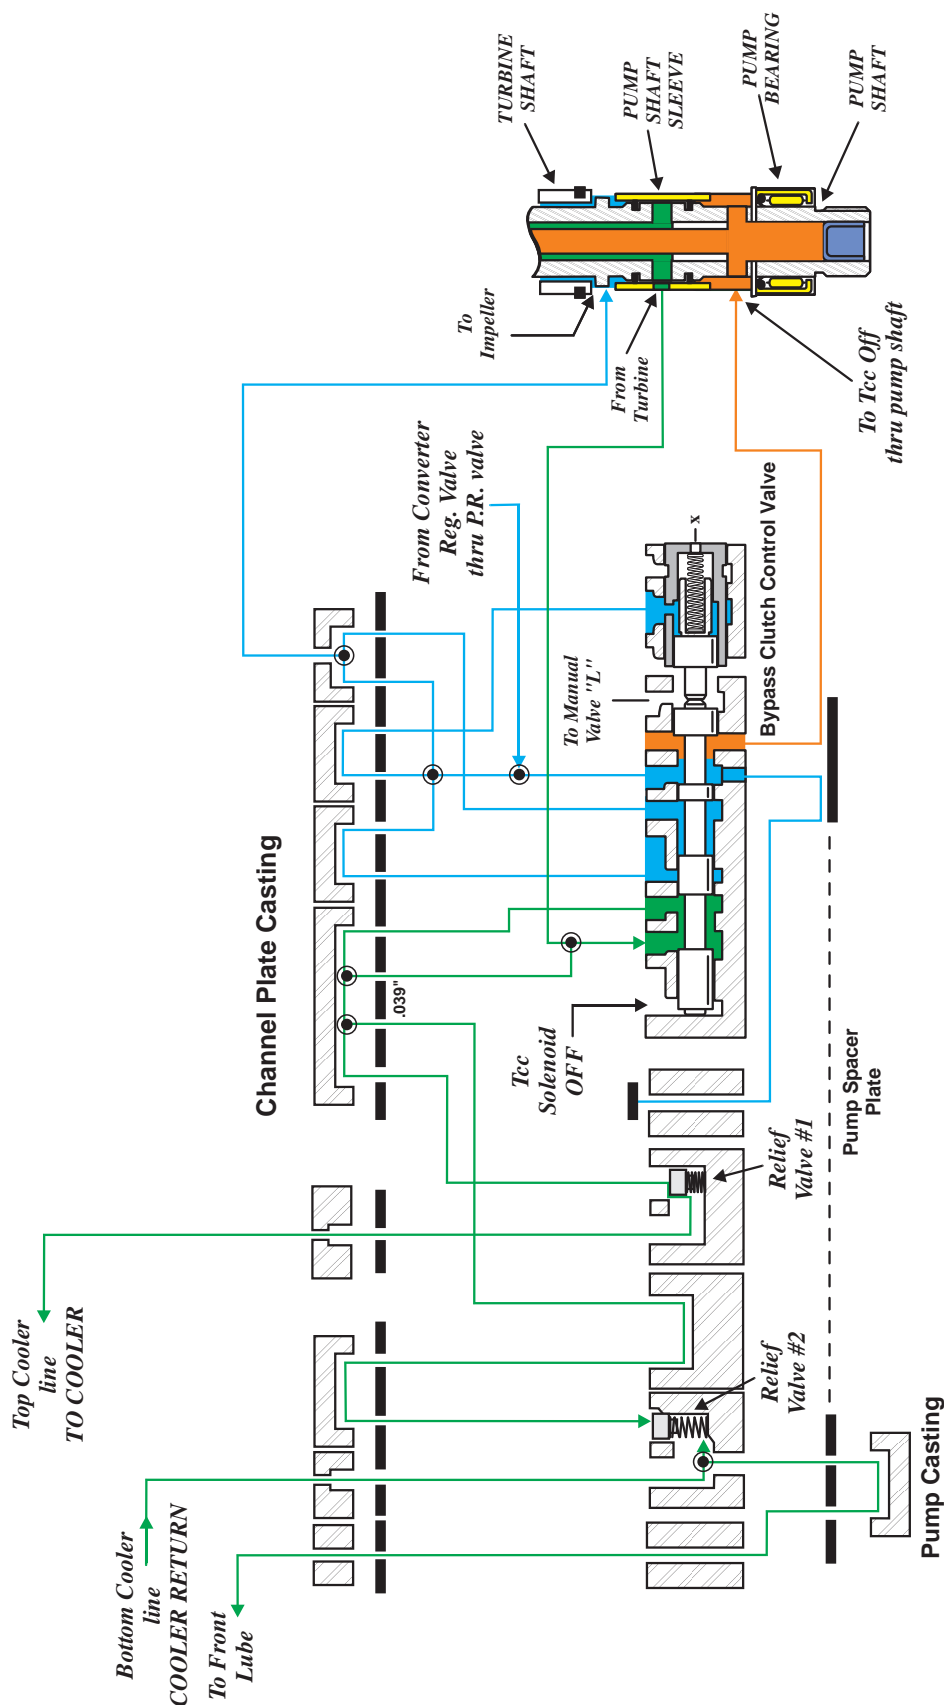
Figure 5

Summary: To Cooler oil comes from the Turbine Circuit in the torque converter, flows thru the Bypass Clutch Control Valve and strokes Relief Valve #1 against its spring then travels thru the Top cooler line to the Cooler. This same Cooler oil comes back thru the bottom cooler line, seats Relief Valve #2 against the spacer plate and enters the Front Lube Circuit.

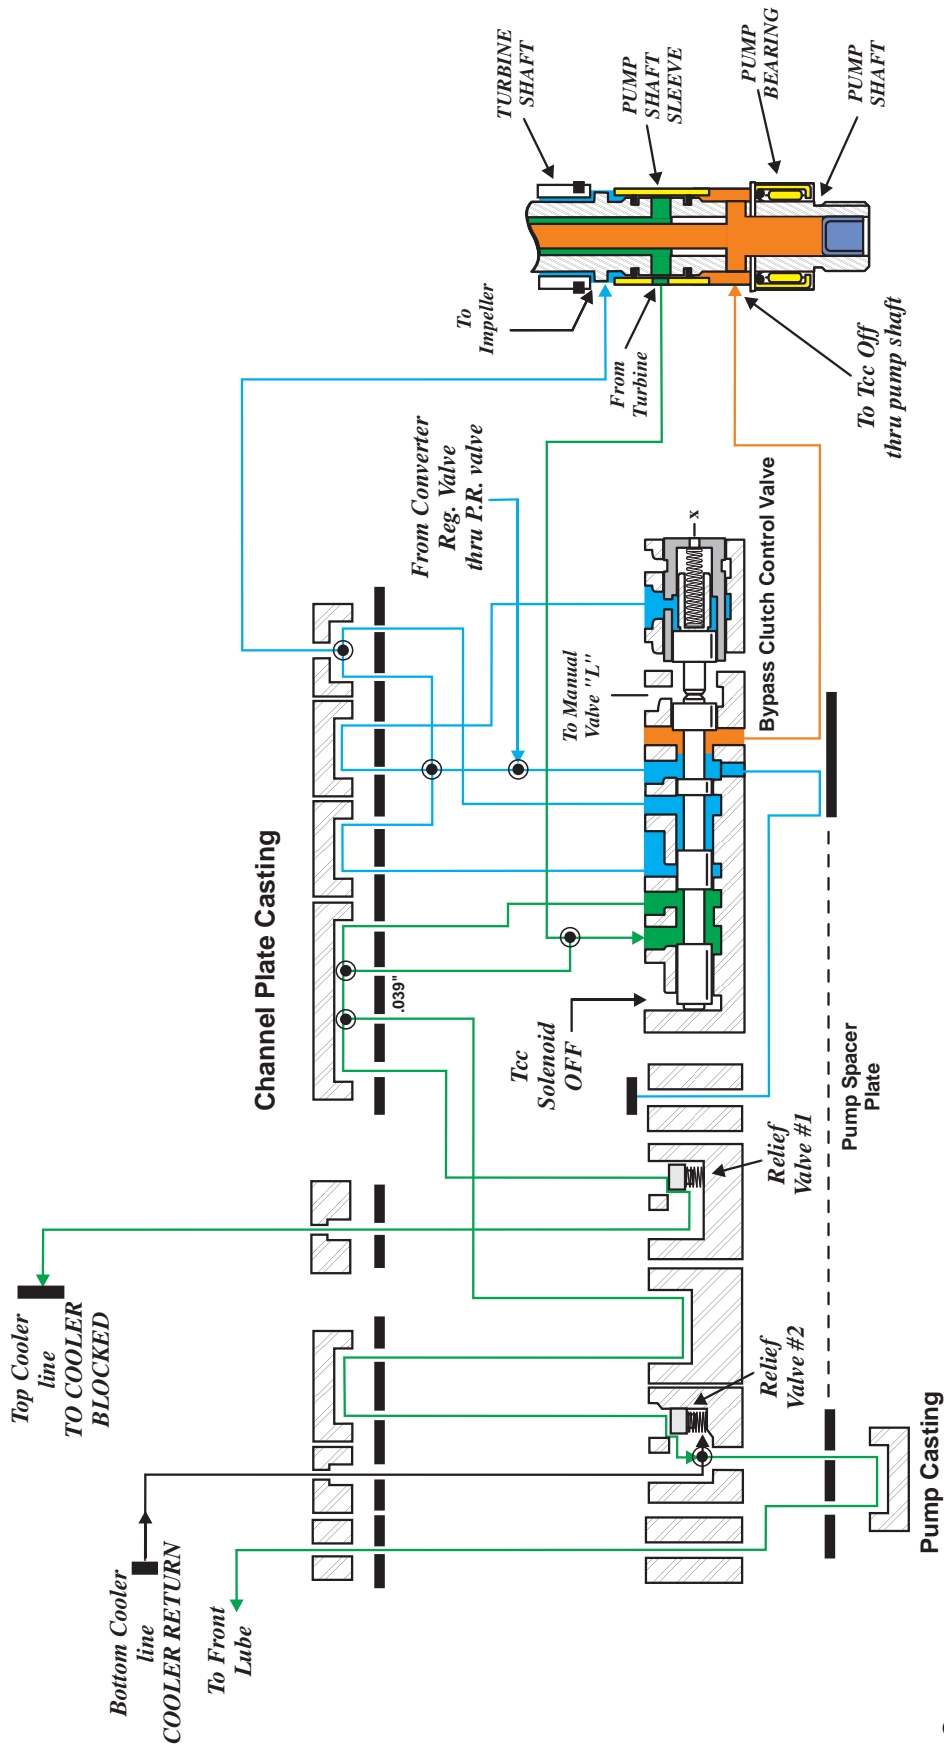
Figure 6

Summary: To Cooler oil comes from the Turbine Circuit in the torque converter, flows thru the Bypass Clutch Control Valve and strokes Relief Valve #1 against its spring then travels thru the Top cooler line to the Cooler. If the Cooler is blocked, this same Cooler oil builds up and strokes Relief Valve #2 against its spring connecting To Cooler to the Front Lube Circuit Bypassing the Cooler.
