"2006" SEMINAR INFORMATION

AUTOMATIC TRANSMISSION SERVICE GROUP

"Top Tech Tricks for 2006"

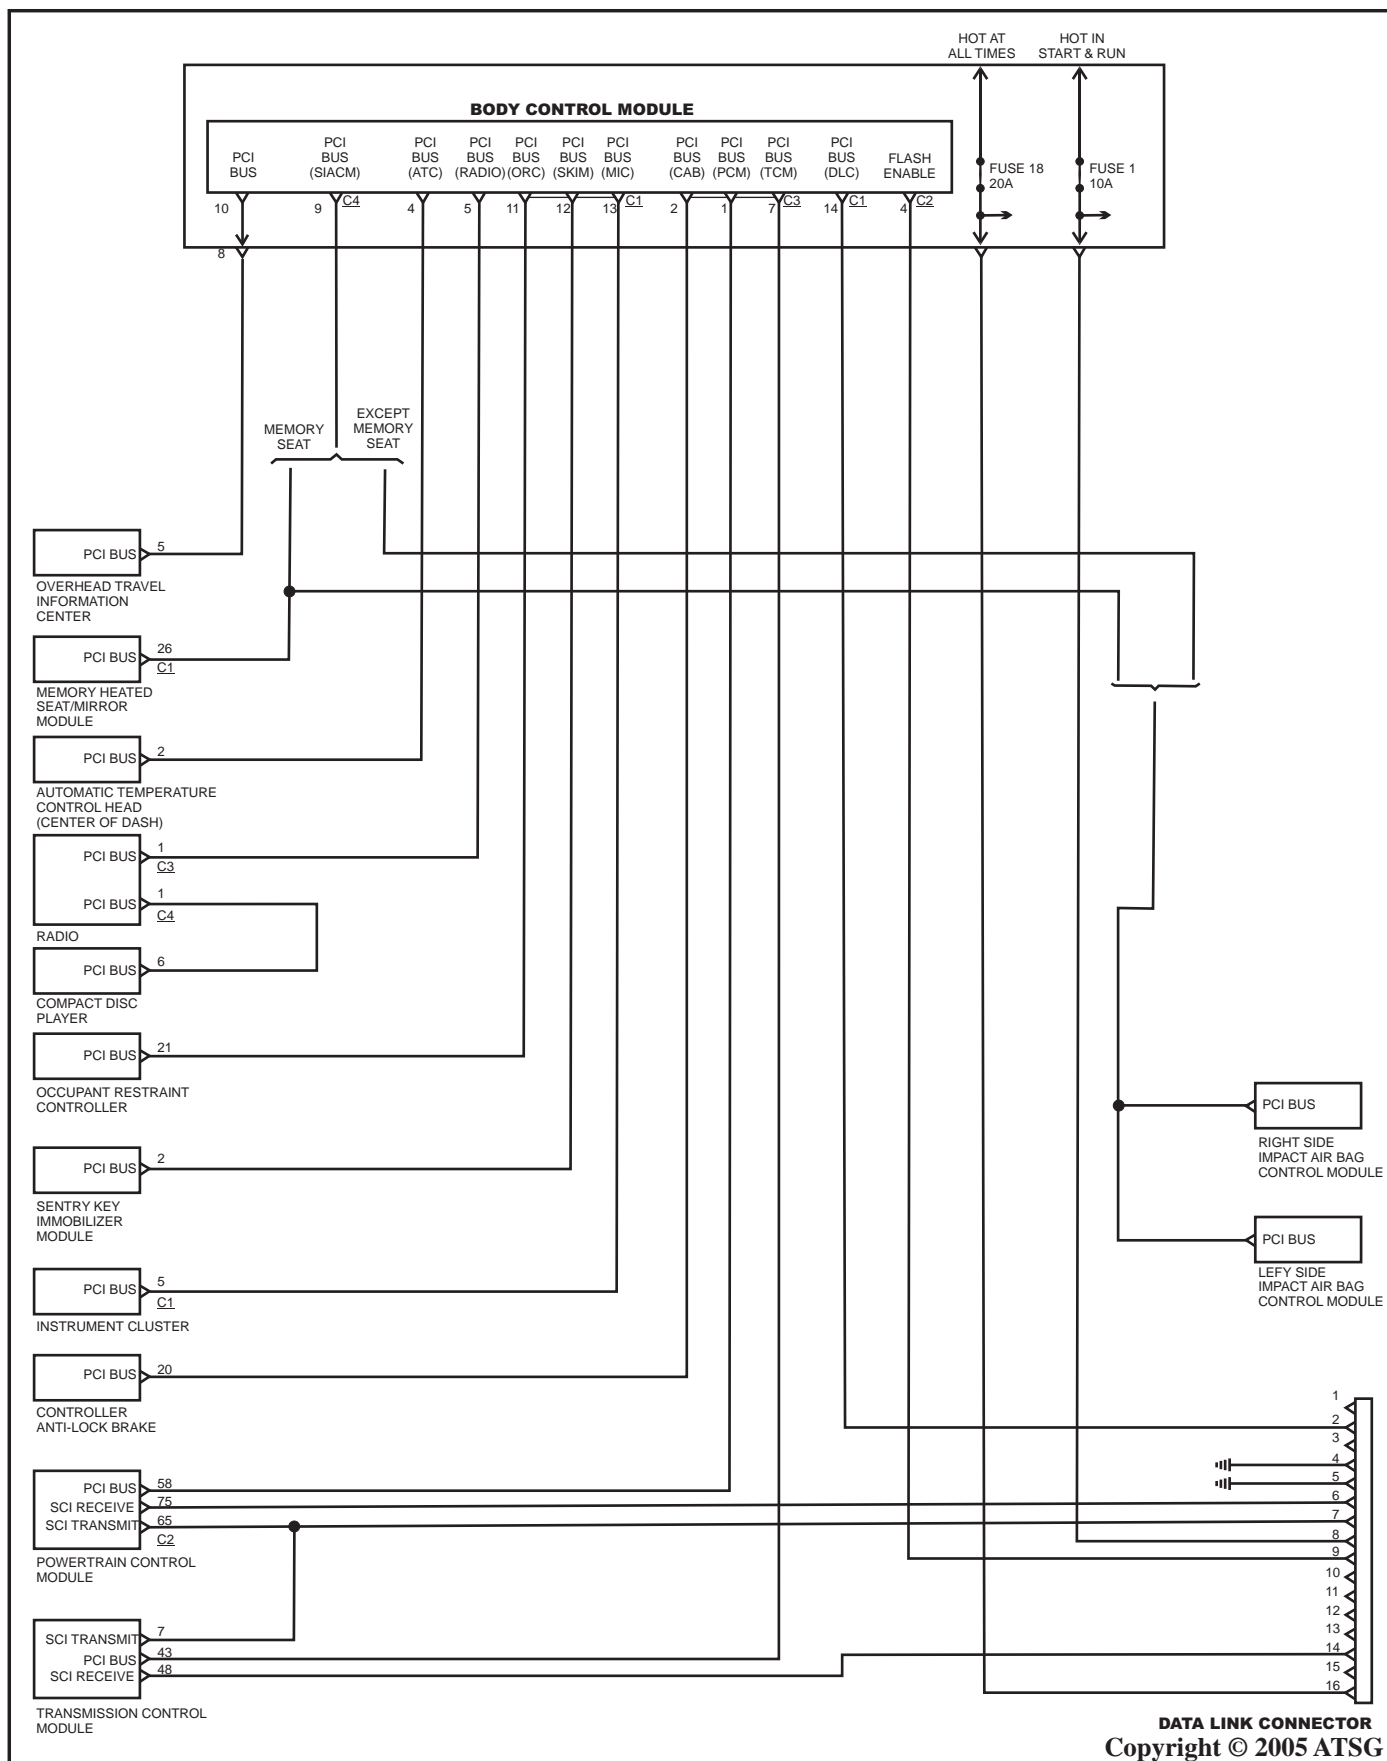
Figure 9

The first diagnostic step is to identify the modules that are on the network of the vehicle being serviced. This can be done with the use of a scanner or a good wiring diagram like the one provided. See Figure 9. This schematic indicates that up to 14 modules can be found on the PCI network plus the Data Link Connector for the scanner.

Using the schematic in figure 9, notice how terminal 2 in the data link connector is wired into the BCM at terminal 14 in the C1 connector. If we check this circuit for resistance, according to SAE, the minimum amount of ohms we can expect to see is 315 ohms and the maximum would be 1,575 ohms depending on the number of modules on the circuit (See Figure 10).

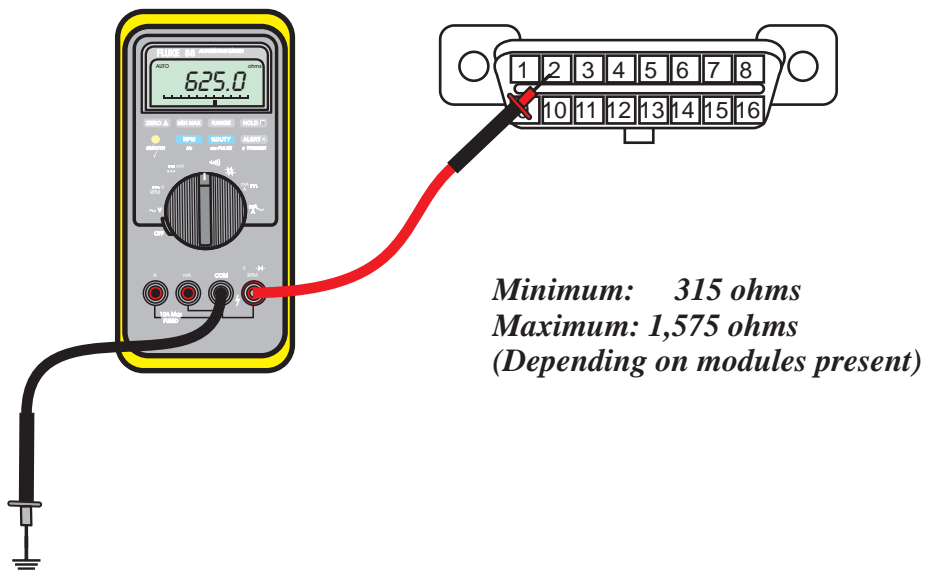
Figure 10

So we have math and theory and now comes reality, putting the meter on terminal 2 of the Data Link Connector as seen in figure 10 where 625 ohms should be observed if all the terminating resistors in each module are good and every module is grounded. This is a quick way to check the integrity of the circuit verifying that all modules can be seen on the PCI bus system.

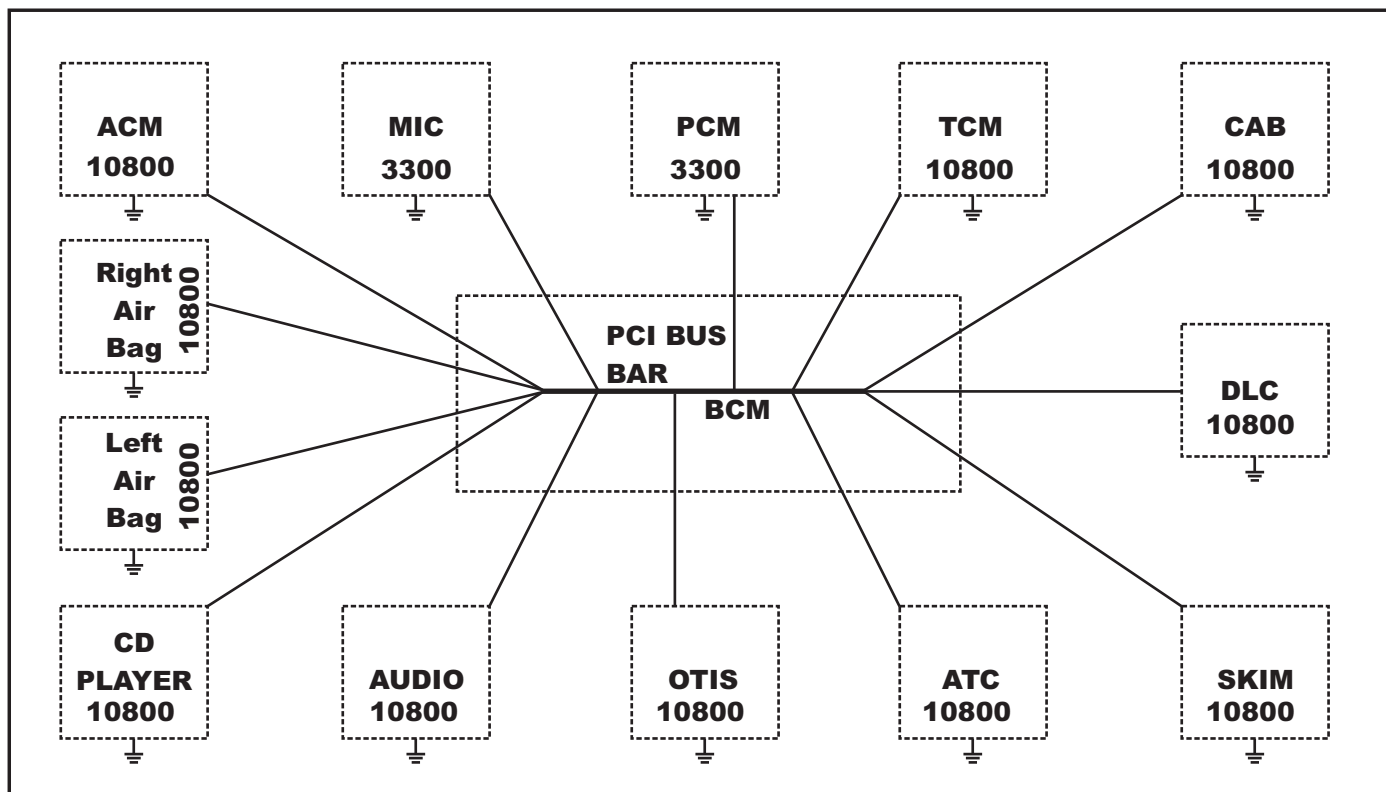
Figure 11

Suppose there is a vehicle that needed to be tested which has 13 modules on the PCI circuit. You determine that there are 2 modules that contain a 3,300 ohm terminating resistor and 11 that contain a 10,800 ohm resistor (See Figure 11). There is a mathematical equation for equivalent resistance in a parallel circuit and it looks like this:

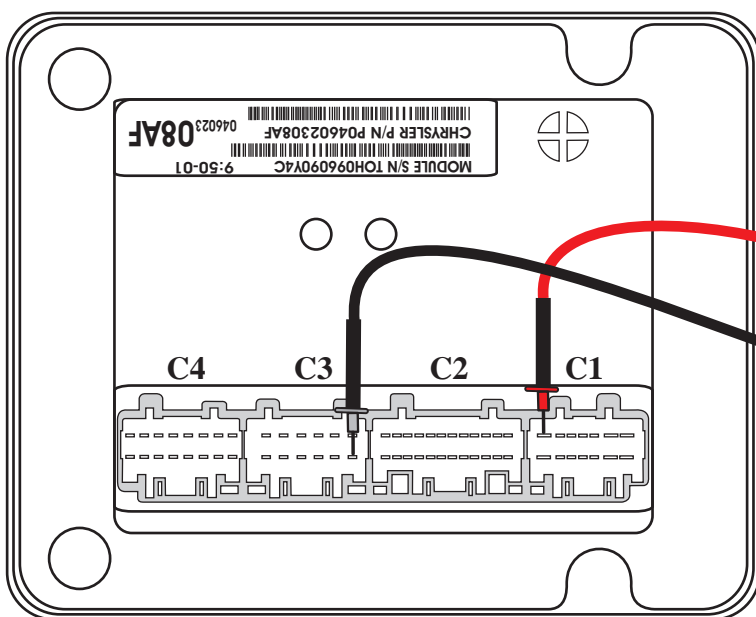
Figure 13
Automatic Transmission Service Group

A short to ground or power takes the entire PCI bus down. A typical technique is to disconnect modules one at a time until the short disappears. With PCI, disconnecting modules doesn't necessarily have to be the first step. In some cases it is very easy to gain access to the BCM as is with a 2001 LH vehicle where the module is located under the driver side dash (See Figure 12). Four of the connectors are very easily accessed while a 5th connector is a bit more difficult as it is located between the Junction Block and the backside of the BCM (See Figure 13).

Figure 13 identifies each connector that plugs into the BCM as well as which connector contains PCI circuits that run through the BCM's BUS bar. An example of making a continuity check across the BUS bar inside the BCM is also shown in figure 13 as well as making individual PCI circuit checks with these connectors unplugged from the BCM. A bad BCM bus bar can be quickly and easily diagnosed with a DVOM as well as any shorts to ground or power on individual PCI circuits. This is a much faster diagnostic step when compared to the typical technique of disconnecting modules one at a time until the short disappears.

Checking for continuity across the BUS bar in the BCM hub between C3 terminal 1 (PCI PCM) and C1 terminal 14 (PCI DLC).

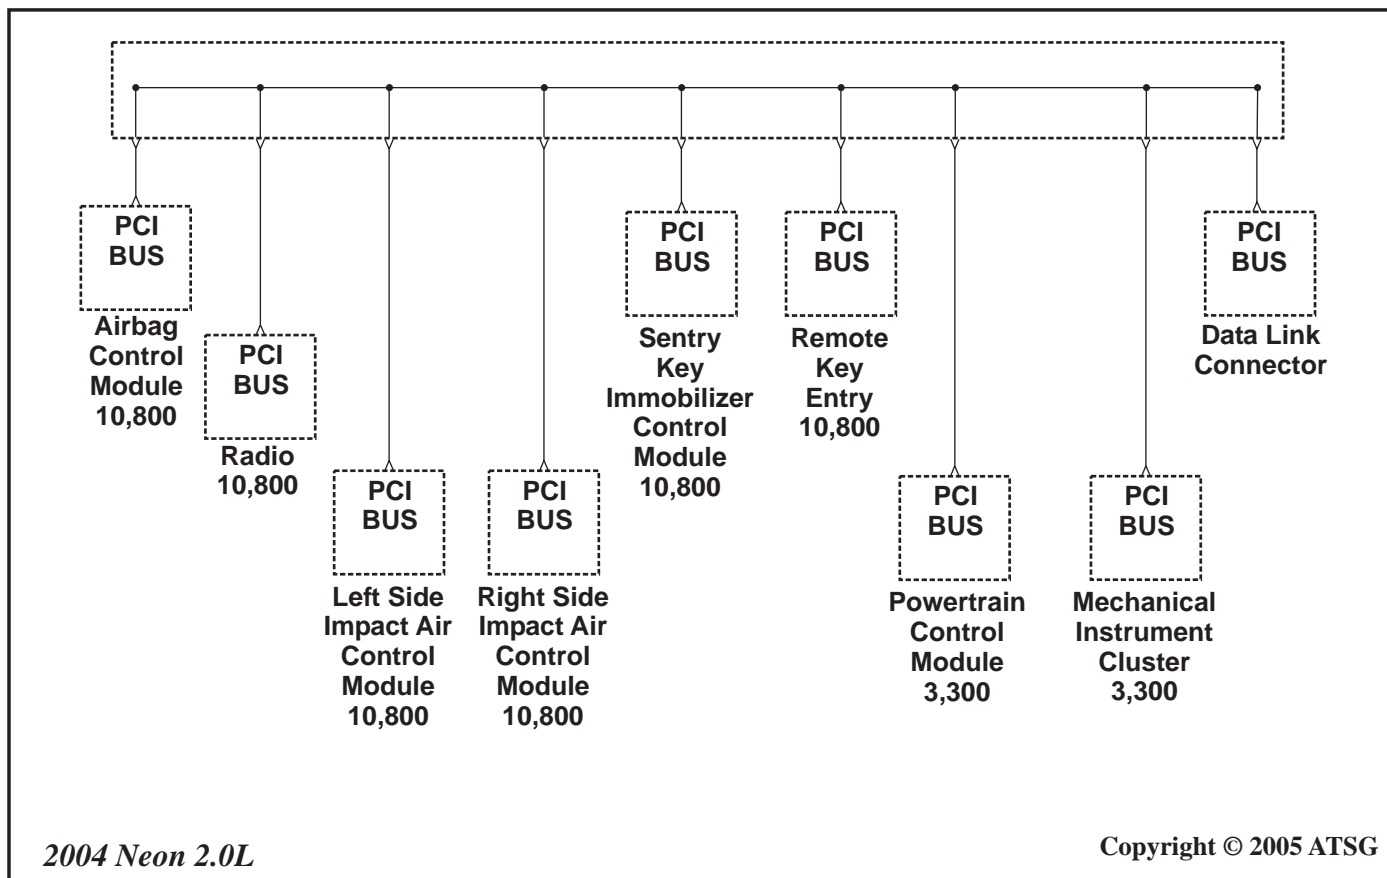
Figure 14

CORRECTION: A quick test that can be performed is to add up all the modules on the Bus and check the resistance of all the modules terminating resistors at the DLC. With this particular vehicle, there are a total of 8 modules on the Bus system (See Figure 14). 2 of the modules have 3,300 ohms while the other 6 have 10,800 ohms. There is a mathematical equation for *equivalent* resistance in a parallel circuit where the equivalent resistance is added up and divided into 1 as provided in figure 15. Since we have two 3300 ohm modules and 6 10800 ohm modules, we do not have equivalent numbers to add up to be divided into 1. To acquire that number we would take the two modules that measure 3300 ohms each and the six modules that measure 10800 ohms each and turn them into fractions: $2/3300 + 6/10800$. Before they can be added together these fractions need to be simplified: $1/1650 + 1/1800$. Now divide the denominator into the numerator and this is what you get: $0.0006 + 0.00056 = 0.00116$. It is this number that can be divided into 1 which equals a total of 862 ohms. This is the total resistance of all the modules in the Neon's PCI Bus circuit and should be seen at the DLC terminal 2 (See Figure 16).

$$\frac{1}{\frac{1}{3300} + \frac{1}{3300} + \frac{1}{10800} + \frac{1}{10800} + \frac{1}{10800} + \frac{1}{10800} + \frac{1}{10800} + \frac{1}{10800}} = 862 \text{ ohms}$$
