A4LD UPDATE HANDBOOK INDEX

Updated
April, 2004

FORD A4LD

"UPDATE HANDBOOK"

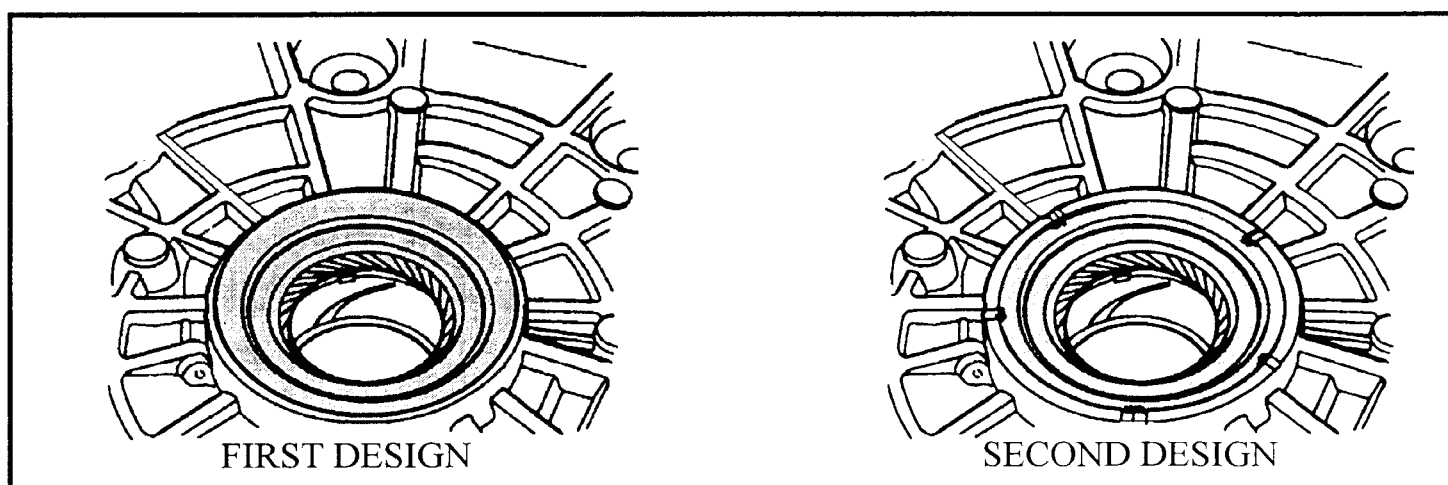
Figure 5

BELL HOUSING - A machined lip was added at the front seal bore to allow the front seal to be staked in place (Refer to Figures 5 & 6).

As long as the engine bolt pattern is the same (See Figures 1 thru 4), bell housings will interchange. However, using an early style bell housing without the lip is not recommended.

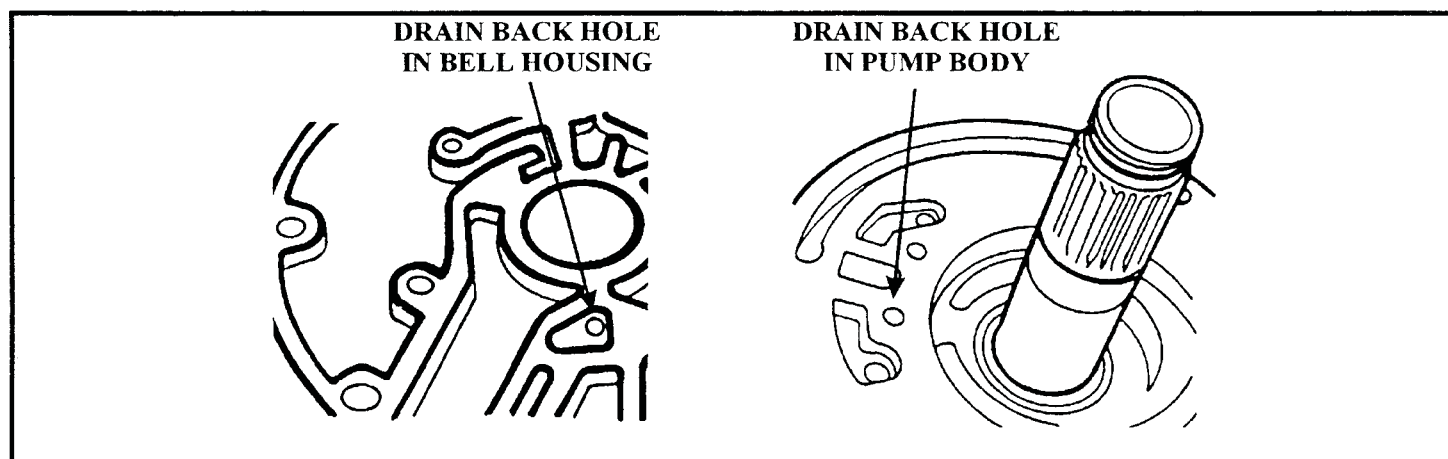
Figure 7

BELL HOUSING - Converter drain back passage area was enlarged for better flow to the drain back hole in the pump body (Refer to Figure 7). It is not necessary to replace the bell housing to cure this problem. Using a rotary file, or die grinder, remove material to allow "full flow" to the drain back hole (Refer to Figure 7). Also enlarge the existing drain back hole in both the bell housing and the pump body to 1/4" (Refer to Figure 8).

As long as the engine bolt pattern is the same (See Figures 1 thru 4), all late model bell housings will retrofit to early models. Early model bell housings will interchange but the drain back modifications must be made.

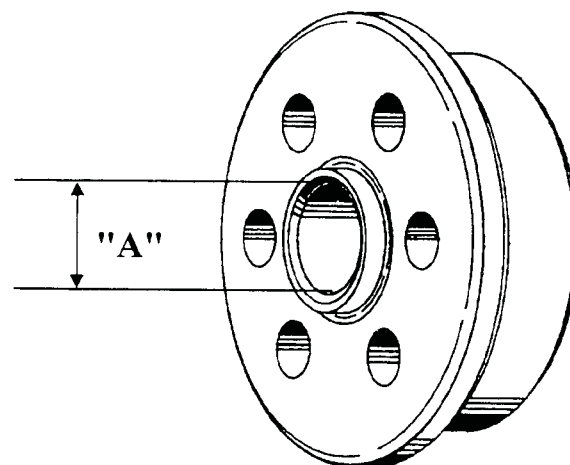
CAUSE: The cause may be a "Crankshaft to Flywheel Spacer" worn in the area that supports the converter pilot hub allowing a mis-alignment of the torque converter to the pump, on models equipped with 2.8, 2.9 and 4.0 liter engines.

DIMENSION "A" SHOULD BE .750" ON NEW O.E. SPACER

CORRECTION: Inspect the "Crankshaft to Flywheel Spacer" for abnormal wear and replace as necessary. Refer to Dimension "A" in Figure 11 to measure the spacer. Dimension "A" on a new spacer is .750", and the OEM part number is D4ZZ-6434-A.

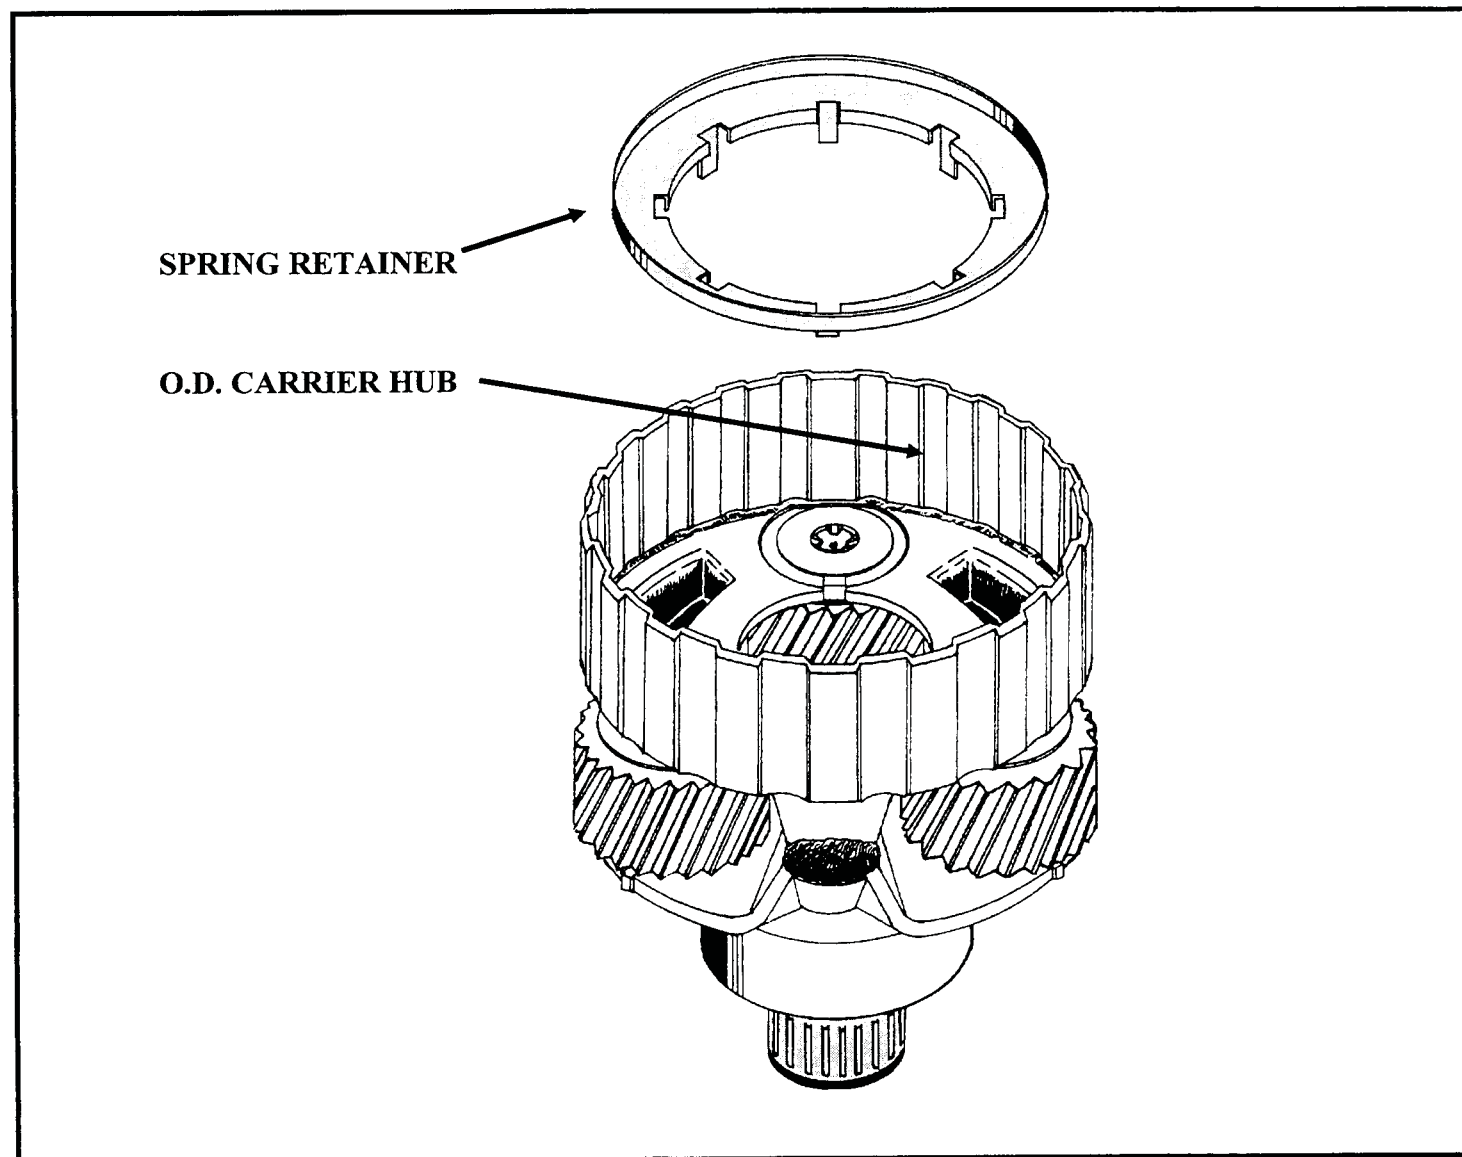
Figure 16

- A. Poorly supported overdrive planetary carrier, allowing the inside diameter of the hub on the overdrive carrier to contact, and turn in a twisting motion, the overrun clutch spring retainer. This will destroy the retainer and return springs in a very short period of time (See Figure 16). NOTE: The dimension between the outside diameter of the overrun clutch spring retainer, and the inside diameter of the overdrive carrier hub, is critical. (See Figure 16).
- B. Bent or improperly installed overrun clutch spring retainer will also drastically affect the clearance between the retainer and the carrier hub.

- CORRECTION:**
- A. Inspect and replace the following, as necessary;
 - 1. Turbine shaft bushings in the pump stator for wear and/or damage.
 - 2. Turbine shaft splines (Overdrive Carrier End) for wear and/or damage.

- 5. Overrun clutch housing bushing for wear and/or damage (See Figure 18).
 - B. Ensure that the overrun clutch spring retainer is supported evenly, using an outer pump gear, when compressing the return springs to avoid ANY distortion. This is critical, and is easily distorted with any uneven pressure.

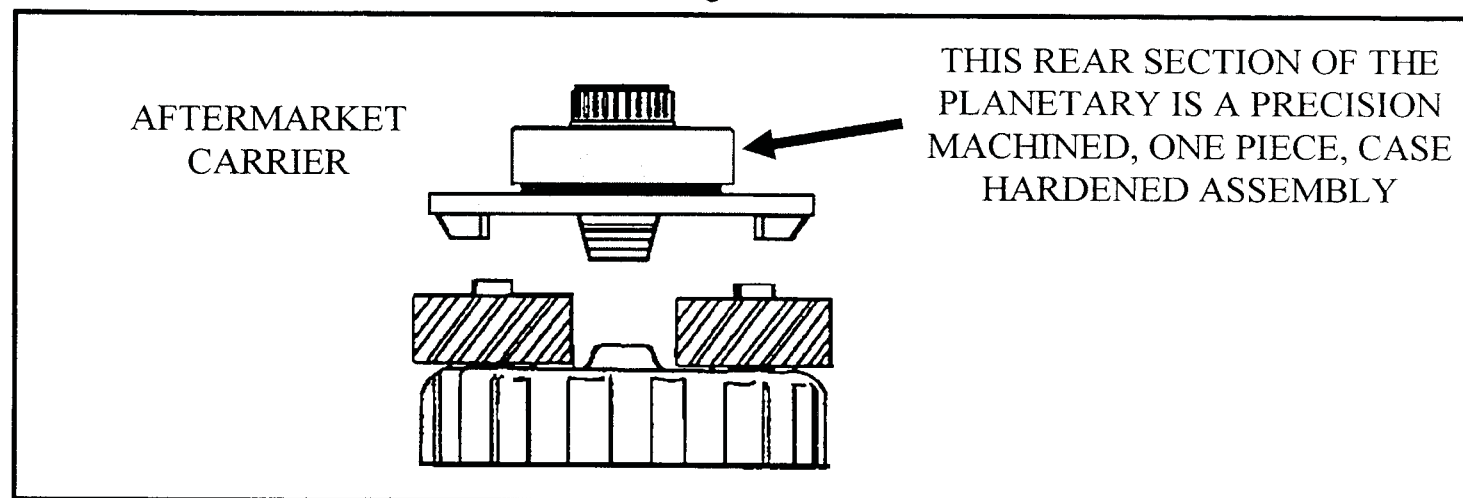
Figure 20

CAUSE: The cause may be, the overdrive sprag inner race broken loose from the carrier (See Figure 19). The problem is not always detectable because the bearing inside the carrier hides the broken area of the carrier. The sprag inner race and splined area for the input shaft "MUST NOT" turn. Use a little force if necessary to check this.

CORRECTION: Replace the overdrive carrier. Remanufactured "HEAVY DUTY" planetary carriers are available from aftermarket suppliers (See Figure 20).

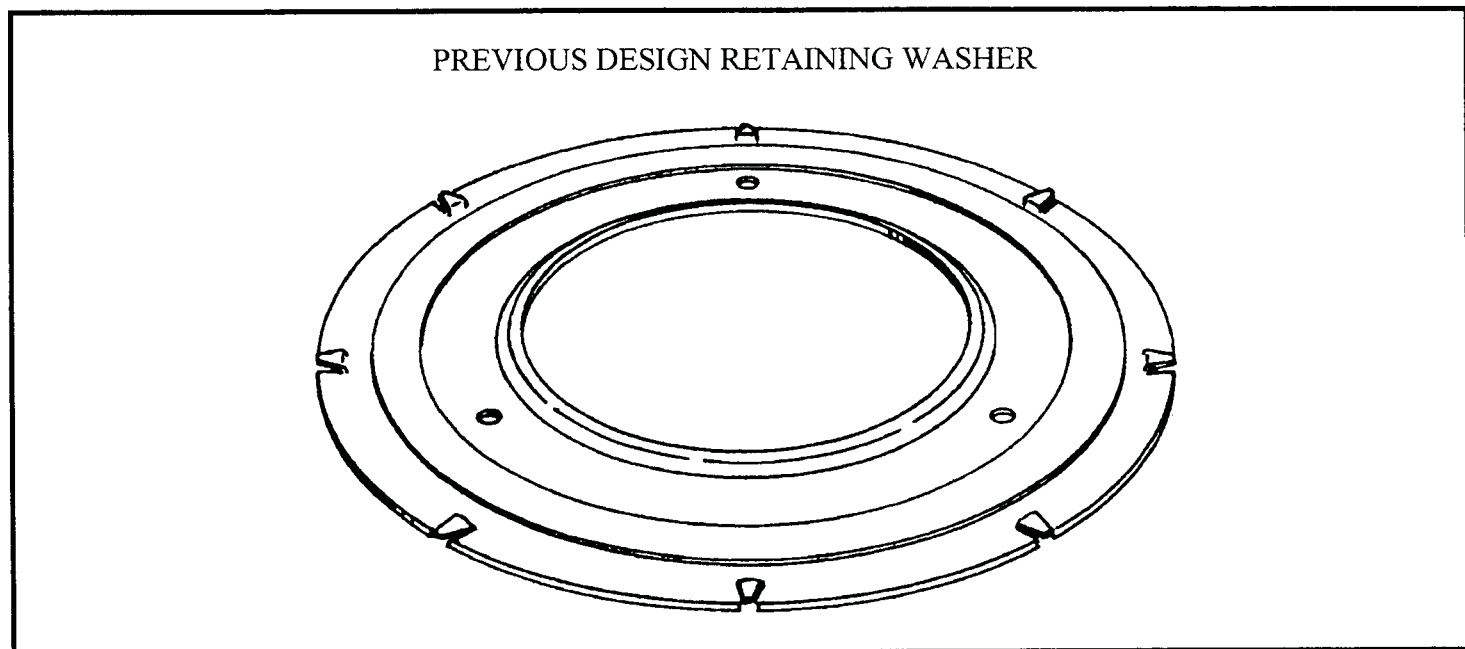
- (1) OVERDRIVE SPRAG ASSEMBLY - Previous design steel caged sprag must be used, as the plastic caged sprag is no longer serviced, which requires the use of the previous design ring gear and the previous retaining washer (See Figure 22).
- (2) OVERDRIVE RING GEAR - Previous design ring gear must be used to accommodate the steel caged sprag and retaining washer that must be used. Measure the overdrive ring gear, as shown in Figure 23, to ensure you have the proper one.
- (3) RETAINING WASHER - Previous design retaining washer shown in Figure 22 must be used to accommodate the previous design overdrive ring gear.

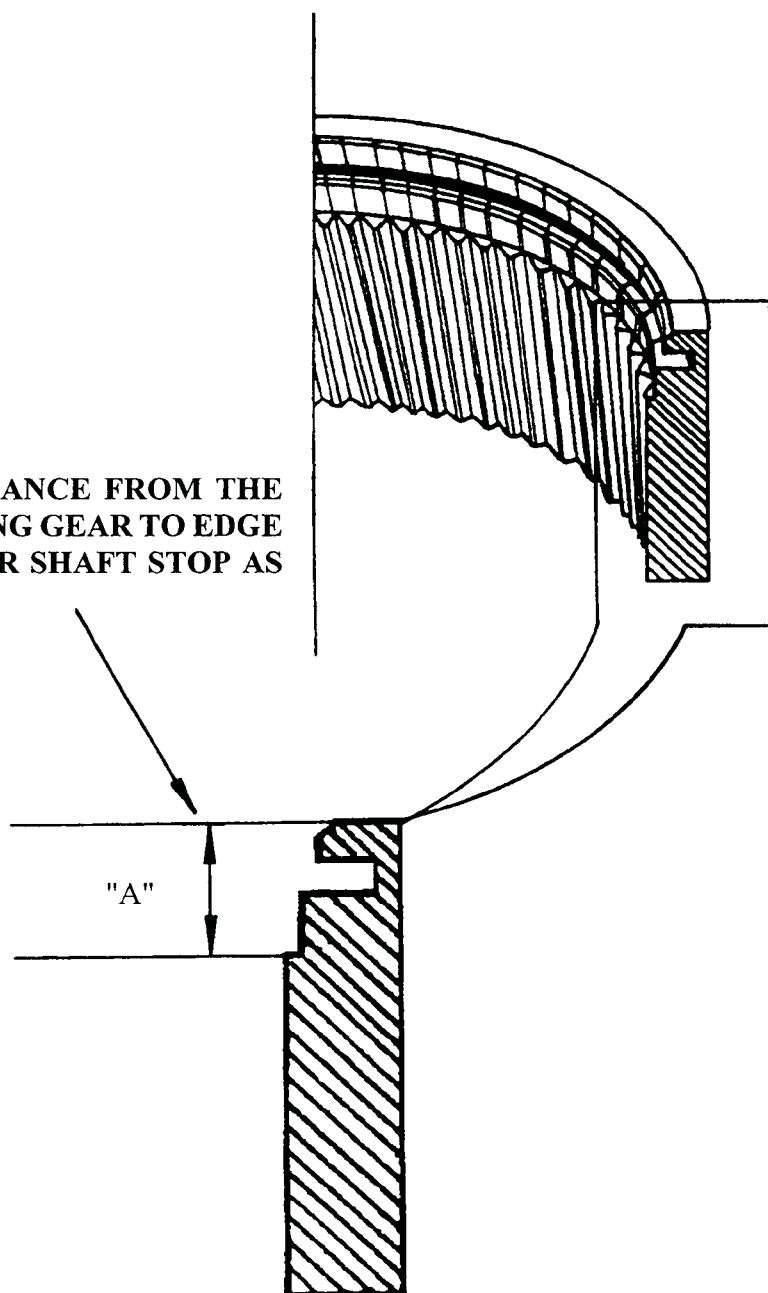
Figure 23

MEASURE DISTANCE FROM THE TOP OF THE RING GEAR TO EDGE OF THE CENTER SHAFT STOP AS SHOWN HERE

PREVIOUS DESIGN WITH STEEL CAGED SPRAG, "A" = .335"
DESIGN LEVEL WITH PLASTIC CAGED SPRAG, "A" = .295"

COMPATABLE PARTS MUST BE USED TOGETHER

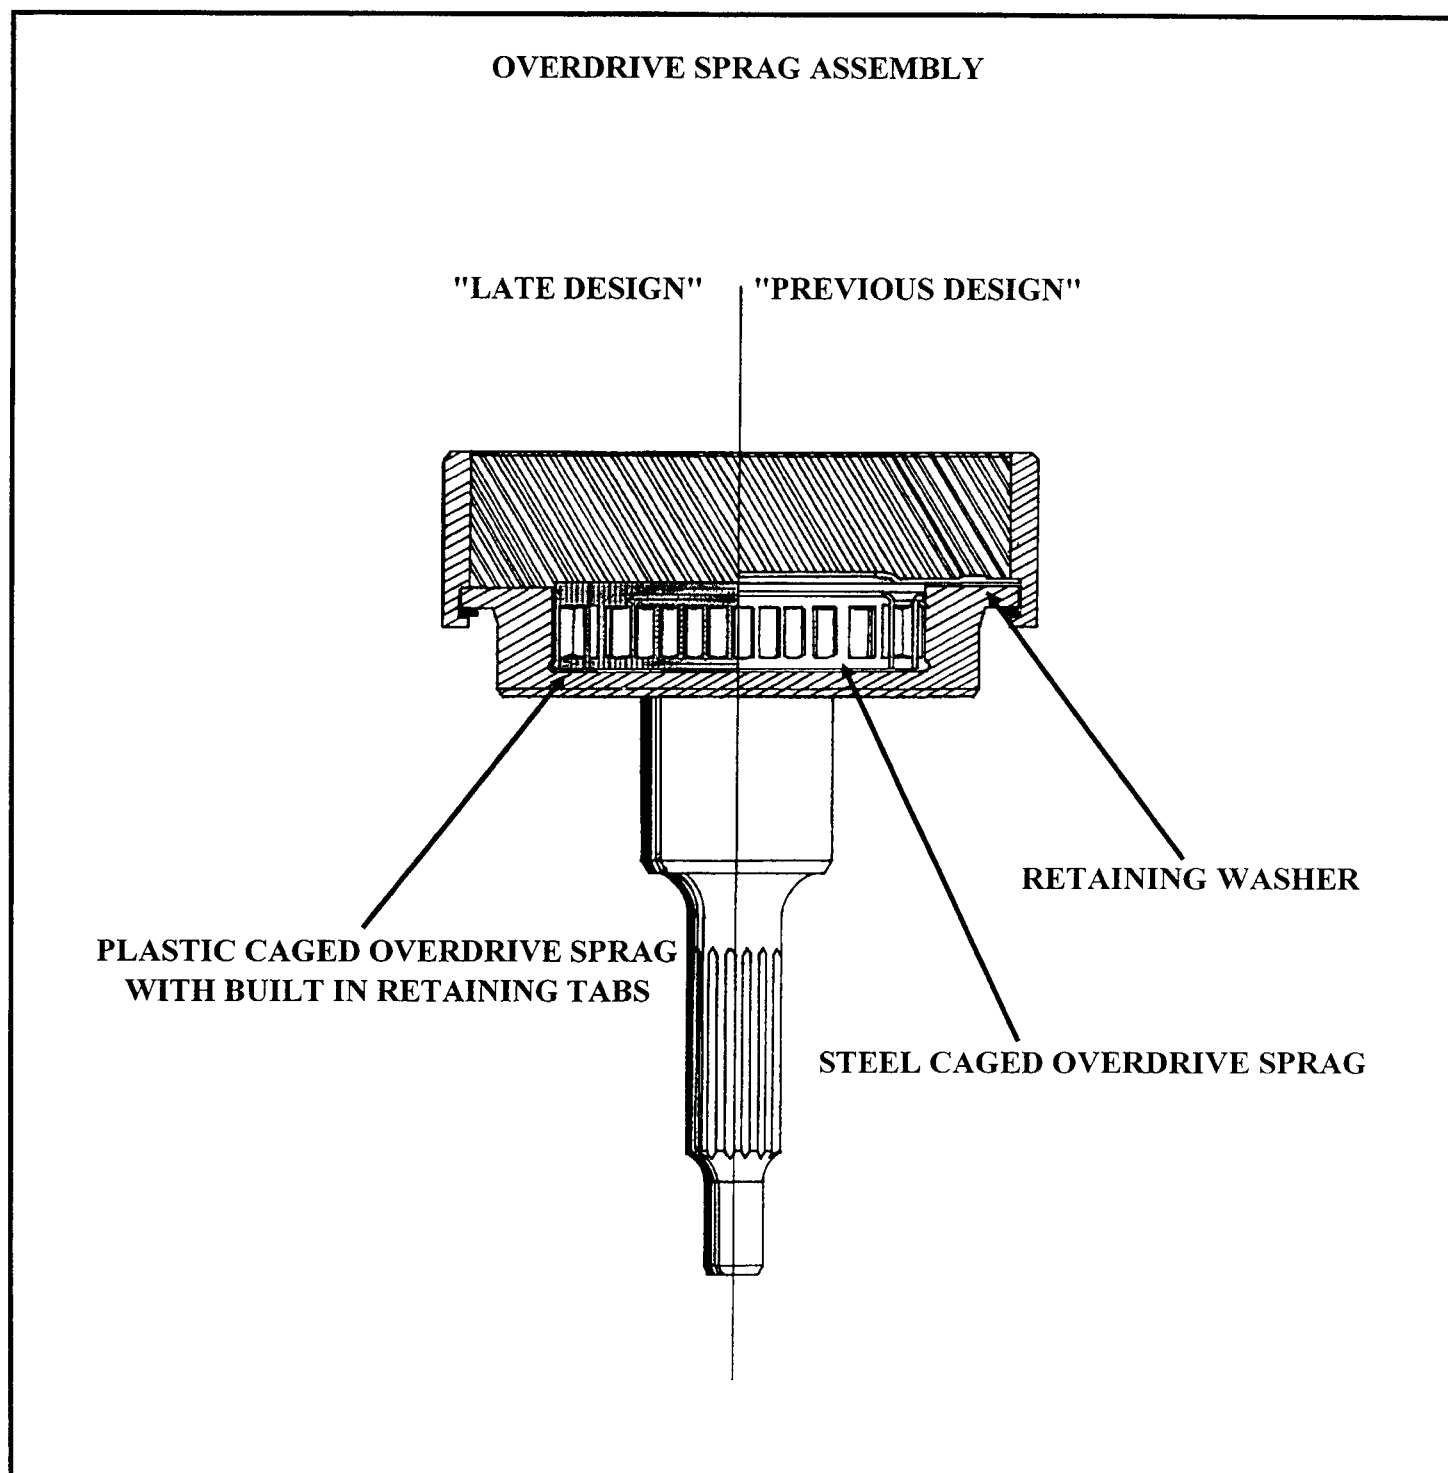
Figure 24

CHANGE: Vehicles equipped with A4LD transmissions built after June 9, 1992 contain a plastic caged overdrive sprag assembly that is no longer serviced. The previous design steel caged sprag and all related parts must be used for service (See Figure 24).

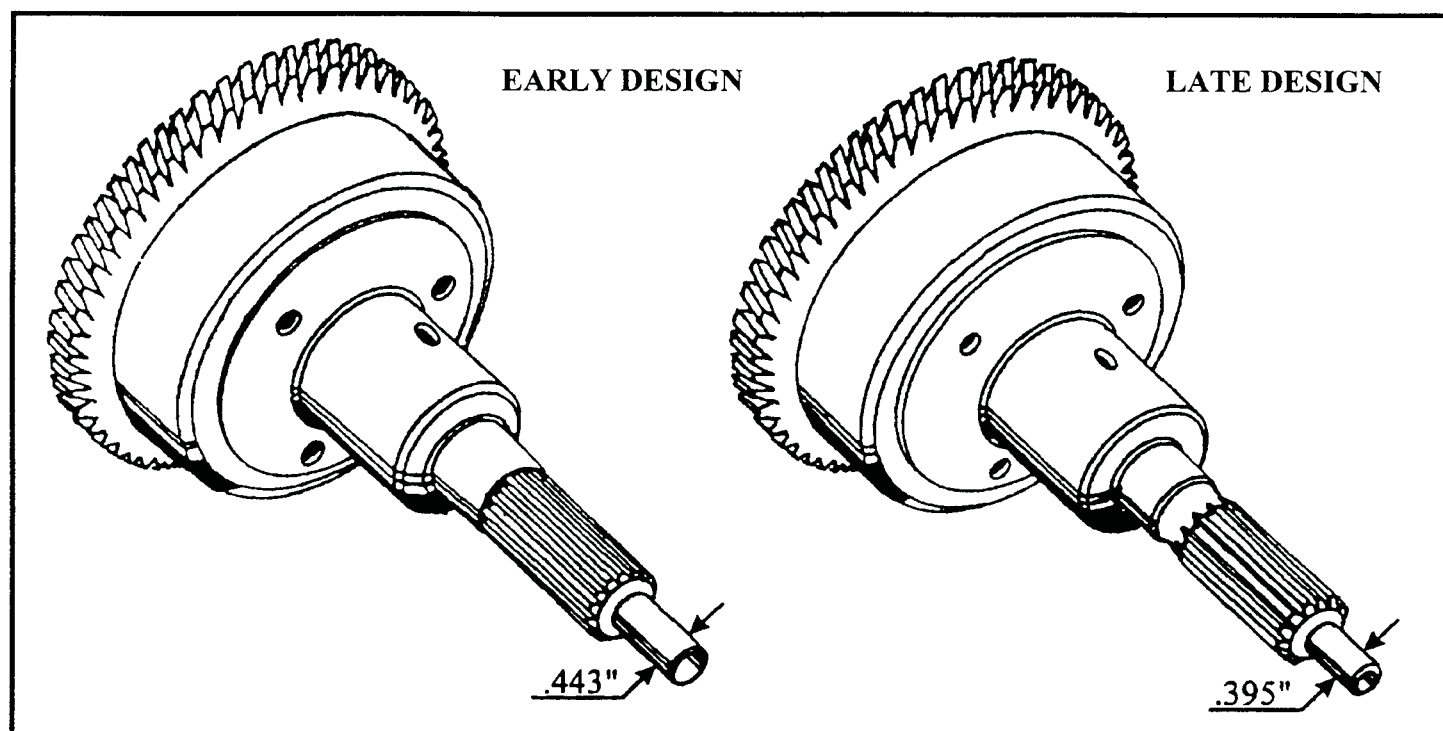
Figure 25

- (1) O.D. CENTER SHAFT - The diameter of the pilot on the shaft was machined .048" smaller than the previous design, to accommodate the bearing added to the output shaft. The new design pilot diameter is .395", and the previous design pilot diameter is .443". (See Figure 25)
- (2) OUTPUT SHAFT - Previous design bushing was replaced by a caged needle bearing. (See Figure 26). The caged needle bearing is not serviced separately from Ford Motor Co.

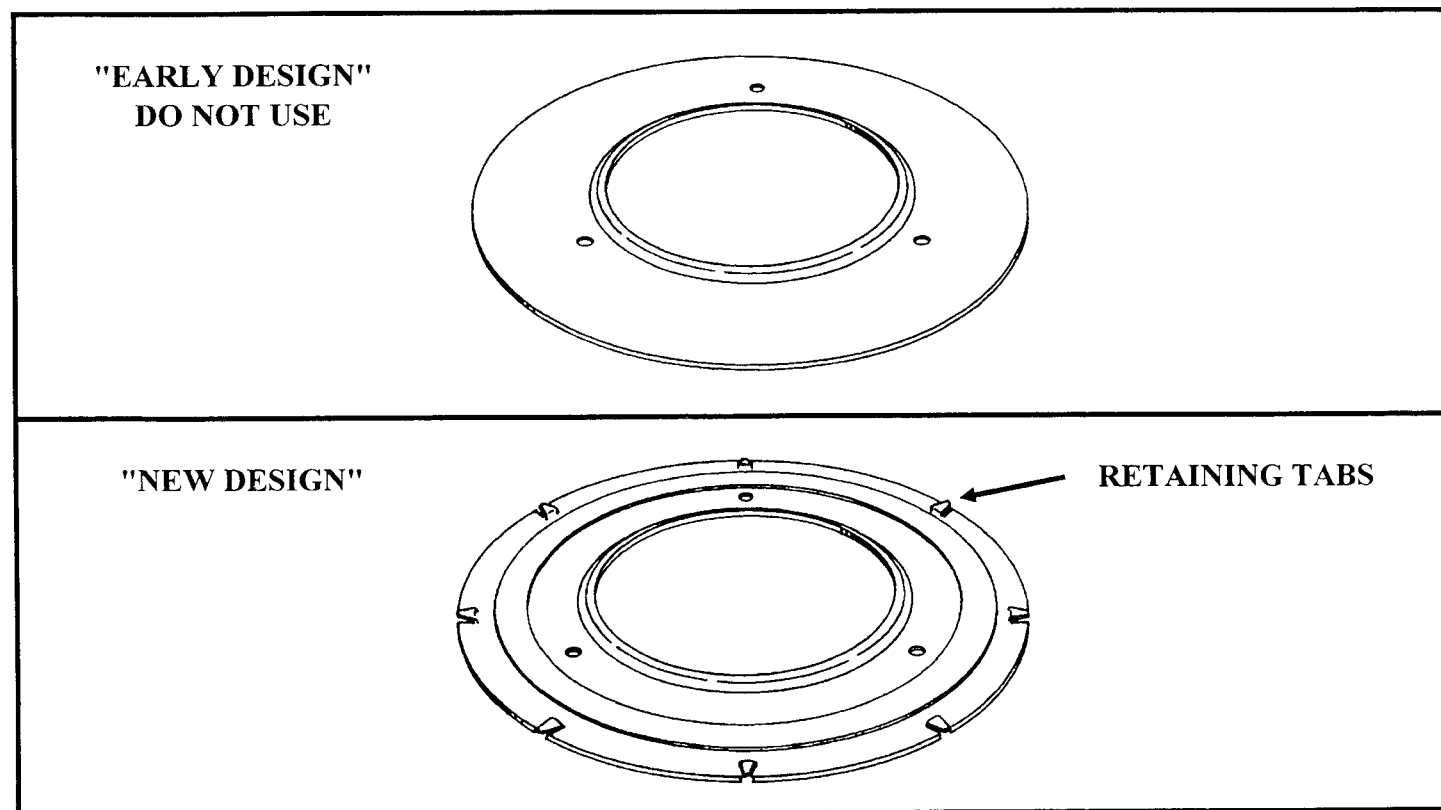
Figure 27

- (1) OVERDRIVE SPRAG RETAINING WASHER - The new design retaining washer increased in overall diameter and has retaining tabs stamped into it to prevent the washer from rotating in the overdrive ring gear. (See Figure 27).

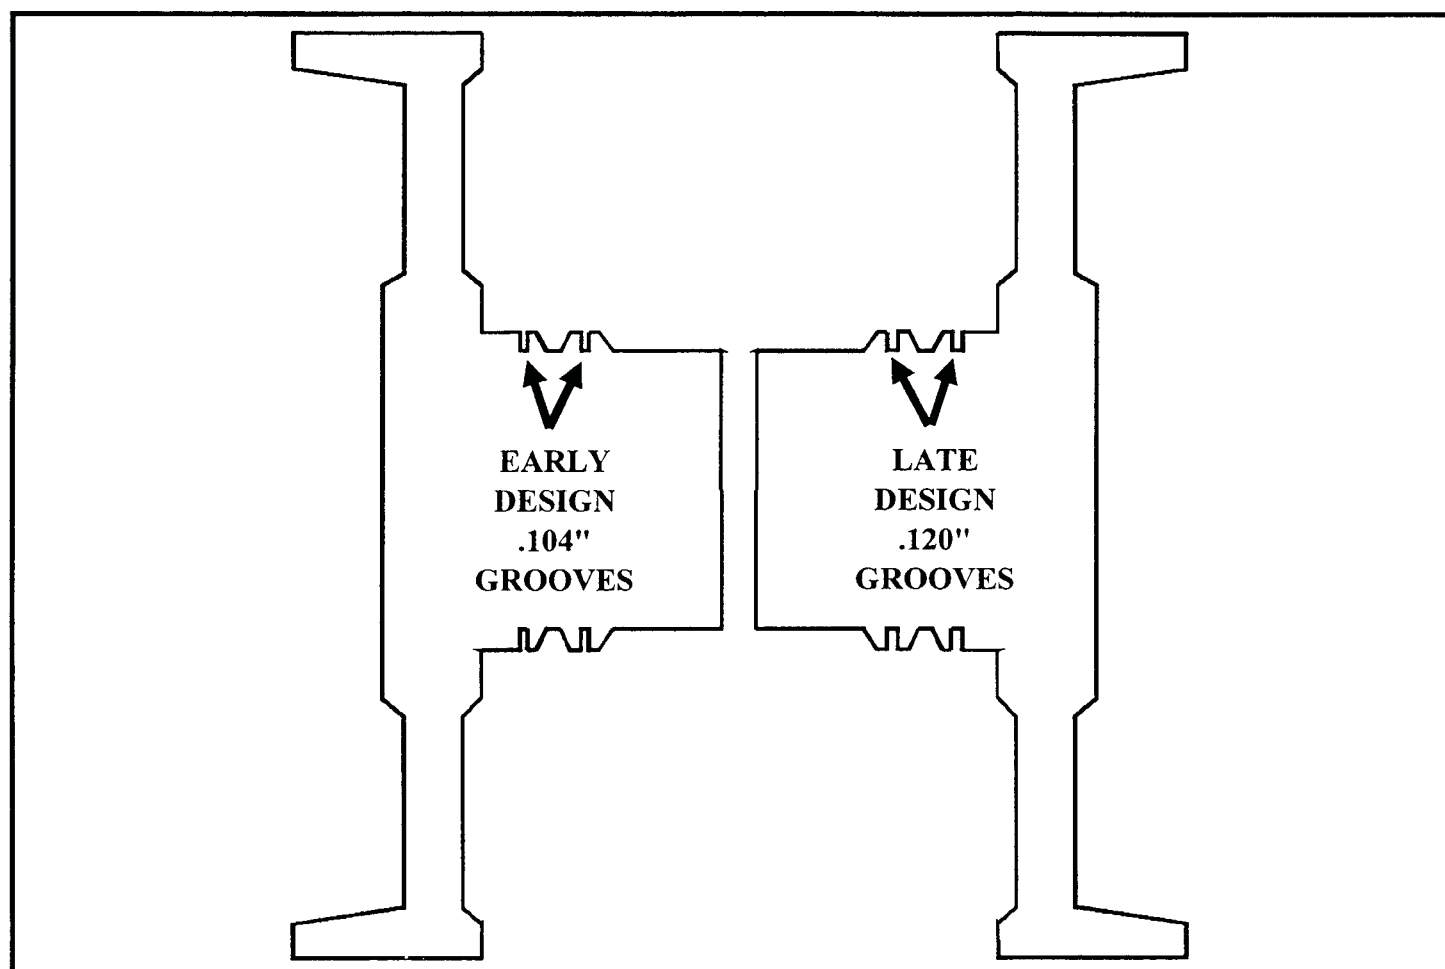
Figure 29

(1) **CENTER SUPPORT** - The sealing ring grooves were widened from .104" to .120"
(See Figure 29).

The center supports are interchangeable, however, you must use the correct size rings for the center support you are using.

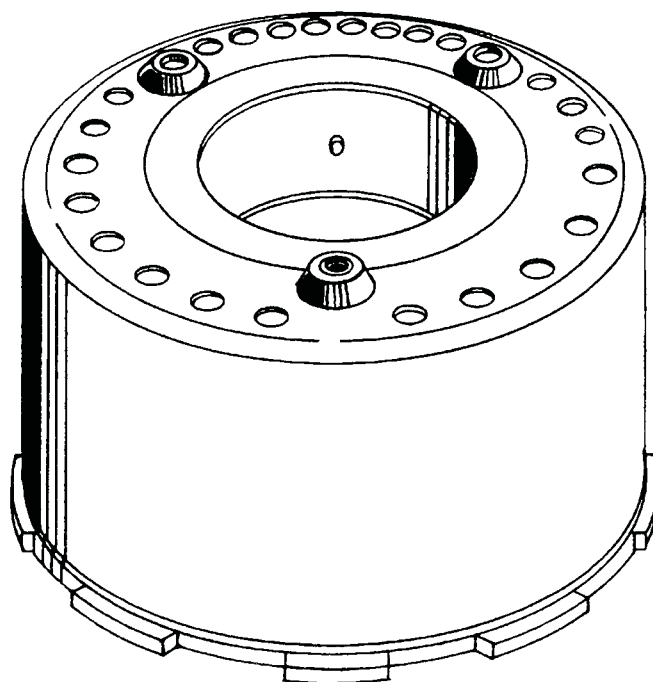
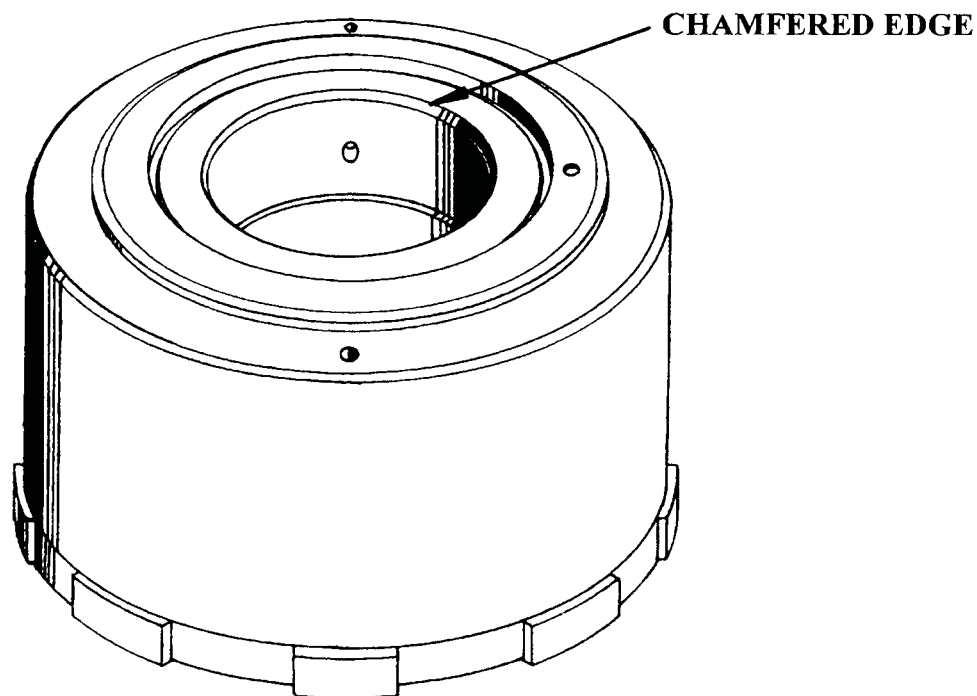
Figure 30

- (1) **DIRECT CLUTCH DRUM - 1st Change:** Was changed from a stamped steel drum to a cast drum, and the sealing ring bore area was chamfered for ease of assembly (See Figure 30).
2nd Change: The "Lug" area where the direct clutch drum engages the sun gear shell, was machined approximately .200" thinner, and a .050" deep groove was machined into the drum to accommodate the added retaining tabs on the "Snap Shell" (See Figure 31). This now allows the sun shell and the direct drum to "Snap" together for easier assembly (See Figure 32). This change also allows the elimination of the number 4 thrust washer, located between the direct clutch drum and center support.

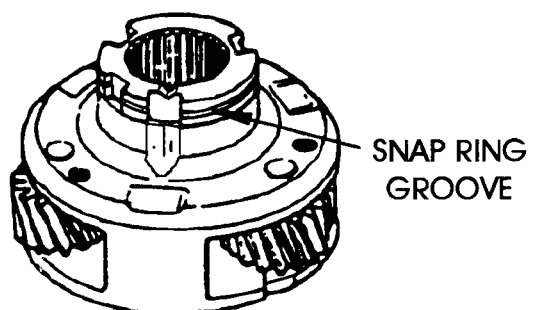
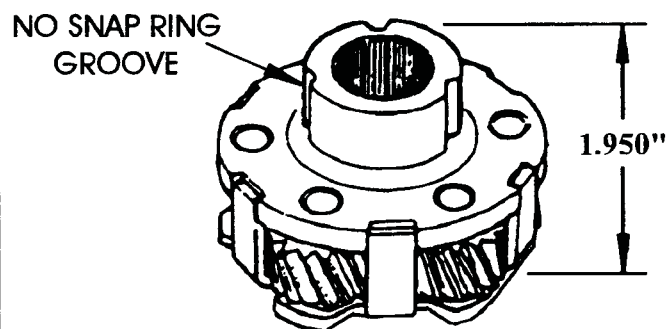
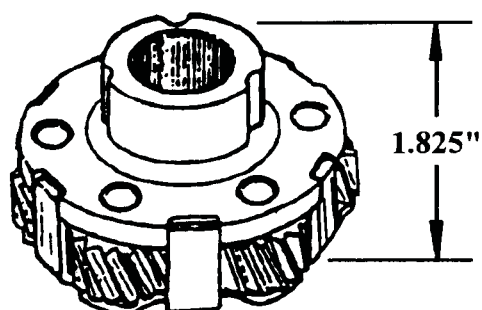
Figure 41

CHANGE: Sometime in model year 1987, the 1st design **3 pinion aluminum** front planetary carrier was replaced with a revised **4 pinion steel** front planetary carrier (See Figures 41 and 43). In model year 1990, on 4.0L engine models only, the steel front planetary carrier was once again revised to a **6 pinion steel** carrier (See Figures 41 and 43). These changes have affected many of the related parts and created confusion for many rebuilders.

- (1) **FRONT PLANETARY CARRIER** - The 1st design **3 pinion aluminum** carrier was eliminated and replaced with a revised **4 pinion steel** carrier. The snap ring groove and the snap ring that previously retained the carrier into the ring gear were eliminated (See Figure 41). In 1990 the steel carrier was once again upgraded with a **6 pinion steel** carrier, for 4.0L engine models only. The 6 pinion steel carrier was also shortened in overall height, by approximately .125", to accommodate a new design number 6 (3 piece) thrust bearing (See Figures 41 & 43). **NOTE:** The 1st Design 3 pinion aluminum and 2nd Design 4 pinion steel front carriers are no longer serviced by Ford Motor Co. They are now upgraded to the latest 3rd Design 6 pinion steel front planetary system, which comes as a service package and includes all necessary hubs and washers to make it compatible.

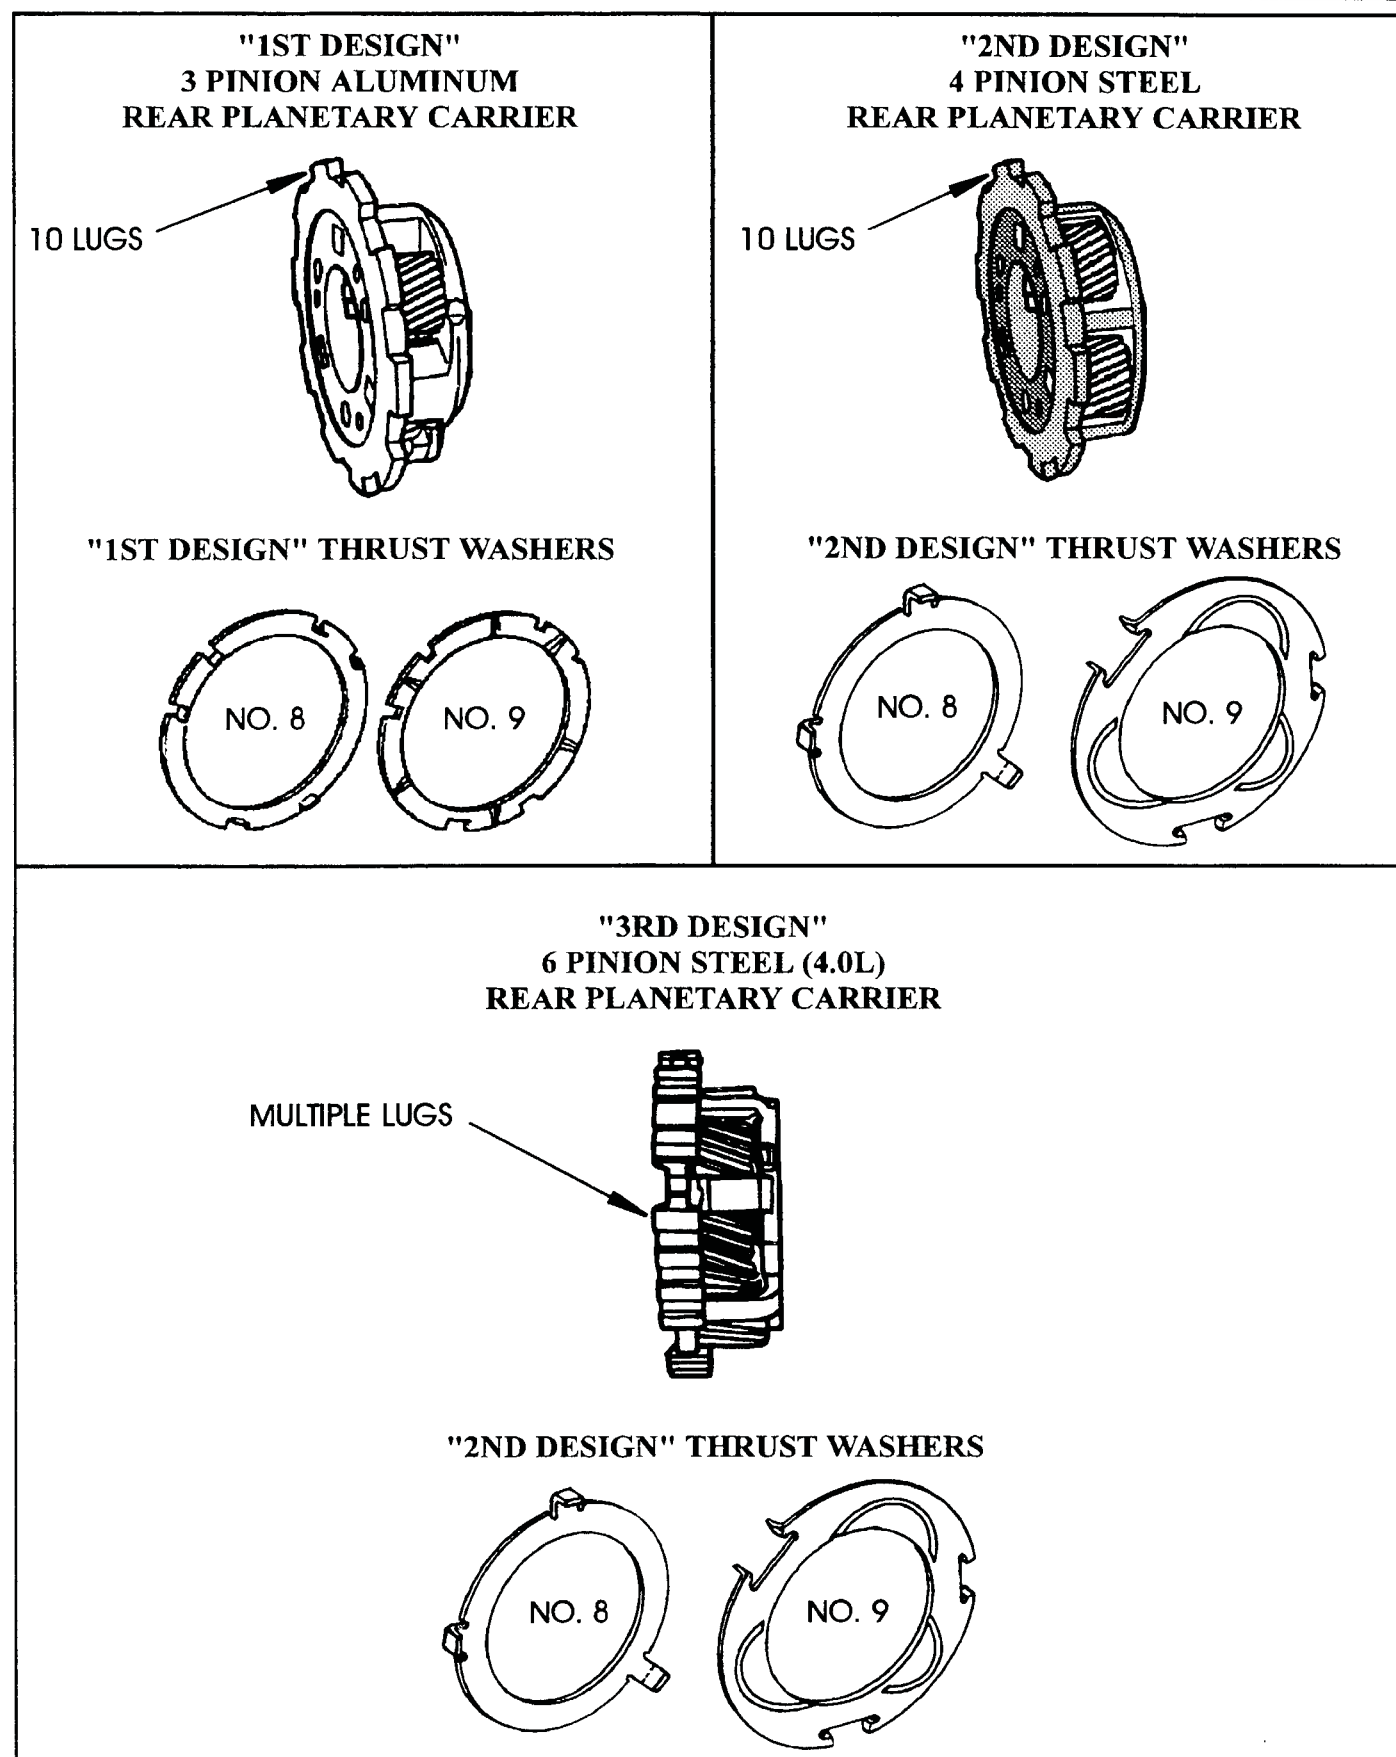
Figure 45
AUTOMATIC TRANSMISSION SERVICE GROUP

- (1) **REAR PLANETARY CARRIER** - The 1st design *3pinion aluminum* rear carrier was eliminated and replaced with a 2nd design *4 pinion steel* rear carrier, as shown in Figure 45. Both 1st and 2nd design rear carriers have 10 lugs where it lugs into the reverse drum, as shown in Figure 45. The 1st design 3 pinion aluminum rear carrier is no longer serviced by Ford Motor Co, and automatically supercedes to the 4 pinion steel rear carrier. It is available as a service package under OEM part number E7SZ-7D006-C, which includes the number 8 and number 9 thrust washers, to make it compatible. Beginning in 1990, on 4.0L engine models only, Ford introduced a 3rd design *6 pinion steel* rear carrier, which has multiple lugs where it lugs into the reverse drum (See Figure 45).

- (4) **NUMBER 8 THRUST WASHER** - Thrust washer tab locations and design changed, to accommodate the 2nd design 4 pinion steel rear carrier (See Figure 45). The 2nd design number 8 thrust washer was carried forward, and used also on the 6 pinion steel rear carrier for the 4.0L engine models (See Figure 45).

- (1) 1ST DESIGN, 3 PINION ALUMINUM, REAR CARRIER - *Not recommended for use in any A4LD*, but if used, it must be used with all 1st design parts listed above.
- (2) 2ND DESIGN, 4 PINION STEEL, REAR CARRIER - Recommended for all 2.3L, 2.8L, 2.9L, 3.0L engines, and *mandatory* for all 2.3L Turbo models. Must be used with all 2nd design parts listed above, except output shaft which must be 1st design.
- (3) 3RD DESIGN, 6 PINION STEEL, REAR CARRIER - *Mandatory for all 4.0L models*, and must be used with all 3rd design parts listed above, and the 2nd design output shaft.

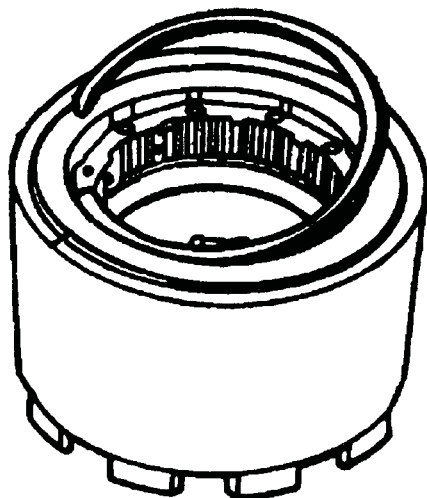
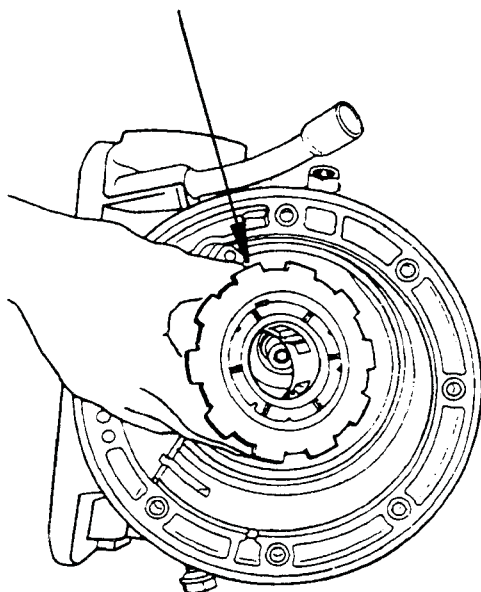
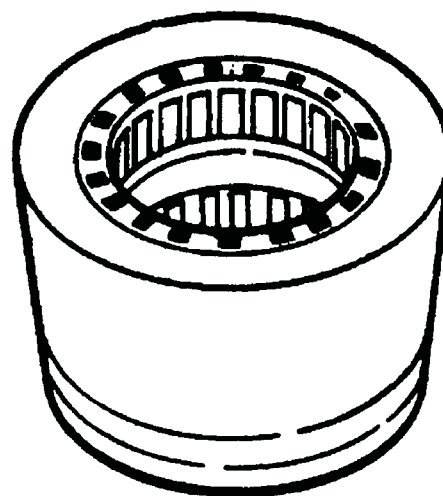
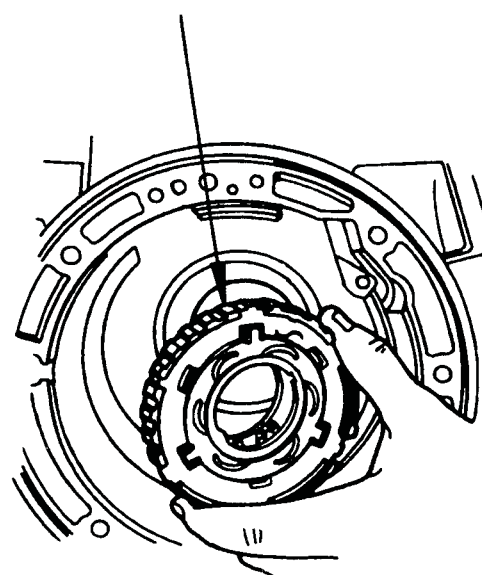
Figure 46
AUTOMATIC TRANSMISSION SERVICE GROUP

- (2) **REVERSE DRUM** - The 1st design Reverse Drum contains the *low roller clutch* and has the "Castles" on the front of the drum to accept the 10 lug, 4 pinion steel rear carrier, as shown in Figure 46. The 2nd design Reverse Drum contains the *low sprag clutch* and is machined to accept the multiple lug, 6 pinion steel rear carrier for the 4.0L models, as shown in Figure 46.

**"1ST DESIGN"
REVERSE DRUM
WITH ROLLER CLUTCH**

**REQUIRES THE "2ND DESIGN"
10 LUG REAR CARRIER**

**"2ND DESIGN"
REVERSE DRUM
WITH SPRAG**

**REQUIRES THE "3RD DESIGN"
MULTIPLE LUG REAR CARRIER**

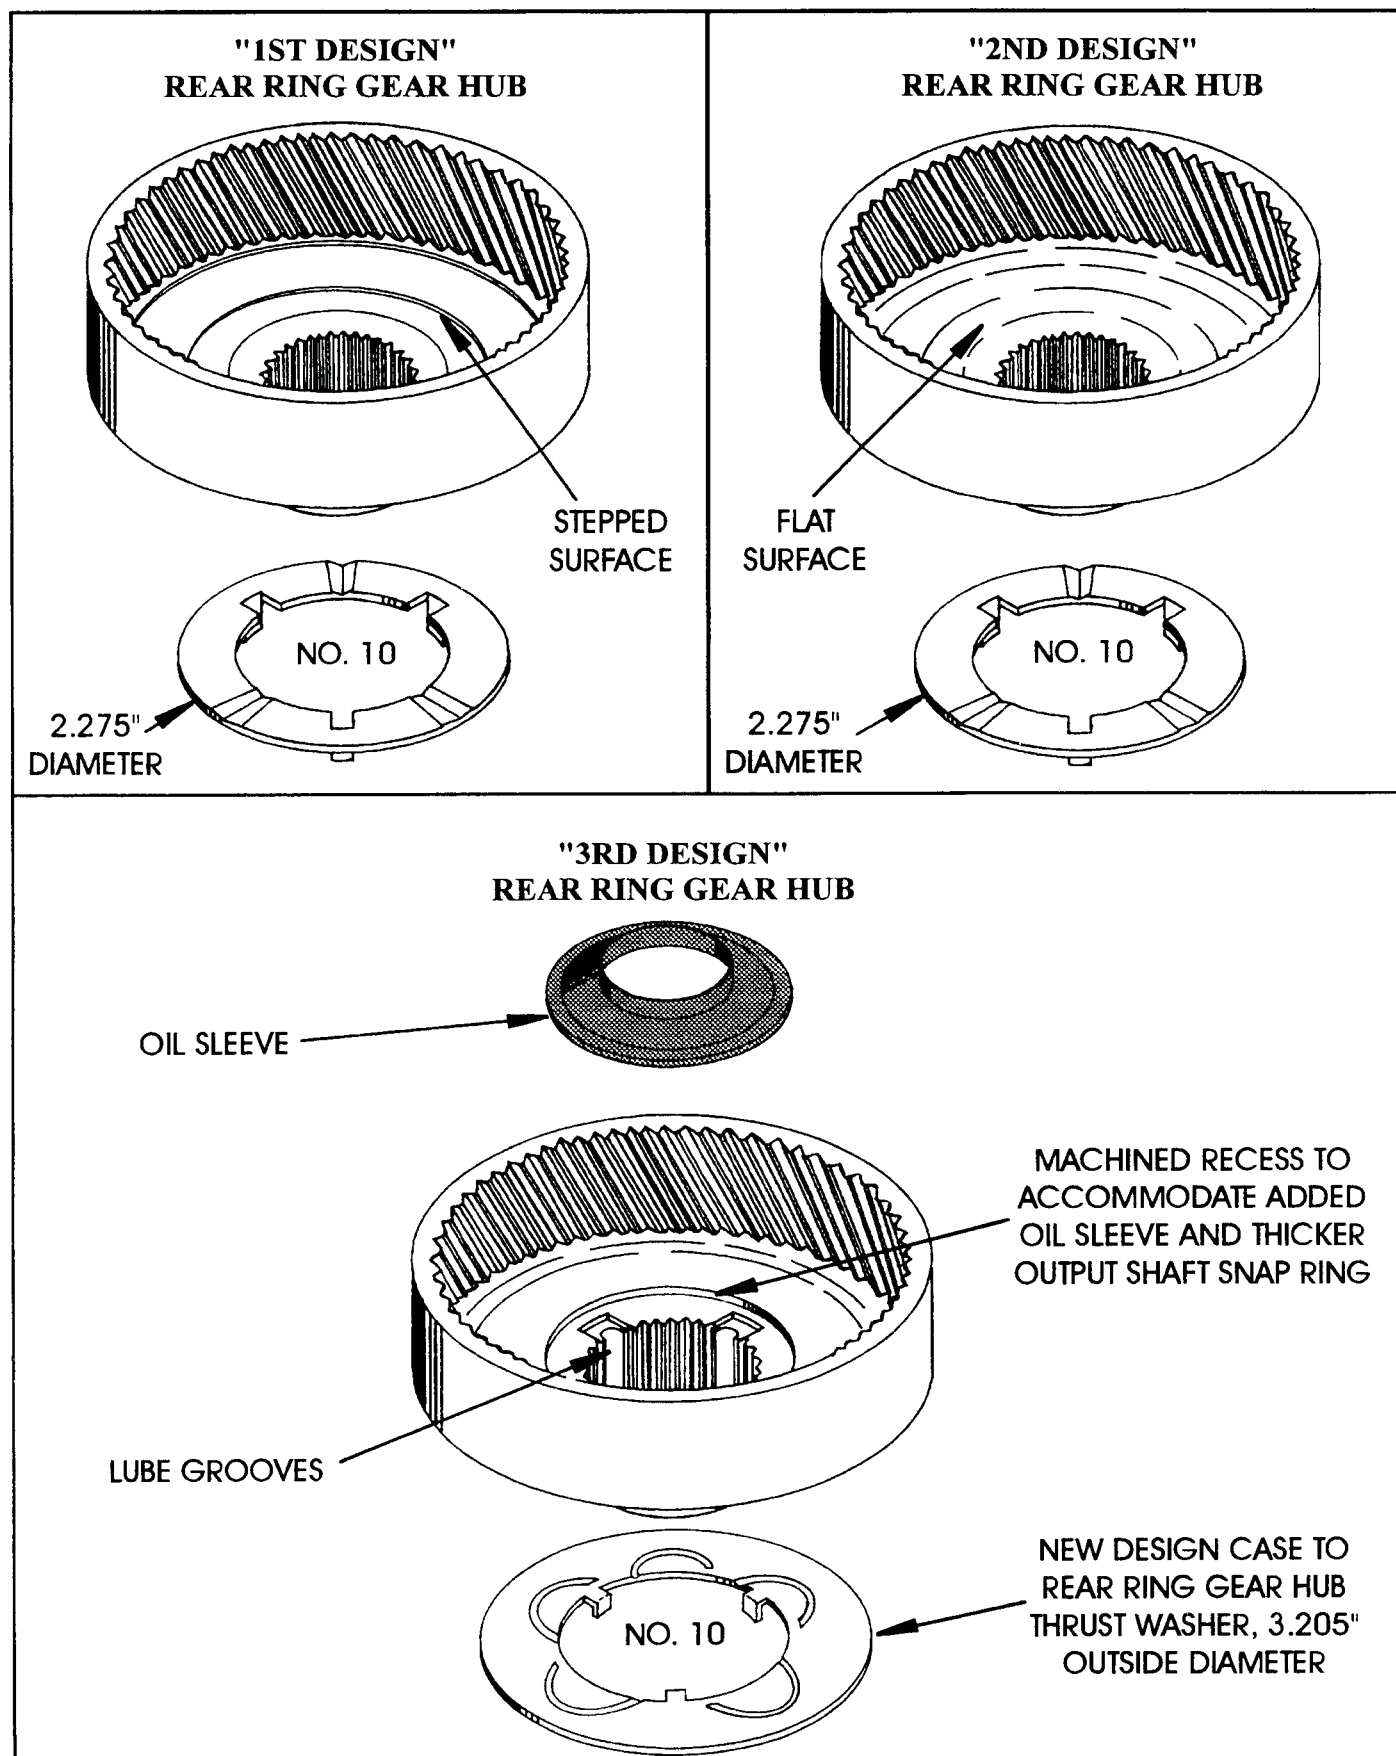
Figure 47

- (3) **REAR RING GEAR HUB** - The 1st design Rear Ring Gear Hub is identified with a "Stepped" washer surface as shown in Figure 47, and uses the 1st design number 9 thrust washer as shown in Figure 45. The 2nd design Rear Ring Gear Hub is identified with a "Flat" washer surface as shown in Figure 47, to accommodate the new 2nd design number 9 thrust washer (See Figure 45). The 3rd design Rear Ring Gear Hub is identified with a machined recess to accommodate the added oil sleeve and the thicker output shaft snap ring, and you can also see the added lube grooves in the spline area to accommodate the internal lube flow changes (See Figure 47). The 2nd & 3rd design Ring Gear Hub also has step removed out next to the ring gear teeth, to accommodate larger diameter of the 2nd design number 9 thrust washer (See Figure 47).
