A4LD UPDATE HANDBOOK INDEX

Updated
April, 2004

FORD A4LD

"UPDATE HANDBOOK"

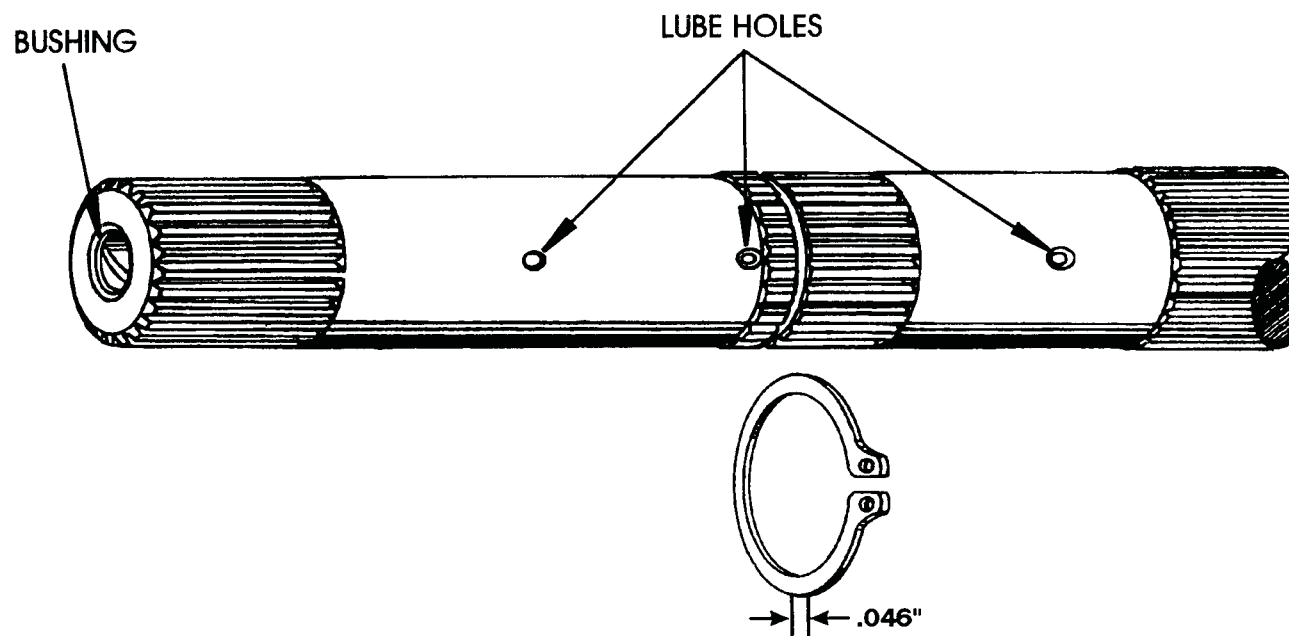
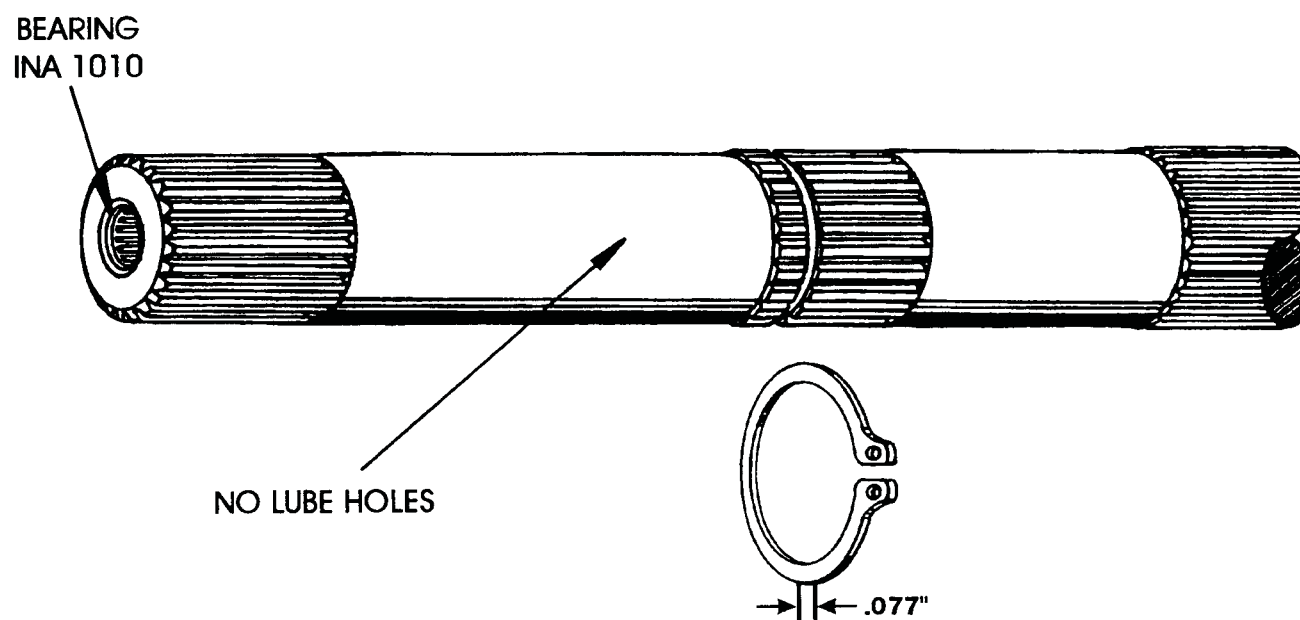
Figure 48

- (8) OUTPUT SHAFT - The Output Shaft was revised in three areas:
 - The front output shaft bushing was replaced with a caged needle bearing (See Figure 48).

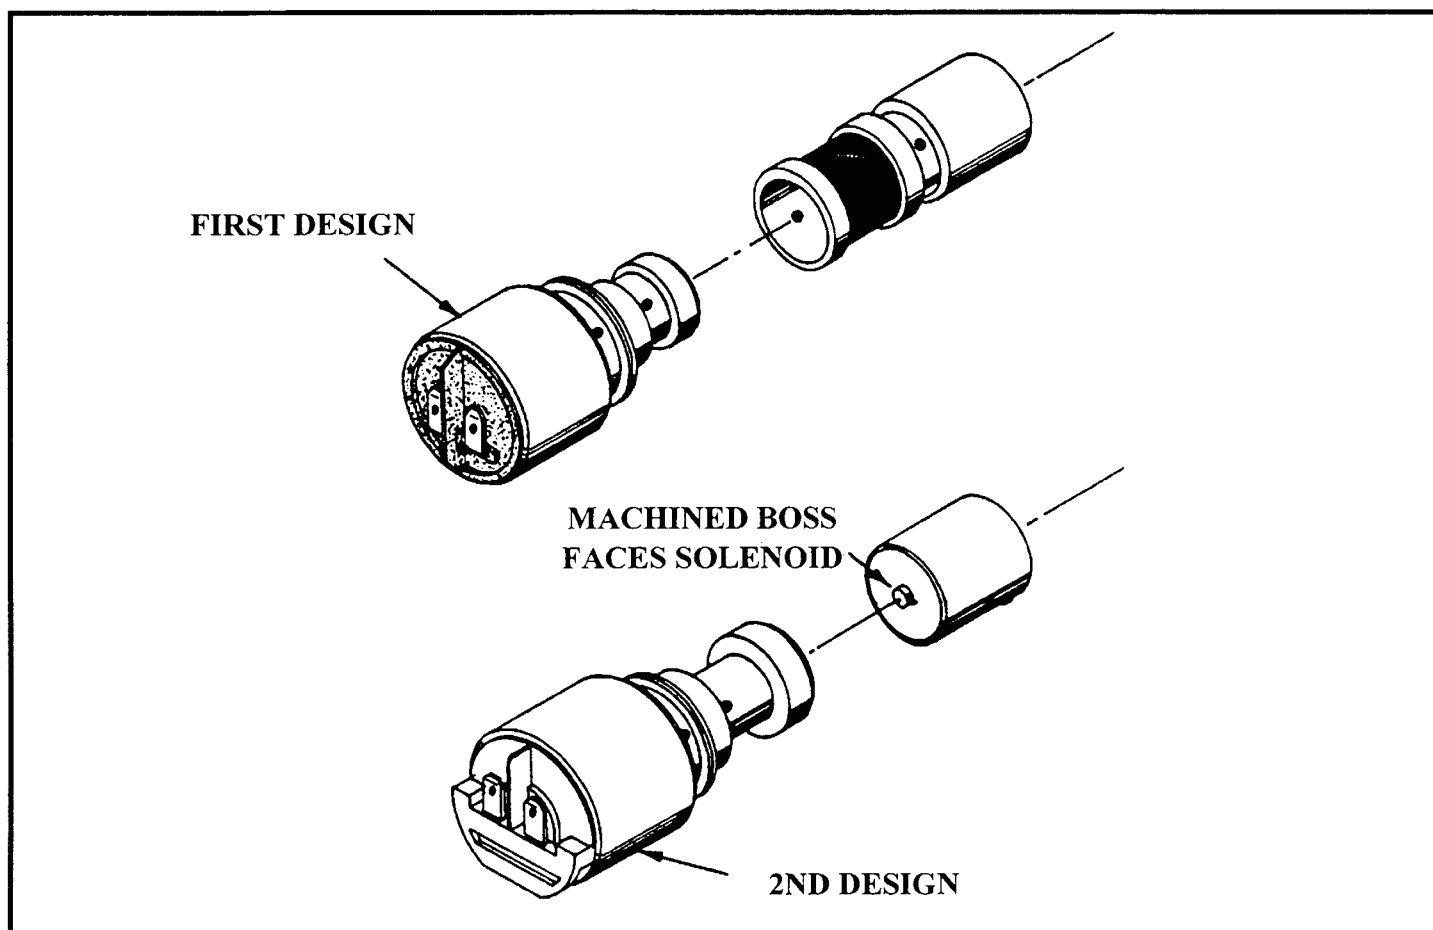
Figure 66

3-4 SHIFT SOLENOID - The 2nd design 3-4 shift solenoid eliminates the screen, has dimensional changes on the solenoid itself, and includes a new plug with a boss machined on one end. The plug must be installed with the machined boss facing the solenoid as shown in Figure 66.

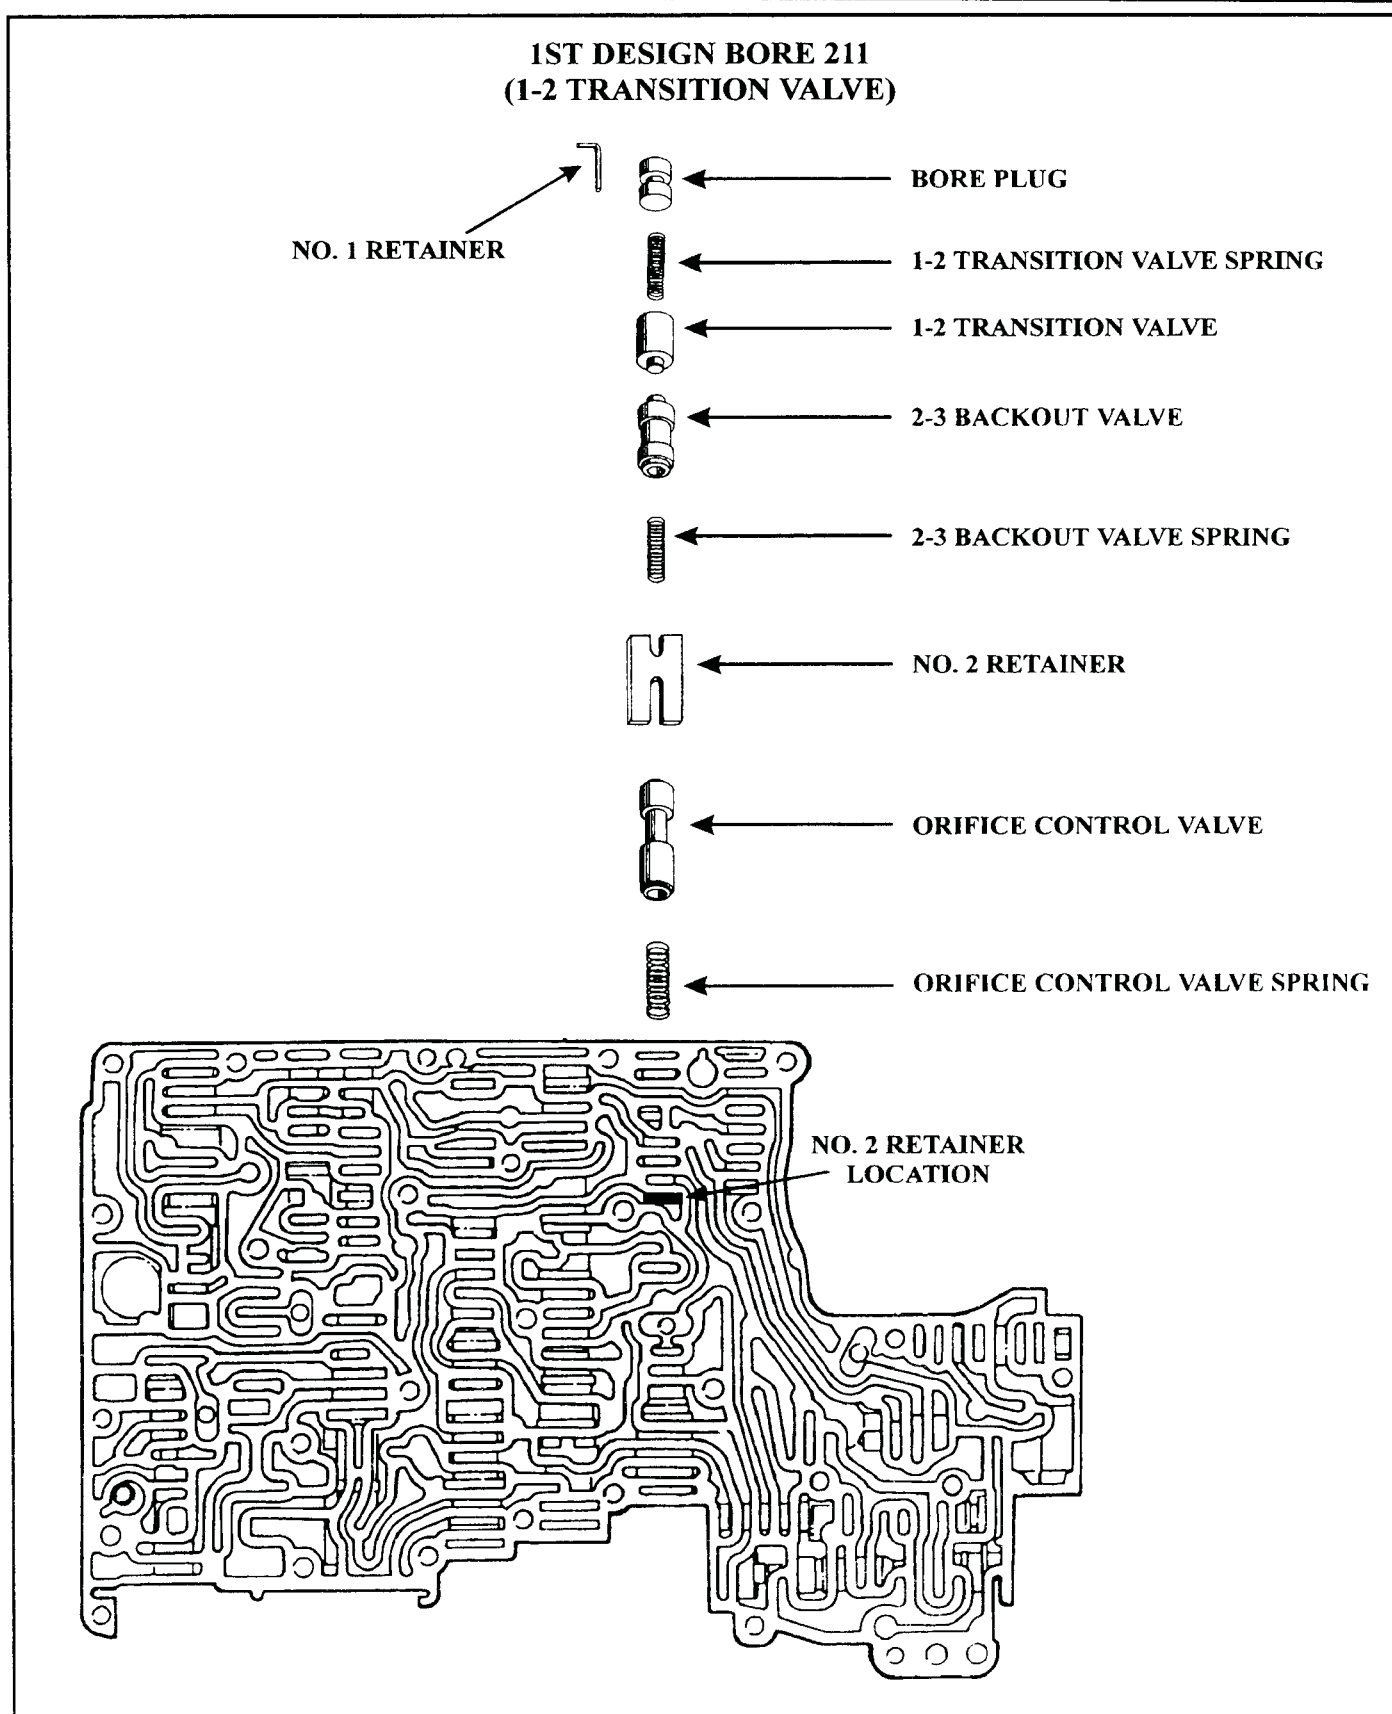
Figure 67

This bore contains the 1-2 Transition Valve and is located as shown in Figure 67. Notice the location of the No. 2 retainer in valve body is also shown in Figure 67. Figure 68 shows the "Large Hole" spacer plate that is required on the valve body with the 1st design bore 211. Figure 68 also identifies the holes that were eliminated on the two solenoid valve bodies.

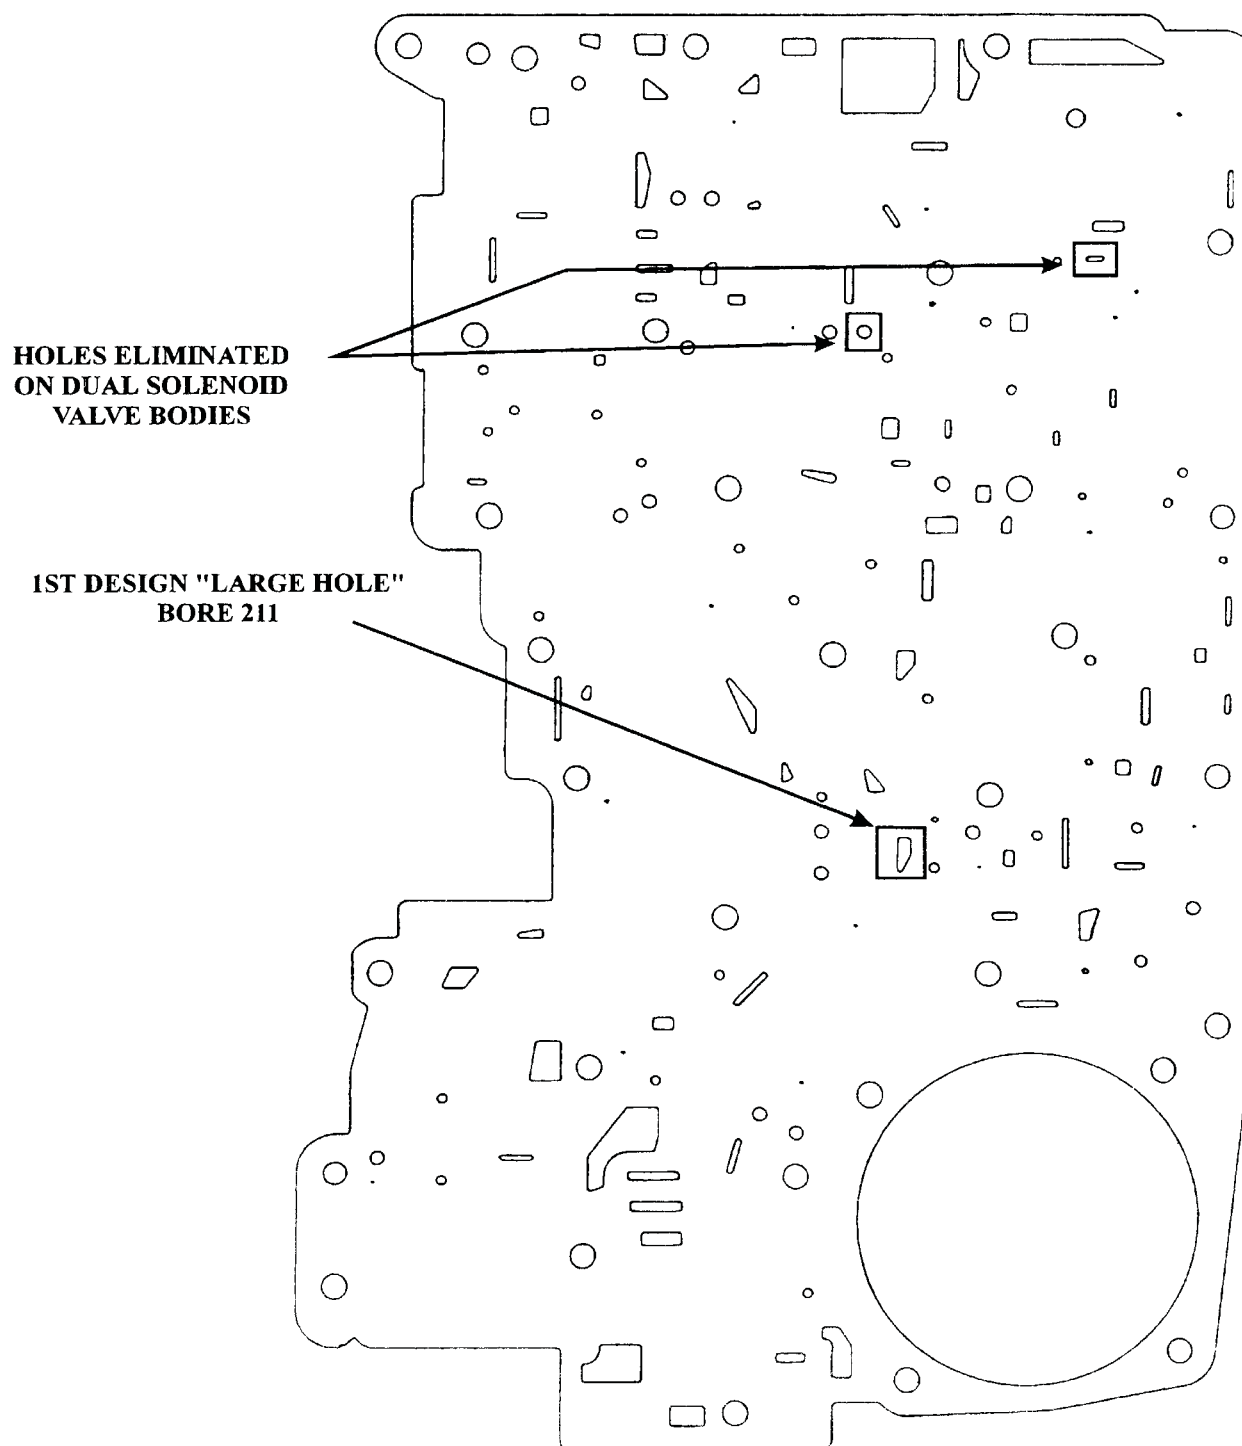
Figure 68

"LARGE HOLE" SPACER PLATE REQUIRED WITH 1ST DESIGN BORE 211 (1-2 TRANSITION VALVE)

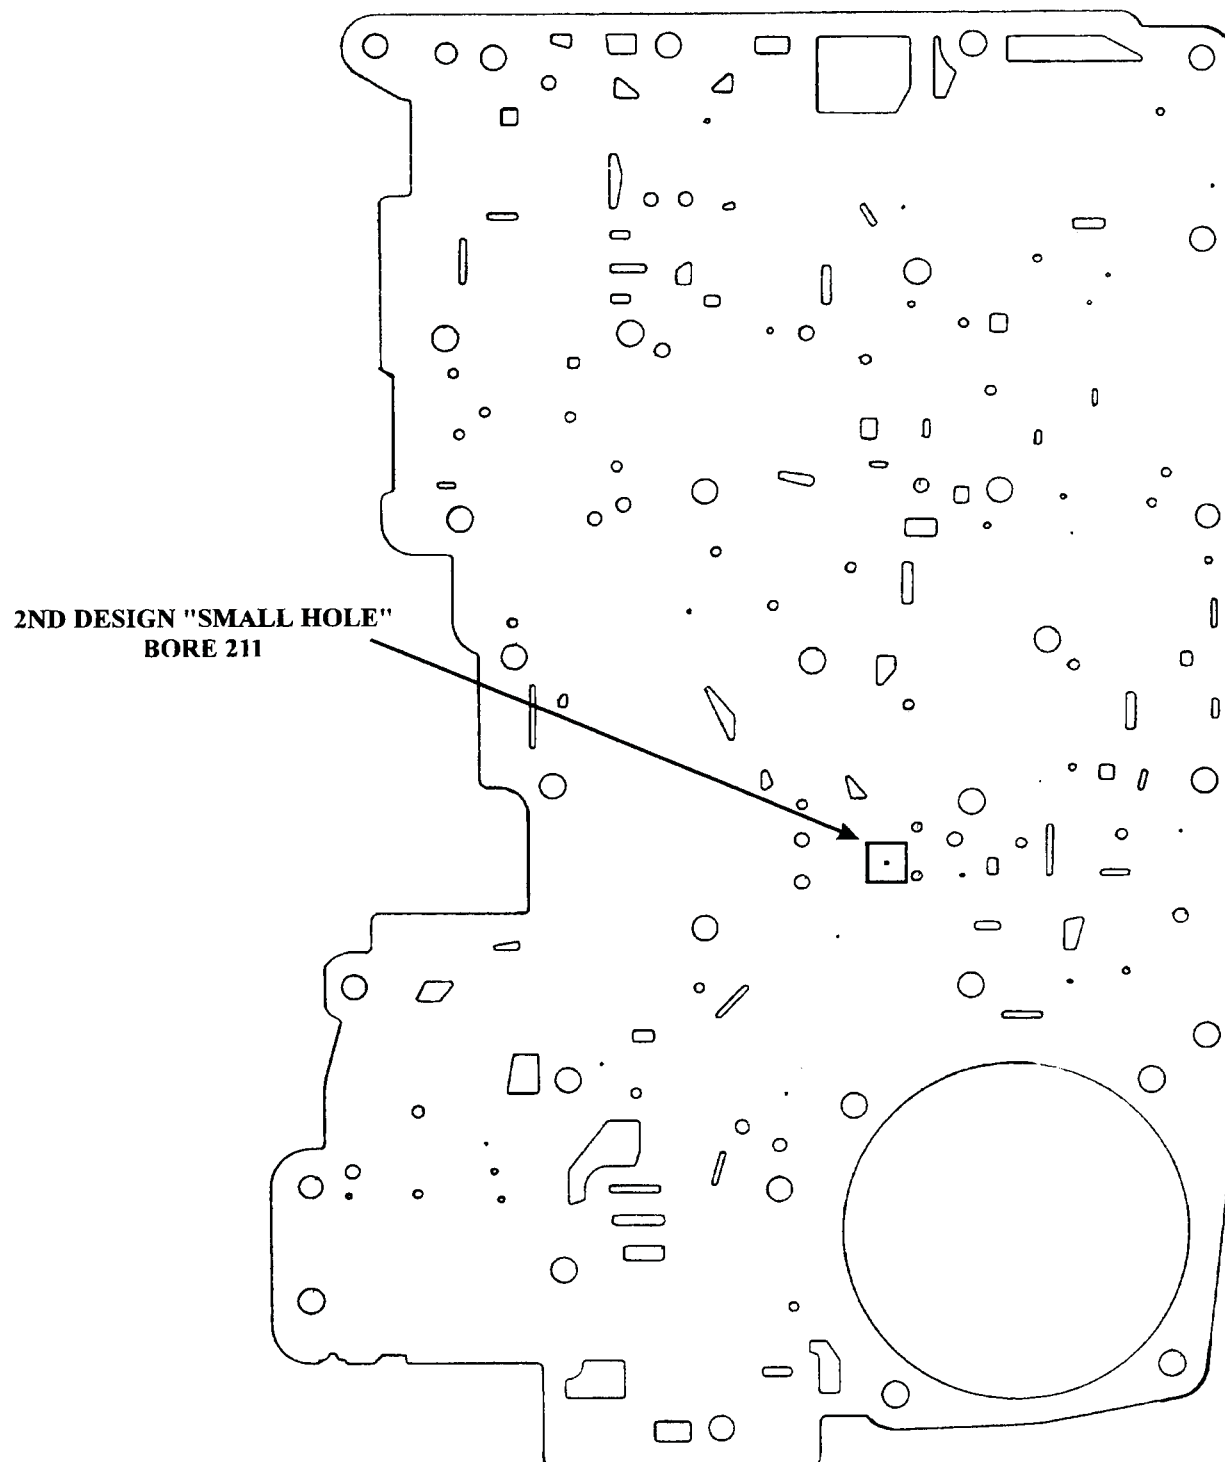
Figure 70

**"SMALL HOLE" SPACER PLATE
REQUIRED WITH 2ND DESIGN BORE 211
(1-2 TRANSITION VALVE)**

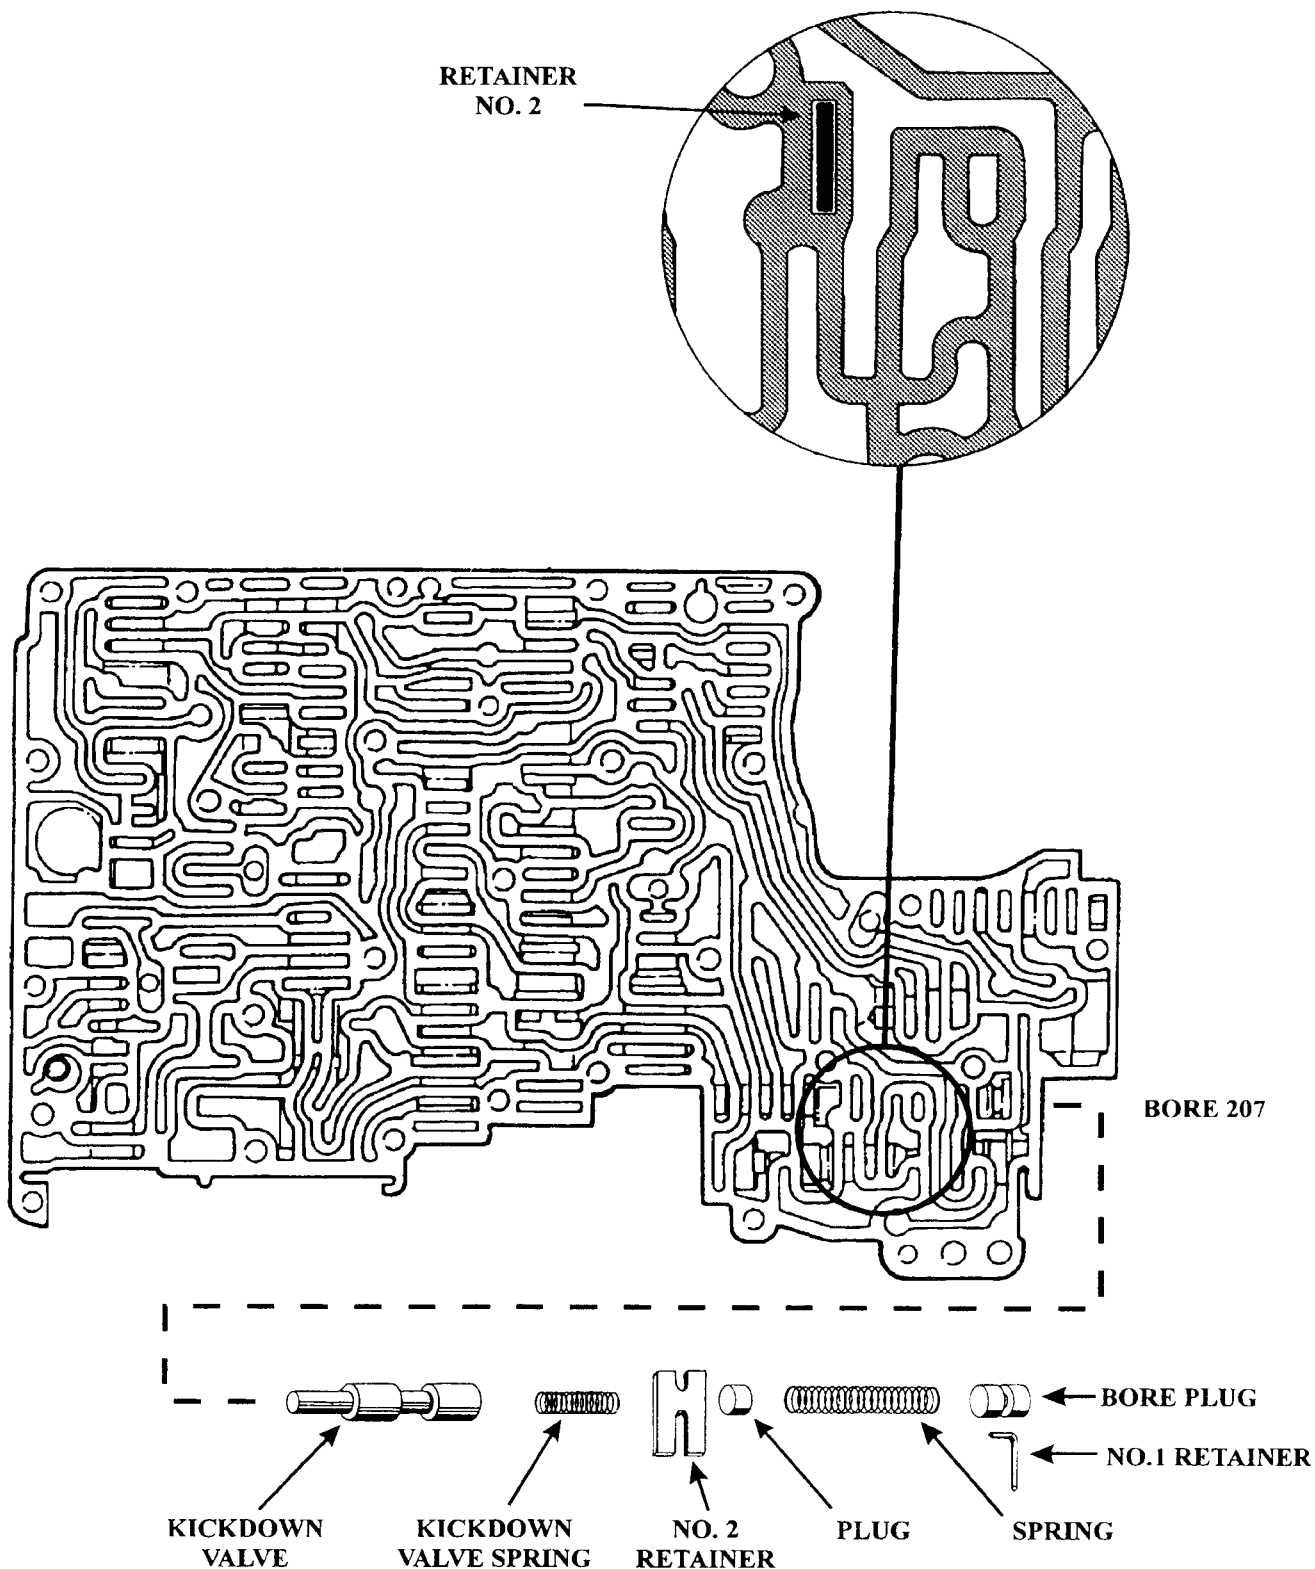
Figure 71 shows the correct line-up for this bore, and the No. 2 retainer location in the valve body casting. Figure 72 shows the "Slot" in the spacer plate that is required for the 1st design bore 207, "Without" reverse engagement valve.

Note: Valve body castings are also different in the worm track area, when it comes to bore 207. Compare the inset in Figure 71 to the inset in Figure 73, and you will see the difference in the passages, which *will not* allow you to install reverse engagement valve into a 1st design valve body casting.

1ST DESIGN BORE 207 "WITHOUT" REVERSE ENGAGEMENT CONTROL VALVE

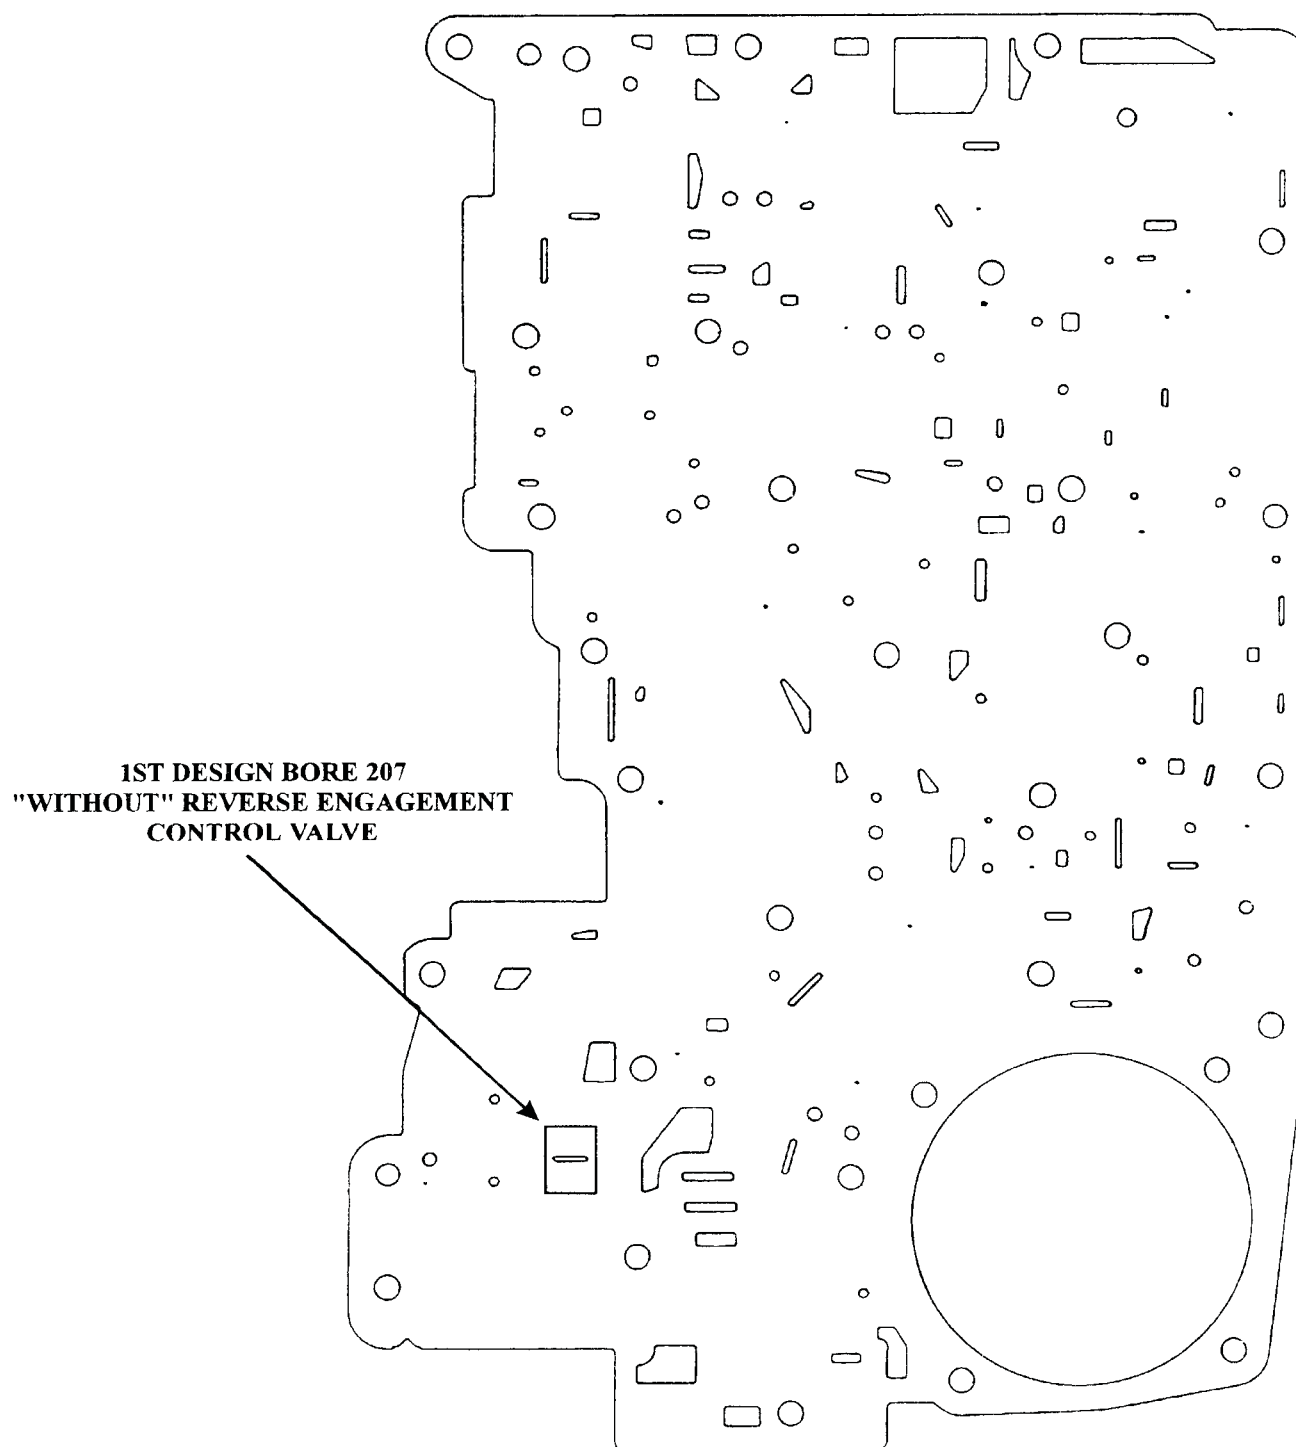
Figure 72

**"SLOT" IN SPACER PLATE
REQUIRED WITH 1ST DESIGN BORE 207
"WITHOUT" REVERSE ENGAGEMENT CONTROL VALVE**

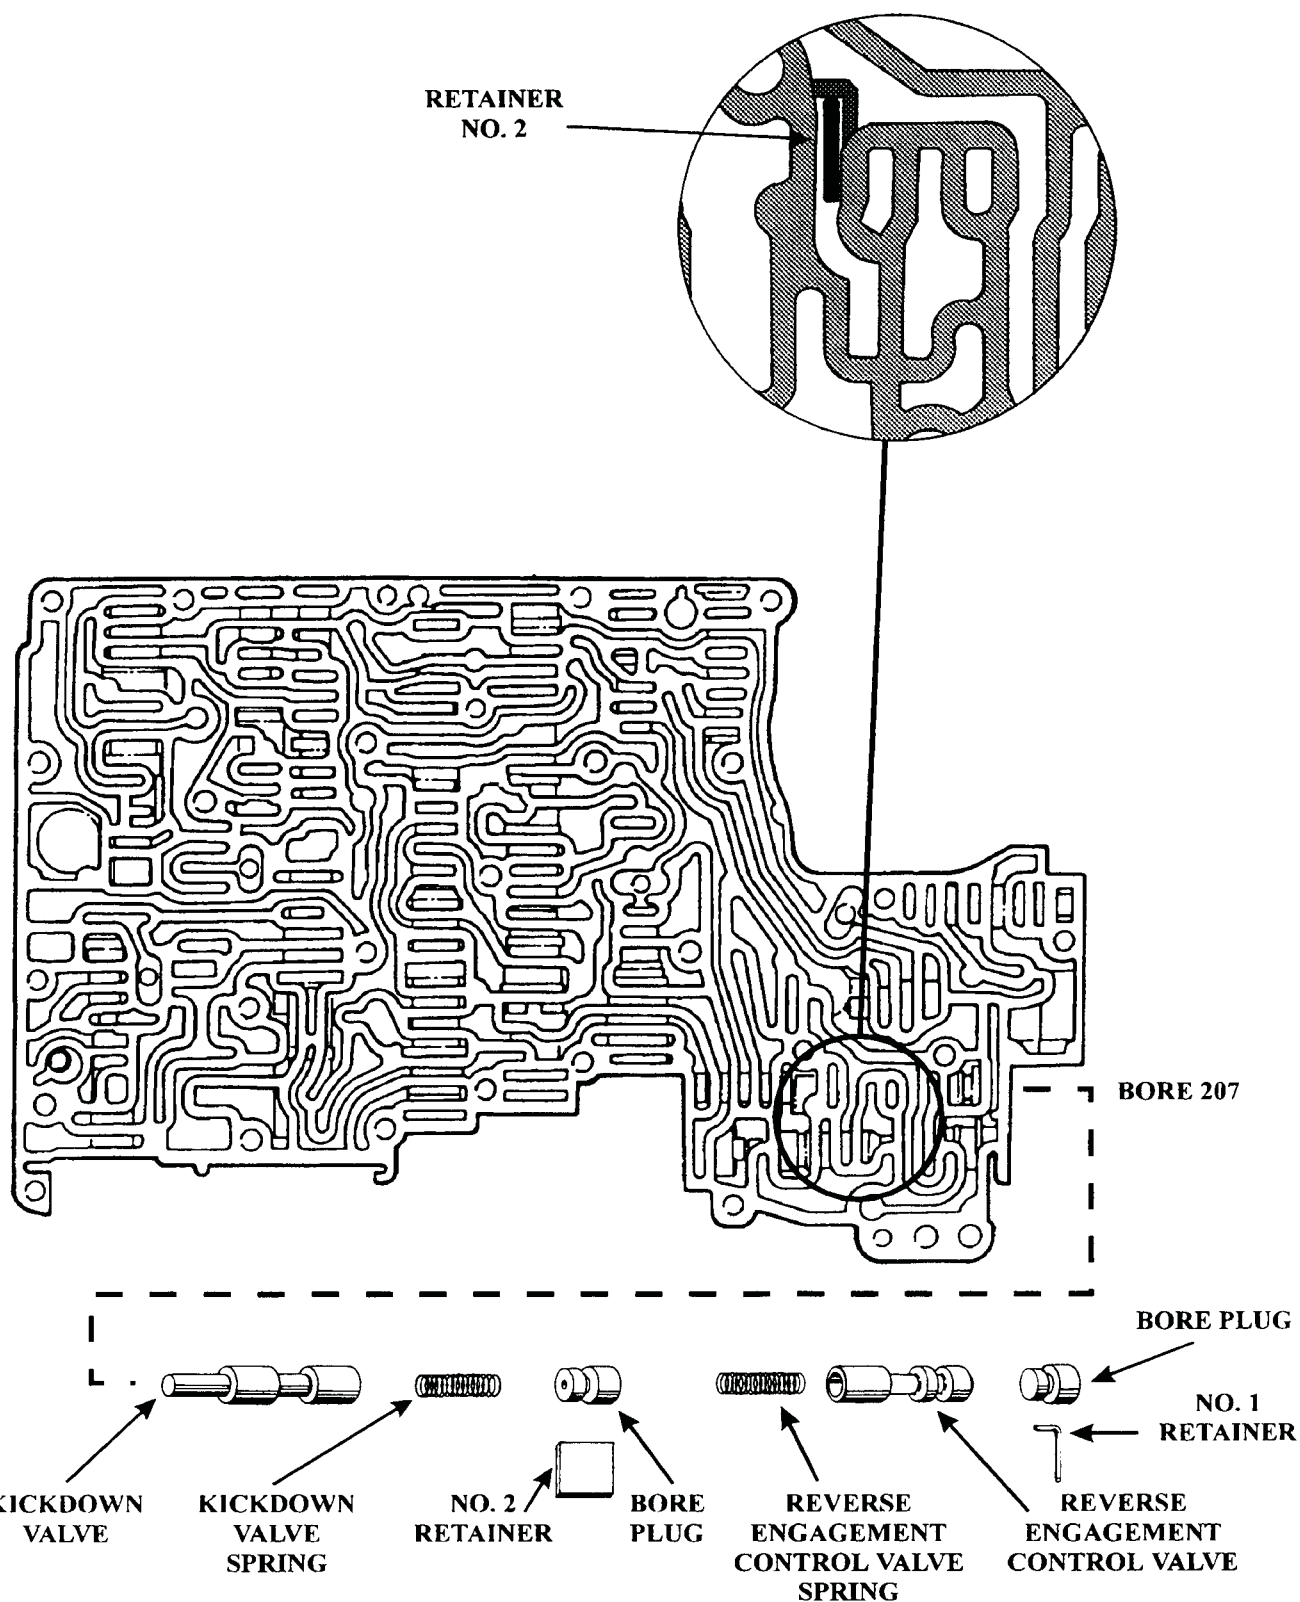
Figure 73

This is when the reverse engagement control valve was added to bore 207, as shown in Figure 73, and also shows the location of the No. 2 retainer in the valve body casting and the direction of the bore plugs. Figure 74 shows the "3 Hole" spacer plate that is required on valve bodies containing the reverse engagement control valve.

2ND DESIGN BORE 207 "WITH" REVERSE ENGAGEMENT CONTROL VALVE

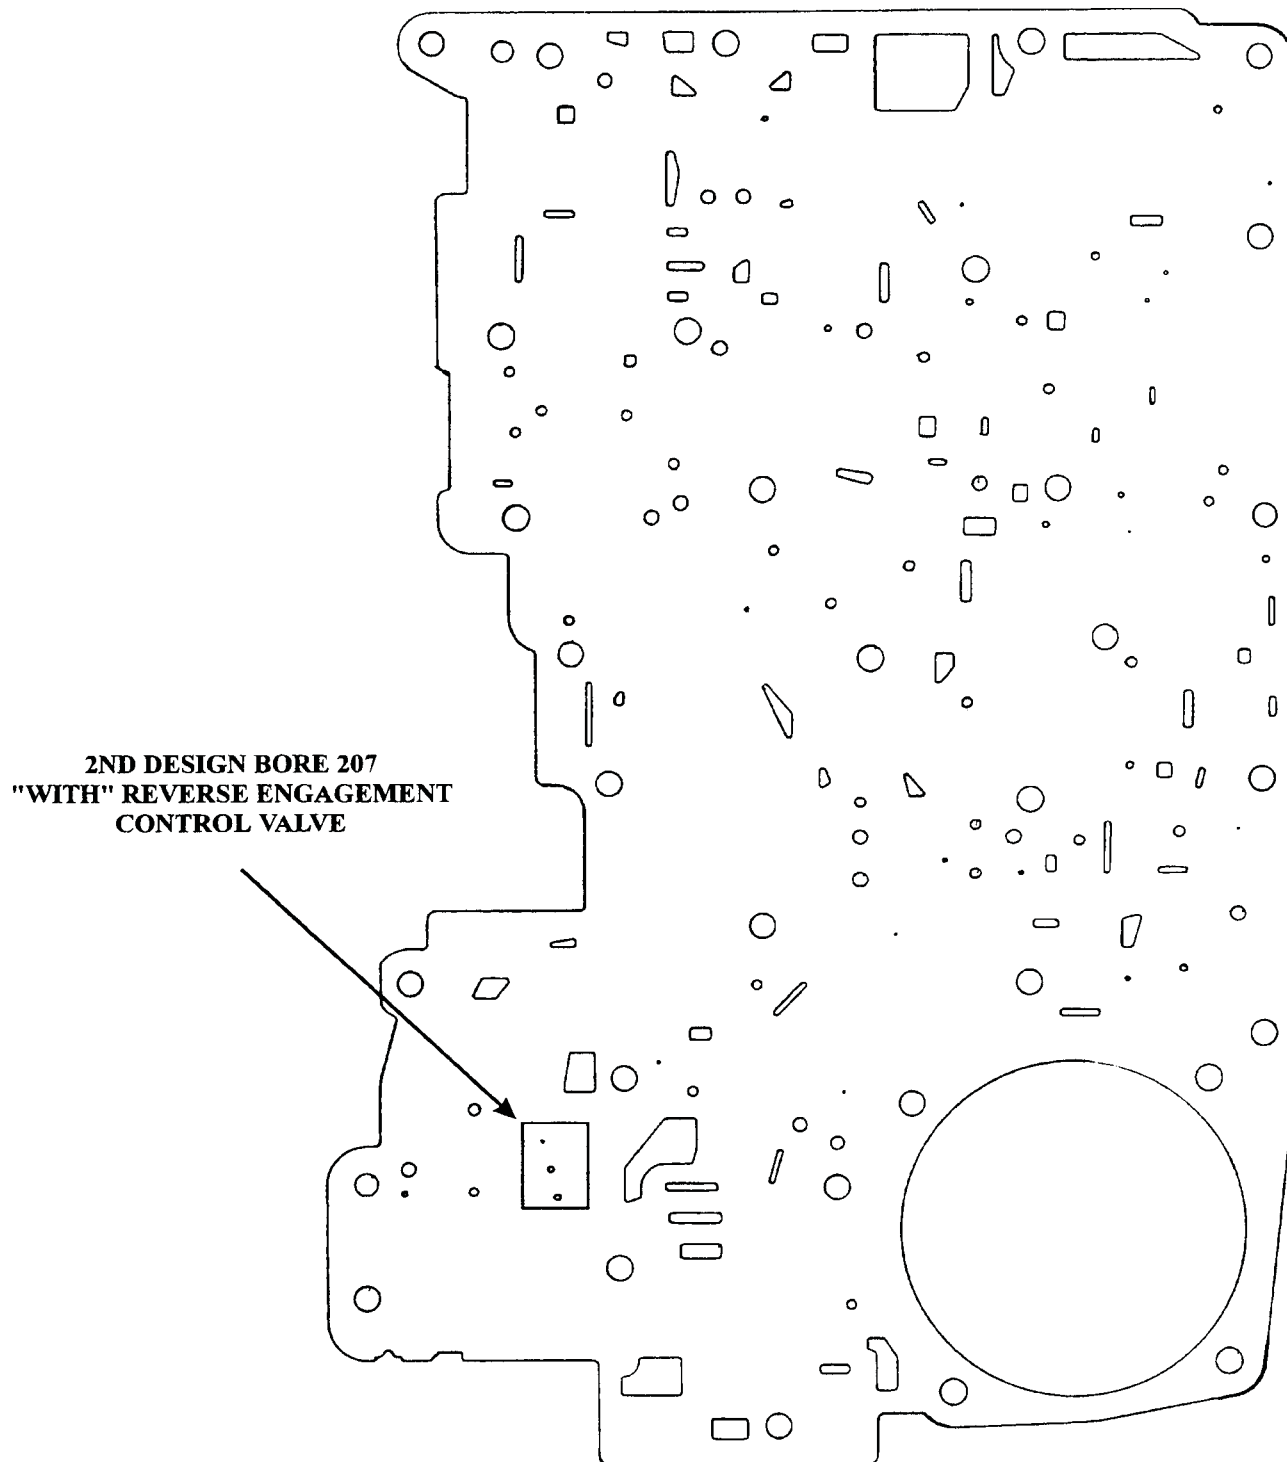
Figure 74

**"3 HOLE" SPACER PLATE
REQUIRED WITH 2ND DESIGN BORE 207
"WITH" REVERSE ENGAGEMENT CONTROL VALVE**

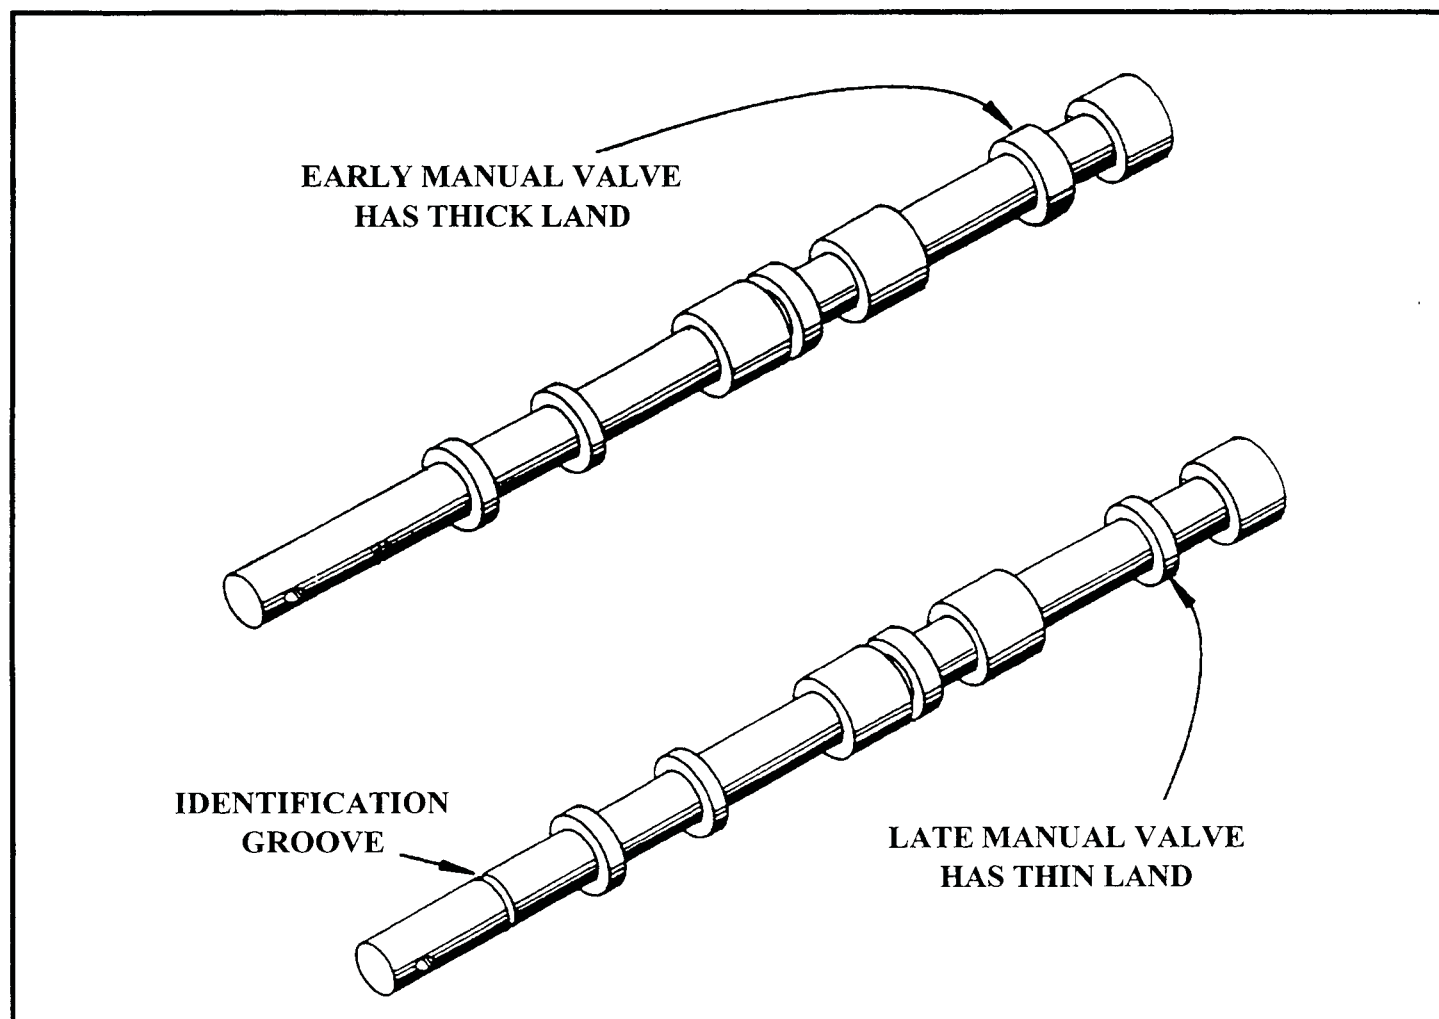
Figure 76

COMPLAINT: After overhaul, your A4LD transmission exhibits a "Tie-Up" condition, when the selector lever is placed into the park position.

CAUSE: The cause may be, an improperly adjusted manual valve. The .075" puck supplied in some gasket sets & some valve body kits WILL NOT WORK ON ALL MODELS. On SOME valve bodies, using the "Puck" to adjust the manual valve, will allow the manual valve to move past the Park position and apply the forward clutch.

The 2nd design manual valve will retro fit to all models and is highly recommended.

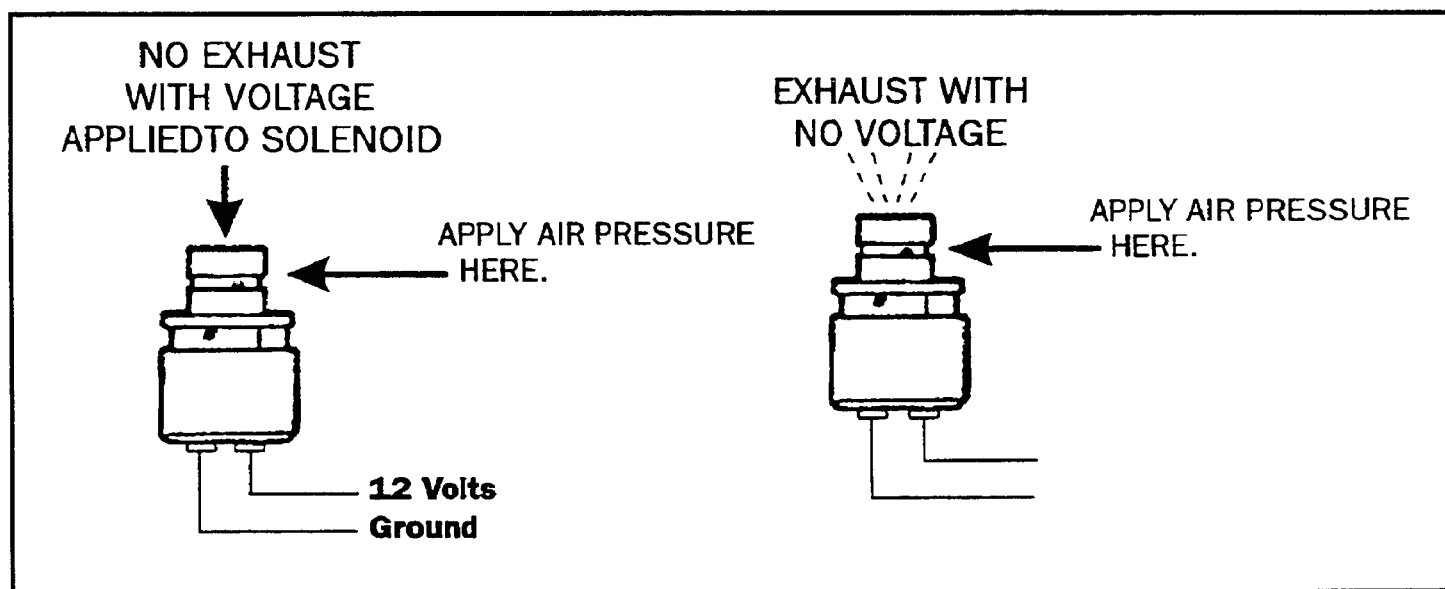
Figure 78

- CAUSE:**
- (1) The lock-up solenoid may not have been correctly bench checked during overhaul or when failure is suspected. This is due to confusion in printed material regarding air test procedures and ohms check procedures.
 - (2) The converter clutch shuttle spring is broken or collapsed
 - (3) The converter clutch TV modulator spring is not strong enough to shut off line pressure to the converter clutch shuttle valve during coastdown.

- (1) The proper air test procedure is shown in Figure 78. You must use no more than 70psi. when checking the lock-up solenoid or else the results will not be valid. Ohms check the solenoid across the two terminals. There should be 25 - 40 ohms of resistance across both terminals but no continuity to the solenoid body.

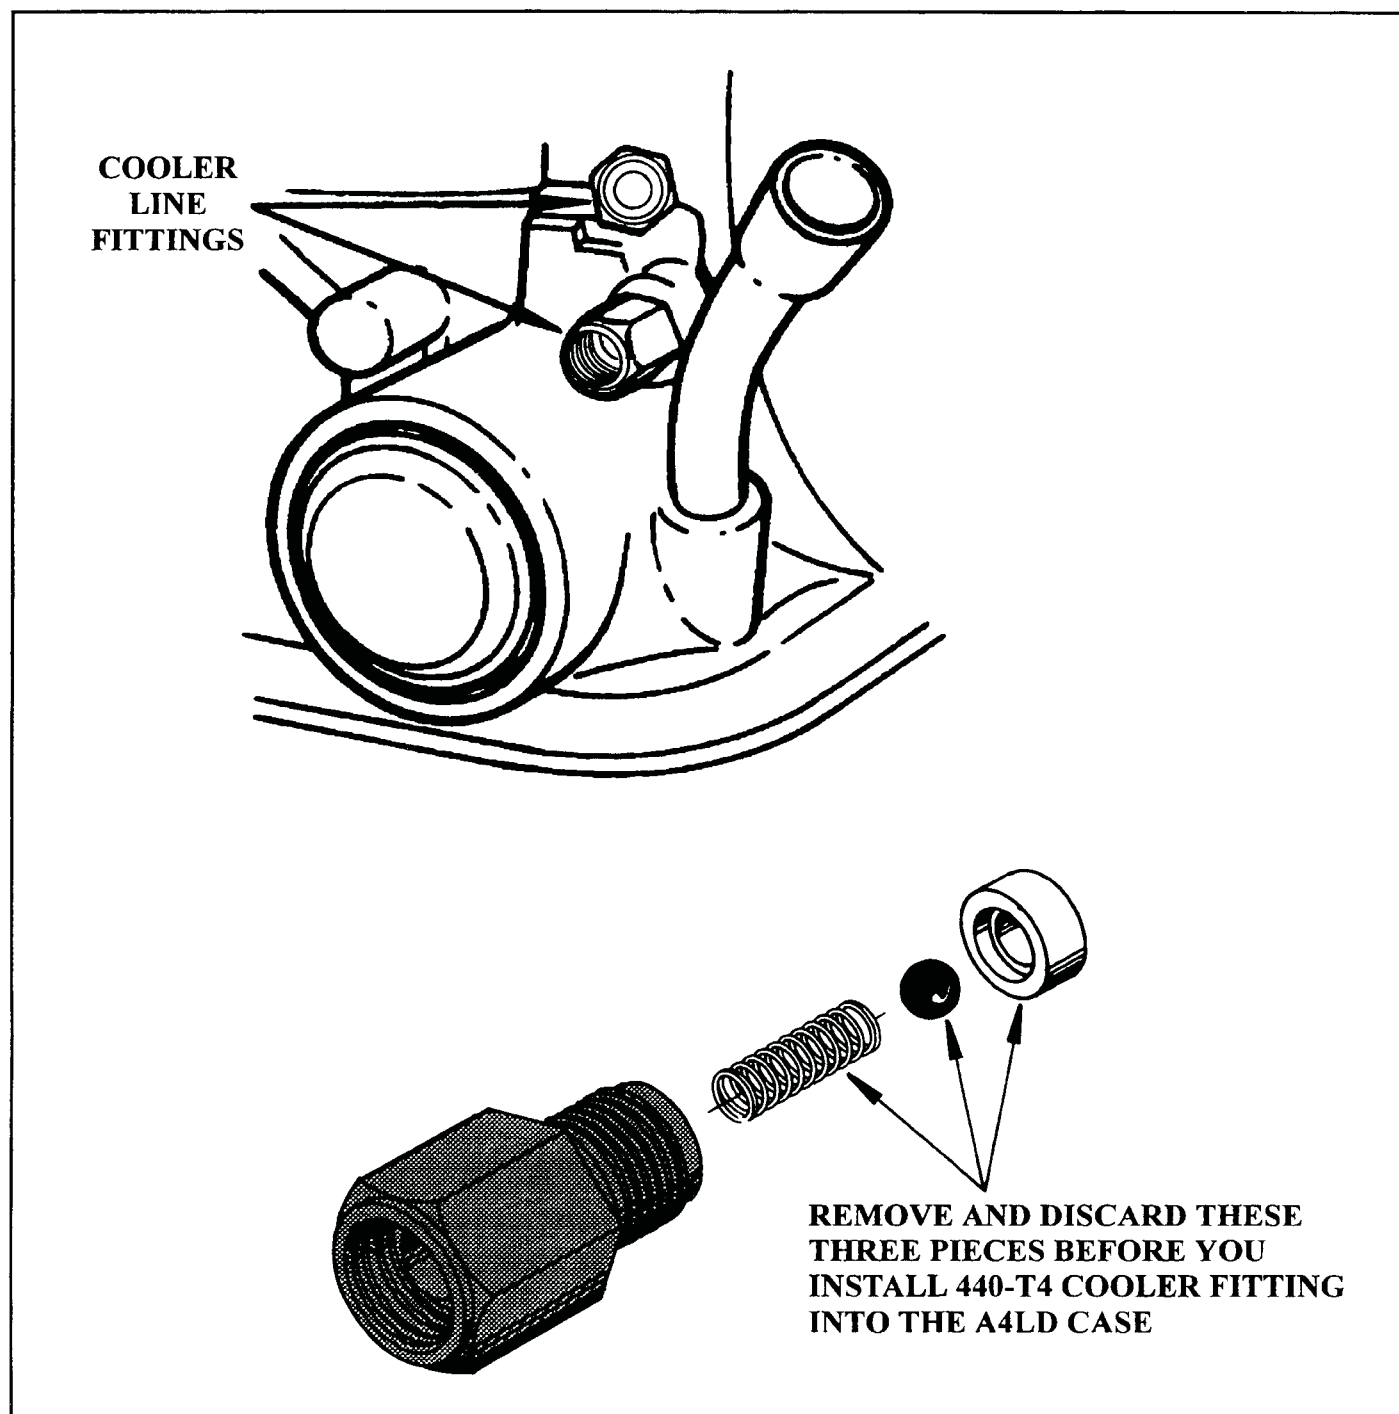
Figure 103

There are currently two different size cooler line fittings for the A4LD case. The cases for the small fittings (1/8" Pipe Thread) are no longer serviced by Ford Motor Co. There are adapters available from Ford, for installing the small cooler line fittings into a large thread case, and are available under OEM part number E7TZ-7D273-B.

However, the large black cooler line fitting from the THM 440-T4 transaxle will also fit in the A4LD large thread case, **but you must remove and discard the ball and spring from the 440 fitting.** (See Figure 103).
