Chrysler A604

Since the introduction of the Chrysler A604 Transaxle in model year 1990, there have been many engineering changes to improve Pleaseability, Driveability, and Durability concerns. These changes have affected many parts used in the A604 transaxle. This "update handbook" will explain each change, and any parts interchangeability problem created by the change, along with any part numbers deemed necessary.

CHRYSLER A604 NEW 4 RING STATOR

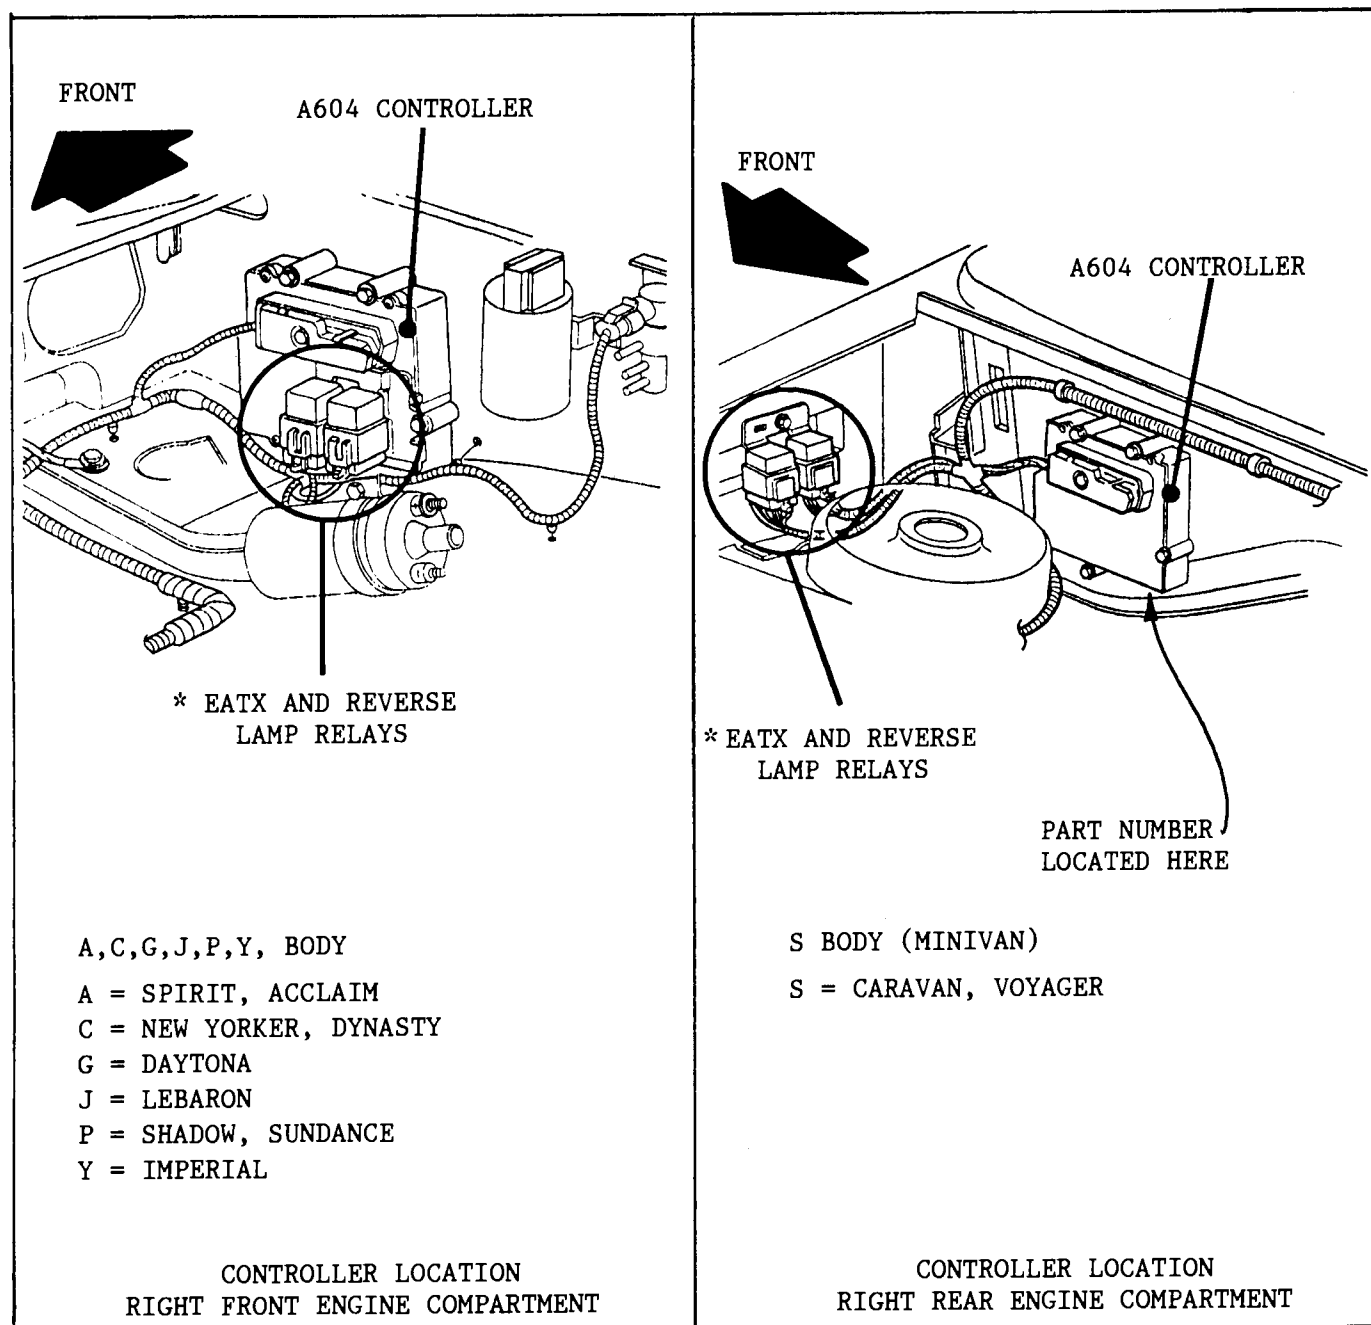
- (1) TRANSAXLE CONTROLLER - The controllers are identified by the last three digits of the OEM part number. The part number is on a sticker that is located on the bottom of the controller as shown in Figure 7. The locations of the controllers will vary depending on the model of the vehicle. Refer to Figure 7 for the different locations. Figure 7 and 8 also shows the locations of the EATX relay, as their location will also vary depending on the model of the vehicle.

* NOTE: Since the EATX and the Reverse Lamp Relay connectors could be installed in either position, you must use the wire colors in the connectors to identify the correct relay.

- (1) The EATX Relay has a Red and a Light Green wire in its connector.
- (2) The Reverse Lamp Relay has a White and a Violet wire in its Conn.

NOTE: When updating earlier controllers, do not Routinely replace the controller P/N 5234678 with P/N 4557120, Unless the customer has encountered highway cycling driveability conditions. When updating controller P/N 5234623 or P/N 5234649, by all means use controller P/N 4557120.

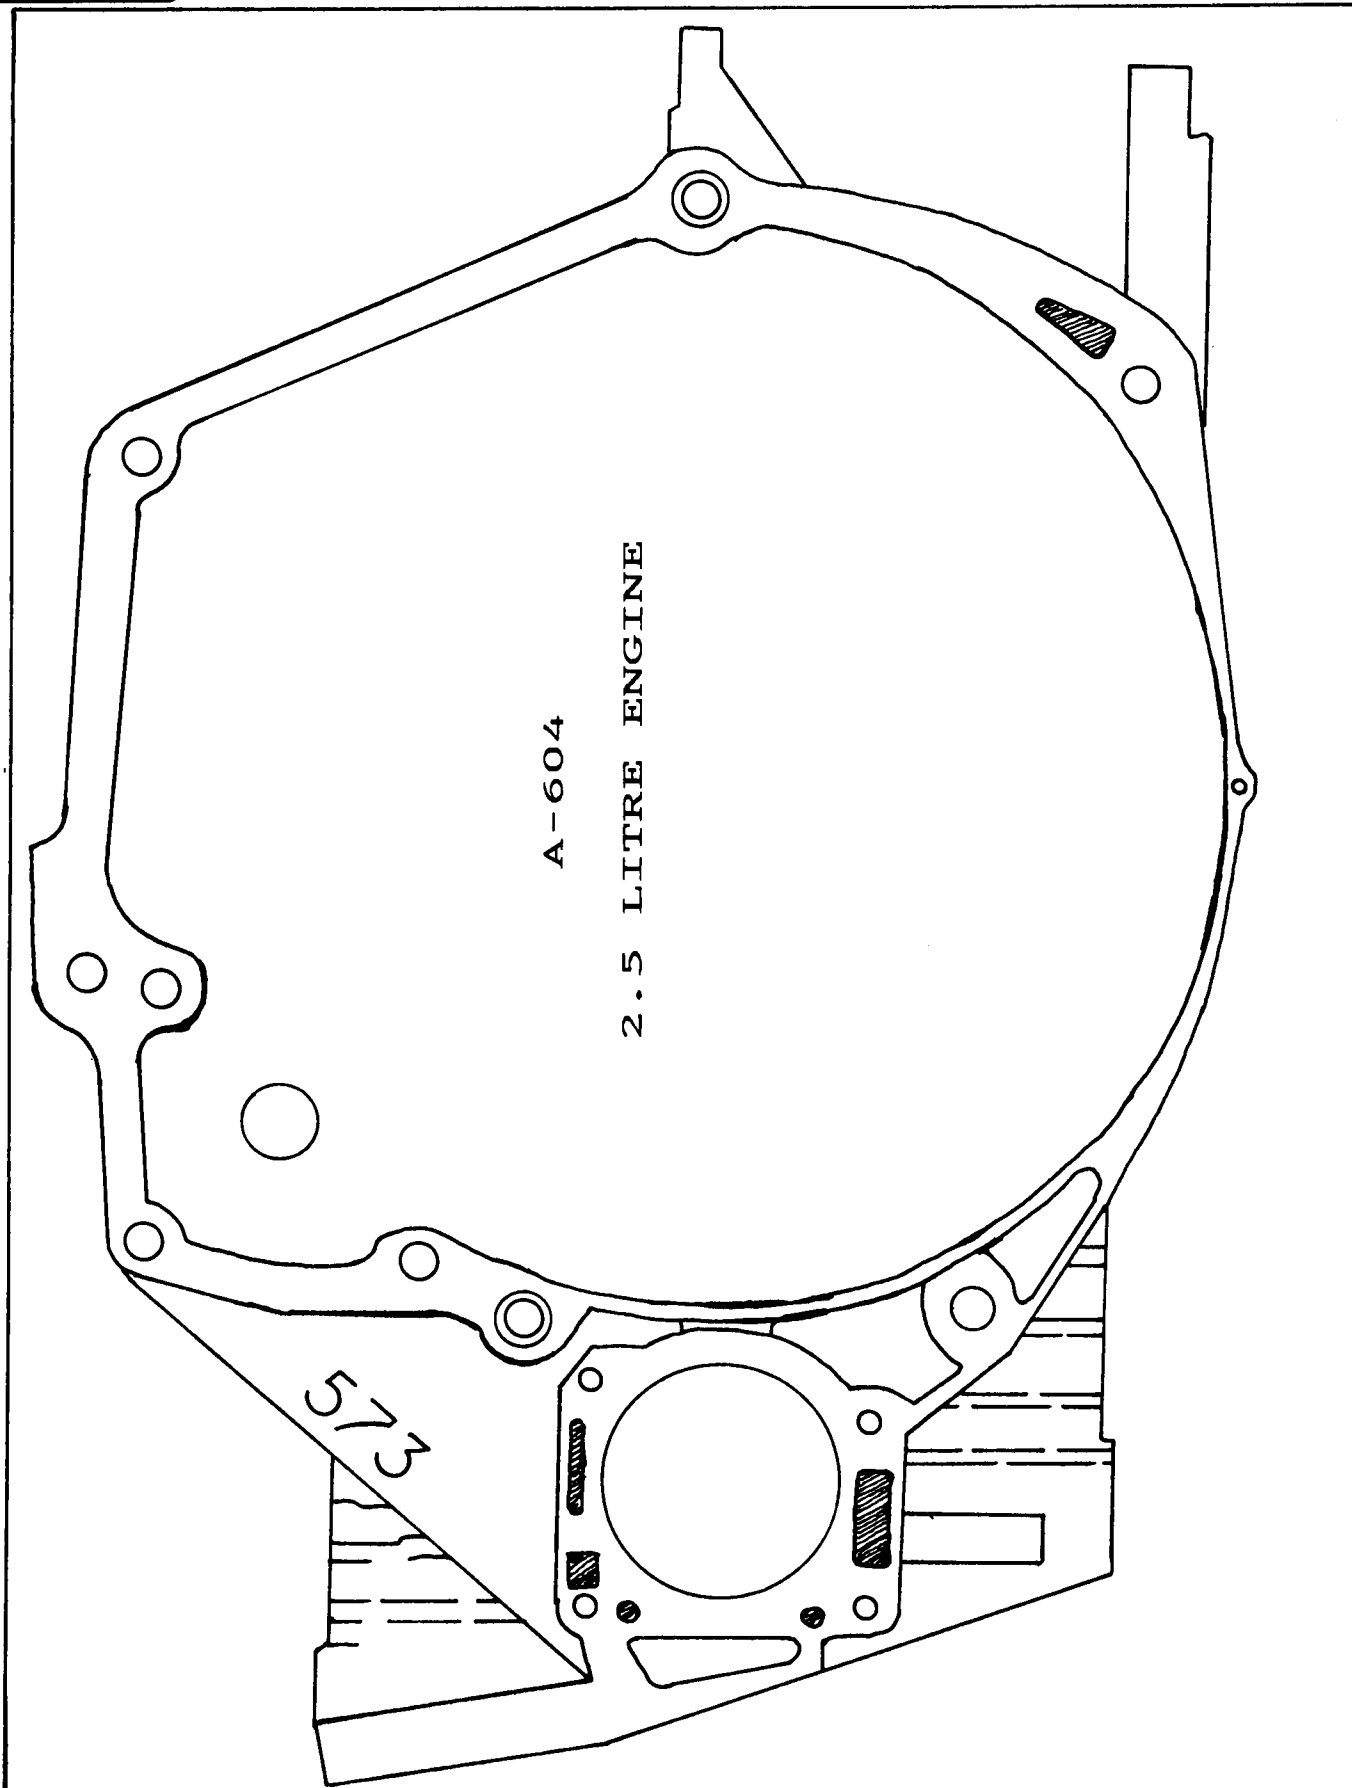
Figure 9
AUTOMATIC TRANSMISSION SERVICE GROUP

- (1) **TRANSAXLE CASE** - Because of the three different engines that are now used, it requires three different bell housing bolt patterns.
 - For the 2.5 Litre Bell Housing pattern, refer to Figure 9.
 - For the 3.0 Litre Bell Housing pattern, refer to Figure 10.
 - For the 3.3 Litre Bell Housing pattern, refer to Figure 11.
- (2) **TURBINE SHAFT SPLINES** - The 2.5 Litre engine uses a turbine shaft with 22 splines for the torque converter, and the 3.0 and 3.3 Litre engines will use the current 24 spline turbine shaft (See Figure 12).

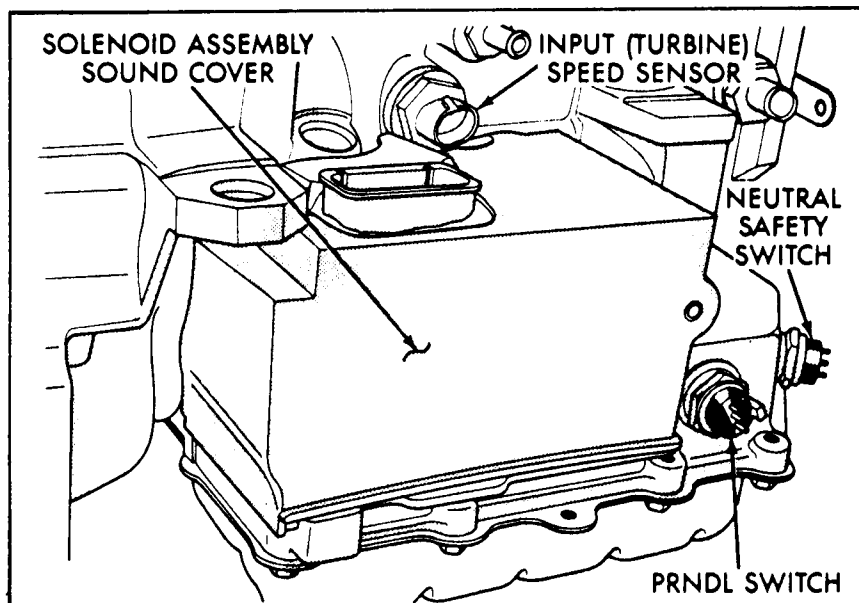
CHANGE: PRNODL Switch and Neutral Safety Switch have been changed for the 1990 model year, as well as the vehicle wiring harness connectors. Refer to Figure 17 for location of switches on the transaxle.

REASON: Positive locking mechanism, with a weathertight seal, to prevent the connection from becoming loose.

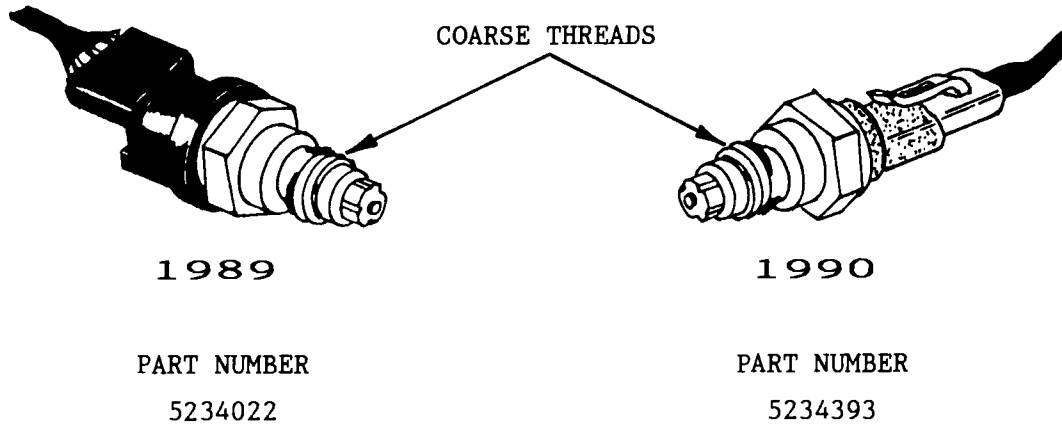
FIGURE 18

- (1) PRNODL SWITCH AND CONNECTOR - The PRNODL Switch and its wiring harness connector have changed for 1990, and can be identified visually (See Figure 18). These PRNODL Switches WILL NOT interchange with one another.
- (2) NEUTRAL SAFETY SWITCH AND CONNECTOR - The Neutral Safety Switch and its wiring harness connector have changed for 1990, and can be identified visually (See Figure 19). These Neutral Safety Switches WILL NOT interchange with one another.

NOTE: Each of the new for 1990 switches may look similar at first glance, but the PRNODL switch features a "Coarse" thread, while the Neutral Safety switch is black and features "Fine" threads. (See Figures 18 and 19).

THESE PRNODL SWITCHES WILL NOT INTERCHANGE.

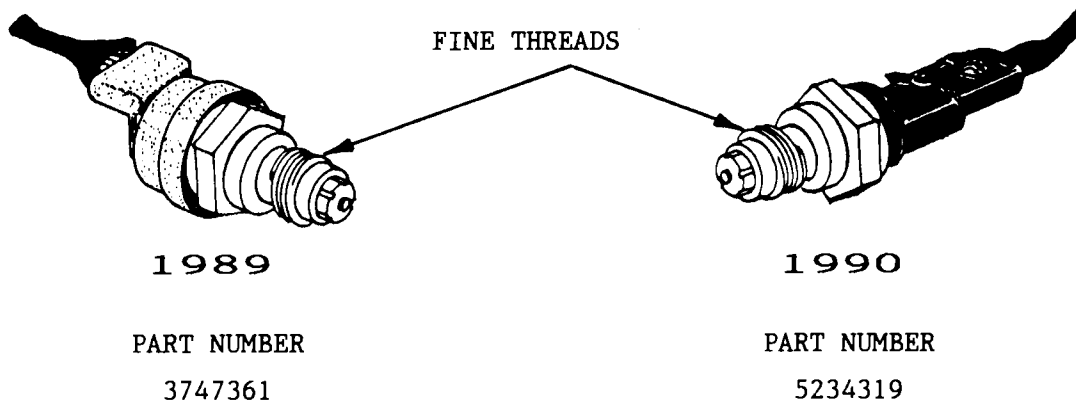
FIGURE 19

THESE NEUTRAL SWITCHES WILL NOT INTERCHANGE.

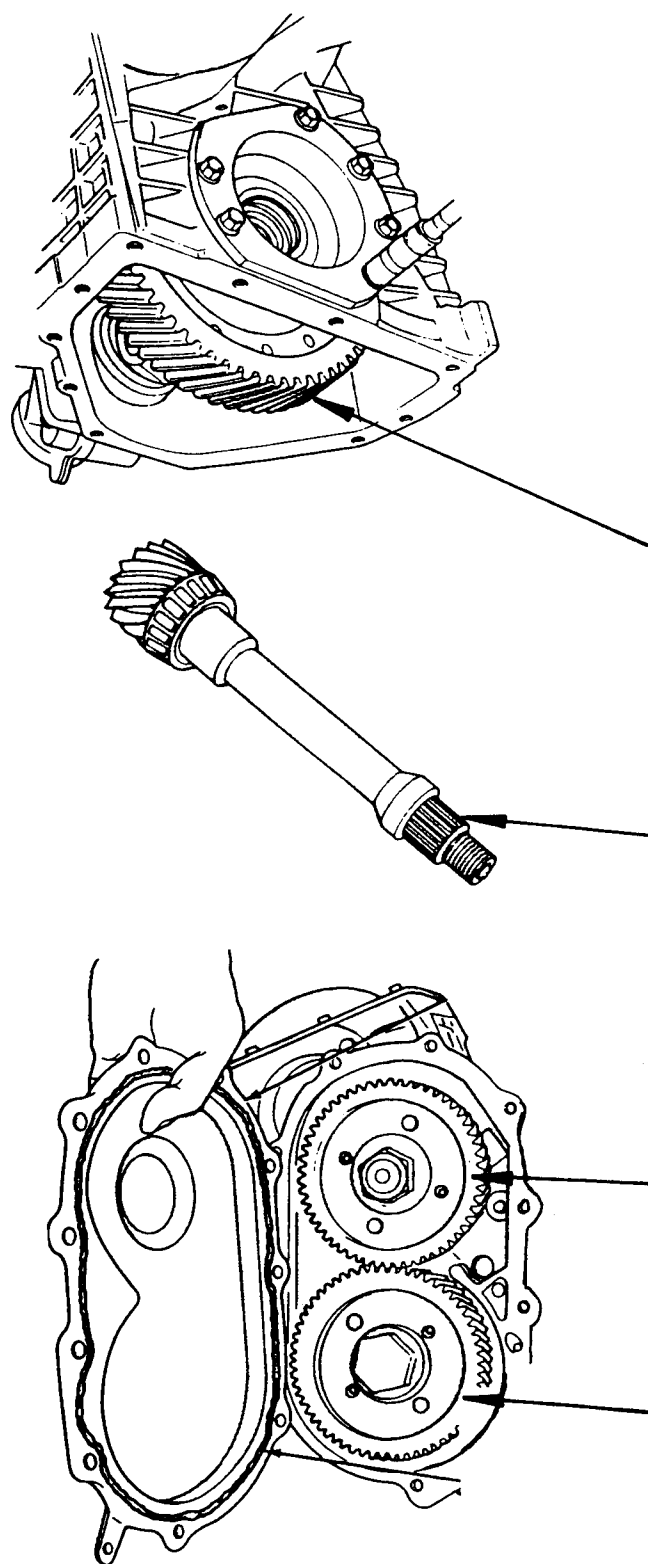
Figure 20

- (1) **OUTPUT AND TRANSFER GEARS** - There are now 2 different gear combinations, (New) 55T-58T, and (Previous) 59T-54T, depending on model and engine size. "Shot Peened" output and transfer gears are used in 3.3 litre, 2.5 litre turbo, and transaxles exported to Mexico. Refer to the chart in Figure 20.
- (2) **TRANSFER SHAFT AND RING GEAR** - There are now 2 different final drive combinations, (New) 17T-59T, and (Previous) 16T-60T, depending on model and engine size. Refer to the chart in Figure 20.

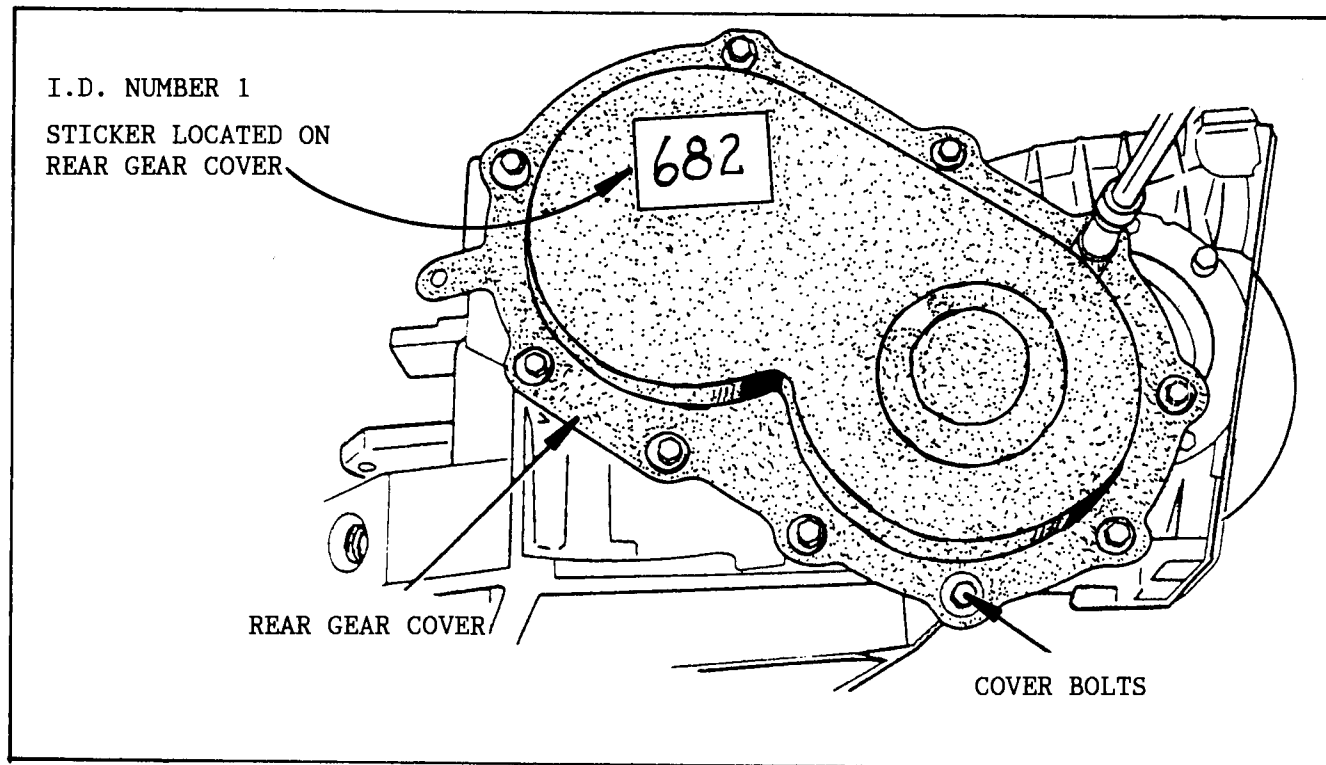
Figure 21

NOT INTERCHANGEABLE. It will be imperative that you identify the trans-axle properly. The transaxle is identified by the "Last 3 Digits" of the OEM part number, and is found on a sticker located on the rear gear cover (See Figure 21). Then refer to the chart in Figure 24 for proper applications.

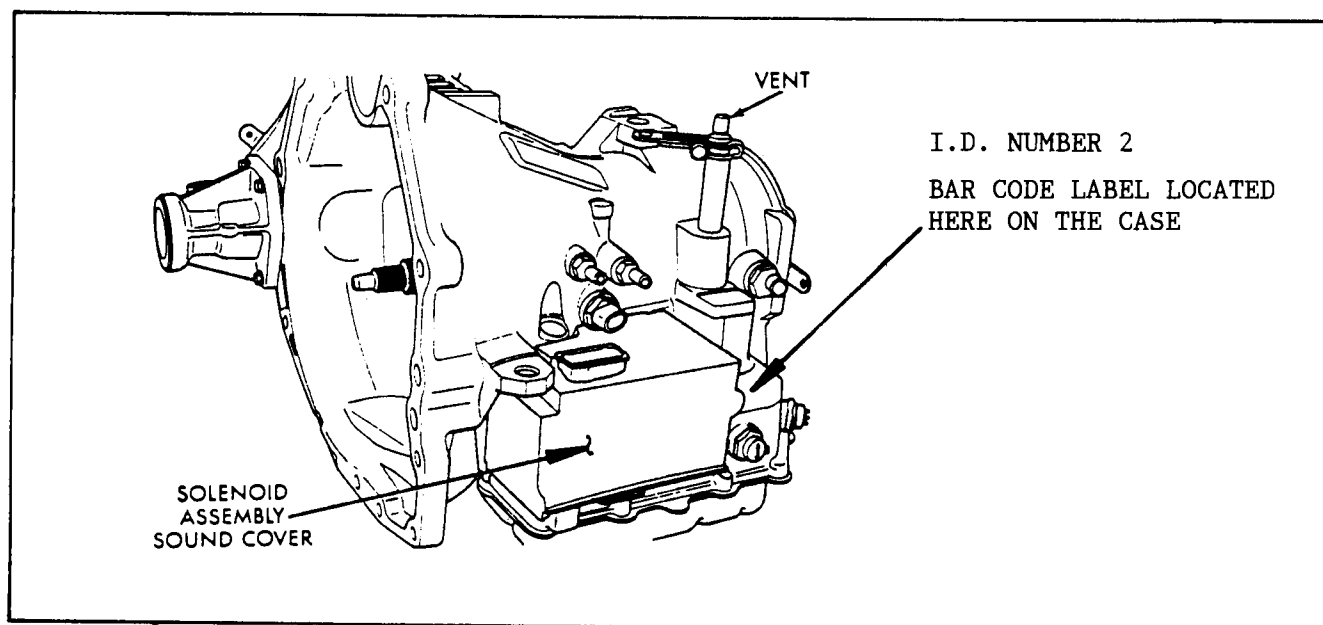
Figure 22

If that sticker is missing, or painted over, there is another bar code decal located on the case directly above the PRNODL and neutral safety switches (See Figure 22).

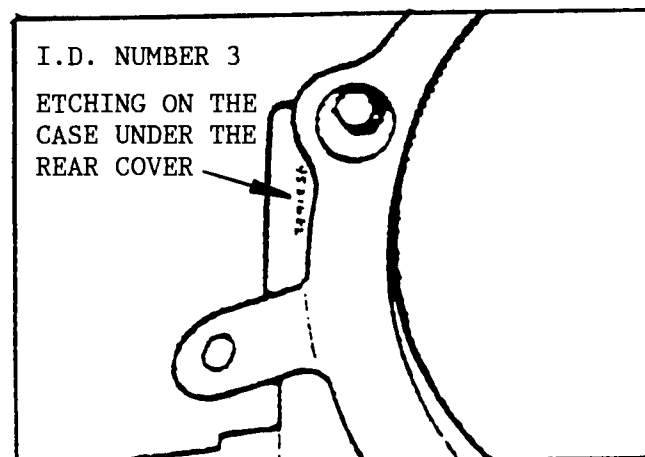
Figure 23

The most permanent form of identification is an etching, in the case, located near the rear gear cover (See Figure 23). It may be necessary to remove the rear cover to see the part number, but if the vehicle has been in service for some time, this may be the only way to identify the unit.

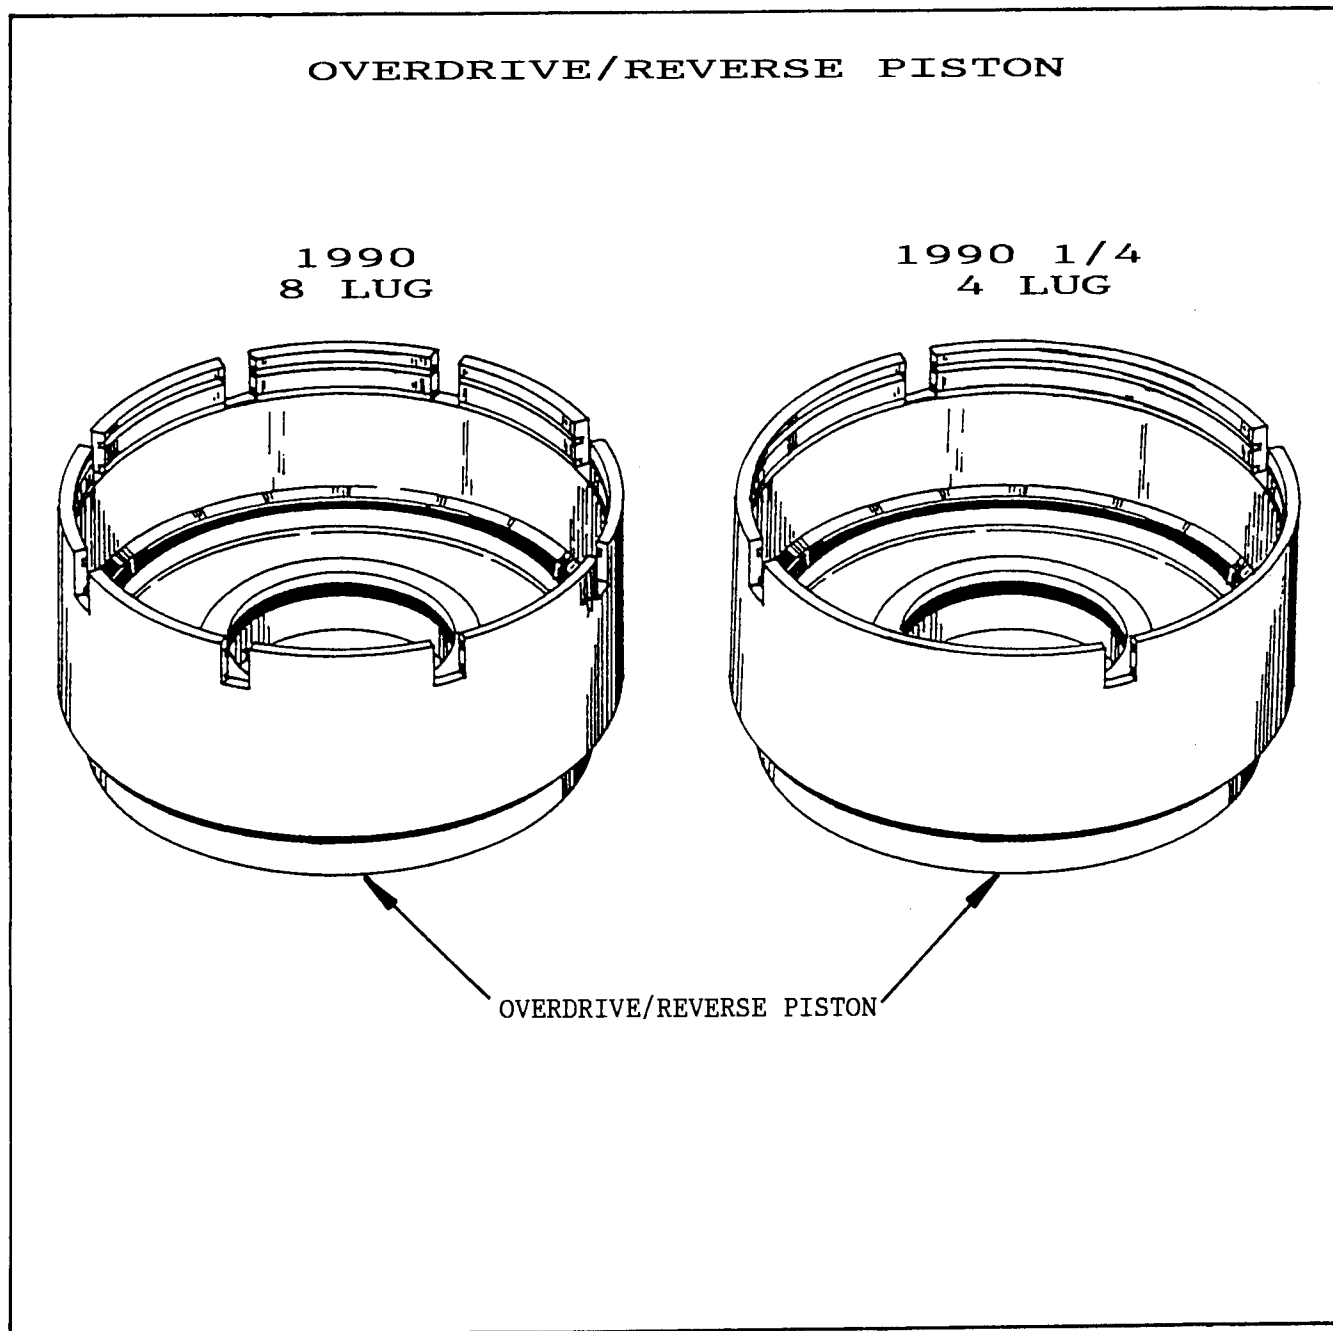
Figure 25

CHANGE: A new Overdrive/Reverse Piston has been introduced for 1990 1/4 model transaxles, and features four reaction plate slots instead of eight slots (See Figure 25).

The revised Input Clutch Retainer WILL NOT work with the previous style 8 lug overdrive/reverse piston. Since the part number did not change, to replace an input clutch retainer built in 1990, before the change to the 4 lug overdrive/reverse piston, you MUST also change to the 4 lug design piston and pressure plate.

1990 1/4 OVERDRIVE/REVERSE PISTON
WITH FOUR SLOTS

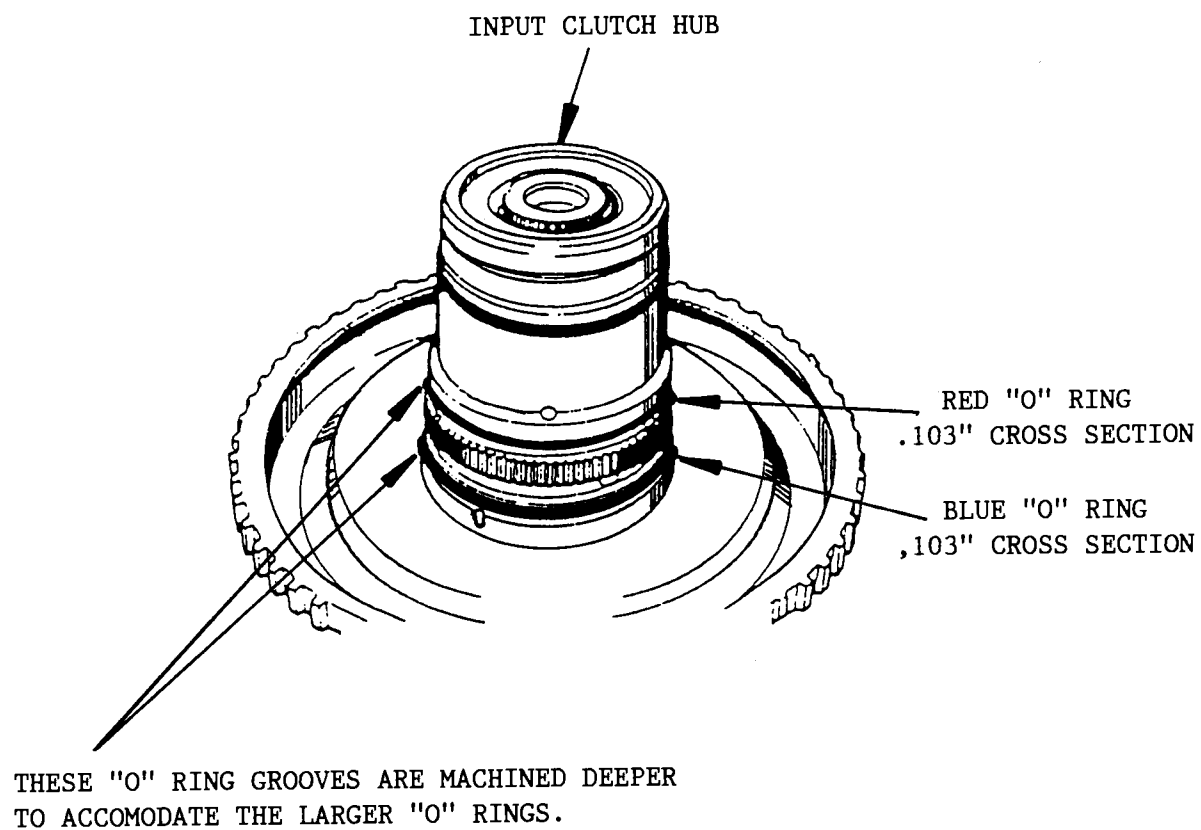
Figure 29

- (1) INPUT CLUTCH HUB - The "O" ring grooves on the Input Clutch Hub are cut deeper to accomodate the larger cross section color coded "O" rings (See Figure 29).

1990 1/4 INPUT CLUTCH HUB

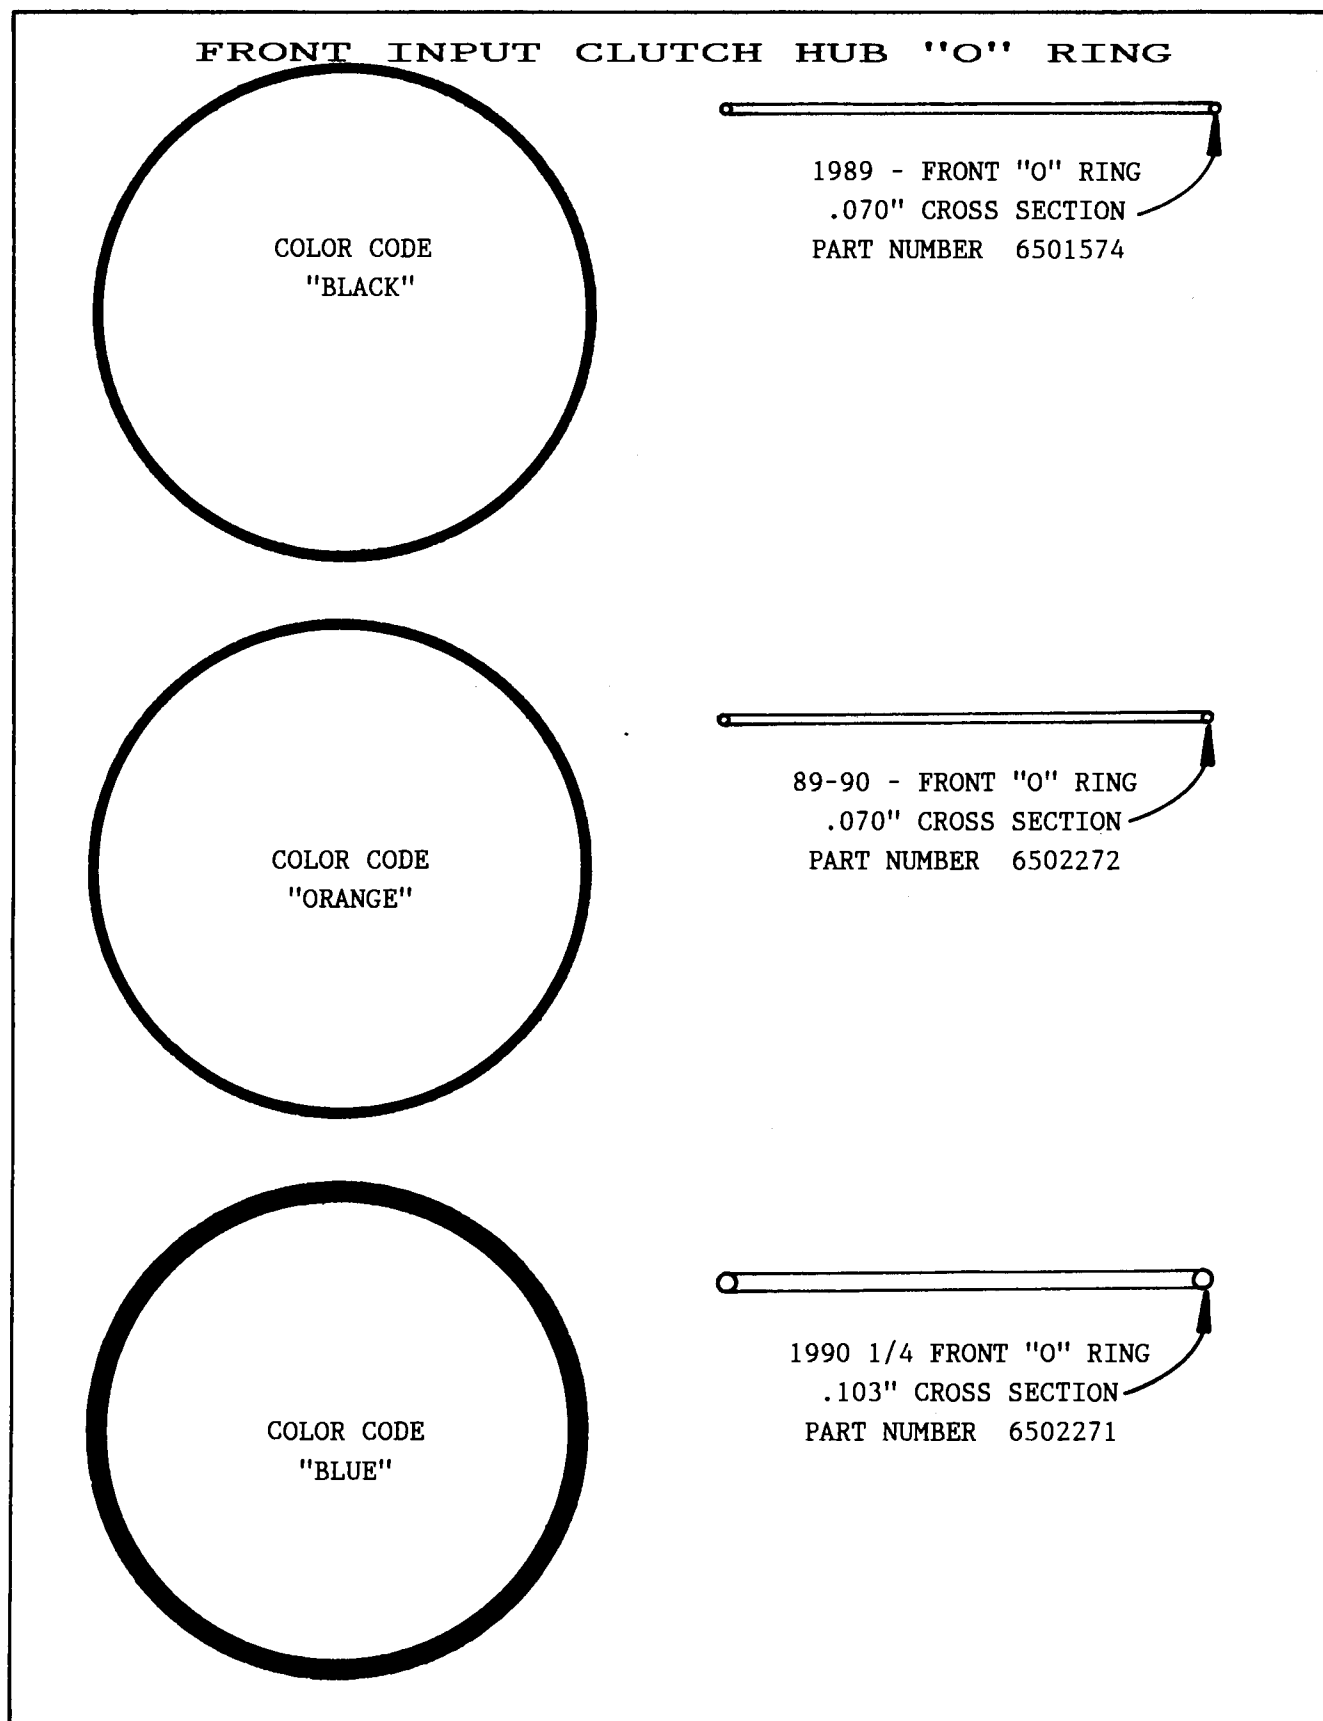
Figure 30

- (2) FRONT INPUT CLUTCH HUB "O" RING - This "O" ring now has a larger, .103" cross section and is color coded BLUE for identification purposes. Remember that this is the 3rd change on this "O" ring. The original "O" ring was BLACK with a .070" cross section, the 2nd design "O" ring was ORANGE with a .070" cross section, and the 3rd design "O" ring is BLUE with a .103" cross section (See Figure 30).

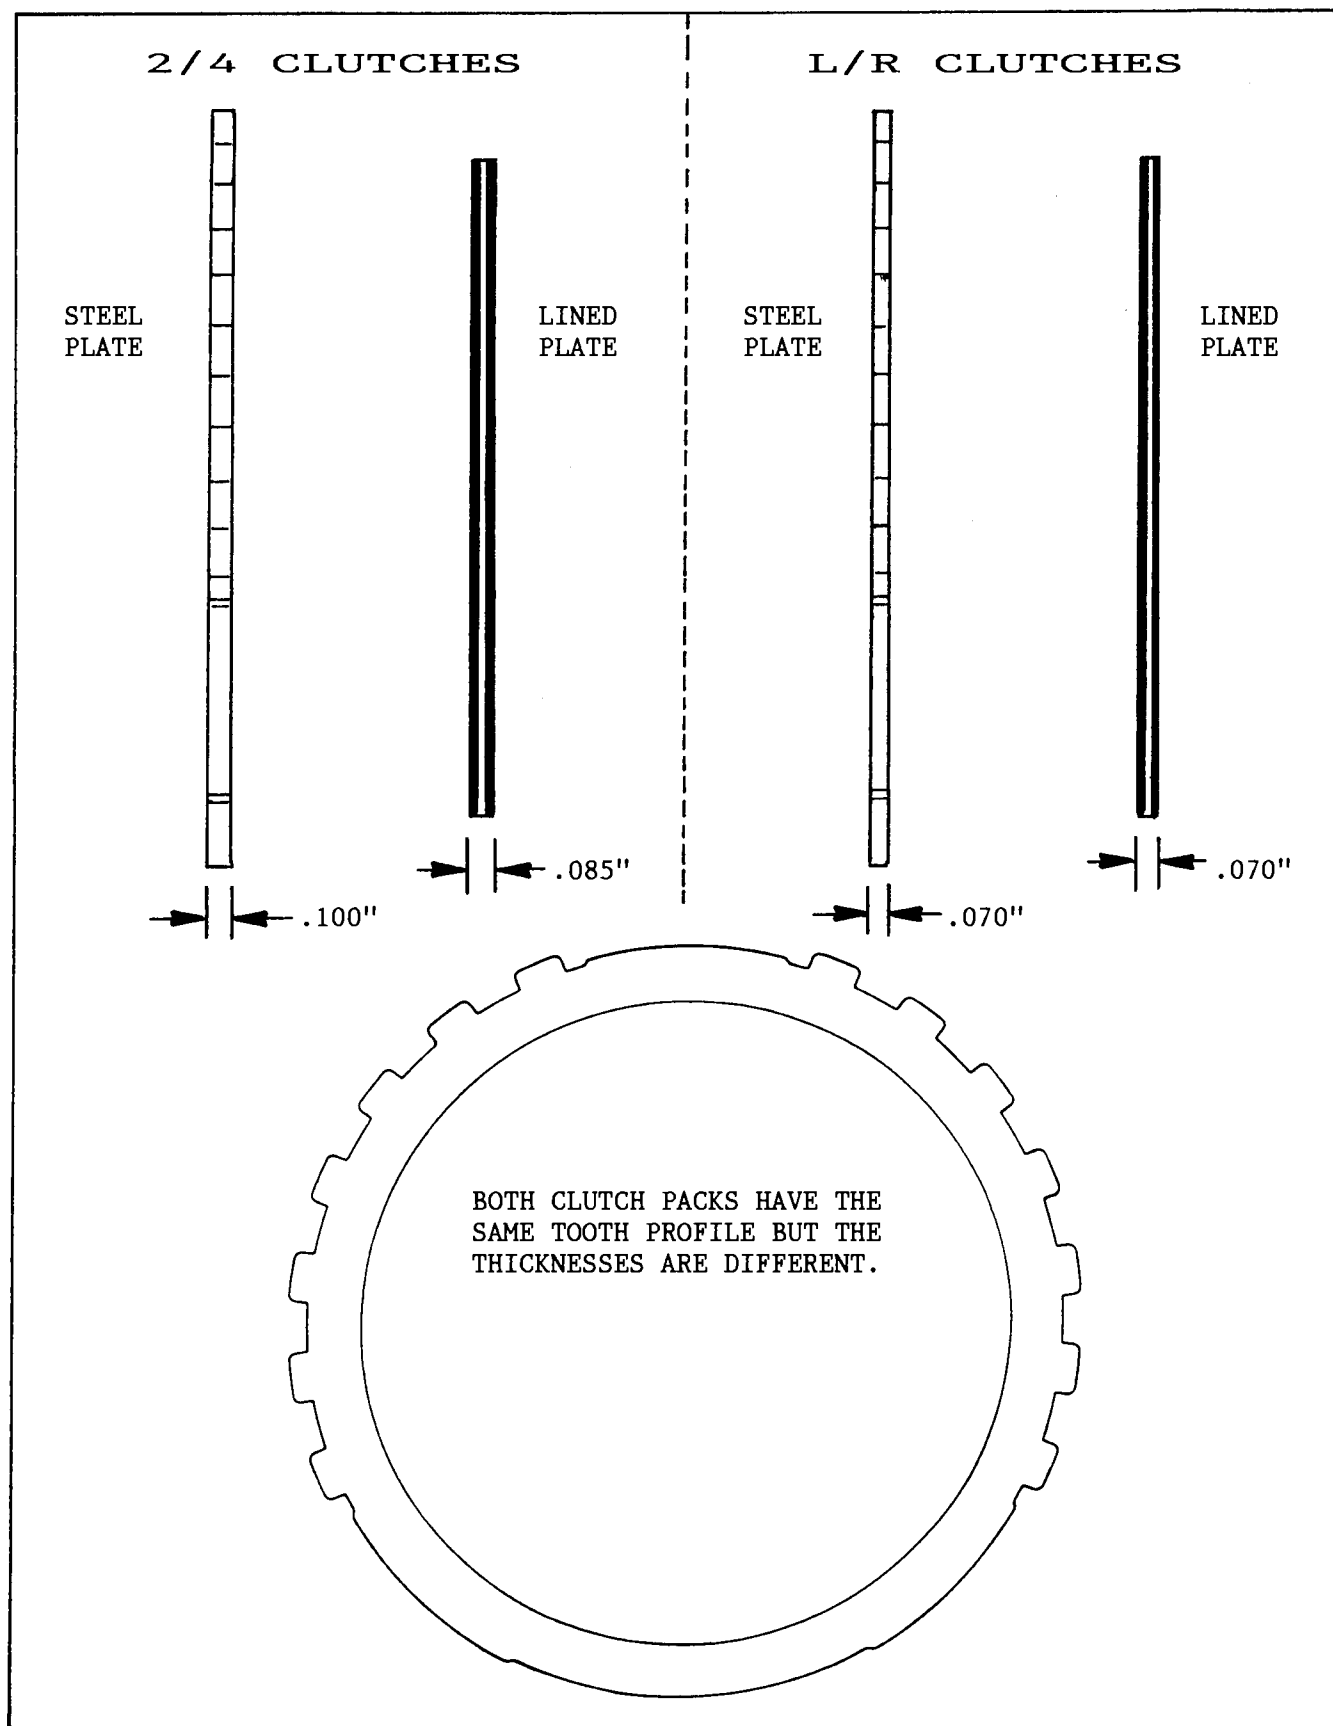
Figure 32

- (1) Both clutch packs, on the steel plates, have the same tooth profile, but the thicknesses are different (See Figure 32).
 - A. 2/4 STEEL PLATE THICKNESS IS .100" (4 Required).
 - B. L/R STEEL PLATE THICKNESS IS .070" (5 Required).
- (2) Both clutch packs, on the lined plates, have the same tooth count and the same lining, but the thicknesses are different (See Figure 32).
 - A. 2/4 LINED PLATE THICKNESS IS .085" (4 Required).
 - B. L/R LINED PLATE THICKNESS IS .070" (5 Required).

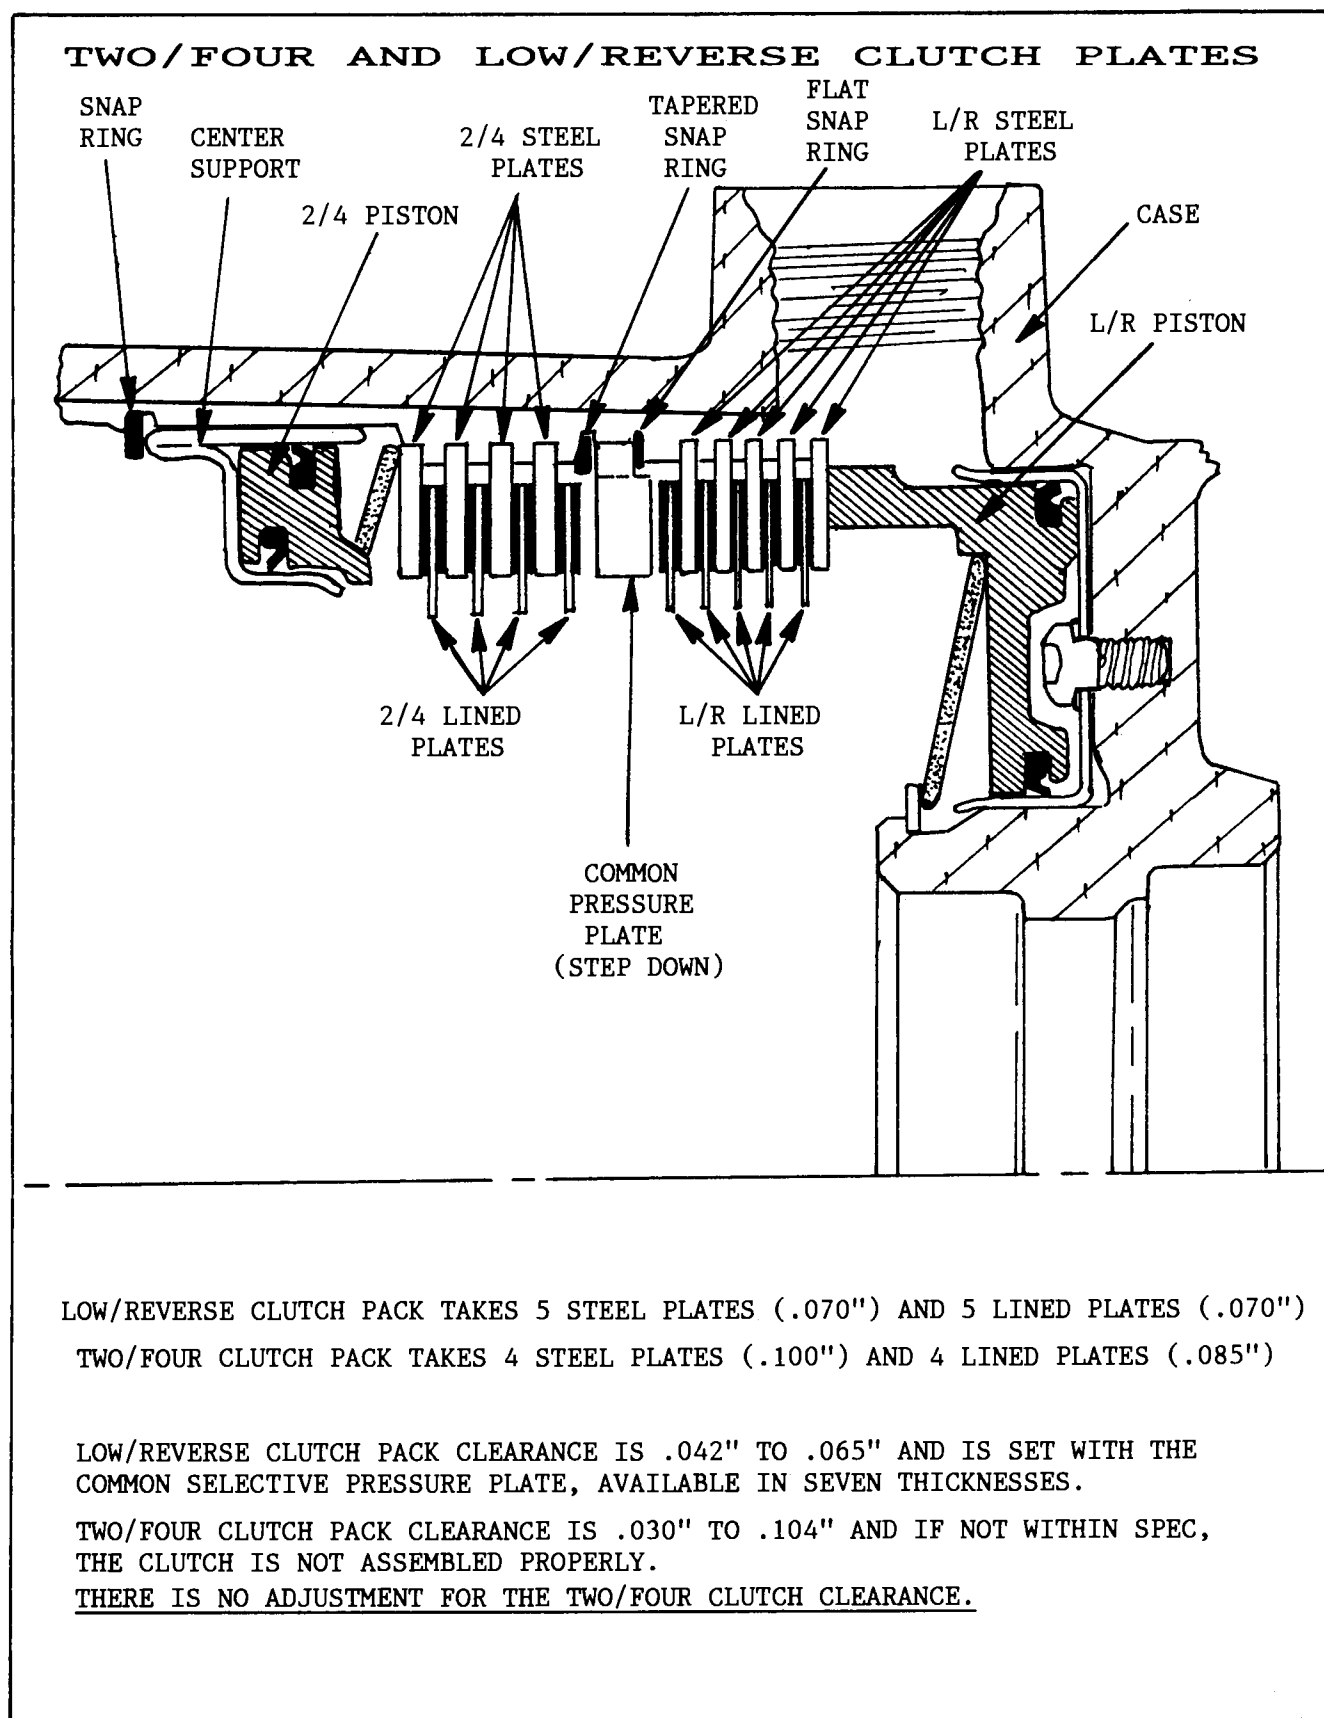
Figure 33
AUTOMATIC TRANSMISSION SERVICE GROUP

We have provided you with the proper clutch stack up for these clutch packs, to assist you with proper assembly for the 2/4 and L/R clutch packs. Refer to Figure 33 for proper assembly procedures.

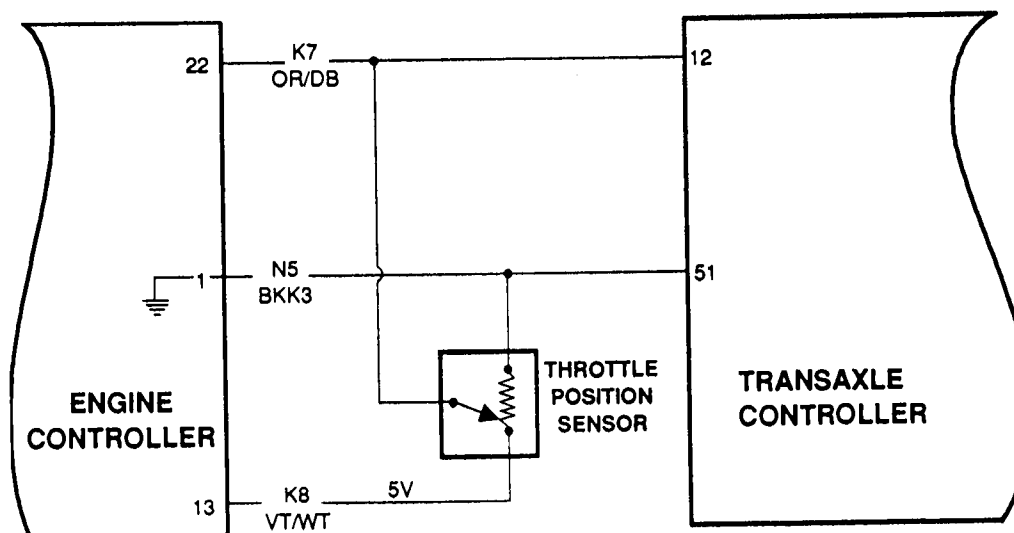
Code 29: Throttle Position Signal

Background: The EATX controller receives the throttle signal (K7 circuit) and its ground (N5 circuit) from the Throttle Position Sensor (TPS). The TPS has a 5 volt pull up (K8 circuit) supplied by the engine controller. The throttle signal is checked for out-of-range as well as intermittency (excessive signal changes).

- Open/shorted K7 circuit.
- Open N5 circuit.
- Open K8 between TPS and engine controller.
- 60-way connector problem.
- Defective TPS.
- Defective engine controller.
- Internal controller failure.

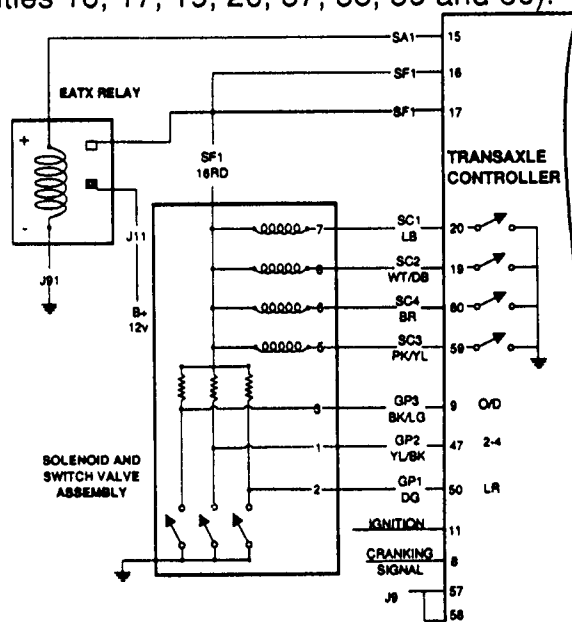
Background: Four solenoids are used to control the friction elements (clutches). The continuity of the solenoid circuits are tested periodically. Each solenoid is turned off and an inductive spike should be detected. When no spike is detected, the solenoid circuits are tested a second time to verify the failure. In addition to the periodic testing, solenoid circuits are tested when a speed or pressure switch circuit error occurs. In this case, one failure will result in setting the appropriate code.

- Open/shorted SC1, SC2, SC3 and SC4.
- Open J9 circuit.
- 8-way connector problem (cavities 4, 5, 6, 7, 8).
- 60-way connector problem (cavities 16, 17, 19, 20, 57, 58, 59 and 60).
- Solenoid Pack internal problem.
- Internal controller failure.

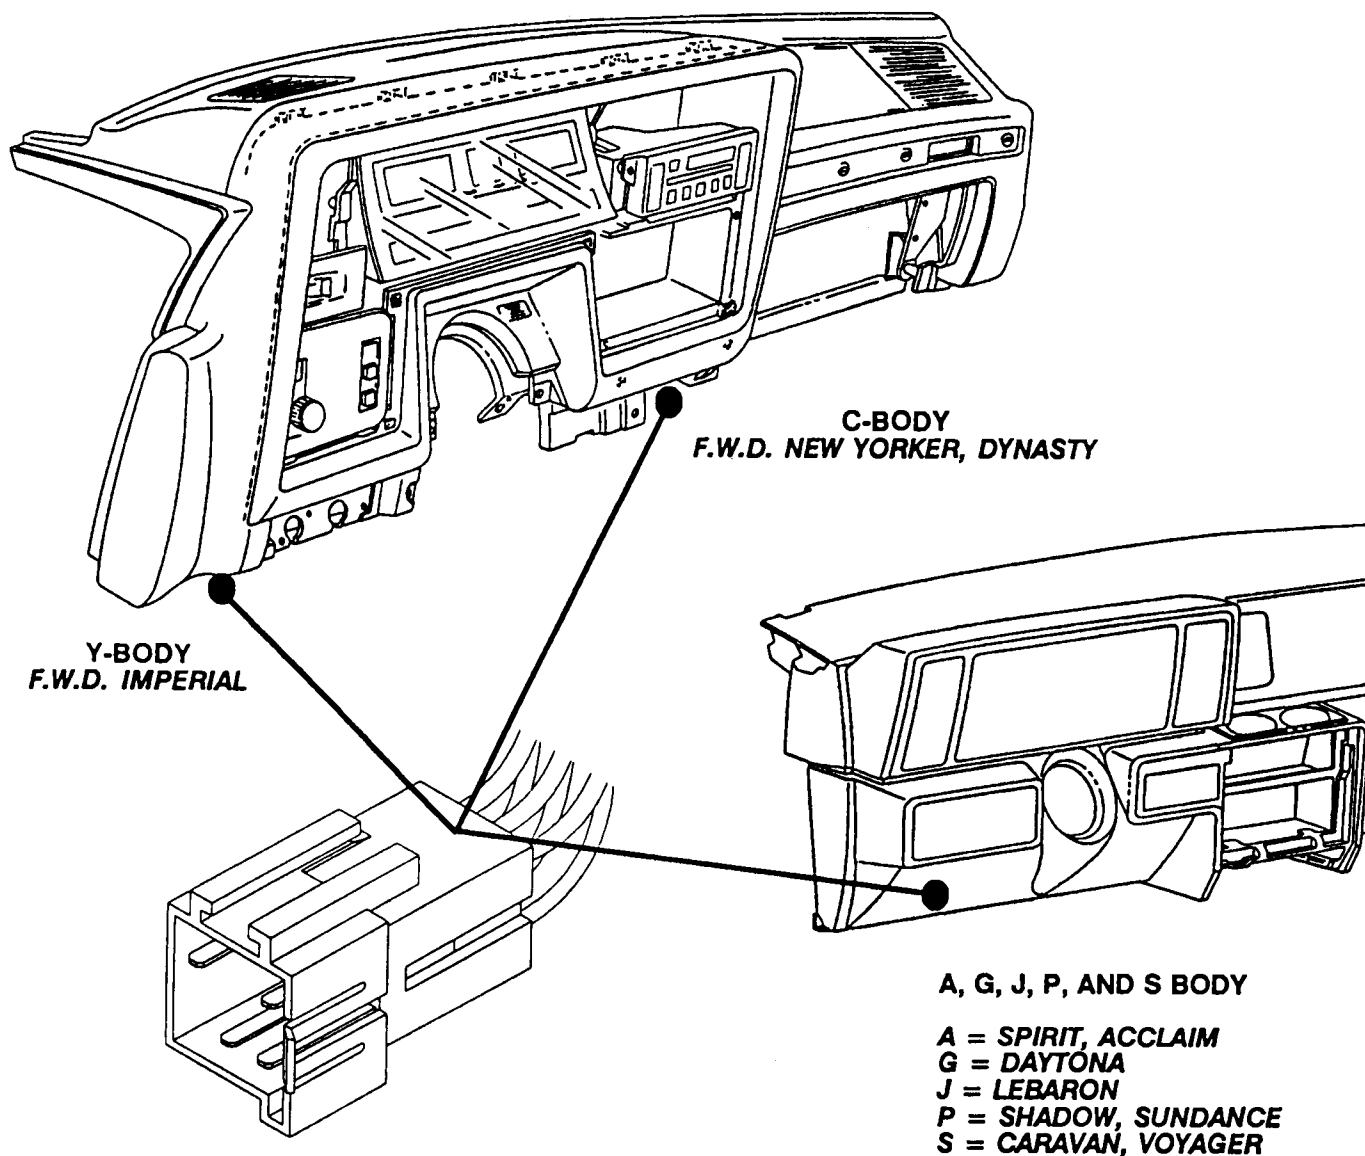
On the Y body, this connector is located inside the vehicle, under the dash, to the left of the steering column.

On the A, G, J, P and S bodies, the connector is located inside the vehicle, under the dash, on the extreme left, behind the fuse access panel.
