"VOLUME II"

INTRODUCTION

THM 440-T4 (4T60)

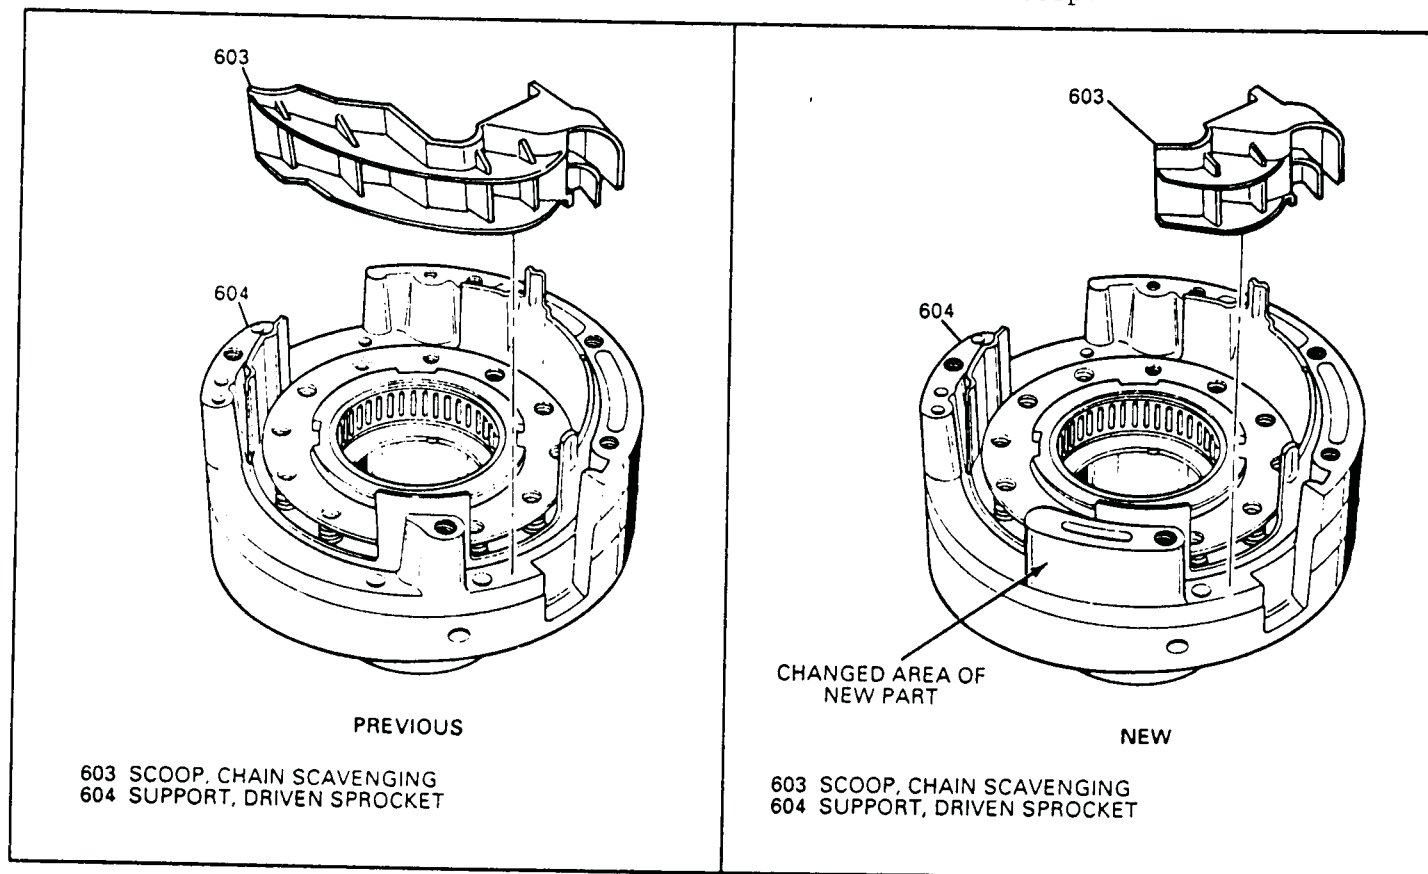
Figure 1

CHANGE: A new Driven Sprocket Support and Chain Scoop is now used in production on all 1990 vehicles equipped with a THM 440-T4 (4T60) transaxle. (See Figure 1).

- (1) **DRIVEN SPROCKET SUPPORT** - The new design sprocket support has an increased width of one leg on the support (See Figure 1). The wider leg on the new support will accomodate a new lube feed passage for the new THM F-31 (4T60-E) transaxle. Lube feed for the THM F-31 (4T60-E) will be thru the channel plate, instead of the pipe from the accumulator cover as on the THM 440-T4 (4T60) (See Figure 2).
- (2) **CHAIN SCOOP** - The new sprocket support requires the chain scoop, both black and white, to be about 1/3 the length of the previous chain scoop. (See Figure 1).

The new driven sprocket support will service all past models, but the new length (Short) chain scoop must be used with it. The previous (Long) chain scoop will not fit, but can be cut to fit the new support. Lay the previous chain scoop on the actual size drawing in Figure 3 and cut straight down, as indicated, with a hack saw. Smooth off the rough cut edge with sandpaper. The new length (Short) chain scoop must be used ONLY with the new design driven sprocket support.

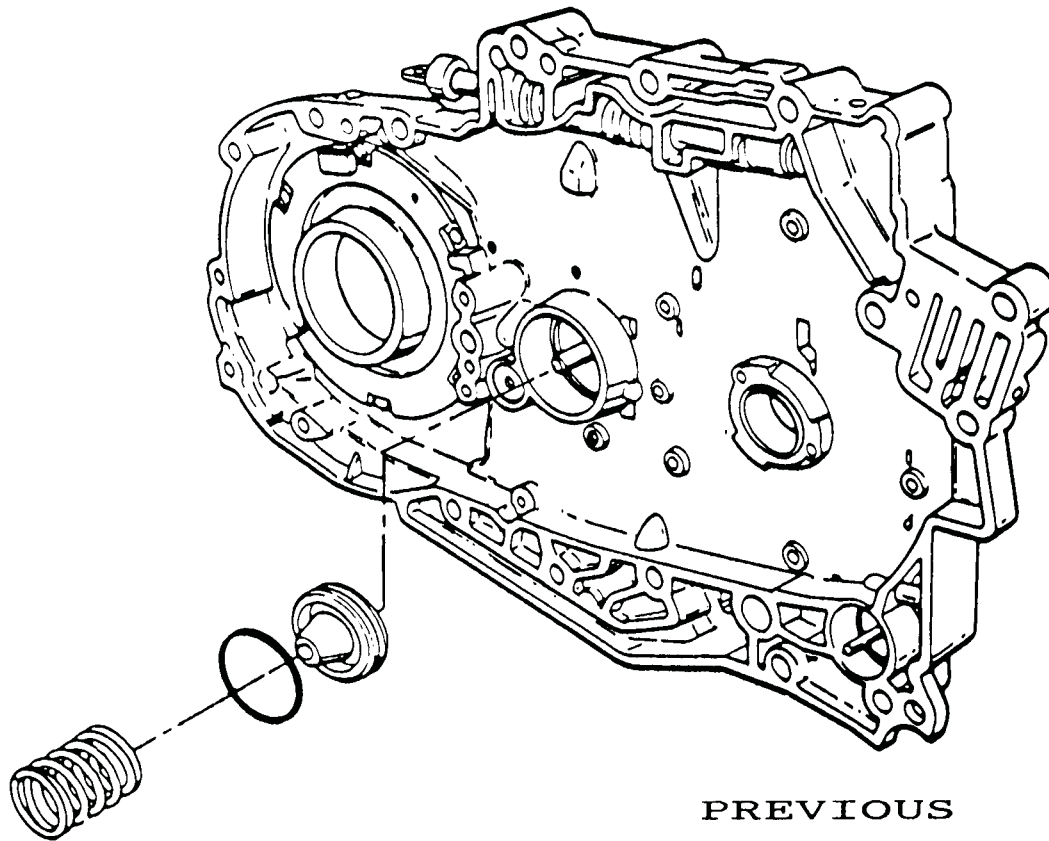
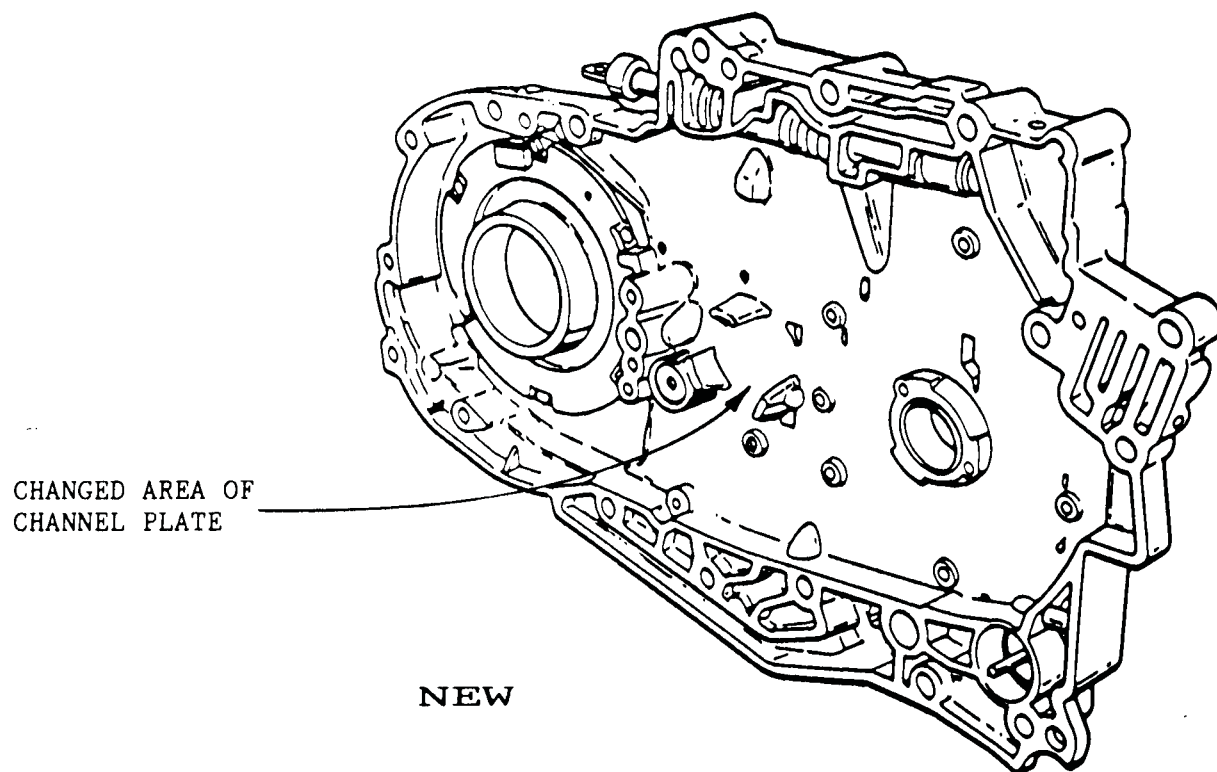
Figure 19

CHANGE: The Input Clutch Accumulator has been eliminated from the channel plate (See Figure 19).

- (1) CHANNEL PLATE - The input clutch accumulator piston, piston pin, and accumulator spring have been eliminated from the channel plate, which of course changes the channel plate casting (See Figure 19).
- (2) INPUT HOUSING - Top snap ring groove moves .060" closer to the top of the input housing, to accomodate the added wave plate (See Figure 20).
- (3) INPUT CLUTCH STEEL PLATES - The steel plates are .027" thinner to help accomodate the added wave plate (See Figure 21). The new steel plates are .049" thick, and the old steel plates are .076" thick (Figure 21).
- (4) INPUT CLUTCH "STACK-UP" - The input clutch stack has also been revised to accomodate the new changes. Refer to Figure 21 for proper assembly of the new input clutches.

NOT RECOMMENDED TO INTERCHANGE WITH PREVIOUS MODELS.

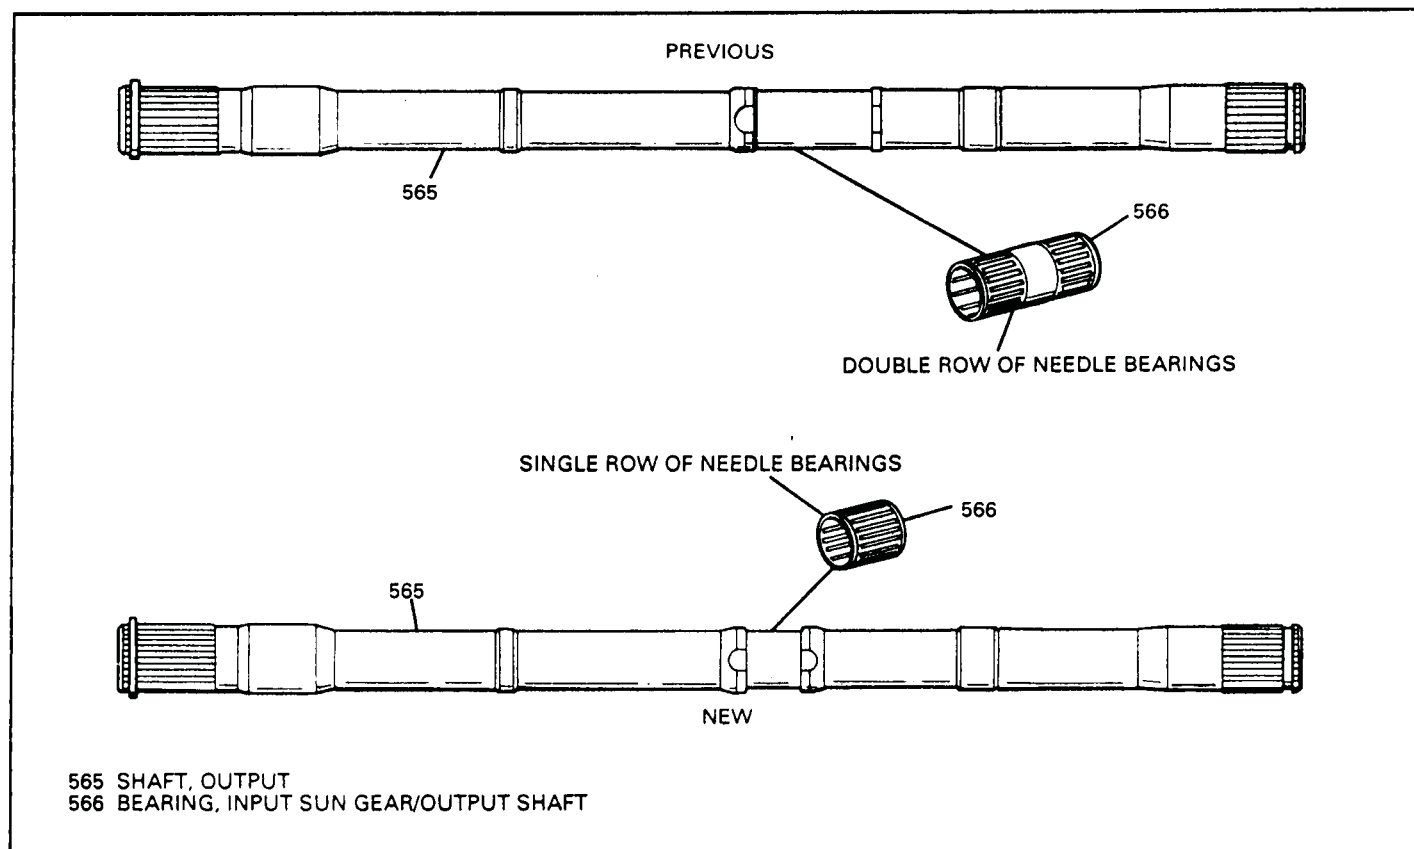
Figure 22

CHANGE: There is now a new Output Shaft/Bearing Assembly, and a new style (5th Design) 3rd Roller Clutch Assembly (See Figures 22 and 23). Beginning on December 11, 1989 (Julian Date 345) all 1990 model 440-T4 transaxles were built with the new 3rd Roller Clutch Assembly, and the new Output Shaft/Bearing Assembly went into production on January 25, 1990 (Julian Date 025).

- (1) OUTPUT SHAFT/BEARING - The new bearing has a single row of needle bearings instead of a double row, and the output shaft is machined different to accomodate the new bearing (See Figure 22). This change will improve lube oil flow to the 3rd roller clutch and input sprag.
- (2) 3RD ROLLER CLUTCH ASSEMBLY - The new 3rd roller clutch outer race has four (4) less lube holes than previous models. The four lube oil holes are in line with the very end of the rollers (See Figure 23). Elimination of these four holes helps keep the rollers from "Skewing" (Running at an Angle), thus generating less heat.

Output Shaft and Bearing Assembly (New Style)	8668990
Needle Bearing Only (new Style)	8675032
3rd Roller Clutch Assembly (5th Design)	8677016

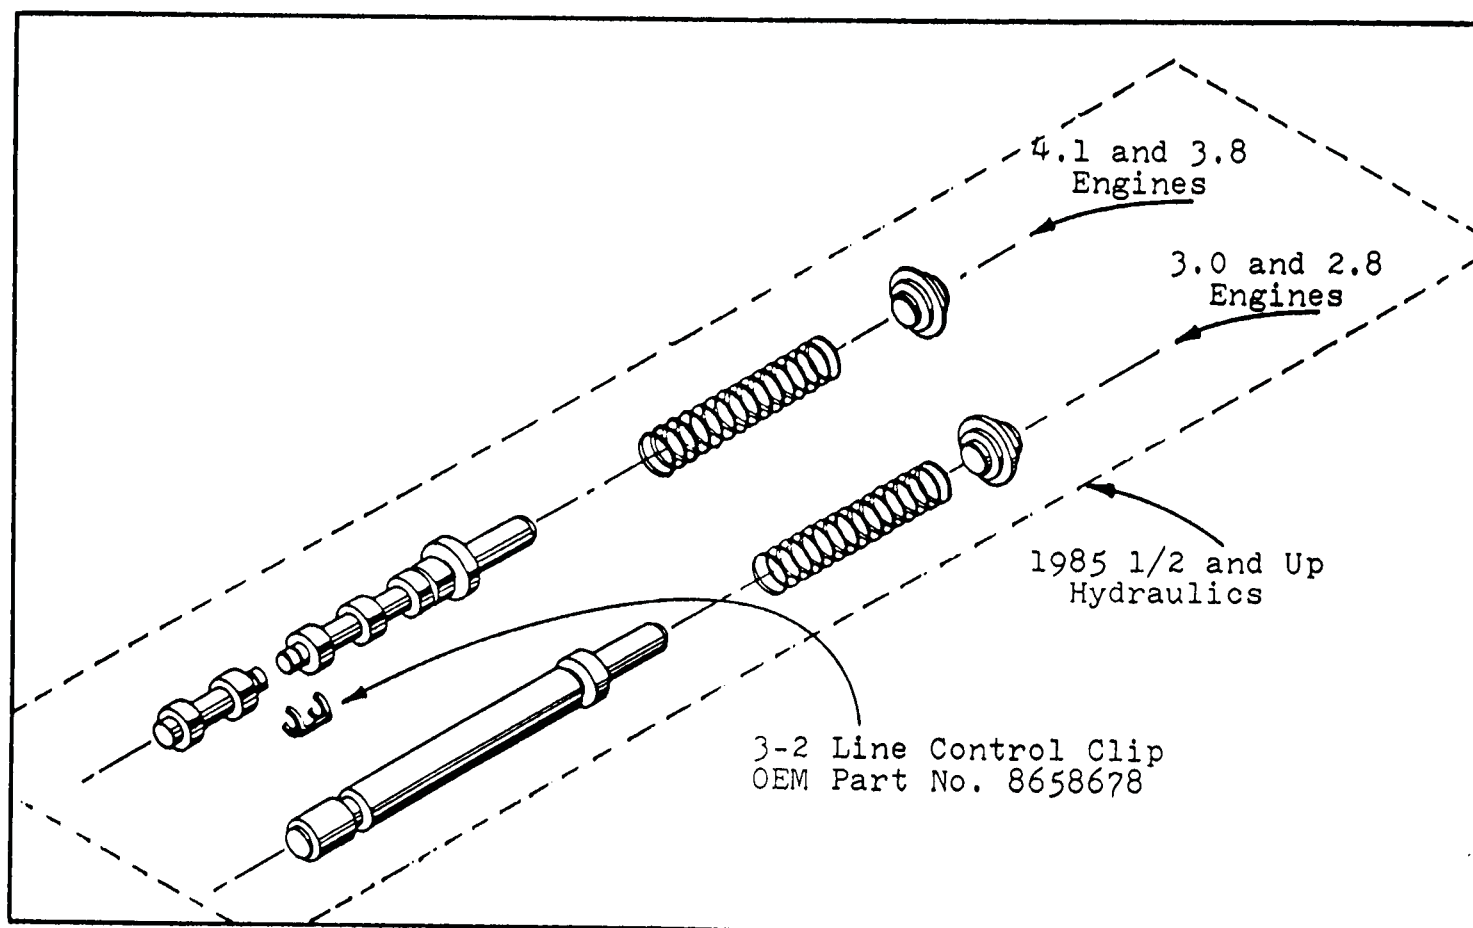
Figure 24

Proper spacer plate identification and selection is a MUST on the THM 440-T4. There are 2 different line-ups for the 3-2 line control valve, located in the channel plate, on all 1985 1/2 and later hydraulics. The 2 piece 3-2 line control valve is used on 4.1L and 4.5L Cadillac Engines, 3.8L Buick Engines, 3.3L Buick Engines, and 3.1L Turbocharged Engines (See Figures 24 and 25). The "Plug" that is also shown, is used on 3.1L Pontiac Engines, 3.0L Buick Engines, and 2.8L Chevrolet Engines (See Figures 24 and 25).

THESE SPACER PLATES WILL NOT INTERCHANGE

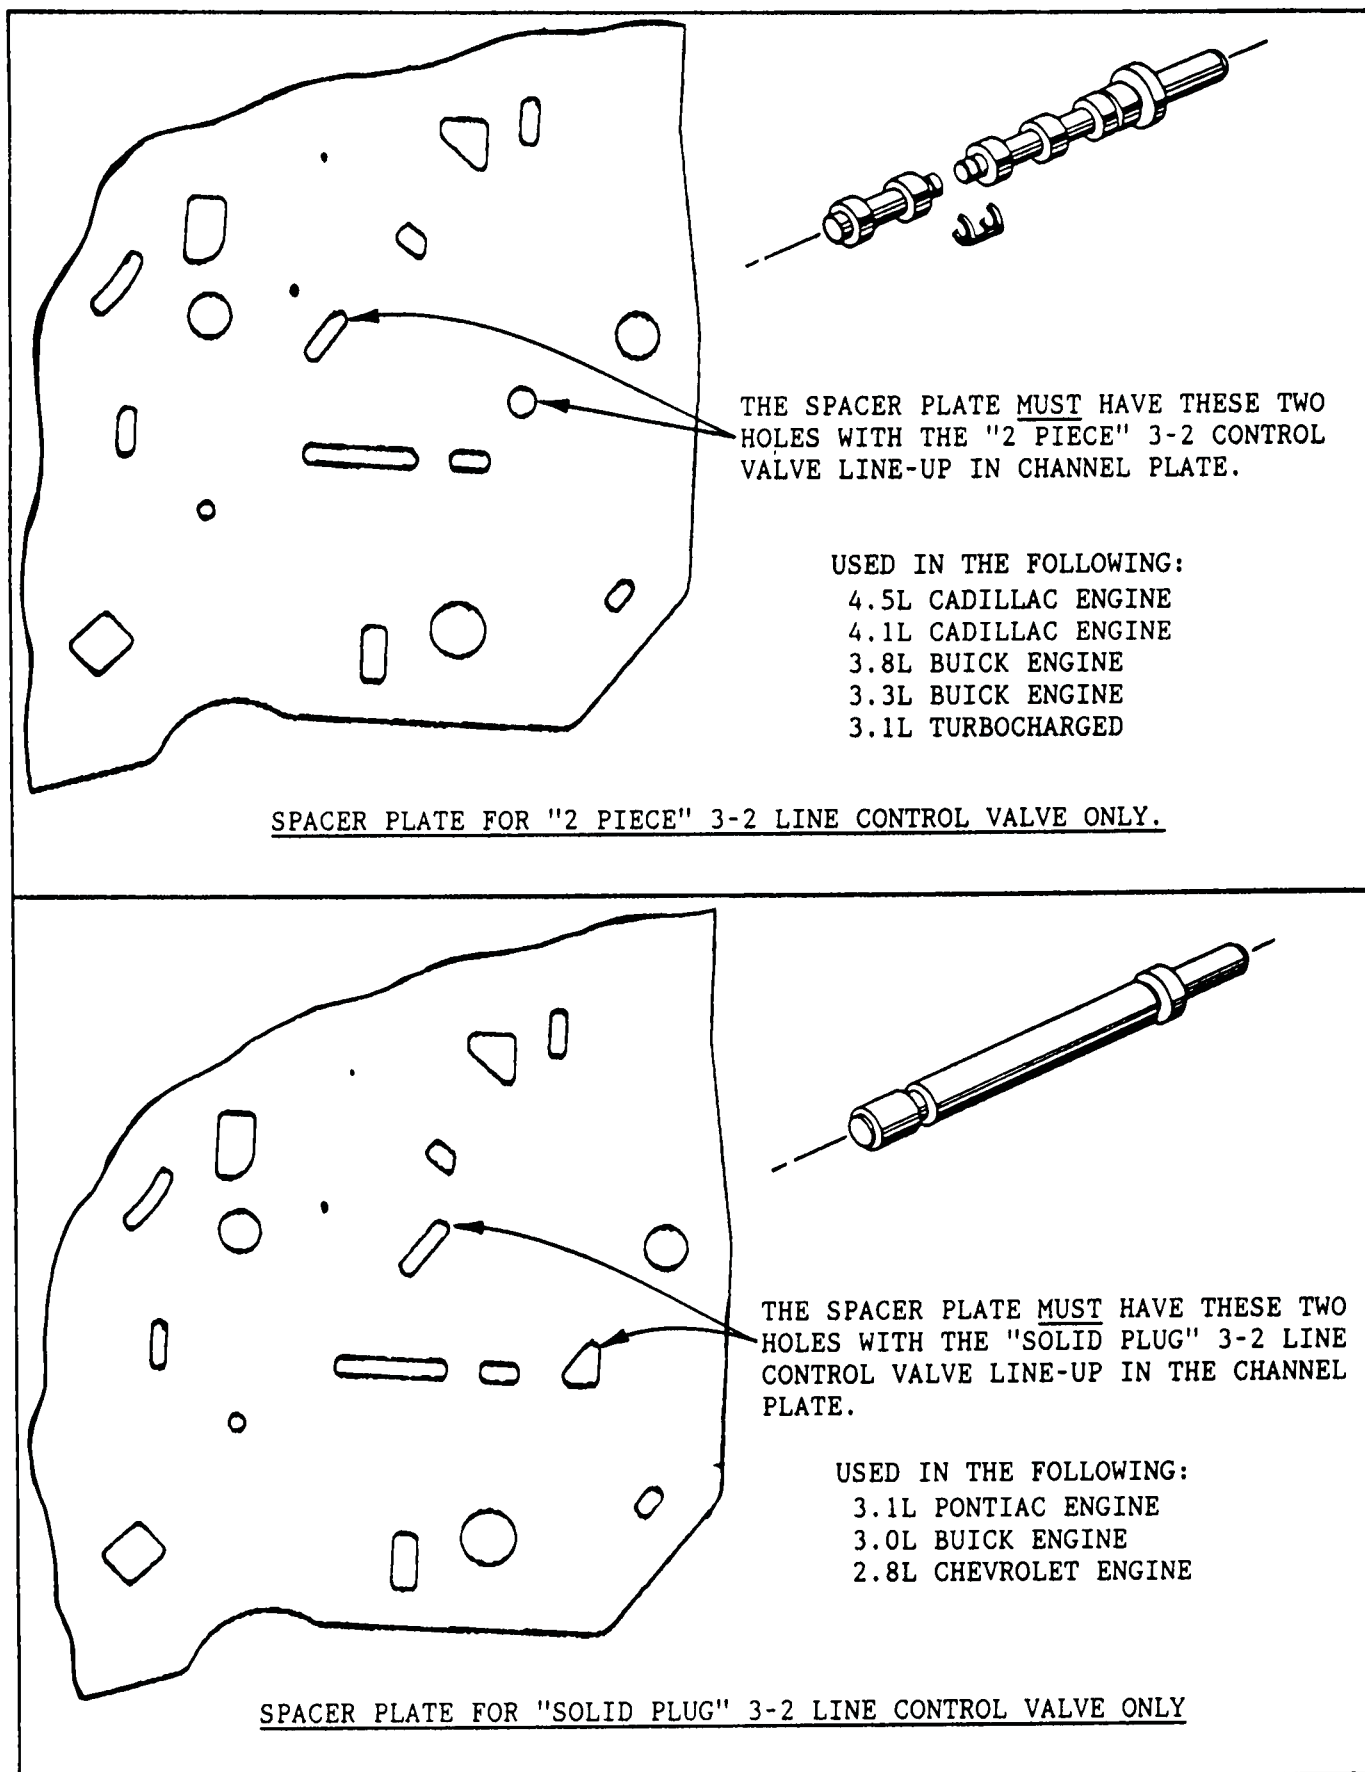
Refer to Figure 25 for the specific holes in the spacer plate to identify which valve line-up the spacer plate is compatible with.

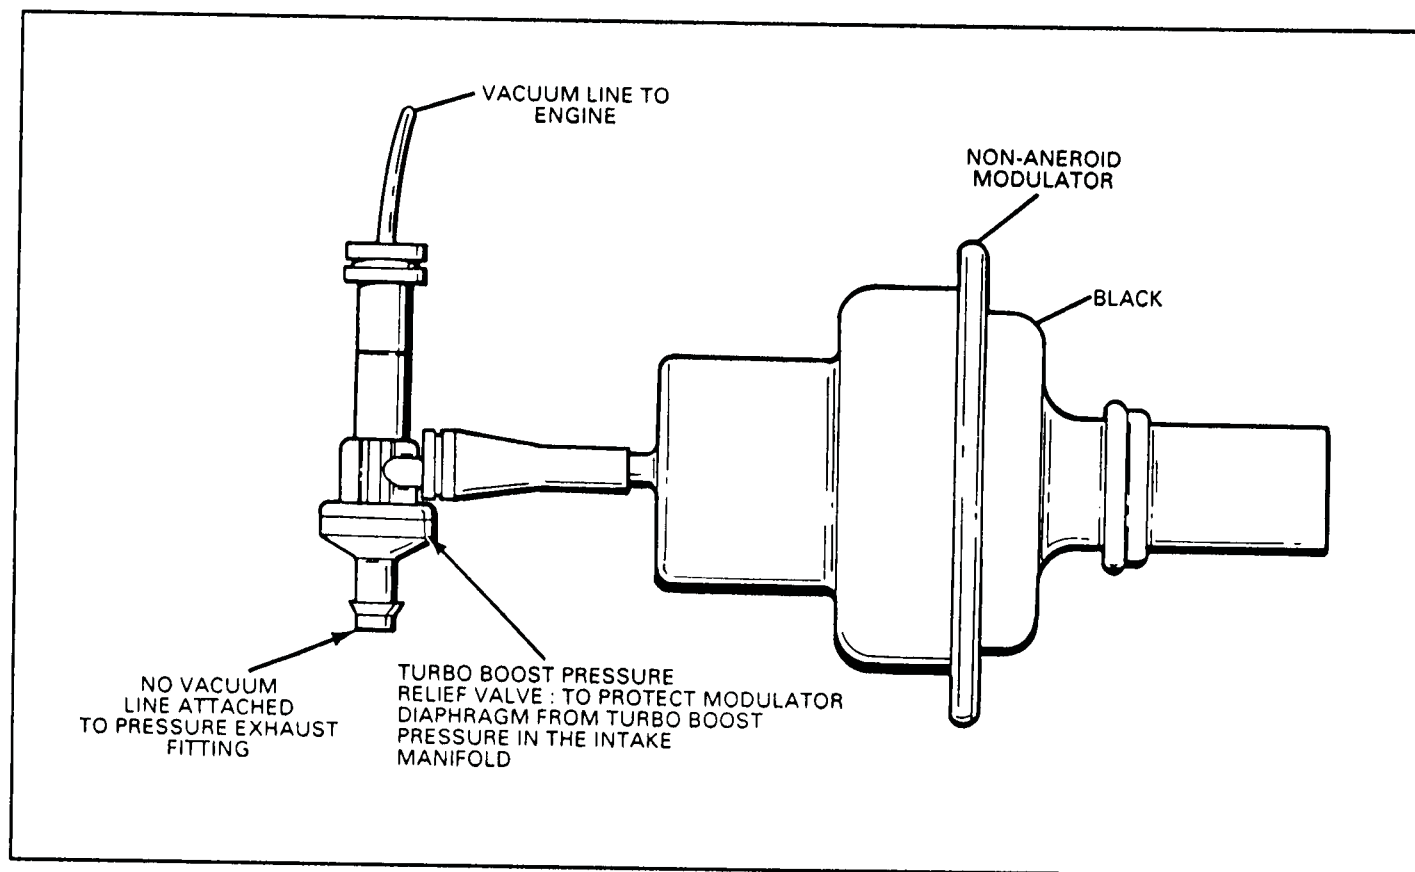
Figure 41

- (1) VACUUM MODULATOR - Special non-aneroid modulator that is compatible with the 3.1L Turbocharged Engine ONLY. The transmission model codes are OLAH, and OYRH, and found in the "W" car.
- (2) PRESSURE RELIEF VALVE - To protect the diaphragm in the modulator from turbo boost pressure in the intake manifold. This is a "One-Way" valve and must be installed as shown in Figure 41.

NOT INTERCHANGEABLE - FITS TURBOCHARGED MODELS ONLY.

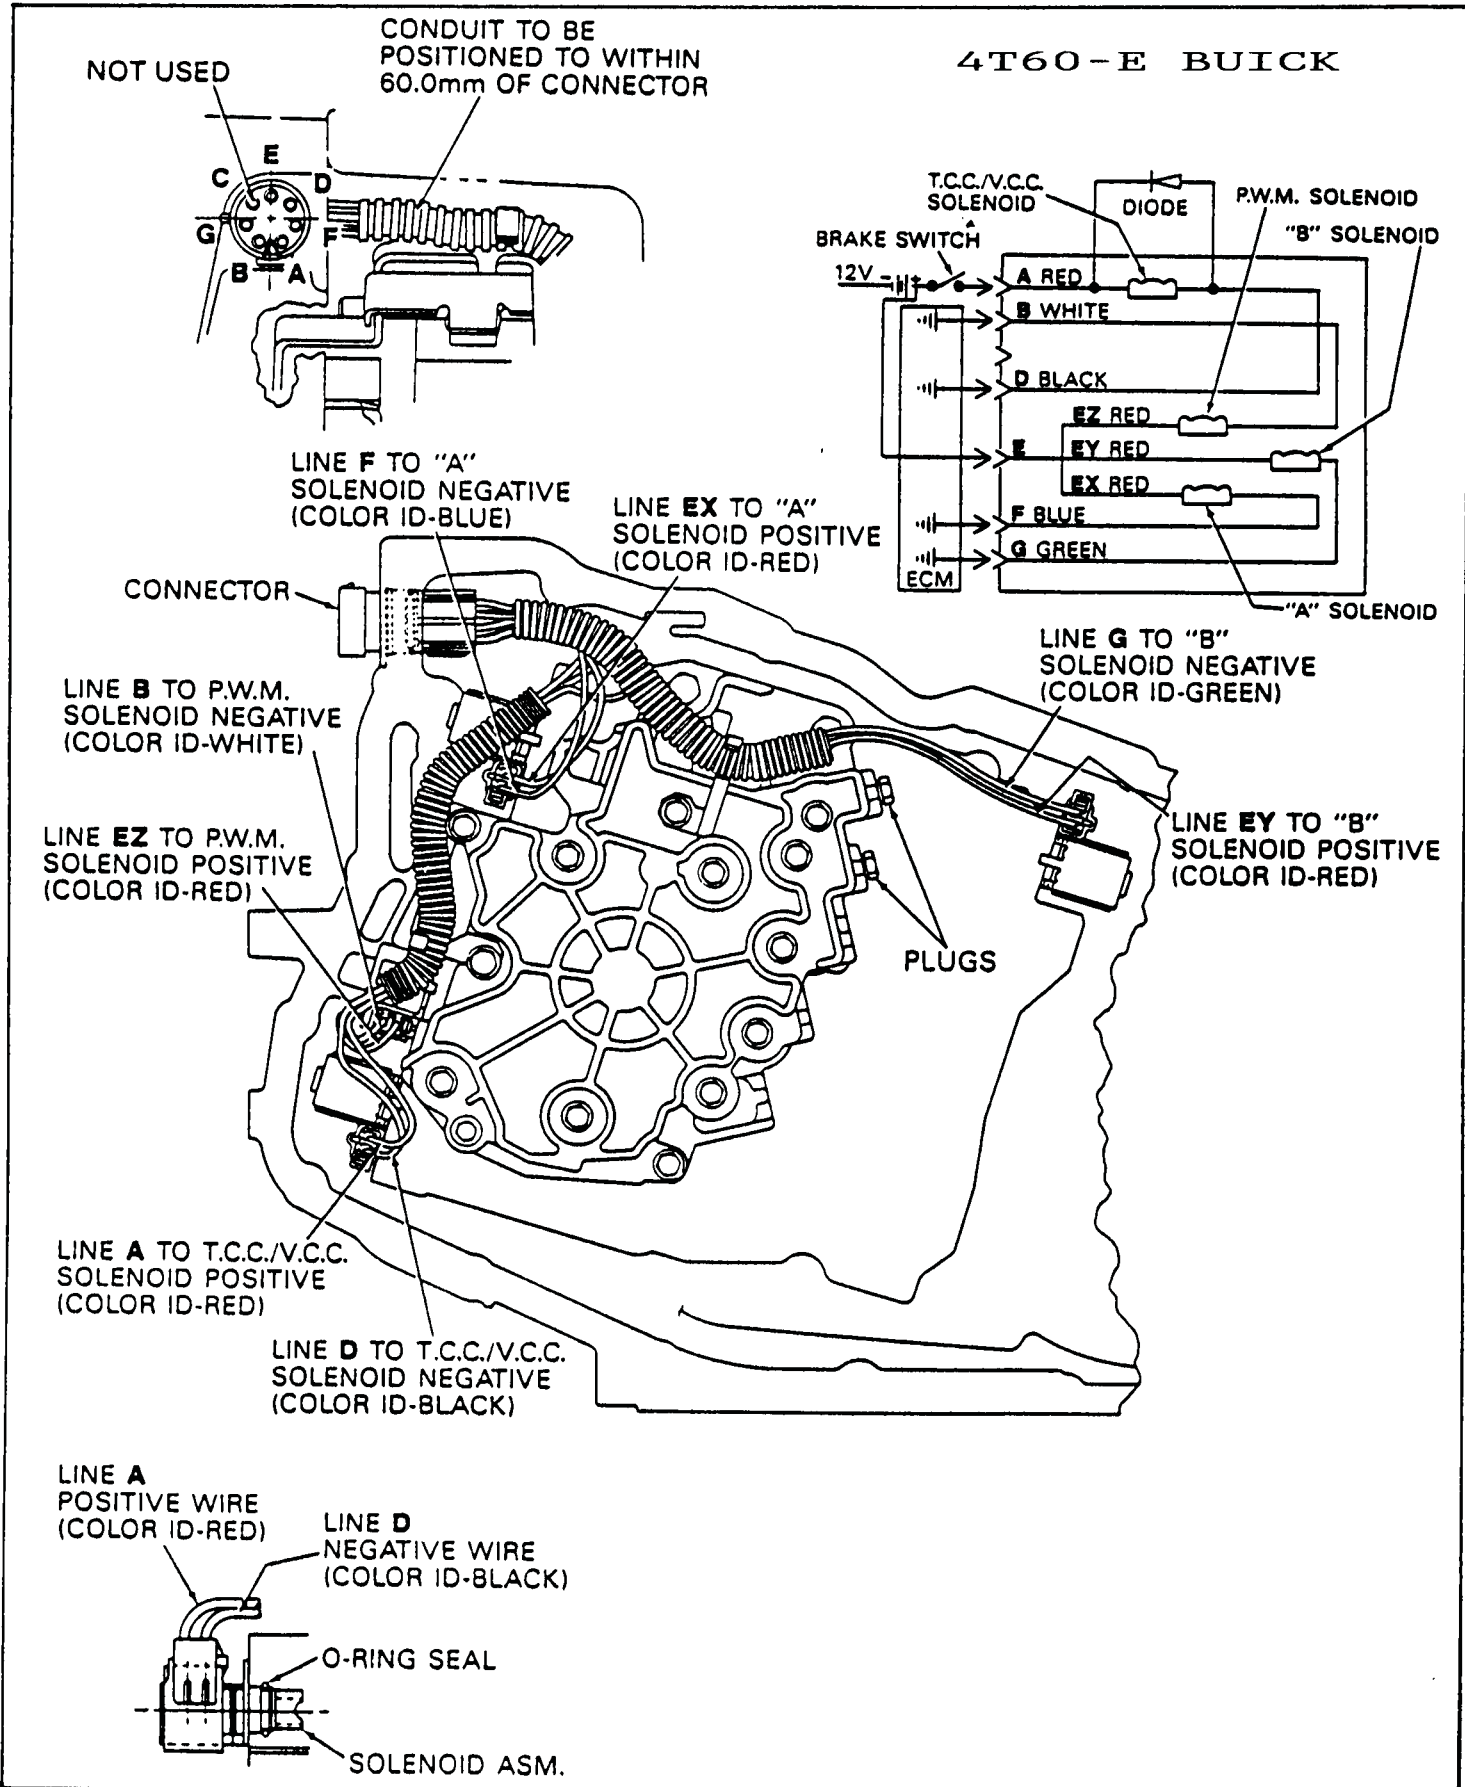
The shift pattern is controlled electronically with solenoids that receive a ground signal from the PCM (Powertrain Control Module). The PCM will vary shift points, as it is constantly interpreting numerous electronic signals from various operational sensors located on the vehicle. The PCM also controls application of the converter clutch and TCC apply feel electronically with solenoids. Refer to Figure 42 for wiring schematic, solenoid location, and wiring color codes.
