1996 SEMINAR INFORMATION

## "THE BEST FIX IN '96"

AUTOMATIC TRANSMISSION SERVICE GROUP  
9200 S. DADELAND BLVD. STE 720  
MIAMI, FLORIDA 33156  
(305) 670-4161

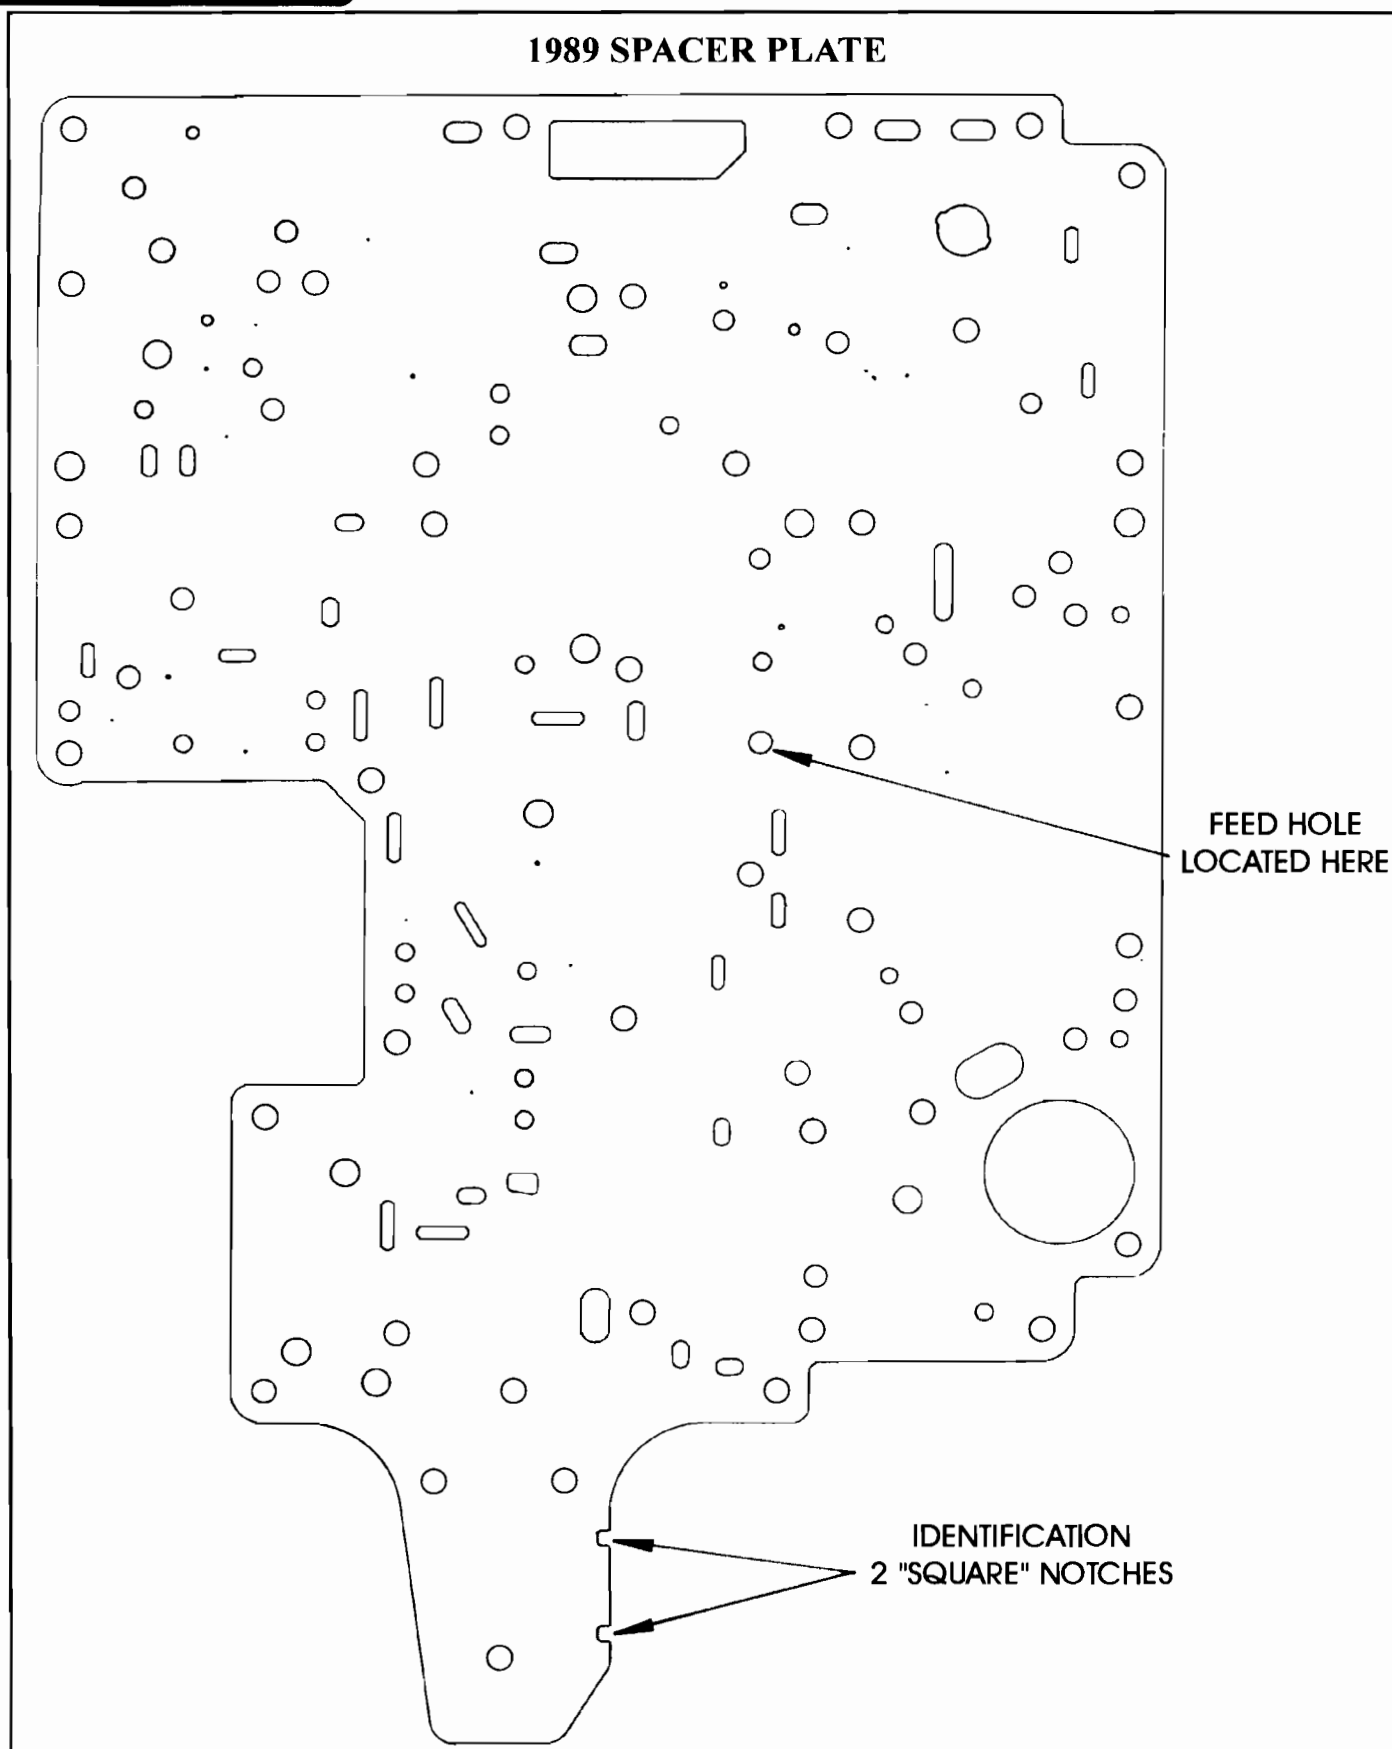
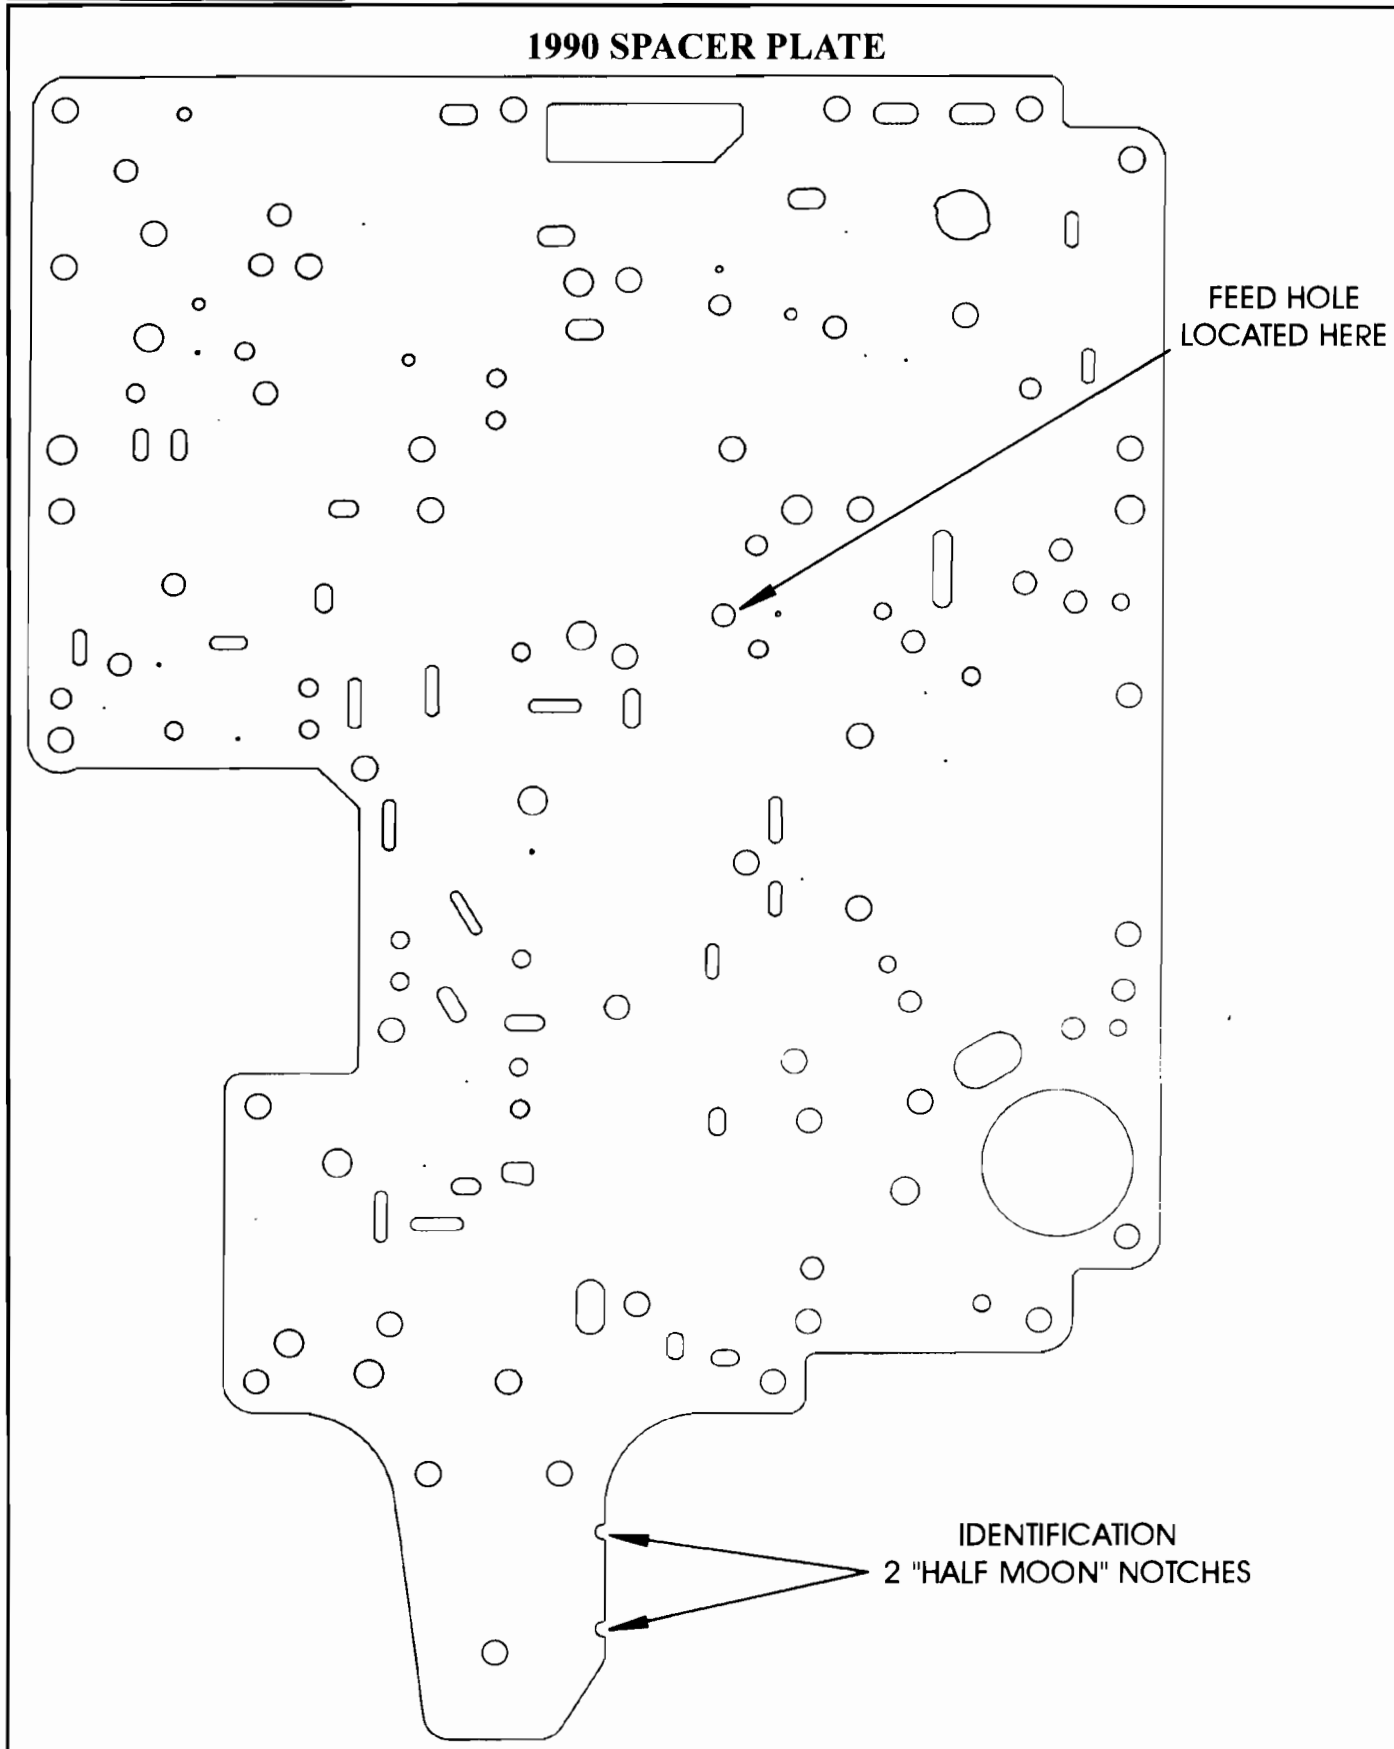
Figure 10  
*Automatic Transmission Service Group*

**CAUSE:** The cause may be, a 1990 Main Valve Body installed onto 1989 spacer plate, 89 gaskets, and 89 checkball locations. This will block solenoid feed oil to the 1-2 shift valve. Since shift solenoid 2 is OFF electronically, and shift solenoid 1 is OFF hydraulically (Feed Oil Blocked), the transmission will be in 4th gear.

- (1) MAIN VALVE BODY SPACER PLATE - Can be positively identified by the solenoid feed hole location, as shown in Figures 10 and 11. Can also be identified by the shape of the I.D. notches in the spacer plate, as shown in Figures 10 and 11.

- (2) VALVE BODY GASKETS - **Must** have solenoid feed hole locations in the gaskets that match the solenoid feed hole locations in the spacer plate, as shown in Figures 10 and 11.

Main Valve Body Spacer Plate (1989 Models) ..... E9TZ-7A008-A  
Main Valve Body Spacer Plate (90-UP Models) ..... F0TZ-7A008-A

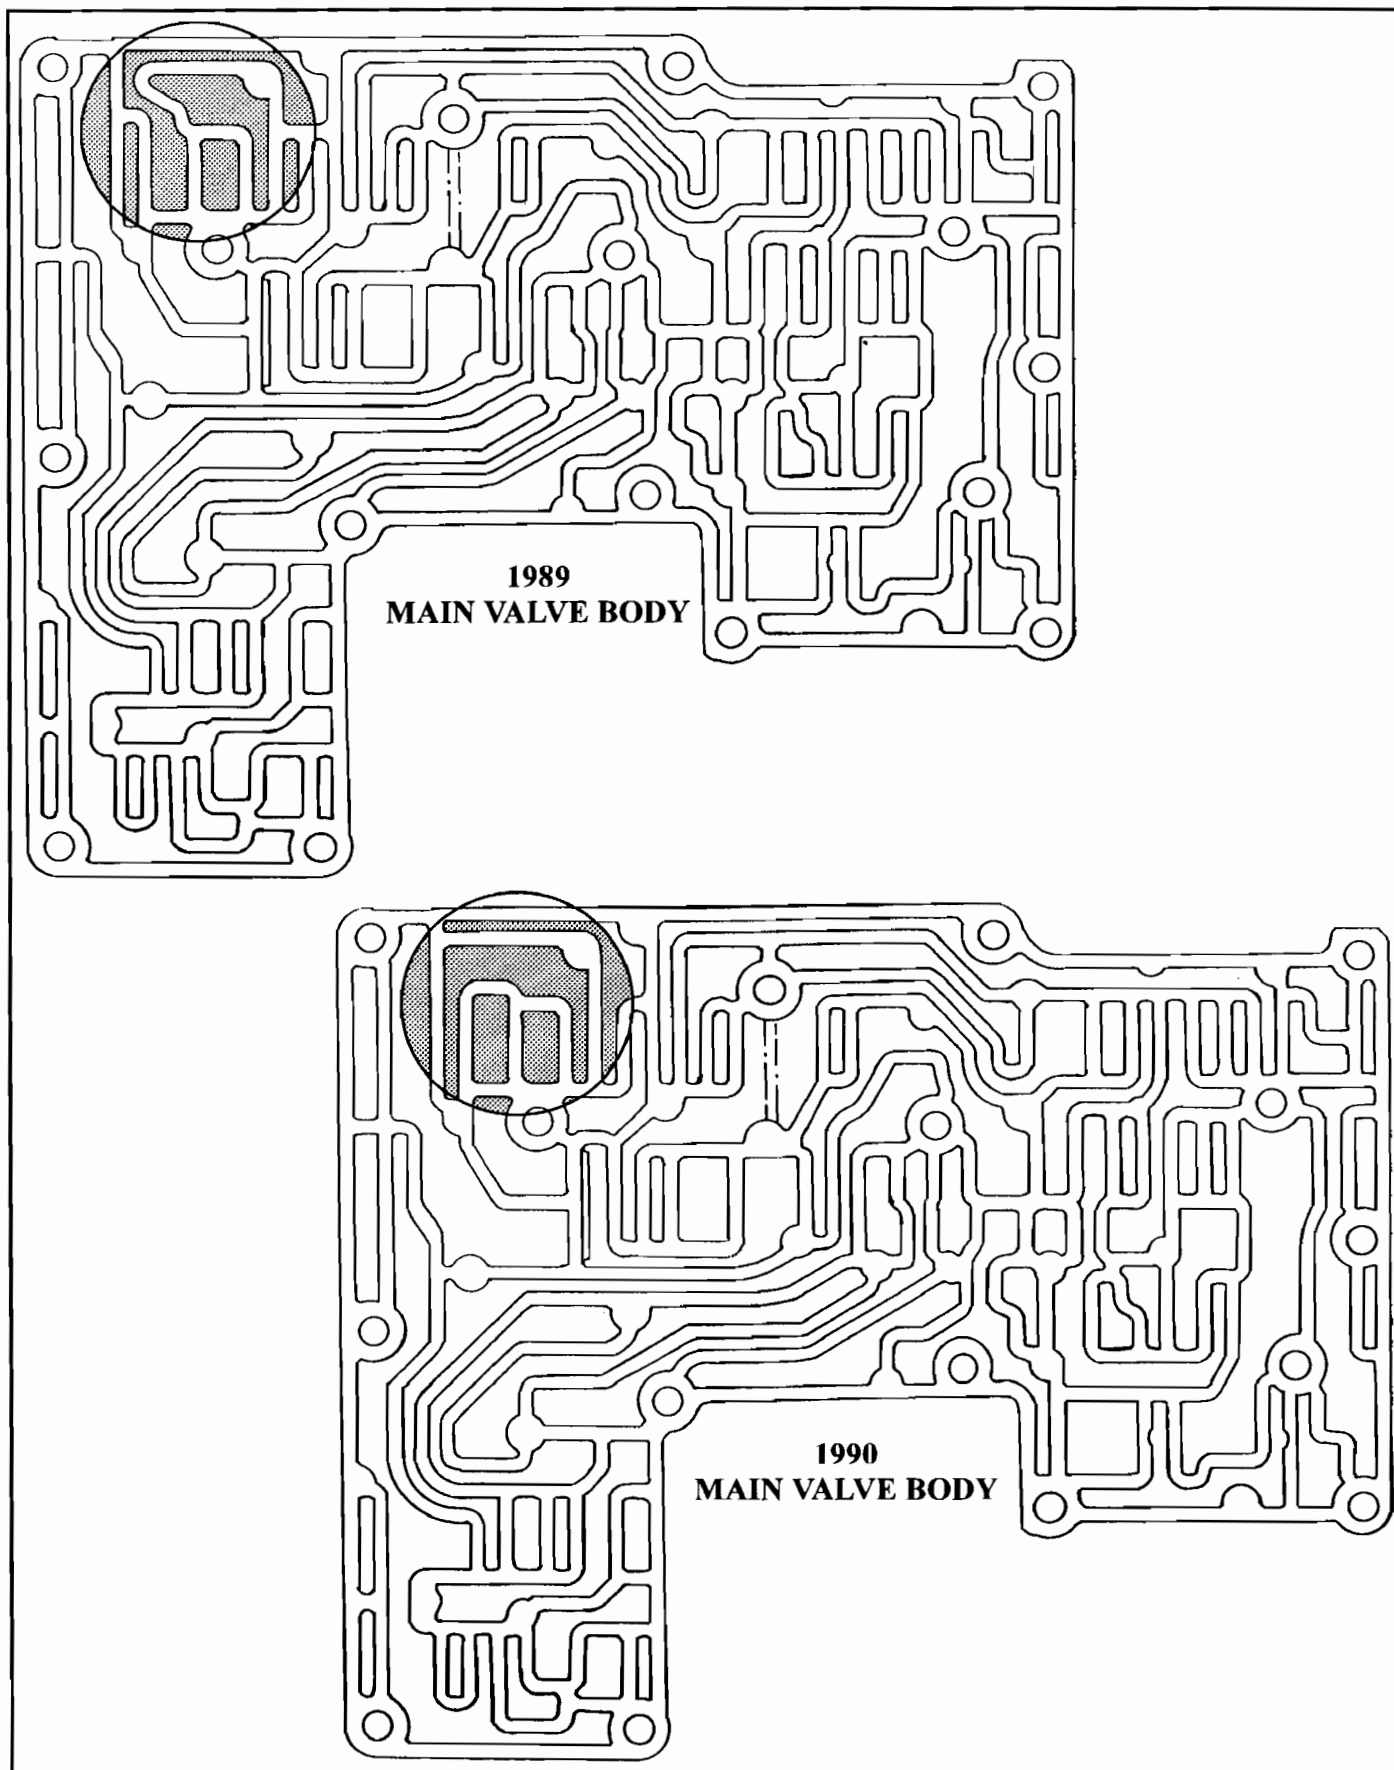
Figure 12

- (3) MAIN VALVE BODY - Can be identified by the differences in the worm track area at the 1-2 shift valve, as shown inside the circles in Figure 12. Can also be identified by the rough forging number cast into the valve body in the location shown in Figure 13.  
RF-~~E~~9TP-7A092 = 1989 Model  
RF-~~F~~0TP-7A092 = 1990 Model

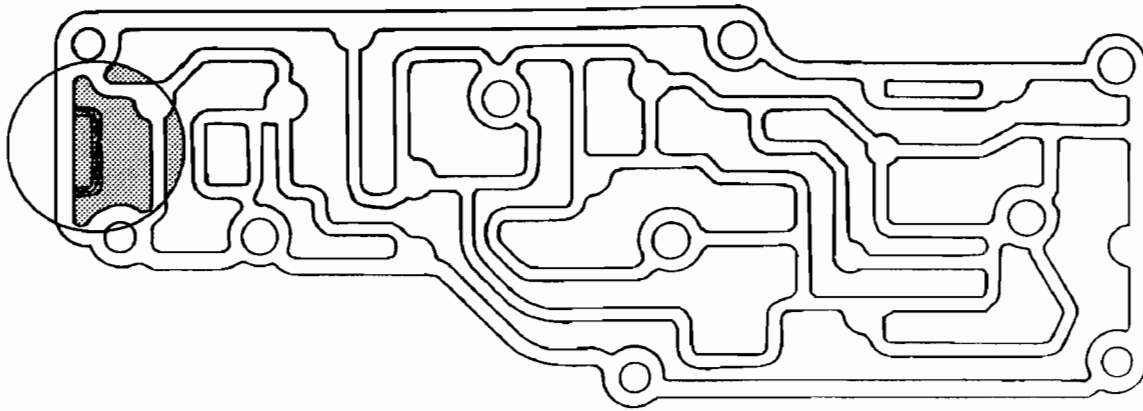
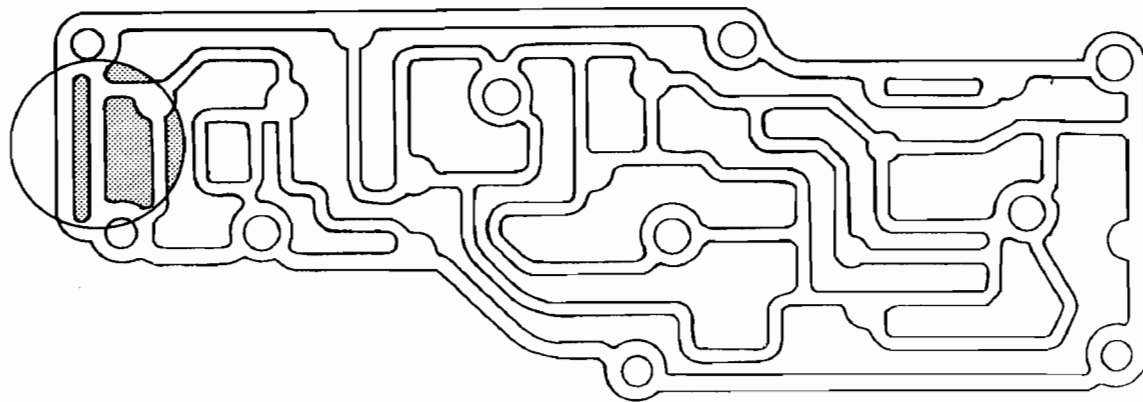
Figure 15

- (5) LOWER VALVE BODY - The engagement control valve retaining clip on 1989 models, was replaced by bore plug and new design clip on the 1990 model, which also changed the worm track configuration in that area, as shown inside the circles in Figure 15. The lower valve body can also be identified by the rough forging number cast in valve body.  
RF-~~E~~9TP-7A101 = 1989 Model  
RF-~~F~~0TP-7A101 = 1990 Model

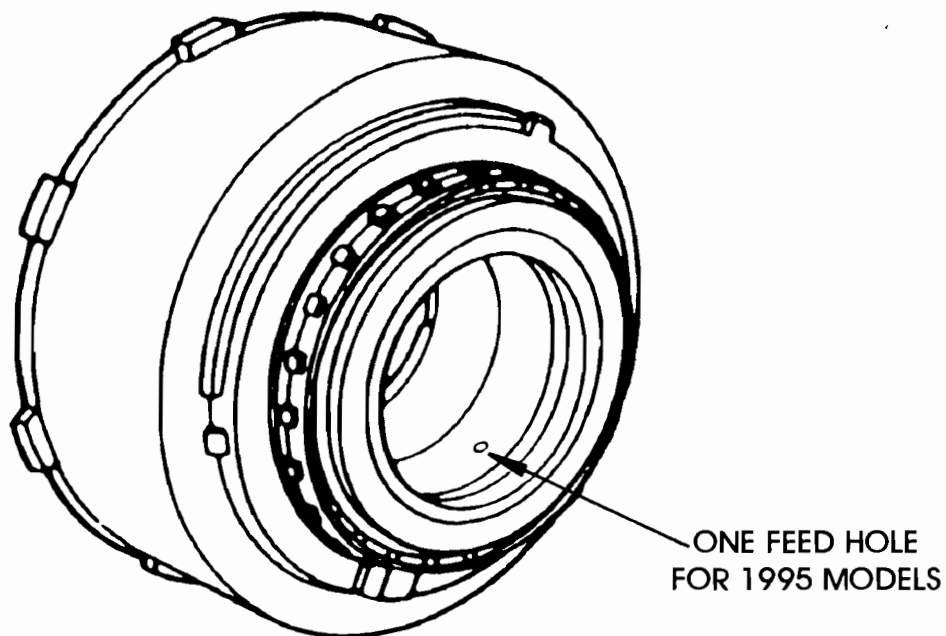
Figure 18

**CHANGE:** Beginning at the start of production for the 1995 model year, all E4OD transmissions were built with a revised Direct Clutch Housing (Intermediate Brake Drum) as shown in Figure 18.

- (1) **DIRECT CLUTCH HOUSING** - 1995 models now have only *one* direct clutch apply pressure feed hole, instead of the *two* feed holes found in previous models (See Figure 18).

89-94 Direct Clutch Housing (2 Feed Holes - 3/4 Clutch) .....	E9TZ-7D044-A
1995 Direct Clutch Housing (1 Feed Hole - 3/4 Clutch) .....	F5TZ-7D044-A
1995 Direct Clutch Housing (1 Feed Hole - 5 Clutch ) .....	F5TZ-7D044-B

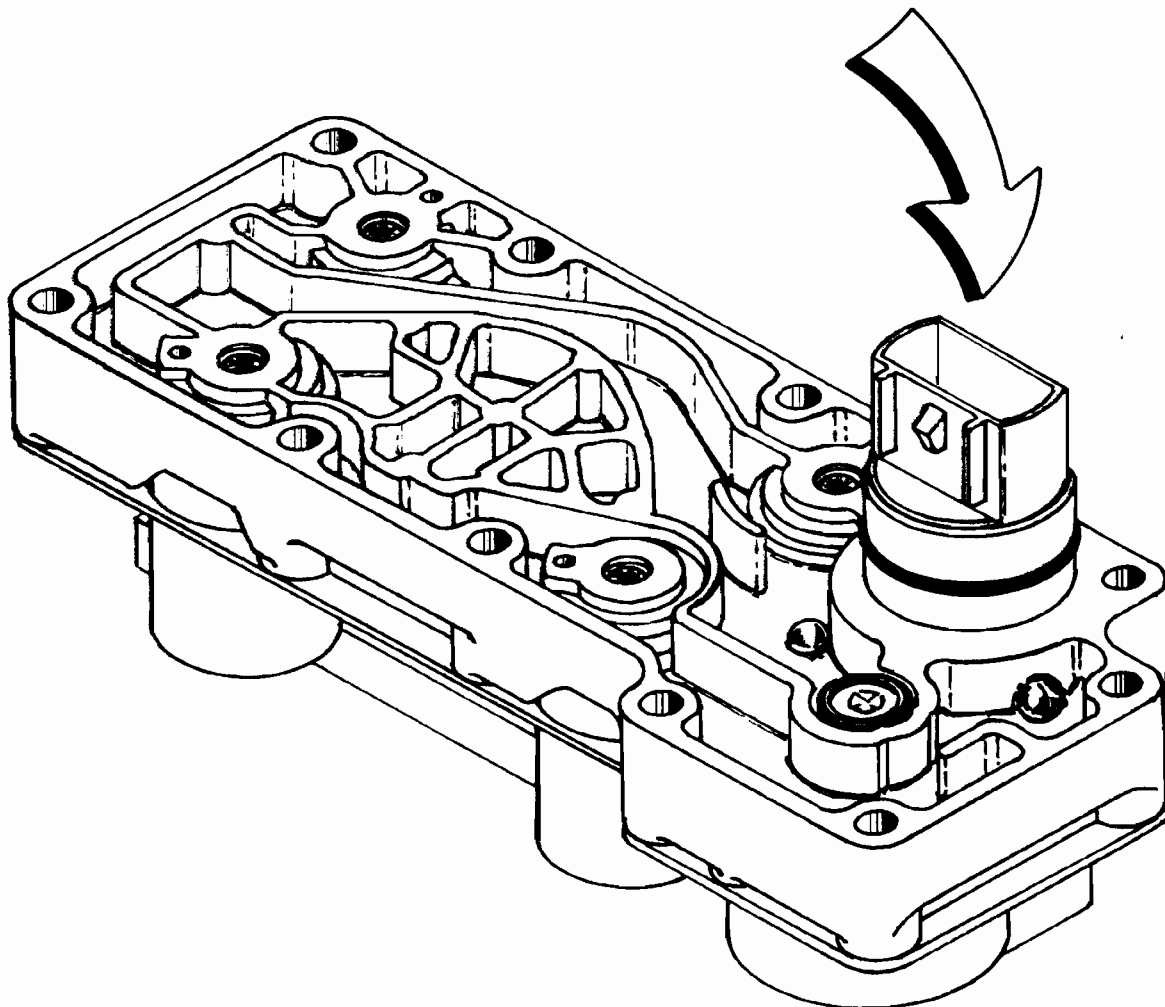
- (1) **SOLENOID PACK** - New design solenoid assembly case connector to accommodate the new design vehicle harness connector. Refer to Figure 19 for identification of the previous design and the new design solenoid assemblies.

**NOTE:** The plastic sleeve incorporated in the previous design solenoid pack has been eliminated on the new design solenoid pack (See Figures 19 and 20). This plastic sleeve will sometimes remain on the vehicle harness connector when it is disconnected. If a new solenoid pack is installed (which includes sleeve), it will be imposible to reconnect the vehicle harness to the solenoid pack until the old sleeve is removed from vehicle harness connector. Refer to Figure 20.

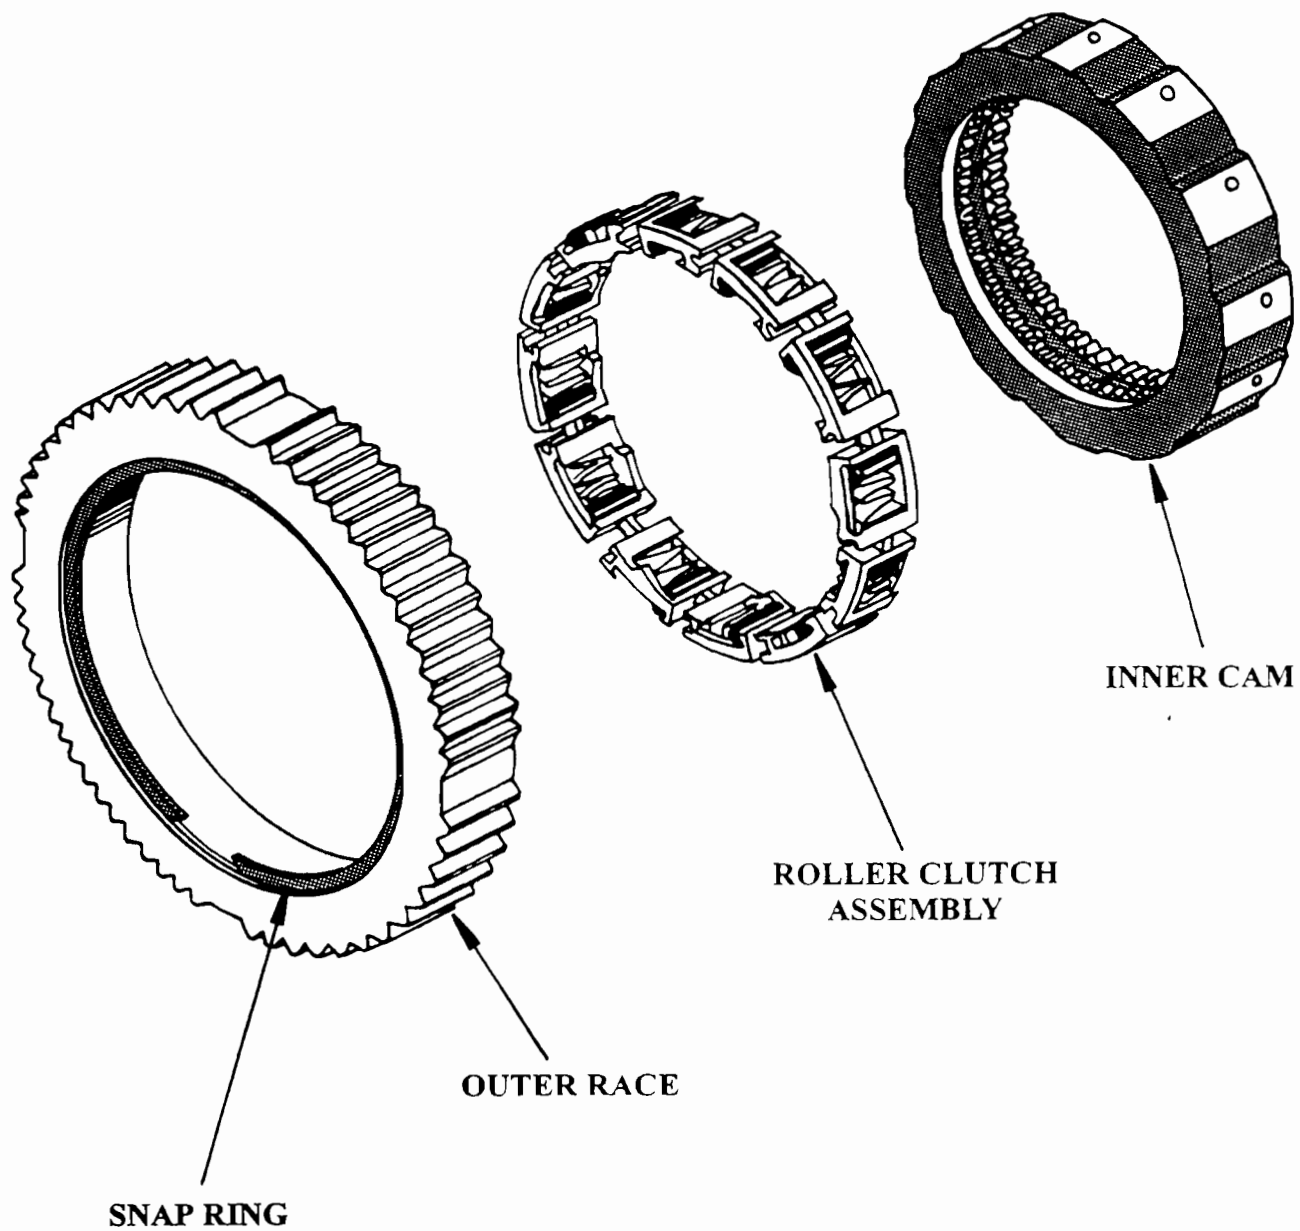
Figure 21

The previous design Overdrive Sprag (E9TZ-7A089-A) **is no longer available**. The previous part number will now supercede to one of the part numbers listed below under "Service Information", as there is one number for F-Super Duty and Motorhomes and another number for all others. The new design "Overdrive Roller Clutch Service Kit" will retro-fit back on **all** previous models (See Figure 21).

However, ATSG recommends that the "Overdrive Roller Clutch Kit" be installed on all previous models, **only if you have also installed the "Ball Bearing Center Support Kit"**, available under OEM part number F4TZ-7A130-B. Refer to ATSG bulletin No. 95-05 for the Ball Bearing Center Support information and dimensions.

Overdrive Roller Clutch Service Kit, (All Except Super Duty and Motorhome) ..... F5TZ-7A089-A  
Overdrive Roller Clutch Service Kit, (7.5L F-Super Duty and Motorhome) ..... F4TZ-7A089-A

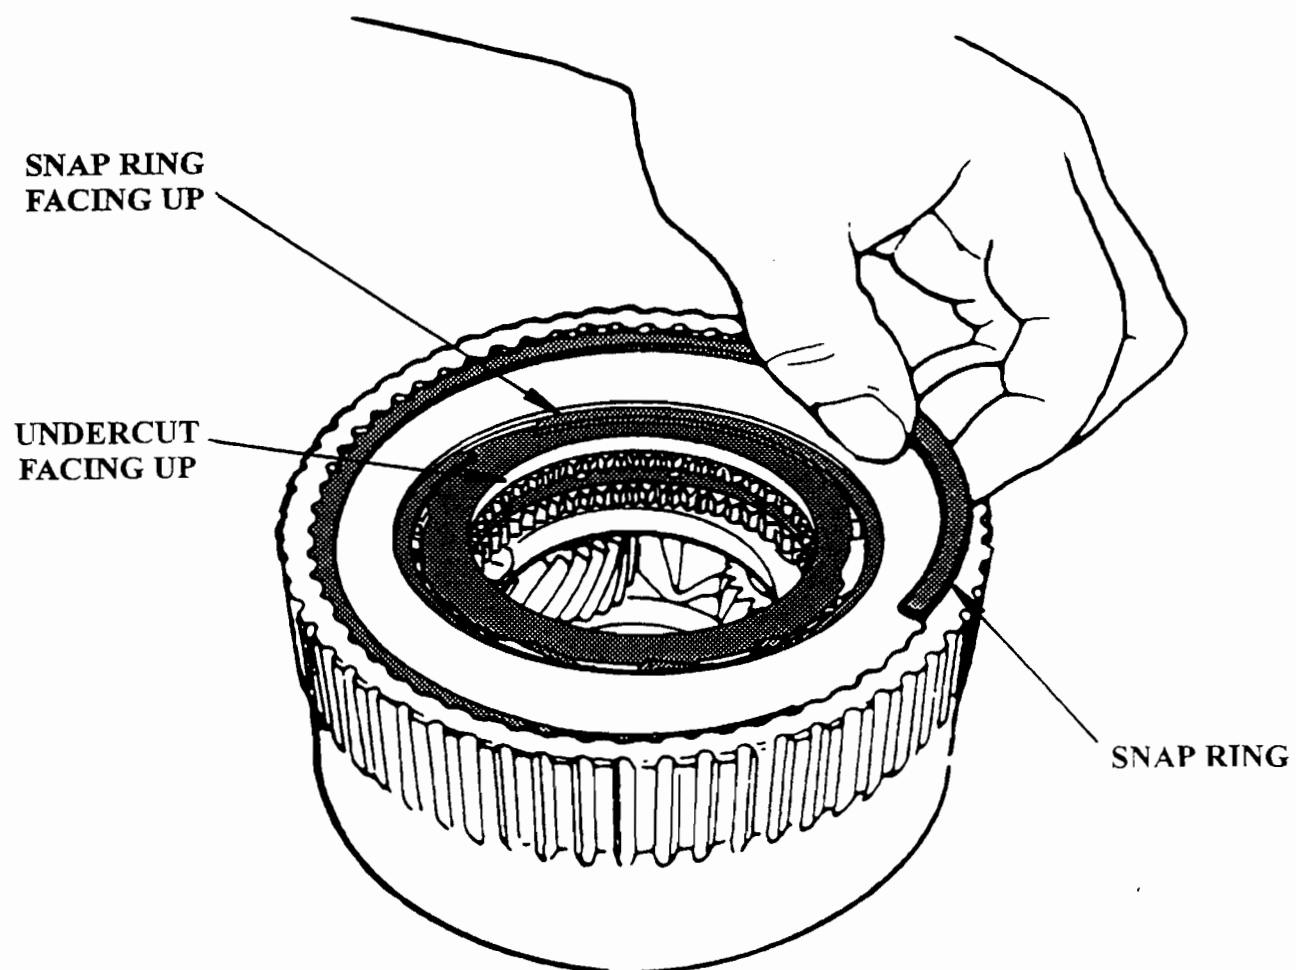
Figure 26

**NOTE:** *With the outer race snap ring facing up, and the inner cam "undercut" facing up, the inner cam should freewheel in a counter-clockwise direction and lock clockwise, while holding the outer race. Refer to Figure 25.*

- (6) Install the completed Overdrive Roller Clutch Assembly into the overdrive ring gear, with the snap ring and the inner ring undercut, **facing up**, and install the outer race to ring gear snap ring, as shown in Figure 26.

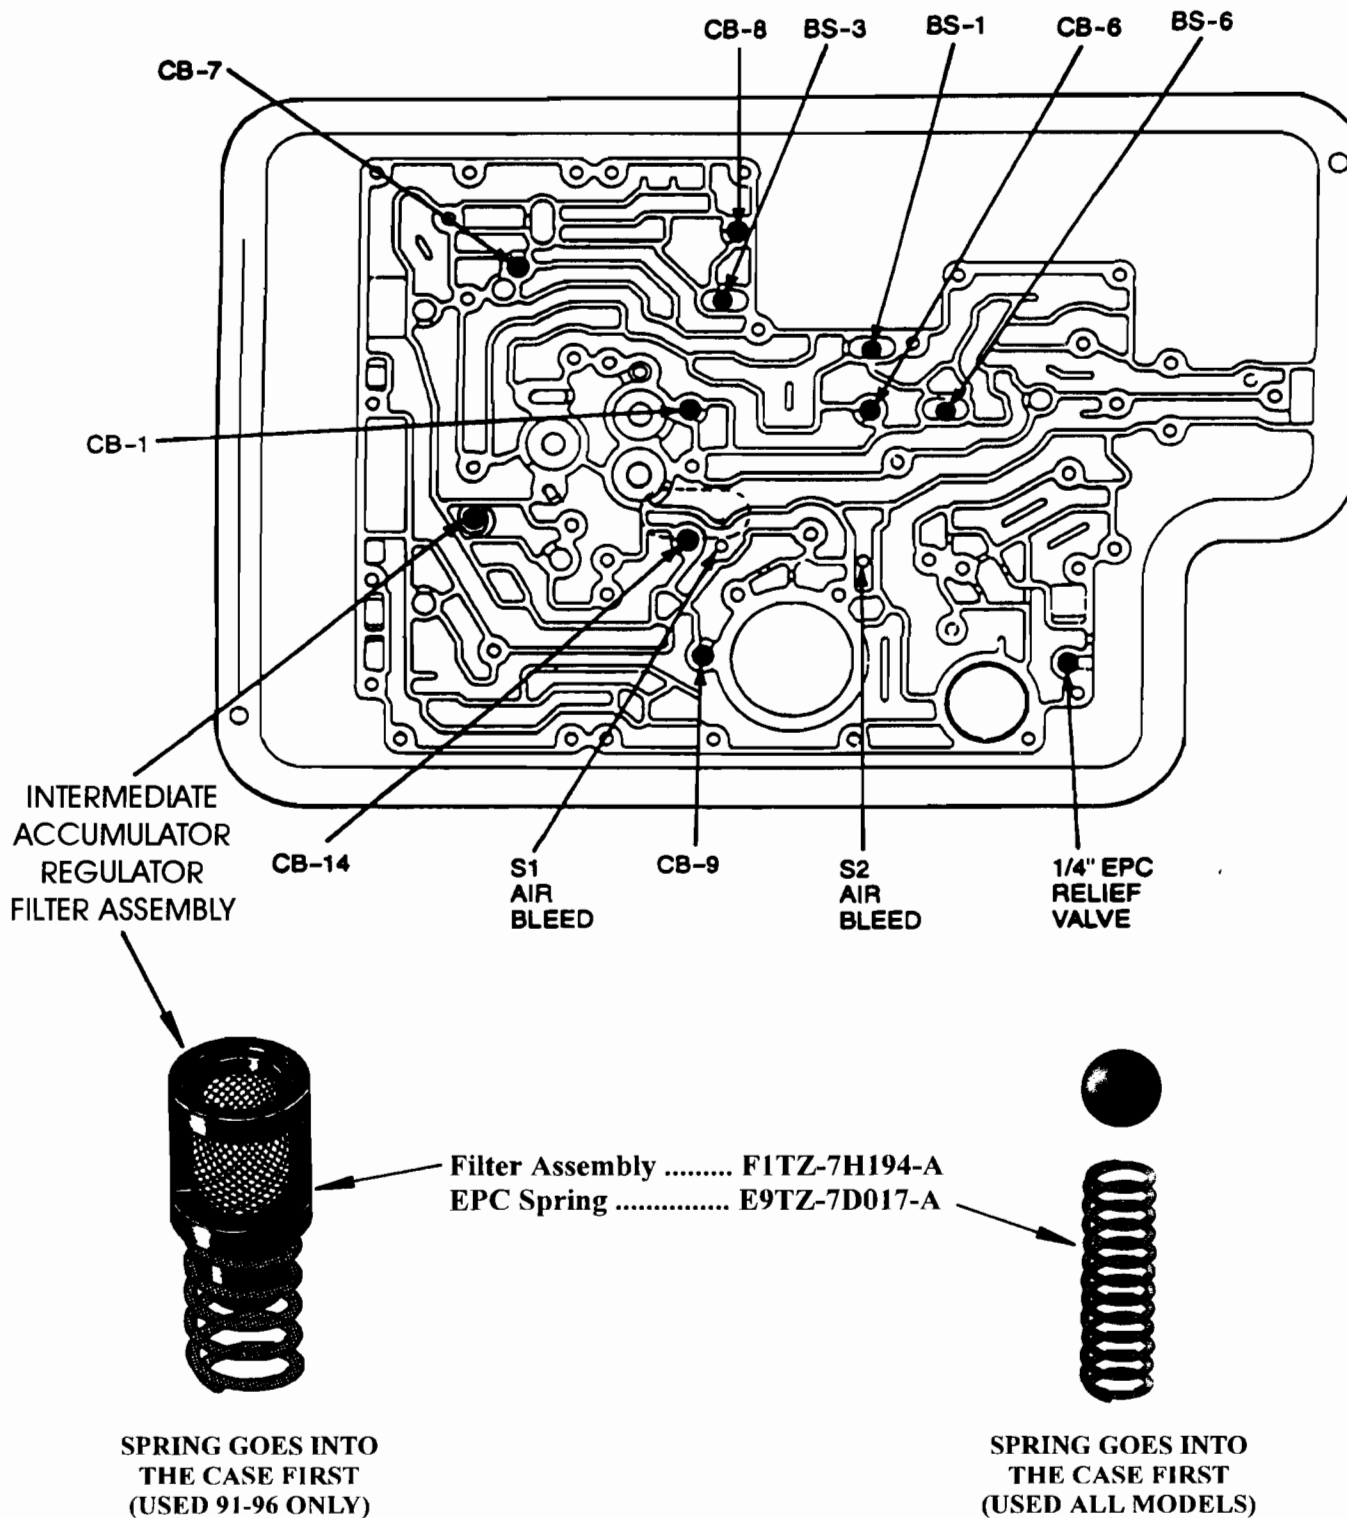
Figure 30  
Automatic Transmission Service Group

These models use 9 rubber checkballs in the case, and the EPC Relief Ball and Spring, as shown in Figure 30.

1991-1996 models also use an Intermediate Accumulator Regulator Filter Assembly in the case, and is located in the case in the position shown in Figure 30.

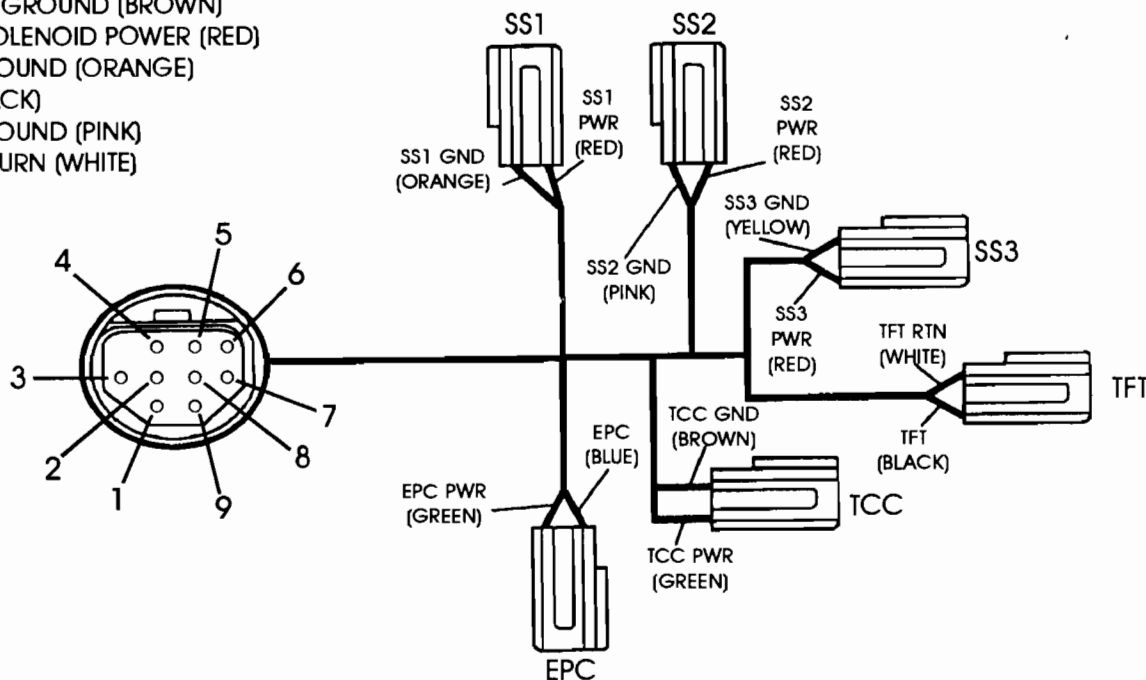
Figure 2

**COMPLAINT:** *After rebuild*, harsh shifts (High Line) and/or a "Clicking" or cycling noise may be heard from the side cover area, that is usually accompanied by an ON/OFF bind-up sensation that coincides with the "Clicking" noise. These symptoms may be accompanied with Diagnostic Trouble Code (DTC) 652 (MCCC Shorted or Open Circuit), DTC 624 (EPC Circuit Failure), and/or one Shift Solenoid DTC 621, 622, or 624.

**CORRECTION:** Connect the internal wiring harness connectors to their proper solenoids, using the wire colors, as shown in Figure 1 and 2. Proper connection of solenoids can also be verified externally through the case connector using the Ohms chart in Figure 2.

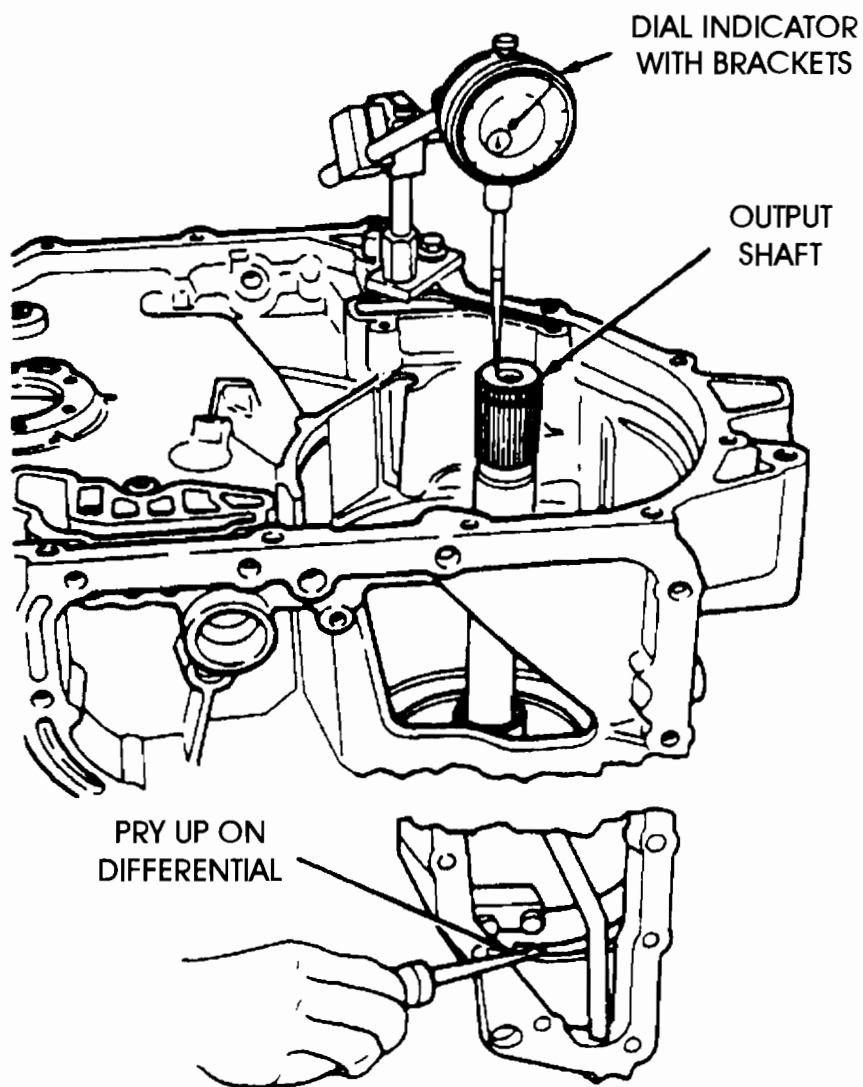
Figure 13

**FINAL DRIVE END PLAY MEASUREMENT**

**FINAL DRIVE END PLAY SHOULD BE .004" MINIMUM TO .016" MAXIMUM.**

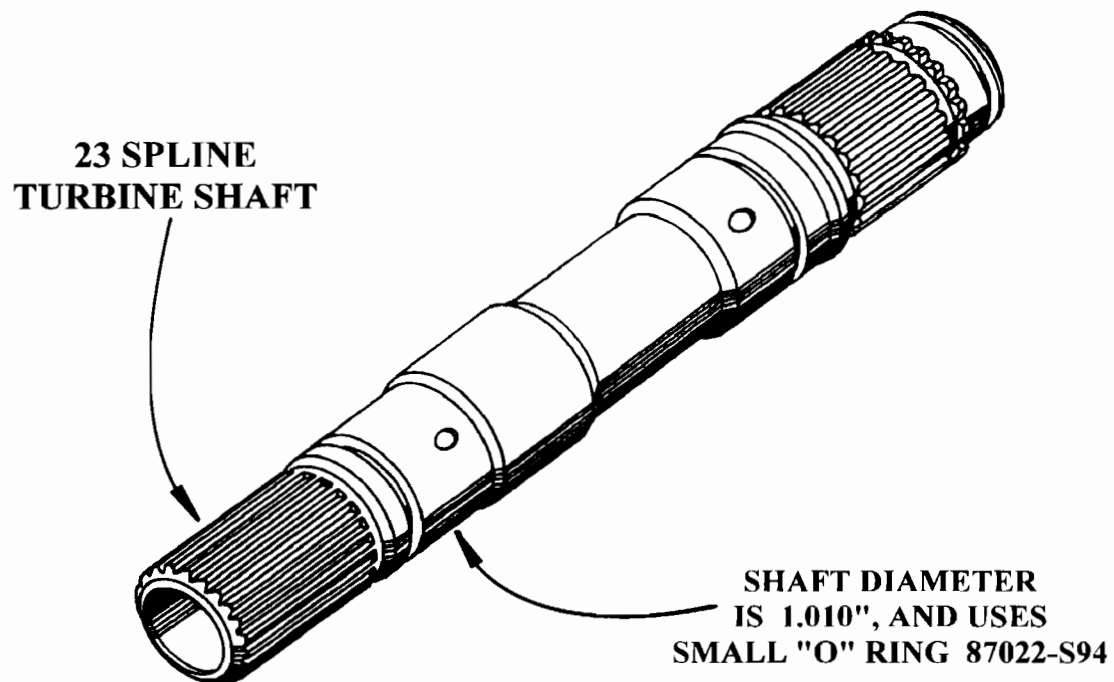
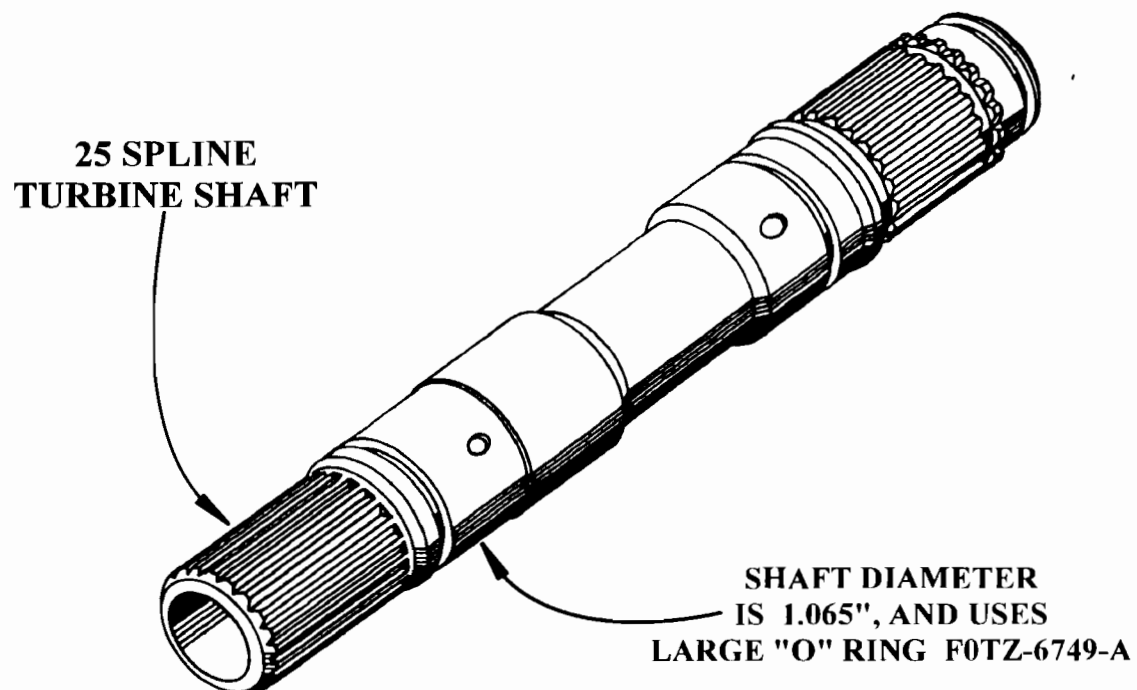
Figure 14  
*Automatic Transmission Service Group*

**CAUSE:** The cause may be, the wrong size "O" ring seal (23 Spline) installed onto a 25 spline turbine shaft (See Figure 14).

Turbine Shaft (23 Spline) .....	E6DZ-7F213-A
Turbine Shaft (25 Spline) .....	F4DZ-7F213-A
Turbine Shaft "O" Ring (23 Spline) .....	87022-S94
Turbine Shaft "O" Ring (25 Spline) .....	F0TZ-6749-B

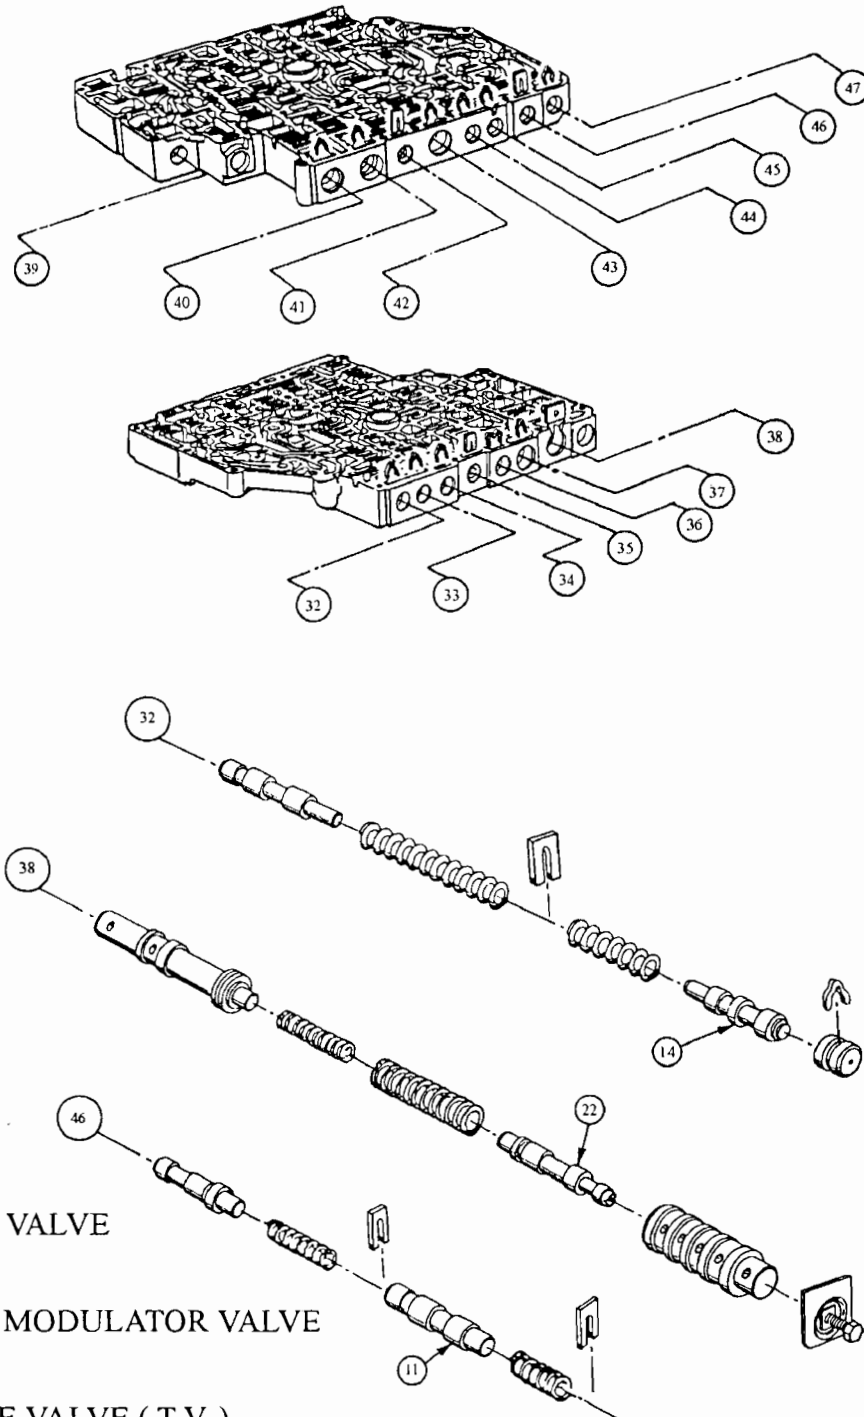
Figure 20

1. *The T.V. Cable not adjusted properly.*
2. *The T.V. Valve in the valve body stuck.*
3. *The T.V. Limit Valve in the valve body stuck.*
4. *The T.V./Line Modulator Valve in the valve body stuck or installed backwards.*
5. *The B3 Checkball located in the pump is missing, leaking, or off location.*

1. Install a 0-100 lb. pressure gauge into the T.V. pressure port, which is located on the side of transaxle as shown in Figure 19, and set the T.V. cable so that T.V. pressure reading is between 12-16 PSI.
2. Check the T.V. Valve in the valve body to ensure it is not stuck (See Figure 20).
3. Check the T.V. Limit Valve in the valve body to ensure it is not stuck, and location is shown in Figure 20.
4. Check the T.V./Line Modulator Valve in the valve body to ensure it is not stuck and is installed in the proper direction, as shown in Figure 20.
5. Ensure that the B3 Checkball located in the pump is in the proper location, as shown in Figure 21, and is the proper diameter.

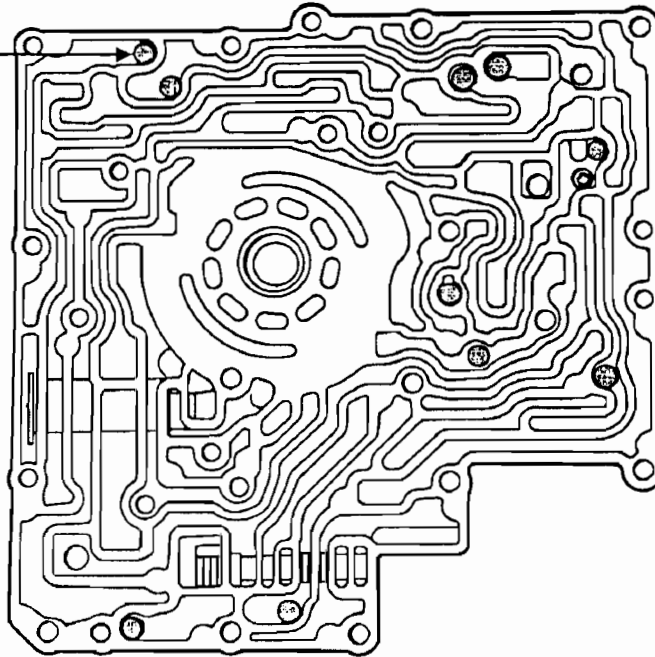
Figure 21

**B3 CHECKBALL  
LOCATION**

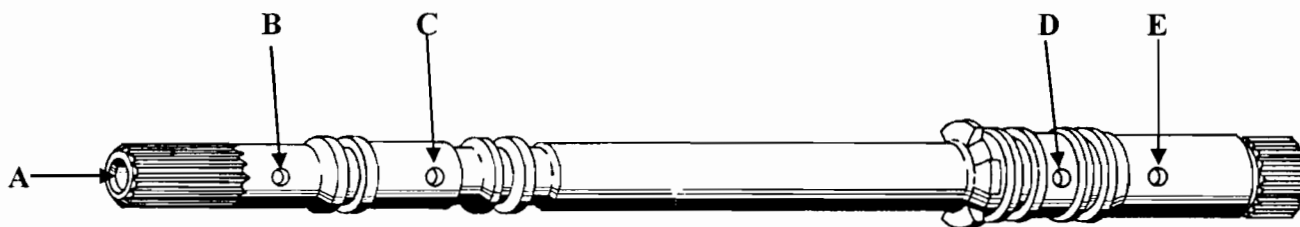
#### OIL PUMP DRIVE SHAFT

1. *The converter feed passage in the Oil Pump Drive Shaft blocked with debris or was not machined properly to allow converter feed oil to enter the converter.*
2. *The Oil Pump Drive Shaft leaking or not machined properly, allowing converter feed passage and converter release passage to be connected.*

**NOTE:** THERE ARE ADJOINING HOLES ON THE OPPOSITE SIDE OF THE OIL PUMP DRIVE SHAFT THAT ARE NOT ILLUSTRATED.

**CORRECTION:** Refer to Figure 22 to *check* the Oil Pump Drive Shaft, and clean or replace as necessary.  
**NOTE:** *We have seen some replacement shafts, both reman and new that were leaking between the converter apply and release passages.*

**APPLY AIR PRESSURE INTO HOLE "D" AND ENSURE THAT AIR PRESSURE ESCAPES THROUGH HOLE "C" ONLY.**
