1996 SEMINAR INFORMATION

## "THE BEST FIX IN '96"

AUTOMATIC TRANSMISSION SERVICE GROUP  
9200 S. DADELAND BLVD. STE 720  
MIAMI, FLORIDA 33156  
(305) 670-4161

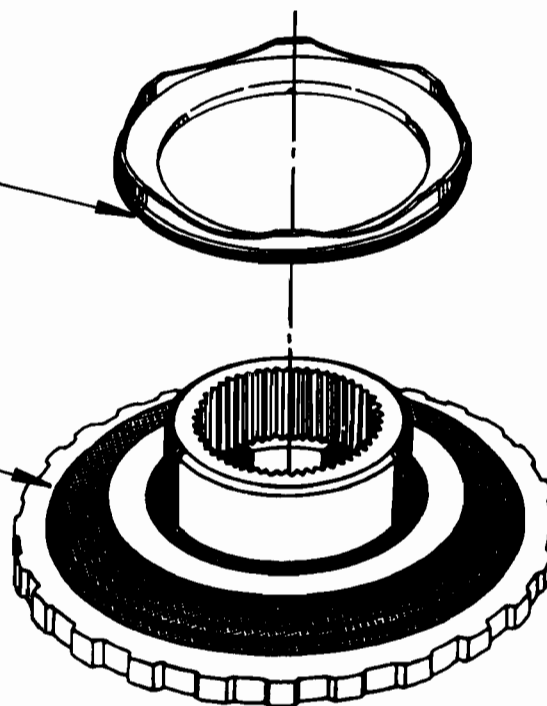
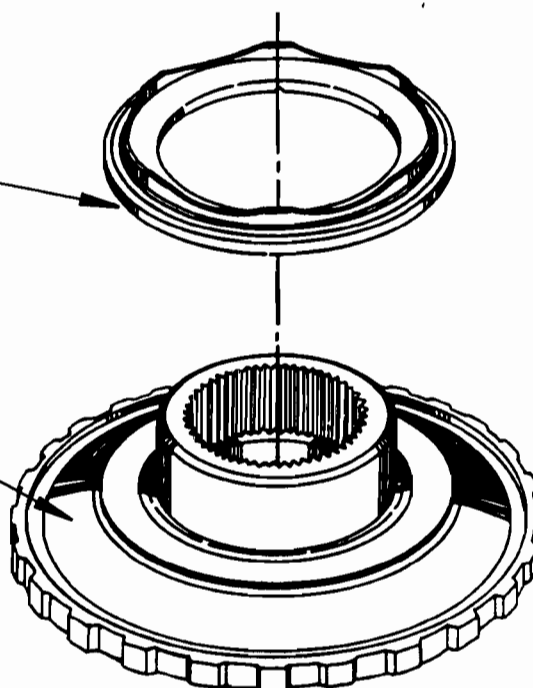
Figure 1

There is a different profile on the supports and each support **requires** a different style rear case bearing, as shown in Figure 1. The AOD-E transmission **requires** a two piece open (needles exposed) rear case bearing that is approximately .113" thick (See Figure 1). The 4R70W transmission **requires** a three piece closed (needles not exposed) rear case bearing that is approximately .144" thick (See Figure 1).

**DIFFERENT PROFILE ON SUPPORT  
AND WILL NOT INTERCHANGE  
WITH THE 4R70W**

**THREE PIECE (CLOSED)  
REAR CASE BEARING  
APPROX .144" THICK  
PART NO. F3LY-7F242-A**

**DIFFERENT PROFILE ON SUPPORT  
AND WILL NOT INTERCHANGE  
WITH THE AOD-E**

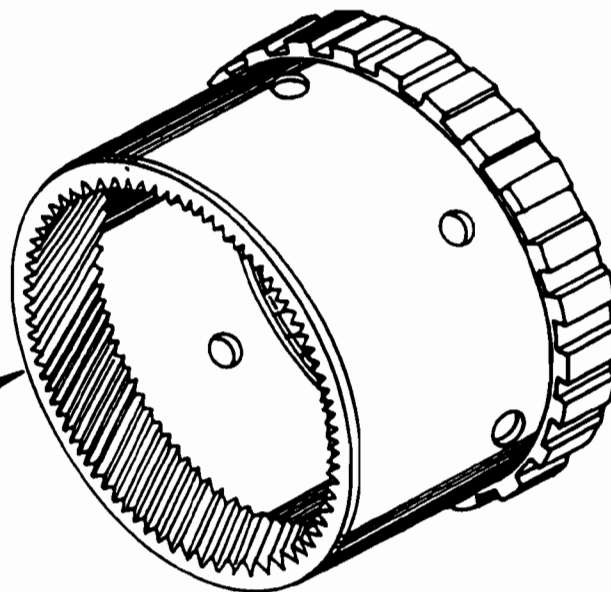
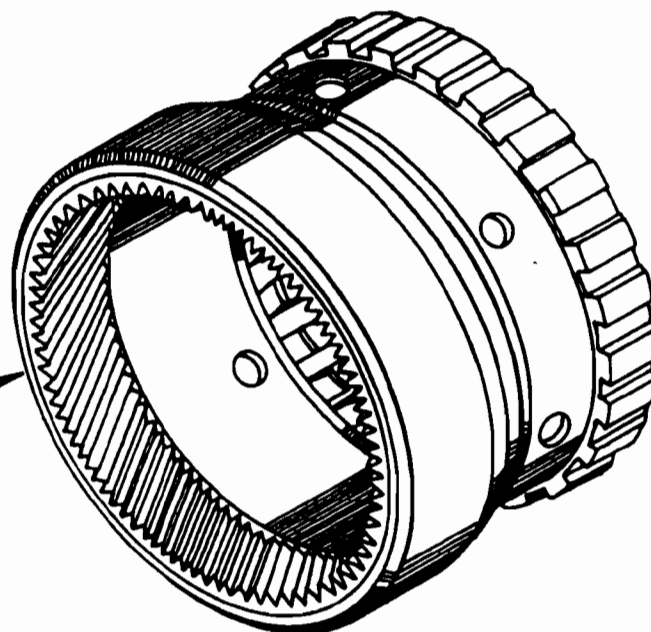
Figure 2

The AOD-E has 72 teeth on the Output Shaft Ring Gear, and the direct drum **will not** pass through the front side of the ring gear (See Figure 2).

The 4R70W has 88 teeth on the Output Shaft Ring Gear, and the direct drum **will** pass through the front side of the ring gear (See Figure 2).

72 TEETH, AND THE RING GEAR  
IS SMALLER IN DIAMETER THAN  
THE 4R70W RING GEAR

**DIRECT CLUTCH HOUSING CANNOT  
BE REMOVED THROUGH FRONT**

88 TEETH, AND THE RING GEAR  
IS LARGER DIAMETER THAN  
THE AOD-E RING GEAR

**DIRECT CLUTCH HOUSING CAN  
BE REMOVED THROUGH FRONT**

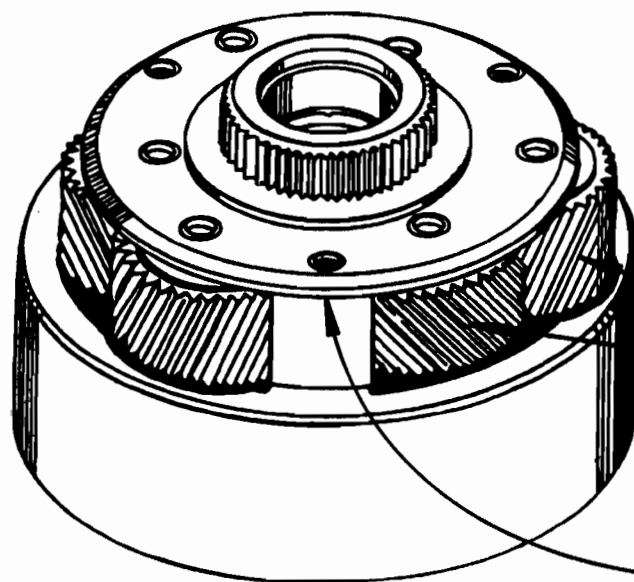
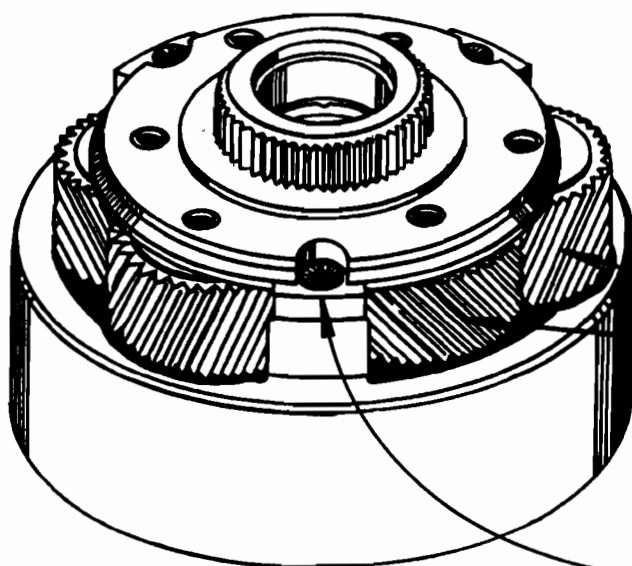
The AOD-E has 18 teeth on both the long, and the short pinions, and the thrust plate retaining pins are **flush** with the retaining plate (See Figure 3).

The 4R70W has 25 teeth on the long pinions, 24 teeth on the short pinions, and the thrust plate retaining pins are **recessed** (See Figure 3).

**LONG PINIONS : 18 TEETH  
SHORT PINIONS: 18 TEETH**

**THRUST PLATE RETAINING  
PINS ARE FLUSH WITH PLATE**

**LONG PINIONS: 25 TEETH  
SHORT PINIONS: 24 TEETH**

**THRUST PLATE RETAINING  
PINS ARE RECESSED ON PLATE**

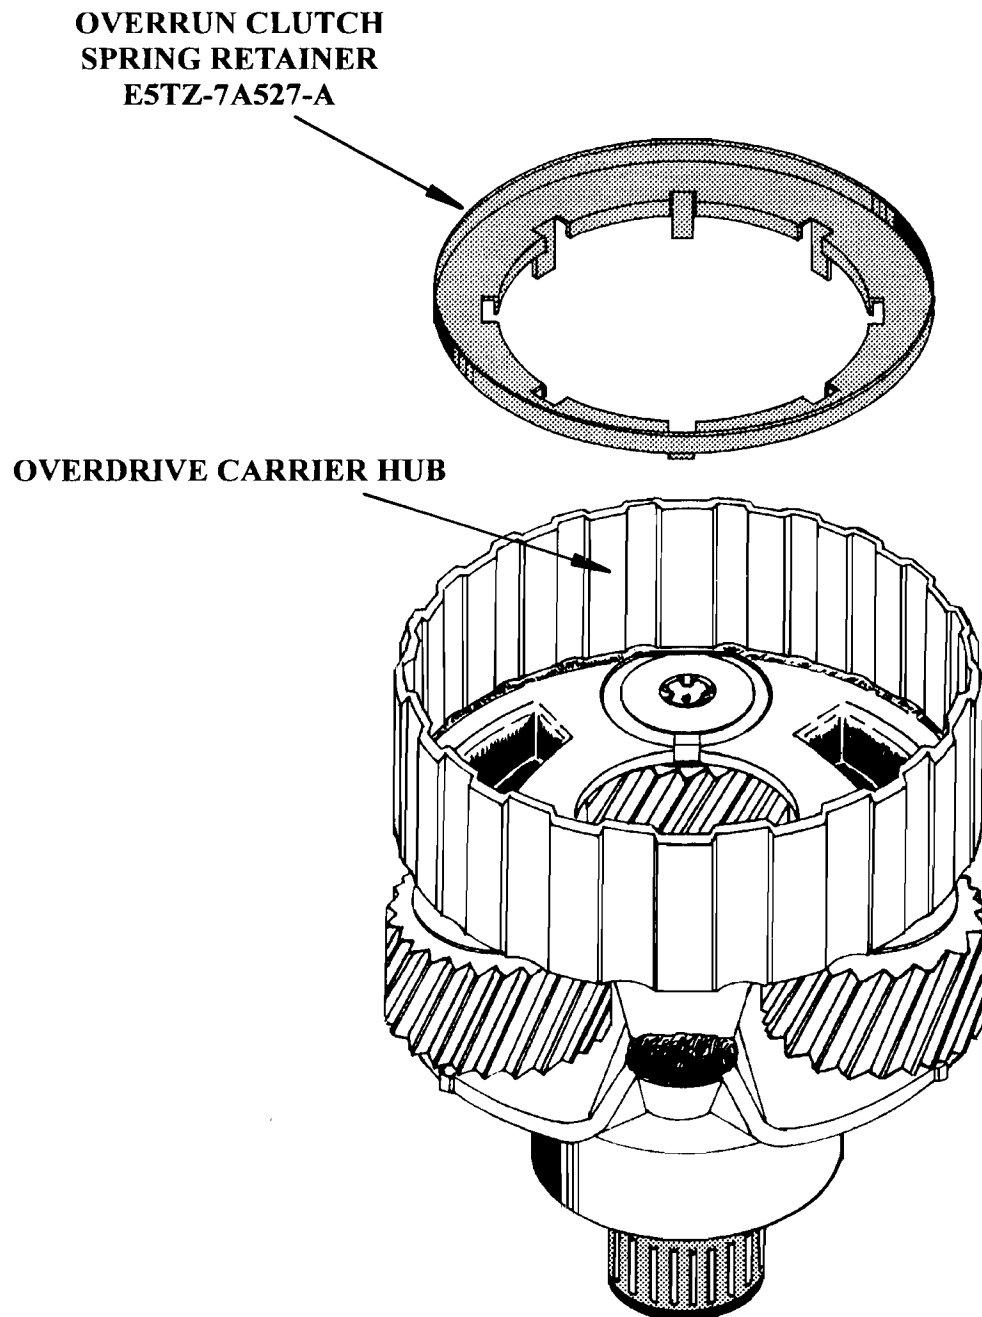
Figure 1

1. Poorly supported overdrive planetary carrier, allowing the inside diameter of the hub on the overdrive carrier to come in contact with, and turn in a *"twisting"* motion, the overrun clutch spring retainer. This will destroy the retainer and the return springs in a very short period of time (See Figure 1).

**NOTE:** *The dimension, or clearance between the outside diameter of the overrun clutch spring retainer, and the inside diameter of the overdrive carrier hub is extremely critical (See Figure 1).*

Overrun Clutch Spring Retainer ..... E5TZ-7A527-A

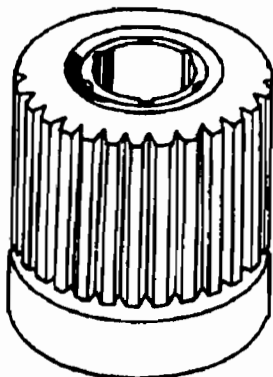
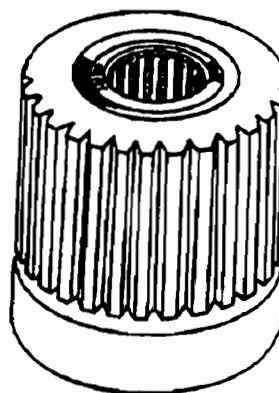
Figure 2

1. Turbine shaft bushings in the pump stator for wear and/or damage.
2. Turbine shaft splines (Overdrive Carrier End) for wear and/or damage.
3. Turbine shaft splines in the overdrive carrier, for wear and/or damage.
4. Bushing in the front end of the output shaft for wear and/or damage. This bushing supports the forward clutch drum, and the overdrive center shaft. Replace bushing on *all* units during rebuild (See Figure 2).

NOTE: In later applications a caged needle bearing is used in this location.  
Inspect and replace as necessary (See Figure 2).

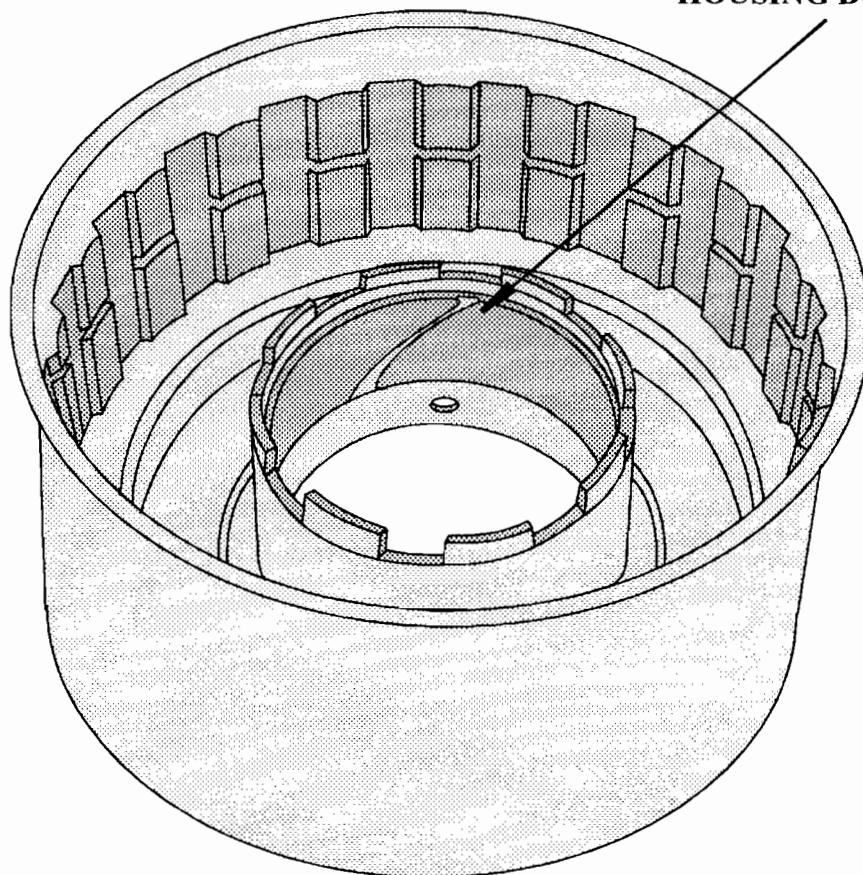
Figure 3

5. Overrun clutch housing bushing for wear and/or damage (See Figure 3).

**OVERRUN CLUTCH  
HOUSING BUSHING**

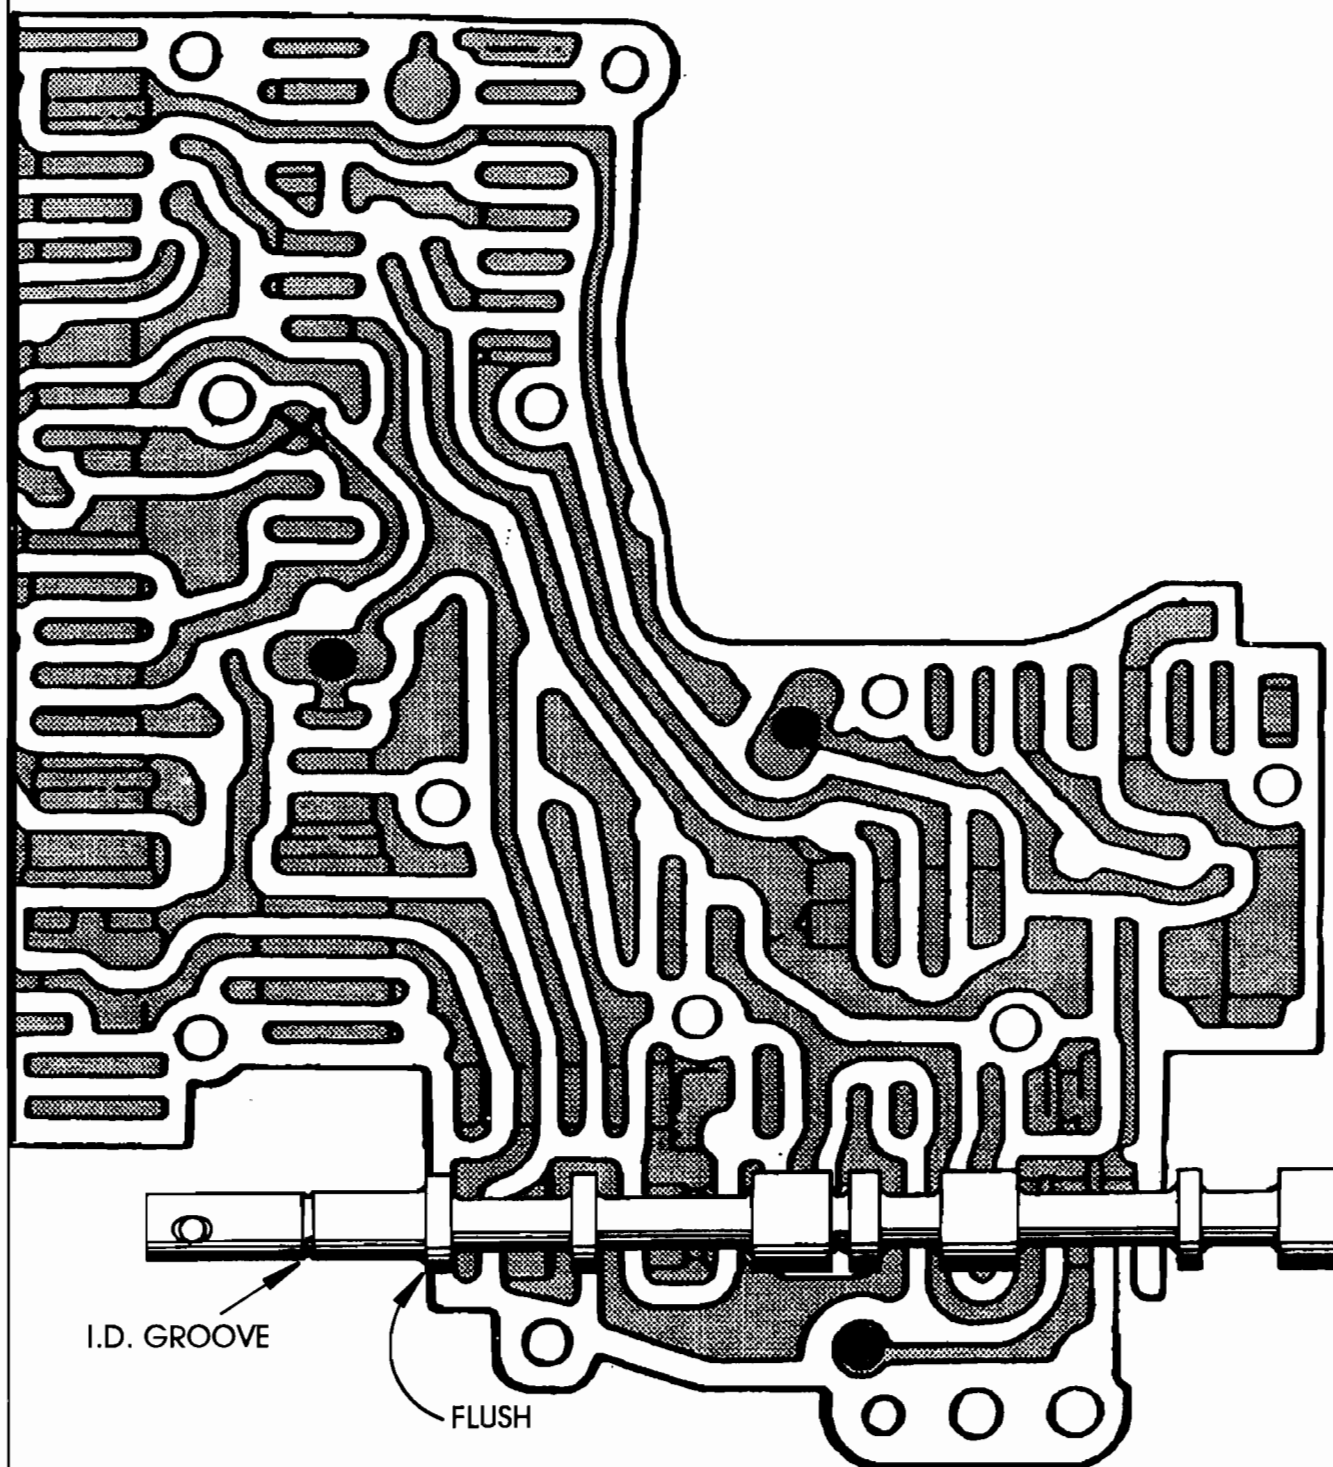
Figure 4

**WITH THE MANUAL LEVER IN THE "D2" POSITION, THE FIRST LAND ON THE MANUAL VALVE SHOULD BE FLUSH WITH THE VALVE BODY CASTING, AS SHOWN ABOVE.**

1. Measure the link hole in the manual valve to ensure that it is .157" in diameter, and has not elongated due to wear. It is also recommended to use the latest design valve from Ford Motor Company, with the I.D. groove near the link hole, and available under OEM part number E8TZ-7C389-A (See Figure 4).
2. With the valve body installed on the transmission, place the manual lever into the "D2" position.
3. With the manual lever in the "D2" position, the 1st land on the manual valve should be flush with the valve body casting, as shown in Figure 4. However, approximately .010" below flush to .020" above flush with the valve body casting is acceptable.
4. Bend the manual valve link as necessary to achieve the dimensions listed above.

Manual Valve (Latest Design) ..... E8TZ-7C389-A

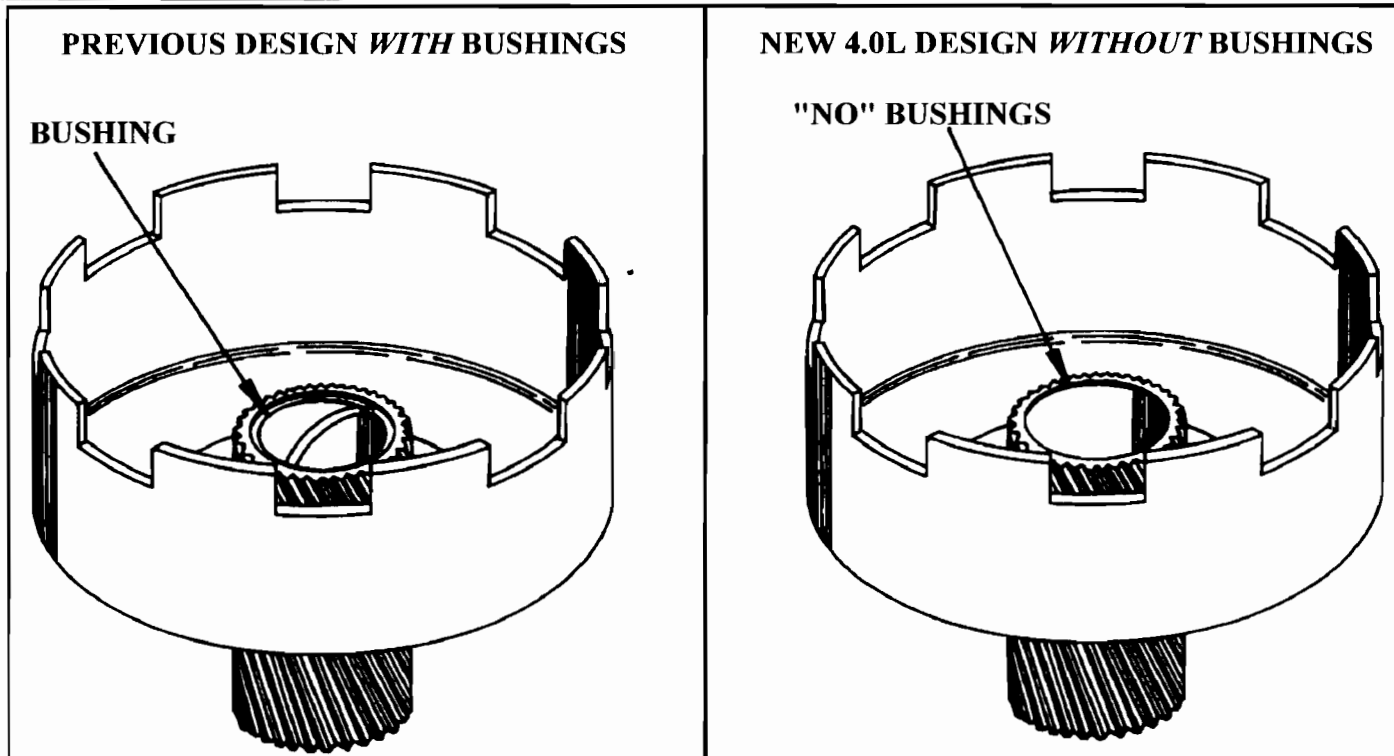
Figure 13

- (1) **SUN GEAR** - Both bushings, inside the sun gear, were eliminated to allow full lubrication flow to the front planetary (See Figure 13).
- (2) **SUN GEAR SHELL** - "Snap Shell" was introduced in 1993 4.0L engine models, and has two retaining tabs stamped into the sides 180° apart, as shown in Figure 14. These tabs are used to retain the new direct drum in the sun gear shell.

- (1) The new design sun gear **WITHOUT** bushings **WILL** retro-fit back to all previous models.  
(See Figure 13).
- (2) The previous design sun gear **WITH** the bushings **CANNOT** be used forward into the 4.0L engine models (See Figure 13).

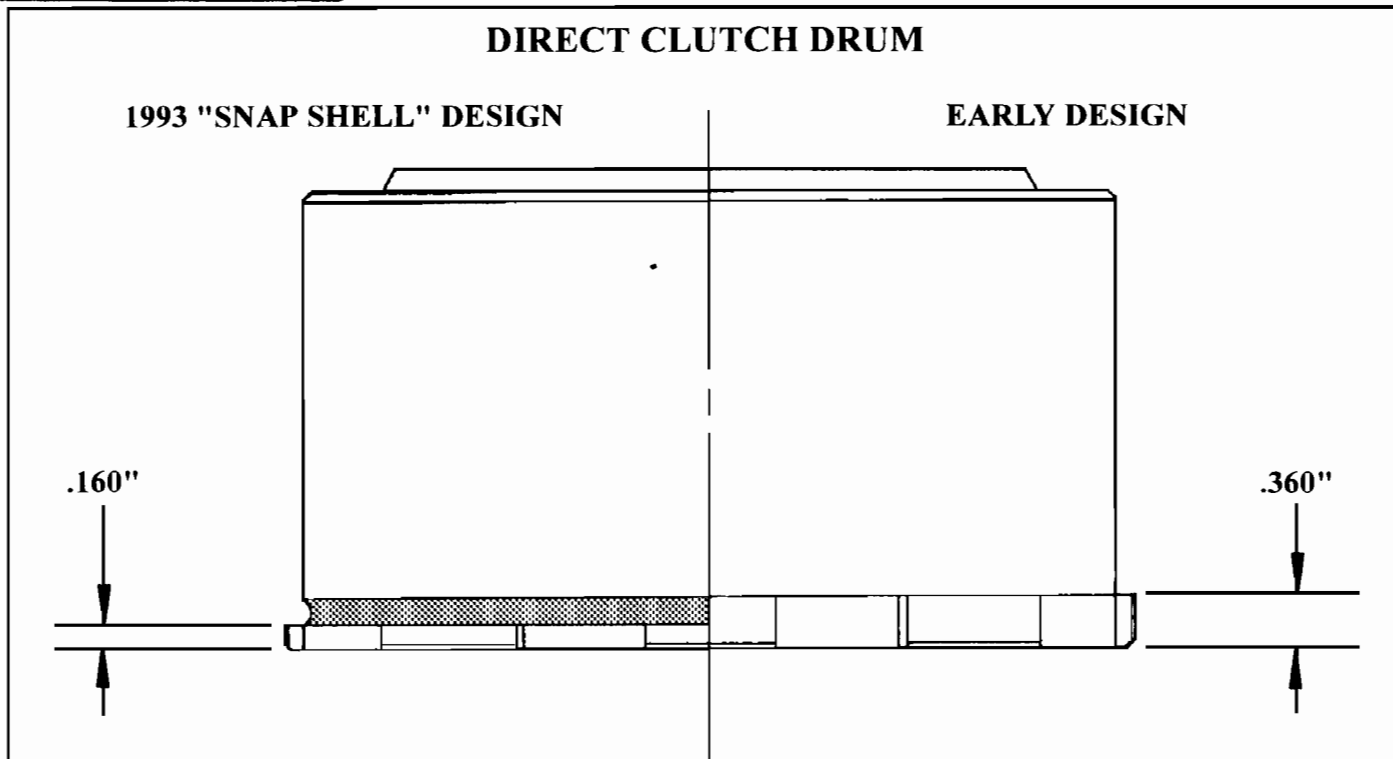
Figure 15

- (3) **DIRECT CLUTCH DRUM** - The "Lug" area where the direct clutch drum engages the sun gear shell, was machined approximately .200" thinner, and a .050" deep groove was machined into the drum to accommodate the added retaining tabs on the "Snap Shell" (See Figure 15). This now allows the sun shell and the direct drum to "Snap" together for easier assembly (See Figure 16). This change also allows the elimination of the number 4 thrust washer, located between the direct clutch drum and the center support.

- (3) The new design "Snap Shell" **must be used only** with the direct clutch drum that is machined to accept the retaining tabs (See Figure 15).
- (4) The direct clutch drum **WITH** the machined groove for the "Snap Shell" **WILL** retro-fit back to **ALL** previous models (See Figure 15).

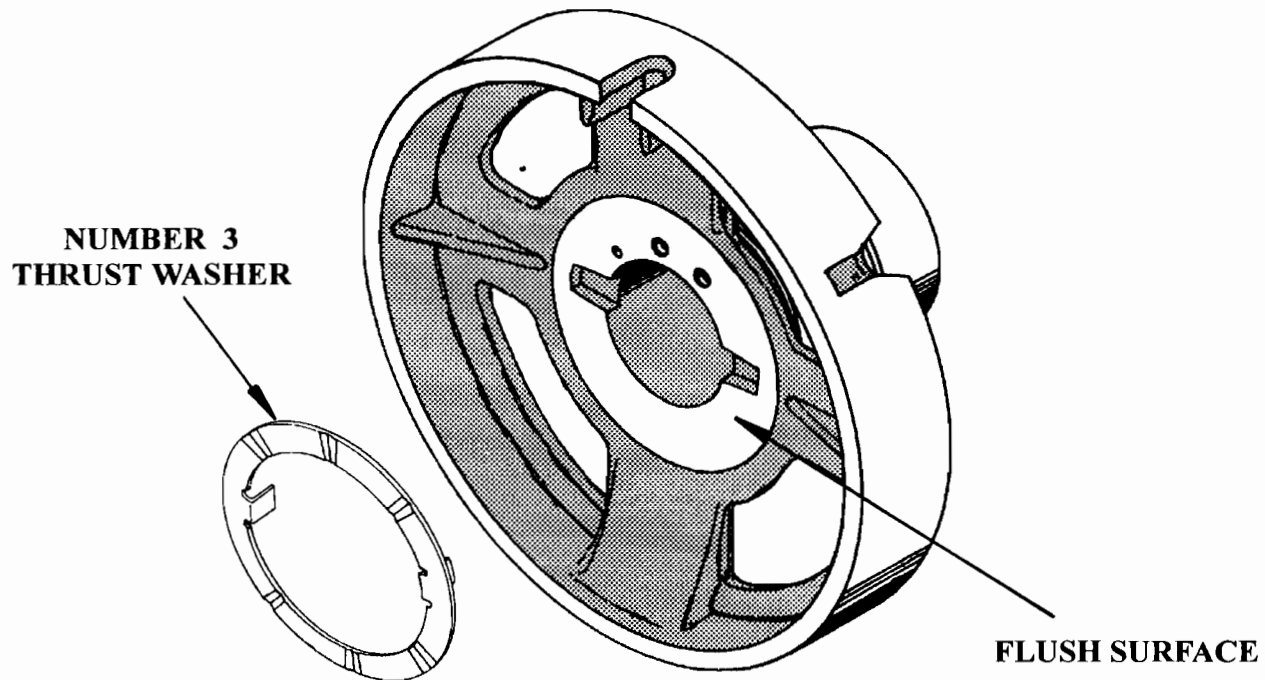
Figure 17

- (4) **CENTER SUPPORT** - When the "Snap Shell" was introduced in 1993, the number 3 thrust washer was eliminated (See Figure 17), and number 3 thrust bearing was added, as shown in Figure 18. The addition of the number 3 thrust bearing required machining the surface deeper to accommodate the bearings added thickness (See Figure 18).  
The new design center support also has a machined recess at the base of the sealing ring hub to accommodate the newly added number 5 thrust bearing (See Figure 20). Remember, the number 4 thrust washer was eliminated when this change occurred (See Figure 19).  
There are four easy steps to identify the new design center support:

- (6) The previous design center support **CANNOT** be used forward into **ANY** model that is using the "Snap Shell" (See Figure 17).
- (7) The new design forward clutch drum **WILL** retro-fit back on **ALL** previous models.  
(See Figure 21).

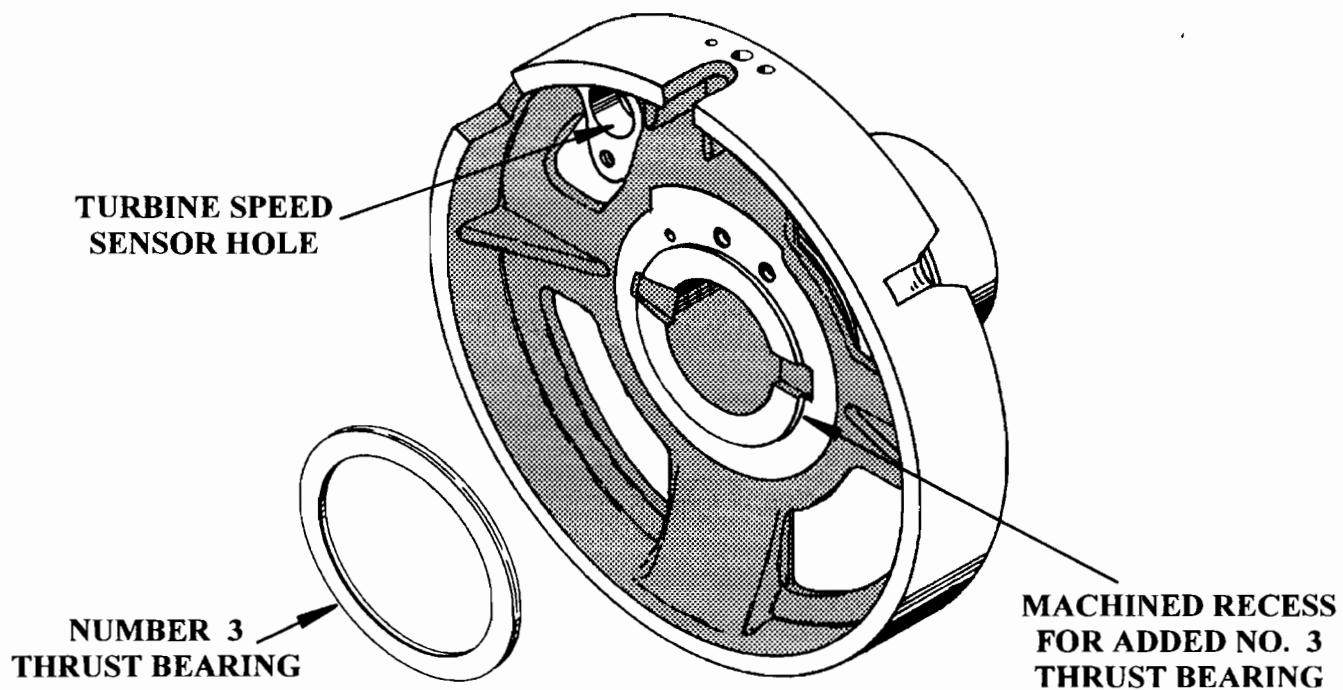
Figure 18

1. Machined recess for added number 3 thrust bearing (See Figure 18).
  2. Machined recess for added number 5 thrust bearing (See Figure 20).
  3. Machined hole for turbine speed sensor getting ready for 4R55E (See Figures 18 and 20).

- (5) The new design level center support **CANNOT** be used in **ANY** previous models, unless updated with **ALL** of the parts listed above (See Figures 18 and 20).

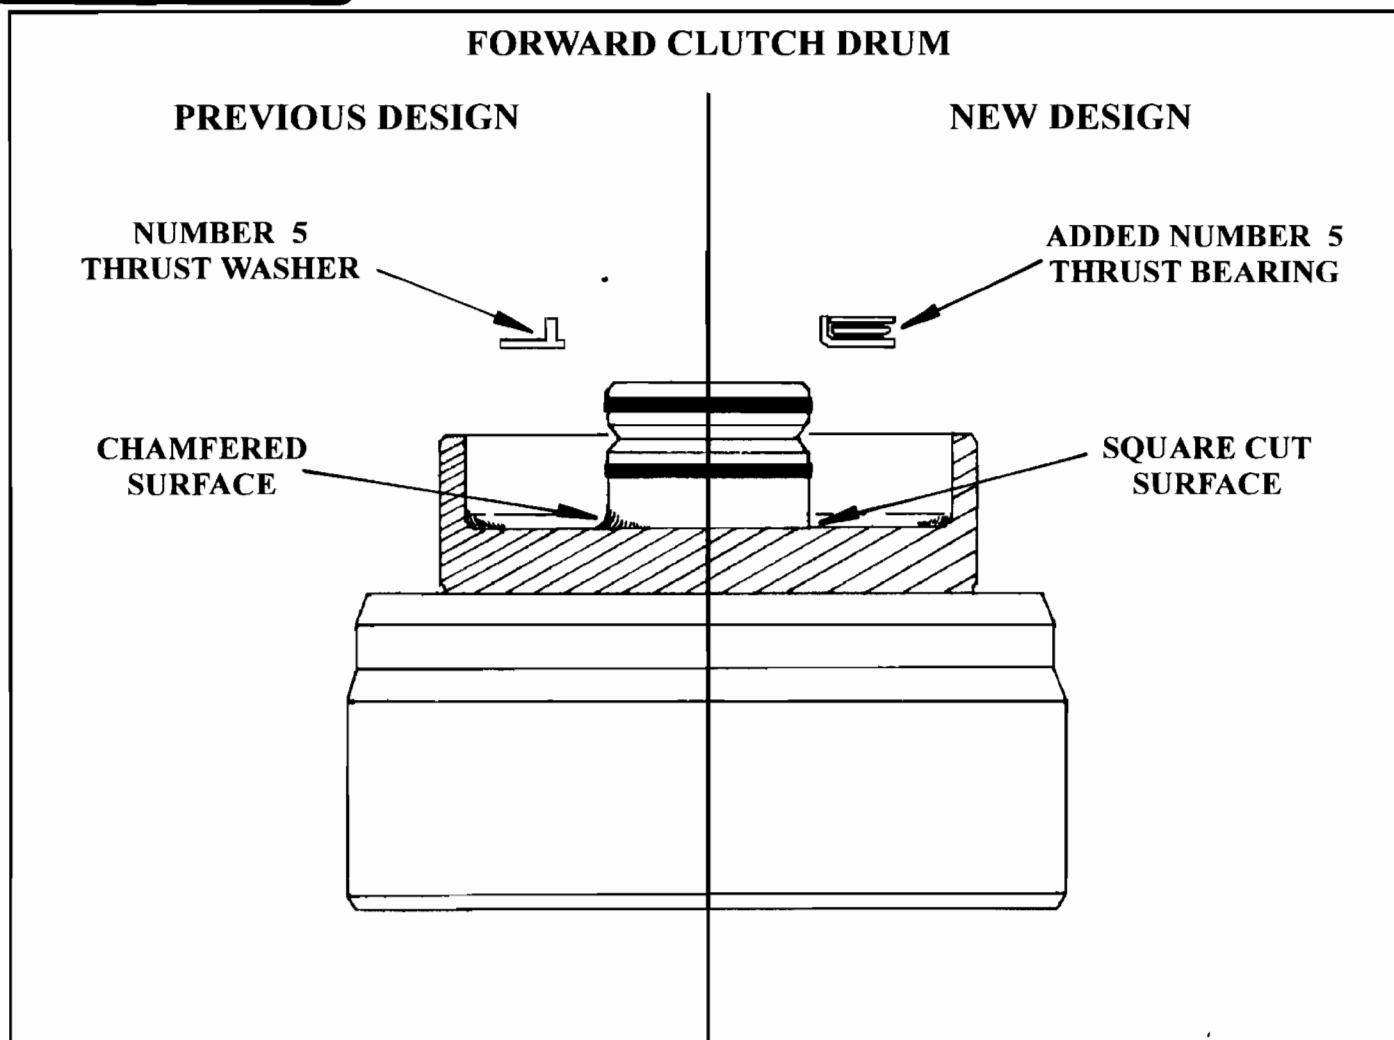
Figure 21

4. Casting number on new design center support is 92GT-7L328-AA.
- (5) **FORWARD CLUTCH DRUM** - Was machined at the base of the sealing ring hub to eliminate the chamfer, and provide a flat surface to accommodate the added number 5 thrust bearing, as shown in Figure 21.

- (8) The previous design forward clutch drum **CANNOT** be used in 1993 and later models, as the chamfered area at the base of the hub will not let the number 5 bearing seat properly.  
(See Figure 21).

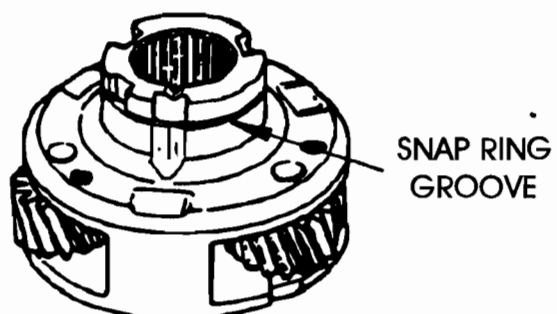
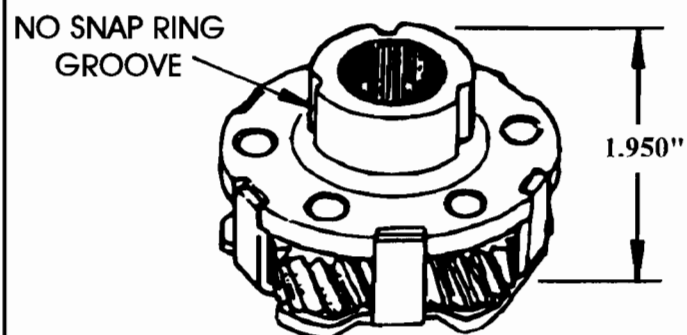
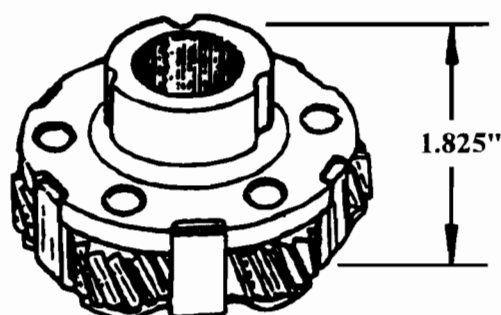
Figure 22

**CHANGE:** Sometime in model year 1987, the 1st design **3 pinion aluminum** front planetary carrier was replaced with a revised **4 pinion steel** front planetary carrier (See Figures 22 and 24).

- (1) **FRONT PLANETARY CARRIER** - The 1st design **3 pinion aluminum** carrier was eliminated and replaced with a revised **4 pinion steel** carrier. The snap ring groove and the snap ring that previously retained the carrier into the ring gear were eliminated (See Figure 22).

In 1990 the steel carrier was once again upgraded with a **6 pinion steel** carrier, for 4.0L engine models only. The 6 pinion steel carrier was also shortened in overall height, by approximately .125", to accommodate a new design number 6 (3 piece) thrust bearing (See Figures 22 & 24).

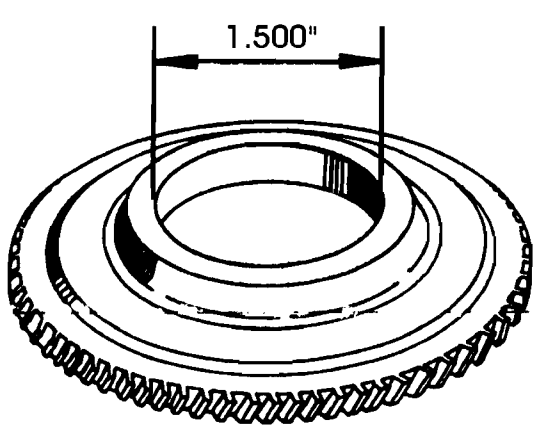
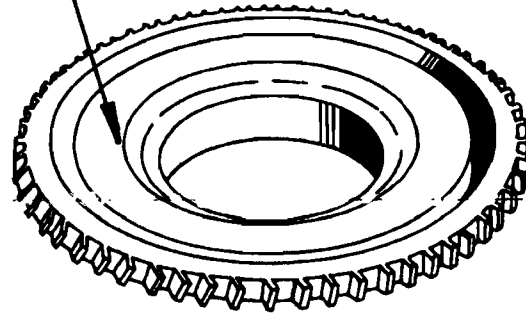
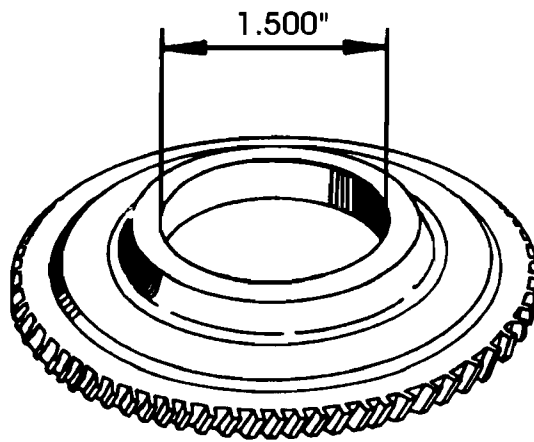
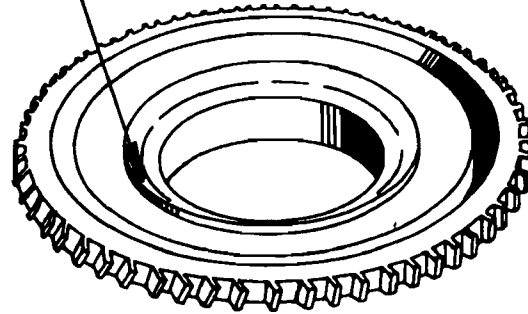
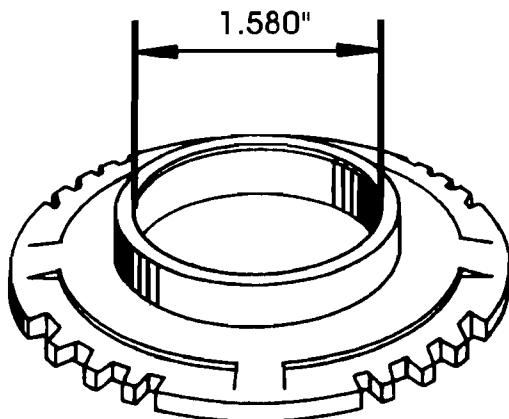
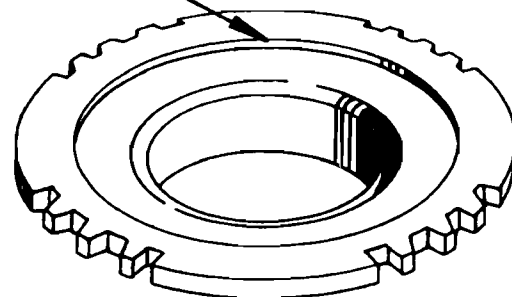
Figure 23  
Automatic Transmission Service Group

- (2) **FORWARD RING GEAR HUB** - The 1st Design forward ring gear hub uses a number 7 thrust washer as shown in Figure 24. On the 2nd Design ring gear hub, a recess was machined to accommodate an added number 7 thrust bearing, that replaced the number 7 thrust washer. Refer to Figures 23 and 24. Both 1st and 2nd design ring gear hubs inside diameter measure 1.500", as shown in Figure 23.

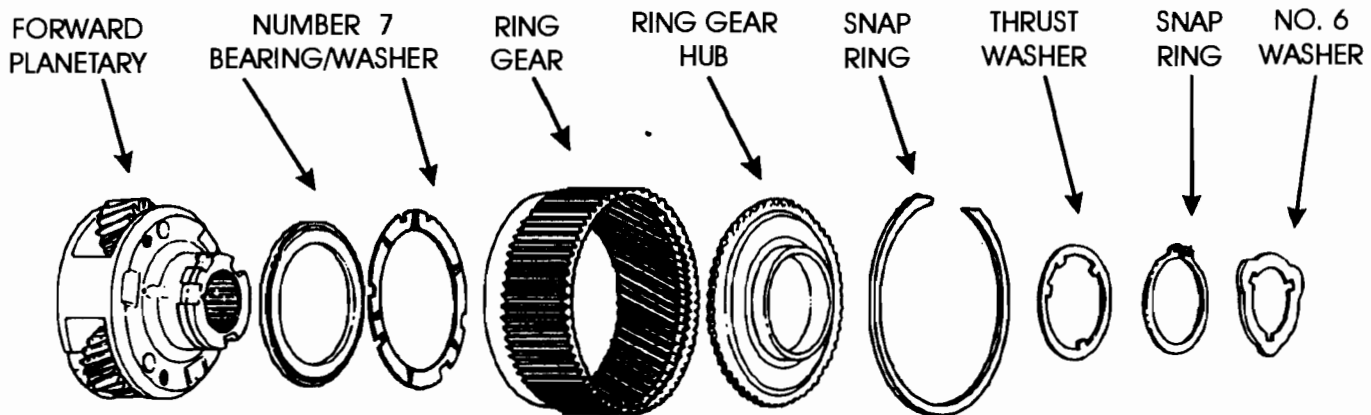
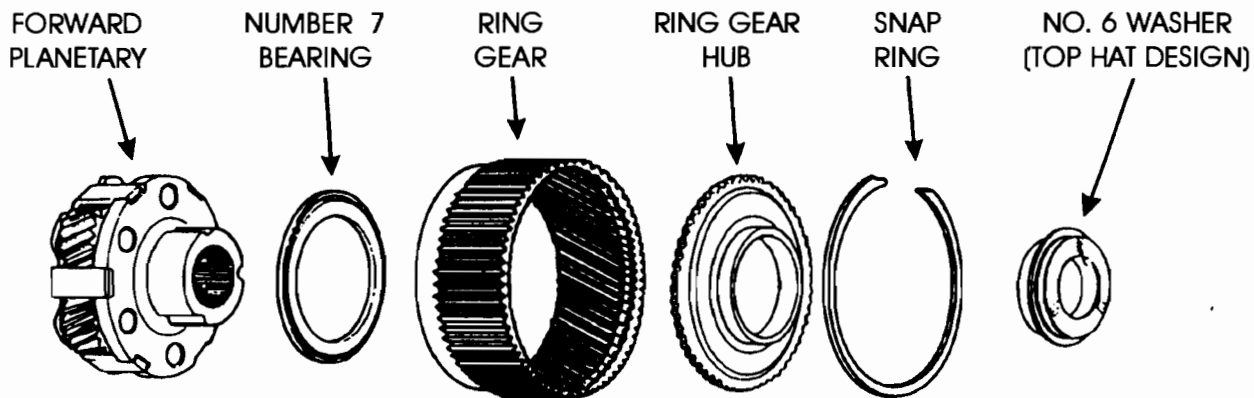
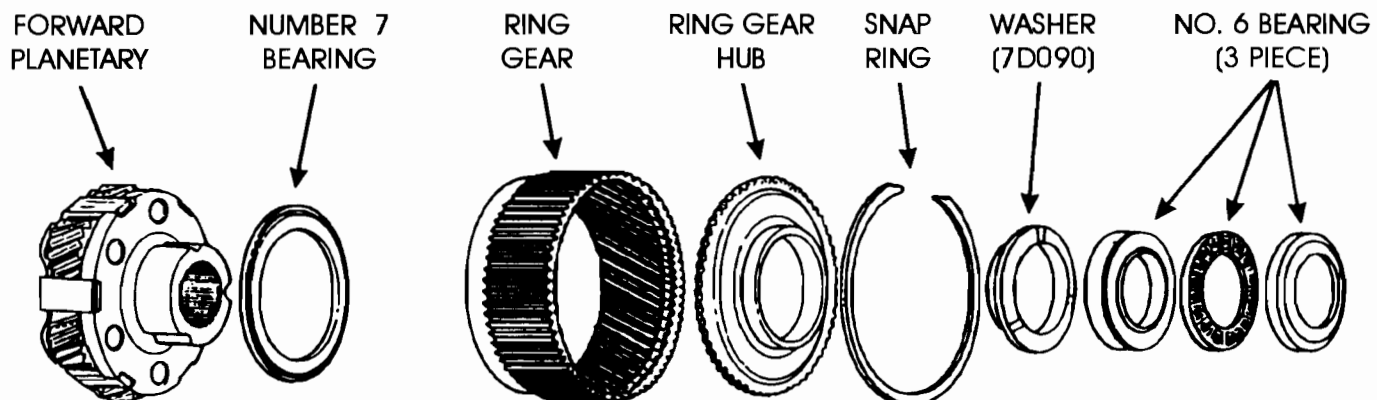
Figure 24  
Automatic Transmission Service Group

Beginning in 1990, on 4.0L engine models, the number 6 "Top Hat" thrust washer was replaced with a new number 6 (3 piece) thrust bearing, as shown in Figure 24. Notice also the added washer (7D090), that must be used with the 3 piece bearing design (See Figure 24). This is what required the carrier to be machined shorter. The 3 piece thrust bearing has now been changed to a normal "Torrington" (Snap Together) type bearing, and replaces the 3 piece design, without any other changes.

- (4) **NUMBER 7 THRUST WASHER** - Sometime in 1986, the number 7 thrust washer was eliminated, and replaced with a number 7 thrust bearing as shown in Figure 24. This change required the machined recess in the ring gear hub, to make room for the thrust bearing, as shown in Figure 23. The number 7 thrust bearing is still used through current production (See Figure 24).

- (1) The **1st Design 3 pinion aluminum** front planetary carrier system, as shown in Figure 24, is recommended for nothing larger than 2.3L engine models. The 1st Design 3 pinion aluminum front planetary carrier is no longer serviced by Ford Motor Co. It now upgrades to the latest 3rd Design 6 pinion steel front planetary carrier system, which comes as a service package and includes all necessary hubs and washers to make it compatible, and is available under OEM part number F0TZ-7A398-E.

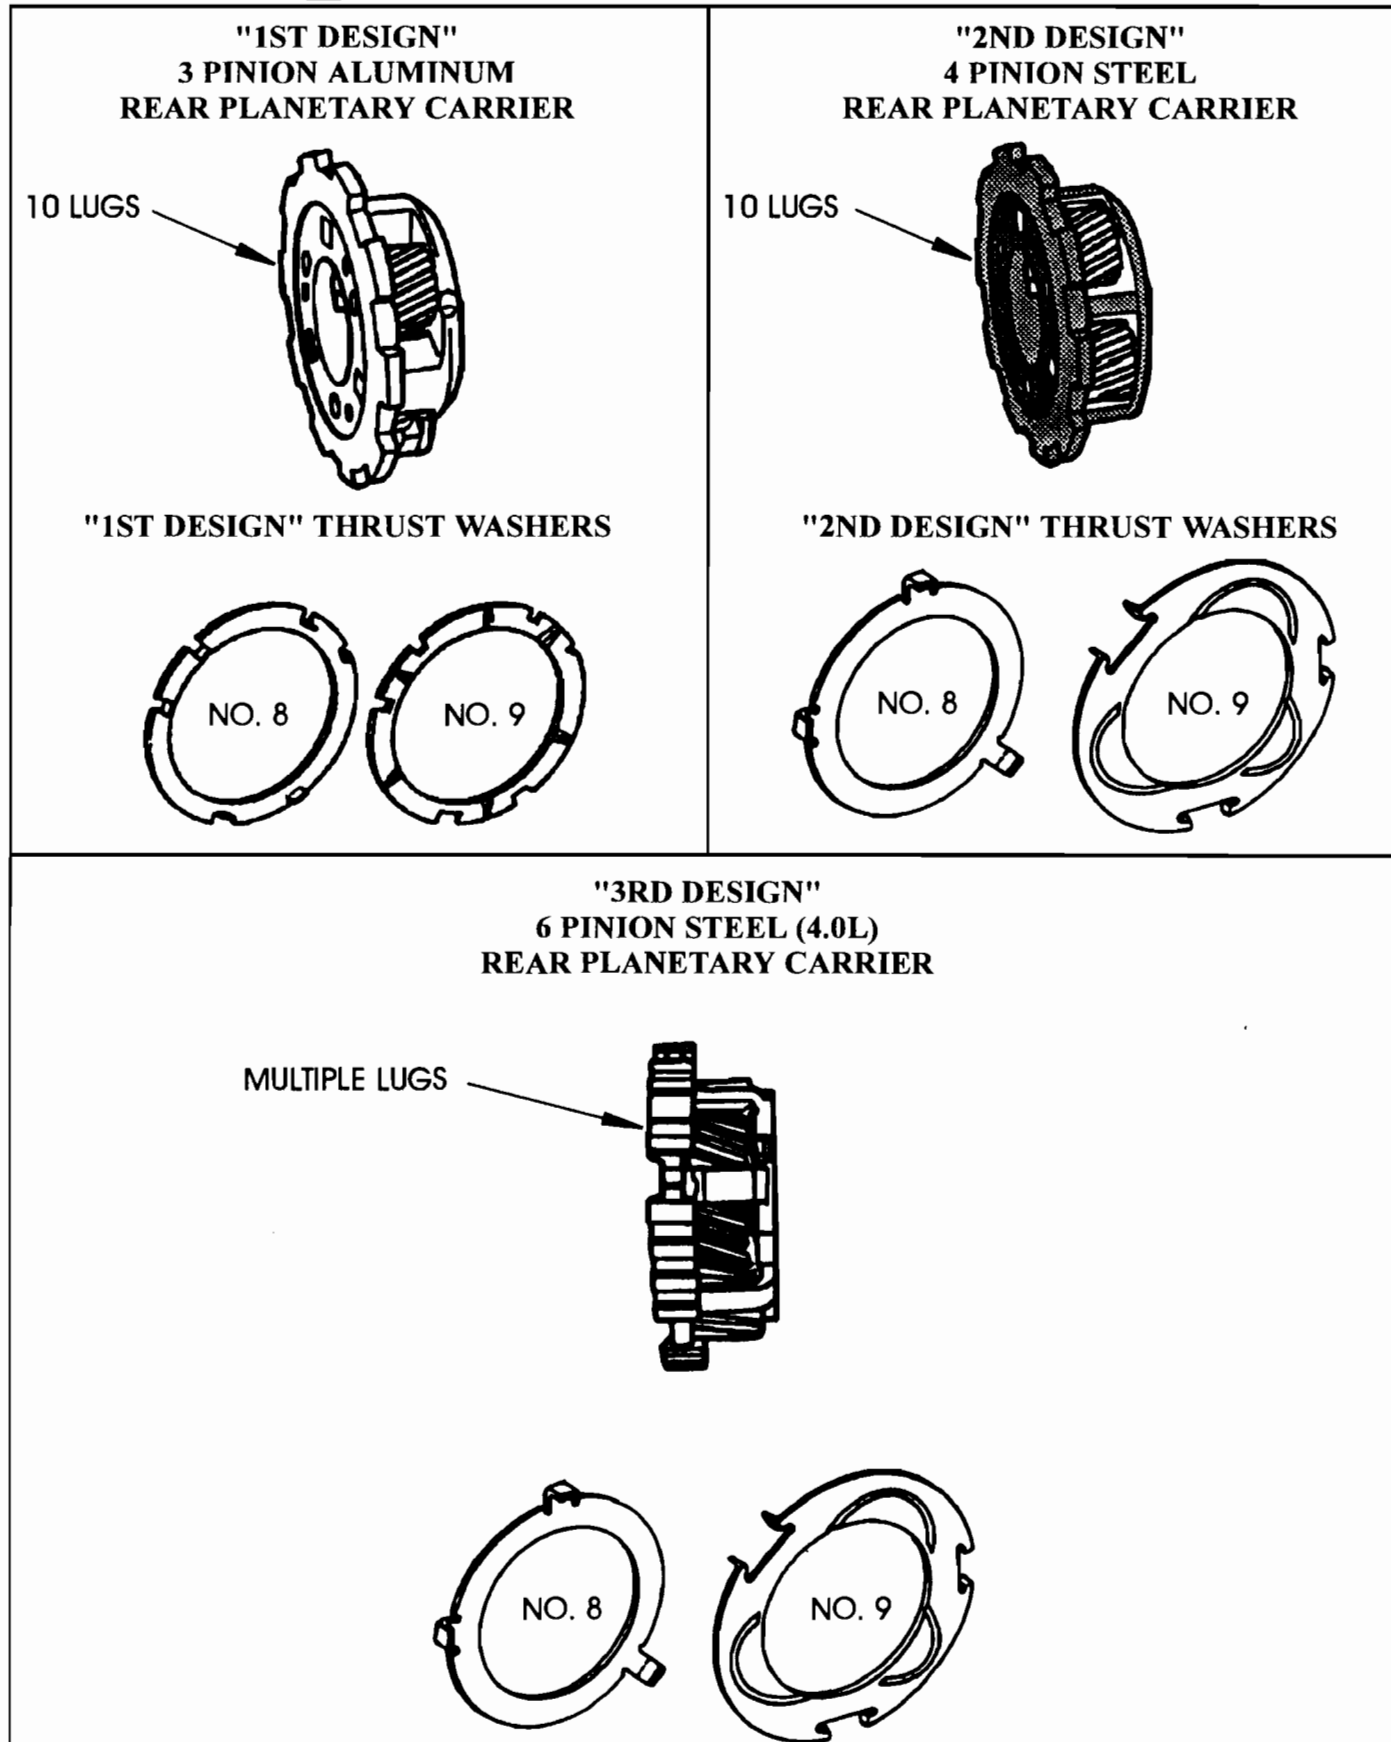
Figure 26

**CHANGE:** Sometime in model year 1987, the 1st design *3 pinion aluminum* rear planetary carrier was replaced with a 2nd design *4 pinion steel* rear planetary carrier (See Figure 26). In model year 1990, on 4.0L engine models only, the 4 pinion steel carrier was once again revised to a *6 pinion steel* rear planetary carrier (See Figure 26). Included in this change were changes in the internal lubrication circuit. These changes have affected many of the related parts and created confusion for many rebuilders.

- (1) **REAR PLANETARY CARRIER** - The 1st design *3 pinion aluminum* rear carrier was eliminated and replaced with a 2nd design *4 pinion steel* rear carrier, as shown in Figure 26. Both 1st and 2nd design rear carriers have 10 lugs where it lugs into the reverse drum, as shown in Figure 26. The 1st design 3 pinion aluminum rear carrier is no longer serviced by Ford Motor Co, and automatically supercedes to the 4 pinion steel carrier. It is available as a service package under OEM part number E7SZ-7D006-C, which includes the number 8 and number 9 thrust washers, to make it compatible.  
Beginning in 1990, on 4.0L engine models only, Ford introduced a 3rd design *6 pinion steel* rear carrier, which has multiple lugs where it lugs into the reverse drum (See Figure 26).

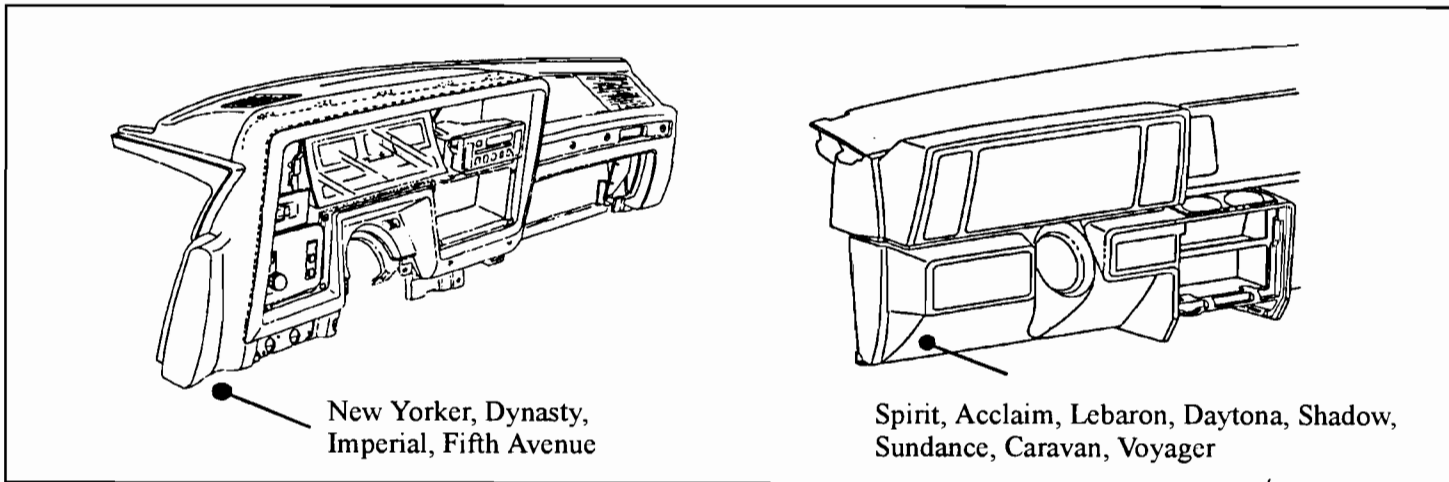
Figure 1

1. Be sure that you are attached to the diagnostic connector located under the dash and not under the hood (See Figure 1).
2. Verify that you have chosen the CCD mode and not the Engine selection. With Snap-On, when choosing the CCD mode, be sure that you choose CCD SYSTEMS and not DEMO; CCD SYSTEMS. Also, be sure the correct cartridge is being used.

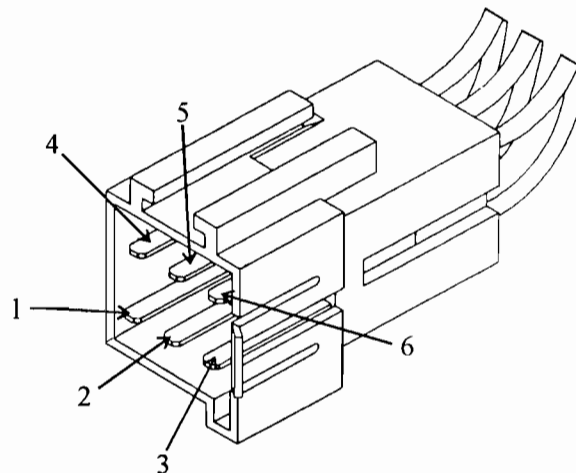
Figure 2

3. Check the battery and charging system for proper voltage and repair if necessary
4. Check terminal 2 in the CCD connector (See Figure 2) for battery voltage by placing the positive meter lead to the terminal and the negative lead to a good known ground. If 0 volts is seen, check fuses. Depending on model and year, it could be fuse 2, 7, 11, 13, 15 or 23. If battery voltage is present, check the ground wire by placing the negative meter lead to terminal 6 and the positive lead to the negative post of the battery (See Figure 2). There should be 0.1 volt or less. If a higher voltage value is seen, clean or repair the ground wire.

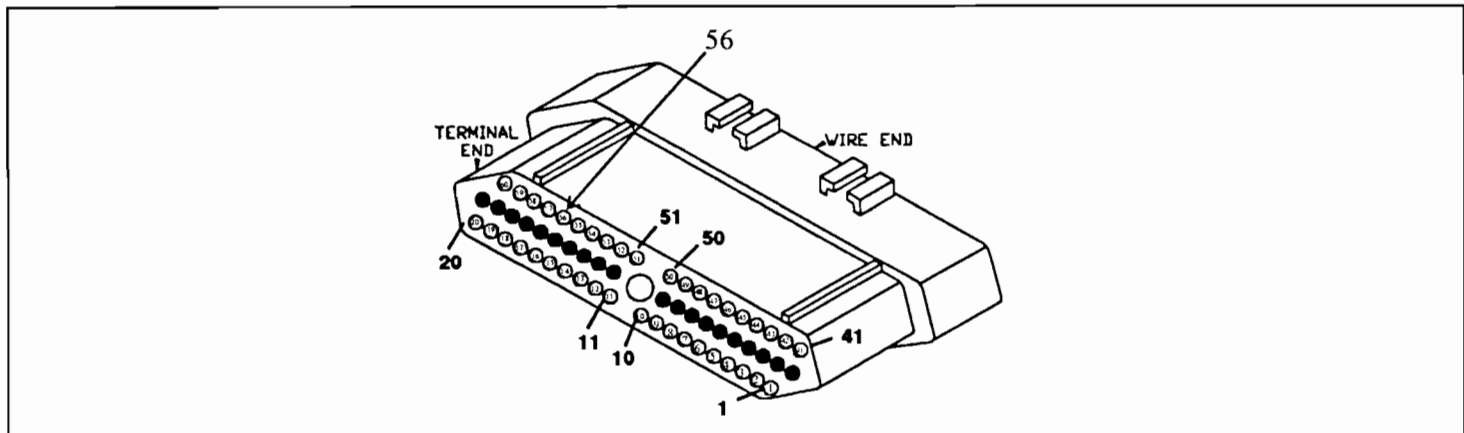
Figure 3

1. Check for battery voltage on the J11 circuit at pin 56 which is in the 60 way connector that plugs into the EATX controller (See Figure 3). If battery voltage is not seen, a fuse or a fusible link may be blown (See Figure 4). Fusible links are color coded and can usually be found below and between the battery and driver side spring tower (See Figure 5). Refer to Figure 6 for fusible link color or fuse number.
