1996 SEMINAR INFORMATION

## "THE BEST FIX IN '96"

AUTOMATIC TRANSMISSION SERVICE GROUP  
9200 S. DADELAND BLVD. STE 720  
MIAMI, FLORIDA 33156  
(305) 670-4161

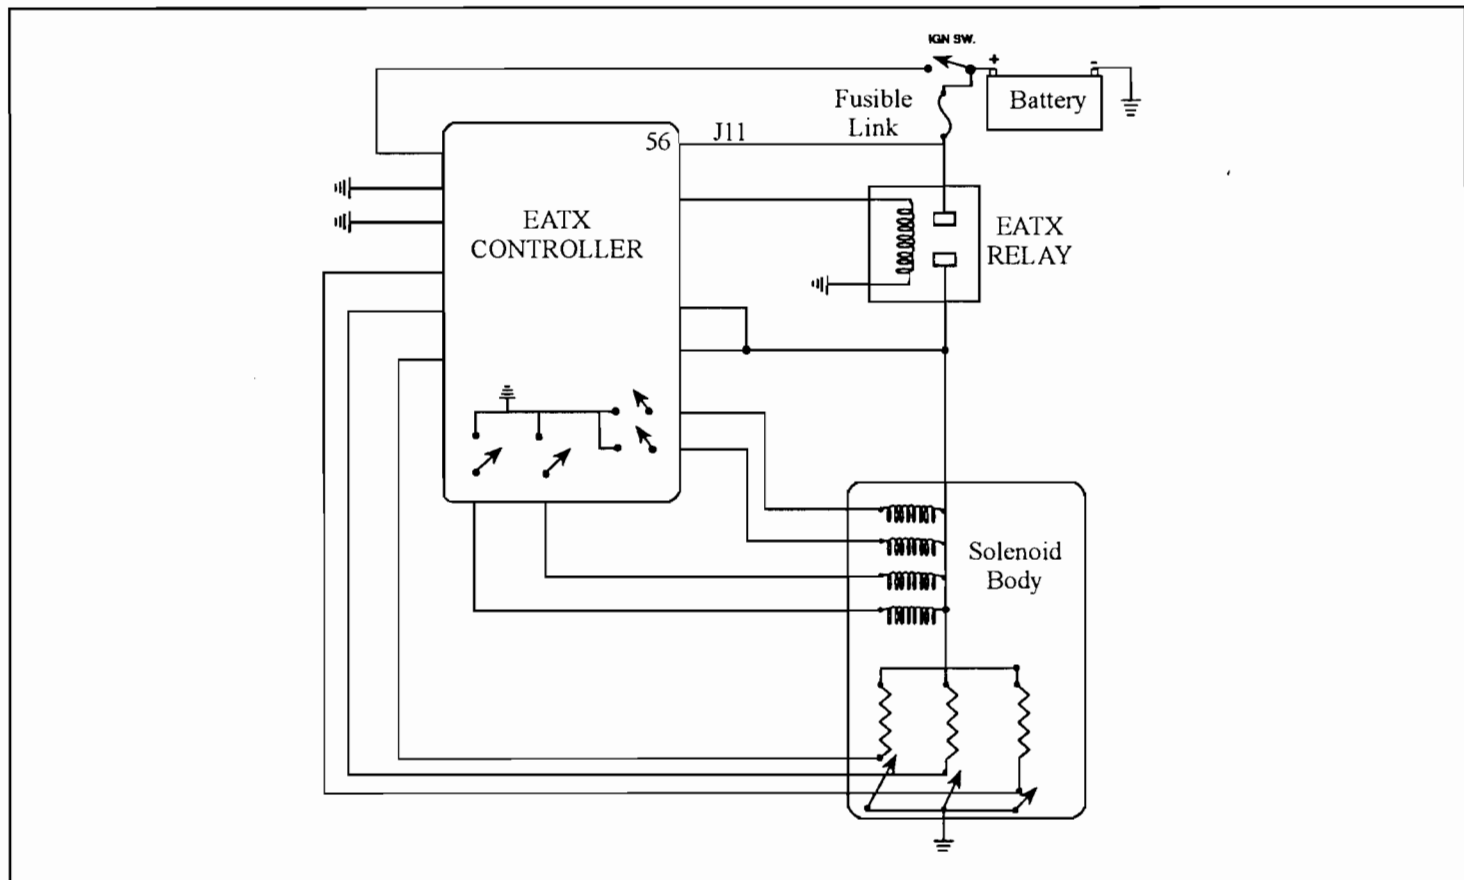
Figure 4

1. Check for battery voltage on the J11 circuit at pin 56 which is in the 60 way connector that plugs into the EATX controller (See Figure 3). If battery voltage is not seen, a fuse or a fusible link may be blown (See Figure 4). Fusible links are color coded and can usually be found below and between the battery and driver side spring tower (See Figure 5). Refer to Figure 6 for fusible link color or fuse number.

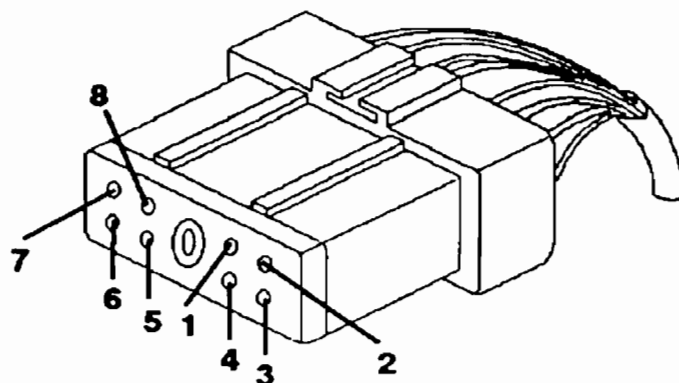
Figure 15

## SOLENOID CONNECTOR TERMINAL IDENTIFICATION

- (10) Using an OHM meter, check for continuity between cavity D at the relay and terminal 4 at the solenoid body connector. See figure 15 for solenoid connector terminal identification. If there is no continuity, the wire from cavity D at the relay to terminal 4 in the solenoid connector has an open. Repair the wire and repeat this check to insure that you have continuity across this wire.

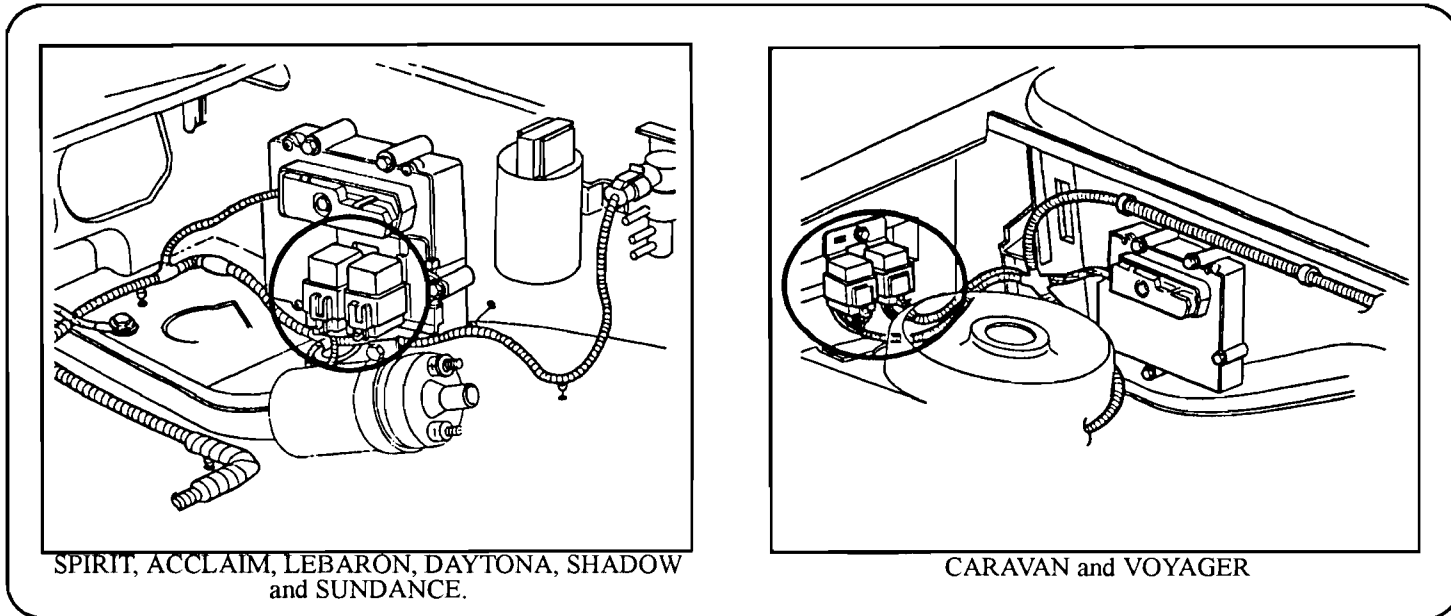
Figure 16

EATX RELAY LOCATION FOR SPIRIT, ACCLAIM, LEBARON, DAYTONA, SHADOW, SUNDANCE, CARAVAN and VOYAGER.

- (1) Locate the EATX relay location by using figure 16 and refer to figure 17 for cavity identification.
- (2) Carefully bend the EATX relay bracket to gain access to back probe the connector. **NOTE:** FOLLOWING TEST CANNOT BE MADE WITH CONNECTOR REMOVED.
