AUTOMATIC TRANSMISSION SERVICE GROUP

SEMINARS 1989

TECHNICAL INFORMATION PACKAGE

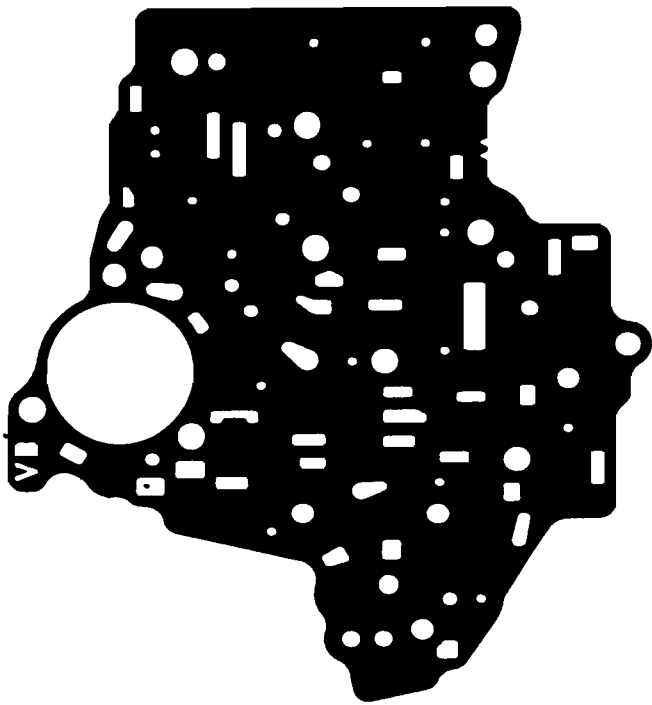
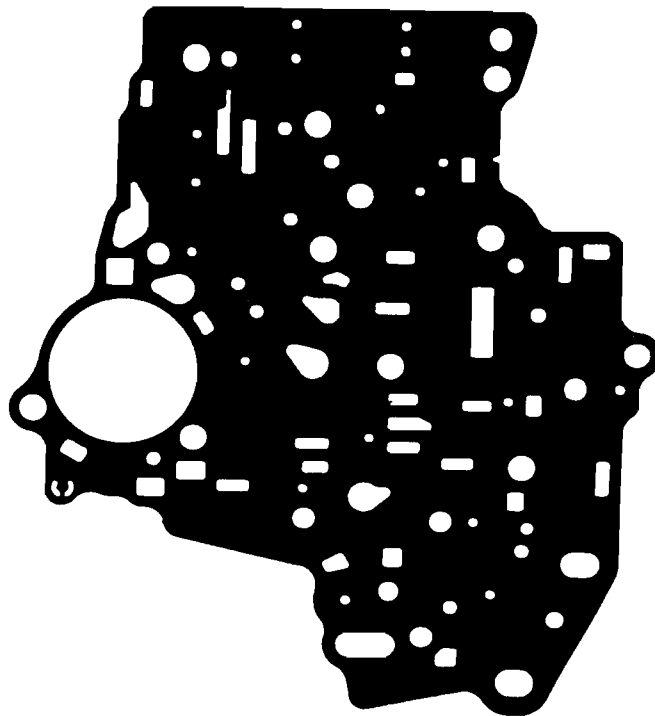
Beginning November 23, 1987, all TH400 transmissions were built with new valve body gaskets. (SEE BELOW) This change and additional changes done to the case, valve body, and separator plate, were done to relieve a harsh park/neutral to reverse engagement shift feel.

8670447

8670458

See Bulletin 88-33 for case and separator plate differences.

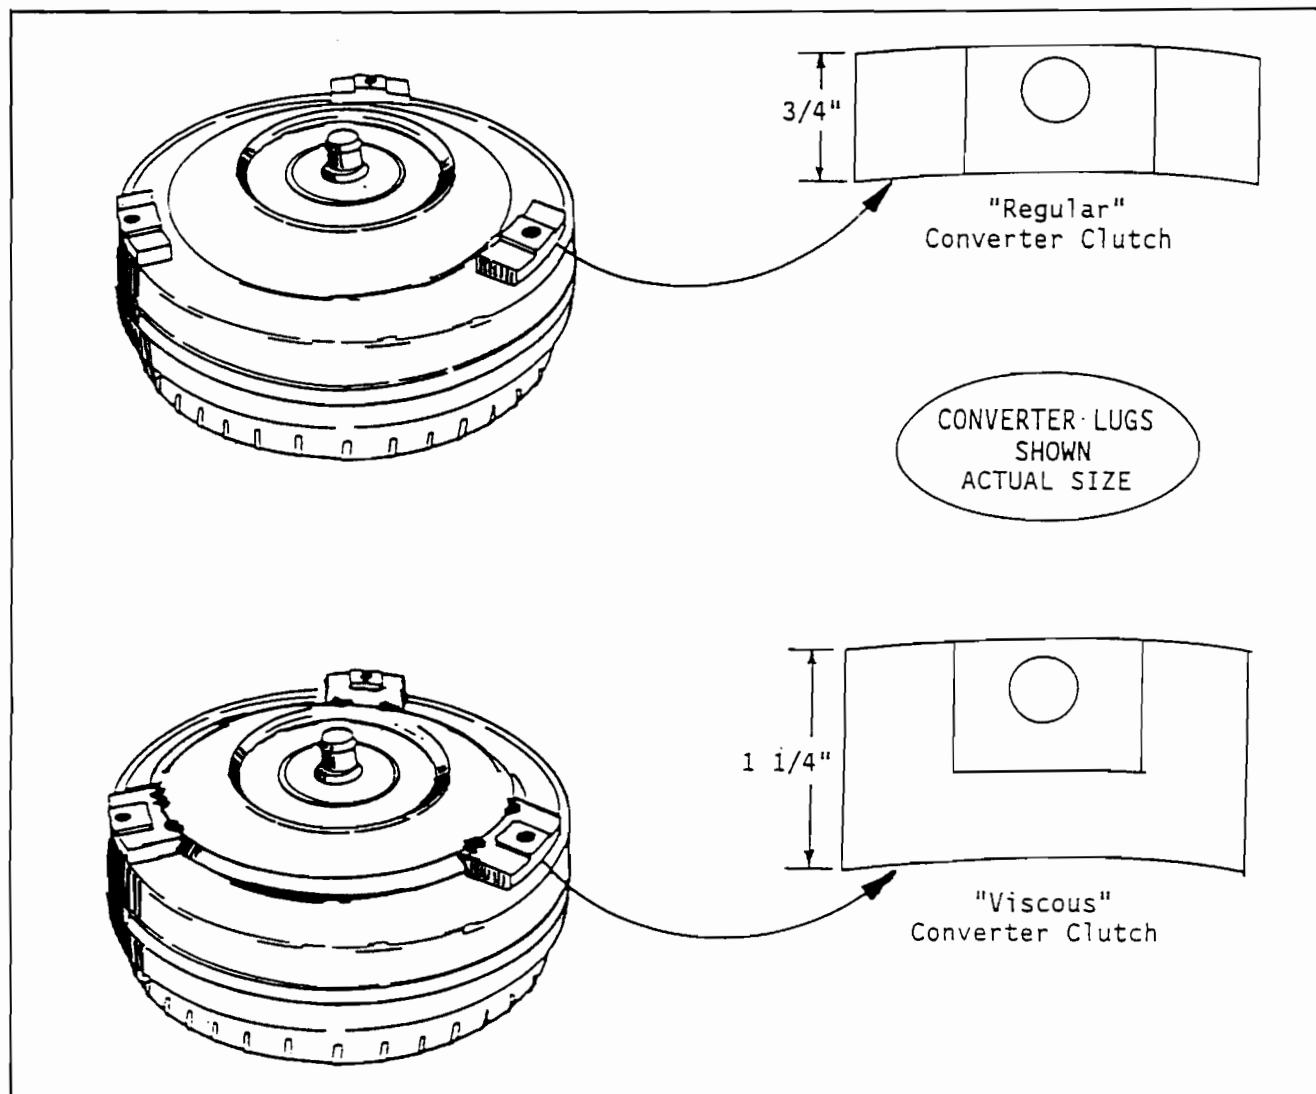
Figure 60

CONVERTER IDENTIFICATION

Identification of the "VISCOUS" converter from the "REGULAR" converter, can be done very easily externally. Notice the difference in the size of the converter drive lugs (see Figure 60). The profile of the converter covers are also different, but takes a closer look to detect, than do the drive lugs.

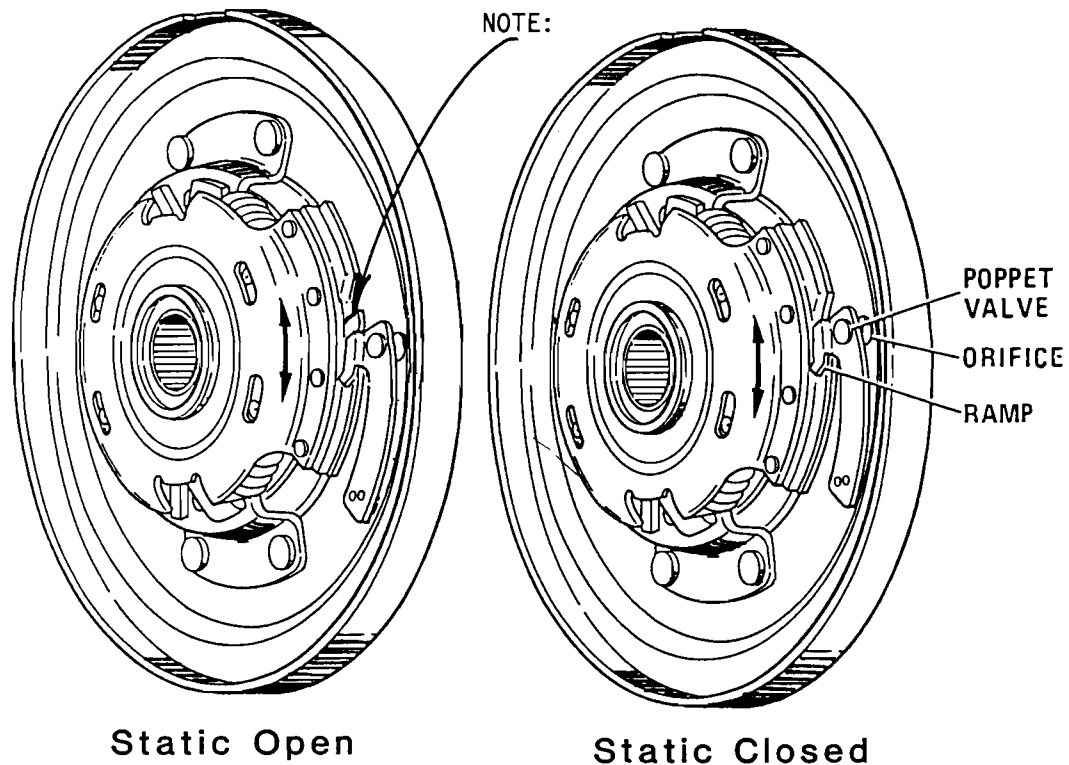
Figure 1

NOTE: In Figure 1, the static open clutch assembly, you can see the poppet valve is set on the ramp in the open position.

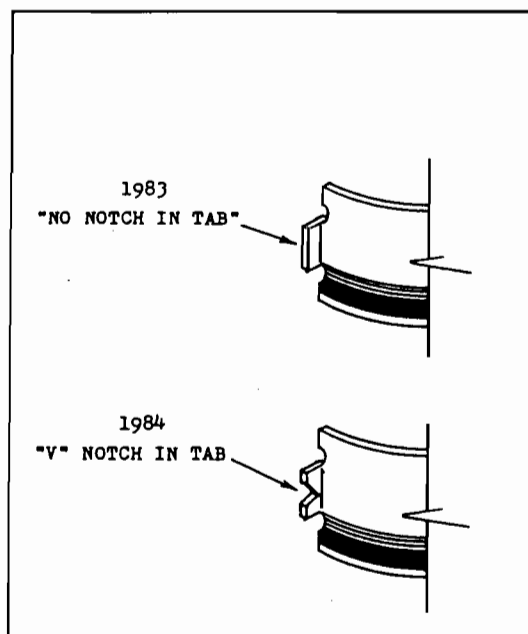
Figure 2

For 1984 the THM 125C has 5 L&R friction plates that are .010" thicker, and 5 L&R steel plates that are .010" thicker, for a total of .100". They had to make room for that extra .100" in the L&R clutch pack. They accomplished this by moving the final drive ring gear spacer snap ring .050" closer to the final drive and of course this requires a thinner ring gear spacer (See Figure 1). The 1983 ring gear spacer measures 1.344" and can be identified by no notch in the tab. The 1984 ring gear spacer measures 1.294" and can be identified by a "V" notch in the tab (See Figure 2).

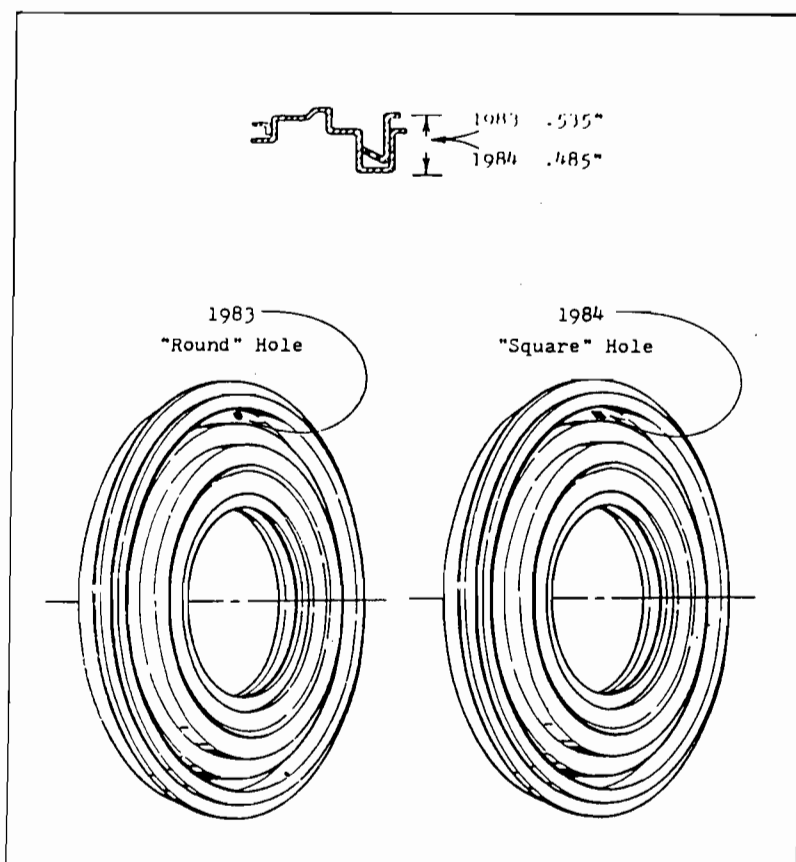
Figure 3

The other .050" was handled by making the L&R piston .050" thinner. The 1983 piston measures .535" (total height) and is identified by a "round" hole in the lip seal retainer on the back of the piston. The 1984 piston measures .485" (total height) and is identified by a "square" hole in the lip seal retainer on the back of the piston (See Figure 3). Needless to say these parts cannot be interchanged.

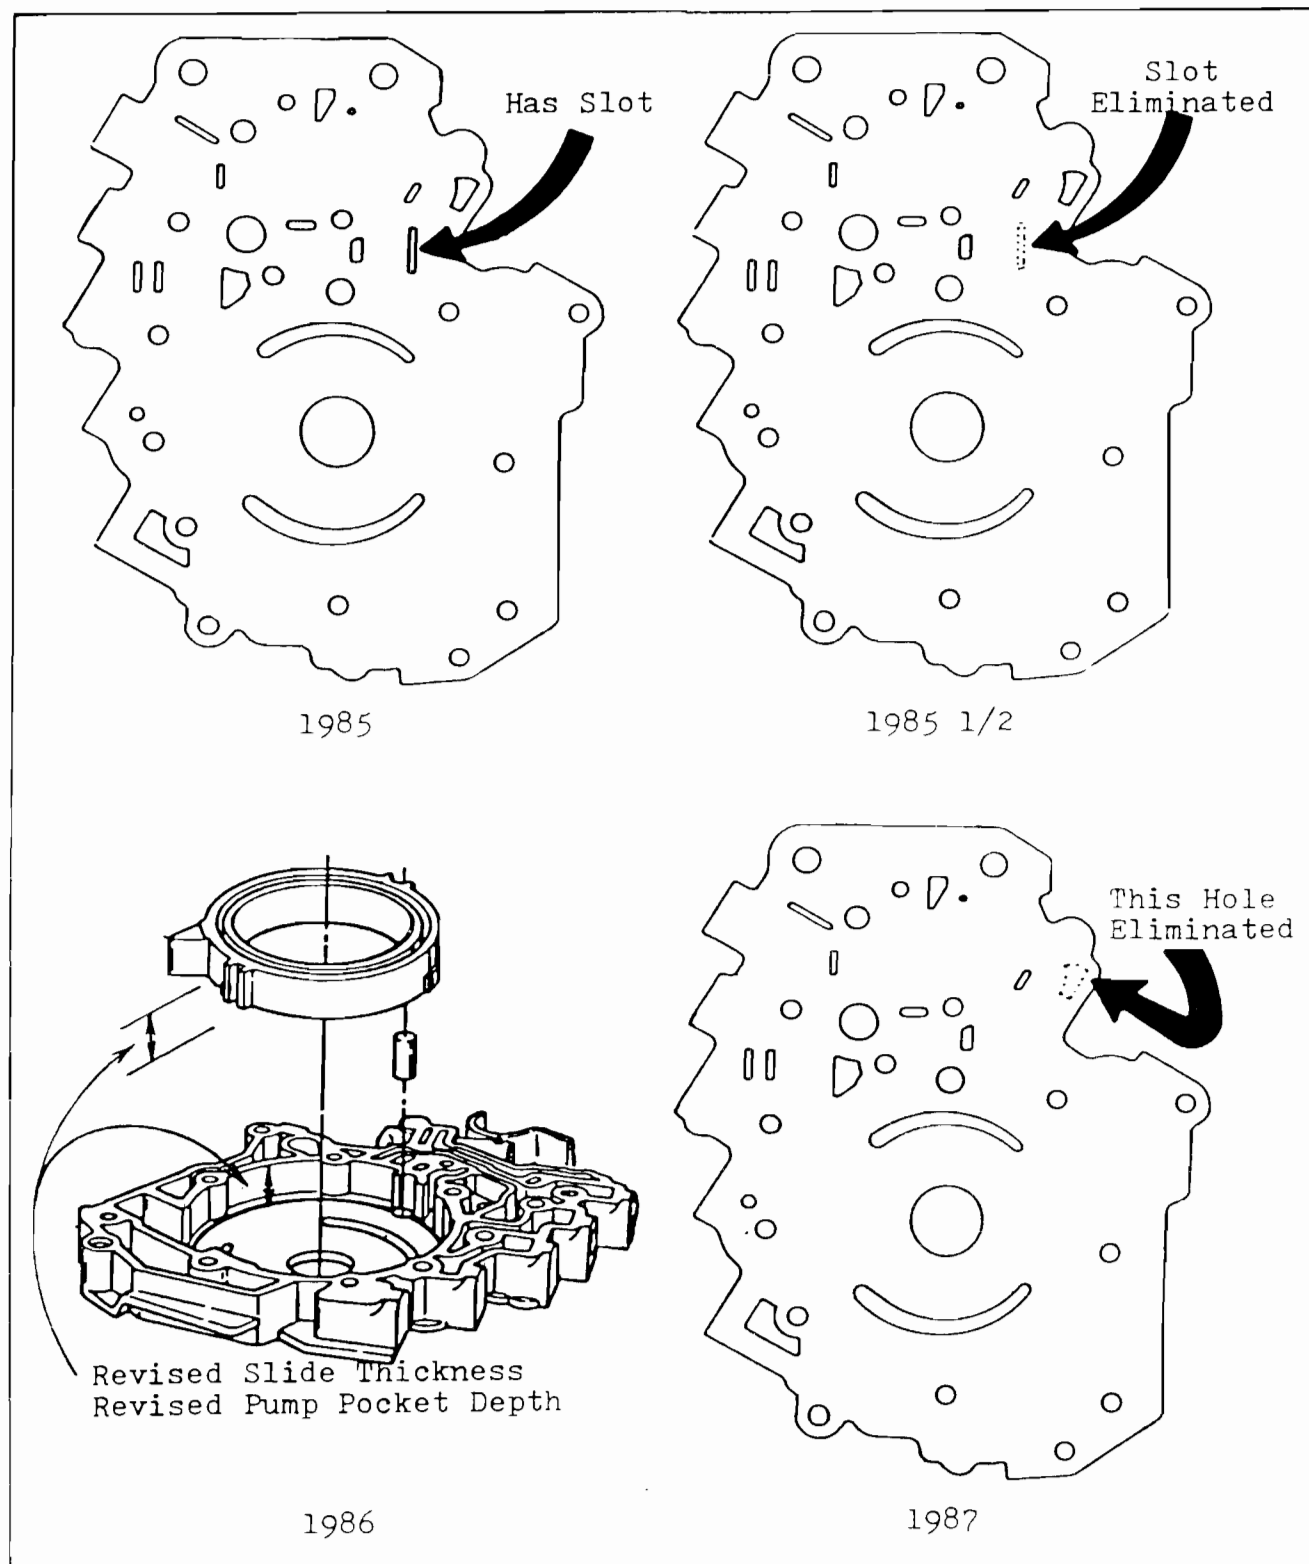
Figure 5

1985	Identification:	Has slot in pump body (See Figure 5).
	Interchangeability:	The 1985 pump body will not work on 1985 1/2 up valve body unless spacer plate is used to eliminate slot. If used without the spacer plate result will be tie-up when transaxle shifts to 4th gear.
1985 1/2	Identification:	Slot in pump body was eliminated (See Figure 5).
	Reason:	Addition of 3-2 TV bias valve in valve body and complete revision of hydraulic circuit for improved 3-2 downshift.
	Interchangeability:	Will interchange on 85 1/2 and 1986 models only.
1986	Identification:	No way to identify from 1985 1/2. Pump pocket depth was made shallower by .0001" which created 5 new slide sizes unique to the 1986 pump. See chart on page 6.
	Reason:	Improved pump capacity.
	Interchangeability:	Will interchange with 85 1/2 only, as long as proper slide selection is made to correspond with depth of pump pocket.
1987	Identification:	Hole eliminated in pump body (See Fig. 5).

Reason:	Improved 3-2 downshift. Modulator oil was fed thru the hole in pump body to stroke the 3-2 coastdown valve. Improved 3-2 downshift could be obtained by using servo release oil to stroke the valve, so hole was eliminated and the 3-2 maneuver pipe was added to carry servo release oil to the 3-2 coastdown valve in pump body (See Figure 6). This also made a change in the pump cover necessary with an additional hole and seal to accept the 3-2 maneuver pipe.
	Interchangeability:	Will retro fit back to 85 1/2, and is recommended. The 3-2 maneuver pipe must be used with it. Not interchangeable unless 3-2 maneuver pipe is used.

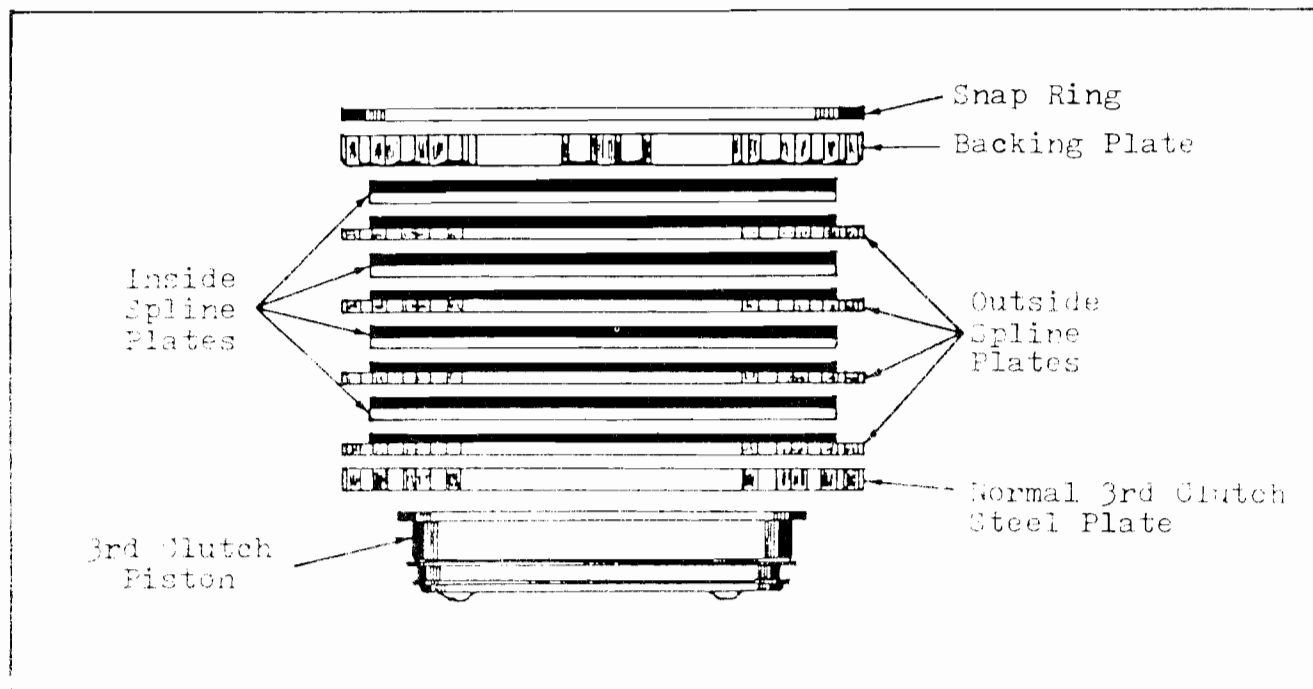
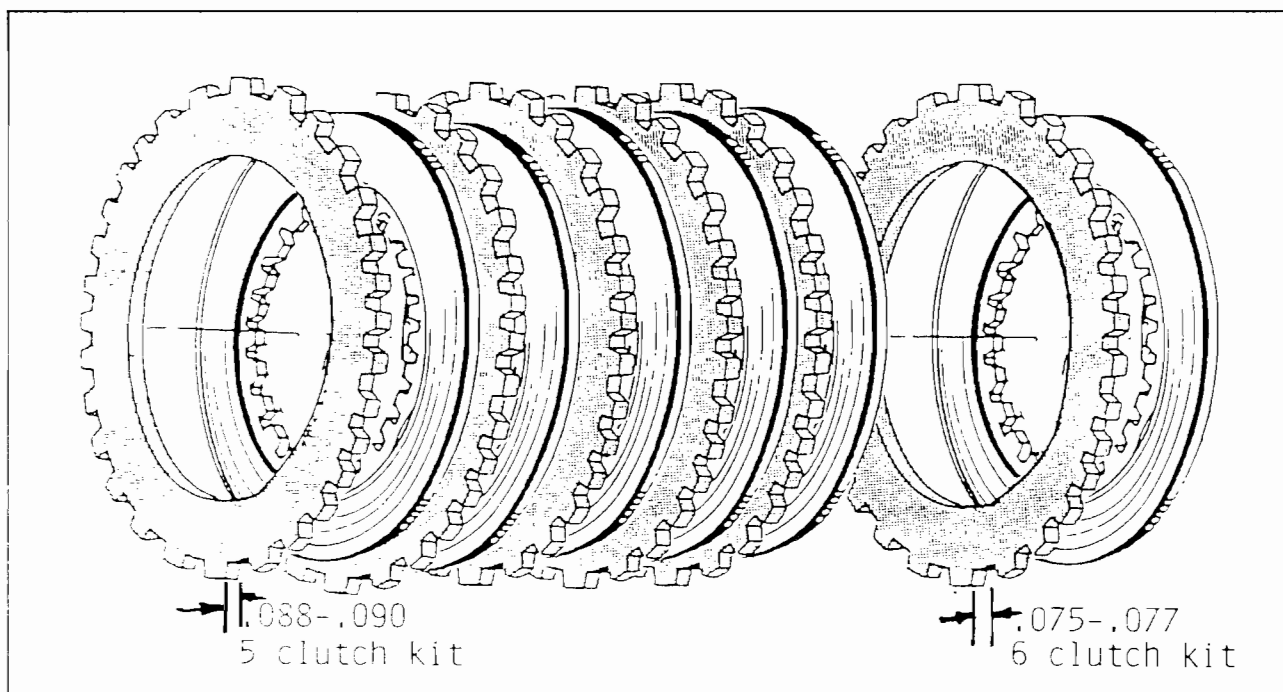
8662913 (5) Clutch Kit 1984-86

THM 440 T4 1-2 Slide Shudder

Complaint of a 1-2 slide shudder on THM 440 T4 1984-87. Can be caused by clutch lining compatability of lined plates. This can also be a problem encountered with SRTA or factory rebuilt units. To correct this problem Install kit number 8662913 for 1984 thru 1986 which comes with 5 lined plates and 5 steel (koline) plates. the koline plates in this kit are .088-.090 thick. For the 1987 units use kit number 8662914 comes with 6 lined plates and 6 steel (koline) plates. •The koline plates in this kit are .075-.077 thick.

8662914 (6) Clutch Kit 1987

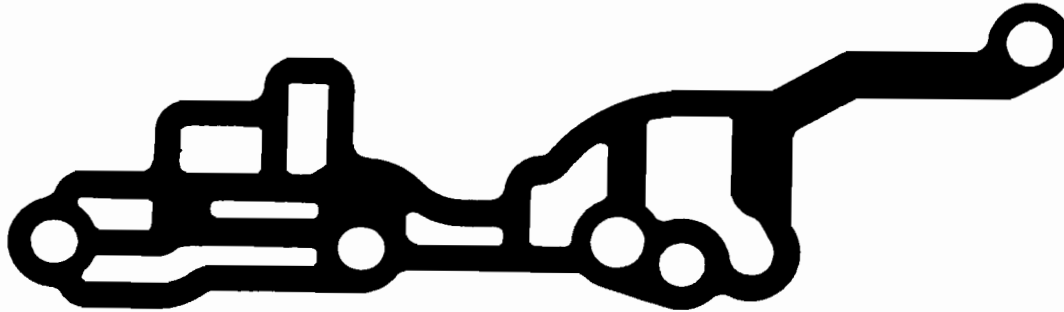
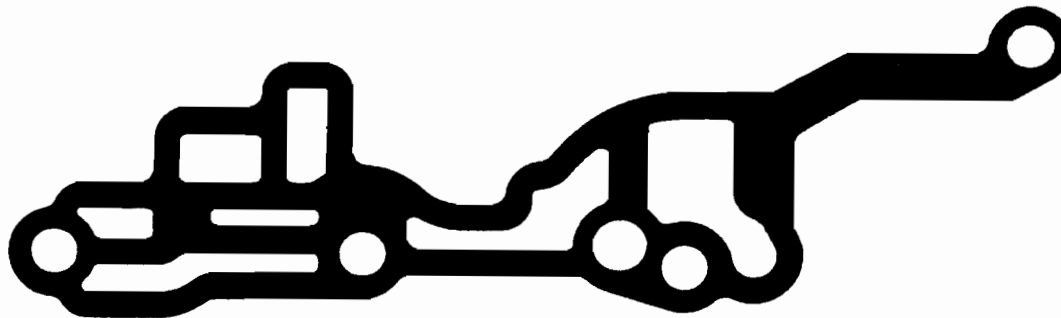
THM 440-T4 CASE COVER GASKET CHANGE

"Early" - 1984 and 1985 Hydraulics

"Late" - 1985½ and 1986 Hydraulics

NOTE: Early gasket will fit the late model units, but late will not fit early.

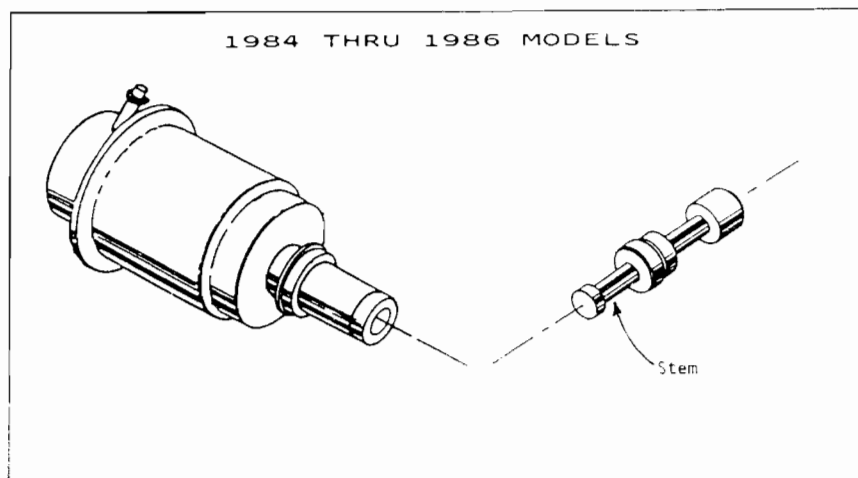
The dimensions of the new vacuum modulator and the new modulator valve have changed drastically. If the previous style vacuum modulator was to be installed on top of the latest modulator valve, all boost capabilities are lost, and immediate damage to the transaxle would be the result.

Refer to Figure 1 for the previous design vacuum modulator and modulator valve, and Figure 2 for the latest design vacuum modulator and modulator valve.

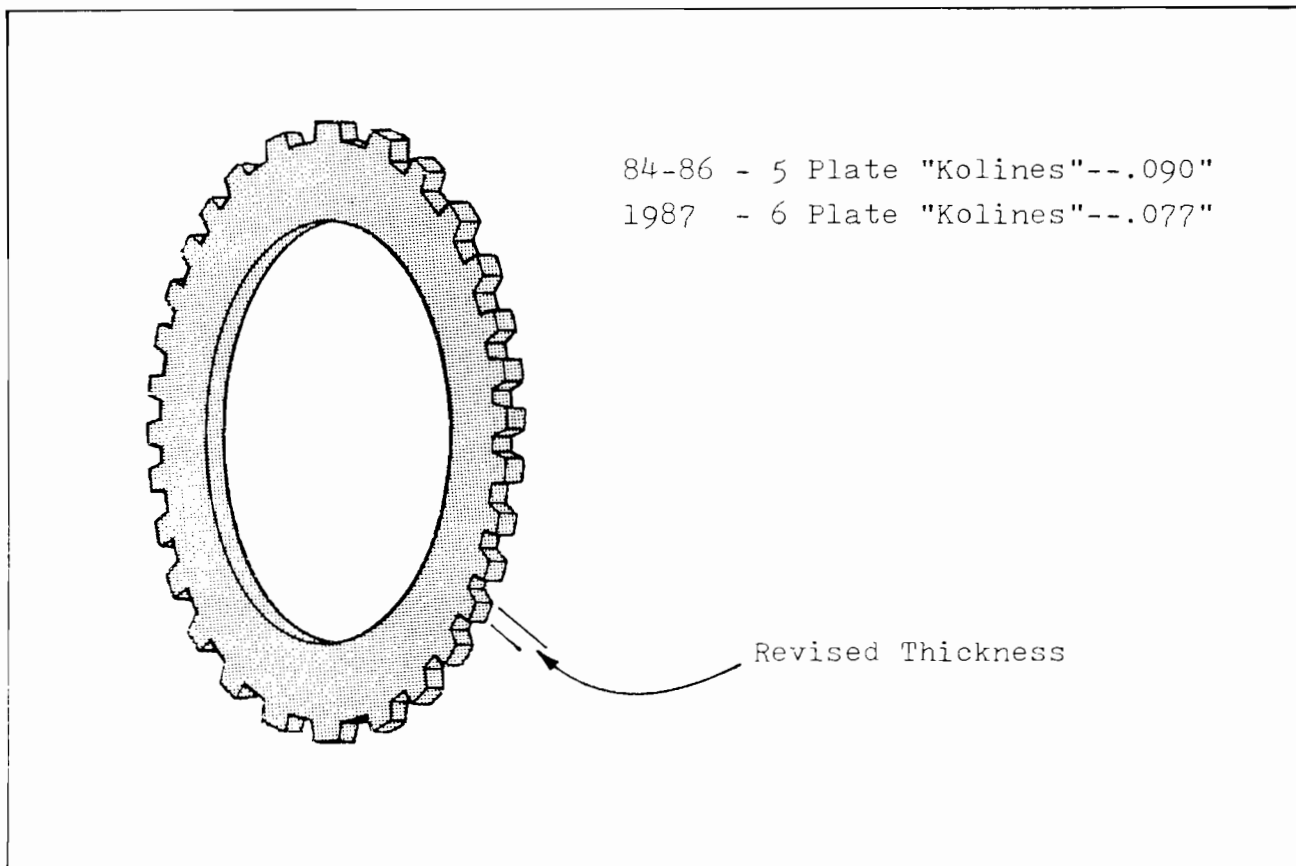
Figure 35

"Koline" Steel Plates

The steel plates in the 440-T4 2nd clutch are unique, in that they are black in color. They have a black coating on them called "Koline" plating, for shift pleasability (See Figure 35).

The 2nd clutch steel plates CANNOT be tumbled as it will remove the "Koline" plating. If the "Koline" plating is worn from the steel plates, they will have to be replaced.

The thickness of the "Koline" plates were revised for 1987, with the addition of the 6 plate 2nd clutch pack (See Figure 35).

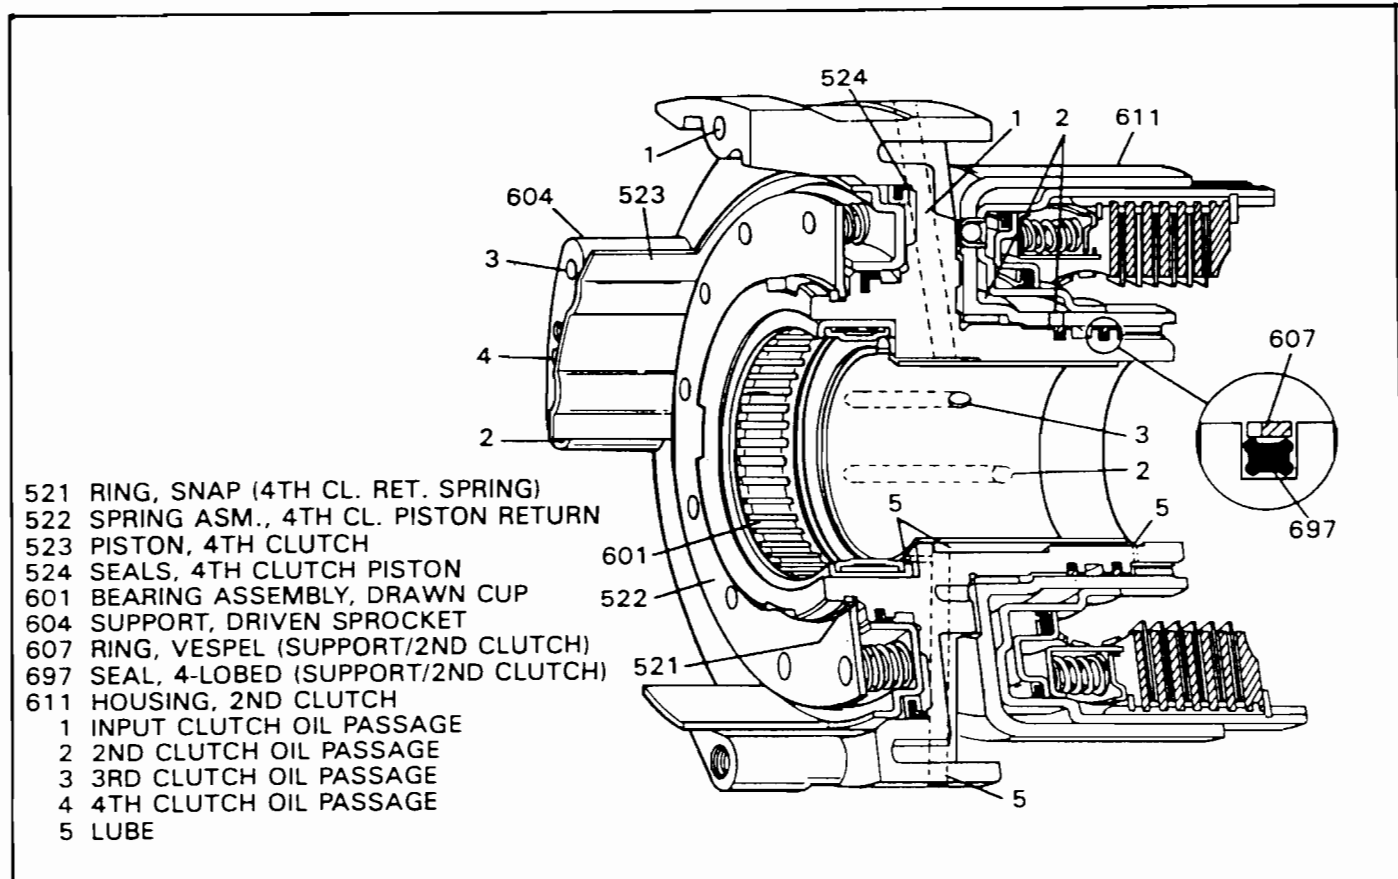
Figure 36

Change: "Vespel" Sealing Rings and 4 Lobe Ring (See Figure 36).

This change, also initiated in the 1987 models, related to 2nd clutch durability and was on the driven sprocket support. The 84-86 models have large steel, hook joint, sealing rings to feed the 2nd clutch. In 1987 models the steel rings were replaced with "Vespel" (Plastic), step joint, sealing rings, that have tabs on them to prevent them from spinning in the driven sprocket support (See Figure 37). This made it necessary to machine slots in the driven sprocket support, to accept the tabs on the "Vespel" rings. There is also a special 4 lobe ring that goes in the ring groove under the "Vespel" ring, and acts as an expander for the "Vespel" sealing rings (See Figure 36).

- 1) Driven Sprocket Support - Slots added to accept tabs on the "Vespel" sealing rings, and ring grooves machined deeper to make room for the 4 lobe ring (Expander).
- 2) No. (697) 4 lobe ring acts as expander for (607) "Vespel" sealing ring (See Inset, Figure 36).

Will retro fit backwards, and is recommended, as long as all parts affected are used.

- 1) Driven Sprocket Support ----- 8662523
- 2) "Vespel" Sealing Ring ----- 8662330
- 3) 4 Lobe Ring (Expander) ----- 8662329

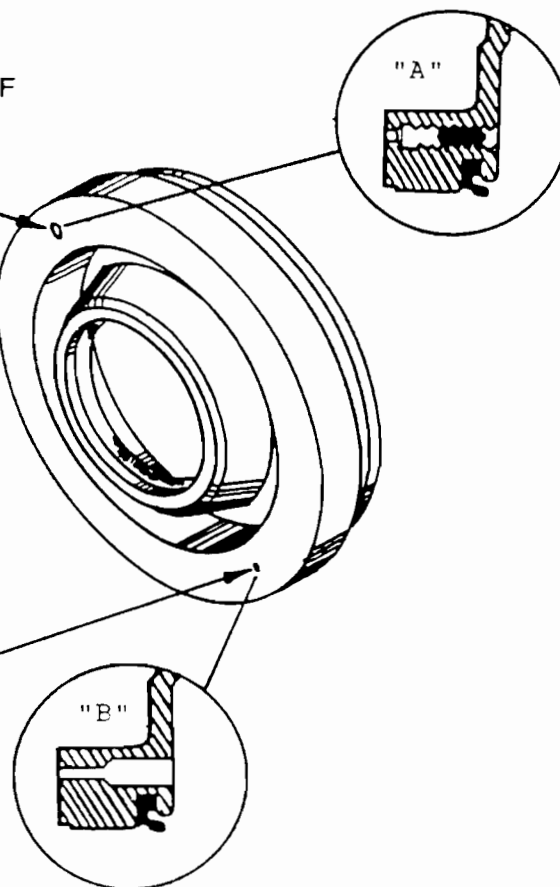
Figure 32

THM 700-R4 PREMATURE REVERSE INPUT CLUTCH FAILURE

- COMPLAINT:** Premature reverse input clutch failure on 1987 or 1988 models only.
- CAUSE:** The cause may be the orifice hole in the new aluminum piston, drilled too large (Original was .116").
- CORRECTION:** Plug the original hole from the back side of piston with an allen head set screw, flush or below. Retain the set screw with Loc-tite (See Figure 32, Inset "A").
- 180 degrees from original orifice hole you will find a hole started but not drilled through. Drill through here with a 1/16" drill bit, from the front side of piston. Turn the piston over and from the back side of piston, drill about half way through with a 1/8" drill bit. (See Figure 32, Inset "B").

PLUG THIS ORIFICE HOLE WITH SMALL ALLEN HEAD SET SCREW FROM BACK OF PISTON, FLUSH OR BELOW (INSET "A").

DRILL THROUGH HERE WITH 1/16" DRILL BIT, AND ABOUT HALF WAY THROUGH WITH 1/8" DRILL BIT FROM BACK SIDE OF PISTON. (SEE INSET "B").

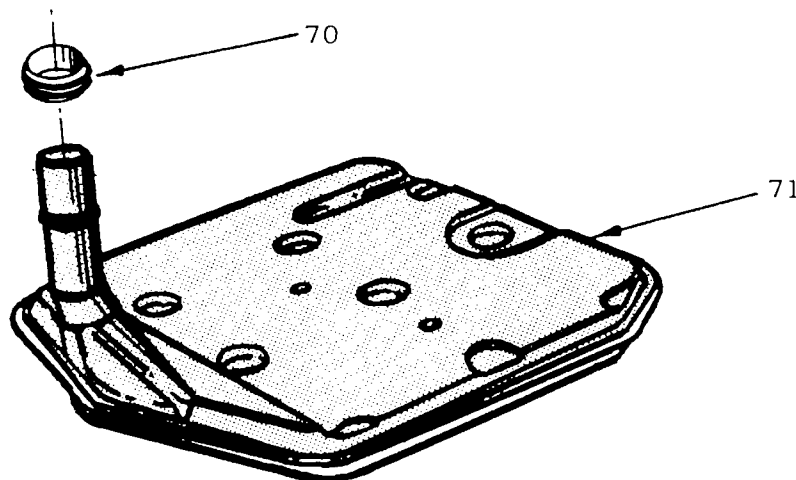
Figure 48

REASON: Eliminates the potential for transmission noise caused by air suction through the filter seal or filter neck.

- (1) Oil Filter - The new design filter is wider, has a felt element in place of the screen, and is bottom suction instead of top suction (See Figure 48).
- (2) Oil Filter Seal - Best description of the new seal is "It looks like "O" rings moulded together" (See Figure 48).

SPECIAL NOTE: Late filter will retro fit in MOST CASES. To be sure make the following check. Install pan without gasket. If the pan rocks, or is not flush with the pan rail on the case, then install the early filter or the late model deep pan.

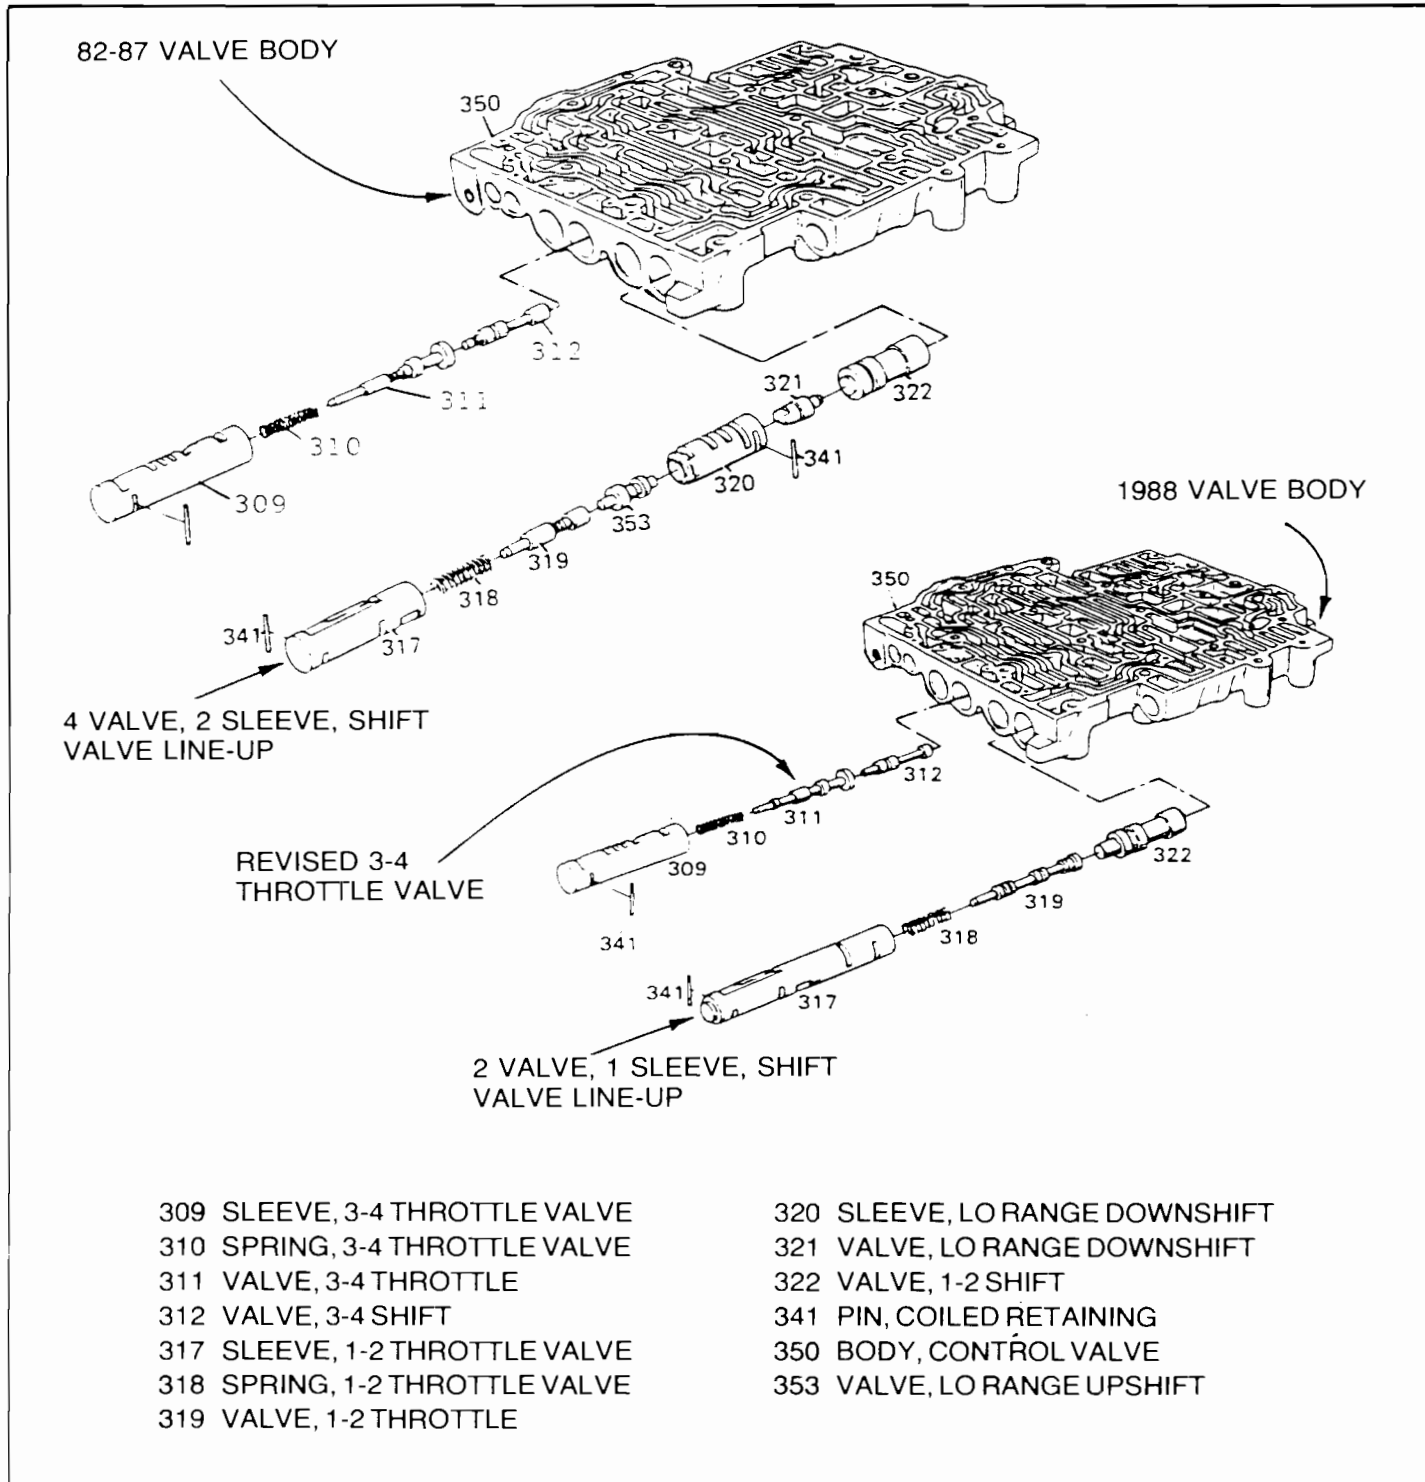
Figure 41

CHANGE: Revised 1-2 shift valve line-up in the main valve body, and a revised 3-4 throttle valve (See Figure 41).

REASON: This change reduces internal leakage, thus improving consistency for the 1-2 and 3-4 shifts, and allows engine braking at a higher speed during a manual 2-1 downshift.

- (1) 1-2 Shift Valve Line-up – The 1-2 shift valve line-up changes from 4 valves and 2 sleeves, to 2 valves and 1 sleeve. The Lo Range Downshift Valve(321), Lo Range Control Sleeve(320), and the 1-2 Lo Range Upshift Valve(353) have been eliminated from the 1988 models (See Figure 41).

- (2) 3-4 Throttle Valve – The 3-4 throttle valve and sleeve have been revised (See Figure 41).
- (3) Spacer Plate – Spacer plate has been revised to be compatible with the new valve body, as have both valve body gaskets. There is now a "Two" letter code on all 87-88 spacer plates and can be identified as follows:

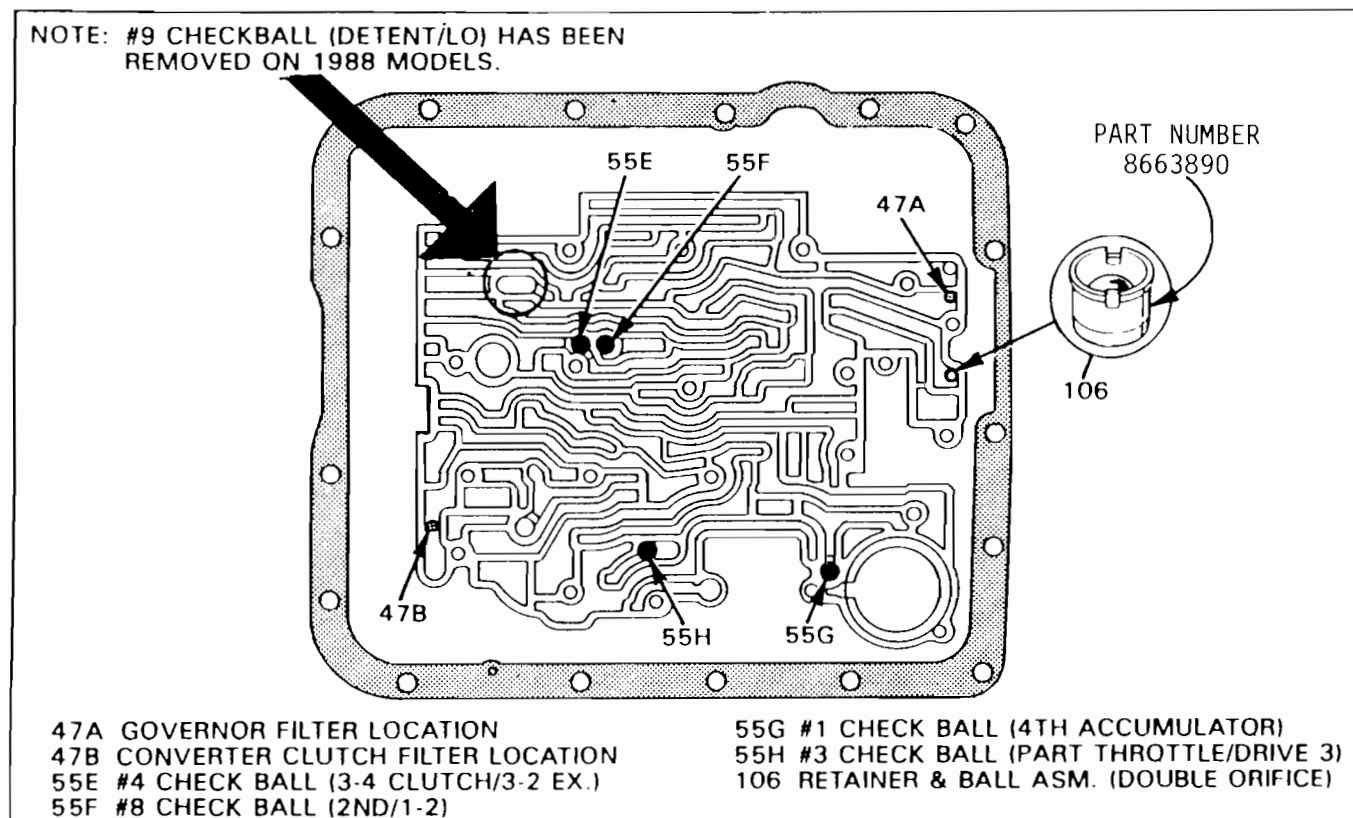
Figure 42

- 1987 – First letter will always be "A" (See Figure 19).
 - 1988 – First letter will always be "B" (See Figure 42).
- (4) Number 9 Checkball – The number 9 checkball, located in the case, has been eliminated on all 1988 models (See Figure 43). The spacer plate has been modified, with a rectangular hole, on some models so that even if the technician installs the checkball in a 1988 model, it will be ineffective. (See Figure 42).

NOTE: INSTALLING THE NO. 9 CHECKBALL IN A 1988 MODEL CASE WITHOUT A MODIFIED SPACER PLATE WILL BURN THE LOW REVERSE CLUTCH.

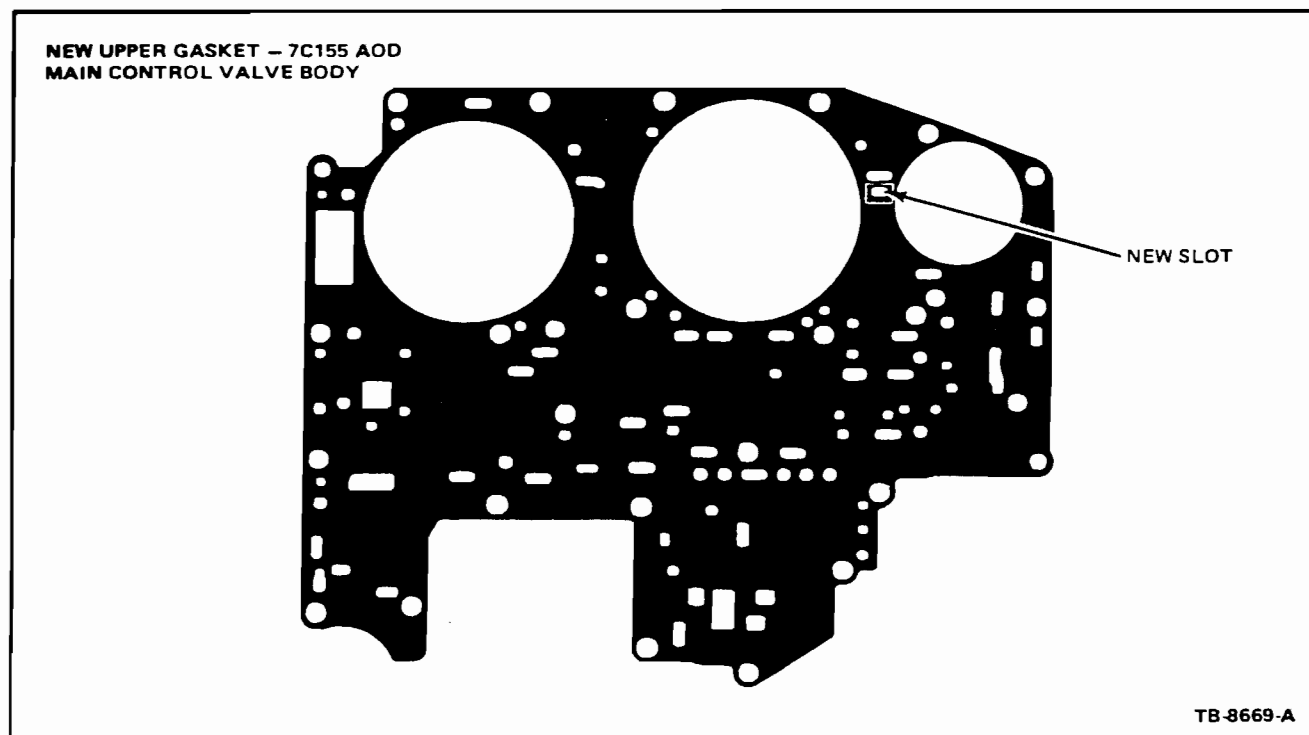
Figure 11

New upper and lower main control valve body gaskets have been released for service. The new gasket has an additional slot, which reduces the chance for contamination of the 3-4 shift valve (refer to Figures 11 and 12). The new gaskets can be used on all AOD main control valve bodies produced for the 1980-86 model years.

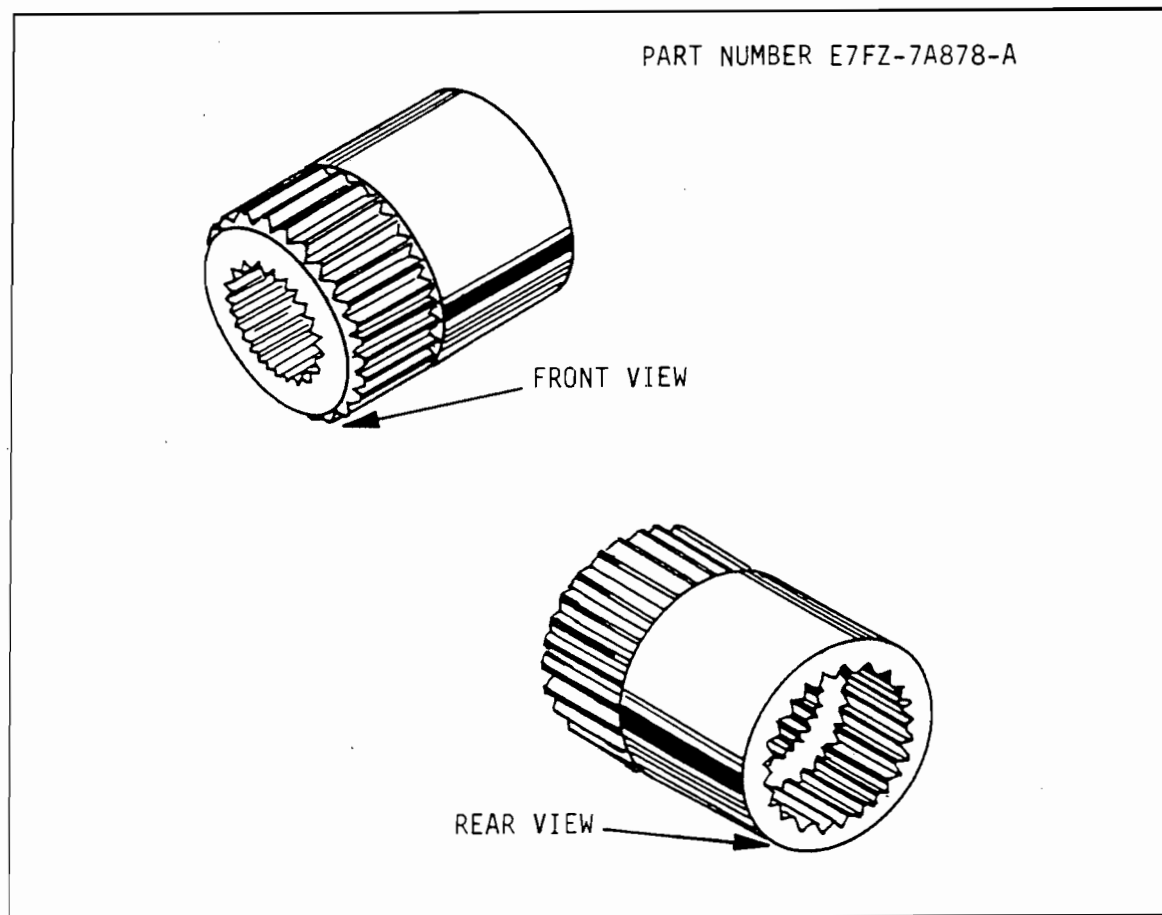
Figure 1

1987-88 Tempo Topaz only use a converter adapter sleeve, Part Number E7FZ-7A878-A. This sleeve has two internal splines and one external spline. (See Figure 1) Since this is a slip on adapter, it can stay engaged in the torque converter turbine hub upon removal of the converter from the transmission. If this adapter IS NOT reinstalled on the transmission (turbine and intermediate shafts), a NO DRIVE CONDITION WILL BE THE COMPLAINT AFTER INSTALLATION. (See Figure 2)

Remove Converter Turbine Sleeve.

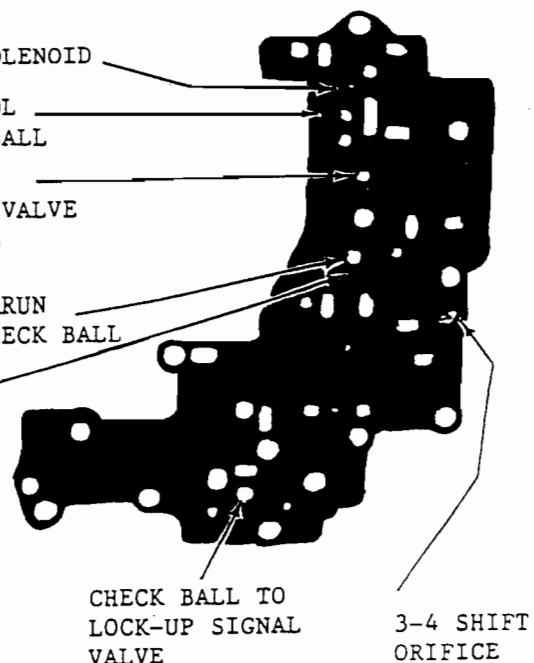
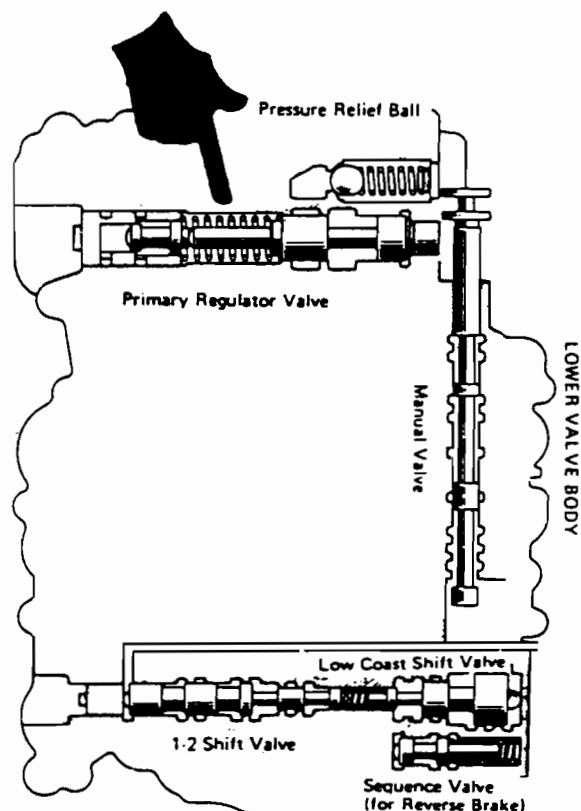
LINE TO LOCK-UP SIGNAL VALVE CHECK BALL.
NOTE: THIS BALL IS .250" (1/4")

DETENT STEEL CHECK BALL

2-3 CHECK BALL

NEUTRAL DRIVE CHECK BALL
"C1" CLUTCH

INTERMEDIATE MODULATOR VALVE CHECK BALL

CAUSE: Missing or mis-positioned check ball. High line pressure.

CORRECTION: Install check-ball in proper location or replace Primary Valve Spring with a new spring, part # 90501-18028.

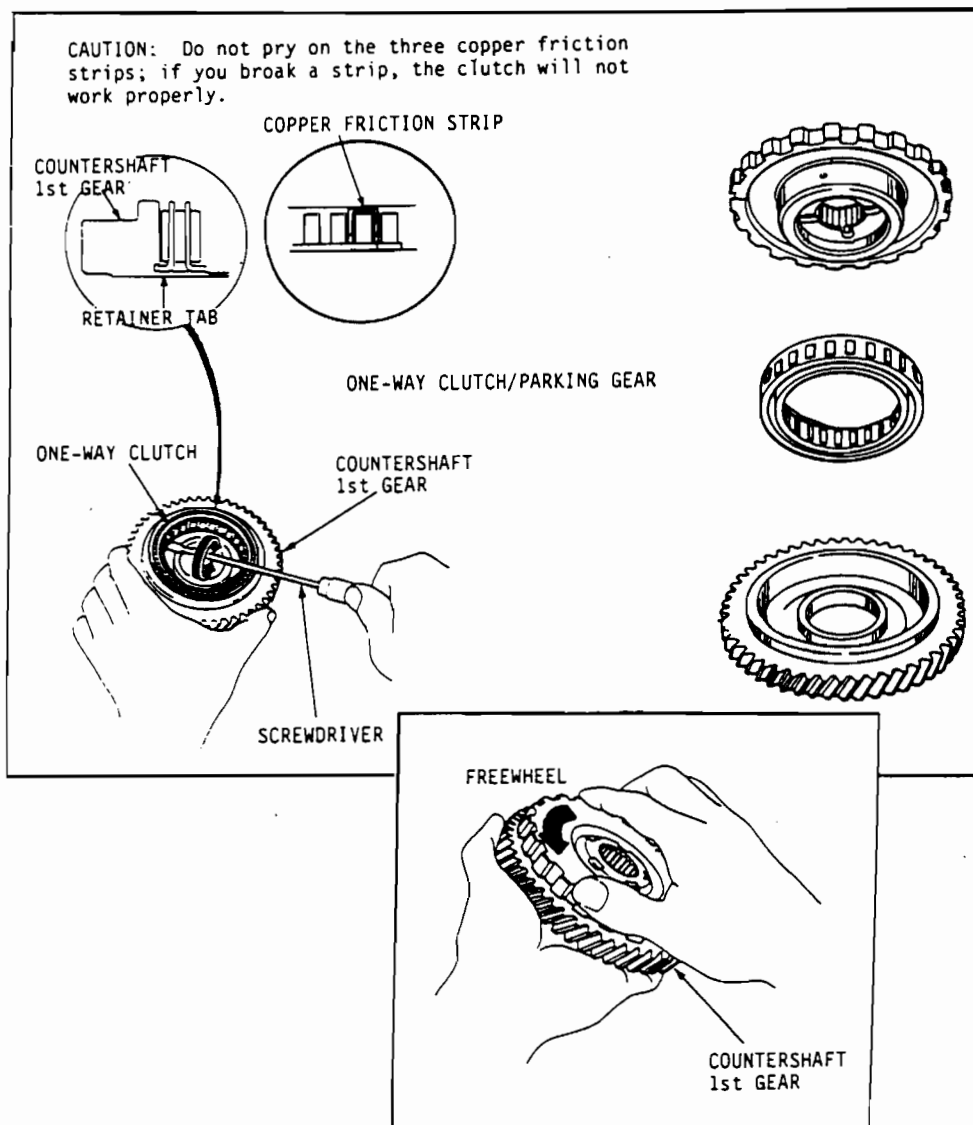
HONDA FOUR SPEED PROPER SPRAG INSTALLATION

This bulletin purpose is to show the technician the proper sprag installation. Figure 1 shows freewheel counter clockwise, locks clockwise.

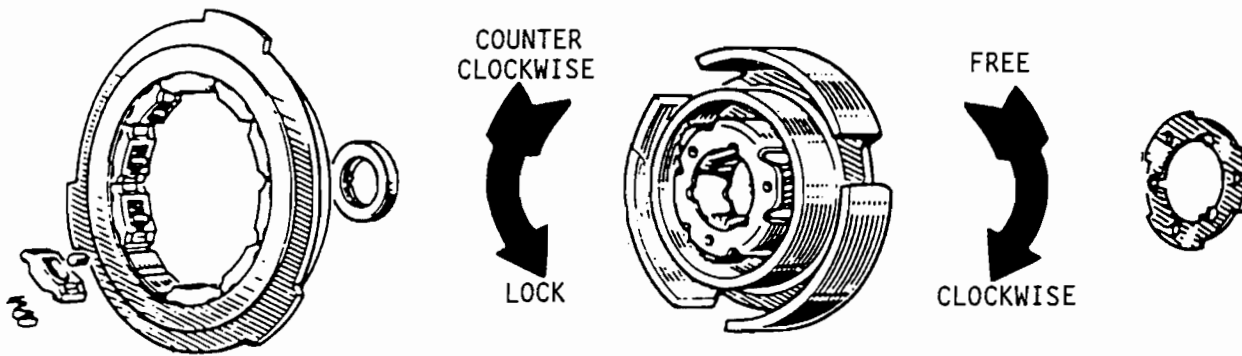
MB1-MJ3 SPRAG ROTATION

For proper sprag rotation, it should lock counter clockwise and freewheel clockwise.
