AUTOMATIC TRANSMISSION SERVICE GROUP

SEMINARS 1989

TECHNICAL INFORMATION PACKAGE

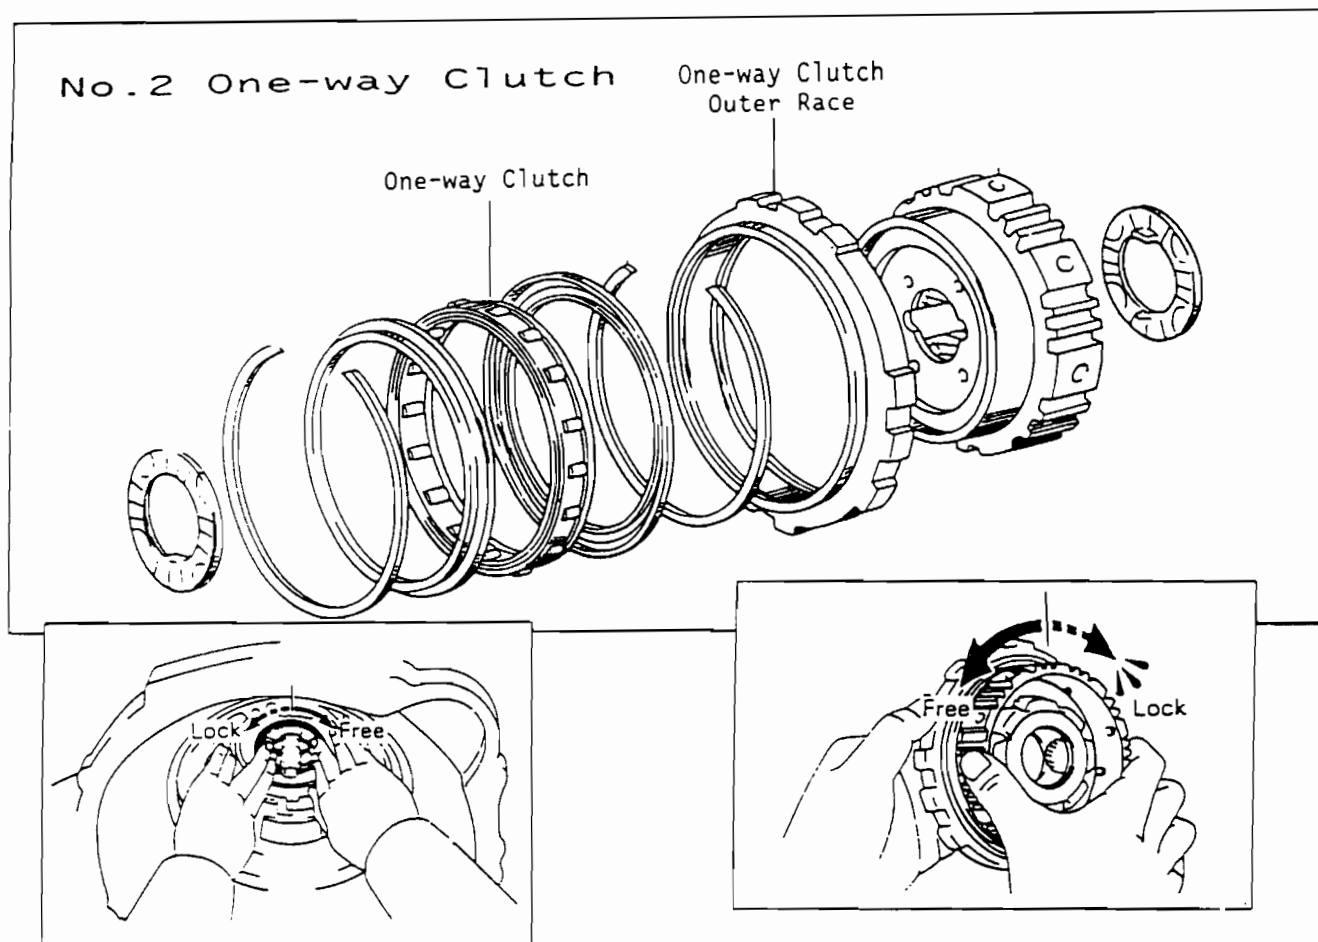
FIGURE 2

Install No.2 One-way clutch into case with shiny side upward.

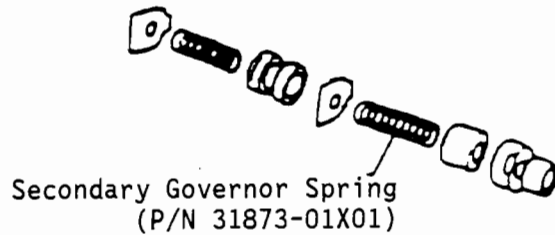
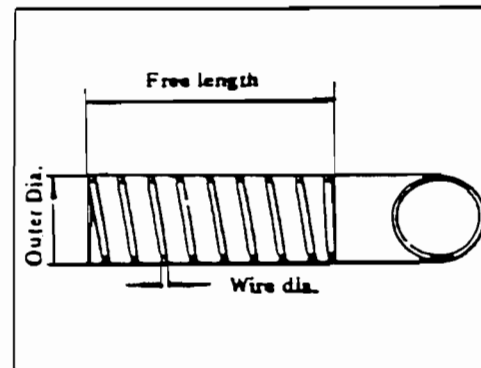
COMPLAINT: Stanza models exhibit a 3-2 down shift clunk.

CORRECTION: Install new Secondary Governor Spring, part # 31873-01X01
