"2000" SEMINAR INFORMATION "FIXES TODAY FOR Y2K"

"2000" SEMINAR INFORMATION
"FIXES TODAY FOR Y2K"

INTRODUCTION

The third and final manual for the "FIXES TODAY FOR Y2K" seminar continues to present practical information on Chrysler vehicles. The seminar and this manual ends with the Import section.

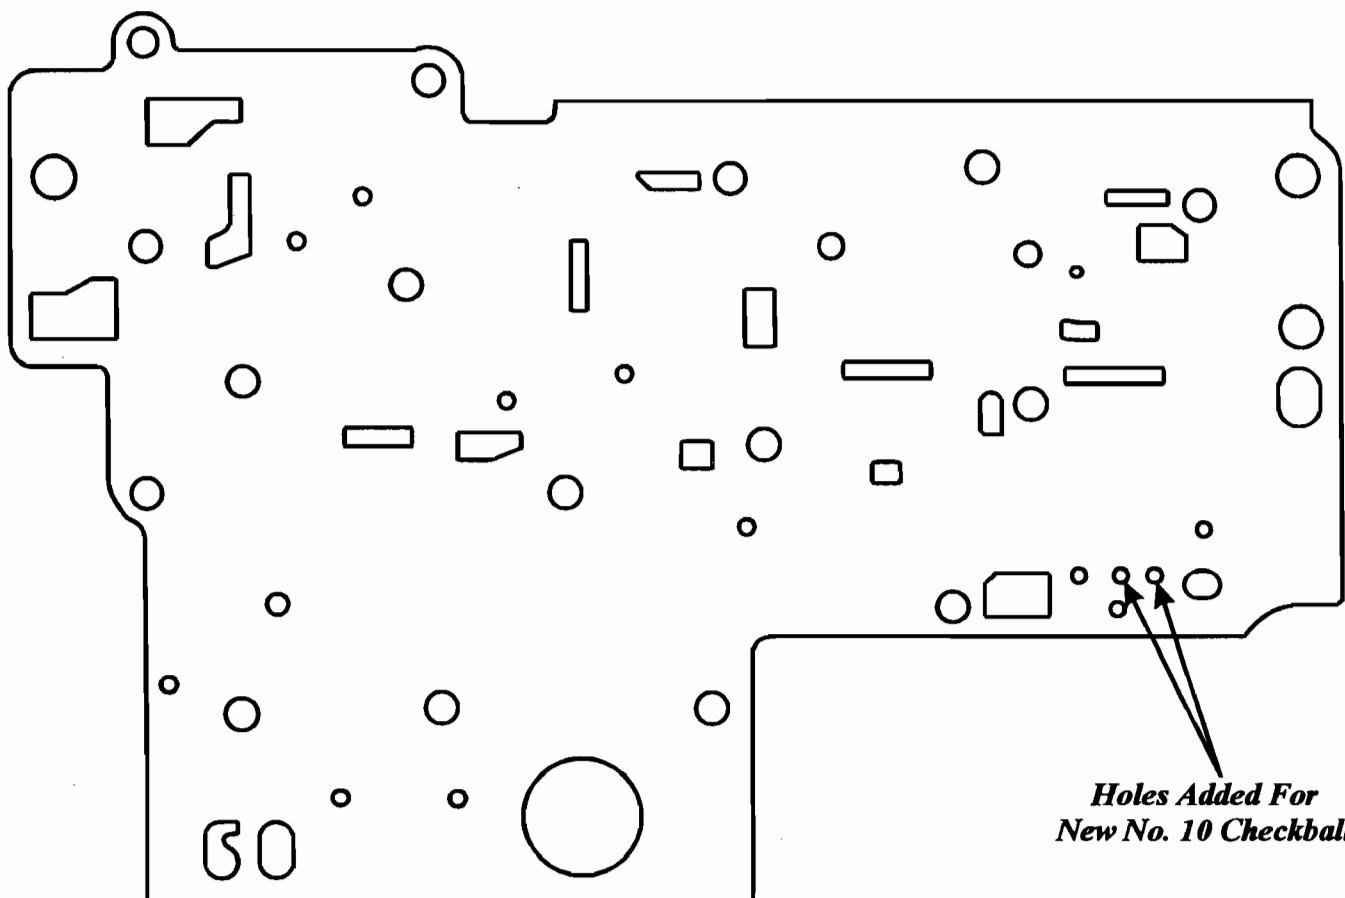
**OVERDRIVE VALVE BODY
SPACER PLATE**

*Holes Added For
New No. 10 Checkball*

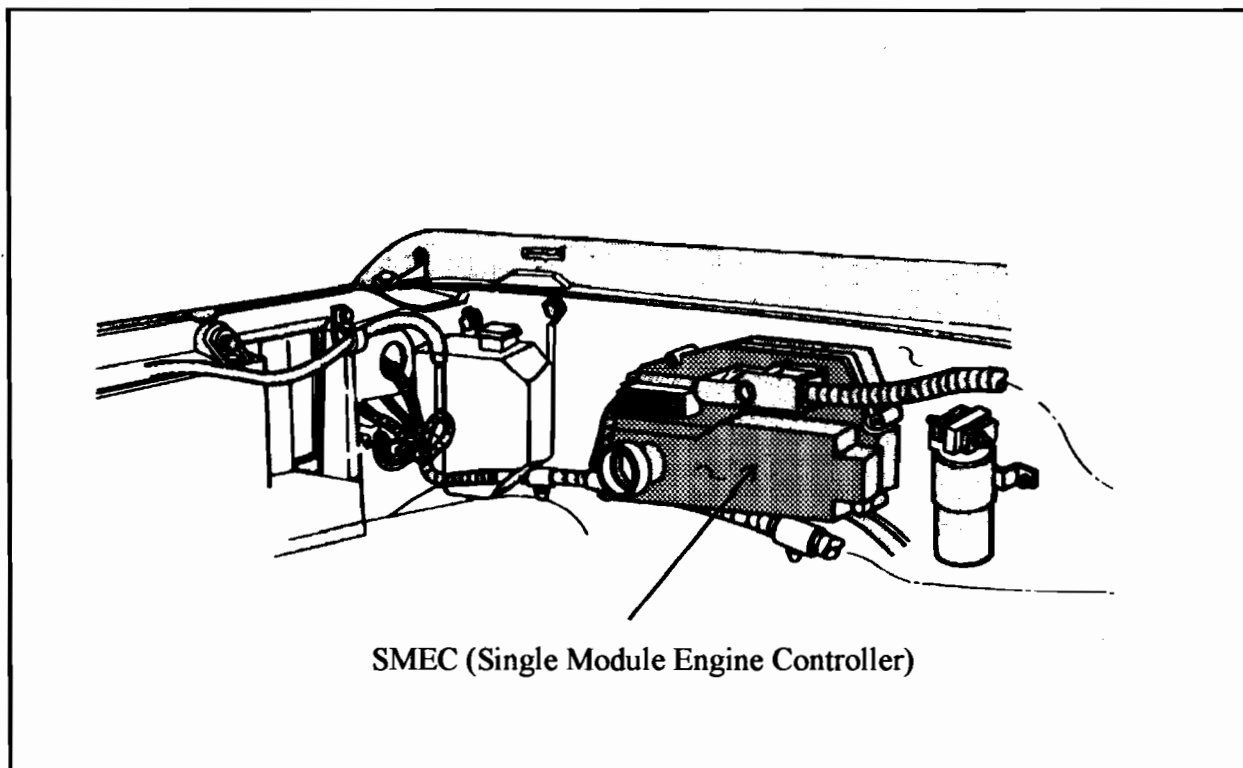
Figure 1

CAUSE: ATSG and ATRA has produced bulletins addressing this complaint. A bad VSS, TPS, ECT, OD Cancel Switch, Solenoid and or Solenoid Gasket, Ignition Switch or the Park Neutral Switch are mostly the cause of a no 3-4 shift or TCC apply. But ATSG has had many incidents where early model trucks had been equipped with the incorrect SMEC directly from the factory (See Figure 1). Vehicle owners were unaware of a no 3-4 shift. After overhaul the technician know struggles to correct this condition. At some point and time the computer is determined to be defective. When the computer is replaced, it may once again be replaced with an incorrect computer. The confusion is that Ram Vans, Wagons, Pickups and Ram Chargers could have a 3 speed transmission (904, 999 or 727). They may also be equipped with a 4 speed A500 or 518. When ordering a computer, it is imperative to specify that the vehicle has a 4 speed transmission. Do not rely on engine size alone. A 1989 5.2 liter Pickup with a 3 speed would have a SMEC part number of 894379887 while the same vehicle equipped with a 4 speed will have a part number 894379889.

CORRECTION: Install the correct computer.

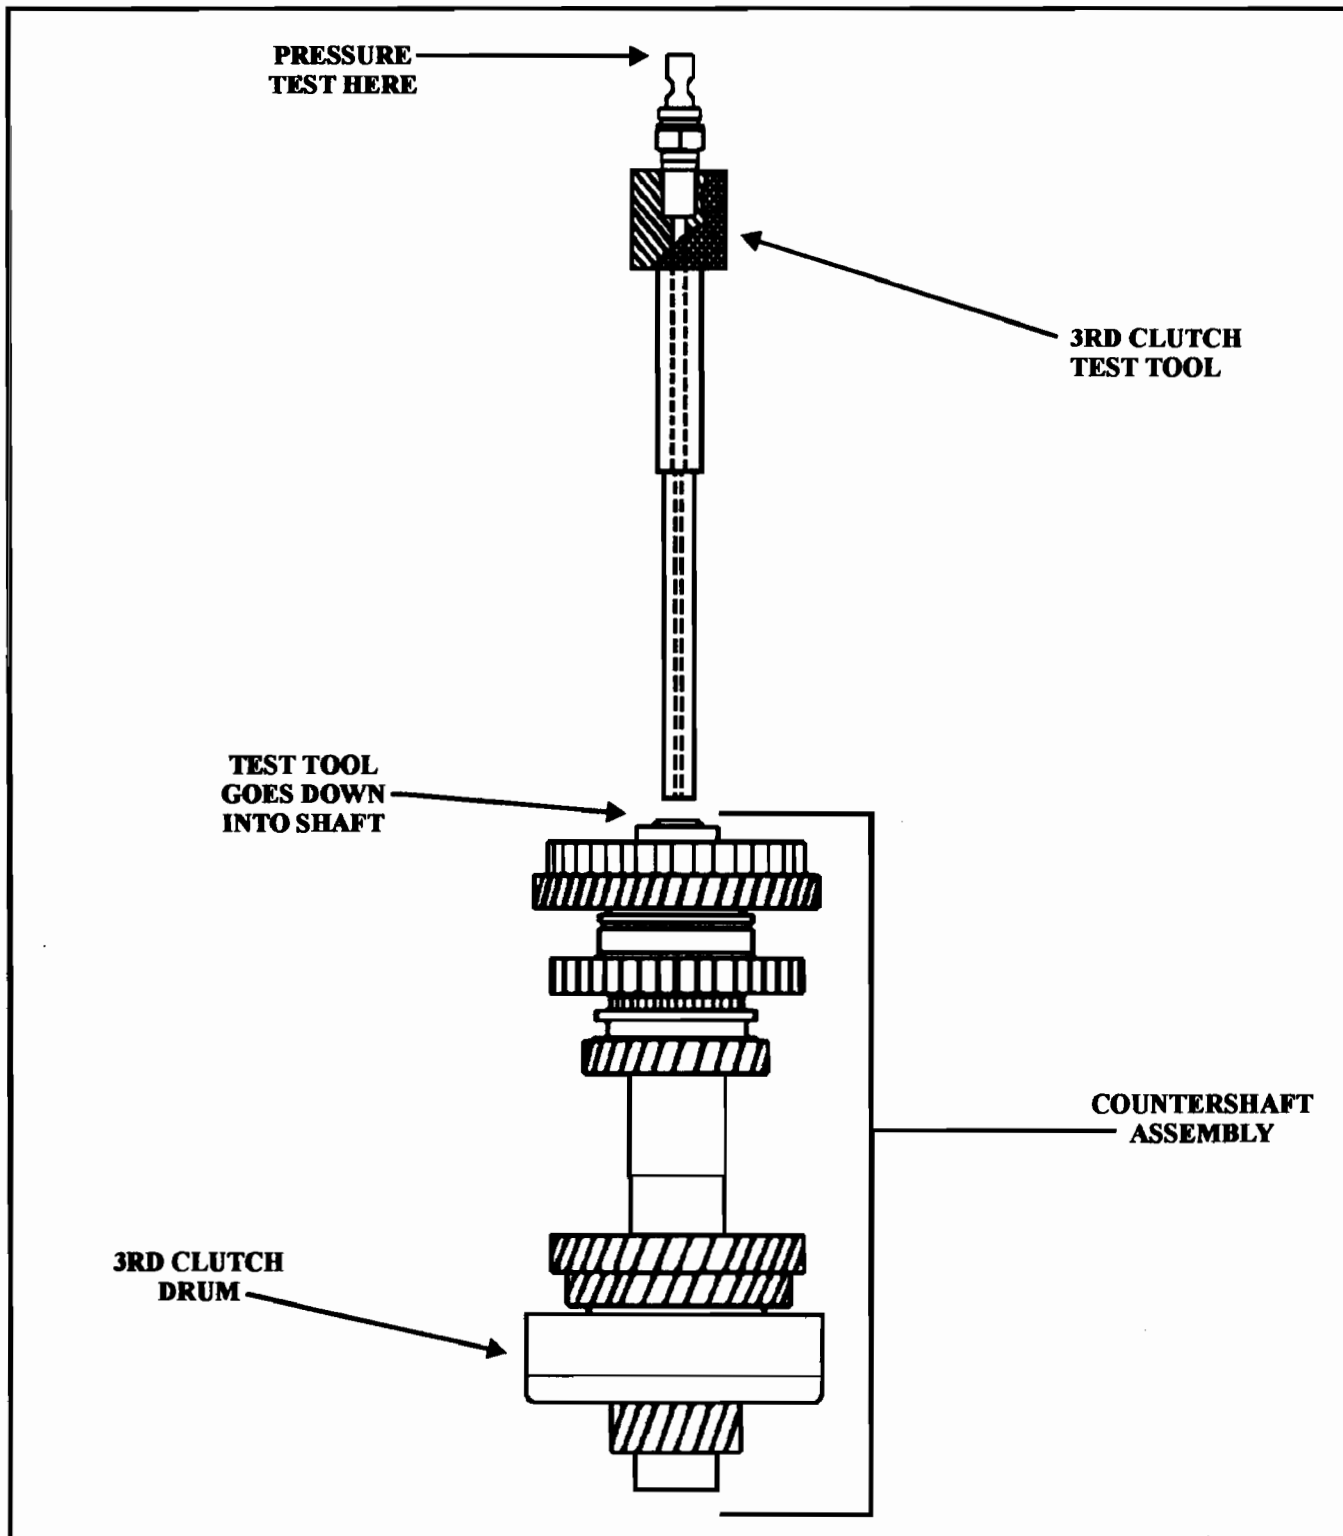
Figure 1

HONDA/ACURA
CHRONIC INTERNAL LEAKS

These test fixtures can be used with the Answermatic VB2000 or the AMI test machines to check oil retention of these clutch circuits or wet air tests with regulated air and oil for leakage.

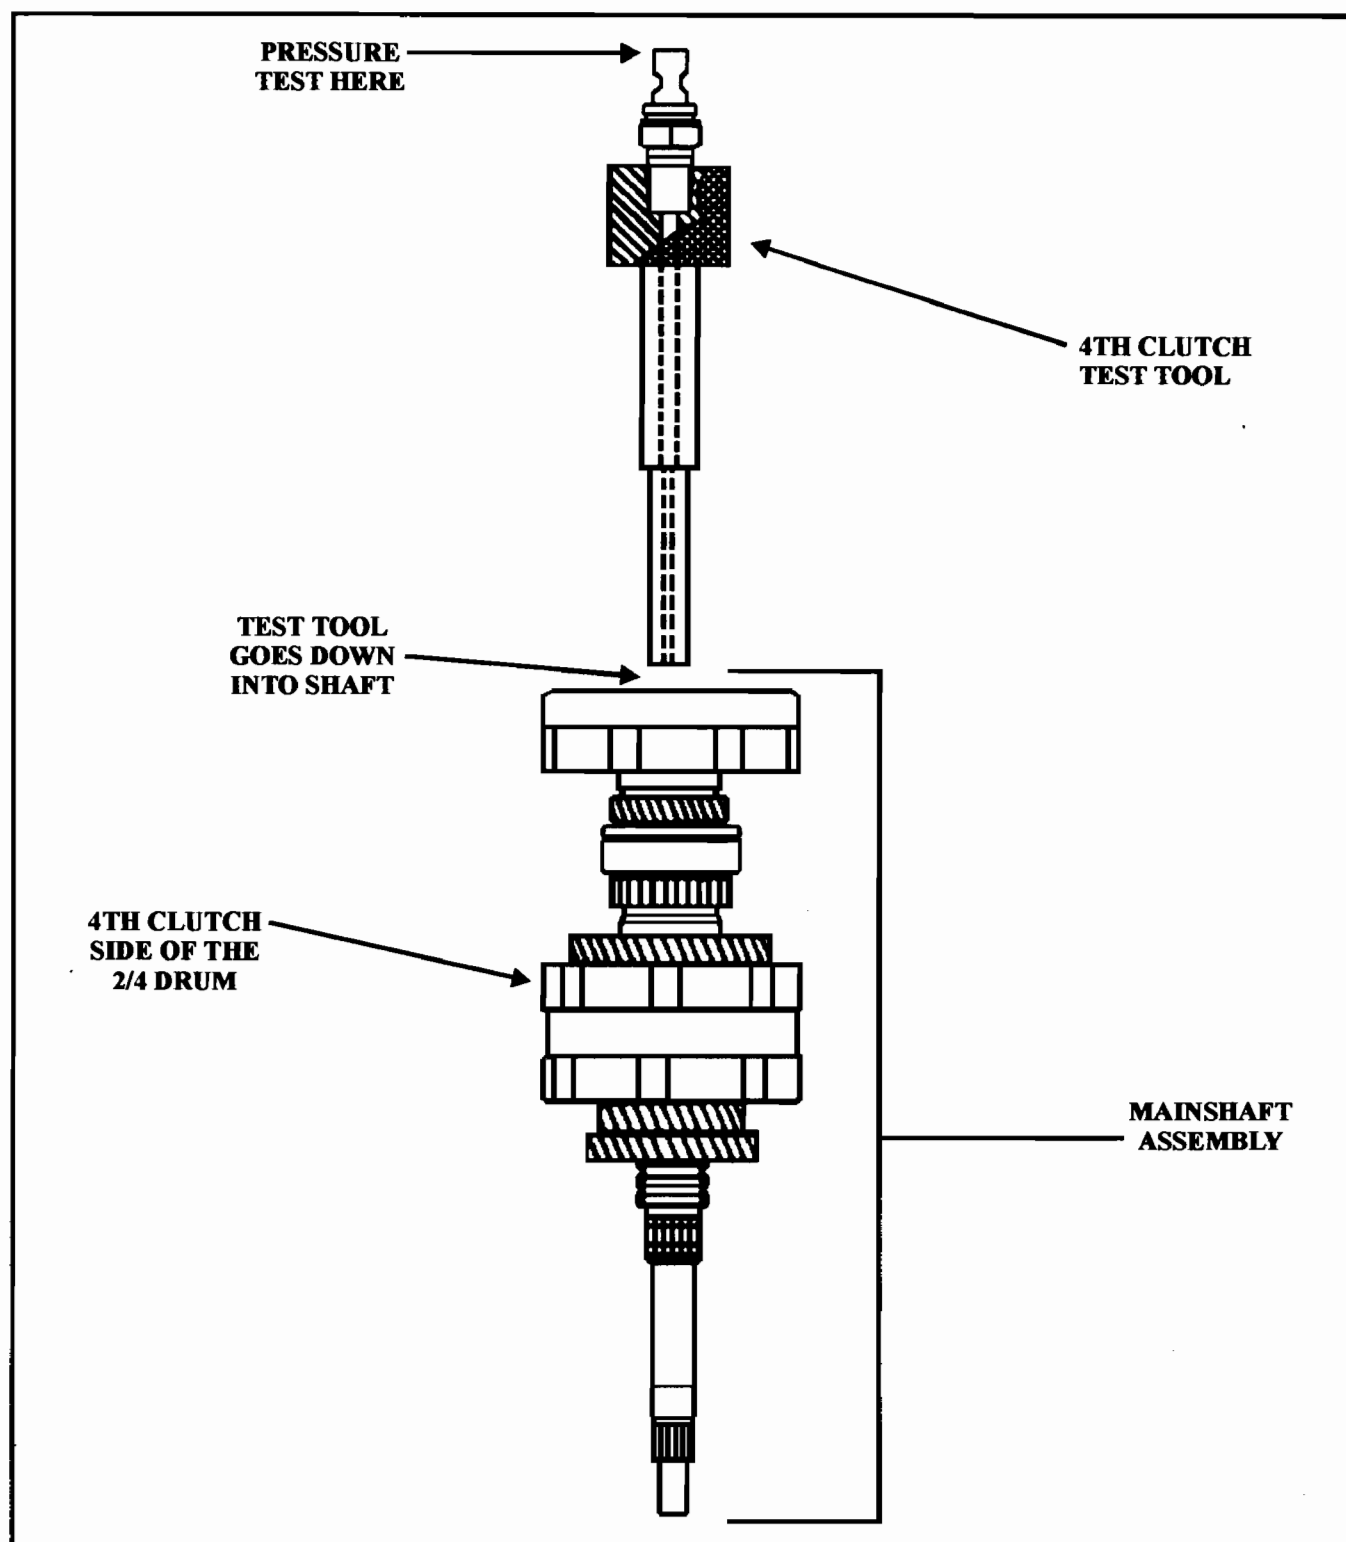
Figure 2

HONDA/ACURA
CHRONIC INTERNAL LEAKS

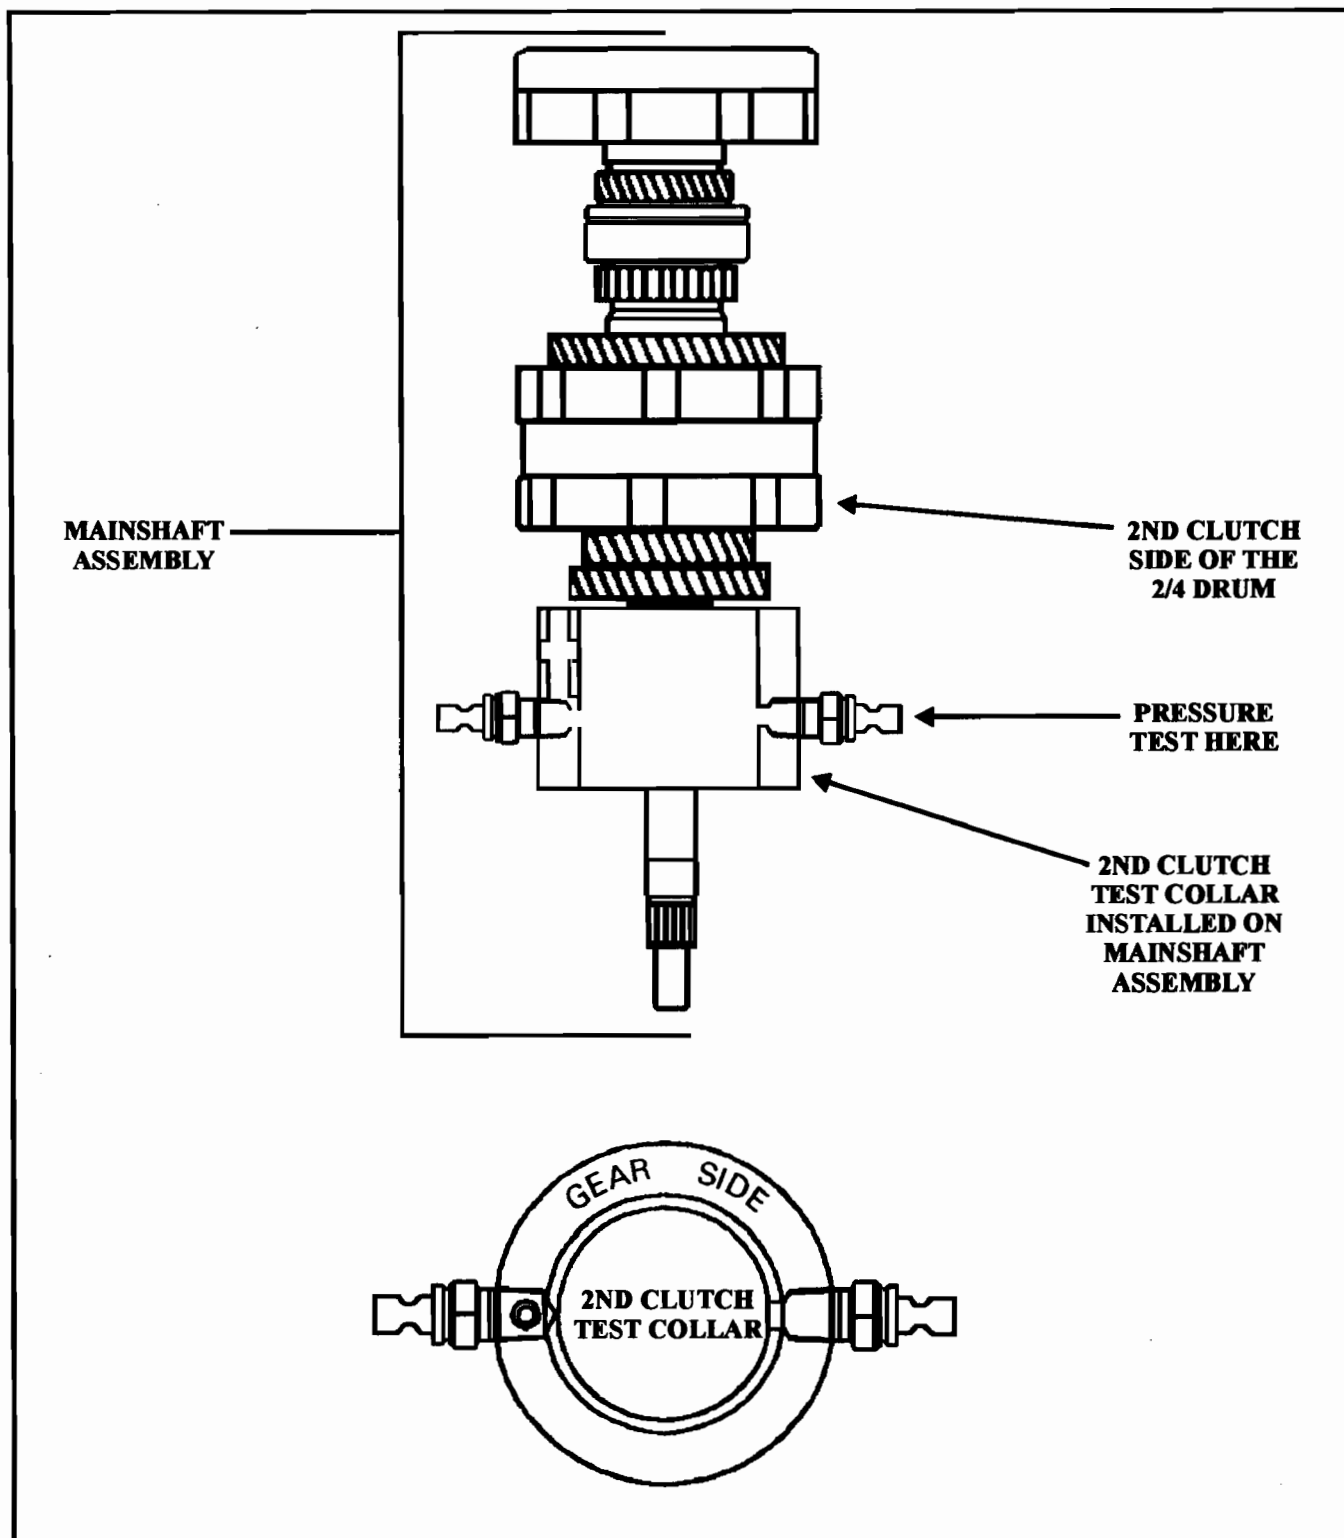
Figure 3

HONDA/ACURA
CHRONIC INTERNAL LEAKS

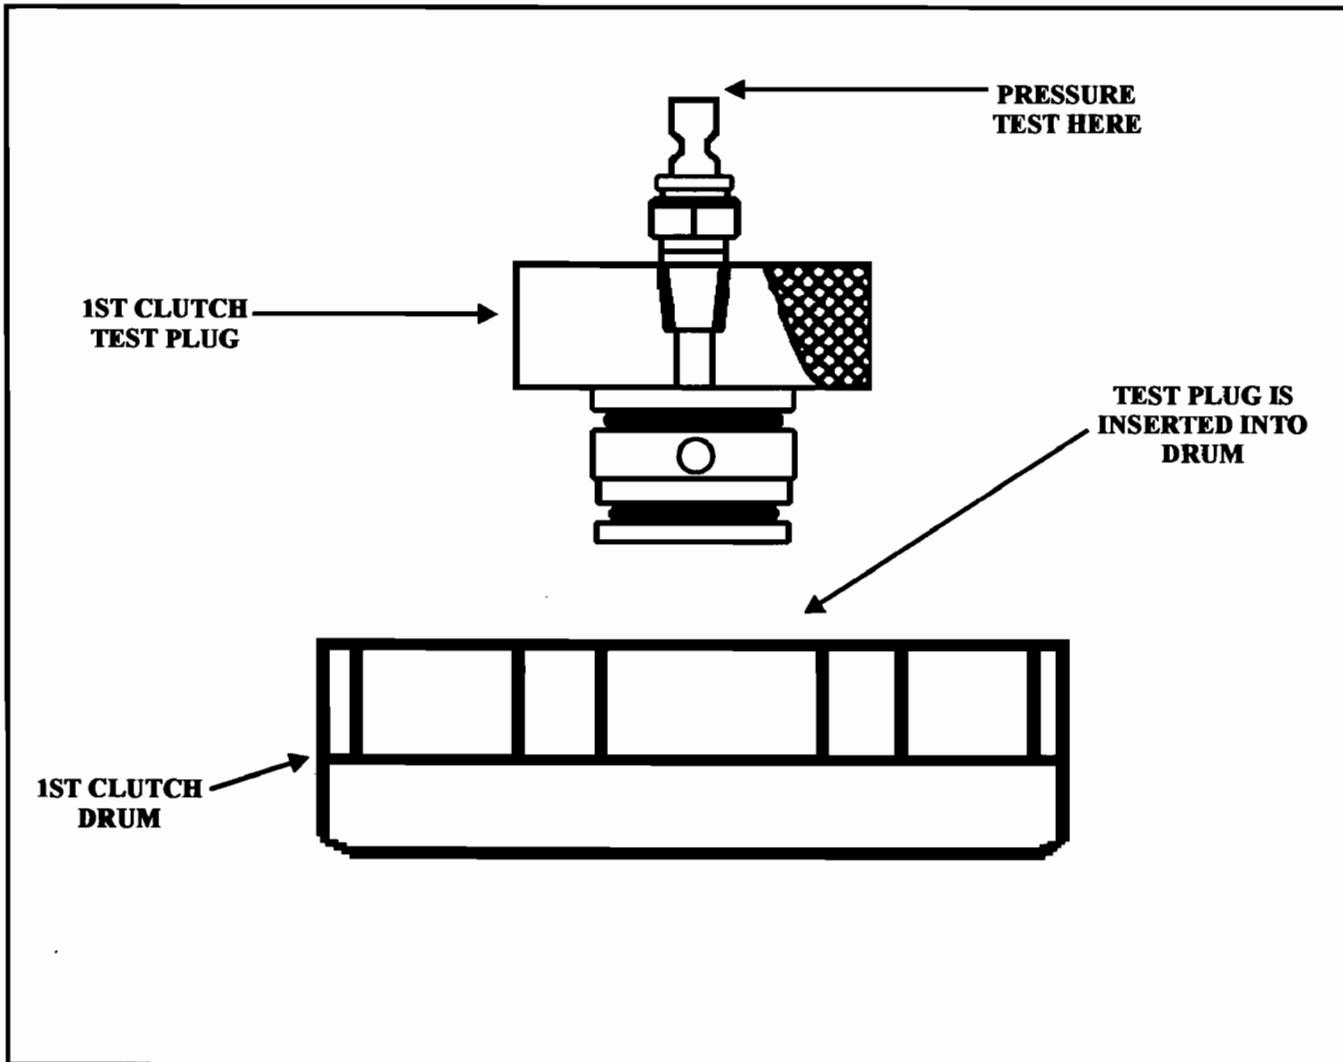
Figure 4

HONDA/ACURA
CHRONIC INTERNAL LEAKS

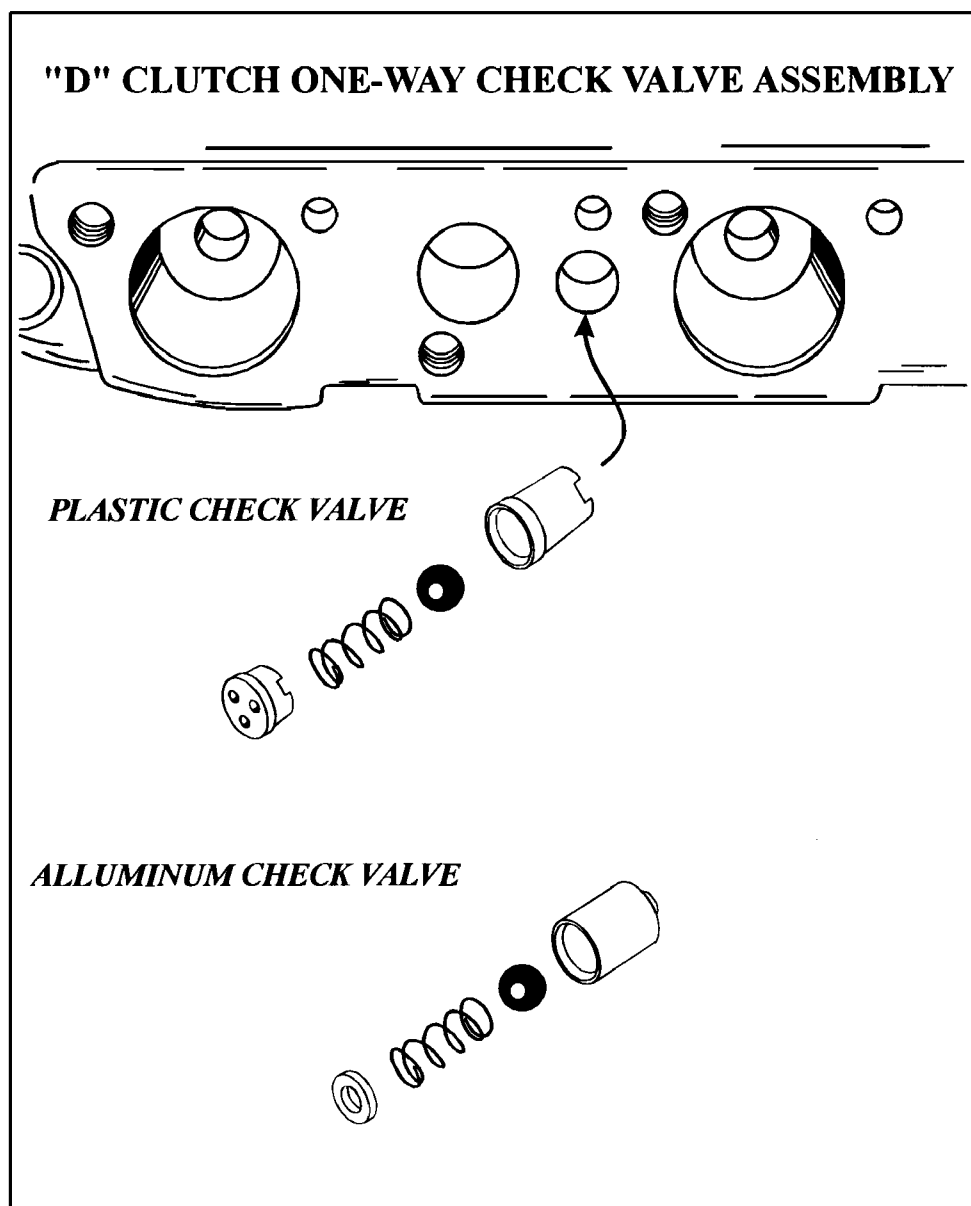
Figure 2

CAUSE: The cause may be, the plastic "D" Clutch One-way Check Valve assembly located in the Lower Rear valve body, shown in Figure 1, may be broken allowing the "B" Clutch (Reverse Input Clutch) to be on while the "D" Clutch (Low / Reverse Clutch) is on in 1st gear.

CORRECTION: Replace the "D" Clutch One-way Check Valve assembly , as shown in Figure 2, with a new "Alluminum" check valve assembly offered by *Mario Aristides. Ph.# 305-666-3544 or Fax# 305-666-8238.*

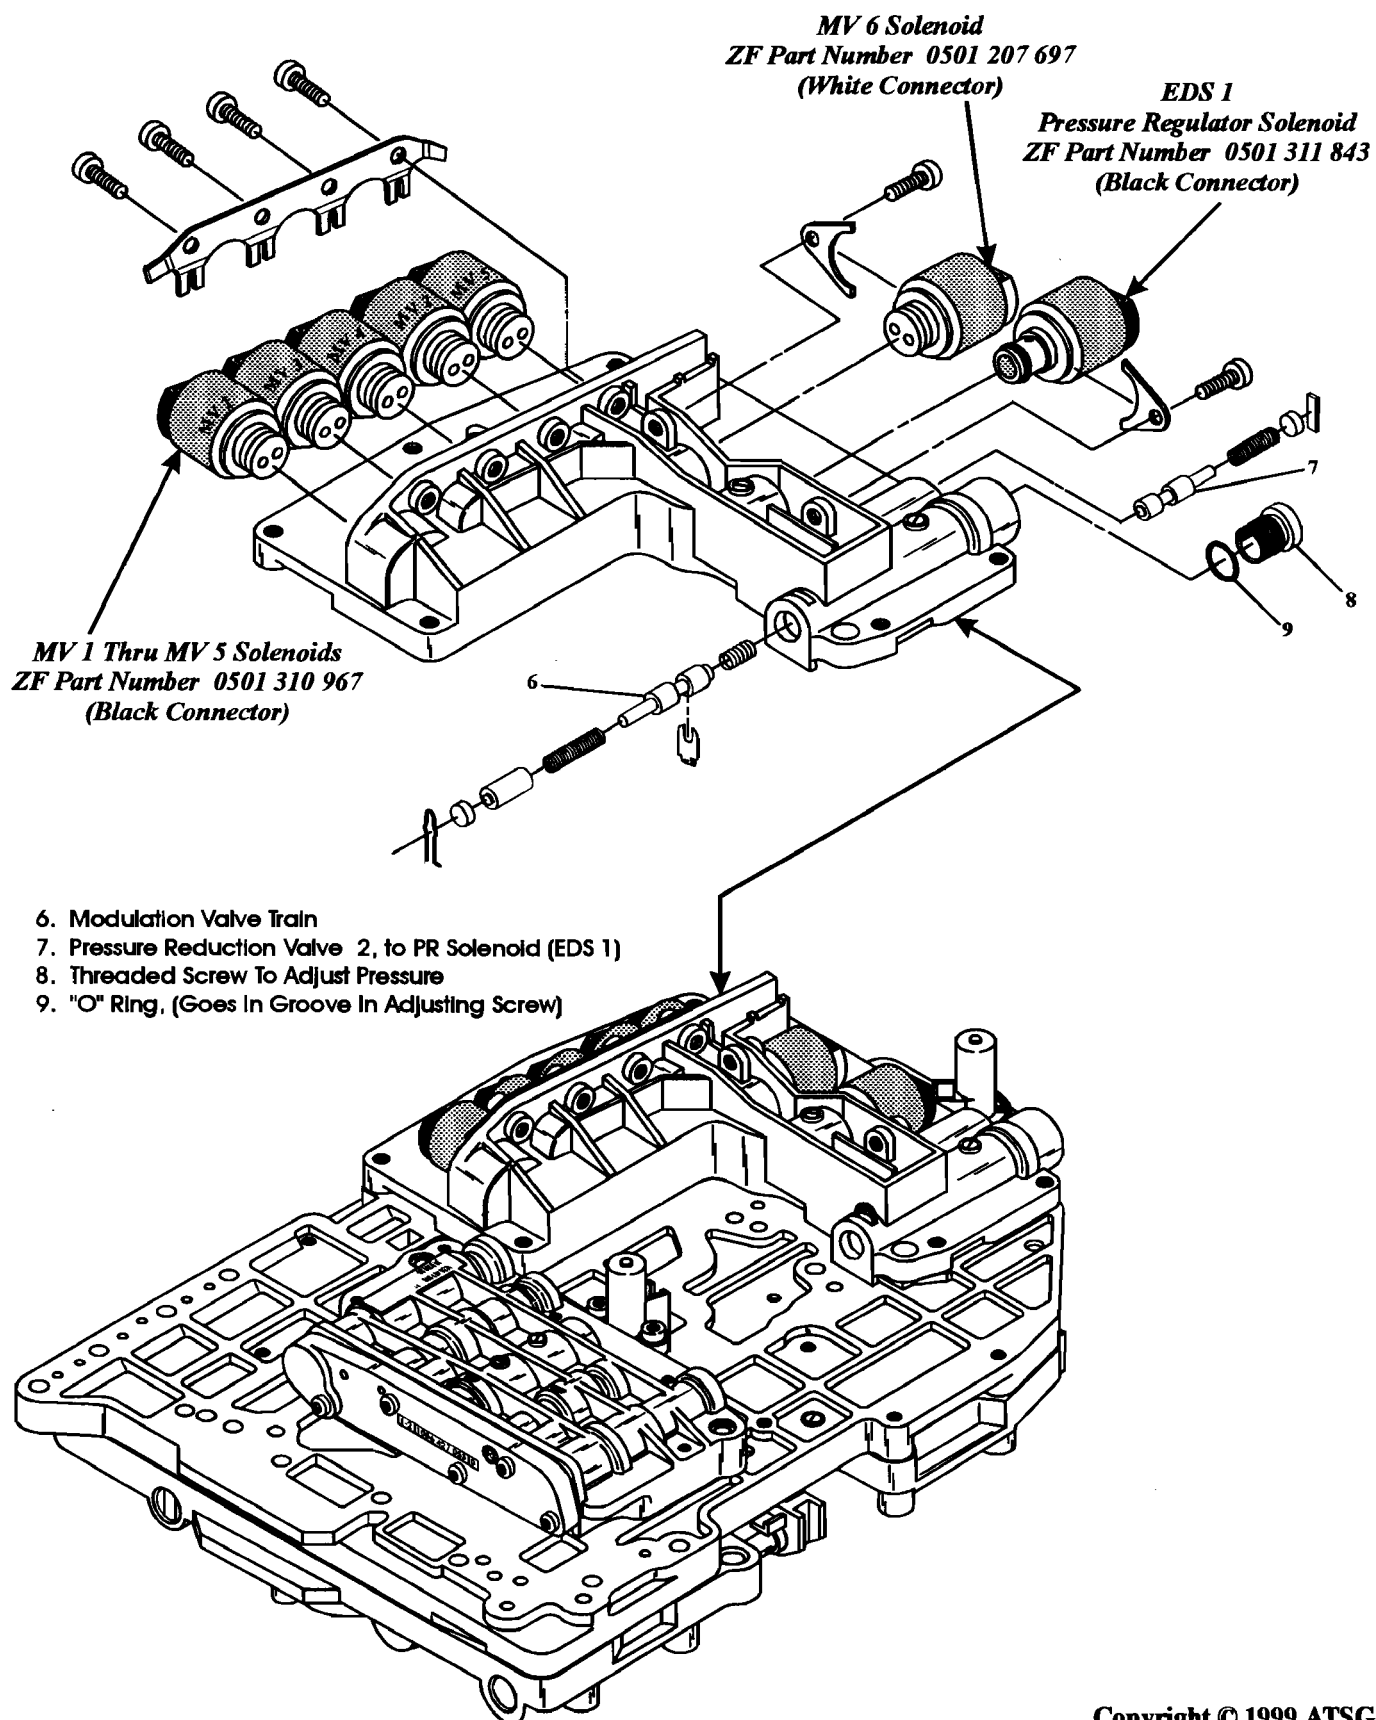
Refer to Figure 15 for exploded view of the Solenoid Valve Body with valves identified. Notice that there is an "O" ring on the adjustment screw that goes in the groove.

SOLENOID VALVE BODY

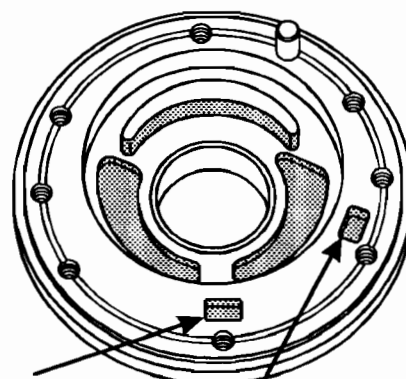
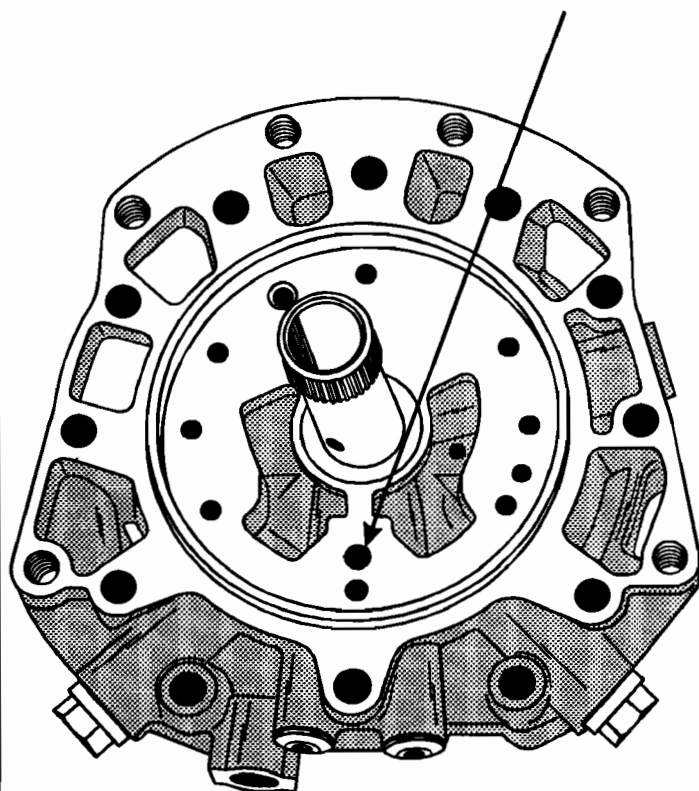
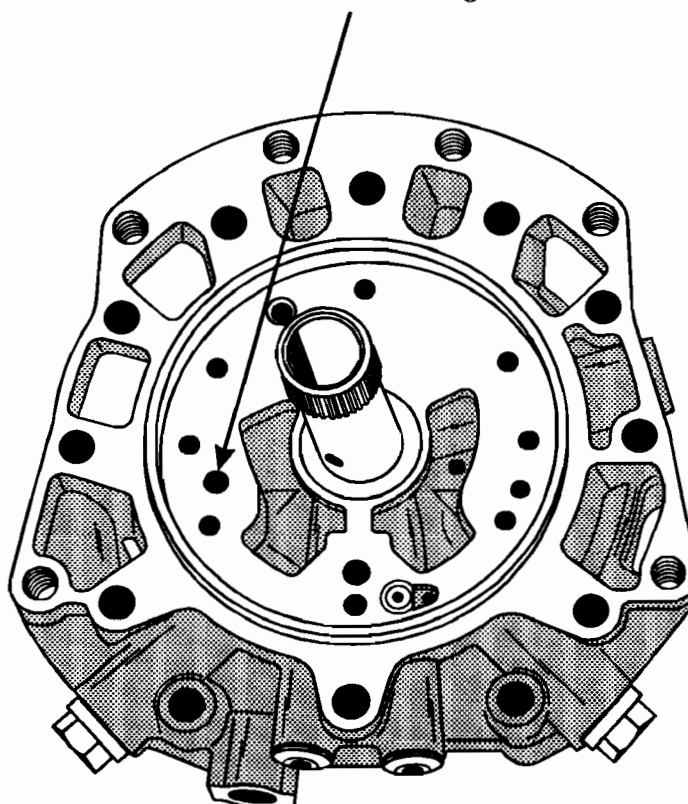
Figure 1

- COMPLAINT:** Repeated leakage of transmission fluid, coming from the bell housing area on any vehicle equipped with the ZF-4HP-22 or 4HP-24 transmission. This usually occurs after rebuild coupled with pump parts replacement that was necessary.

- CAUSE:** Beginning in the 1989 model year, ZF implemented a running change to the pump body and pump cover on both the 4HP-22 and the 4HP-24 transmissions. This change was made to increase the durability of the converter bushing with increased lubrication to this area. This change however, created the possibility of mis-matching parts that are not compatible. The 1st design pump body and cover has the drain back hole located at the 6 O'clock position and the drain back passage was moved to the 3 O'clock position in the 2nd design pump body and cover, as shown in Figure 1. Installing 2nd design pump body with 1st design pump cover will completely block the drain back passage and the repeated leakage will occur. Installing the 1st design pump body with 2nd design pump cover will function, but you will now be faced with the possibility of premature converter bushing failure.

2ND DESIGN PUMP BODY
AND PUMP COVER

- CORRECTION:** To eliminate both conditions, always install the 2nd design pump body, matched with the 2nd design pump cover, as shown in Figure 1.

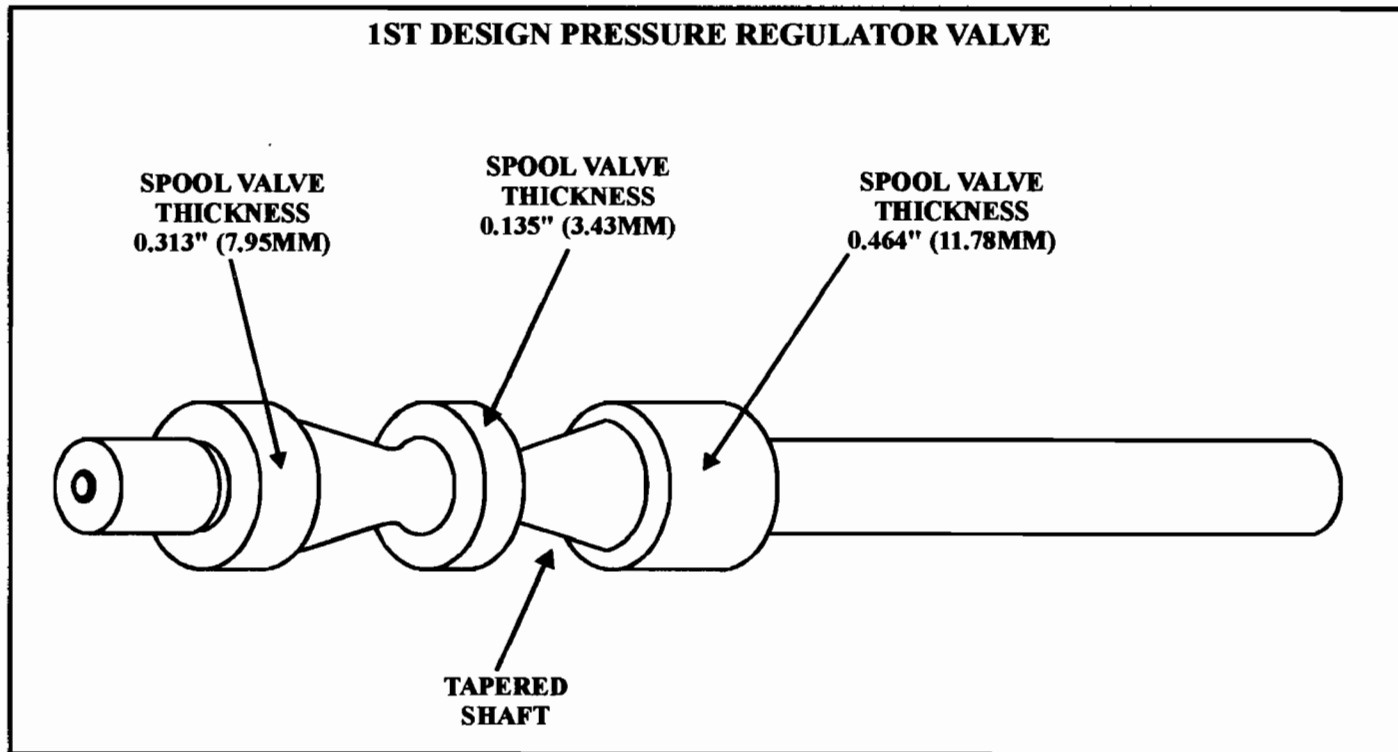
Figure 2

PRESSURE REGULATOR VALVE CHANGE

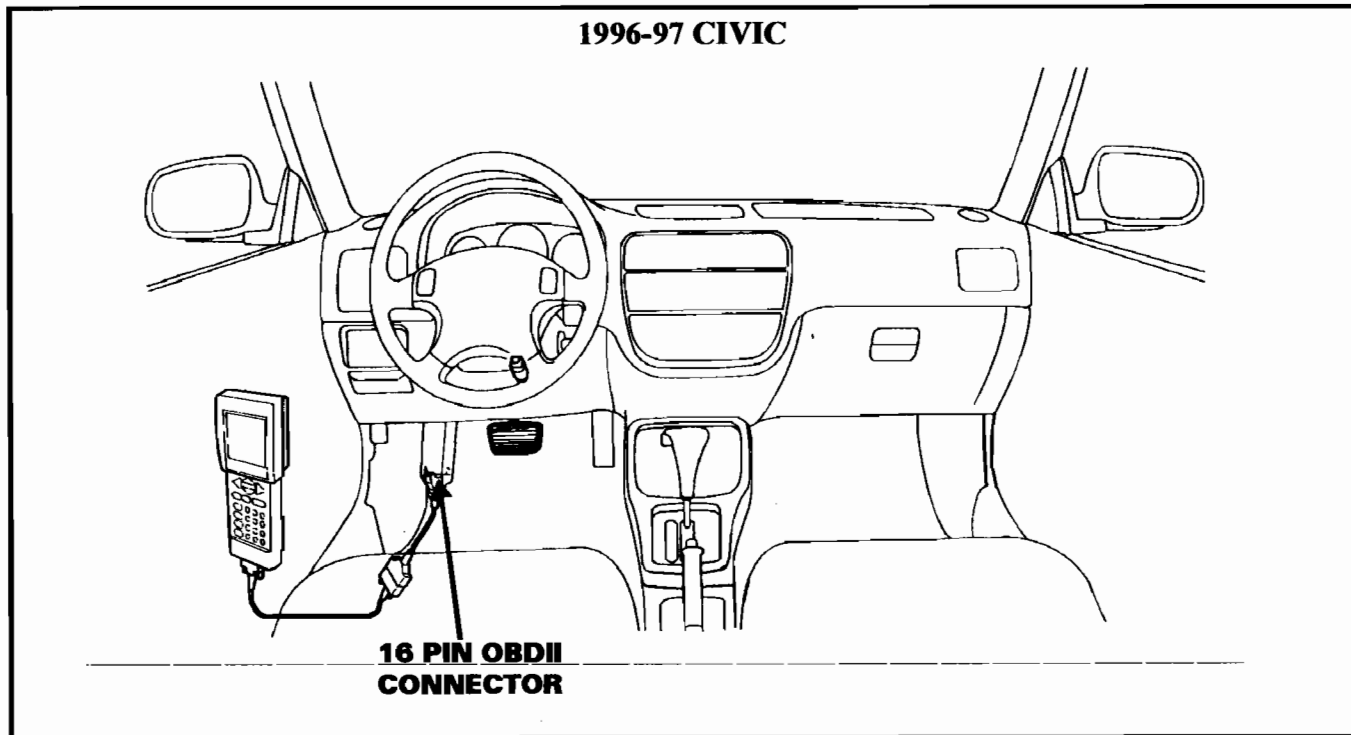
Figure 1

CAUSE: The above mentioned vehicles received marginally defective thermostats from the factory which will keep the engine from reaching normal operating temperature in cold weather which in turn will inhibit converter clutch application.

NO TCC APPLICATION

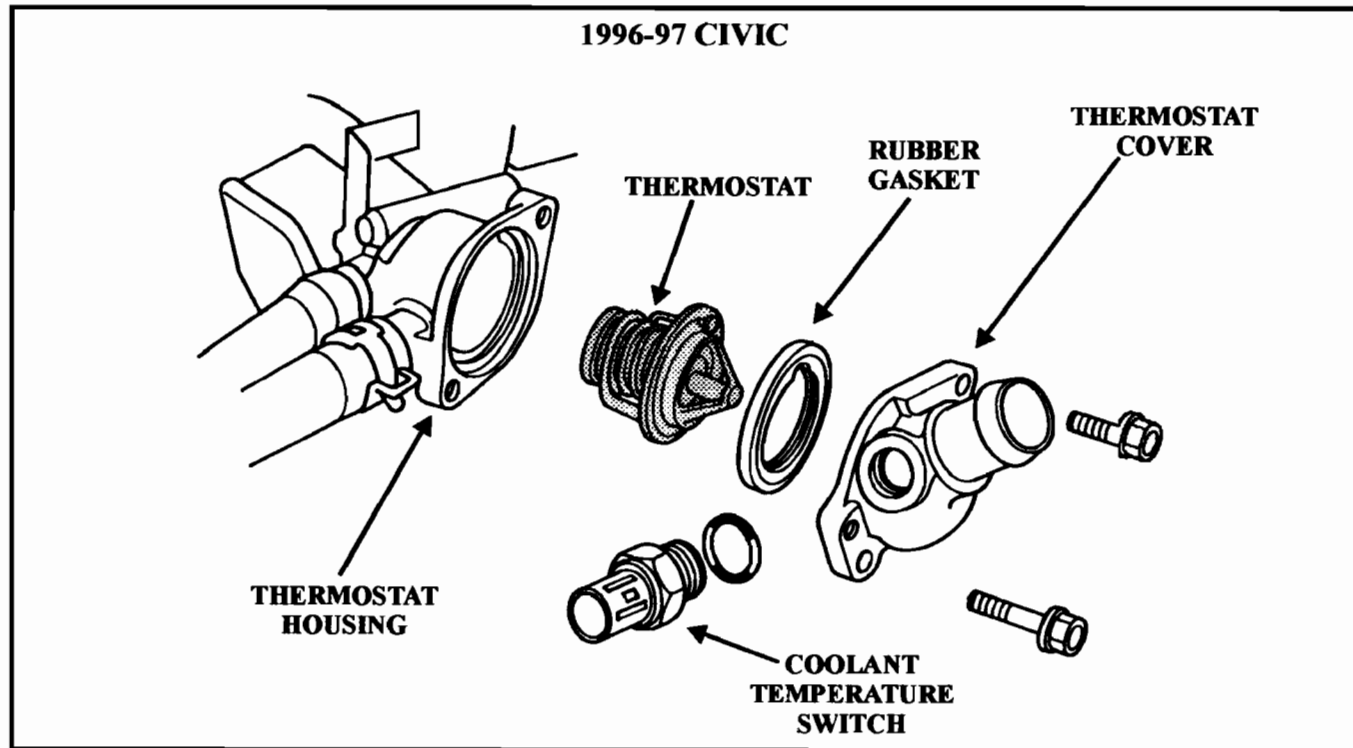
Figure 3

NO TCC APPLICATION

(5) If steps 3 and 4 have failed to reach the desired values, replace the thermostat, (Refer to Figures 3 and 4), and refill radiator with a 50/50 mix of antifreeze and water.

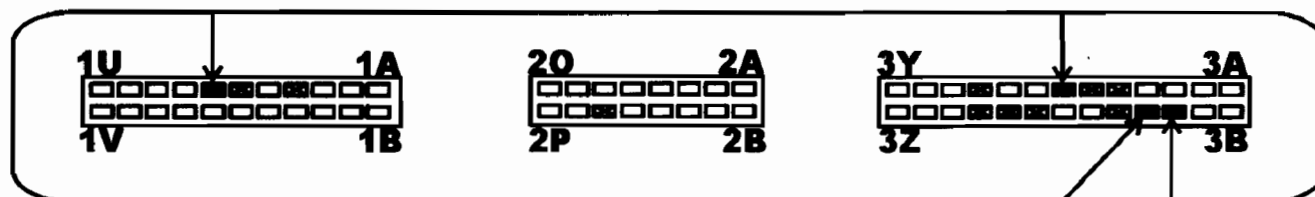
WIRE SIDE VIEW OF CONNECTORS

Code 6 VSS - An approximate 5 DC volt pulse should be seen on the green wire with a red tracer going to terminal 1M as the wheels rotate slowly. An averages of 2.5 volts will be observed during driving conditions.

Code 25 FPCS - Unplug connector 3. With the key on and engine of, system voltage should be observed on the green wire going to terminal 3M.

Code 55 PSG - Plug connector three back into the PCM. Set meter to AC volts and probe the white wire at terminal 3F with the positive meter lead. Probe the red wire at terminal 3H with the negative lead. AC volts should be observed as soon as the vehicle is started and should increase proportionally with turbine shaft rotation.

CORRECTION: The PCM can be located below the front center of the console (See Figure 1). From here all three circuits can be verified for proper operation before changing the computer (See Figure 2). If the following checks are observed, change the PCM.

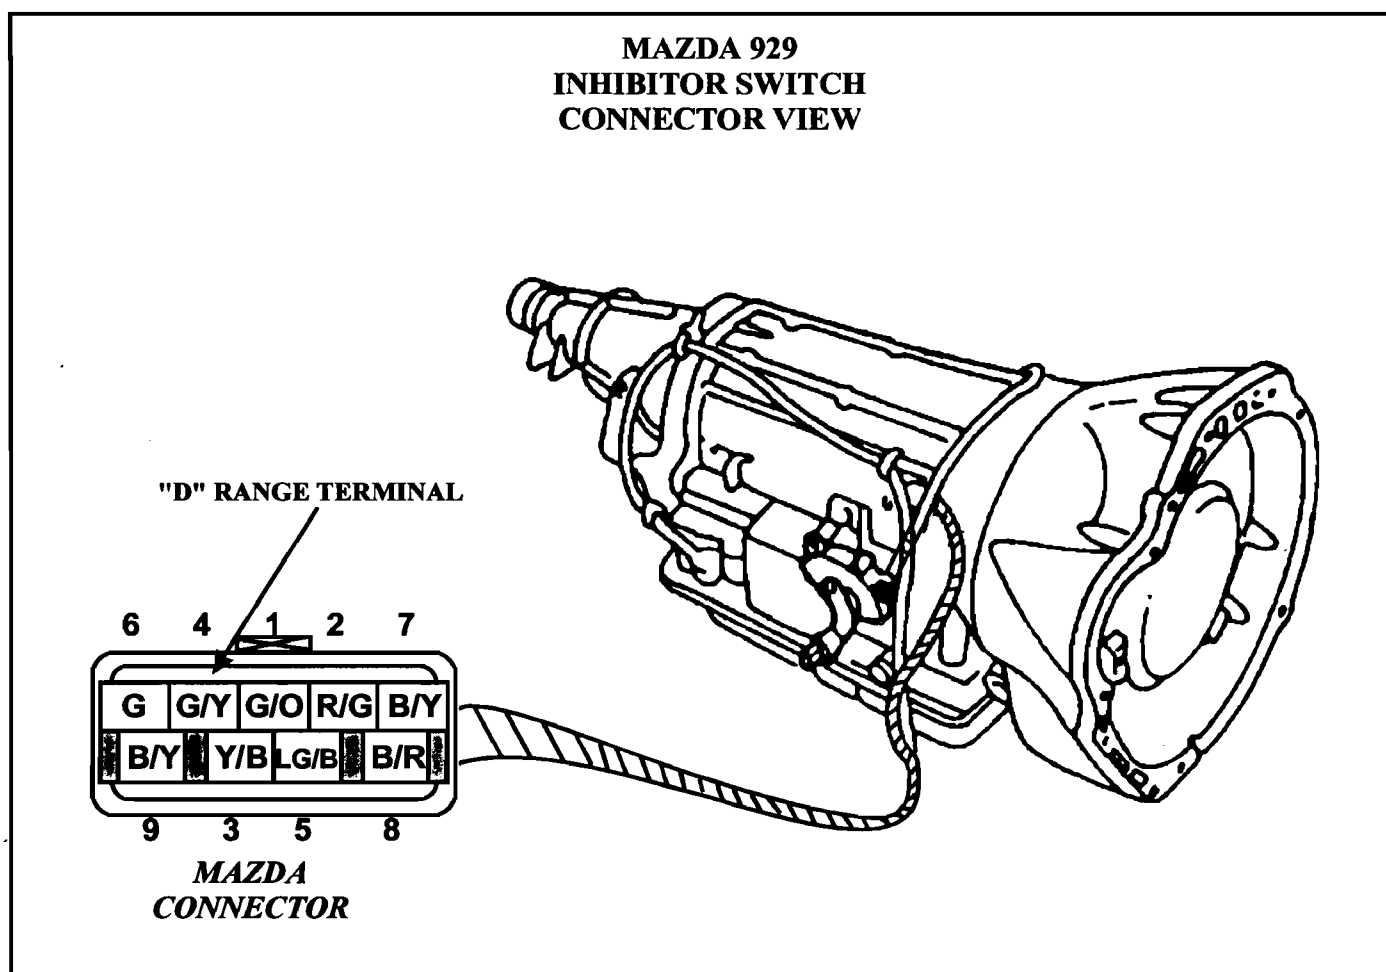
COMPLAINT: Vehicle exhibits a **NO FOURTH** gear shift or it Cycles from 4th to 3rd to 4th gear. This condition may appear before and/or after rebuild.

CAUSE: The cause may be, a loose or broken "D" Range signal wire to the inhibitor switch, bent or corroded pin in the harness connector, or a defective inhibitor switch. The switch may be determined to be defective and is replaced only to go bad again. *A bad starter solenoid can draw excessive amps causing damage to the inhibitor switch (See Figure 2 and 3).* If the battery voltage is acceptable yet cranking is slow or lazy, this may indicate a bad starter solenoid.

CORRECTION: Check the Inhibitor Switch and the connectors for any bent and/or corroded pins. If the connectors and pins are good, inspect the wires in the harness, from the computer to the inhibitor switch, for any opens or shorts to ground using your DVOM. Refer to Figure 1 for the inhibitor switch view of the connector which identifies the "D" Range signal terminal. If the inhibitor switch has been replaced and has been damaged after starting the vehicle, the starter solenoid may need to be replaced.

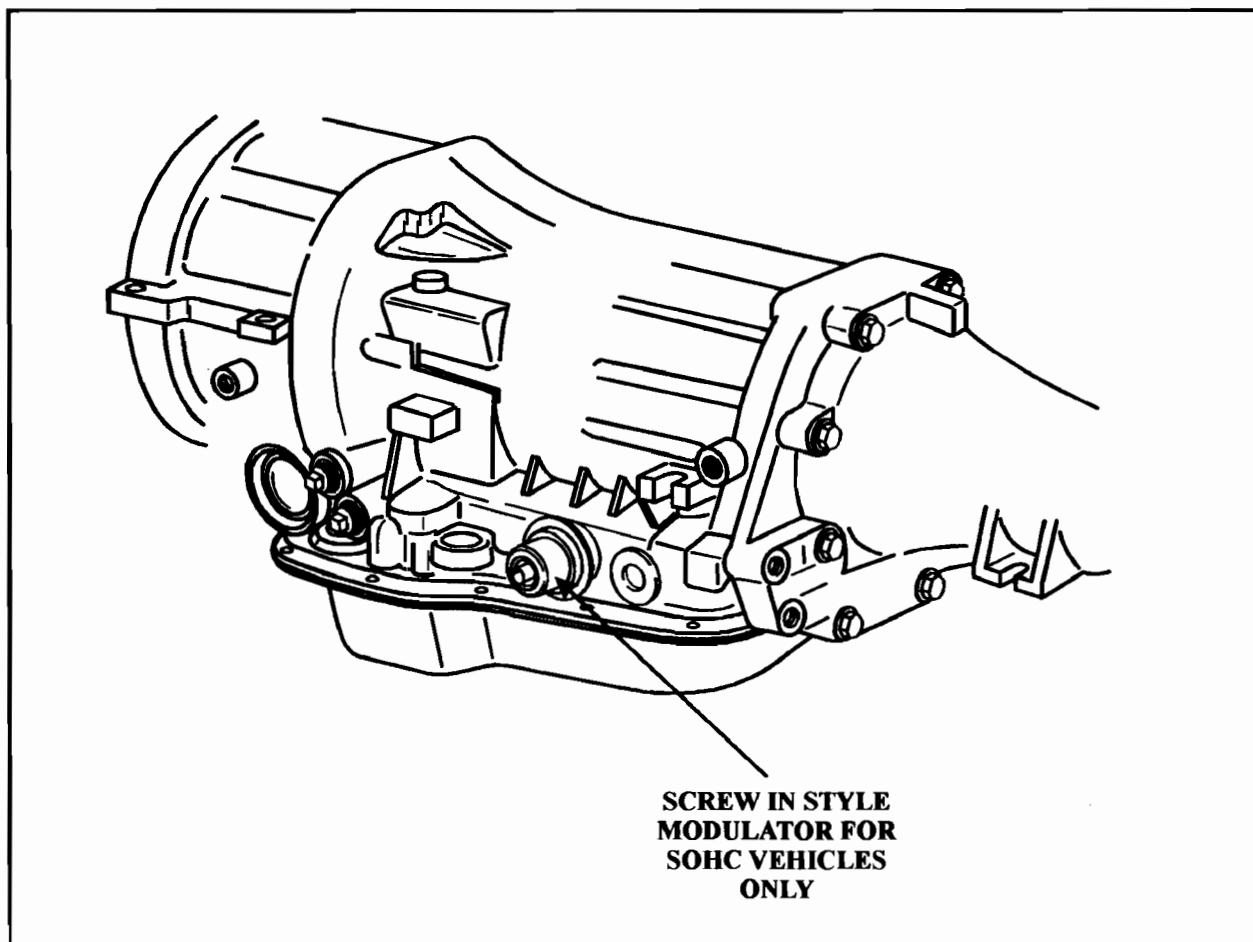
Figure 1

CAUSE: One cause may be that the wrong transmission was installed into the vehicle. DOHC vehicles must use an N4AEL transmission with a push in modulator while SOHC vehicles uses a transmission with a screw in modulator (See Figure 1). If a screw in modulator style unit was placed into a vehicle with a DOHC engine, soft, flared or drawn out shifts may be observed.

CORRECTION: Install the correct transmission.

INFORMATION: SOHC Modulator (Screw in type) part number is BV04-19-823A
DOHC Modulator (Push in type) part number is BT07-19-823
