"2000" SEMINAR INFORMATION "FIXES TODAY FOR Y2K"

"2000" SEMINAR INFORMATION
"FIXES TODAY FOR Y2K"

INTRODUCTION

The third and final manual for the "FIXES TODAY FOR Y2K" seminar continues to present practical information on Chrysler vehicles. The seminar and this manual ends with the Import section.

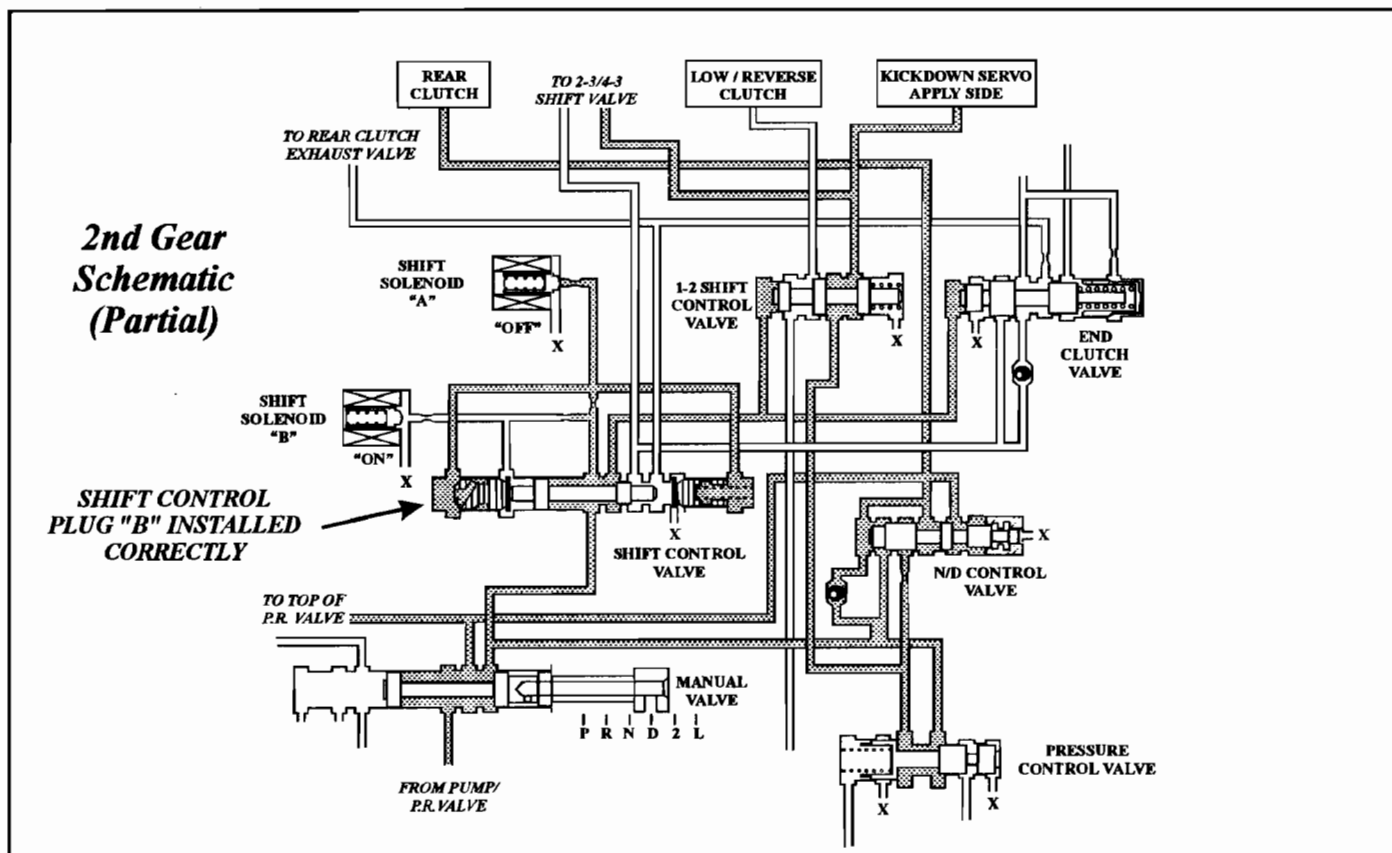
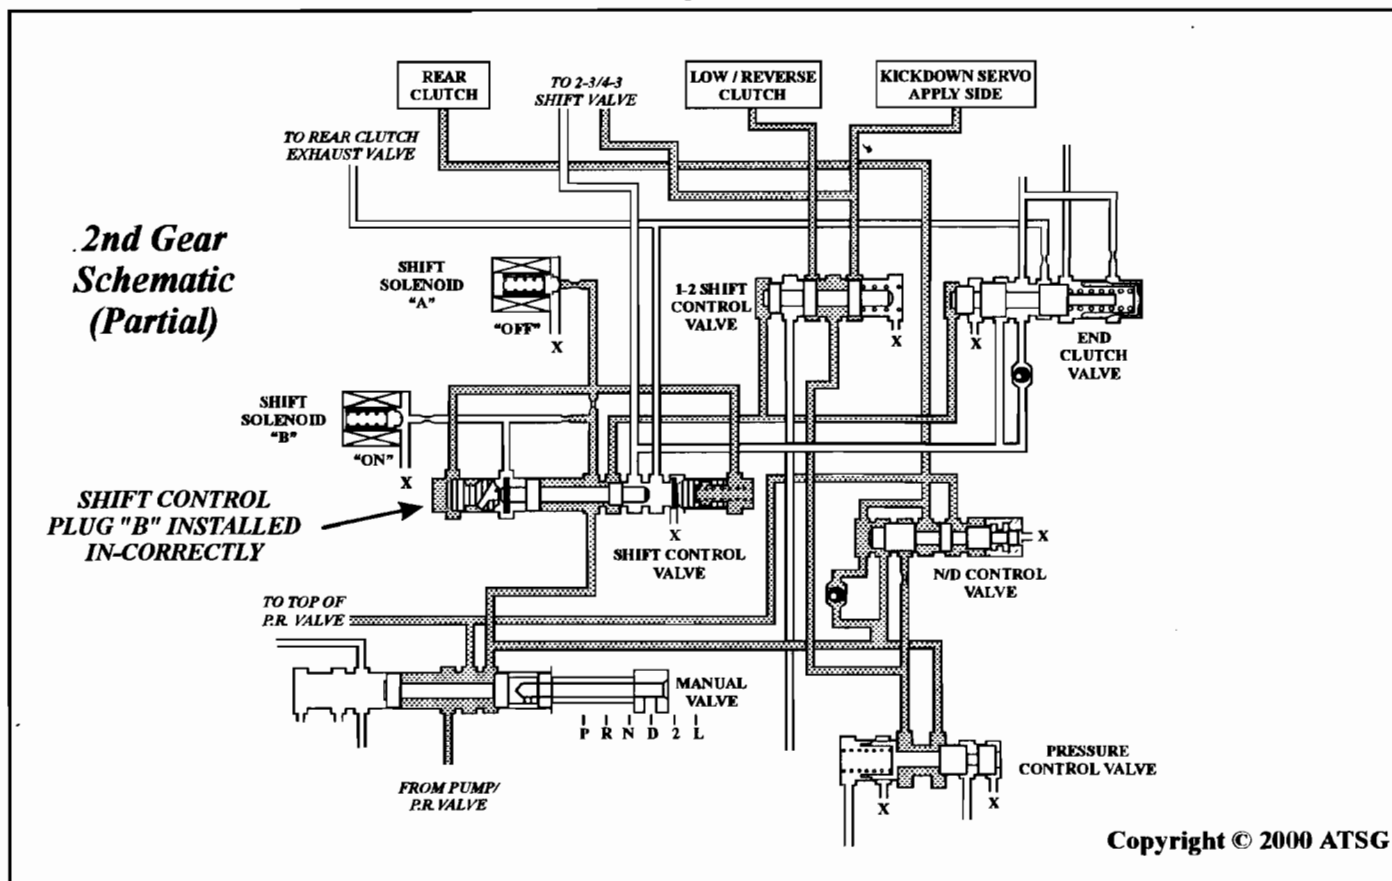
COMPLAINT: After overhaul, vehicles equipped with KM 4 speed automatic transaxles may exhibit a binding condition on the 1-2 upshift.

CAUSE: The cause may be, shift control valve plug "B" was installed backwards. When plug "B" is installed backwards, solenoid "A" pressure is not able to move plug "B" and the shift control valve far enough to completely stroke the 1-2 shift valve. This allows the Low-Reverse clutch to come on while the 1-2 upshift is taking place. Refer to Figures 2 and 3.

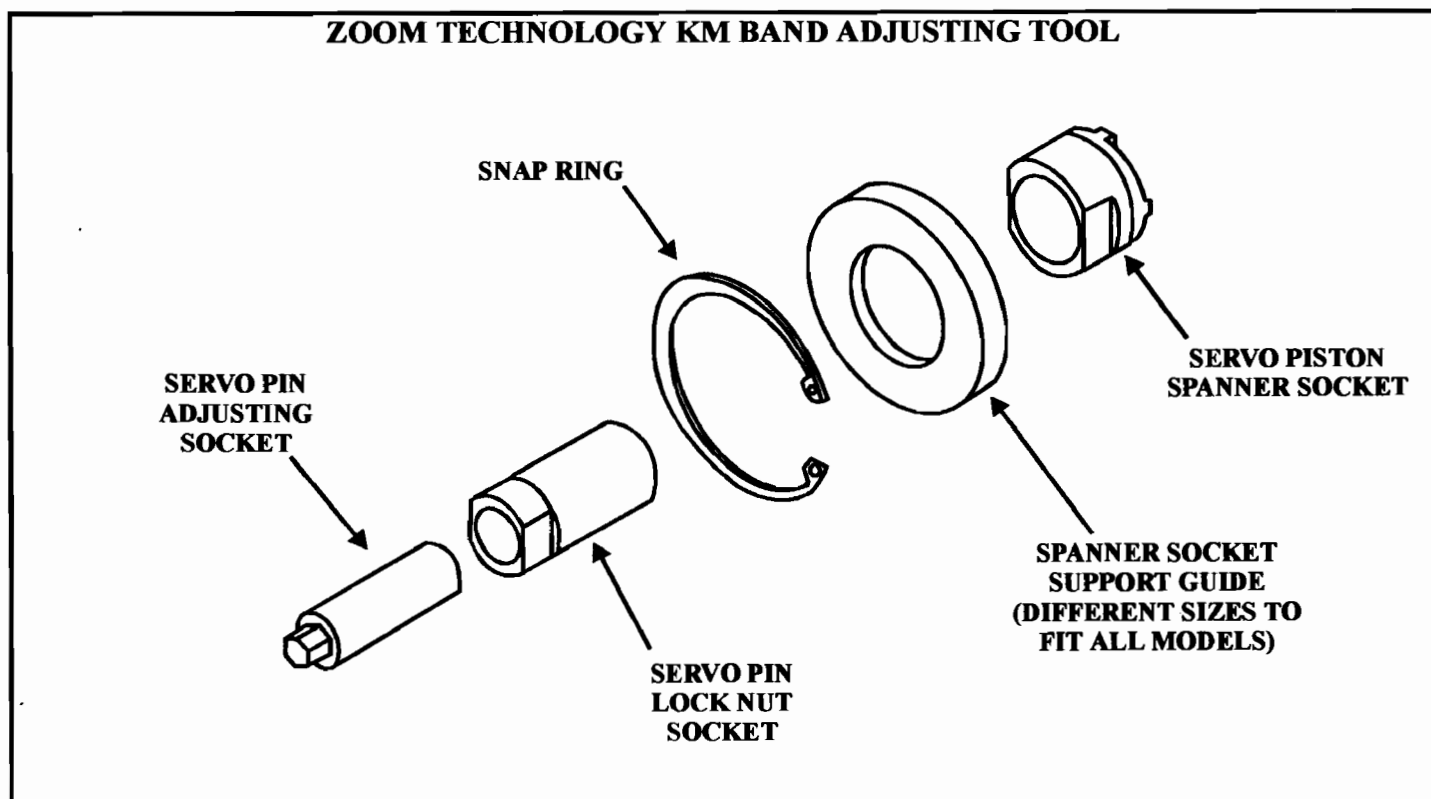
Figure 1

COMPLAINT: The transmission exhibits a soft or flared 1-2 and/or 3-4 shift, or a cut loose 4-3 or 3-2 kickdown. A new band may have been installed during overhaul but, in many cases, the band adjustment is not done, which could leave the band with too loose an adjustment causing the above complaints and possibly premature failure of the band.

CAUSE: Adjusting the band in a KM transmission, at best, is a difficult procedure without the proper tool. It is almost impossible to keep the servo assembly from turning while attempting to loosen or tighten the adjustment rod lock nut or the adjustment rod itself without the use of the OE adjustment tool.

The Zoom KM band adjusting tool components are shown in figure 1 and in figure 2 the tool is shown installed on the servo assembly. Figures 3 and 4 show the band adjustment being made.

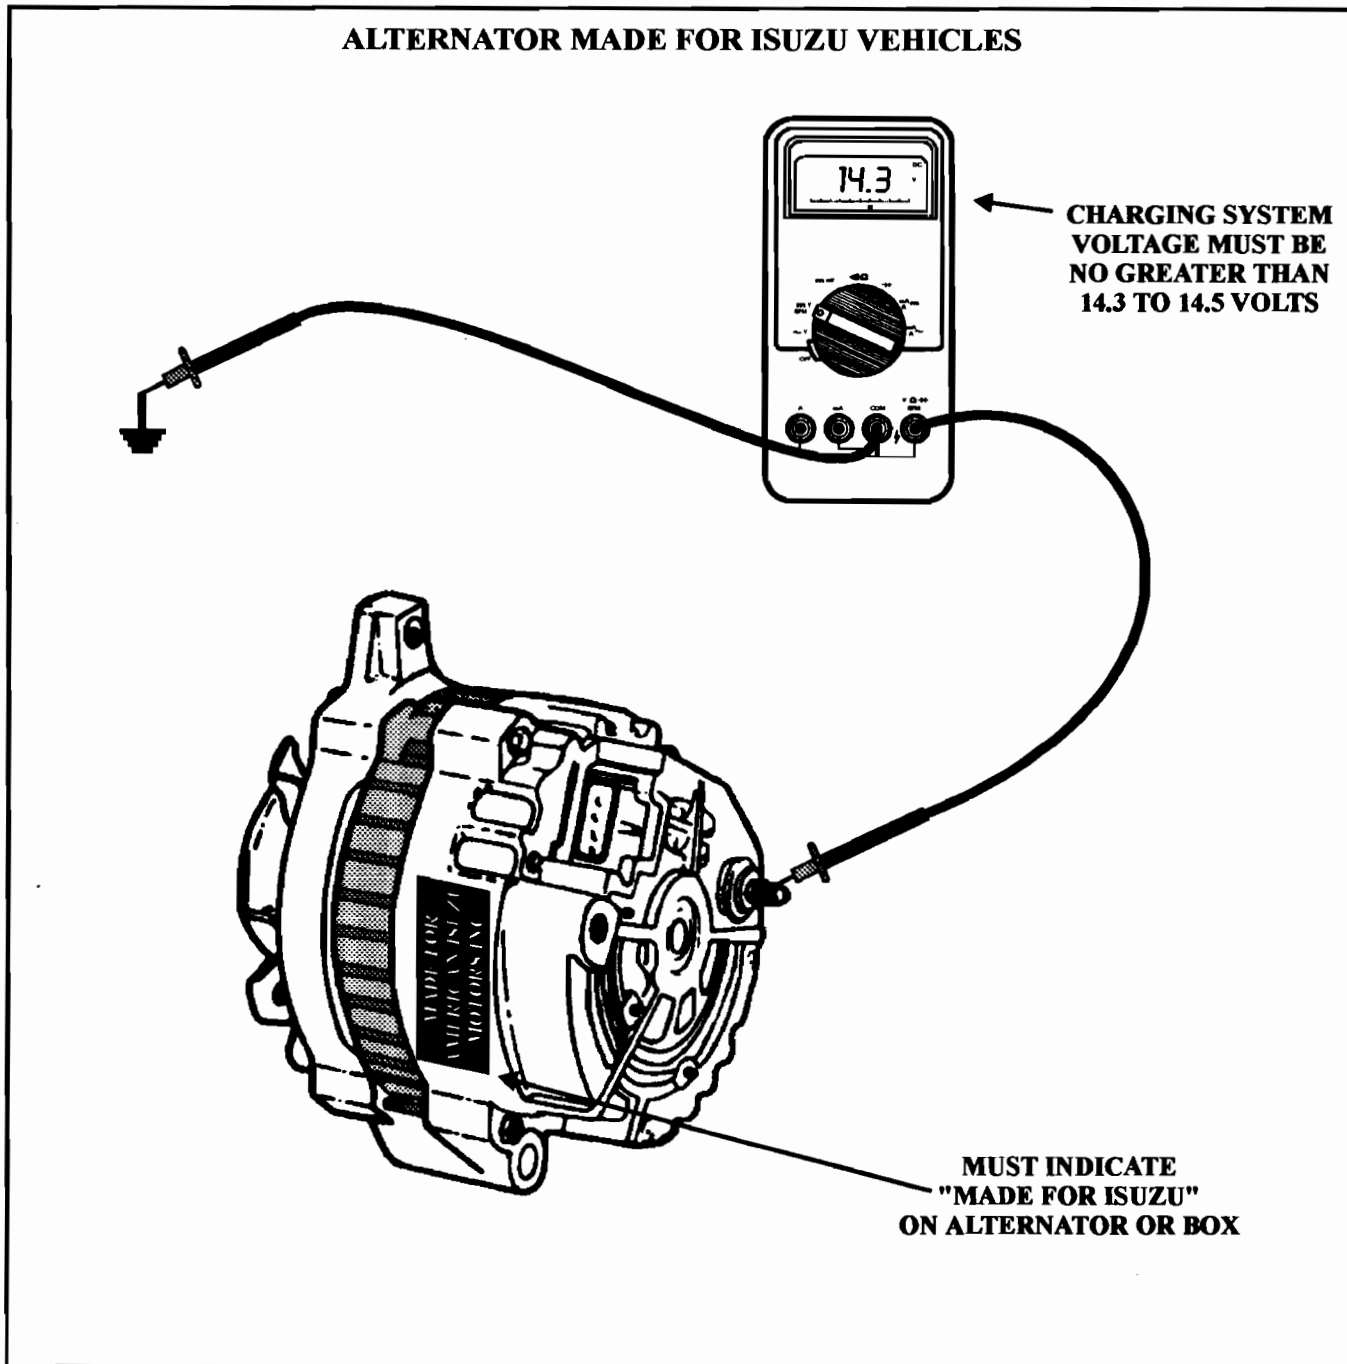
Figure 2

ALTERNATOR MADE FOR ISUZU VEHICLES

- (1) Make certain the battery is in good condition. When alternator replacement becomes necessary, make certain that the replacement alternator indicates somewhere on the alternator or its package "**MADE FOR AMERICAN ISUZU MOTORS**" as shown in figure 2 in order to avoid an over voltage problem for the TCM. Utilizing the chart shown in figure 3, insure shift and band apply circuit integrity by checking solenoid resistance which will also check the integrity of the case connector.
- (2) Check the main TCM ground circuits as illustrated in figures 4,5,6, and 7, using the voltage drop method, including the negative battery cable condition at both ends and repair any ground circuit that contains 300 millivolts or higher. (Refer to figure 8)

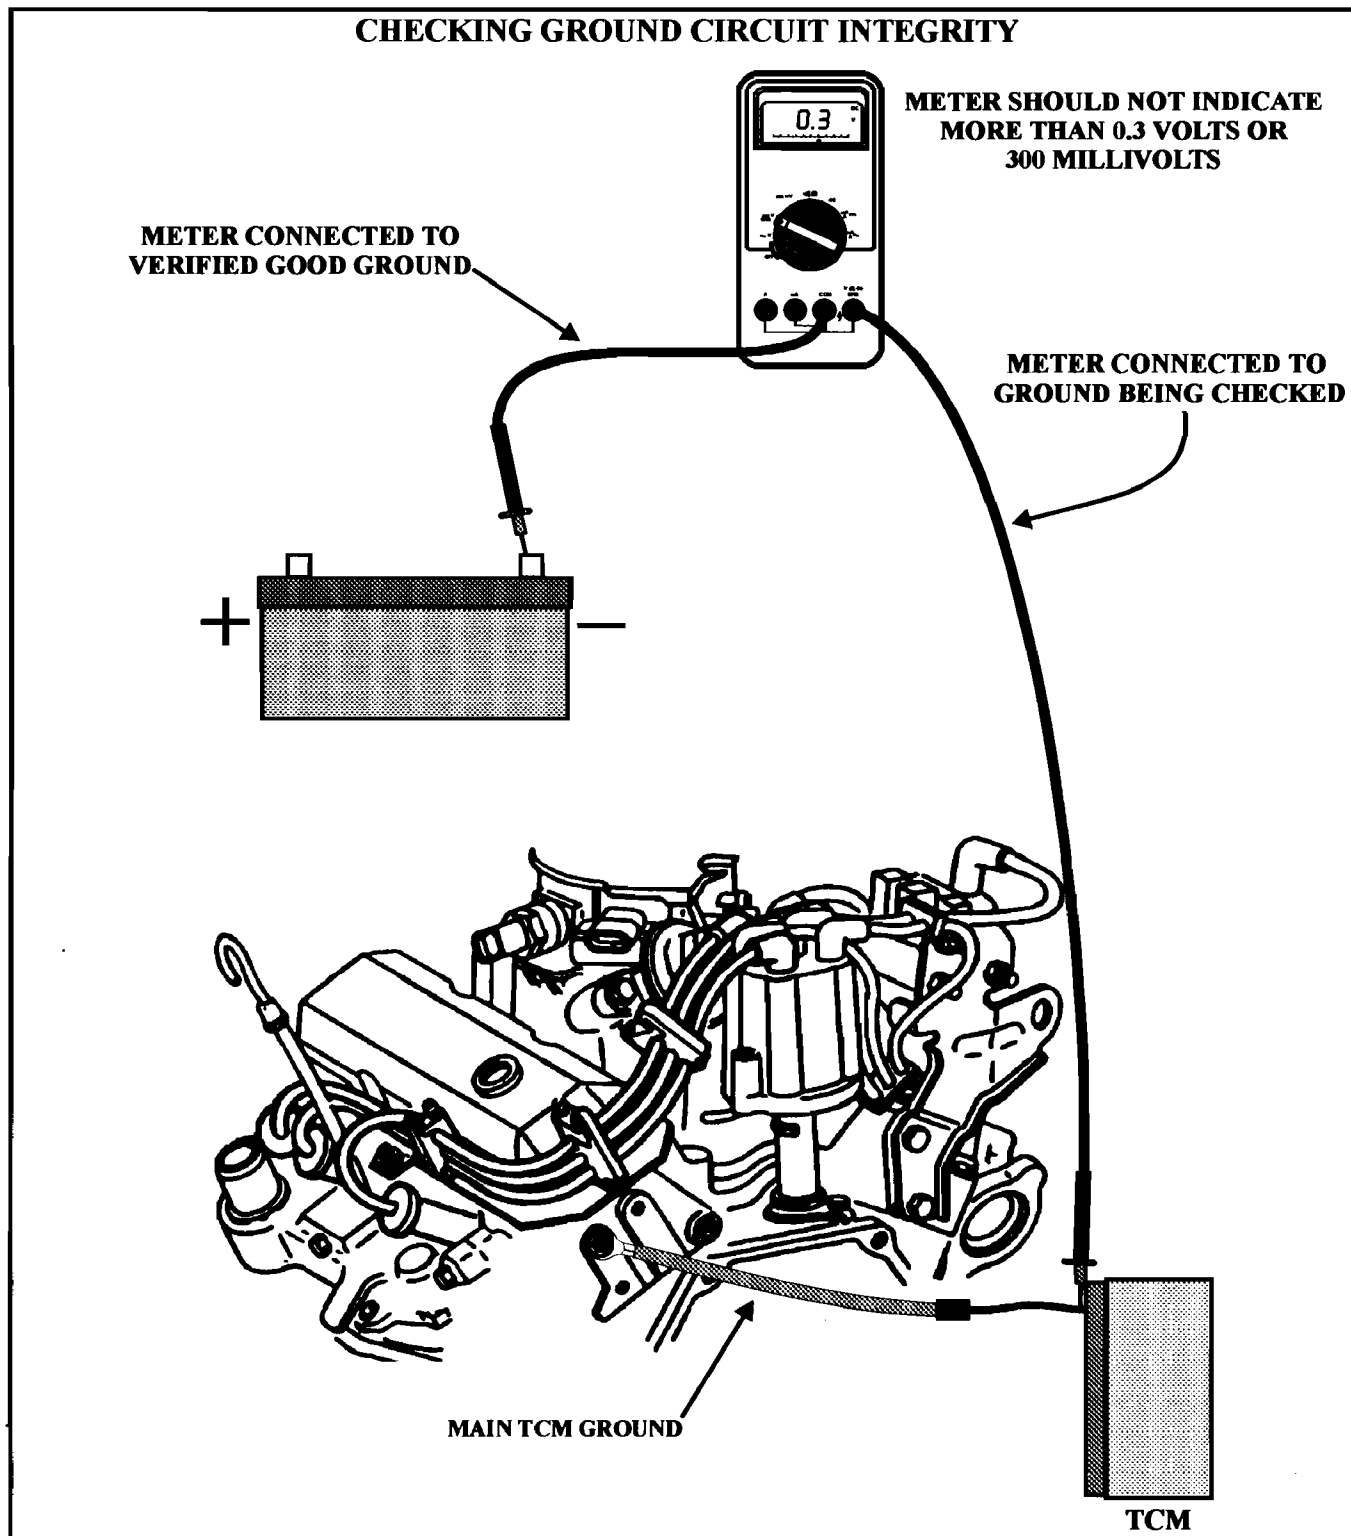
Figure 8

CHECKING GROUND CIRCUIT INTEGRITY
