"FIXES ARE GREAT IN '98"

INTRODUCTION

AUTOMATIC TRANSMISSION SERVICE GROUP
9200 S. DADELAND BLVD.
SUITE 720
MIAMI, FL 33156
(305) 670-4161

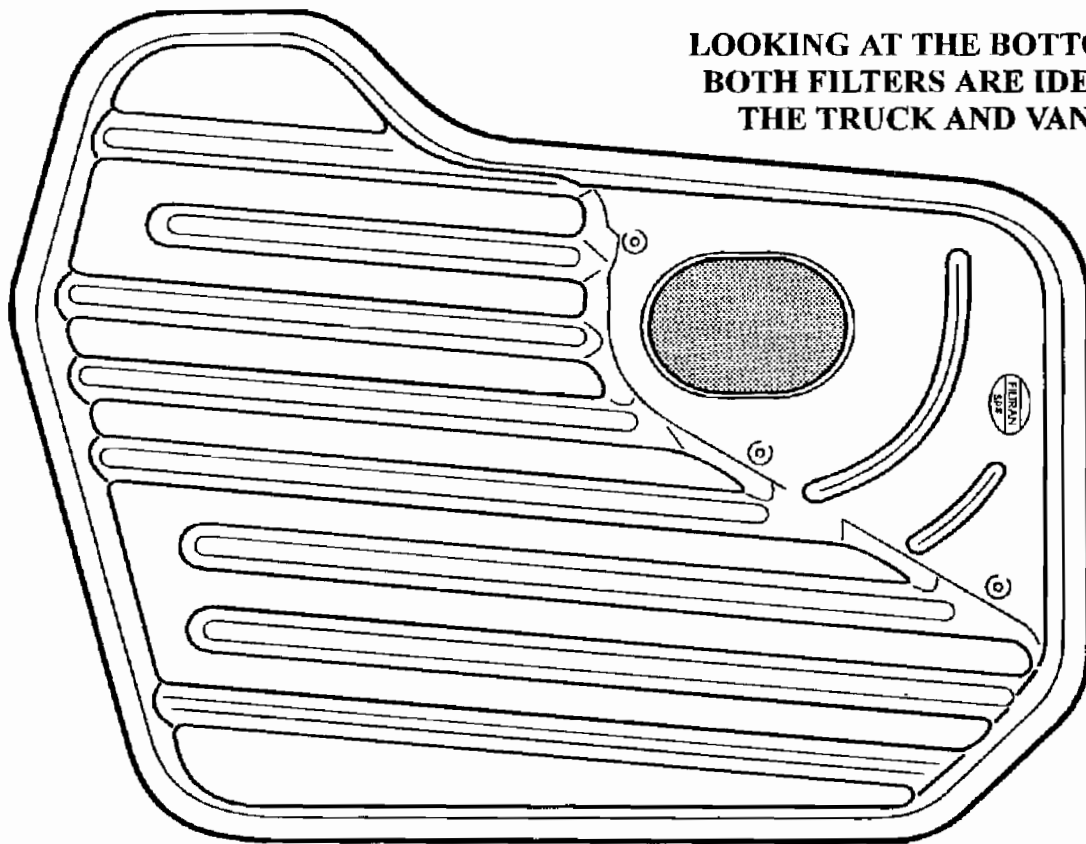
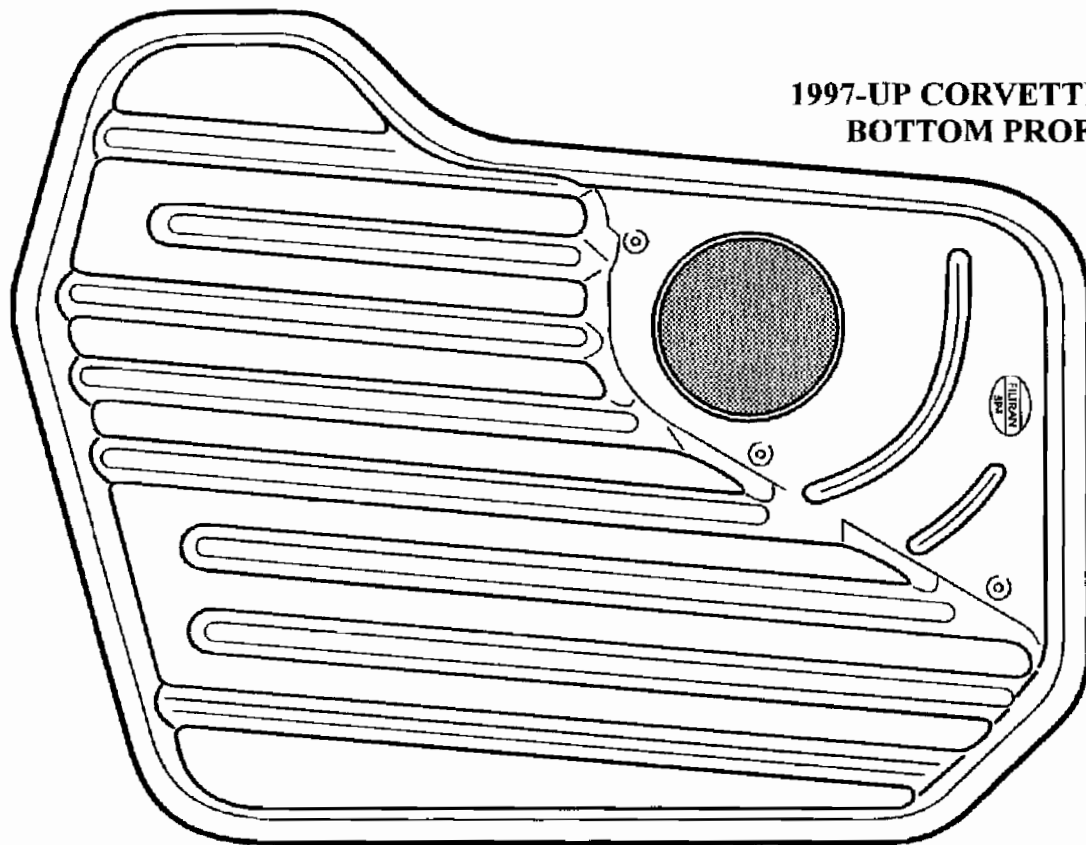
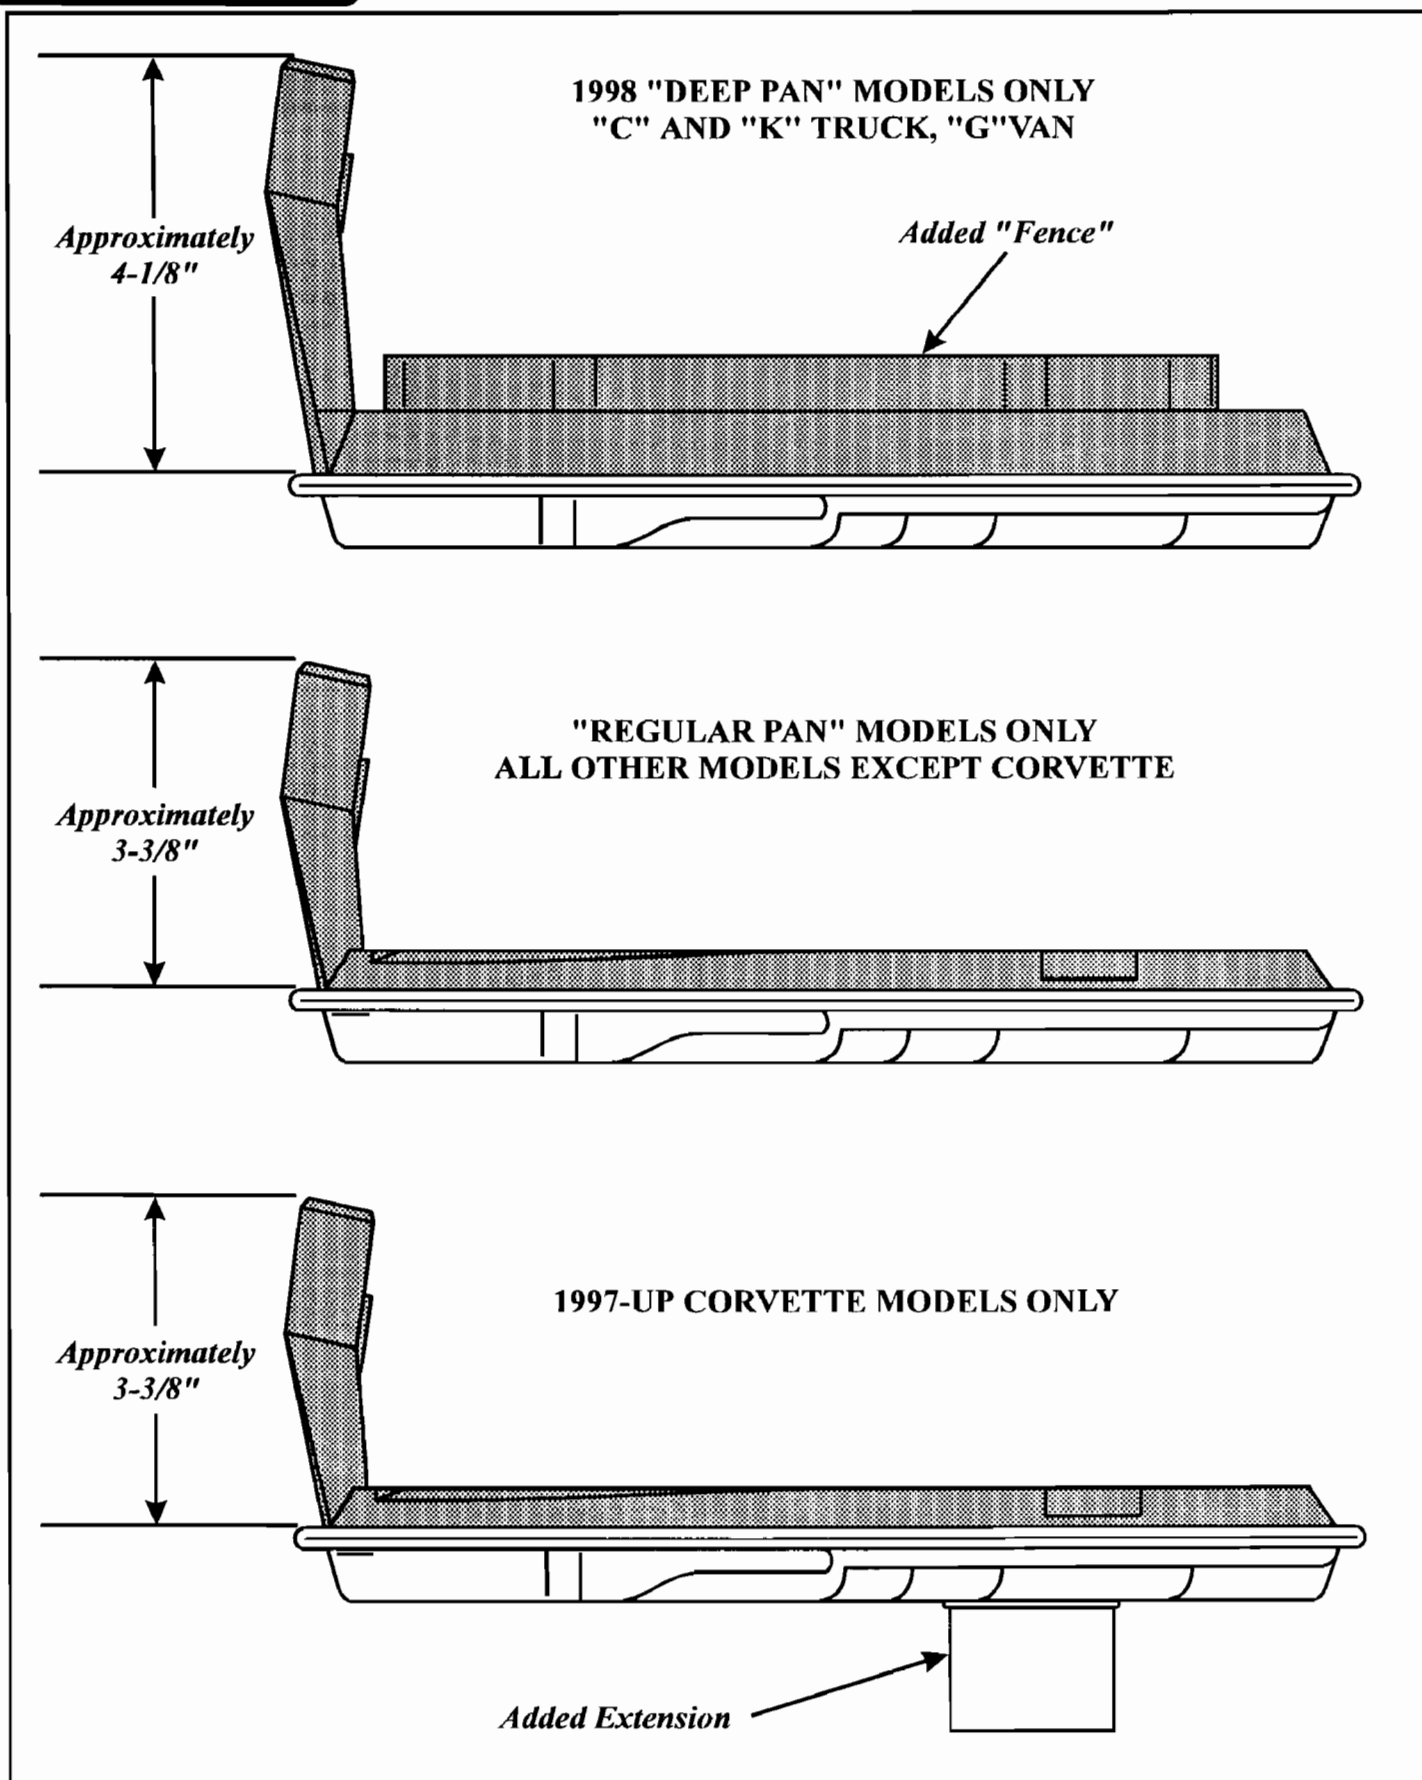
Figure 1

Bottom pan filters must be used with the correct design level bottom pans and must be used on the models that they were intended for, as shown in Figures 1, 2, and 3.

**LOOKING AT THE BOTTOM PROFILE
BOTH FILTERS ARE IDENTICAL ON
THE TRUCK AND VAN MODELS**

**1997-UP CORVETTE ONLY
BOTTOM PROFILE**

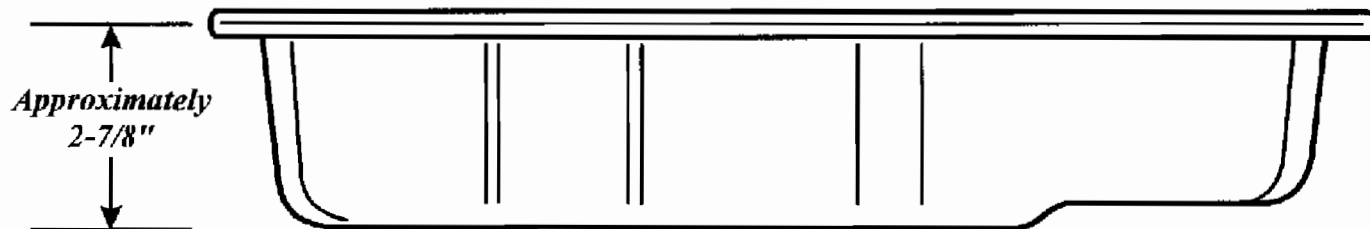
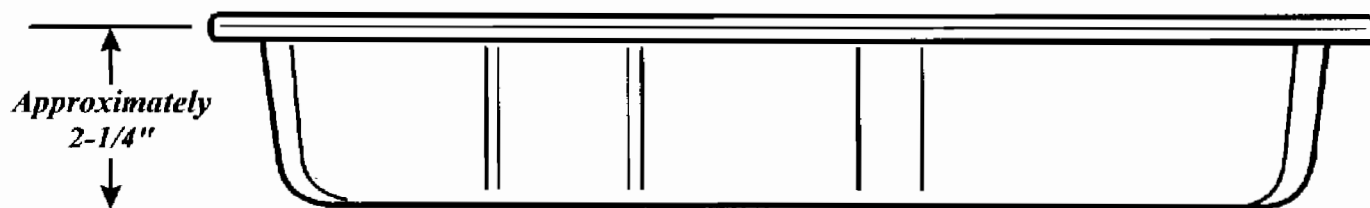
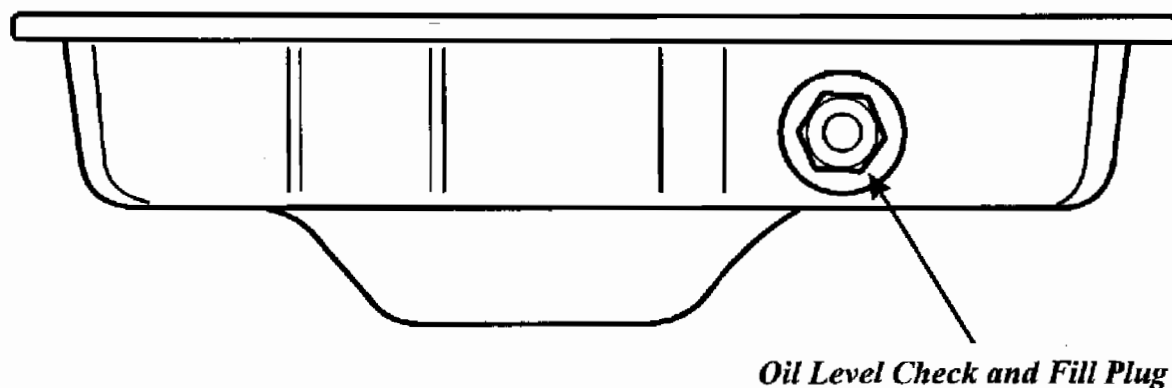
Figure 3

**"DEEP PAN" IS FOUND IN 1998
"C" AND "K" TRUCK AND "G" VAN**

**"REGULAR PAN" IS FOUND IN 1998
ALL OTHER MODELS EXCEPT CORVETTE**

1997-UP CORVETTE ONLY

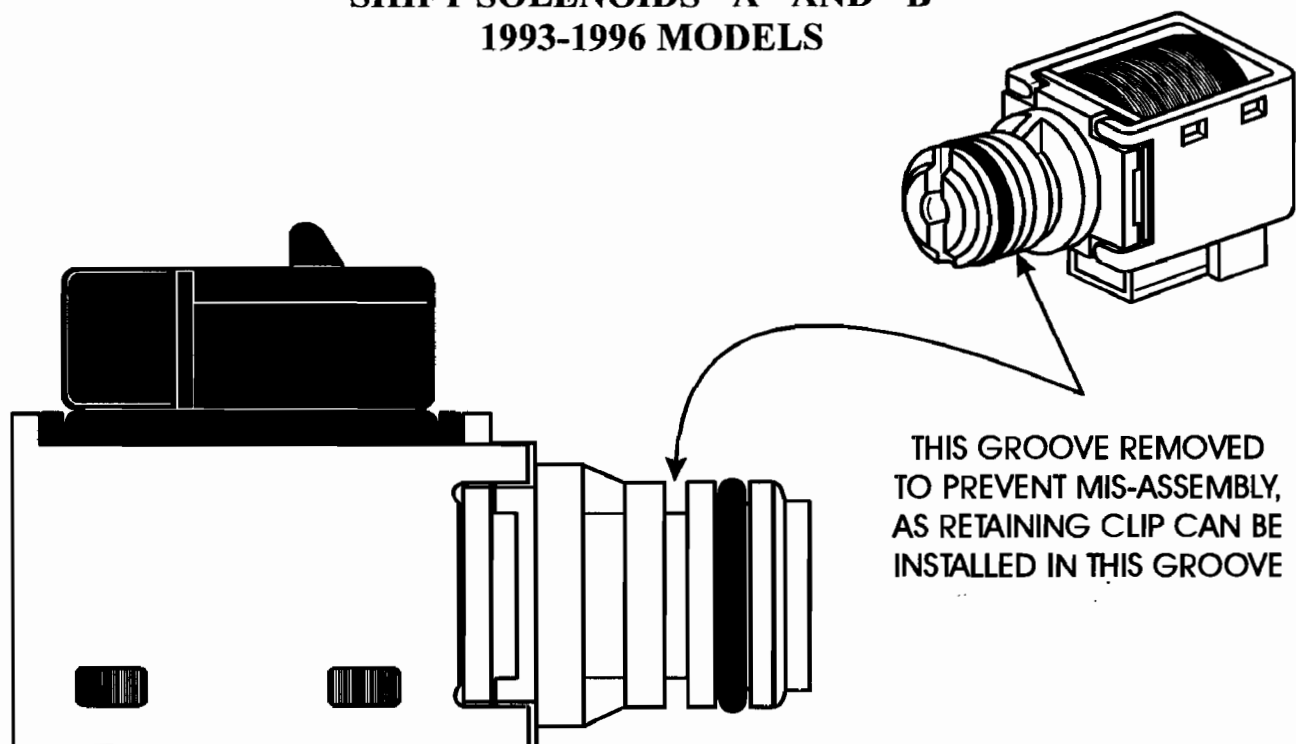
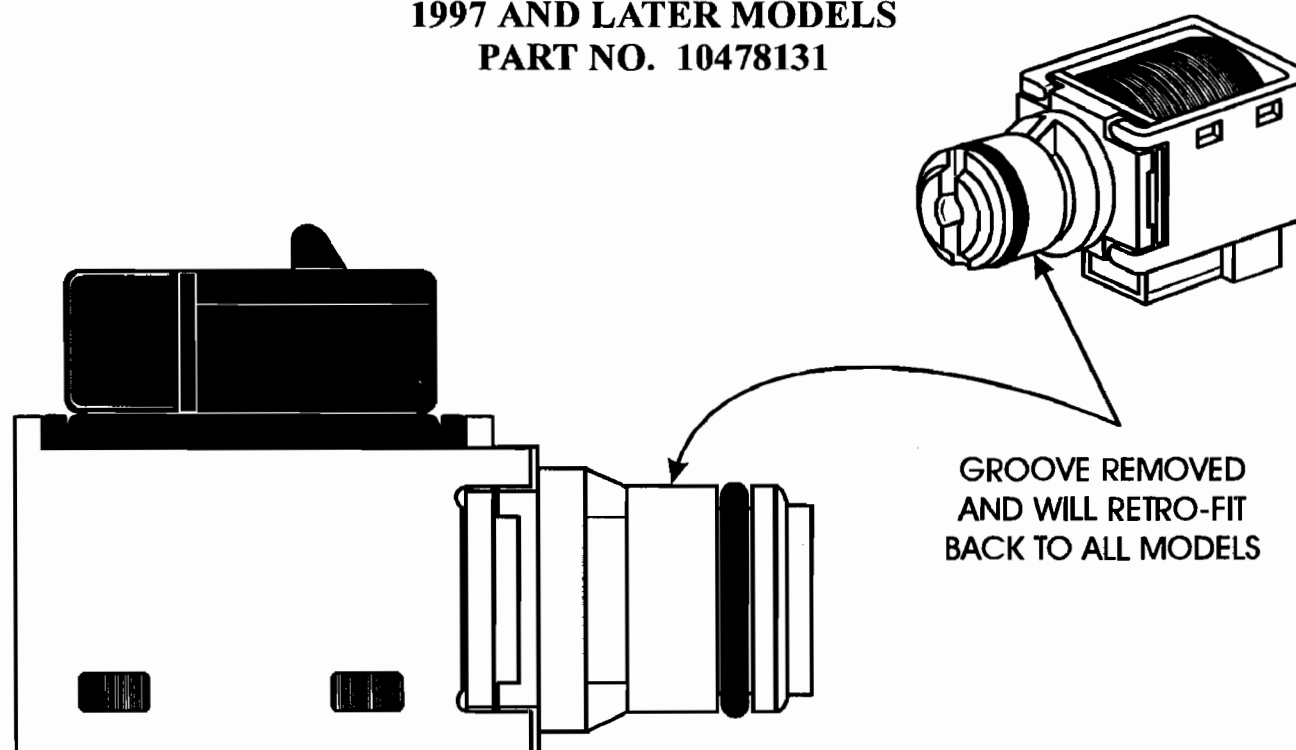
Figure 2

**THM 4L60-E
SHIFT SOLENOIDS "A" AND "B"
1993-1996 MODELS**

**THM 4L60-E
SHIFT SOLENOIDS "A" AND "B"
1997 AND LATER MODELS
PART NO. 10478131**

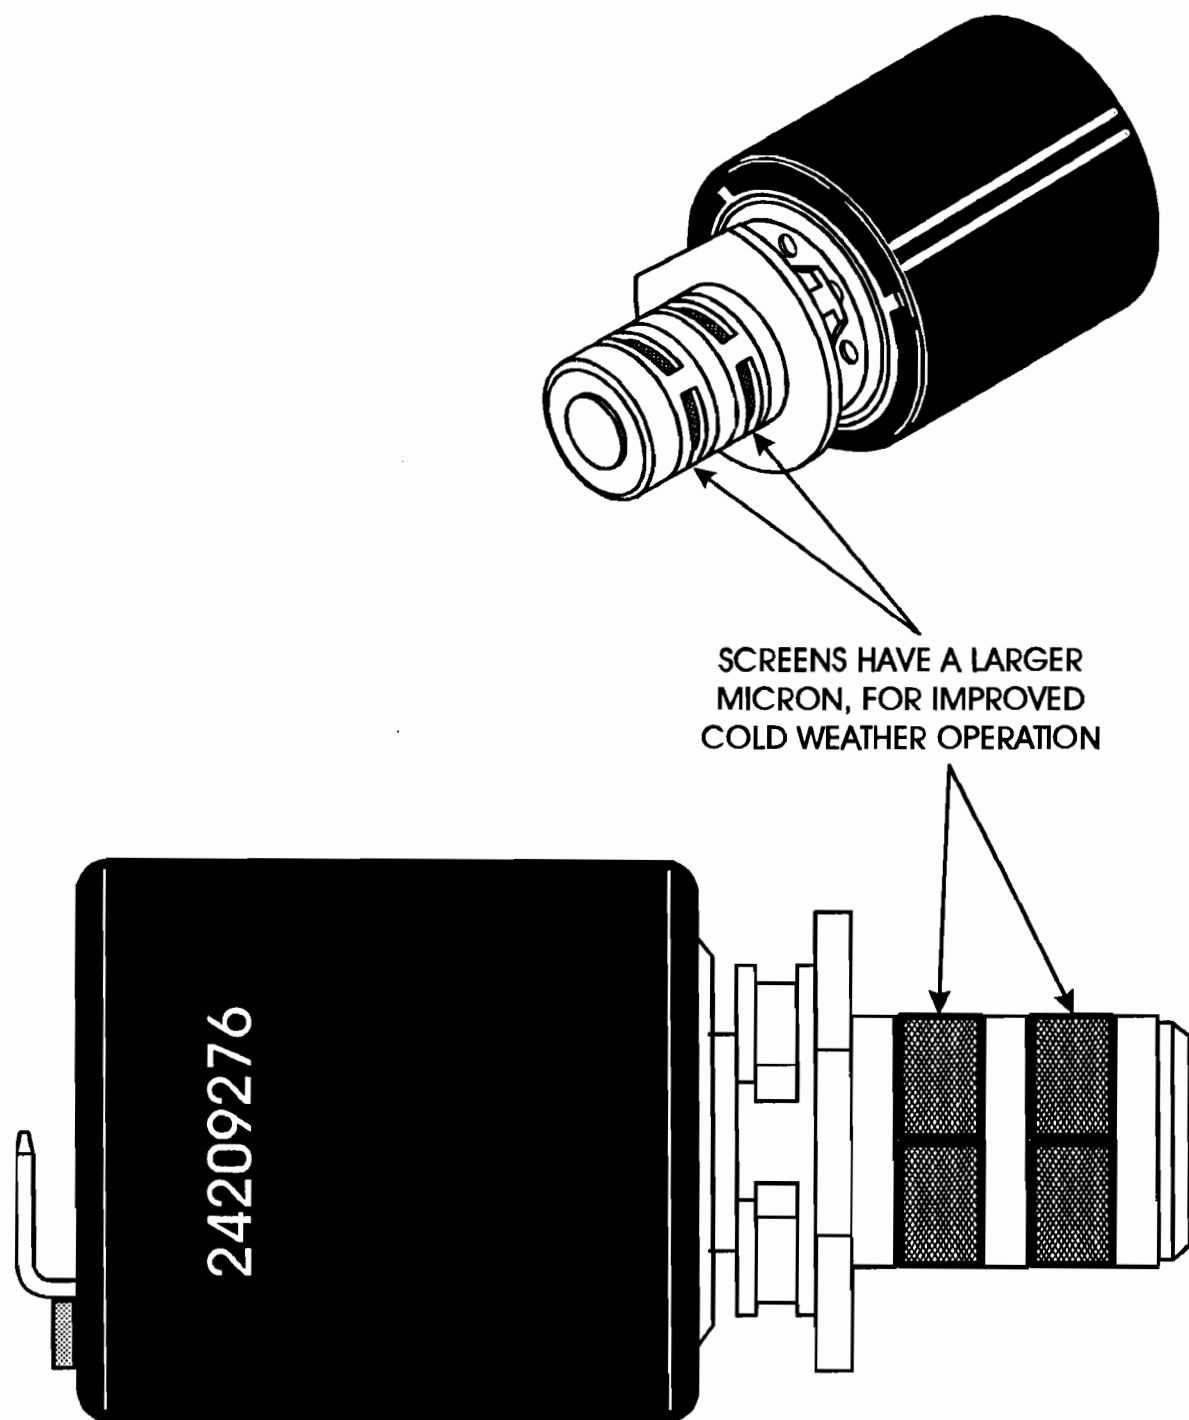
Figure 3

**NEW ELECTRONIC PRESSURE CONTROL SOLENOID
PART NUMBER 24209276**

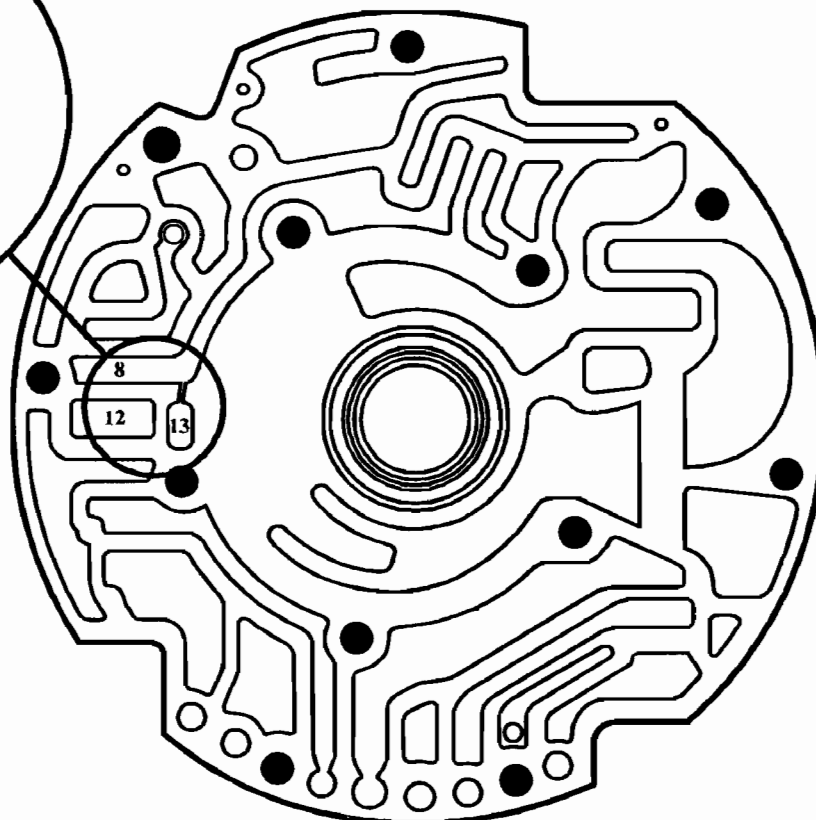
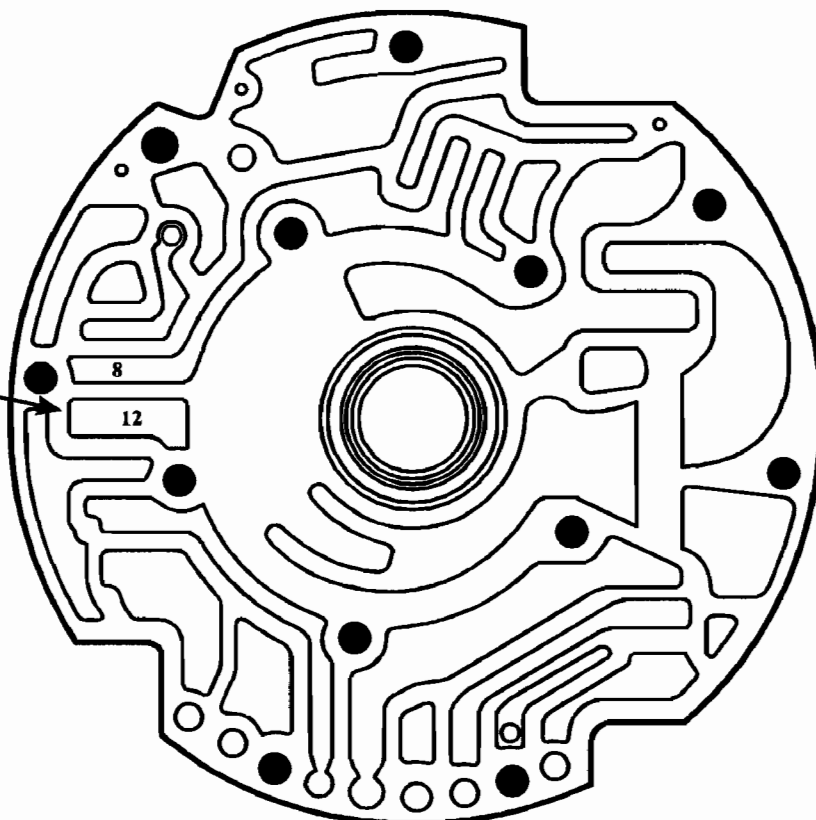
Figure 1

**NEW DESIGN
PUMP COVER**

**PREVIOUS DESIGN
PUMP COVER**

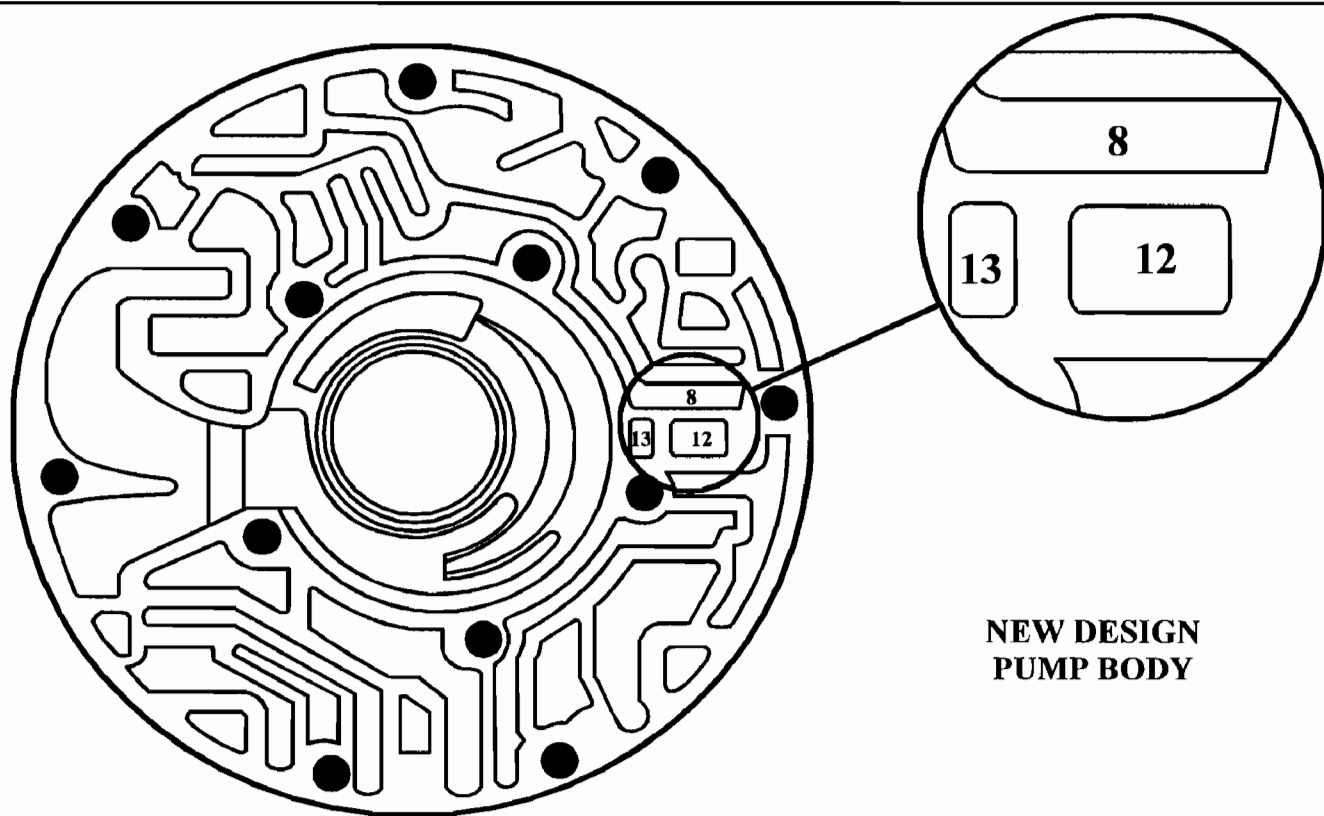
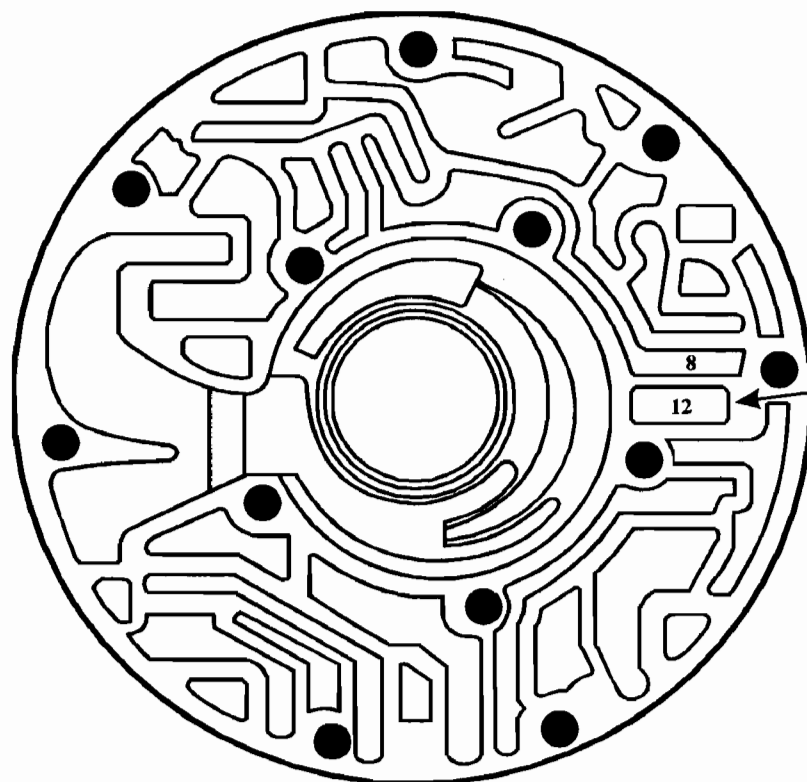
Figure 2

**NEW DESIGN
PUMP BODY**

**PREVIOUS DESIGN
PUMP BODY**

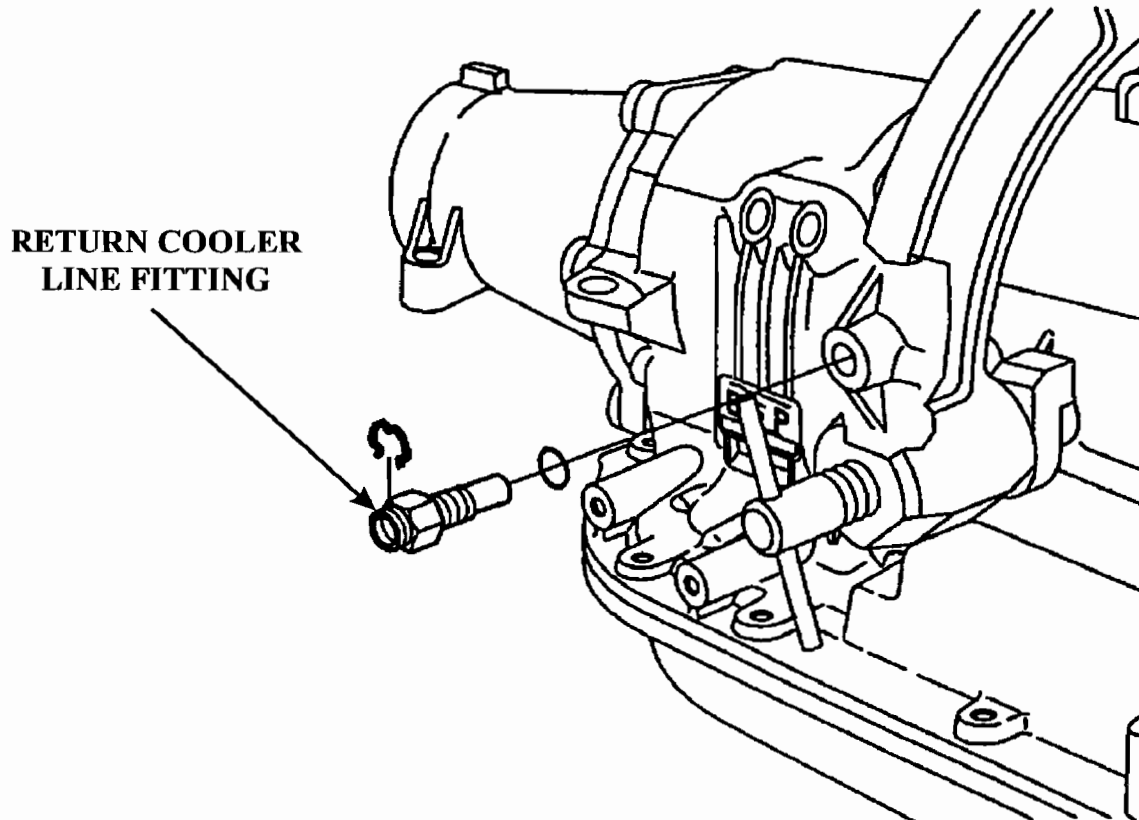
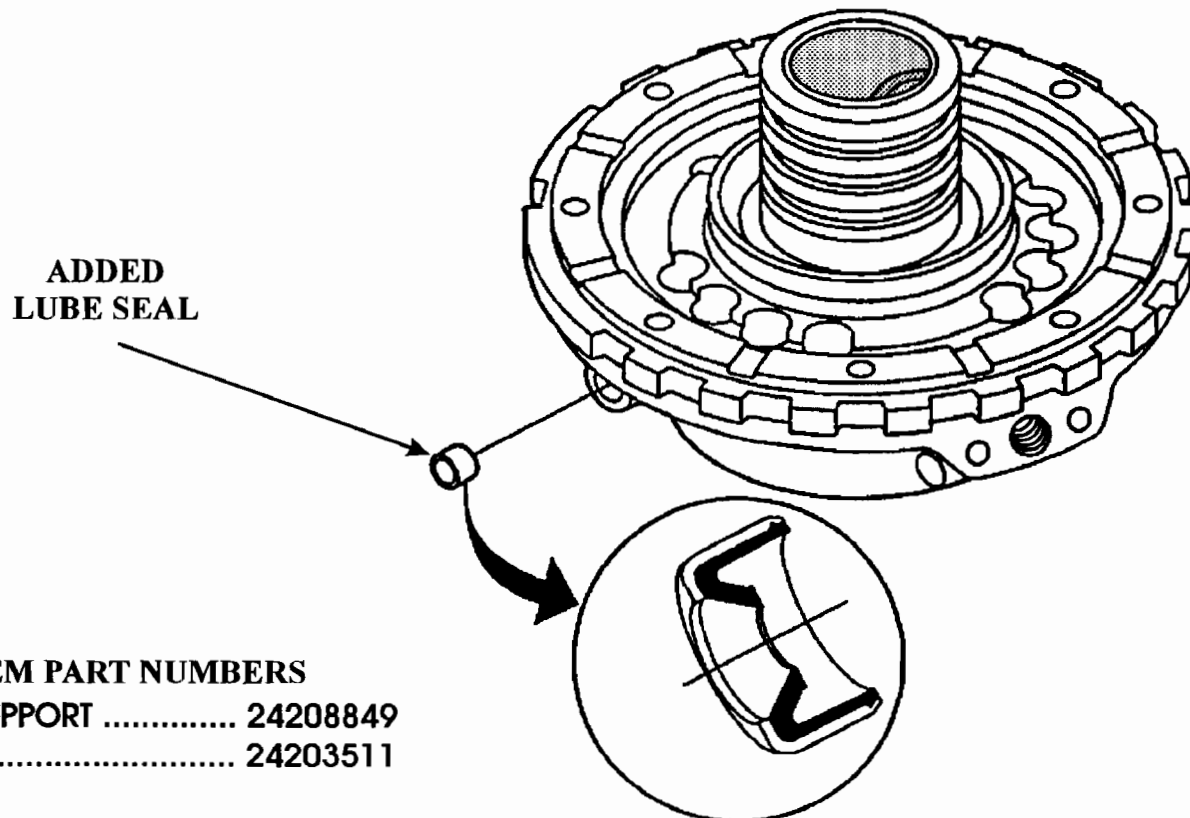
Figure 3

- (2) **CENTER SUPPORT** - A new metal clad lube seal and a new lube passage were added to the center support, as shown in Figure 3. The center support bushing length has been extended and the grooves modified to connect the reaction carrier bushing lube passage to center lube supply at the outer diameter of the sun gear shaft. The intermediate clutch lube orifice was also reduced. Refer to Figure 3.
These changes now require removing the return cooler line fitting, before removing the center support, to eliminate any damage to the related parts.

1997 MODEL RETURN COOLER LINE FITTING LOCATION

1997 MODEL CENTER SUPPORT WITH LUBE SEAL

OEM PART NUMBERS
 CENTER SUPPORT 24208849
 LUBE SEAL 24203511

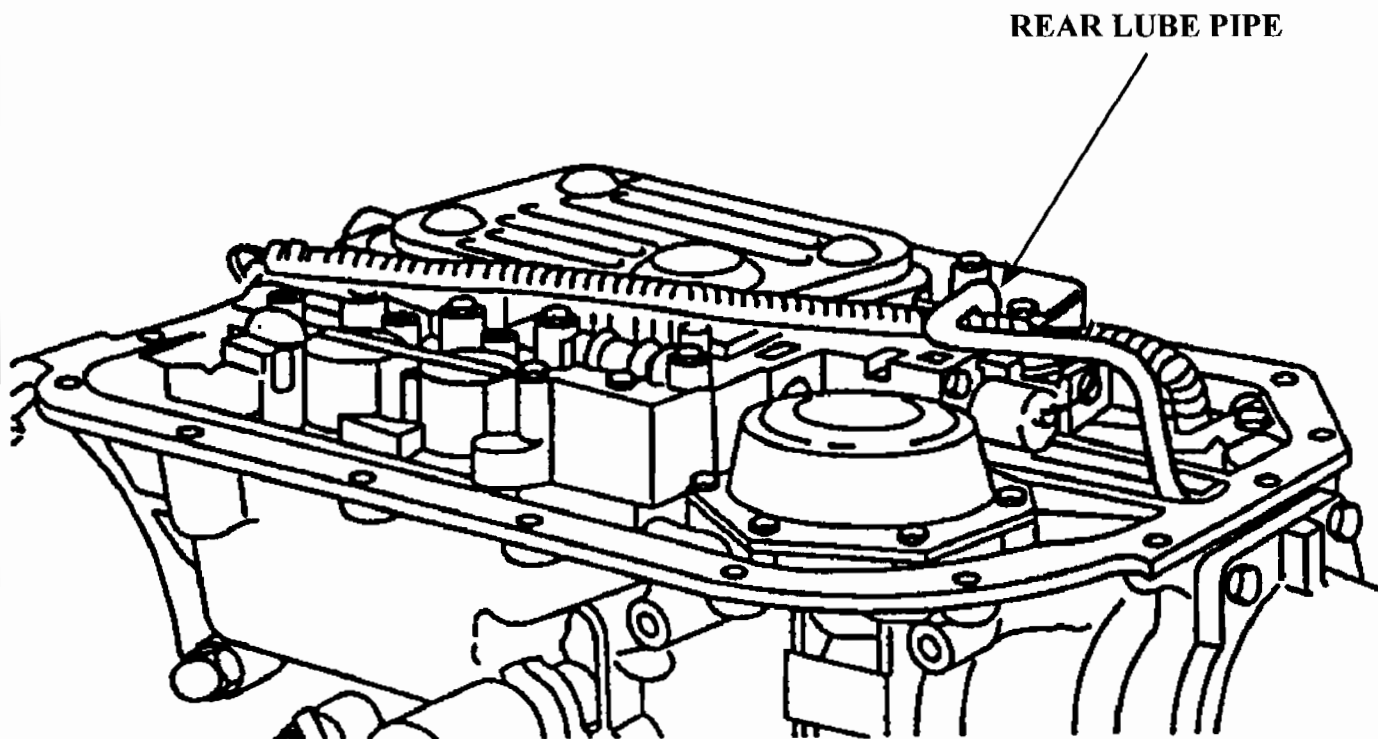
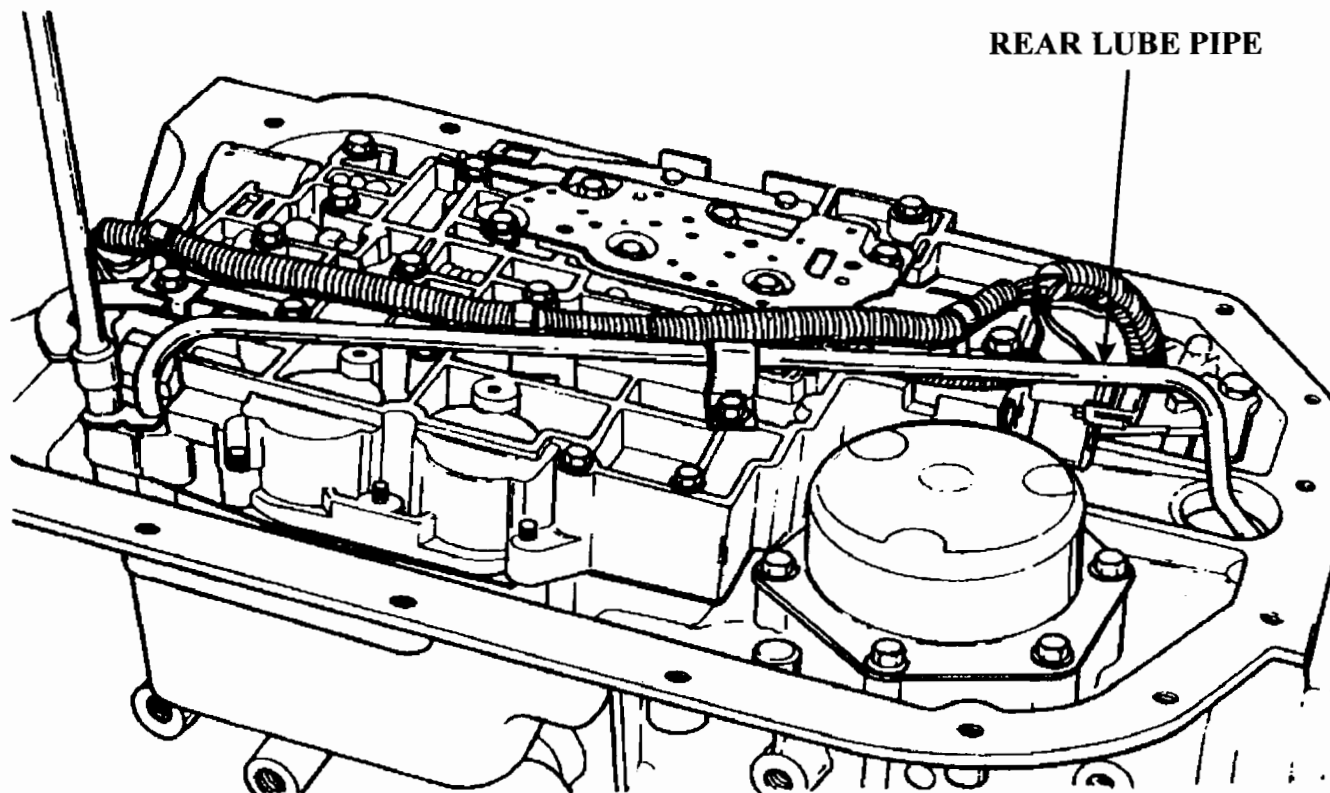
Figure 4

NEW DESIGN REAR LUBE PIPE

PREVIOUS DESIGN REAR LUBE PIPE

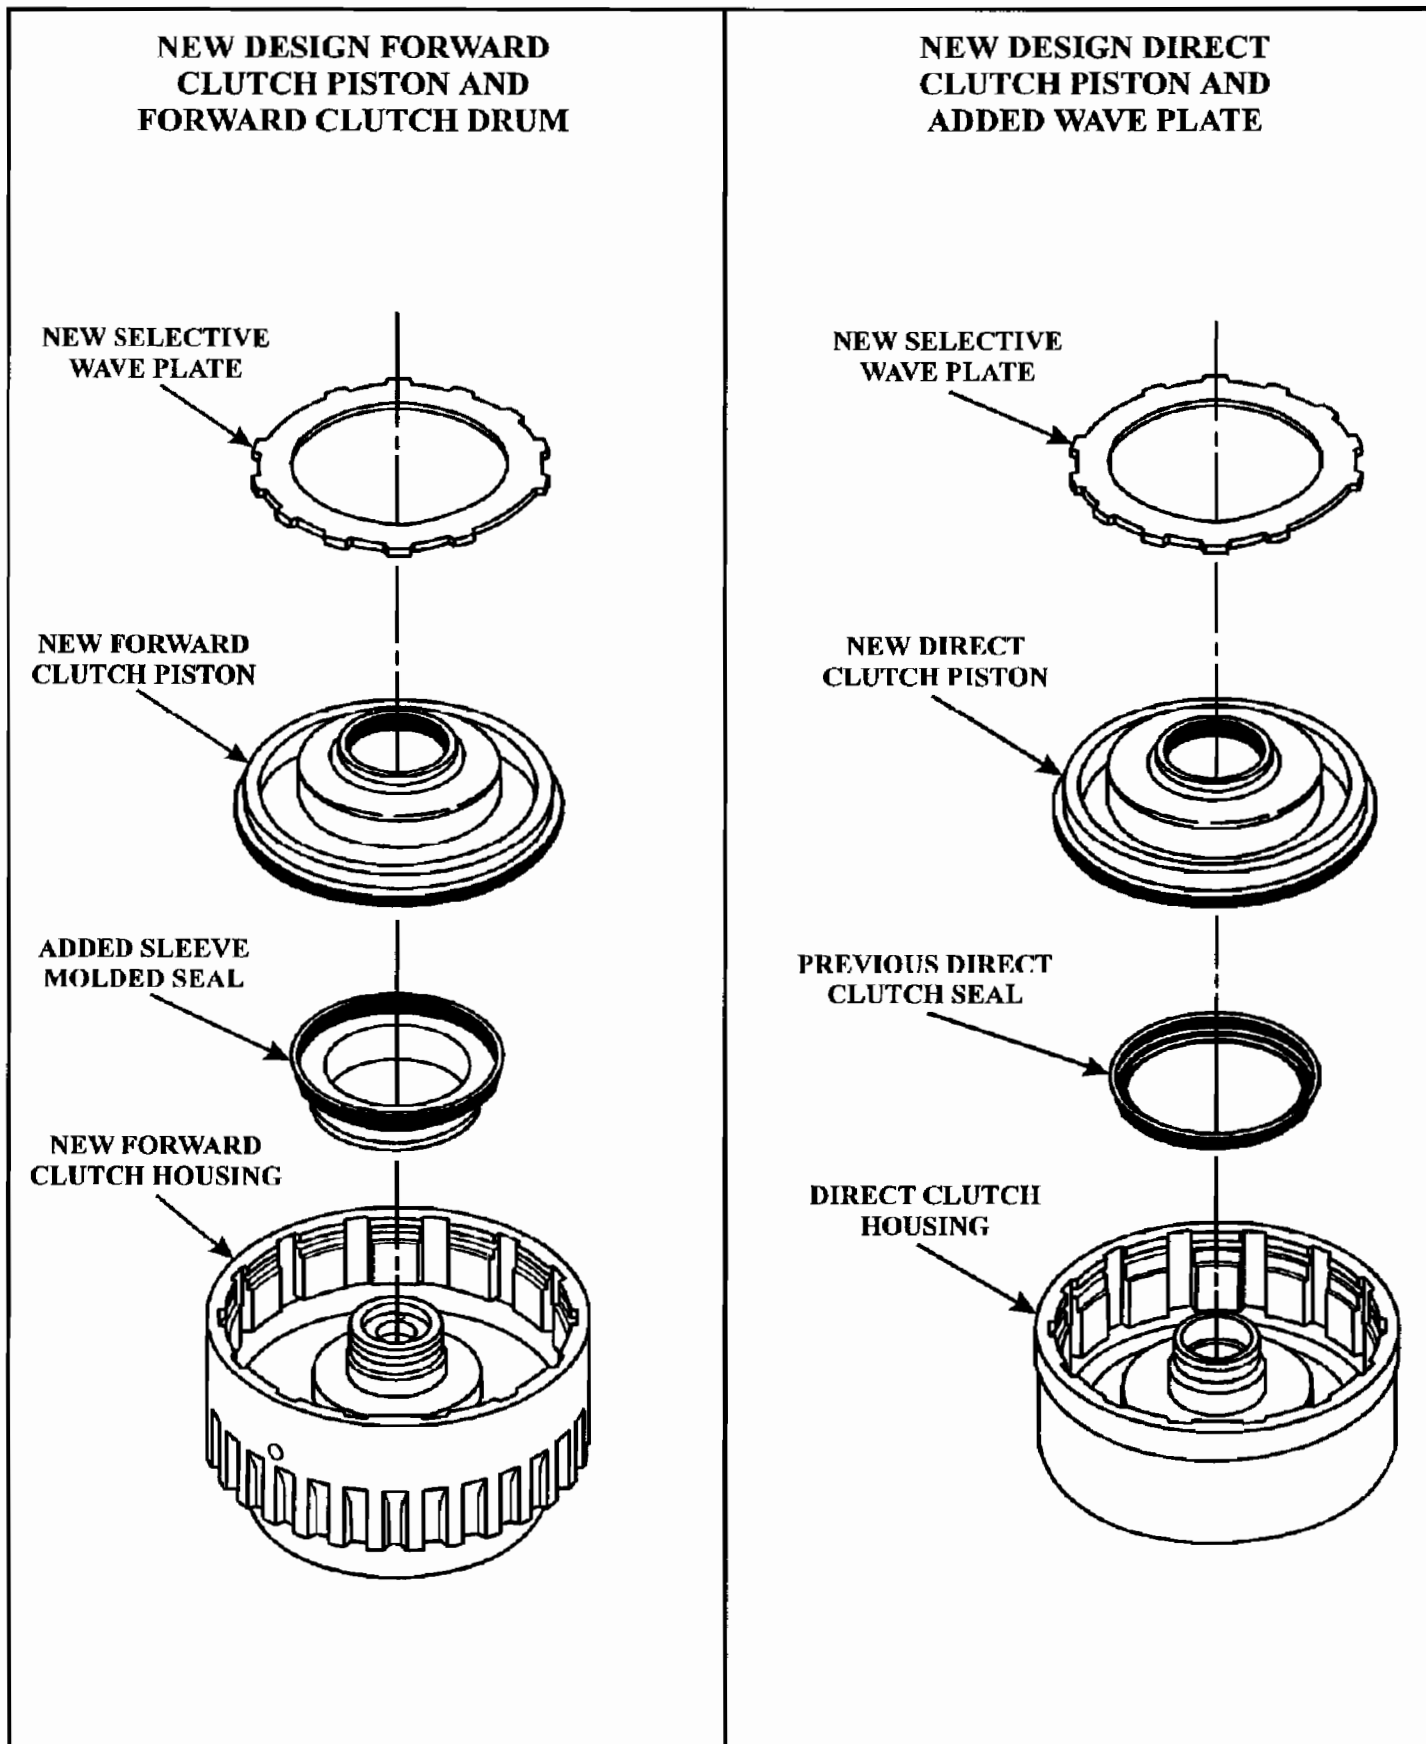
Figure 1

CHANGE: Beginning at the start of production for 1997, all THM 4L80-E transmissions were produced with new design forward and direct clutch piston assemblies that are stamped steel with molded rubber seals, as shown in Figure 1. The new design level forward clutch piston also changes the forward clutch housing, with the addition of a stamped steel forward clutch sleeve with a molded seal, that replaces previous lip seal, as shown in Figure 1.

- (1) FORWARD CLUTCH HOUSING - Has previous intermediate seal groove and intermediate lip seal eliminated, and is now machined to accept a new steel sleeve with a molded seal that replaces the previous lip seal located in the housing, as shown in Figure 1.

- (2) FORWARD CLUTCH PISTON - New design piston is stamped steel with molded seals to replace the previous cast aluminum piston, as shown in Figure 1.
- (3) FORWARD CLUTCH INTERMEDIATE LIP SEAL - Has been eliminated and replaced with a steel sleeve with the molded seal, as shown in Figure 1. (Currently not serviced separately)

- (4) DIRECT CLUTCH PISTON - New design piston is stamped steel with molded seals to replace the previous design cast aluminum piston, as shown in Figure 1.

Direct Clutch Piston (Stamped Steel)	24204961
Forward Clutch Piston (Stamped Steel)	24204957
Forward Clutch Housing (Includes Molded Seal)	24208850
Wave Plate, Forward and Direct	24205559
Wave Plate, Forward and Direct	24205560

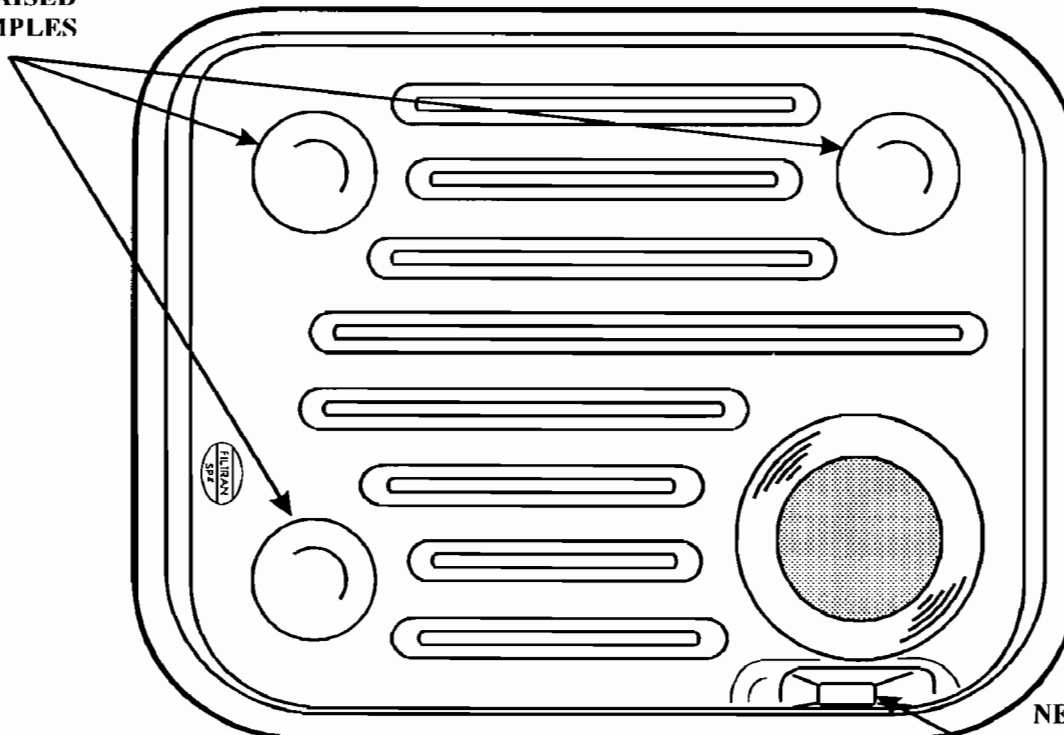
**3 RAISED
DIMPLES**

**NEVER USE A FILTER
THAT DOES NOT HAVE
THIS 4TH STAND-OFF
BY THE INLET HOLE**

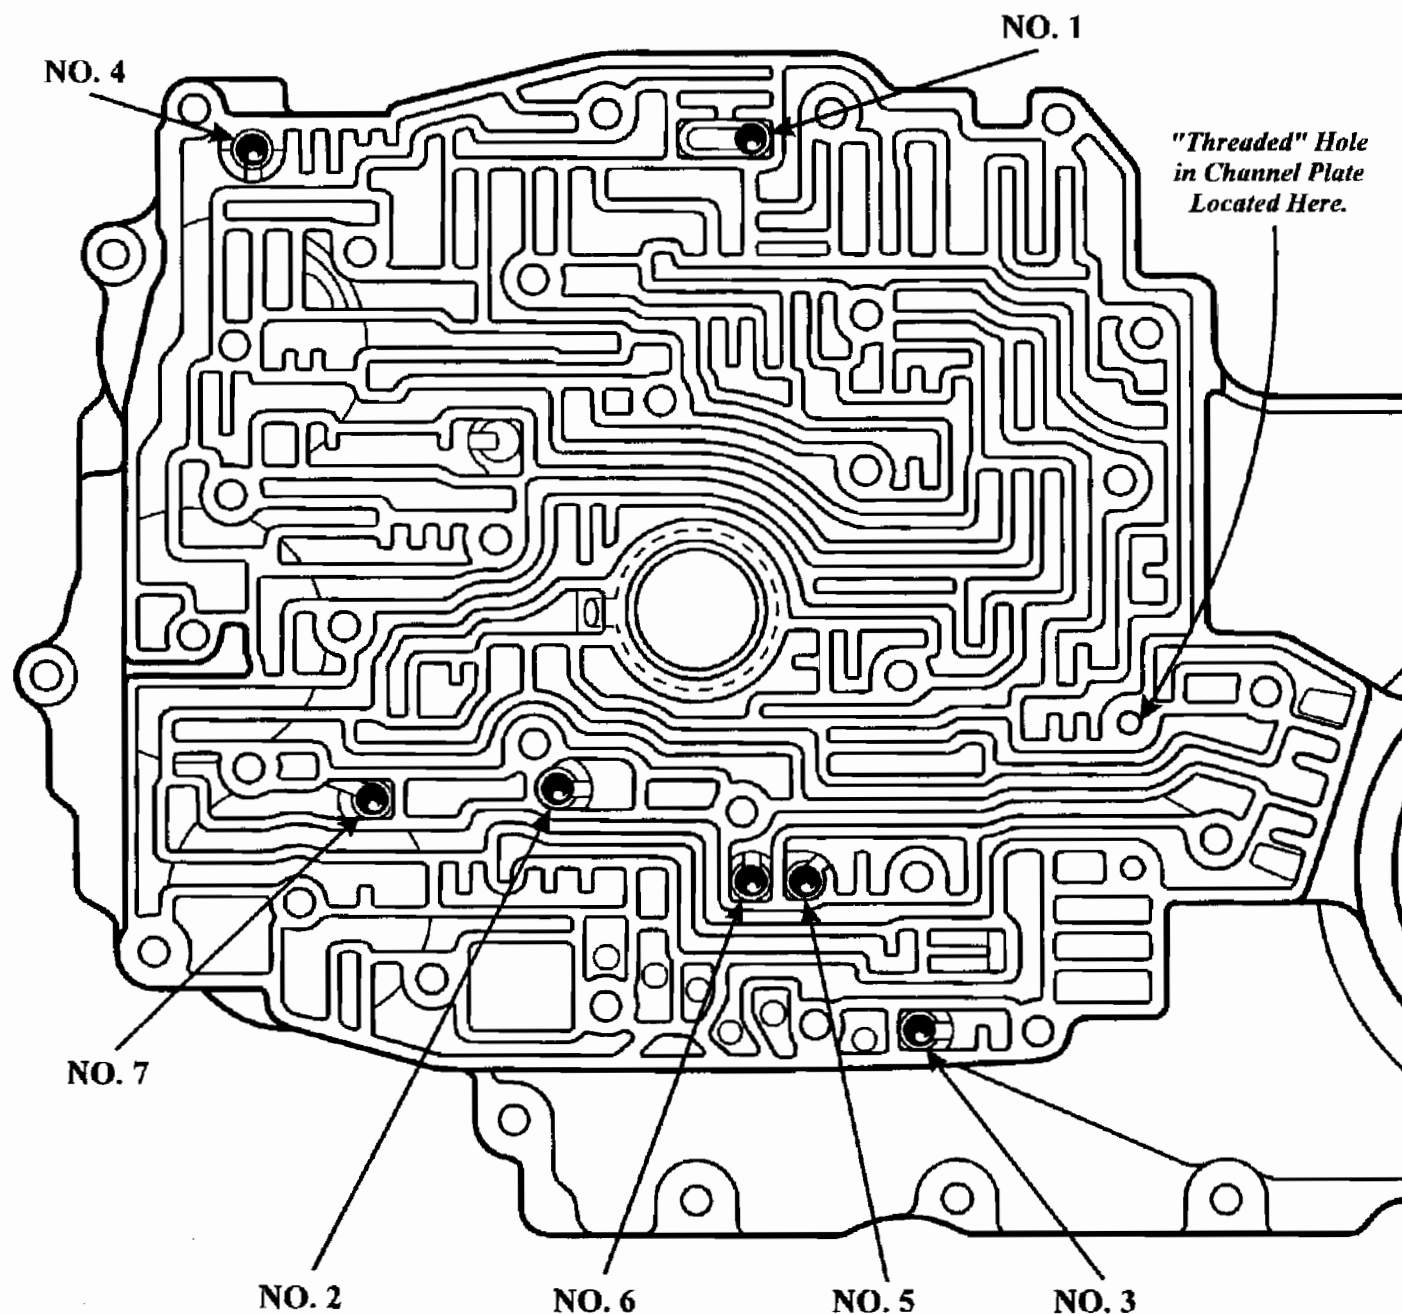
- (3) **CHECKBALL LOCATIONS** - The number 6 checkball moves from the direct clutch apply circuit, and into the 2-3 accumulator circuit. There were no changes in worm track configuration, however we also show the "Threaded" hole that changed to a "Non-Threaded" hole in the channel plate. Refer to Figure 5 for 1995-1996 checkball locations, and Figure 6 for the 1997-Up checkball locations.

THM 4T40-E 1995-1996 MODELS ONLY
CHECKBALL LOCATIONS
