"FIXES ARE GREAT IN '98"

INTRODUCTION

AUTOMATIC TRANSMISSION SERVICE GROUP
9200 S. DADELAND BLVD.
SUITE 720
MIAMI, FL 33156
(305) 670-4161

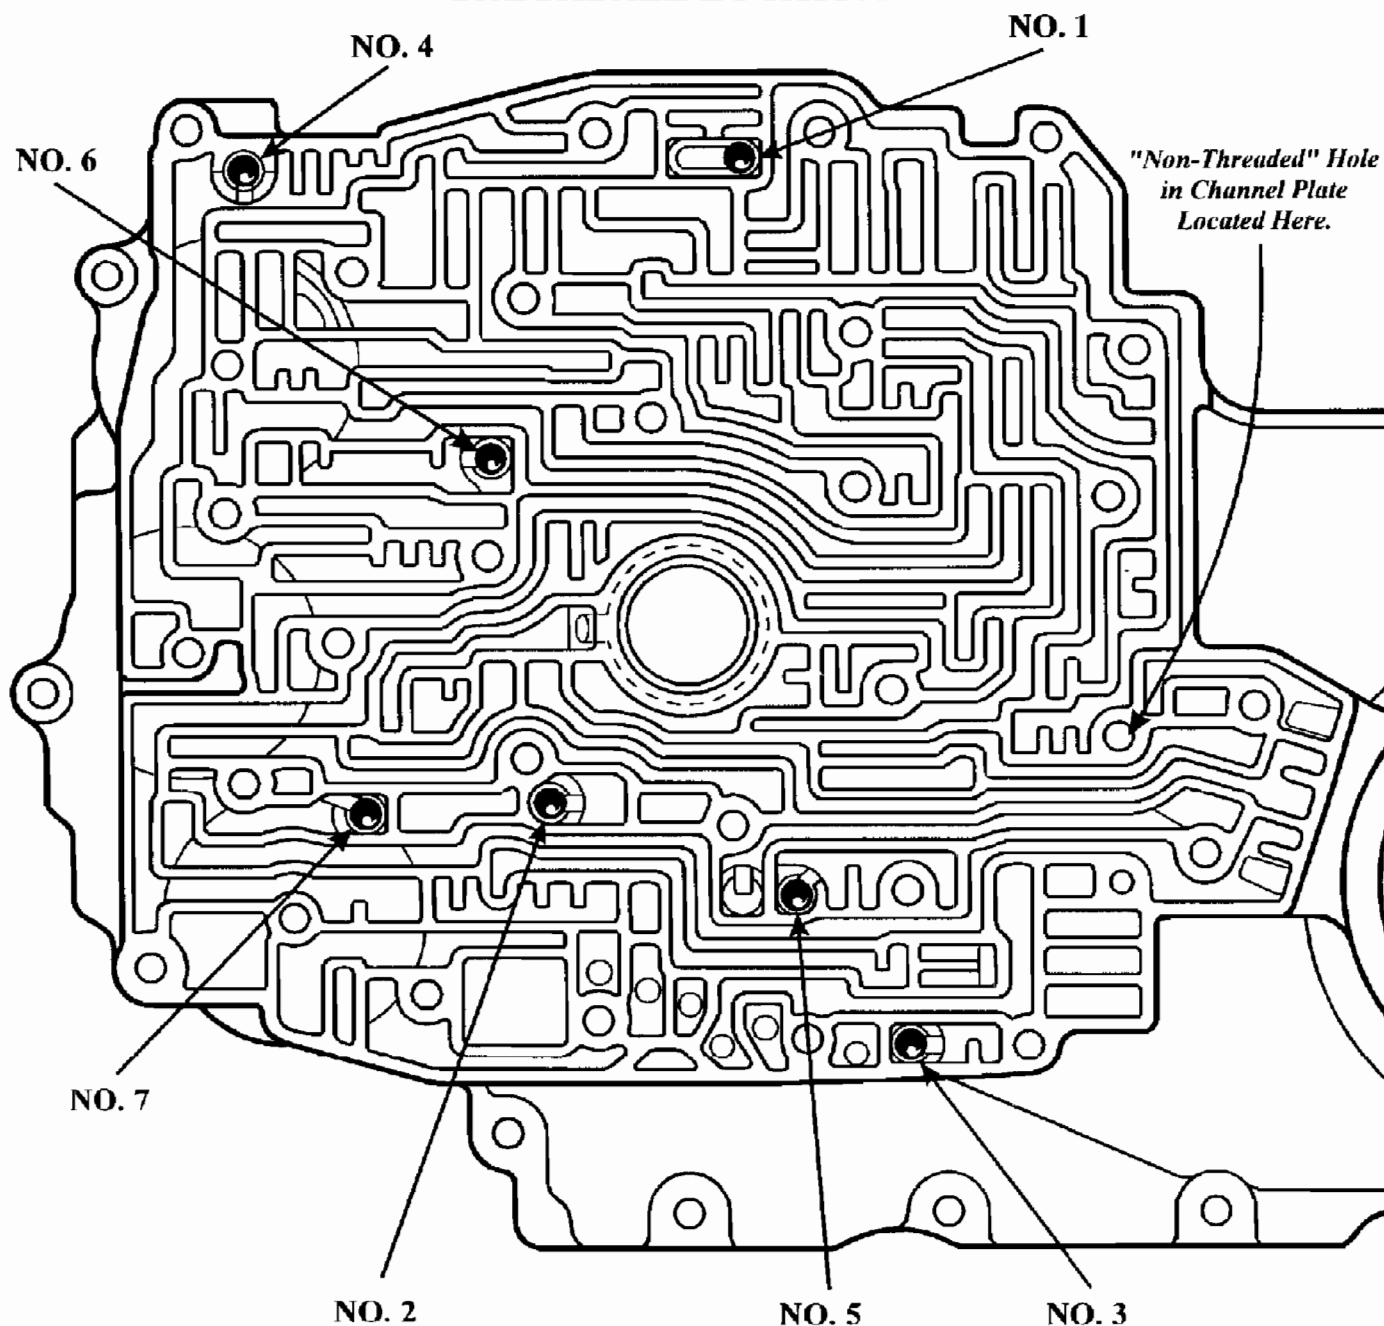
- (3) **CHECKBALL LOCATIONS** - The number 6 checkball moves from the direct clutch apply circuit, and into the 2-3 accumulator circuit. There were no changes in worm track configuration, however we also show the "Threaded" hole that changed to a "Non-Threaded" hole in the channel plate. Refer to Figure 5 for 1995-1996 checkball locations, and Figure 6 for the 1997-Up checkball locations.

**THM 4T40-E 1997-UP MODELS ONLY
CHECKBALL LOCATIONS**

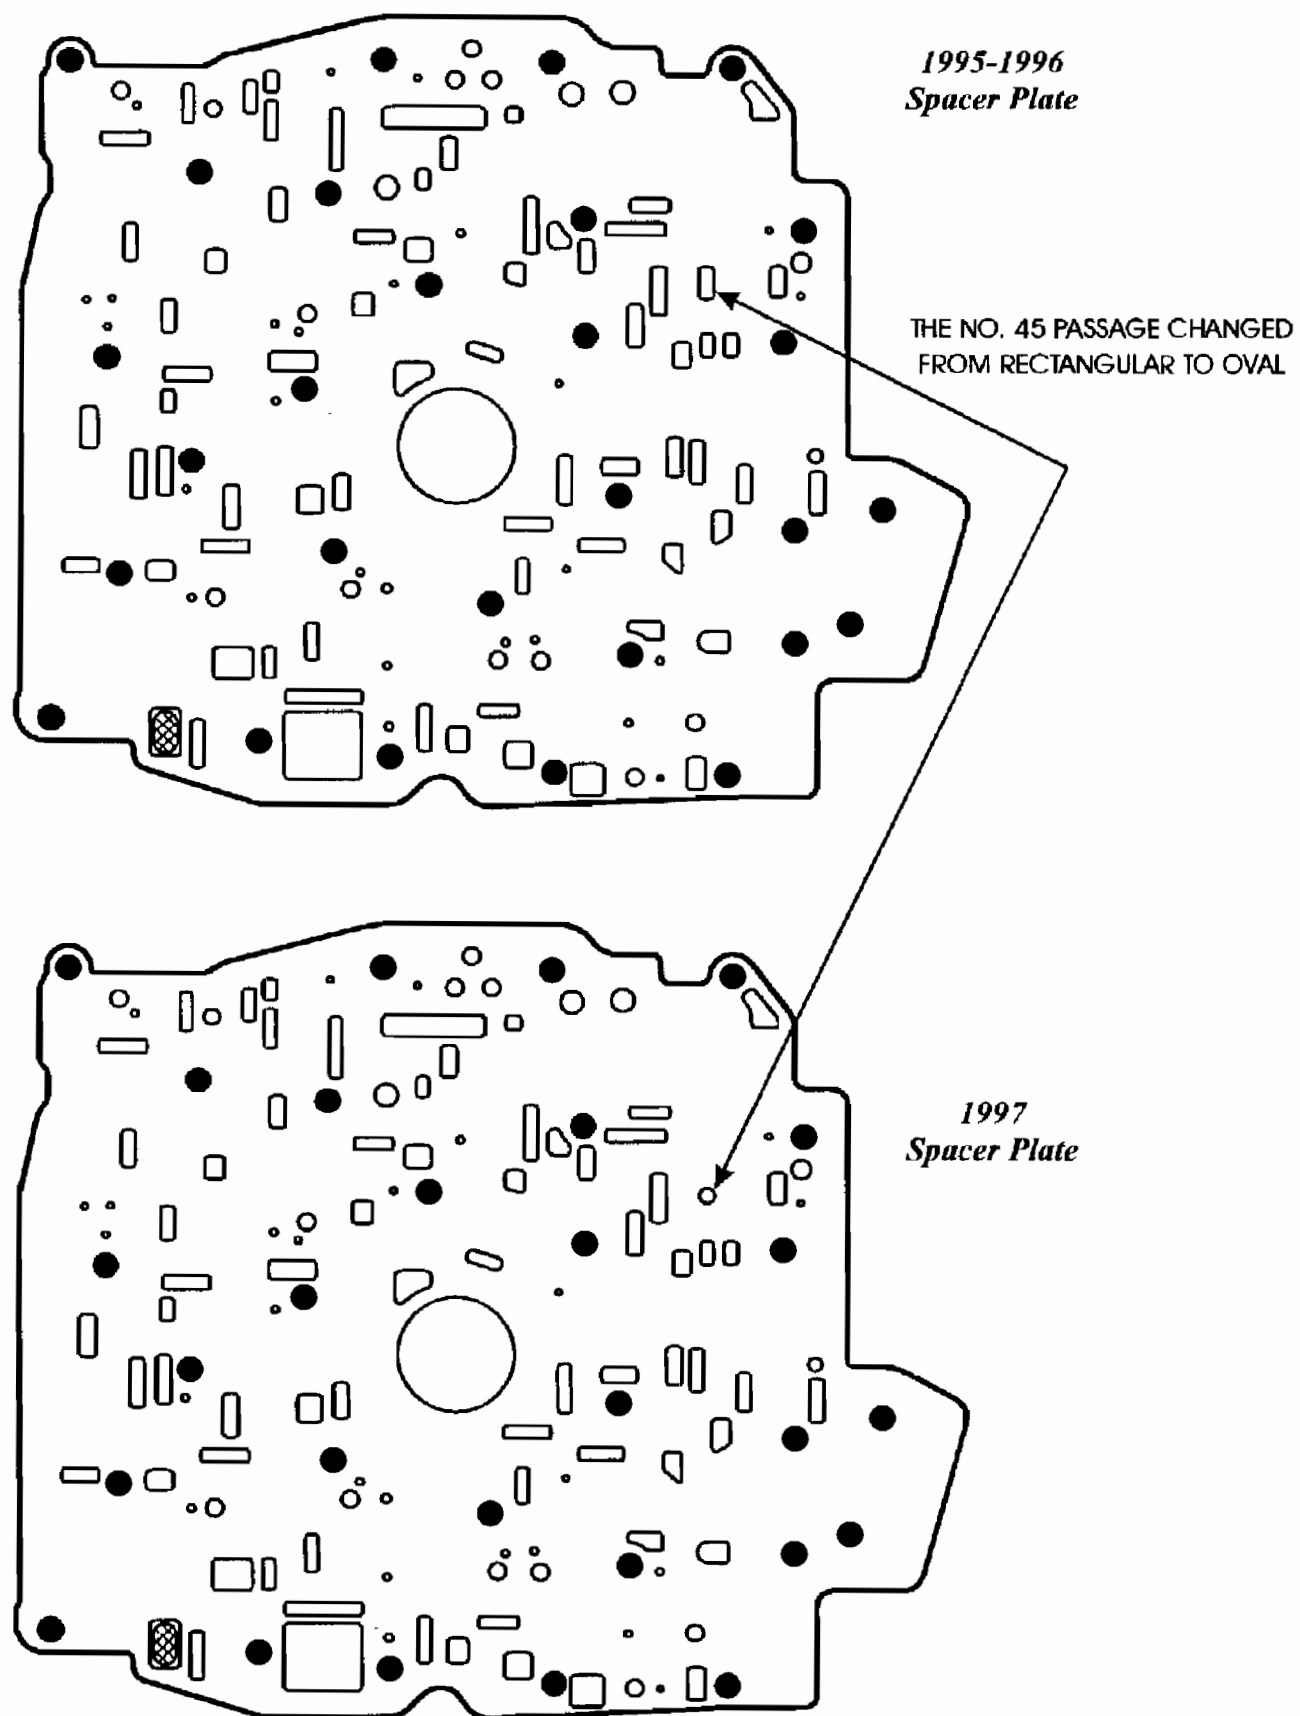
Figure 7

- (4) **SPACER PLATE** - The number 45 exhaust passage in the spacer plate has changed from a rectangular hole to a small oval hole, as shown in Figure 7.

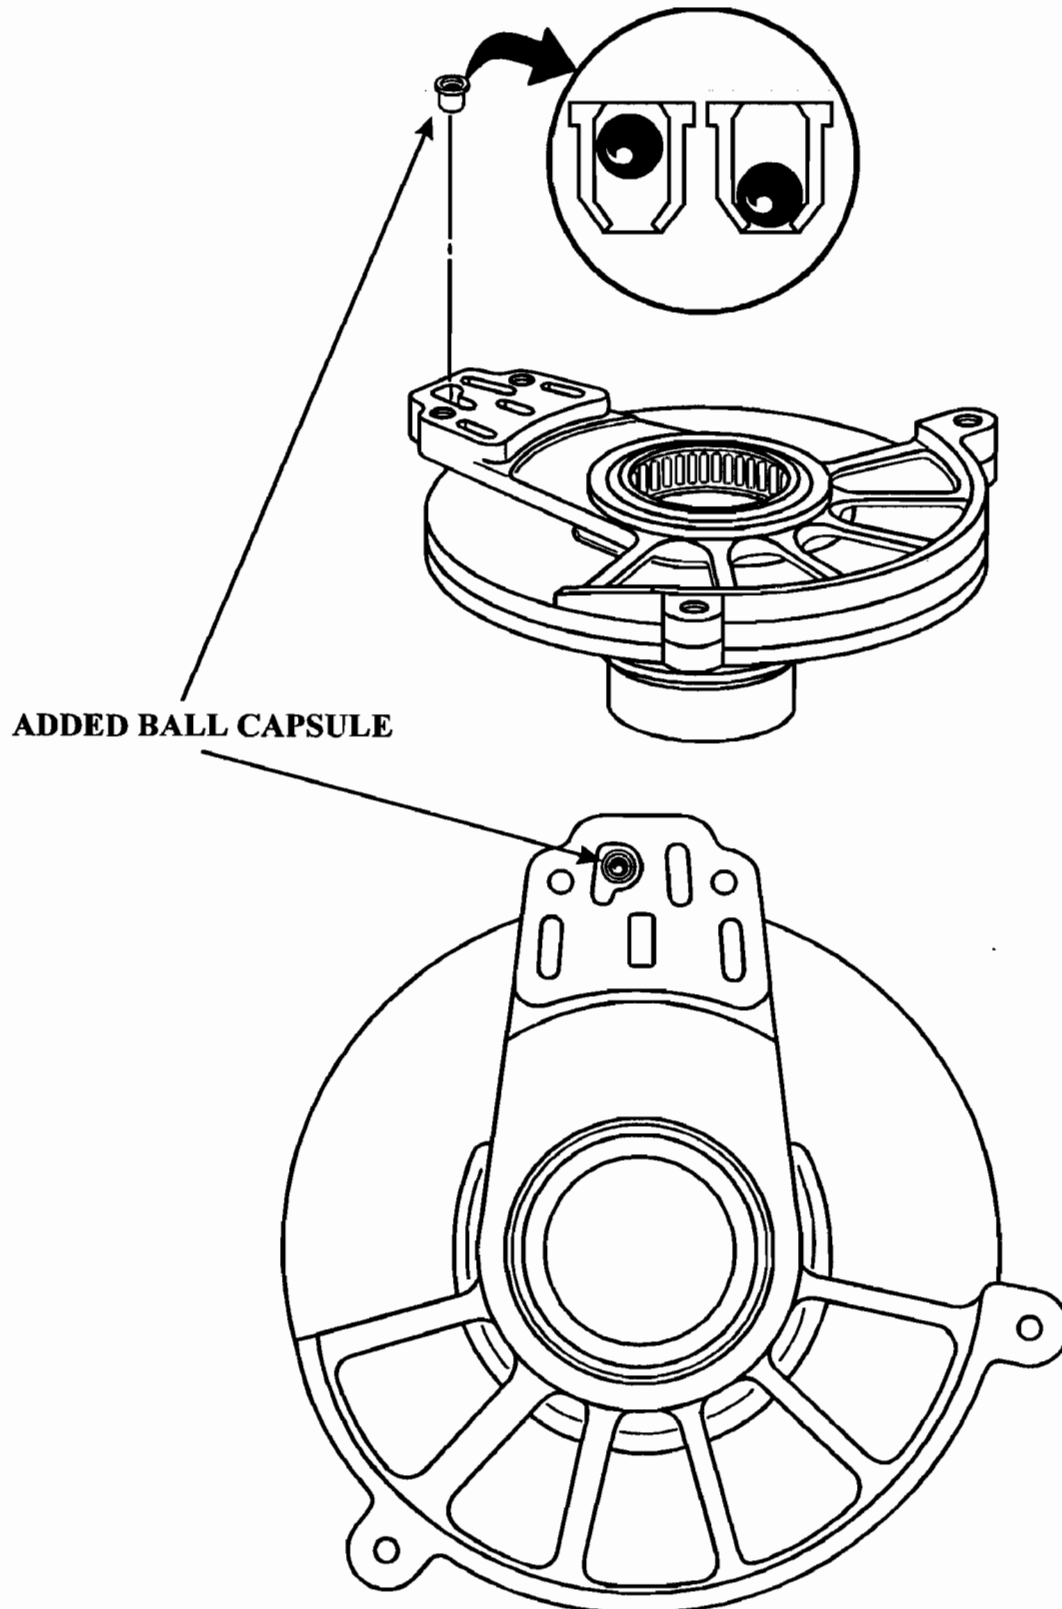
Figure 8

- (5) **DRIVEN SPROCKET SUPPORT** - Ball capsule added in the direct clutch circuit to act as an air bleed to improve direct clutch apply, as shown in Figure 8.

**THM 4T40-E 1997-UP MODELS ONLY
DRIVEN SPROCKET SUPPORT**

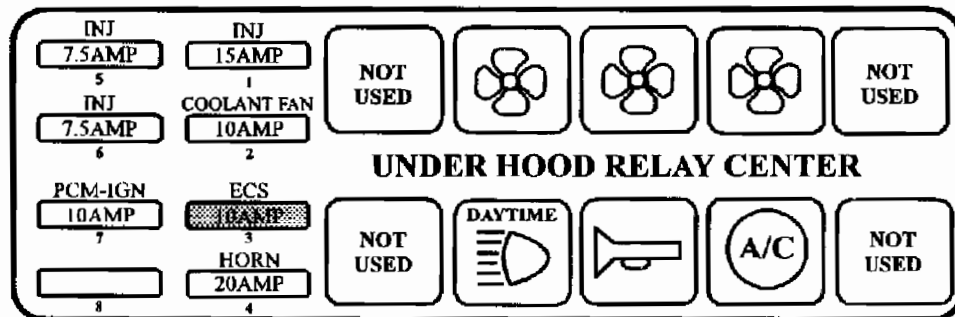
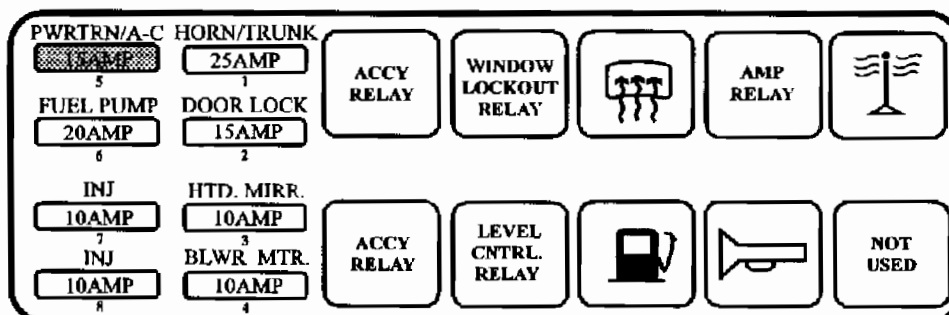
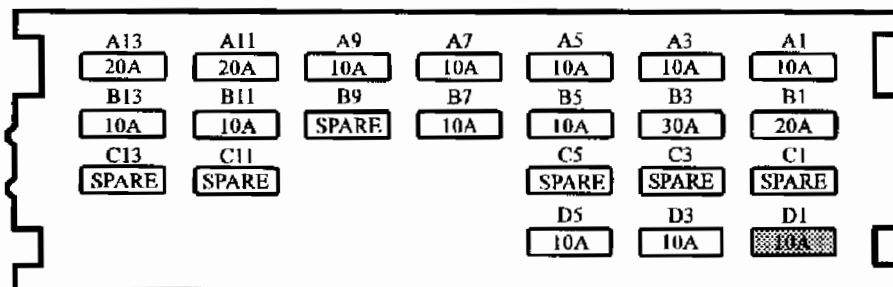
Figure 2

CAUSE: The cause may be, the "Fuse" that supply's the solenoids in the transmission and the Power Steering Pressure Switch with battery voltage may have blown. NOTE: Some years have the transmission solenoids, the EGR solenoid, Brake switch, Canister purge solenoid, Power Steering Pressure Switch and Air conditioning Relay all on the same fuse. A short or wiring problem on any and all of the above may cause the fuse to blow.

CORRECTION: Locate the "E" terminal on the harness connector, shown in Figure 1, and check for battery voltage with the ignition on. If there is NO voltage at terminal "E", refer to Figures 2&3 for fuse location and vehicle application and replace the fuse. NOTE: The fuse in question is highlighted for identification purposes.

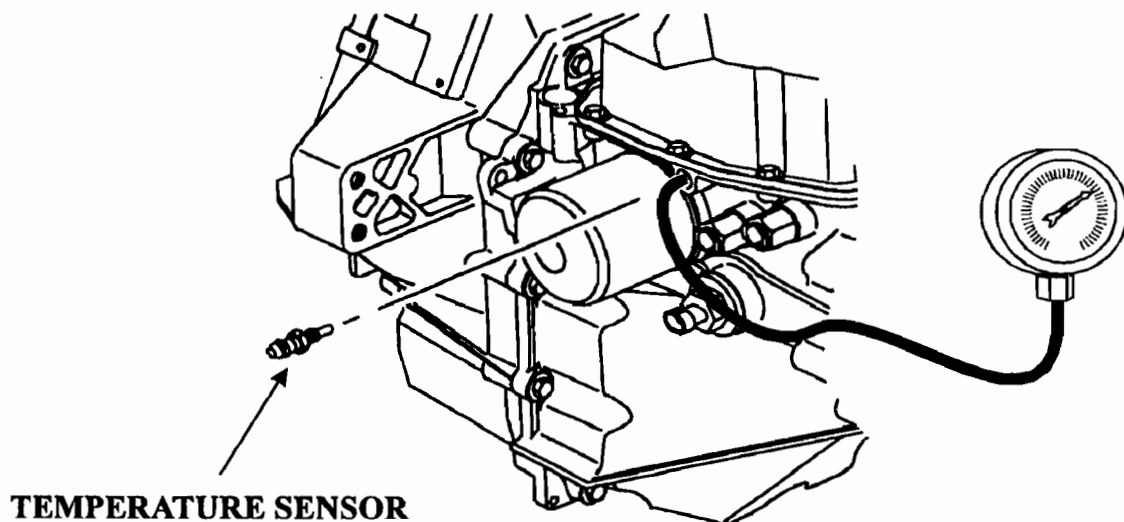
Figure 1

**LINE PRESSURE MUST BE 175 PSI, *MINIMUM*, AT IDLE IN REVERSE
WITH "LP" LINE PRESSURE ACTUATOR FUSE REMOVED**

CORRECTION: Warm vehicle up to operating temperature. Remove temperature sensor and install a 0-300 psi. pressure gage, as shown in Figure 1. Remove 7.5 amp. Line Pressure Actuator fuse shown in Figure 2. Place selector in Reverse at an *Idle* and ensure that line pressure is not less than 175 psi. If the pressure gage indicates low pressure, remove the valve body and dis-assemble the Pressure regulator valve line up as shown in Figure 3. Locate the Line Pressure Regulator Valve Cushion Spring and inspect it for breakage. If the spring is not broken, reinstall the pressure regulator valve and place a flashlight over the valve body, shown in Figure 3, and look for light peering out between the valve and its bore. If light is seen or the Line Pressure Regulator Valve Cushion Spring is broken, replace the upper valve body with Saturn upper valve body kit, part no. 21005813.

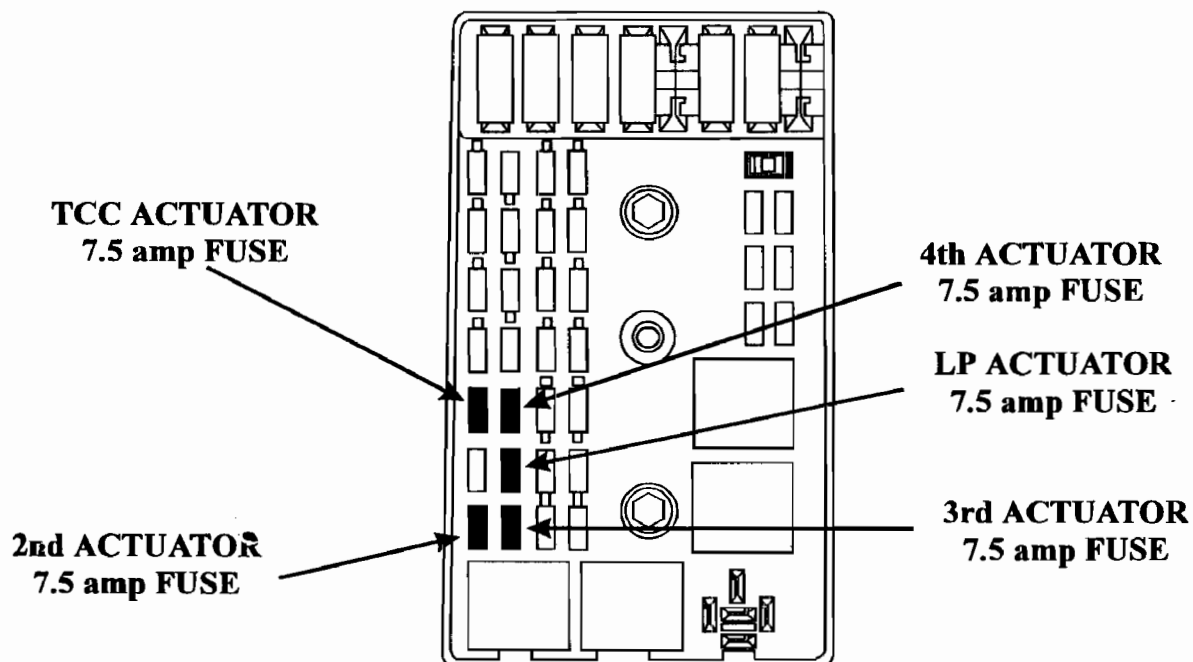
Figure 2

UNDER HOOD JUNCTION BOX

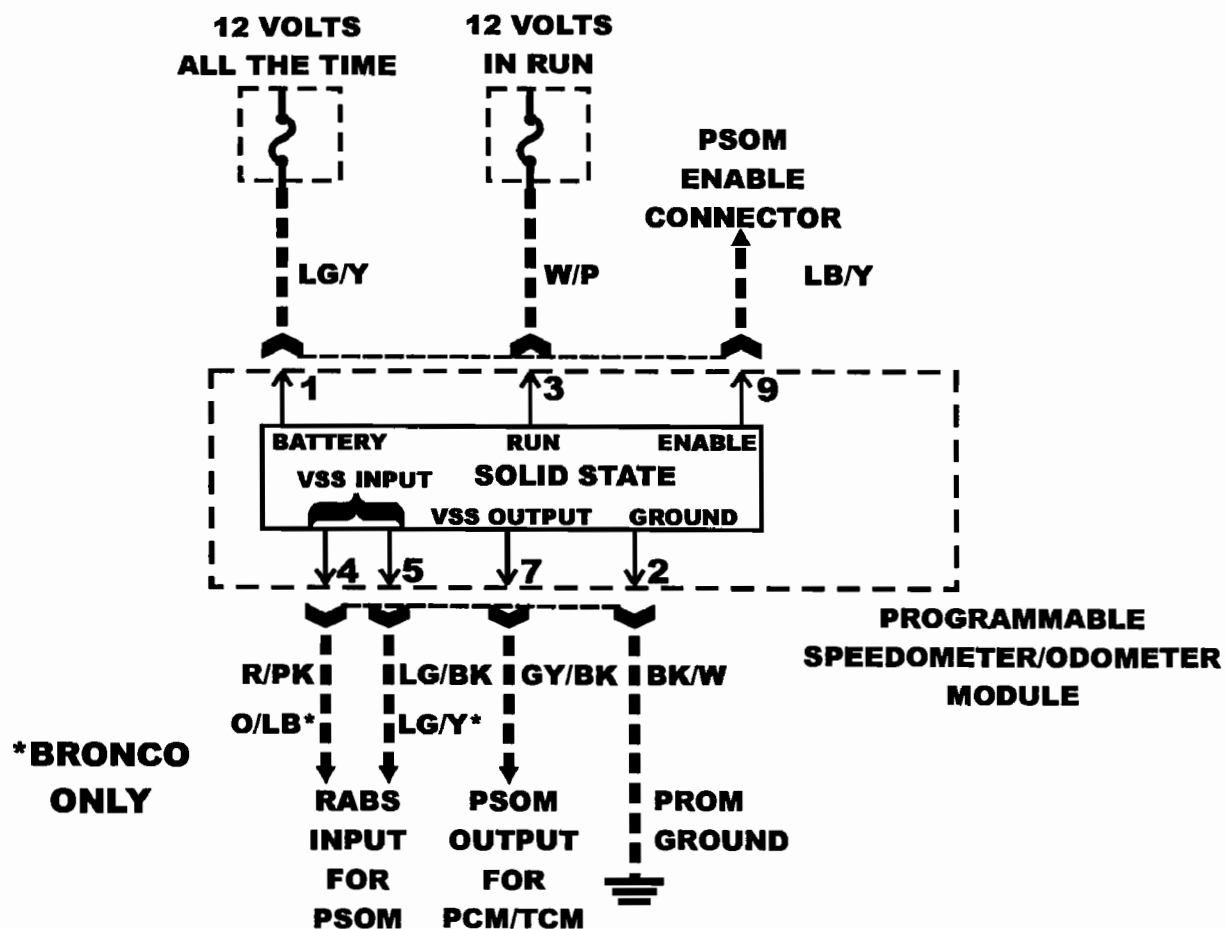
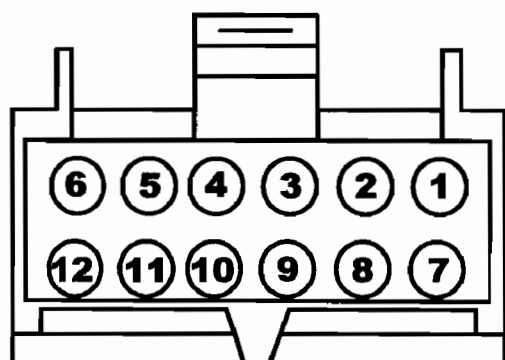
Figure 6

- PIN 1 12 Volts all the time
- PIN 2 Ground .1 volt or less
- PIN 3 12 Volts run only
- PIN 4 RABS signal input
- PIN 5 RABS signal return
- PIN 6 NOT USED
- PIN 7 Speed output to instrument cluster
Cruise Control & PCM/TCM
- PIN 8 NOT USED
- PIN 9 PSOM dealer enable
- PIN 10 NOT USED
- PIN 11 NOT USED

4. Remove the instrument cluster from the dash to gain access to the PSOM connector and refer to the schematic in **Figure 6 for steps 5 through 10.**
5. Begin with the **LIGHT GREEN/YELLOW (CIRCUIT 54)** wire at PSOM connector pin 1 which is keep alive power at all times, this must have battery voltage even with the ignition off. If it does not the #8 15 amp fuse in the under dash fuse box should be checked (Refer to Figure 7) or the LG/Y wire is faulty.
If fuse #8 has no power then the 50 amp "S" maxi-fuse in the under hood fuse box should be checked as shown in figure 8.

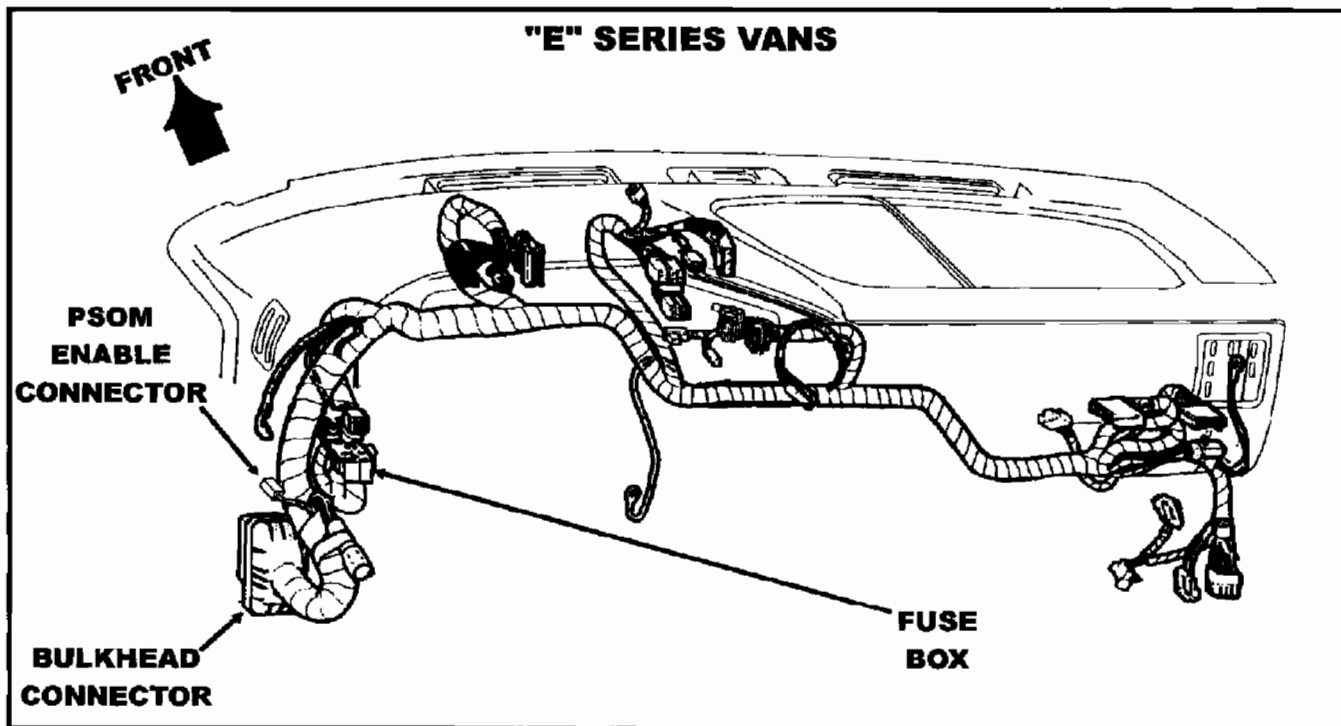
Figure 9

10. If the PSOM requires recalibration, the **LIGHT BLUE/YELLOW, CIRCUIT 567** wire at PSOM connector pin 9 is the PSOM enable circuit used to reprogram the PSOM. This LB/Y wire goes to the PSOM Enable Connector located under the left side of the dash below the fuse box near the bulkhead connector on "E" series vans (Refer to Figure 9) and under the center of the dash below the glove box on "F" series trucks. (Refer to Figure 10)

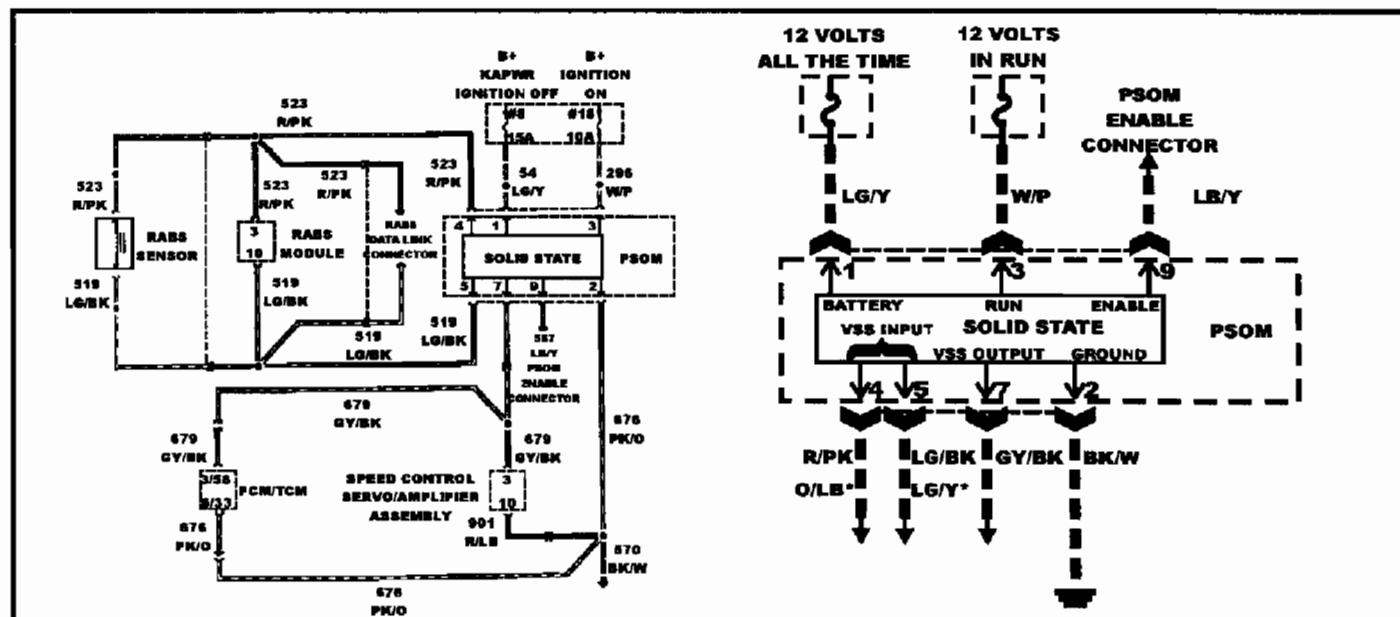
Figure 11

11. A diagnostic tree is provided in figures 11 and 12.

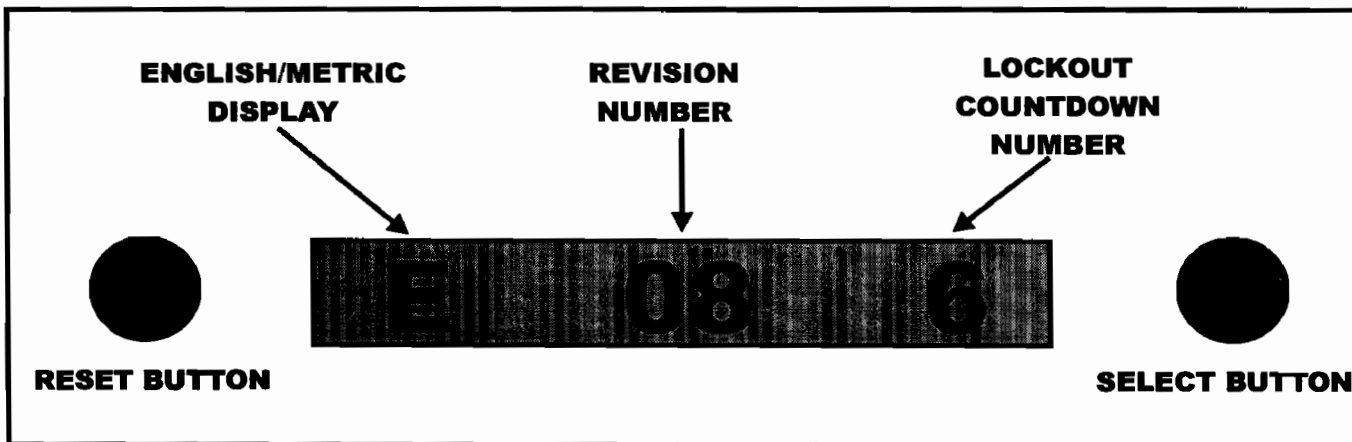
Figure 13

Next, While pushing in on the trip odometer reset button (See Figure 13), turn the ignition "ON", do not start the engine, then release the trip odometer reset button.

In the LCD odometer window, you will now see the English/Metric display, the revision level number and the lockout countdown number which indicates how many times the PSOM can be reprogrammed. (Refer to Figure 13)

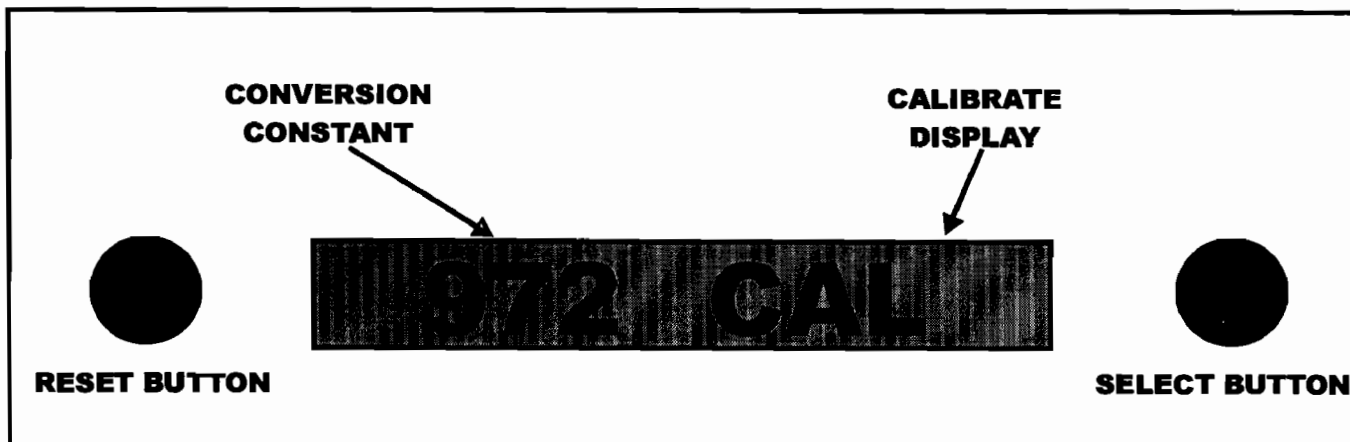
Figure 14

Next, press the odometer reset button once again, and now you will see the conversion constant number, without the decimal point, in the odometer window, followed by the abbreviation "CAL". (Refer to Figure 14)

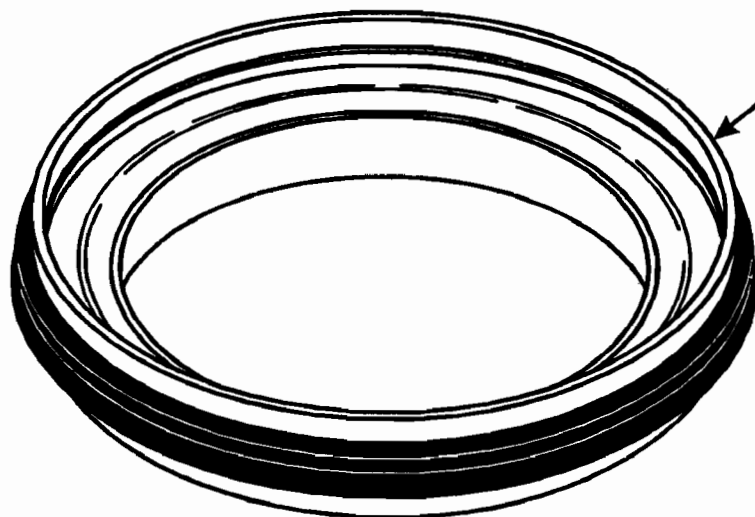
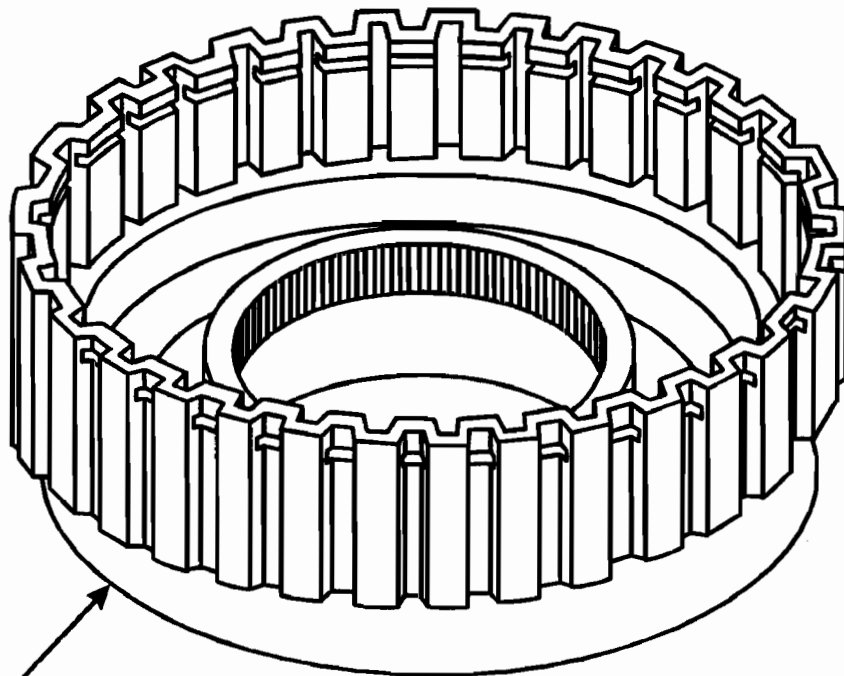
COMPLAINT: Some 1996-1998 Windstar vehicles equipped with the AX4S (AXODE) transaxle may experience an intermittent neutral condition after driving and coming to a stop.

CAUSE: The cause may be, the molded rubber seal on the forward clutch piston intermittently not sealing during the 3-2 downshift (See Figure 1).

CORRECTION: Replace the forward clutch piston *and* the forward clutch cylinder with the OEM part numbers listed below. Refer to Figure 1 for new design and Figure 2 for previous design

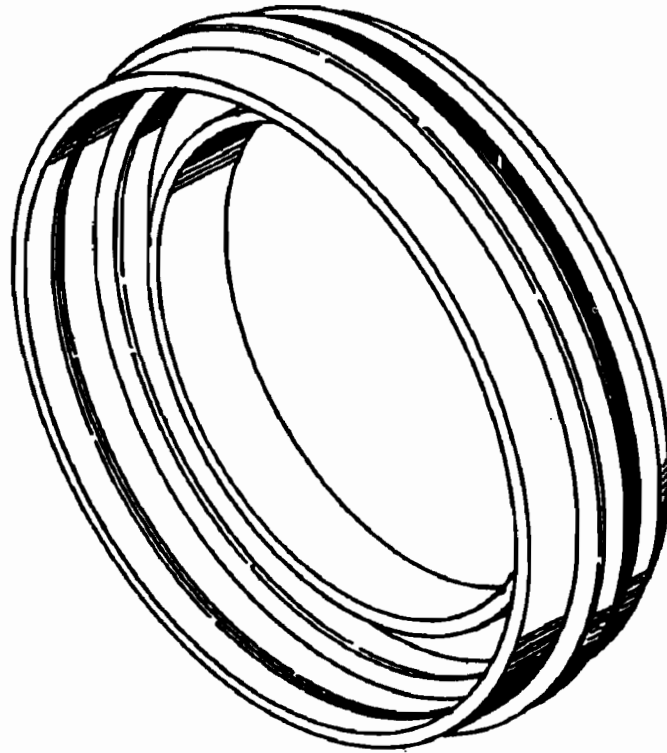
Figure 2

**PREVIOUS DESIGN STEEL FORWARD CLUTCH PISTON
OEM PART NUMBER F4DZ-7A262-A**

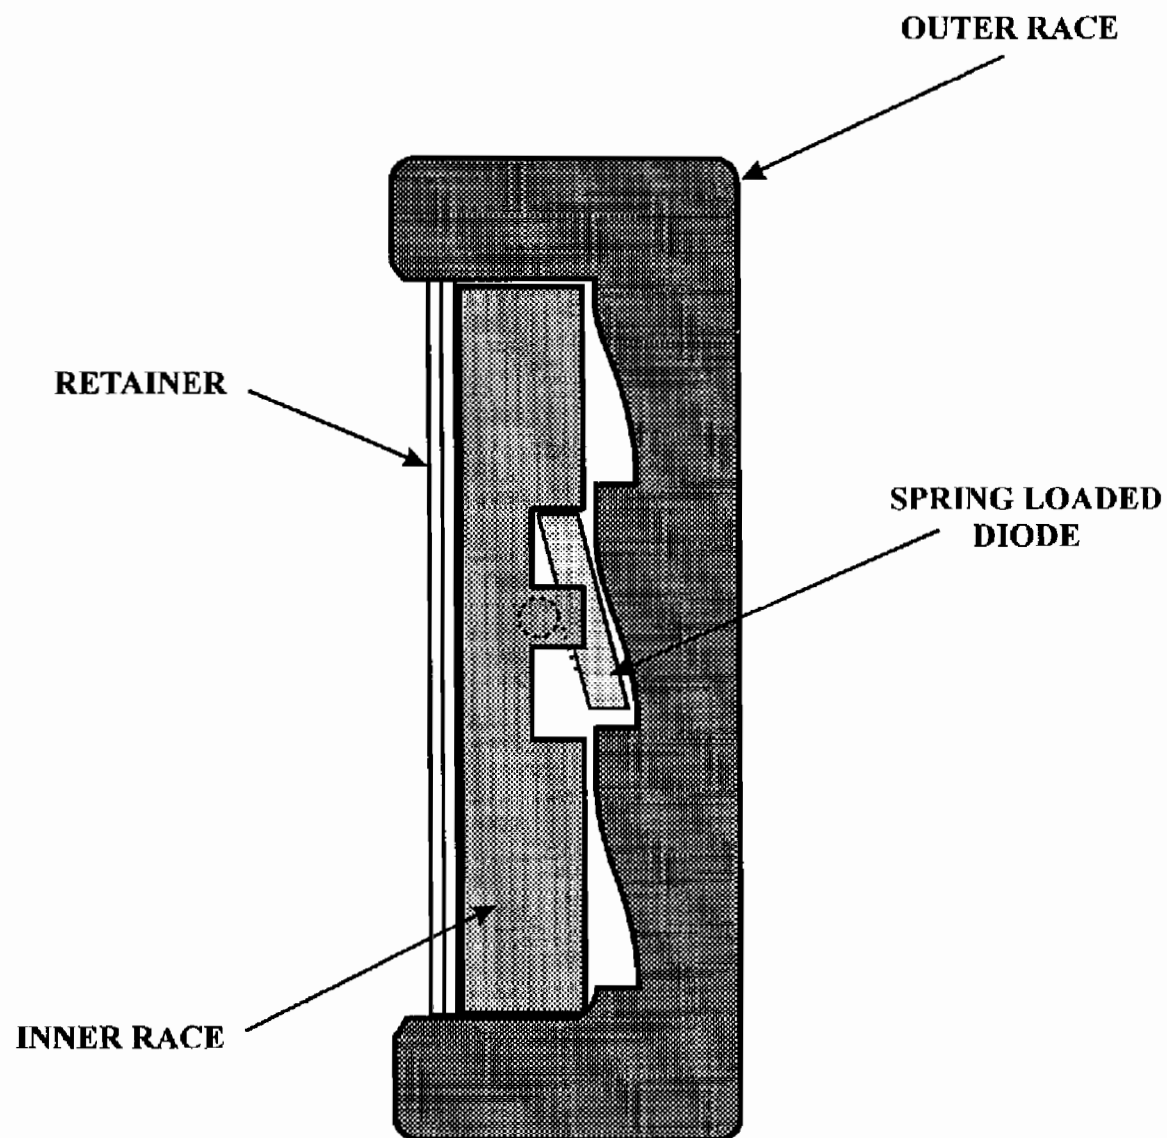
Figure 1

- (1) **MECHANICAL DIODE SPRAG ASSEMBLY** - Totally new design to replace the previous design intermediate roller clutch in AODE and 4R70W transmissions (See Figures 1 and 2).
- (2) **REVERSE INPUT HOUSING** - New design housing with "Splines" in place of the previous inner race, to accommodate the new design mechanical diode sprag assembly. Refer to Figures 1 and 2.
- (3) **RETAINING RING** - No dimensional changes on the snap ring, you still use the original snap ring. When installed, the mechanical diode assembly may move back and forth approximately .010" and this is normal (See Figure 2).

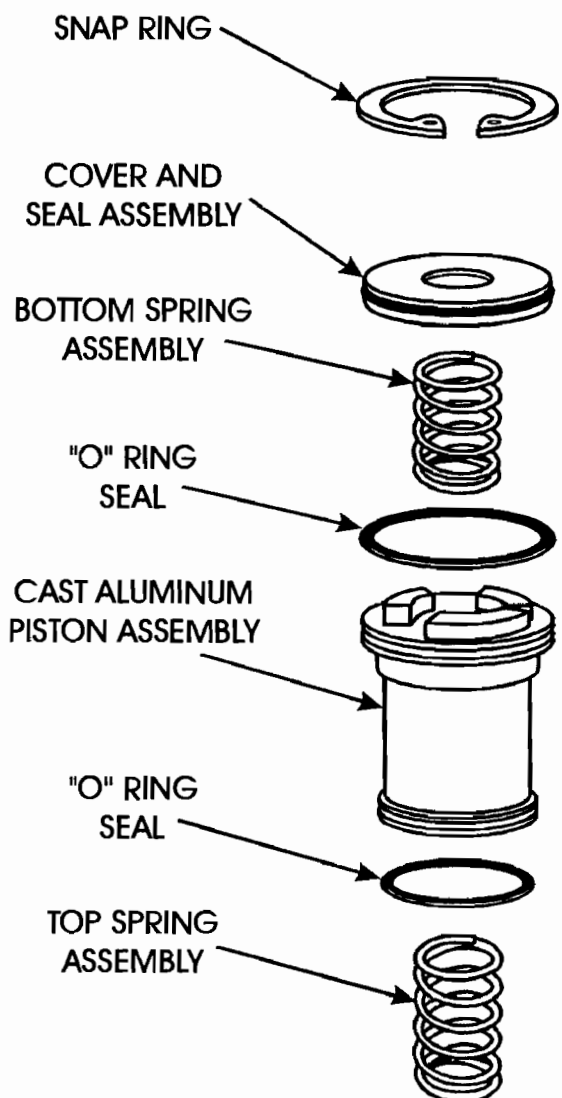
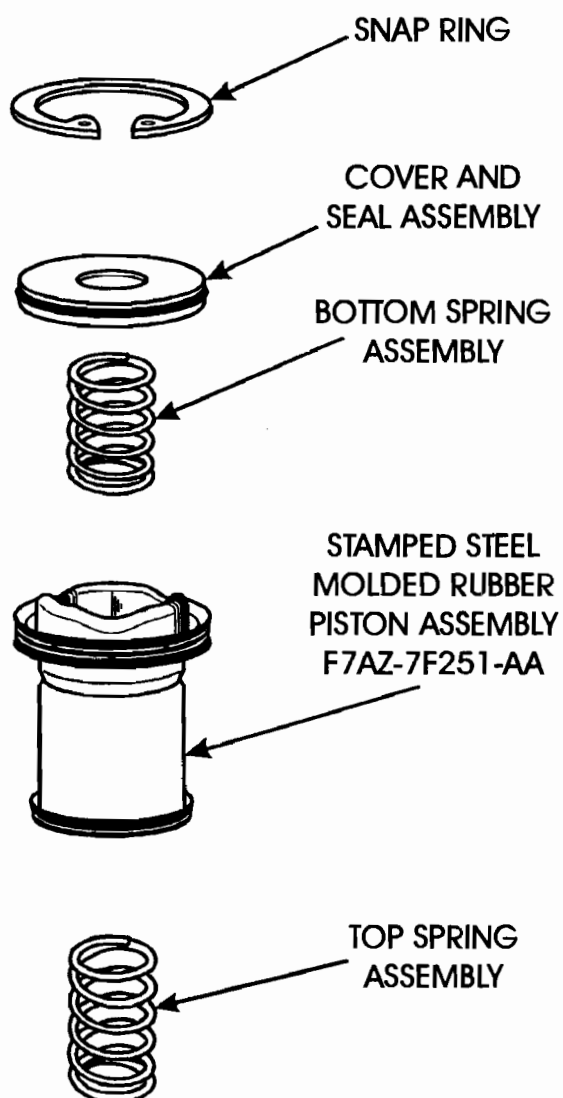
COMPLAINT: Before and/or after rebuild, the vehicle exhibits a slipping condition on the 1-2 upshift, and sometimes will not be displayed until some miles have been put on the vehicle.

CAUSE: The cause may be, premature 1-2 accumulator seal wear, which also creates the case accumulator bore to become scuffed, which leads to the loss in the 1-2 shift.

CORRECTION: Replace the cast aluminum 1-2 accumulator piston with a new design one piece stamped steel piston with molded rubber lip seals, and replace the top accumulator spring with the revised parts available from Ford Motor Co. Case replacement should not be necessary with the use of the revised stamped steel accumulator piston. Refer to Figure 1 to remove the piston assembly. Refer to Figure 2 for illustration of both design stack-ups, and to Figure 3 for a chart to install the proper revised springs into the proper model.

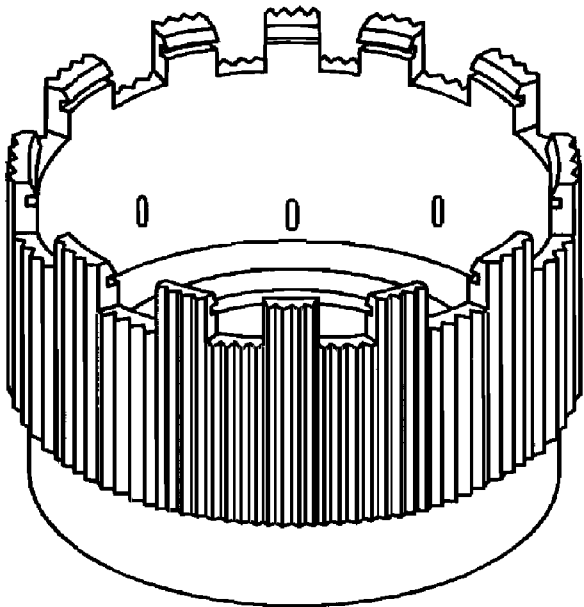
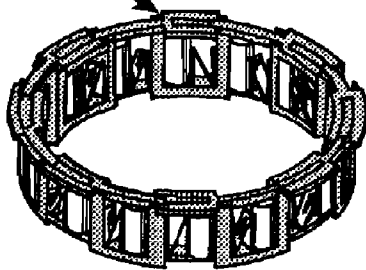
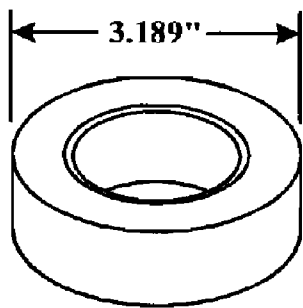
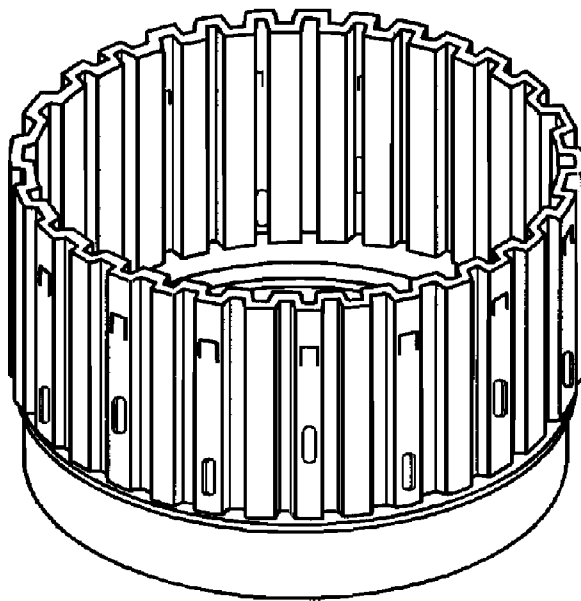
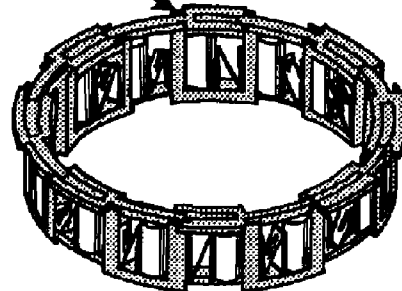
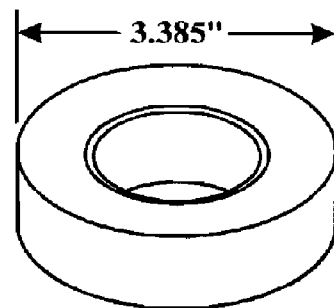
Figure 1

**1989-1996 DESIGN LEVEL
REVERSE CLUTCH HUB,
LOW ROLLER CLUTCH,
AND INNER RACE**

**1997-UP DESIGN LEVEL
REVERSE CLUTCH HUB,
LOW ROLLER CLUTCH,
AND INNER RACE**

The new design parts will retro-fit back to all previous models, as long as all parts listed above are used as a package. The low roller clutch assembly *must* be installed into the back side of the reverse clutch hub regardless of which design level you are using, as shown in Figure 5.

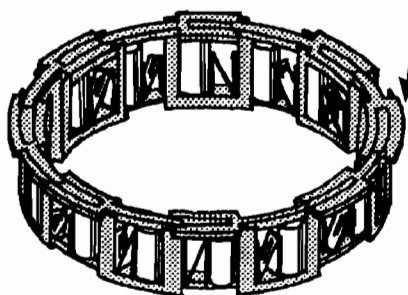
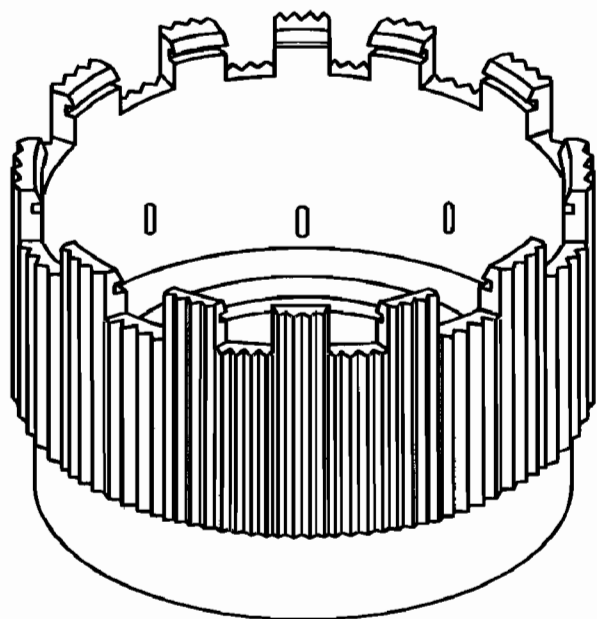
Figure 5

**"INCORRECTLY"
INSTALLED**

IF THE ROLLER CLUTCH IS INSTALLED IN THIS DIRECTION, THE REVERSE HUB WILL FREEWHEEL IN BOTH DIRECTIONS.

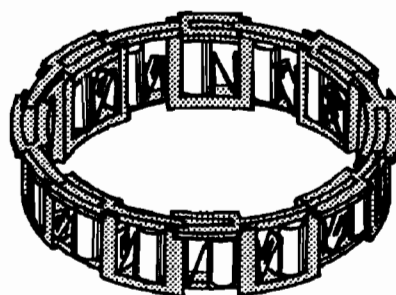
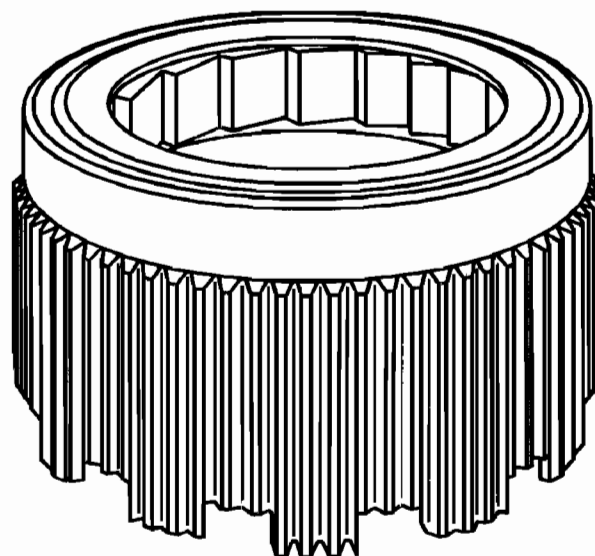
**"CORRECT"
INSTALLATION**

DISCARD BOTH SNAP RINGS. THEY ARE NOT USED WITH THE PLASTIC ROLLER CLUTCH

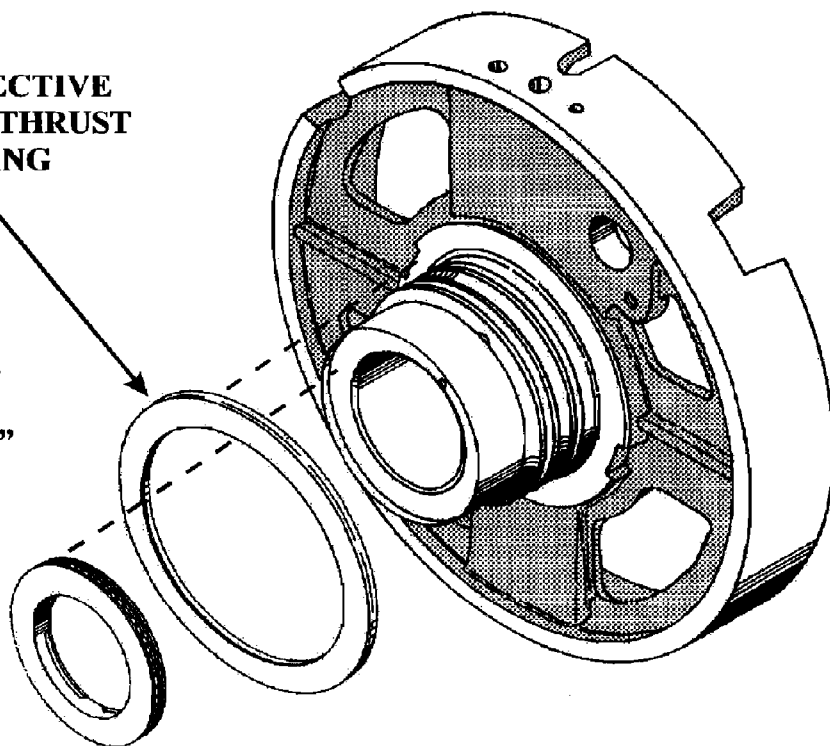
Figure 1

**NEW SELECTIVE
NUMBER 4 THRUST
BEARING**

**NUMBER 5 BEARING
NOT USED WHEN LATE
CENTER SUPPORT IS
USED WITH "NON-SNAP"
DESIGN UNITS**

- (1) NUMBER 4 THRUST WASHER - Was replaced by a new *selective* Number 4 thrust bearing, as shown in Figure 1.
