## CHRYSLER AND DODGE VEHICLES

### 1776 SOLENOID SWITCH LATCHED IN THE LR POSITION

**COMPLAINT:** The on board computer system for the transmission may intermittently produce a code P1776 Solenoid Switch Valve Latched in the LR Position causing a default to limp.

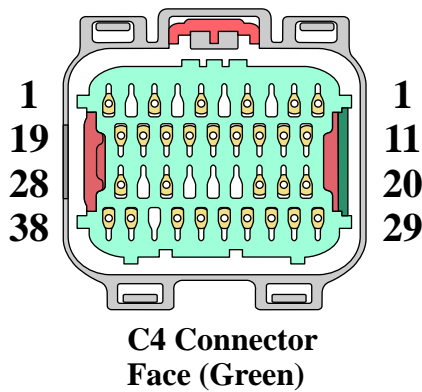
Figure 6

PIN CAVITY	WIRE COLOR	FUNCTION
1	YL/GY	Overdrive Clutch Solenoid Control
2	YL/DG	4th Clutch Solenoid Control
3		
4	DG	Multi-Select Solenoid Control
5		
6	YL/LG	2nd Clutch Solenoid Control
7		
8	YL/LB	Underdrive Clutch Solenoid Control
9		
10	DG/WH	LR/TC Clutch Solenoid Control
11	YL/GY	Line Pressure Control Solenoid Control
12	BK	Ground
13	BK	Ground
14	BK	Ground
15	DG/LB	Transmission Range Sensor (T1) Signal
16	DG/DB	Transmission Range Sensor (T3) Signal
17	DG	Towhaul Overdrive Off Switch Sense
18	YL/DB	Transmission Control Relay Control
19	YL/OR	Transmission Control Relay Output
20	BR/YL	4th Clutch Pressure Switch Signal
21	YL/WT	Underdrive Clutch Pressure Switch Signal
22	DG/TN	Overdrive Clutch Pressure Switch Signal
23		
24		
25		
26	DG/LB	Transmission Range Sensor (T2) Signal
27		
28	YL/OR	Transmission Control Relay Output
29	YL/TN	Low/Reverse Clutch Pressure Switch Signal
30	DG/YL	2nd Clutch Pressure Switch Signal

31	YL/BN	Line Pressure Sensor Signal
32	DG/BN	Output Speed Sensor Signal
33	DG/OR	Input Speed Sensor Signal
34	DG/VT	Speed Sensor Ground
35	DG/OR	Transmission Oil Temperature Sensor Signal
36		
37	DG/YL	Transmission Range Sensor (T42) Signal
38	YL/OR	Transmission Control Relay Output

3. Inspect the Low/Reverse Pressure Switch signal wire from the transmission to the computer for a short to ground and replace as necessary.
    - A) For the 41TE and 42LE transmissions with a TCM: wire 2 at the solenoid block to terminal 50 at the TCM (PCM Models - Terminal 29 in the C4 connector).

- B) For the 42RLE transmission with a TCM: wire 10 at the solenoid block to terminal 50 at the TCM (PCM Models - Terminal 29 in the C4 connector).

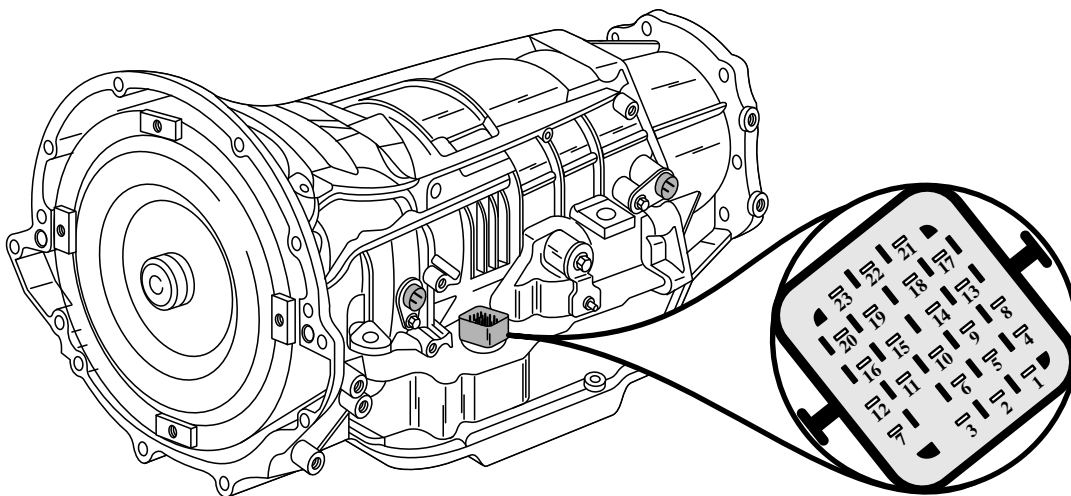
Figure 7

PIN CAVITY	WIRE COLOR	FUNCTION
1	WT/GY	Fused Ignition Switch Battery Voltage
2	DG/WT	LR/TC Clutch Solenoid Control
3	BN/YL	Park/Neutral Position Switch Signal
4	YL/LB	Transmission Range Sensor (T41) Signal
5	DG/YL	Transmission Range Sensor (T42) Signal
6	WT/LG	Back-Up Lamp Feed
7	YL/GY	Overdrive Clutch Solenoid Control
8	DG/DB	Transmission Range Sensor (T3) Signal
9	DG/LB	Transmission Range Sensor (T1) Signal
10	YL/OR	Transmission Control Relay Output
11	BR/YL	4th Clutch Pressure Switch Signal
12	YL/GY	Line Pressure Control Solenoid Control
13	DG/LB	Transmission Range Sensor (T2) Signal
14	YL/TN	Low/Reverse Clutch Pressure Switch Signal
15	DG/YL	2nd Clutch Pressure Switch Signal
16	DG/TN	Overdrive Clutch Pressure Switch Signal
17	YL/LB	Underdrive Clutch Solenoid Control
18	YL/WT	Underdrive Clutch Pressure Switch Signal
19	YL/DG	4th Clutch Solenoid Control
20	YL/LG	2nd Clutch Solenoid Control
21	DG	Multi-Select Solenoid Control

22	DB/DG	Speed Sensor Ground
23	DG/OR	Transmission Oil Temperature Sensor Signal
