# THE SEMINAR TO SEE IV '93

Automatic Transmission Service Group  
9200 South Dadeland Blvd.  
Suite 720  
Miami, FL 33156  
(305) 661-4161

# **TRANSMISSION SEMINAR 1993**

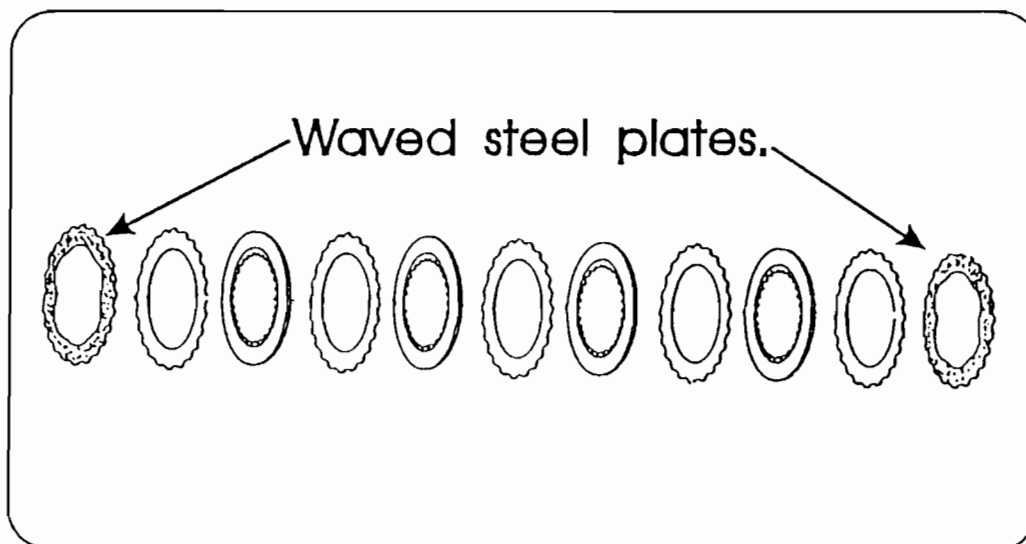
Step #5. When Installing the forward clutches, waved steel plates must be installed at both ends of the clutch pack. Clutch clearance should be .060-.080 in. See Figure 4.

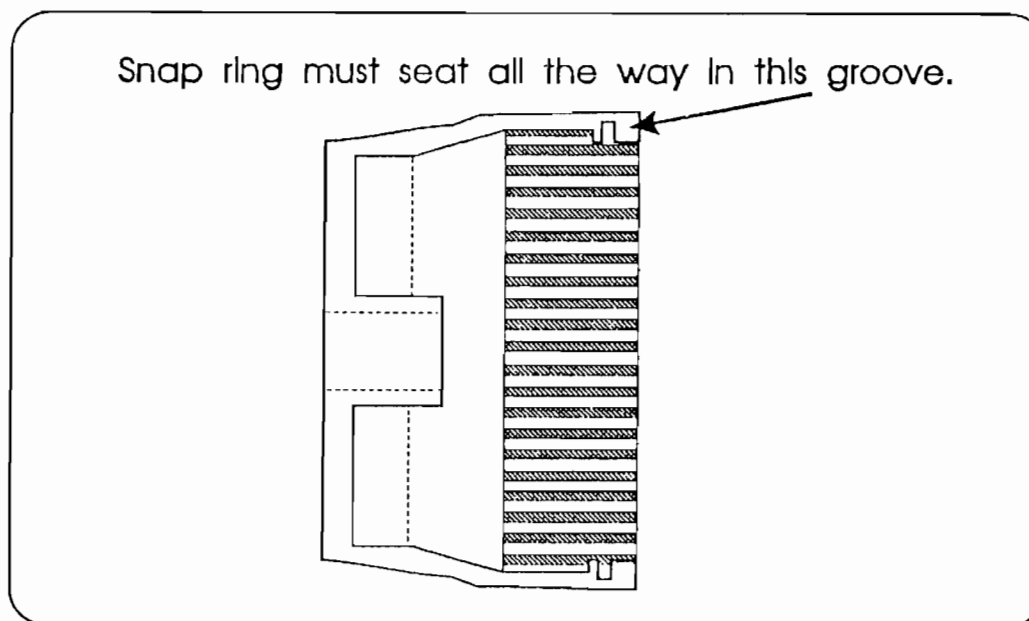
Step #6. Care must be taken to insure that the snap ring retaining the forward clutch hub to the drum be fully seated in the snap ring groove. See Figure 5.

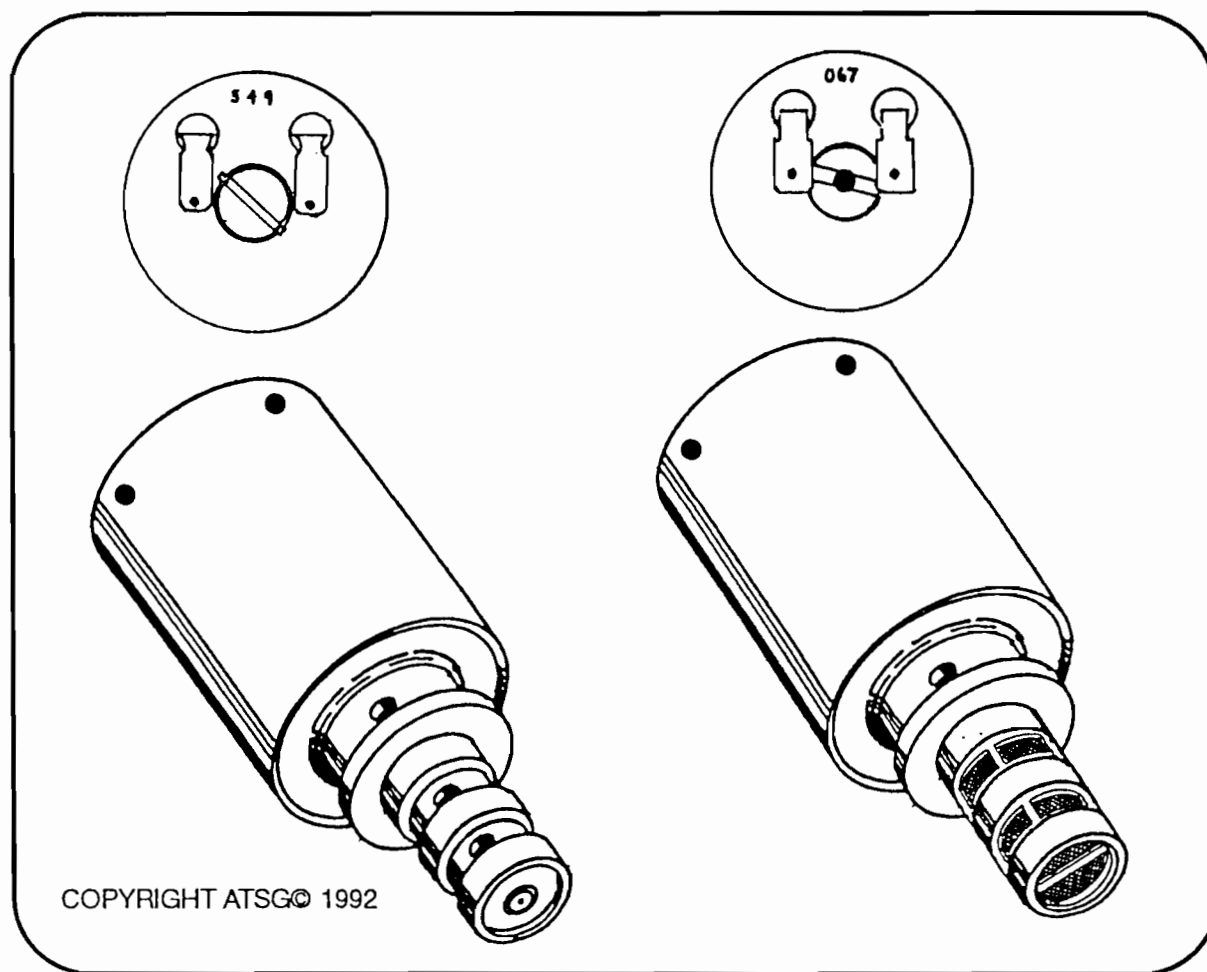
Figure 2.

The BMW Pressure Regulator on the left uses no screens. The G.M. 4L80-E Force Motor on the right has screened ports and a steel ball pressed into the screw head to prevent tampering.

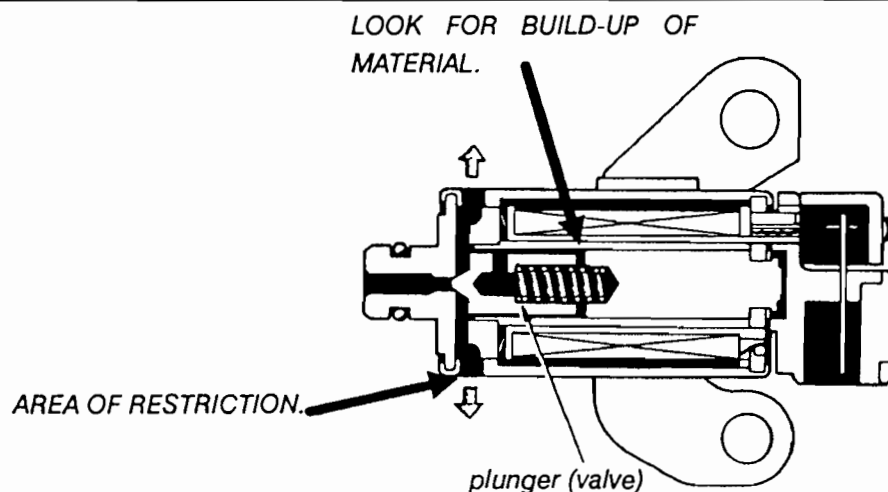
**CAUSE:** Shifts solenoids may be partially restricted.

**NOTE:** The number 1 solenoid wire is white, and the number 2 solenoid wire is black.

**CORRECTION:** Replace defective solenoid/solenoids.

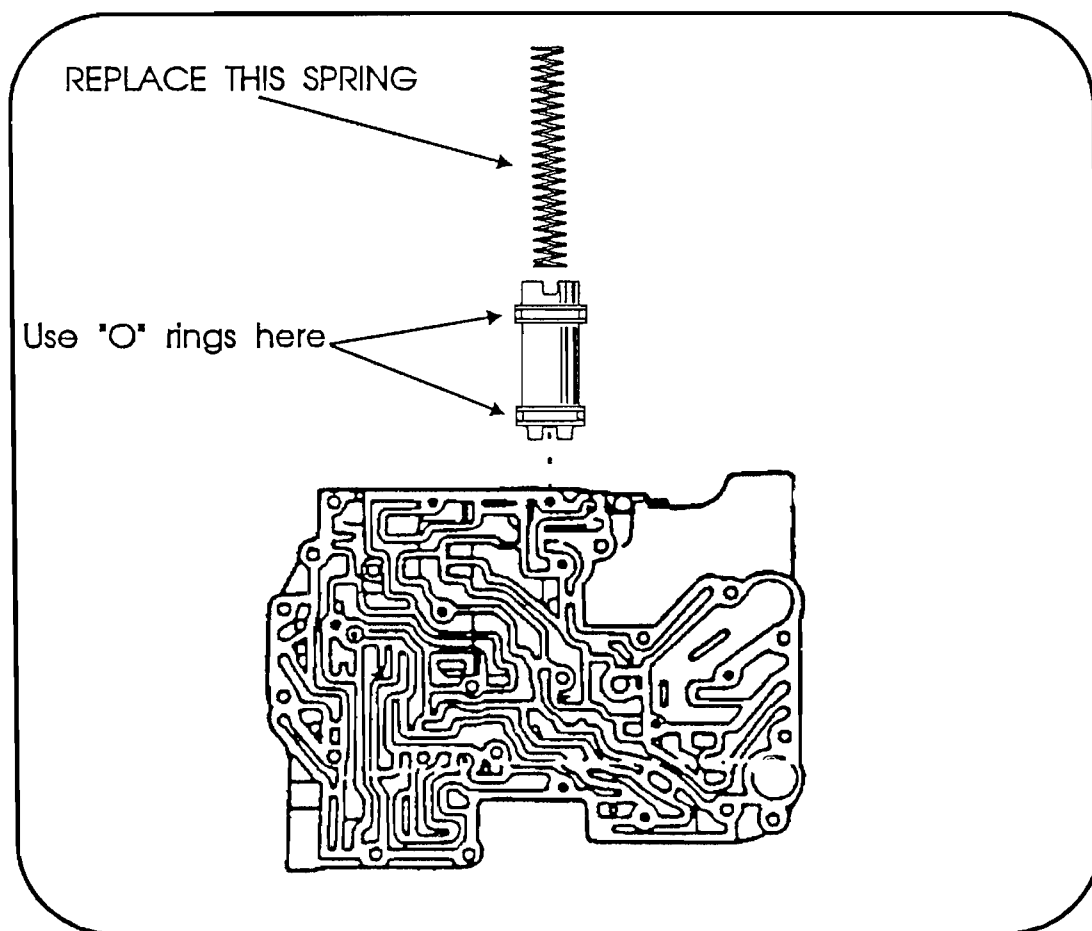
Figure 1.

**Cause:** Valve body calibration problems related to fluid temperature.

- Correction:**
1. Check all accumulator piston teflon rings for fit.
  2. Replace the 1-2 accumulator piston teflon rings with suitable "O" rings. Replace the 1-2 accumulator spring with a stronger spring (A 700-R4 throttle plunger spring is sufficient if it is shimmed 1/4 in. on the piston side). **SEE FIGURE 1.**
  3. Move orifice B (servo release orifice) to the orifice D (direct clutch orifice) location and move the orifice D to the orifice B location. **SEE FIGURE 2.**
  4. Replace the intermediate band servo spring with a weaker one. The L4N71B servo spring is weaker or a blue accumulator spring from an AXOD.

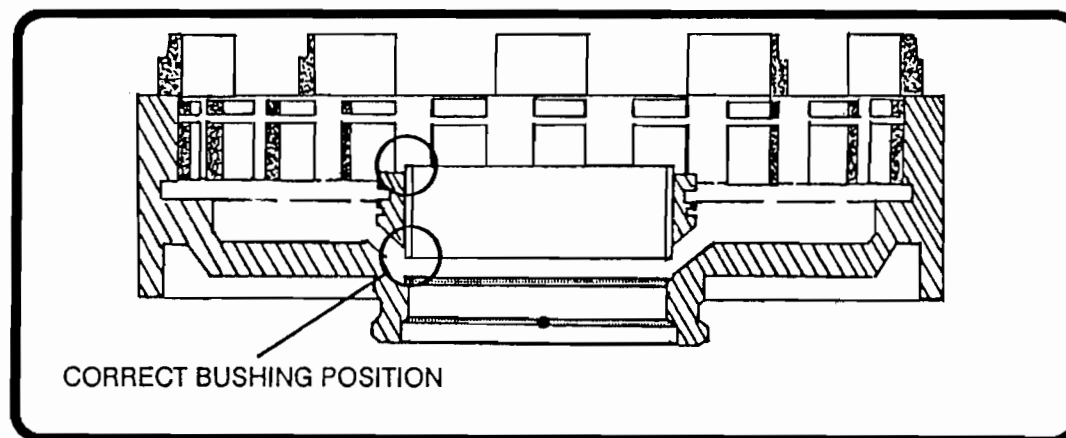
FIGURE 2

**CAUSE:** The reverse drum sleeve has moved forward in the drum and blocks the two oil feed holes (see figure 1). The normal position of the sleeve is about .060 in. above the drum surface and covers 50% of the feed holes (see figure 2).

**CORRECTION:** Replace the reverse drum.

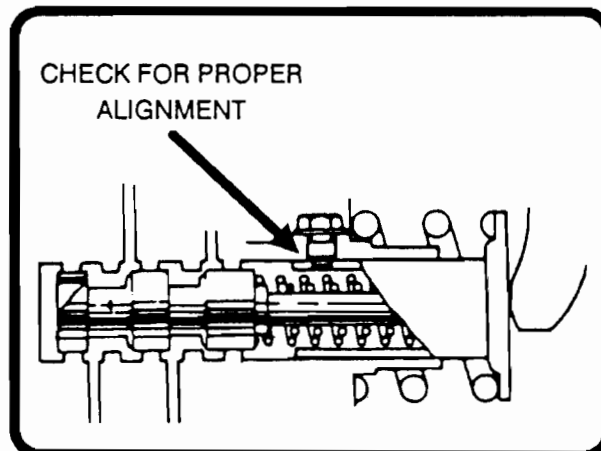
FIGURE 2

- COMPLAINT:** Harsh engagement, harsh shifts, high line pressure.
- CAUSE:** Pressure regulator retaining bolt jamming spring retainer (figure 1).
- CORRECTION:** When installing retainer and bolt make sure that the slot on the retainer lines up with the bolt hole before installing the bolt (figure 2).

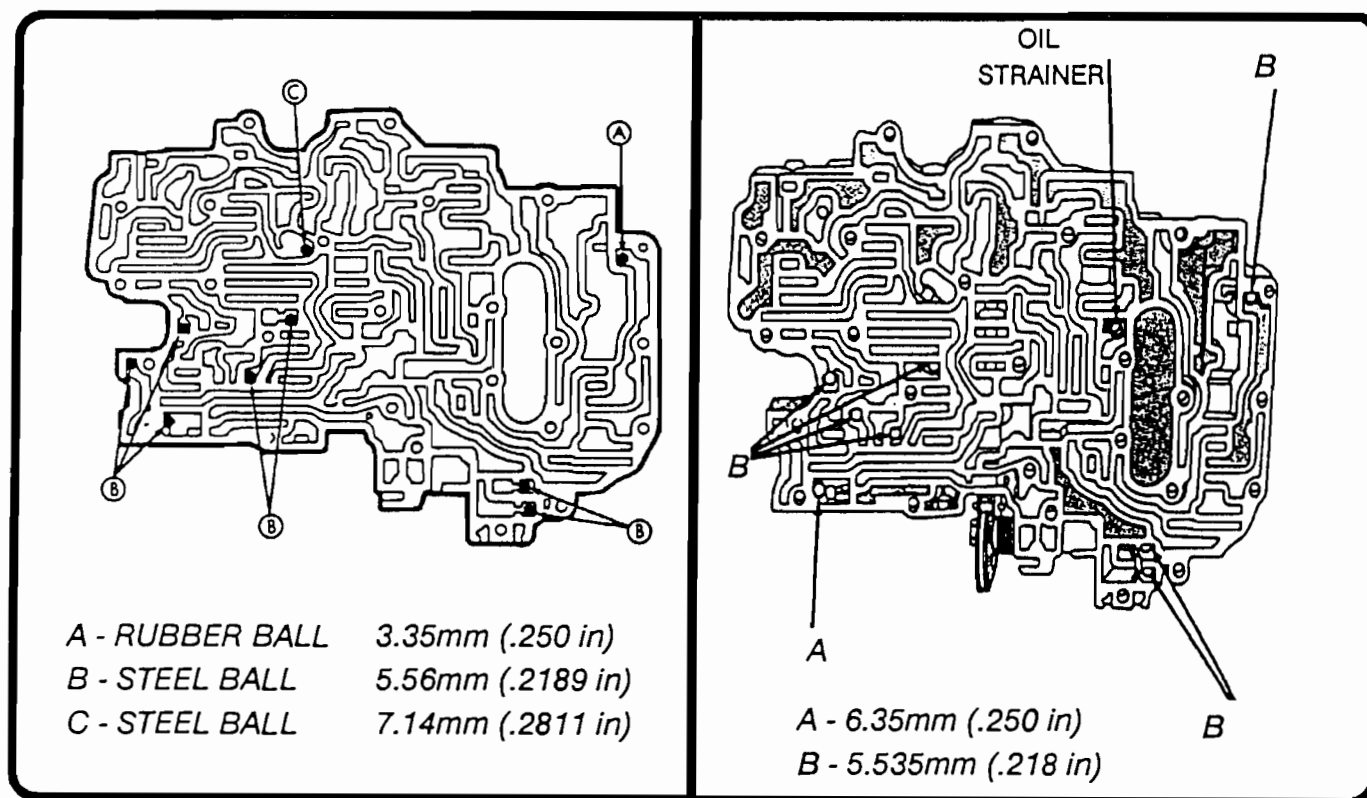
Figure 1

Prior to 1991 the AW-4 modles used 9 check balls with three different sizes and had a combination of both steel and rubber balls (figure 1). In 1991, they went to 8 checkballs all being rubber with two different sizes. The location of these balls are changed and they added an oil strainer (figure 2).

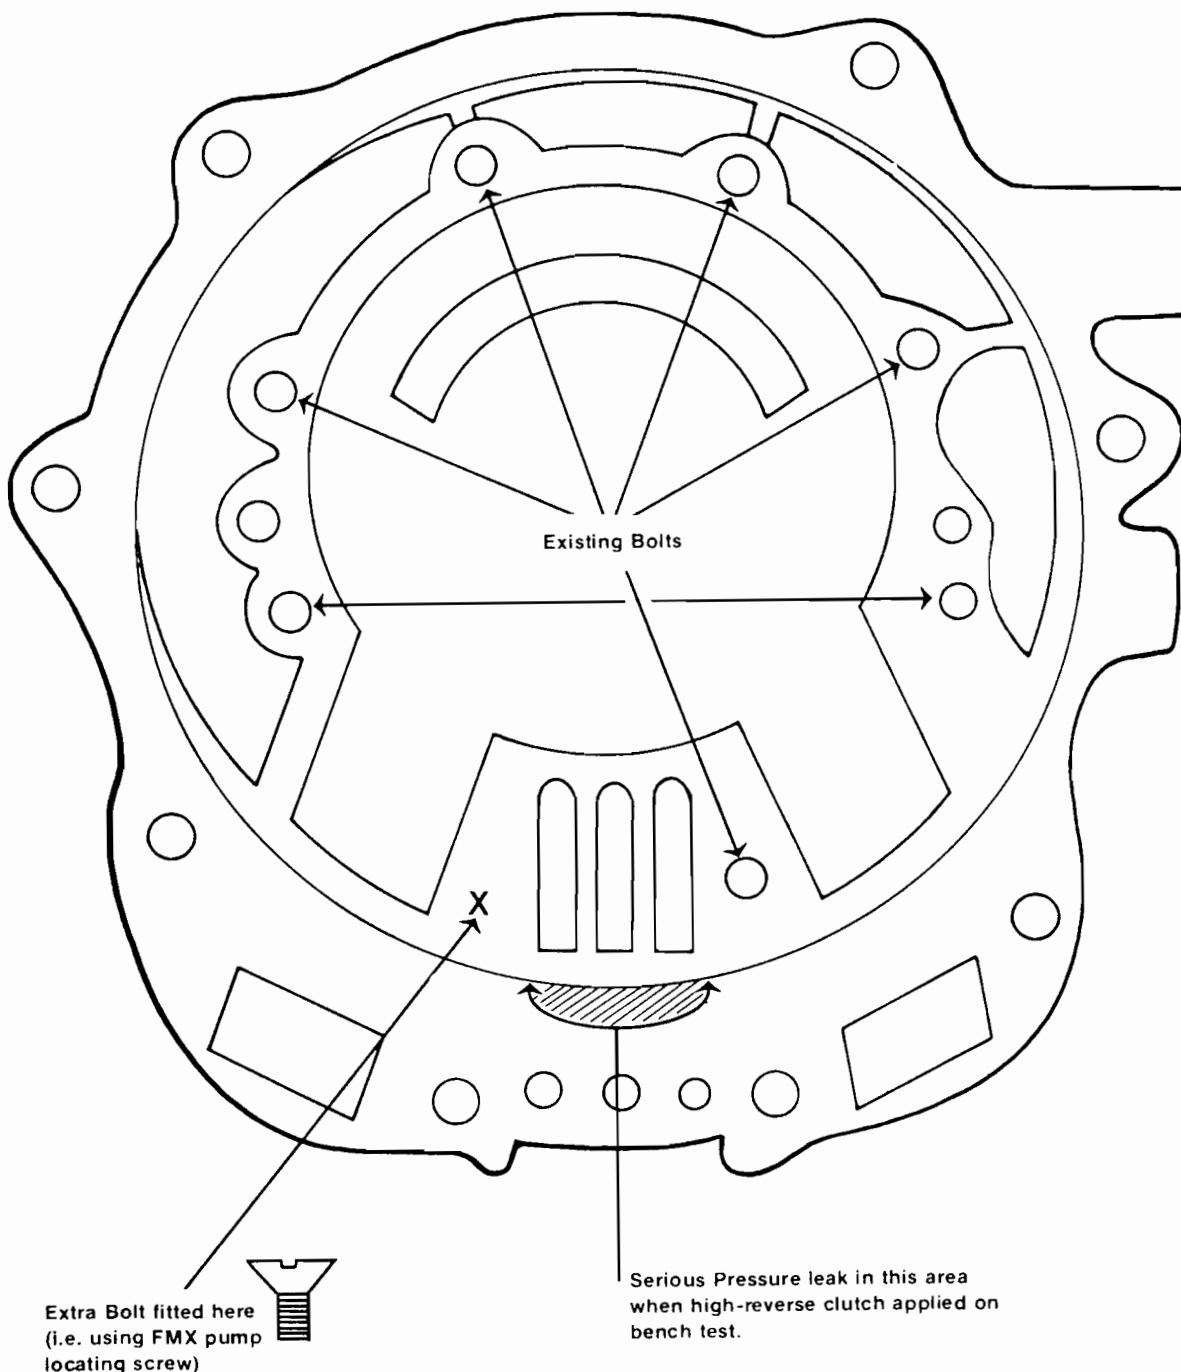
Attached is a diagram of Jatco F3A transmission pump, showing area of leakage of clutch circuit caused by distortion of pump body (inner) during application of high-reverse clutch.

This problem was overcome by drilling and tapping of pump housing to take a 3/16" counter sunk screw, at point indicated on diagram.

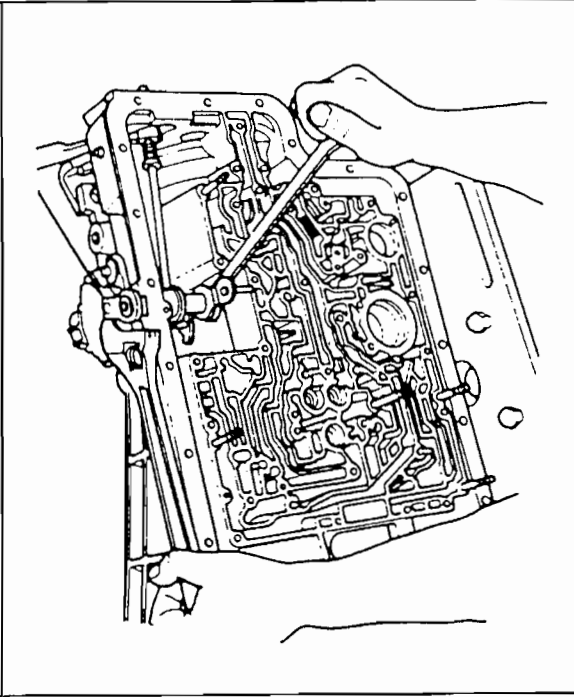
FIGURE 3

**CAUSE:** While removing the 22mm. nut from the manual lever in order to replace the linkage seal, the rooster cone gets caught under the spring and bends it rearward.

1. Remove manual lever detent bolt and spring (See Figure 1).
2. Using side cutters or suitable tool remove manual lever roll-pin from the case (See Figure 2).
3. Remove lever nut while holding lever with suitable tool. (See Figure 3).
4. Remove detent rooster cone and park actuating rod (See Figure 4).
5. Remove manual lever position sensor bolts and lever.
6. Replace seal.
7. Reverse steps 1-4.

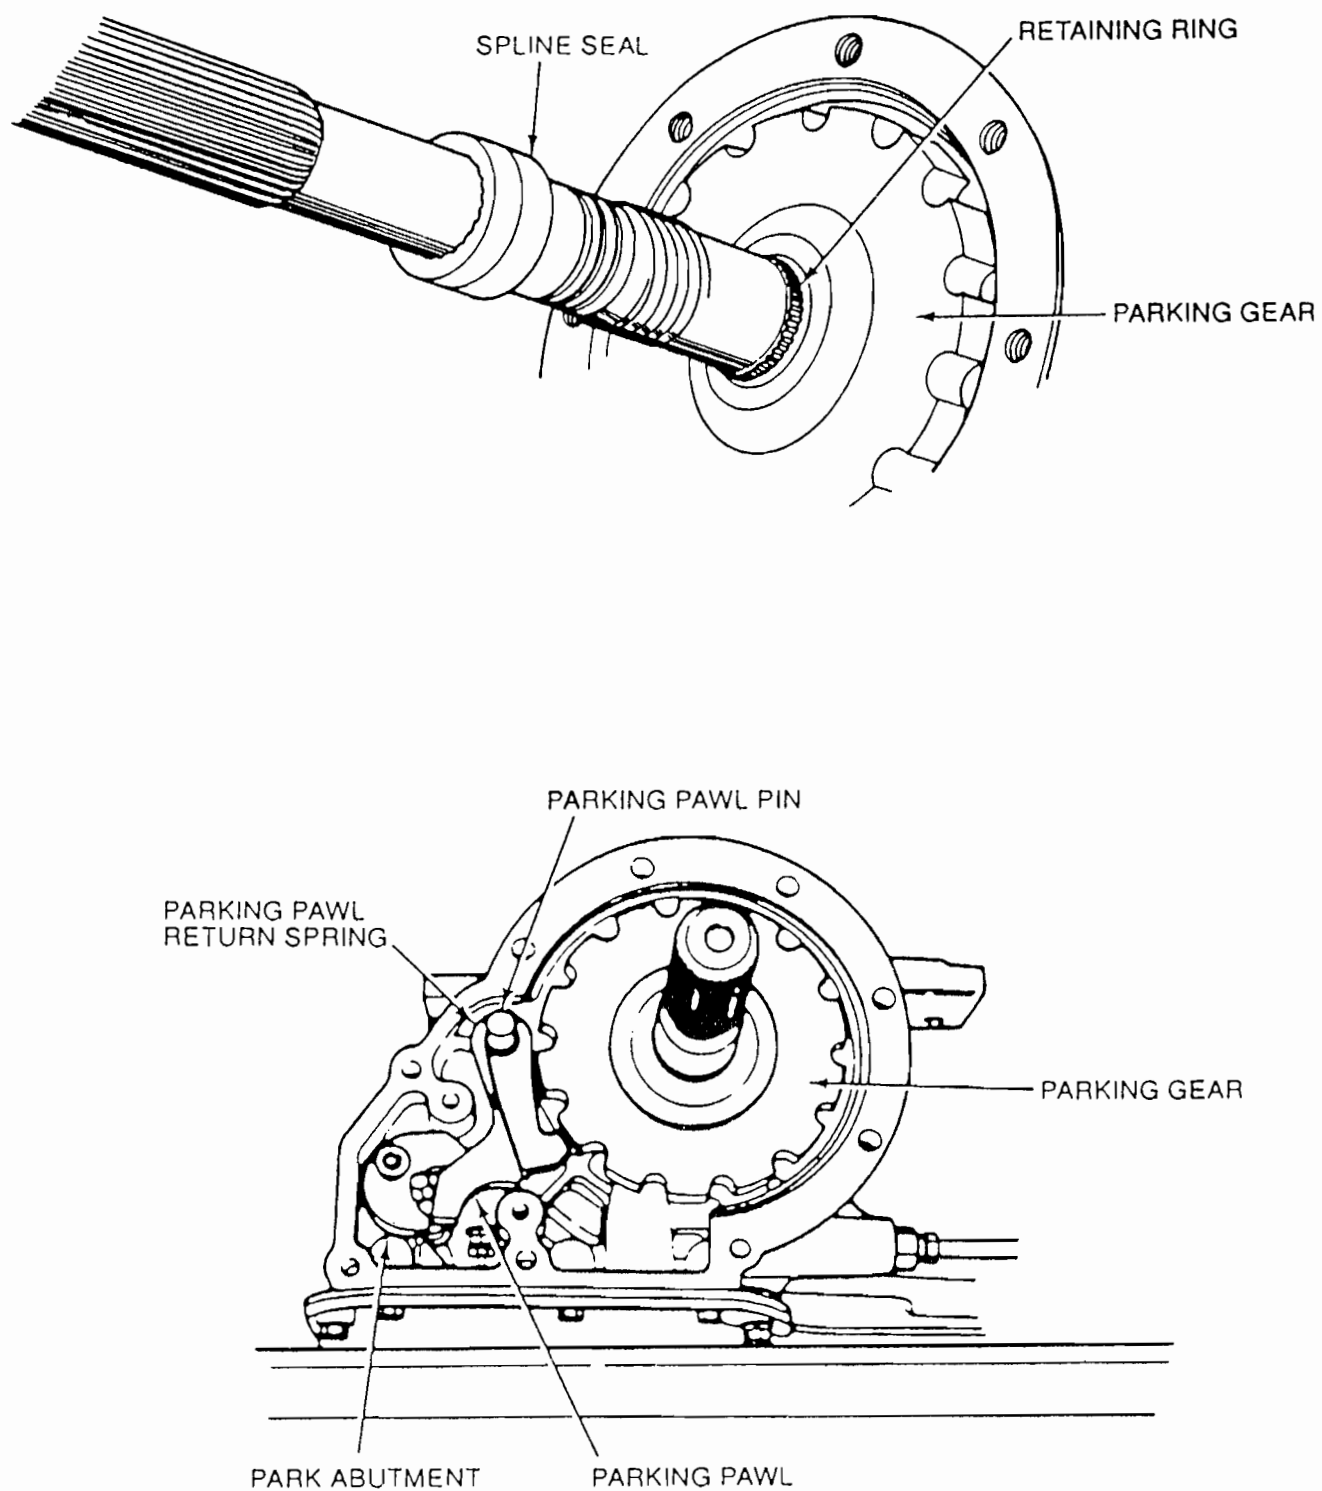
Figure 1

**CAUSE:** The cause may be a broken snap ring on the output shaft, allowing the parking gear to move rearward, and then the parking pawl cannot engage into the parking gear (See Figure 1).

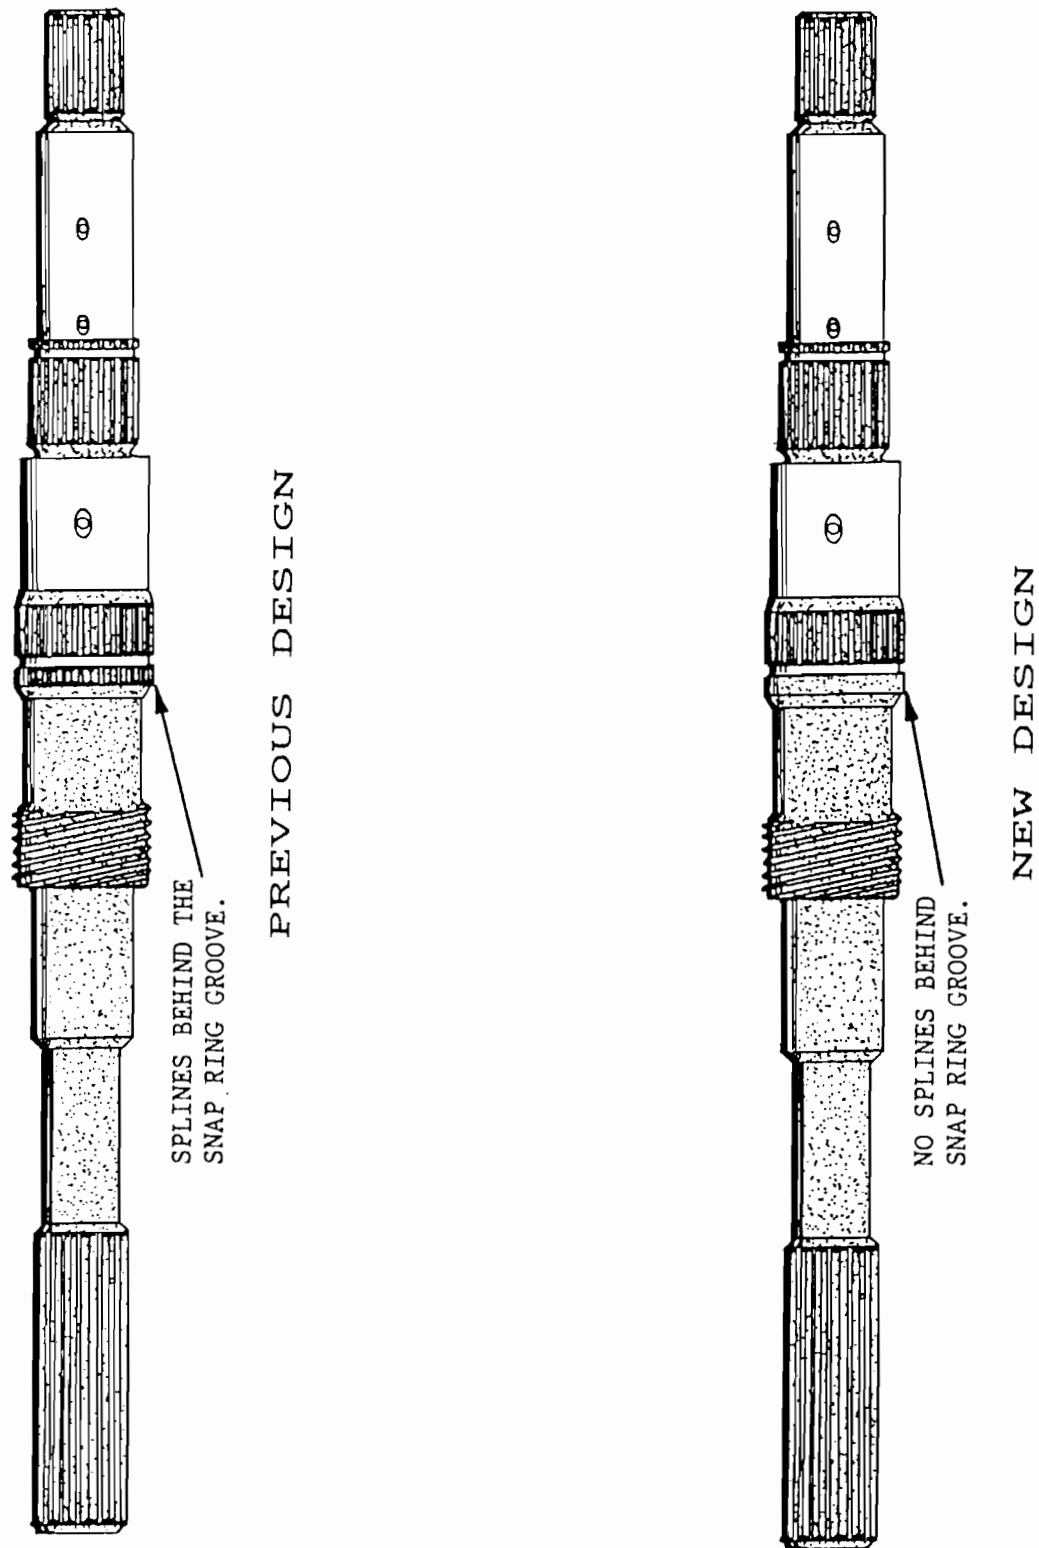
Figure 5

The output shaft has also been re-designed, and has the splines removed from behind the parking gear snap ring groove, which creates an increased shoulder for the snap ring, and helps prevent the snap ring from breaking (See Figure 5). Refer to "Service Information" OEM output shaft part numbers.

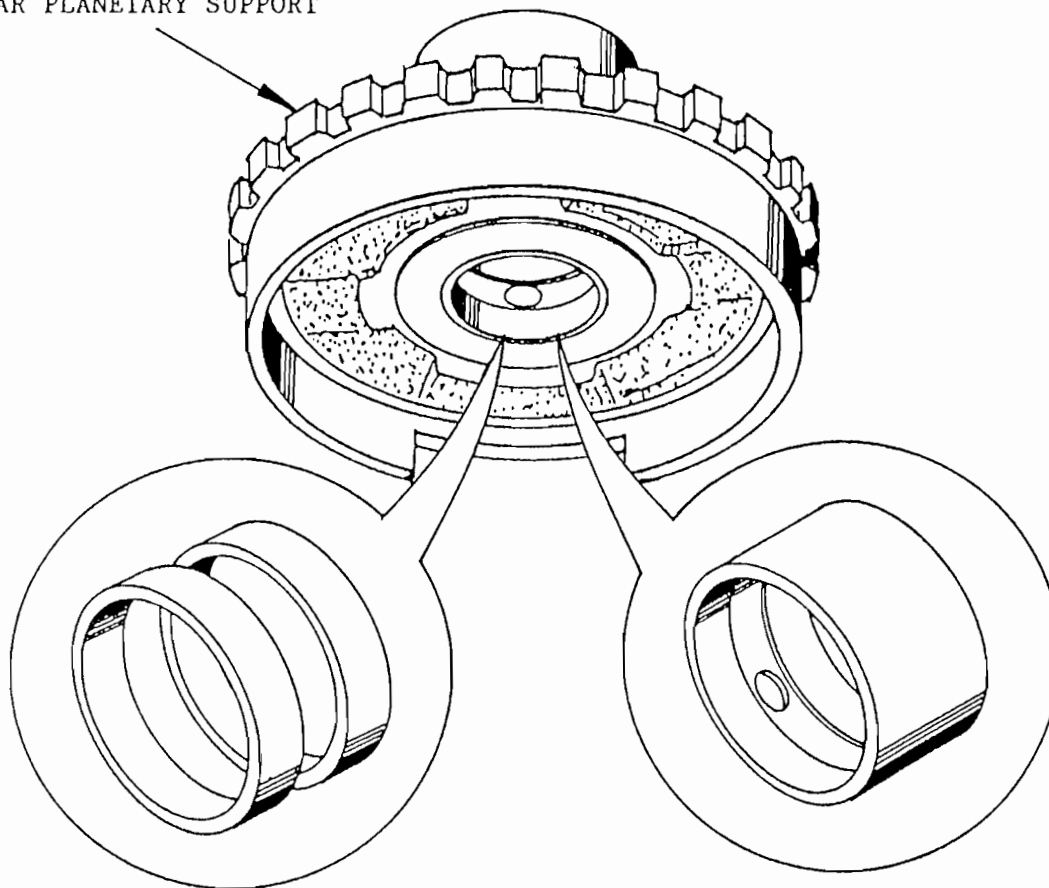
Figure 3

3. Inspect the bushings in the rear planetary support, as these bushings can move out of position and block the lube hole located in the support between them. The 1988 and later rear planetary support has a new second design, wider, one piece bushing with a groove and lube hole in the center. This will provide more surface area to prevent the bushing from moving. Refer to Figure 3.  
The later rear planetary support, with the 2nd design bushing, will retro fit back to ALL previous models and is highly recommended. The new design rear planetary support is available under OEM part number E6DZ-7A130-A.

THE LATER REAR PLANETARY SUPPORT, WITH THE 2ND DESIGN BUSHING, WILL RETRO FIT BACK TO ALL MODELS AND IS HIGHLY RECOMMENDED.

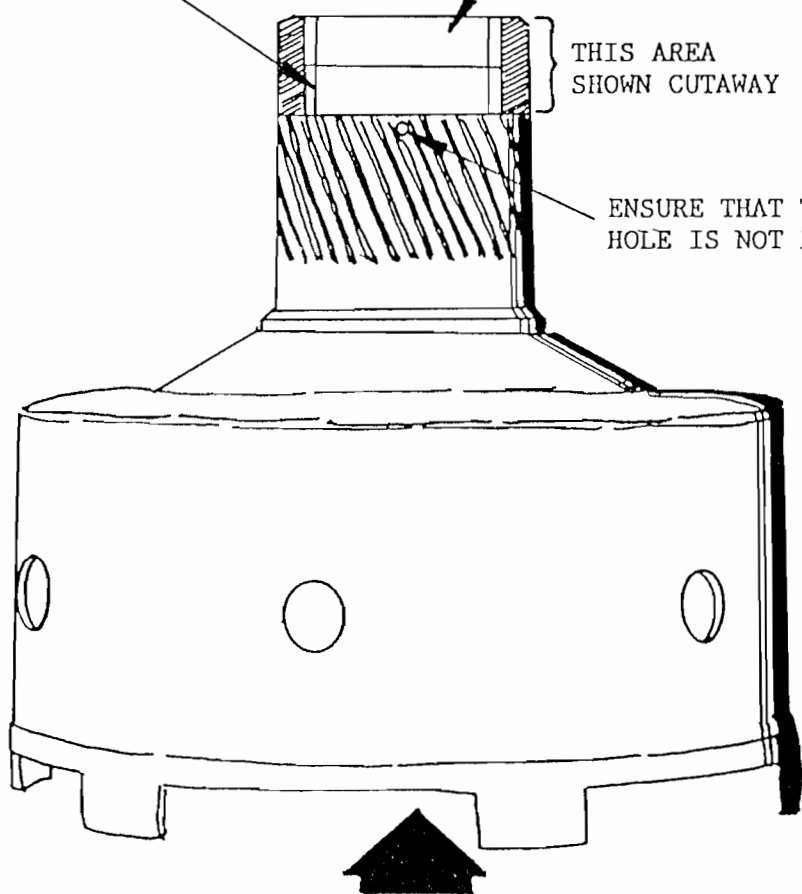
Figure 5

ENSURE THAT THIS LUBE HOLE IS NOT BLOCKED.

5. Install "Double Bushings" at the rear of sun gear as shown in Figure 5. After both bushings are in place, ensure that lube oil hole in the sun gear is not blocked.

SUPPORT SUN GEAR FROM THIS END WHILE PRESSING BUSHINGS TO PREVENT DAMAGE TO SUN GEAR SHELL.

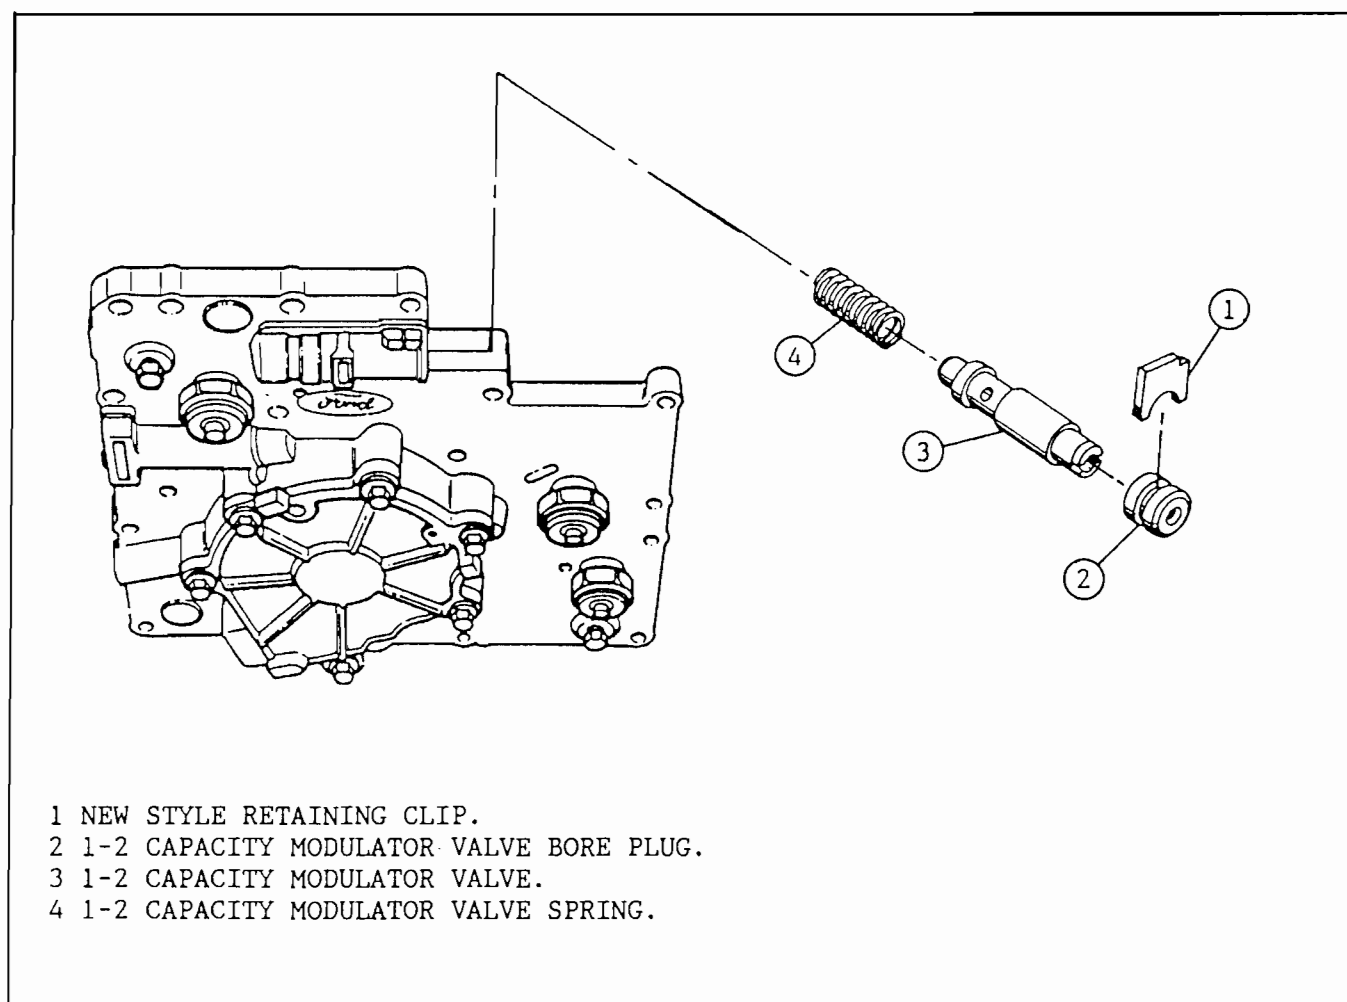
Figure 1

CAUSE: The cause may be a lack of oil volume to the intermediate and/or direct clutch packs.

CORRECTION: FOR SOFT 1-2 SHIFT:  
Replace the 1-2 capacity modulator valve spring with the Red spring manufactured by Shift Technology Products (Part # K006). The kit also comes with a new style bore plug retaining clip. Assemble into the oil pump as shown in Figure 1.

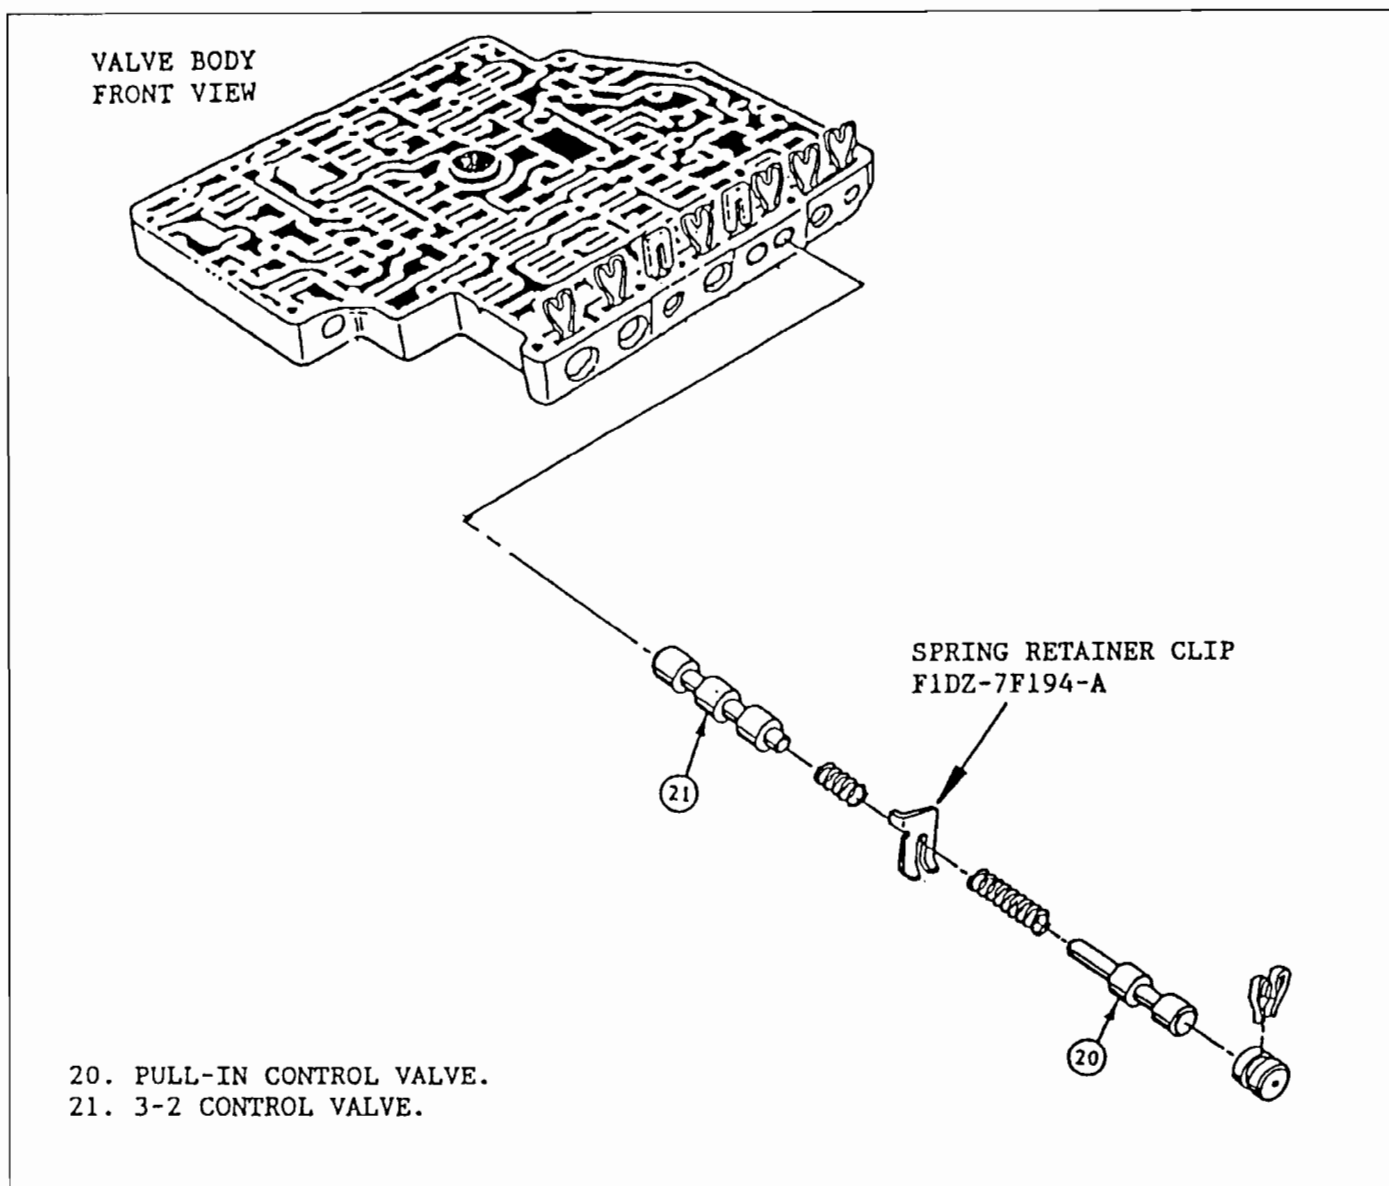
Figure 1

**COMPLAINT:** A delayed shift may occur during 3-2 forced downshifts, or "Kickdown," and/or the transaxle will shift to neutral during the 3-2 kickdown.

**CAUSE:** The cause may be, a broken spring retainer clip between the pull-in control valve spring and the 3-2 control valve spring, as shown in Figure 1.

**CORRECTION:** Replace the spring retainer clip with OEM part number F1DZ-7F194-A.

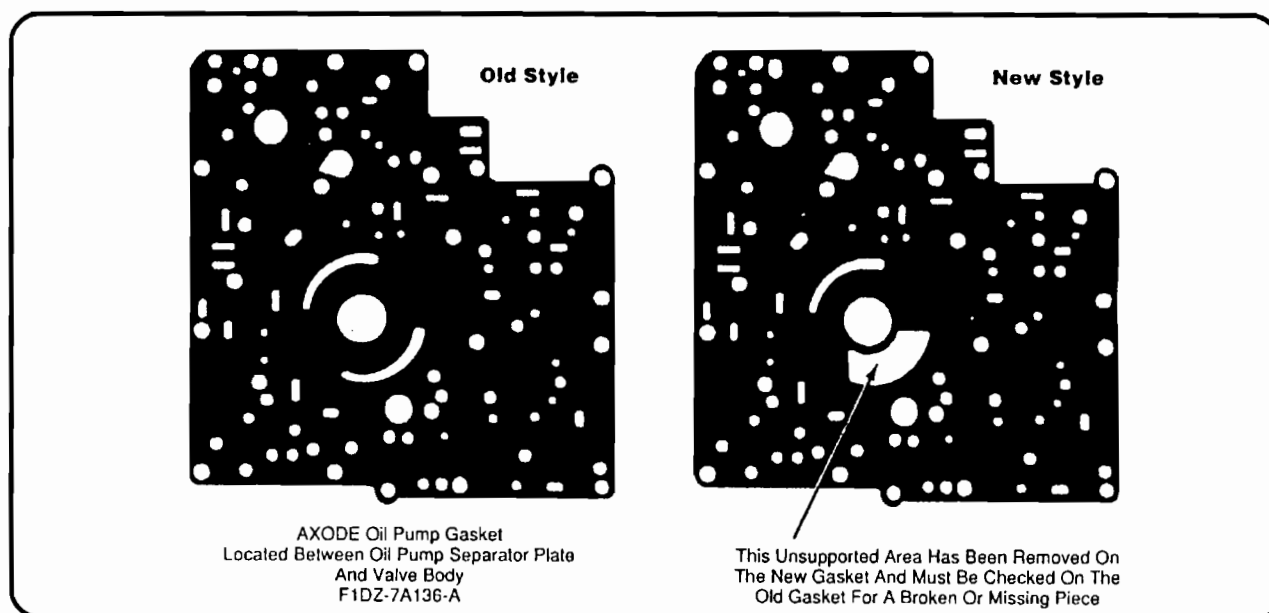
Figure 1

**COMPLAINT:** Loss of lube oil and planetary gear failure.

**CAUSE:** Particles of gasket material from the pump gasket block the lube oil passage. If you look at Figure 1, old style gasket, you will notice the area by the inlet is solid and the new style has a large cut out. the old style gasket had no support of the plate and would tear and the pieces would travel through the lube passage. The new style gasket removed the area of the gasket that was not supported.

**CORRECTION:** Install new gasket located between the oil pump plate and the valve body.

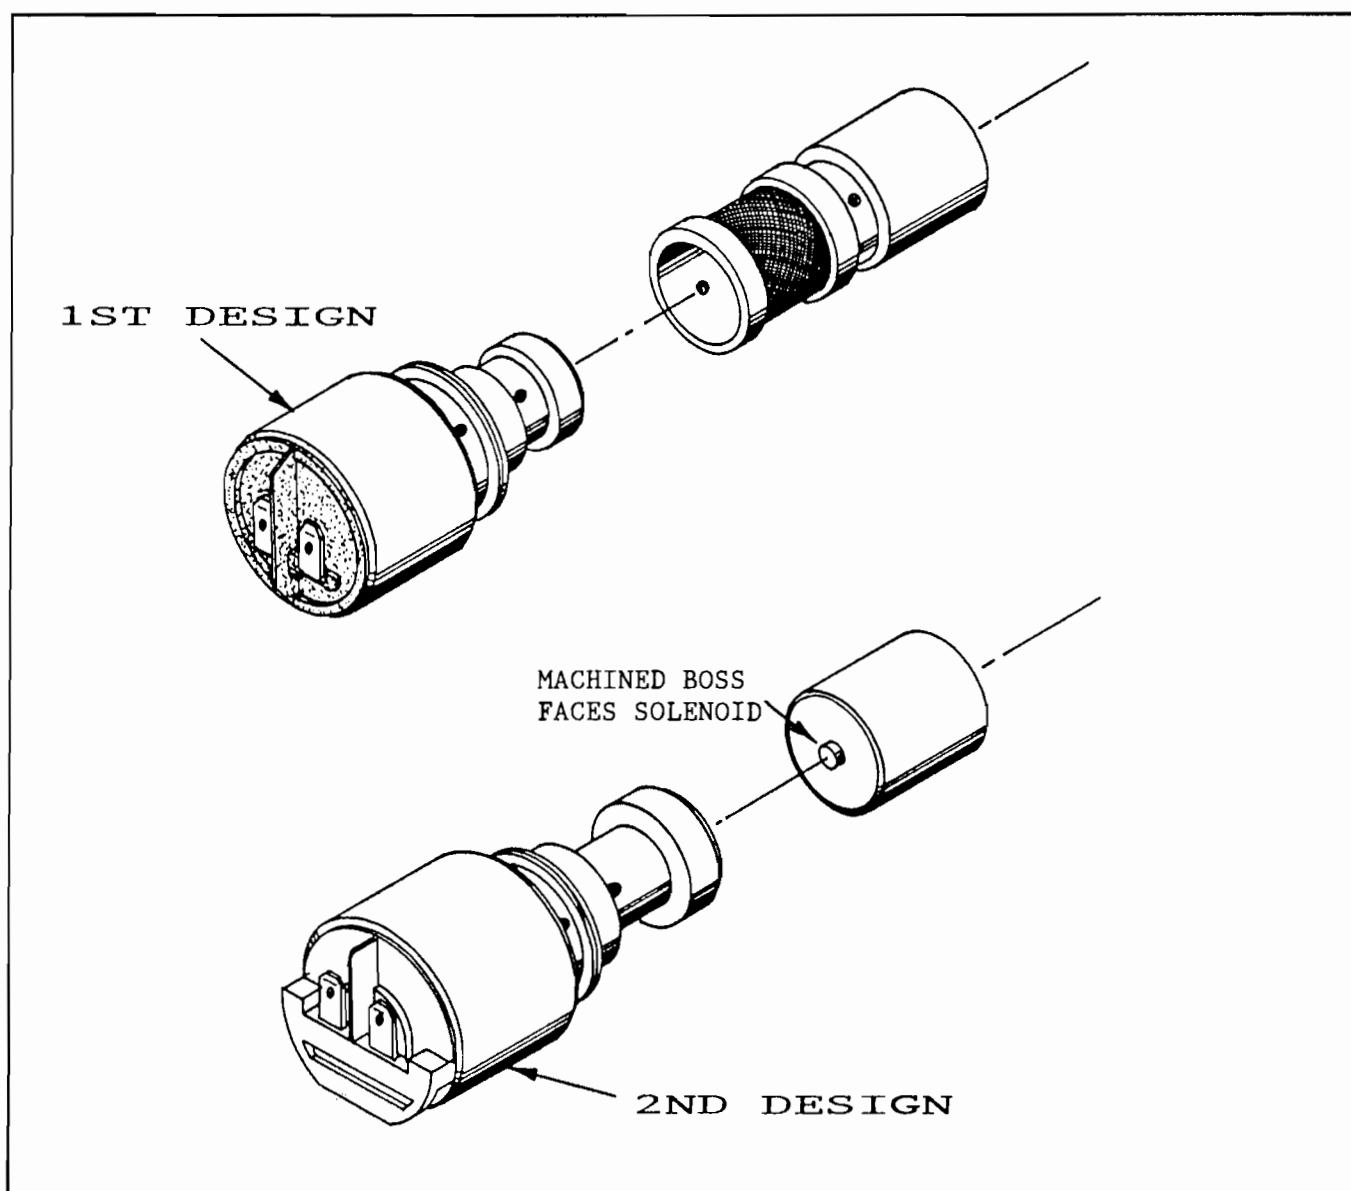
FIGURE 1

The 2nd design eliminates the screen, has dimensional changes on the solenoid itself, and includes a new plug with a boss machined on one end. The plug must be installed with the machined boss facing the solenoid as shown in Figure 1.

The 2nd design 3-4 shift solenoid WILL retro-fit back to all previous models, if it is required.
