"2005" SEMINAR INFORMATION

AUTOMATIC TRANSMISSION SERVICE GROUP

"Out by Five in 2005" *Seminar Information*

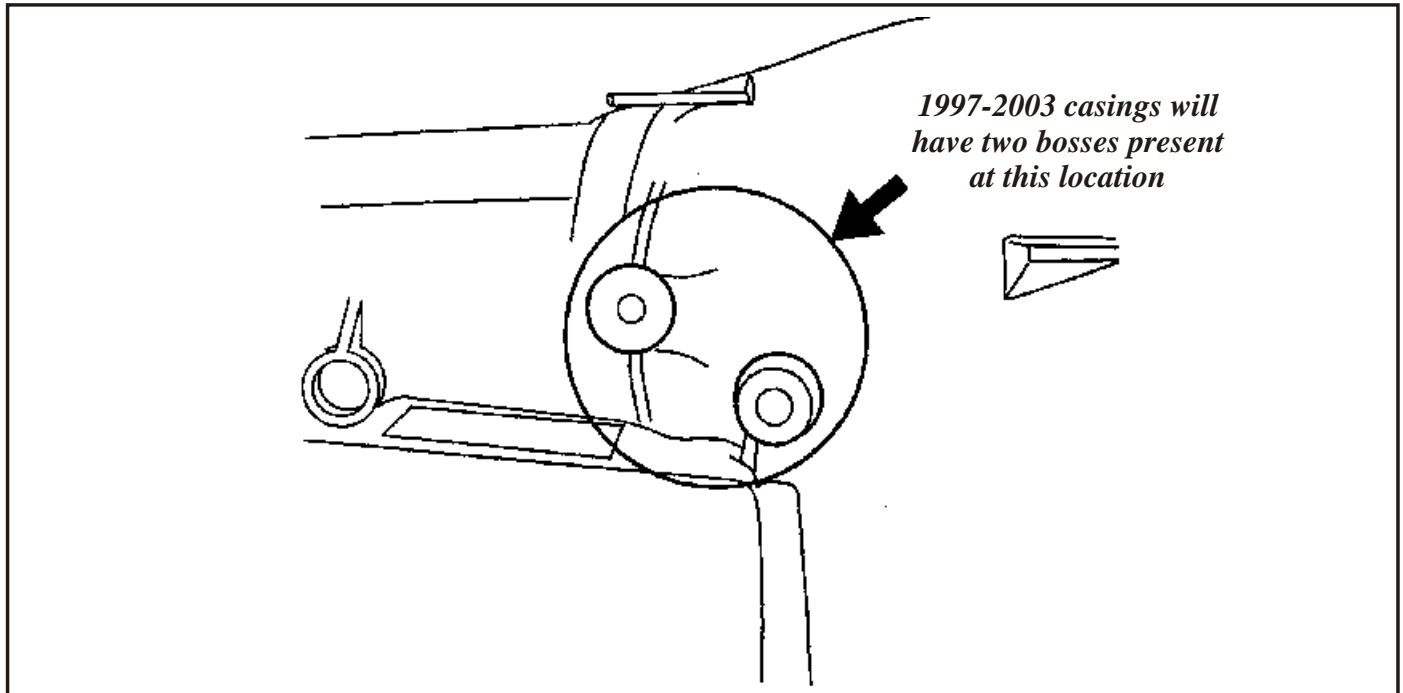
Figure 1

OVERDRIVE GEAR SET FAILURE

CAUSE: During the overhaul process either the transmission casing or the oil pump or pump cover was replaced using incompatible parts causing a loss of lube oil to the overdrive gear train.

CORRECTION: The transmission casing had a casting change for the 2004 model year. The oil pump cover has been modified with the addition of an aluminum plug. The change in the case casting will allow lube oil designated for the overdrive planetary gear set to exhaust back to the sump if the oil pump cover has not been modified with the installation of an aluminum plug to prevent this from happening. When the transmission casing or pump requires replacement then care must be taken to properly identify which case will be used for the repair and/or determine if a pump modification is necessary. The earlier design 1997 - 2003 "center lube" type casing can be identified externally by the presence of two bosses in the front cooler line fitting area. (See figure 1) The later design 2004 casing can be identified externally by the presence of only one boss at the front cooler line area. (See figure 2) ***This case must use the pump with the aluminum plug present in the pump cover.*** With the transmission on the bench and the oil pump removed, the most important difference in these castings can be observed. Notice that the later design case has no aluminum or "blind hole" area present in the casing (See figure 3) as there was in the previous design "center lube" case. (See figure 4)

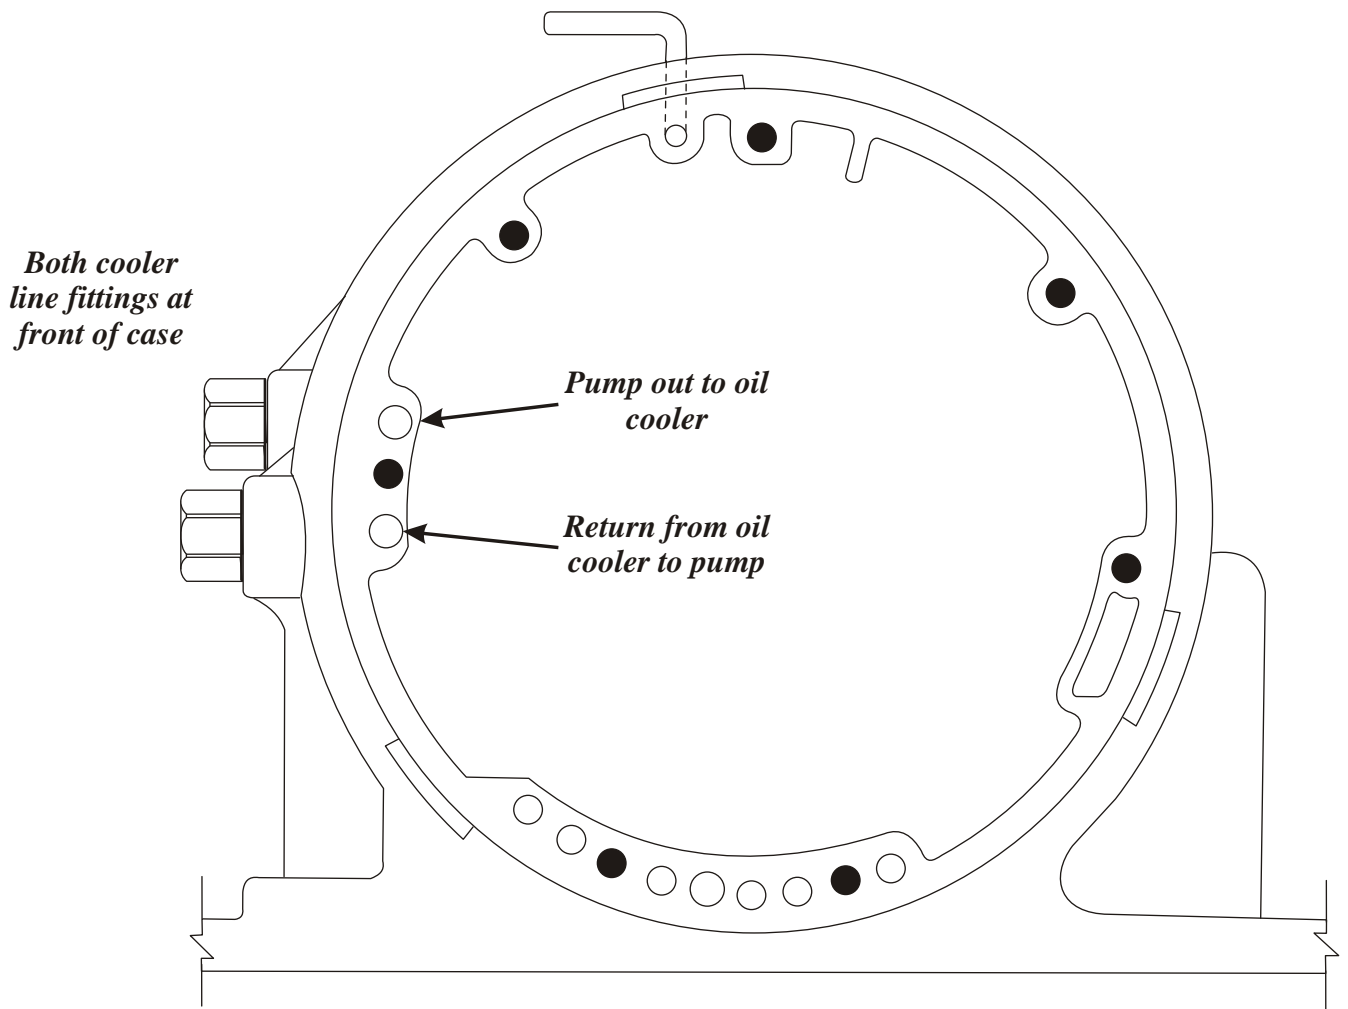
Figure 5

*1991 - 1996 CASE
PUMP ATTACHING SURFACE*

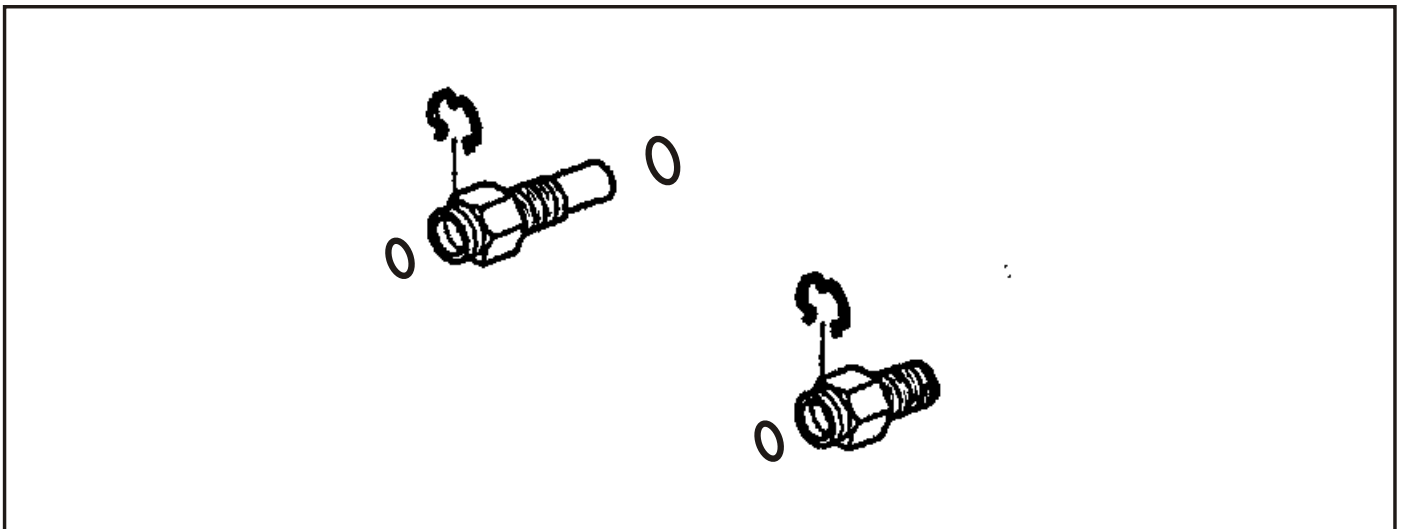
Figure 9

COMPLAINT: Technicians may have difficulty locating replacement case cooler line fittings or the small retaining clips.

CAUSE: When the transmission was being removed, installed or overhauled, the technician noticed that the original case cooler line fittings or retaining clips were damaged or missing altogether.

CORRECTION: 1997 and later center lube transmissions had the oil cooler return line relocated to direct oil returning to the transmission from the cooler directly into the center support at the middle area of the case instead of returning to the pump as in the 1996 and earlier units. This change also made a redesign of the case fittings necessary. The profile of the rear fitting was changed to make it longer so that the inner end will fit into a seal in the center support. At the same time, the front fitting as well as the rear fitting, was modified for quick connect / disconnect in place of the earlier flared line / threaded type. (See figure 9)

<i>Retaining clip only -</i>	<i>24205103</i>
<i>Front fitting with clip -</i>	<i>24205102</i>
<i>Rear fitting with clip -</i>	<i>24207013</i>

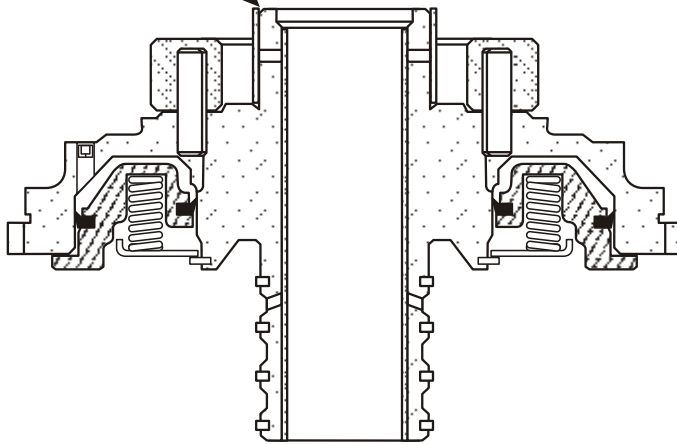
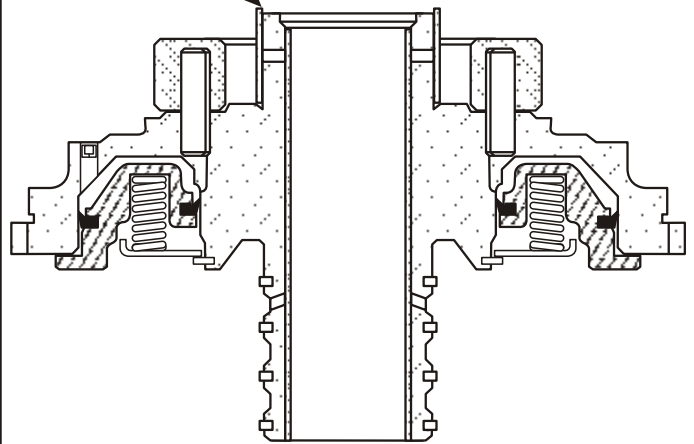
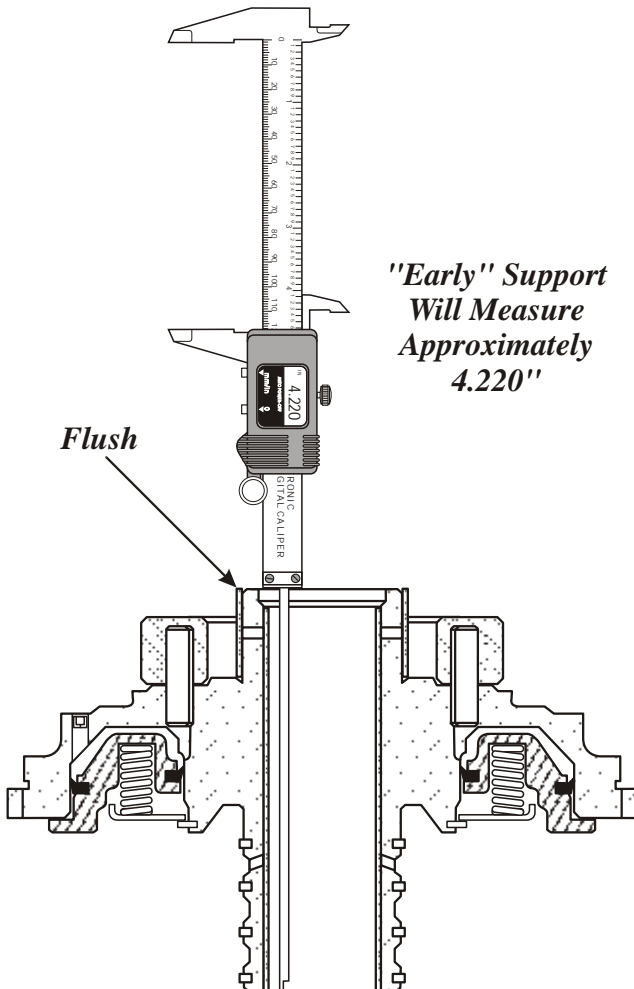
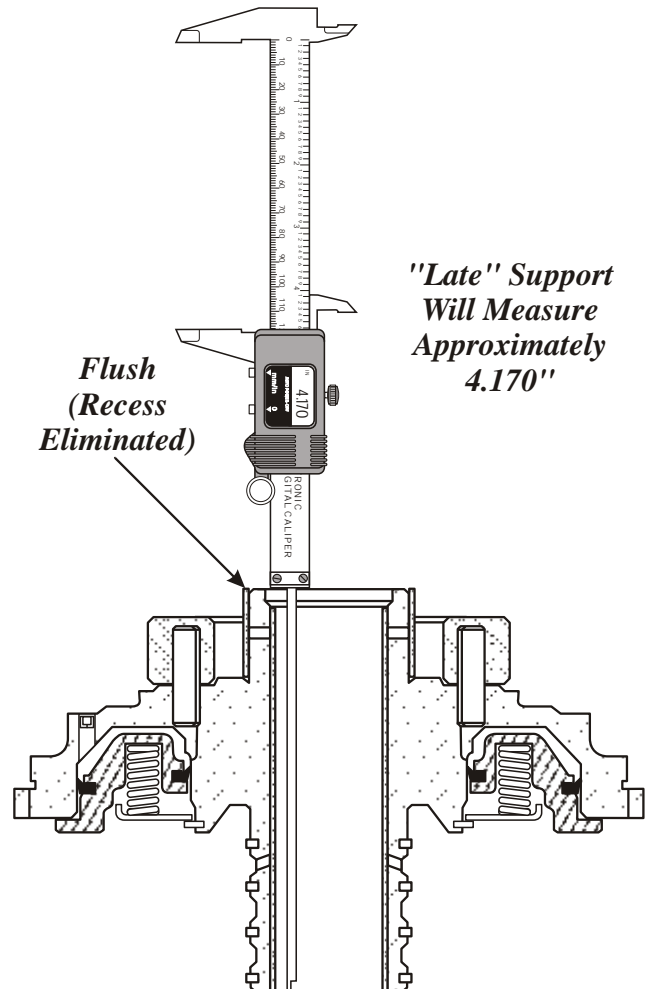
Figure 3

1997-98 DESIGN LEVEL CENTER SUPPORT

1999 DESIGN LEVEL CENTER SUPPORT

.041" Recess

2000 & LATER DESIGN LEVEL CENTER SUPPORT

*"Early" Support
Will Measure
Approximately
4.220"*

*"Late" Support
Will Measure
Approximately
4.170"*

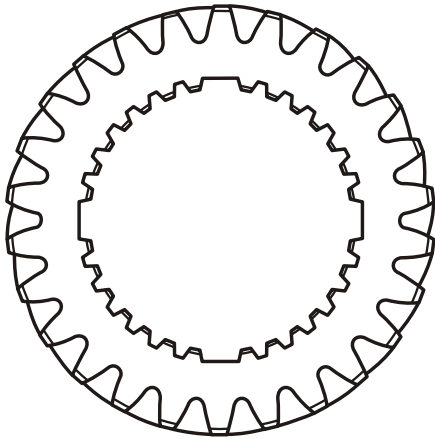
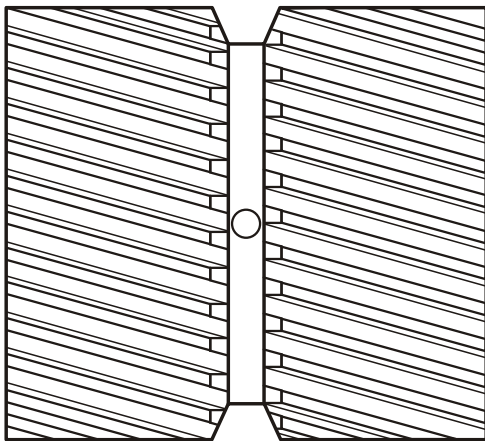
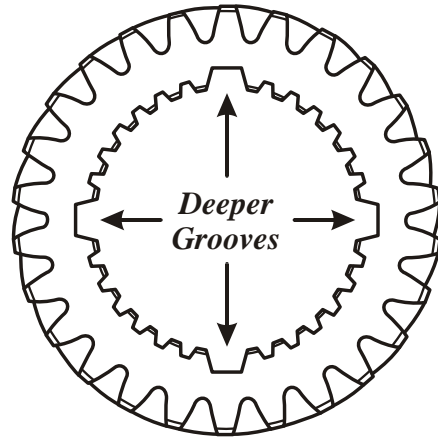
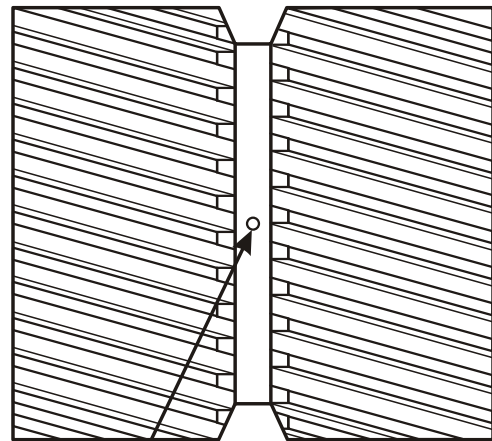
Figure 5

PREVIOUS DESIGN LEVEL SUN GEAR

1997-UP DESIGN LEVEL SUN GEAR

Smaller Hole Here

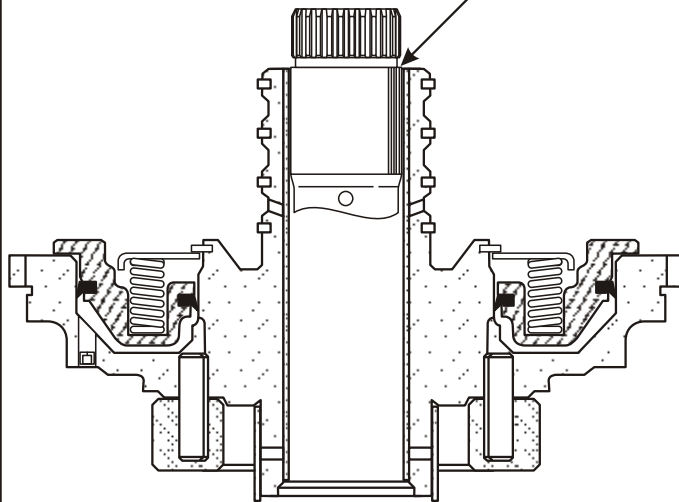
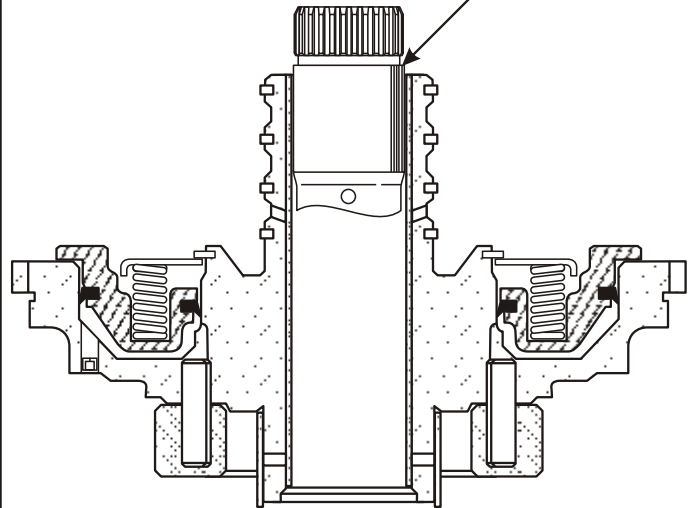
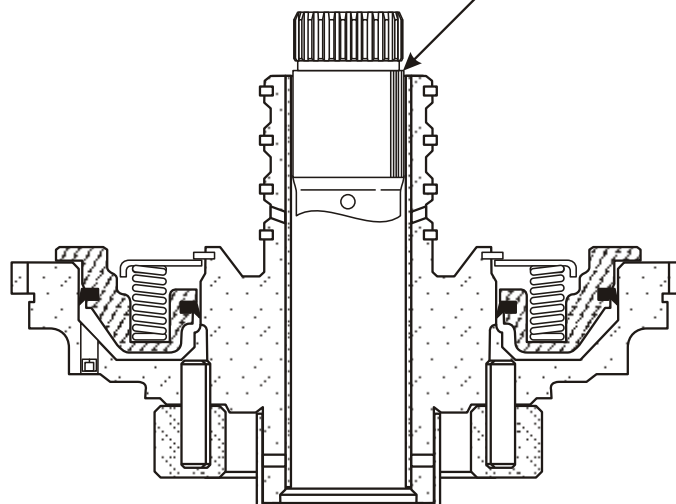
SPECIAL NOTE: Some mis-assembly examples are illustrated in Figure 8 with some dimensional checks to prevent this from happening to you.

1999 SUN GEAR SHAFT
WITH 1997-98 CENTER SUPPORT
AND NO .041" SHIM

*Shaft Journal
Approximately
Flush With Support*

1997-98 SUN GEAR SHAFT
WITH 1999 CENTER SUPPORT
AND WITH .041" SHIM

*Shaft Journal
Approximately
.090" Above Support*

"CORRECT ASSEMBLY"
WITH PROPER
SUN GEAR SHAFT
AND CENTER SUPPORT

*Shaft Journal
Approximately
.050" Above Support*

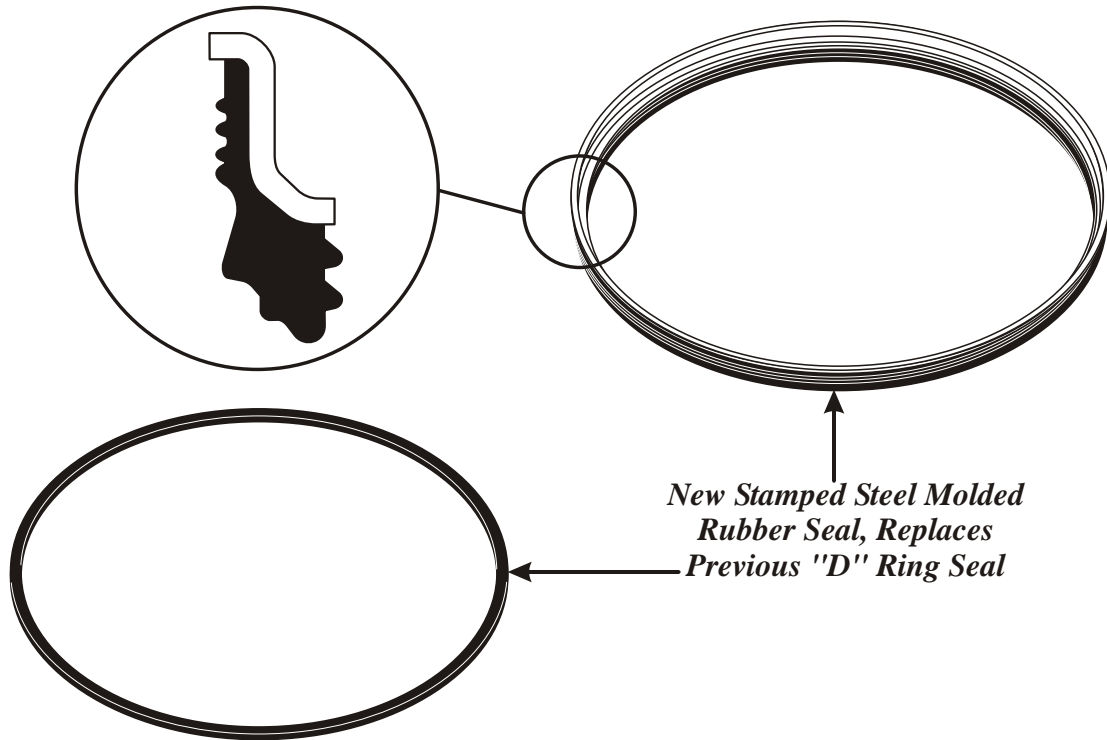
Figure 1

CHANGE: An improved oil pump to case seal design has been implemented on the 4L60-E/4L65-E family of transmissions, to replace the previous design "D" ring seal, as shown in Figure 1. The complete design was implemented in three phases, beginning in September, 2002 and completion in March 2004.

REASON: To eliminate damage to the previous design "D" ring seal during assembly.

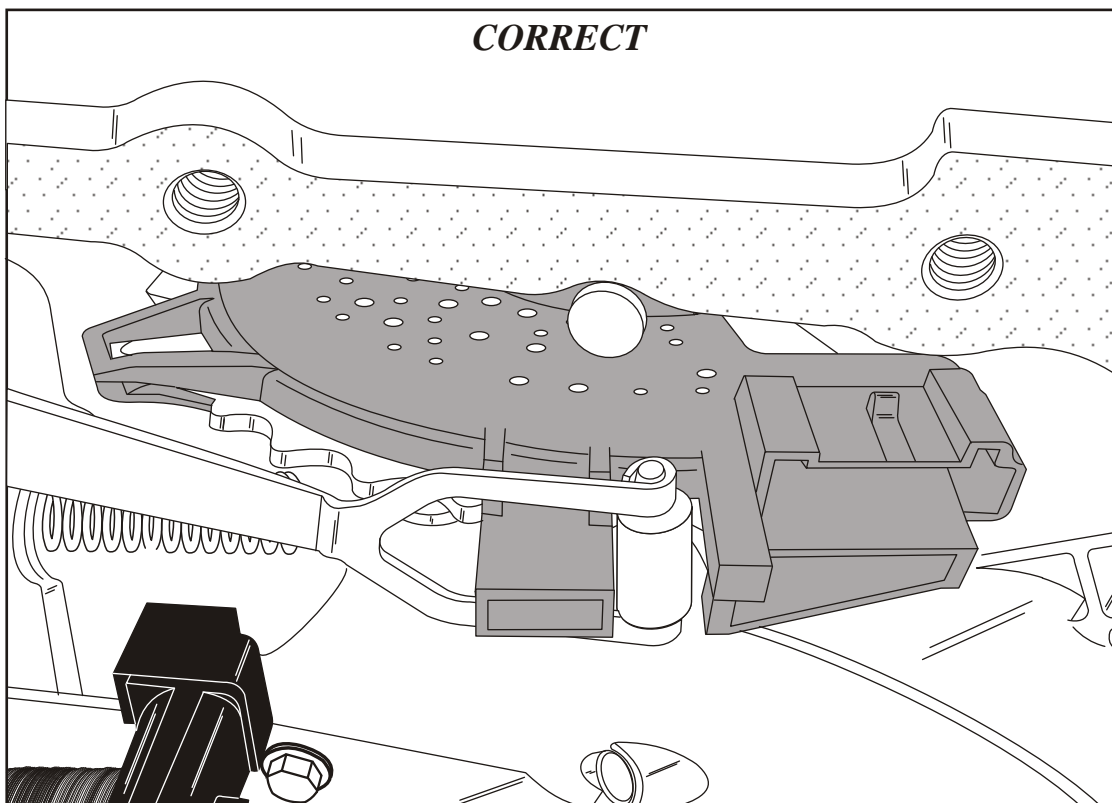
Figure 6

- CAUSE:** When the detent spring was installed during the overhaul, it was not indexed in its proper location at the IMS which can be seen in figure 5. When this is done the IMS can move across the detent lever $\frac{1}{4}$ " in either direction. therefore movement of the shift lever is not synchronized with the IMS causing the above complaints.

- CORRECTION:** Install the detent spring at the IMS as shown in figure 6. ***It is the detent spring roller that properly indexes the IMS.*** When the IMS and detent spring are indexed correctly, there will be no movement of the IMS across the detent lever.
NOTE: This type of IMS can also be found on the 4T80E and 5L40E.

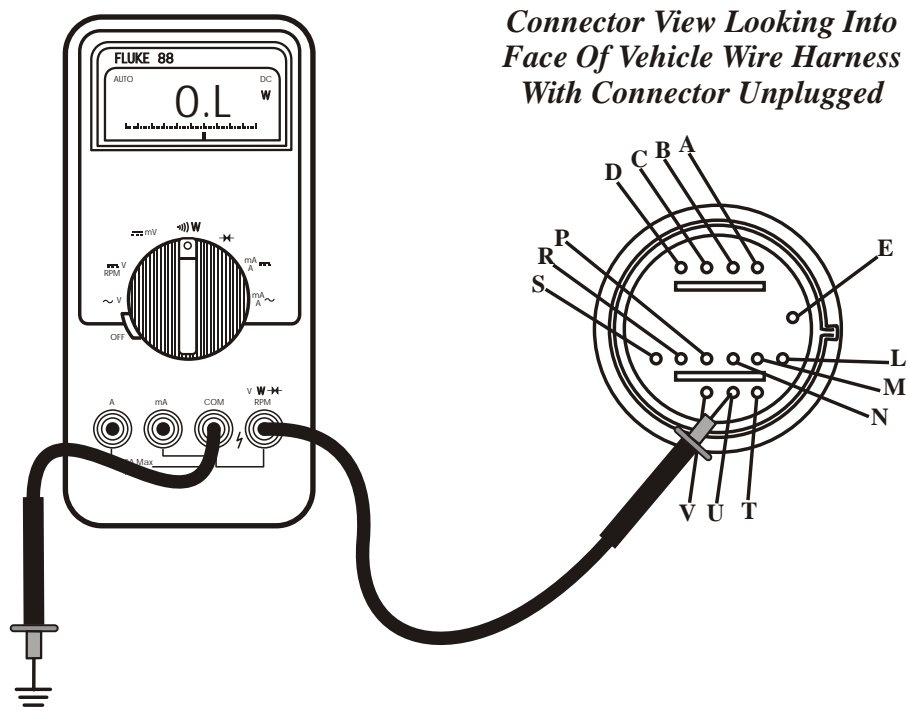
Figure 2

- (5) Connect the positive lead from DVOM to terminal "U" on the vehicle harness connector, as shown in Figure 2, and the negative lead from DVOM to a known good ground.
- (6) There should be no continuity on the DVOM. If you do have continuity, the wire from the transaxle case connector to the PCM is grounded and ***must*** be repaired or replaced. If you do not have continuity, continue to step (7).
- (7) You now have it narrowed down to the Pressure Switch Assembly (PSA) with a defective TCC switch, or an internal wiring harness that is grounded internally. Either way we have to take it apart.
- (8) To check the internal harness for a short to ground, refer to Figure 3. To check the Pressure Switch Assembly, refer to Figure 4.

CHECKING FOR GROUNDED WIRE FROM PCM TO TRANSAXLE CASE CONNECTOR

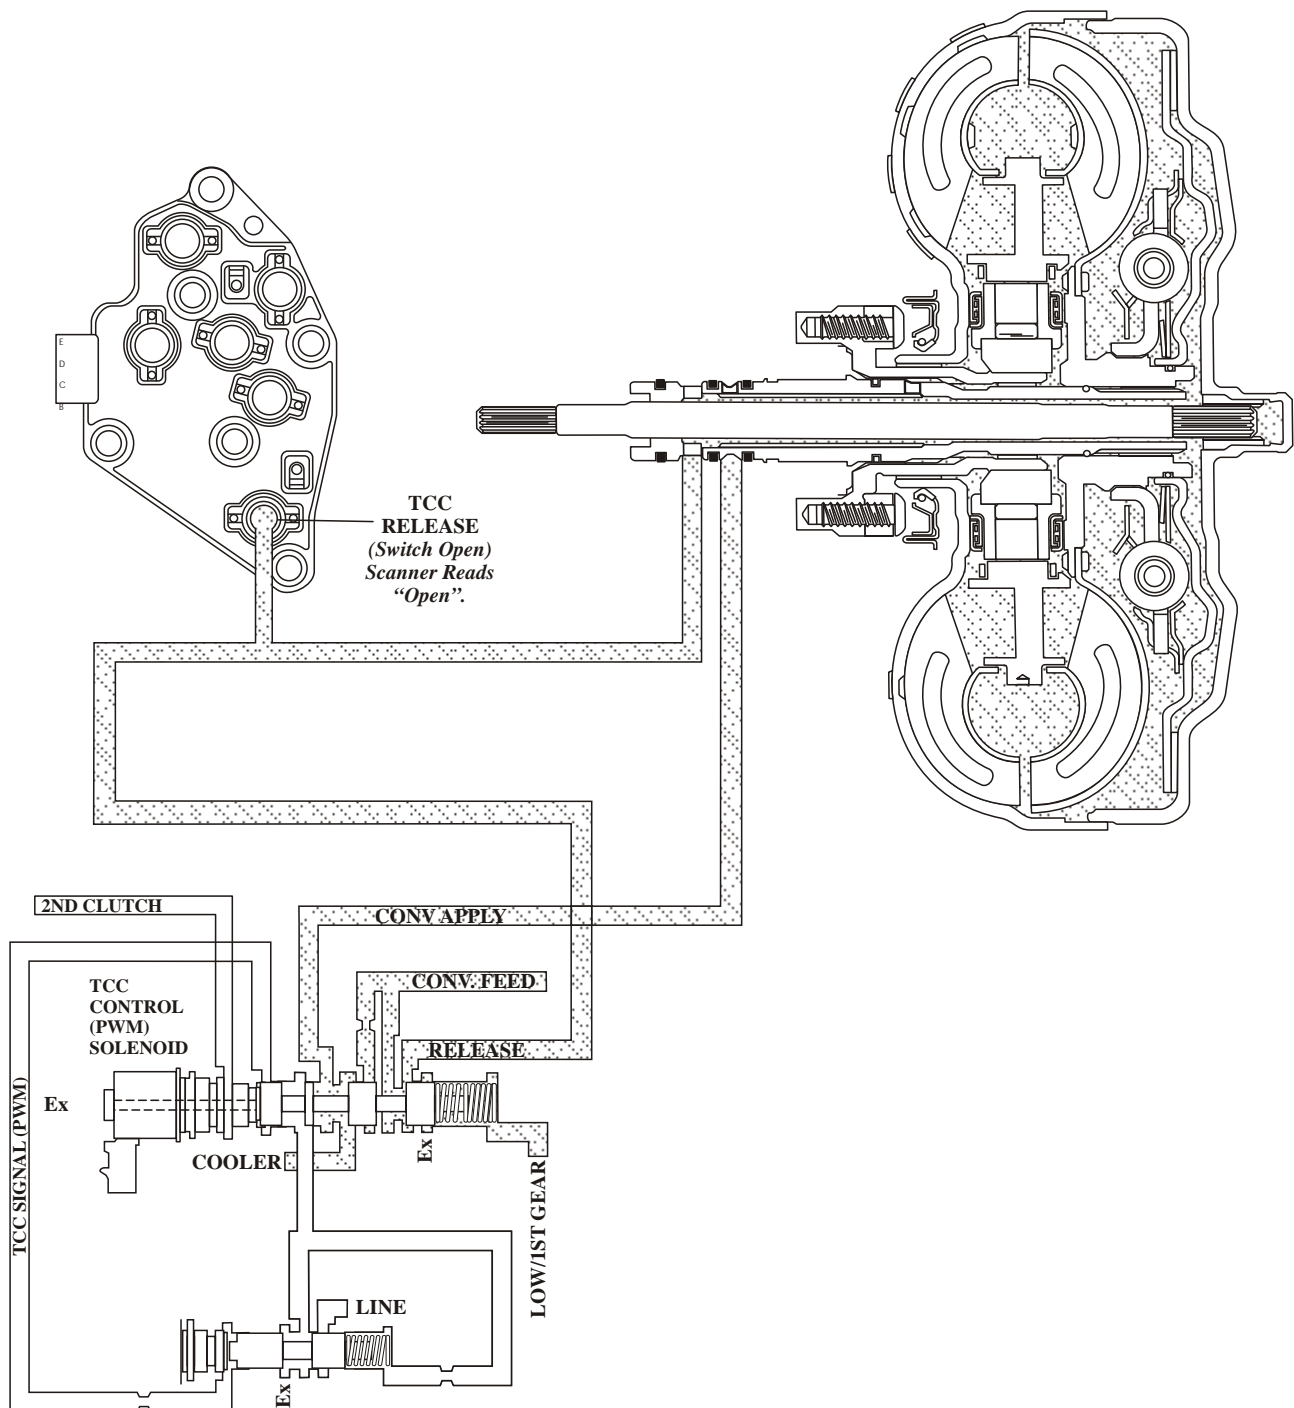
Figure 7

This diagram shows the transmission in either Park, Reverse, Neutral, or Drive 1st gear including Manual Low.

Notice that Lo/1st oil is routed to the spring side of the TCC valve and with no second clutch oil fed to the TCC/PWM solenoid, converter clutch apply is prevented

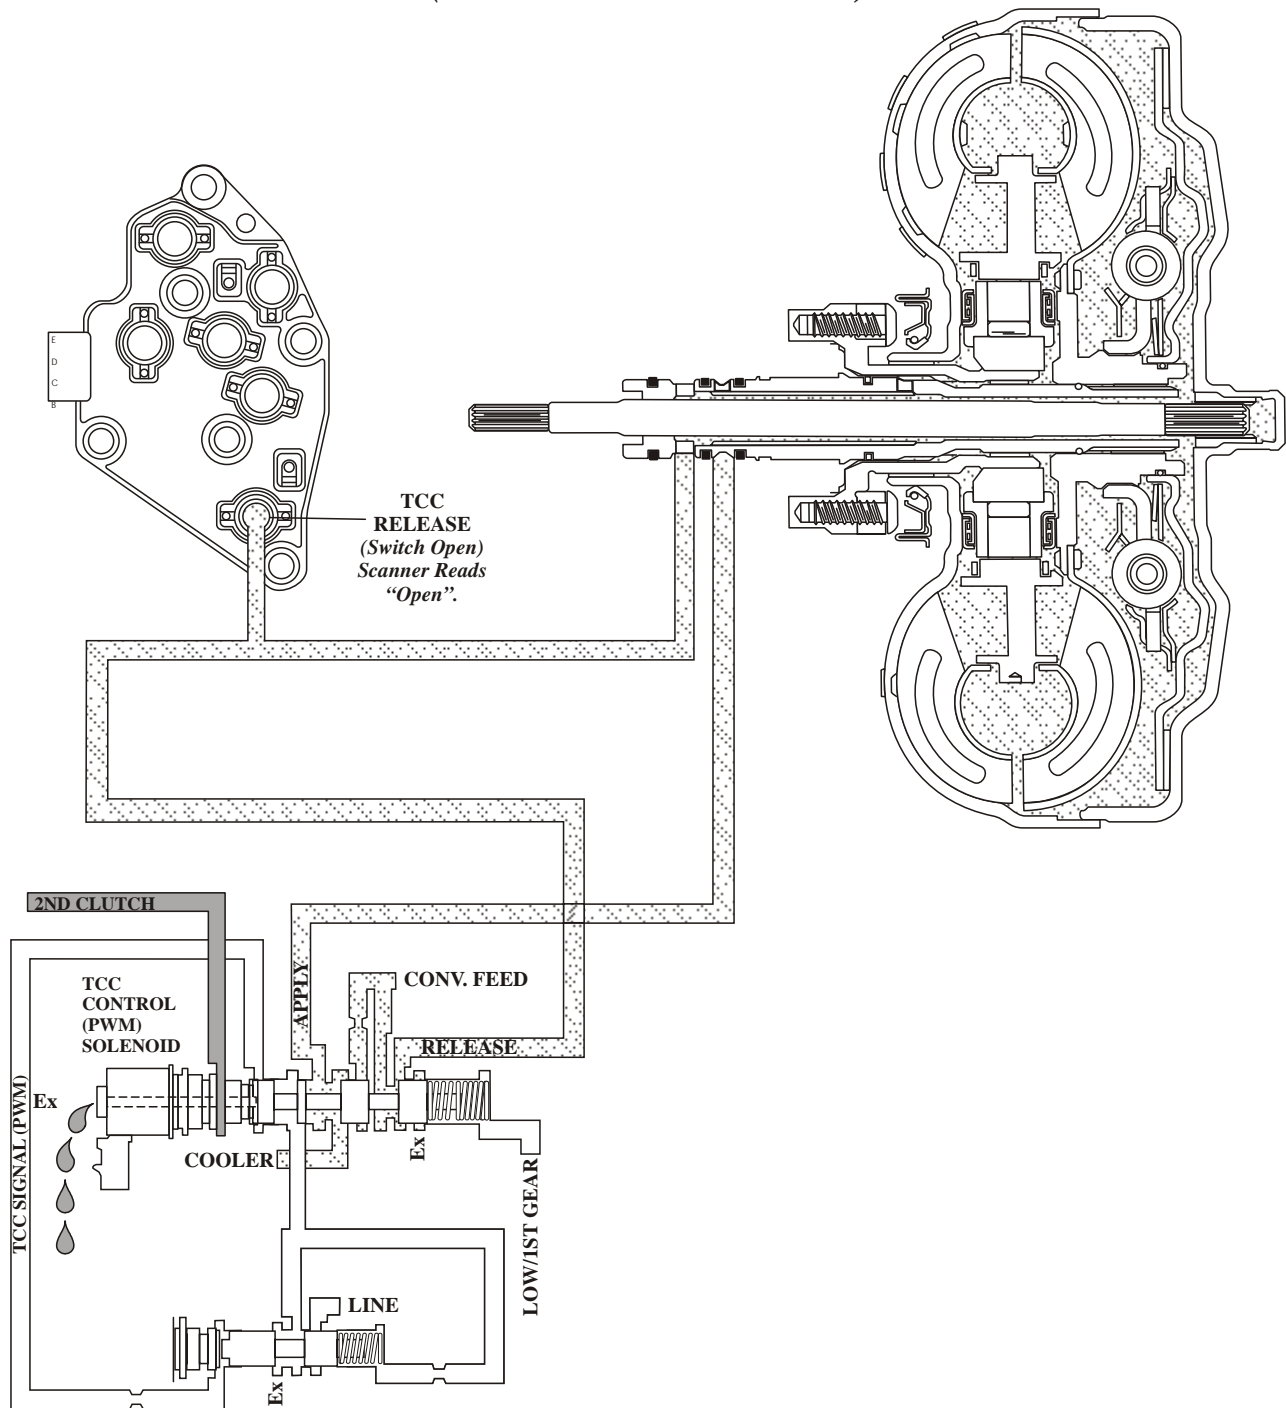
The hydraulic diagram shown in Figure 8 represents the transmission in Drive 2nd. Gear, 3rd. Gear, and 4th. Gear, with the Torque Converter Clutch **Released**. Notice the presence of 2nd gear oil pressure in the circuit. With the solenoid "OFF" and not energized, the solenoid should exhaust 2nd clutch pressure so that the pressure in the solenoid doesn't become great enough to cause the TCC valve to stroke inward against the spring. Lock-up will not be engaged at this time.

This diagram shows the transmission in 2nd, 3rd, or, 4th gear, with converter clutch released. Notice the TCC PWM solenoid is exhausting the TCC signal oil (2nd Clutch) and pressure is not high enough to overcome spring pressure on the TCC valve, so the release oil is not exhausted.

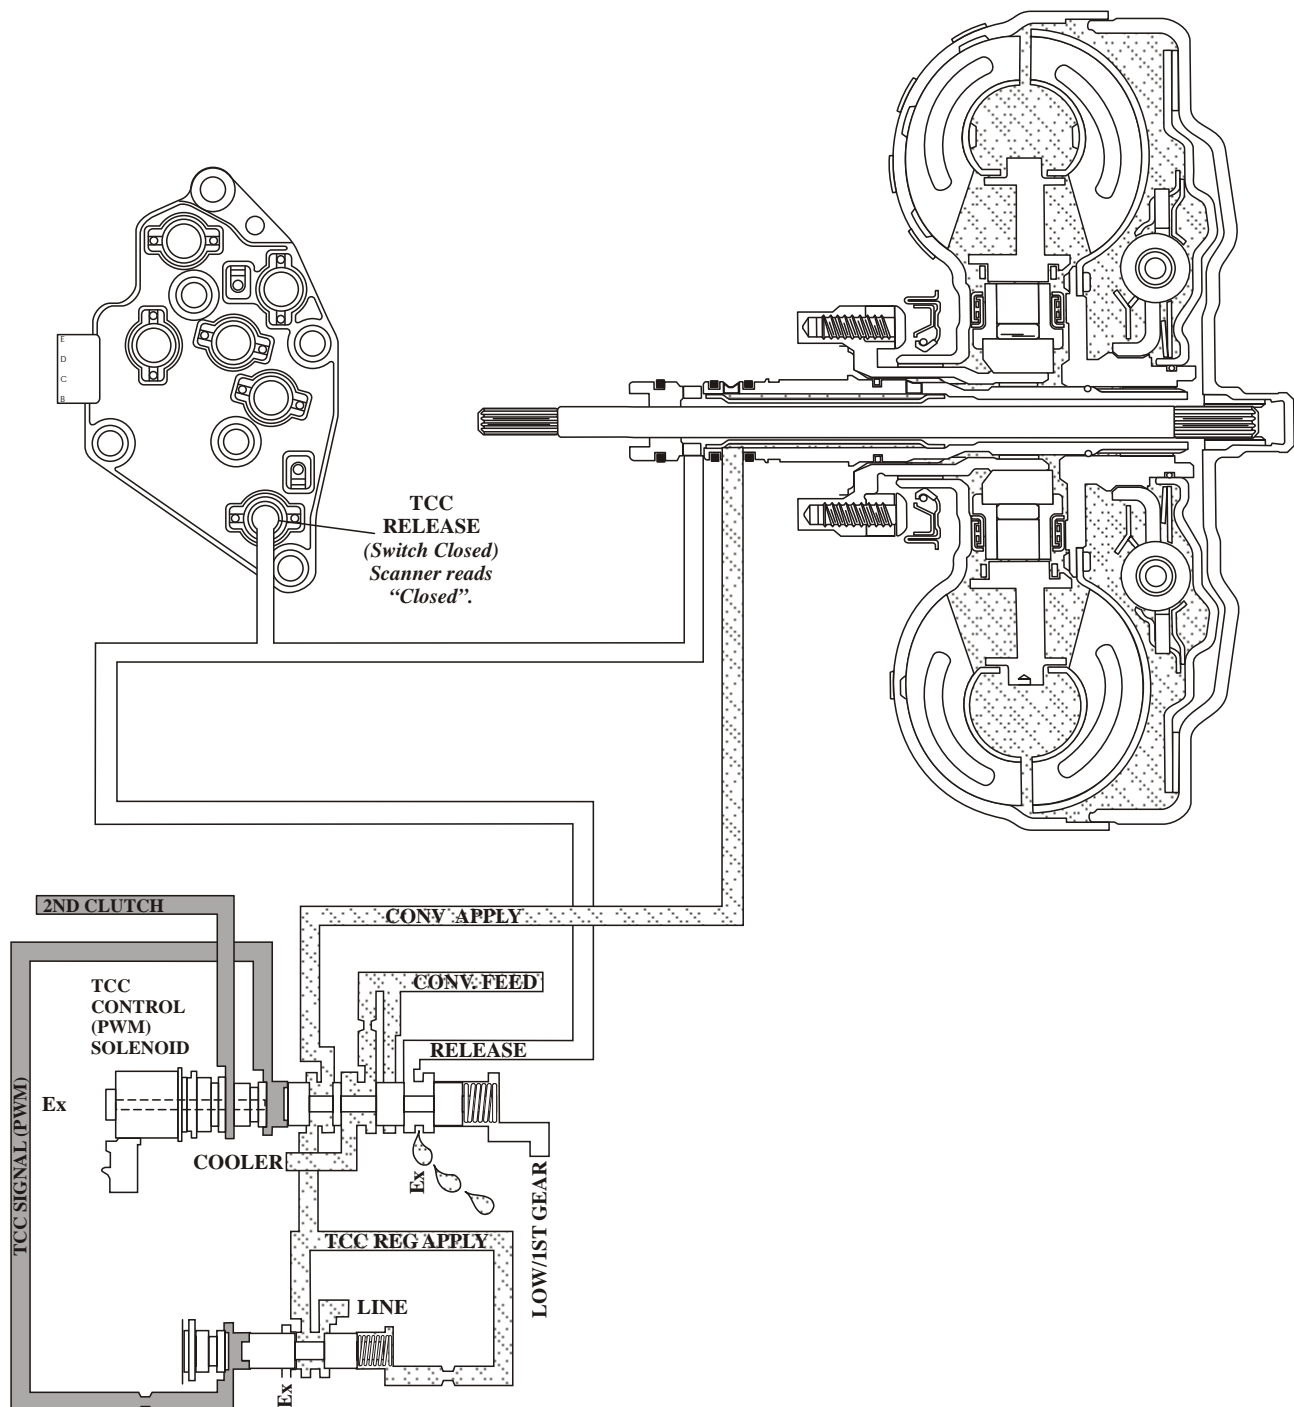
The hydraulic diagram shown in Figure 9 also represents the transmission in Drive 2nd. Gear, 3rd. Gear, and 4th. Gear, Torque Converter Clutch **applied**. If for some reason the TCC solenoid is not capable of exhausting 2nd clutch oil pressure, the result will be the TCC control valve overcoming spring tension and moving into the lock-up position. TCC release oil will exhaust through the valve, the converter clutch will engage with the shift into second gear. Replacing the TCC PWM solenoid should correct the problem.

This diagram shows the transmission in 2nd, 3rd, or, 4th gear, with converter clutch applied. Notice the TCC PWM Solenoid is energized and not exhausting the TCC signal oil, (2nd Clutch) and TCC signal oil is pushing TCC valve to the right, causing release oil to exhaust at the valve.

Use "ONLY" the TCC PWM Solenoid for a 4T65-E transaxle, identified by a purple splotch of paint on the canister for identification, and available under OEM part number 24214974.

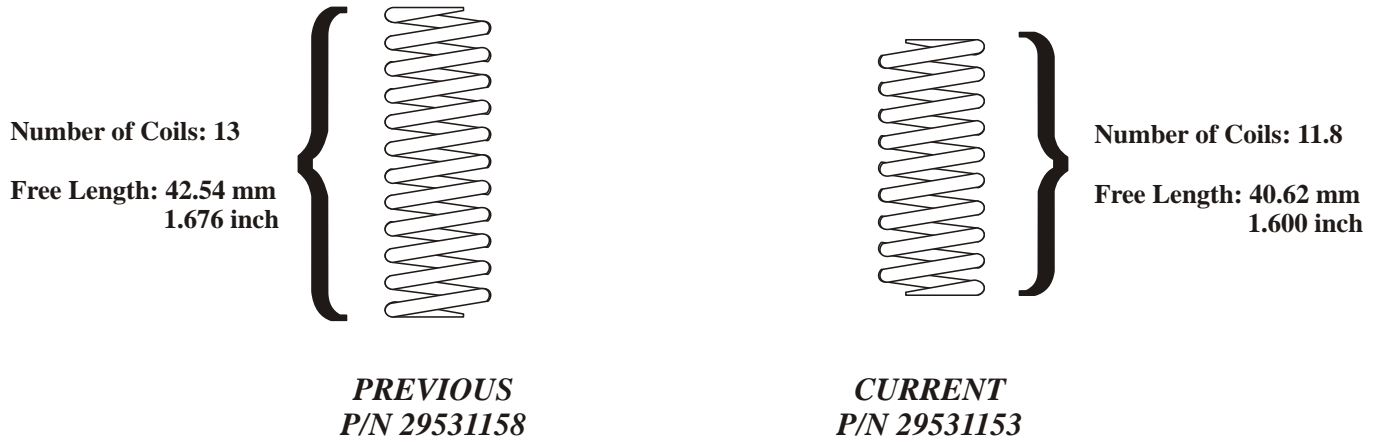
Figure 7

- (5)The Control Main Regulator and Control Main Relief Springs have changed demensionally as shown in Figure 7.
- (6)A Modulated Main Valve Body has been added to accommodate the "G" Solenoid as seen in Figure 8).

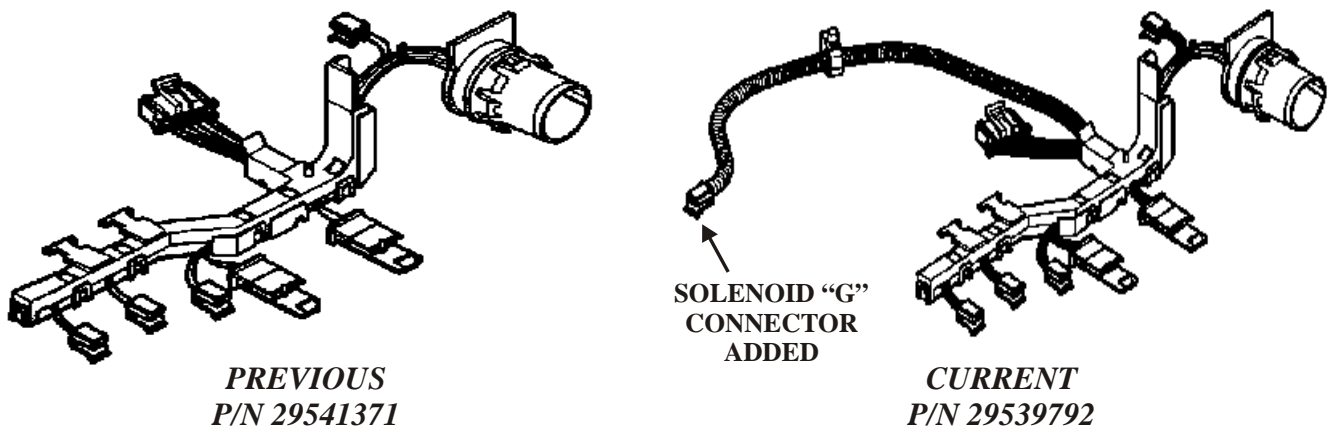
Figure 9

- (7)The internal wiring harness has been changed to accommodate the "G" Solenoid, (See Figure 9).
- (8)This feature also includes the addition of Solenoid "G" as well as the additional circuitry from case connector terminal "R" to the "J2" (RED) TCM connector at terminal 30 as shown in Figure 10.

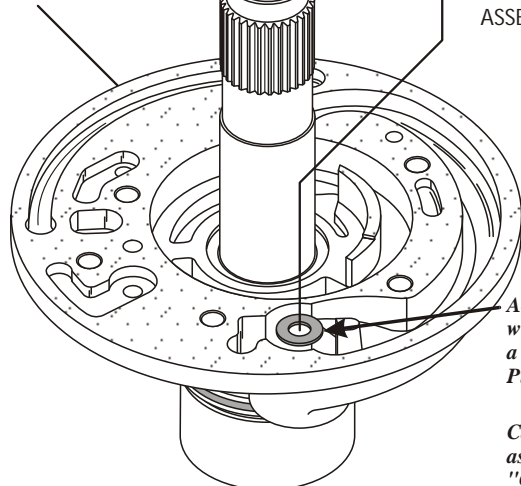
Ensure "O" Ring Is In Place On Relief Valve

A4LD pump washer placed here will raise Relief Valve Assembly for a better "O" ring seal against the Pump Spacer Plate.

Caution: Do not raise the sleeve assembly above the pump surface, "Only" the "O" ring.

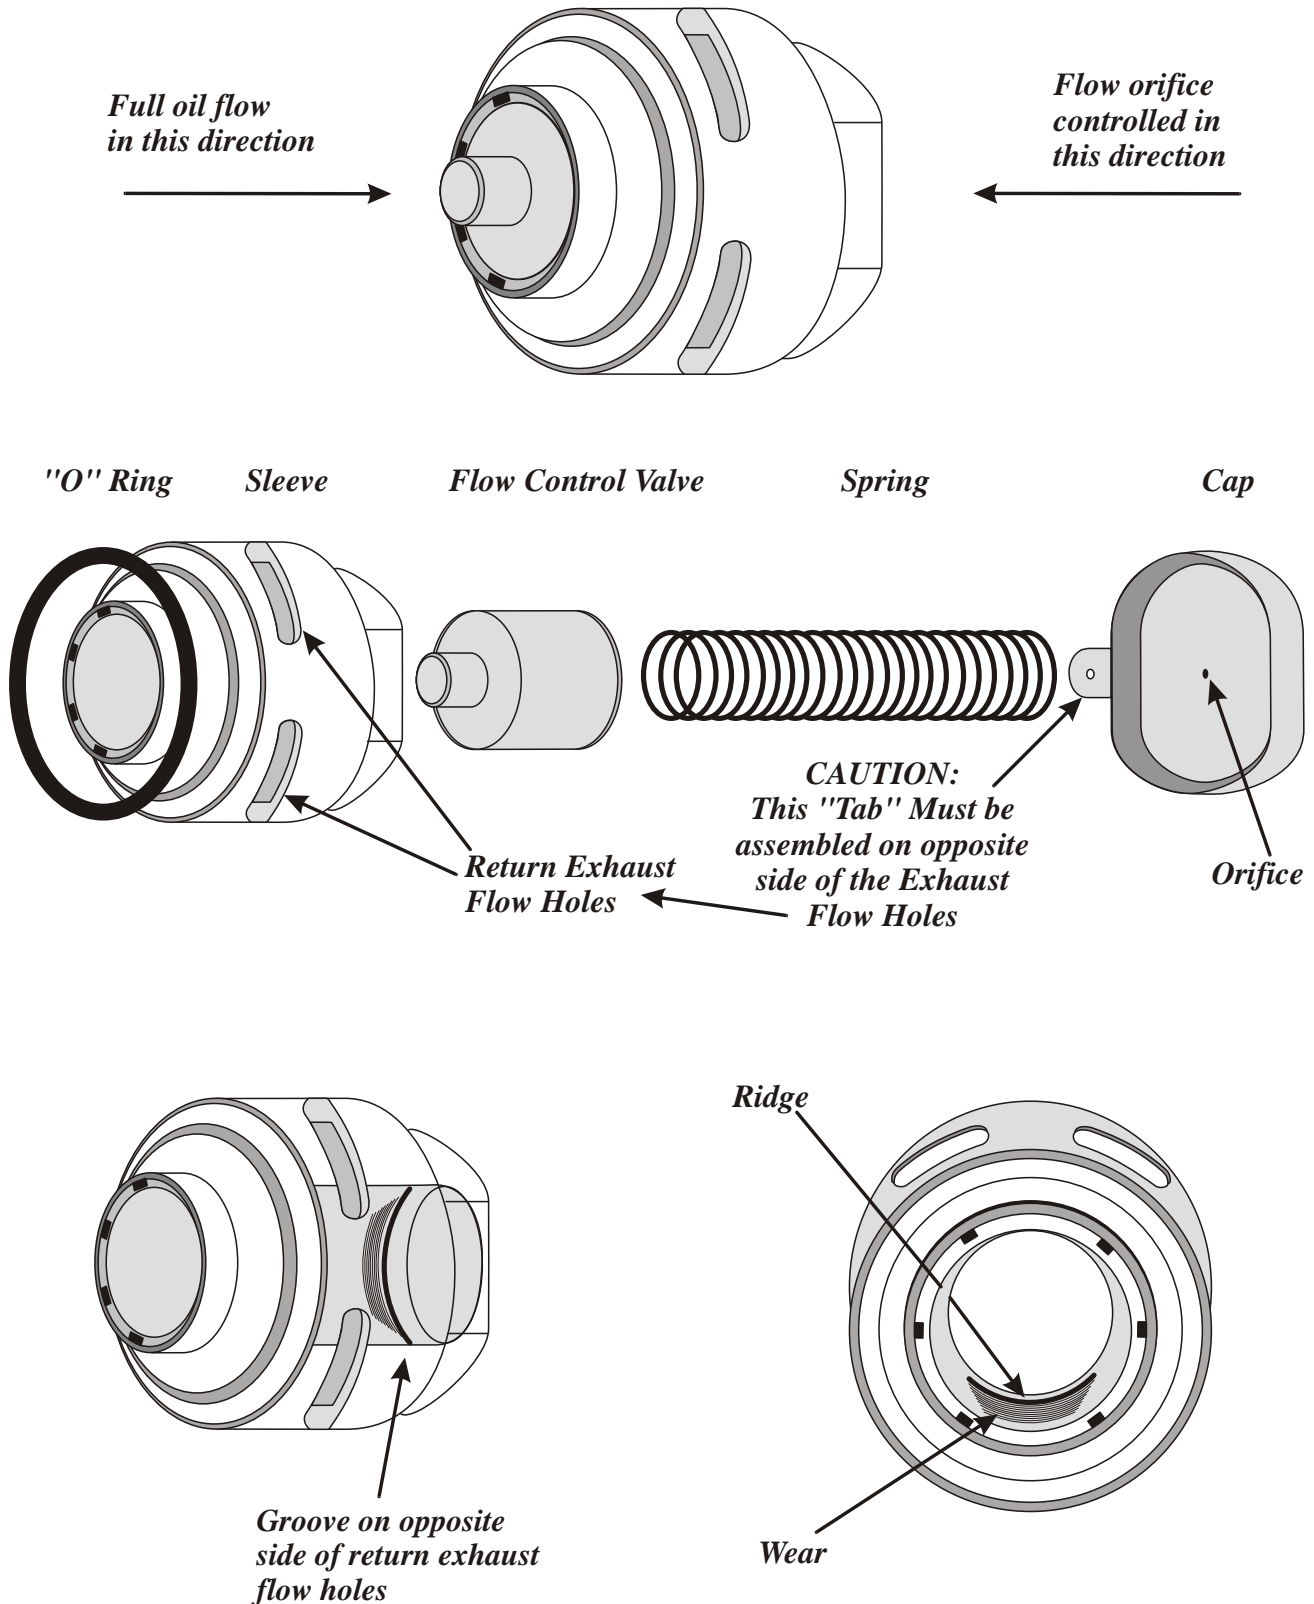
Figure 1

CAUSE NO. 1: The above concern could be oil leaking past the o-ring that belongs on the relief valve sleeve between the pump plate and sleeve, as shown in Figure 1, or the "O" ring totally missing. This "O"-ring is very thin with minimal compression against the pump plate.

CAUSE NO. 2: The cause may be, the Line Pressure Relief Valve Assembly (Flow Control Valve) located in the pump stator, as shown in Figure 1, stuck in the open position due to extreme bore wear in the relief valve sleeve. Figure 2 shows the area prone to wear causing the valve to stick in the open position, and lodged onto the ridge at the end of the worn area. The partial hydraulic schematic in Figure 3, will show that if the valve were to stick in the open position, the oil from the pressure side of the pump would follow the path of least restriction and return to the suction side of the pump. The oil pressure would then be severely compromised through out the rest of the unit.

LINE PRESSURE RELIEF VALVE ASSEMBLY
