"2005" SEMINAR INFORMATION

AUTOMATIC TRANSMISSION SERVICE GROUP

"Out by Five in 2005" *Seminar Information*

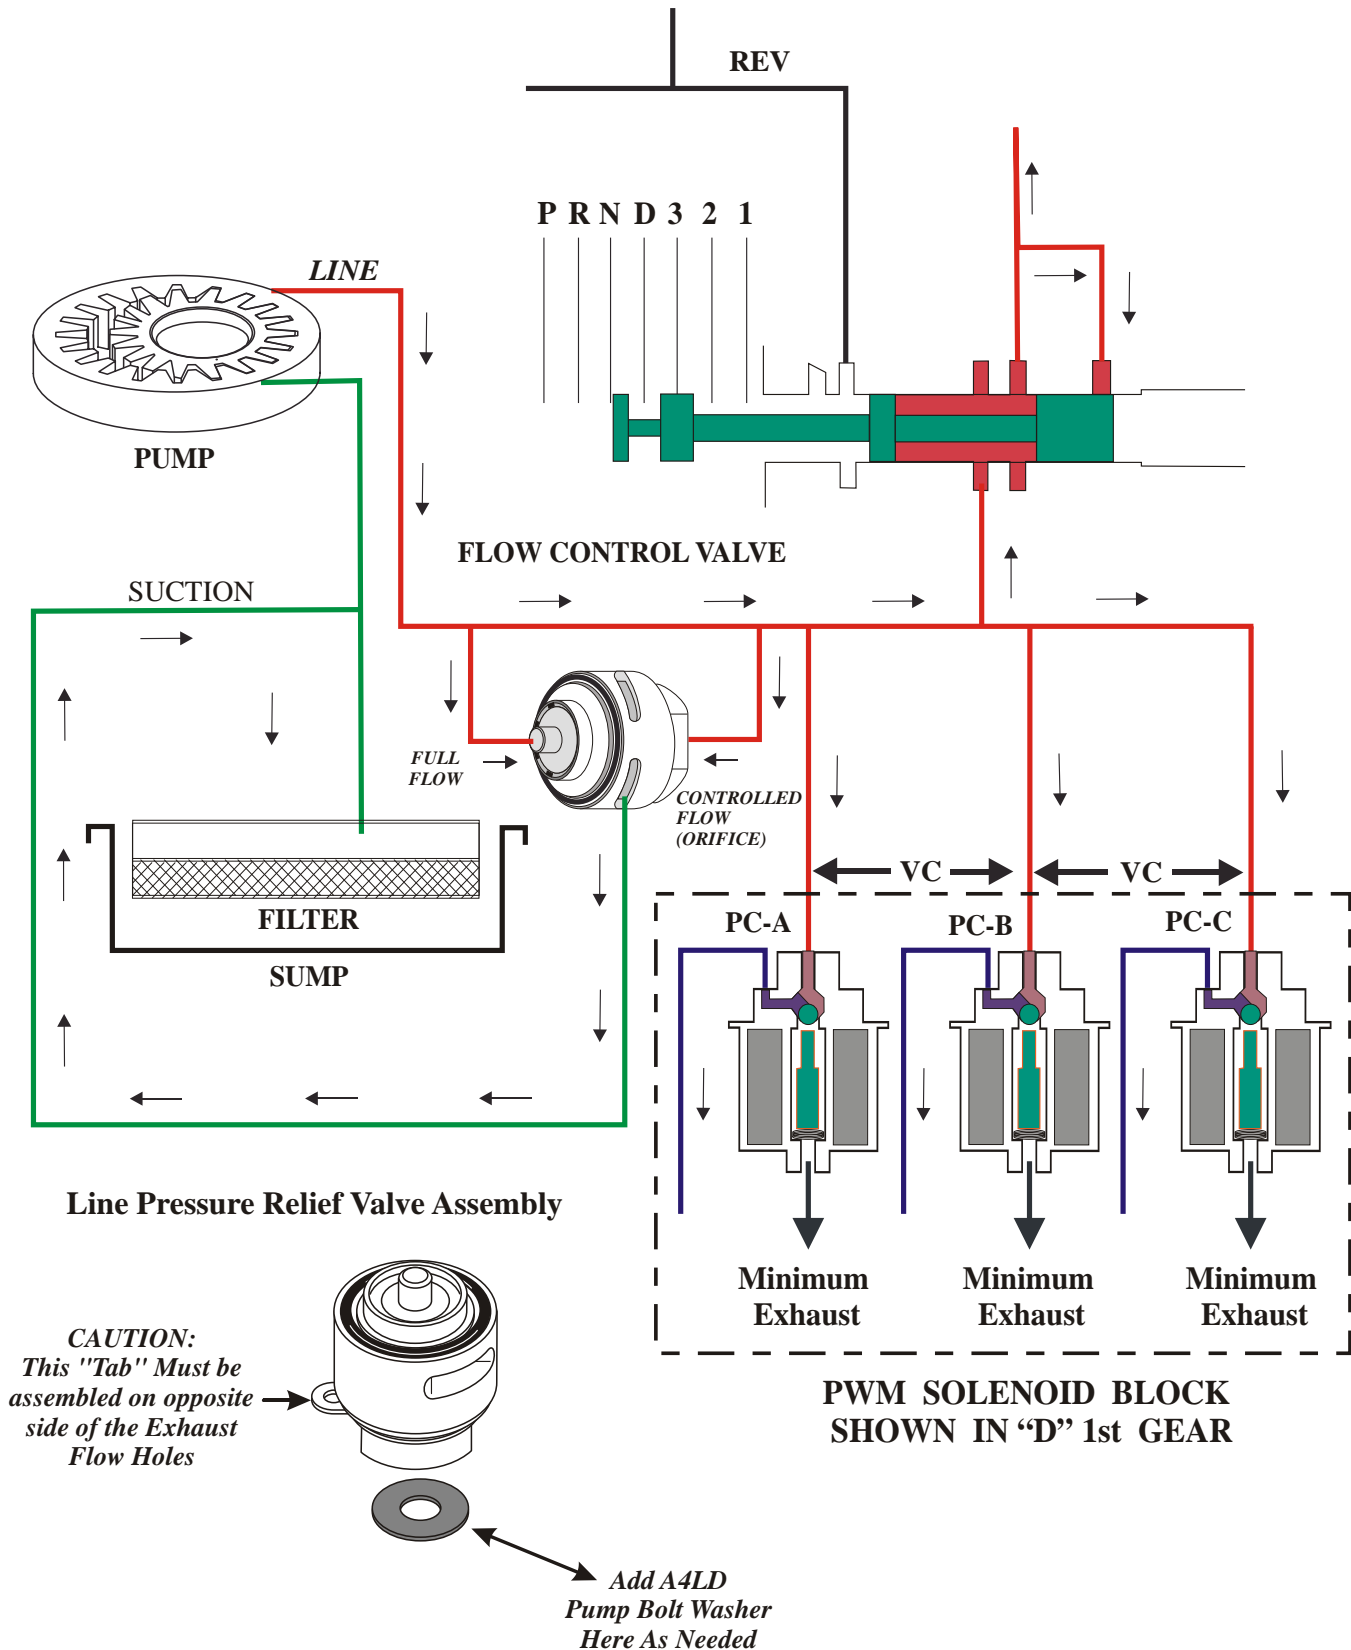
CAUSE NO. 2: The cause may be, the Line Pressure Relief Valve Assembly (Flow Control Valve) located in the pump stator, as shown in Figure 1, stuck in the open position due to extreme bore wear in the relief valve sleeve. Figure 2 shows the area prone to wear causing the valve to stick in the open position, and lodged onto the ridge at the end of the worn area. The partial hydraulic schematic in Figure 3, will show that if the valve were to stick in the open position, the oil from the pressure side of the pump would follow the path of least restriction and return to the suction side of the pump. The oil pressure would then be severely compromised through out the rest of the unit.

Line Pressure Relief Valve Assembly Oil Flow

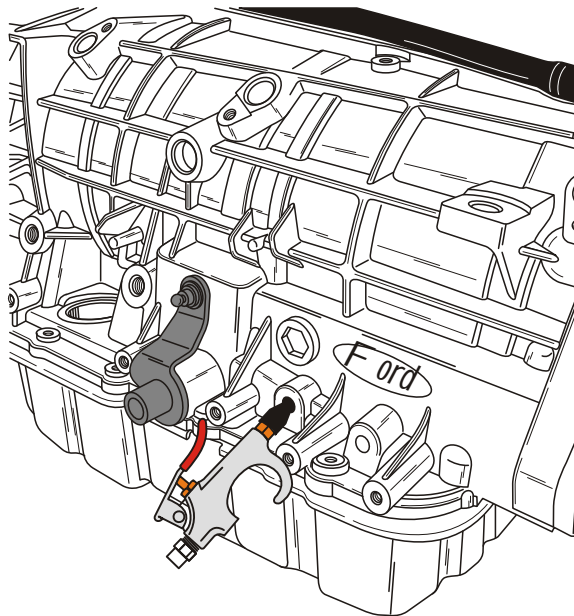
Figure 3

If air and/or fluid is forced out of the vent, (Refer to Figure 5), the flow valve is faulty or the o-ring is missing. If the air test holds pressure then the flow valve is good, however it is recommended that it be changed at the time of overhaul as it is a high failure item.

**IF AIR OR OIL COME OUT OF
VENT, THE FLOW VALVE IS
FAILED OPEN OR THE
O-RING IS MISSING**

Superior now has a replacement flow control valve assembly available for this unit under Superior part number K060.

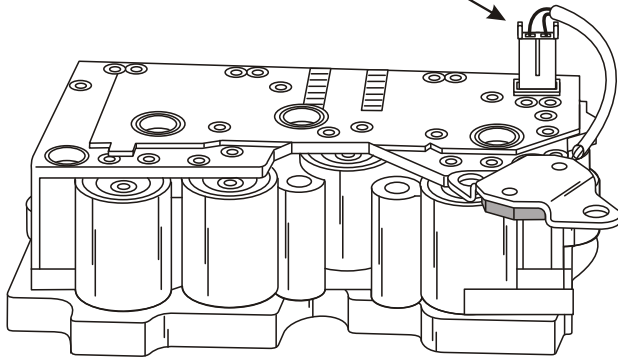
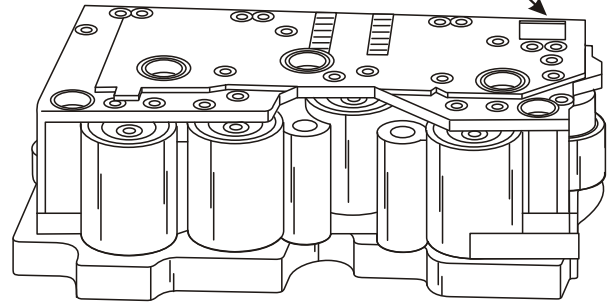
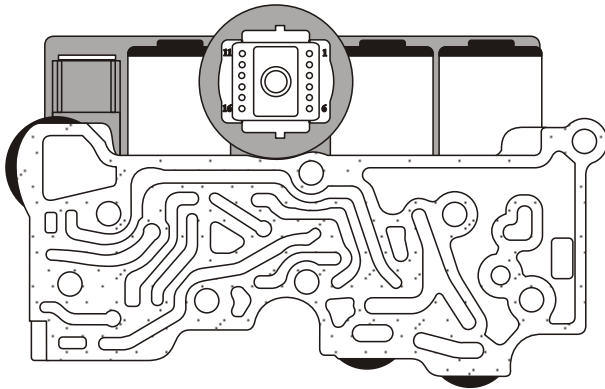
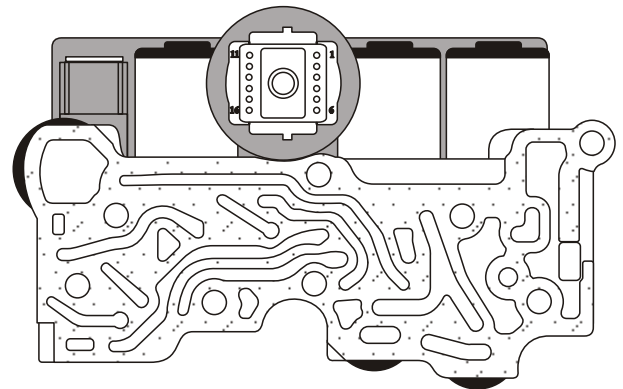
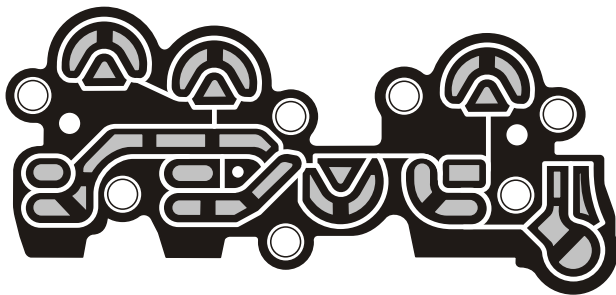
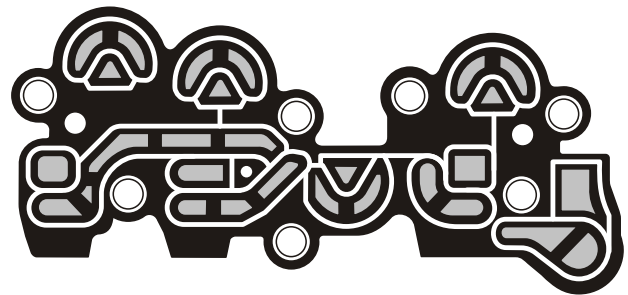
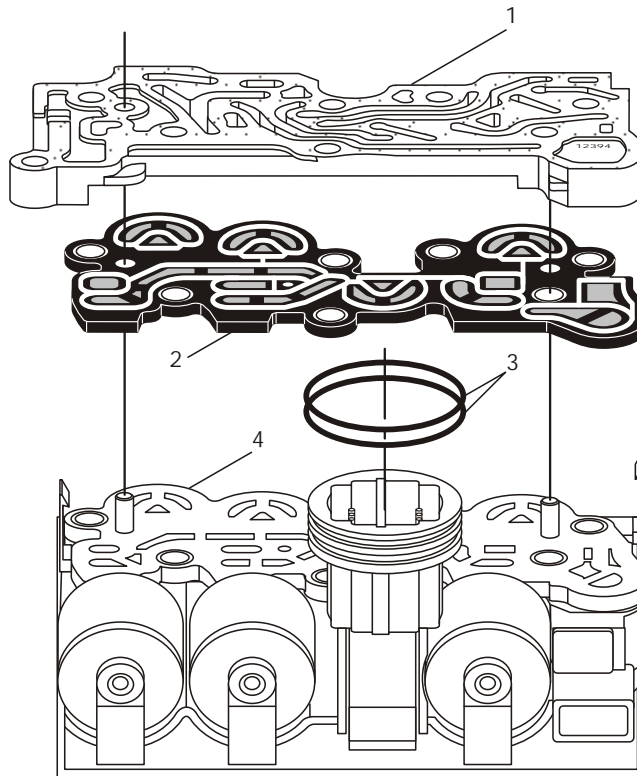
COMPLAINT: Installing the wrong solenoid body gasket onto a 5R55W/S usually creates a no reverse condition and the gaskets are almost identical, as shown in Figure 1.

CAUSE: Currently, most aftermarket gasket sources package the 5R55N gasket into the 5R55W/S gasket pack by mistake. They are currently in the process of correcting this error.

None of the parts shown in Figure 1 will interchange with one another, nor will the solenoid packs correctly assembled interchange between the 5R55N and 5R55W/S.

**"NOTICE" DIFFERENCE IN
WORM TRACKS**

**"NOTICE" DIFFERENCE IN
GASKETS**

CORRECTION: Ensure that you install the correct solenoid body gasket during overhaul or repair. Use the illustrations in Figure 1 to identify the different solenoid blocks and the different solenoid gaskets. Refer to Figure 2 for the proper assembly procedure.

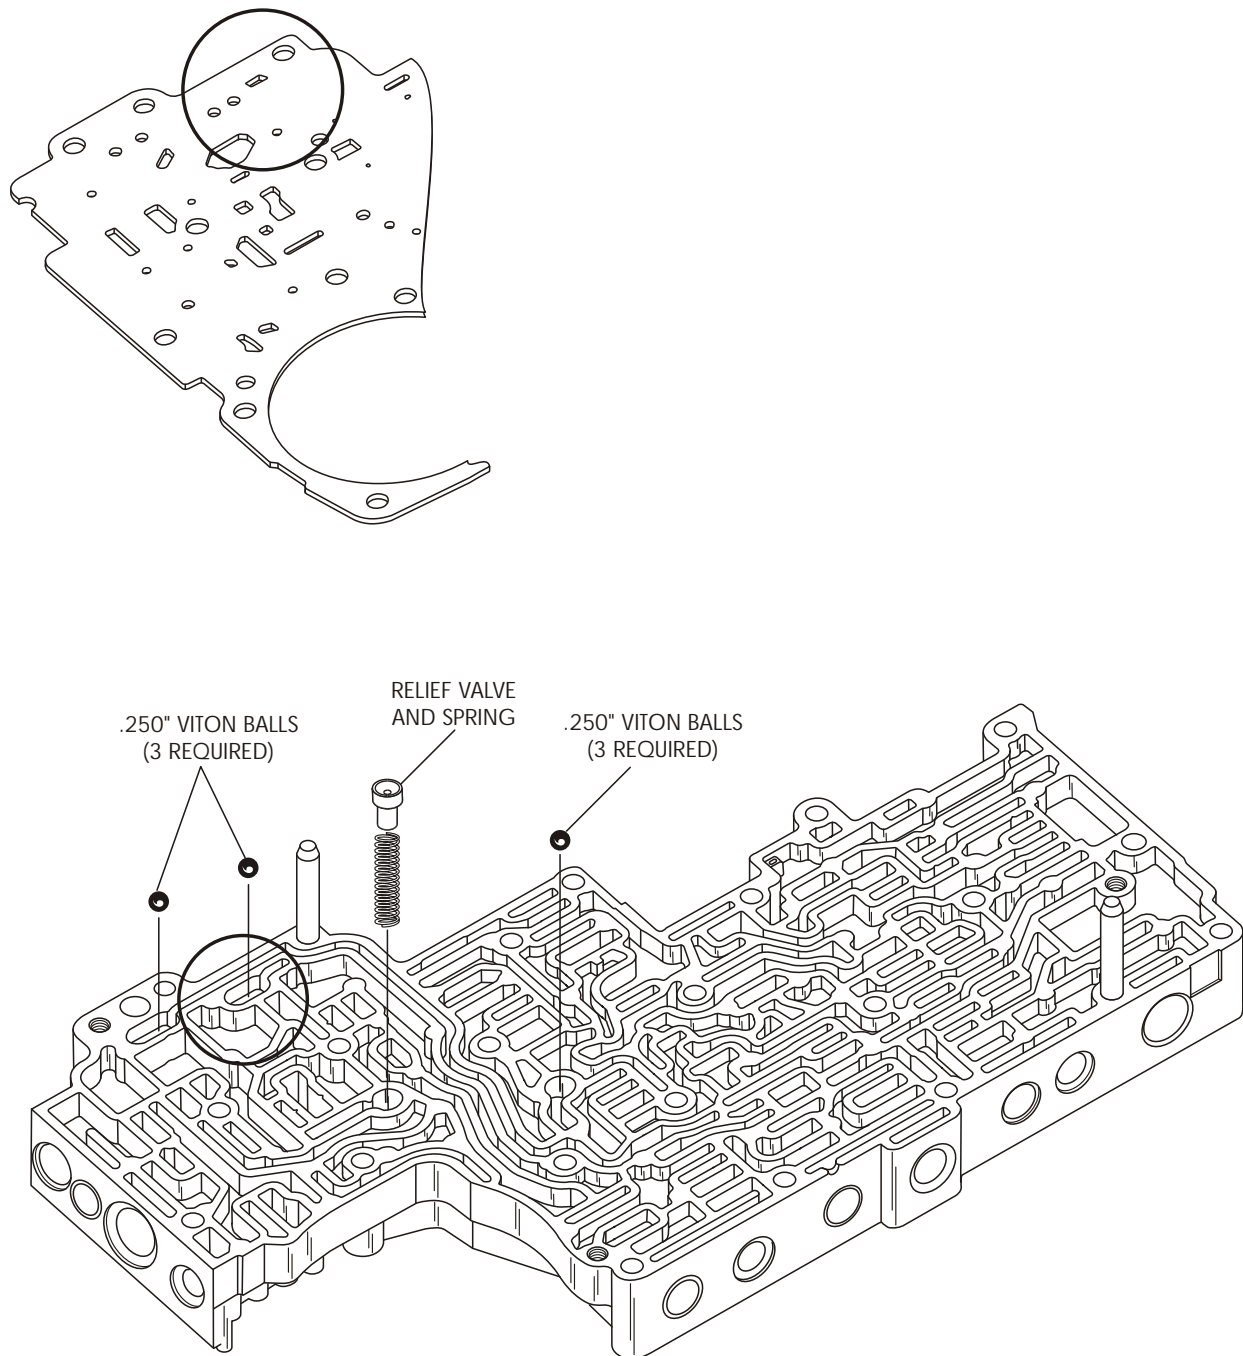
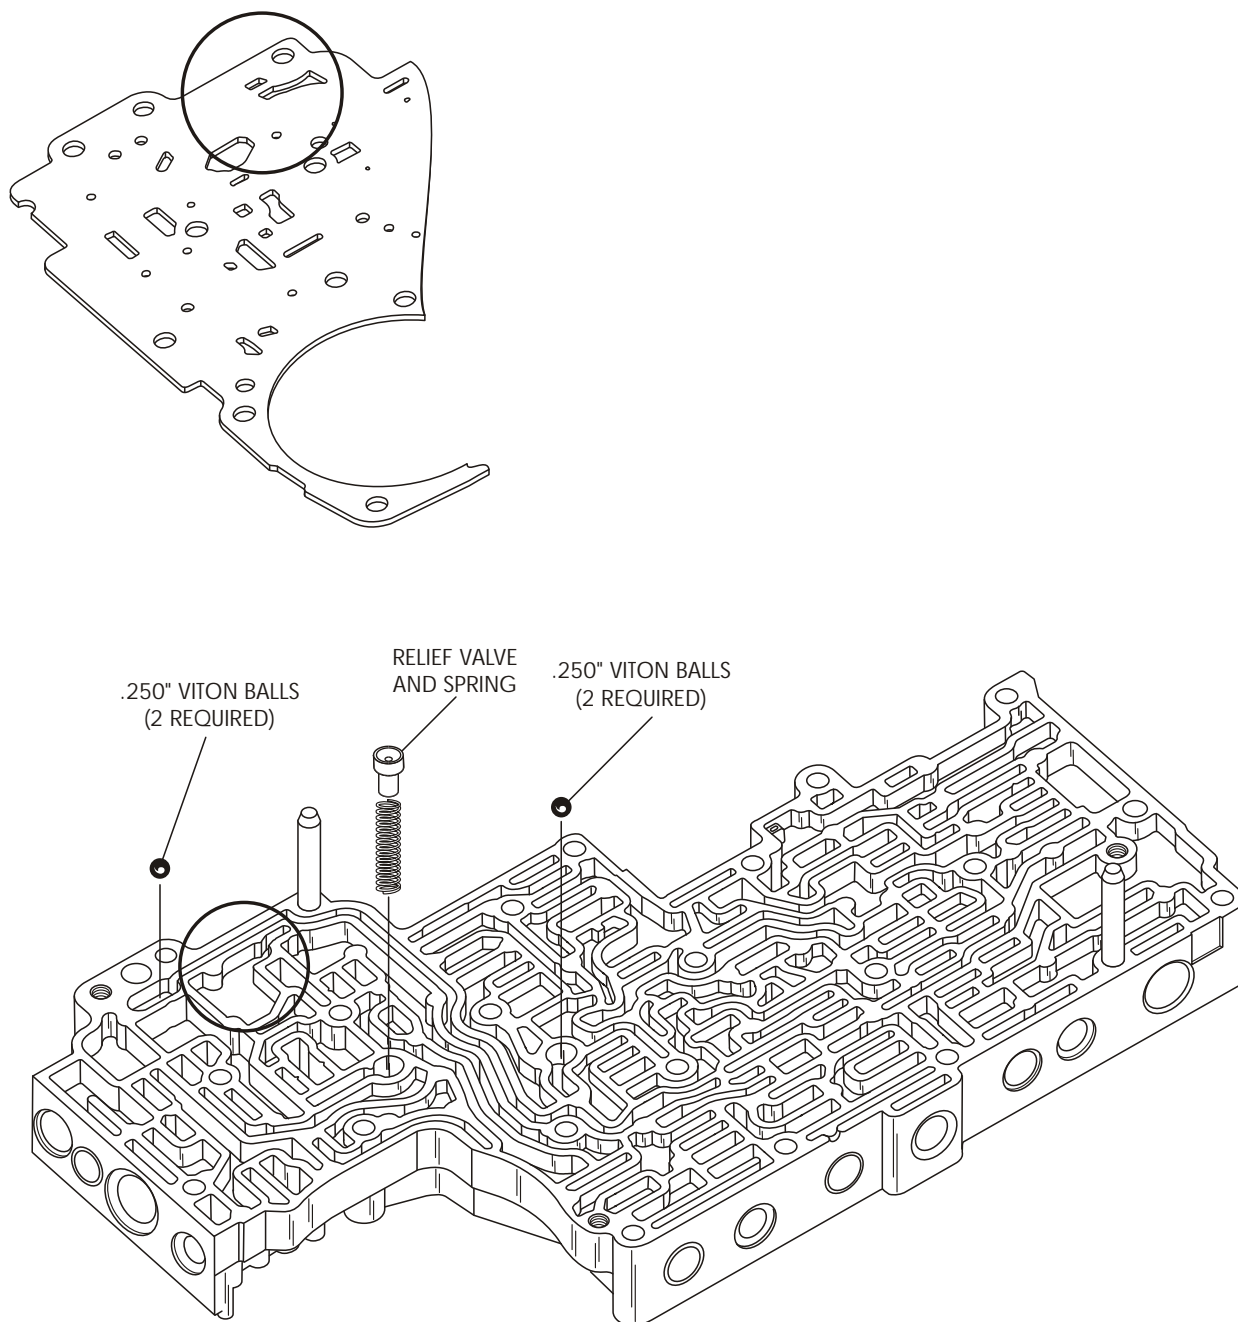
"EARLY STYLE" 3 CHECKBALL VALVE BODY AND SPACER PLATE

"LATE STYLE" 2 CHECKBALL VALVE BODY AND SPACER PLATE

The "Late Style" valve body and spacer plate as a package will retro-fit back on all models of the 5R55N transmission and is recommended.

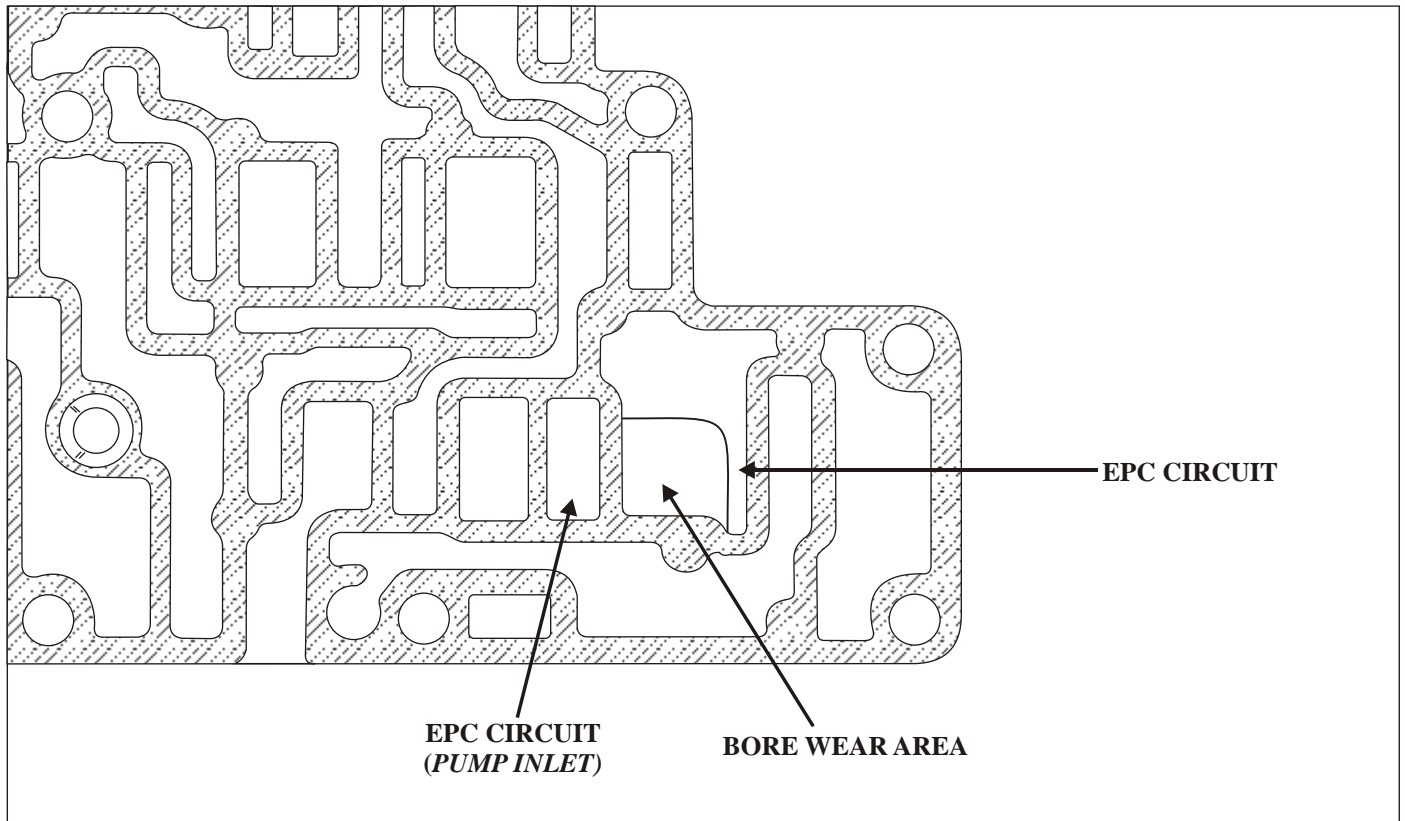
Figure 1

COMPLAINT: The transmission is slipping in all gears as well as during shifts. When line pressure is checked, the gauge indicates little or no line rise. A check of EPC pressure reveals a near zero reading. EPC solenoid amperage is correct and replacement of the EPC solenoid did not cure the complaint.

CAUSE: EPC pressure is routed to the Pressure Regulator Valve along side a circuit Ford identifies as the Boost Circuit. These oil passages can be identified in both the valve body and the case as seen in Figures 1 and 2. This is illustrated by the hydraulic schematic shown in Figure 3. This circuit is routed back to the inlet side of the pump. When the Pressure Regulator Valve or its bore is worn, (See Figure 4), EPC pressure is allowed to be sucked away by the suction side of the pump (See Figure 5 & 6) preventing any line pressure rise from occurring when the throttle is opened.
