"The Seminar to See for 2003" Technical Seminar

INDEX *Ford, Chrysler & Imports*

AUTOMATIC TRANSMISSION SERVICE GROUP

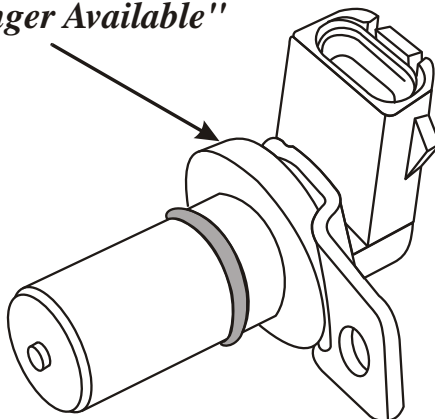
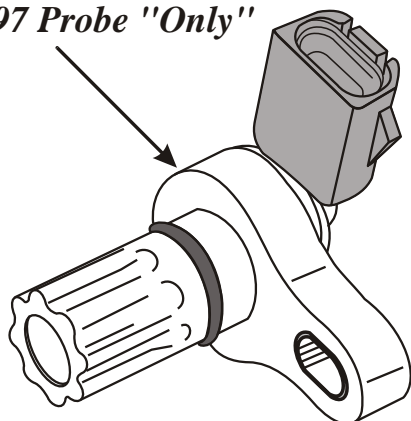
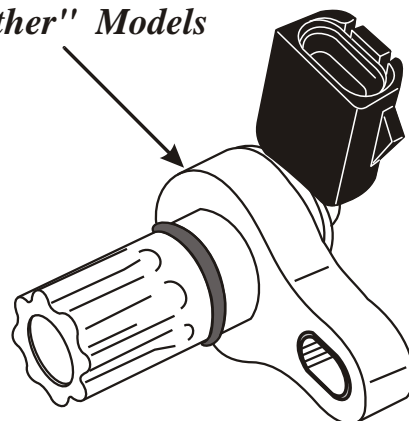
Figure 2

"All Black" Sensor
Part Number F7RZ-7M101-AA
"No longer Available"

White With "Green" Connector
Part Number F7RZ-7M101-KA
1994-1997 Probe "Only"

550 - 950 Ohms

White With "Black" Connector
Part Number 1S7Z-7M101-KA
"All Other" Models

625 - 1150 Ohms

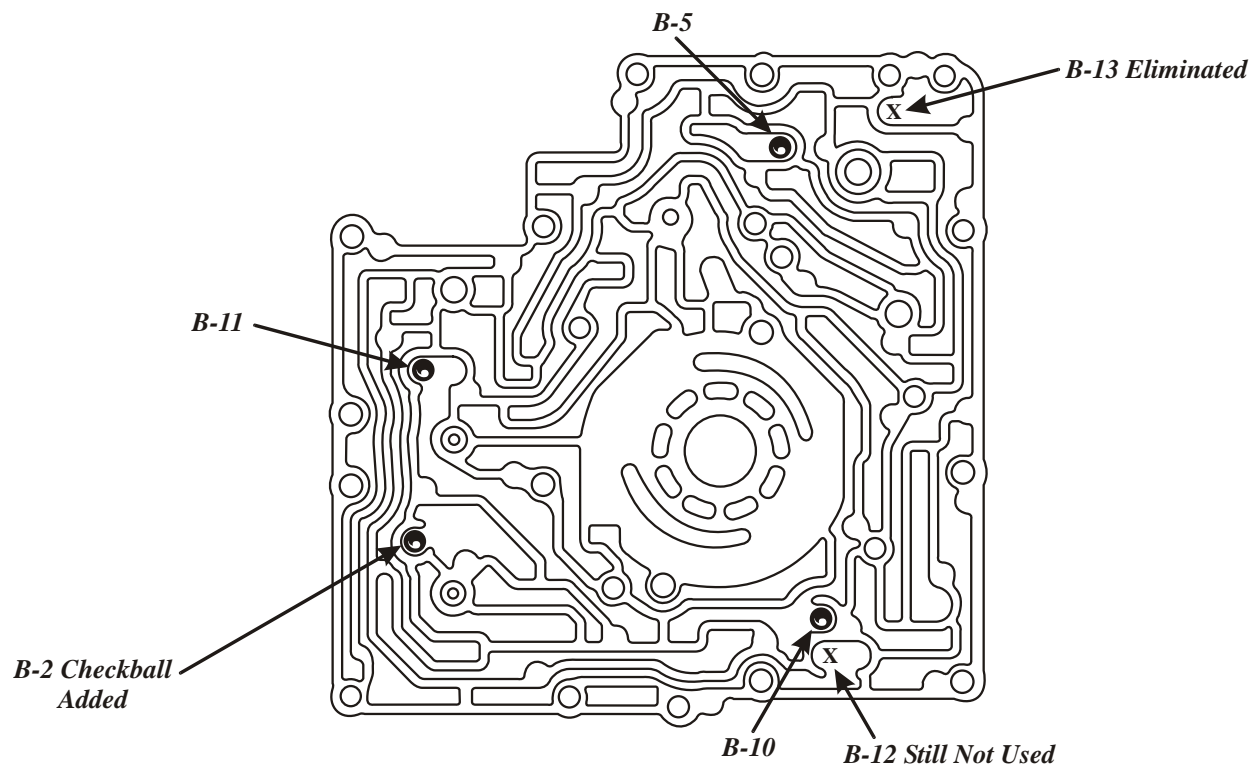
Figure 1

1992-1998 Only - Uses 6 checkballs, as shown in Figure 4. The No. 7 Checkball was eliminated.

CHECKBALL LOCATIONS 92-98 MODELS "ONLY"

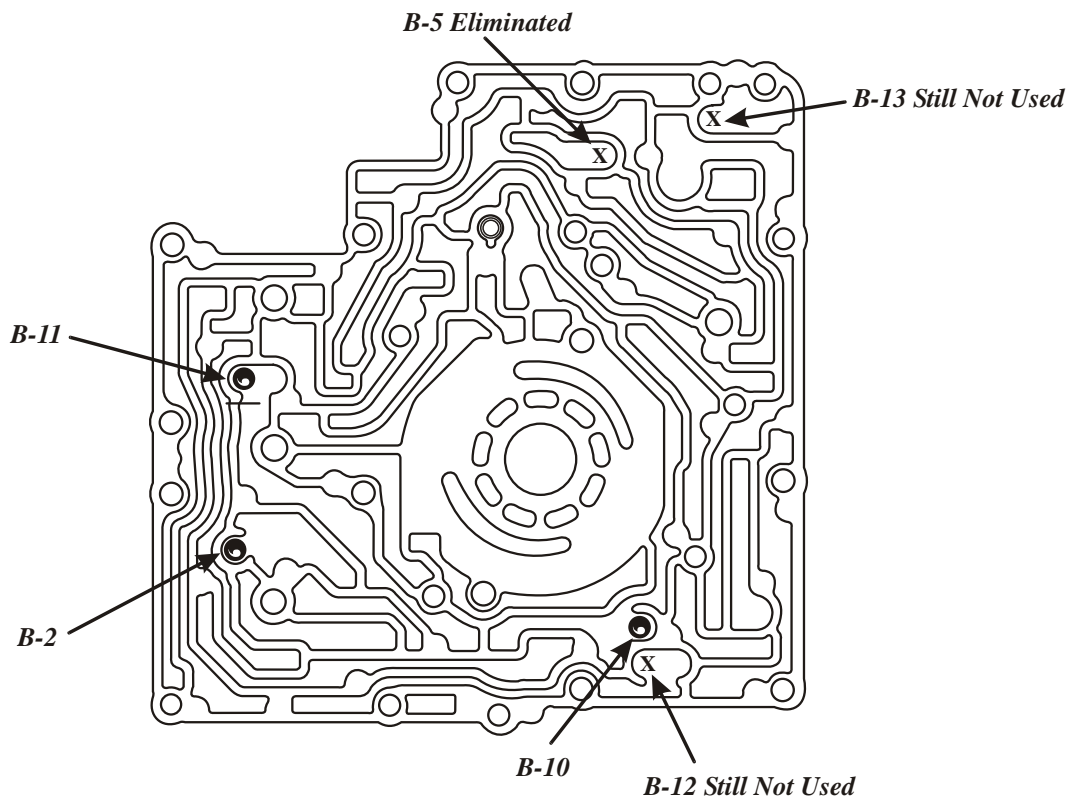
Figure 2

1999-2002 Only - Uses 6 checkballs, as shown in Figure 5. Also notice that one relief valve moved.

CHECKBALL LOCATIONS 1999 AND LATER "ONLY"

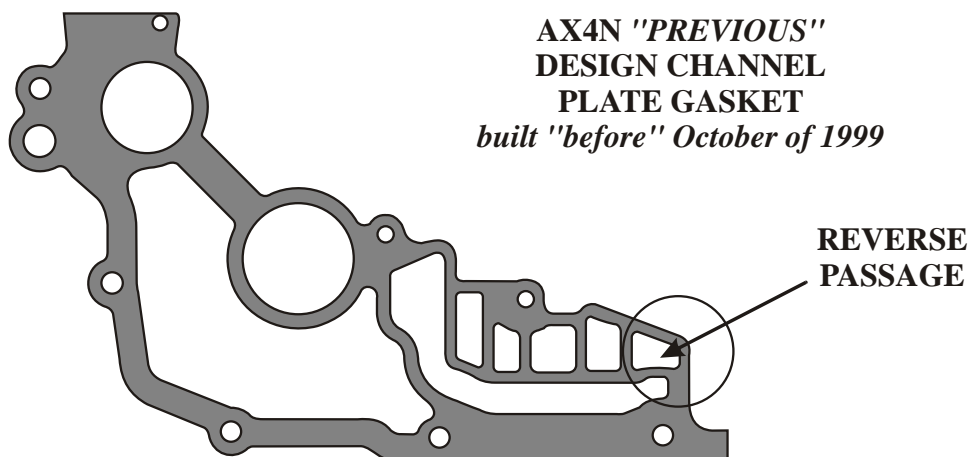
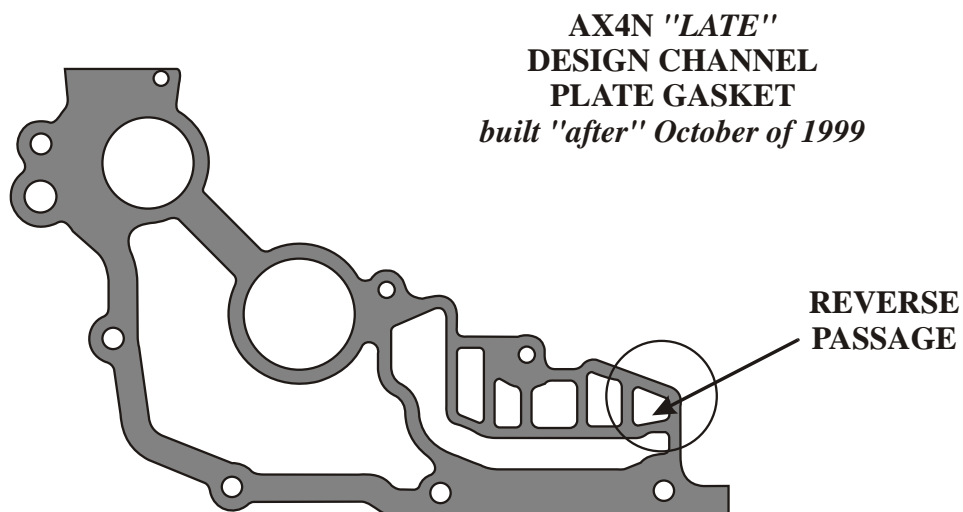
Figure 2

CAUSE: The cause may be, that the *Previous Design* Channel Plate Gasket, was used on a *Late Design* case as shown in Figure 1. When this happens, Reverse apply pressure will be exhausted back into the case because of the gasket hanging over the case casting.

"AX4N" CHANNEL PLATE GASKET I.D.

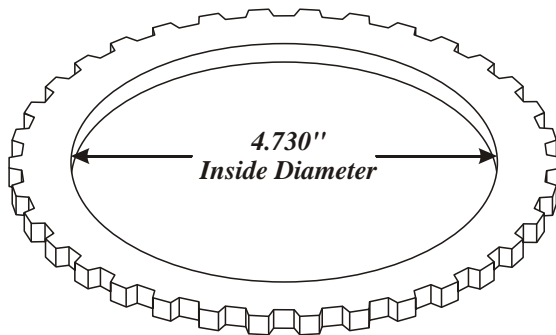
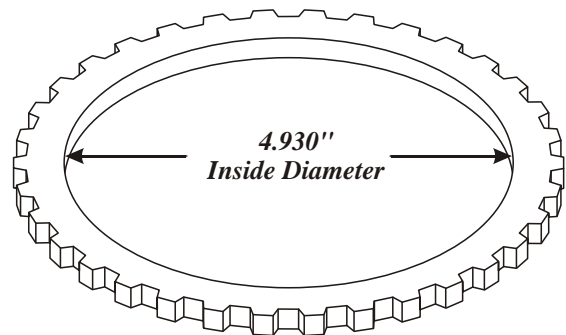
Figure 4

- (4) FORWARD CLUTCH PRESSURE PLATE - Has an increased inside diameter to 4.930" from the previous 4.730", to accommodate the increased diameter of the sprag outer race, as shown in Figure 4.

**FORD AXOD/AXODE
FORWARD STEEL PLATE
USED 1989-1991**

**FORD AXODE (AX4S)
FORWARD STEEL PLATE
USED 1992 AND LATER**

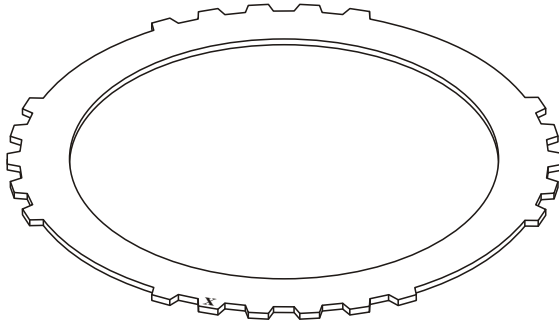
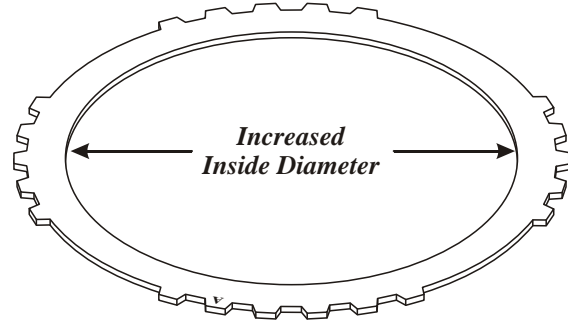
Figure 5

- (5) FORWARD CLUTCH "WAVE" PLATE - Has an increased inside diameter to 4.930" from the previous 4.730", to accommodate the increased diameter of sprag outer race (See Figure 5).

*21 External Teeth
Inside Diameter 4.730"
Material Is .075" Thick
I.D. Stamped "X" On 1 Tooth
Part Number F0DZ-7E085-A*

*21 External Teeth
Inside Diameter 4.930"
Material Is .083" Thick
I.D. Stamped "A" On 1 Tooth
Part Number F2DZ-7E085-A*

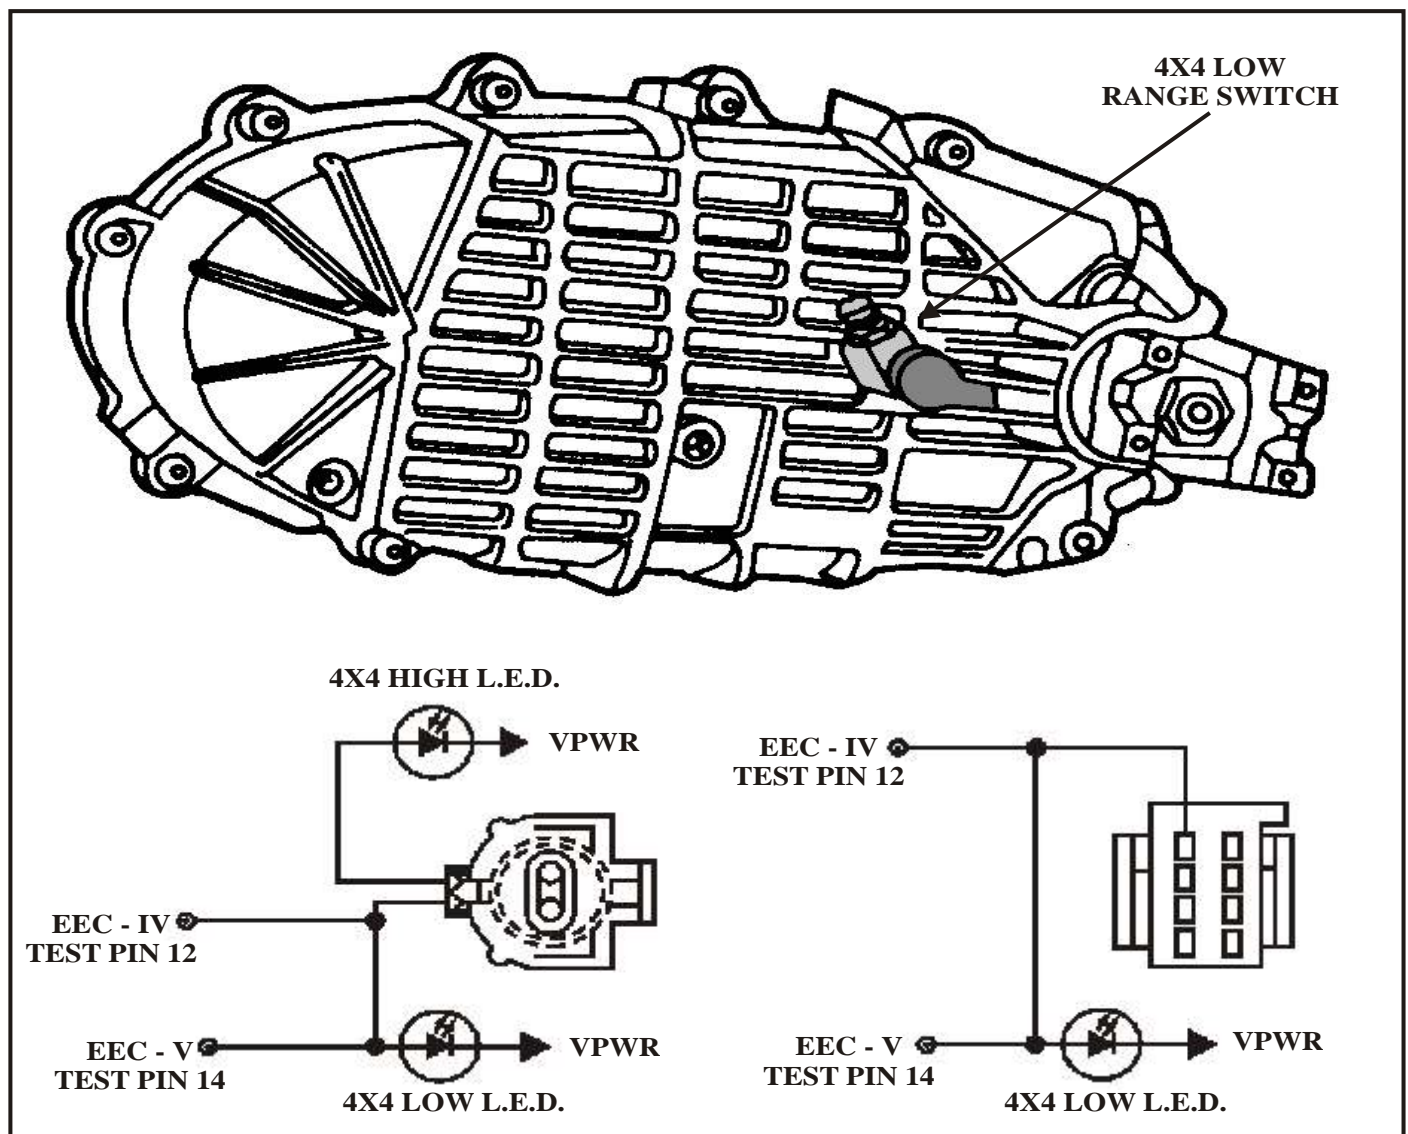
Figure 1

CAUSE: Some 2 wheel drive F-Series Pick Up's may have been equipped with a 4x4 wiring harness. Should the "4x4 LOW" signal wire become grounded in some way, a false signal is sent to the PCM causing the rapid up-shift. Since the vehicle is 2 wheel drive, the 4x4 parameter may be overlooked.

CORRECTION: All 1989 and some 1990 vehicles, the cause of the problem can not be detected with the use of a scanner as data stream is not available. On vehicles with data stream capabilities, the 4x4 Switch "ON/OFF" status can be observed through the scanner. With 2 wheel drive vehicles this status should remain "OFF" at all times. If an "ON" status is observed, the wire has been grounded in some way or the PCM is malfunctioning.

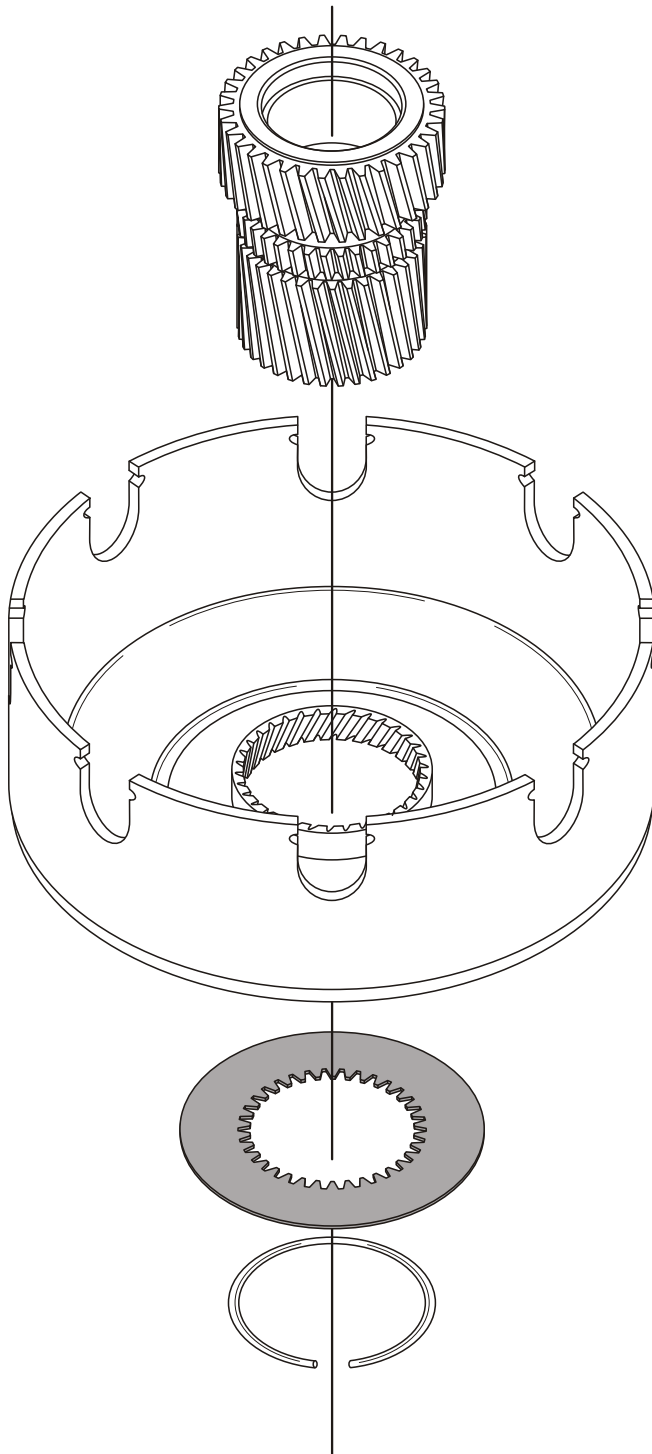
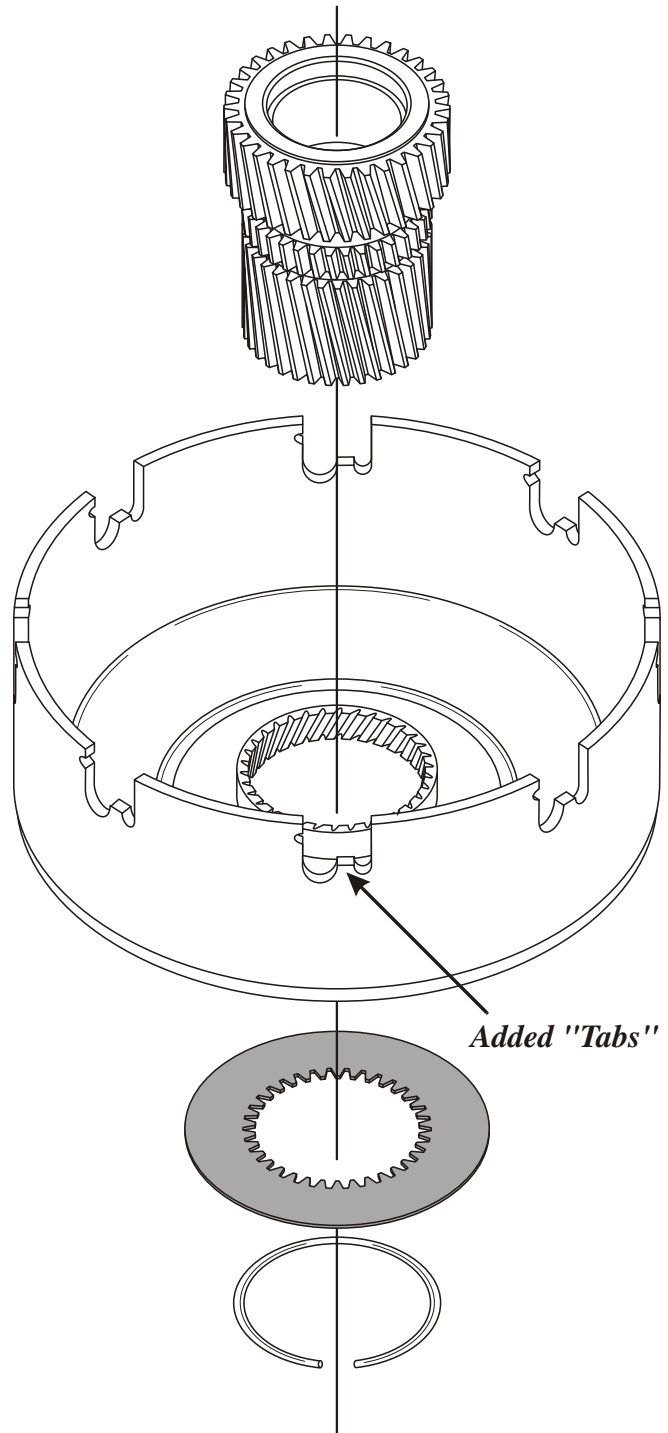
"No Longer Available From Ford"

*May Be Used With "ONLY"
The Previous Design Direct Drum
And Requires The No. 8 Washer
(See Figure 2)*

*May Be Used With
Both Design Direct Drums
With Or Without Washer
(See Figure 2)*

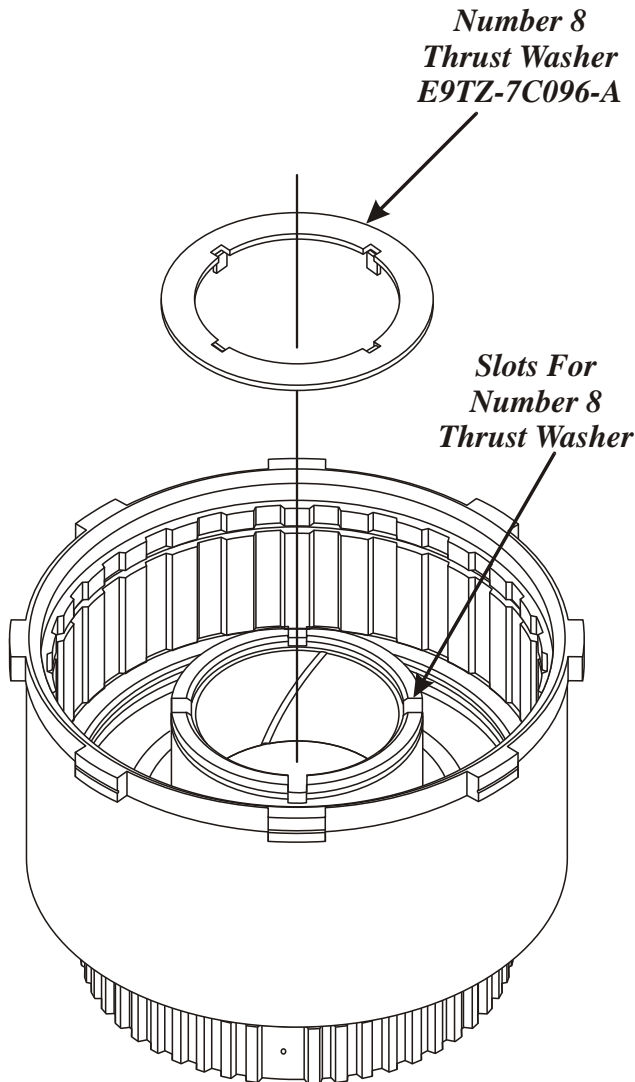
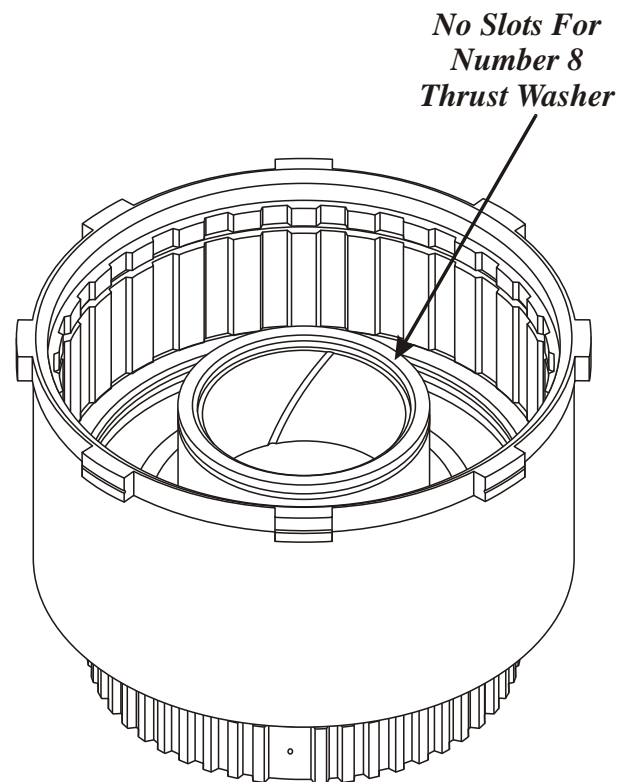
Figure 2

**PREVIOUS DESIGN DIRECT CLUTCH
DRUM "WITH" SLOTS FOR THE
NUMBER 8 THRUST WASHER
PART NO. F81Z-7D044-BA**

*May Be Used With
Both Design Sun Shells
(See Figure 1)*

**NEW DESIGN DIRECT CLUTCH
DRUM "WITHOUT" SLOTS FOR THE
NUMBER 8 THRUST WASHER
PART NO. YC3Z-7D044-BA**

*May Be Used With "ONLY"
The New Design Sun Shell
(See Figure 1)*

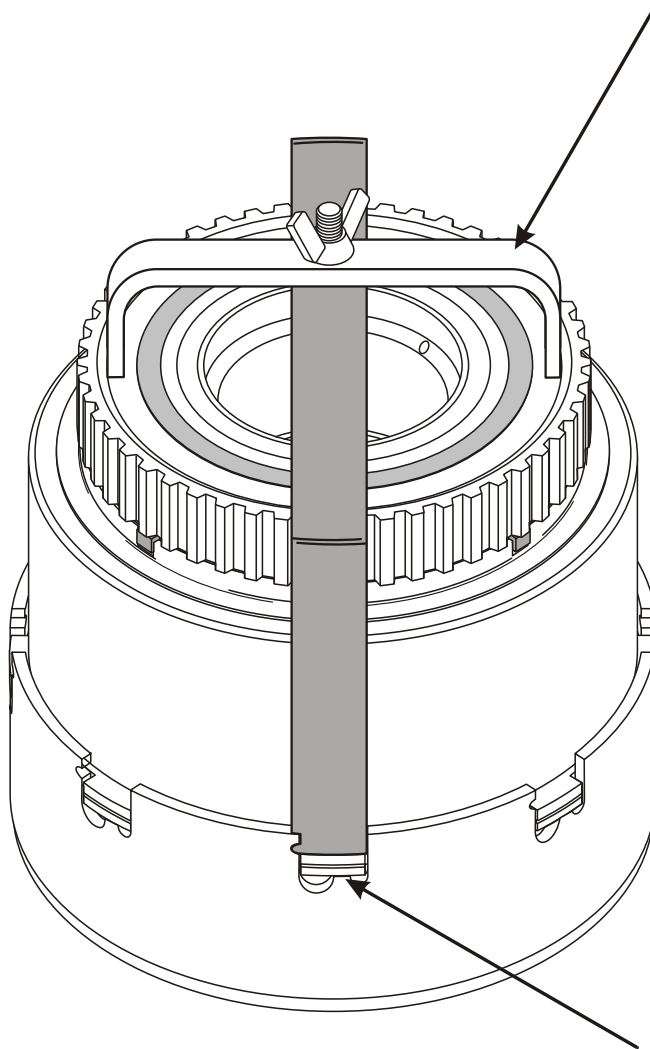
Figure 3

*New Design Loading Tool
Works On Both Sun Shells
Available From Ford Motor Co.
Under Part Number 307-436*

*Lugs On Direct Clutch Housing
Now Supported By "Tabs" Added
To Center of Sun Shell Slots Which
Allowed Elimination Of The
Number 8 Thrust Washer*

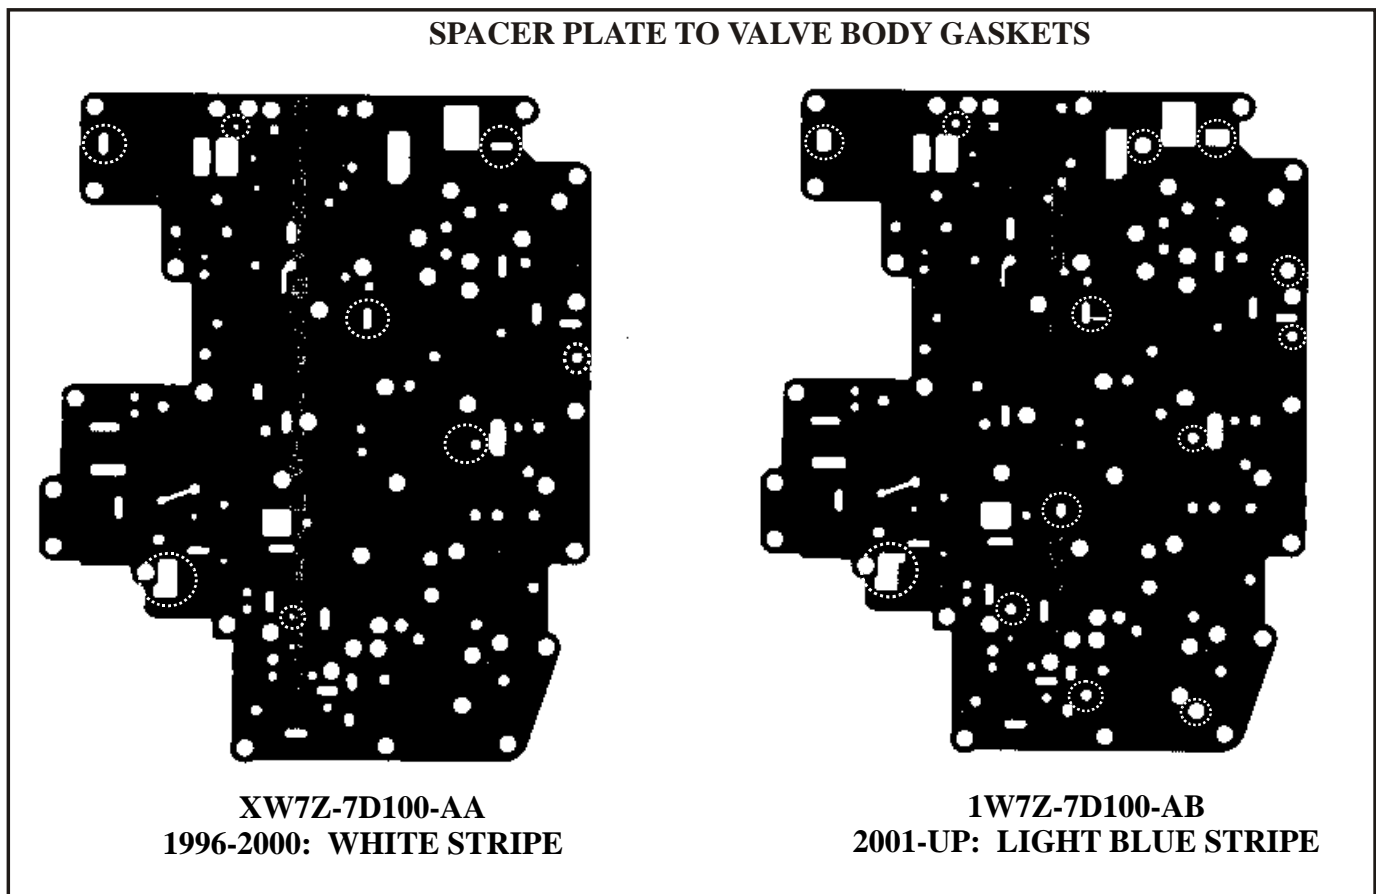
Figure 1

The spacer plate to valve body gasket with part number **XW7Z-7D100-AA** has a white identification stripe and is used for 1996 to 2000 (See Figure 1). The spacer plate to valve body gasket with part number **1W7Z-7D100-AB** has a Light Blue identification stripe and is used for all 2001 and up applications. This gasket will NOT retrofit back to any previous model years (See Figure 1).

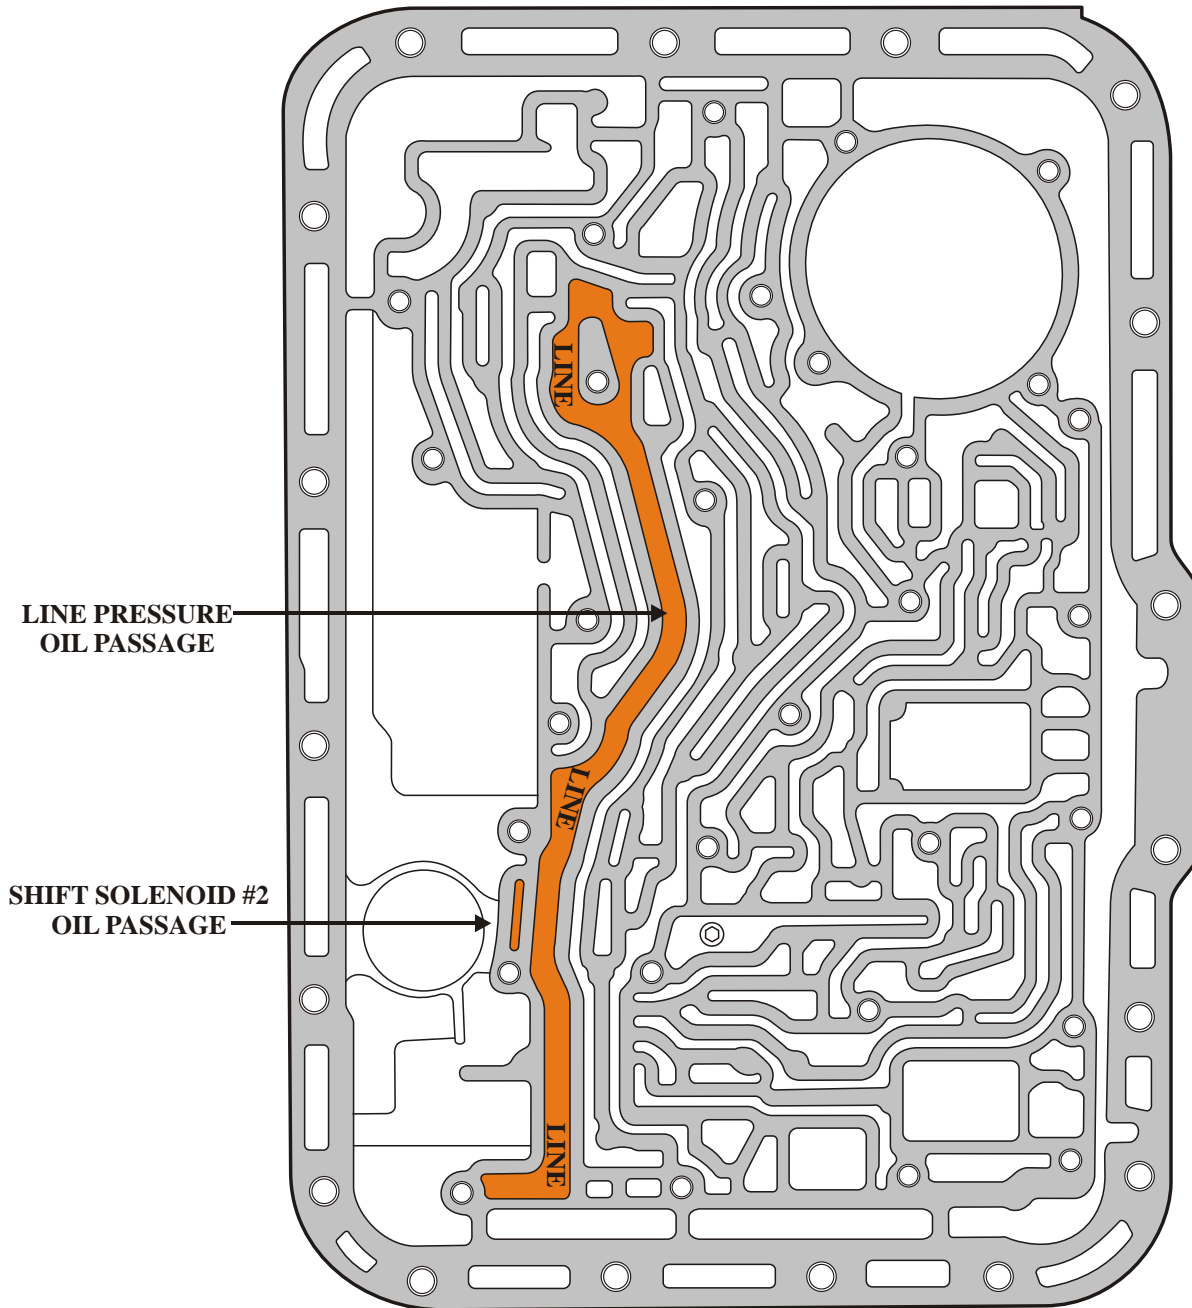
Figure 2

VALVE BODY GASKET BLOW OUT

TRANSMISSION CASE OIL PASSAGES

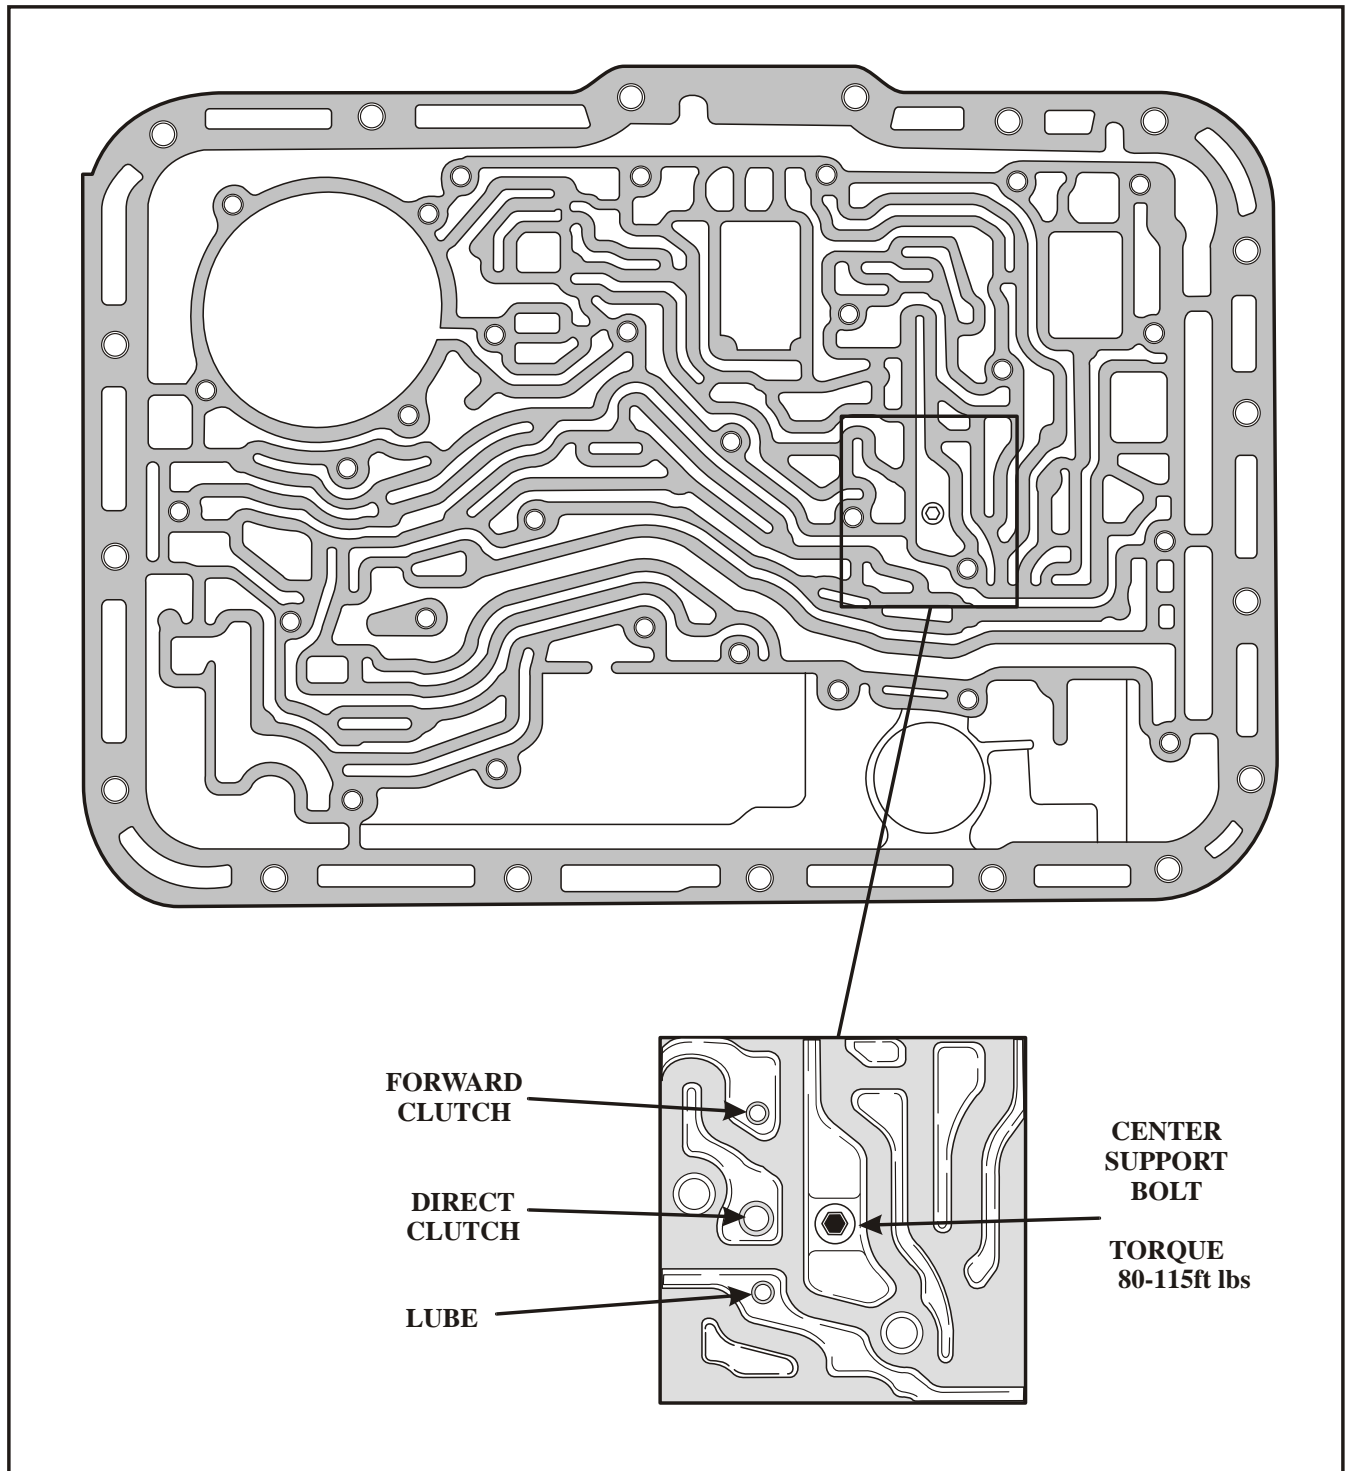
Figure 1

- COMPLAINT:** After a rebuild, the vehicle exhibits a delayed engagement when hot. Other symptoms that can accompany this concern is soft or flared up shifts. Particularly the 2 to 3 on 4R units and 3-4 on 5R units. Common building practices such as replacing the pressure regulator valve spring with an A4LD yellow spring, tweaking the EPC solenoid 1/8 turn in and eliminating the engagement control valve spring have all been employed and still the problem persists.
- CAUSE:** During rebuild, the center support bolt was overlooked and not tightened down causing a loss of clutch apply pressure (See Figure 1). If a line gauge was installed on the unit, a sluggish line rise may be observed with base line pressure being 10 to 20 pounds lower than factory specifications.
- CORRECTION:** Tighten the anchor bolt with a 5 mm Allen wrench 80 to 115 inch pounds.

**4R44/55E and 5R55E
DELAYED ENGAGEMENT WHEN HOT**

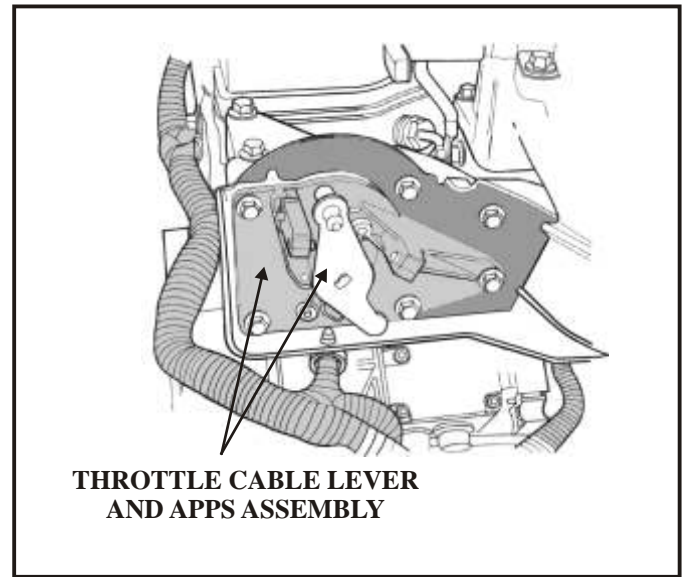
Figure 3

CORRECTION: The APPS is located at the front left of the Engine Compartment under a plastic protective cover (See Figure 2). When the cover is removed it can be seen how the accelerator pedal cable operates a throttle cam which is attached to a mounting plate (See Figure 3). On the back side of this assembly is the where the APPS is located (See Figure 4). The APPS connector terminal identification is shown in Figure 5. The number 3 terminal sends a typical .5 to 3.5-4.0 throttle opening signal voltage to the ECM at connector terminal # 25 (See Figure 6). The ECM in turn sends that same signal to the PCM from ECM terminal # 28 to PCM terminal # 23 in the C1 Black connector (See Figure 7). Simply inspect the voltage from the APPS to the ECM to insure that the APPS is functioning correctly. Then inspect the signal from the ECM to the PCM. If the signal is incorrect, the ECM will need to be replaced. For further verification that an ECM needs to be replaced, cut the wire entering terminal 23 in the PCM's black C1 connector. Run a jumper lead from terminal 3 in the APPS connector to terminal 23 in the C1 connector. If the direct signal from the APPS into the PCM corrects the problem, the ECM has been confirmed faulty.

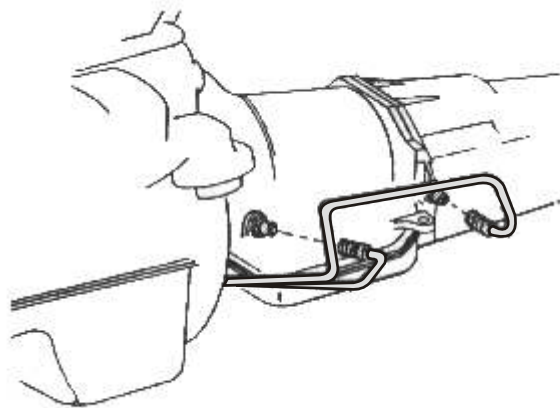
Figure 1

COMPLAINT: Chrysler rear wheel drive transmissions with quick disconnect 1/2" cooling lines may experience repeated front line clip melt down failures.

CAUSE: RWD transmissions behind diesel engines are the most common to experience this complaint after heavy trailer towing or reverse to drive rocking situations. This causes the front cooling line (which is the line out to the cooler) to be the recipient of the high fluid temperatures produced by the converter. The front quick disconnect clip assembly suffers greatly under these conditions.

CORRECTION: Replace the transmission quick disconnect fittings with threaded fittings that will not melt. This will require 2 cooling lines with the appropriate attaching fittings, 2 case fittings to accommodate the case threads and line fittings plus, approximately 2 feet of flexible hydraulic lines to attach the new lines to the existing lines.

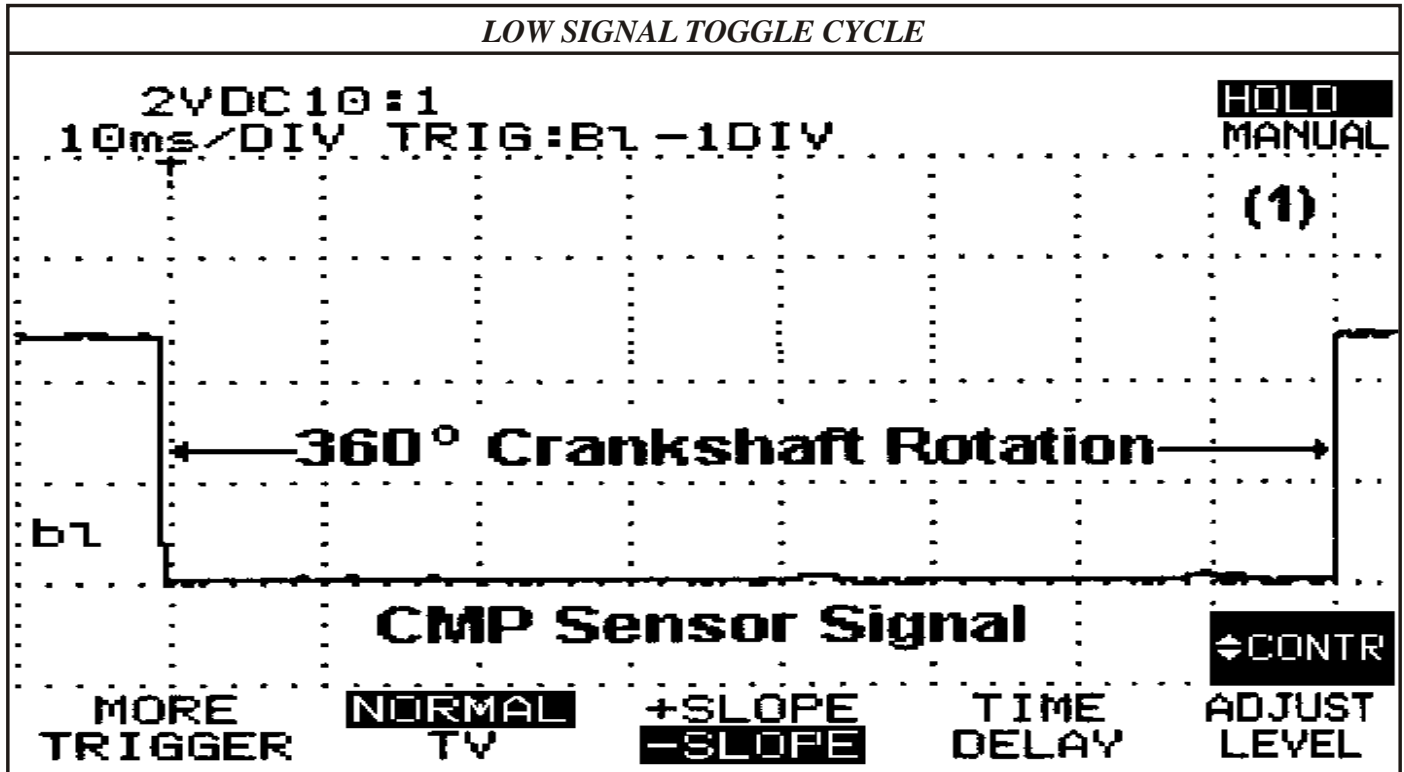
Figure 3

The CMP Sensor operation is unique because it produces a **LOW** toggle signal during one revolution of the crankshaft, (See Figure 3), and a **HIGH** toggle signal for the next complete revolution of the crankshaft (See Figure 4).

The illustration of the distributor in figure 5 shows that the CMP Sensor exciter ring only goes half way around the distributor base, which creates the high toggle signal per 360° of crankshaft rotation, and a low toggle signal for the next 360° of crankshaft rotation as illustrated in the oscilloscope waveform patterns in figures 3 and 4.

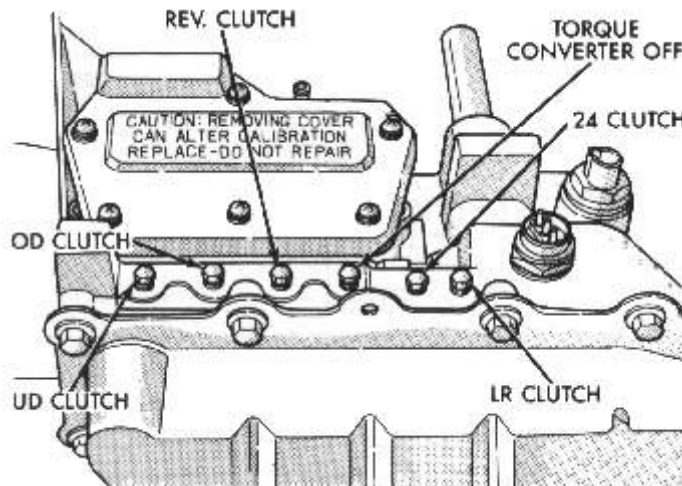
Figure 4

To check it with a pressure gauge, attach the gauge to both the Low/Reverse Pressure tap and Underdrive tap (See Figure 4). In drive with the brake applied and engine rpm brought up to 1,000 rpms, both circuits should be approximately 120 psi. If both are the same but significantly low, the pressure regulator valve and/or pump needs to be repaired or replaced.

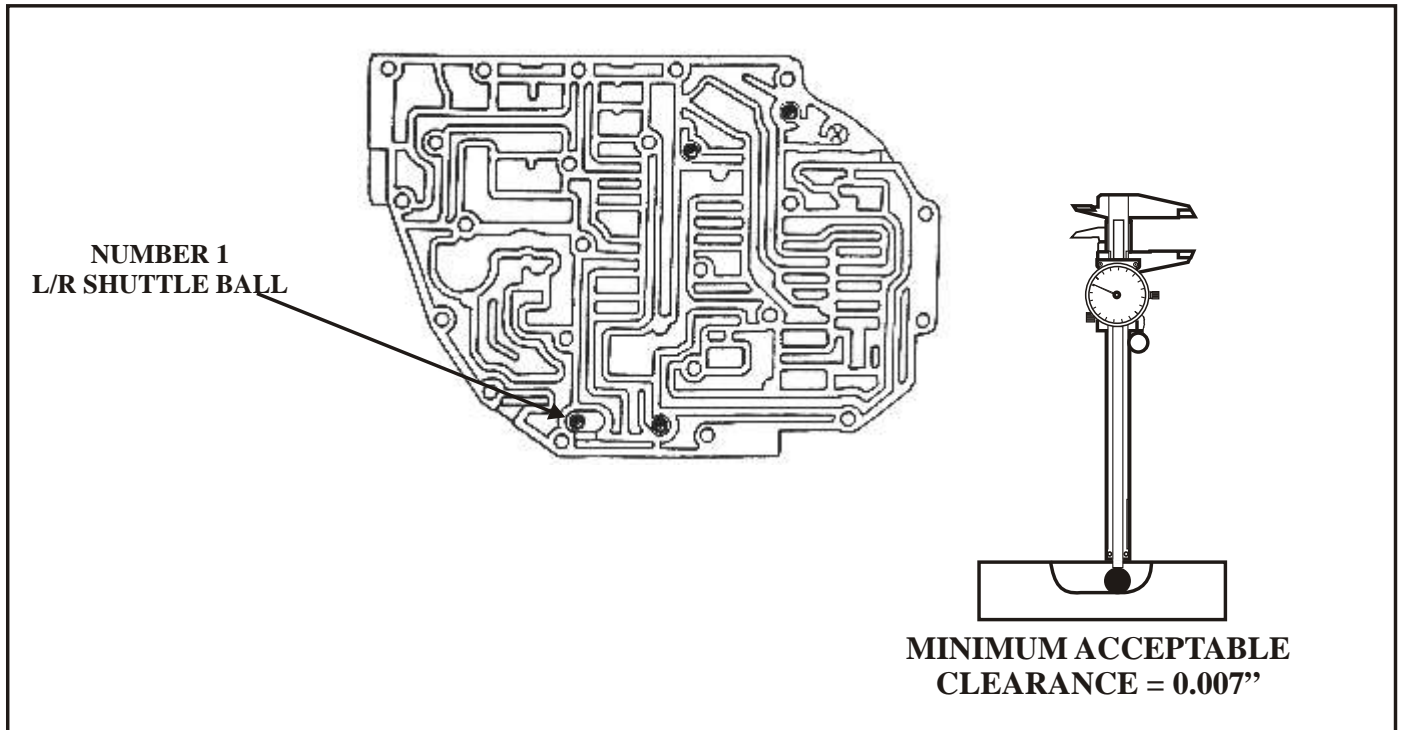
Figure 5

One other possibility regarding the L/R clutch circuit is the # 1 shuttle ball in the valve body (See Figure 5). If there is insufficient clearance for the ball to roll when the unit gets hot, the ball can stick or drag against the spacer plate and cause a delayed low/reverse clutch apply. The minimum acceptable clearance from the top of the ball to the surface of the valve body given by the manufacturer is 0.007". Typically approximately 0.040" is seen but some valve body casting have been known to have a shallow of a bathtub pocket pinching the ball against the plate when hot. This ball has since been eliminated and replaced with a Low/Reverse Switch Valve (See Figure 6). This newer style valve body is available for non Transmission Range Switch style valve bodies and TRS style valve bodies.

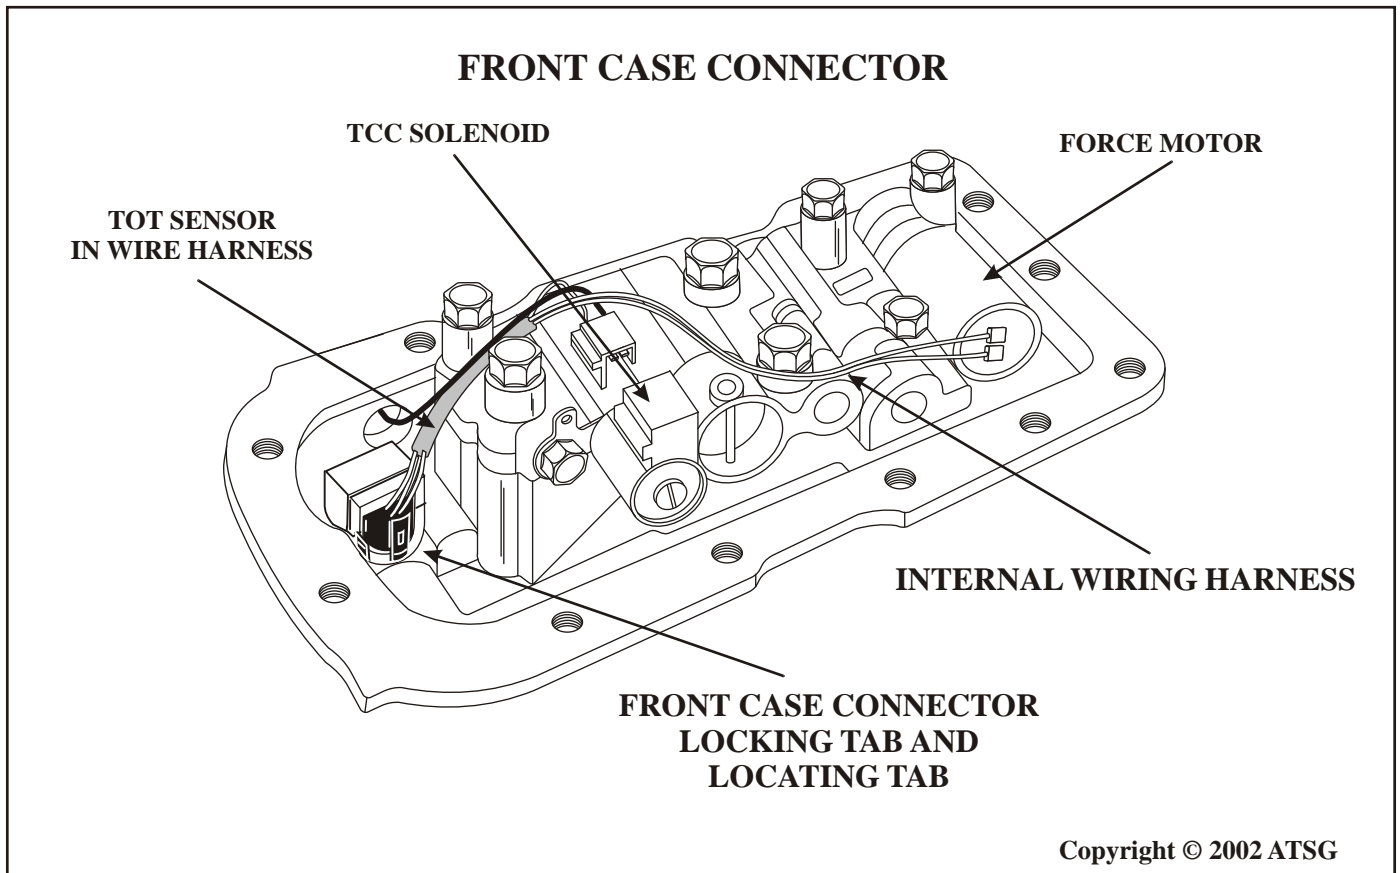
Figure 7

CAUSE: The cause may be that during removal of the front internal harness connector, the locking tab, on the front case connector shown in Figure 7, was broken off.
The reason for the trouble codes setting is because the locking tab is also a *locating* tab so the internal harness can only be plugged connected in 1 way. When the locating tab is broken the internal harness can be plugged in any direction.

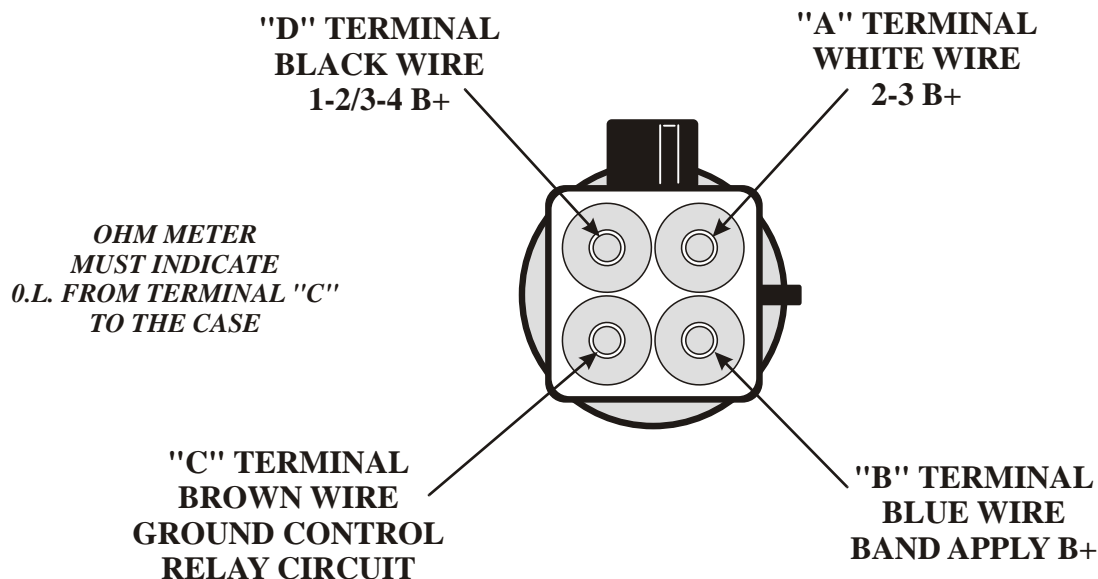
Figure 9
Automatic Transmission Service Group

CASE CONNECTOR TERMINAL AND INTERNAL WIRE COLOR IDENTIFICATION

CORRECTION: Inspect the Protective Conduit as shown in Figure 10 and replace the internal harness if needed. After the pan is put back on the case, take an ohm meter and connect the positive terminal to terminal "C," as shown in Figure 9, and the Negative terminal to the case and make sure that the meter indicates an open circuit.
