"The Seminar to See for 2003" Technical Seminar

INDEX *Ford, Chrysler & Imports*

AUTOMATIC TRANSMISSION SERVICE GROUP

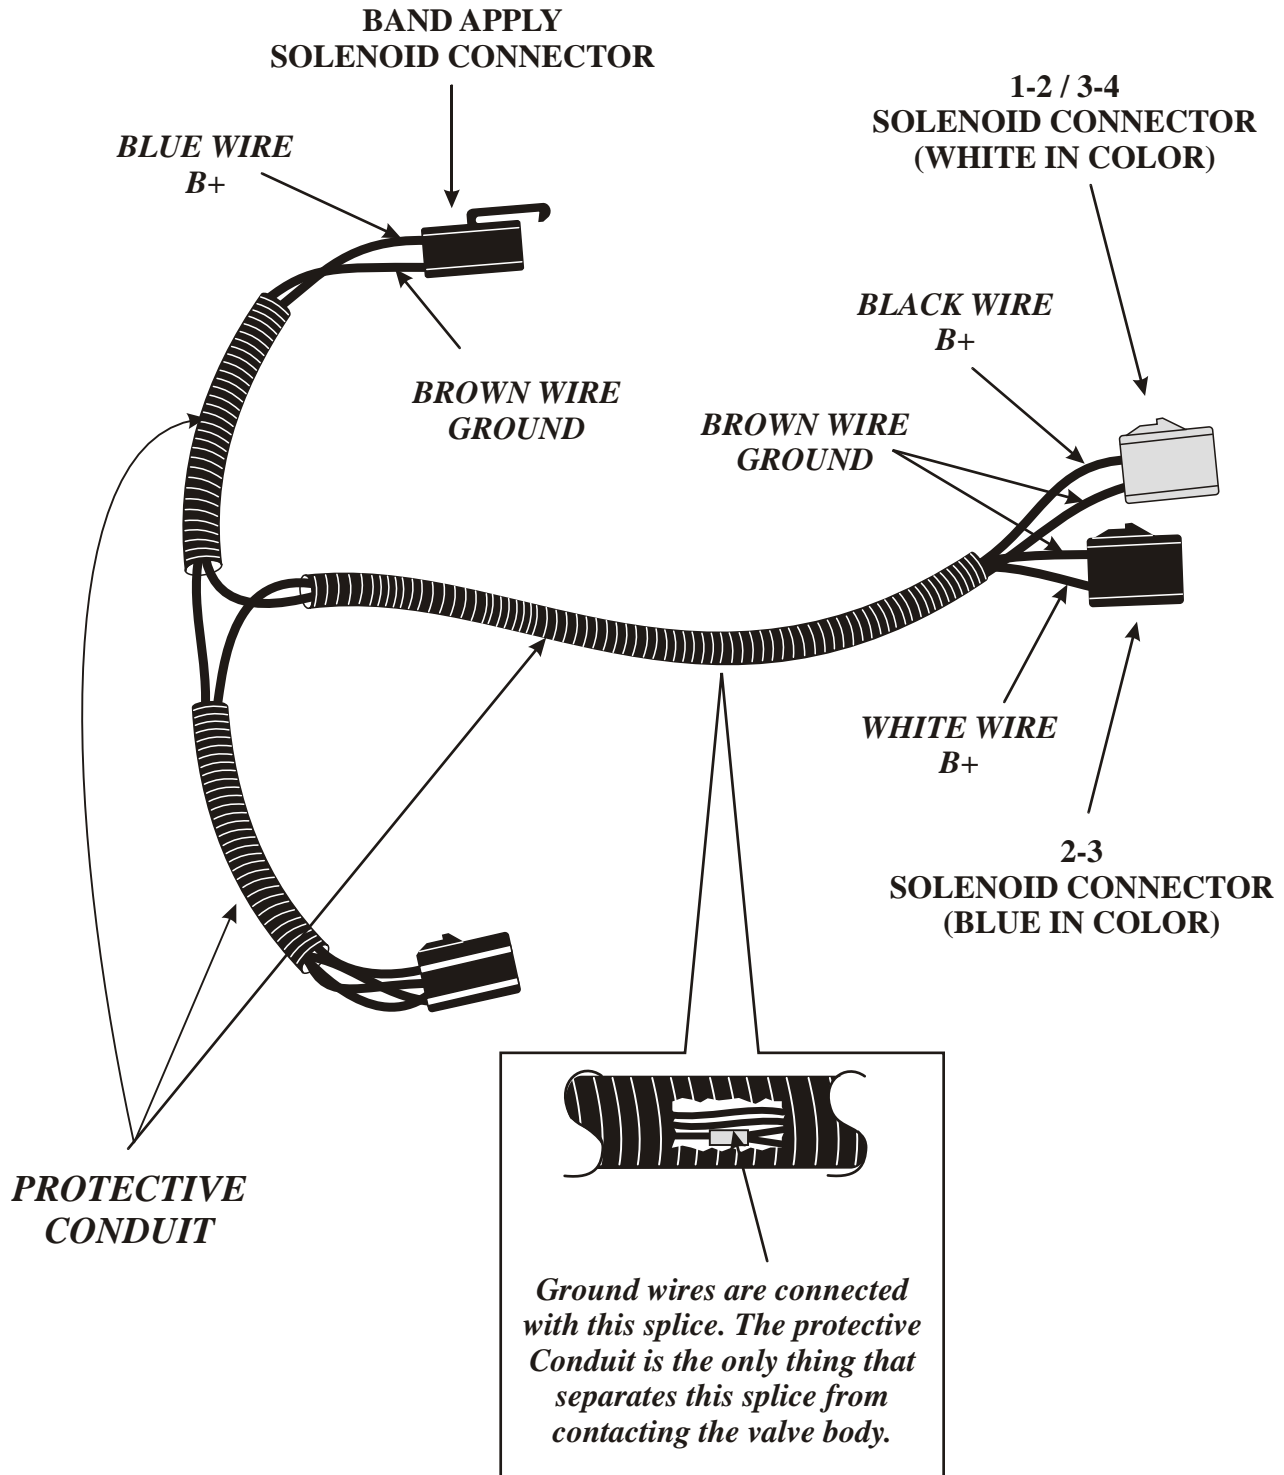
Figure 10
Automatic Transmission Service Group

CAUSE: The cause may be that the Protective Conduit, as shown in Figure 10, had become very brittle from heat and had deteriorated causing the splice to contact the valve body.
The Transmission Control Module controls the Shift and Band Apply solenoids on the Positive side, for gear changes and Band control. The Transmission Control Module also controls the Ground side of these solenoids thru an internal relay, which is connected from Terminal 54 at the TCM to the "C" terminal, which is connected to all three solenoids, at the case connector as shown in Figure 9.
The reason the code 43 sets is because the TCM detected that the Ground Control Relay circuit was already grounded before the TCM could ground it.

CORRECTION: Inspect the Protective Conduit as shown in Figure 10 and replace the internal harness if needed. After the pan is put back on the case, take an ohm meter and connect the positive terminal to terminal "C," as shown in Figure 9, and the Negative terminal to the case and make sure that the meter indicates an open circuit.

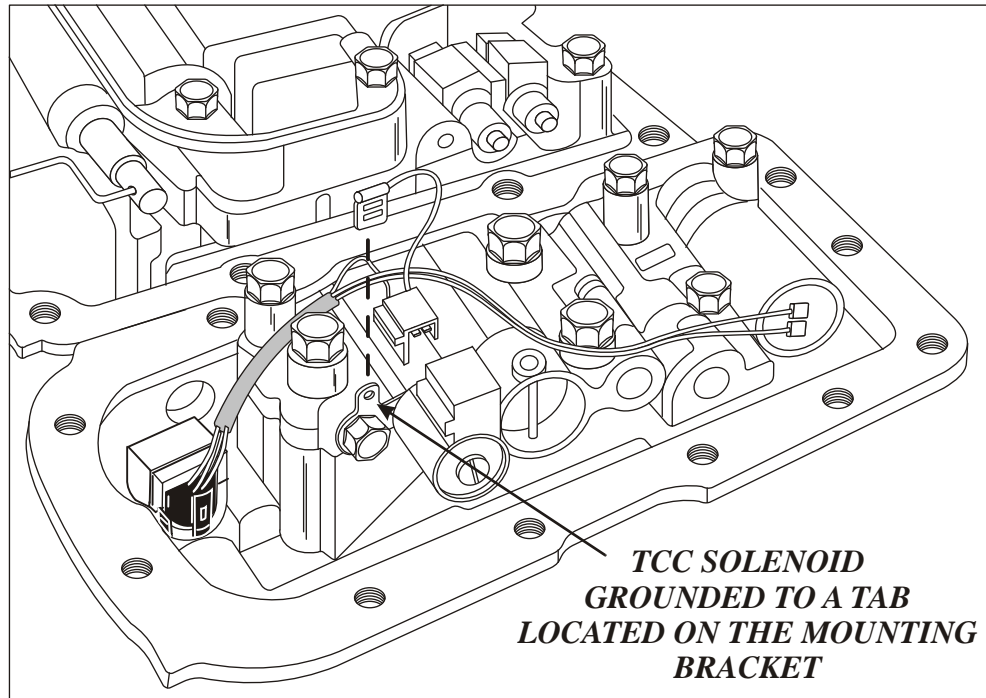
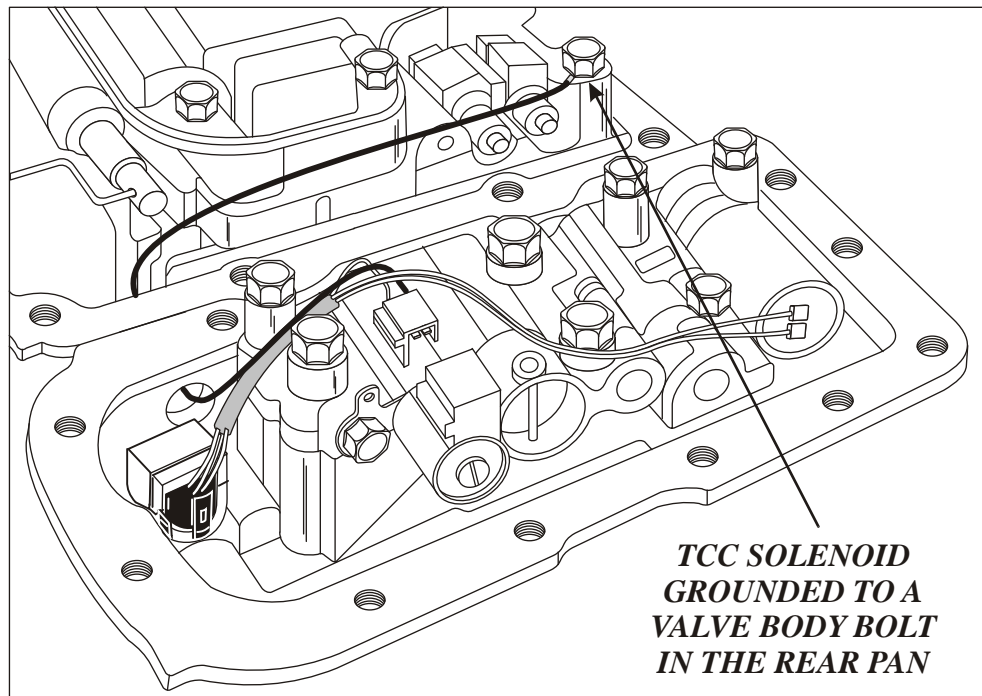
Figure 12

CAUSE: The cause may be, an insufficient ground connection for the Torque Converter Clutch Solenoid.
The first design solenoid ground, as shown in Figure 12, was connected to the terminal that was part of the TCC solenoid bracket.
The second design solenoid ground, also shown in Figure 12, is now connected to a valve body bolt in the rear pan.
The reason for this change was to provide a better ground path for the solenoid because of the gaskets between the pump, overdrive housing and the main case.
