"2007" SEMINAR INFORMATION

GM & Ford

"Tech is Rev'n in 2007"

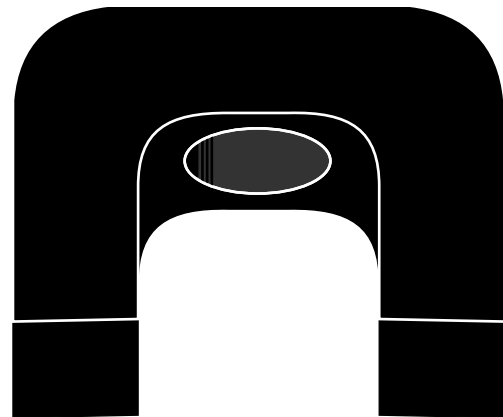
Figure 2

CAUSE: During the re-assembly of the vehicle, the left and right front wheels were switched to opposite sides. This action caused the Tire Pressure Monitoring System Sensors in each of those wheels (Refer to Figure 2) to alert the TPMS, turn on the warning lamp and store the above mentioned codes. This occurs because this is a Direct TPMS system, in other words it is a stand alone system whose only purpose is to monitor tire pressures.

- (1) The entire reprogramming procedure must be completed within 5 minutes, if not, start over.
- (2) Individual TPM sensor reprogramming must be accomplished within 1 minute, if not, start over.
- (3) If the horn chirps twice before reprogramming is complete, this indicates the TPM receiver has exited the programming mode, start over.
- (4) DO NOT replace the tire stem cap with anything other than the O.E. cap. Any other cap can block the transmitters signal because the tire stem is the transmitters antenna.

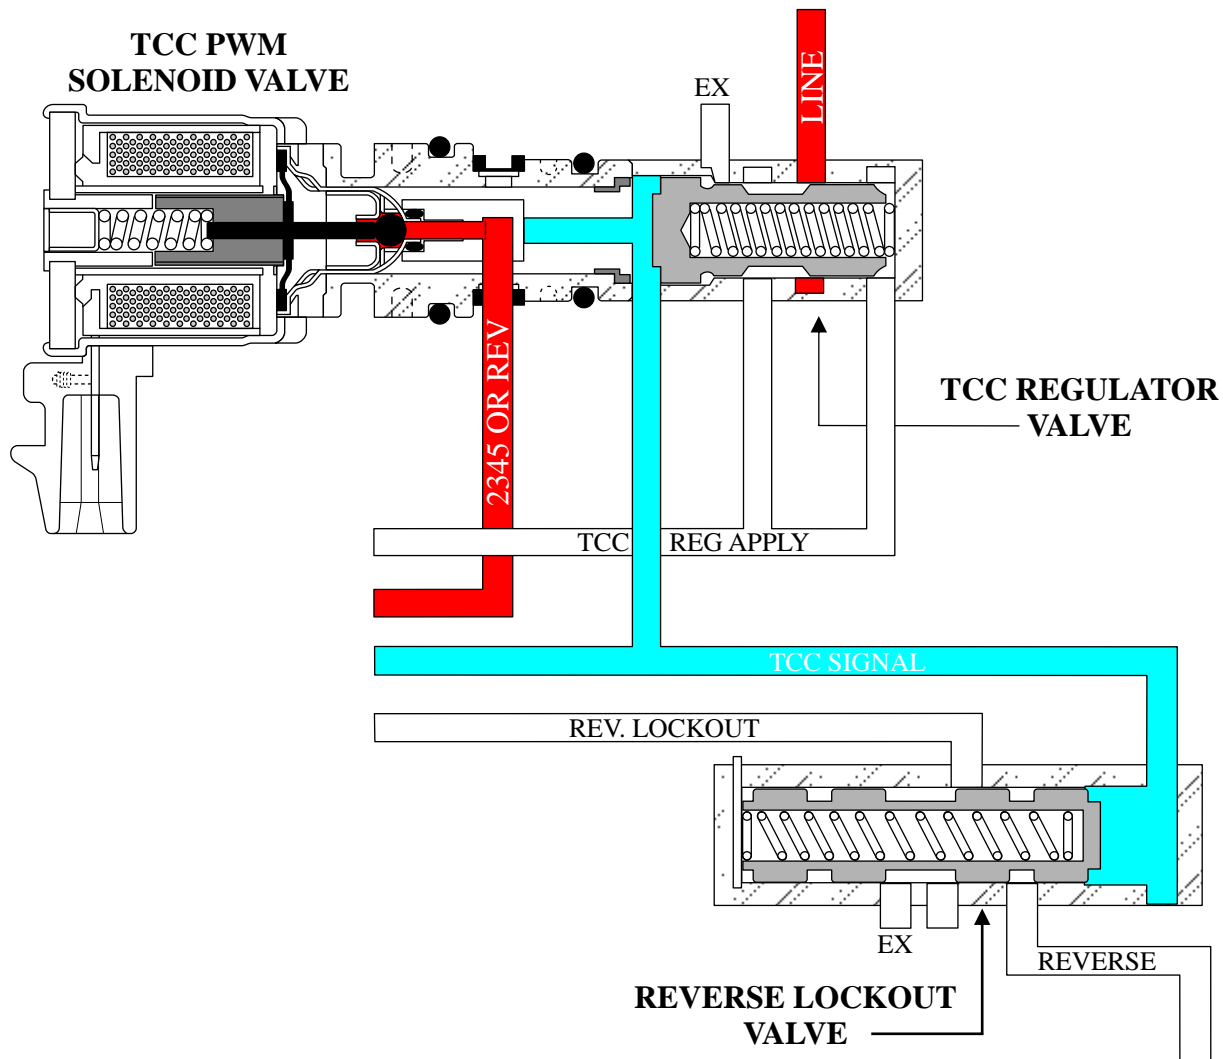
Figure 1

Oil pressure from the manual valve is directed into the 2,3,4,5, and Reverse circuit in 2nd, 3rd, 4th, 5th, and Reverse gears. In the forward ranges, 2,3,4,5 oil is utilized to control movement of the TCC REGULATOR VALVE for lockup/TCC apply. In Reverse, it is used to control the REVERSE LOCKOUT VALVE, for reverse lockout function. If this solenoid becomes restricted, oil pressure can build up enough to stroke the REVERSE LOCKOUT VALVE, inhibiting reverse from engaging by blocking oil pressure from going to the reverse clutch.

CORRECTION: Replace the TCC Pwm Solenoid and verify the Reverse Lockout valve is not stuck. Refer to Figures 3 and 4 for the location of the Solenoid and the Reverse Lockout Valve-train.

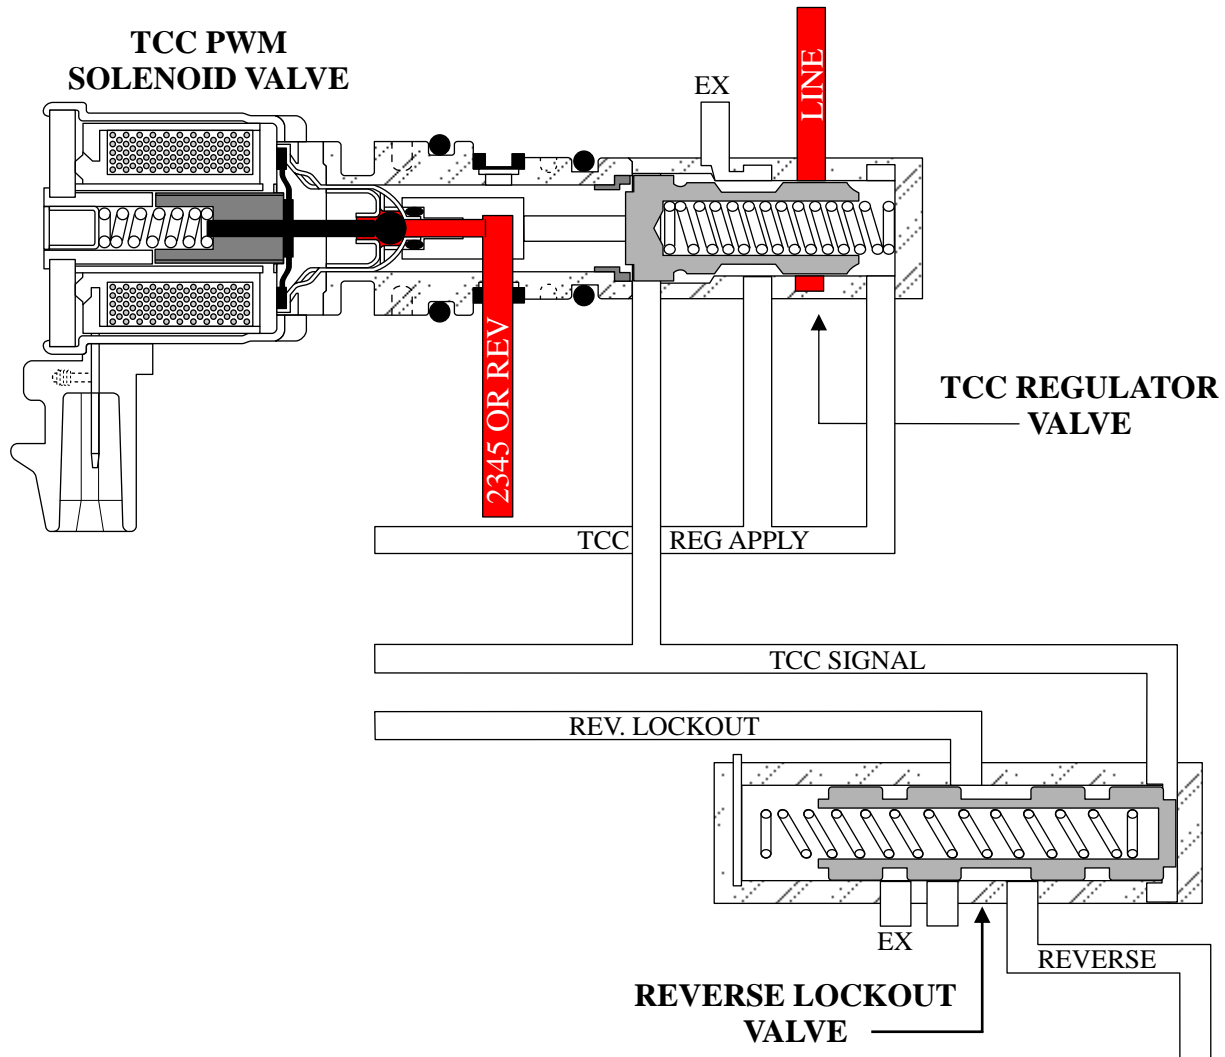
Figure 2

Summary: Reverse Lockout valve in the position to allow Reverse application

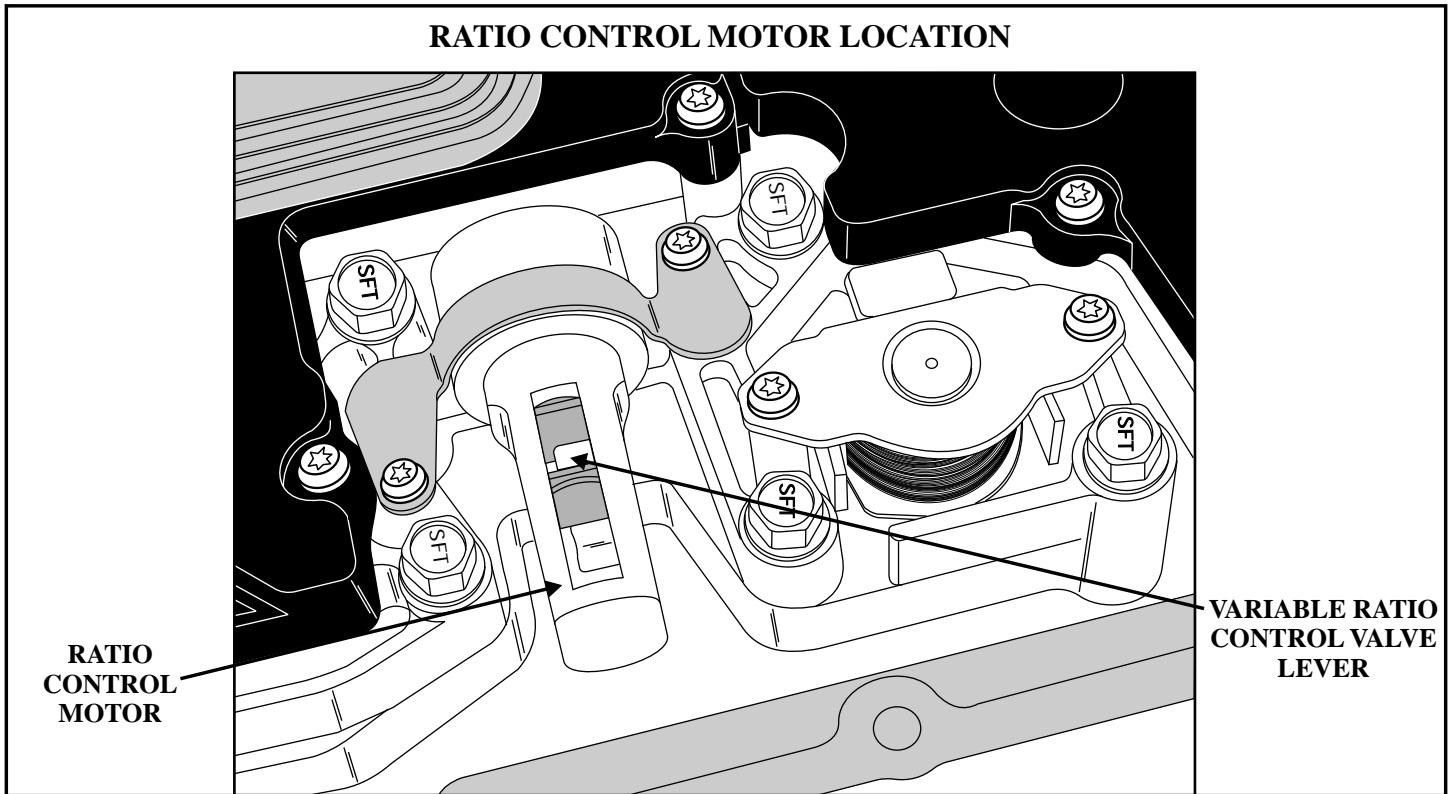
Figure 1

CAUSE: The Variable Control Valve lever has not been indexed correctly into the Drive Pulley Follower pocket, or the Ratio Control Motor lever has been wedged between the pintle and the housing.

This can easily be corrected as the valve body is on top of the transmission, just remove the valve body and index the lever into the pocket and re-fasten the valve body to case. Then re-install the Ratio Control Motor being careful that the lever sits inside the pintle pocket and not wedged between the pintle and housing.

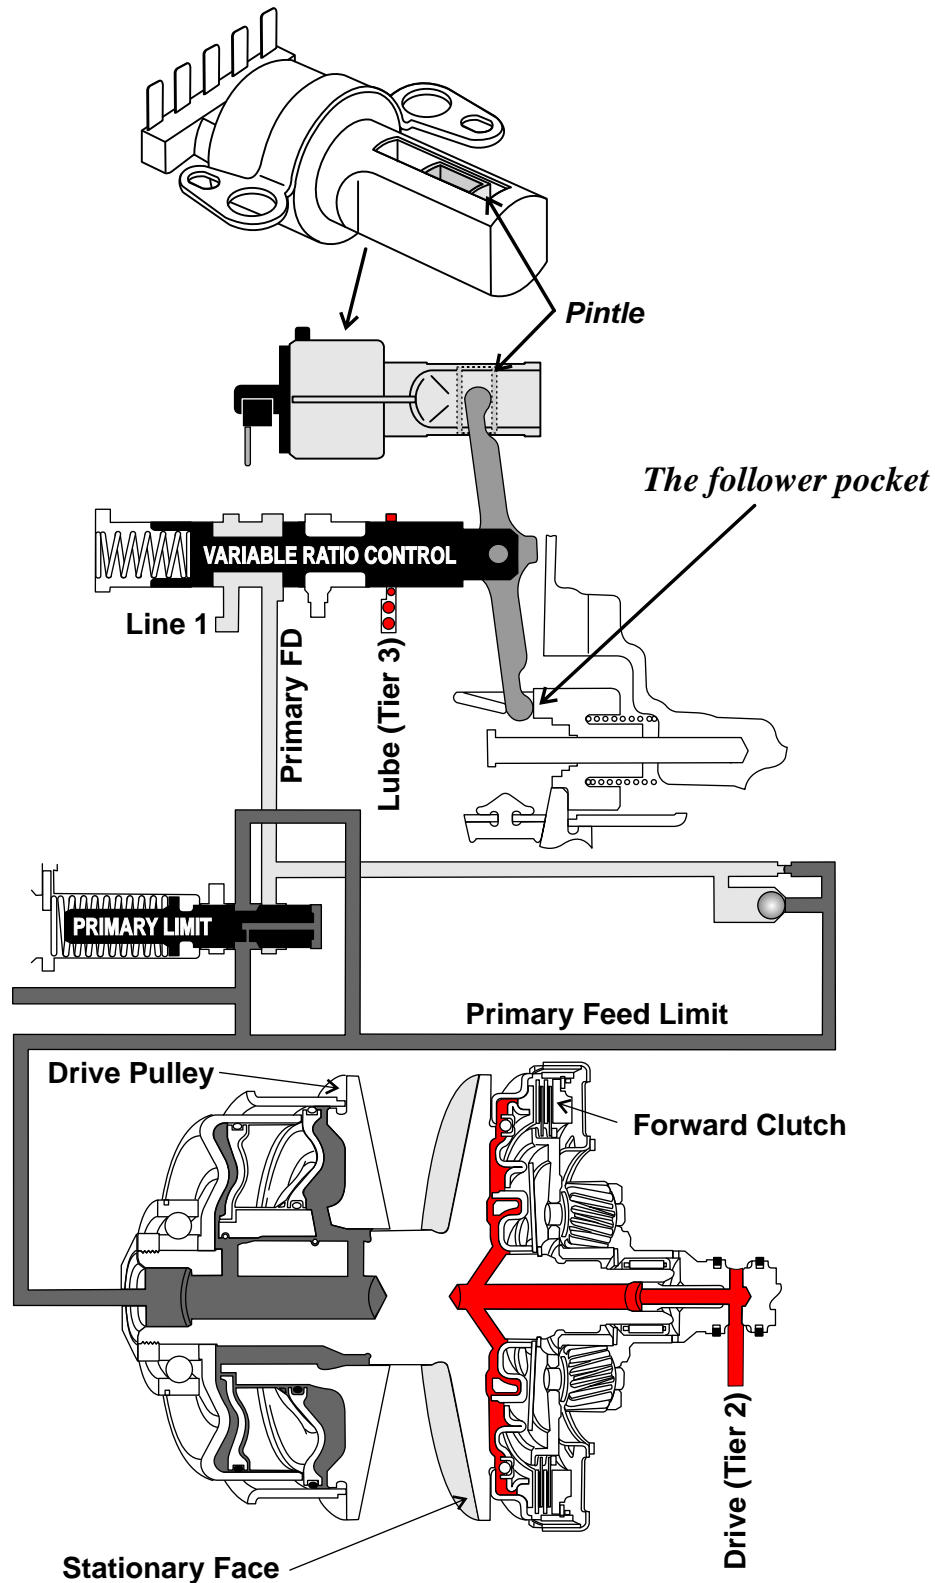
Figure 5

With one end of the lever being in the Ratio Control Motor and the other end being in the Drive Pulley Follower, (Refer to Figure 5), the follower acts as a movable pivot point for the lever. As a result of this action, it becomes a mechanical sensor influencing the variable ratio control valve tailoring the feed fluid into the drive pulley piston.

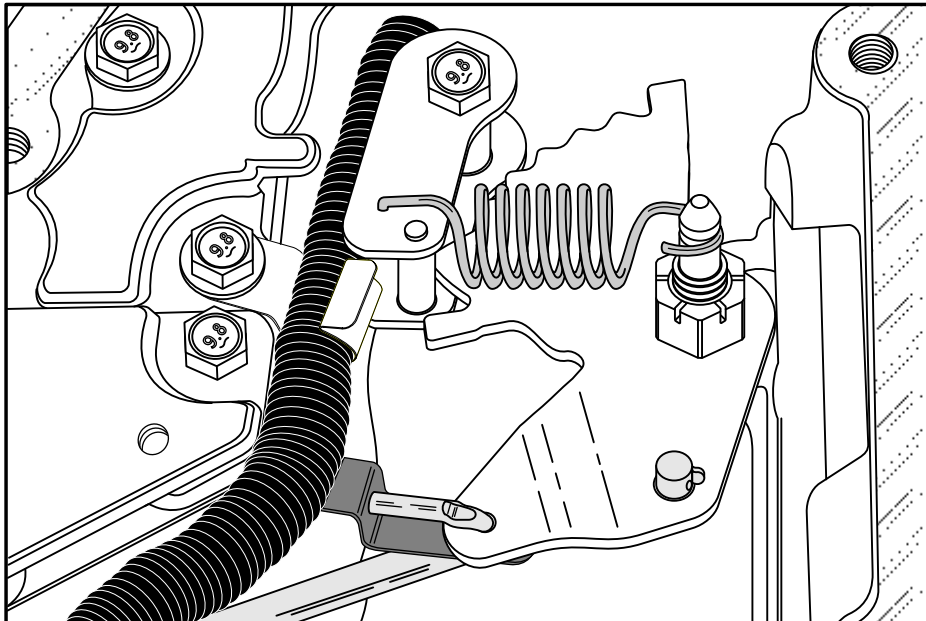
Figure 1

CAUSE: One cause may be the Manual Link and Clip Assembly installed incorrectly. If the Manual Link is installed incorrectly into the Detent Lever, it will throw off the manual valve position enough that line pressure at the manual valve will be blocked and not fill the Drive passage. Note: When in the wrong position, Park will be a little difficult to select but it will go.

INCORRECT INSTALLATION

Note the position of the detent lever in the illustration below. The detent lever (rooster comb) is not in proper alignment with the detent roller. Notice also the manual link and clip assembly is not properly aligned.

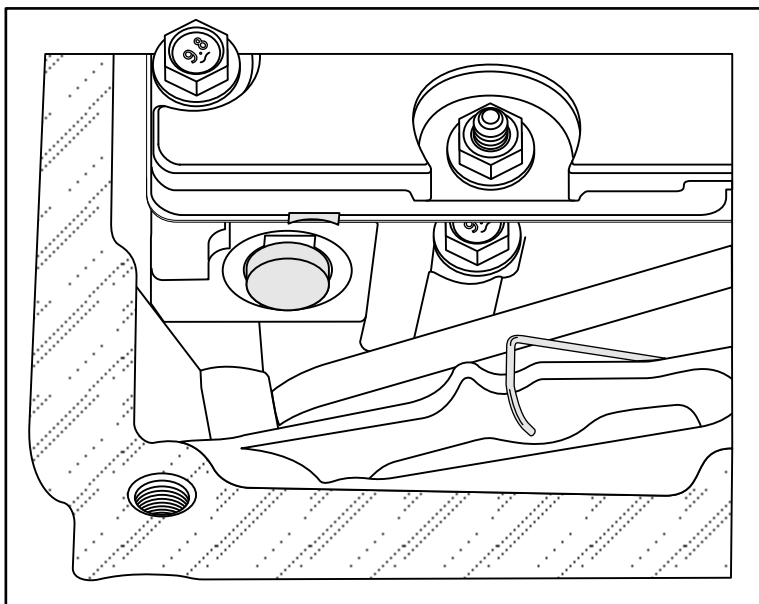
Figure 2

INCORRECT INSTALLATION

Notice the manual valve is extended and not flush with the edge of the bore in the illustration below. With the selector lever in Park, this indicates the manual valve is not correctly adjusted.

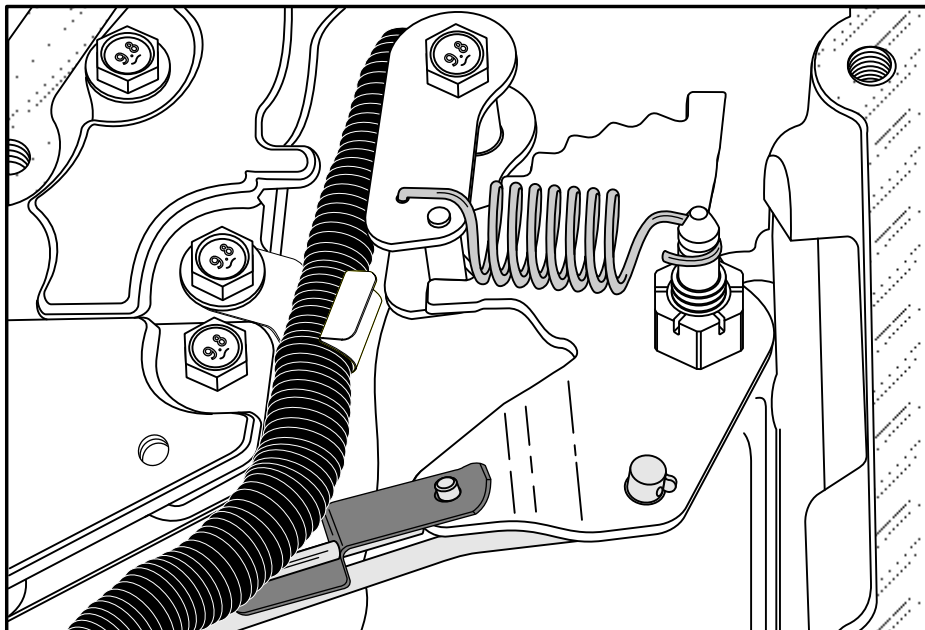
Figure 3

CORRECT INSTALLATION

Note the position of the detent lever in the illustration below. The detent lever (rooster comb) is properly aligned with the detent roller. Notice also the manual link and clip assembly is also properly aligned.

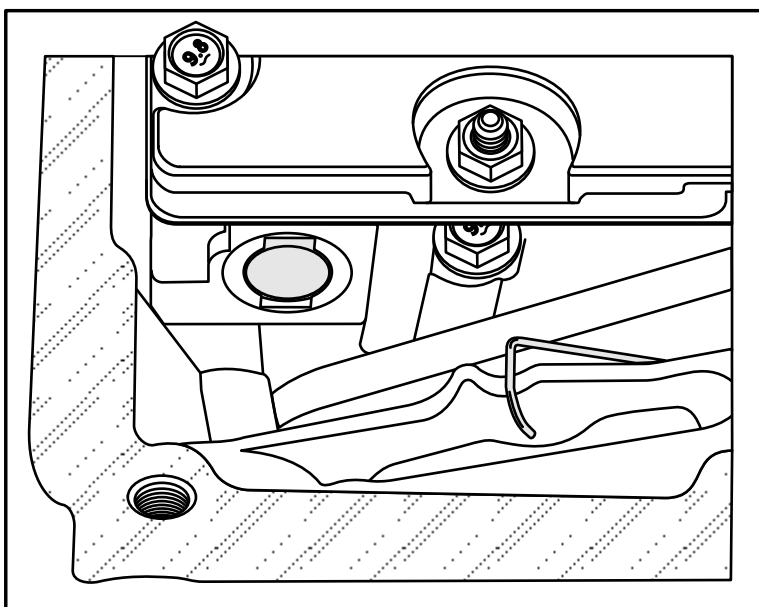
Figure 4

CORRECT INSTALLATION

Notice the manual valve is flush with the edge of the bore in the illustration below. With the selector lever in Park, this indicates the manual valve is correctly adjusted.

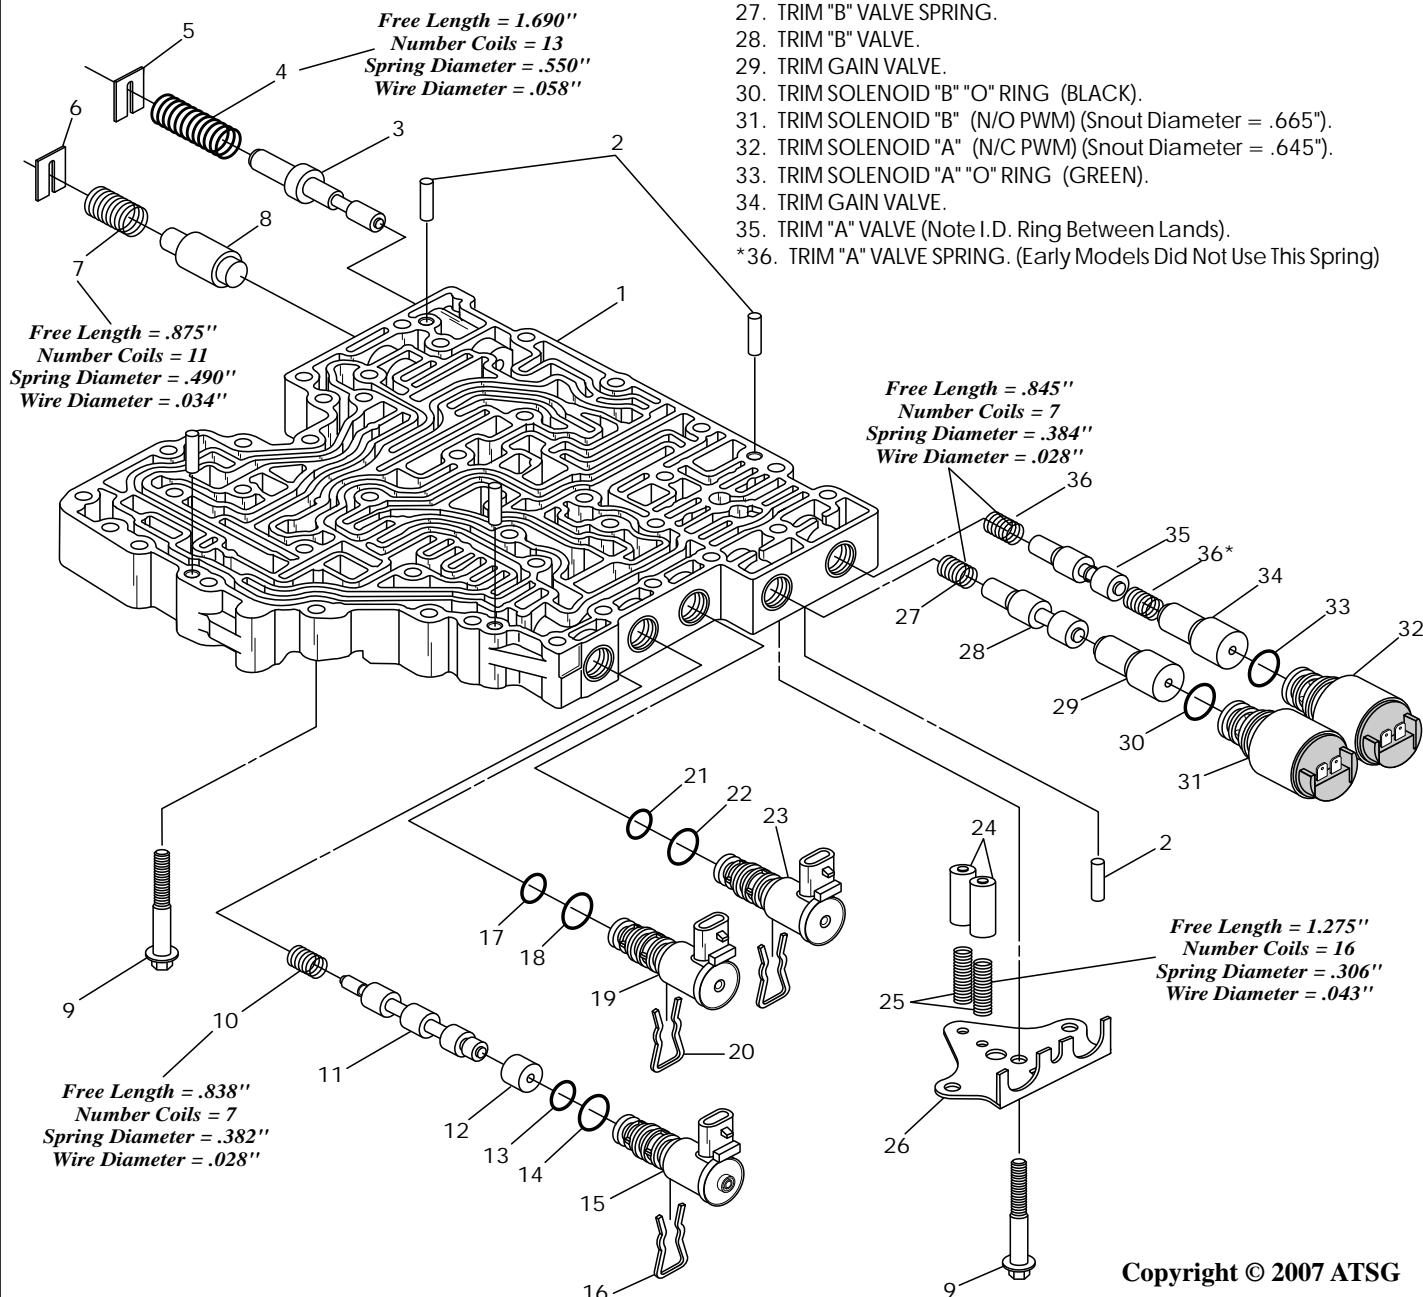
Figure 5

This means that there could be a mechanical problem with Shift Solenoid "E", Shift valve "E" is stuck or the "E" pressure switch is stuck closed. The same could be true with Shift Solenoids "C" and "D" as well as Shift Valves "C" and "D" when diagnosing other pressure switch codes. So, the way the diagnostic course goes is, shift solenoid controls shift valve and shift valve operates pressure switch, (Except Reverse). Refer to Figures 5 and 6 for solenoid and valve identification.

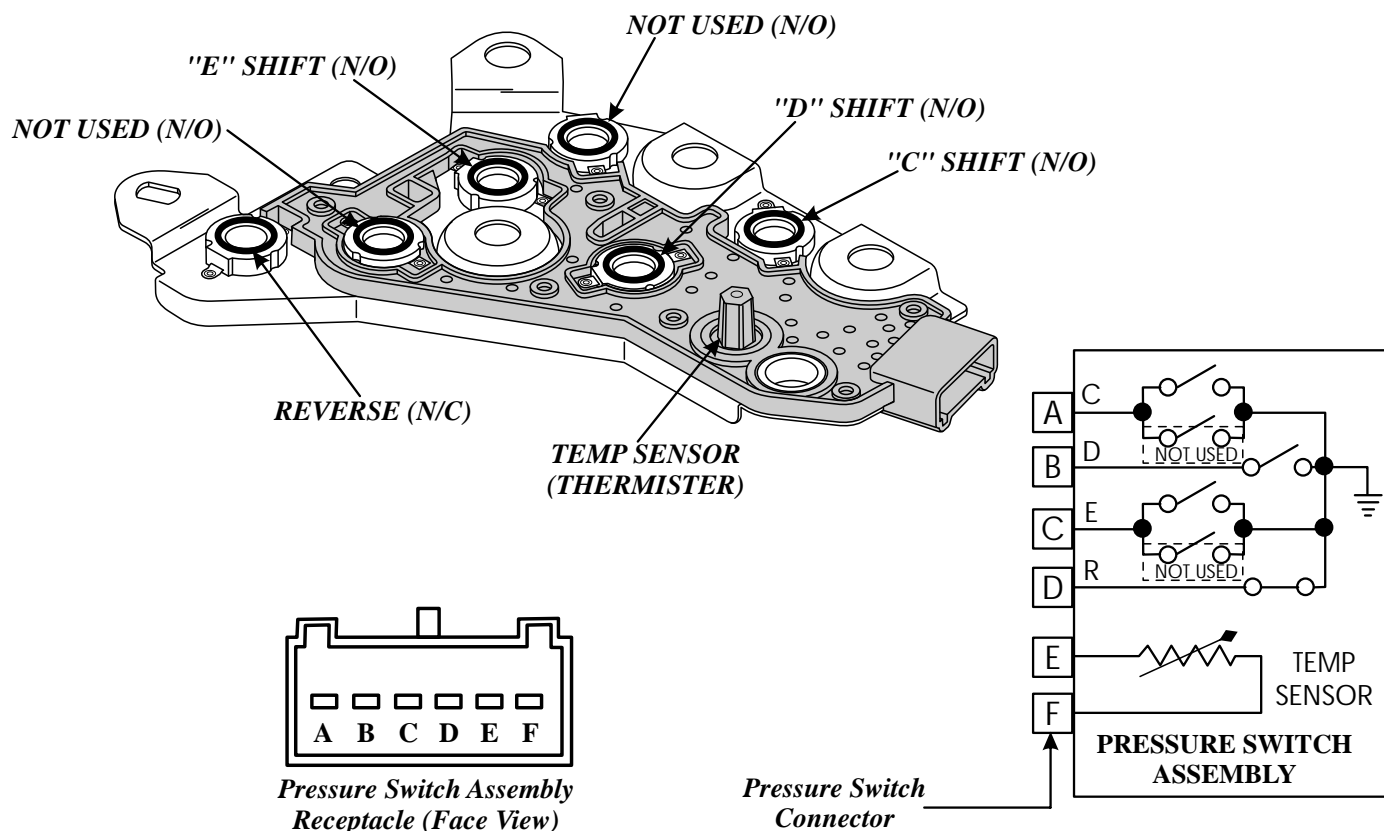
Figure 8

BENCH TESTING PRESSURE SWITCH ASSEMBLY

Since Shift Solenoids C, D and E are identical, one can be switched with the other to see if the solenoid is causing the pressure switch code. The shift valve is either stuck or not, and the pressure switch assembly can be checked for mechanical operation on the bench with an ohm meter connected to the switch terminals and physically pushing on the switch and releasing it while watching the meter to see if it changes from an open to a closed state, See Figure 8.

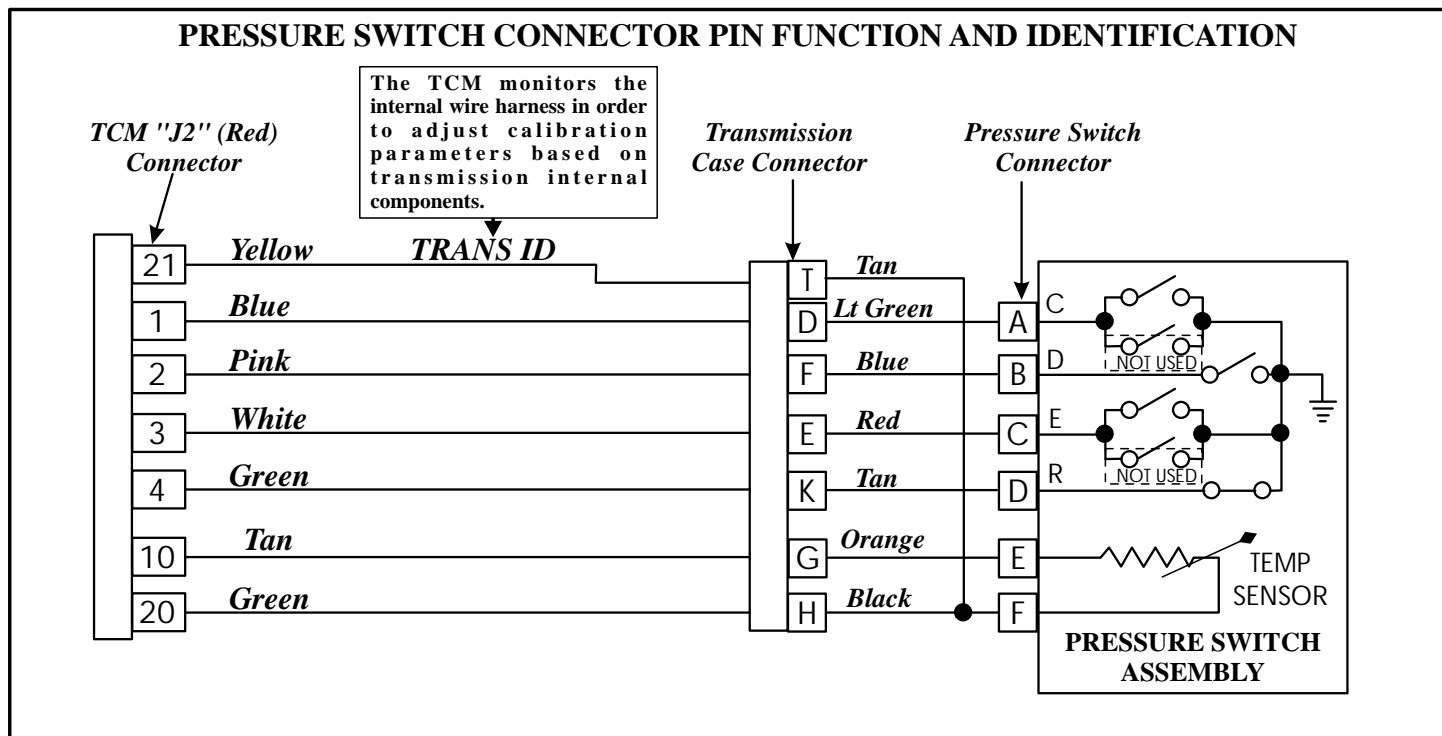
Figure 9

There is much confusion between wiring diagrams and scan tool parameter displays concerning the pressure switch identification. Referring to Figure 9, notice that the pressure switch electrical circuits are labeled A, B, C and D, but the pressure switch identification is Pressure Switch C, D, E and R. Be careful not to confuse this.

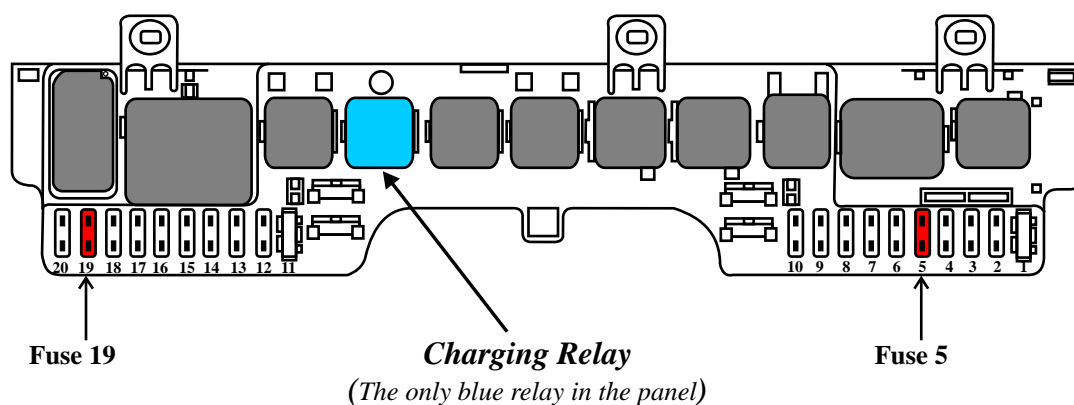
Figure 4

The coil in the relay was damaged and would not energize sufficiently to allow the internal relay contacts to pull together and supply power to fuse #19, (this may have been caused by the alternator going bad). Instead it remained grounded keeping the 4 warning lamps lit.

FUSE AND RELAY PANEL IS LOCATED BELOW THE GLOVE BOX

CORRECTION: When the charging relay acts as a ground, the alternator may be bad, the wire from terminal 1 at the alternator to terminal 4 of the charging relay is broken or the relay is malfunctioning. The relay will not interchange with any other relay in the underdash fuse box which is why it is the only BLUE colored relay in the panel as shown in Figure 4. Replace the relay or repair the broken wire.

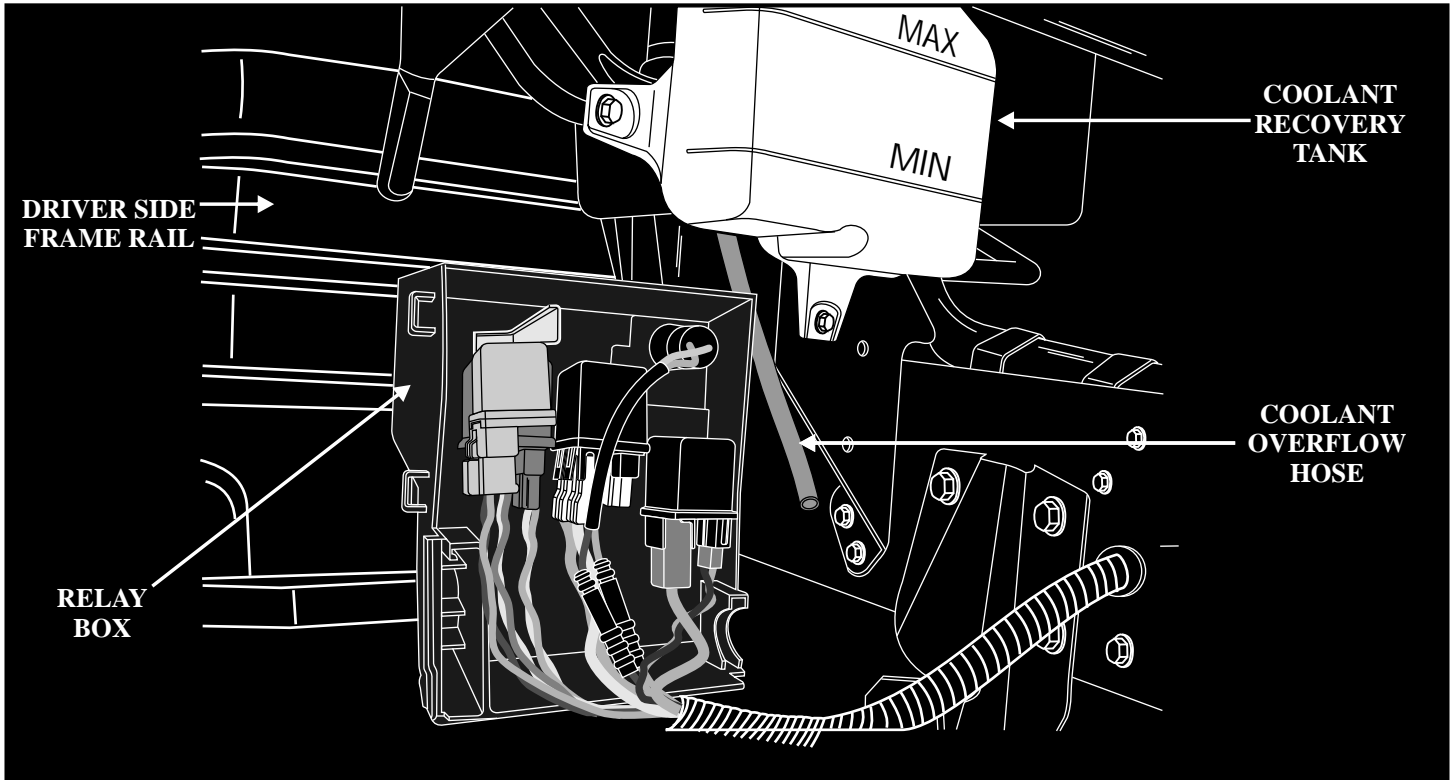
Figure 1

CAUSE: The coolant recovery tank is mounted on the frame rail over a relay junction box as shown in Figure 1. The relay box usually has a cover over it to protect it from the elements and other contamination. The cover has a bracket to hold the overflow hose in place. At some point in time the relay box cover is not re-installed or fell off allowing the overflowing coolant to blow into the open relay box.

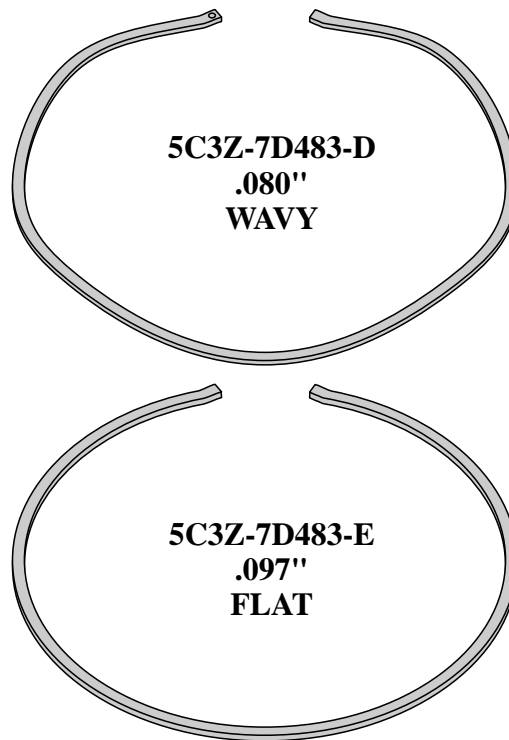
Figure 1

CHANGE: Sometime in the 2005 model year Ford Motor Company redesigned the Low/Reverse Clutch retaining snap ring for the Diesel and Gas applications replacing the two previous designs . There was a Ford Customer Satisfaction program, 05B27 Supplement #1 that ended in September of 2006 that would cover the replacement of this snap ring and or transmission case under warranty regardless of miles, on certain 2005 models. This new snap ring is a mandatory replacement and will back service all models.

REASON: The reason for this replacement was, "When the affected vehicles are used for snow plowing, it is common to shift between forward and reverse repeatedly, and at times, rapidly. Under this condition, the snap ring that retains the low/reverse clutch in the 5R110 Torqshift transmission may rotate out of position and become partially unseated from the transmission case splines, leading to either partial or complete loss of transmission reverse gear function. This program is being conducted to change the snap ring to a revised design to avoid this concern."

NEW DESIGN LOW REVERSE SNAP RING

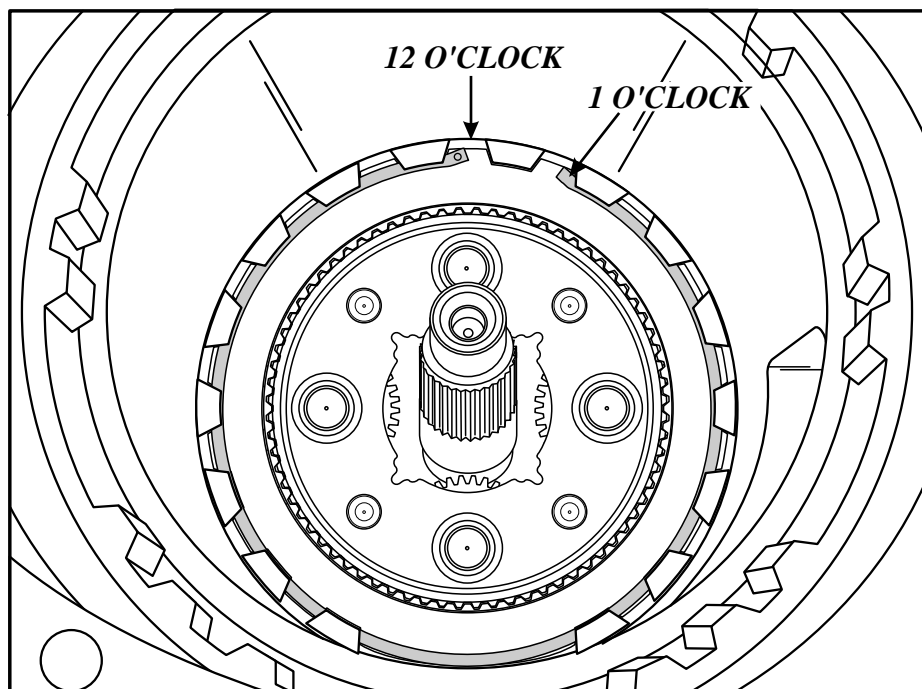
Figure 2

LOW REVERSE SNAP RING INSTALLATION

*Verify the left end of the snap ring is in the 12 o'clock position in the case
and the right end of the snap ring is in the 1 o'clock position* Copyright © 2007 ATSG

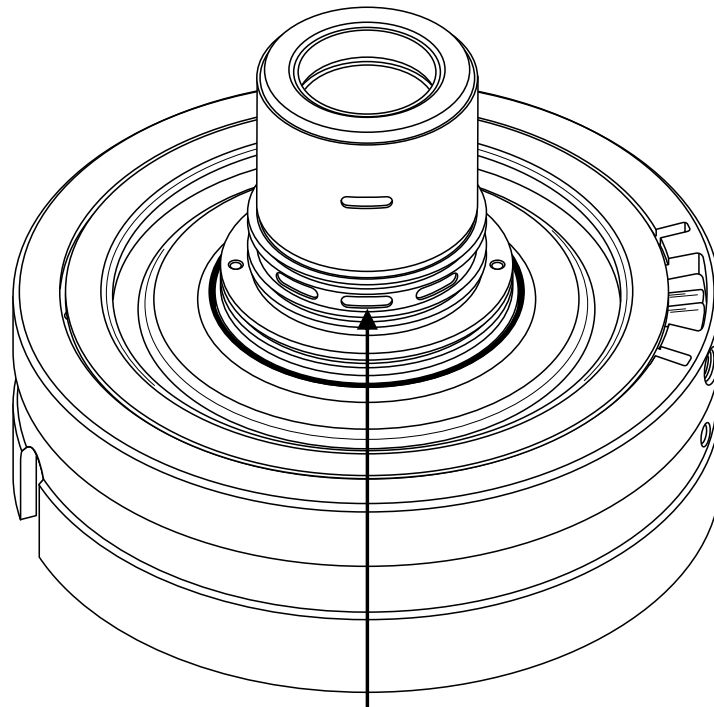
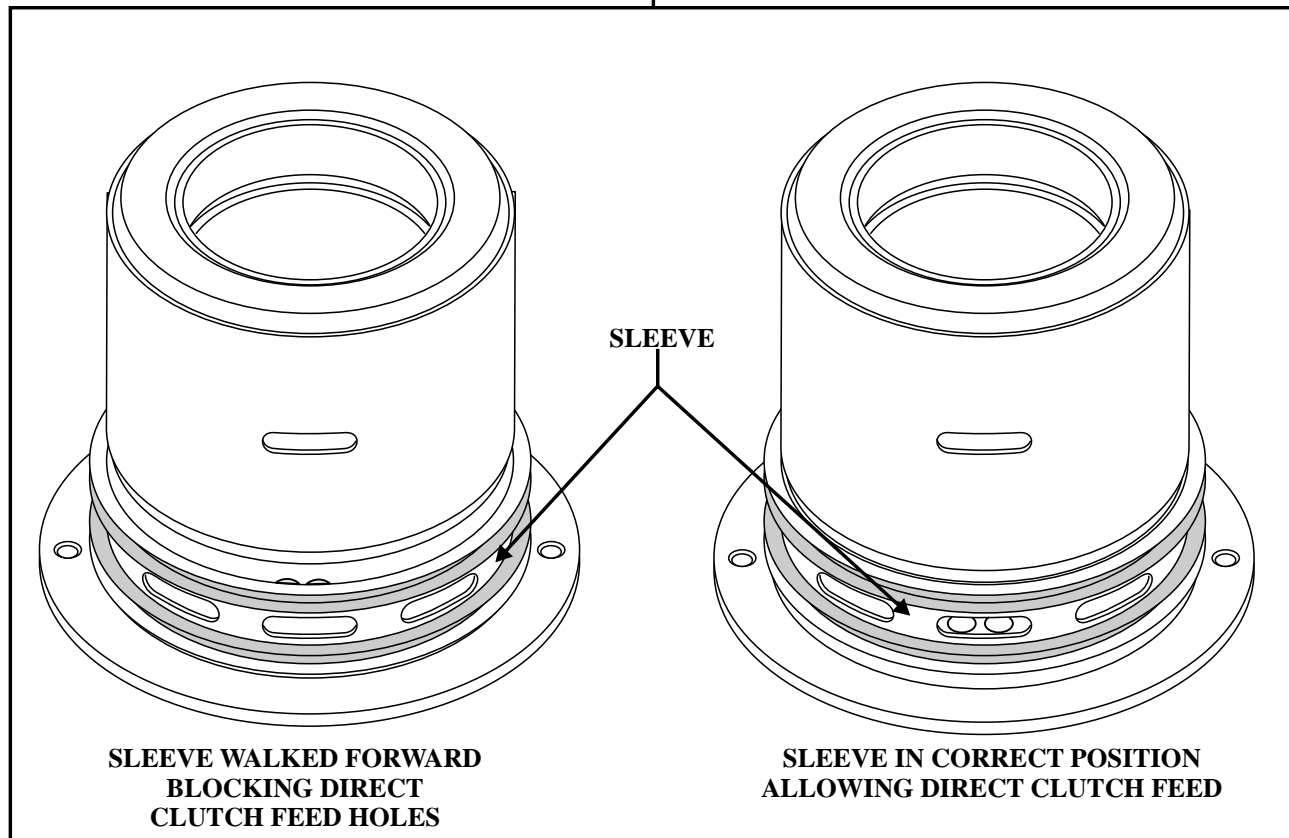
Figure 1

CAUSE: The cause of the complaint was the fact that the center support sleeve had walked forward out of position thereby blocking the direct clutch feed holes, Refer to Figure 1.
The loss of reverse is easily explained after inspection of the clutch application chart in Figure 2. The loss of fourth gear and the shift issues are not that easy, and here is why. The 5R110W is a six speed transmission. The shift strategy is such that it uses only five speeds at any given time. When the transmission is cold, (5° F or less), the transmission will shift 1-2-3-4-6, skipping fifth gear. When the transmission warms up, it will shift 1-2-3-5-6, skipping fourth gear.

LOSS OF REVERSE & SEVERAL FORWARD GEARS

5R110W CENTER SUPPORT

CORRECTION: Replacement of the center support corrected the complaint.

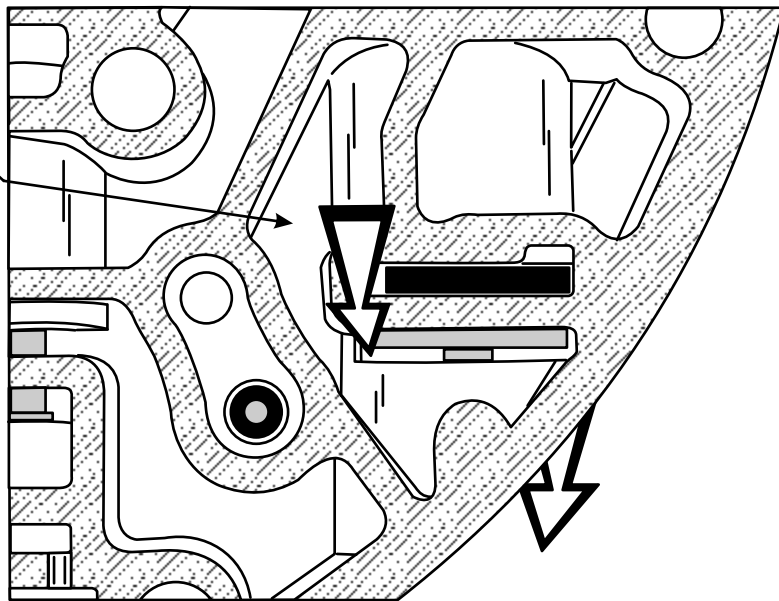
CAUSE: The cause may be, that during the Pump rebuild, the Torque Converter Control Valve sleeve was mis-assembled and pushed too far into the bore opening the CCL circuit, which is the regulated apply circuit for the Torque Converter Clutch, to an exhaust.

INCORRECT RETAINER LOCATION

CCL CIRCUIT

Summary: The CCL circuit, which is regulated Converter apply pressure, will be drained at the end of the Converter Control Valve sleeve

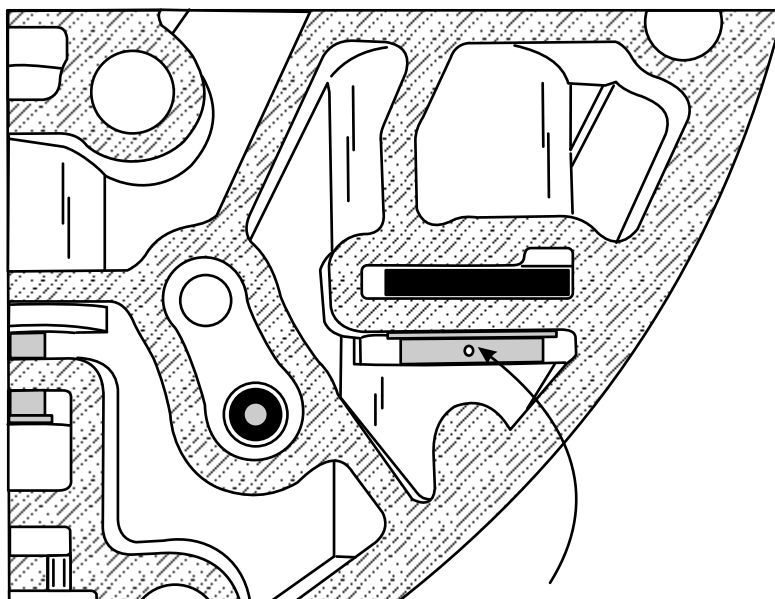
CORRECT RETAINER LOCATION

When the retainer is installed correctly, the feed holes in the Converter Control Valve sleeve can be seen

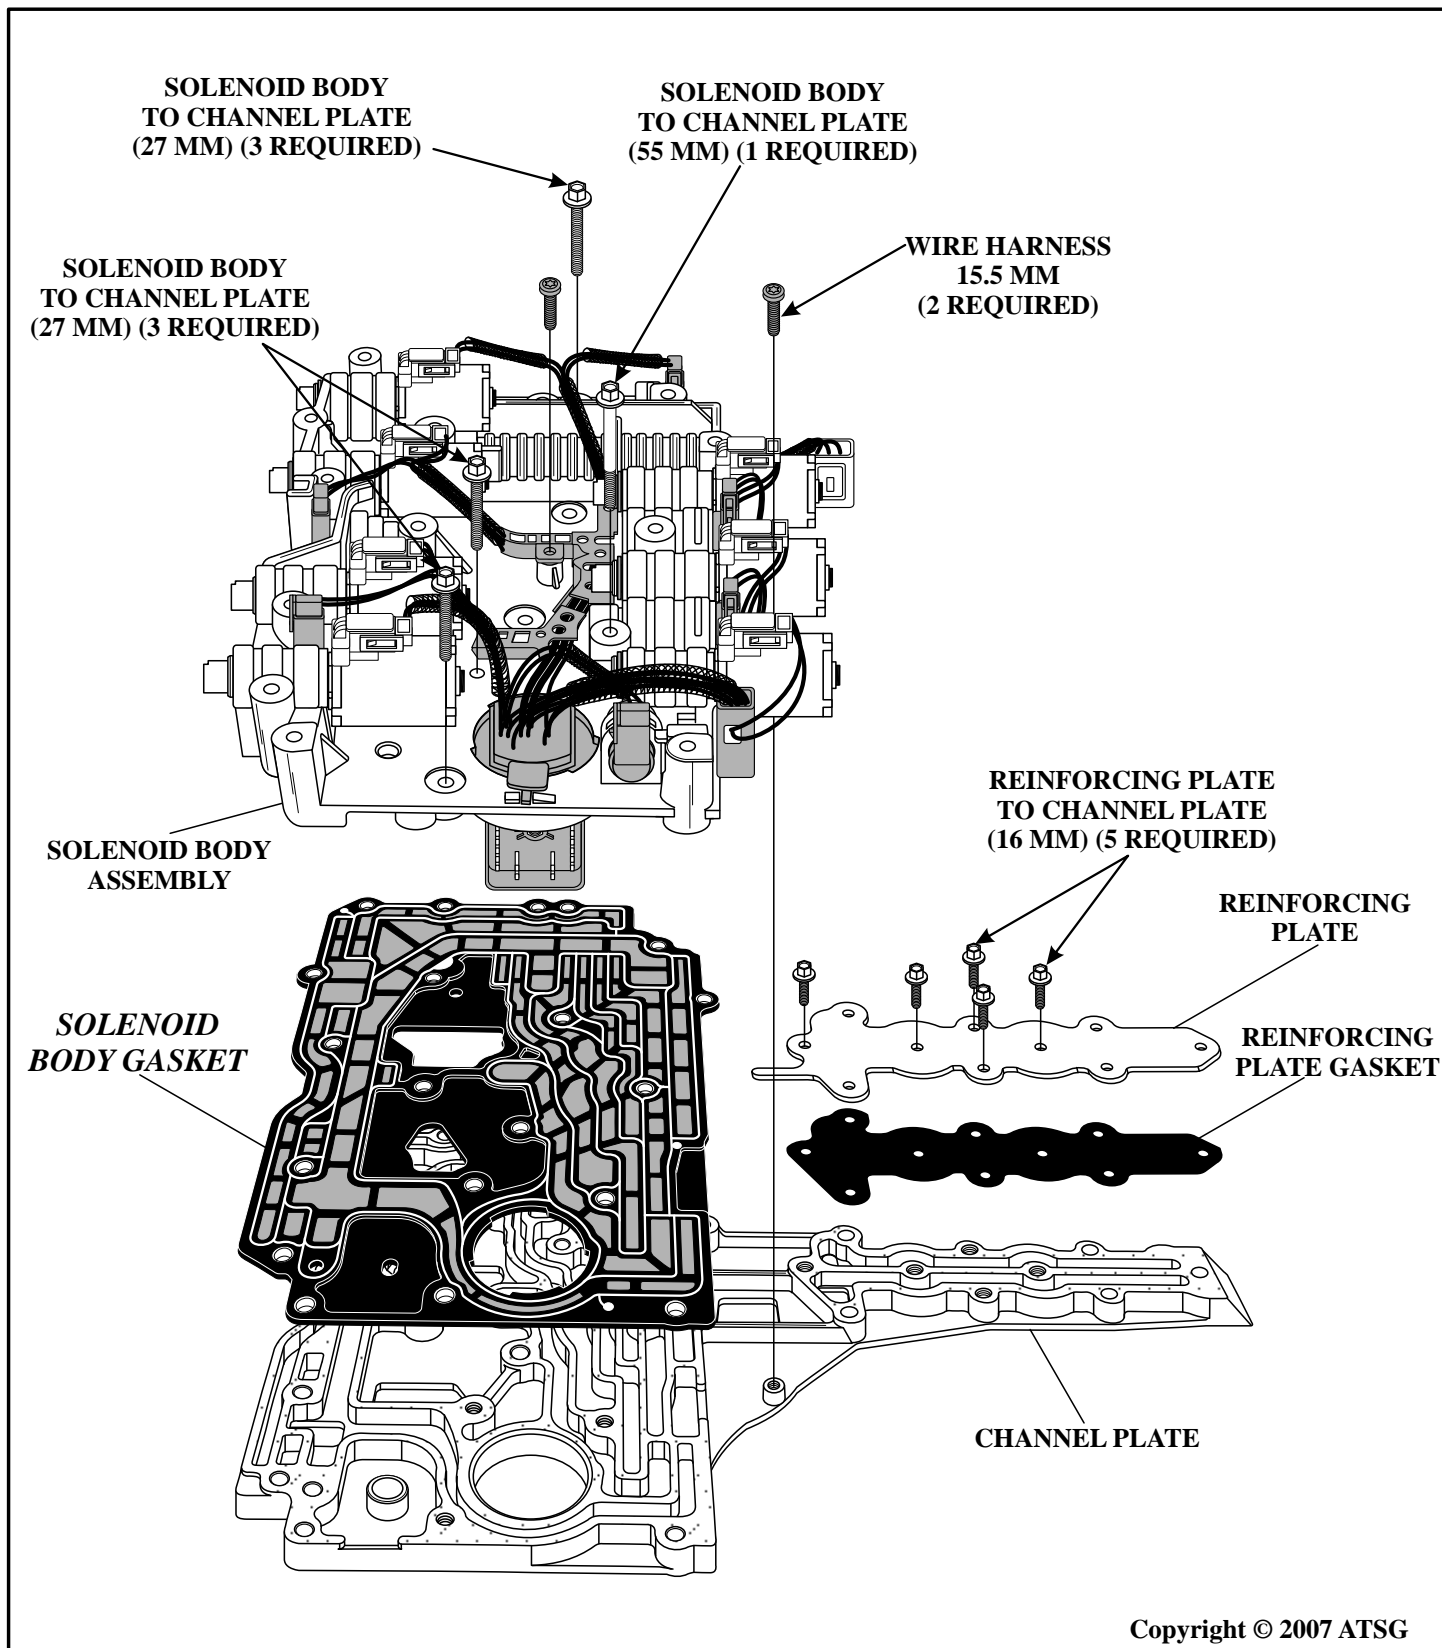
Figure 1

CAUSE: A small piece of metal debris from the original transmission damage has finally come loose from the cooler and lodged itself in the TCC feed hole of the solenoid body gasket, (Refer to Figures 1 & 2).

CORRECTION: Make certain the cooler has been thoroughly flushed and the in line filter, located in the cooler line manifold, has been changed. Be aware of additional oil to air coolers, if the transmission sustained severe damage, they may not flush satisfactorily and will require replacement.

NOTE: It is not recommended to reuse the solenoid gasket after washing it in solvent as we have had complaints of the rubber beading becoming deformed.

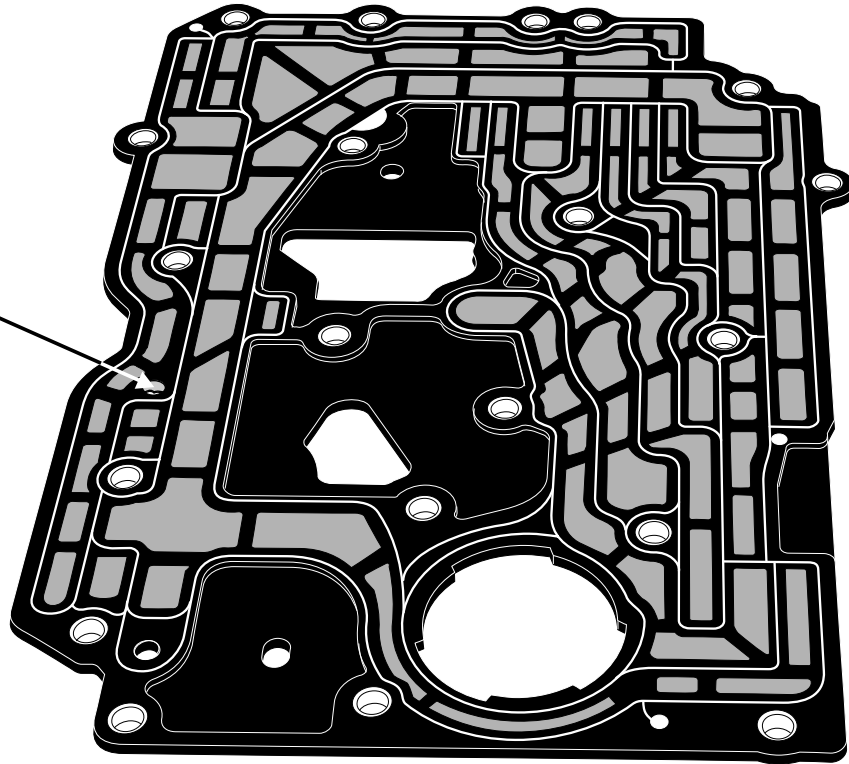
Figure 2

5R110W SOLENOID BODY GASKET

**PIECE OF METAL DEBRIS
LODGED IN TCC FEED HOLE**
