"2007" SEMINAR INFORMATION

GM & Ford

"Tech is Rev'n in 2007"

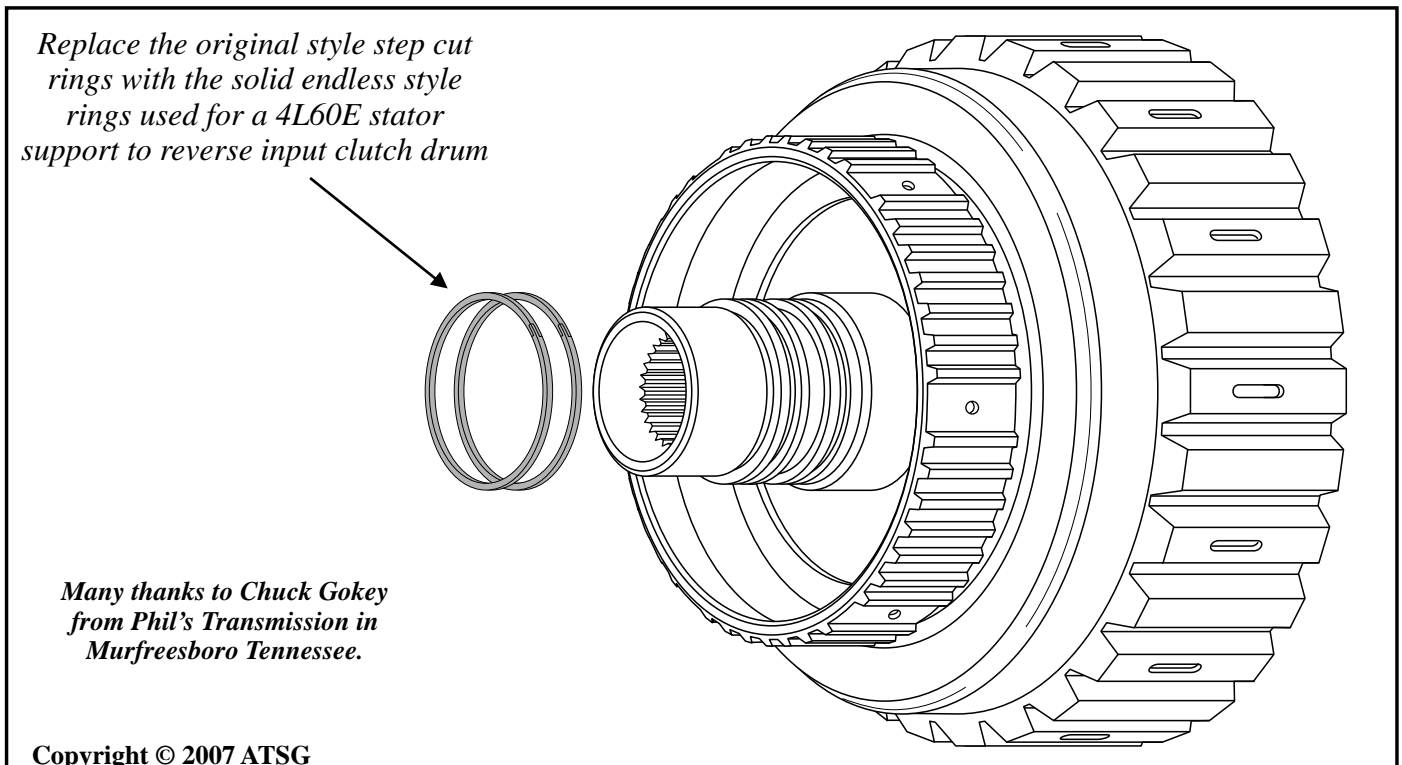
Figure 1

CAUSE: The cause may be a poor seal at the forward clutch sealing rings. (See figure 1)

CORRECTION: Check and verify that there are no line pressure and rise problems that may indicate a faulty pressure control solenoid, sticking PR valve, boost valve or faulty oil pump. Carefully inspect the forward clutch housing, piston and the seal ring area in the center support for any wear or damage and repair or replace as necessary. Place the completely assembled forward clutch housing into the center support and air check the forward clutch through the support to see if excessive leakage is revealed with the air check. If excessive leakage is detected, then the problem may be resolved by replacing the original step cut style sealing rings with a pair of solid endless style rings used for the stator support to reverse input clutch drum in a 4L60E transmission. The sizing tool for the 4L60E rings can also be used to ensure proper fit. After installing and sizing the new rings, check for a slight drag when installing the forward clutch housing into the center support and perform the air check again to see a noticeable difference.

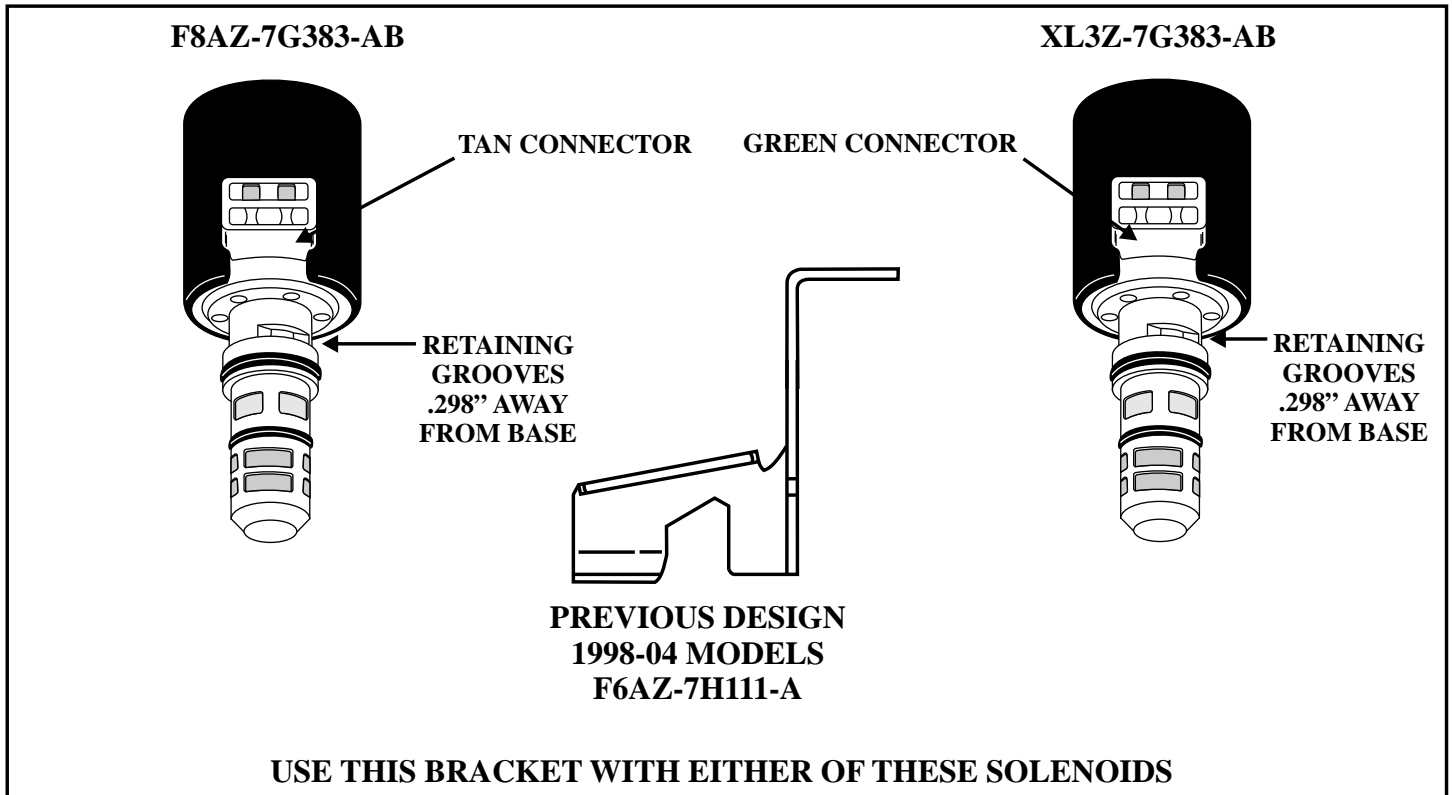
Figure 1

CAUSE: The incorrect EPC solenoid was installed. It did not match the solenoid retaining bracket.

EPC SOLENOID & BRACKET IDENTIFICATION

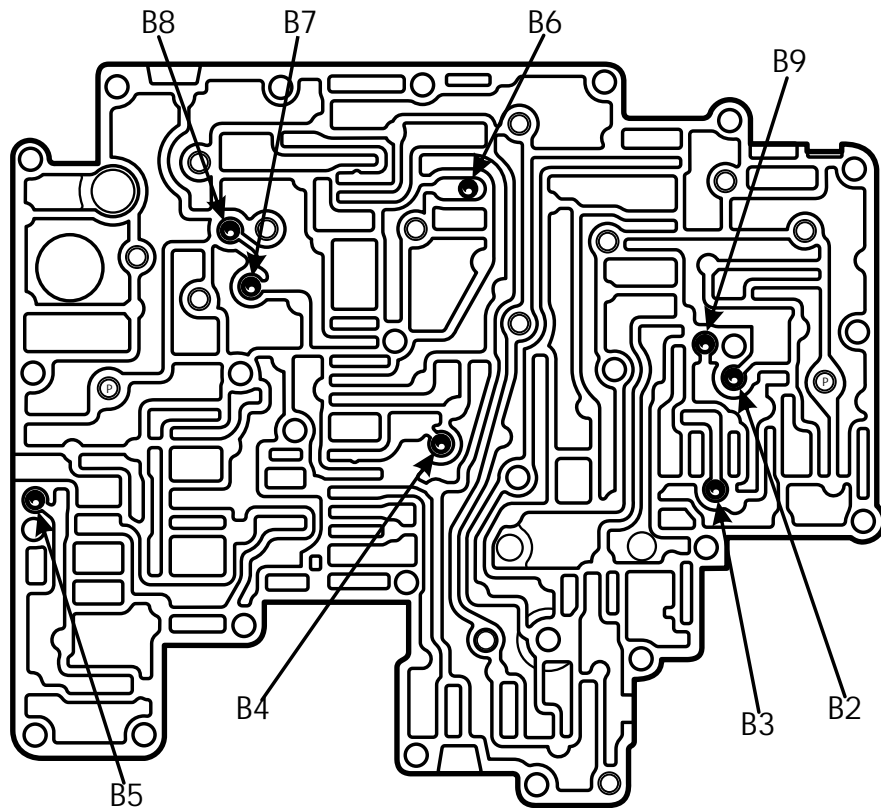
Figure 1

CAUSE: The #7 check ball in the valve body, (Refer to Figure 1), has become too small and is allowing line pressure from the 2-3 shift valve to stroke the Bypass Clutch Control Valve which will apply the converter clutch as soon as a 1-2 shift occurs as shown in the hydraulic diagram in Figure 2. The hydraulic diagram in Figure 3 illustrates how the TCC circuit should operate when the #7 check ball is the correct size.

4R70W/4R70/75E CHECKBALL LOCATIONS

CORRECTION: Although this bulletin refers to specific years and models, any 4R70W, 4R70/75E in any vehicle would have the same complaint should the #7 check ball become too small. Replacement of the #7 check ball will remove the complaint and restore TCC to computer control strategies.

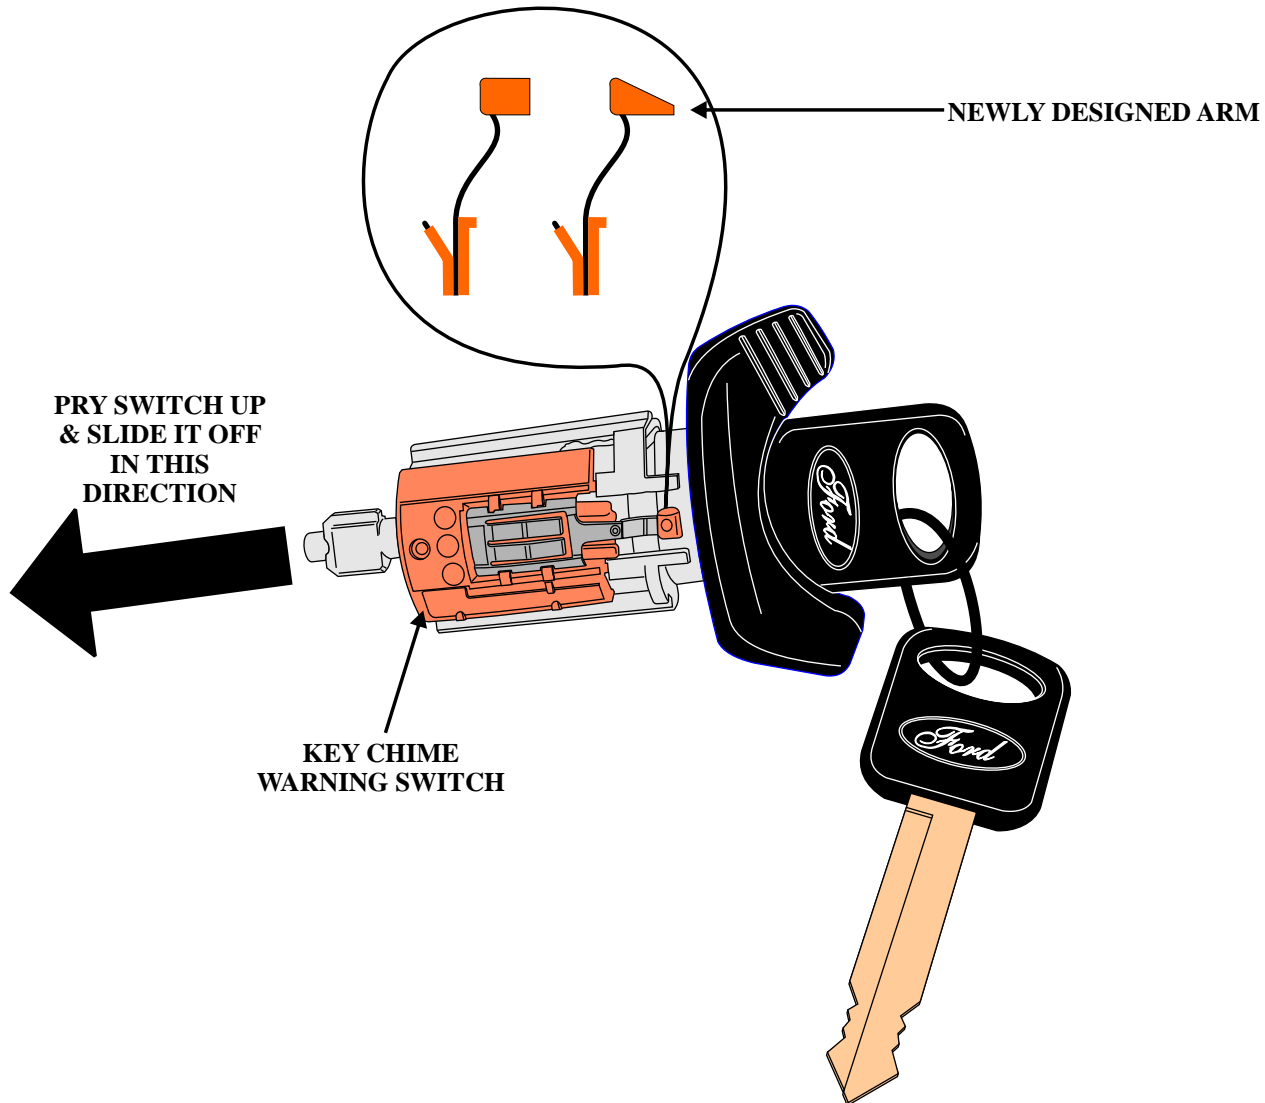
Figure 1

CAUSE: The cause is the "Key-In-Ignition" Warning Chime Switch, located on the key cylinder, (Refer to Figure 1). The contact arm of the chime switch (See Figure 1) gets caught in the Key cylinder causing the above complaints. The newly designed chime switch now has a tapered contact arm (See Figure 1) to prevent this from happening.

KEY-IN-IGNITION WARNING CHIME
