"The Seminar to See for 2003" Technical Seminar

INDEX *Imports*

AUTOMATIC TRANSMISSION SERVICE GROUP

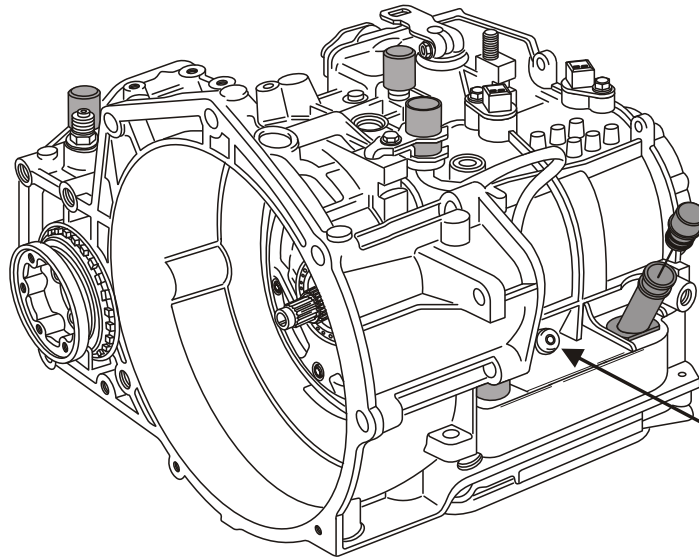
- COMPLAINT:** The vehicle comes into shop with a complaint of a harsh 1-2 upshift at all times. Other shifts may also be affected.
- CAUSE:** The TCMs in these vehicles have many problems. One of them is the task of energizing Solenoid "E" or EV5 which is momentarily turned on to cushion the 1-2 shift. When the transmission is ready to make the 1-2 up shift, line pressure on throttle up rises to approximately 160 psi and then, drops back down to approximately 65 -70 when the 1-2 shift is going to take place. If the computer fails to energize the EV5 Solenoid to drop the pressure, the result will be, a harsh 1-2 up shift.

**65 PSI DURING
THE 1-2 SHIFT**

**160-170 PSI
IN GEAR**

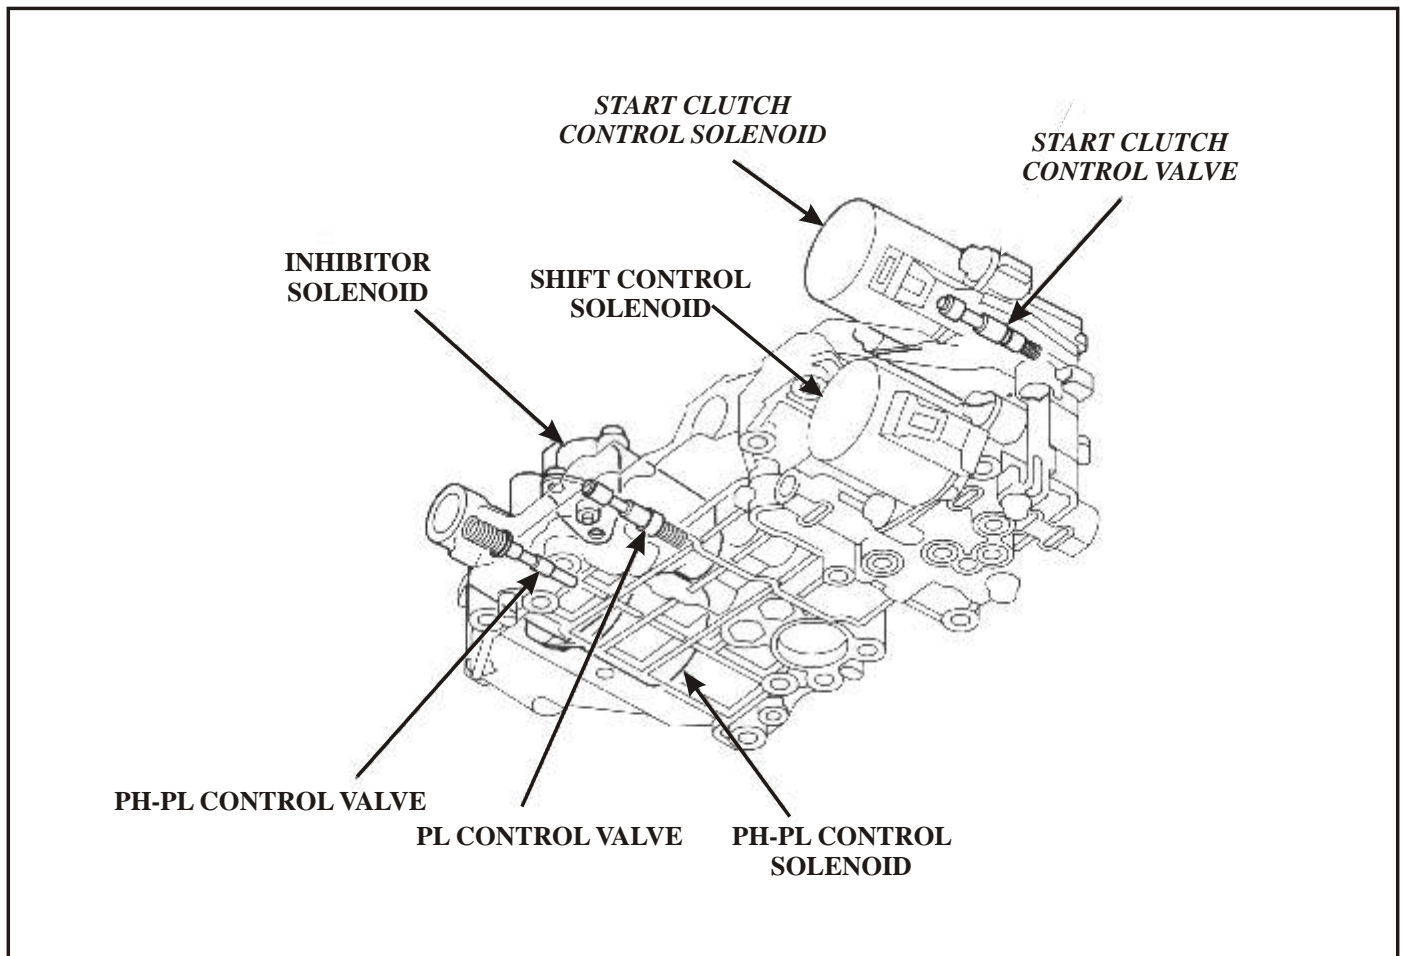
Figure 1

CAUSE: Some of the common causes which produces this complaint would be:

1. A mechanically failed Start Clutch Solenoid (Figure 1).
2. Sticking Start Clutch Control Valve (Figure 1).
3. A leak in the Start Clutch Drum circuit (Figure 2).
4. A cracked Drive Pulley (Figure 2).
5. A stretched Steel Belt slipping in the pulleys (Figure 2).

**HONDA CIVIC HX
DELAYED BANG ENGAGEMENT**

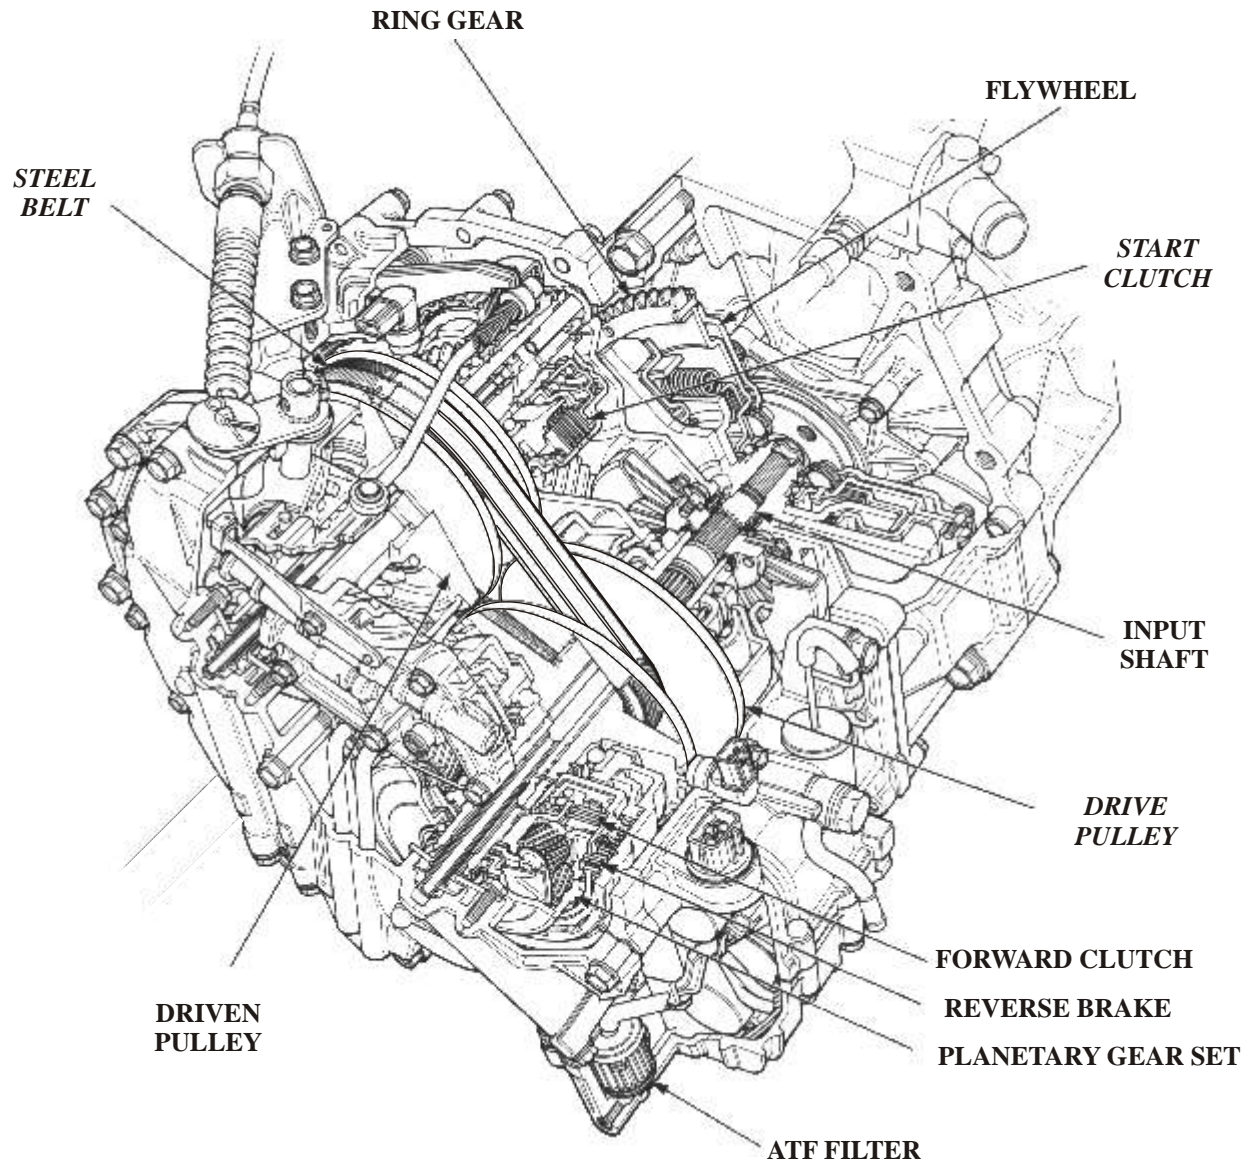
Figure 2

Pulleys are known to crack causing a loss of squeeze pressure on the belts. Figure 3 illustrates the remaining pressure tap locations with pressure specifications in the chart shown in Figure 3. Pressure check both the Drive and Driven Pulleys. If one or both are low, an internal inspection will be needed. Many times the cracks in the pulleys can be seen. If the pressures are within specification, chances are the Steel Belt has stretched and will need to be replaced.

**HONDA CIVIC HX
DELAYED BANG ENGAGEMENT**

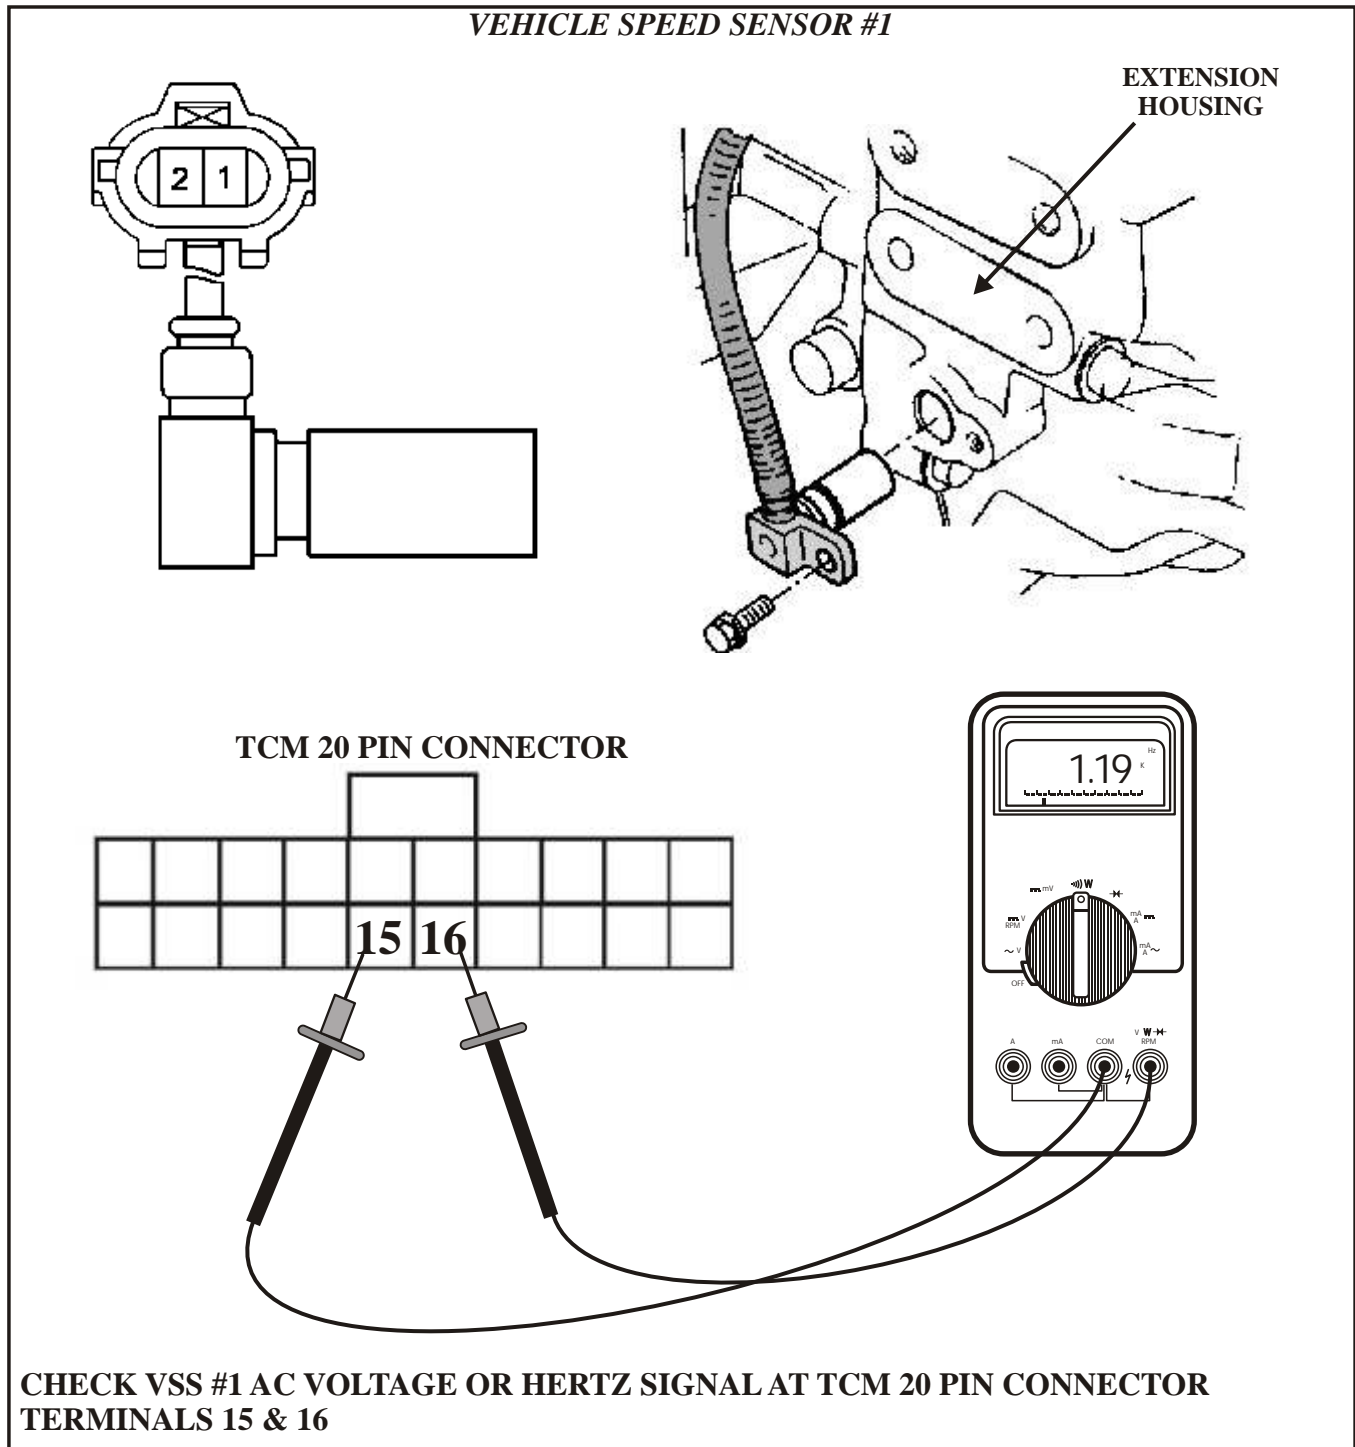
Figure 1

CAUSE: Vehicle Speed Sensor #1 shown in figure 1, which is located in the extension housing and excited by the park gear is responsible for the stacked shift complaint. The problem is, the speed sensor checked good, but is faulty.
Rather than just buy a speed sensor, there is a way to verify the VSS #1 fault.

ISUZU NPR/GMC FORWARD TILTMASTER STACKED SHIFTS

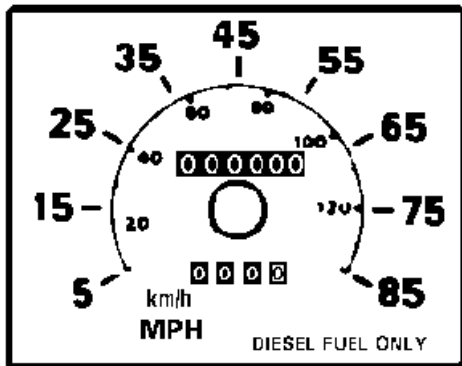
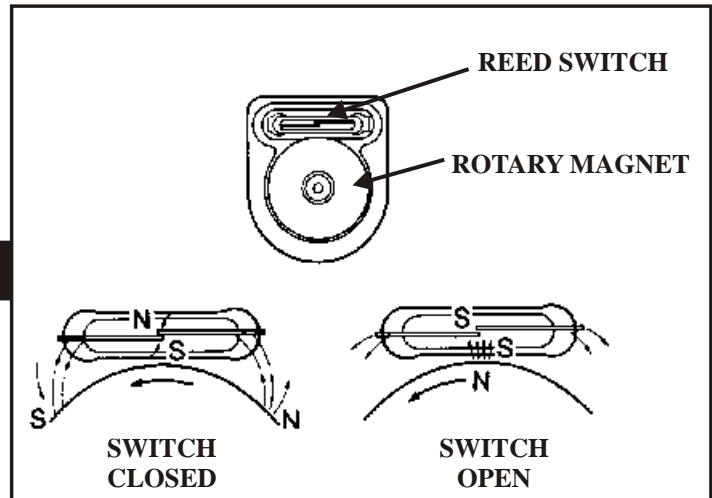
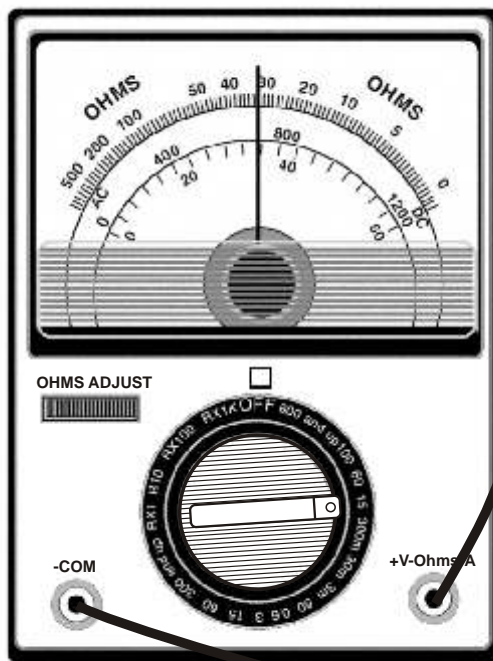
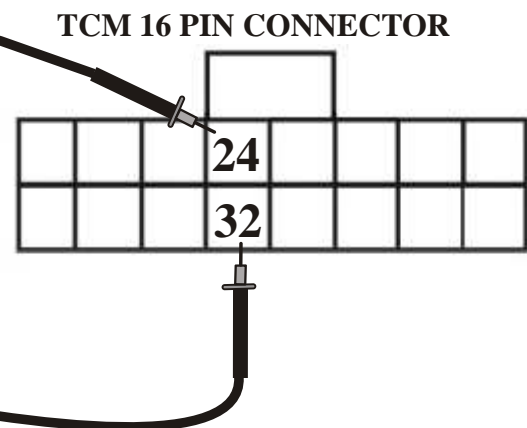
Figure 2

VEHICLE SPEED SENSOR #2 IN SPEEDOMETER HEAD (1988-94)

CHECK VSS #2 0-5 VOLT PULSED
SIGNAL AT TCM 16 PIN CONNECTOR
TERMINALS 24 & 32

CORRECTION: These vehicles also have a #2 Speed Sensor which is located in the instrument cluster (Refer to figure 2) on 1988-1995 models, or a gear driven speed sensor located in the extension housing (Refer to figure 3) on 1995½-1998 models.
The #2 VSS will take over the function of the #1 VSS should it fail.
Therefore, all one needs to do is disconnect the #1 VSS and let the #2 VSS take over.
Now, if the transmission shift timing is correct, you have verified that VSS #1 is causing the stacked shift complaint.

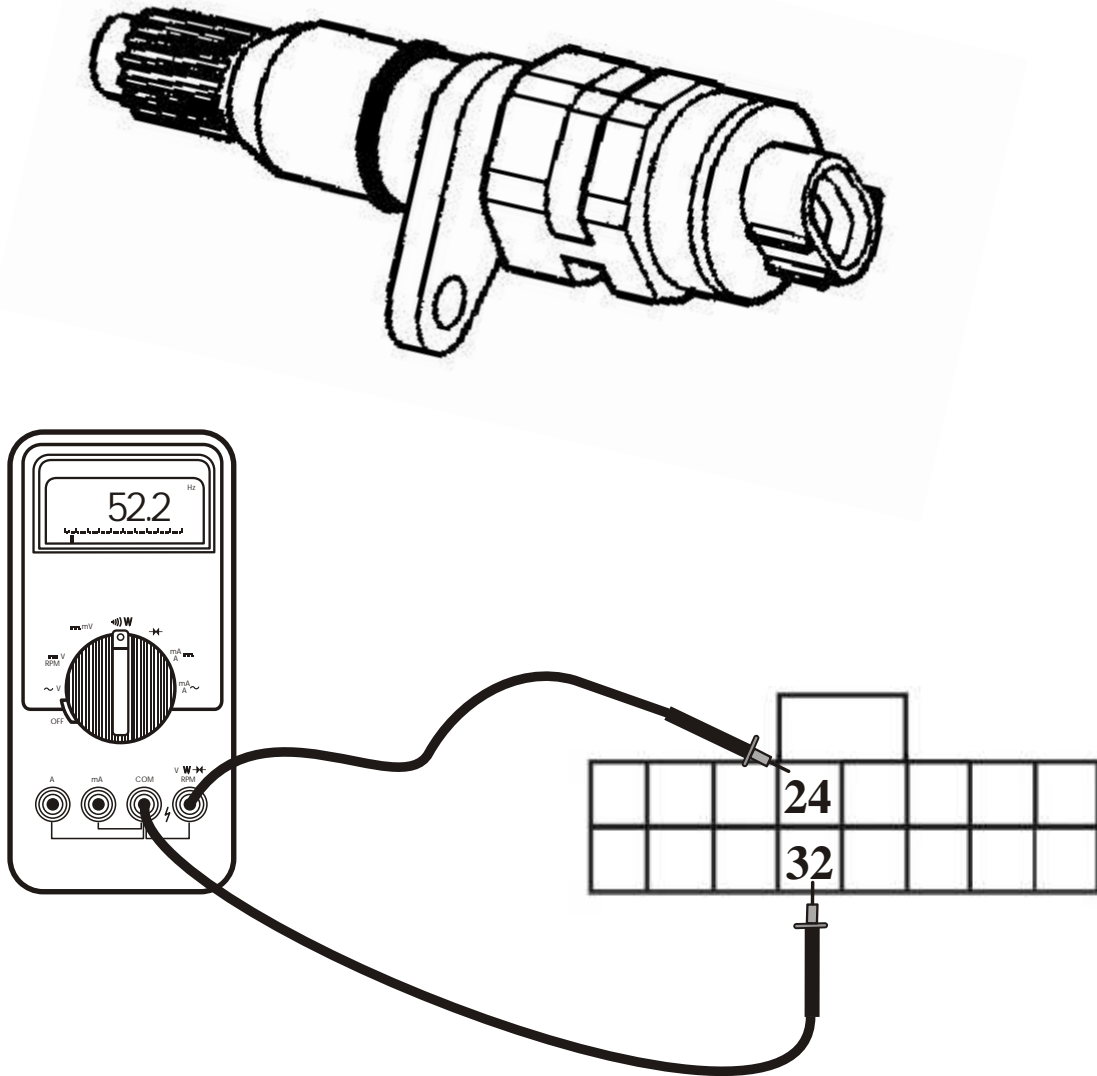
Figure 3

VEHICLE SPEED SENSOR #2 IN TRANSMISSION (1995½ - 1998)

**CHECK VSS #2 AC VOLTAGE OR HERTZ SIGNAL AT TCM 20 PIN CONNECTOR
TERMINALS 24 & 32**

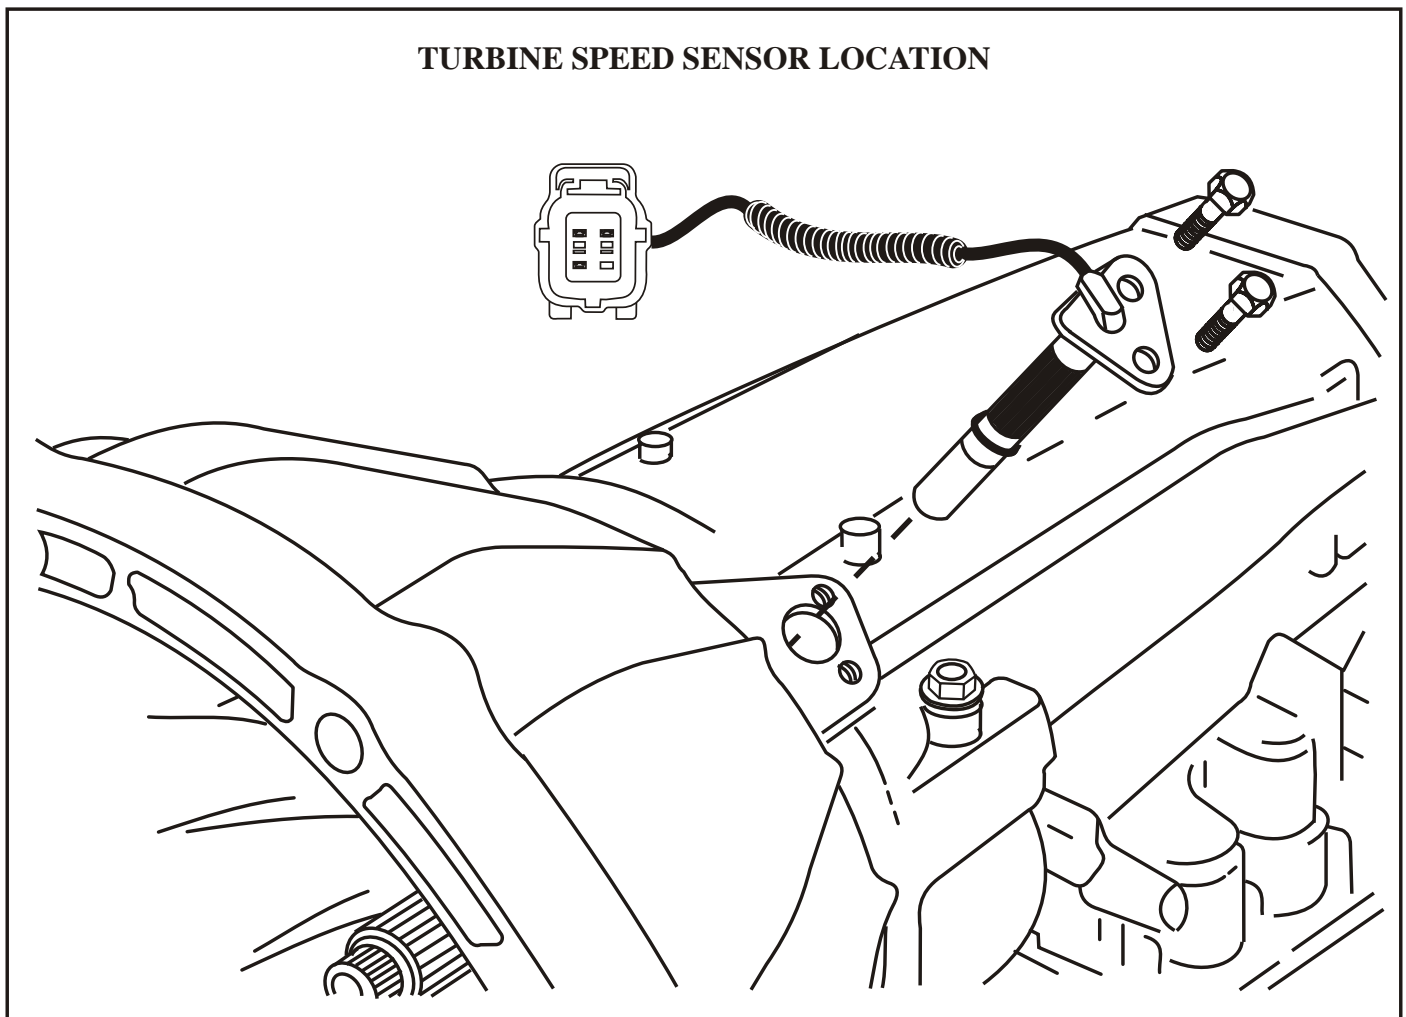
COMPLAINT: During the removal of the transmission, it is not uncommon to get the Turbine Shaft Speed Sensor wiring harness tangled and snagged where the wires are pulled out of the connector (See Figure 1 for sensor location). When the technician attempts to repair the wiring, it is noticed that the wire colors on the sensor side of the connector do not match to that on the main harness connector making the proper connection unknown.

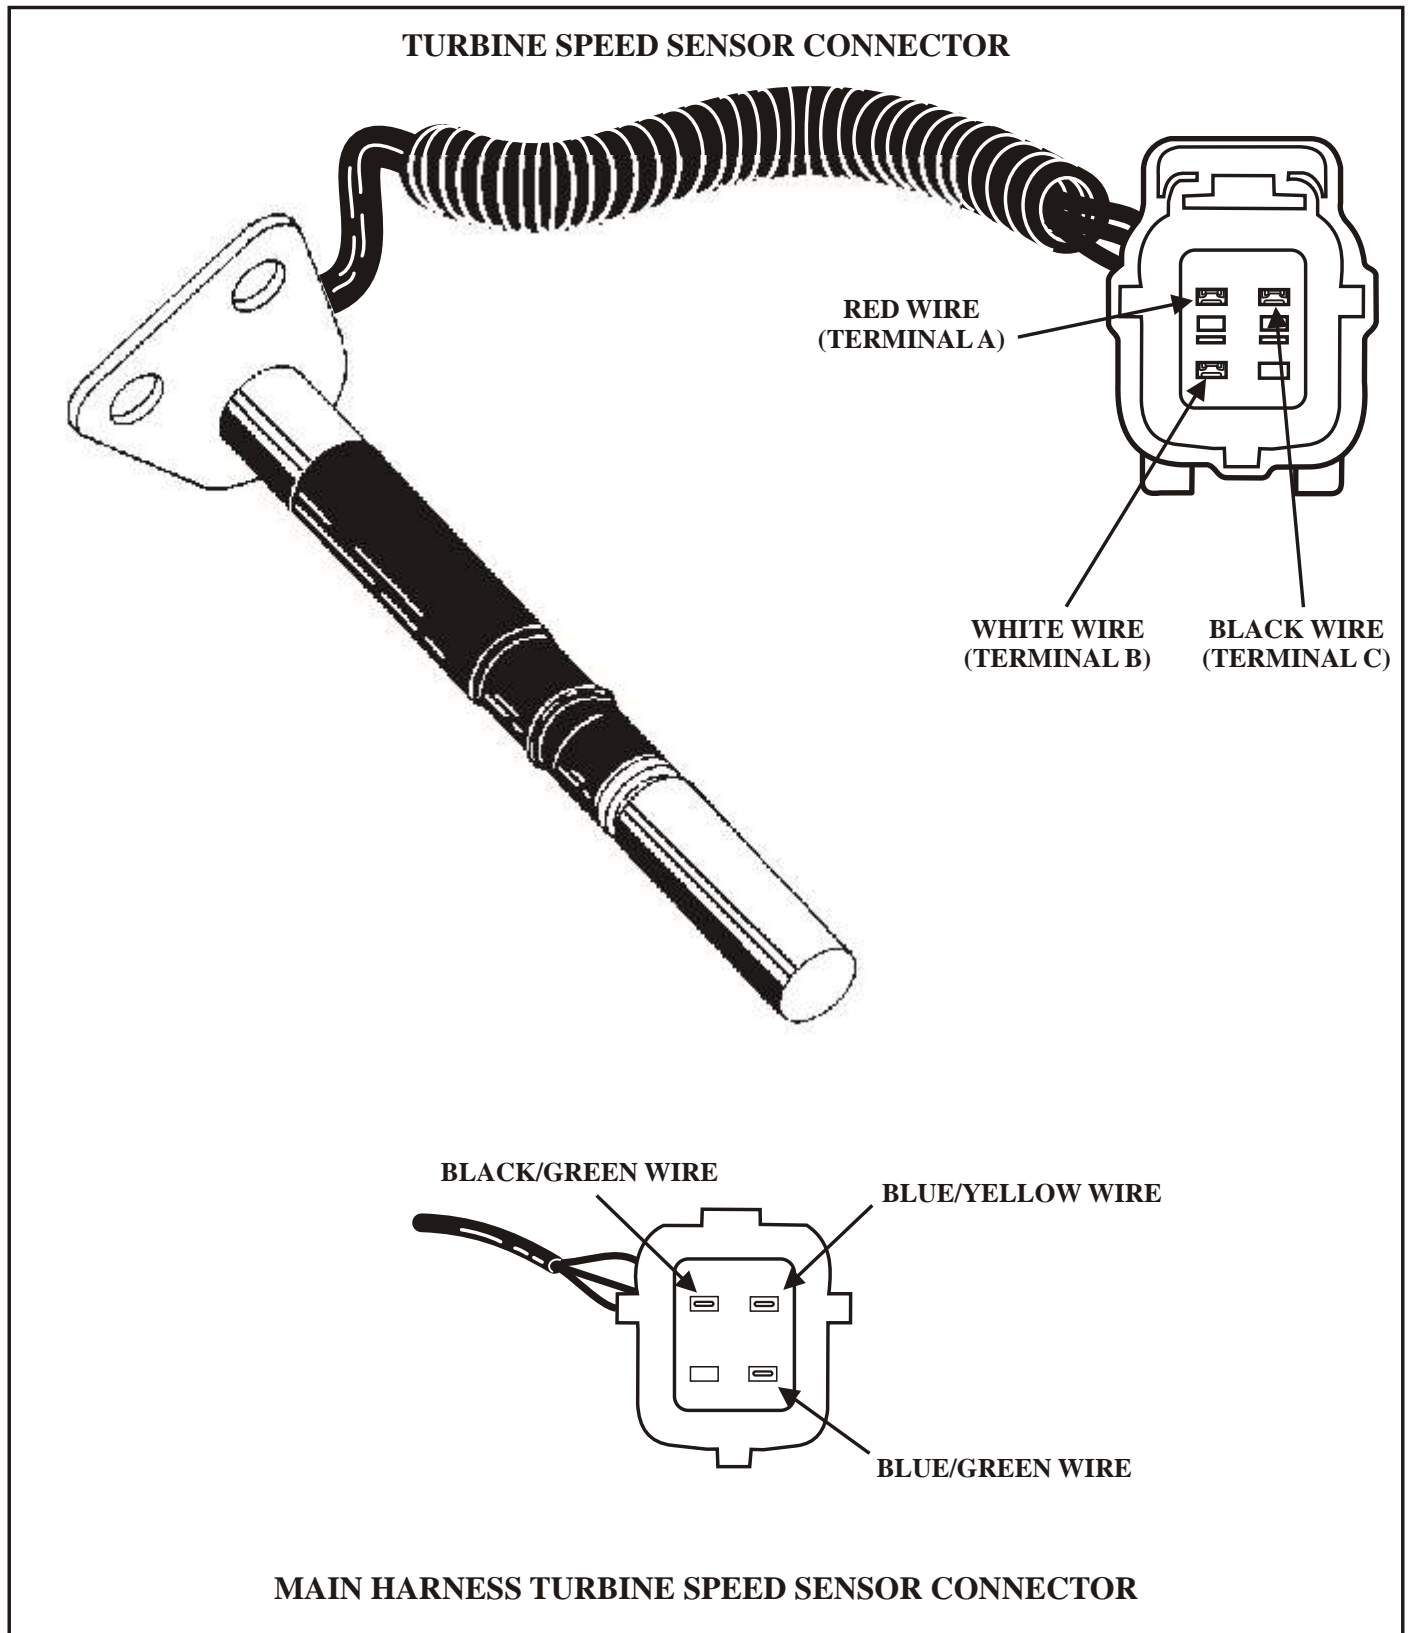
Figure 2

**MAZDA R4A-EL
TURBINE SENSOR WIRE/CONNECTOR CONFIGURATION**

CORRECTION: Using Figure 2, the **Red Wire** in the sensor harness matches up with the **Blue/Yellow** wire in the main harness. The **Black Wire** in the sensor harness matches up with the **Black/Green** wire in the main harness. The **White Wire** in the sensor harness then matches up with the **Blue/Green Wire** in the main harness.

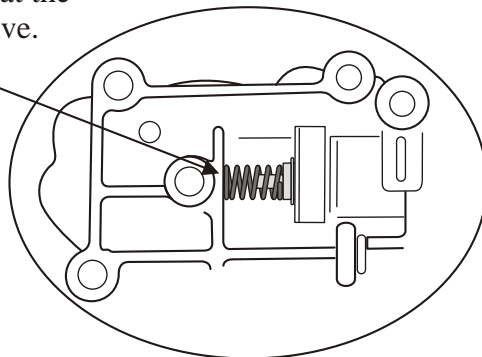
Figure 1

Before or after an overhaul, a vehicle equipped with the RL4FO3A/V transaxle exhibits a no up-shift condition after warm-up.

To correct this problem
push a 350/700 governor
spring onto the stem at the
back of the TV valve.

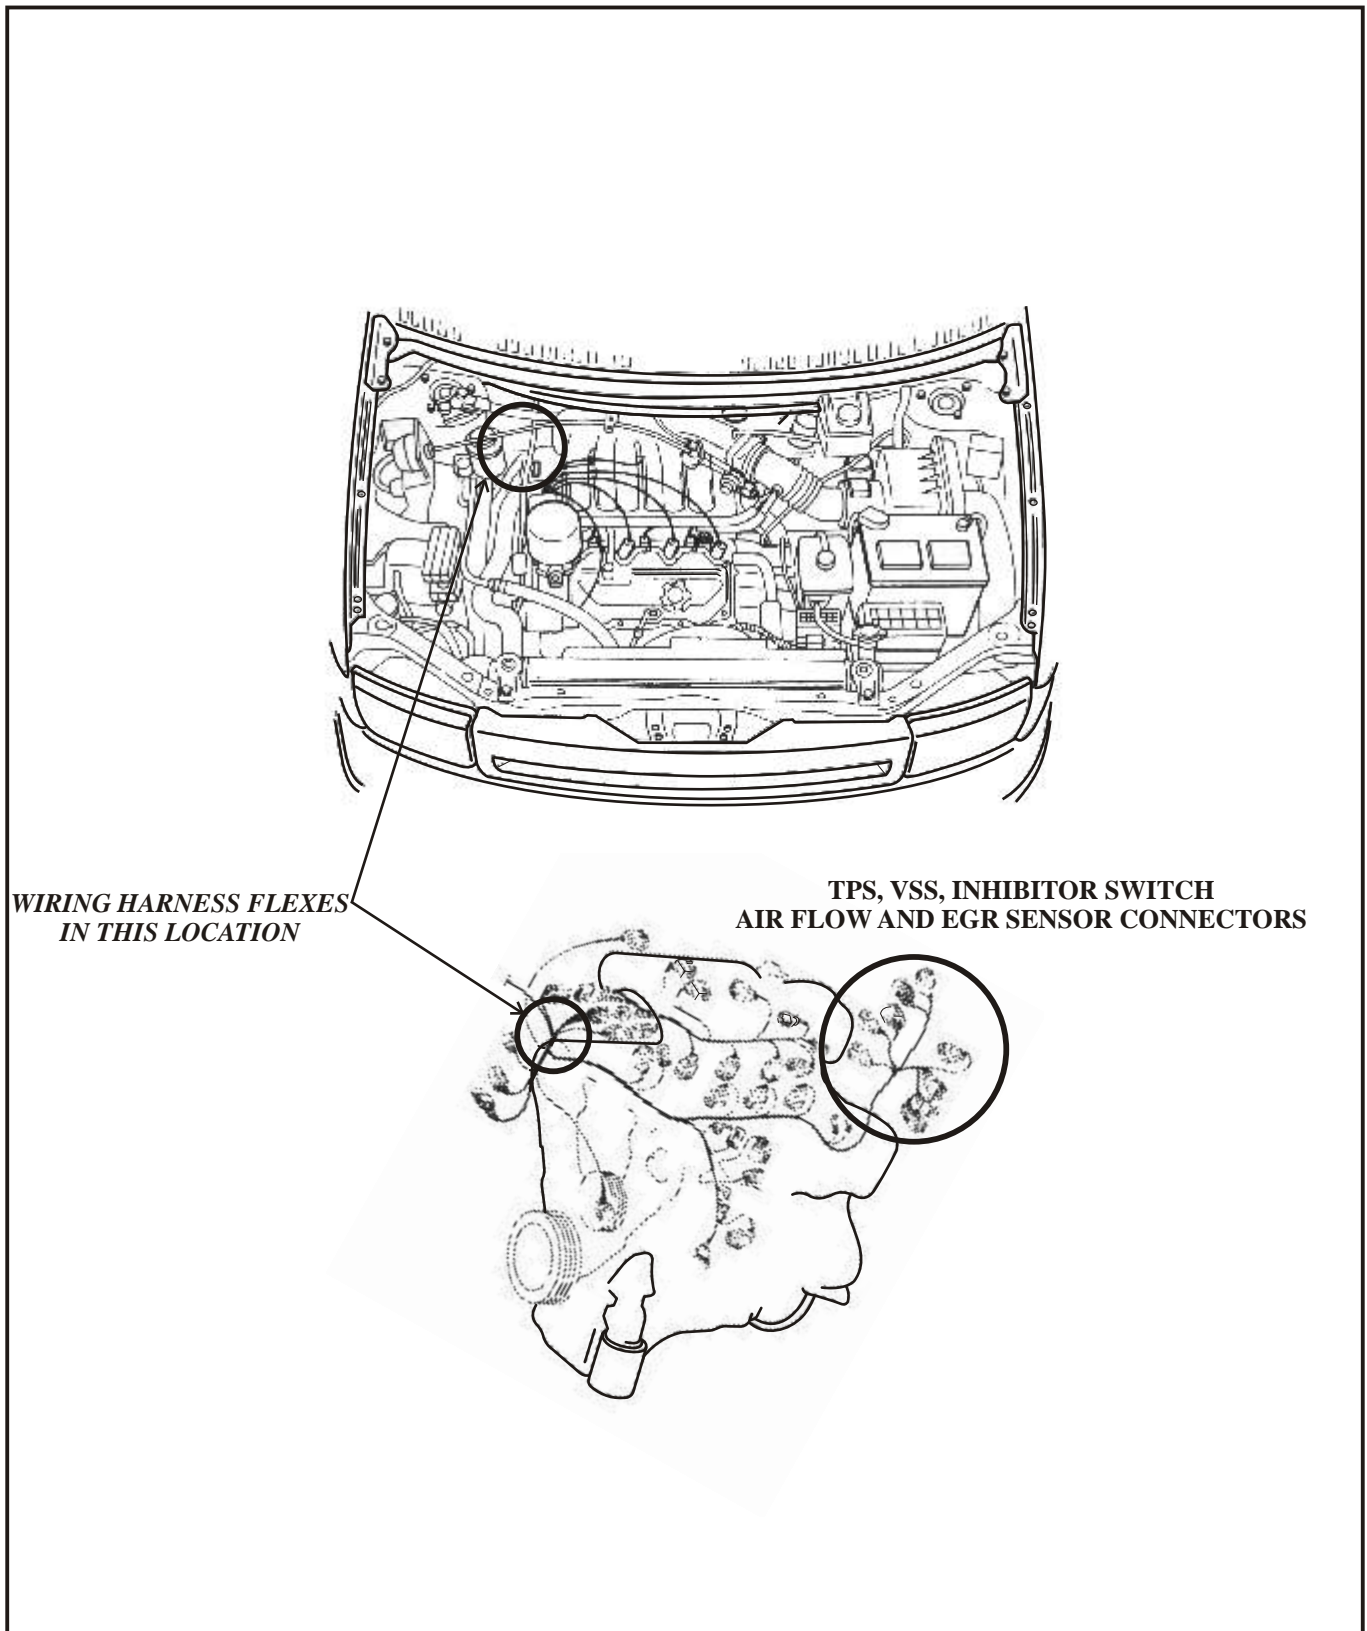
Figure 1

HARNESS FATIGUE

CORRECTION: Repair the mounts and the damaged wire or wires related to the complaint.

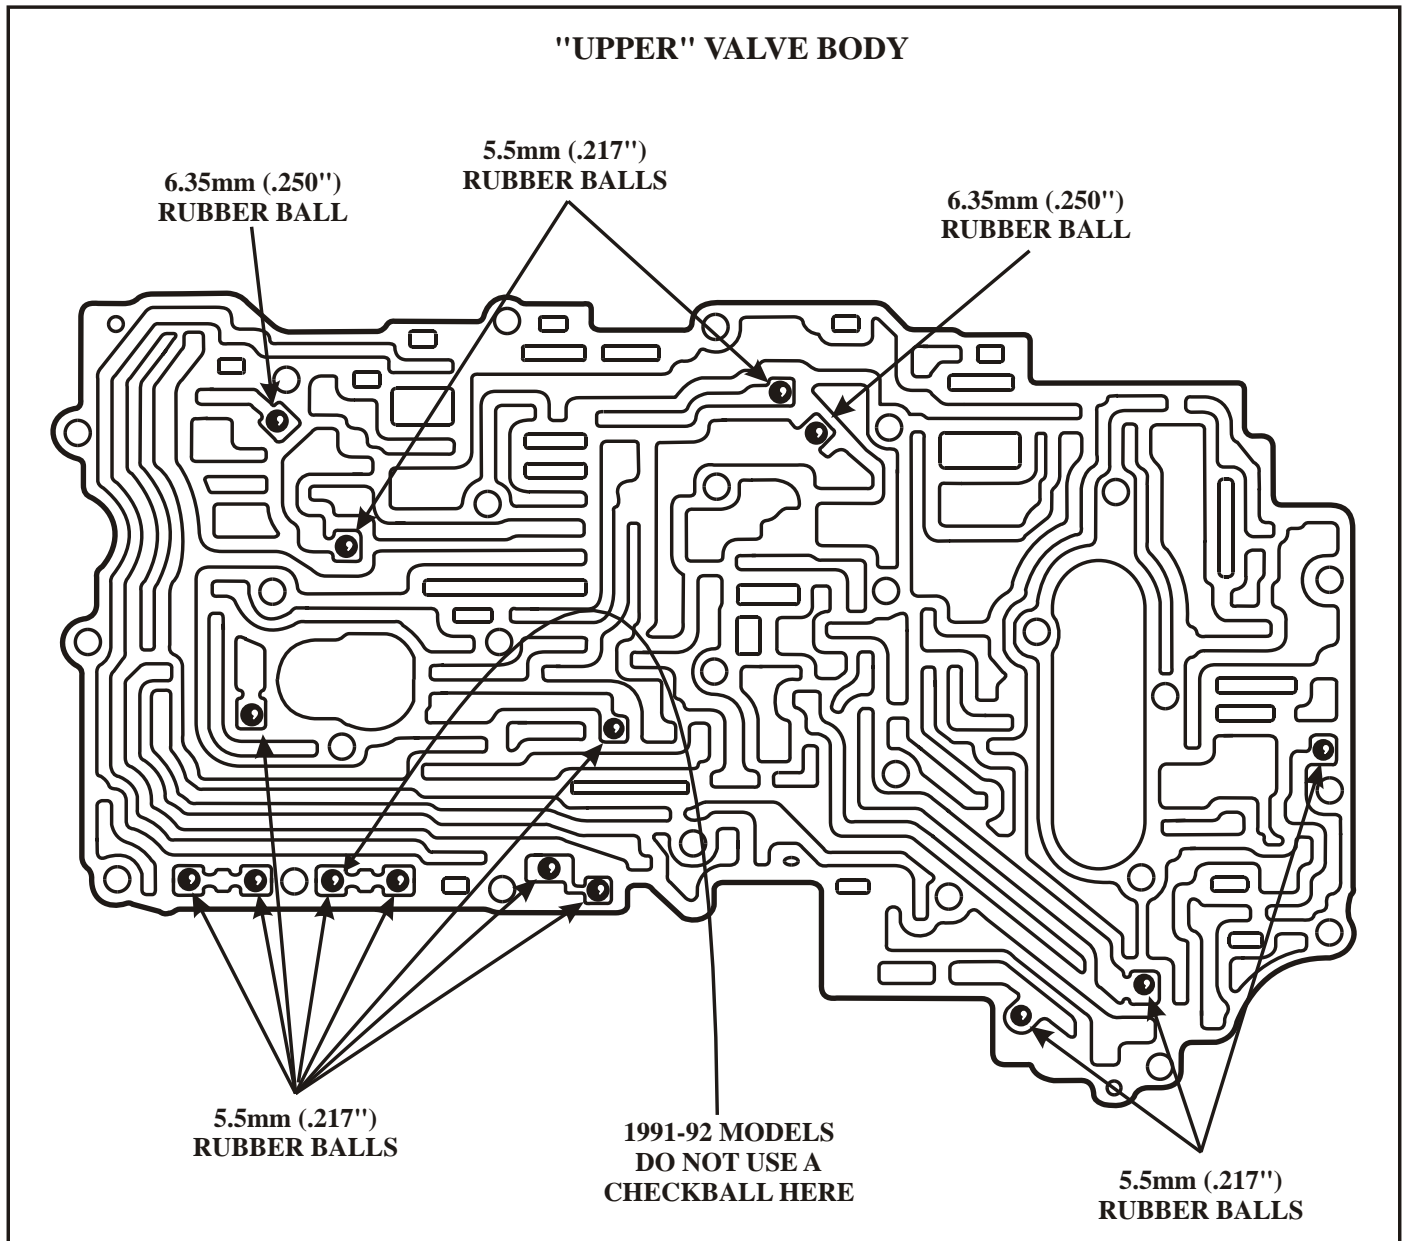
Figure 7

The valve body in figures 5, 6 and 7 is the Lexus 341E version which can be found various Lexus models from 1991-1997. Figures 5, 6 and 7 identify the solenoids, checkball and small parts location. This valve body also has four solenoids but uses a throttle cable for line pressure control. A PCM is used to control the transmission and the engine.
