# Technical Service Information

## CHRYSLER 45RFE/55RFE BIND ON 3-4 OR 4-5 UPSHIFT

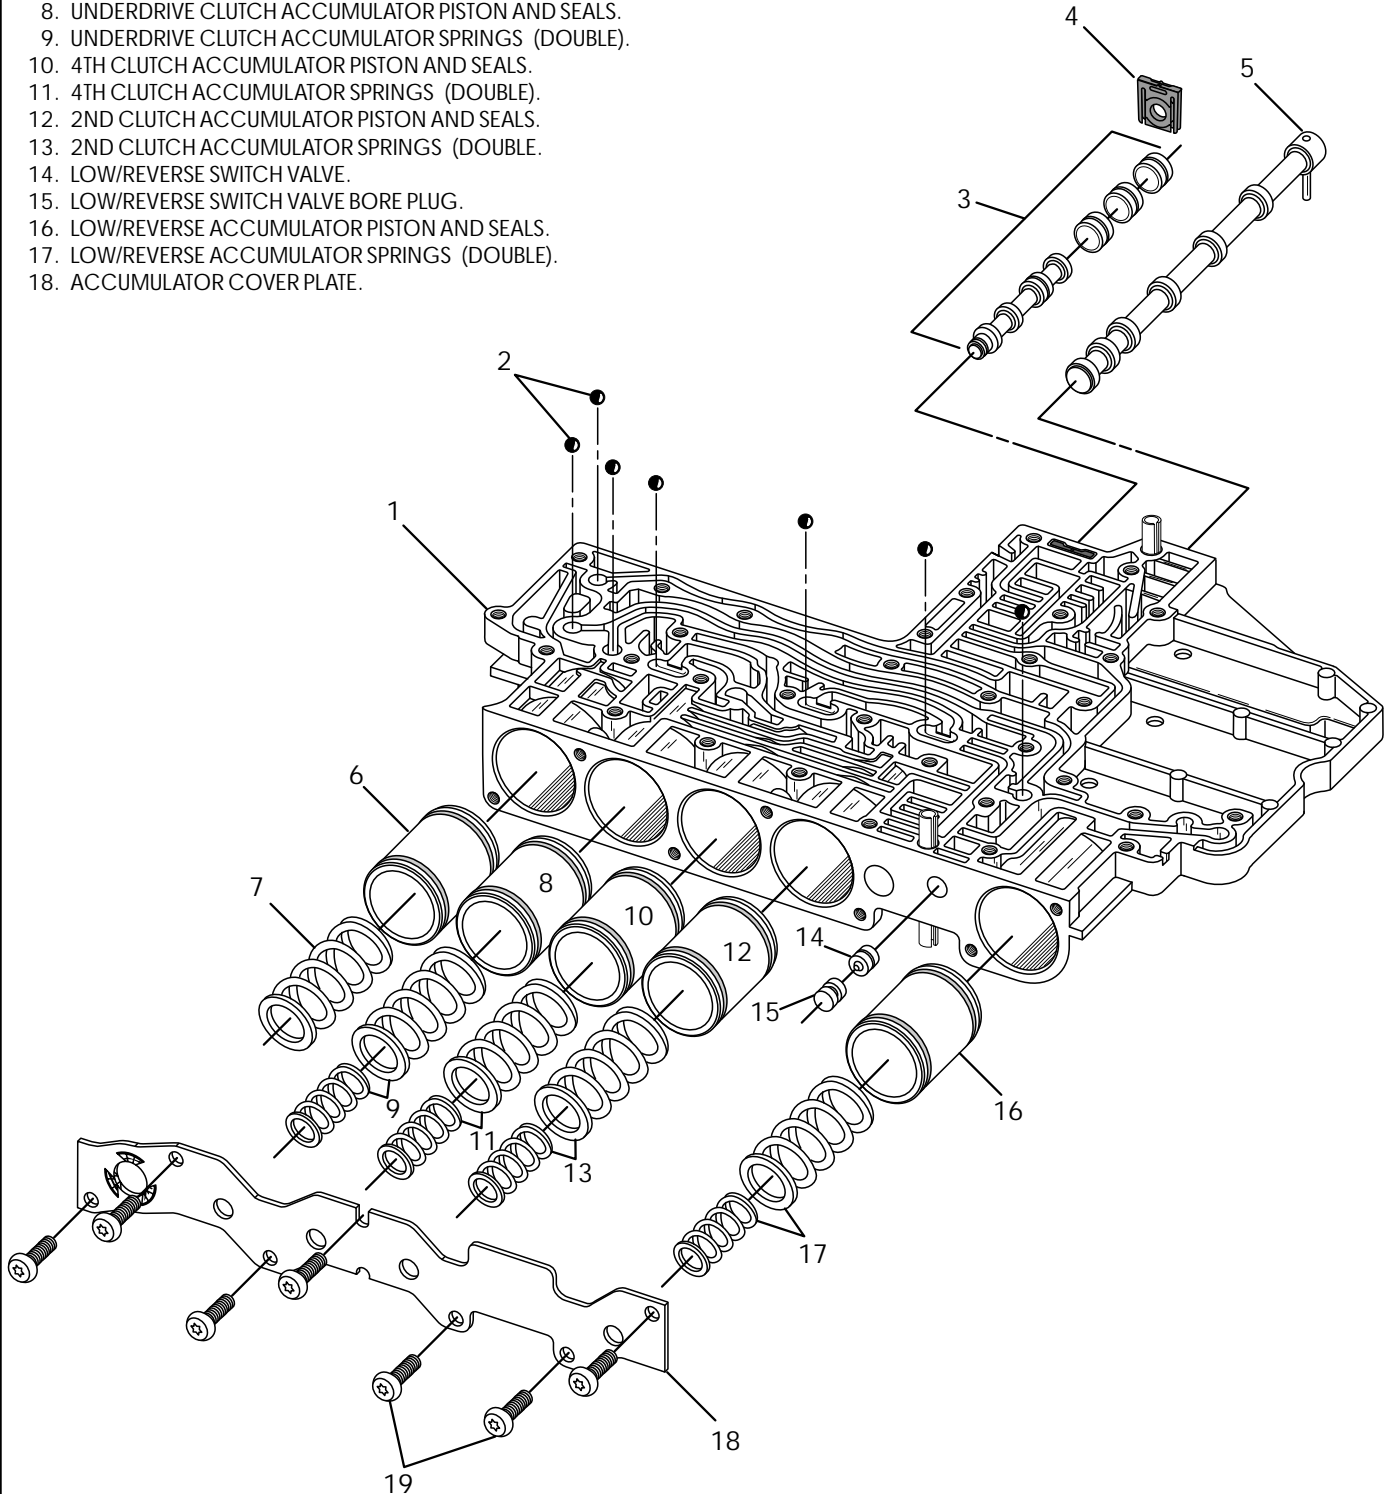
Figure 2

## MAIN VALVE BODY EXPLODED VIEW

**CORRECTION:** Replace the checkballs with new plastic checkballs available in aftermarket rebuild kits or from an O.E. supplier. For Valvebody Exploded views refer to Figures 2 and 3.

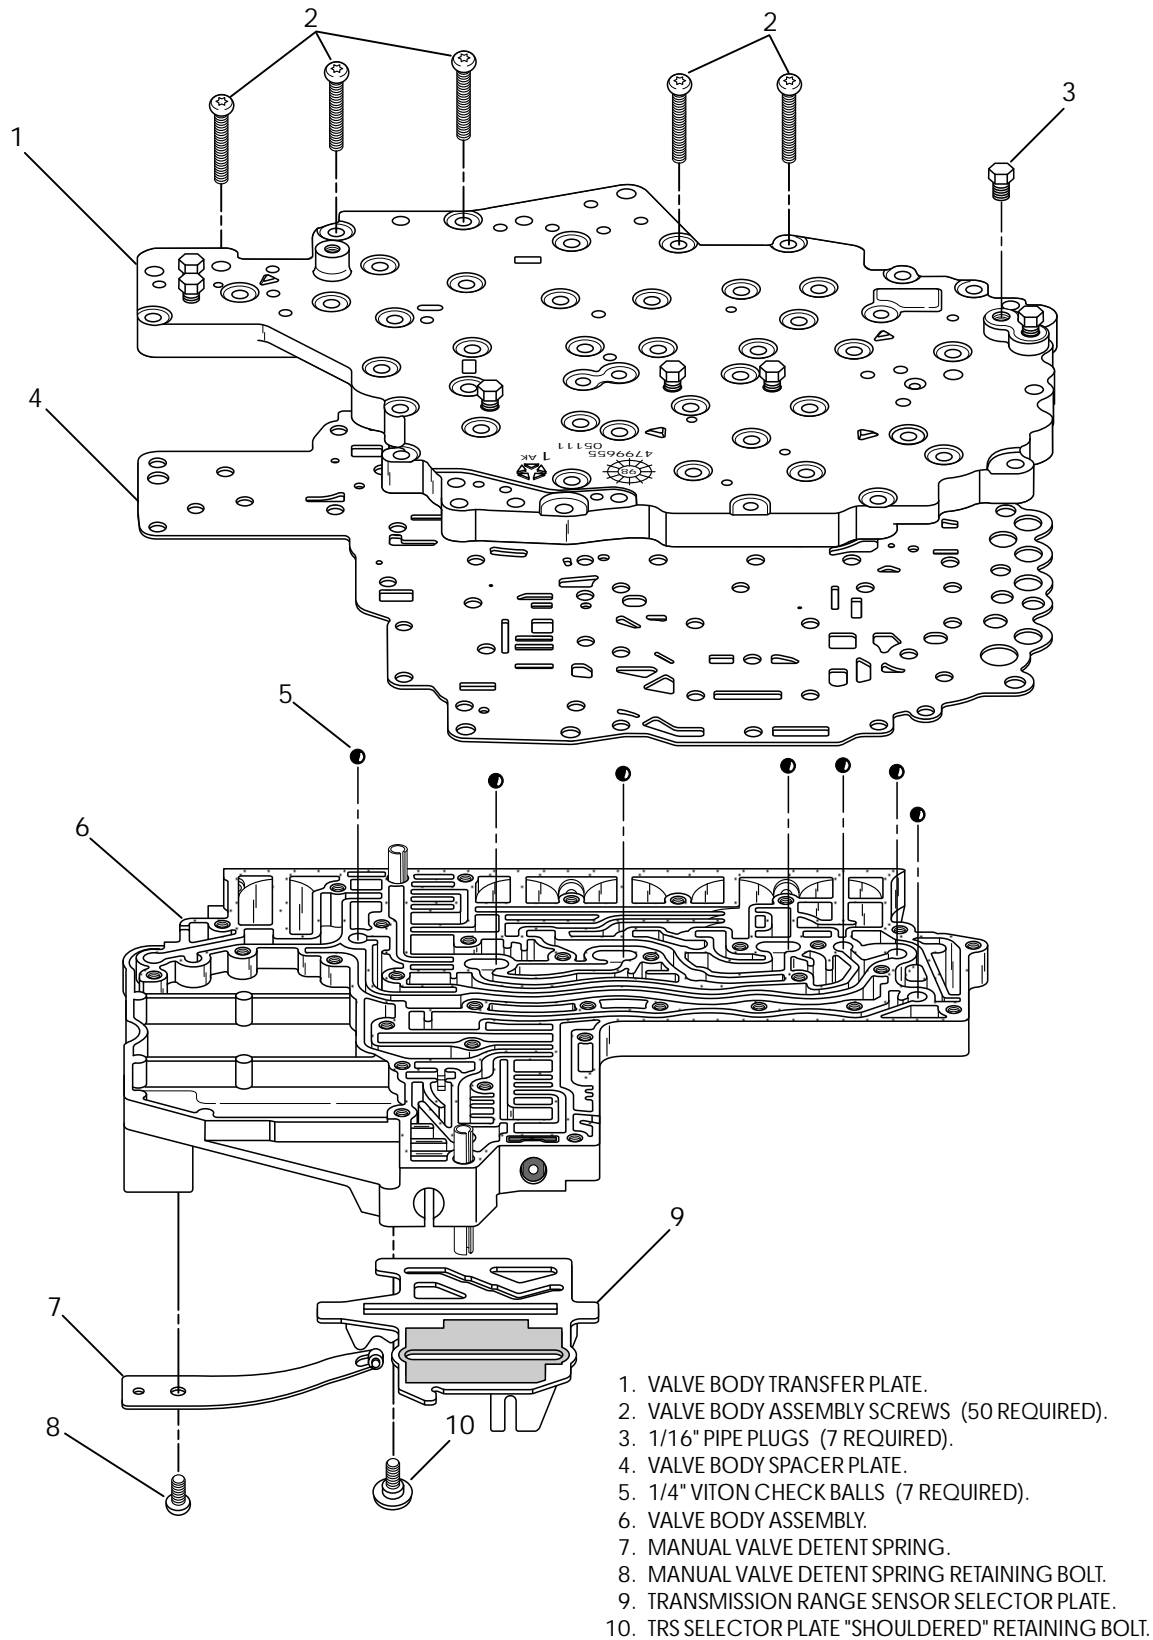
Figure 3

## VALVE BODY ASSEMBLY EXPLODED VIEW
