"2005" SEMINAR INFORMATION

AUTOMATIC TRANSMISSION SERVICE GROUP

"Out by Five in 2005" Seminar Information

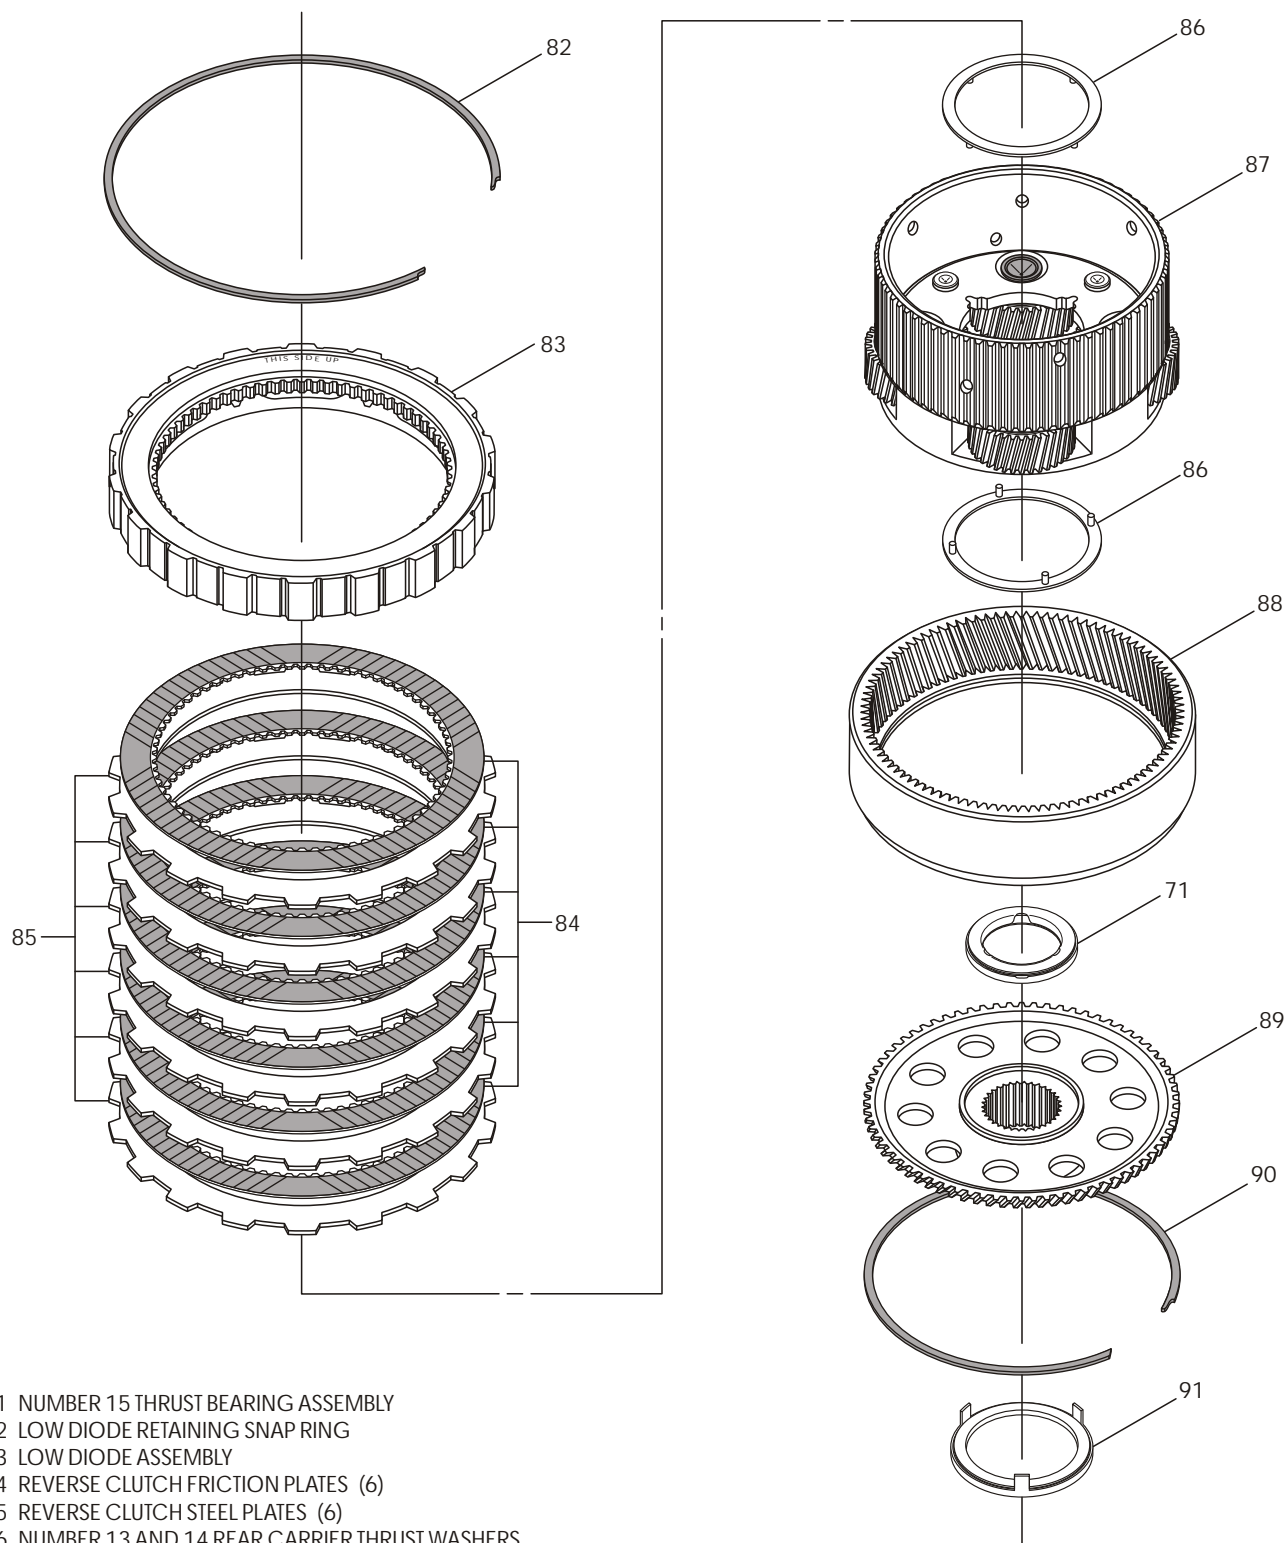
Figure 1

FORD 5R110W *Torqshift*
LOW DIODE FAILURE

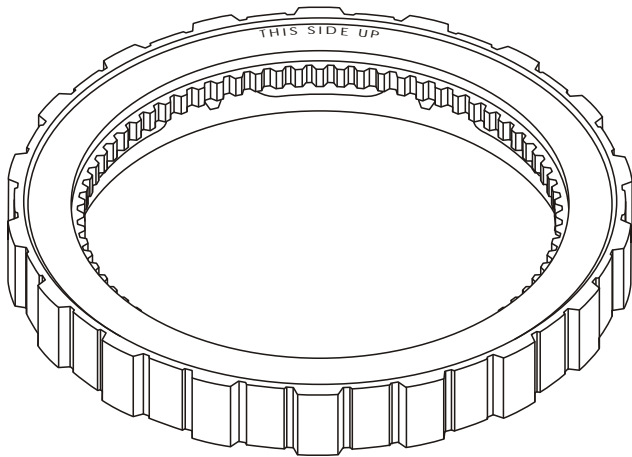
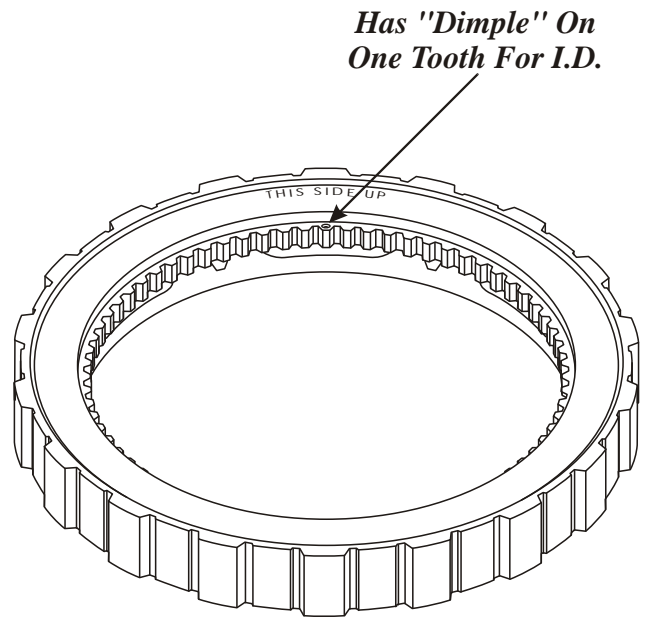
Figure 2

1ST DESIGN LOW DIODE

2ND DESIGN LOW DIODE

Low Diode Assembly (2nd Design) 3C3Z-7A089-AB

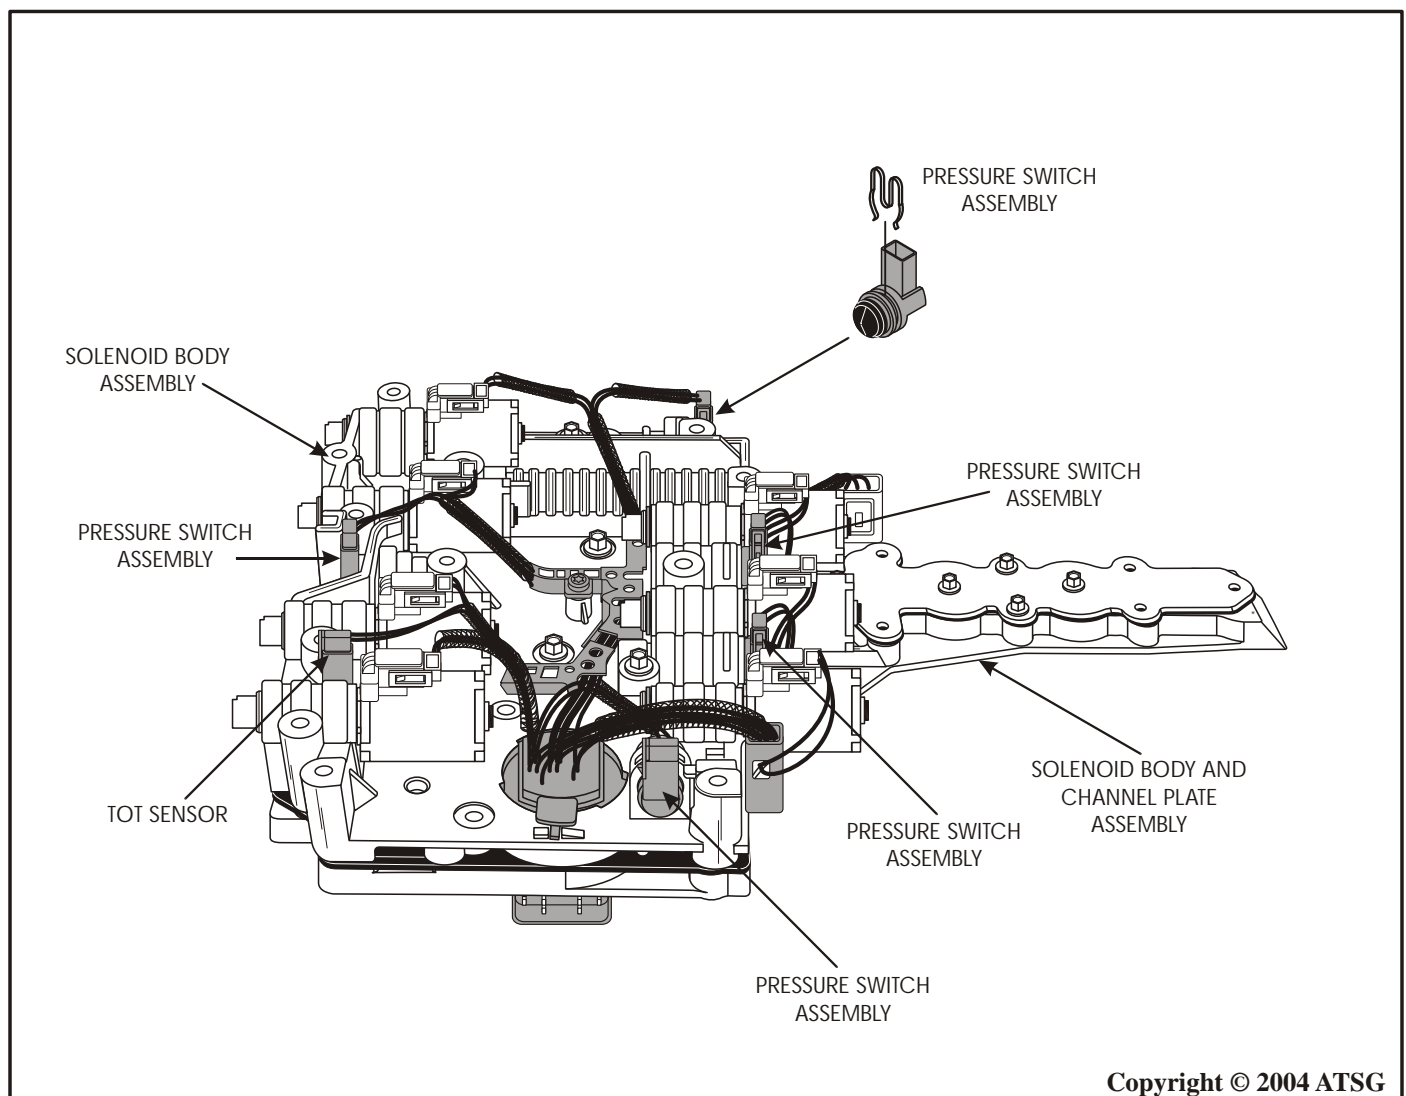
1. You may have to install a new service harness, without pressure switch connectors, into a unit that has pressure switches in the solenoid body. (See Figure 1 for locations)
2. You may have to install a new service solenoid body, without pressure switches, into a unit that has the original internal harness with pressure switch connectors. (See Figure 1 for locations)

Note: *These are both acceptable repairs and will not affect the function or operation of the transmission. Use of the pressure switch input was dropped from the vehicle calibration before the 2003 model year went into production.*

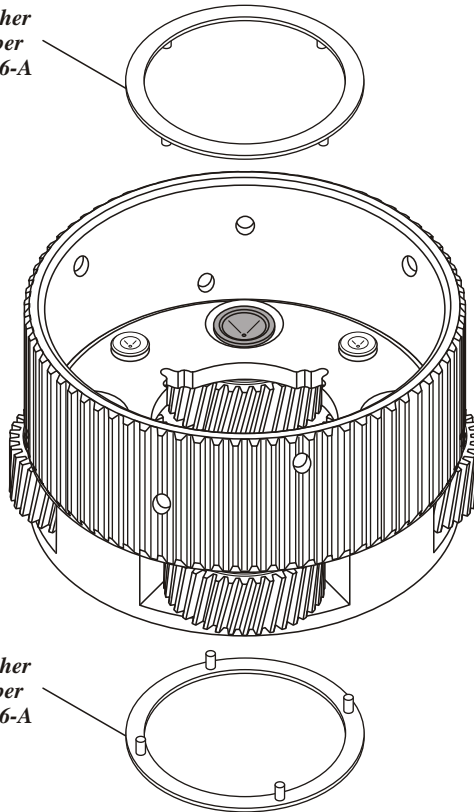
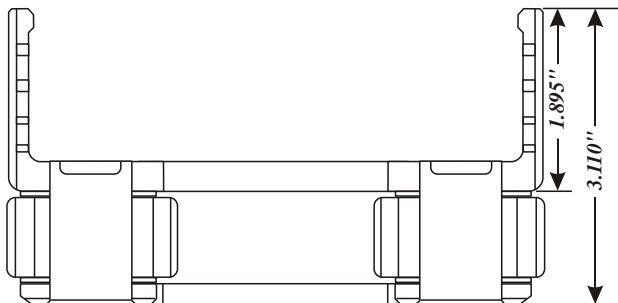
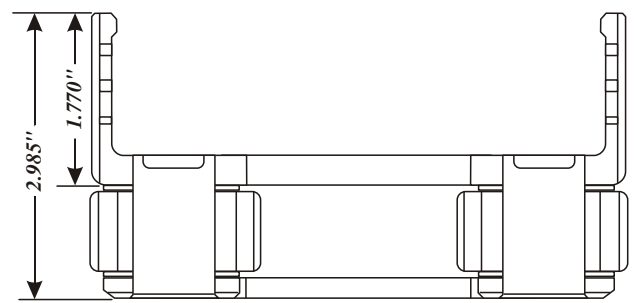
Figure 2

5R110W REAR PLANETARY CARRIER

"DO NOT USE"

**PART NUMBER
5C3Z-7D006-AB**

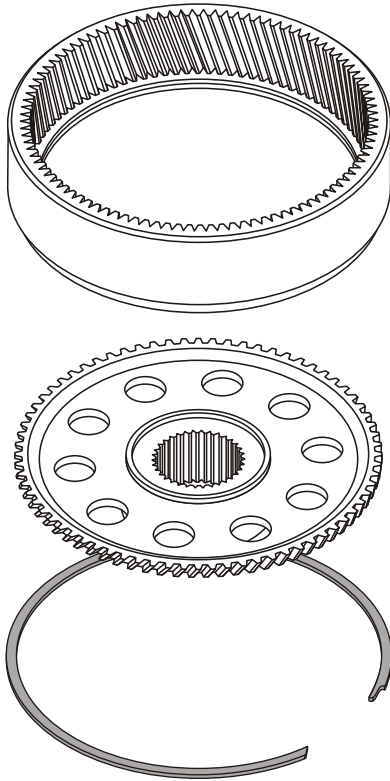
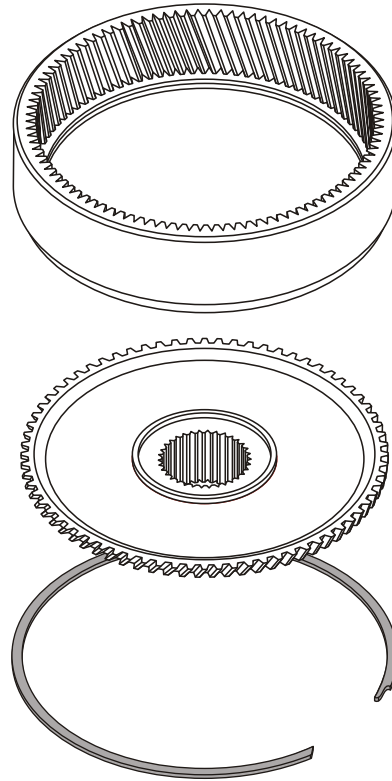
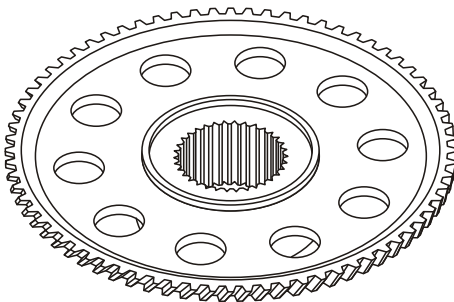
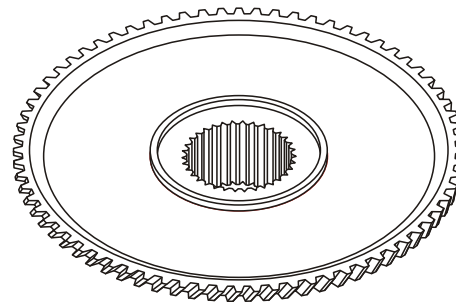
Figure 3

**"OK TO USE"
WITH NEW CARRIER**

The new design ring gear hub will also retro-fit back on all model years, but the earlier design ring gear hub can be reused as long as it is not damaged. Reuse only with the new design carrier.

**PART NUMBER
3C3Z-7D164-AA**

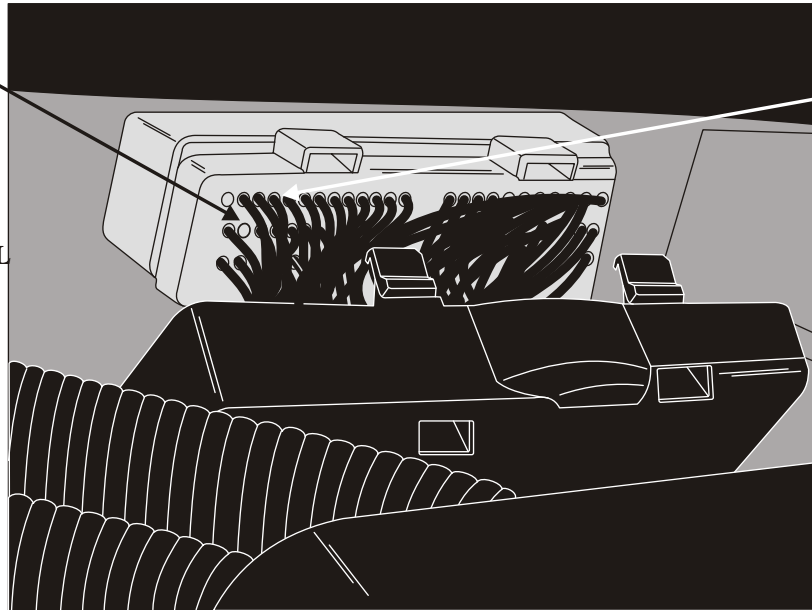
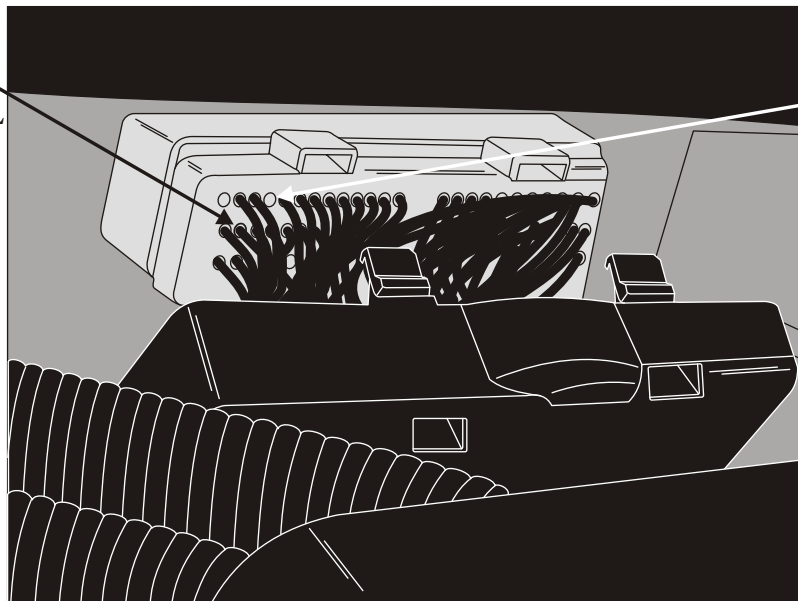
Figure 1

CAUSE: Since all items relating to this type of situation had already been eliminated as the cause of the problem, the technician decided to consult wiring diagrams for this vehicle. Since the factory wiring diagrams were split into two categories, vehicles built before 9/8/97 and vehicles built after 9/8/97, both were compared. The "before 9/8/97" indicated that the TCC ground controlled terminal was at pin 82, (Refer to Figure 1). The "after 9/8/97" diagram indicated this circuit should be at terminal 54, (Refer to Figure 2). The technician decided to check the signal that was being sent on this circuit by the PCM. The Red/Lt Blue wire was located at terminal 82 in the PCM connector. There was battery voltage on the circuit at all times, usually meaning that the PCM did not deliver the ground signal. *The PCM connector location at pin 54 was molded shut!*

WINDSTARS BUILT BEFORE 9/8/97

HAS THE WHITE CONNECTOR TCC SOLENOID AND WILL HAVE TERMINAL 54 MOLDED SHUT AND THIS PCM TERMINAL WILL BE NON-FUNCTIONAL

TERMINAL 82 WILL BE THE FUNCTIONAL TERMINAL FOR THE TCC GROUND CONTROLLED CIRCUIT

WINDSTARS BUILT AFTER 9/8/97

TERMINAL 54 WILL BE THE FUNCTIONAL TERMINAL FOR THE TCC GROUND CONTROLLED CIRCUIT

HAS THE BLUE CONNECTOR TCC SOLENOID AND WILL HAVE TERMINAL 82 MOLDED SHUT AND THIS PCM TERMINAL WILL BE NON-FUNCTIONAL

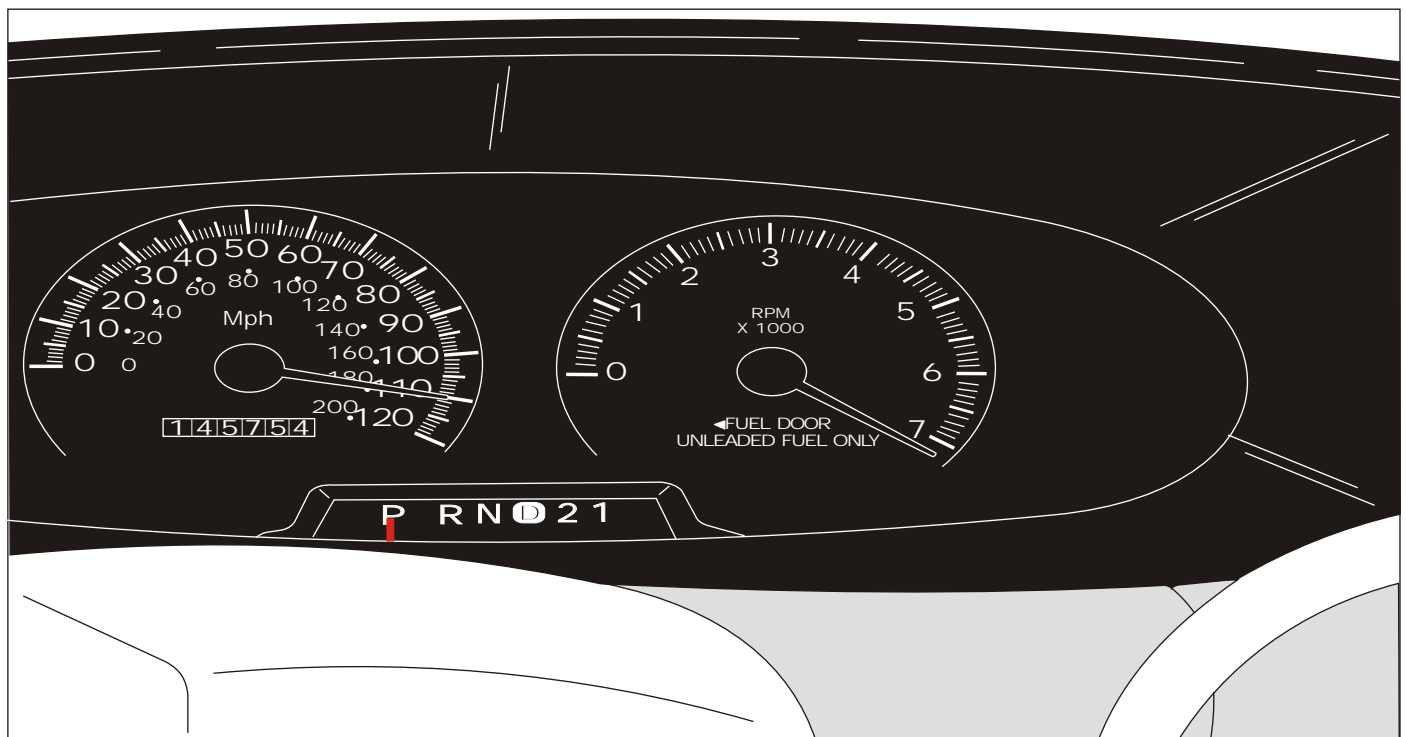
Figure 1

COMPLAINT: On some 1999 and later Ford vehicles with gas engines only, after PCM replacement, either from the wrecking yard, the O.E. dealer, or a donor out of another similar vehicle, the speedometer is inaccurate or inoperative. In addition, the 4x4 lamp is illuminated and there are codes P1639 for "VID Block Not Programmed Or Is Corrupt" and P1635 for "Tire/Axle Out Of Acceptable Range".

CAUSE: Whenever the PCM or instrument cluster has been replaced in these vehicles, it is necessary to program the PCM with the correct Vehicle Identification (VID) Block.

CORRECTION: Currently this is an O. E. dealer process because the NGS scan tool or the WDS diagnostic station must be used. The tire size and axle ratio information is transferred from the original PCM to the replacement or this information is accessed from the Ford Motor Company "Professional Technician Society" website and downloaded from the "As-Built Database". This process becomes even more complicated if the vehicle is equipped with Ford's "PATs" anti-theft system.

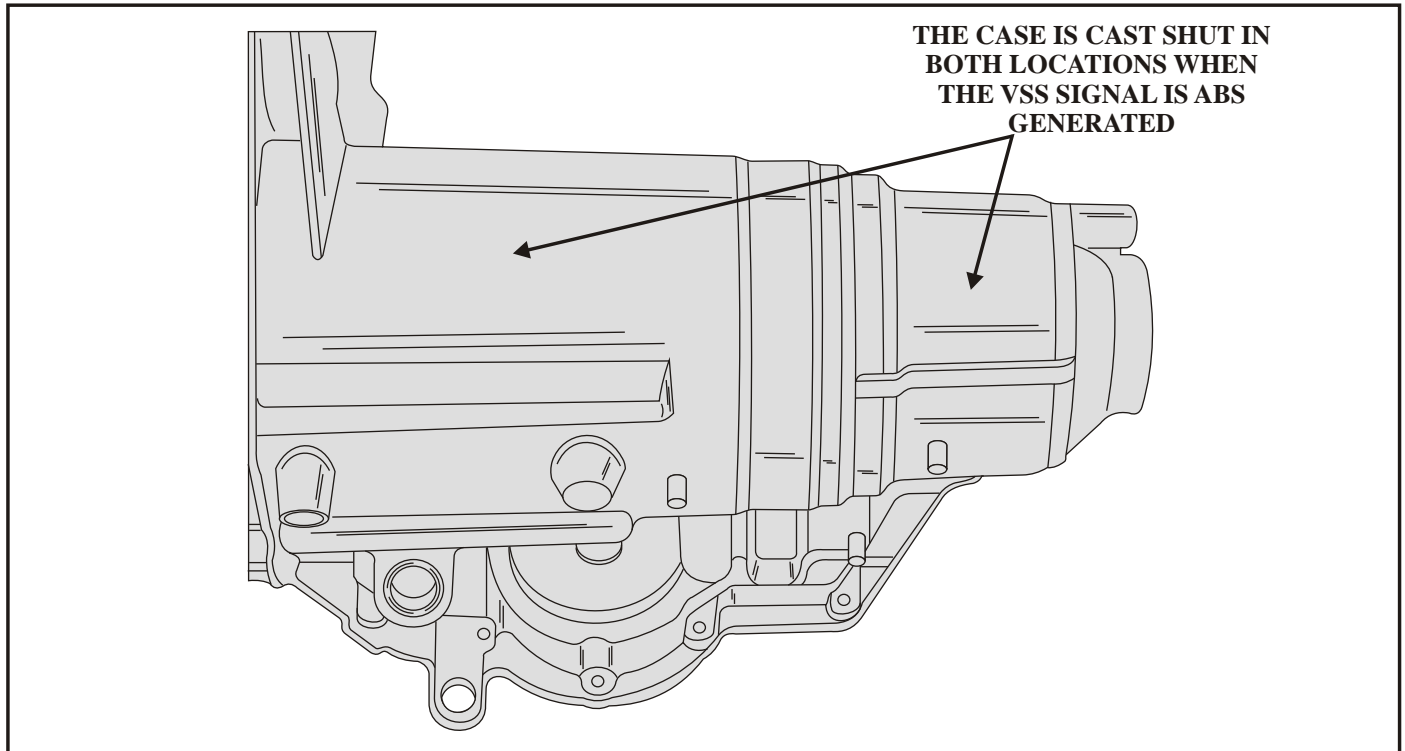
Figure 1

VEHICLE SPEED SENSOR ELIMINATED

CORRECTION: The ABS Module will have to be scanned for wheel speed sensor codes in order to find the one, or more, wheel speed sensor(s) that are faulty. It would also help to view the ABS data to see if all four (4) wheel speeds are the same when driving in a straight line, (no turns).
Note: The reluctors at each wheel can become caked with mud or rust resulting in an erratic or no signal condition, be sure to check for this or any other condition that might cause a problem with the wheel speed sensor to reluctor relationship.

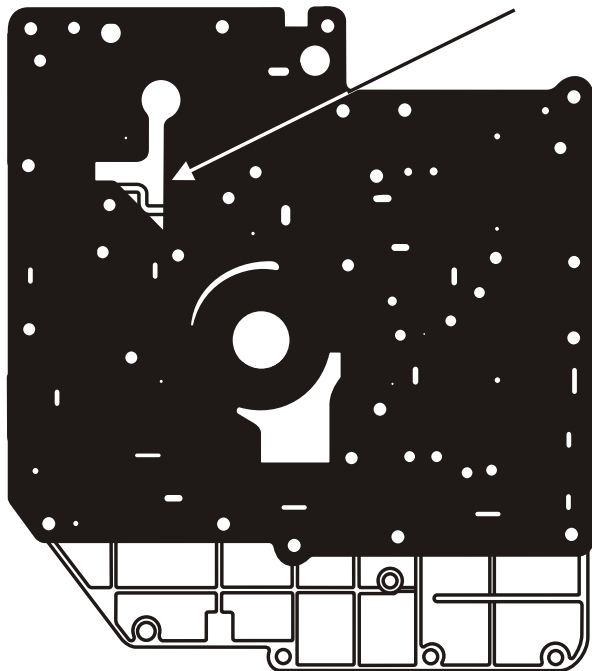
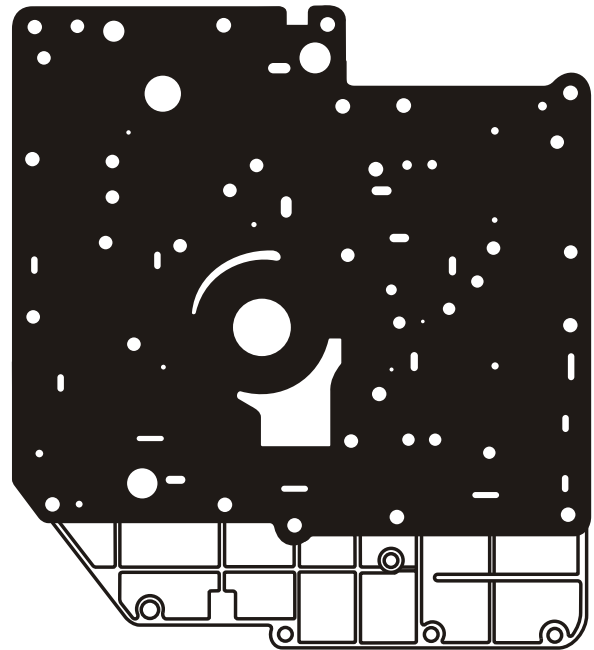
Figure 1

INCORRECT GASKET

1998 and up gasket on a 94-97 Valve body

CORRECT GASKET

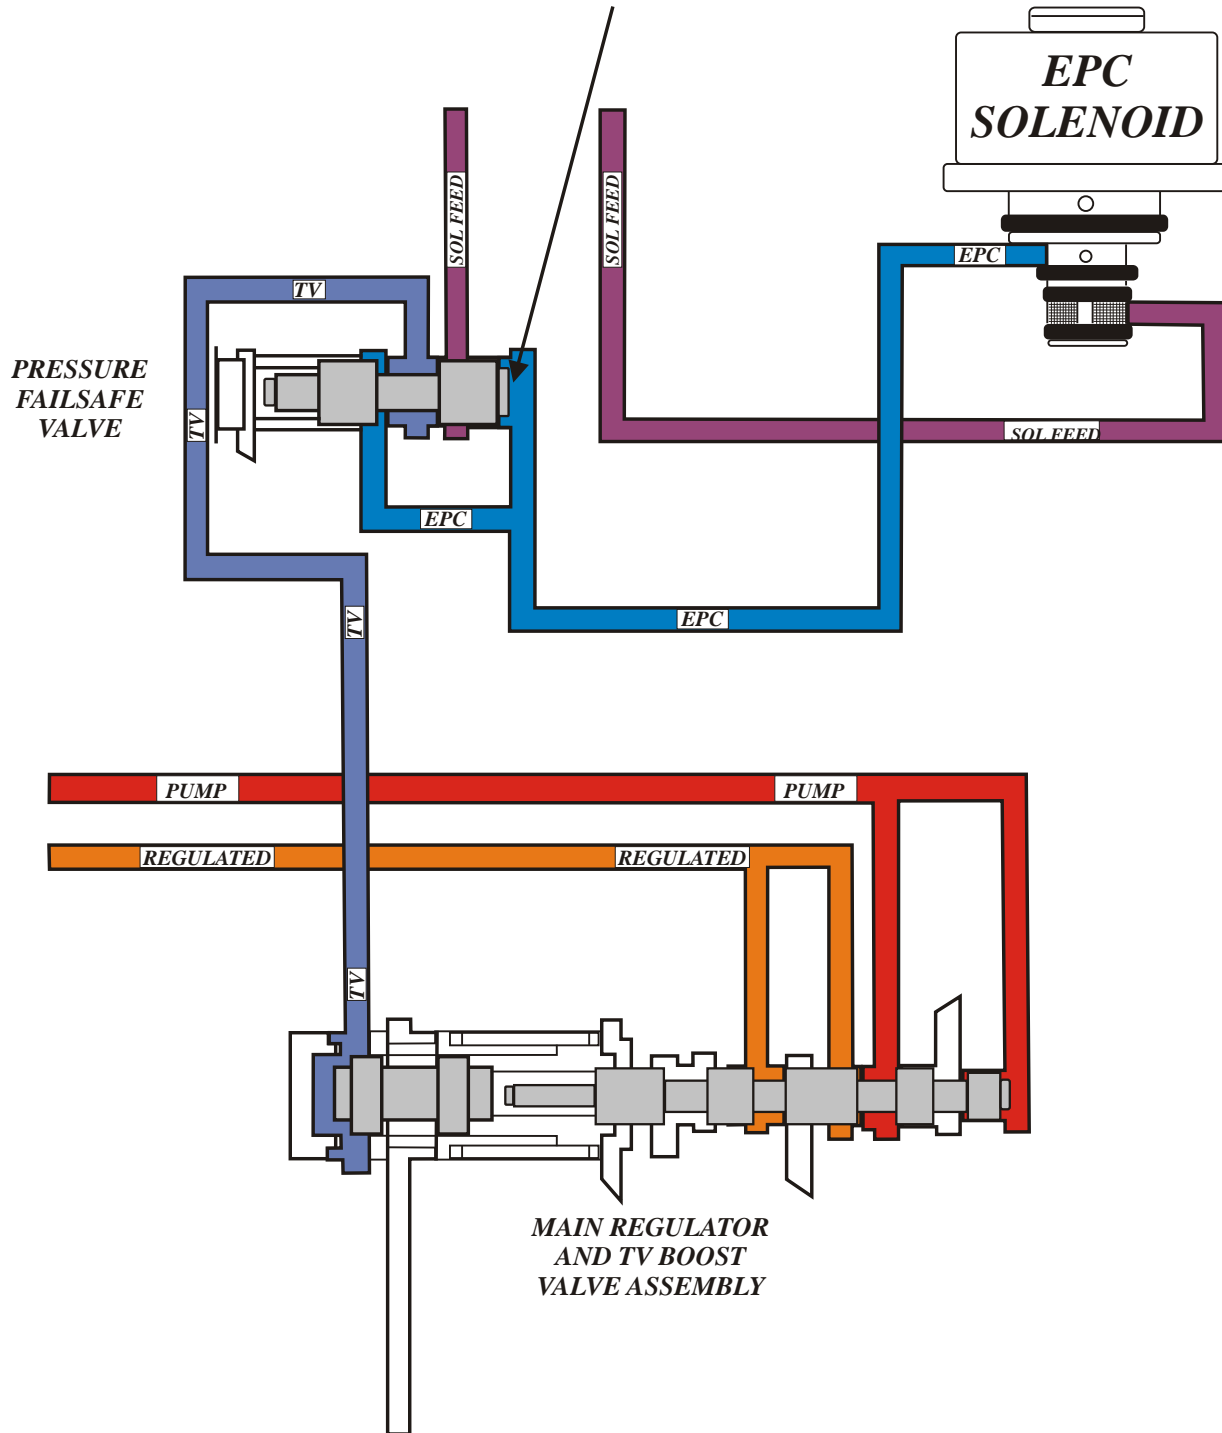
Figure 2

*SOLENOID FEED PRESSURE ACTS ON THIS
END OF THE PRESSURE FAILSAFE VALVE
CAUSING AN INCREASE OF TV PRESSURE*

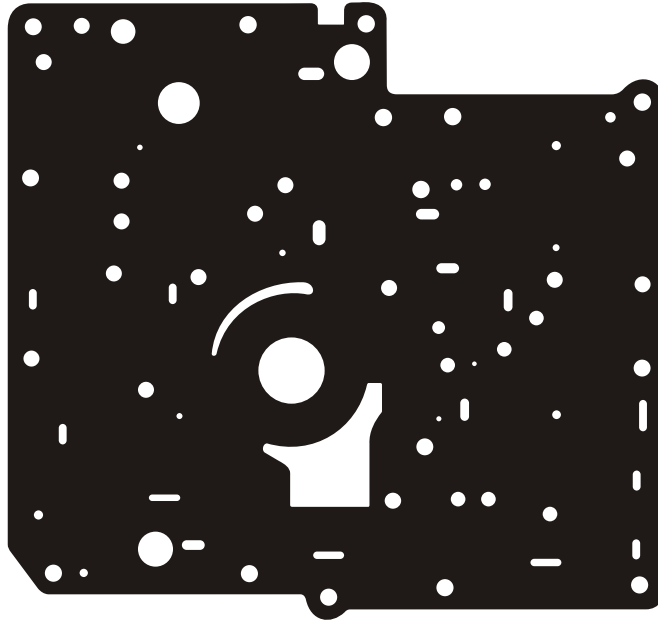
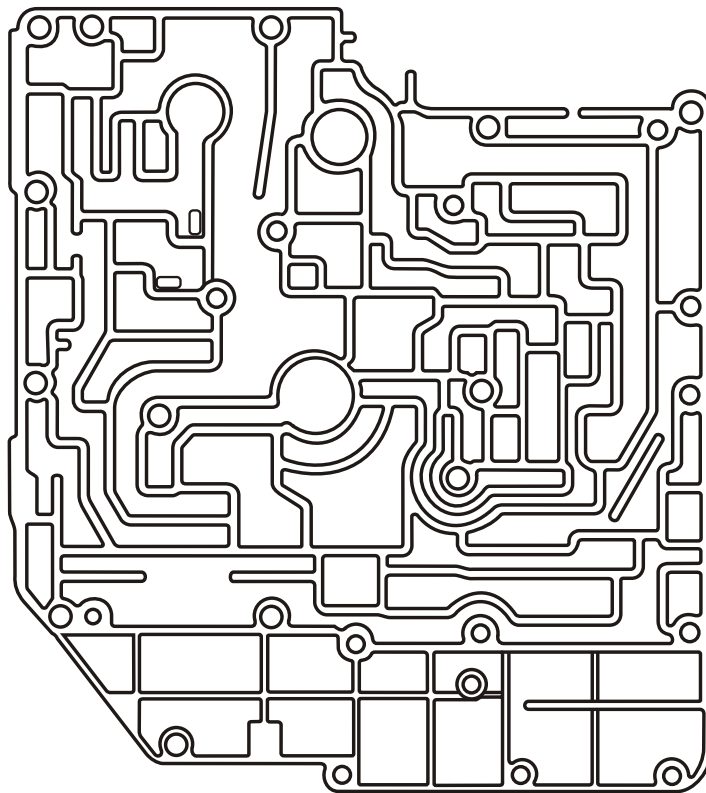
Figure 3

1994-1997 GASKET AND VALVE BODY

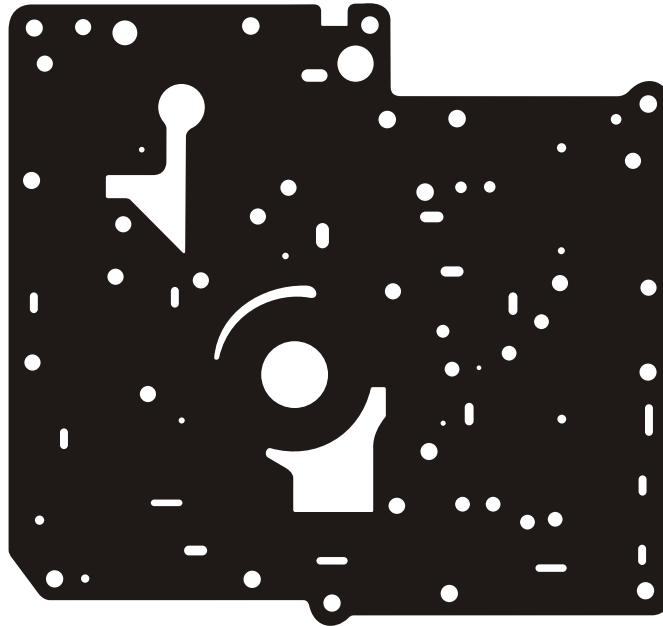
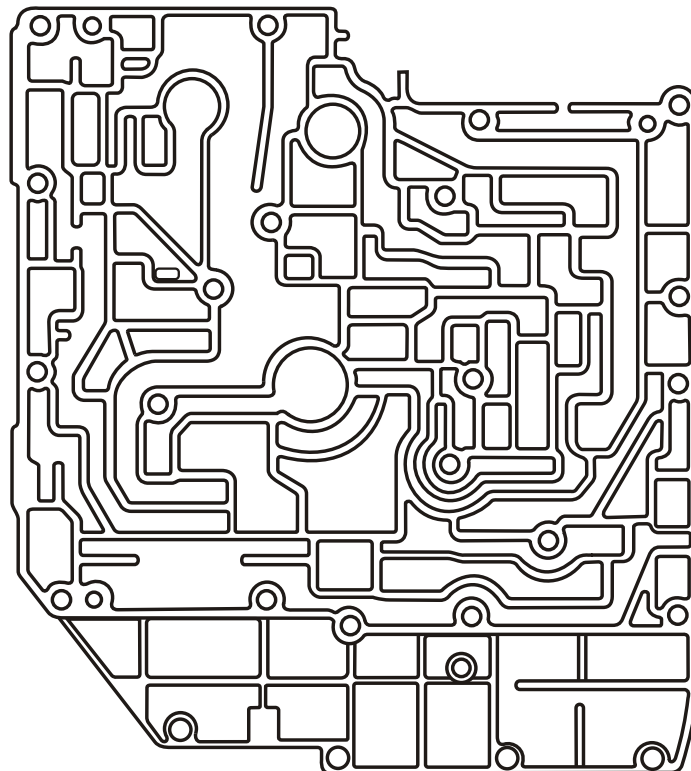
Figure 4

1998 & UP GASKET AND VALVE BODY

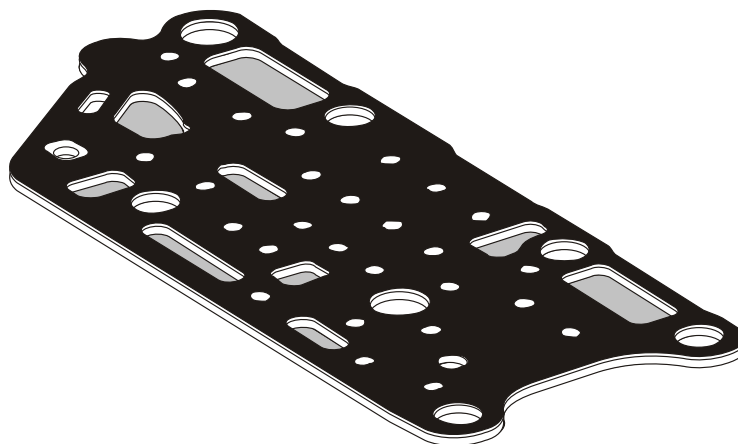
Figure 1

COMPLAINT: Vehicles equipped with the 4F27E transaxle may exhibit a neutral condition in 4th gear after the vehicle is "Hot."

CAUSE: The cause may be, the bonded solenoid gasket is leaking solenoid pressure feeding Shift Solenoid "A." This will cause the 3-4 shift valve not to stroke fully, creating neutral.

CORRECTION: Replace the bonded solenoid gasket as shown in Figure 1. Refer to Figure 2 for the location of the bonded gasket and Figure 3 for the remainder of the valve body assembly.

BONDED SOLENOID GASKET (Ford Part Number).....YS4Z-7Z490-AA

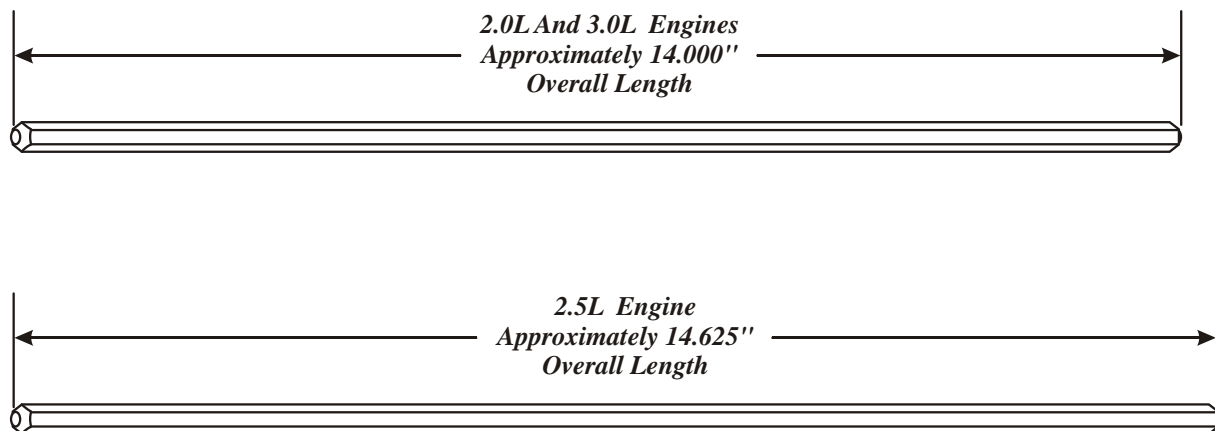
Figure 1

- CAUSE:** One cause may be, a mis-matched turbine shaft and torque converter that was mistakenly installed in the vehicle. The turbine shaft and oil pump drive shaft for the 2.0L and 3.0L engines are approximately 5/8" shorter than the turbine shaft and oil pump drive shaft for the 2.5L engine as shown in Figures 1 and 2. If the short turbine shaft is installed into the 2.5L and converter, the vehicle will exhibit the above concerns. Torque converter identification is provided for you in Figure 3, and as you can see in the height dimension chart, there is approximately 5/8" difference.

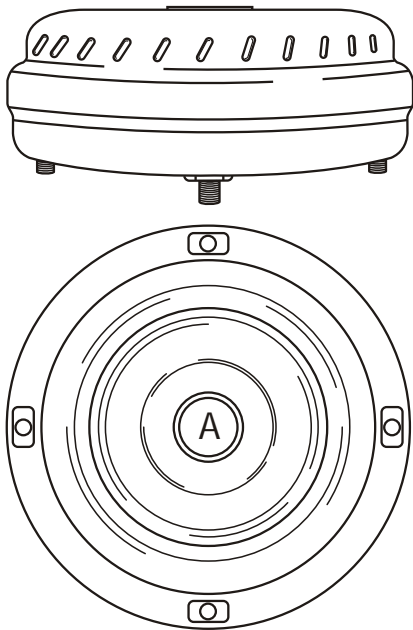
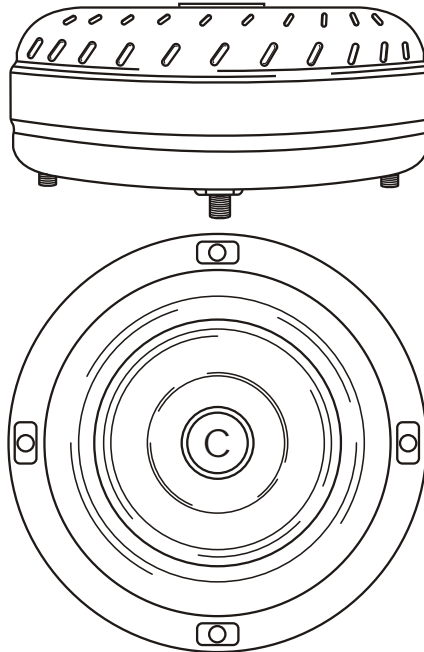
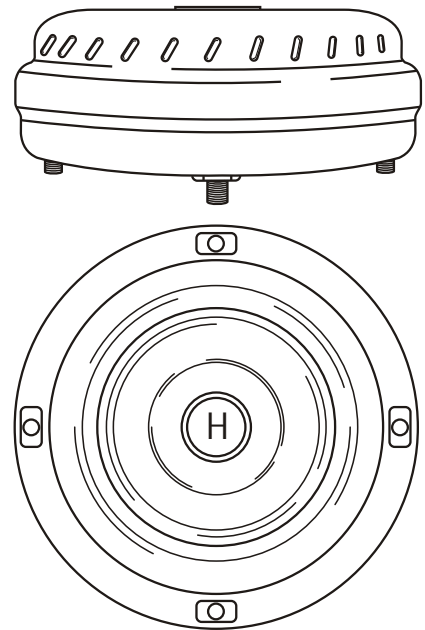
Figure 2

*This Converter "Requires"
The Short Turbine Shaft
And Pump Drive Shaft*

*This Converter "Requires"
The Long Turbine Shaft
And Pump Drive Shaft*

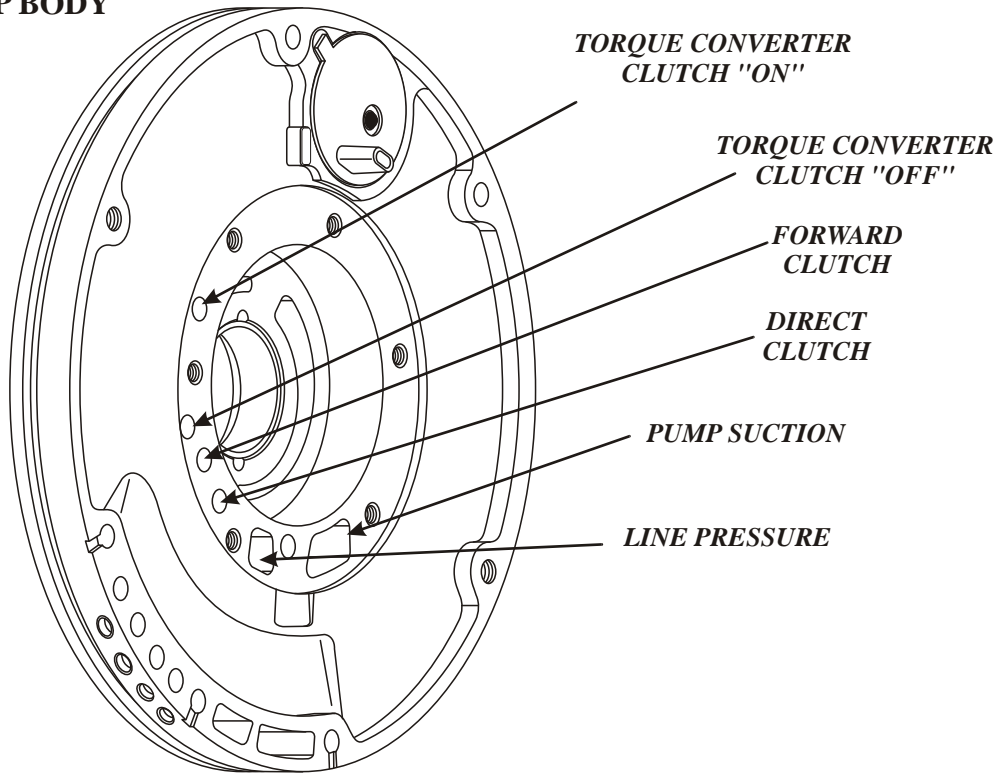
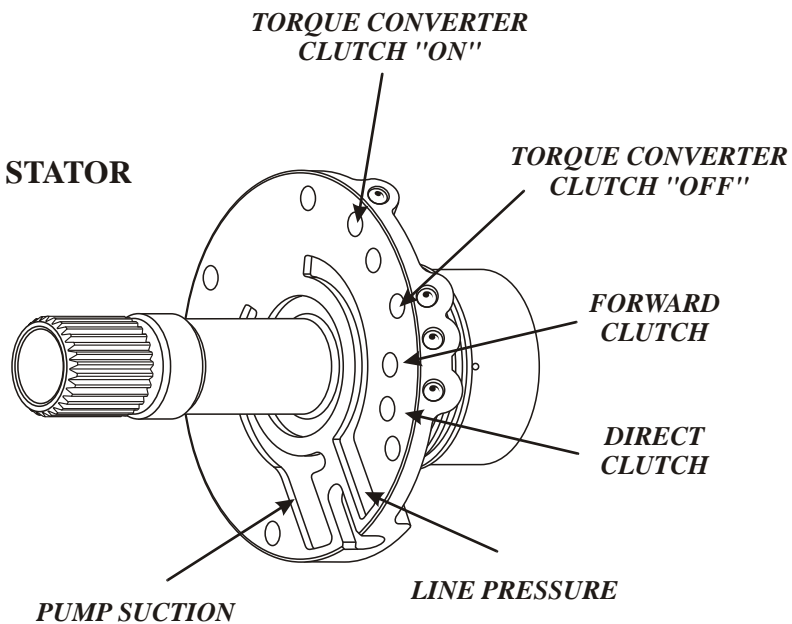
CAUSE : The cause may be, that the mating surface, as shown in Figure 1, between the Pump Body and the Pump Stator is not flat, causing a loss of line pressure and Torque Converter apply pressure. Refer to Figure 2 for port identification of the Pump Body and Pump Stator.

CORRECTION: To verify that the stator surface is flat, Pressurex[®] Film may be used. This is a product from Sensor Products Inc., which uses microcapsules of a paint like substance that changes color intensity depending on pounds per square inch. The higher the psi., the brighter the color. To repair this condition, have the face of the stator machined so that it is flat.

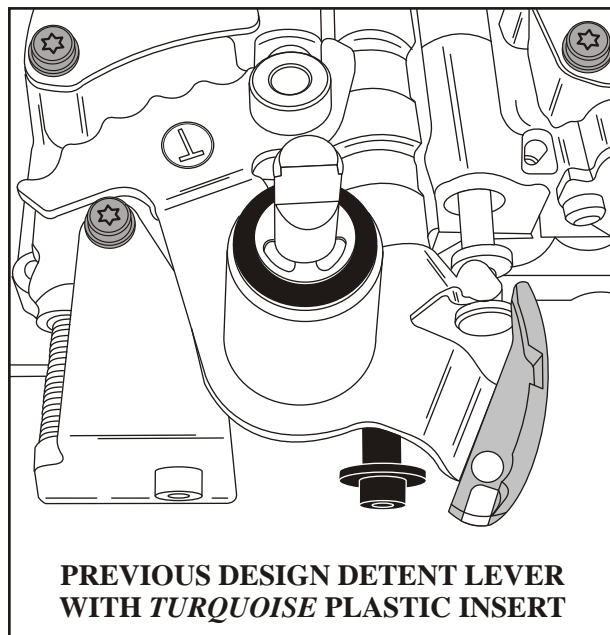
Figure 1

CAUSE: The safety neutral switch and the valve body detent lever changed for the 2000 model year. The switch is longer and the detent lever dimensionally changed to accommodate the new switch. Figures 1 and 2 show the dimensional differences between the previous and current design detent levers. Figures 3 and 4 illustrate the correct and incorrect assembly using the short switch. Figure 5 shows the correct assembly using the long switch.

CORRECTION: The detent lever with the **red** plastic insert goes with the **long** safety neutral switch. The detent lever with the **turquoise** plastic insert goes with the **short** safety neutral switch.
