1996 SEMINAR INFORMATION

## "THE BEST FIX IN '96"

AUTOMATIC TRANSMISSION SERVICE GROUP  
9200 S. DADELAND BLVD. STE 720  
MIAMI, FLORIDA 33156  
(305) 670-4161

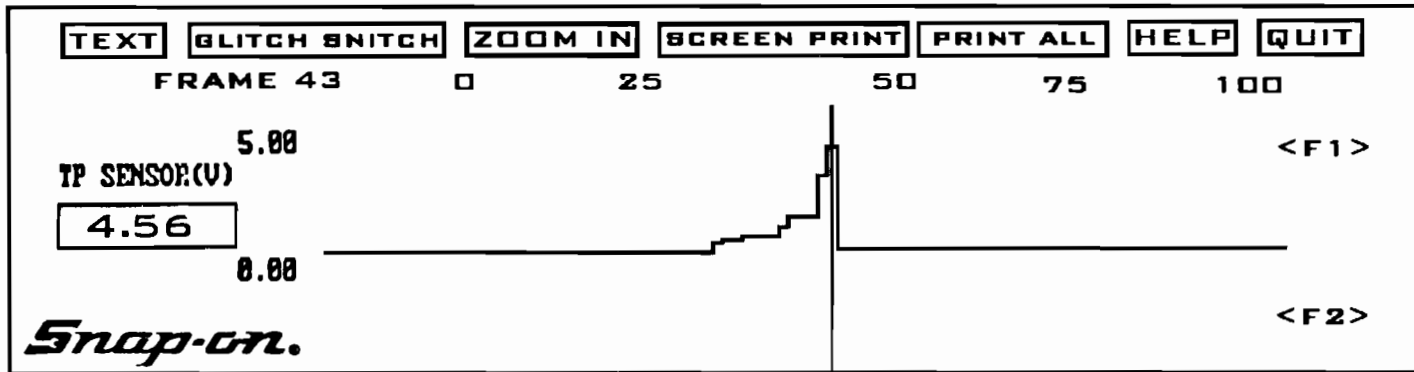
Figure 50

However, when an engine data movie frame is viewed, such as the one in figure 51, we can see that the TPS voltage has spiked to 4.56 volts for 2/10 of a second as shown in the graph in figure 50. The sensor was not out of range for a long enough period of time. This causes a symptom but not a code, which in this case caused the converter to unlock.  
Eventually a code 68 would be stored due to the converter remaining unlocked, which would be totally misleading.

SKEWED PATTERN...41% THROTTLE OPENING...ELAPSED TIME=2/10 SECOND

CORRECTION #1: A skewed sensor is typically caused by an outside influence such as a faulty engine rpm sensor or a faulty alternator.

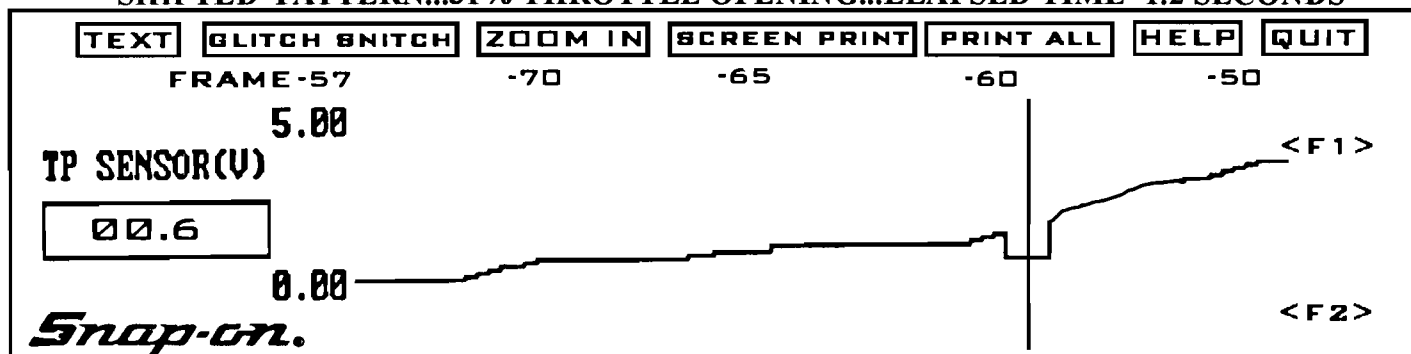
Figure 52

CAUSE #2: If the sensor skirts the spec or time operating window but does not go outside this window, this is a shifted sensor which is shown in the graph in figure 52 and in the Snap-on Scan-Gra-Fix® printout in figure 53.  
The TPS voltage is frozen at .6 volts for a little over a second. The printout in figure 53 indicates TCC unlocked, input and engine rpm went up drastically in frame -53, force motor amps went up causing a drop in line pressure and at 43 mph the transmission went to neutral because at that speed low gear is unobtainable.  
In frame -53 the transmission went to low gear due the TPS voltage drop.  
If this condition were to happen repeatedly, the complaint could be shift hunting.  
Once again, you have a symptom but no codes.

SHIFTED PATTERN...31% THROTTLE OPENING...ELAPSED TIME=1.2 SECONDS

CORRECTION #2: A shifted sensor is typically caused by the sensor which will require replacement.

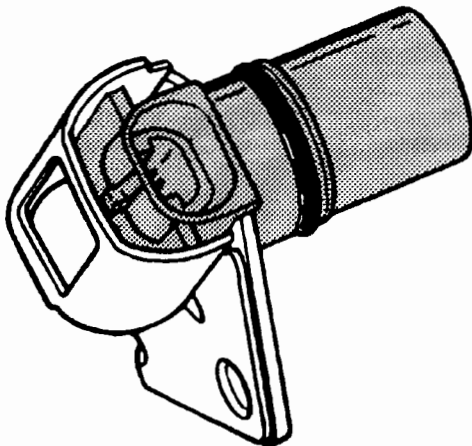
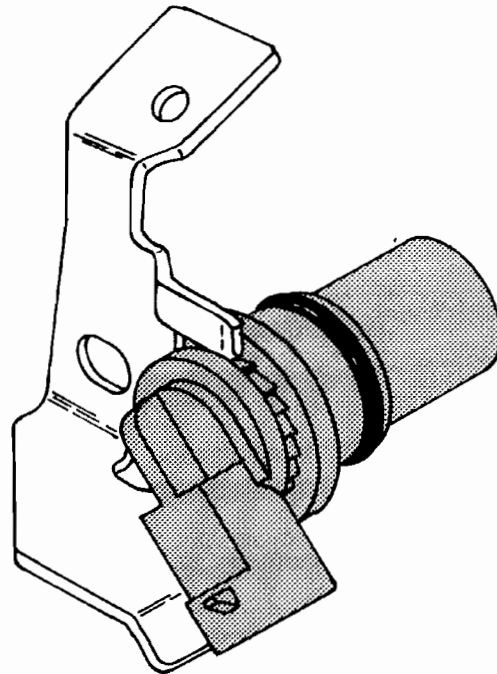
Figure 59

There is now available from G.M. Service Parts, a 4th design Turbine and Output Shaft Speed Sensor for the THM 4L80-E/4L80-EHD transmissions, as shown in Figure 59.

**PREVIOUS DESIGN LEVEL  
NO LONGER AVAILABLE**

**NEW DESIGN LEVEL  
PART NO. 24203876**

**SENSOR RESISTANCE SHOULD BE 1260-1540  
OHMS WHEN MEASURED AT 70°F.**

*Always replace the Turbine and Output Shaft Speed Sensors with the newest design level part.*

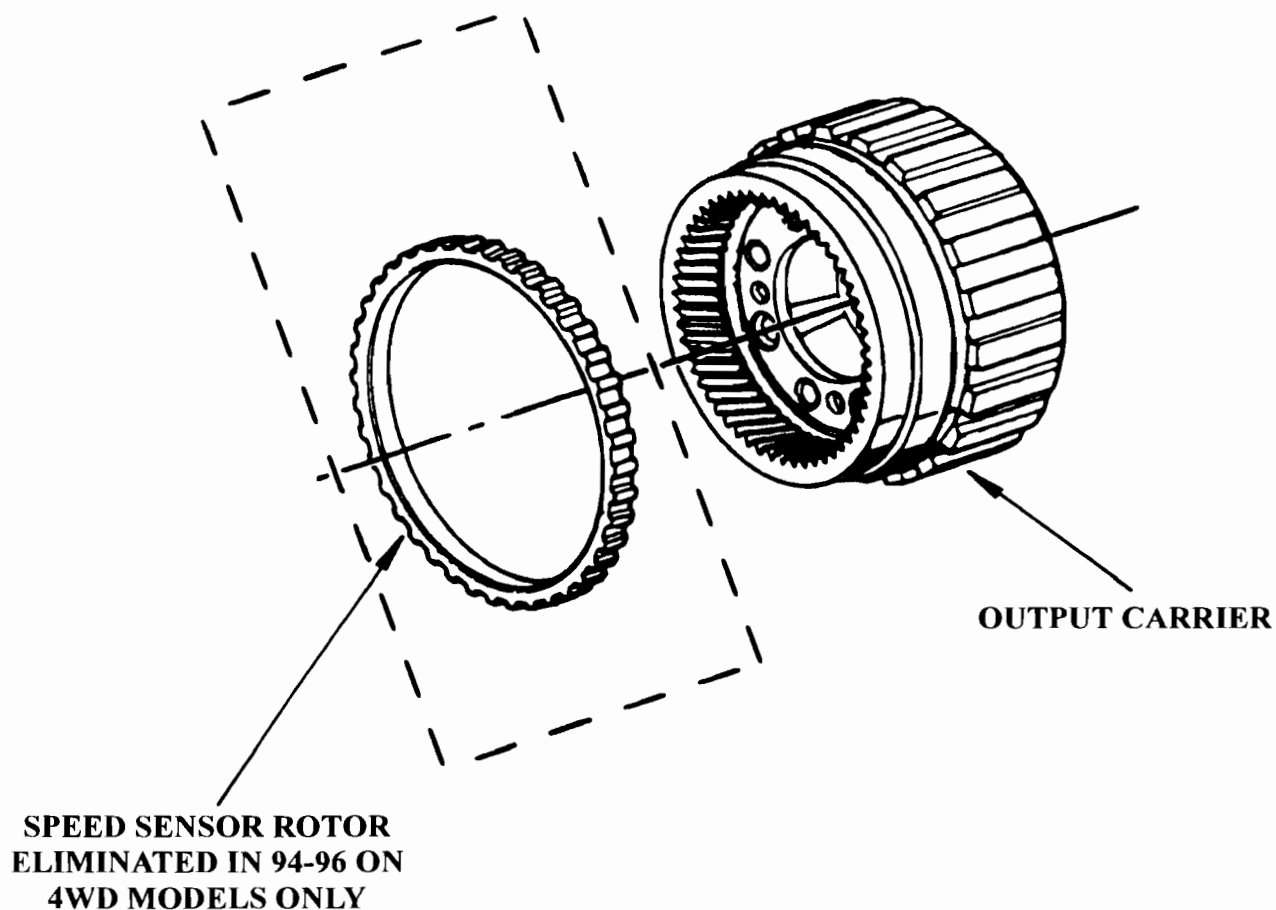
Figure 62

- (2) TRANSFER CASE SWITCH - Previously used to energize the front drive axle thermal actuator, now has an added set of contacts incorporated inside the switch, and an added wire to signal the PCM/TCM when the *4WD LOW* range has been selected (See Figure 61).
- (3) SPEED SENSOR ROTOR - Located on the Output Carrier, has been eliminated on *1994-1996 4WD models only*, as there is no longer any need for it, and is a cost savings. Extra care should be used to ensure that a late Output Carrier *without* the Speed Sensor Rotor, does not inadvertently get installed into a 2WD transmission (See Figure 62).

**CAUTION: TWO WHEEL DRIVE TRANSMISSIONS *MUST*  
HAVE SPEED SENSOR ROTOR INSTALLED.**

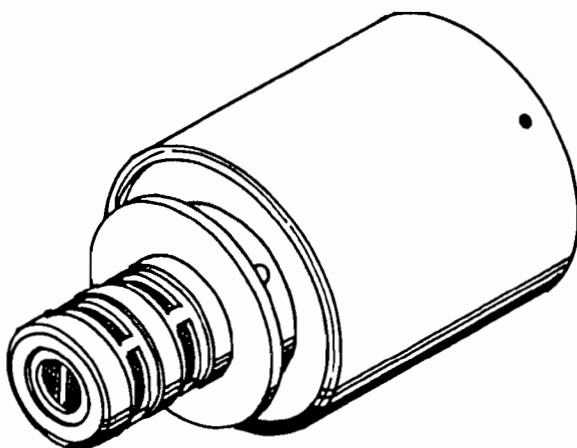
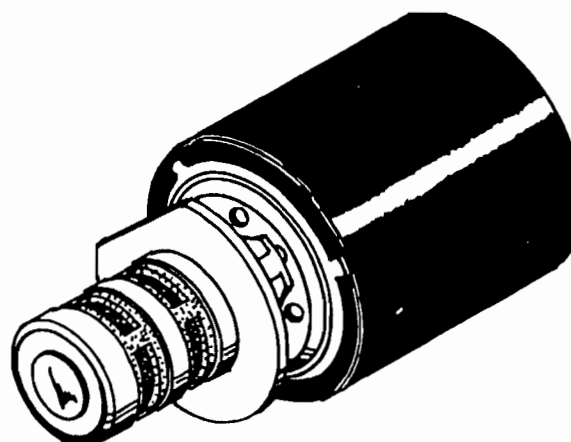
NEW PART NUMBER FOR THE  
FORCE MOTOR/PRESSURE CONTROL SOLENOID

G.M. PART NUMBER  
FOR THE BOSCH 8677314

CAN BE USED ON 4HP22  
(CANNOT BE USED ON 4HP24)

G.M. PART NUMBER  
FOR THE HOLLEY 24203101

USE THIS ONE ON  
ALL 4L80-E TRANSMISSIONS

BRACKET REQUIRED WHEN INSTALLING  
HOLLEY TO REPLACE THE BOSCH  
PART NUMBER 8684217

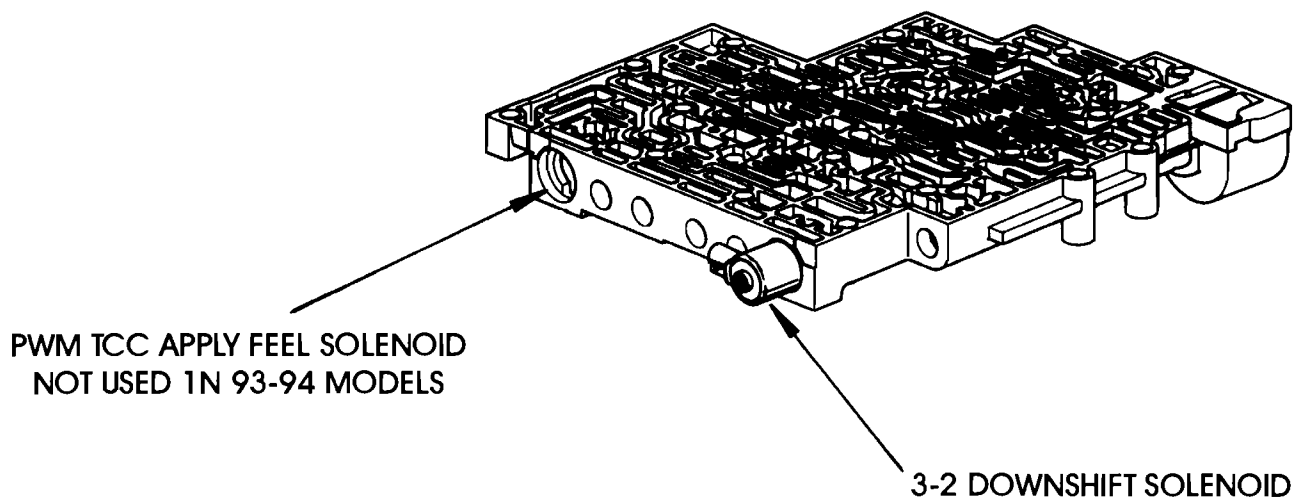
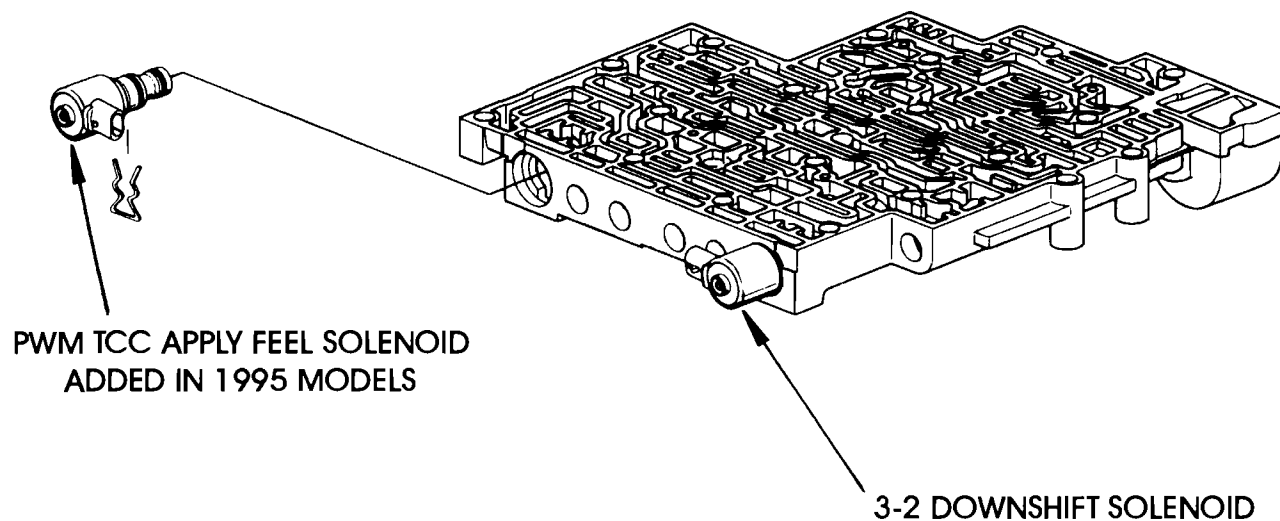
Figure 1

- (1) VALVE BODY CASTING - 1995 models are now machined to accept the added TCC PWM Solenoid, as shown in Figure 1. The added TCC PWM Solenoid is exactly the same and will interchange with the 3-2 downshift solenoid (See Figure 1).

**1993-1994 VALVE BODY  
WITH 3-2 DOWNSHIFT SOLENOID  
(REQUIRES "NON PWM" PUMP ASSEMBLY)**

**1995 VALVE BODY  
WITH 3-2 DOWNSHIFT SOLENOID  
AND TCC APPLY FEEL SOLENOID  
(REQUIRES "PWM" PUMP ASSEMBLY)**

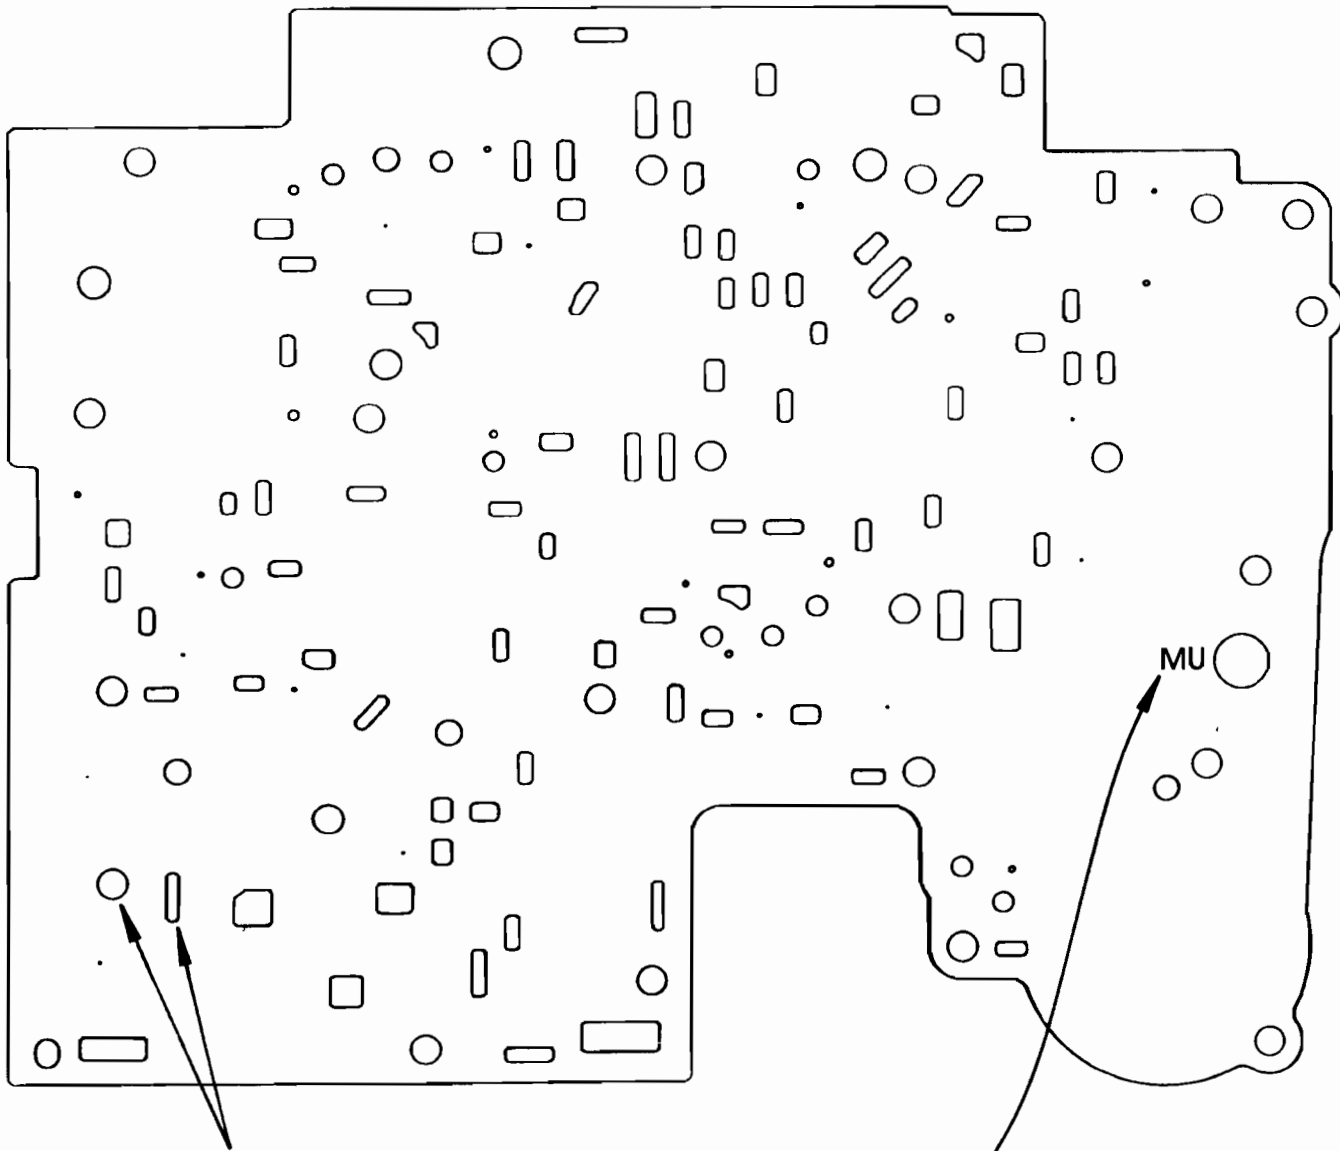
- (2) VALVE BODY SPACER PLATE - There were two holes added in the spacer plate to accommodate the added TCC PWM Solenoid as shown in Figure 2. The 1995 spacer plate can be identified with the first letter of the two digit code being either an "M" or "N", as shown in Figure 2. The first letter of the two digit code on the 1994 spacer plate will be "K" or "L". The 1993 spacer plate first letter will be "J". Refer to Figure 2 for location of the I.D. code stamped into the spacer plate

THESE TWO HOLES ADDED FOR 1995  
MODELS FOR TCC PWM SOLENOID

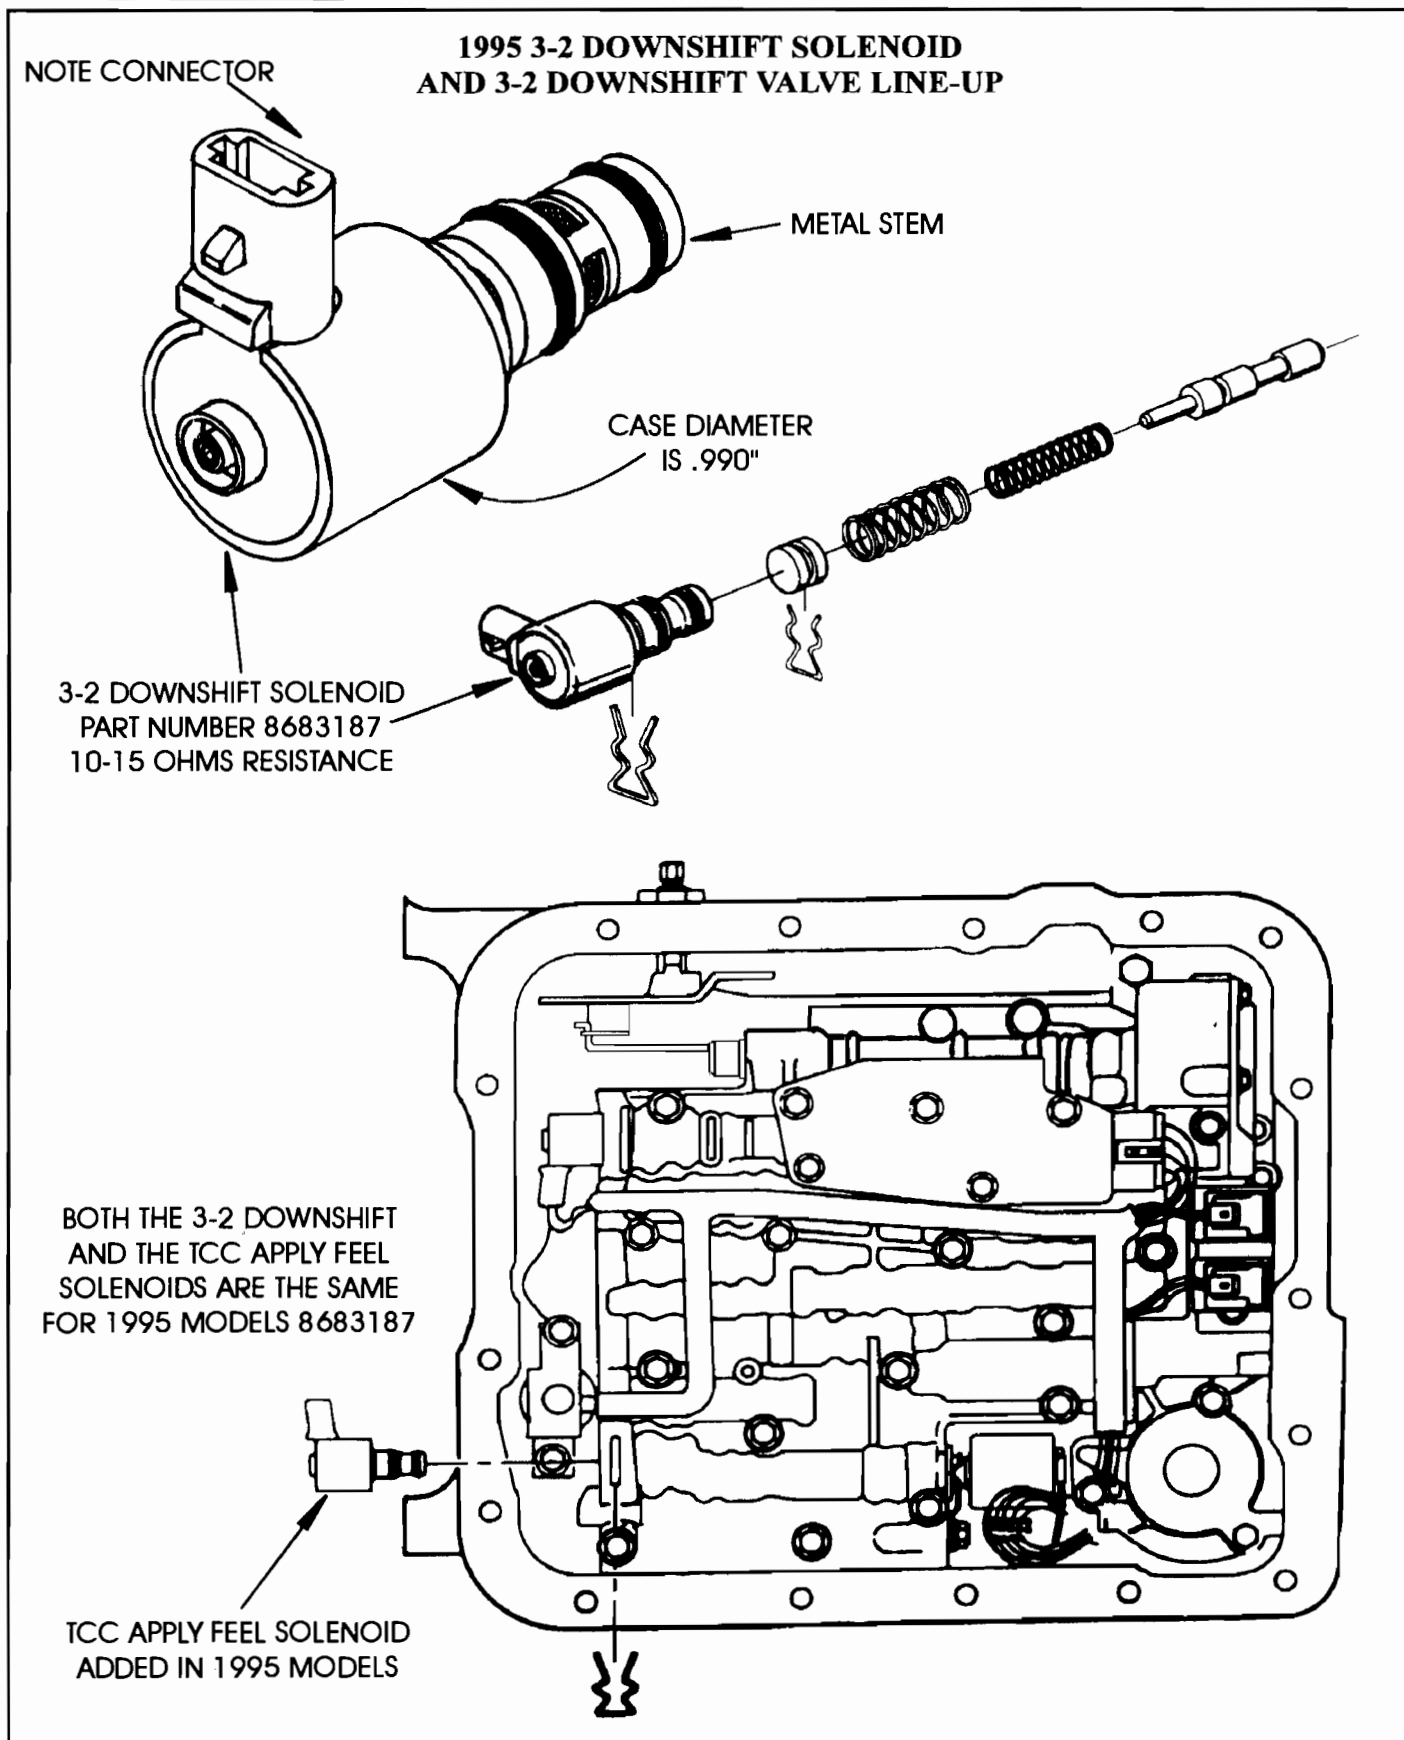
- (2) 3-2 DOWNSHIFT VALVE - The entire 3-2 downshift valve line-up changes to accommodate the new design "On-Off" 3-2 downshift solenoid. Refer to Figure 7 for 1995 models, and Figure 8 for 1996 models.

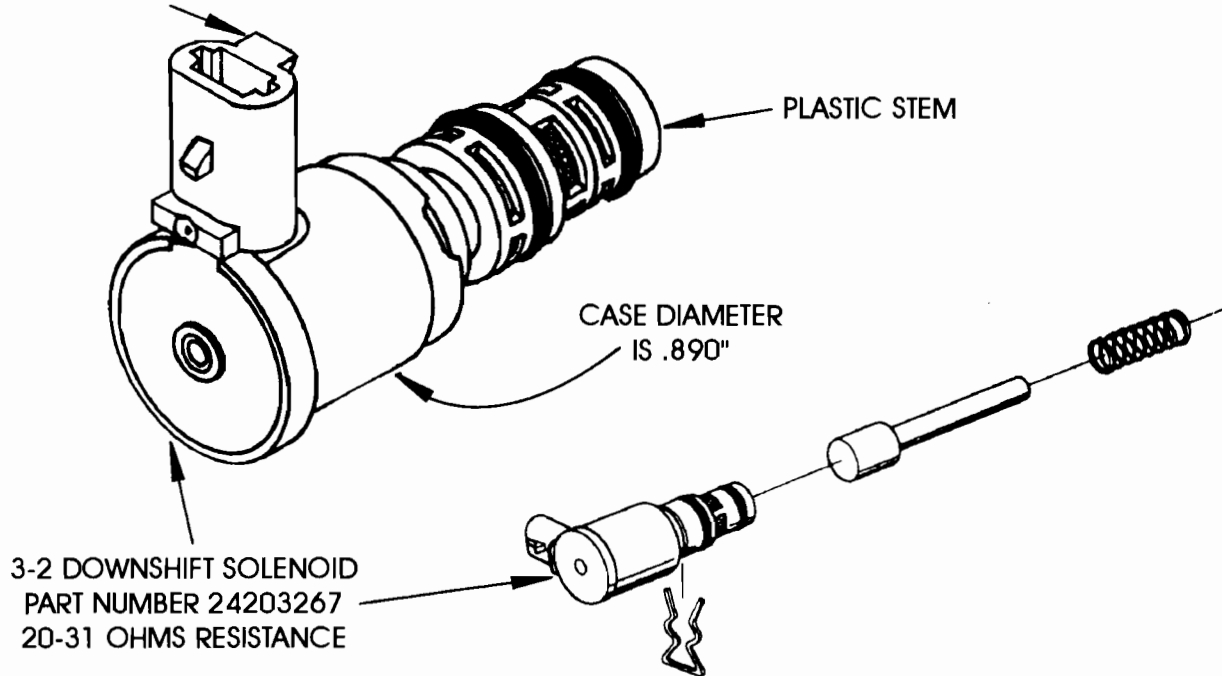
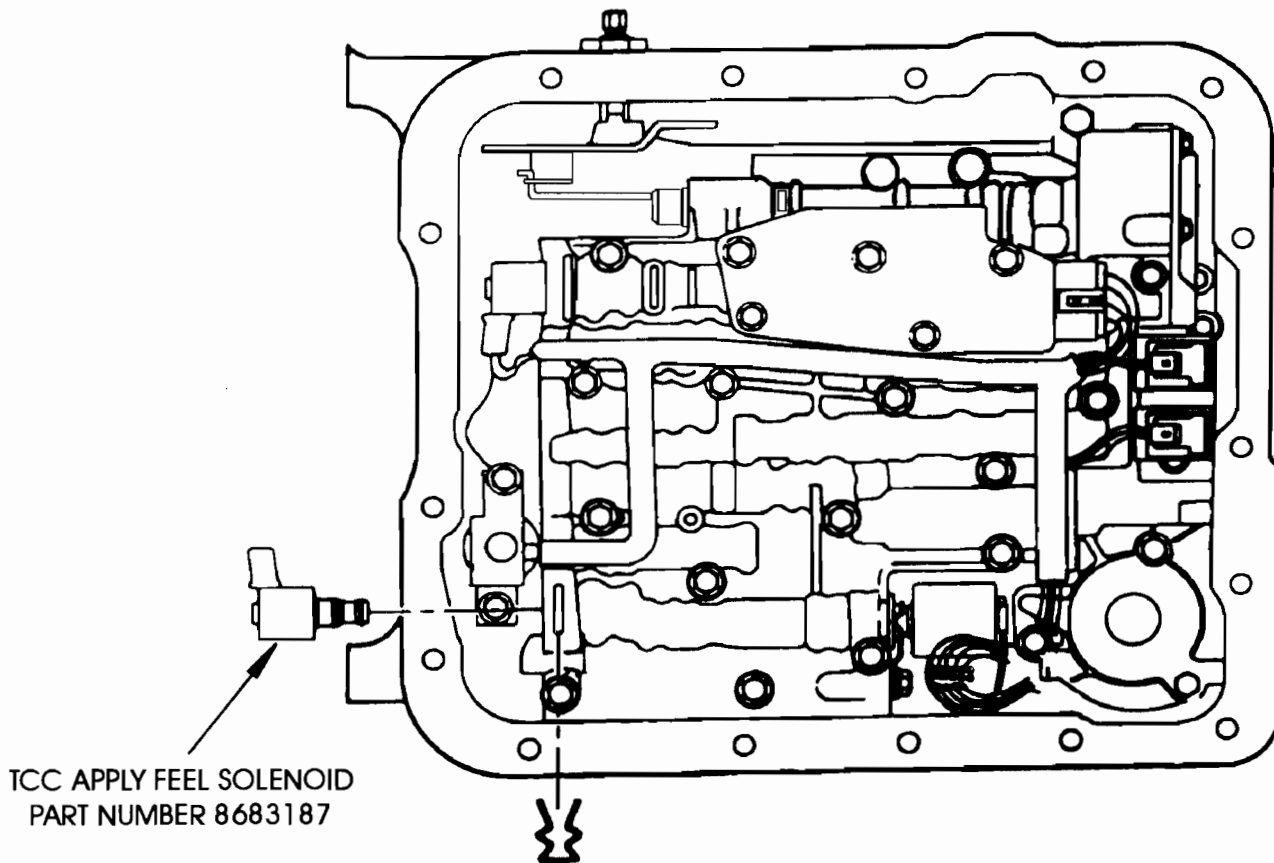
Figure 8

NOTE CONNECTOR  
CHANGES IN 1996

1996 3-2 DOWNSHIFT SOLENOID  
AND 3-2 DOWNSHIFT VALVE LINE-UP

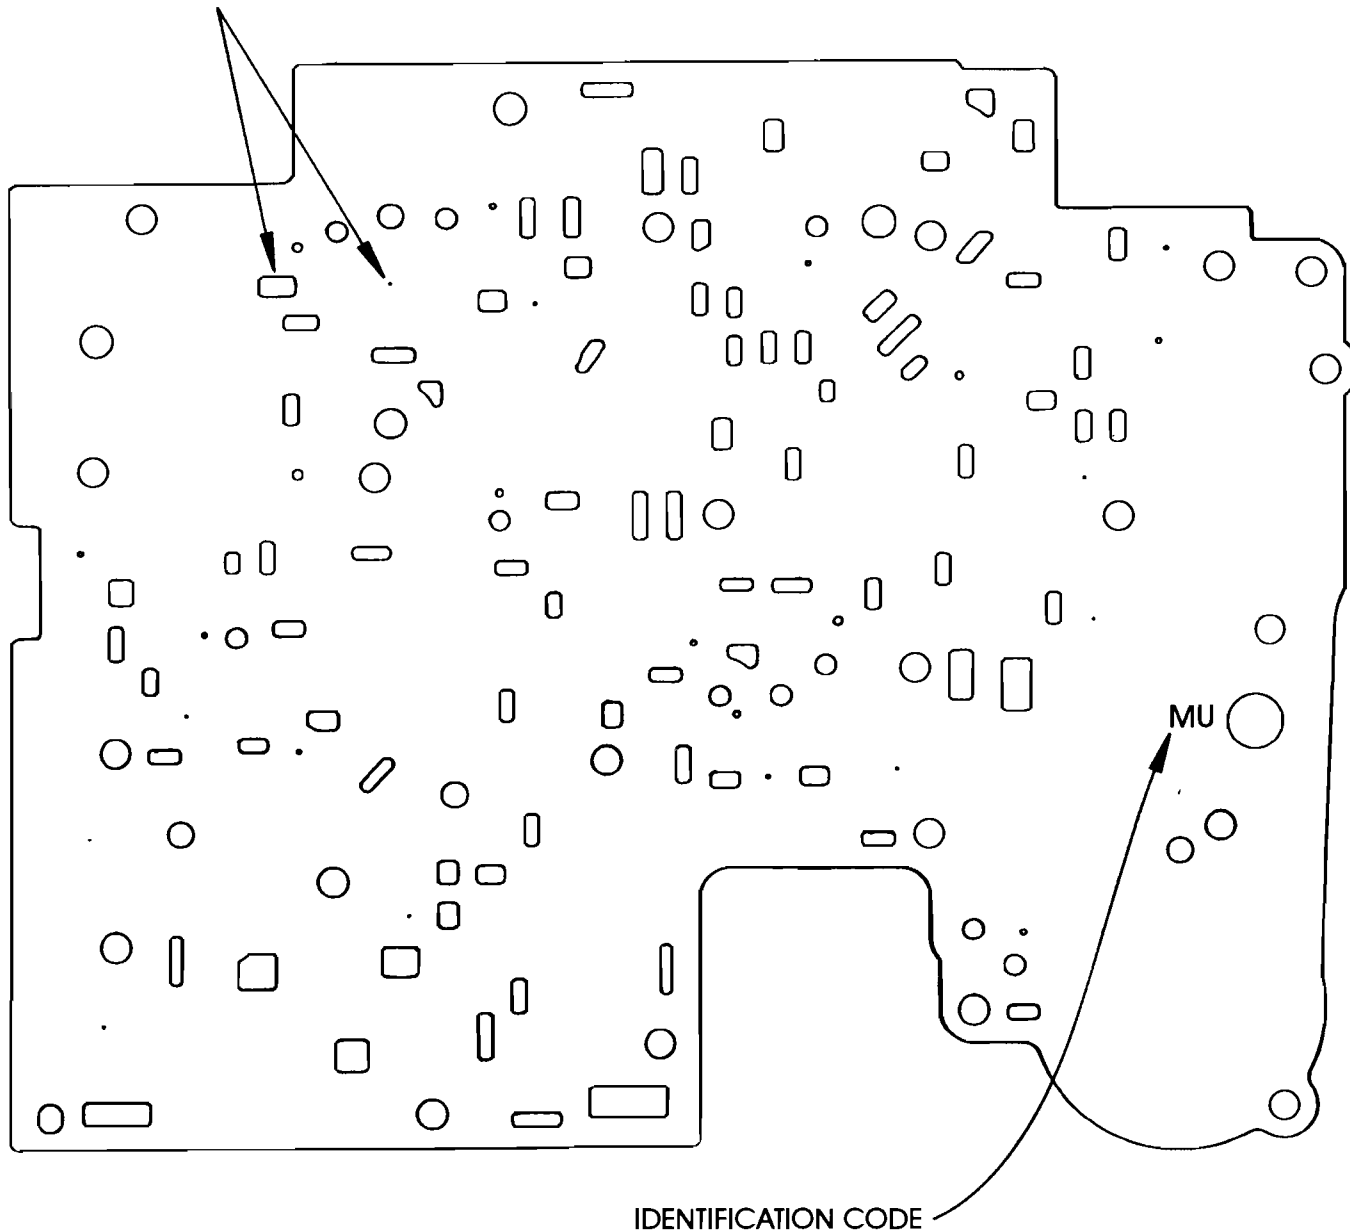
Figure 9

**1995 SPACER PLATE  
USES "PWM" 3-2 DOWNSHIFT SOLENOID**

THESE TWO HOLES ELIMINATED ON THE 1996 MODELS  
THAT USE THE "ON-OFF" 3-2 DOWNSHIFT SOLENOID

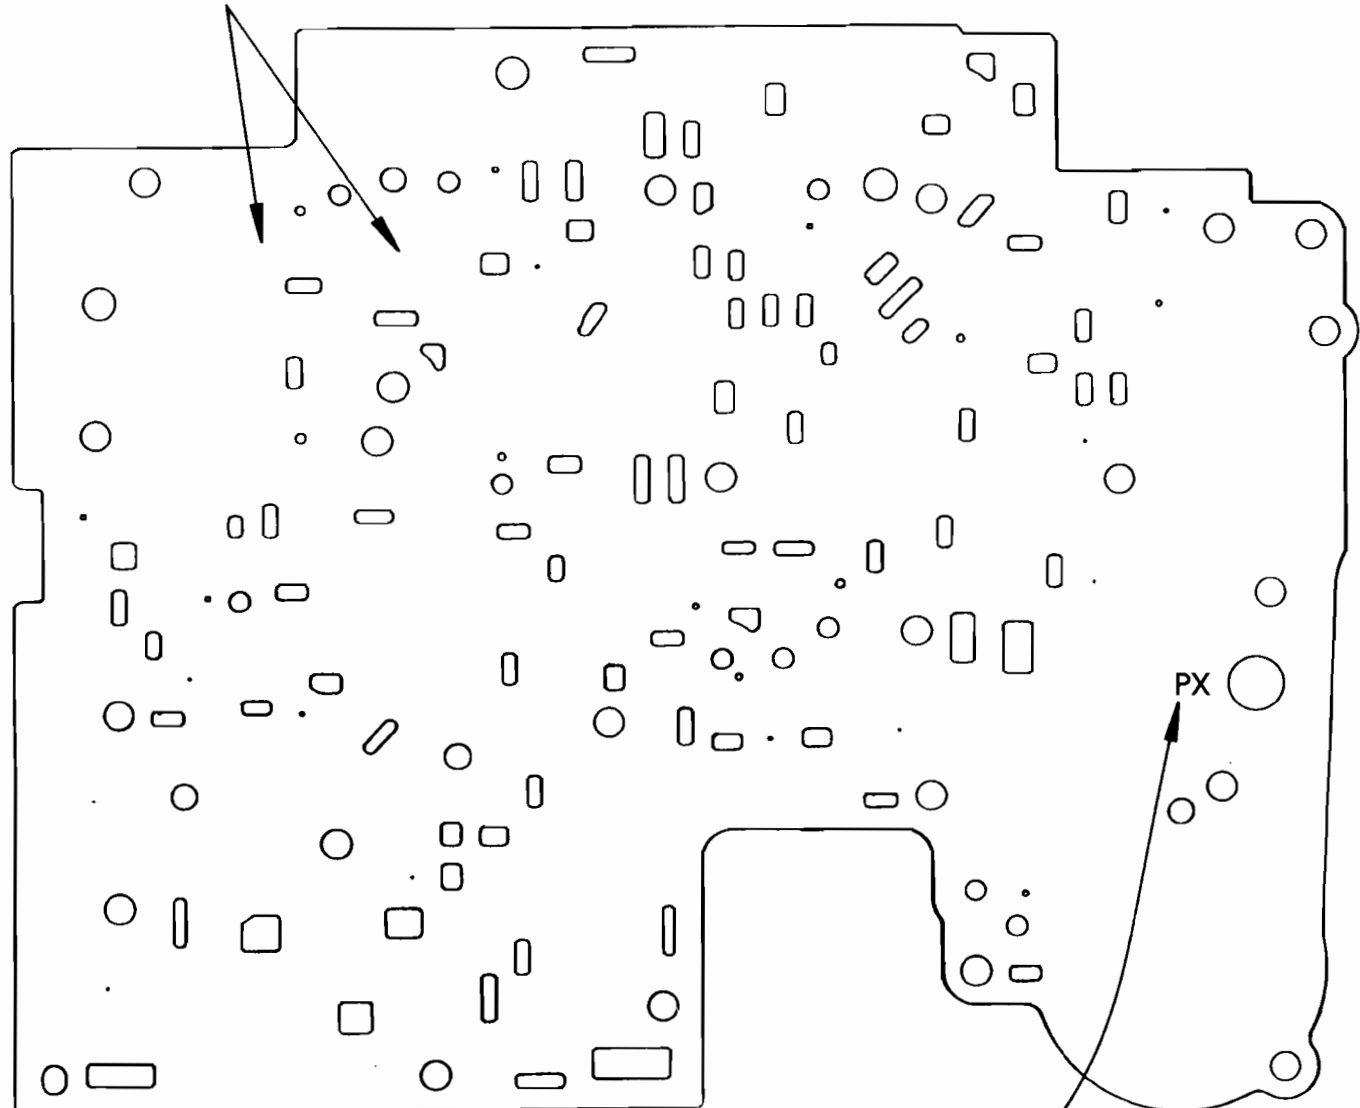
Figure 10

**1996 SPACER PLATE  
USES "ON-OFF" 3-2 DOWNSHIFT SOLENOID**

TWO HOLES ELIMINATED  
OVER 3-2 LINE-UP

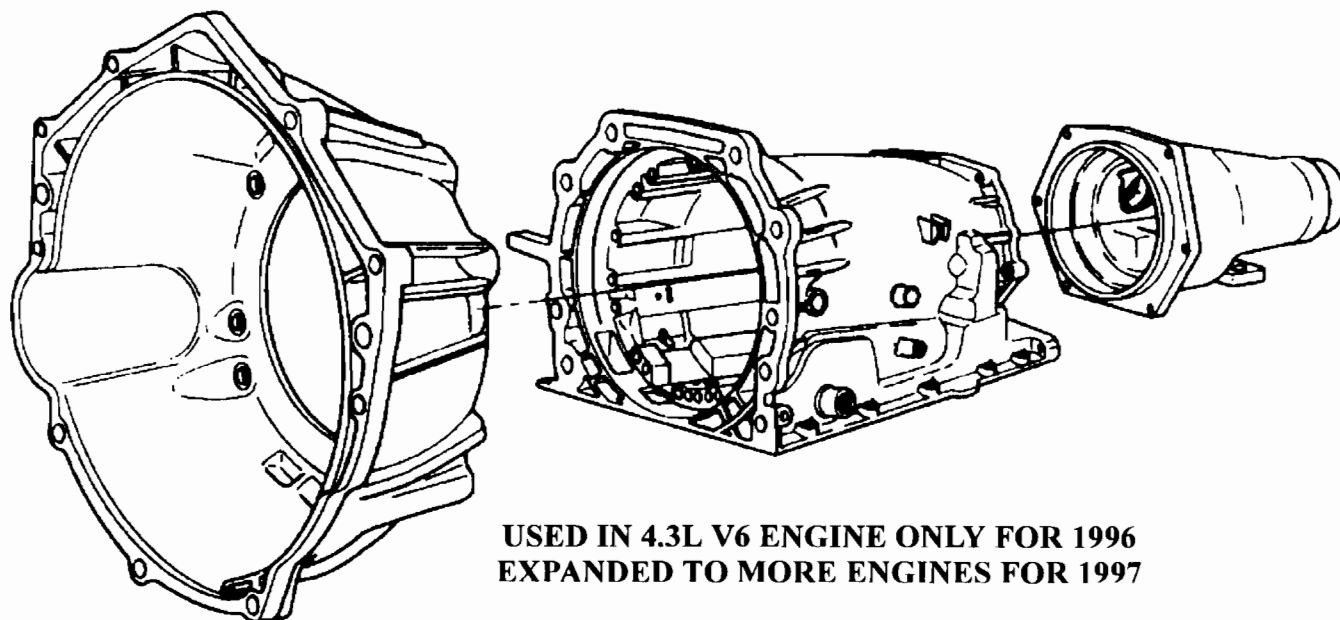
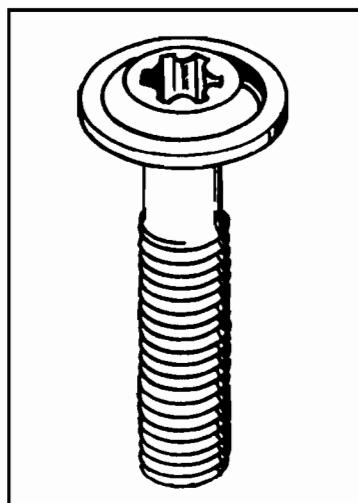
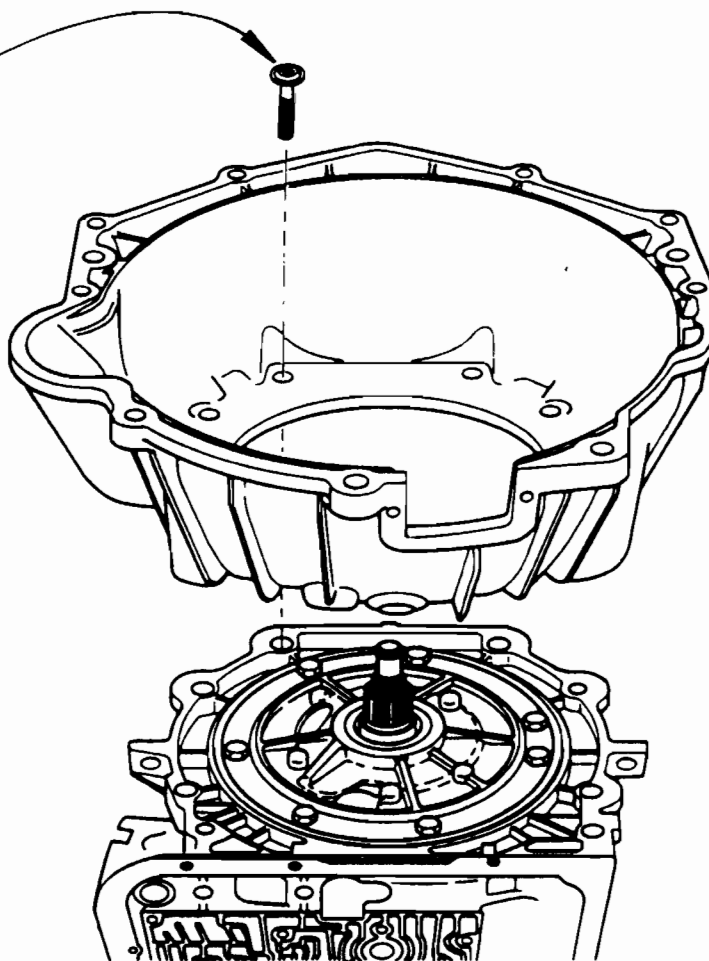
Figure 16

USED IN 4.3L V6 ENGINE ONLY FOR 1996  
EXPANDED TO MORE ENGINES FOR 1997

USE "TORX-PLUS 50-IP" BIT ONLY  
ON BELLHOUSING BOLTS

"TORX PLUS 50-IP"  
OK TO USE

50 TORX BIT  
DO NOT USE

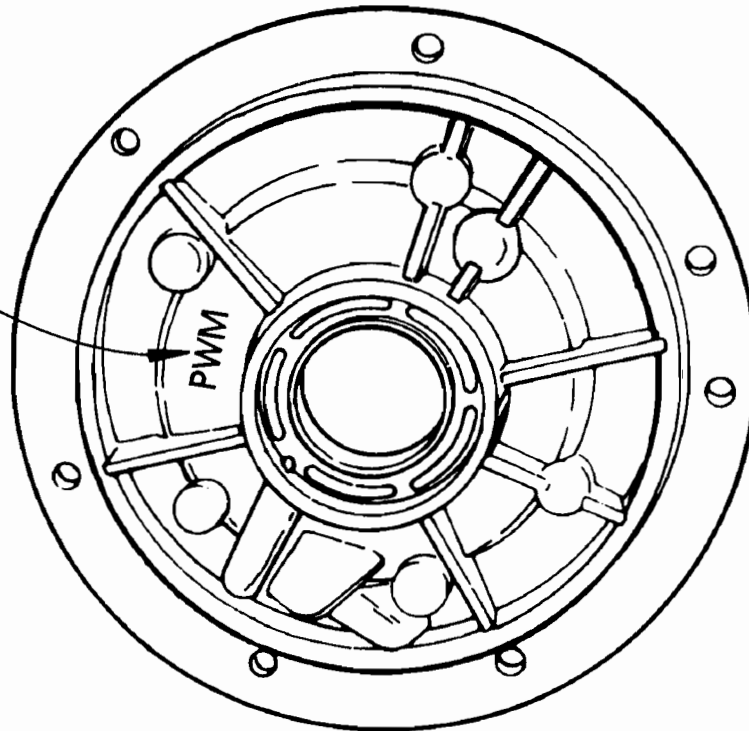
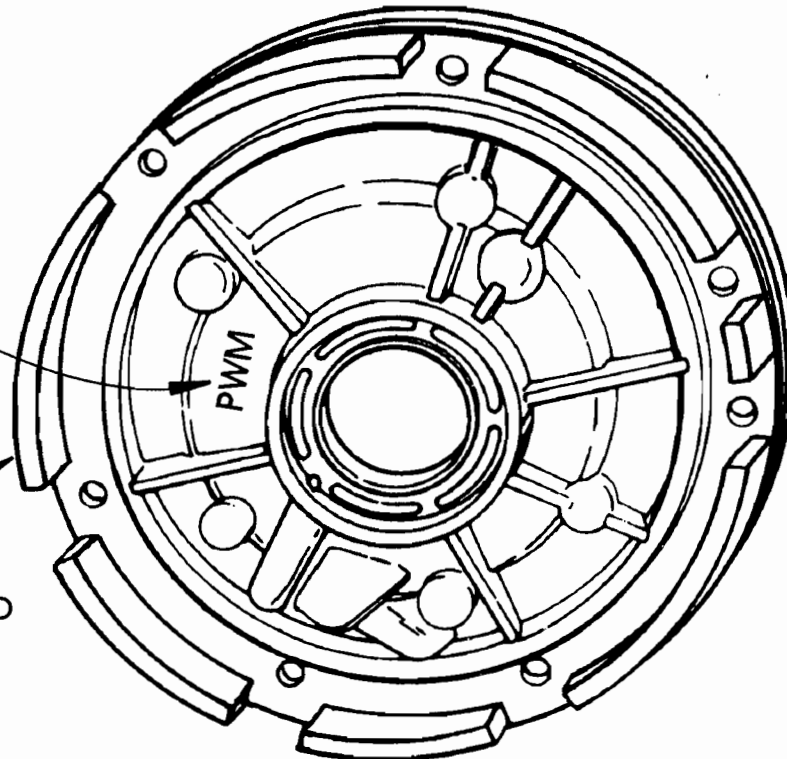
Figure 17

**1995-1996 "PWM" PUMP BODY  
FOR REGULAR CASE**

"PWM" CAST INTO PUMP BODY  
AND LOCATED HERE

**1996 "PWM" PUMP BODY  
FOR BOLT-ON BELL HOUSING**

ADDED MATERIAL AND MACHINED  
TO CENTER THE BELLHOUSING

All of the parts listed above are unique to the 1996 model 2-piece case. However, the pump body with the added machined ring, will be found in some 1995 models, and will back service to 1995 models *only*. It cannot be used in 93-94 models because of worm track cavity differences that occurred in 1995.

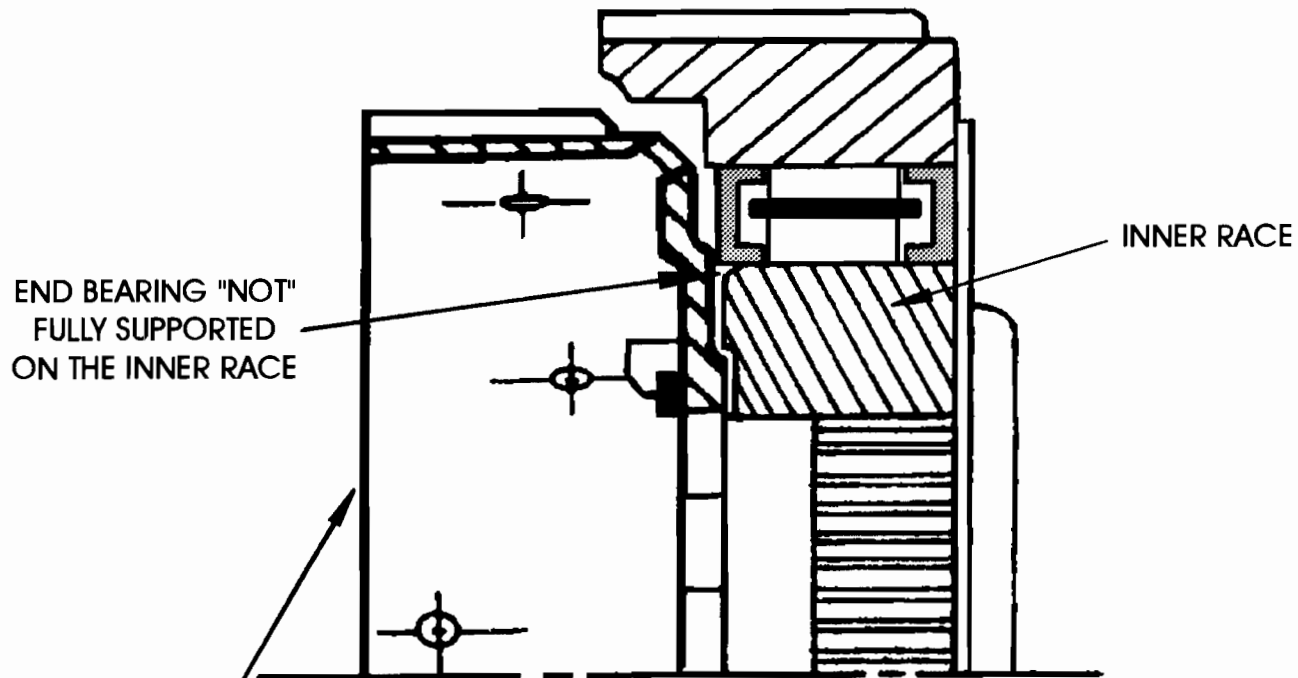
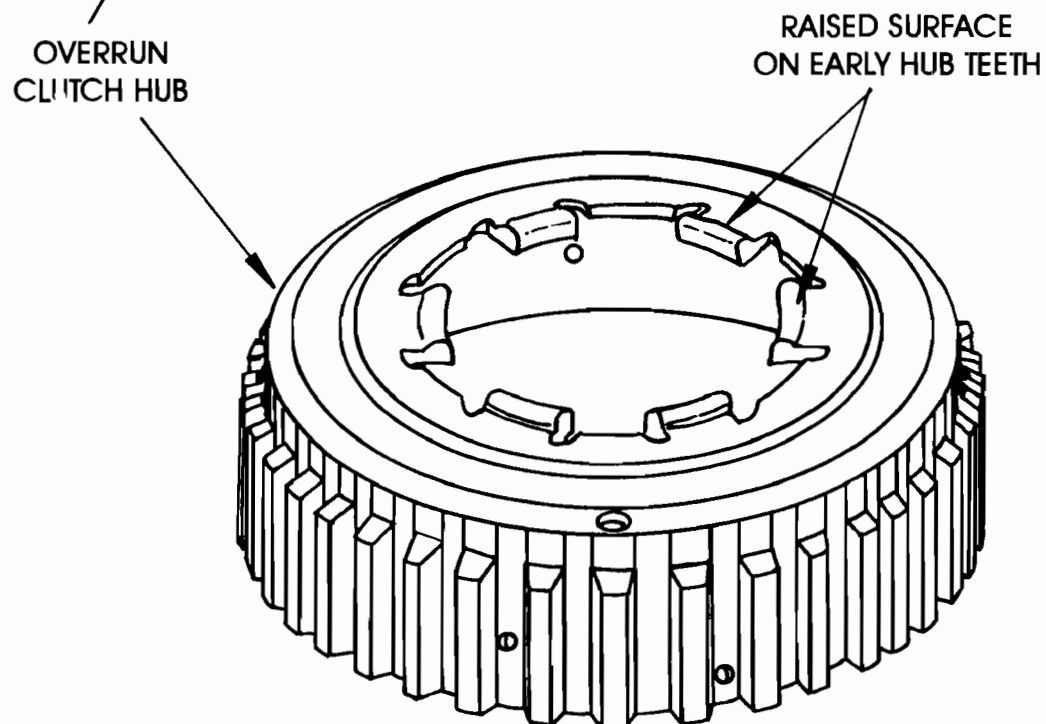
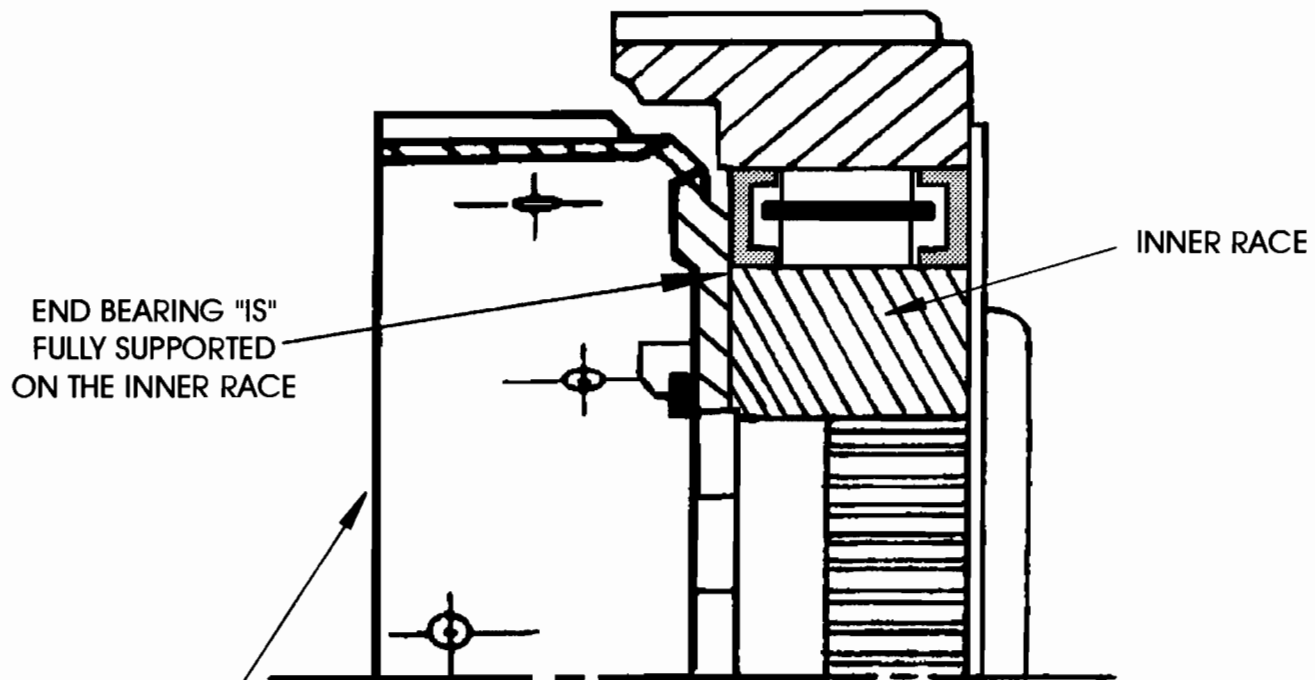
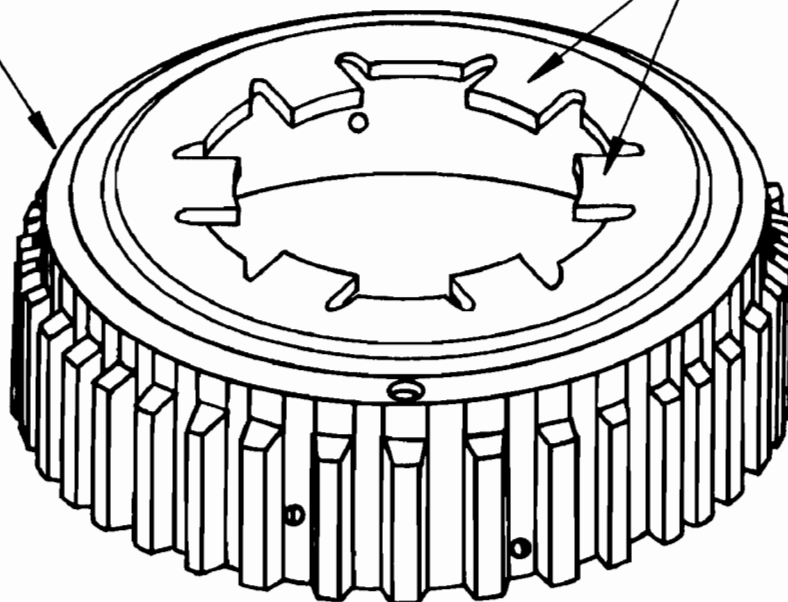
Figure 20

PREVIOUS "SKF" INPUT SPRAG

CURRENT "SKF" INPUT SPRAG

OVERRUN  
CLUTCH HUB

FLAT SURFACE  
ON LATE HUB TEETH

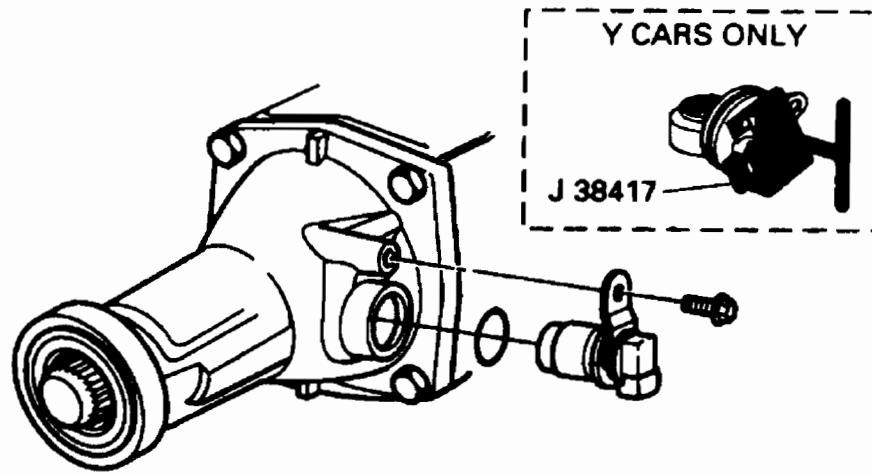
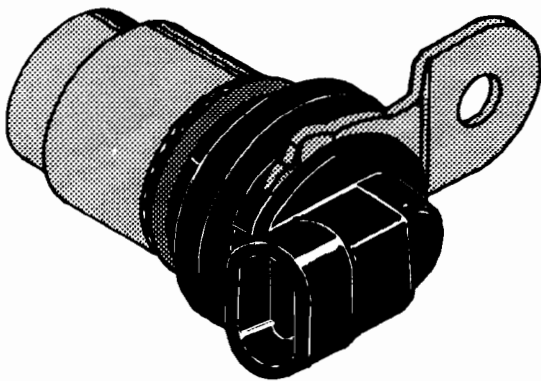
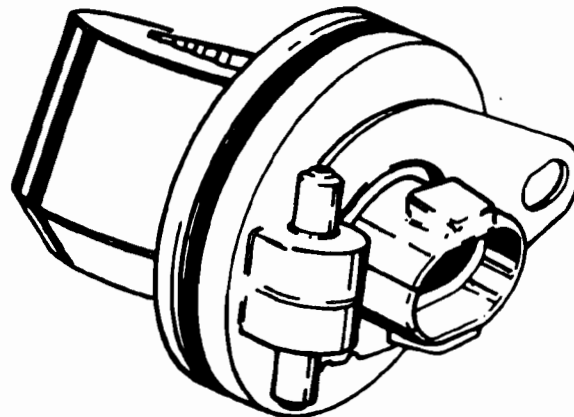
Figure 22

1996 SPEED SENSORS

**1996 SPEED SENSOR  
ALL "EXCEPT" CORVETTE  
PART NUMBER 10456194**

**1996 SPEED SENSOR  
CORVETTE ONLY  
PART NUMBER 8673299**

Output Shaft Speed Sensor (Previous Design) .....	8673299
Output Shaft Speed Sensor (1996 New Design) .....	10456194
