1996 SEMINAR INFORMATION

## "THE BEST FIX IN '96"

AUTOMATIC TRANSMISSION SERVICE GROUP  
9200 S. DADELAND BLVD. STE 720  
MIAMI, FLORIDA 33156  
(305) 670-4161

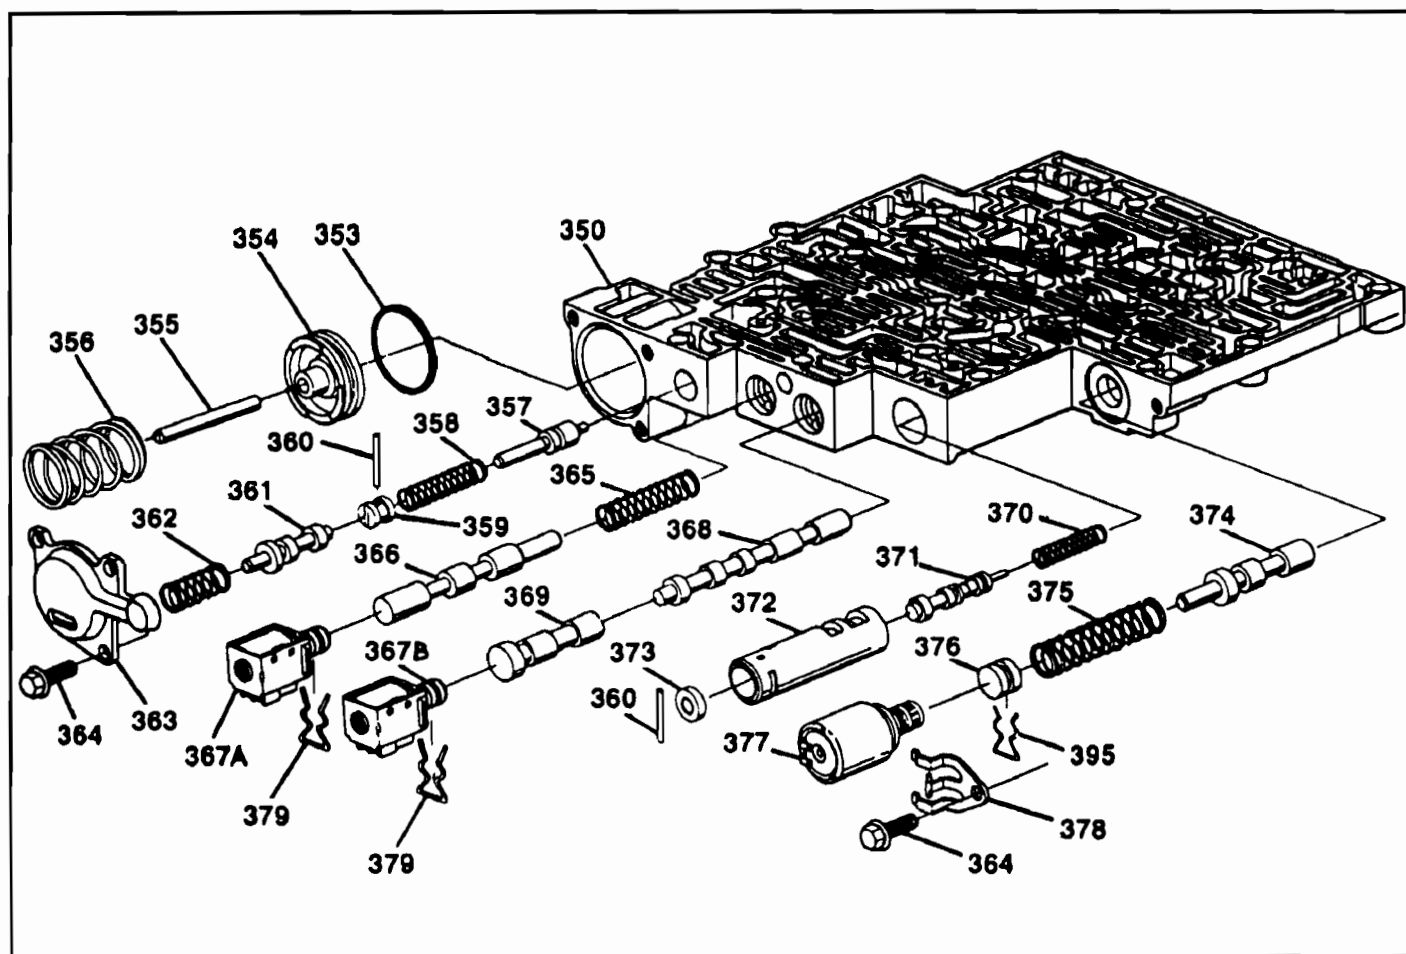
Figure 23

**COMPLAINT:** Some 1994 model vehicles, equipped with the THM 4L60-E transmission may exhibit a soft 1-2 upshift condition.

**CAUSE:** The cause may be, calibration of the 1-2 accumulator valve in the valve body.

1-2 Accumulator Valve Service Package ..... 24202698

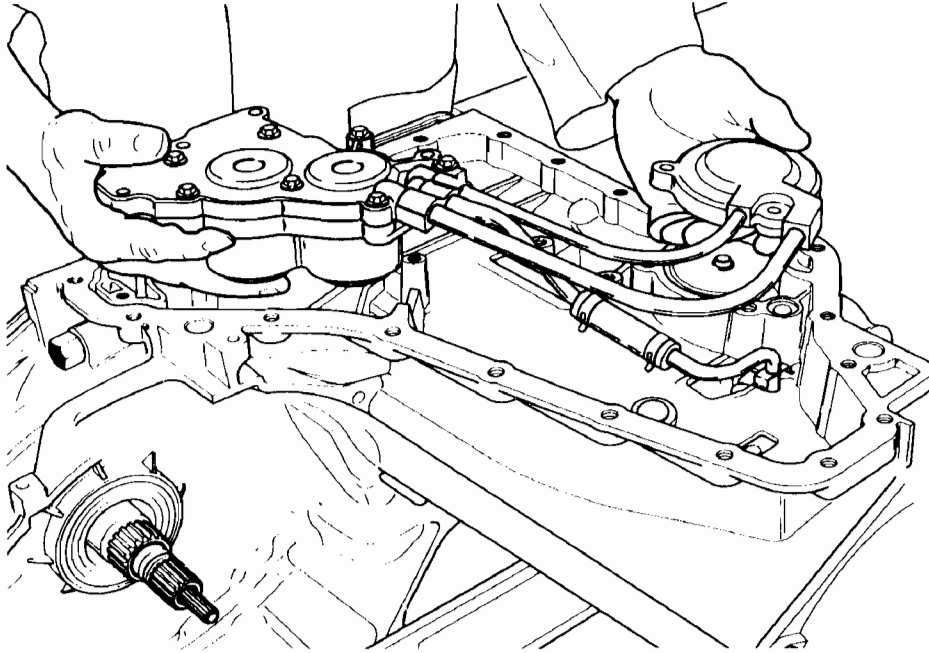
Figure 2

**COMPLAINT:** After rebuild, the vehicle displays a tie-up condition (In Gear) while the selector lever is in the Park position, a tie-up condition in Reverse, moves forward in Neutral, and a tie-up condition on the 2-3 shift.

**CAUSE:** The cause may be, the rear lube pipe and the apply pipe for the 2-1 manual servo, reversed in the accumulator housing cover (See Figure 2). This will allow lube oil to apply the 2-1 manual servo and the band as soon as the engine is started.

*Figure 2 shows the "Incorrect" assembly of the pipes.*

**"INCORRECT" INSTALLATION**

**REAR LUBE PIPE IS IN CENTER HOLE IN ACCUMULATOR COVER**

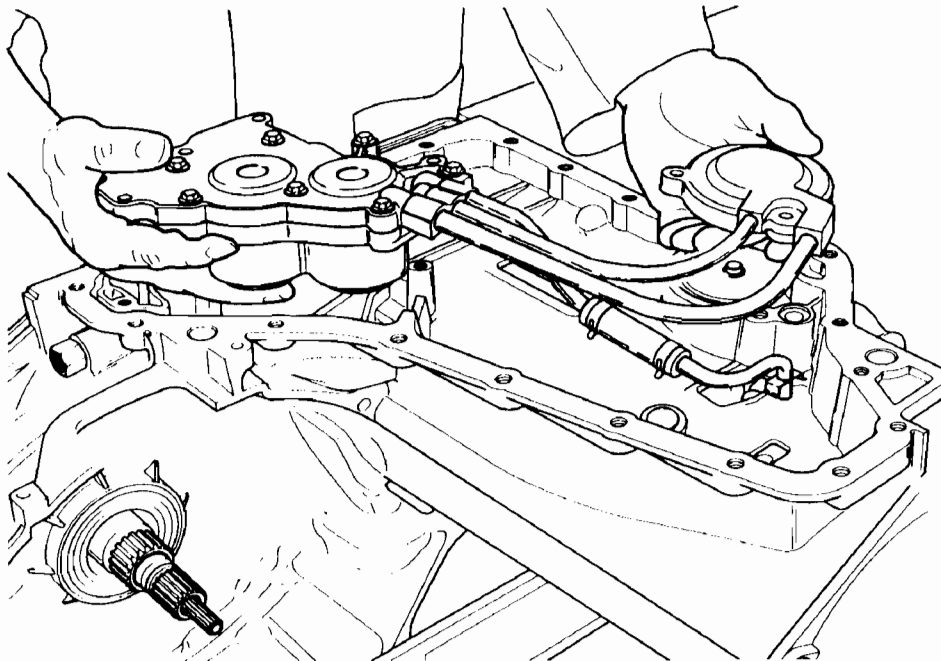
Figure 3

*Figure 3 shows the "Correct" assembly of the pipes.*

**"CORRECT" INSTALLATION**

**REAR LUBE PIPE IS IN RIGHT HOLE IN ACCUMULATOR COVER**

**CORRECTION:** Install the tubes into the accumulator housing cover with the 2-1 manual servo apply pipe in the "Center" hole, as shown in Figure 3, and the rear lube pipe in the right hand hole, as shown in Figure 3. The forward servo apply pipe cannot be installed in the wrong hole as it is a larger diameter than the other two.

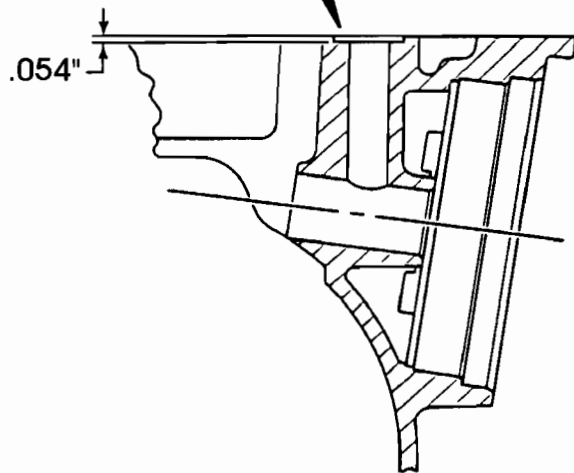
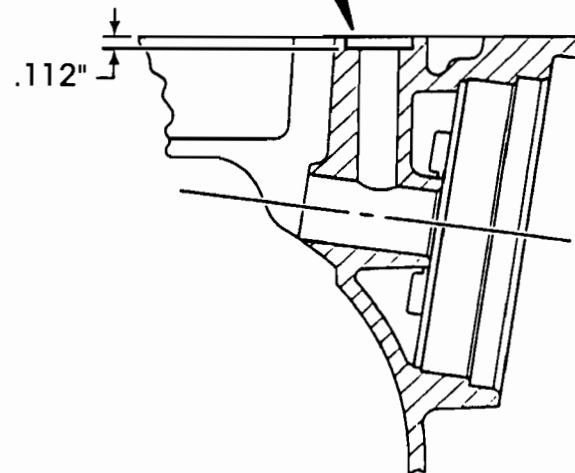
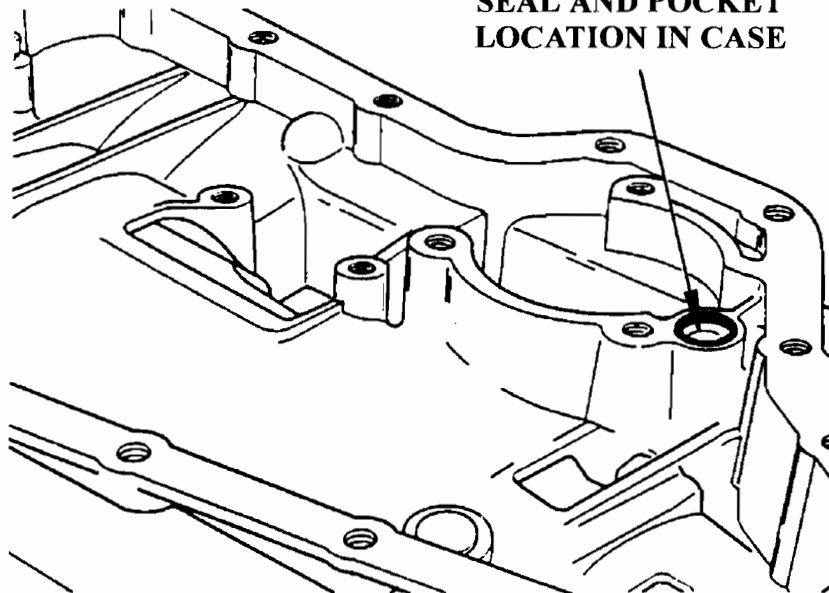
Figure 4

**CHANGE:** Beginning on February 20, 1995, approximately half way through the 1995 model year, all THM 4T60-E transaxles were built using a new design 2-1 servo square cut seal, which also required a deeper seal pocket in the transaxle case (See Figure 4). Since this was implemented as a running change about half of the 95 models will require the previous seal and the other half will require the new design seal.

- (1) 2-1 SERVO "SQUARE CUT" SEAL - New design square cut seal was made twice as tall as the previous design seal. The new design square cut seal measures .132" tall, and the previous design measures .066" tall, as shown in Figure 4. The wall thickness and seal diameter did not change. This seal retains drive oil in the forward servo circuit to apply the forward band.
- (2) TRANSAXLE CASE - The seal pocket in the case was machined deeper to accommodate the new design square cut seal. The new design seal pocket measures .112" deep, and the previous design seal pocket measures .054" deep, as shown in Figure 4.

CASE SEAL POCKET

**NEW DESIGN  
PARTIAL 1995-1996**

**SEAL AND POCKET  
LOCATION IN CASE**

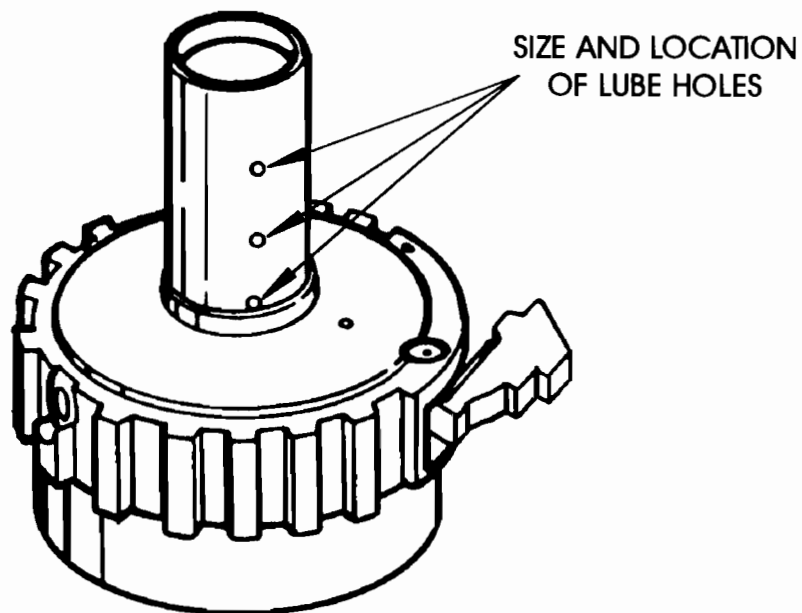
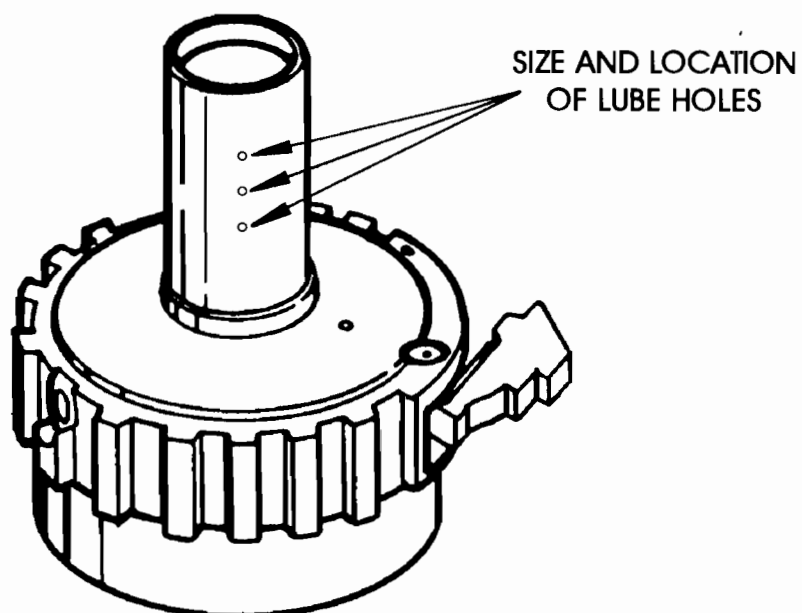
Figure 7

- (8) FINAL DRIVE RING GEAR - Revised lubrication hole sizes and locations in support to accommodate the new design 1-2 roller clutch assembly, as shown in Figure 7.

**1991-1995 FINAL DRIVE  
RING GEAR SUPPORT**

**1996 FINAL DRIVE  
RING GEAR SUPPORT**

The new design 1-2 Roller Clutch Assembly will back service all THM 4T60-E transaxles to 1991, however, *all* parts listed above *must* be used as a package.

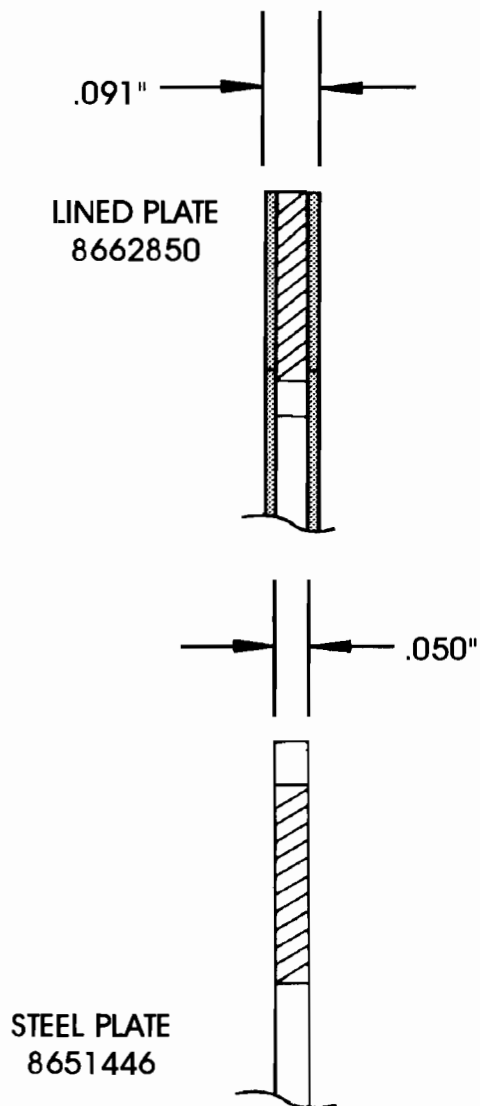
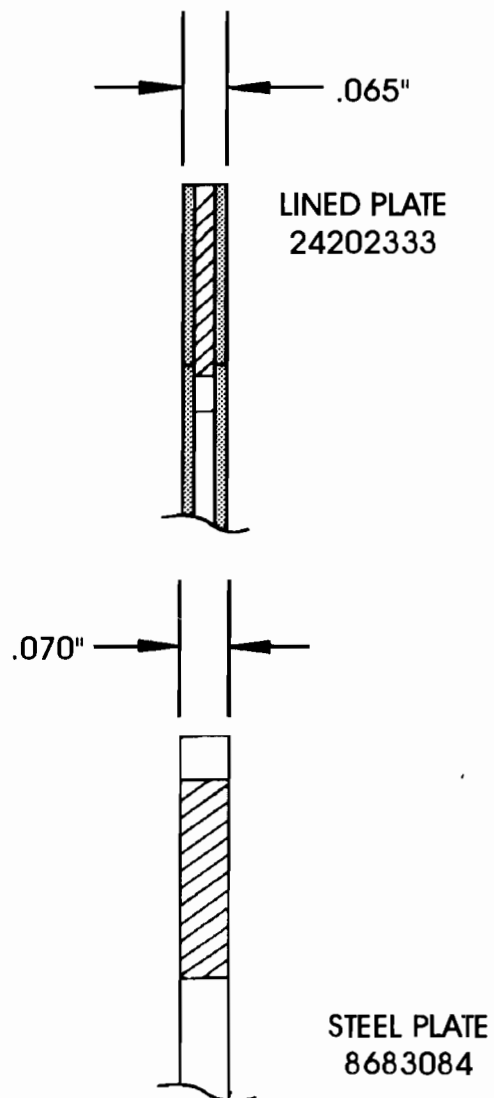
Figure 8

- (1) INPUT CLUTCH LINED PLATES - Were made thinner by approximately .026" to accommodate the thicker steel plates. The new design input clutch lined plates are approximately .065" thick, and the previous design lined plates are approximately .091" thick, as shown in Figure 8.
- (2) INPUT CLUTCH STEEL PLATES - Were made thicker by approximately .020" to improve heat displacement and thereby improve durability. The new design input clutch steel plates are approximately .070" thick, and the previous design steel plates are approximately .050" thick, as shown in Figure 8. The new design input clutch steel plates are now the same as the 3T40 (125C) steel plates.

# INPUT CLUTCH PLATES

## PREVIOUS DESIGN

## NEW DESIGN

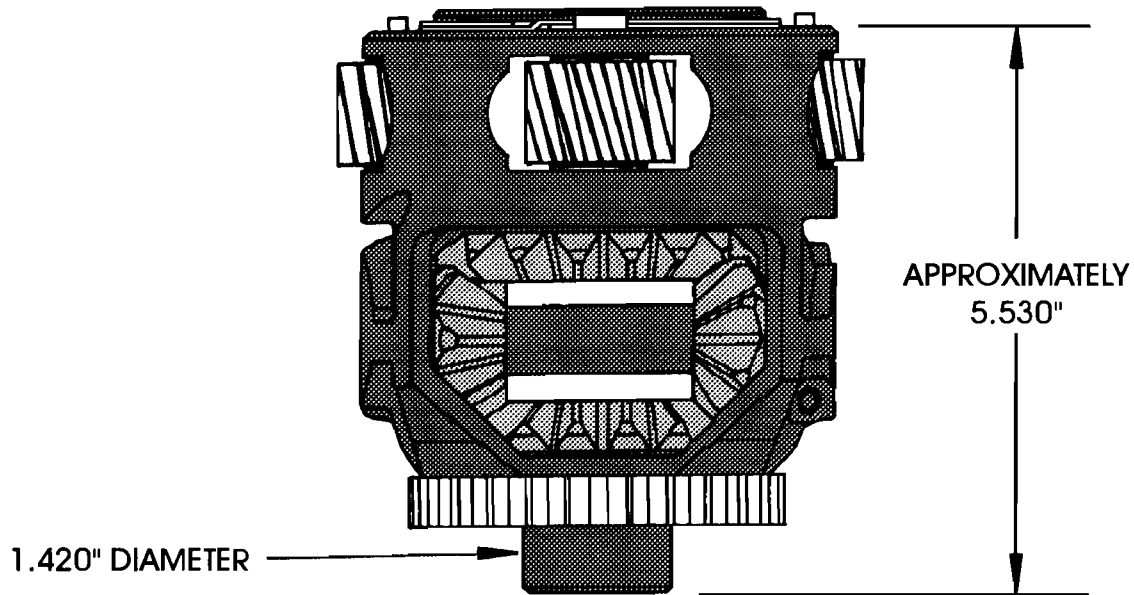
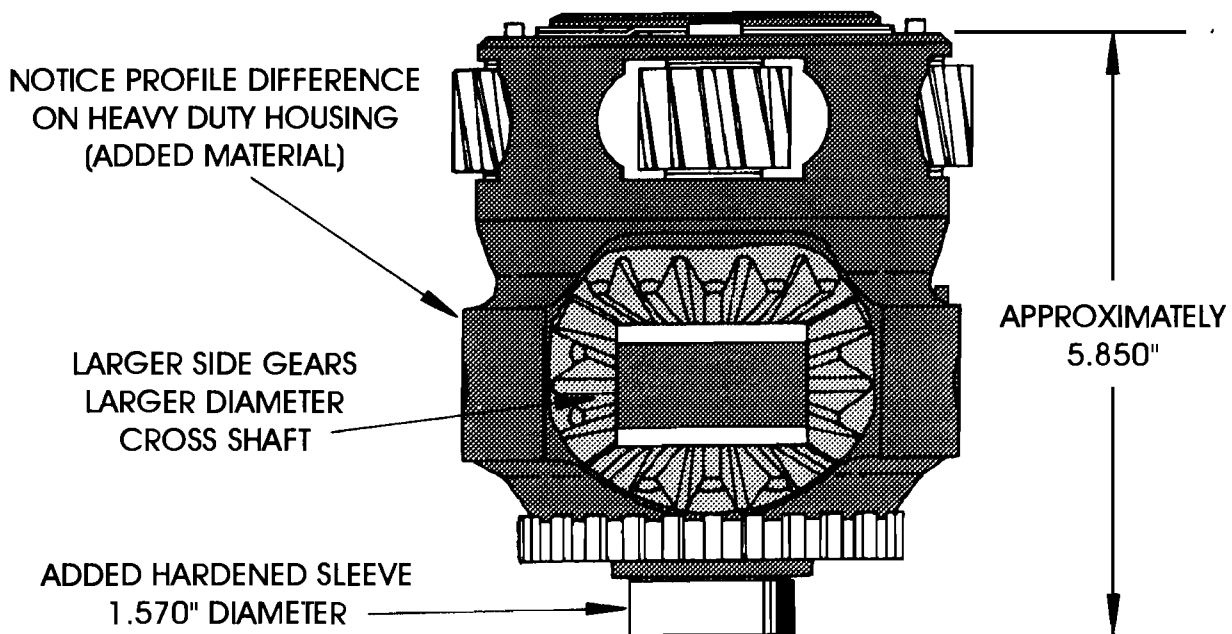
- (1) **FINAL DRIVE ASSEMBLY** - The final drive housing has added material in the cross shaft area, is longer than the previous model, has larger side gears and pinion gears, has a larger diameter cross shaft, and a hardened sleeve added that rides in a new Torrington bearing in the final drive housing. Refer to Figure 12 for comparisons between the previous and new design.

**CURRENT FINAL DRIVE HOUSING**

**HEAVY DUTY FINAL DRIVE HOUSING  
FOR SUPERCHARGED APPLICATIONS**

*None* of the parts listed above will back service *any* previous model 4T60-E transaxle. All of these parts are unique to the supercharged models.

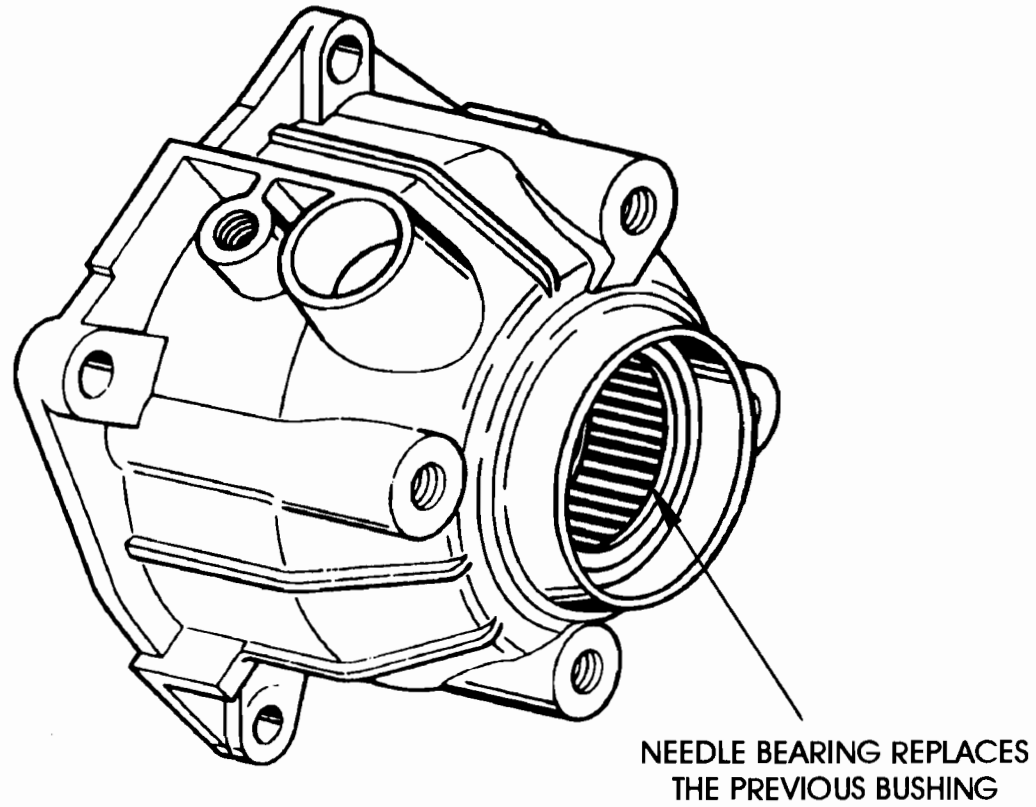
Figure 13

- (2) **FINAL DRIVE HOUSING** - Now a different dimension to accommodate the new design final drive assembly and has an added needle bearing that replaces the previous design bushing, and is shown in Figure 13.

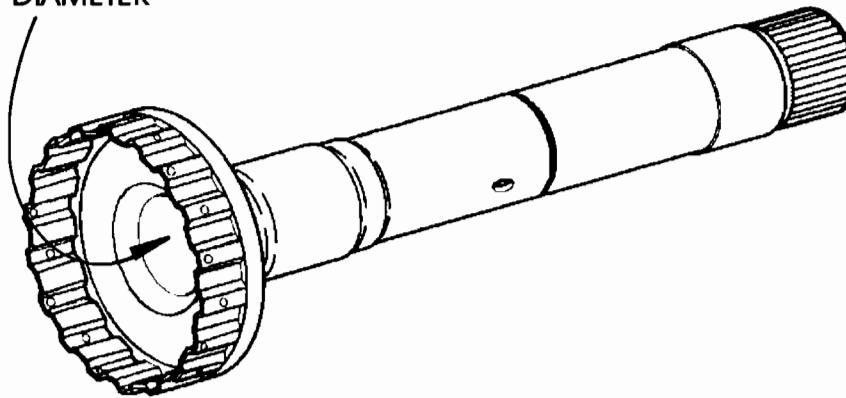
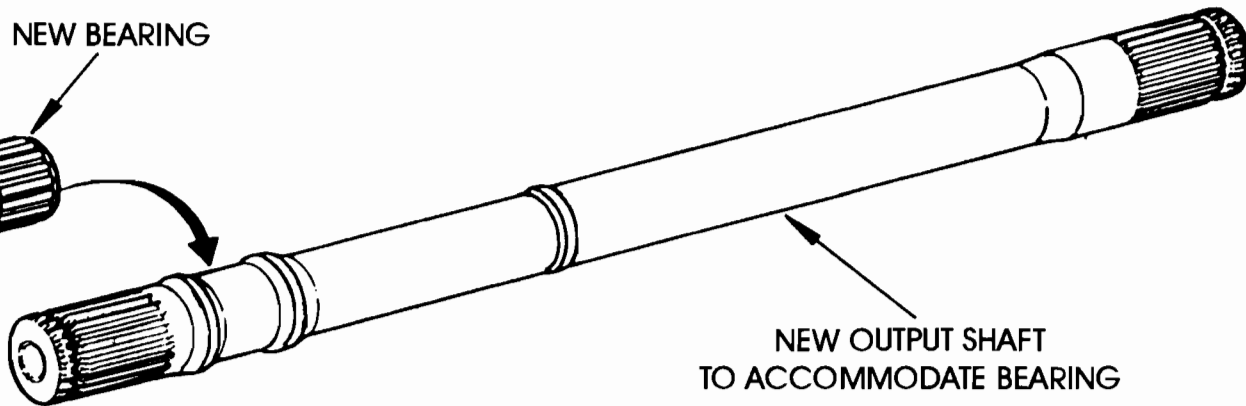
Figure 14

- (3) **OUTPUT SHAFT** - Approximately 1/4" longer to accommodate the thicker and larger side gears. There is also a new bearing added to support the 4th clutch hub (See Figure 14).

- (4) **4TH CLUTCH HUB AND SHAFT** - The previous needle bearing inside the 4th clutch hub has been eliminated, and a hardened sleeve added to the inside diameter to accommodate the new design bearing on the output shaft (See Figure 14).

**NEW DESIGN 4TH CLUTCH HUB  
AND OUTPUT SHAFT**

PREVIOUS BEARING ELIMINATED  
AND HARDENED SLEEVE ADDED  
TO INSIDE DIAMETER

NEW BEARING

NEW OUTPUT SHAFT  
TO ACCOMMODATE BEARING

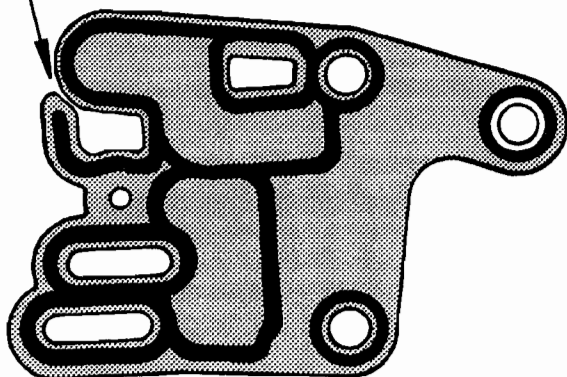
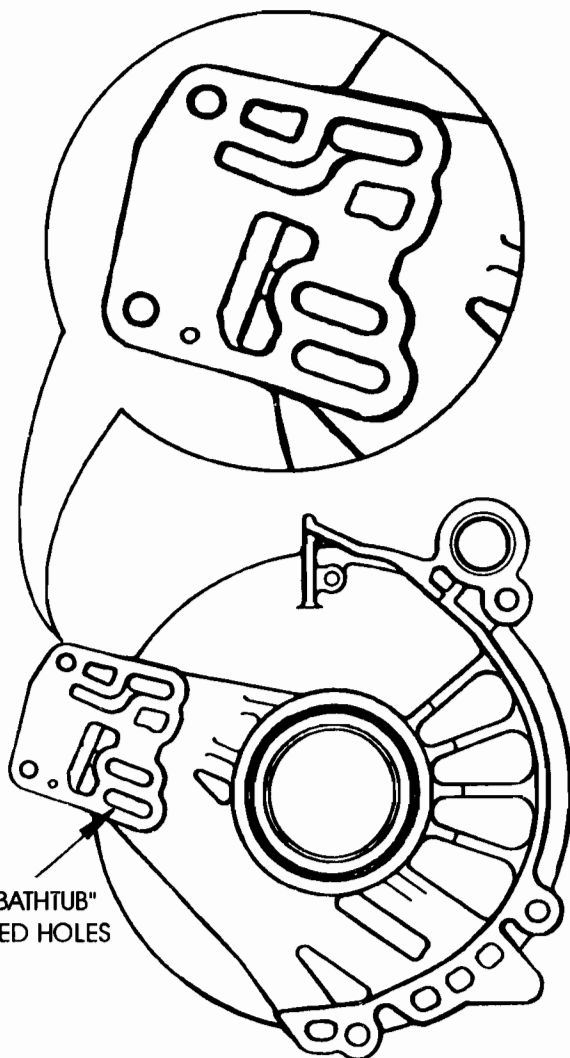
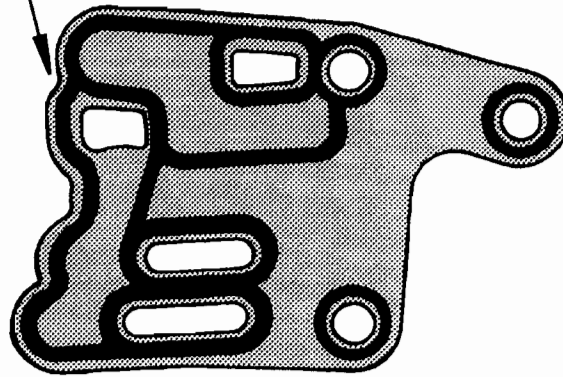
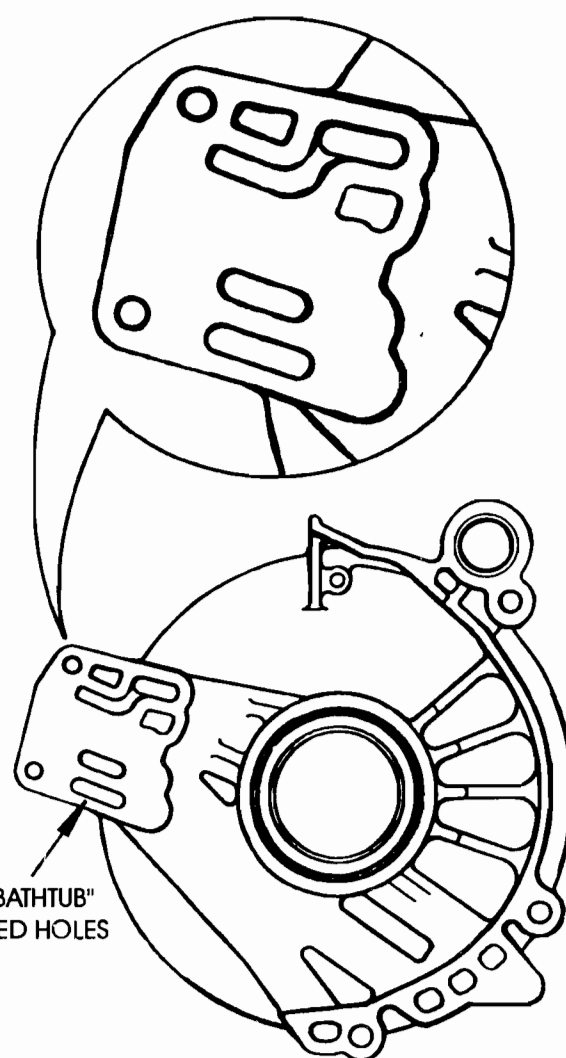
Figure 15

**CHANGE:** Beginning at the Start Of Production for 1995 models, all THM 4T80-E transaxles were produced with a new design level Driven Sprocket Support and center gasket (See Figure 15). This allowed the use of four 2nd clutch plates, instead of the previous three.

- (1) **DRIVEN SPROCKET SUPPORT** - New design level to accommodate 4 second clutch plates instead of the previous 3 second clutch plates. This required moving the two "Bathtub" feed holes in the Driven Sprocket Support (See Figure 15).
- (2) **SPROCKET SUPPORT GASKET** - The two "Bathtub" feed holes in the gasket were moved to accommodate the new design sprocket support. The slot in the gasket was also removed on the new design gasket (See Figure 15).

SLOT IN  
GASKET

NOTE POSITION OF BATHTUB  
HOLES IN SUPPORT AND GASKET

**1995-1996  
DESIGN LEVEL PARTS**

NO SLOT IN  
GASKET

NOTE "NEW" POSITION OF BATHTUB  
HOLES IN SUPPORT AND GASKET

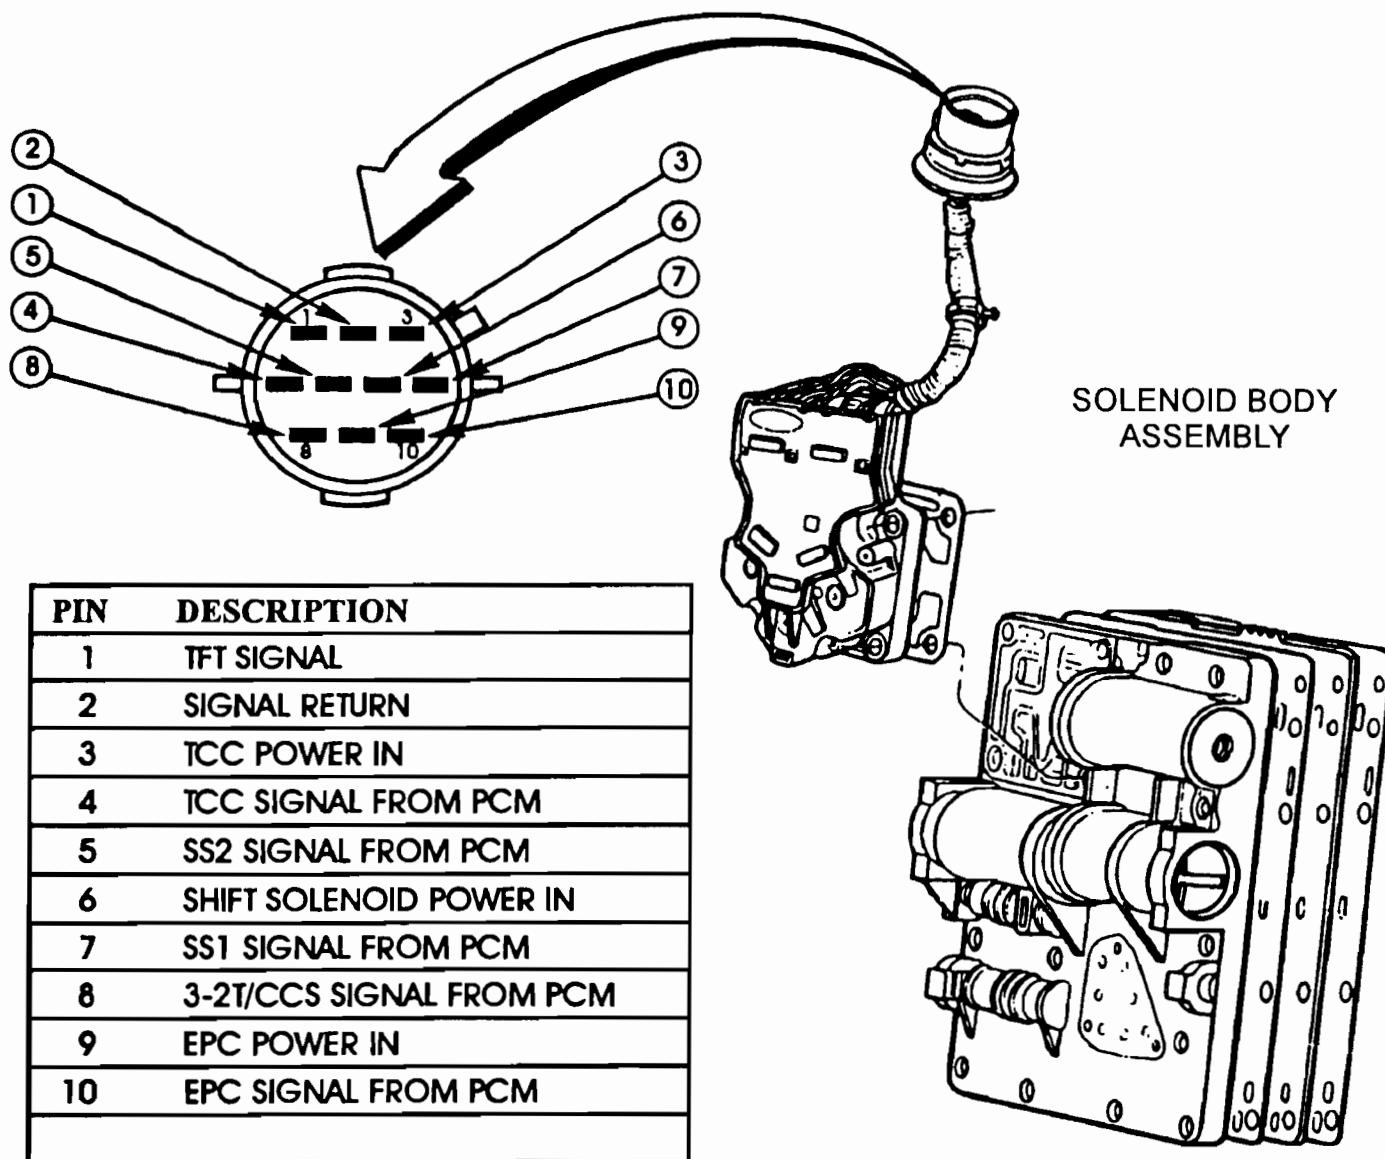
Figure 1

**CAUSE:** Some 1995 CD4E transaxles, built after May 1995, were assembled with solenoid bodies that contain a **high impedance** TCC Solenoid, is identified with a Natural/Beige colored case connector, and has a resistance value of 12.5 - 19.0 ohms.  
The previous design solenoid bodies contain a **low impedance** TCC Solenoid, identified with a Black colored case connector, and has a resistance value of 1.0 - 2.0 ohms, as indicated in the service manuals.

Solenoid Body Assembly (High Impedance-Beige Connector) ..... F6RZ-7G391-A

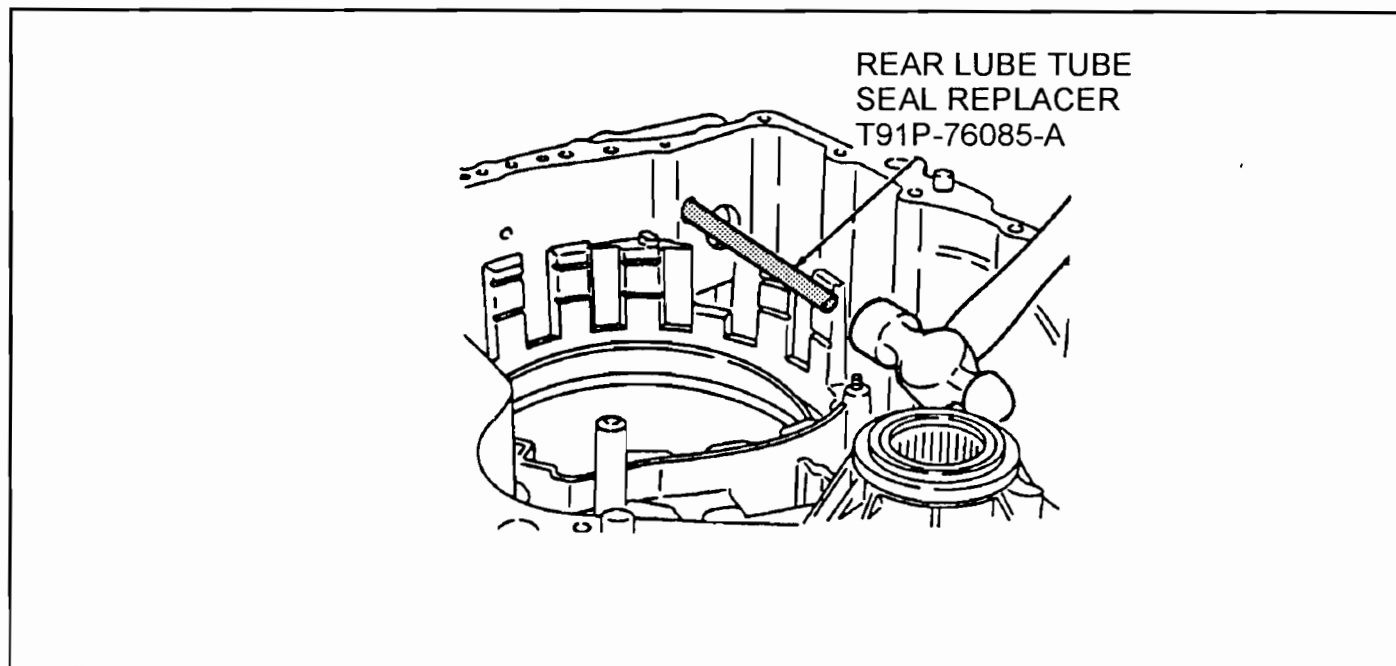
Lubrication for final drive parts is fed through one of these tubes, which has a seal located in the case which must be replaced during the rebuild process, and requires Tool T91P-76085-A (or equivalent), as shown in Figure 2 below. The Final Drive Lube Tube is fed with oil from the solenoid feed circuit.

**NOTE: USE CARE NOT TO BEND LUBE TUBES DURING THE DISASSEMBLY PROCESS, AND INSTALL BOTH LUBE TUBES INTO CASE BEFORE ASSEMBLING THE TRANSAXLE.**

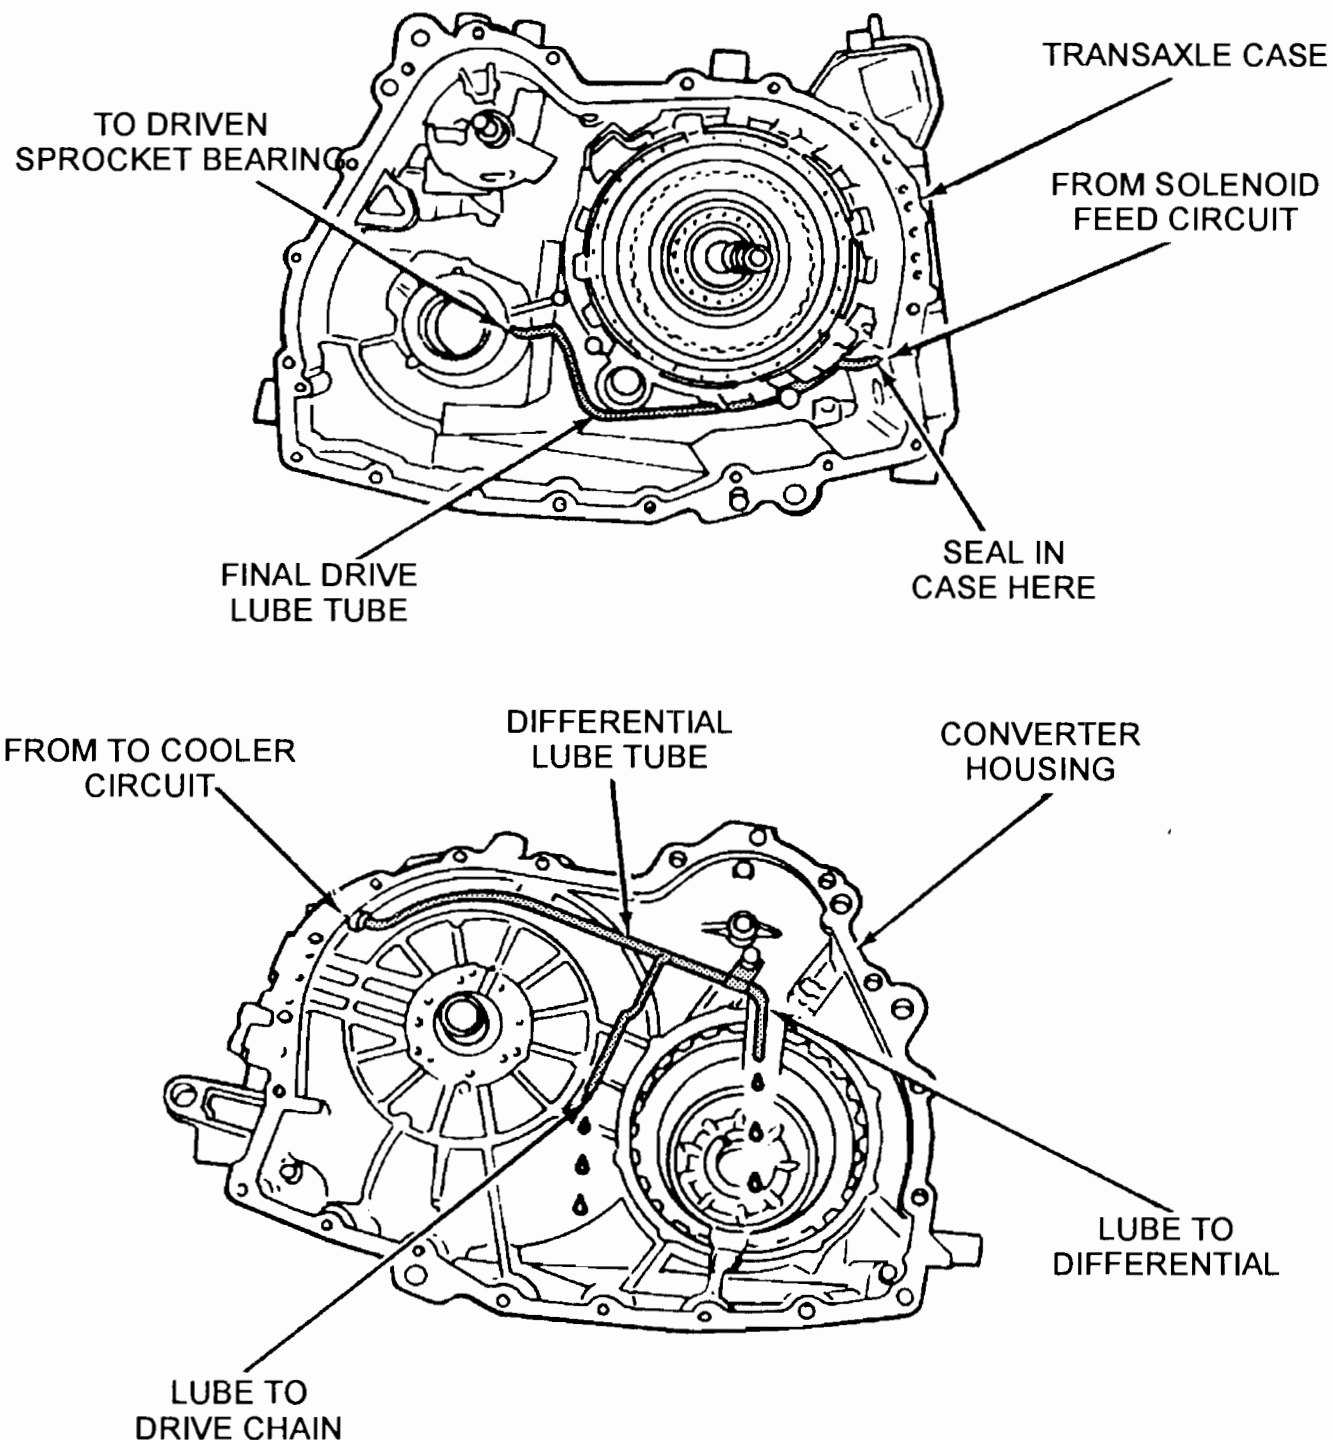
Figure 3

The Differential Lube Tube fits directly into the case (press fit) and must be seated fully, and is retained on the other end with a 8mm bolt through the bracket, as shown in Figure 3. The Differential Lube Tube is fed with "To Cooler" oil from the pressure regulator valve, and also lubricates the drive chain (See Figure 3).

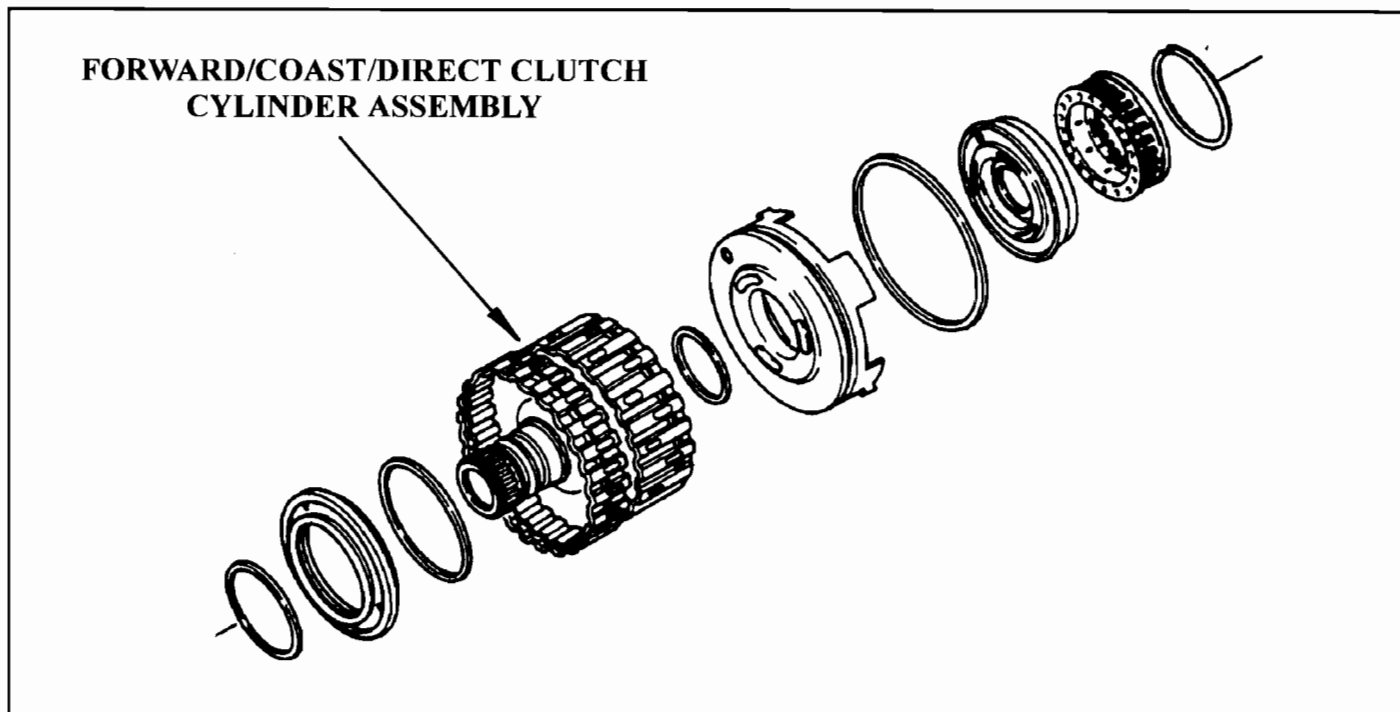
Figure 5

**CAUSE:** The cause may be due to a defective weld condition on the Forward/Coast/Direct Clutch Cylinder, which results in fluid leakage from the forward clutch into the direct clutch. The clutch cylinder and hub weld condition may not be identifiable visually.

**CORRECTION:** When extensive wear is observed on the forward clutch plates and/or the direct clutch plates, and the transaxle serial number is 4271-0000 thru 4303-9999, built between the dates listed above, replace the Forward/Coast/Direct Clutch Cylinder Assembly with the appropriate service part number listed below.

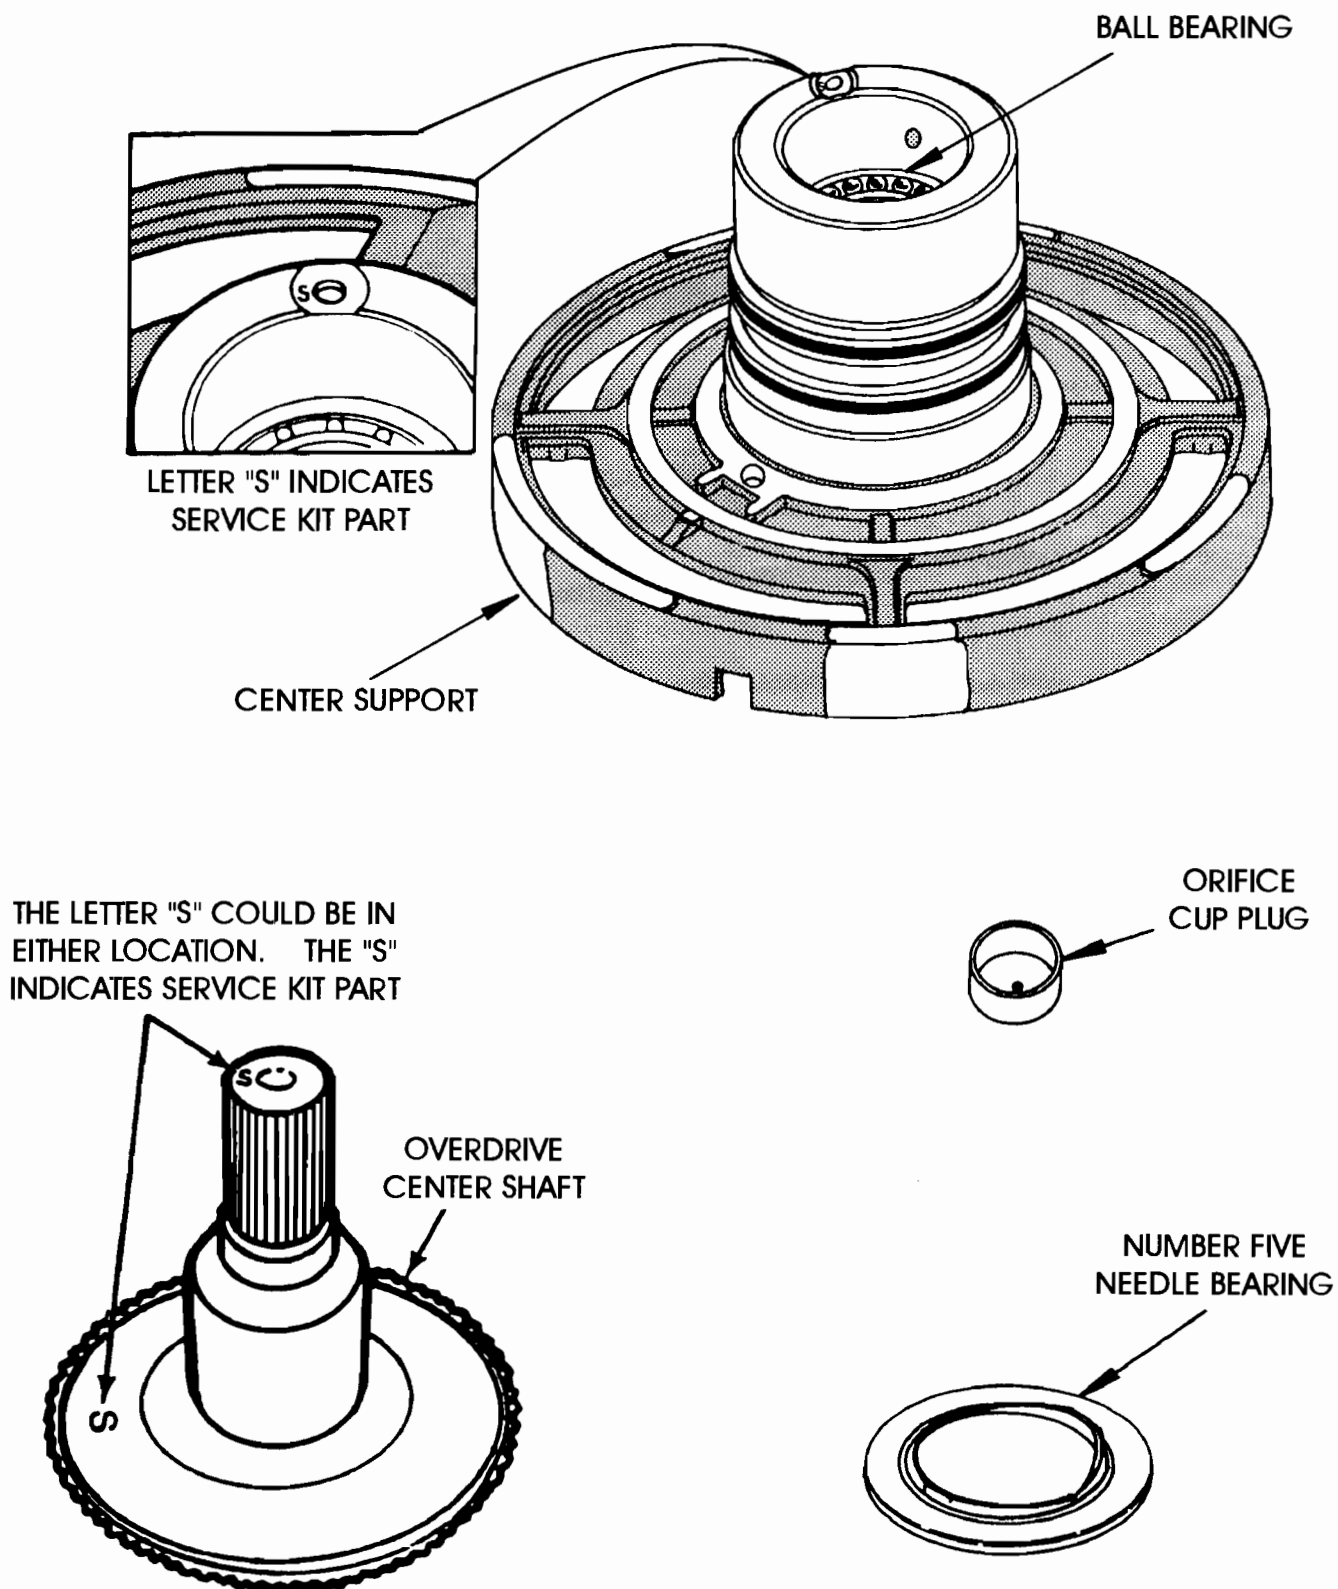
**CAUSE:** The cause may be, forward clutch oil leaking between the steel hub and the aluminum support ring because of mis-machining of the aluminum support ring in the area where the steel hub bolts to it.

**CORRECTION:** Install a new Center Support Service Kit, F4TZ-7A130-B, that has yellow paint on the wide leg of the center support as shown in Figure 1, and a yellow dot on the shipping carton as shown in Figure 1. There was no part number change and Ford has since recalled and reboxed the defective part.

**CHANGE:** There is now available, from Ford Motor Co, a new design center support service kit with a ball bearing in the support. The new design service package is available under OEM part number F4TZ-7A130-B, and will back service all past model 89-94 E4OD transmissions only. The parts in this service kit are different dimensions than 1995 model year production parts. Refer to Figure 2 for service package kit contents.

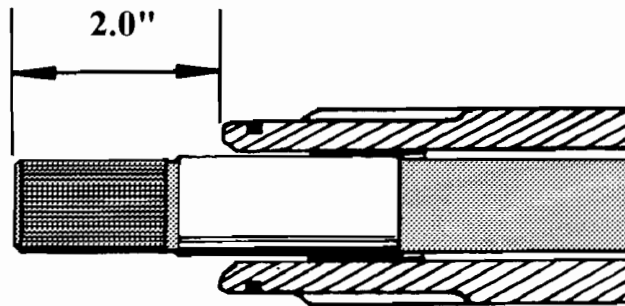
**"INCORRECT"**

PREVIOUS (LONG) INPUT SHAFT USED  
WITH NEW DESIGN OVERDRIVE CARRIER

Refer to Figure 8 to ensure that you have built the unit with matching components. The Input Shaft must extend 1-1/2" past the end of the oil pump stator, if you used the correct input shaft and overdrive carrier. Refer to Figure 8 for proper assembly dimensions.

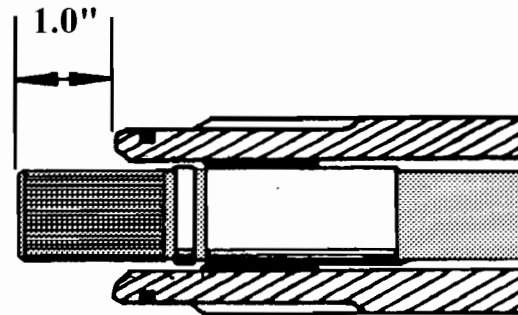
**"INCORRECT"**

NEW DESIGN (SHORT) INPUT SHAFT USED  
WITH PREVIOUS DESIGN OVERDRIVE CARRIER

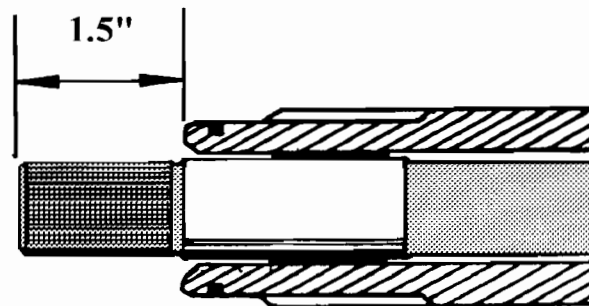
**"CORRECT USAGE"**

THE INPUT SHAFT MUST EXTEND 1.5" PAST THE END OF THE PUMP STATOR  
IF THE CORRECT INPUT SHAFT AND OVERDRIVE CARRIER WERE USED.

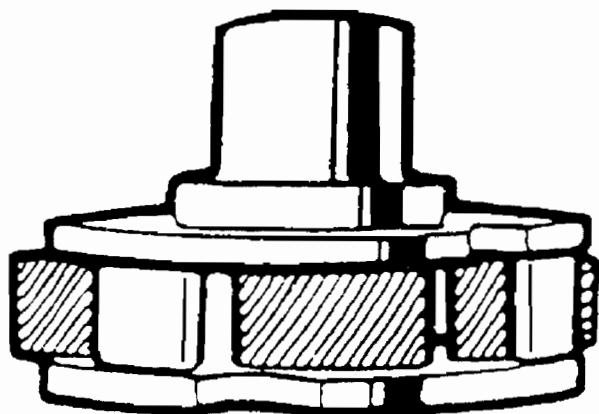
**NEW DESIGN CAST IRON OVERDRIVE CARRIER**

**NEW DESIGN CAST IRON  
OVERDRIVE CARRIER  
F5TZ-7B446-A**

**THE NEW DESIGN CAST IRON OVERDRIVE CARRIER IS THE SHORTER  
VERSION OF THE PREVIOUS CARRIERS, AND *MUST* BE USED WITH THE  
SHORT INPUT SHAFT WITH I.D. GROOVE, AS SHOWN BELOW.**
