Significance of Defects Inside In-Service Aged Winding Insulations

Christof Sumereder and Tilman Weiers

Abstract—This study aims to gain insight into the consequences of local defects in stator winding insulation; therefore, optical (microscopic) inspections and voltage-endurance tests have been carried out on in-service aged generator bars. In this context, generator bars with mica-bitumen insulations and generator bars with mica-epoxy insulations were investigated. The mica-bitumen insulations had been in service for 43 years in a 12 kV hydro-generator. The generator bars with mica-epoxy insulation had been dismantled from two identically constructed 10.5-kV generators after 35 and 36 years of service. The time to breakdown values obtained from the voltage-endurance tests were evaluated using a Weibull distribution. Apart from the scale parameter, Weibull exponent of this distribution allowed for the identification of early failures. The voltage-endurance tests carried out on replacement bars for these generators did not yield any early failures; such failures, however, were detected on both types of the in-service aged insulations. In particular, these occurred at high levels

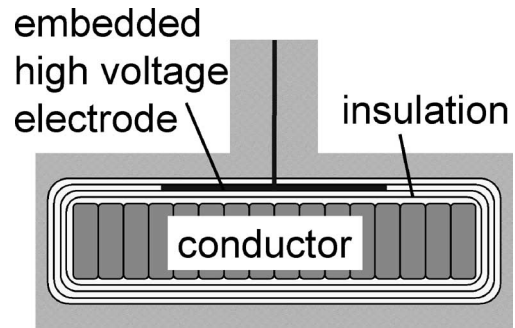
Fig. 9. Embedded electrode for investigations on locally confined defects.

To evaluate the insulation at locally confined defects, embedded high-voltage electrodes, as described in [1] and [24]–[26], were employed. This method allows the measurement of electrical tree propagation times in winding insulation [24]. Similar to a needle tip in needle-plane arrangements, the electrical tree inception occurs at the edges of the high-voltage electrode (Fig. 9). Measurements on the dependence of voltage life on electrode length [25] suggest to use electrodes 20 mm \times 20 mm in lateral dimensions. In order to check the results for consistency with previous investigations [27], the electrodes were embedded 2 mm above the copper conductor. A voltage of 32 kV rms, 50 Hz was applied to the electrode. The procedure for embedding the electrode into the insulation was previously developed. This was done by comparing the time to breakdown values of electrodes embedded into the insulation during taping and electrodes embedded after taping [27].

It must be emphasized that only the groundwall insulation is investigated by the applied experimental procedure. Other parts of the insulation system such as corona protection are not assessed. This procedure was chosen because the local residual dielectric strength of the insulation was expected to vary locally. Its aim was to gather information on the significance of defects detected during the visual inspection.

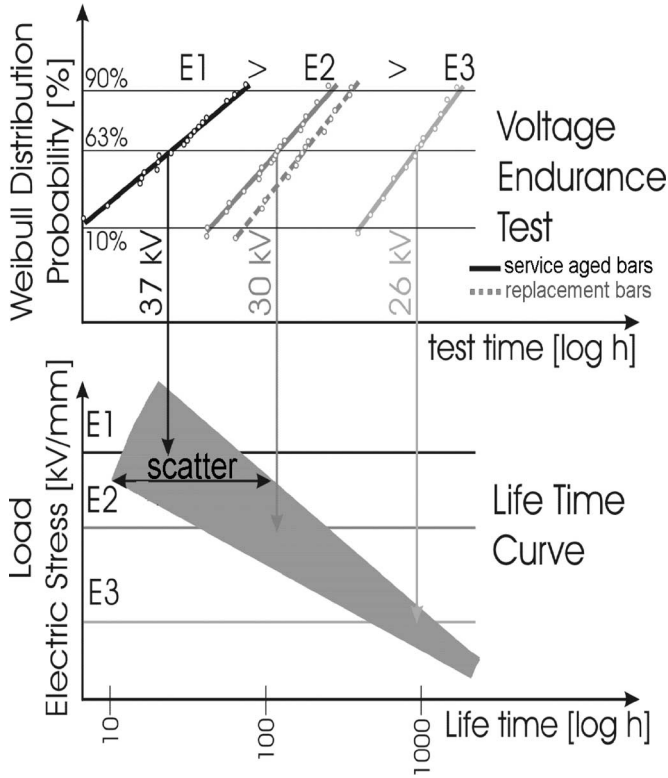
Fig. 10. (Scatter) of the time to breakdown values obtained from in-service aged mica-epoxy insulations depending on the electric stress (E1, E2, and E3).

The scale parameter η specifies the time after which 63% of the specimens have failed. Weibull exponent β relates to the slope of the Weibull curve in the (cumulative) probability plot (Fig. 10). In case of early insulation failures (“infant mortality”), the slope will decrease and the value of β will be less than 1. A value of Weibull exponent $\beta < 1$ has previously been determined [29] on winding insulations with locally confined defects. This suggests that the in-service aged winding insulations, which have been investigated in this study, include locally confined defects, too.

Due to the availability of 63 generator bars and several replacement bars with mica-epoxy insulation systems, the voltage-endurance tests on these insulations could be carried out at three voltage levels: early breakdowns occurred particularly at the higher test levels (37 and 30 kV). Some of these happened very early, so that other factors, apart from electrical aging, must be crucial. The characteristic breakdown behavior of the replacement bars was unambiguous. No early failures occurred. Compared to the in-service aged specimens, the characteristic lifetime (scale parameter η) of the replacement bars was longer by a factor of 2.5. The test durations of all generator bars were statistically evaluated using two-parameter Weibull distributions (1). Fig. 10 shows the results of the statistical evaluation. For each of the three test levels, the corresponding Weibull curve is plotted. In addition, Fig. 10 includes a dashed line that is the

reference curve obtained from the replacement bars. Furthermore, a common lifetime curve was derived from these Weibull distributions. This curve gives the relation between the applied electric field and insulation life. It is depicted below the Weibull probability plots in Fig. 10.

The slope of the Weibull curve corresponding to the higher test levels is smaller than the slope obtained from tests at 26 kV. At the lowest voltage level and during the tests on replacement bars, no early failures were detected. This results in a larger slope of the Weibull curve (Fig. 10). Weibull exponent β obtained from the statistical evaluation of time to breakdown values (1) confirms the assumption of early failures. Weibull exponents corresponding to the 37- and 30-kV test levels were less than 1. This means that these two probability functions were dominated by failures after short test duration. Weibull exponent corresponding to the lowest test voltage of 26 kV and to the tests on the replacement bars were very similar and greater than 1. This behavior is interpreted as pure (electrical) aging of the resin-rich insulation system.
