# BLADE INSPECTION REPORT

BT1 Wind Farm  
Turbine No.239262  
Local Turbine ID WTG18

On May 15, 2024, Bureau Veritas Vietnam conducted a comprehensive drone-based inspection of the rotor blade on turbine **No. 239262** at the BT1 Wind Farm.

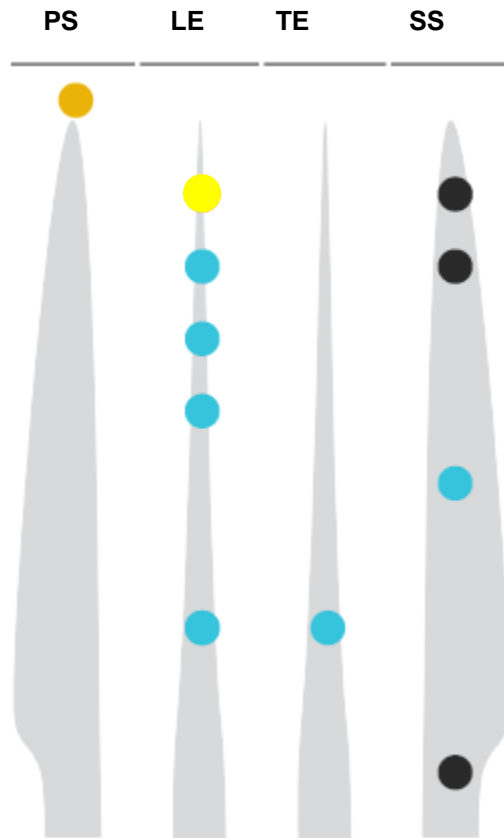
BLADE A Faults Map

No.	Issue Type	Distance from Hub	Blade Edge	Category	Recommendation
1	Erosion	73 m	Leading Edge	4	Repair required within a short time frame
2	Erosion	70 m	Leading Edge	3	Repair must be done within a time frame
3	Erosion	66 m	Leading Edge	3	Repair must be done within a time frame
4	Damage	71 m	Pressure Side	3	Repair must be done within a time frame
5	Erosion	57 m	Leading Edge	2	Repair only if other damages are to be repaired
6	Erosion	49 m	Leading Edge	2	Repair only if other damages are to be repaired
7	Erosion	26 m	Leading Edge	2	Repair only if other damages are to be repaired
8	Erosion	22 m	Leading Edge	2	Repair only if other damages are to be repaired
9	Damage	27 m	Trailing Edge	2	Repair only if other damages are to be repaired
10	Contamination	60 m	Suction Side	1	No Action
11	Damage	10 m	Suction Side	1	No Action

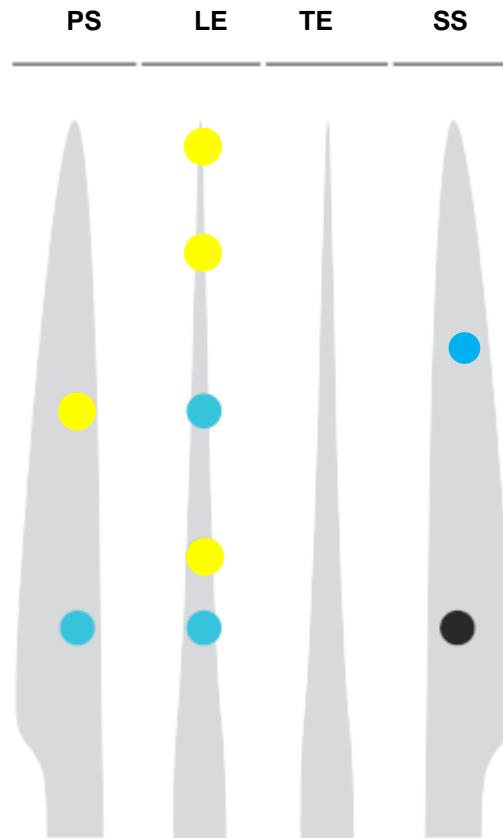
BLADE B Faults Map

No.	Issue Type	Distance from Hub	Blade Edge	Category	Recommendation
1	Erosion	70 m	Leading Edge	3	Repair must be done within a time frame
2	Erosion	34 m	Leading Edge	3	Repair must be done within a time frame
3	Erosion	49 m	Pressure Side	3	Repair must be done within a time frame
4	Erosion	65 m	Leading Edge	3	Repair must be done within a time frame
5	Erosion	50 m	Leading Edge	2	Repair only if other damages are to be repaired
6	Chip	53 m	Suction Side	2	Repair only if other damages are to be repaired
7	Damage	21 m	Pressure Side	2	Repair only if other damages are to be repaired
8	Chip	24 m	Leading Edge	2	Repair only if other damages are to be repaired
9	Damage	23 m	Suction Side	1	No action

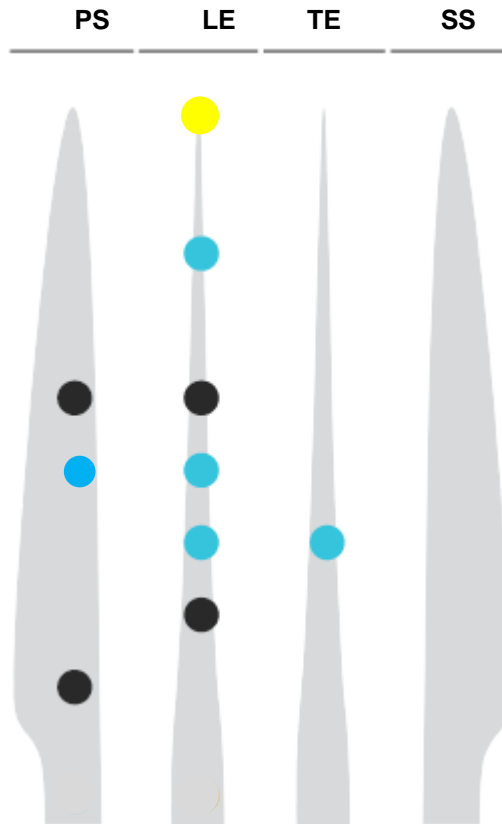
BLADE C Faults Map

No.	Issue Type	Distance from Hub	Blade Edge	Category	Recommendation
1	Erosion	70 m	Leading Edge	3	Repair must be done within a time frame
2	Erosion	41 m	Leading Edge	2	Repair only if other damages are to be repaired
3	Erosion	30 m	Leading Edge	2	Repair only if other damages are to be repaired
4	Erosion	41 m	Pressure Side	2	Repair only if other damages are to be repaired
5	Chip	28 m	Trailing Edge	2	Repair only if other damages are to be repaired
6	Erosion	58 m	Leading Edge	2	No action. Monitor at next inspection
7	Contamination	46 m	Leading Edge	1	No action
8	Erosion	21 m	Leading Edge	1	No action
9	Contamination	43 m	Pressure Side	1	No action
10	Coating Damage	16 m	Pressure Side	1	No action
